**RE: Water Licence 2AM-MRY1325 Baffinland Response to September 2021 Inspection**

### **Baffinland's November 2021 Response to September 2021 CIRNAC Inspection**

**RE: Water Licence 2AM-MRY1325 September 2021 Inspection – Follow Up**

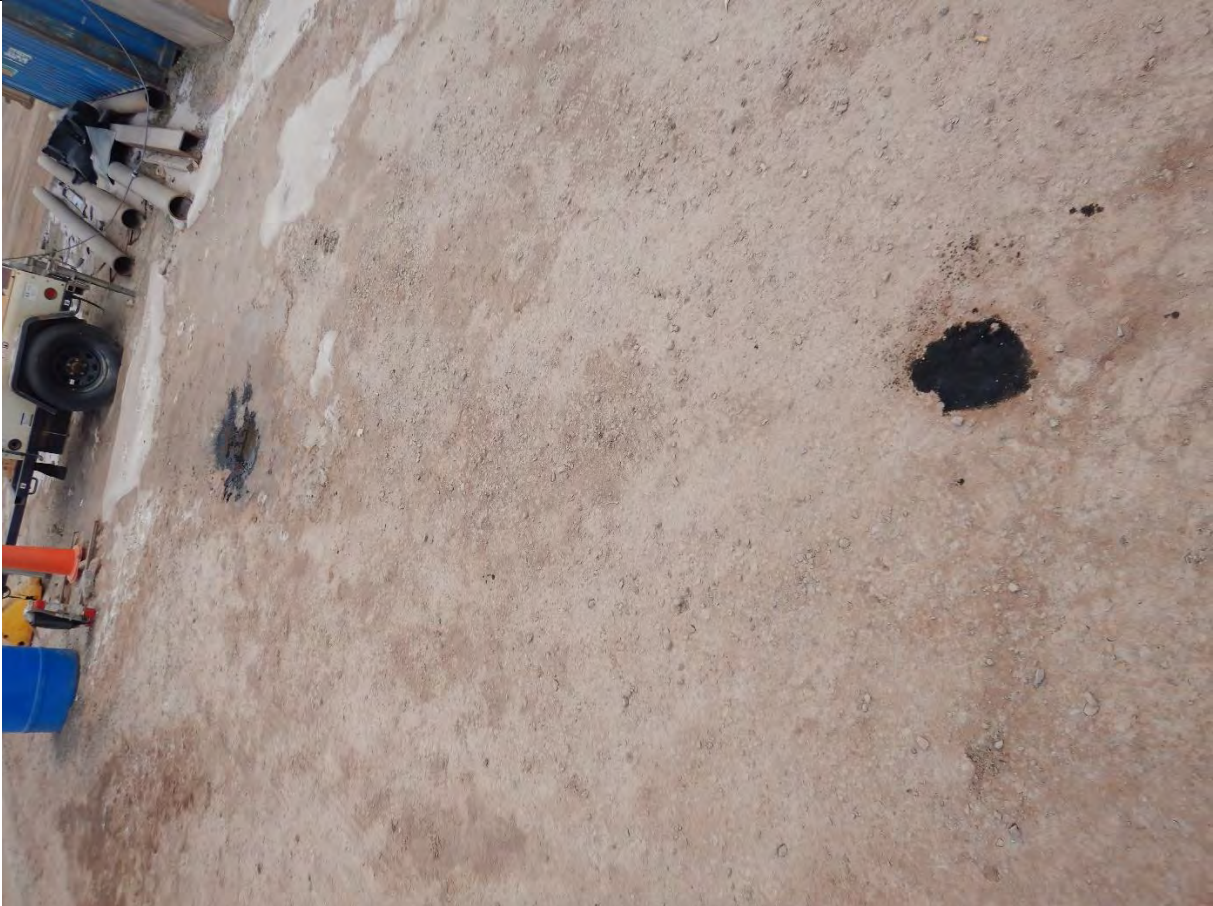
Description: km 60 spill.

Number	Project Location	Description of Concern or Finding	Response
<b>A) Tote Road</b>			
1)	KM-60 Crown Land	Multiple spills of unknown substance (potentially motor oil) on the ground near the parking area. See photo 3 for the spills. The licensee is to install the appropriate erosion control measures to prevent continued erosion identified in comments A1-A7, C1 and C2. The licensee is to remediate all spills noted in this report.	The KM60 Laydown is regularly inspected for surficial staining, and follow-up inspections since the September Water License inspection have confirmed no further staining has been present and no vehicles or stationary equipment were found to be leaking. Surficial staining that is observed on the laydown is cleaned up and placed in appropriate secondary containment. Photo 1 in Attachment 2 show the current status of the KM60 Laydown.

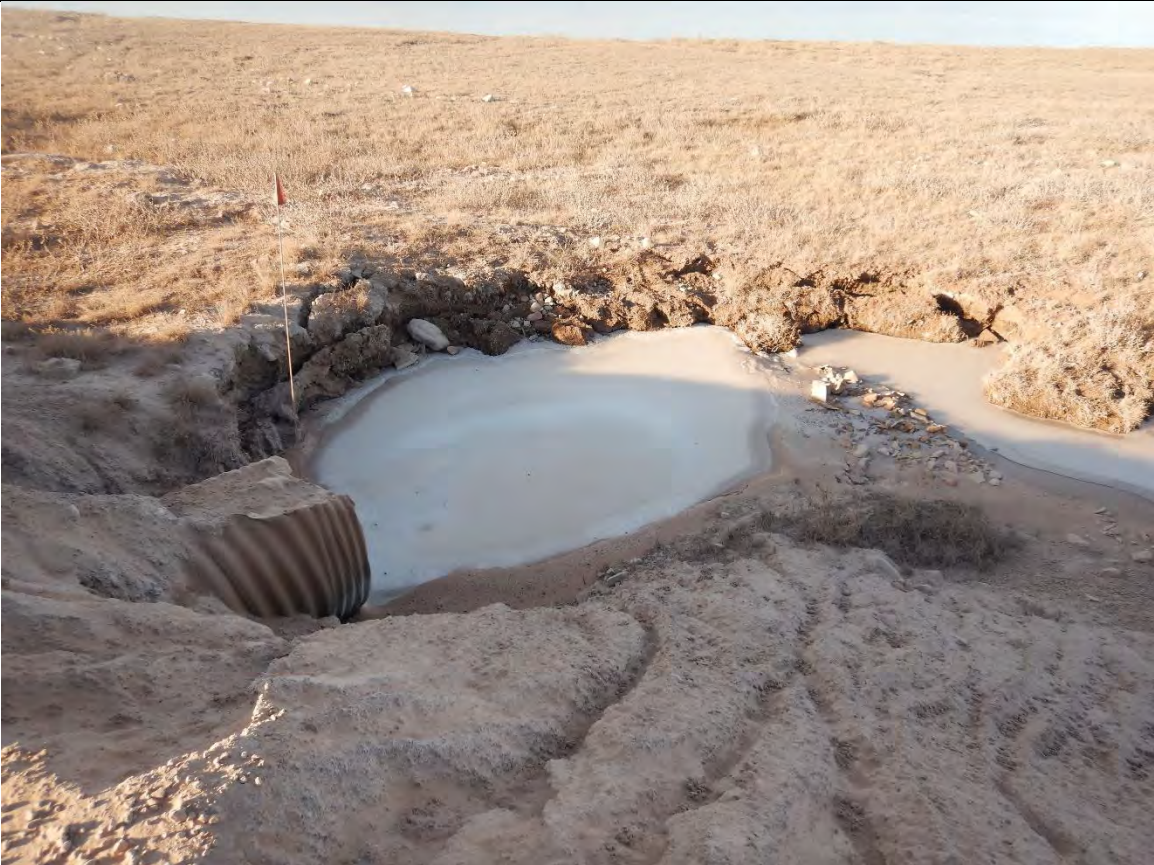
Description: BG-24, erosion on down stream side of culvert/ damaged culvert.

6)	BG-24	Spill 21247- Significant erosion on both sides of culvert. See photos 8-9 for the erosion. The licensee is to install the appropriate erosion control measures to prevent continued erosion identified in comments A1-A7, C1 and C2. The licensee is to remediate all spills noted in this report.	Following the elevated TSS conditions at BG-24 on June 8, 2021, an assessment was completed to identify erosion and sediment control measures around the culvert crossing. Prior to freshet 2022, excess sediment will be removed from the culvert inlet and outlet banks, culvert extensions will be installed and road embankments will be re-armoured.

6	BG-24	Spill 21247- Significant erosion on both sides of culvert. See photos 8-9 for the erosion. The licensee is to install the appropriate erosion control measures to prevent continued erosion identified in comments A1-A7, C1 and C2. The licensee is to remediate all spills noted in this report.	Excess sediment will be removed from the culvert inlet and outlet banks, culvert extensions will be installed and road embankments will be re-armoured.	Complete prior to freshet 2022.
7	CV-001	Spill 21247- Damaged culvert and erosion on down stream side of culvert. See photo 10 for the photos of the damaged culvert. The licensee is to install the appropriate erosion control measures to prevent continued erosion identified in comments A1-A7, C1 and C2. The licensee is to remediate all spills noted in this report.	Excess sediment will be removed from the culvert inlet and outlet banks, culvert extensions installed to repair the damaged end, and road embankments will be re-armoured. KM97	Complete prior to freshet 2022.

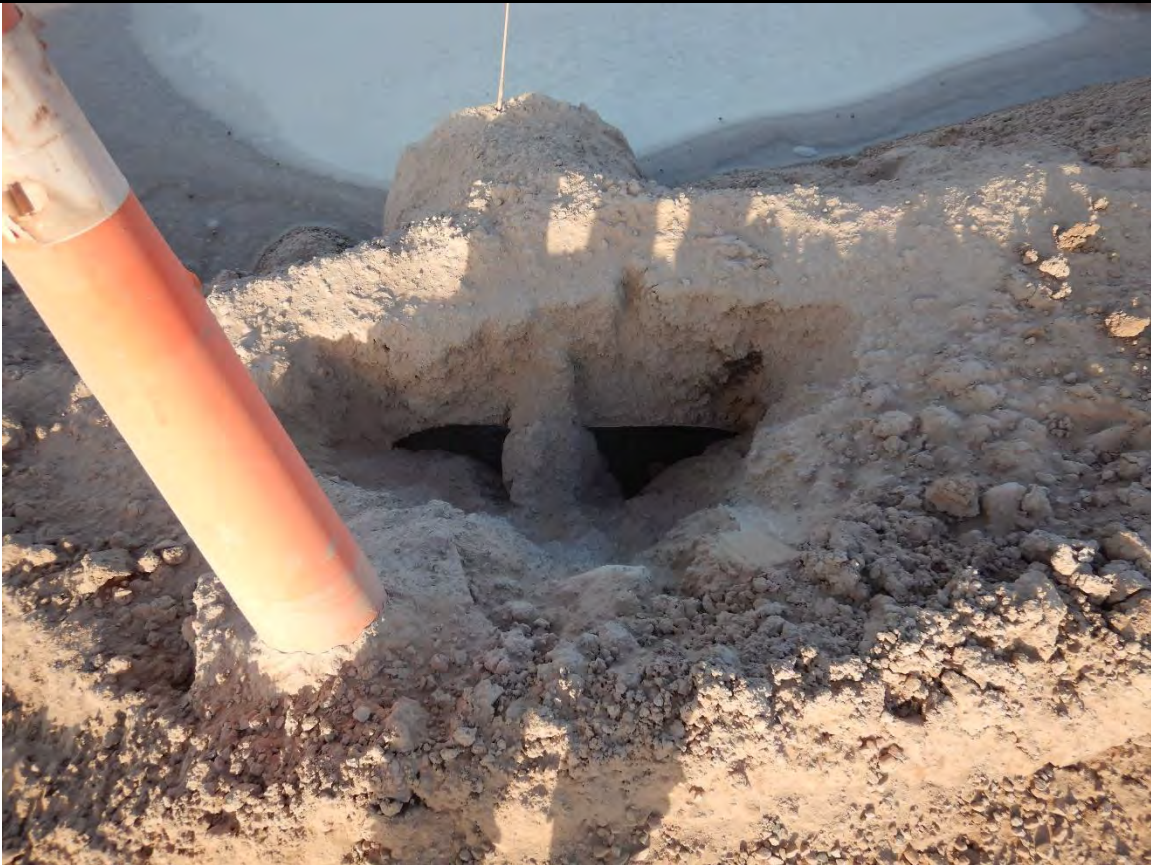
Photo 10

1-001/spill 21247- damaged culvert and erosion on down stream side of culvert. See photo 10 for the photos of the

Description: Cv-001 damaged culvert.

7)	CV-001	Spill 21247- Damaged culvert and erosion on down stream side of culvert. See photo 10 for the photos of the damaged culvert. The licensee is to install the appropriate erosion control measures to prevent continued erosion identified in comments A1-A7, C1 and C2. The licensee is to remediate all spills noted in this report.	Following the elevated TSS conditions at CV-112 on June 1, 2021, an assessment was completed to identify erosion and sediment control measures around the culvert crossing. Prior to freshet 2022, excess sediment will be removed from the culvert inlet and outlet banks, culvert extensions installed to repair the damaged end, and road embankments will be re-armoured.
	KM97	Damaged drip trays were identified in CIRNAC inspection report supporting Photo 1 and Photo 2 beneath fuel drums at KM97.	The fuel drums at KM97 were removed from the area and placed in appropriate secondary containment. Photo 5 in Attachment 2 shows the area at KM97 with the fuel drums and damaged spill trays removed.

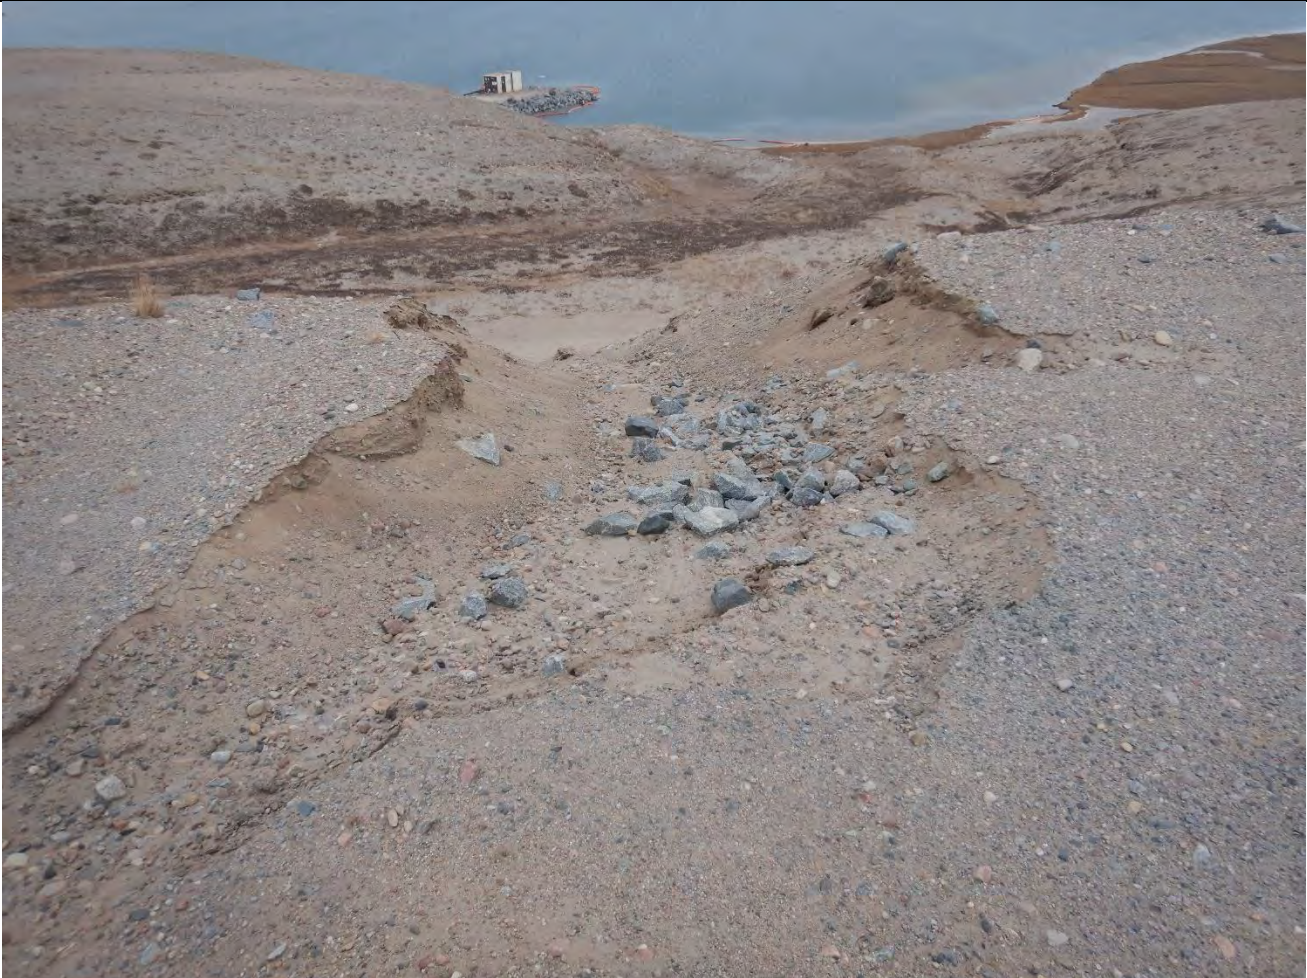
- 1) The inspector noted erosion North of the camp lake intake, is appears surface water from the runway and surrounding area has no water management structure to manage it. This surface water has previously caused erosion near the camp lake tributary and now is eroding the sandy hills north of the water intake. See photo 18 and 19 for pictures of this erosion.

Description: Erosion near water intake, standing on runway perimeter road looking towards camp lake.

<b>C) Mine Site</b>			
1)	North of Camp Lake Intake	<p>The inspector noted erosion North of the camp lake intake, it appears surface water from the runway and surrounding area has no water management structure to manage it. This surface water has previously caused erosion near the camp lake tributary and now is eroding the sandy hills north of the water intake. See photo 18 and 19 for pictures of this erosion.</p> <p>The licensee is to install the appropriate erosion control measures to prevent continued erosion identified in comments A1-A7, C1 and C2.</p>	<p>Baffinland will implement additional erosion and sediment control measures in accordance with the SWAEMP to address the erosion north of the Camp Lake Intake prior to Freshet 2022, which was identified during the September Water Licence inspection. Water management measures for runoff in this area is being addressed as part of the ongoing implementation of Baffinland's Long Term Water Management Plan (LTWMP).</p>

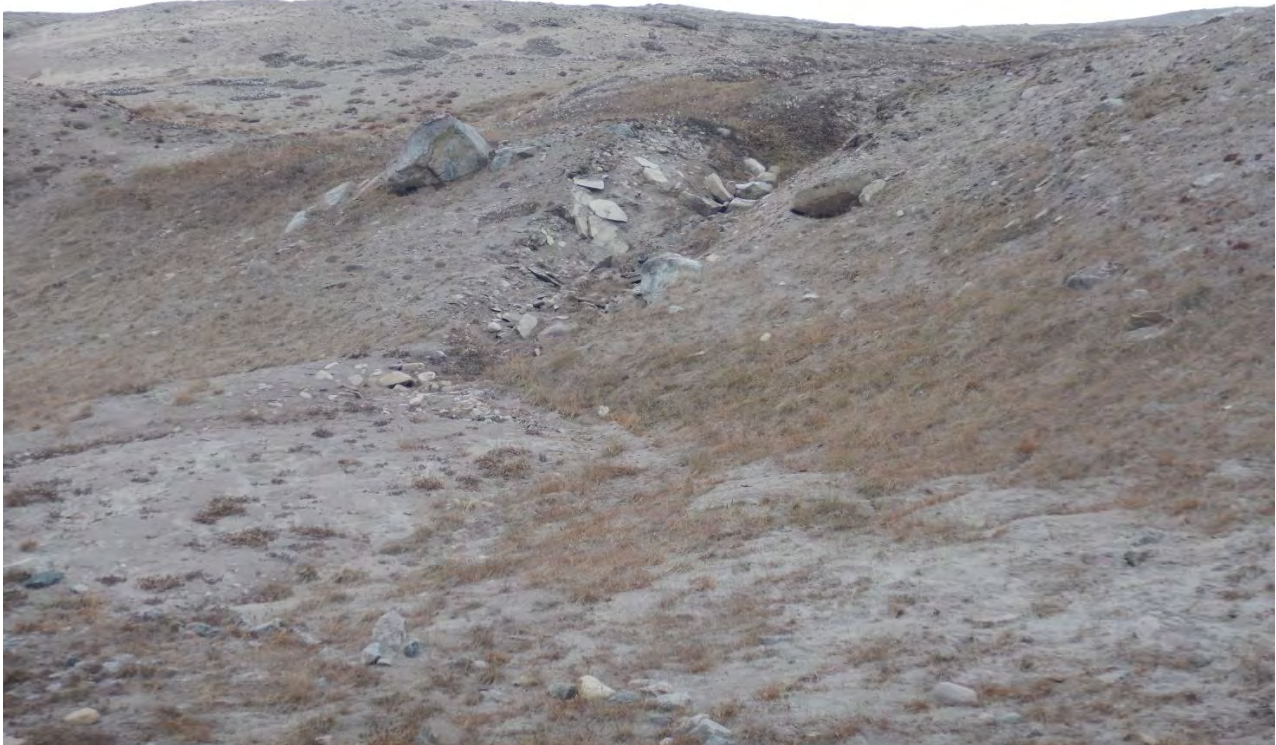
Description: Erosion near water intake, standing near intake looing at the hillside.

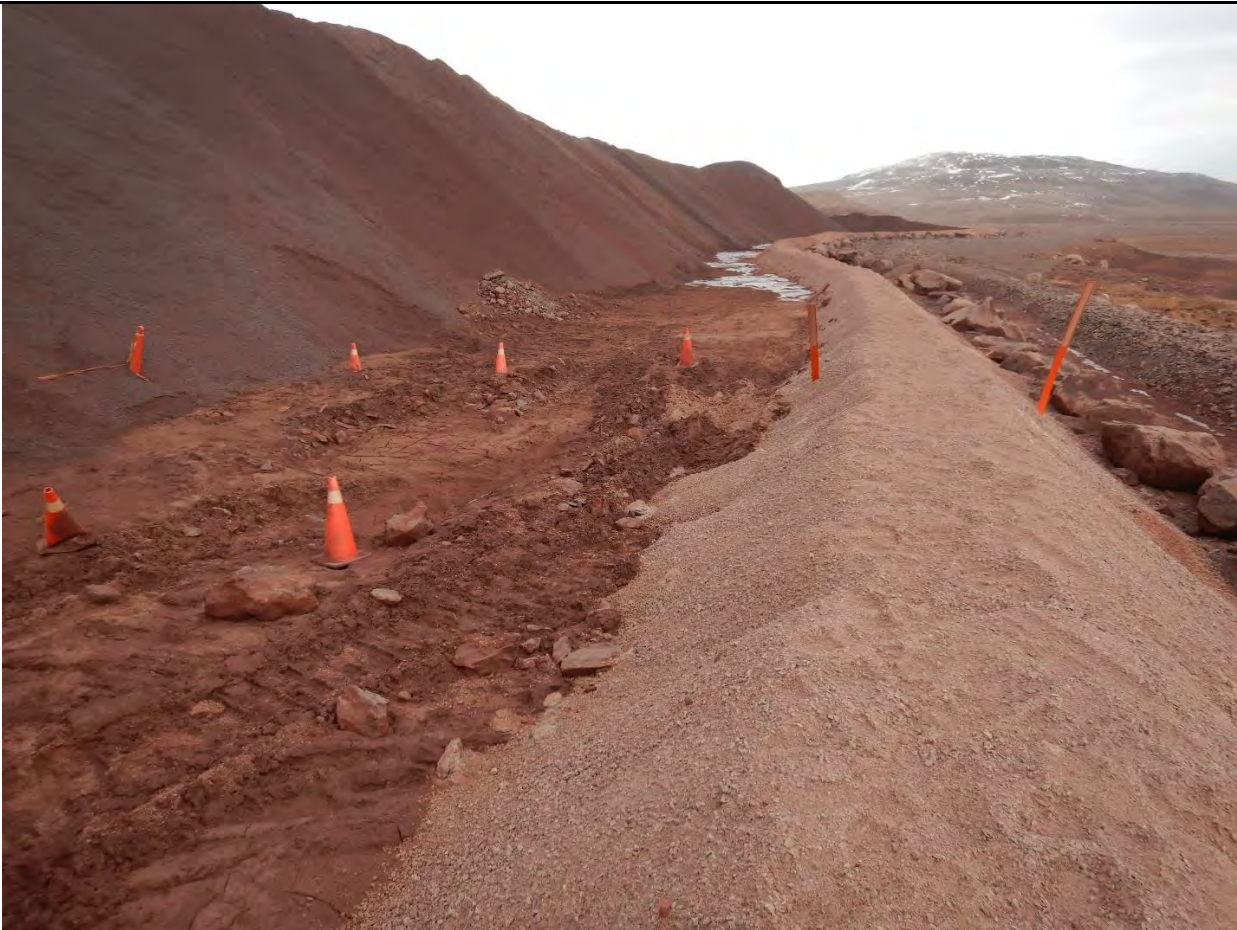
Photo 24

- 7) Crusher Pad and pond- The Crusher pad is currently dealing with a unresolved seepage as well, the ditch that is designed to divert surface water to the containment pond is not operational due to a leak. The licensee currently has a sump installed and is pumping water from the sump into the containment pond. See photo 24 for a photo of the sump and berms installed to keep the surface water out o the ditches.

Description: Berm and sump installed.

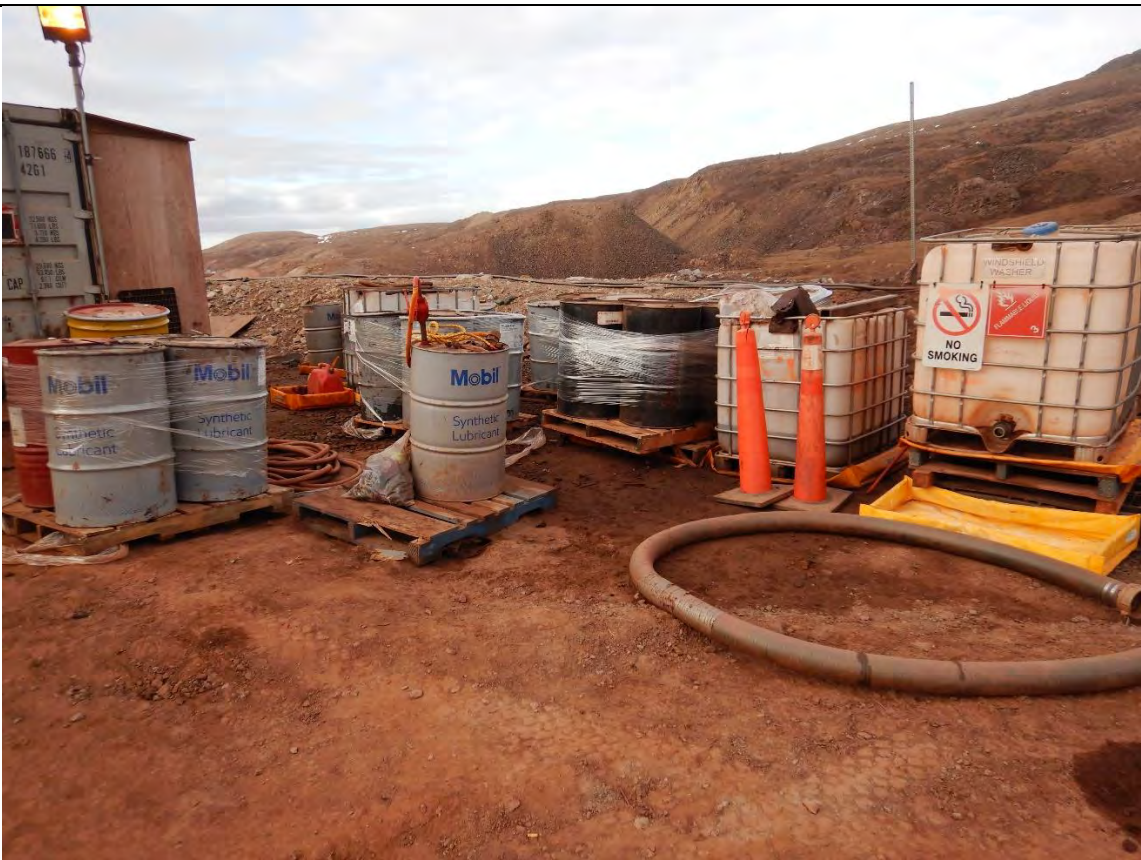
Photo 25

- 8) Km 104 laydown- during the inspection the inspector noted the following concerns at the 104 laydown;
  - Lubricants and hazardous material outside of containment, in damaged containment and staining which smelled strongly of fuel. See photo 25 for the area with staining and hazardous material outside of containment.

Description: hazardous material outside of containment, in damaged containment and staining in the area.

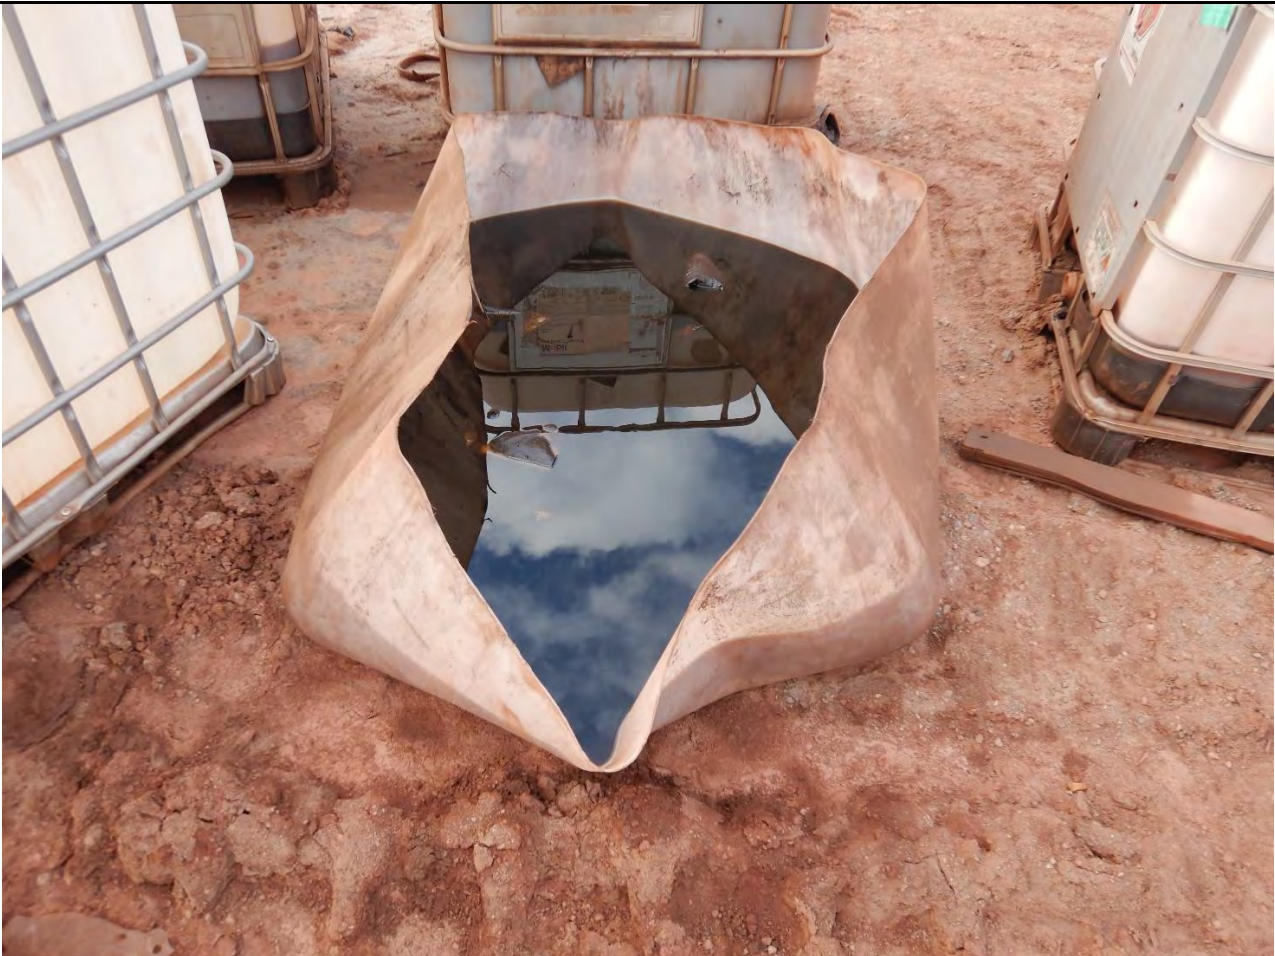
Photo 26

- Open containers with dirty absorbent rags nearing capacity, see photo 26 and 27 for the containers.
  - Heavy equipment actively leaking on the ground with no drip tray, see photos 28 and 29 for photos of fluid under heavy equipment at laydown 104.

Description: dirty spill rags and unknown waste in open container outside of containment

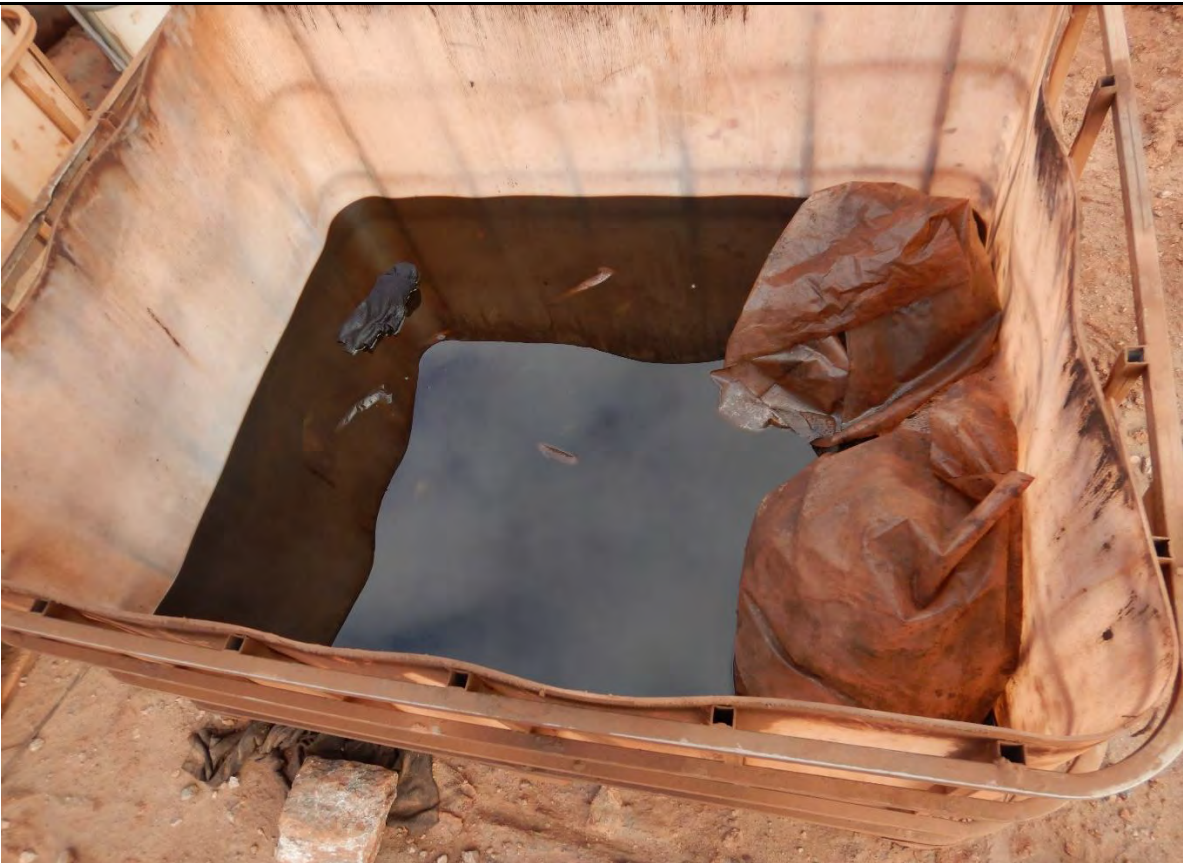
Photo 27

Description: dirty spill rags and unknown waste in open container outside of containment

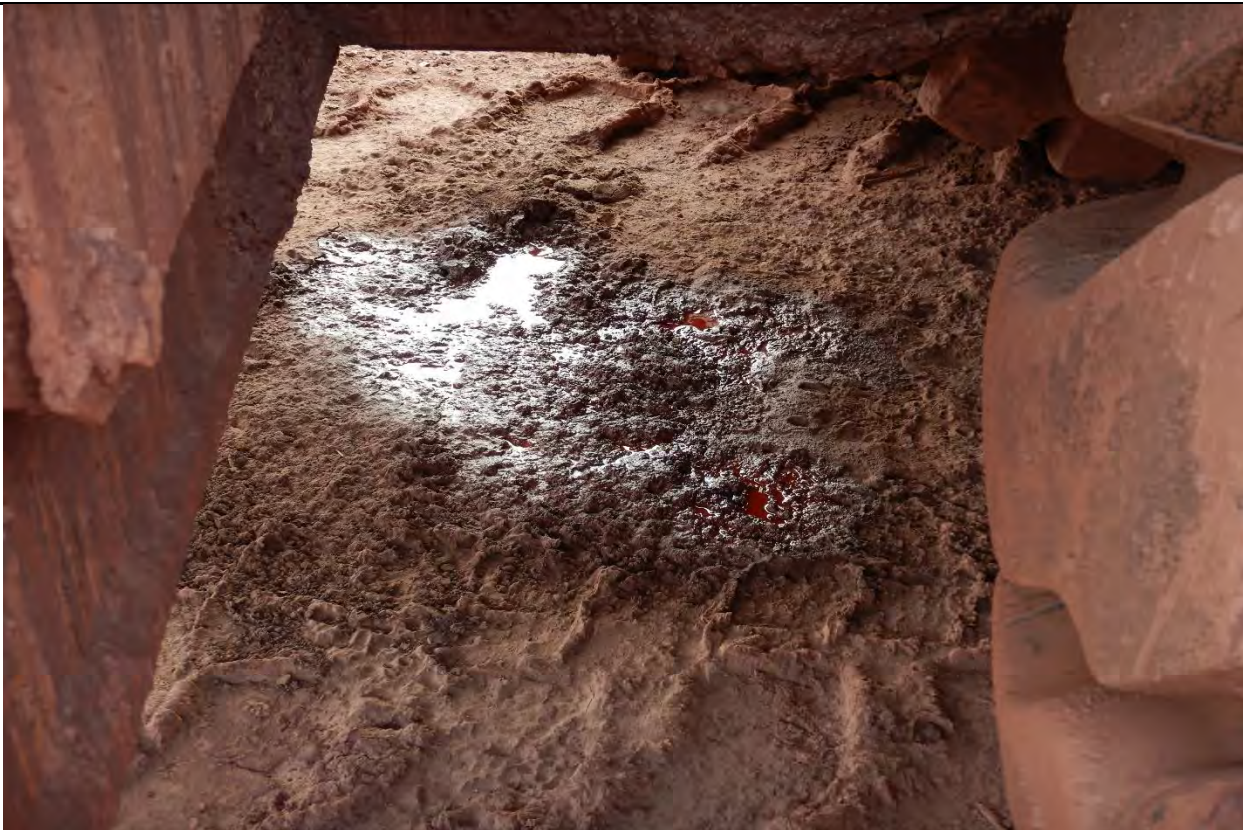
Description: fluid leaking from heavy equipment.

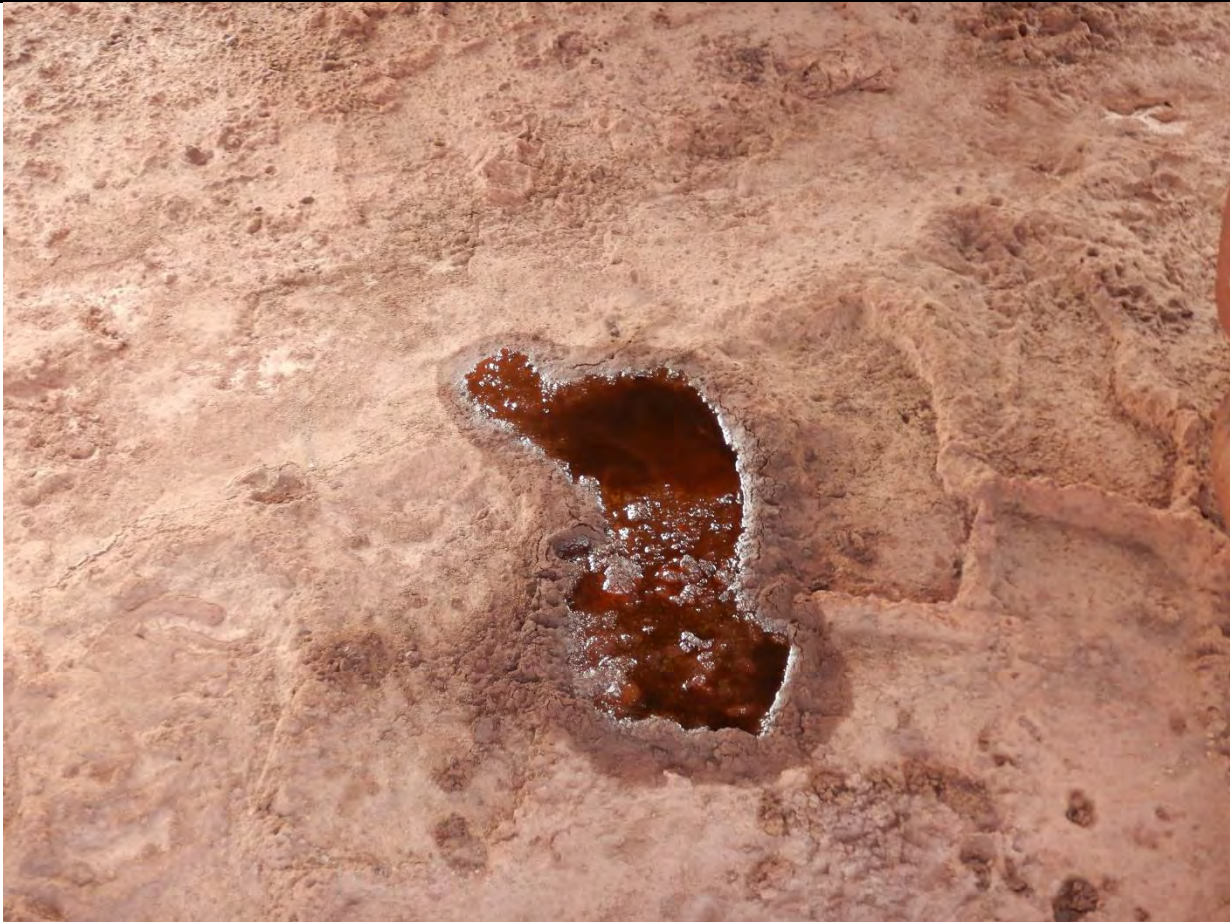
Description: fluid leaking from heavy equipment.

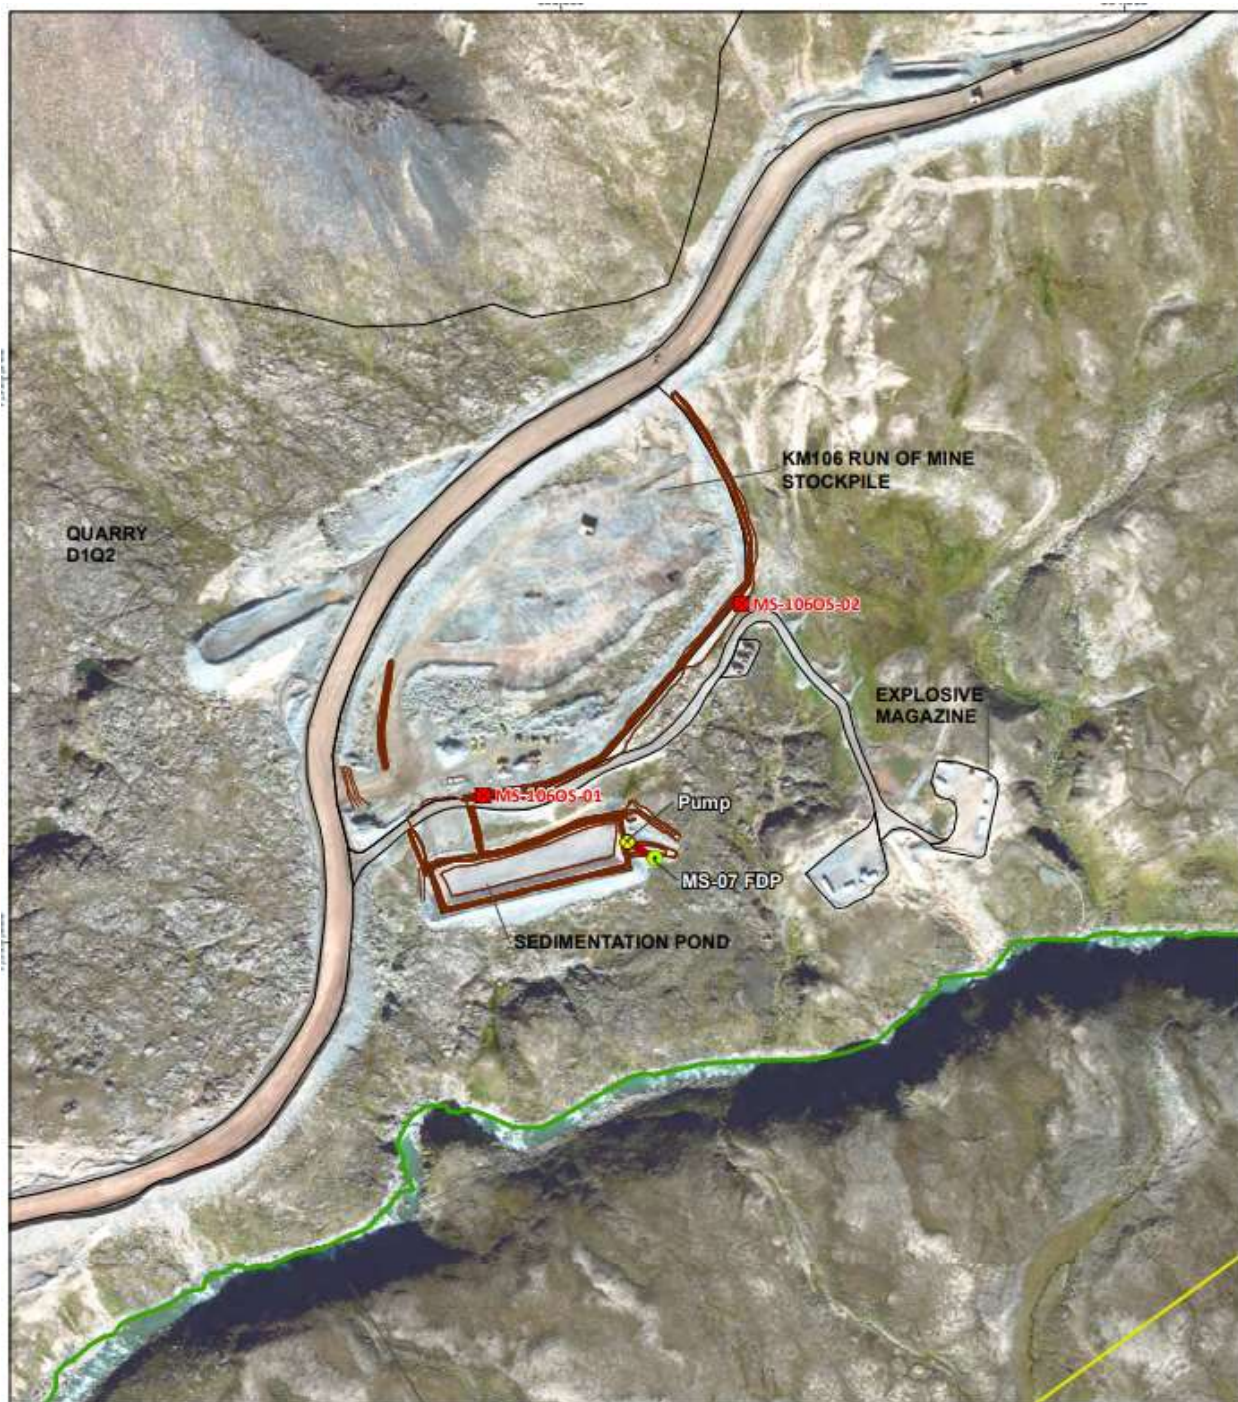
**Figure 1 KM106 Stockpile and Pond Showing Seepage Locations (Baffinland, 2021)**

Photos taken by Baffinland on June 28, 2021 and presented in its above-mentioned report to the agencies (Baffinland, 2021) are included in Appendix A. KP has reviewed the photos, Baffinland's as-built survey as presented in its Construction Summary Report (CSR; Baffinland, 2020a), and a subsequent drone survey from August 21, 2021. It appears the seepages are due to settlement that occurred between September 2020 and August 2021 that has resulted in insufficient grades that do not direct water towards the pond, as well as the presence of coarse, permeable fill and/or overburden materials that allow for some seepage to occur.

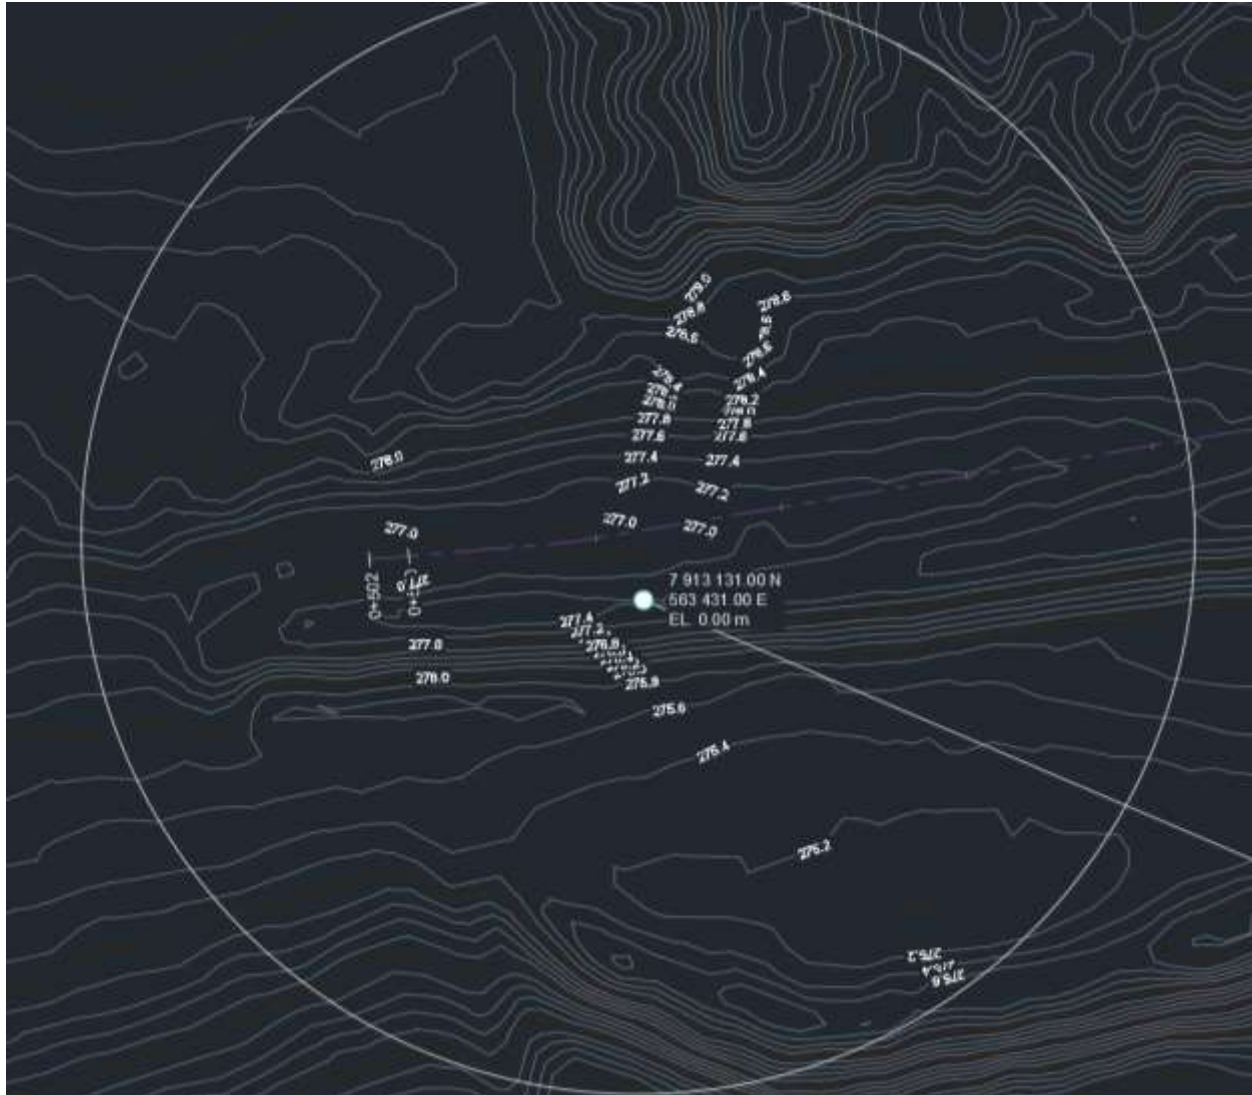
**Figure 2 As-built Survey at MS-106OS-01 Showing Flat Topography**

KP's review of the August 2021 drone survey indicates that the diversion ditch adjacent the seepage location MS-106OS-01 is flat, with multiple 277.0 m elevation measurements along the ditch alignment (Figure 2).

The drone survey suggests that settlement has occurred such that positive drainage is no longer present in this area.

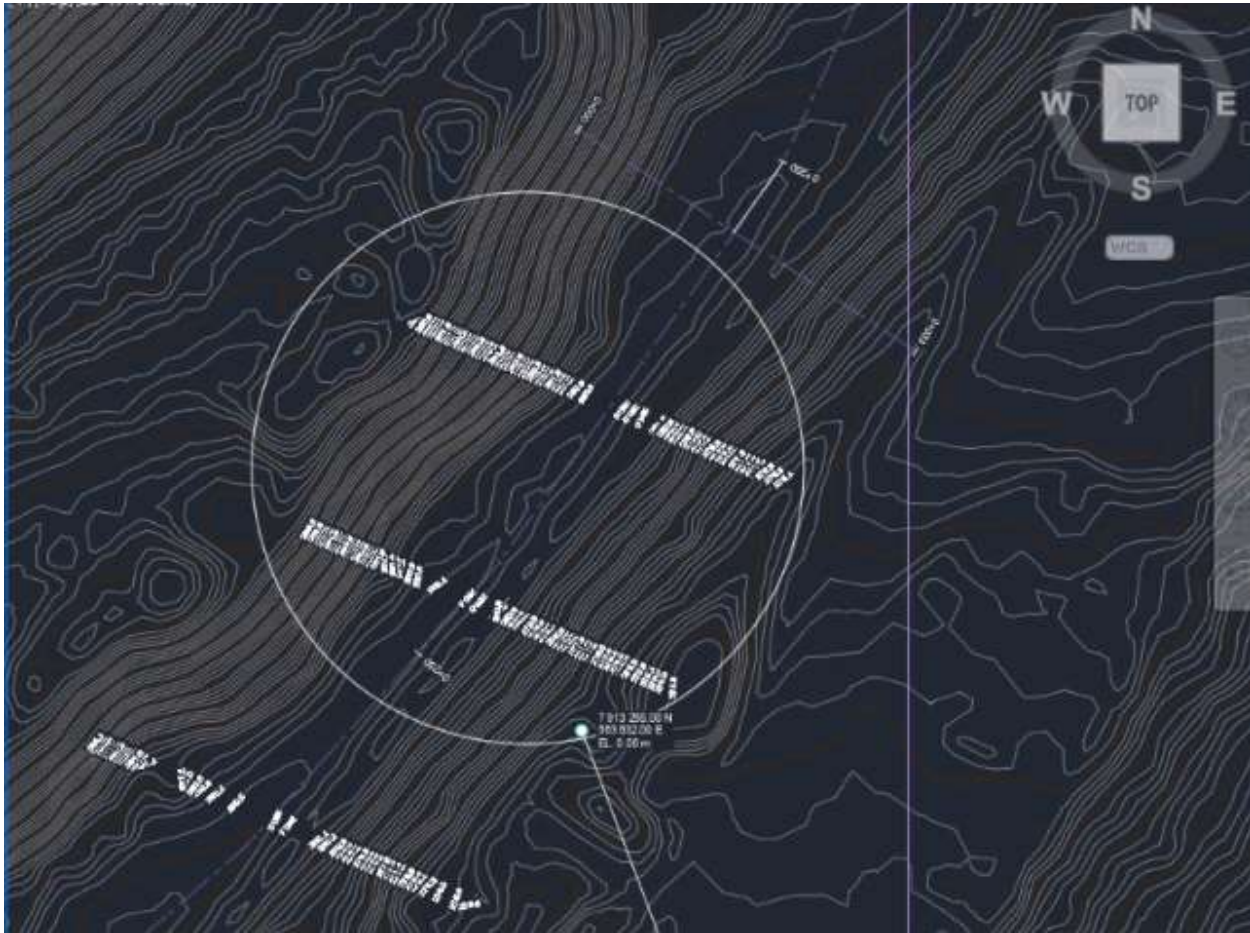
**Figure 3 As-built Survey at MS-106OS-02 Showing a Low Spot**

KP's review of the August 2021 drone survey indicates that a local low spot has formed within the diversion ditch at the location of the seepage at MS106OS-02 (Figure 3). This is also evident with the accumulation of fines at this location, as shown on Photo 5 in Appendix A.

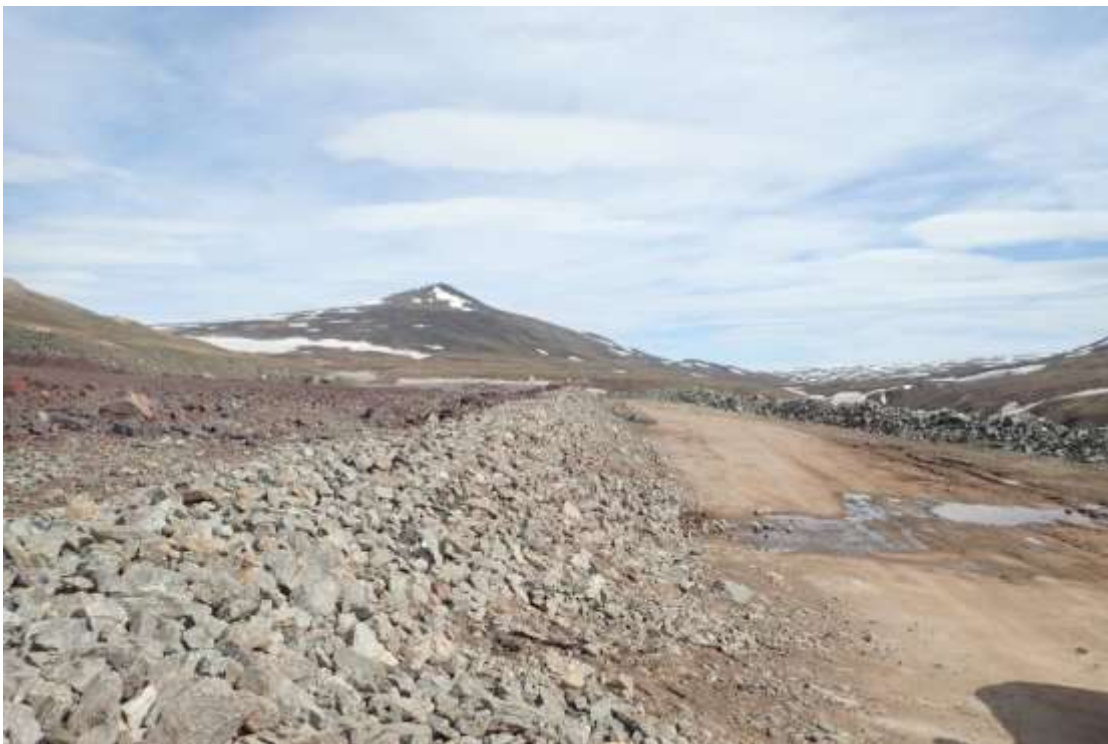
**Photo 2. Spill location MS-106OS-01 on June 29, 2021**

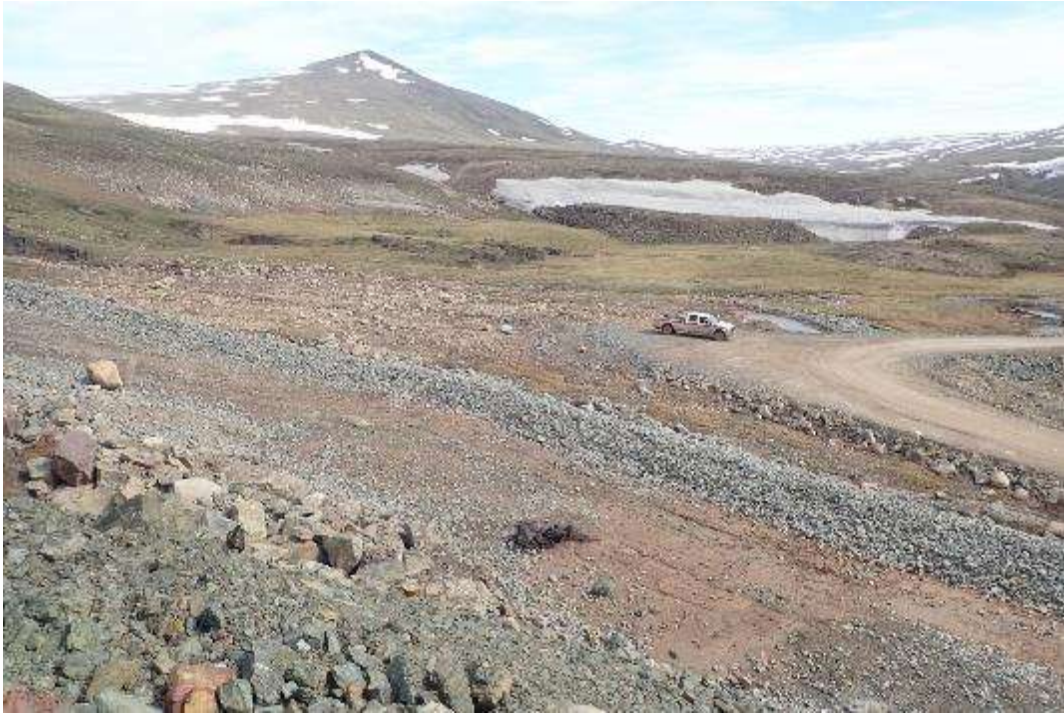
**Photo 5. Upstream of MS-106OS-02 spill location on June 29, 2021**

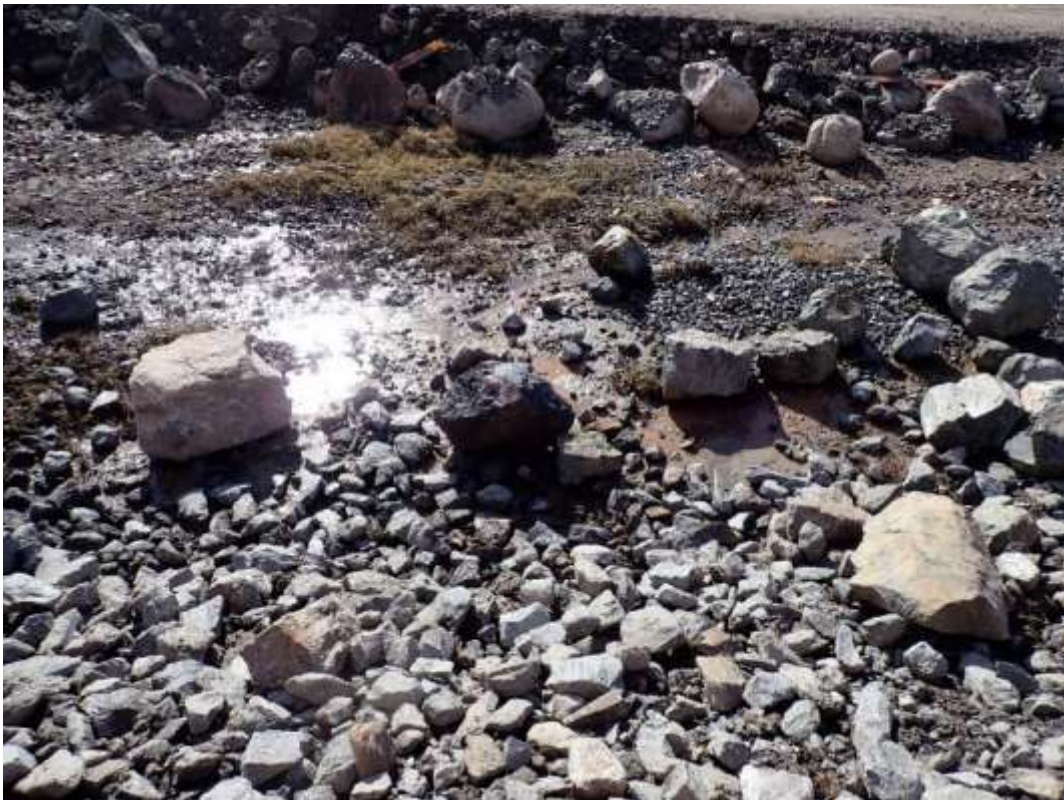
**Photo 6. Spill location MS-106OS-02 on June 29, 2021**
