**WATER LICENCE INSPECTION FORM**☒ Original
☐ Follow-Up Report

Licensee	Licensee Representative
Baffinland Iron Mines Corp – Mary River Project	Katherine Babin
Licence No. / Expiry	Representative's Title
2AM-MRY1325	Environment Coordinator
Land Authorization No. / Expiry	Land Authorization Expiry
N/A	N/A
Date of Inspection	Inspector
June 29 th , 2022	
Activities Inspected	
<input type="checkbox"/> Camp <input type="checkbox"/> Drilling <input checked="" type="checkbox"/> Mining <input type="checkbox"/> Construction <input type="checkbox"/> Reclamation <input type="checkbox"/> Fuel Storage <input type="checkbox"/> Roads/Hauling <input type="checkbox"/> Other: Municipal <input type="checkbox"/> Other:

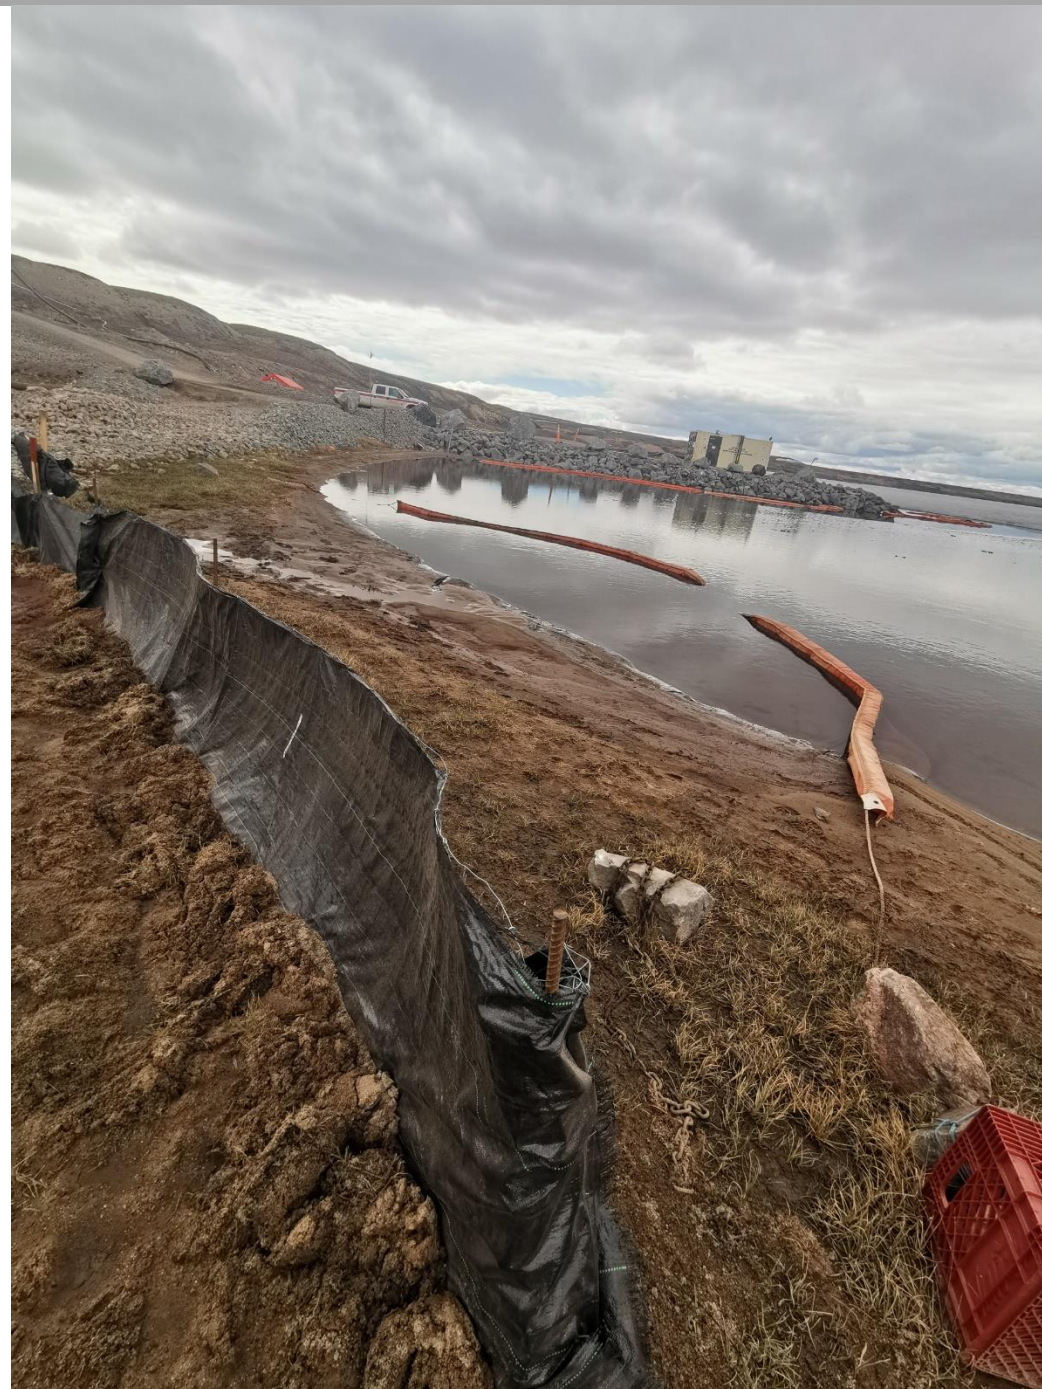
Photo No. 1

Following the inspections of the above noted areas, camp's withdrawal water intake lake (Jetty) was inspected. Licensee did install preventive measures for sediments in the form of booms and rock barriers. Photographs of same were taken and are included in this report. No debris, tailings, garbage or other items of concern that would pose a risk of entering the water intake lake were observed during the inspection.

Jetty – Water intake lake. Booms and sediment prevention.

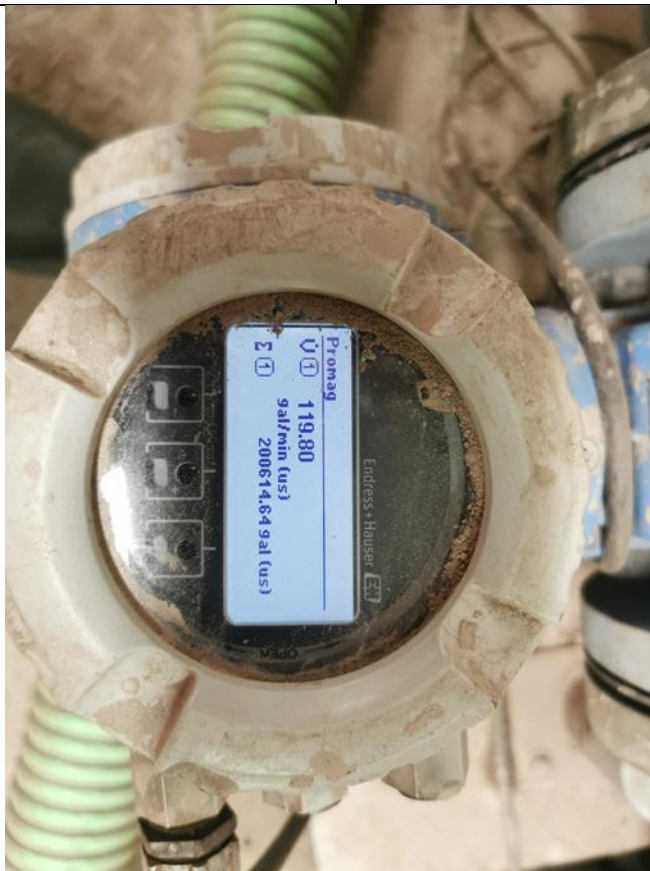
Photo No.2

Water intake meter. Jetty. Engaged and operational.

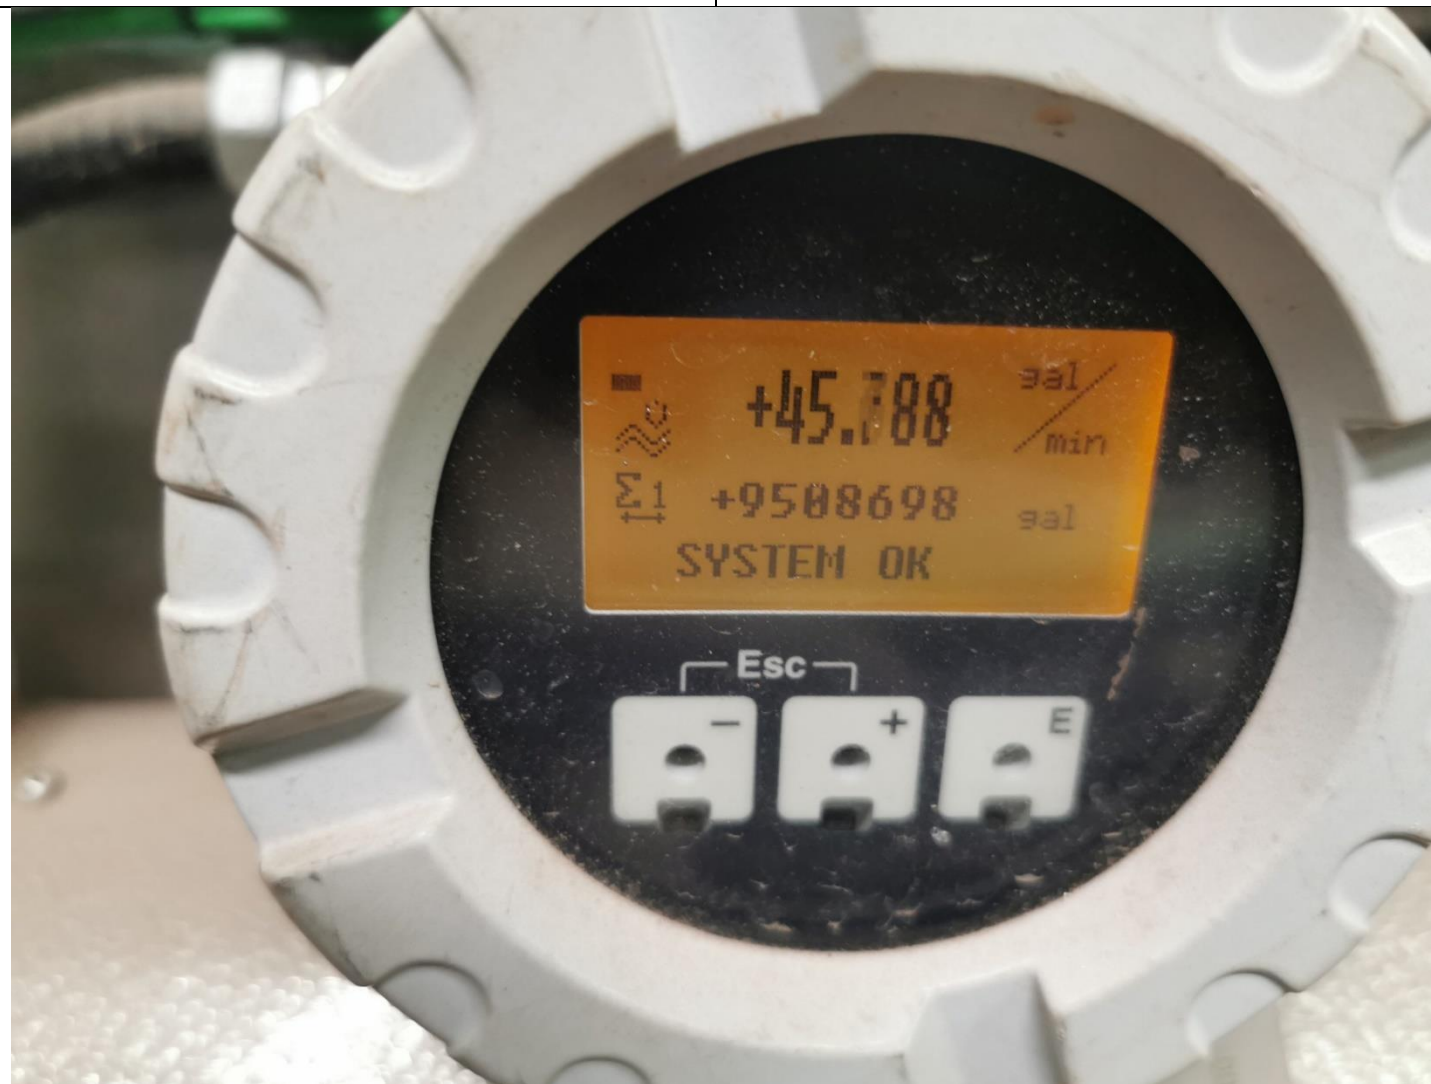
Photo No. 3

Operational and in use water intake monitoring meter 2

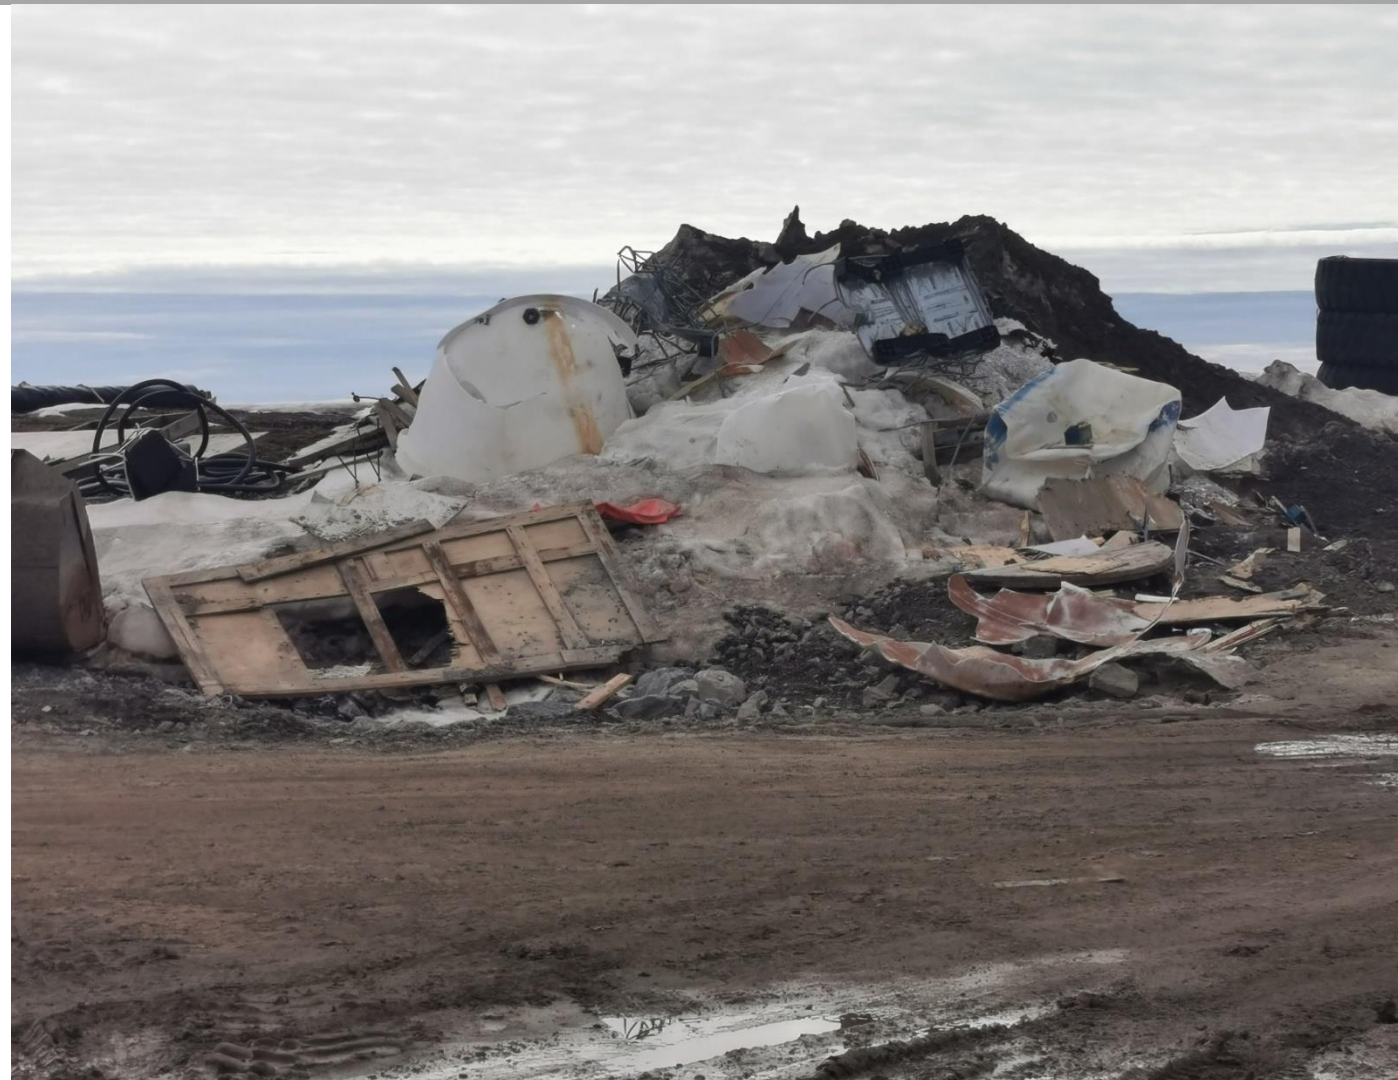
Photo No. 4

Inspector observed that there is ongoing construction at the site's waste rock facility. Numerous construction items were observed outside the construction building that were not properly secured. As such, there was/is a risk present for debris to be blown out of the intended construction area during high winds causing negative impact on the surrounding environment. Inspector did express the concern to Katherine Babin upon which time the inspector was advised that the concern will be addressed.

Construction material at waste rock facility currently under construction.

- Ensure the facilities are identified by a way of outside signage.
- Ensure the signage reflects all of Nunavut's official languages.
- Ensure construction debris is secured, thus preventing potentially negative impact to the environment by windblown items.
- Ensure every facility contains posted and visible copy of the water license.
- Ensure the damaged culvert has been properly addressed (on the road to the airport) and was pointed out to the site's environmental coordinator of its exact location. In addition, the culvert was identified as damaged during the previous inspection but to date was not properly addressed.
- Ensure the signs along the roads are properly erected and visible.

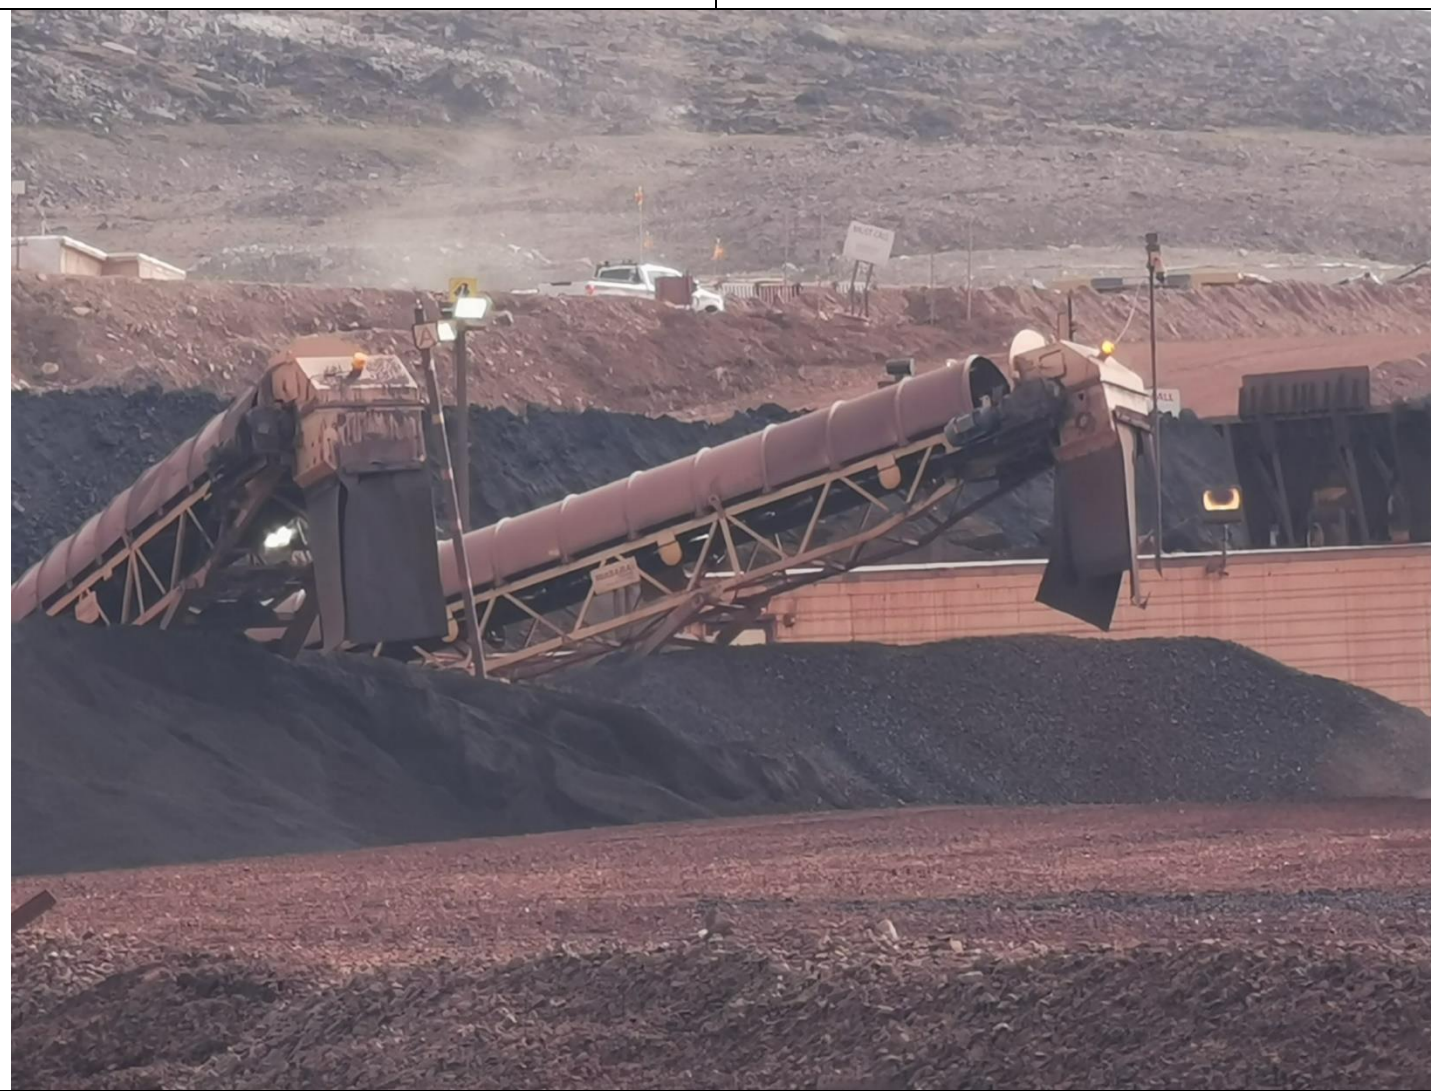
Photo No.5

Description:
Crusher.

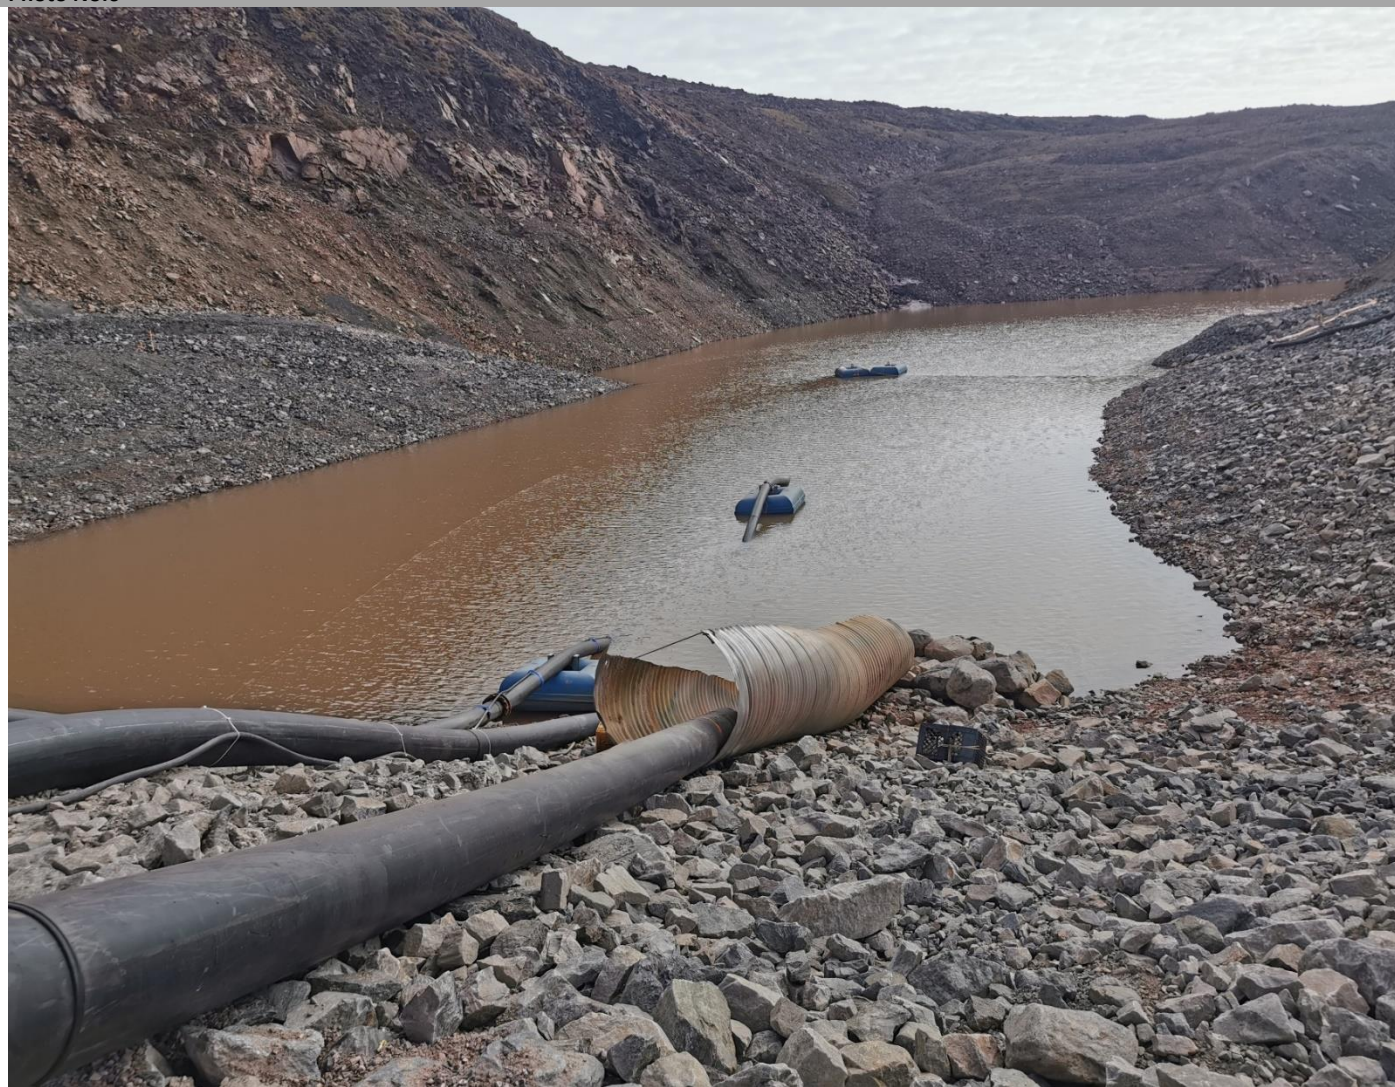
Photo No.6

Mine water storage pond (KM 105)

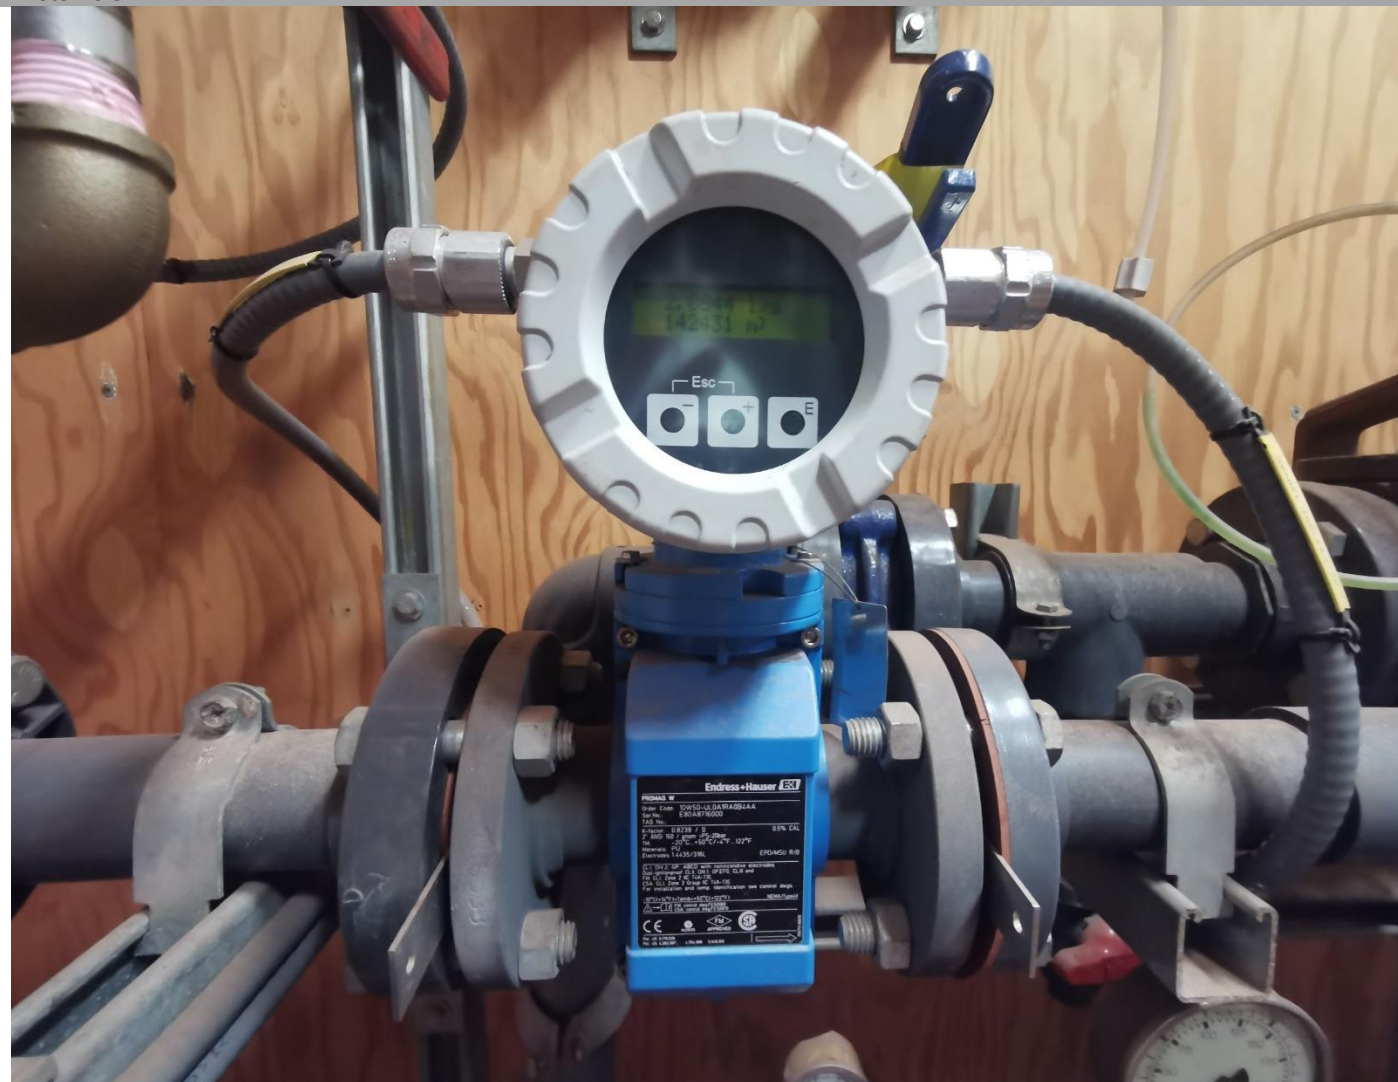
Photo No.8

Wastewater treatment facility meter. Operational and in use.

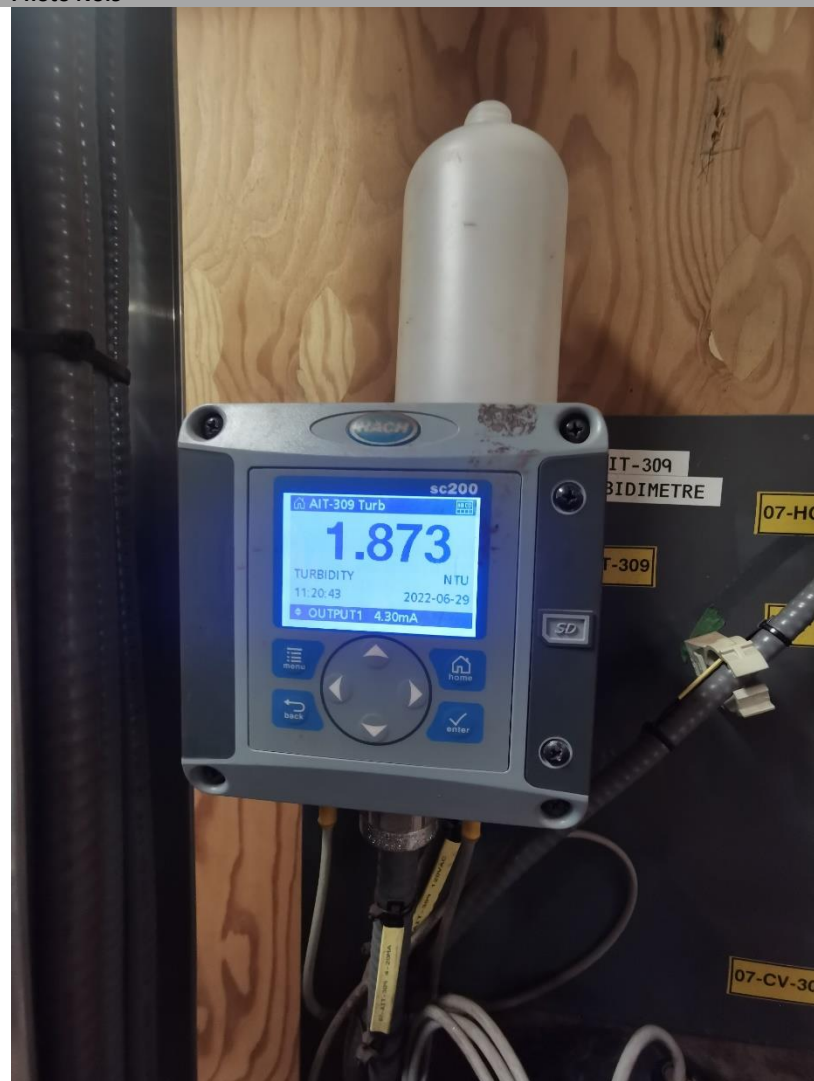
Photo No.9

Waste treatment (main camp) facility's meter in use and operational.
