Re: Water Licence 2AM-MRY1325 Baffinland Response to June 2022 Inspection

The following submission from Baffinland Iron Mines Corporation (Baffinland) is a follow up in response to the Water Licence Inspection¹ conducted on June 29th, 2022, at Baffinland's Mary River Project (the Project) by the Crown-Indigenous Relations Northern Affairs Canada (CIRNAC) Senior Inspector. The attached Table 1 provides a summary of the Inspector's key observations and concerns. Baffinland has detailed responses to these items in Table 1.

Baffinland Response to CIRNAC 2022 June Inspection Report

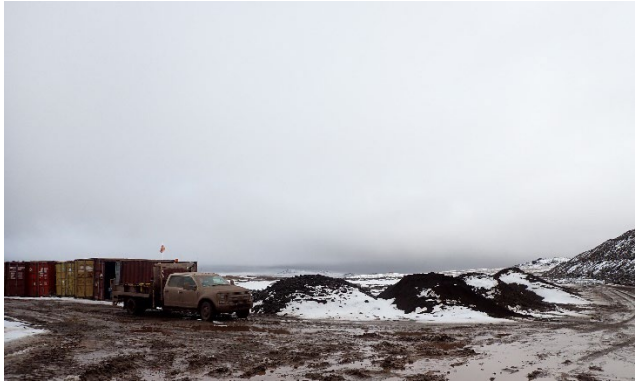
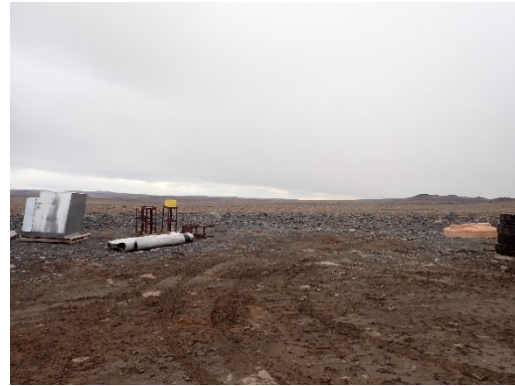
Cm t. #	Project Location	Description of Concern or Finding	Baffinland's Response
1	WRF WTP	Numerous construction items were observed outside the construction building that were not properly secured. As such, there was/is a risk present for debris to be blown out of the intended construction area during high winds causing negative impact on the surrounding environment.	The clean-up of the various waste and construction debris at the WRF WTP laydown has been completed. A photo is provided in Attachment 2.
2	WRF WTP	No copy of water license was observed at the facility. Ensure every facility contains posted and visible copy of the water license.	A copy of Baffinland's 2AM-MRY1325 Water Licence has been placed in the Waste Rock Facility Water Treatment Plant. A photo is provided in Attachment 2.
3	KM110.5 Laydown (Maintenance Shop)	Following the waste rock's facility site, laydown area was inspected. Inspector observed that no signage identifying the area as such was posted. The erected signage needs to be identified in all official languages of Nunavut.	Signage has been erected at the KM110.5 Maintenance Shop and Water Treatment Plant in both English and Inuktitut. A photo is provided in Attachment 2.

Figure 1. Photos of WRF WTP Laydown With Construction Debris Removed

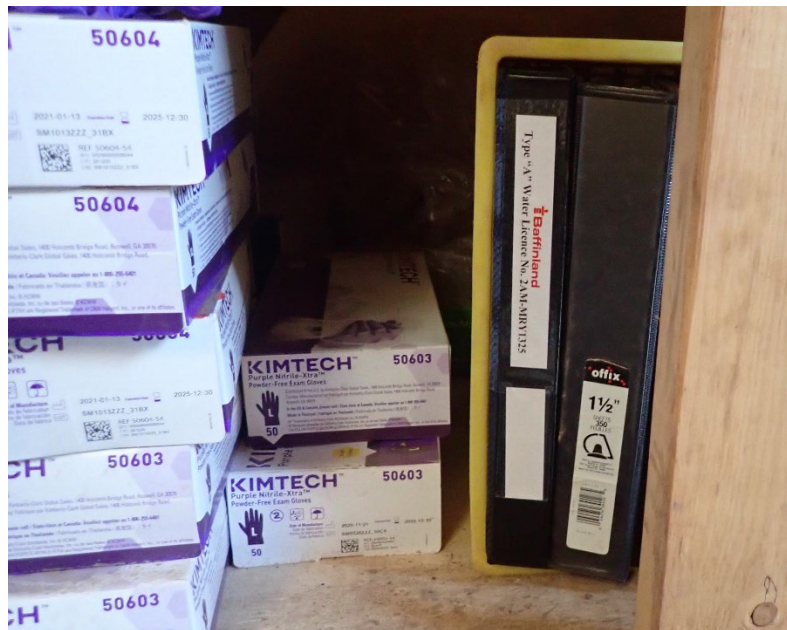
Figure 2. Photo of Water Licence Posted in WRF WTP

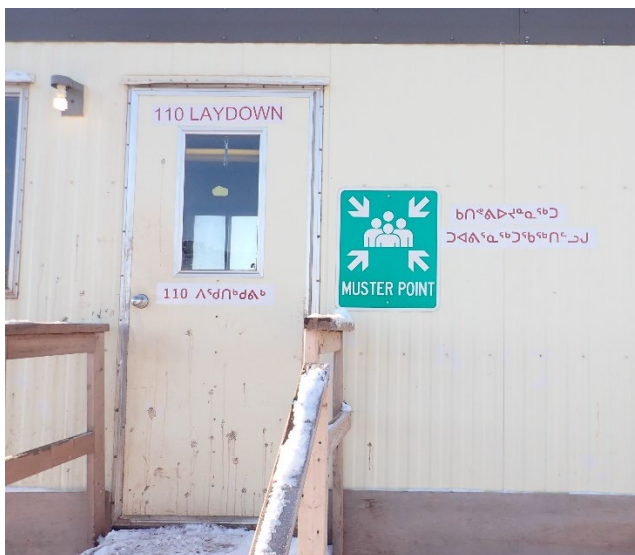
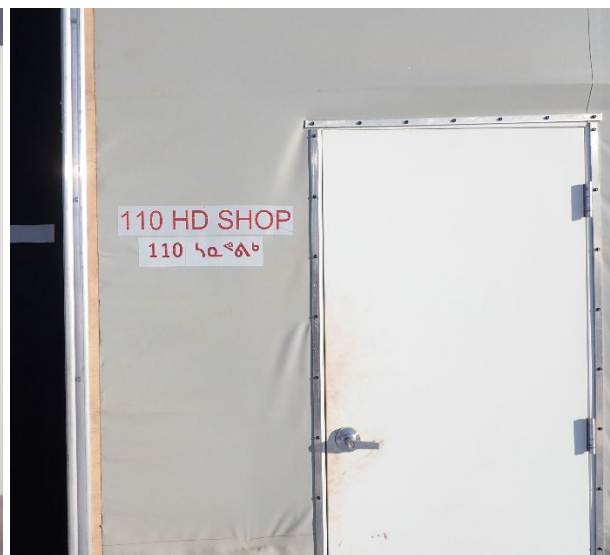
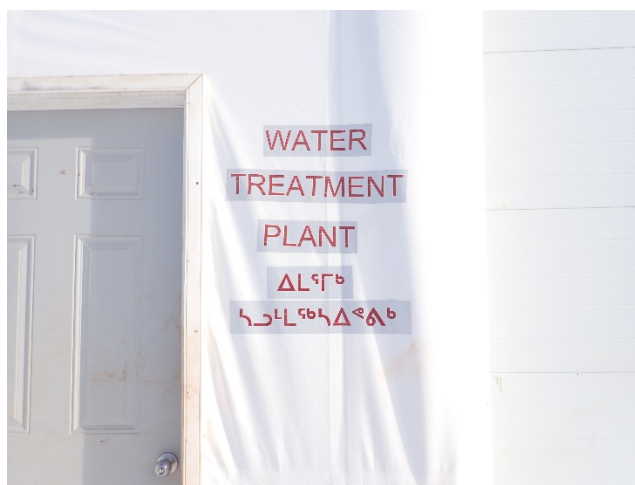
Figure 3. Photos of Signage in English and Inuktitut at KM110 Laydown and KM110.5 Shop

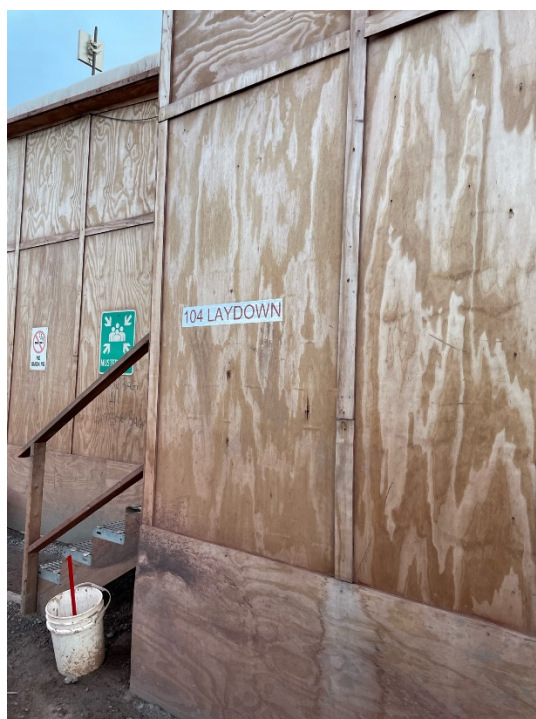
4	KM104 and KM104.5 Laydowns	MS-11 Laydown area (Km 104), was inspected. The inspector observed multiple knocked down signage along the road.	Signage has been erected at the KM104 Laydown in both English and Inuktitut. Signage has also been re-erected along the Mine Haul Road. Photos are provided in Attachment 2.
5	MSC and Sallivik WWTPs Incinerator Open Burn	The wastewater treatment plant (MSC), waste treatment plant (Tamativiik) site, incinerator site and open burn pit (KM 98) was inspected. No copies of the water license were present at all within these facilities were confirmed by the facilities operator at the time of the inspection. Ensure every facility contains posted and visible copy of the water license.	A copy of Baffinland's 2AM-MRY1325 Water Licence has been placed in these facilities. A photo is provided in Attachment 2.

Figure 4. Photo of Signage in English and Inuktitut at KM104 Laydown

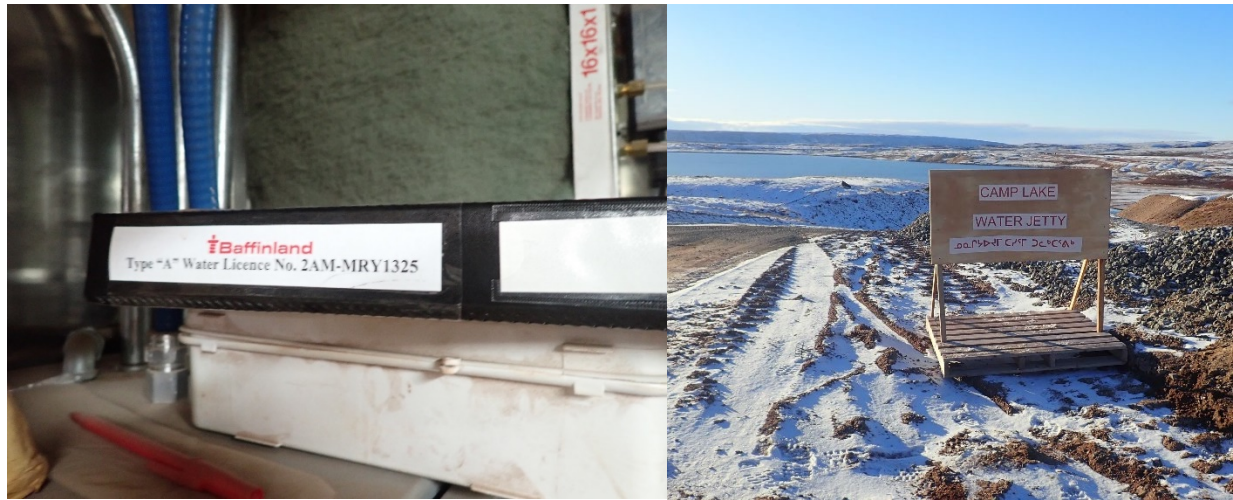
Cm t. #	Project Location	Description of Concern or Finding	Baffinland's Response
6	Camp Lake Jetty	Camp's withdrawal water intake lake (Jetty) was inspected. The inspector noted no visible signs, erected or otherwise, identifying the area as such were present at or near the inspected location. The erected signage needs to be identified in all official languages of Nunavut.	Signage has been erected at the Camp Lake Water Jetty in both English and Inuktitut. A photo is provided in Attachment 2.
7	MS-03B Tank Farm	The fifteen million liters capacity fuel tank was inspected. Melting snow caused water to accumulate within the berms of the fuel tank. Inspector advised the site's environmental coordinator that the sampling of the accumulated water needs to be taken prior of discharge.	MS-03B Fuel Tank Farm was successfully discharged completely in July 2022. Results of this discharge were reported in the July 2022 Monthly Water Licence report. A photo of the post-discharge status of MS-03B is provided in Attachment 2.

Figure 5. Photos of Signage in English and Inuktitut & Copy of Water Licence at Camp Lake Water Jetty

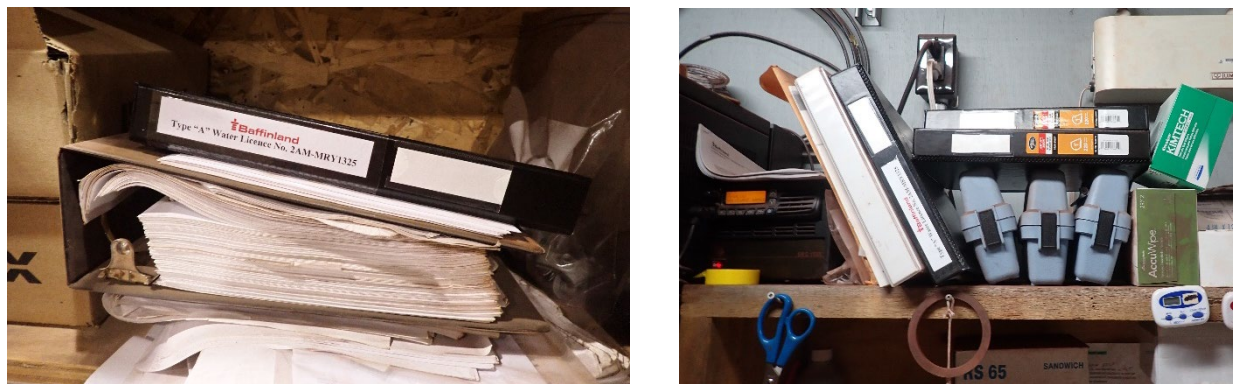
Figure 6. Photos of Water Licence Posted in MSC WTP and WWTP

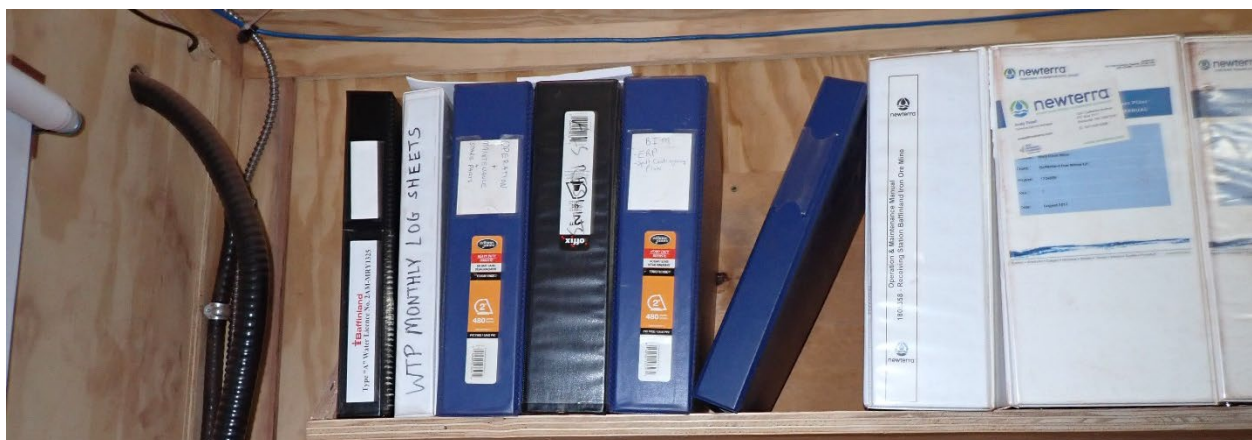
Figure 7. Photo of Water Licence Posted in Sailiivik WTP and WWTP

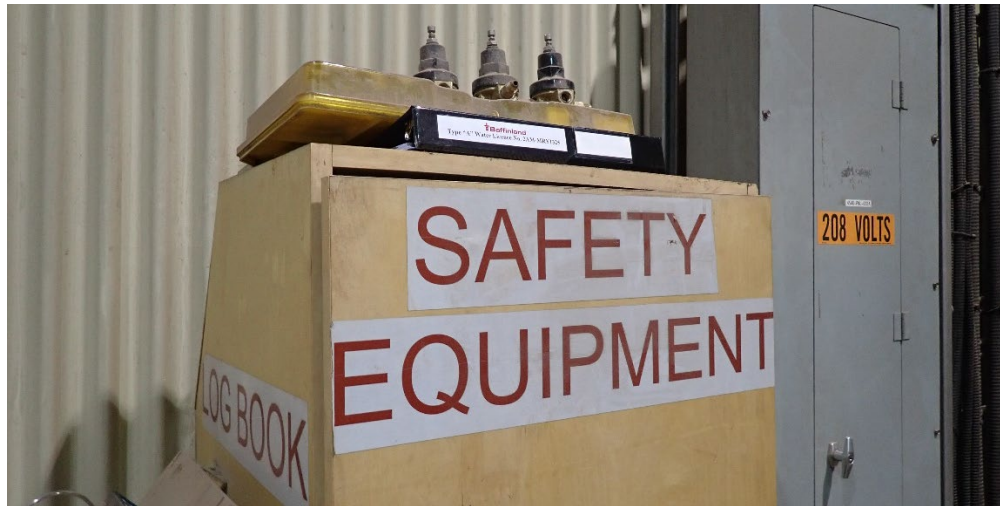
Figure 8. Photo of Water Licence Posted in Mine Site Incinerator Building

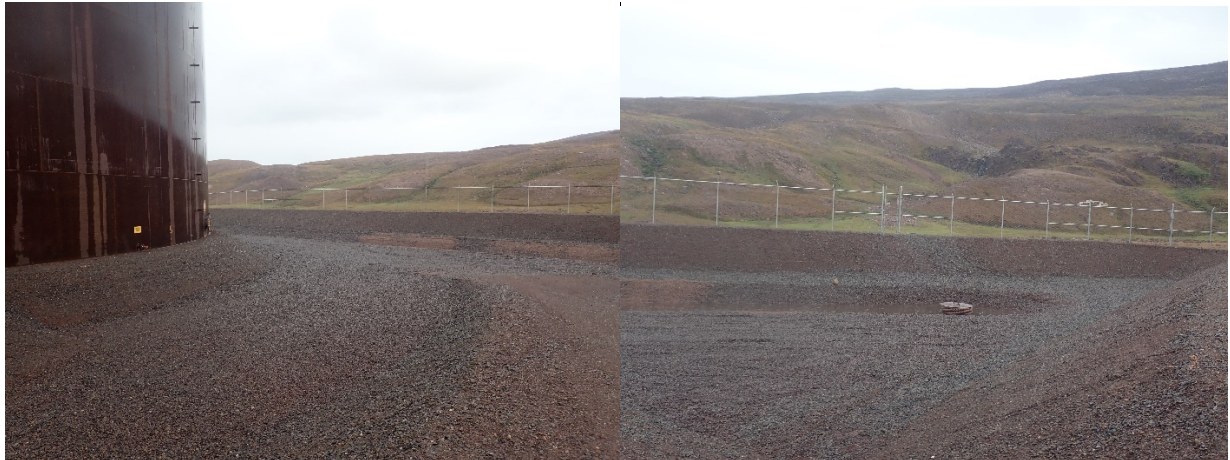
Figure 9. Photos of MS-03B Tank Farm in August After Discharge

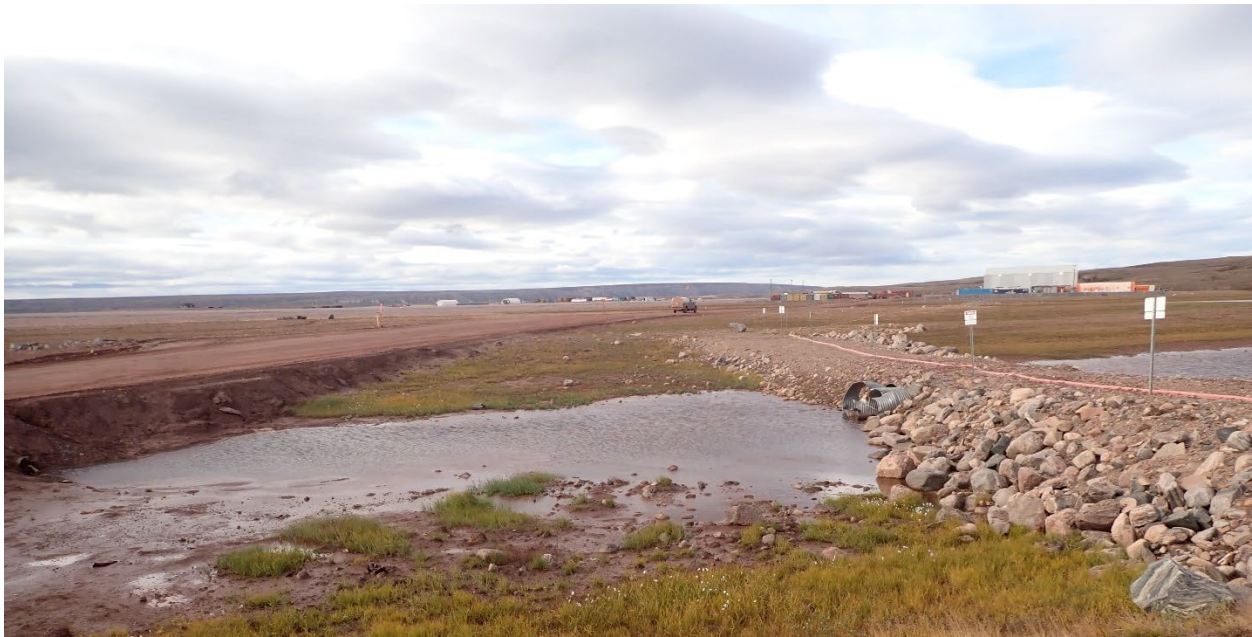
8	KM101 Culvert	Damaged culvert identified in the previous inspection still not addressed. Ensure the damaged culvert has been properly addressed (on the road to the airport).	The culvert end will be repaired prior to Freshet 2023 during frozen conditions. The culvert is under a cable berm that is not driven over, and the culvert is currently not impeding water flow therefore there is low risk for any negative impact to the environment. A photo of the current status of the culvert is provided in Attachment 2.
9	Mine Haul Road	Knocked down signs along the roads. Ensure the signs along the roads are properly erected and visible.	Signage has been re-erected along the Mine Haul Road. A photo is provided in Attachment 2.

Figure 10. Photo of KM101 Culvert under a Berm, Adjacent to Tote Road – August 25, 2022

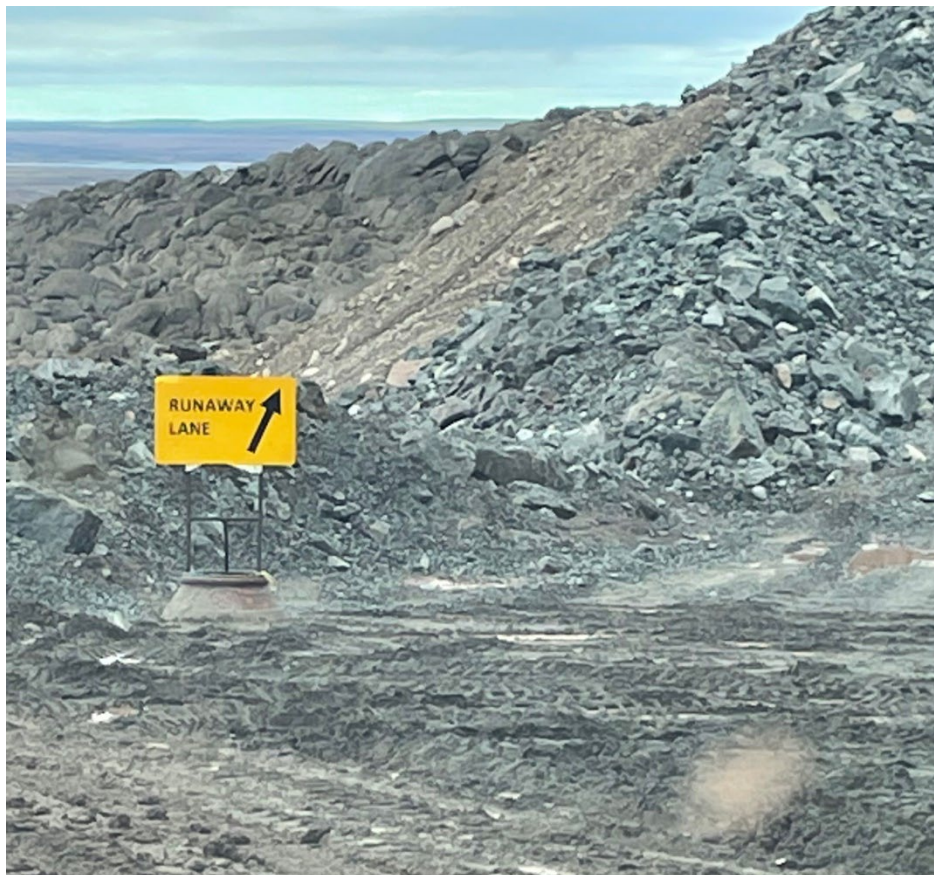
Figure 11. Photo of Signage re-erected along the Mine Haul Road
