**WATER LICENCE INSPECTION FORM**☒ Original
☐ Follow-Up Report

Licensee	Licensee Representative
Baffinland Iron Mines Corp – Mary River Project	Connor Devereaux
Licence No. / Expiry	Representative's Title
2AM-MRY1325	Environment Superintendent
Land Authorization No. / Expiry	Land Authorization Expiry
N/A	N/A
Date of Inspection	Inspector
October 5, 2022	
Activities Inspected	
<input checked="" type="checkbox"/> Camp <input type="checkbox"/> Drilling <input checked="" type="checkbox"/> Mining <input type="checkbox"/> Construction <input type="checkbox"/> Reclamation <input checked="" type="checkbox"/> Fuel Storage <input type="checkbox"/> Roads/Hauling <input type="checkbox"/> Other: Municipal <input type="checkbox"/> Other:

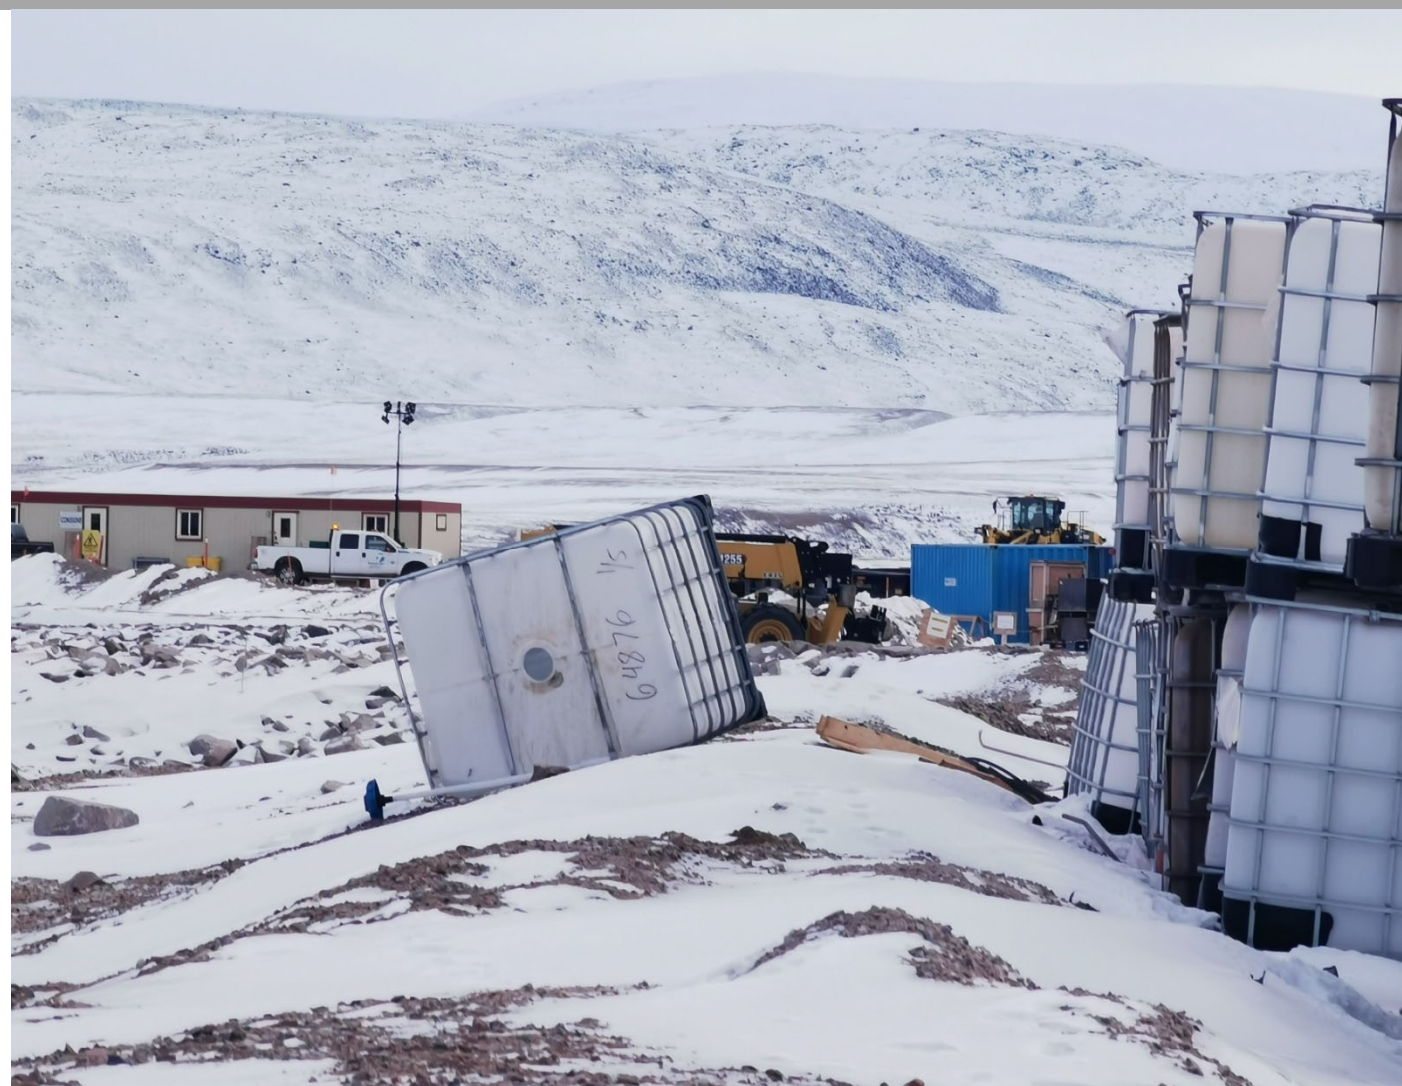
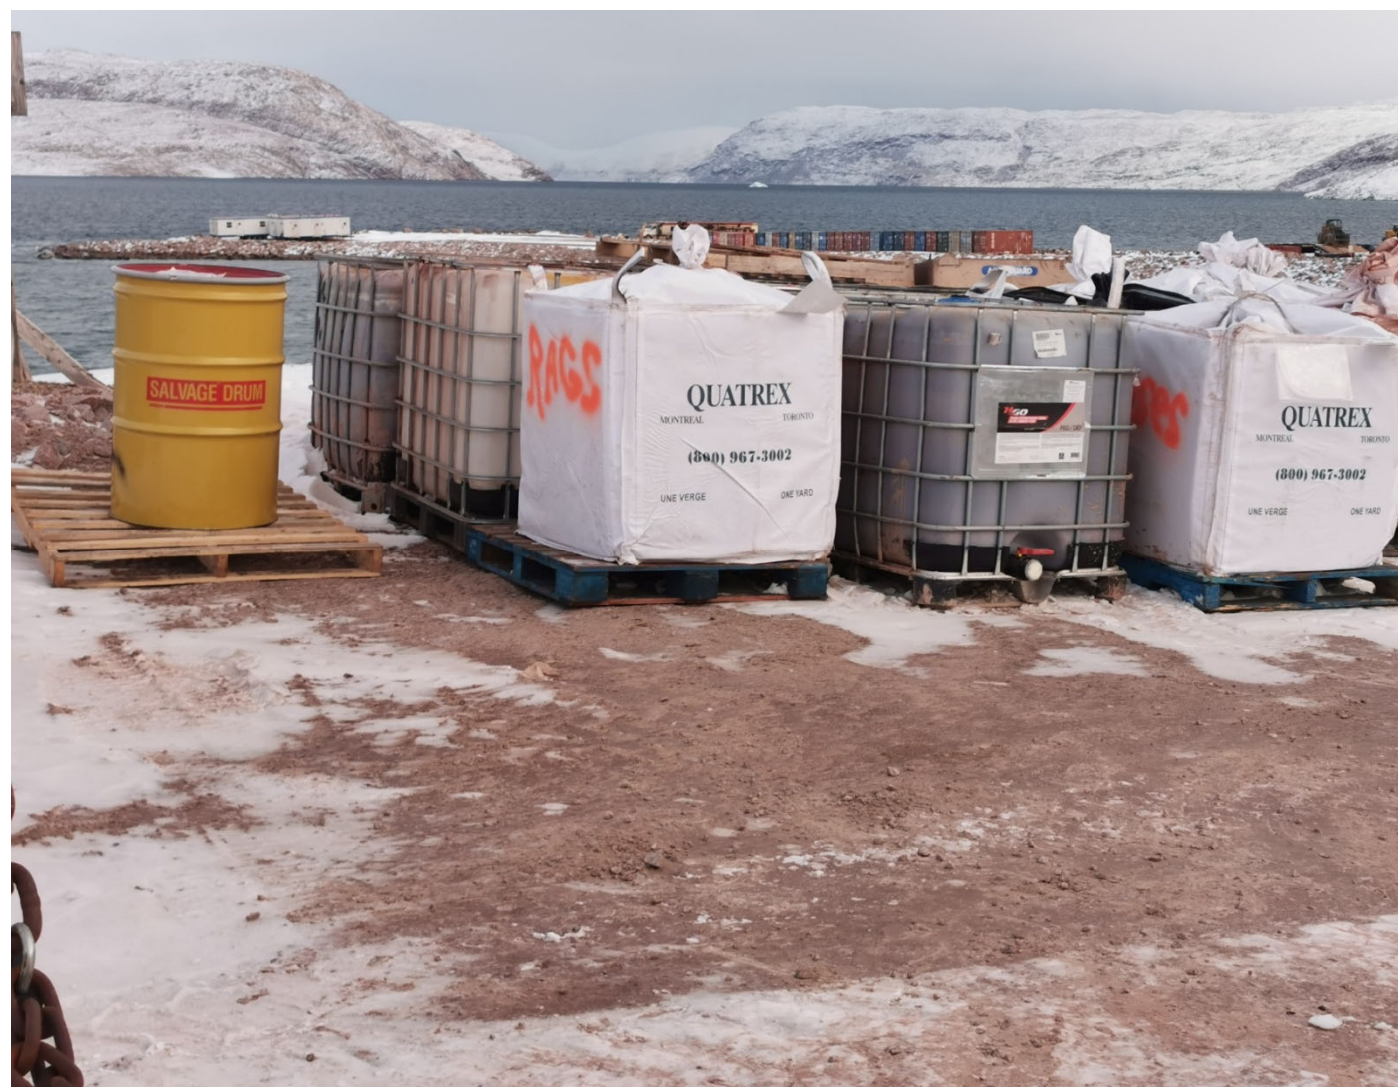
- Plastic tote outside the berm – Hazardous waste – MP-HWB-01

MP-HWB-01 Hazardous waste area and tote outside the berm

- Ensure plastic tote has been removed and secured within the prescribed berm.
- Ensure tote did not contain hazardous material.
- Ensure, if applicable, the spill from the tote is cleaned up and the spill report created.

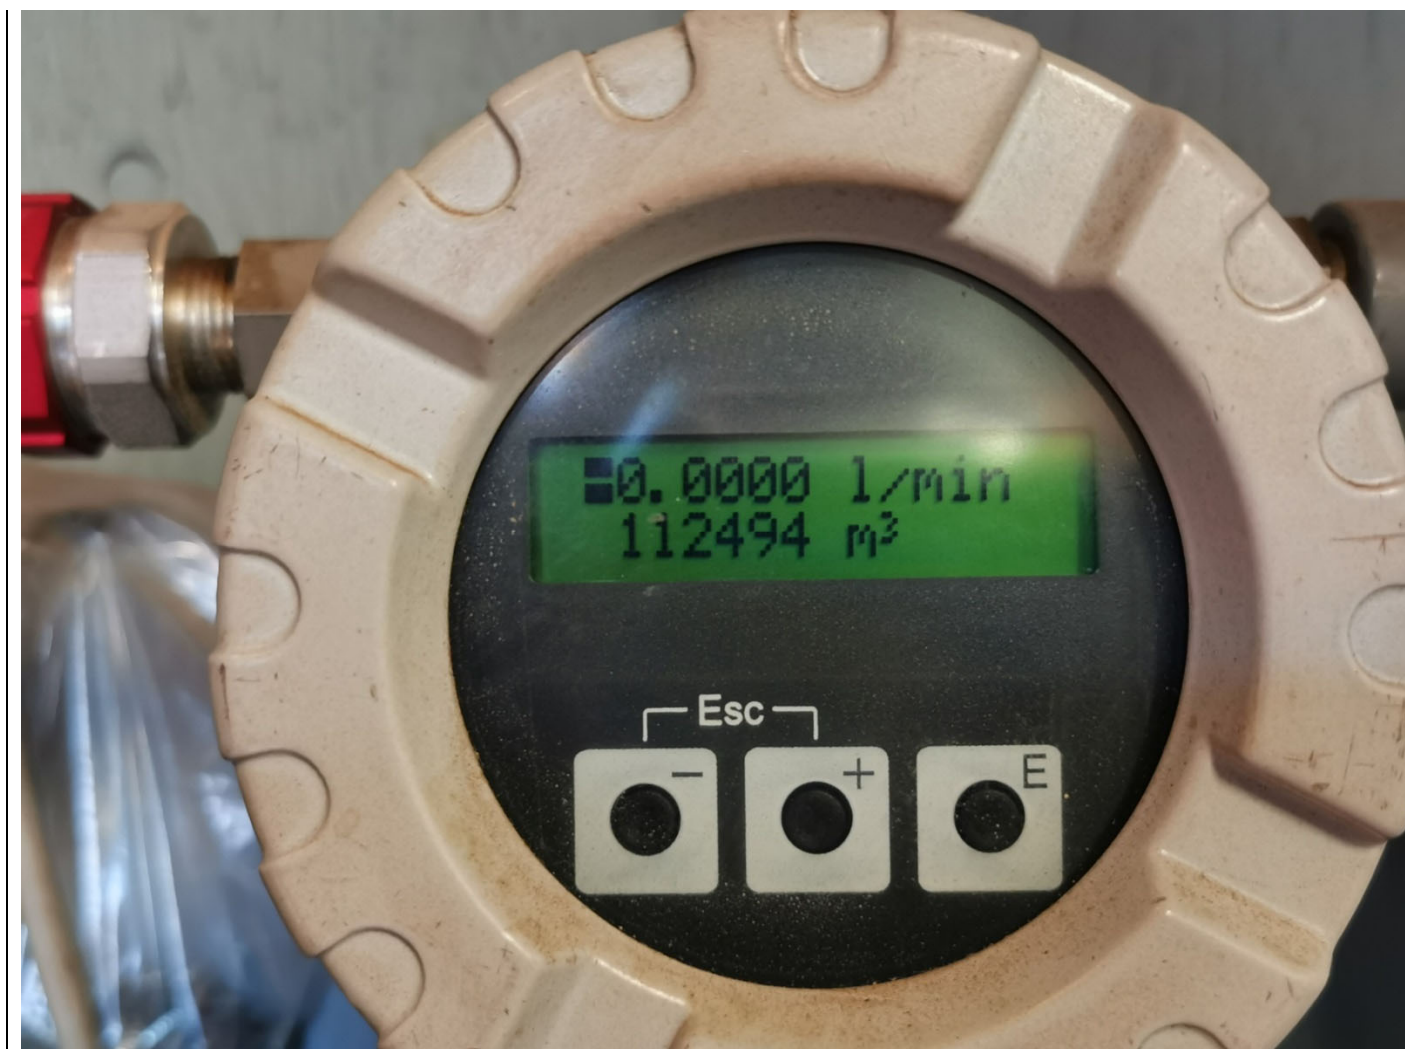
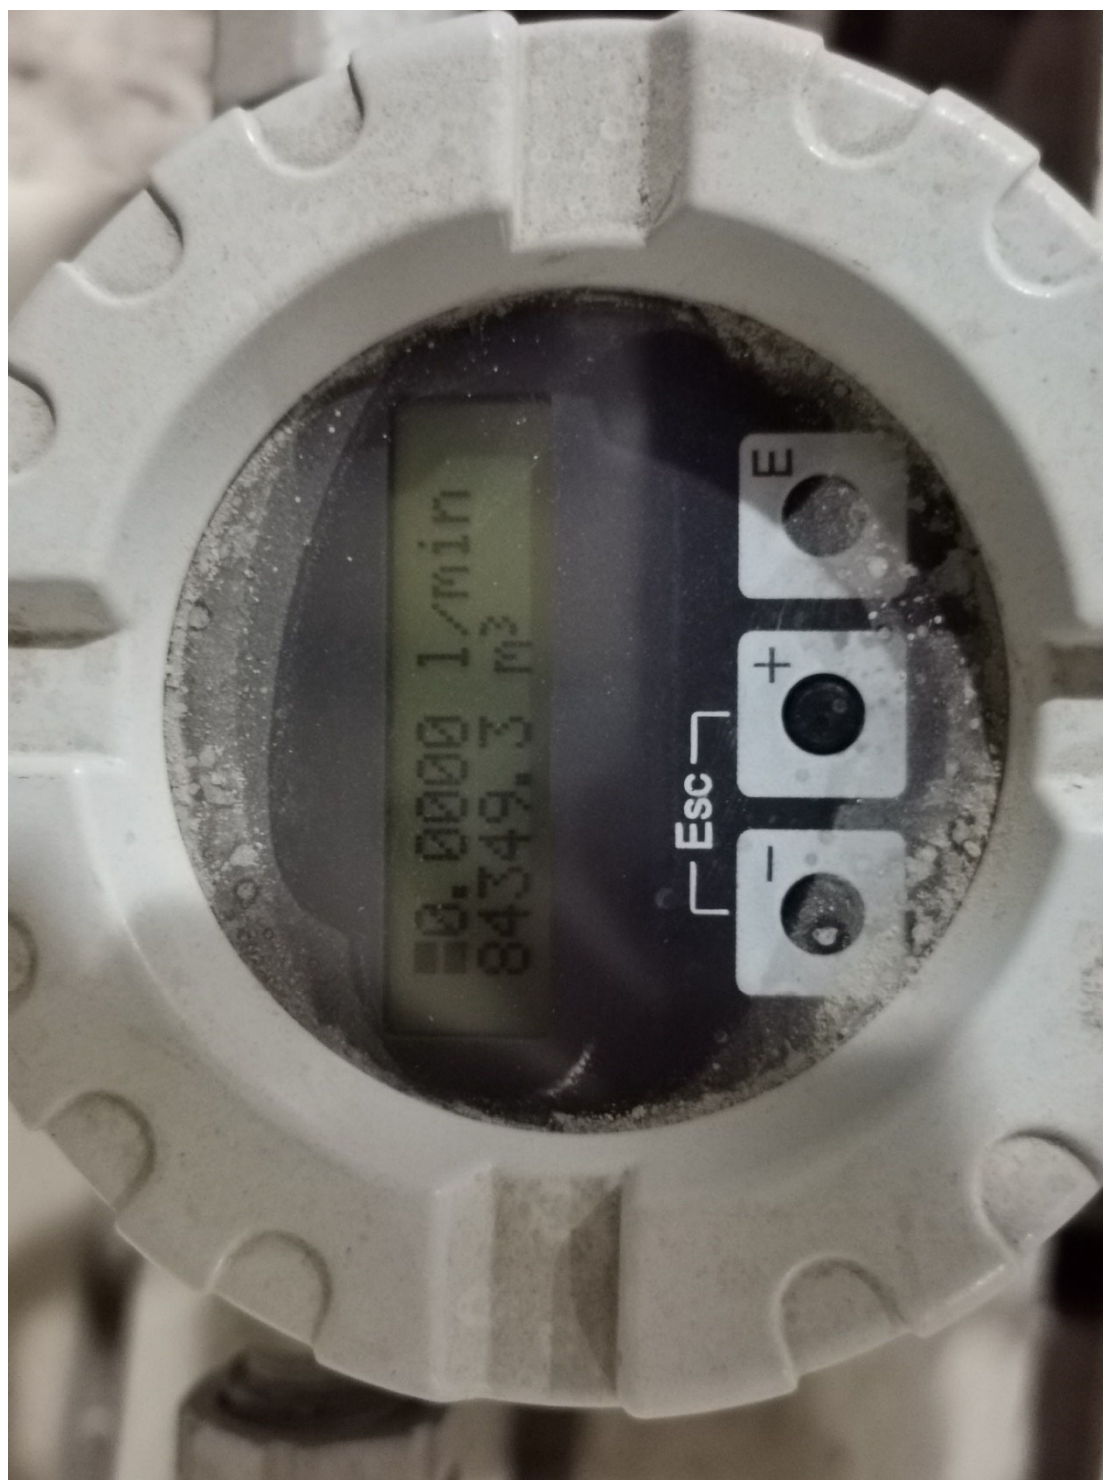
Water treatment and waste treatment facility meters

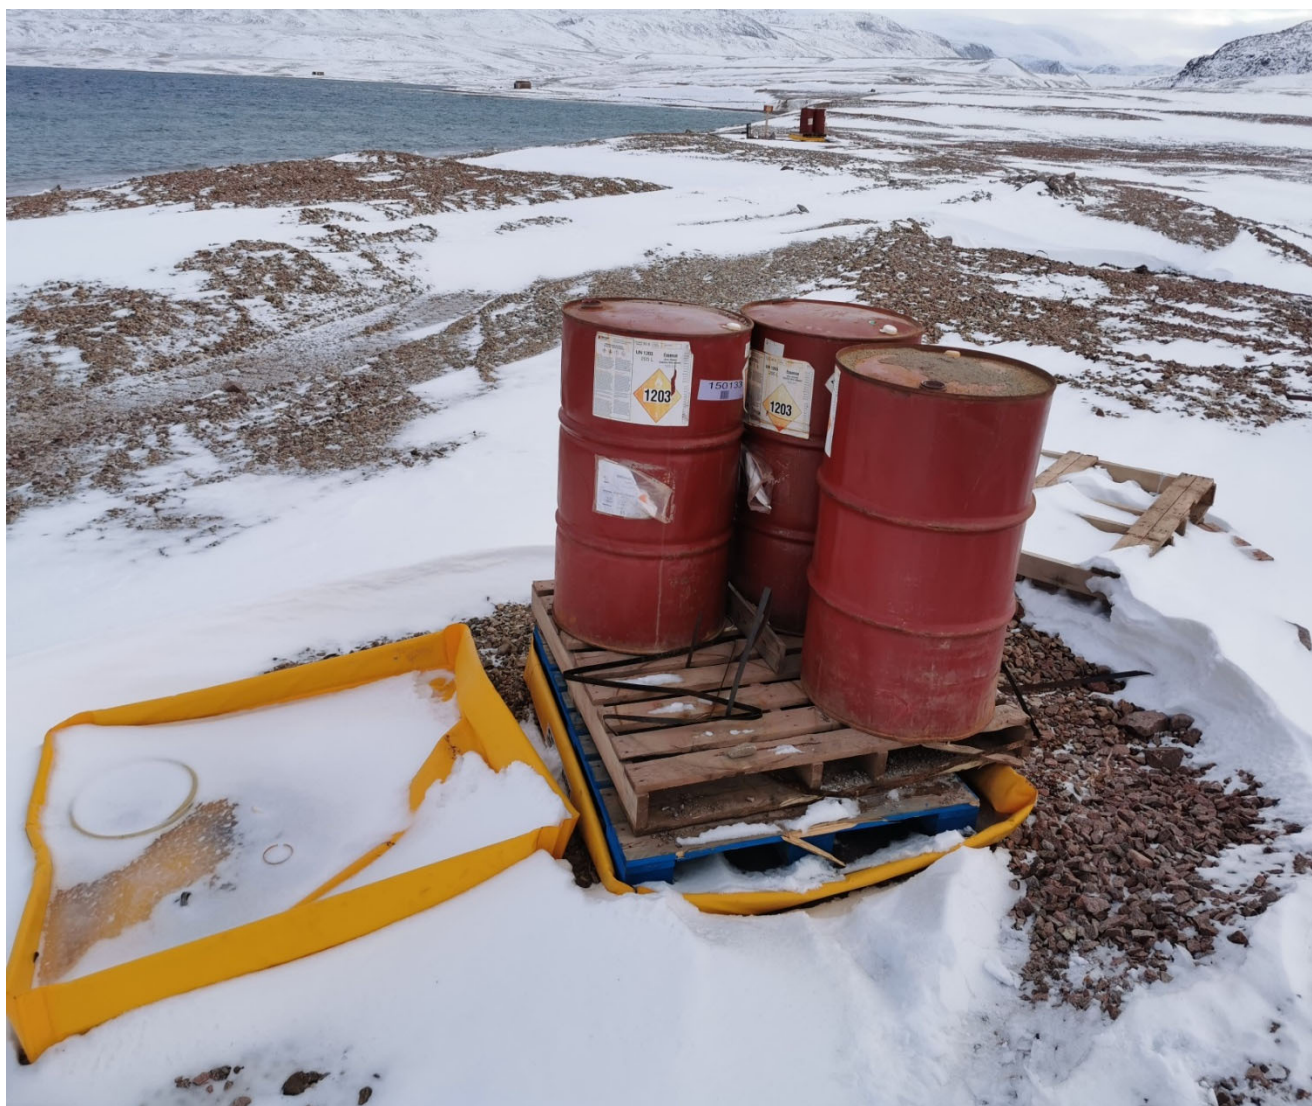
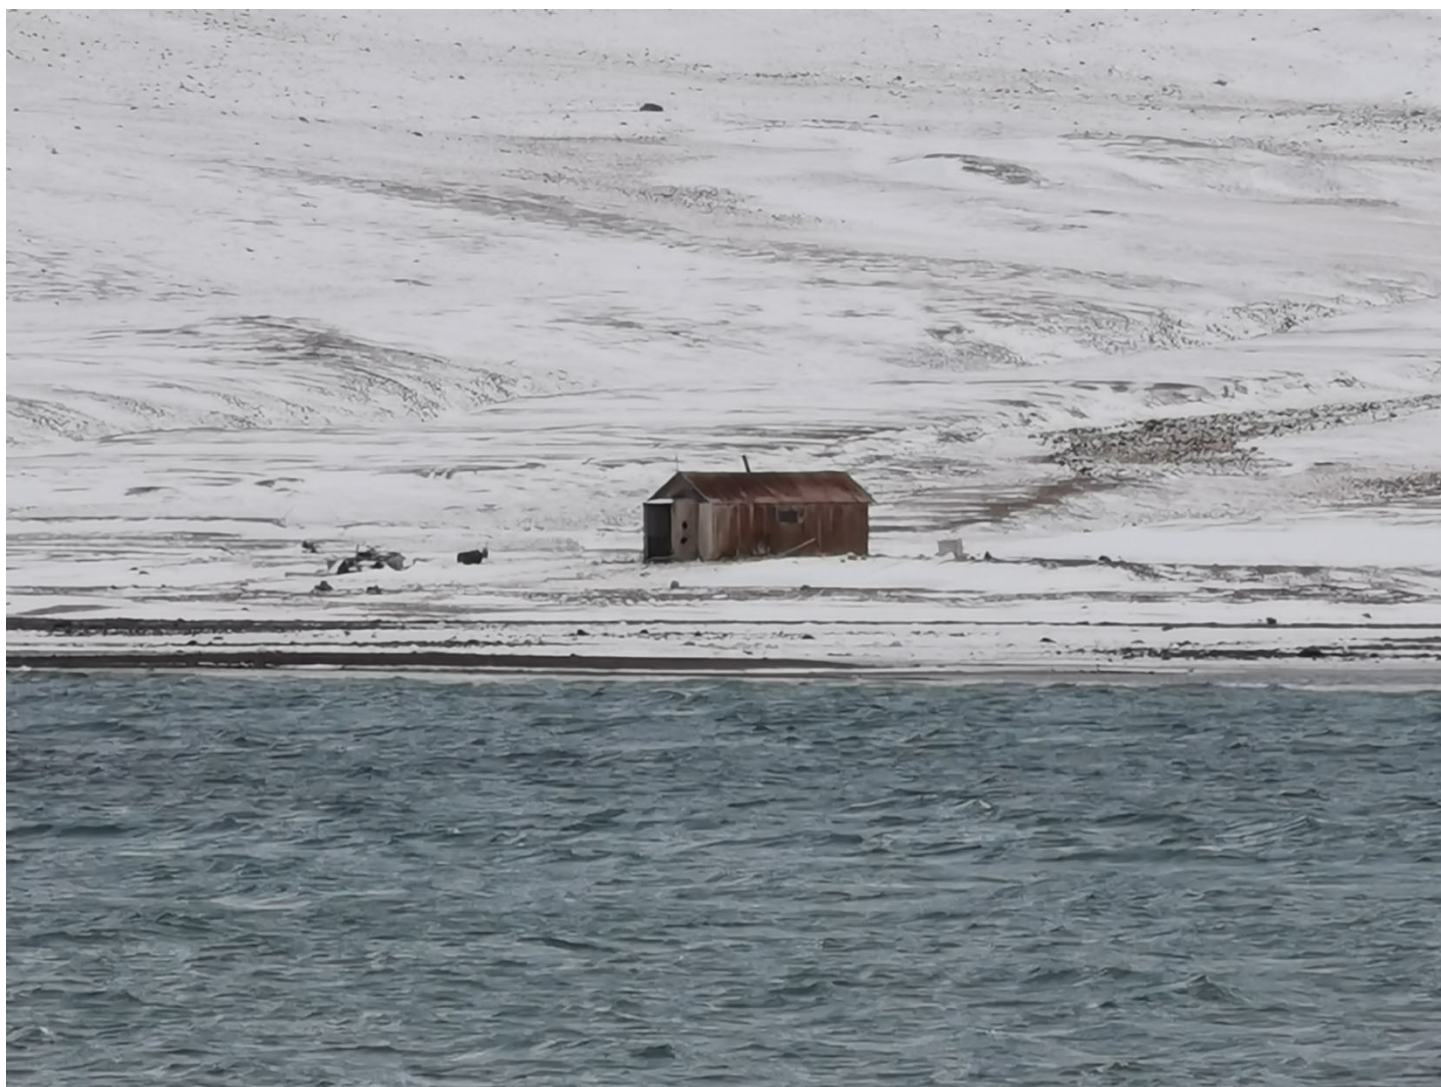
HTO Cabin and fuel storage area for hunters and other users of the cabin

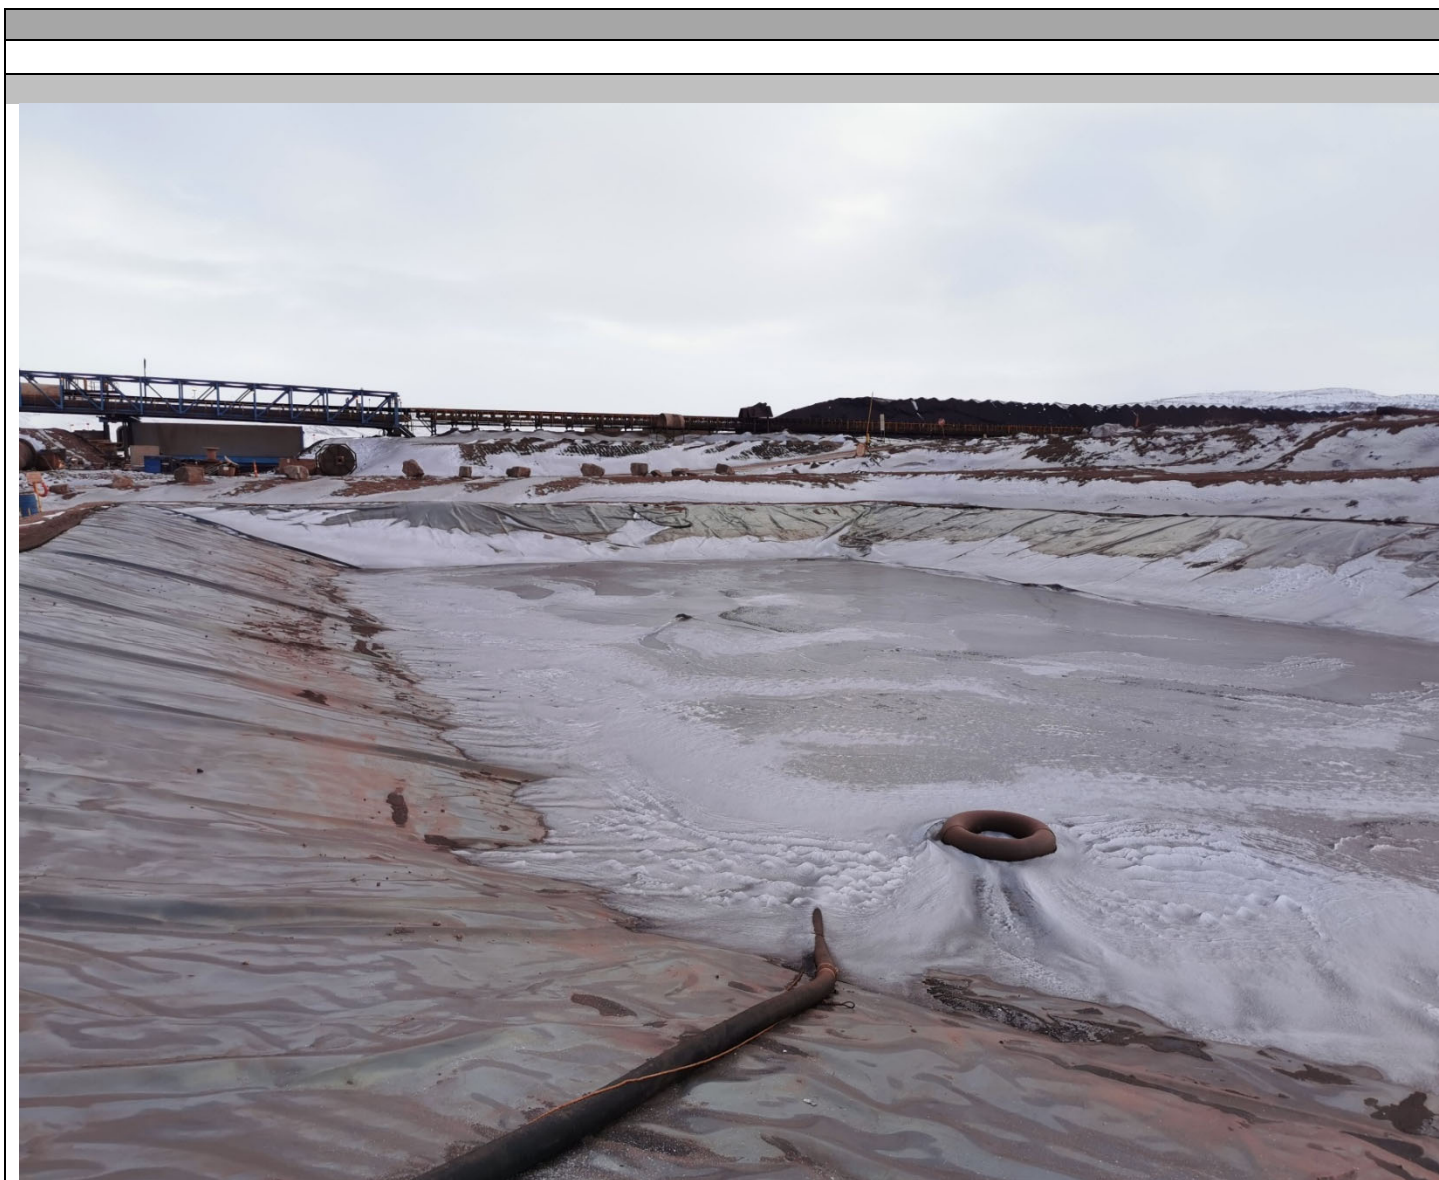
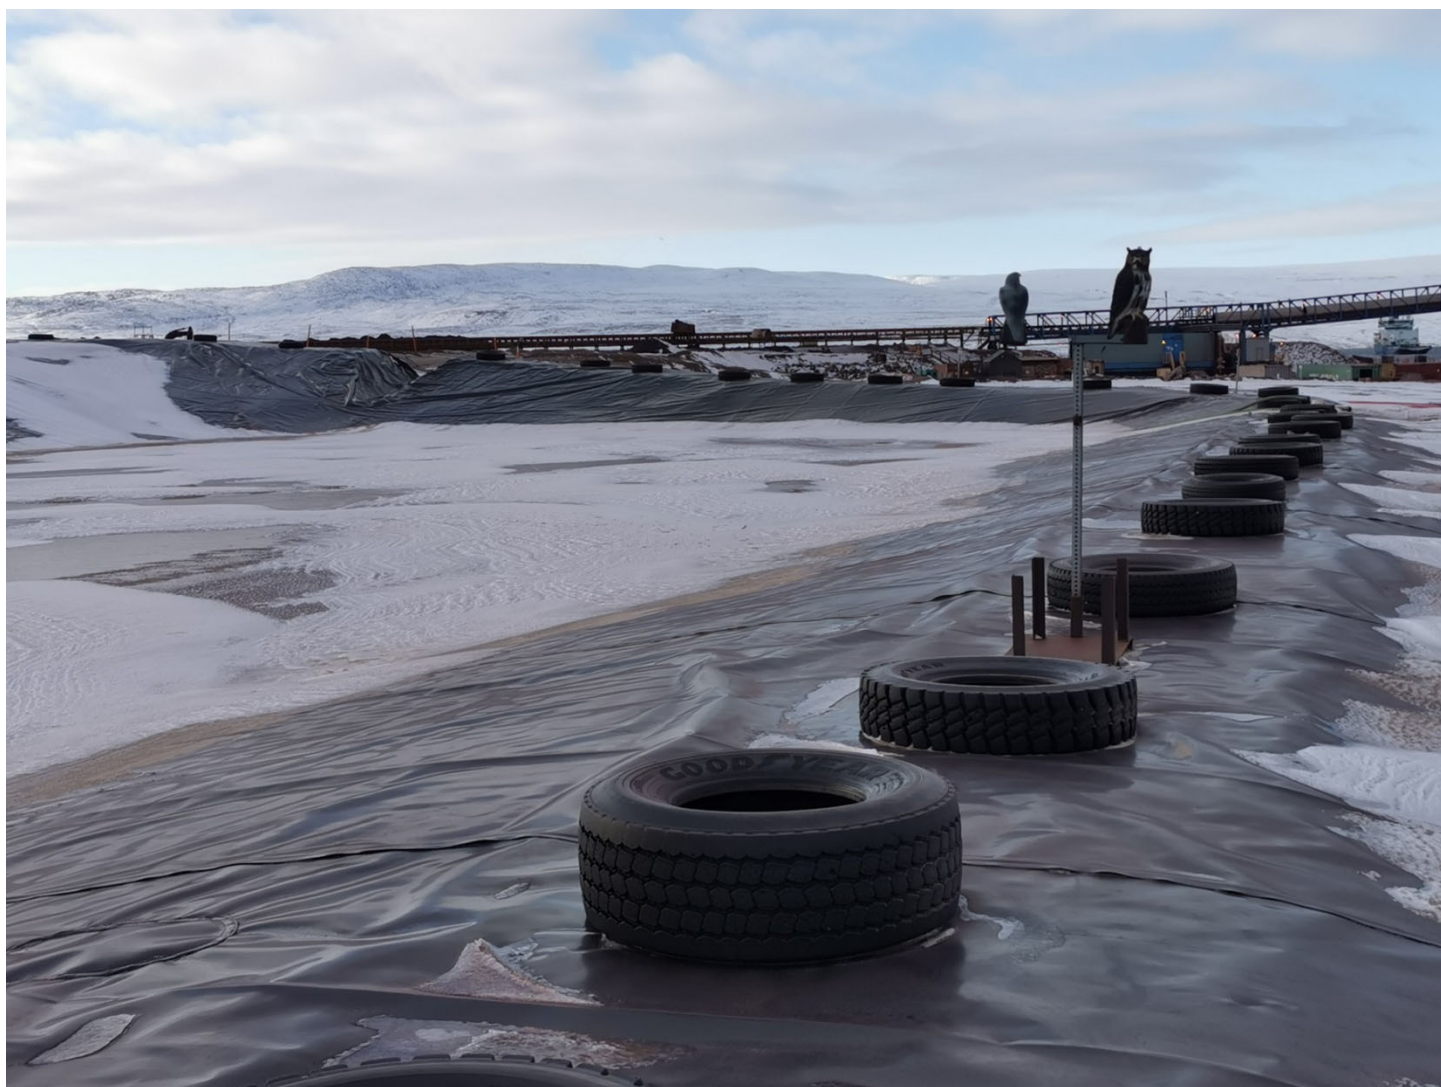
MP06 and MP05 sediment ponds

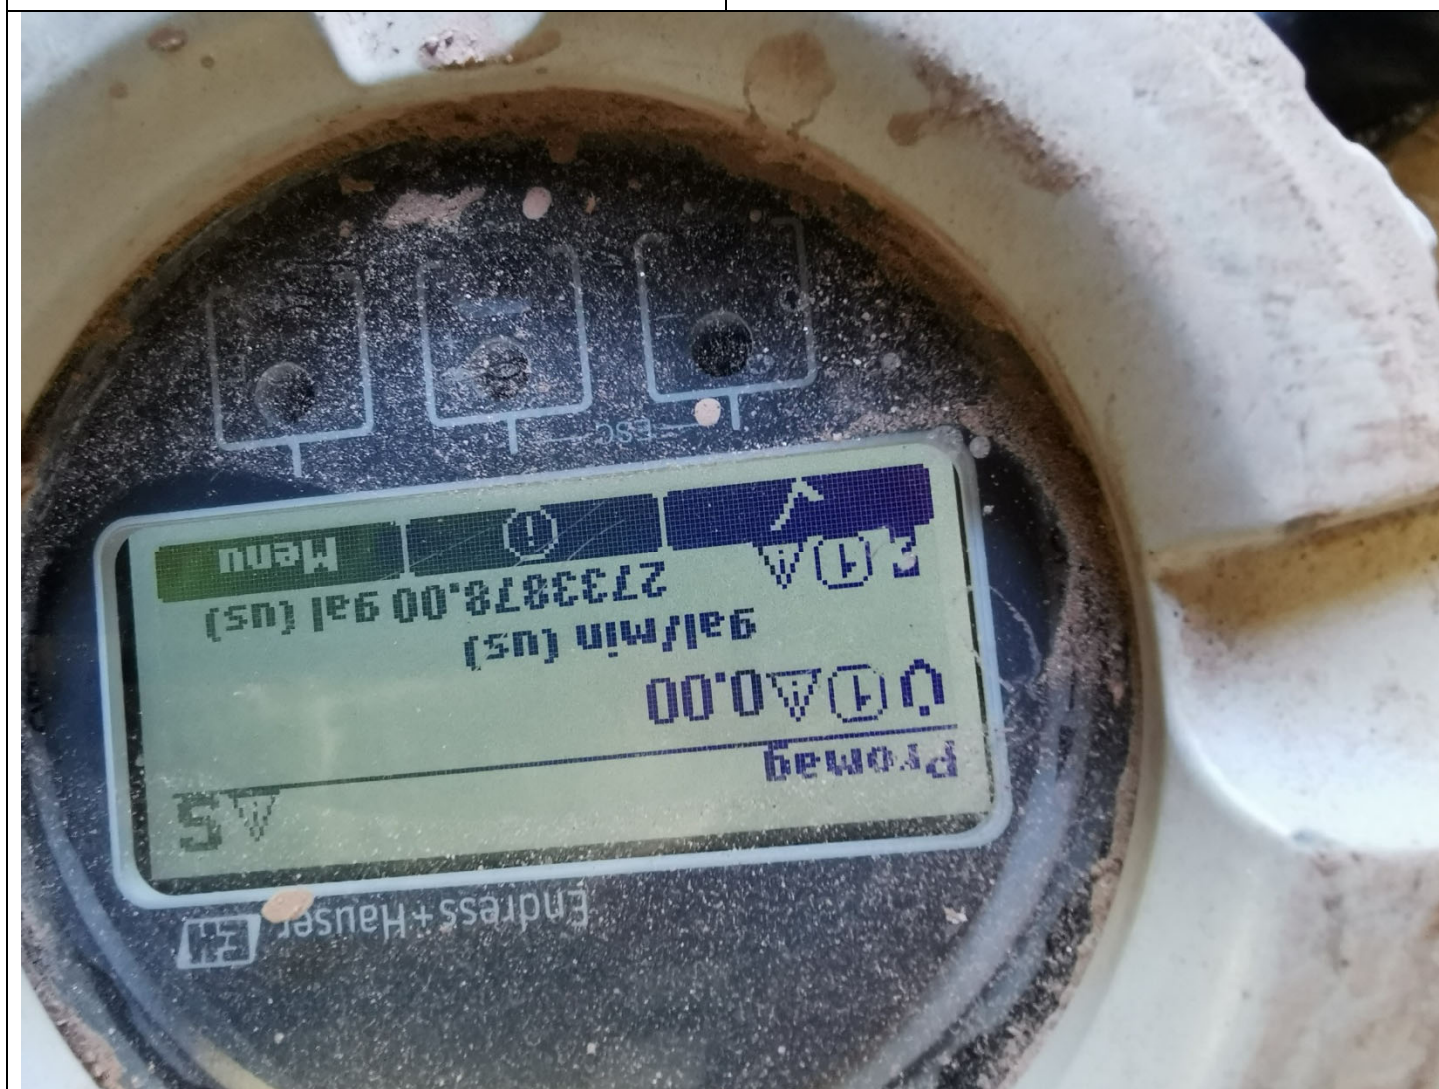
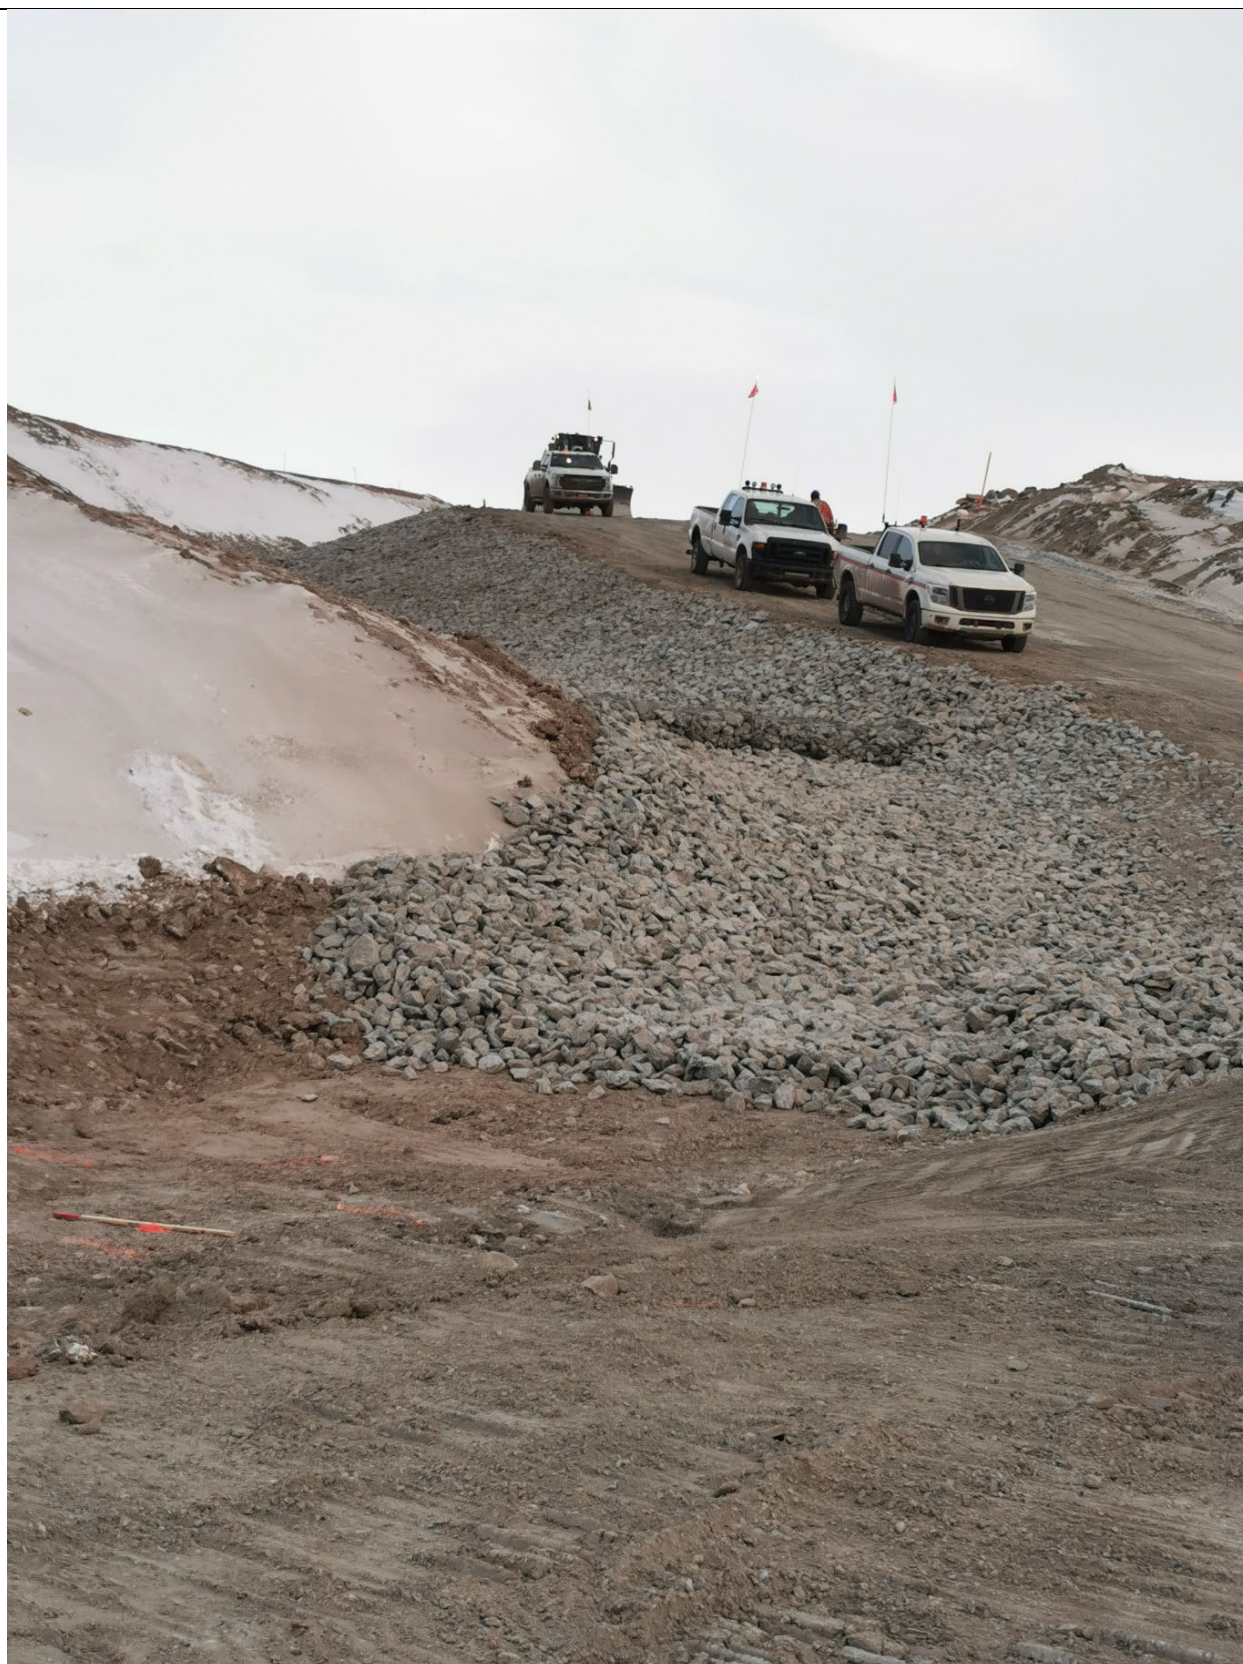
Photo No.5

Water meter (MR) and new construction

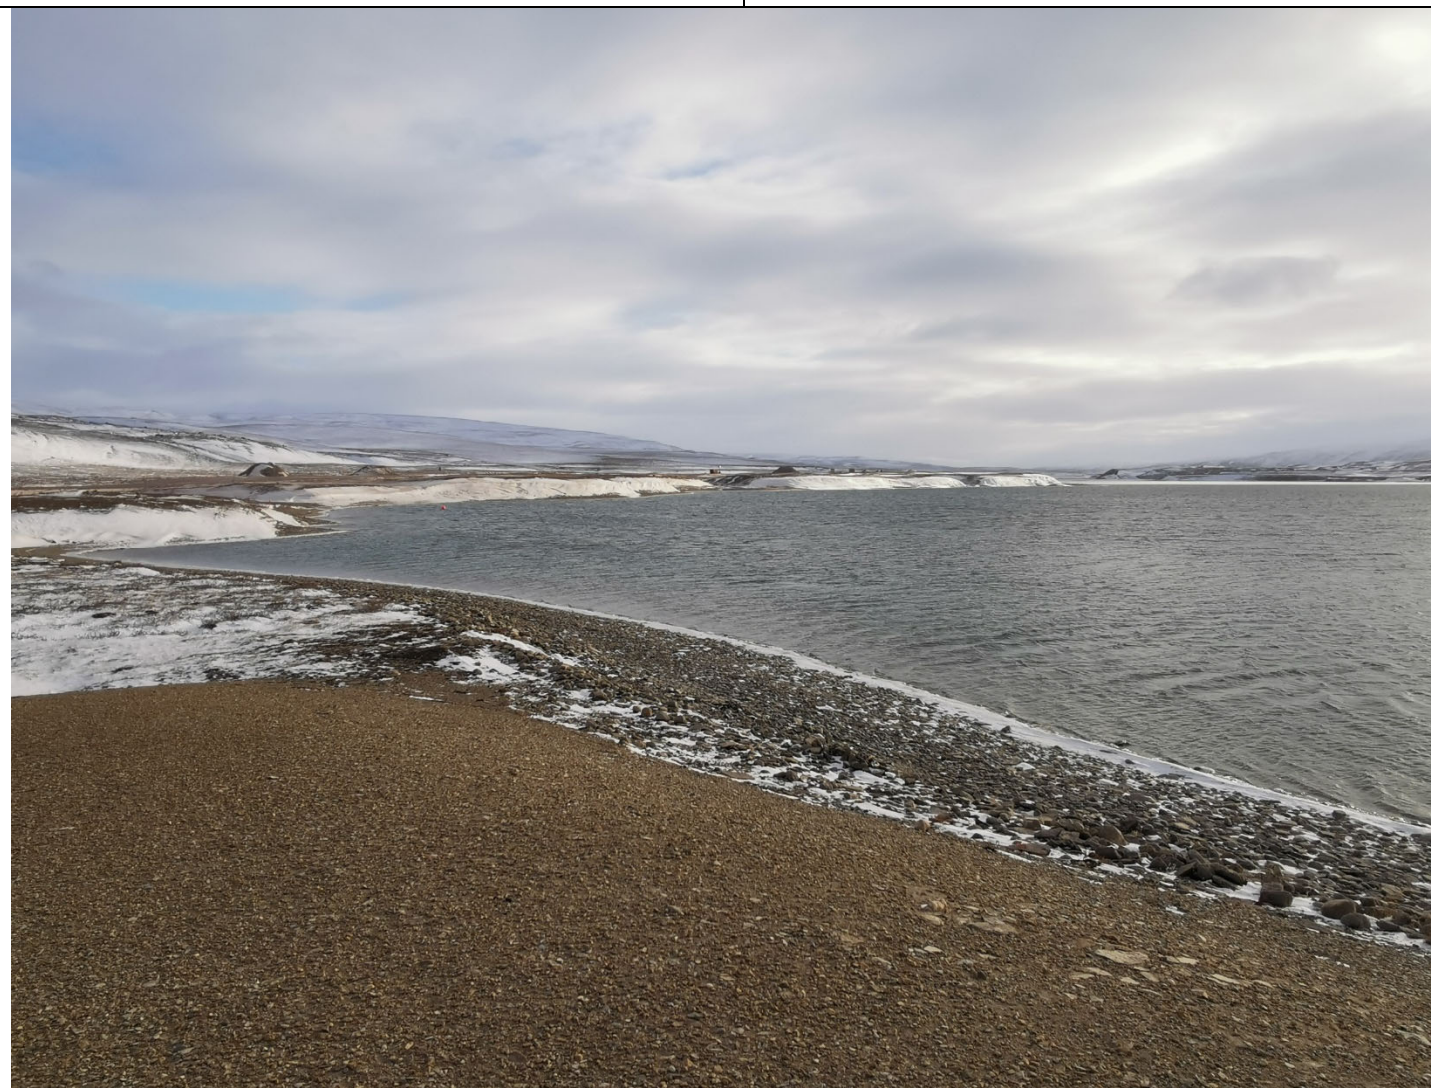
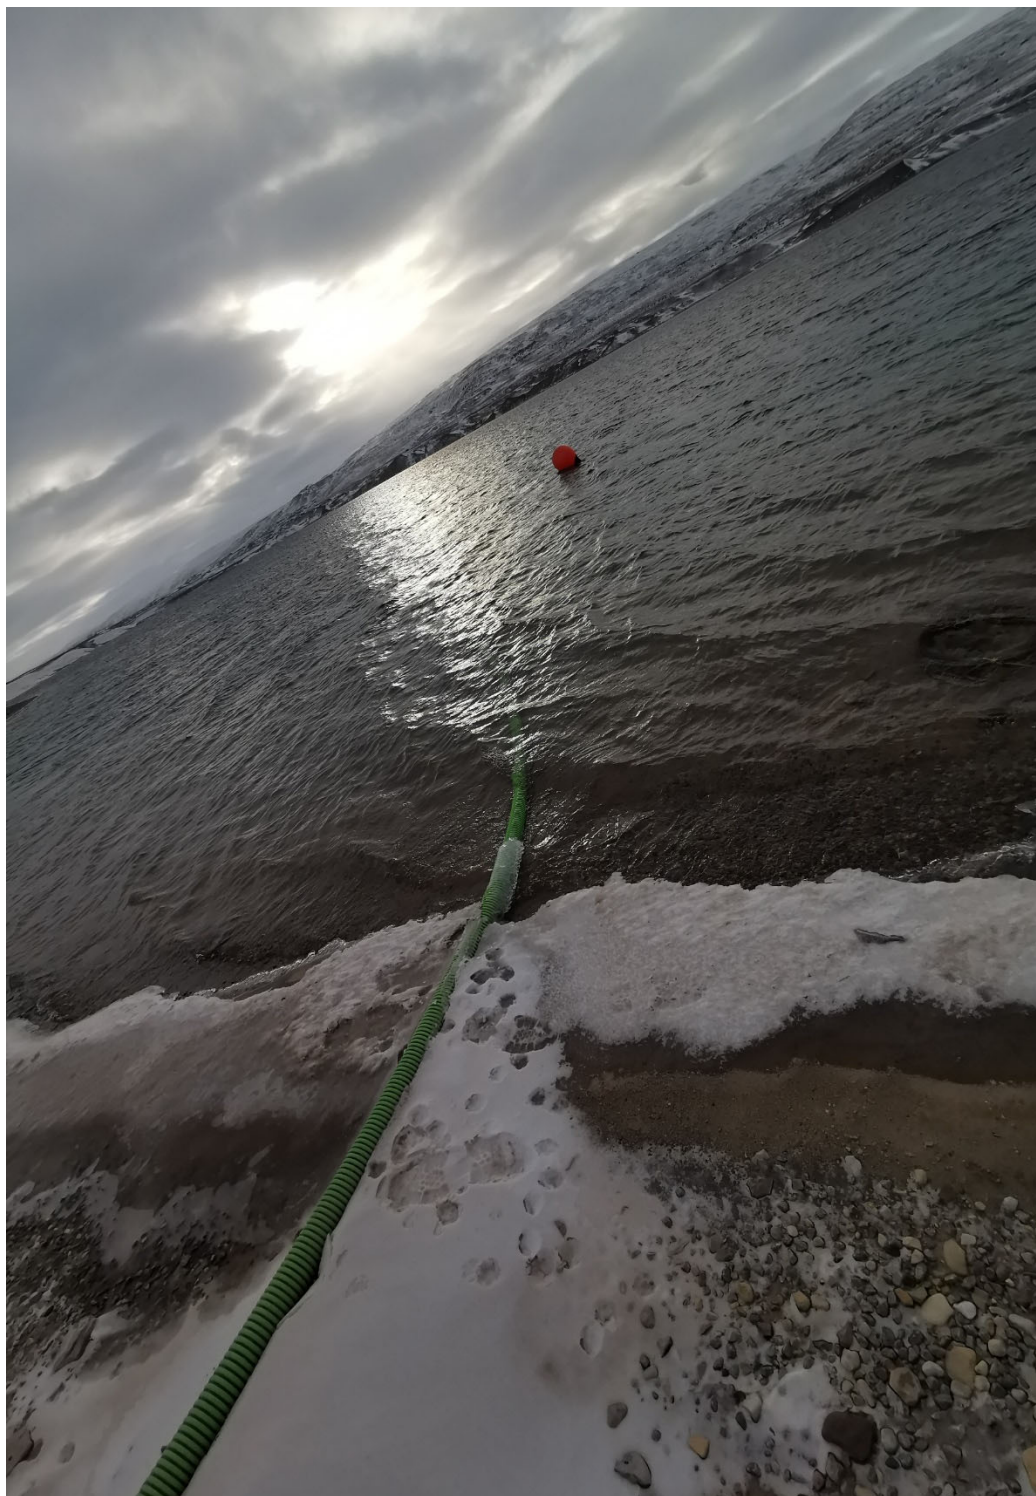
KM 34 water intake lake

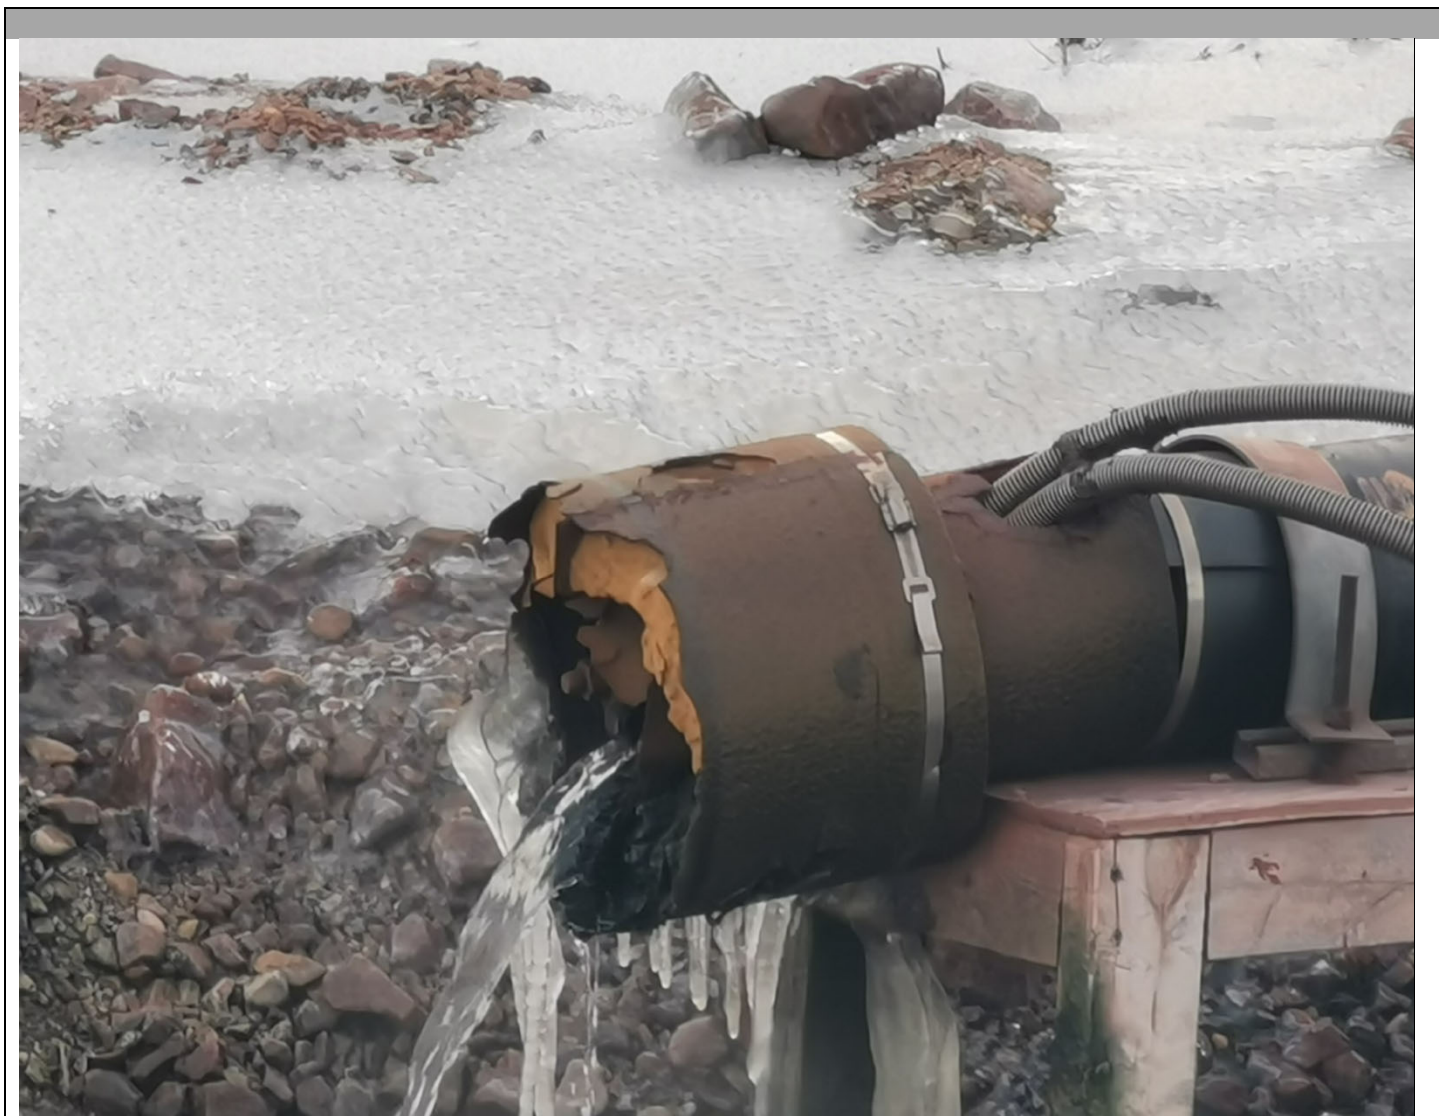
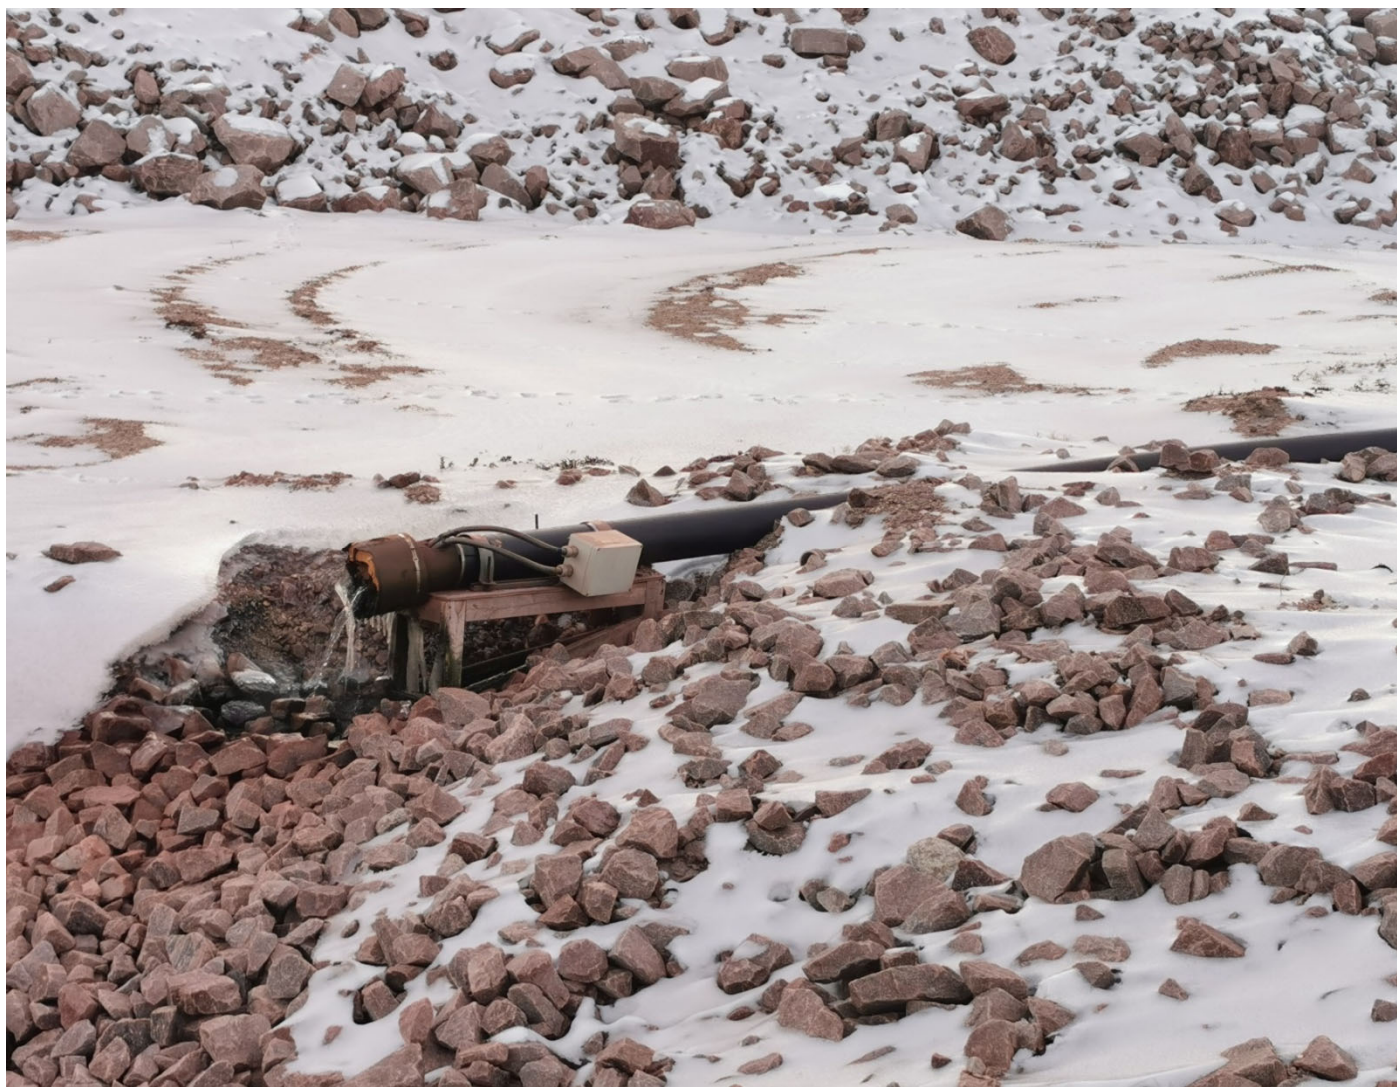
Effluent discharge pipe (MP)
