**Table D.5.1 Spill Report 16-202 and Update No. 1, Tote Road.**

**Table D.6 Construction of Ditches and Drainage System Around Milne Port Ore Stockpile**  
**Sequence of Events and Actions Taken**

**Table D.7 Impacted Snow Removal from Milne Beach and Tote Road Bridges**  
**Sequence of Events and Actions Taken**

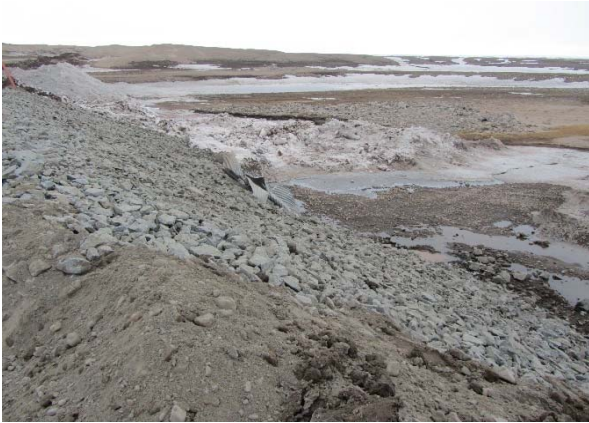
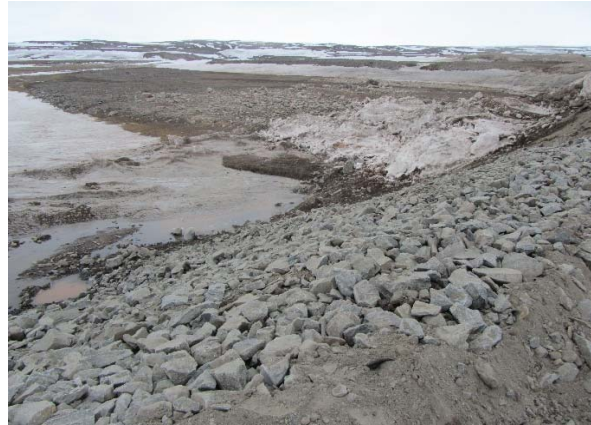
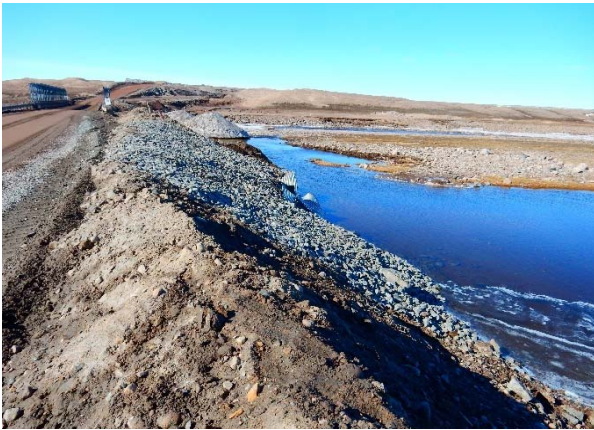
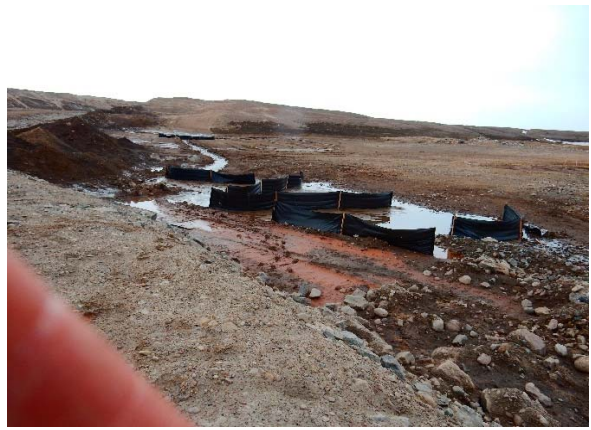
## km 97 - CV223

Constructed Drainage Controls Partially Implemented or Completed.

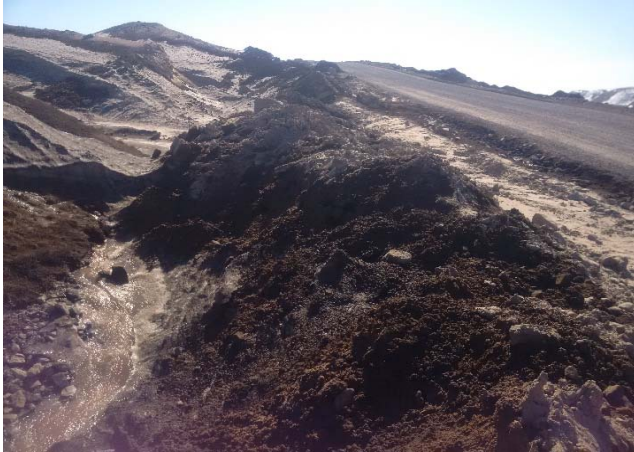
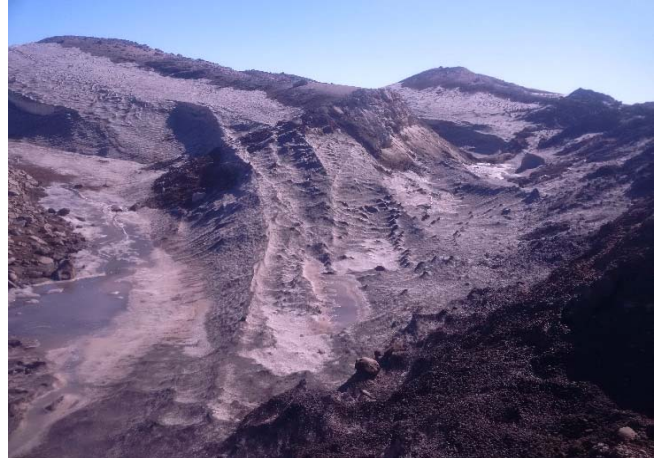
km 91.1

km 91 BG14	Ditching on in ditch and along embankment creating turbid water feeding creek to David Lake	Repair and reinforce check dam at upstream of CV. Excavate and backhaul excess fine sand to a location to be designated?	Check dam completed. Excess sand removed.

**Photos Prior to Construction of Drainage Controls**

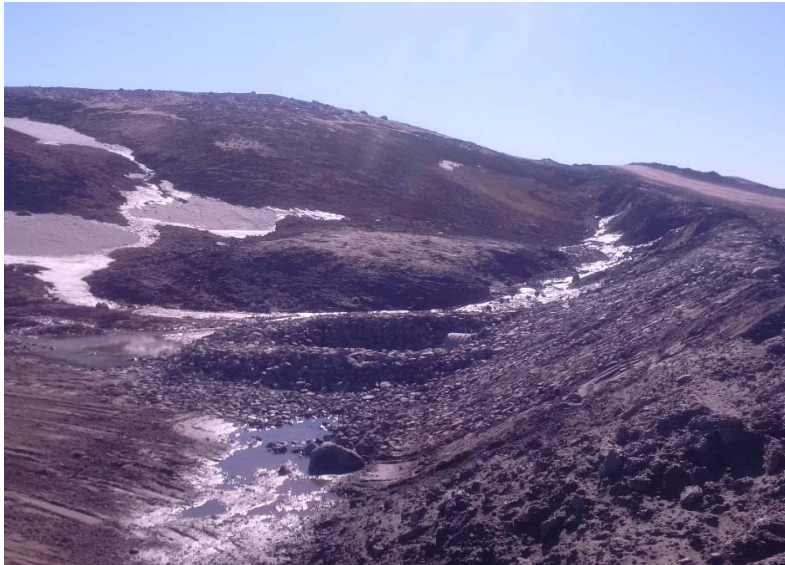
**Constructed Drainage Controls Partially Implemented or Completed.**

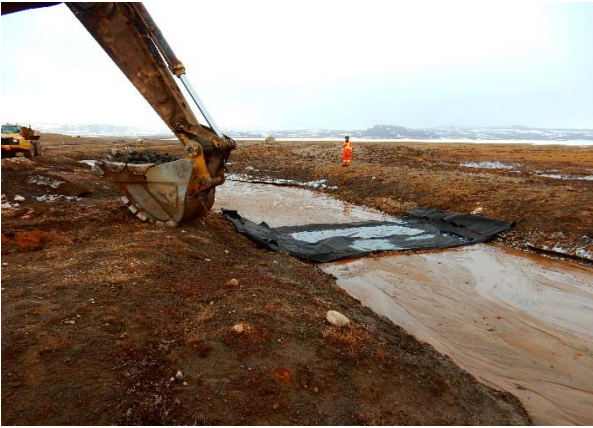
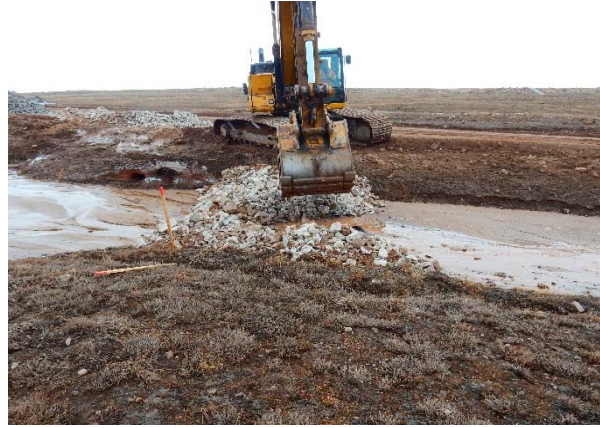
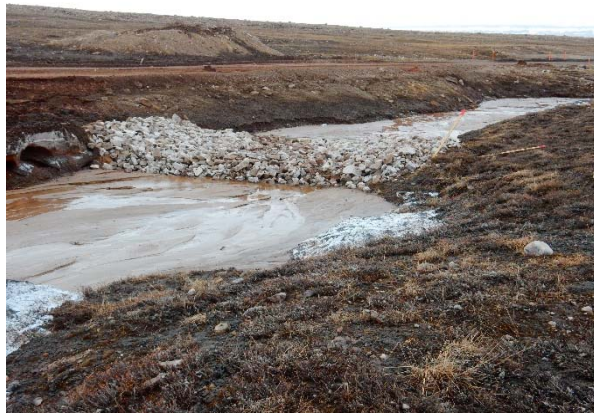
km 82.2

Constructed Drainage Controls Partially Implemented or Completed.

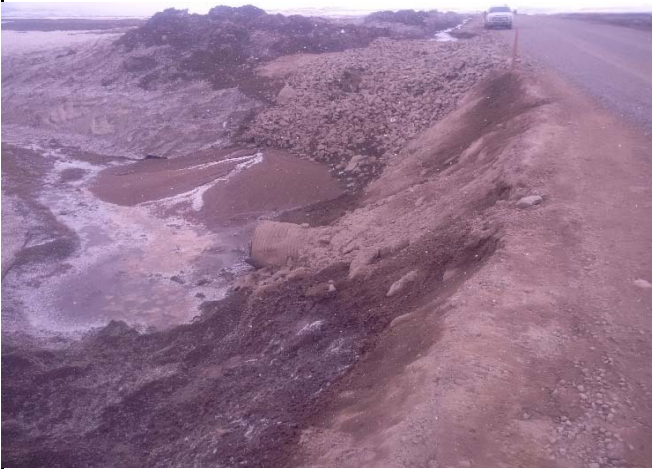
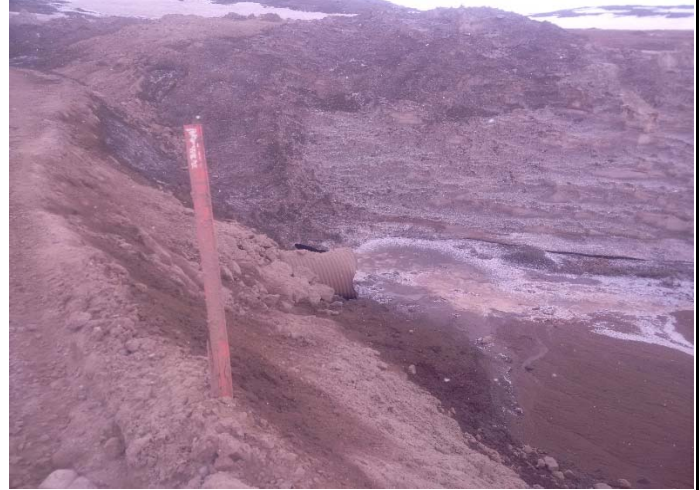
## km 96 - CV224

Photos Prior to Construction of Drainage Controls

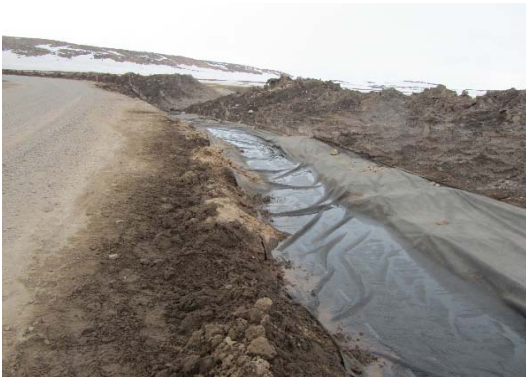
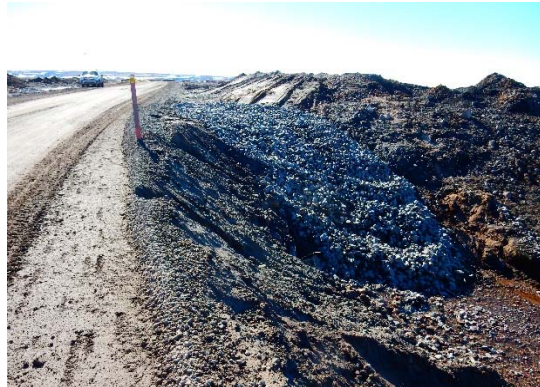
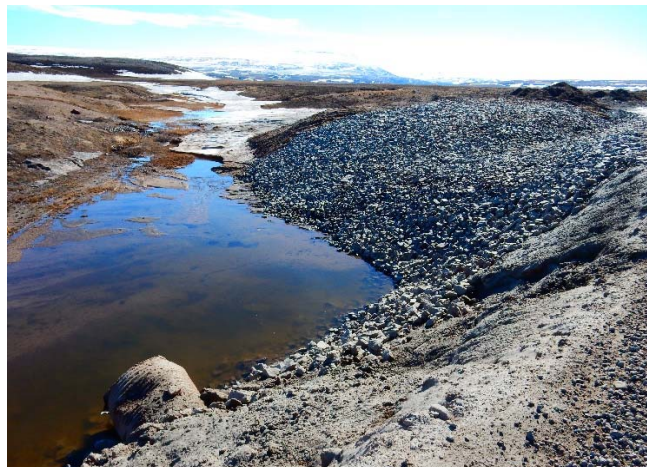
Constructed Drainage Controls Partially Implemented or Completed.

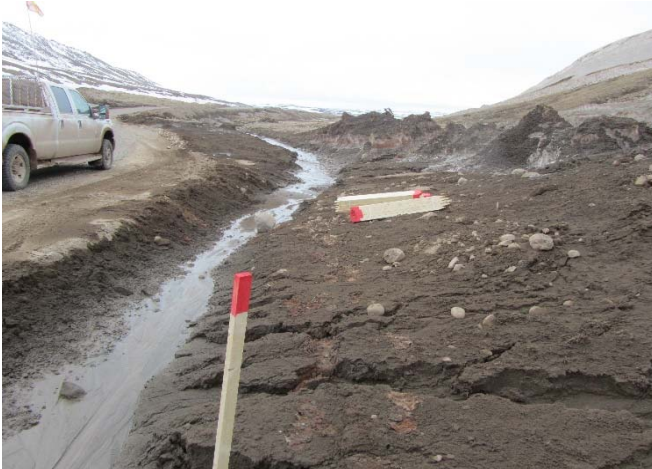
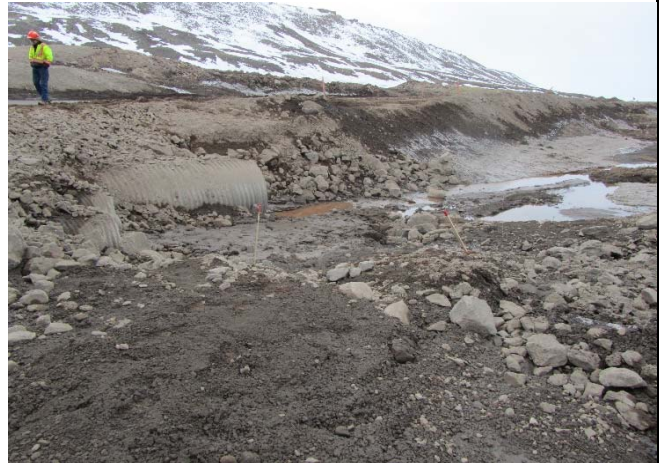
## km 90 - BG17

### Photos Prior to Construction of Drainage Controls

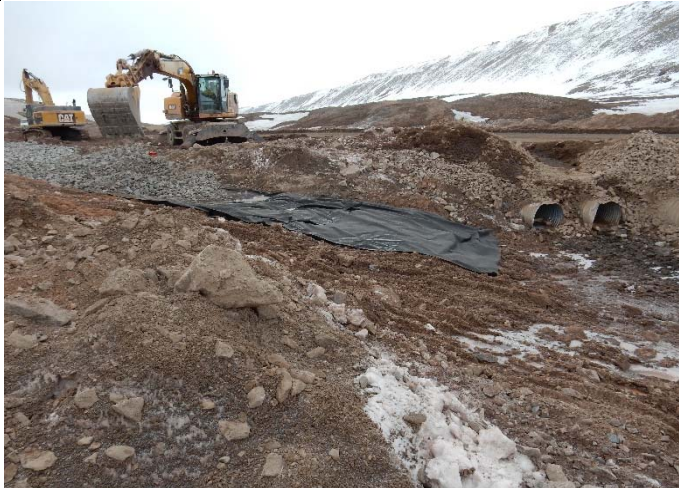
### Constructed Drainage Controls Partially Implemented or Completed.

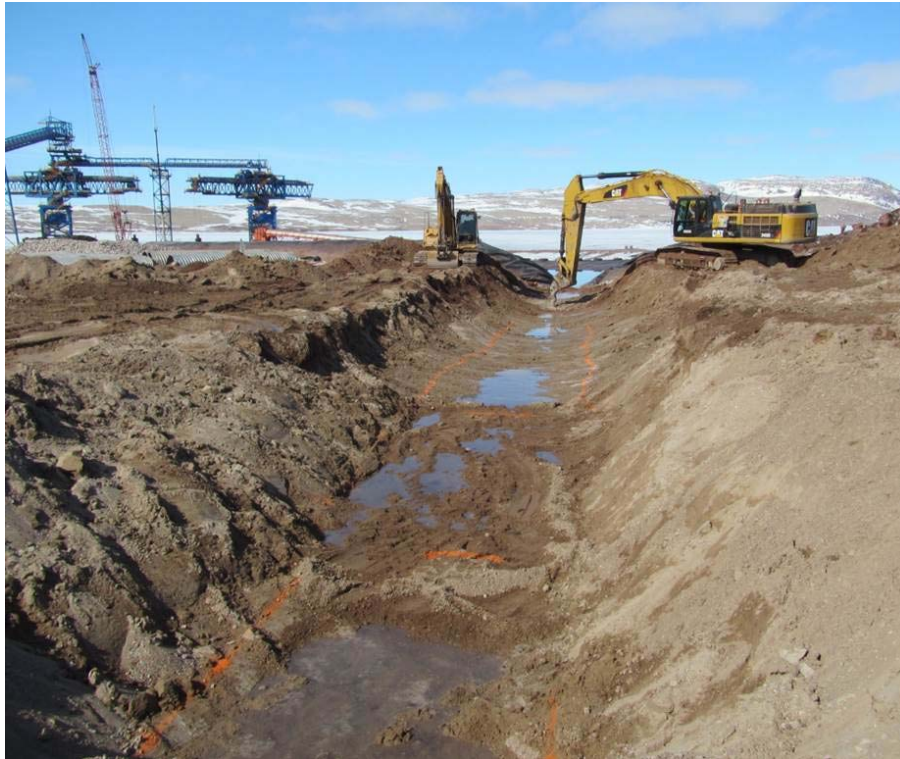
Photo 1 – June 6 2016.

Prior to May 20	Ongoing monitoring of surface water adjacent to the ore stockpile to ensure that there was no adverse impacts due to surface water runoff or seepage.
May 20	Environment Canada and INAC inspectors notify Baffinland that directions under the Fisheries Act will be issued to the Company due partially to the incomplete drainage works around the Milne Ore Stockpile Facility and the Mine Crusher Stockpile Area and Crusher Ore Pad. Written Direction provided June 7. INAC letter of non-compliance received on June 16.
May 23	Document provided to Environment Canada and INAC Inspectors: Milne Stockpile Pad Water Drainage System – Excecution Plan and Schedule. Completion date of July 17.
May 24 to present	Silt fences and silt curtain installed along SDLT immediately downstream of Mine Haul Road discovered sedimentation sources. The drainage system ditches are functionally operational by June 7.

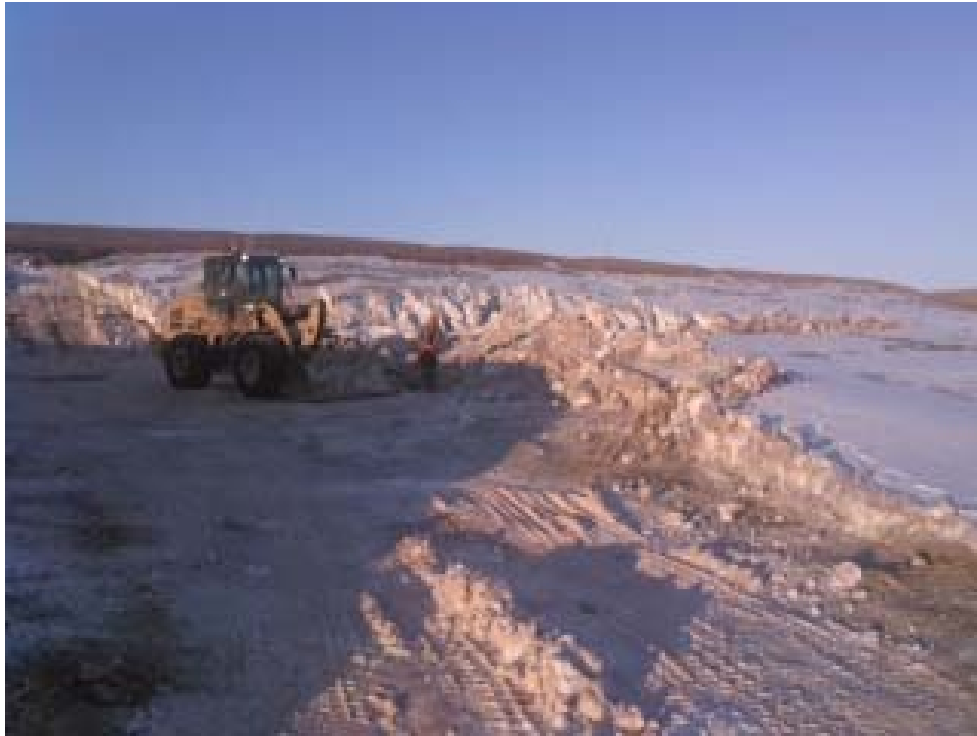
Photo 1 – May 20-21 2016.

May 20	Environment Canada and INAC inspectors notify Baffinland that directions under the Fisheries Act will be issued to the Company. One of the items of concern was dirty snow west of the Ore Loader at Milne and on/under bridges on the Tote Road.
May 21-23	Dirty snow removed from Milne Beach using Loader.
May 21 - 25	Crews mobilized to clean under bridges on Tote Road. Effort is partially successful by hampered by warmer temperatures and soft slushy conditions which posed safety hazard.

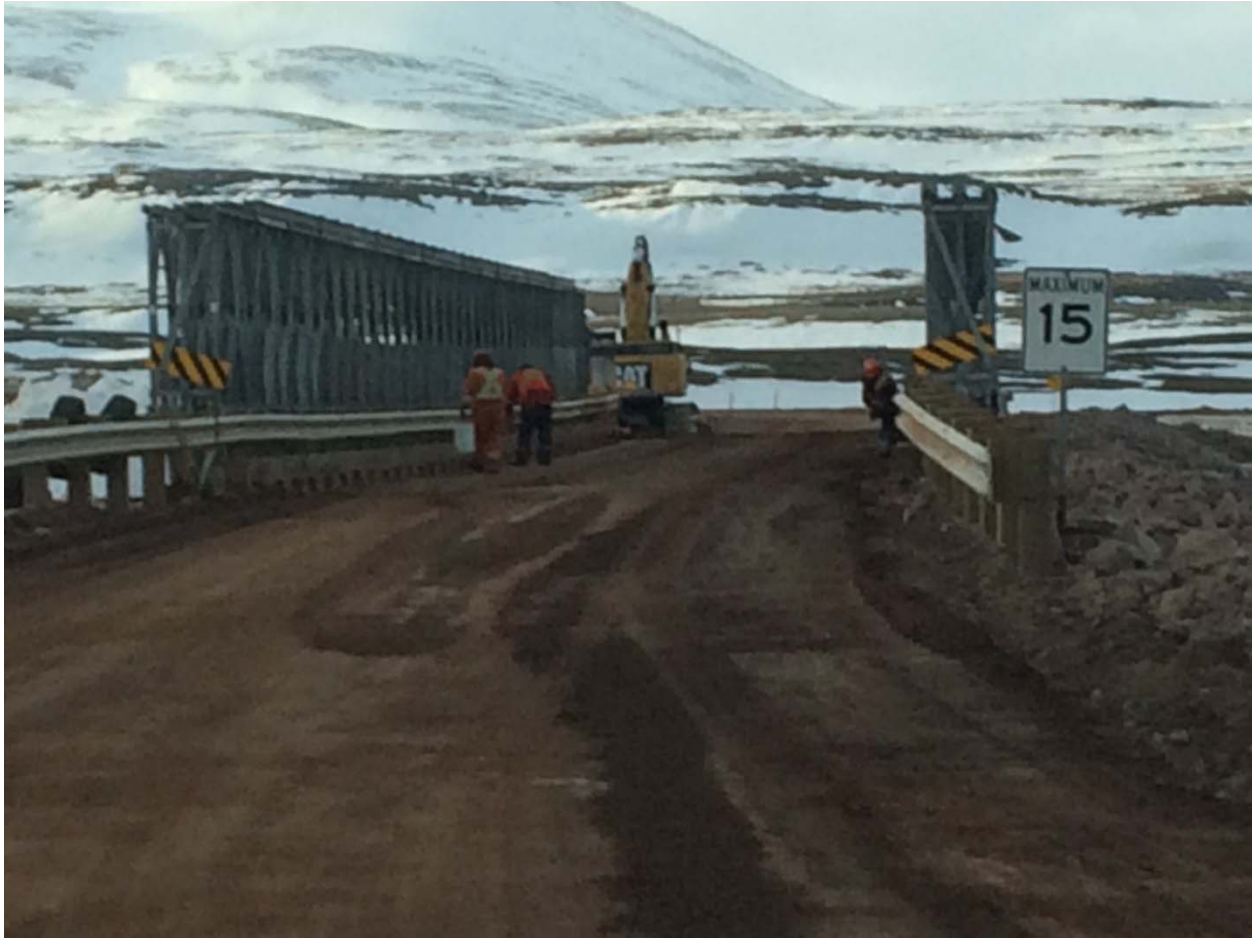
Photo 5 – May 21 2016.

**Photos of removal of Dirty Snow Material from Bridge Km17**
