## **Appendix C**

### **Sequence of Events and Actions Taken by Spill Report and Other Concerns (With Photos)**

## Appendix C.1 - Spill Report 16-158 - Sheardown Lake Tributaries and Sheardown Lake

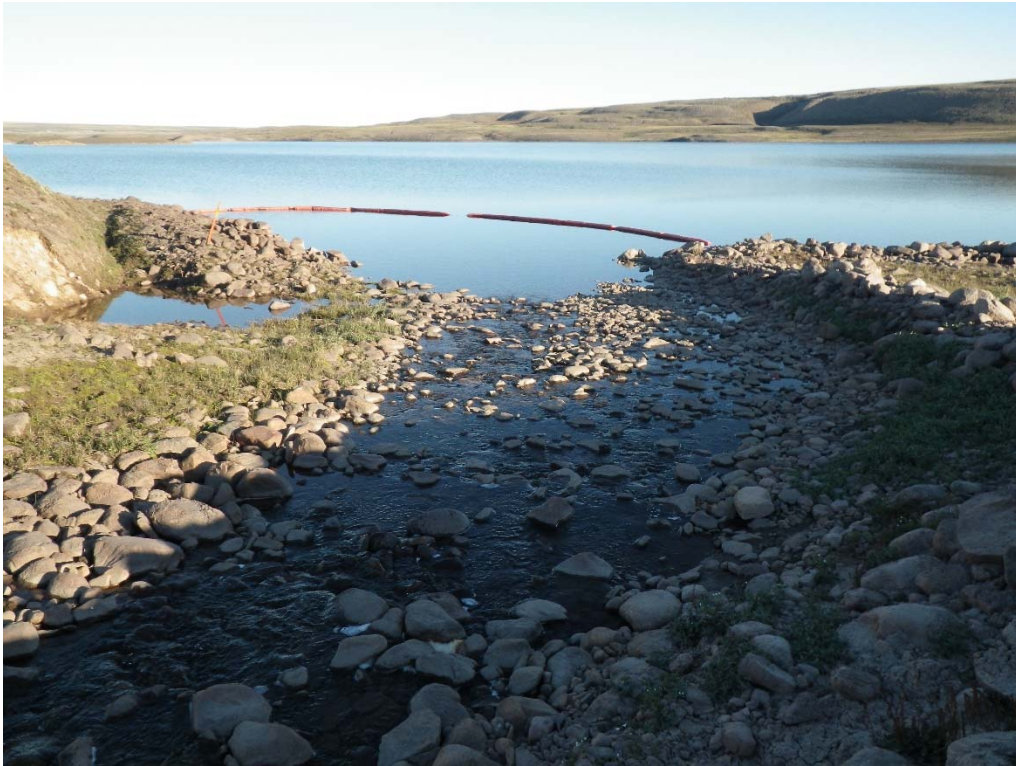
Photo 1 – Outlet at Sheardown Lake Tributary on July 4, 2016

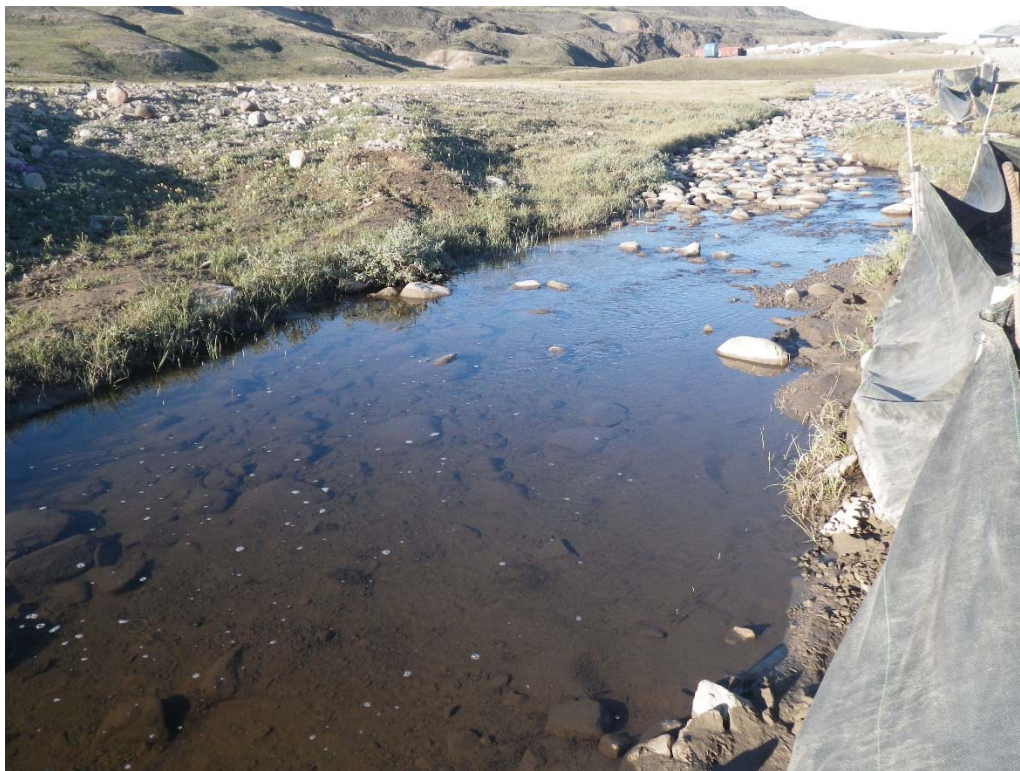
Photo 2 – Sheardown Lake Tributary upstream of CV186 on July 4, 2016

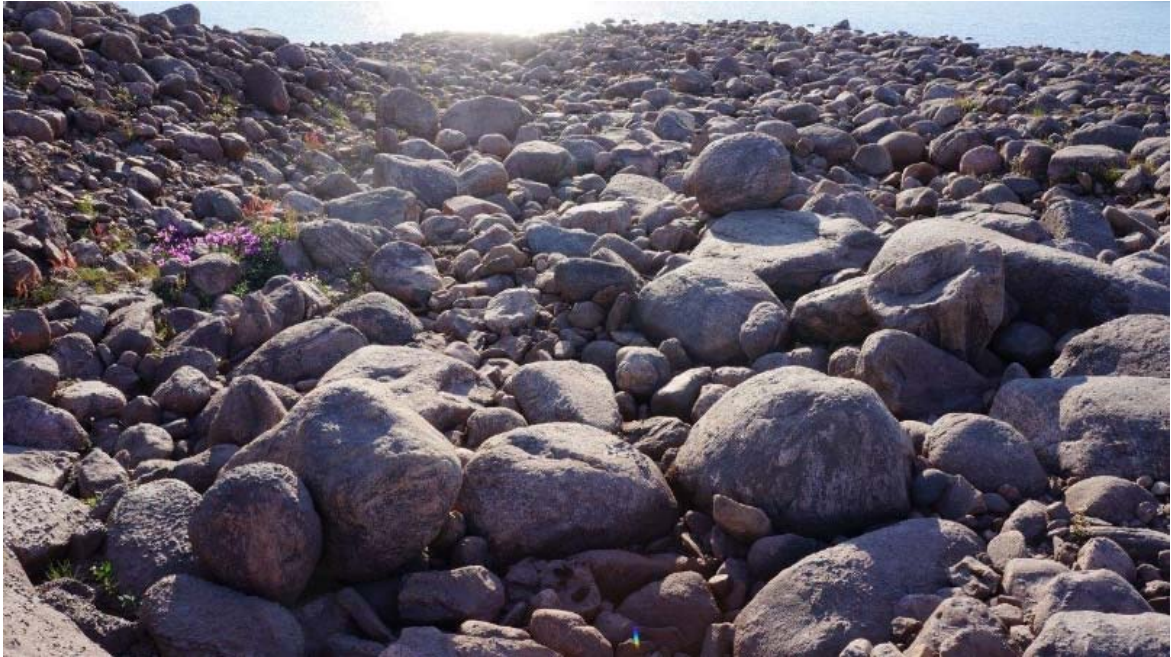
Photo 3 – No flow conditions at Landfill Gate Tributary on July 7, 2016

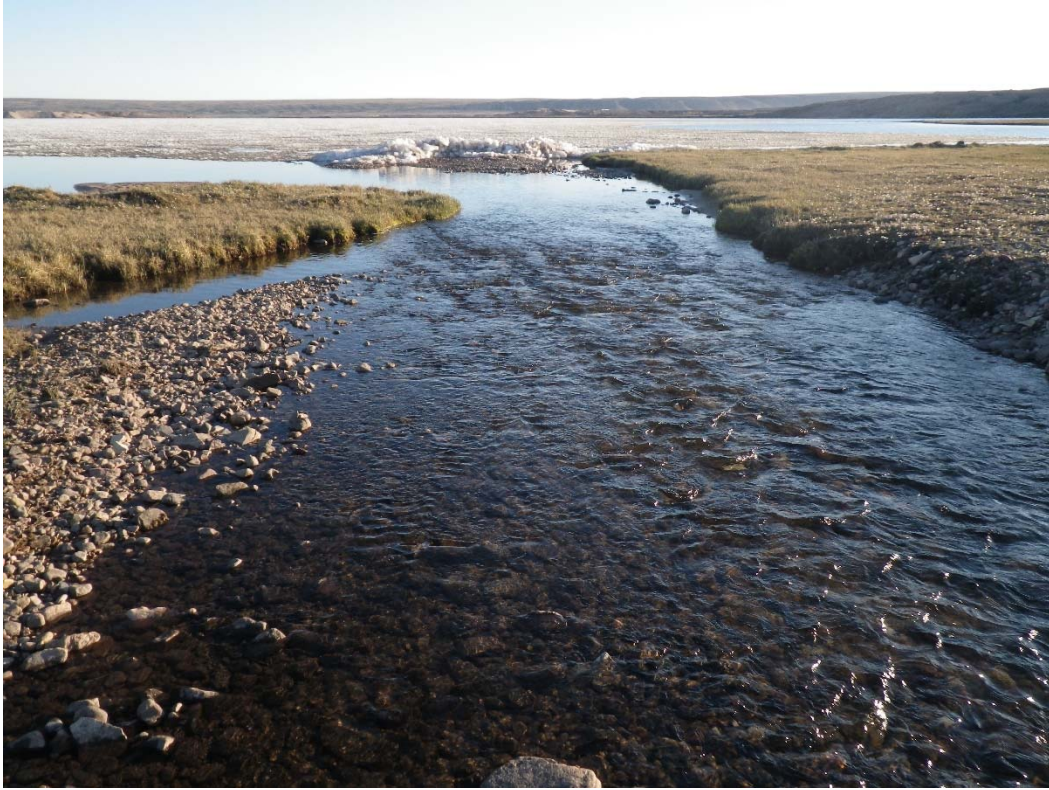
Photo 1 –Outfall to Camp Lake Tributary #1 on July 4, 2016

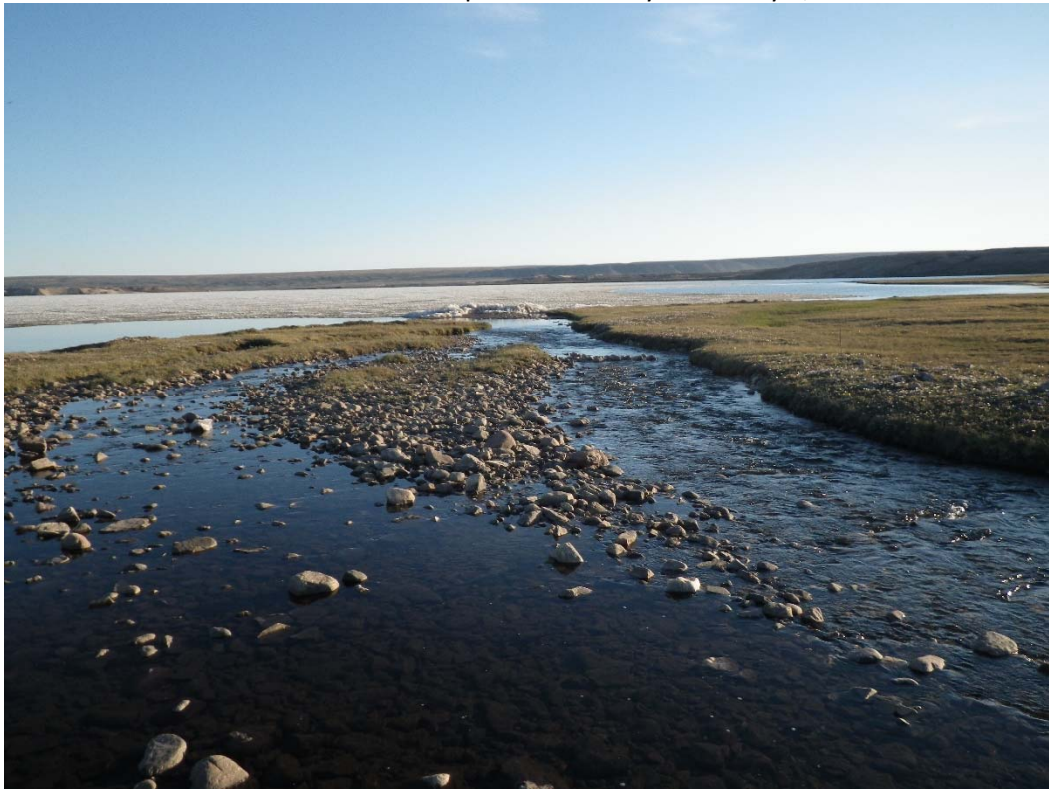
Photo 2 – Camp Lake Tributary #1 on July 4, 2016

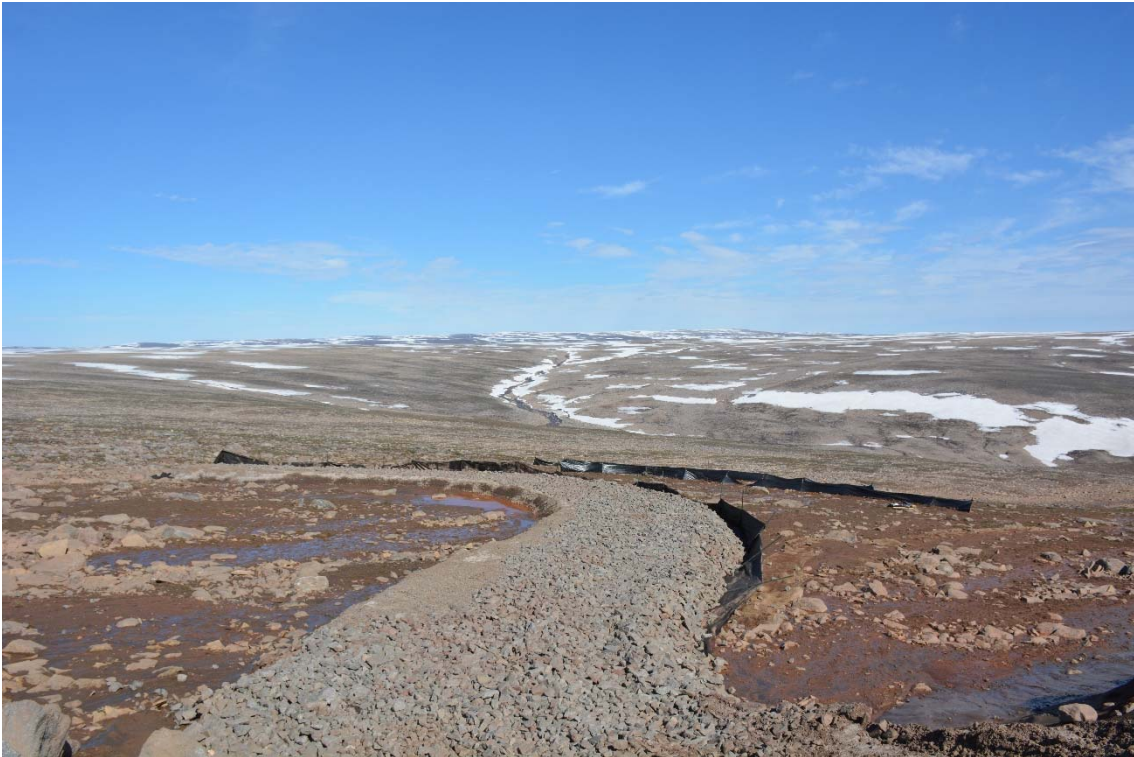
Photo 1– Checkdam #5 constructed at Km 108.5. Picture taken on July 5, 2016.

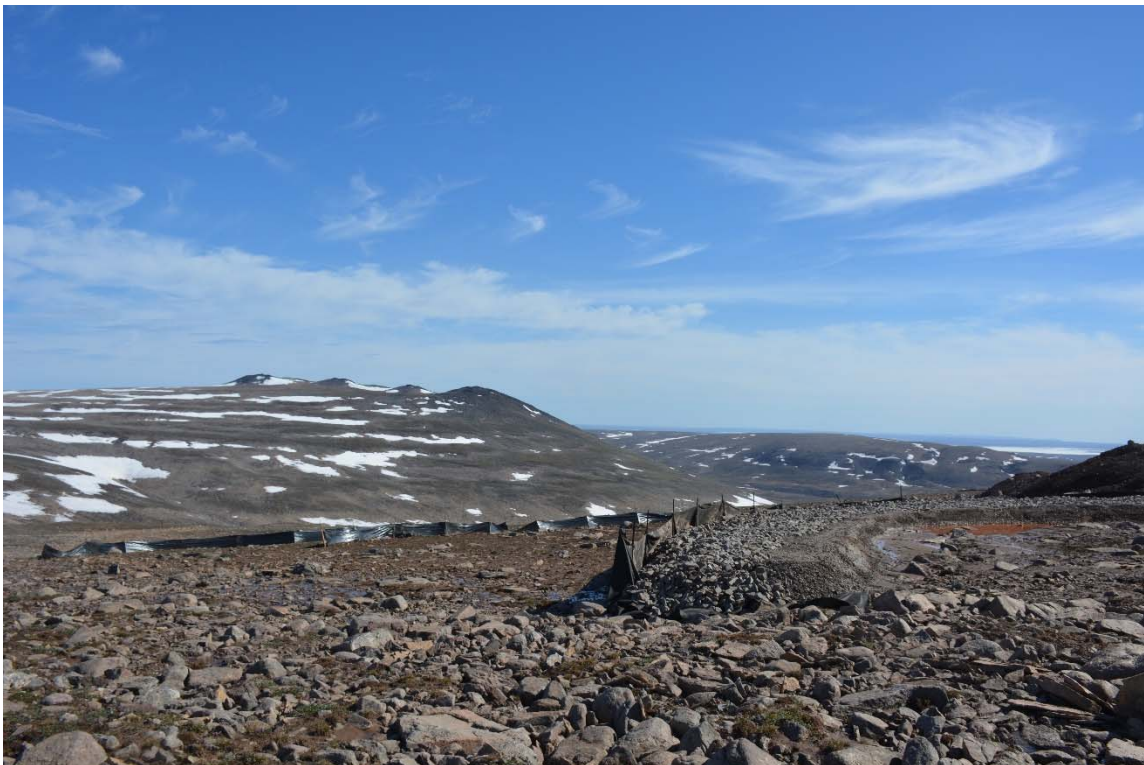
Photo 2 – Silt Fences and Checkdam #5 at Km 108.5. Picture taken on July 5, 2016.

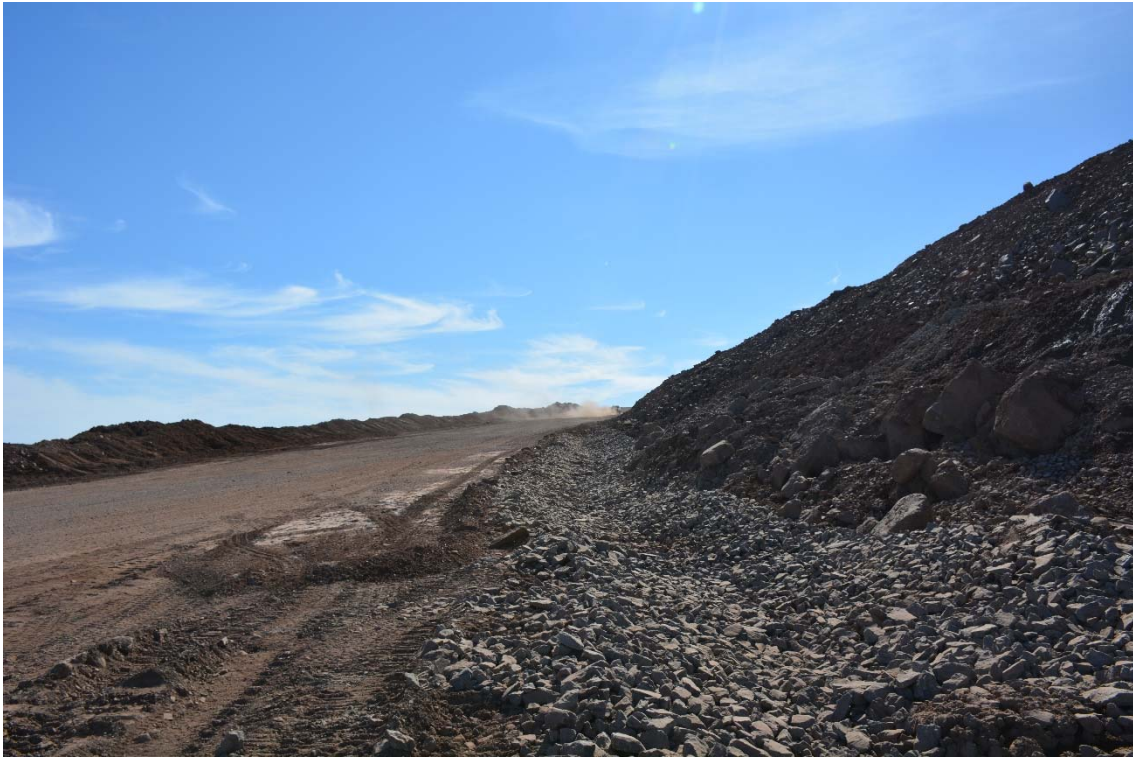
Photo 4 - New ditch with geotextile and rip rap up from Km 108.5. Picture taken on July 5, 2016

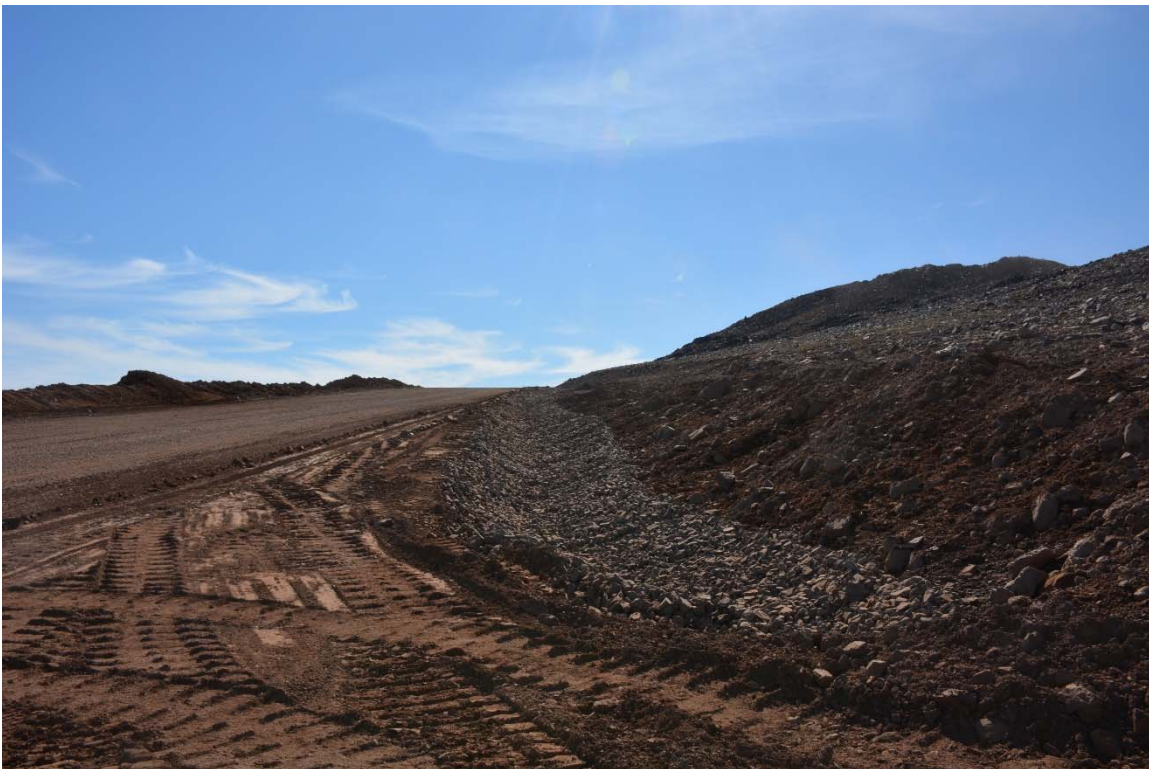
Photo 4 - New ditch with geotextile and rip rap at downhill from Km 108.5. Picture taken on July 5, 2016

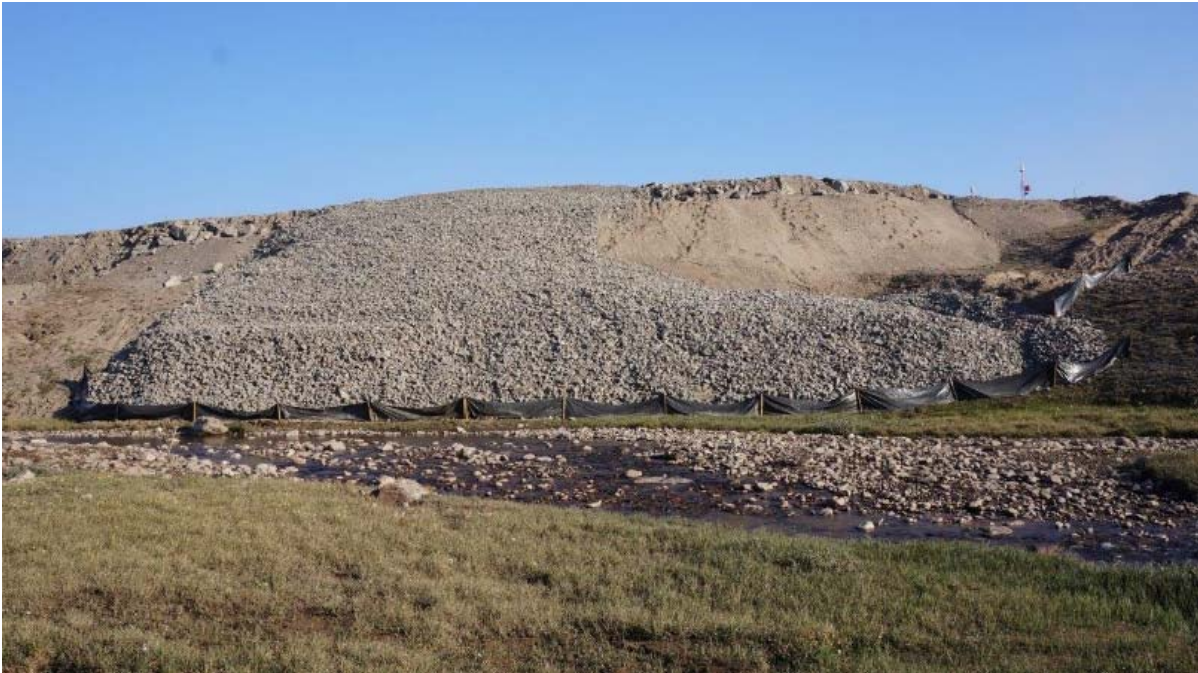
June 25 - July 8	Area of slumping remains stable over the reporting period.

Photo 1 – Update on stable slope face by Camp Lake Tributary #1. Picture taken on July 7, 2016

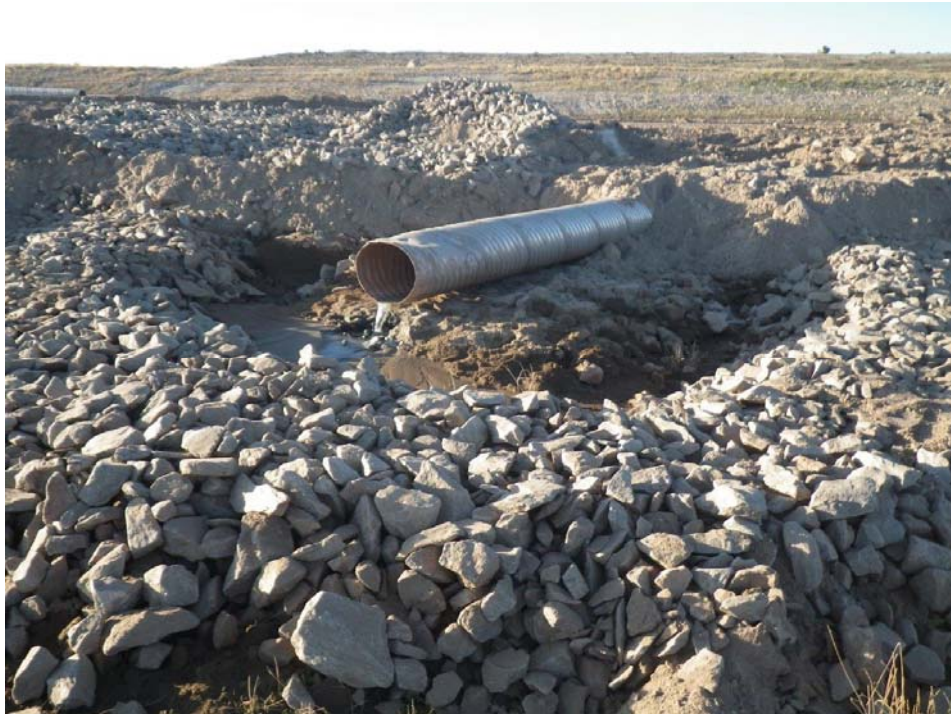
Photo 1 – BG-31. New culvert installation at Km 82 reduces siltation downstream

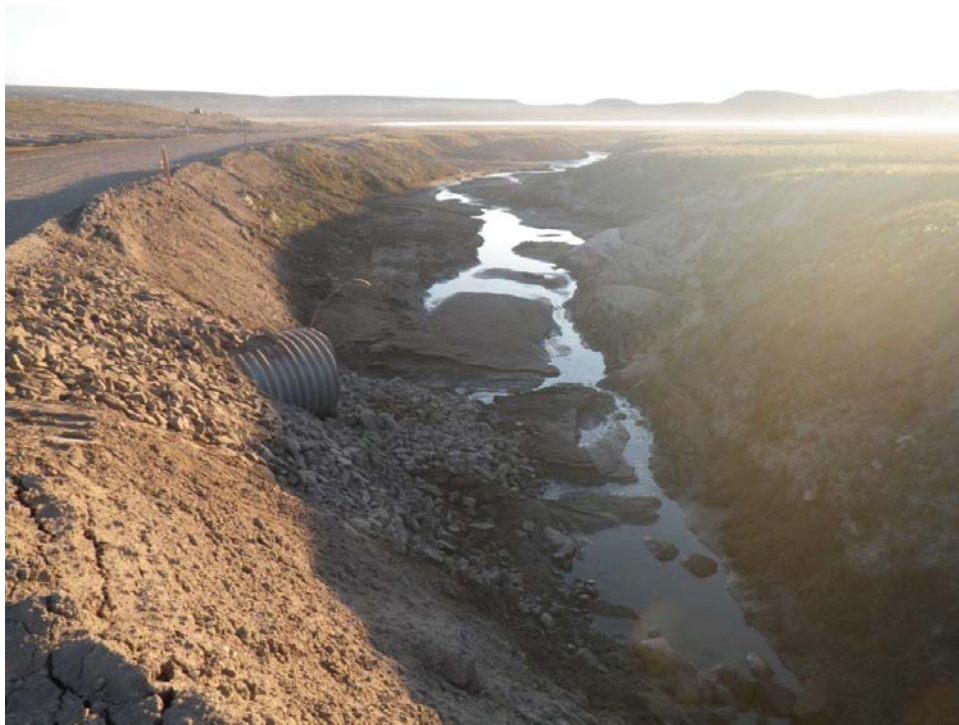
Photo 2 – BG -31 flowing clear downstream of culvert

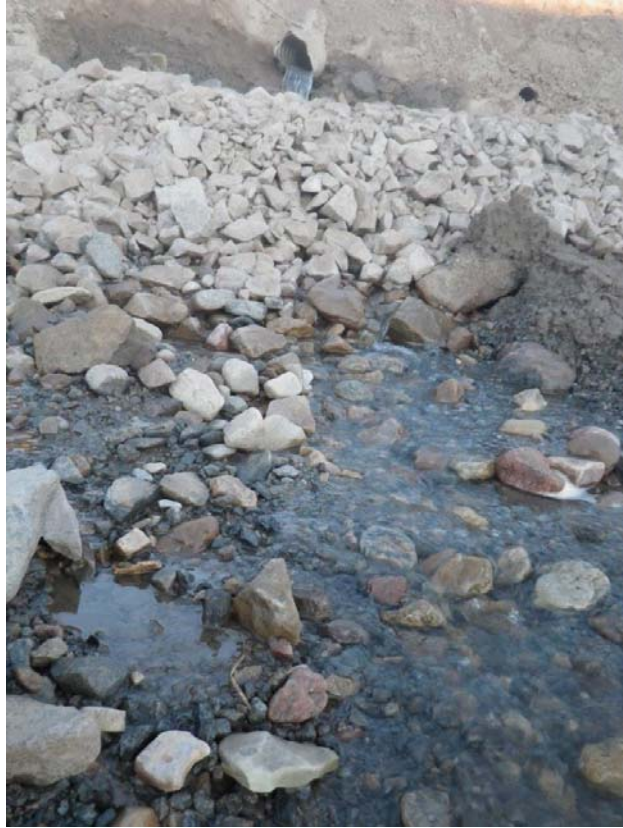
Photo 3 – BG-28 flowing clear at Km 86.5.

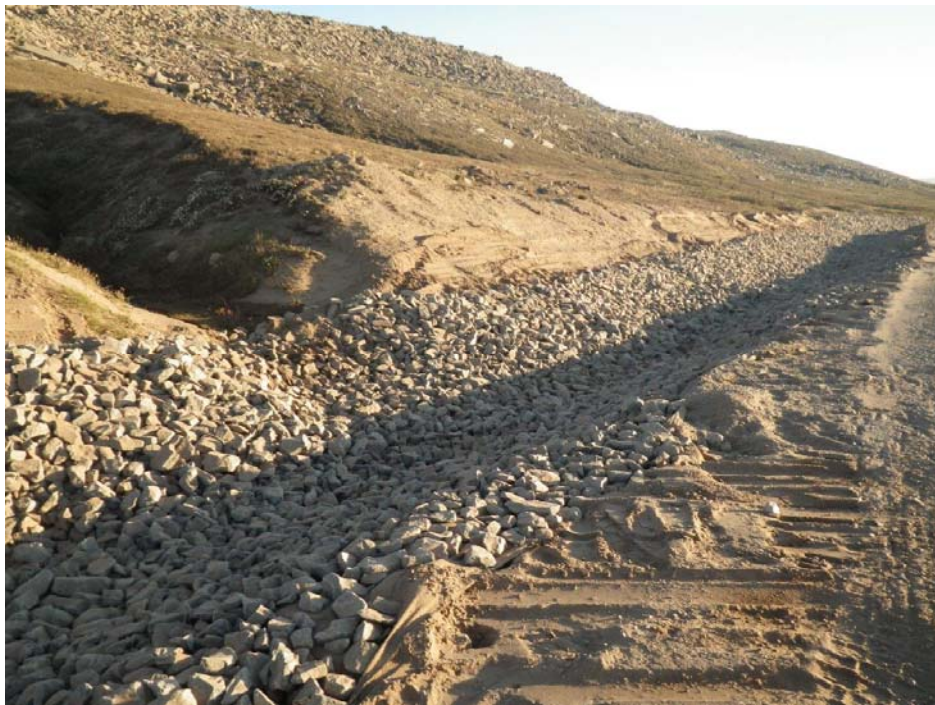
Photo 4- Rip rap in ditch at Km 85

85.25-85.35	Surface water flow through excavated ditch of fine sand contributig to turbidity in downstream drainages.	Ditch fully lined with geotextile and riprap for the entire length.	Completed

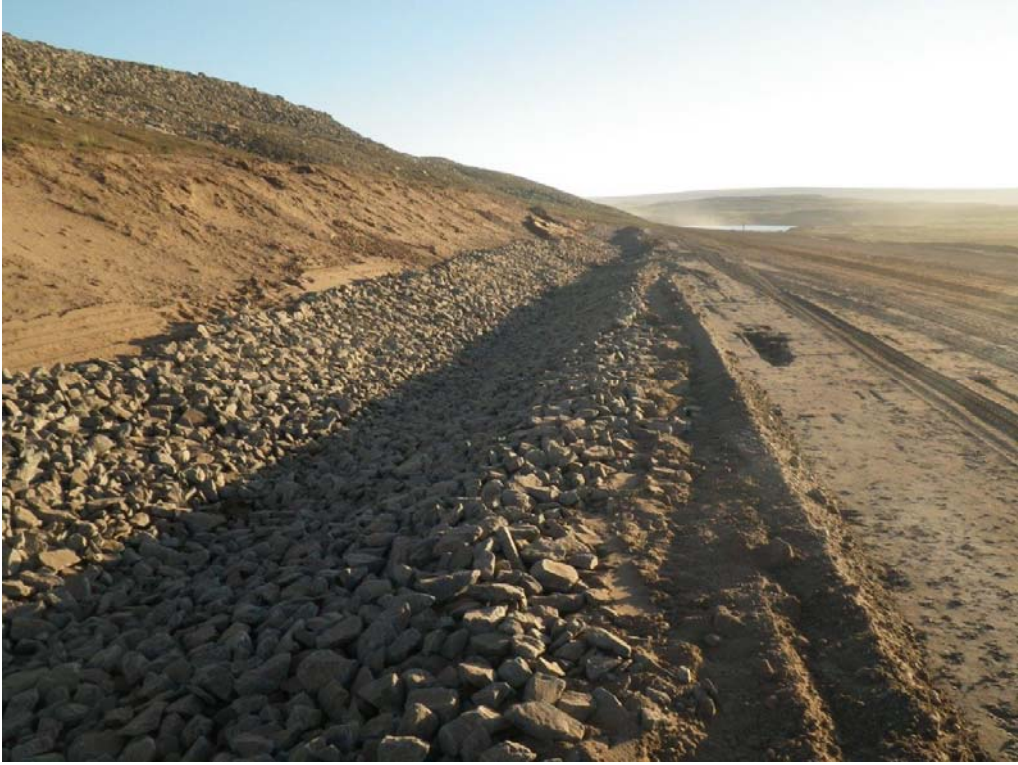
Photo 5: Rip rap in ditch at Km 85
