Appendix C

Sequence of Events and Actions Taken by Spill Report and Other Concerns (With Photos)

Appendix C.1 - Spill Report 16-158 - Sheardown Lake Tributaries and Sheardown Lake

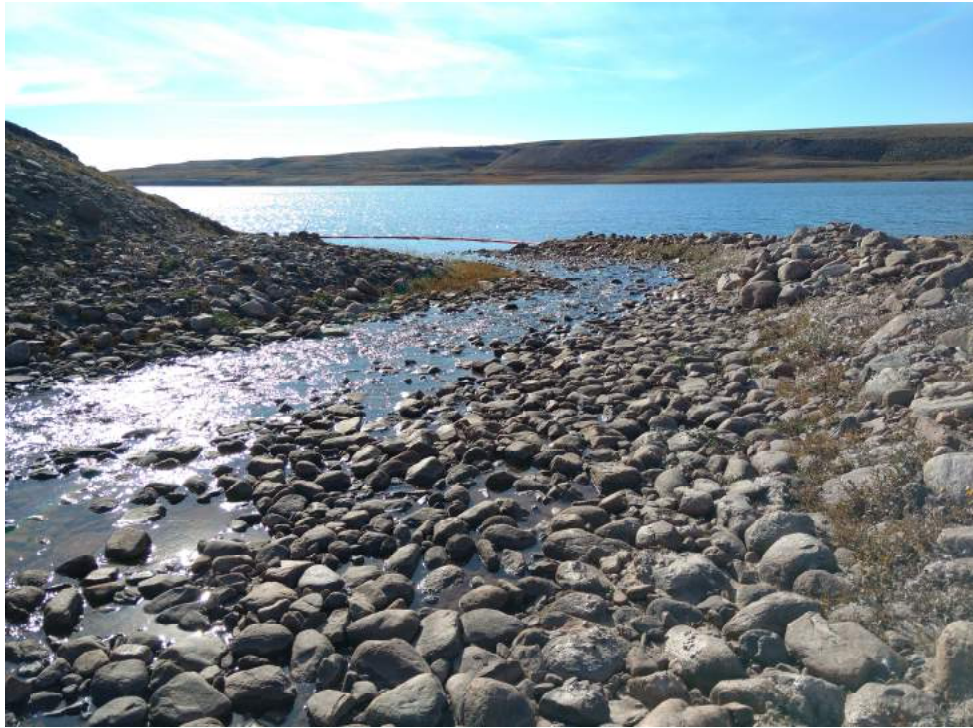
Photo 1 – Outlet at Sheardown Lake Tributary on August 29, 2016

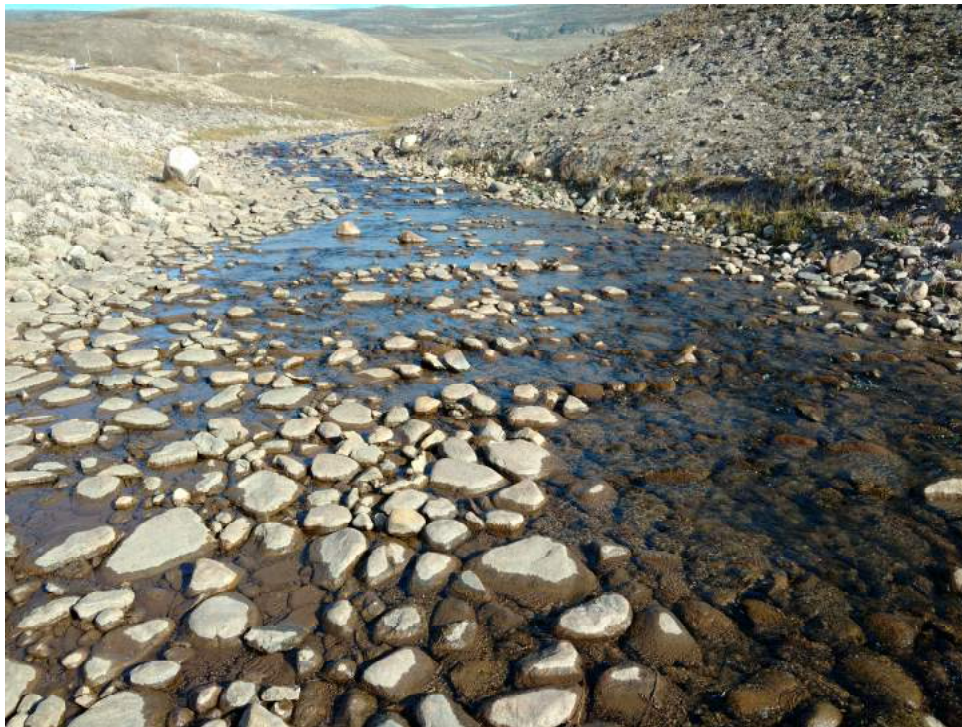
Photo 2 – Upstream at Sheardown Lake Tributary on August 29, 2016

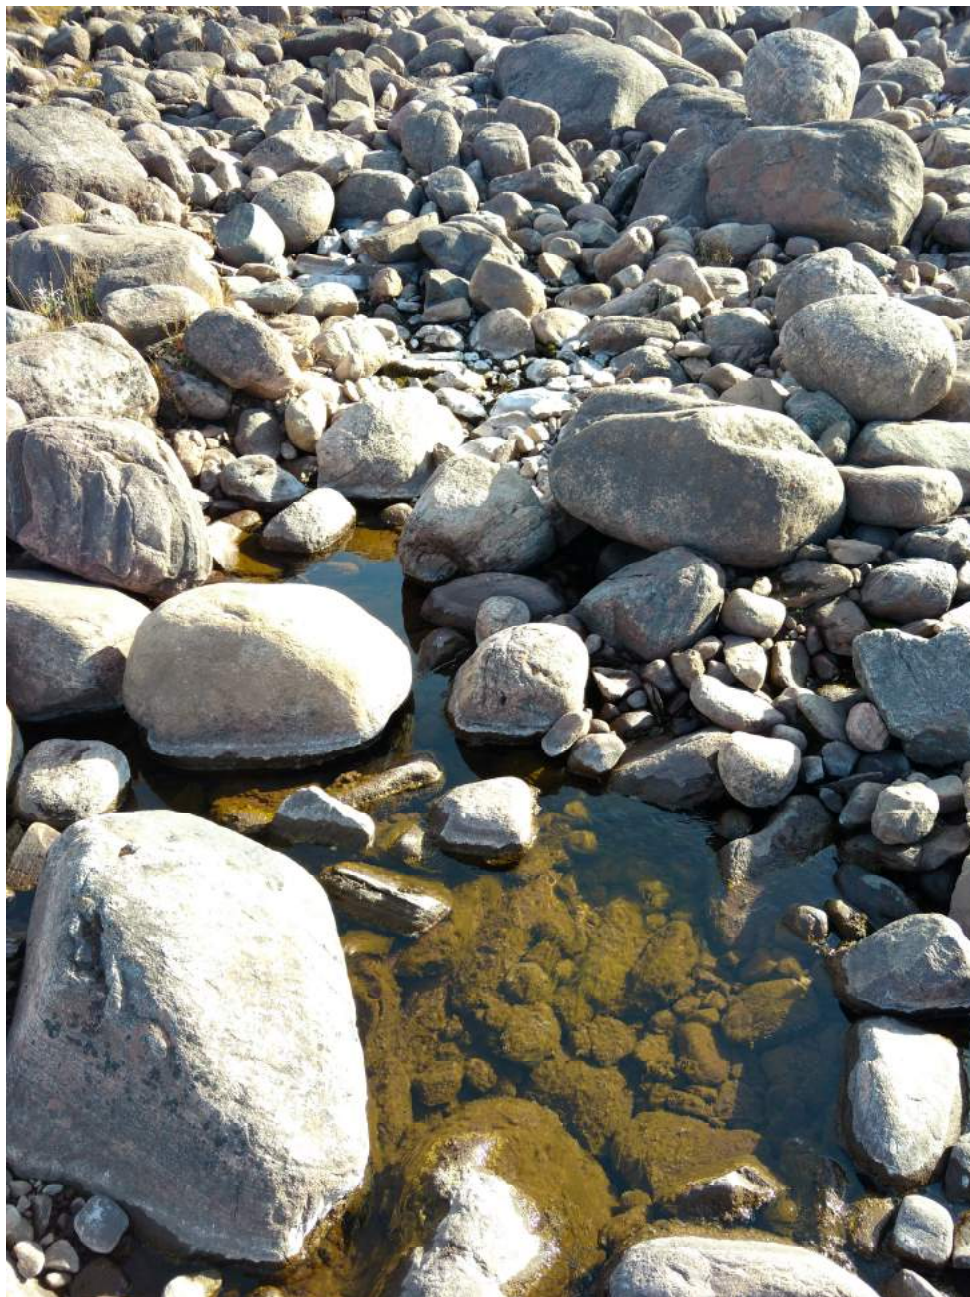
Photo 3 – Flow at Landfill Gate Tributary on August 29, 2016

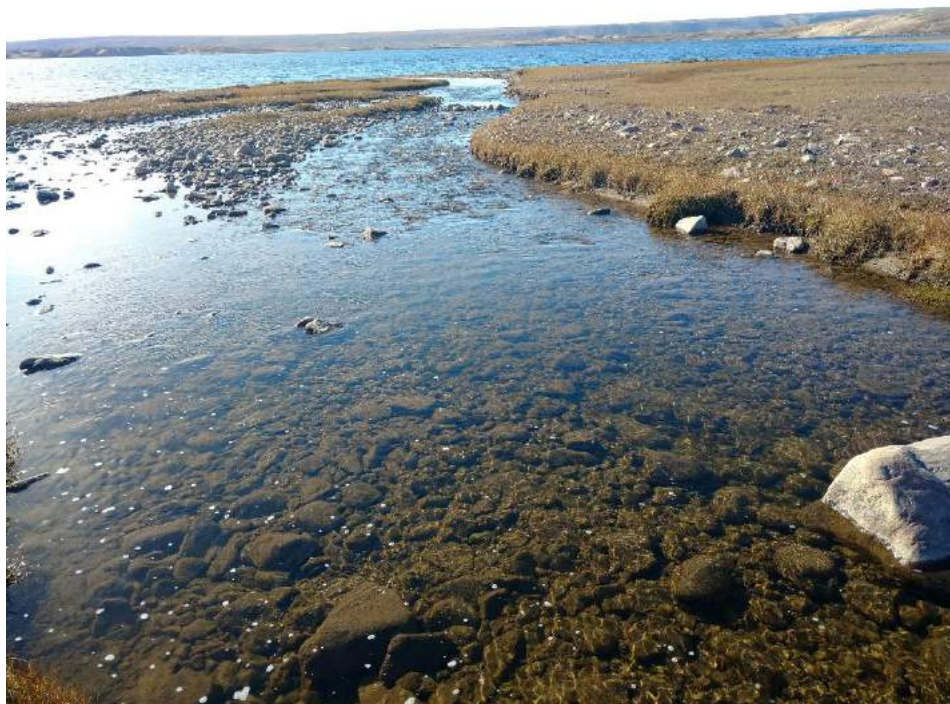
Photo 1 – Outlet at Camp Lake Tributary on August 29, 2016

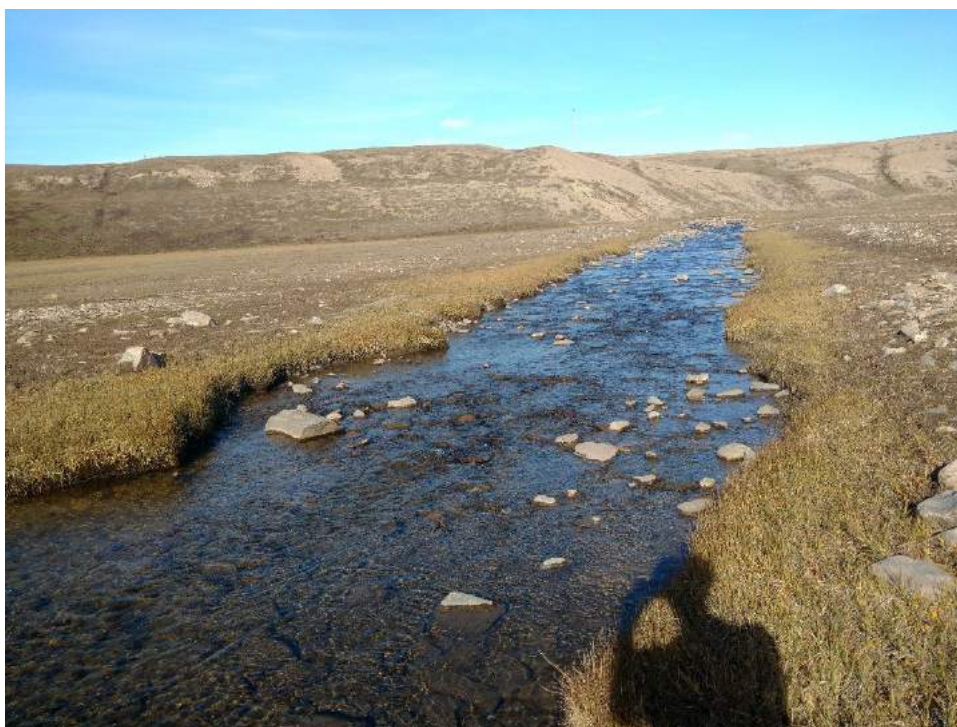
Photo 2 – Upstream at Camp Lake Tributary on August 29, 2016

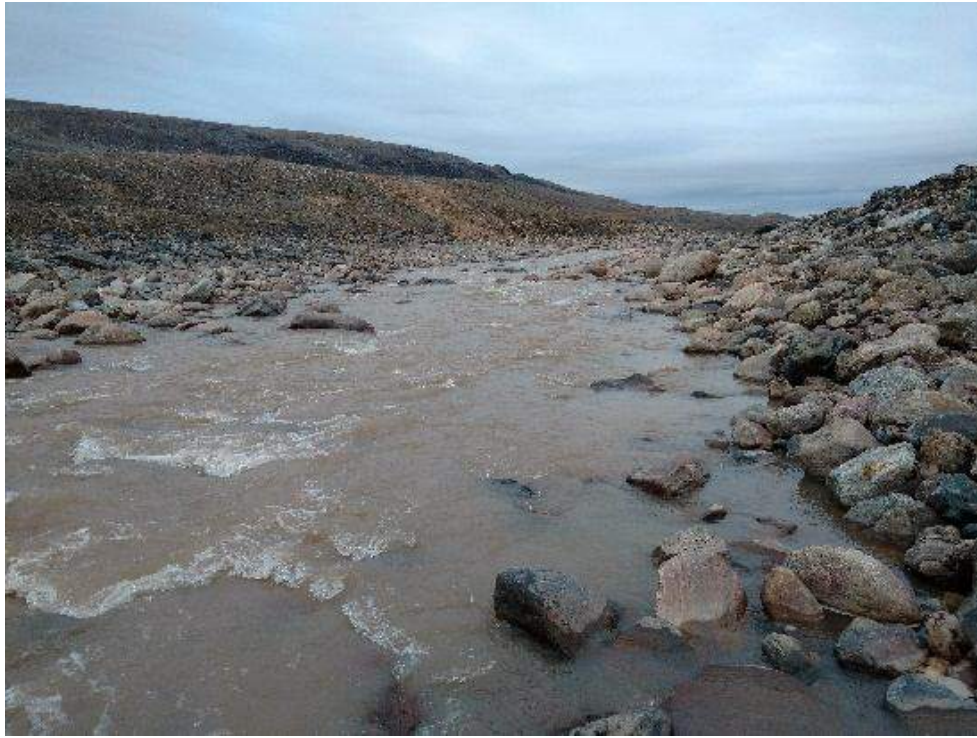
Photo 1 – Mary River upstream of Mine site during natural sediment loading event on August 28, 2016

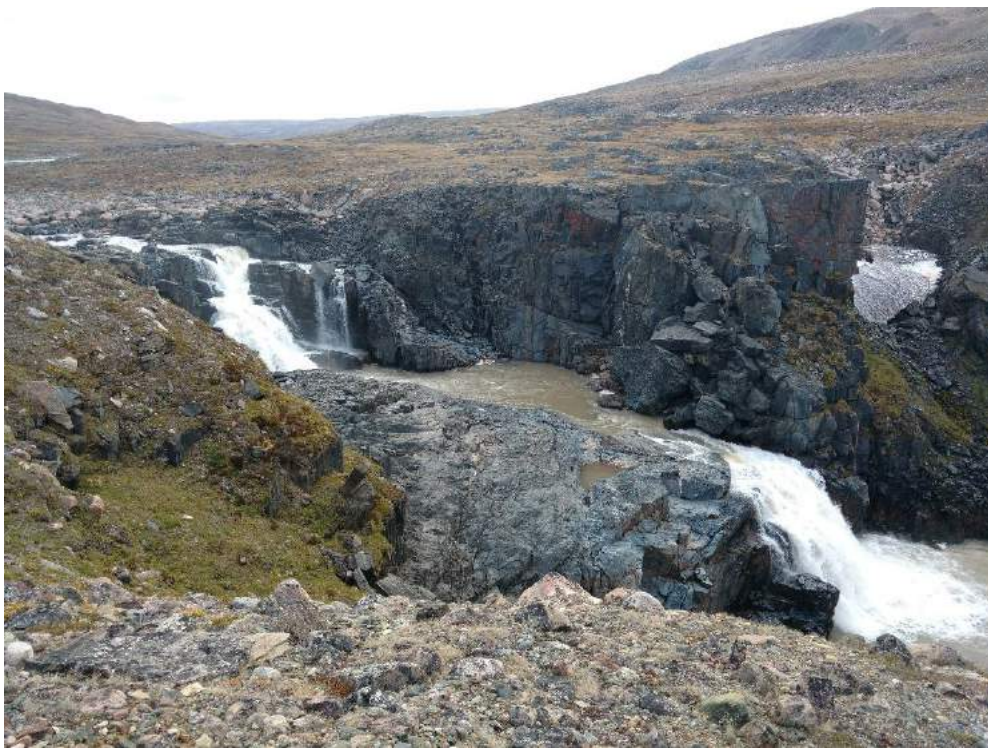
Photo 2 – Waterfall upstream of Mine site during natural sediment loading event on August 29, 2016

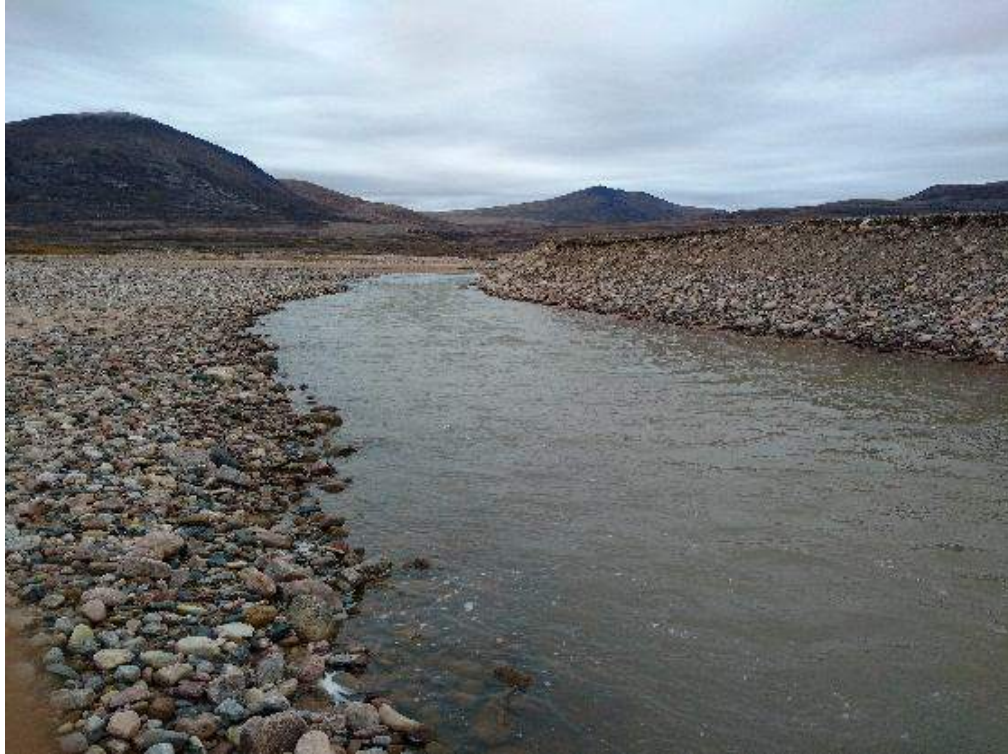
Photo 3 – Mary River downstream of Mine site during natural sediment loading event on August 28

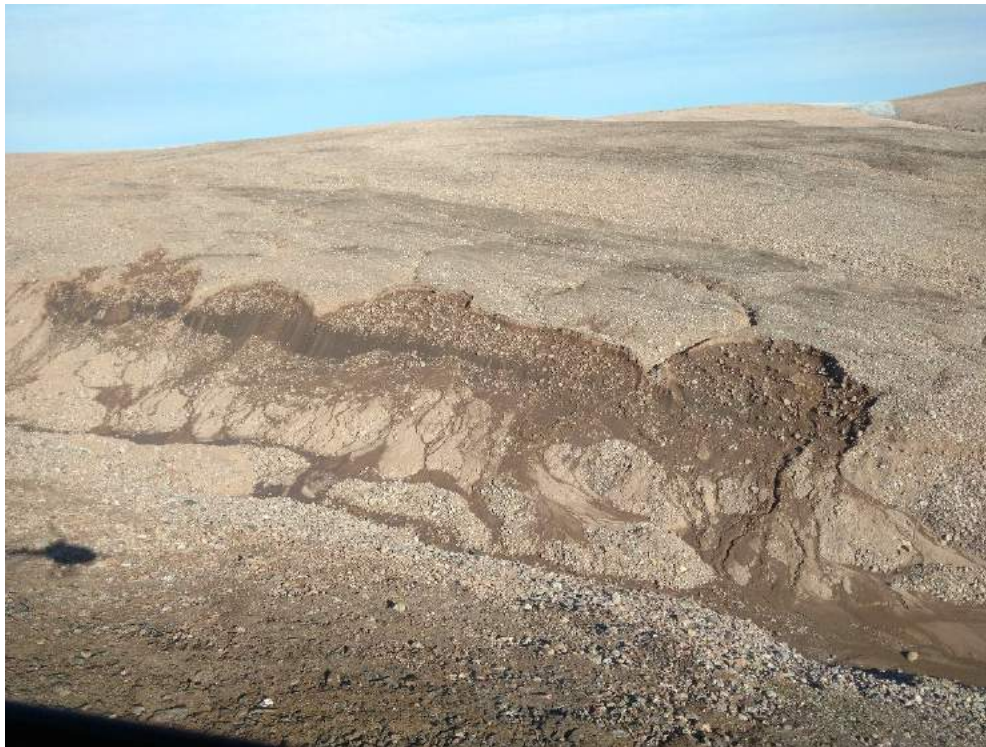
August 27 to Sept 1	Slope sloughing upstream of the project development area above Mary River identified. Increased monitoring of Mary River to evaluate the effects.
	Slope sloughing above the MMER tributary which drains to Mary River identified. Silt fences were erected to mitigate the slope sloughing.
	Silt fences inspected and repaired as required

Photo 4 – Thaw slope sloughing occurring upstream of project development area on August 30, 2016

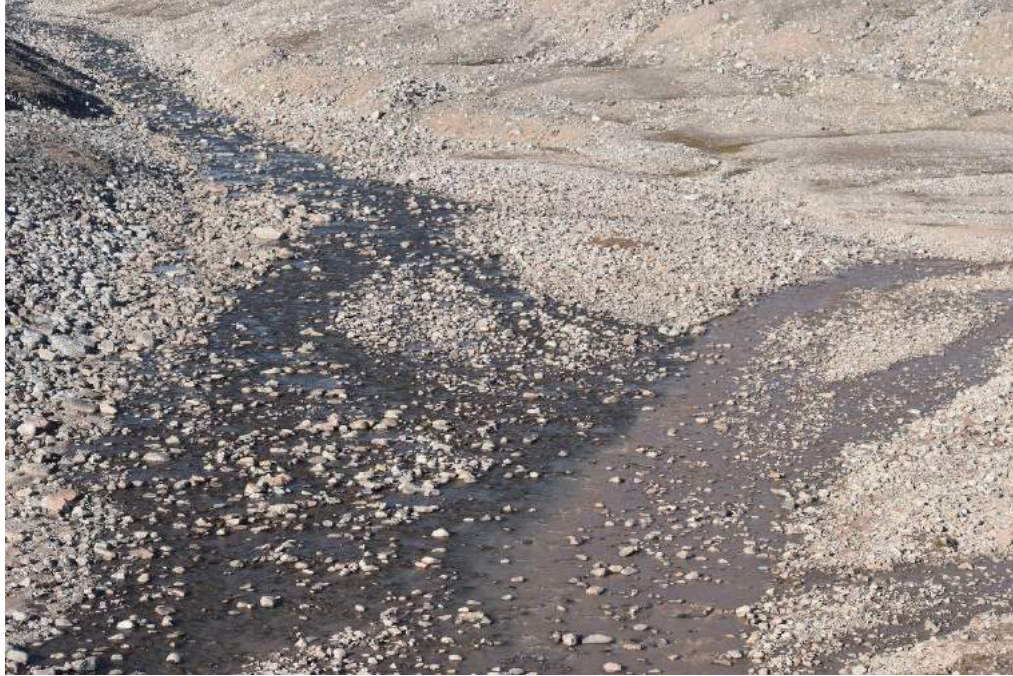
Photo 4 – Tributary downstream of thaw slope sloughing joining Mary River upstream of the project development area on August 30, 2016

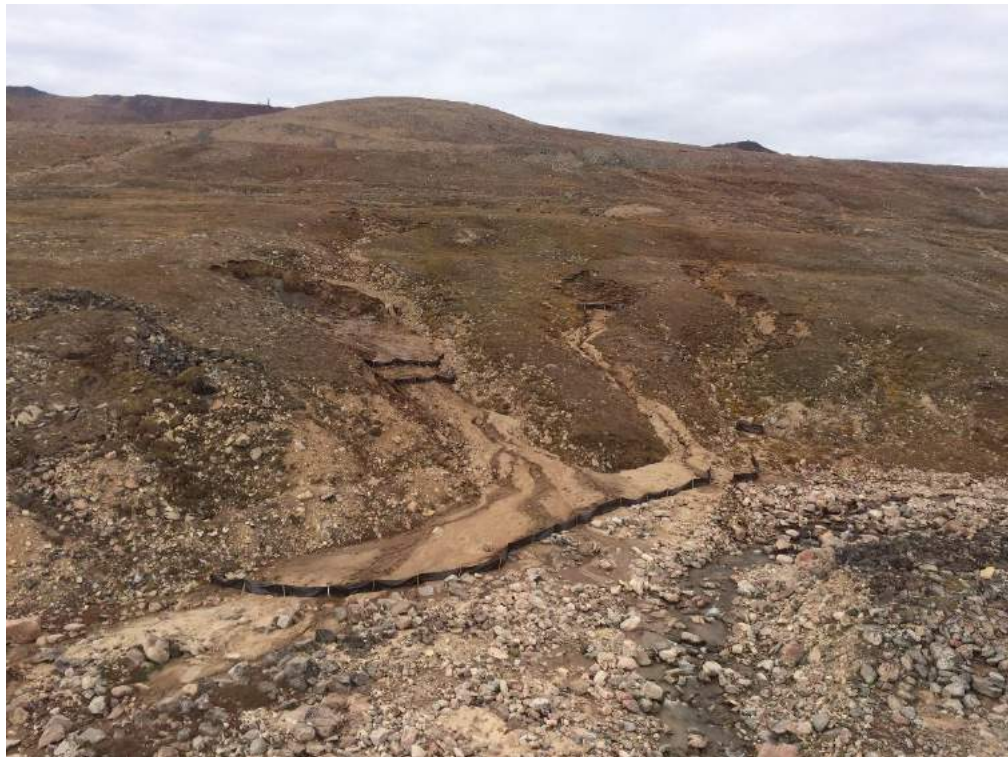
Photo 5 – Slope sloughing on MMER tributary upstream of Mary River with silt fence mitigation measures installed on August 26, 2016

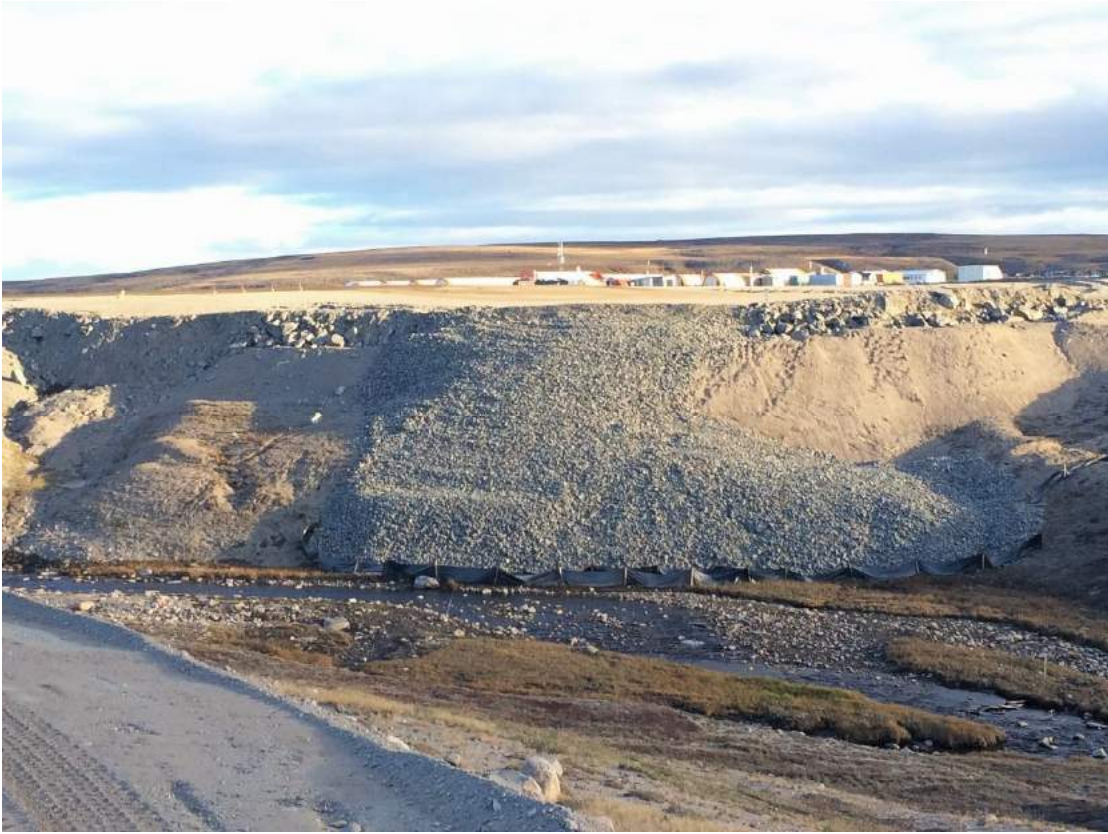
May 31	Sediment deposit along the bank of Camp Lake Tributary #1 (CLT1) discovered near the North end of the Mine Site airstrip. The source of the sediment deposit is determined to be from a slumping section of stream bank along Camp Lake Tributary #1.
	Sediment release to Camp Lake Tributary #1 reported to the NT-NU Spill Line and regulators (NT-NU Spill Report 16-198).
June 1	Installed silt fences around perimeter of sediment deposit to prevent migration of sediment into tributary.
	Removed sediment deposit from stream bank. Lined face of slumping stream bank with geotextile and reinforced with 6" aggregate to prevent similar incidents.
June 1 to 15	AMEC-Foster Wheeler Engineer arrives onsite to develop flocculant treatment systems and pilot test additional siltation controls including geotubes..
June 17 to 21	Kemira Chemicals Chemist arrives onsite to assist Baffinland in developing and optimizing mobile water treatment systems using flocculants.

Photo 1 – Current status of stable slope face by Camp Lake Tributary #1 on August 30, 2016.

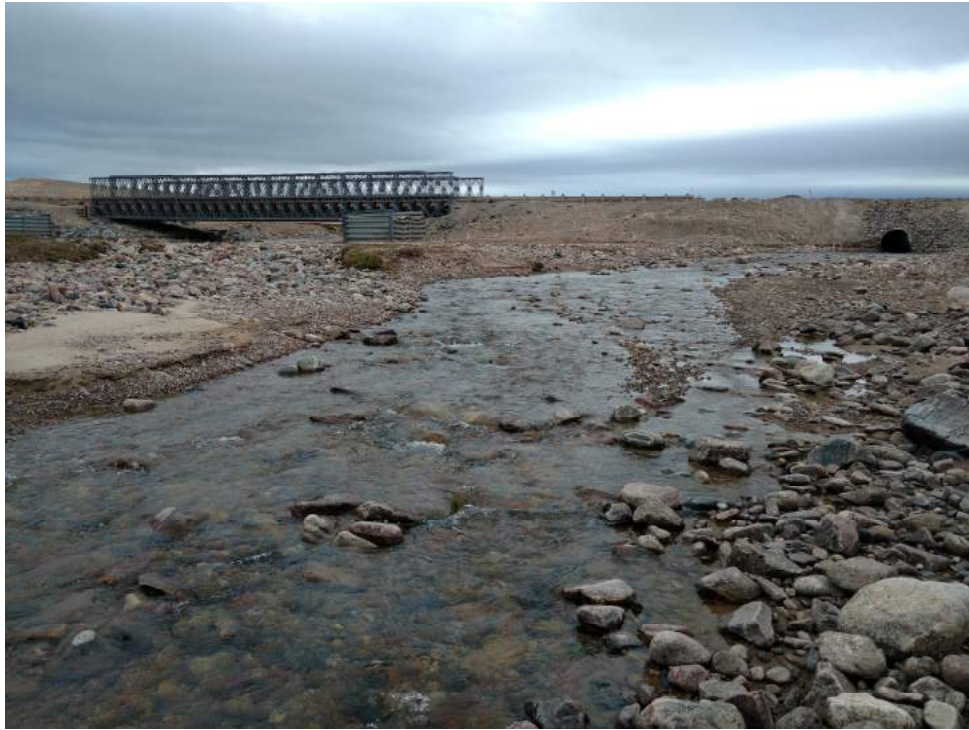
Photo 1 – Water flowing clear downstream of CV223 (km 97) on August 26, 2016

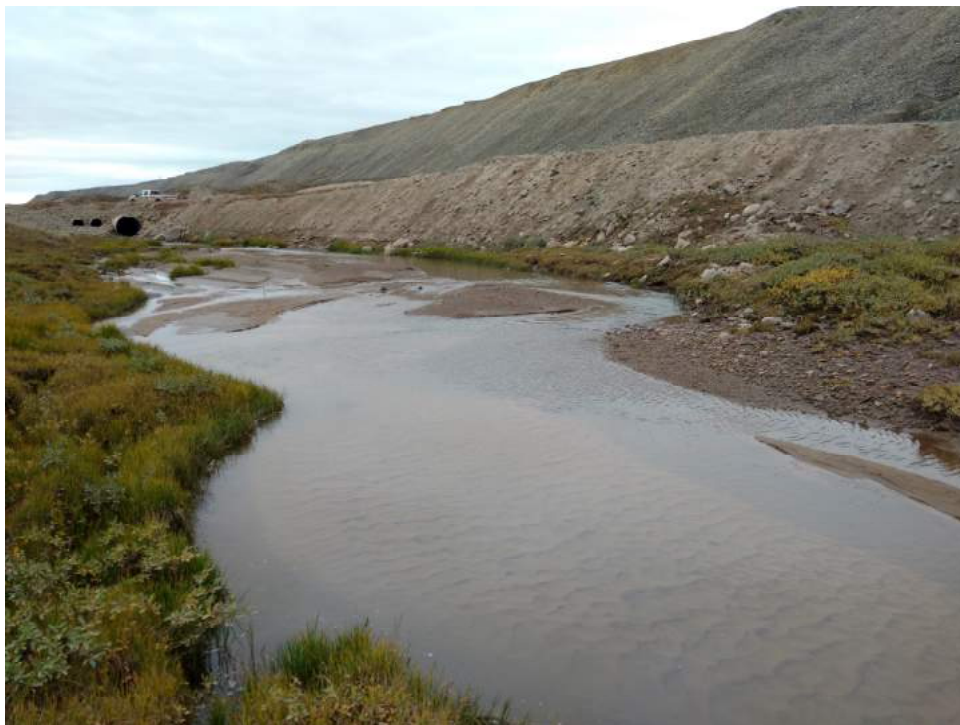
Photo 2 – Water flowing clear downstream of BG-17 (km 90) on August 26, 2016

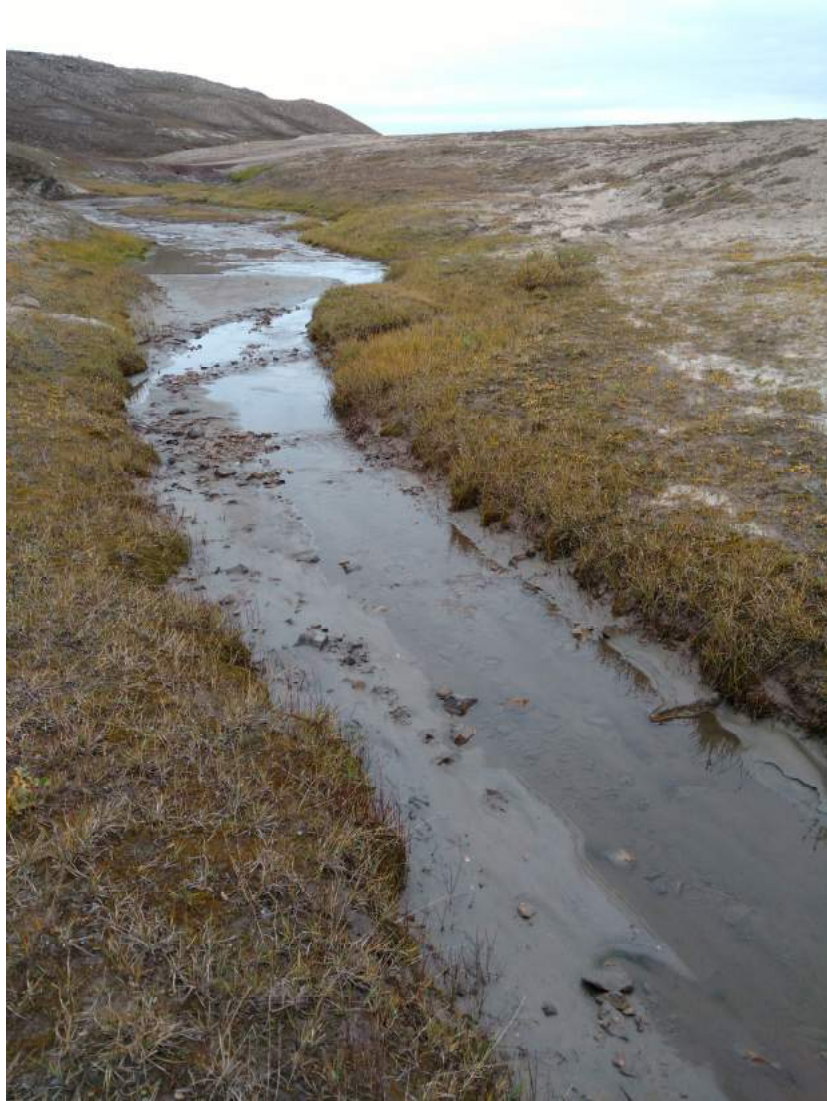
Photo 3 – Water flowing clear downstream of BG-28 (km 86.3) on August 26, 2016

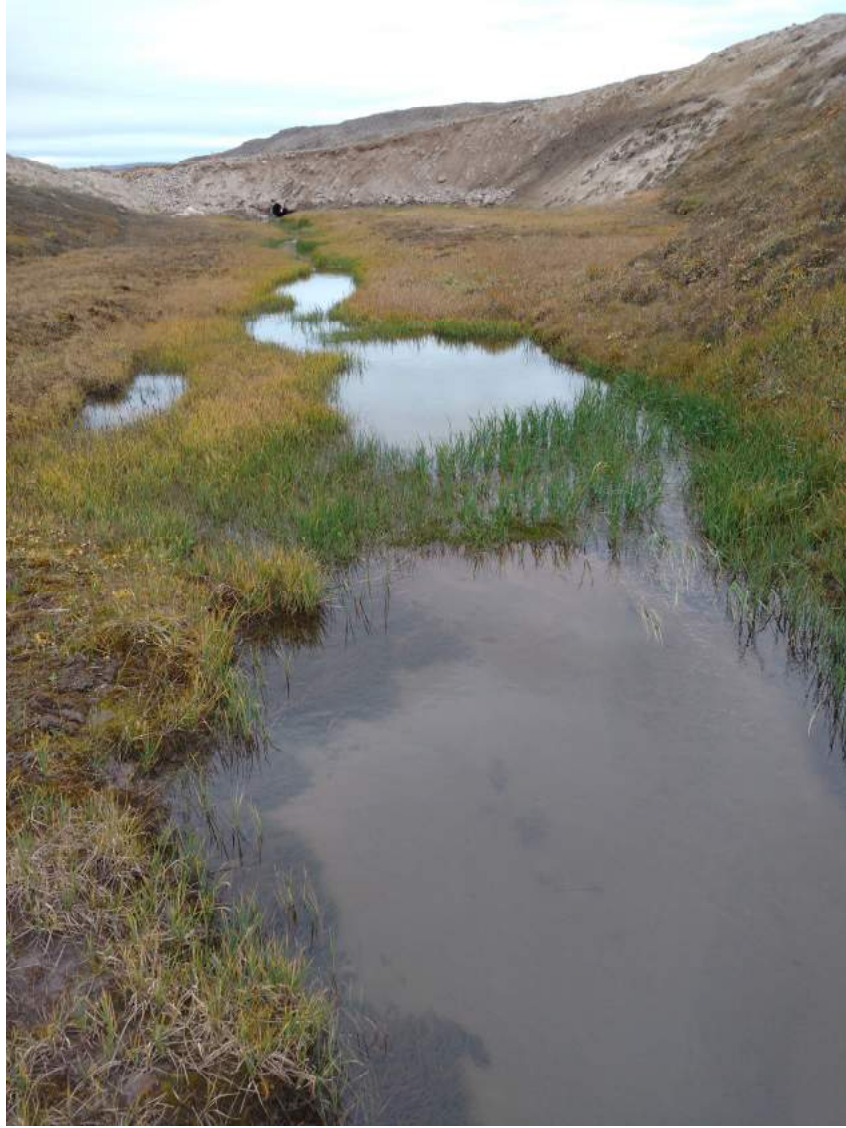
Photo 4 – Water flowing clear downstream of BG-29 (km 85) on August 26, 2016

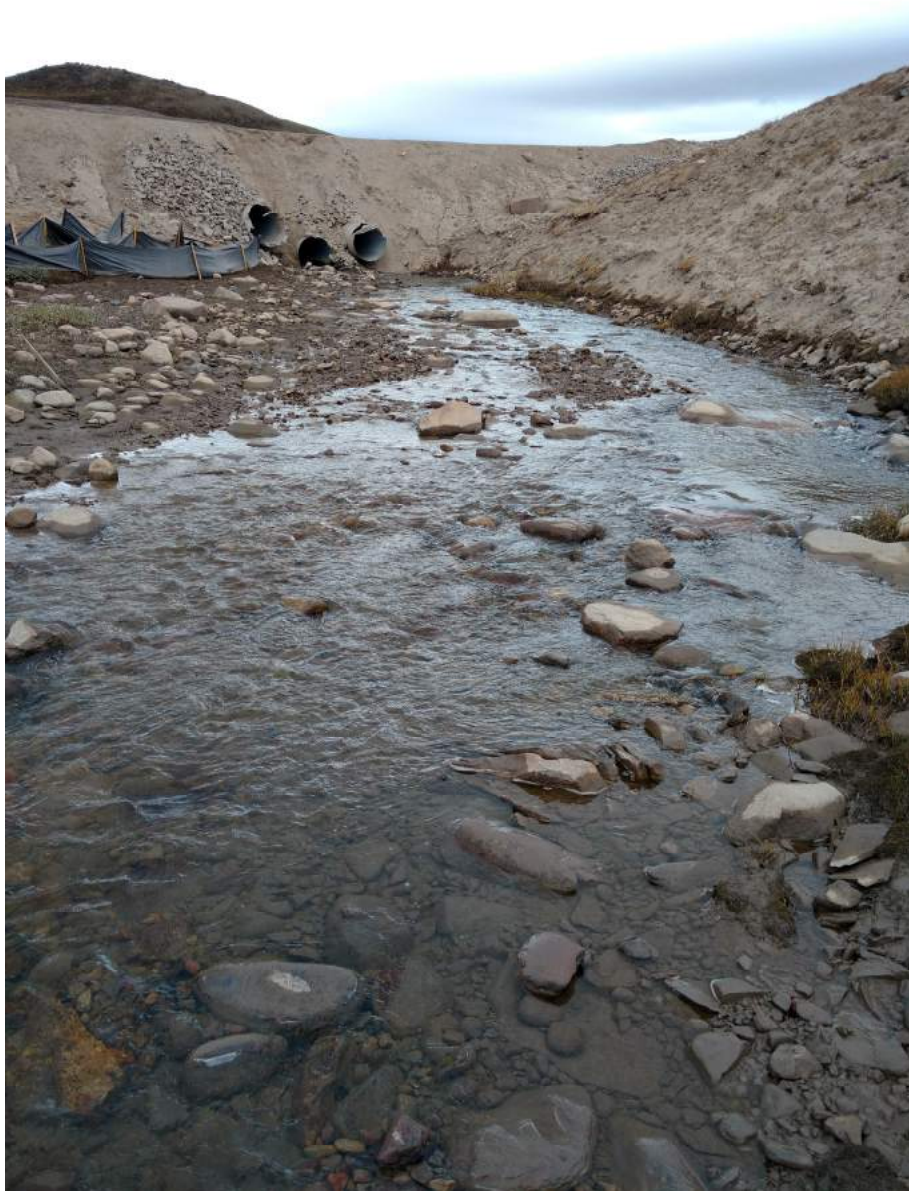
Photo 5 – Water flowing clear downstream of BG-01 (km 100) on August 26, 2016
