## **PHOTOS**

### **Mary River September Inspection**

## **4.0 MILNE INLET**

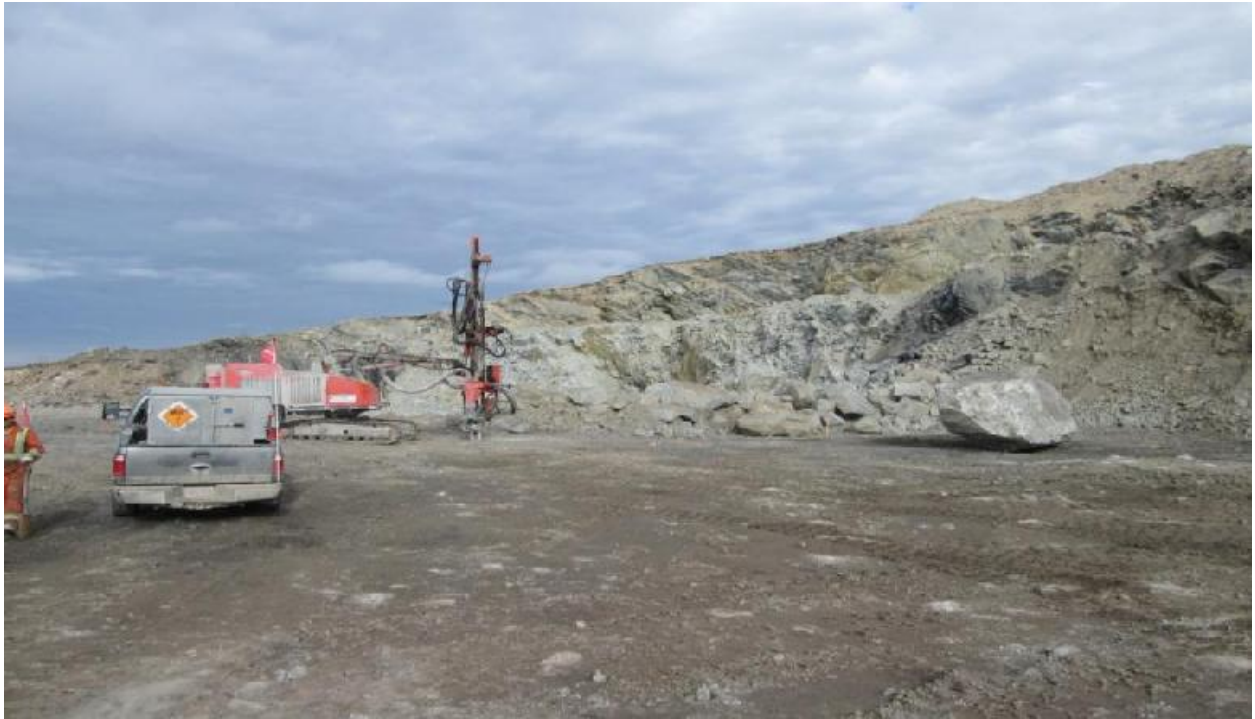
Quarry at Mary River.

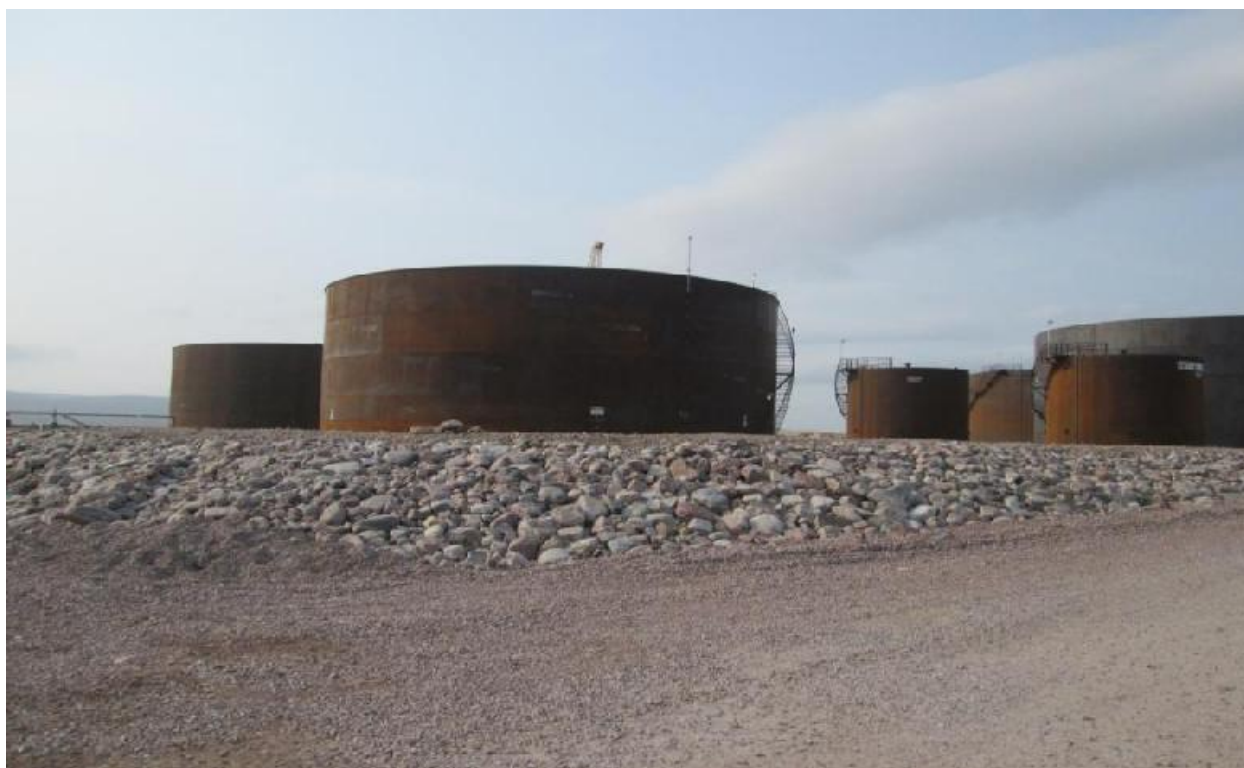
We noted no sign of weakness in any of the structure construction.

At both inspections we noted minor water ponding at the low end of the containment confirming the integrity of the liner.

Photo taken from the south east corner of the steel storage tank containment outside the containment looking north west.

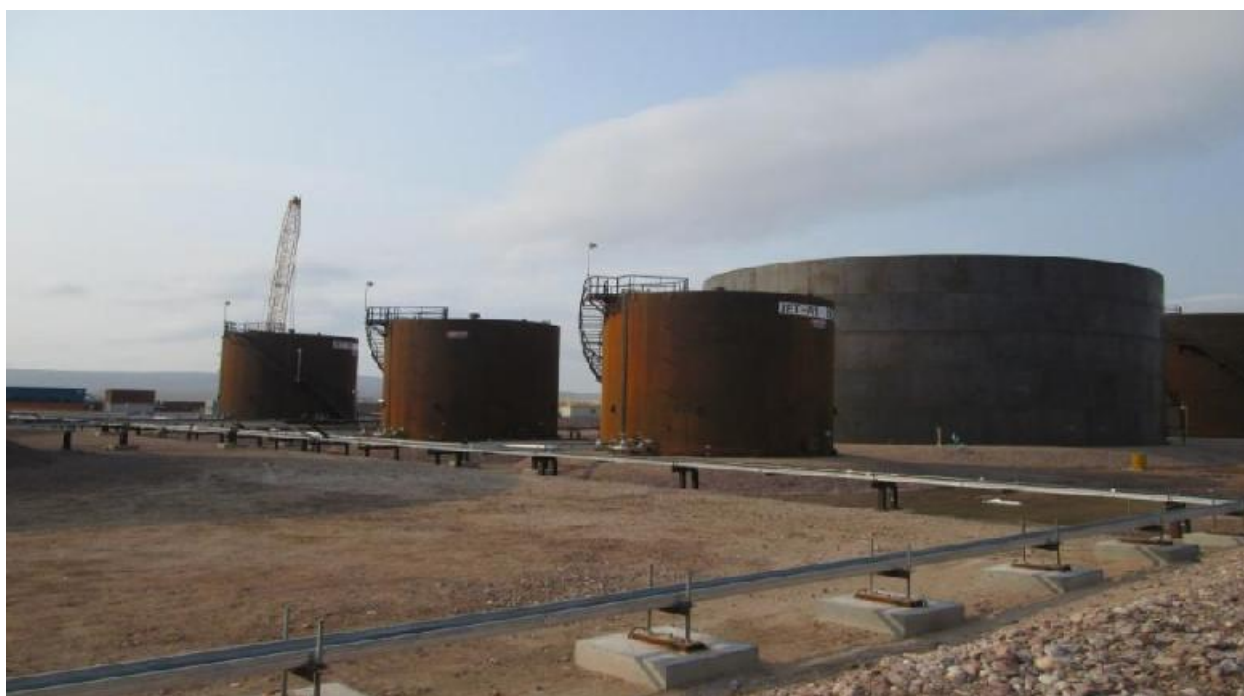
Photo taken from atop the containment dyke looking west into the containment.

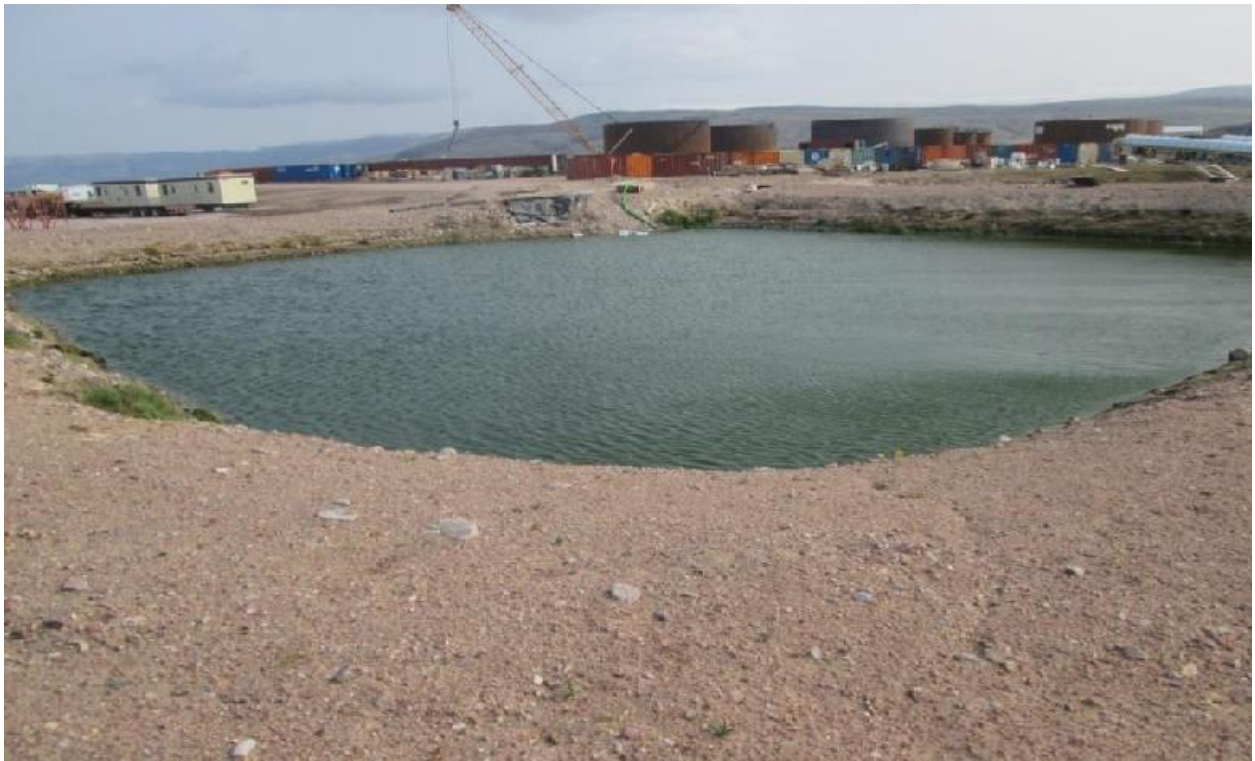
The structure is considered stable over the projected short life of the structure.

Photo taken from atop the soon to be decommissioned PWSP looking south.

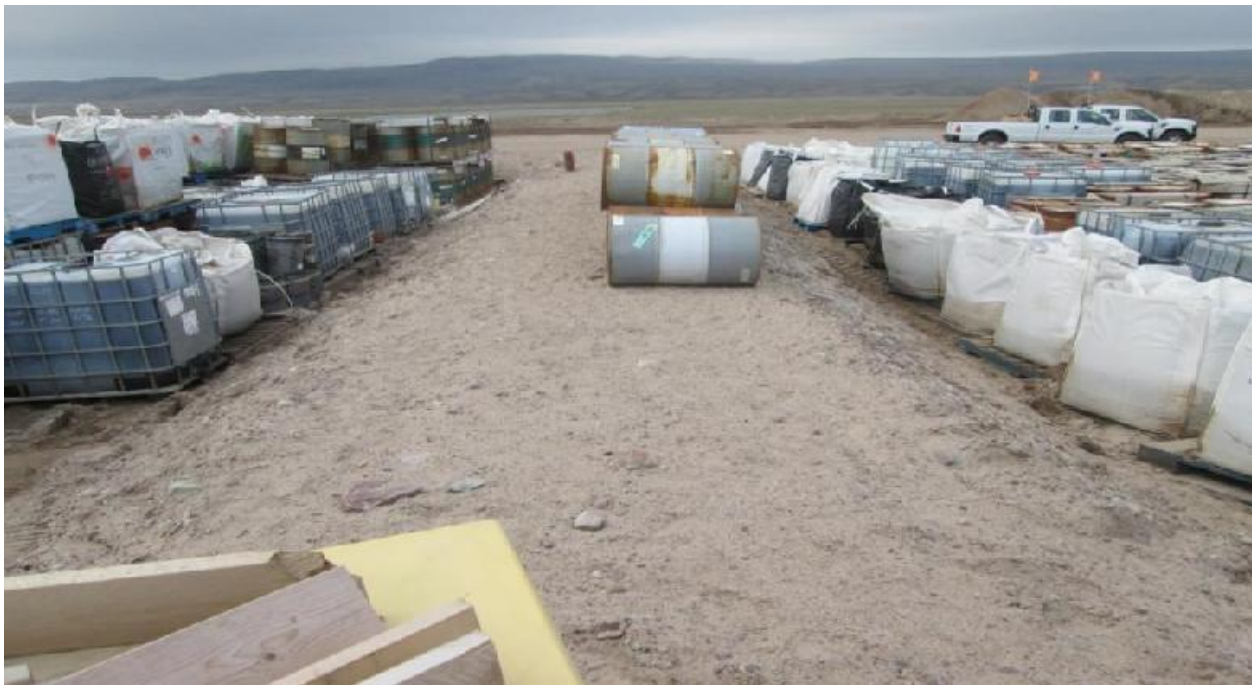
At the time of my August inspection, there was wet sand in the bottom of the two cells indicating the integrity of the liner.

Our review of the area around the cells, at the base of the exterior dyke slopes showed no sign of seepage, at that time.

Photo taken of central dyke in barrel fuel storage looking west.

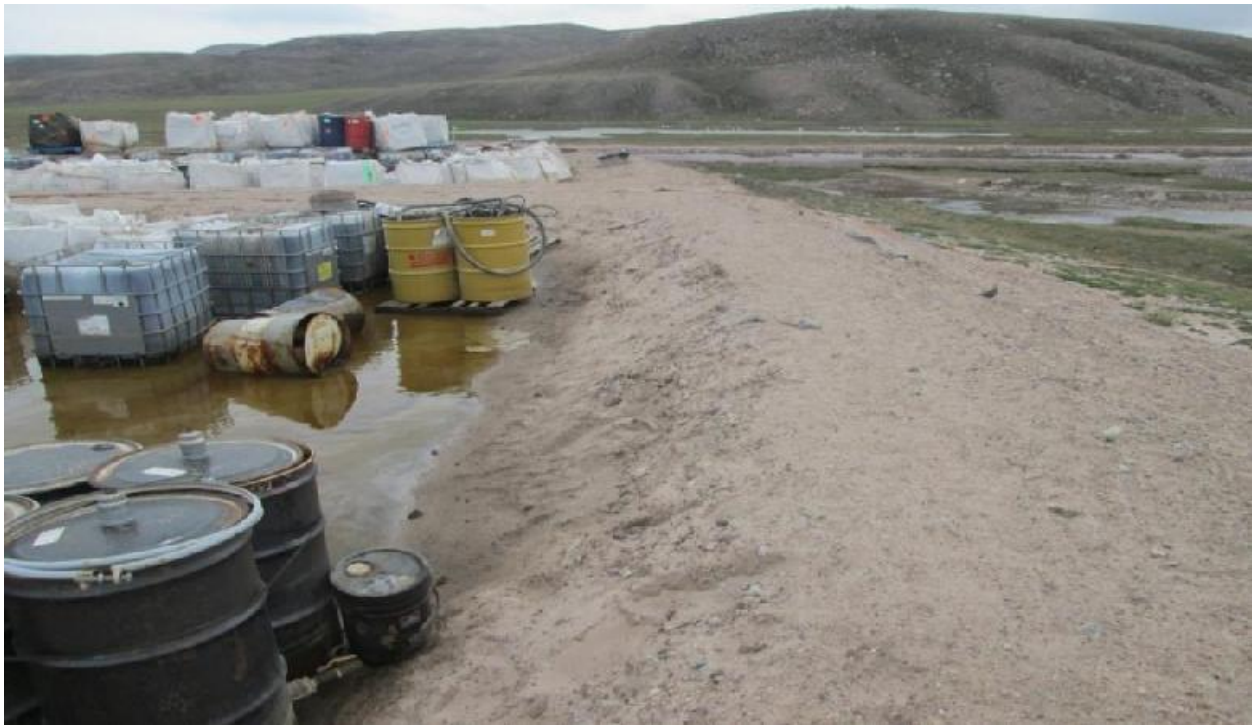
There is water ponding in both cells of the original structure confirming the integrity of the liner at this time.

Our review of the area around the dykes, at the base of the slopes, showed no sign of seepage. The structure is considered stable.

Photos taken along rear dyke at hazardous waste storage area. Note water contained within dyke.

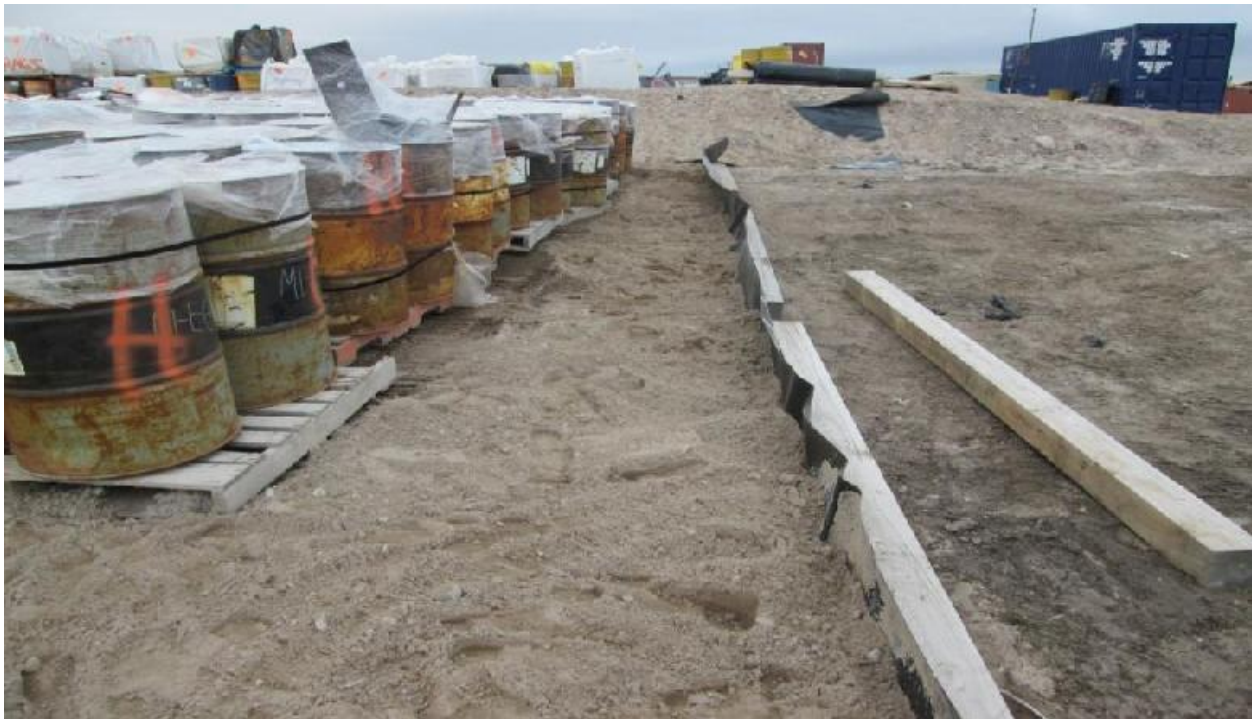
Due to an excess of hazardous waste in the two cells, a third temporary cell has been constructed for the very short term until the ship picks up the hazardous waste at the end of this summer season.

The third cell is constructed with a one piece liner and wood timber curb for this very short term and is contiguous with the south side of the structure.

Photo shows temporary curbed area for hazardous waste awaiting immediate shipment.

We recommend that the use of the temporary third cell, recently constructed, be discontinued when the currently stored hazardous waste is shipped out by the end of this shipping season.

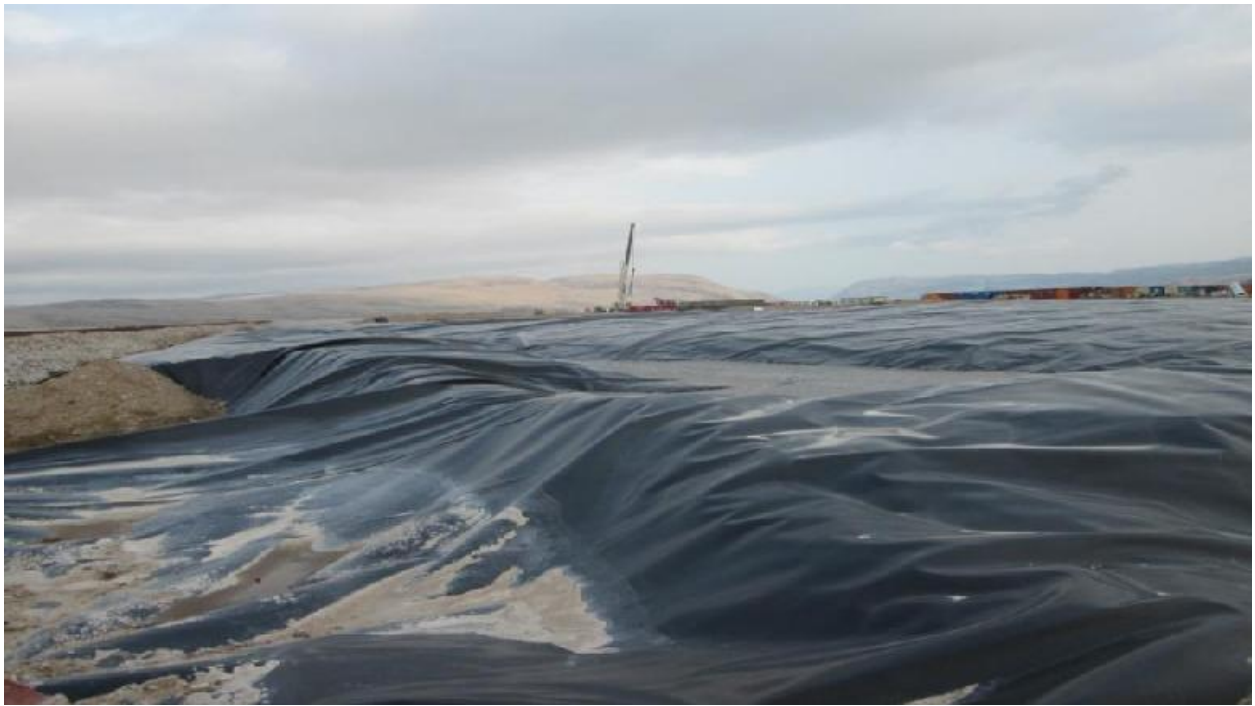
The oil impacted water had been removed and treated and the oil impacted sand/ gravel that was in the bottom of the structure and over the liner on the dykes had been removed from the south end of the structure and had been piled up in the north end where it had been covered to prevent an accumulation of further oil impacted water as noted during our first review in August. By September this facility had been decommissioned and the oil impacted material had been placed in the landfarm.

Photo taken looking north at the covered contaminated granular from the bulk fuel storage facility undergoing decommissioning.

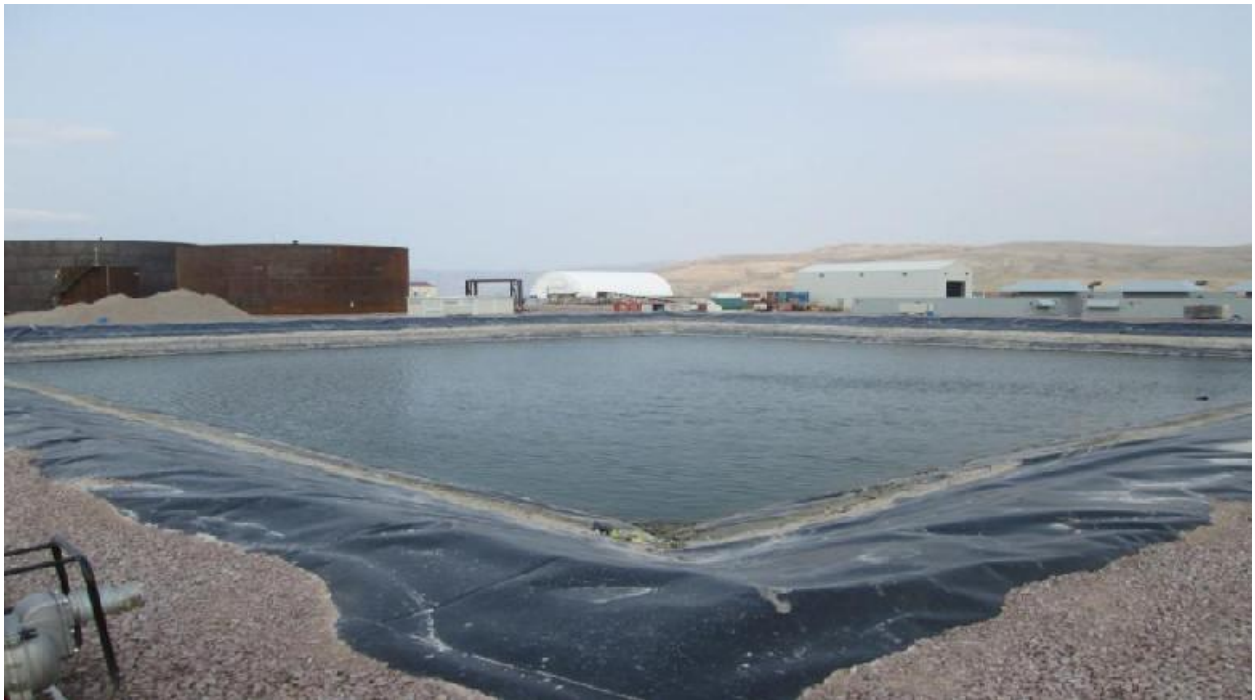
Photo taken from atop the south west corner of the New Sewage Effluent Pond looking north east.

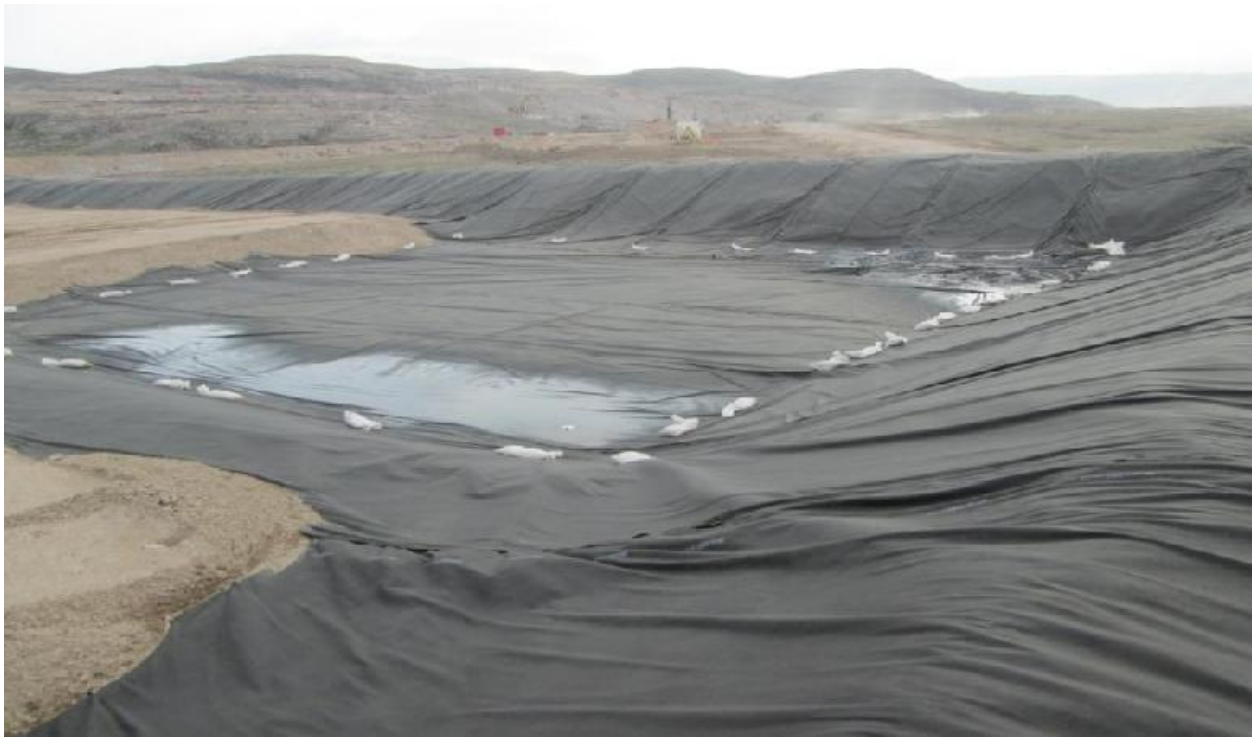
At the time of our August review, the base and dykes of the structure had been formed and the HDPE liner had been installed with a geotextile protection on each side. At the time of our September review the cover had yet to be installed on a small section of the dyke but other areas were covered.

Photo taken looking into the sump at the north east corner of the Landfarm.

We recommend that the remaining dyke structure without protective cover over it be covered as per the design drawings.

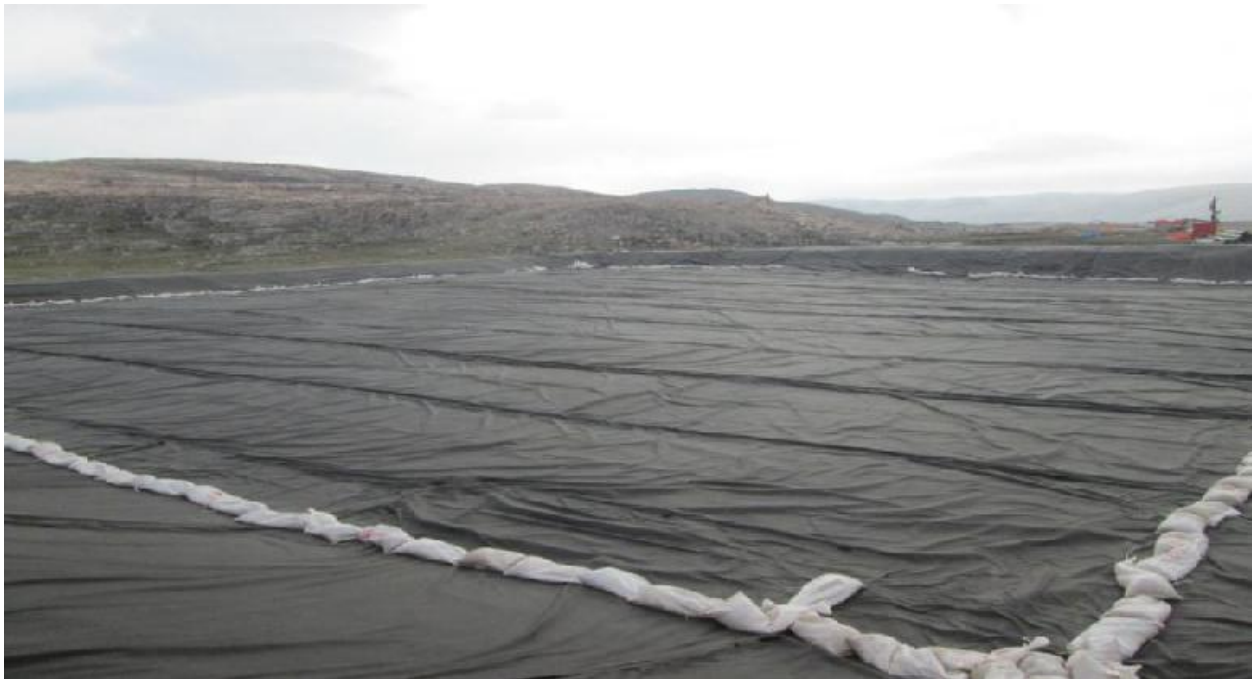
At the time of our August review, the base and dykes of the structure had been formed and the HDPE liner had been placed with a geotextile protection on each side. At the time of our September review construction had been completed in accordance with design drawings.

Photo taken from atop the dyke looking into the contaminated snow containment.

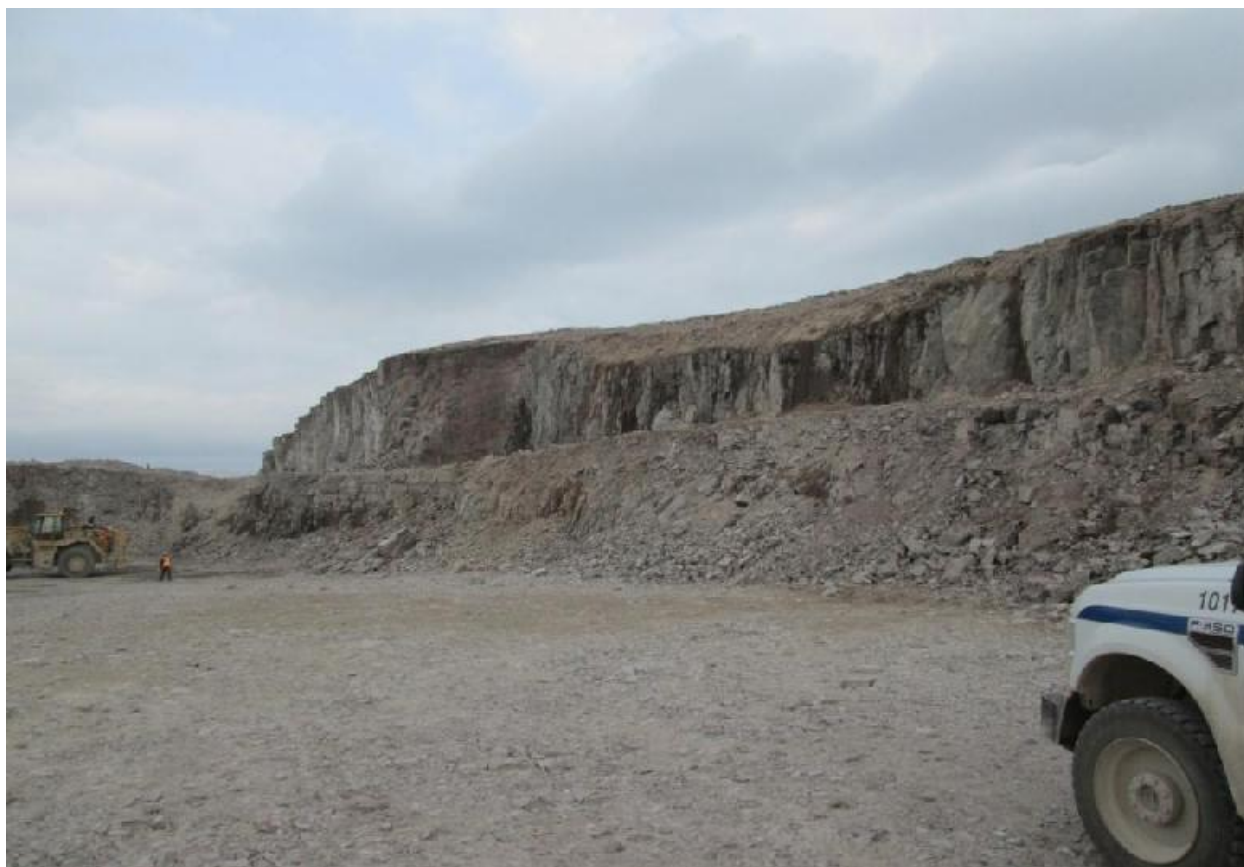
Rock faces appear stable.

Photo taken looking at the quarry face in the quarry showing the well developed benches and cover removed from atop solid rock.

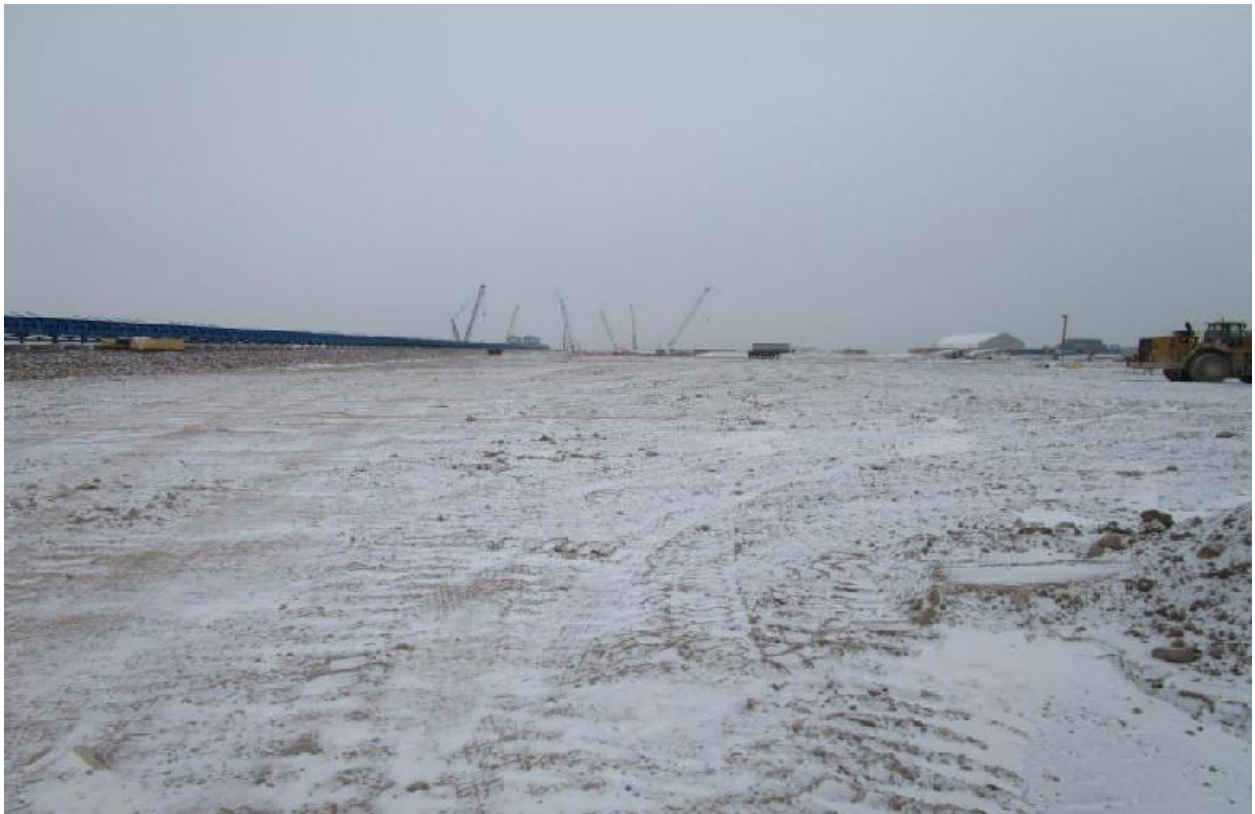
Our review of the area around the south end of the former Bulk Fuel Containment Facility showed no sign of oil or oil/water mixture and we conclude that the integrity of the liner has been maintained during the decommissioning process.

Site of recently decommissioned bulk fuel containment

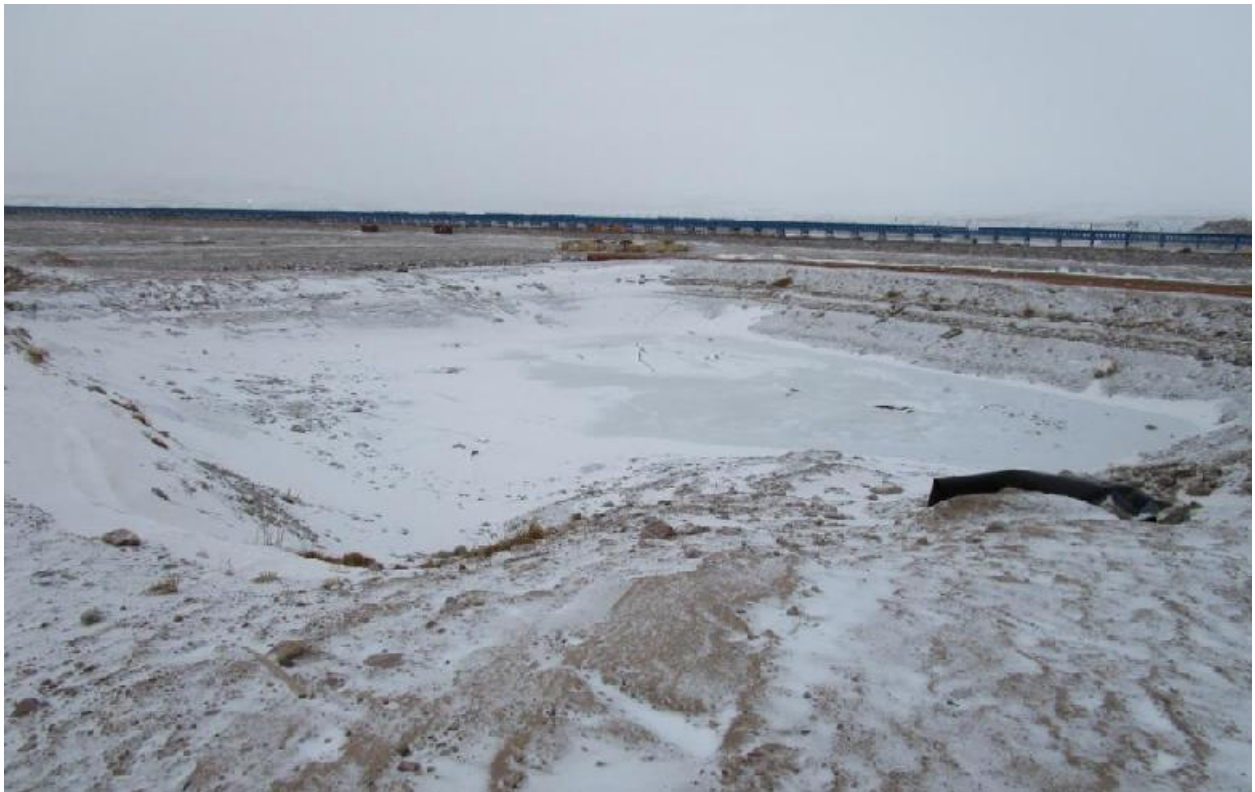
This transfer of effluent was part of the decommissioning of this PWSP. At the time of our second review in September, all effluent had been removed and the dykes were awaiting removal.

Existing PWSP now empty and being decommissioned

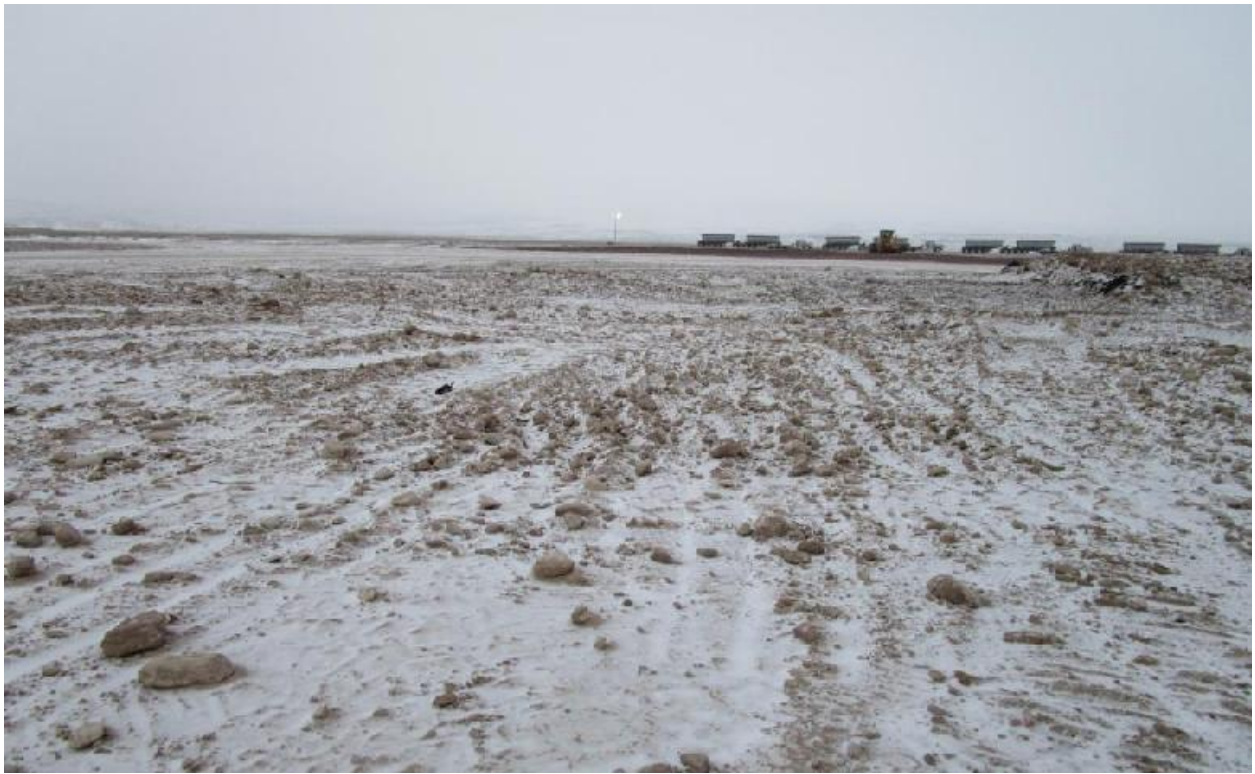
There was no sign of oil impacted granular in the area following decommissioning.

Site of recently decommissioned barrel fuel containment.

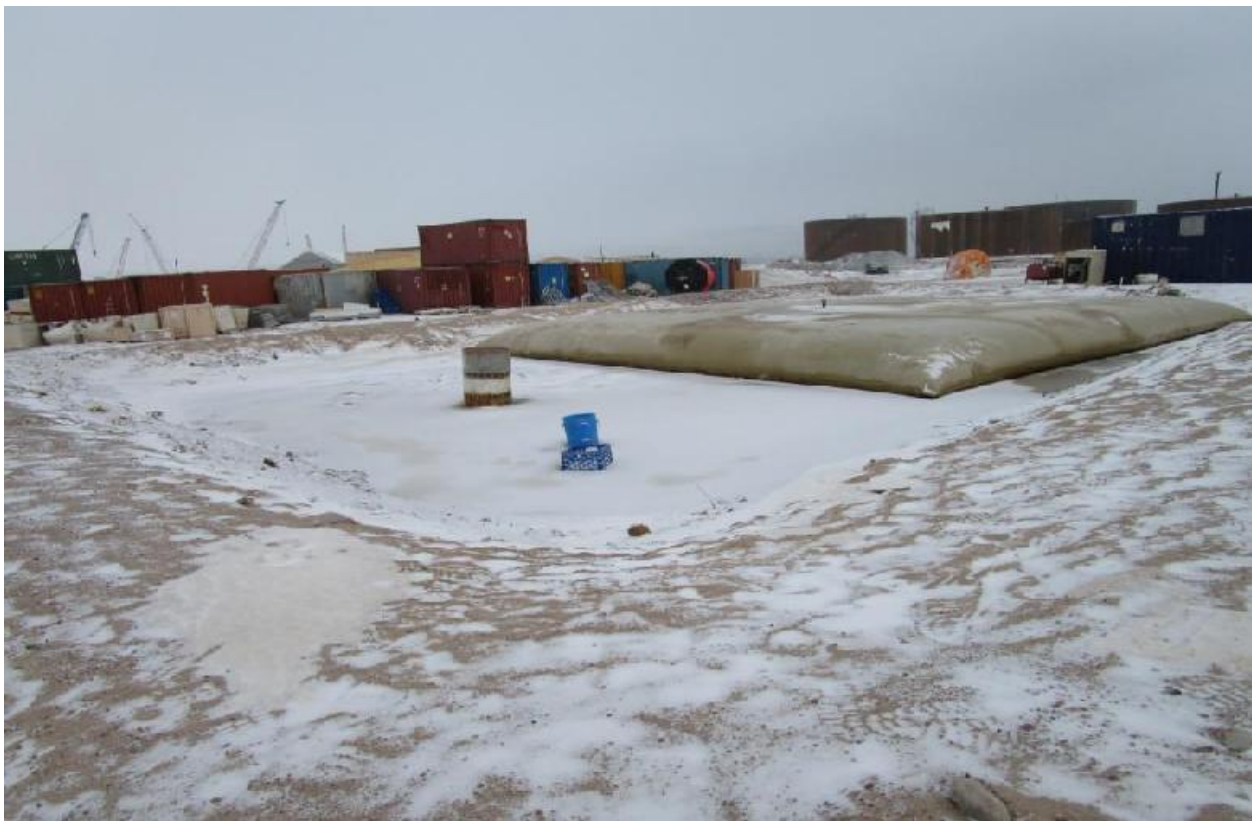
Hazardous waste storage containing bladder of contaminated material.

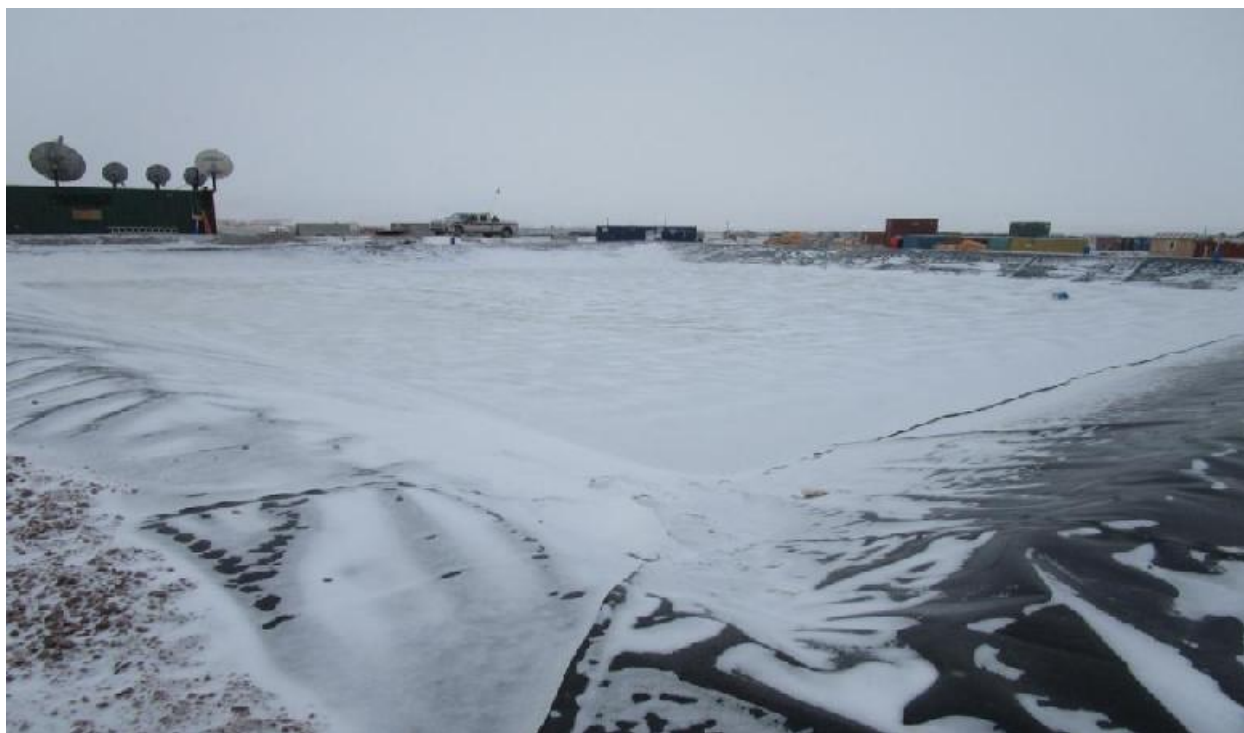
New effluent pond

There was approximately 5' of freeboard at the time of our September review.

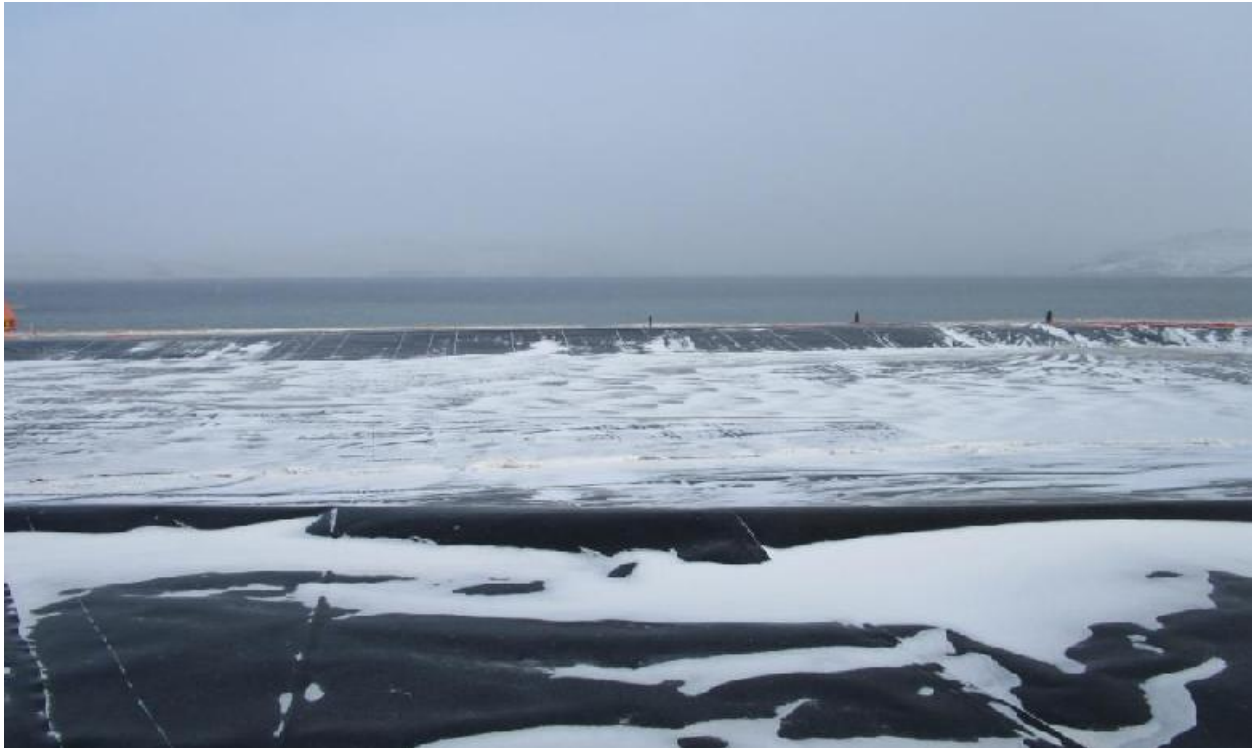
Sediment pond east

The basin is shaped and the liner has been installed throughout the basin from inlet to the berms on the north side of the basin.

There has been no cover placed over the liner to this point and rip rap has not yet been placed in the outlet weir.

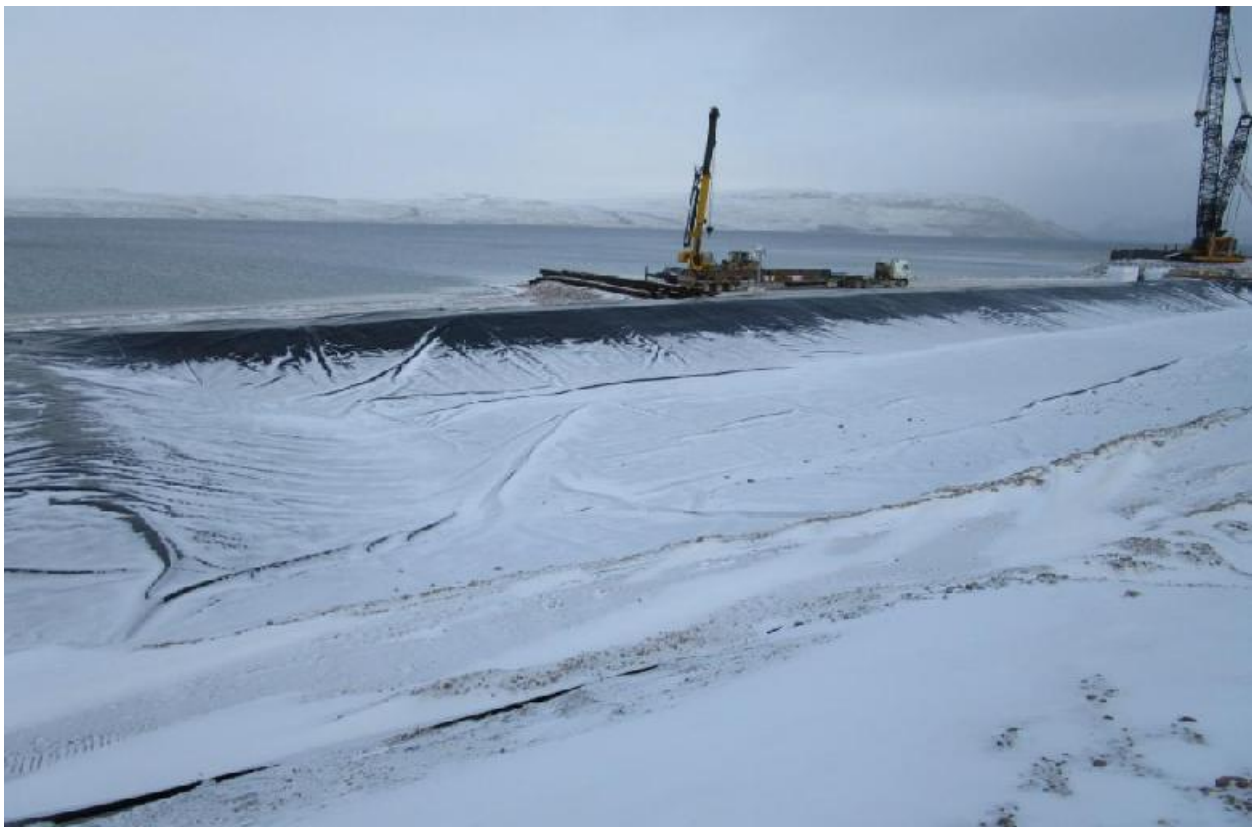
Sediment pond west

As with the east side, the liner is in place over the basin but the liner has yet to be covered
