Re: Close-out of Spill Reported on January 1st, 2014
Mary River Project - Water Licence No. 2AM-MRY1325

Re: Follow-up to Spill #14-361, Reported on October 7th, 2014
Mary River Project - Water Licence No. 2AM-MRY1325

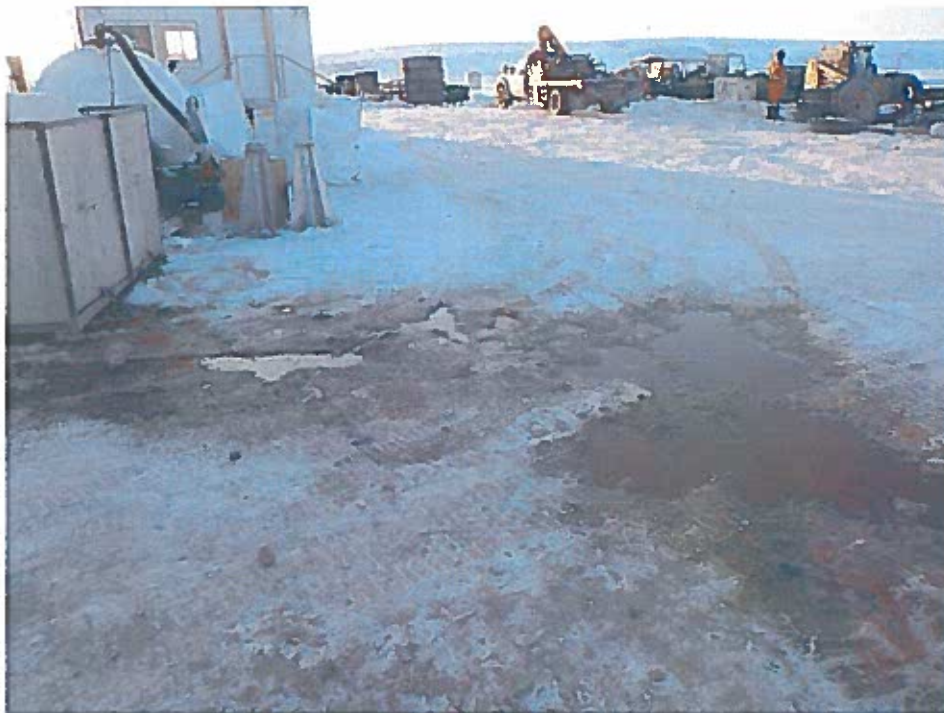
On October 7th, 2014 at approximately 09:00, a Glycol de-icer fluid tote at the Mine Site Weatherhaven Maintenance Shop was discovered to be leaking during a routine inspection, the contents of which overflowed the portable spill berm which the tote was in (Photo 1). It was conservatively estimated that 150 litres was released from the 500 litre Glycol holding tank. The spill resulted in an impacted area of approximately 15m² to the adjacent ground. The location of the spill was greater than 500 meters from the nearest water body. A valve failure on the Glycol holding tank was determined to have caused the leak.

Photo 1: Initial Discovery of Spill

Other similar totes should be inspected to ensure that none of the valves are defective. Also, whenever the totes are not in use and are storing contents they should be placed into lined berm areas for secondary containment as a precautionary measure.

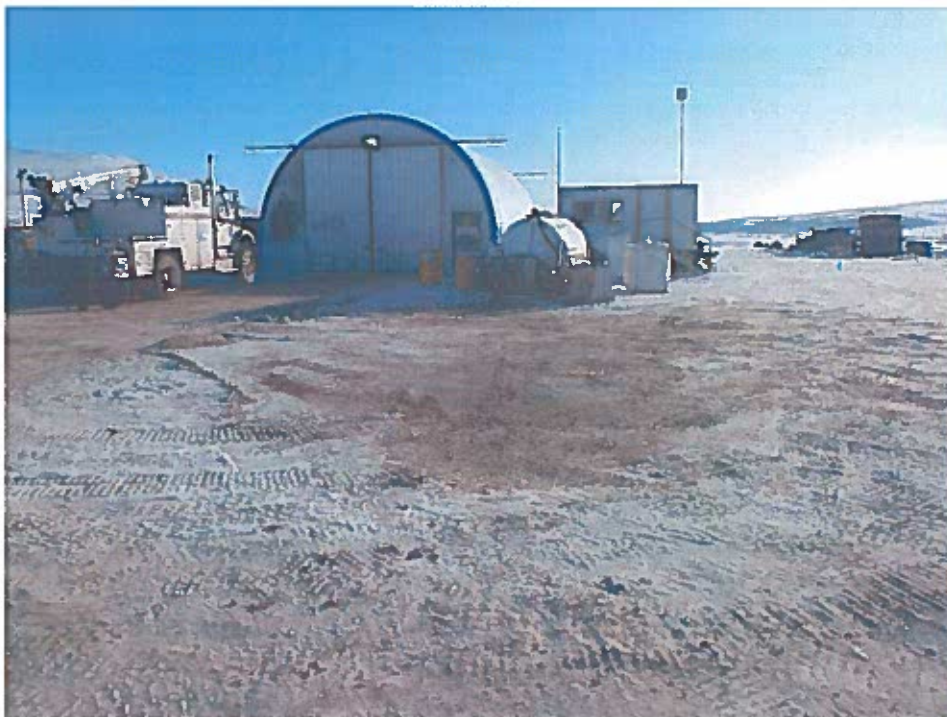
The Environment department immediately notified the Maintenance department and a vacuum truck was used to remove the excess glycol from the impacted area. The contaminated snow and material was then scraped up with a grader and transferred into Quatrex bags.

Photo 2: Impacted Area after Clean-up

The Quatrex bags which contain the contaminated soil and snow have been transported to a lined hazardous waste containment area for storage and the defective valve was replaced on the holding tank.

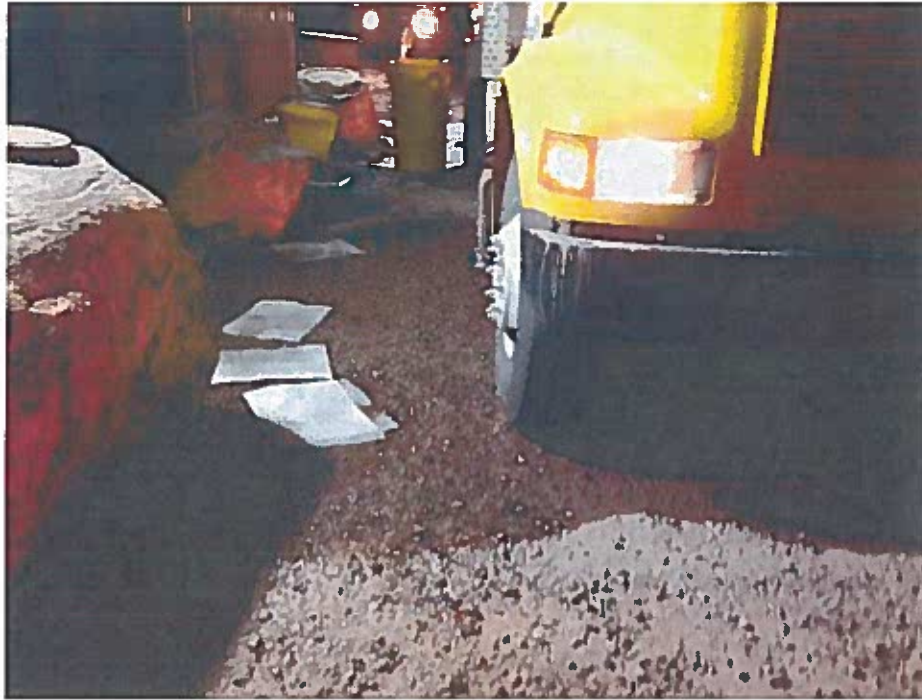
The worker immediately hit the shut-off switch on the fueling module and began recovering the spill using absorbent pads and placing duck ponds under the vent tubes of the truck (photos 1 and 2). Response personnel arrived and continued to work at recovering the diesel using absorbent pads (photo 3). The contaminated area was cordoned off with caution tape until further clean-up during the day shift. Due to the frozen ground and engineered liner at a depth of 1 foot, excavation was limited to 6-8" deep to prevent damage to the liner (photo 4). Area was then back-filled with new material (photo 5).

Figure 1. Front of Truck – First Spill Pads in place

- Have the Scully system repaired;
- Revise refueling procedure so as to provide additional environmental controls such as including a spotter on top of the fuel tank of the truck;;
- Review and sign-off the revised standard operating procedure by all lube/tanker truck operators.

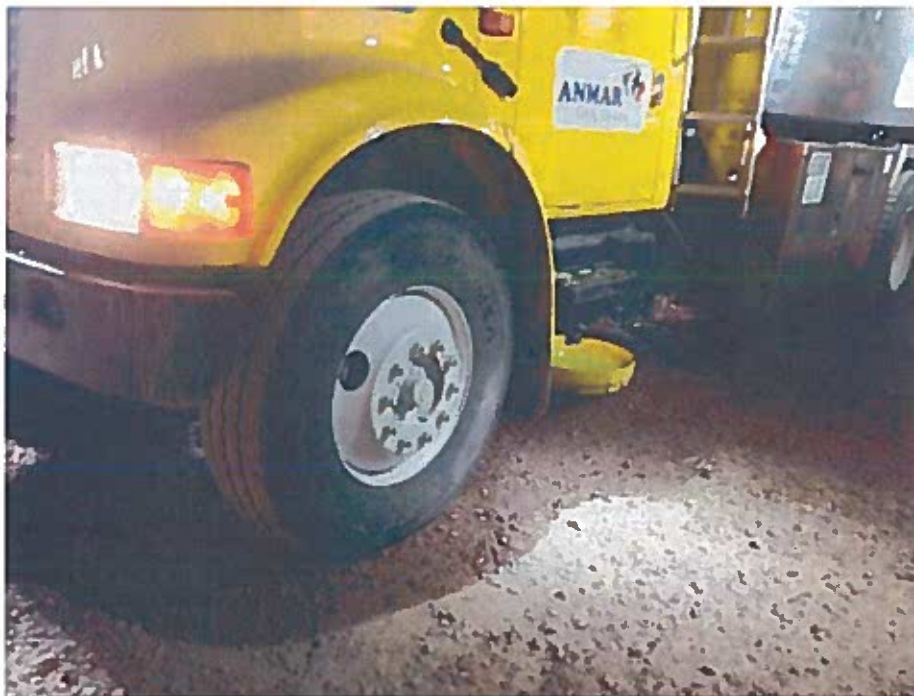
Figure 2. Front of Truck – Spill tray under Vent Tubes

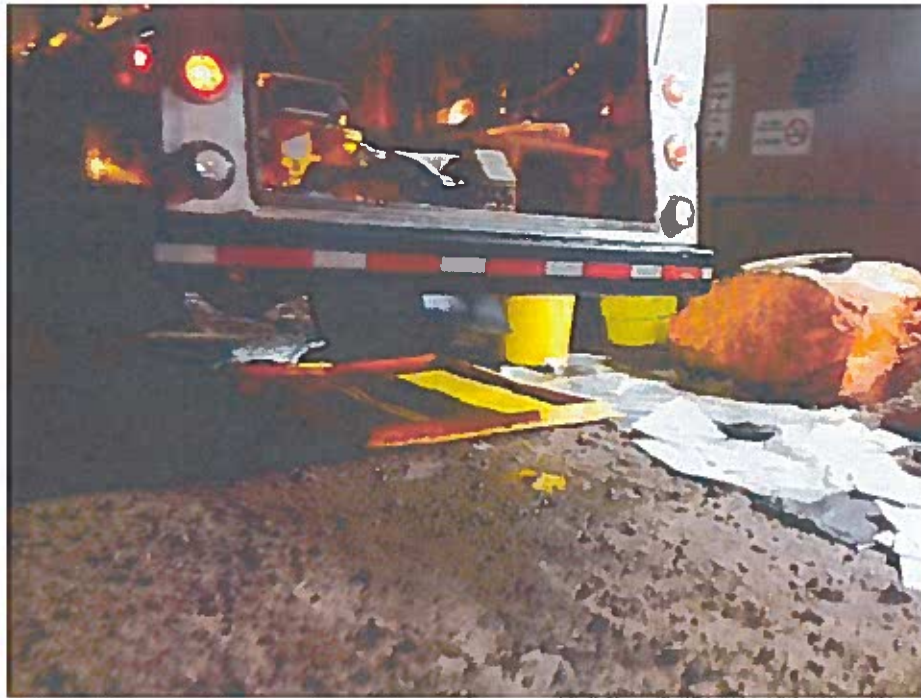
Figure 3. Back of Truck – Cleanup Immediate Actions: Spill Pads and Tray Under Back Vent Tube

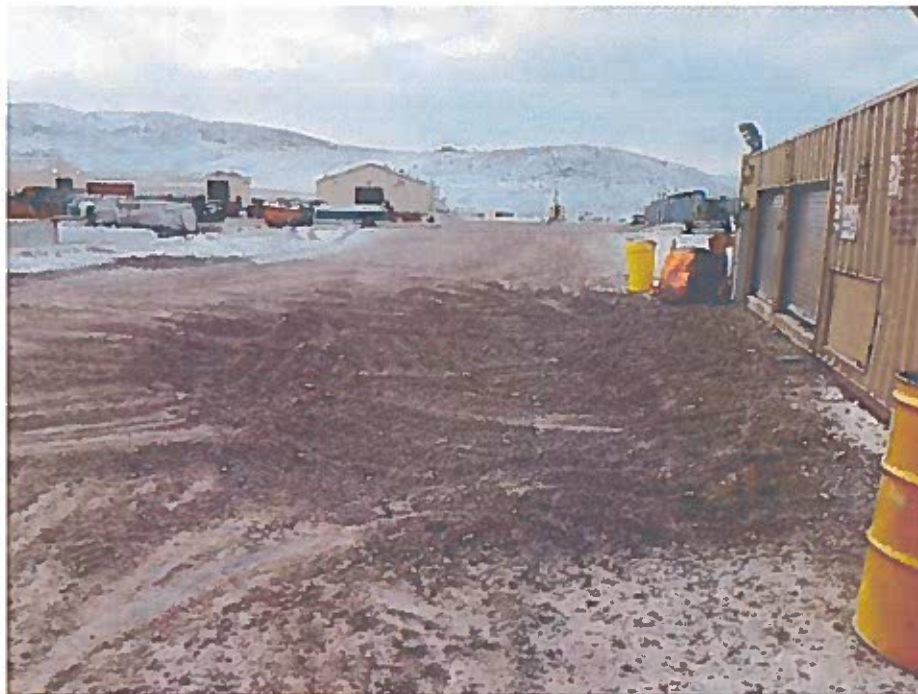
Figure 4. Area Excavated

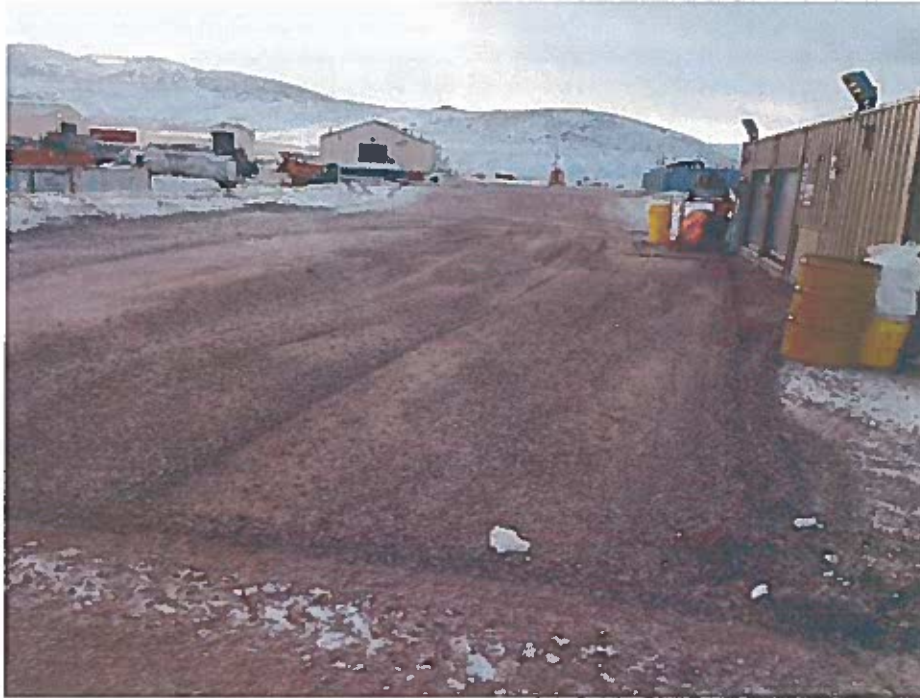
Figure 5. Area Back-Filled with New Material – New Spill Pads in Place

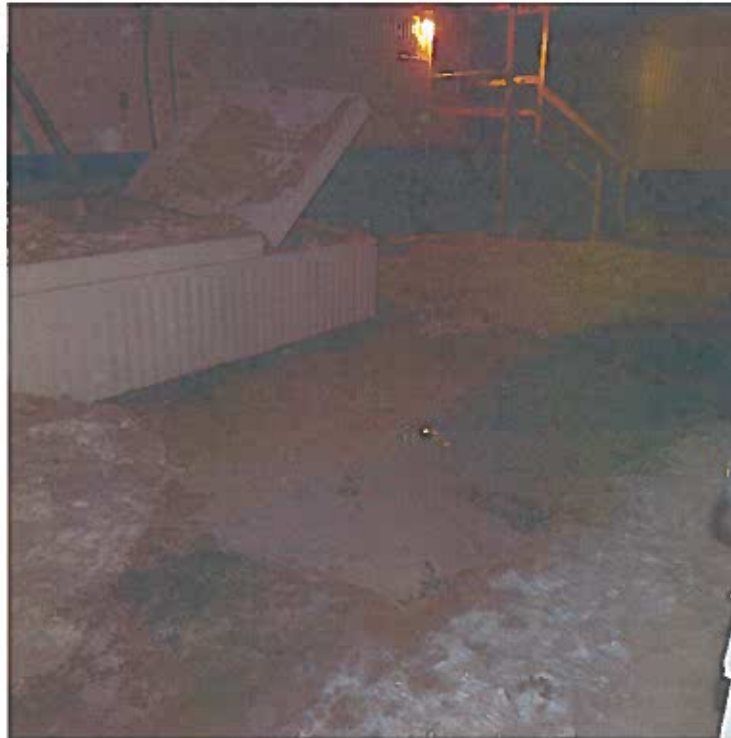
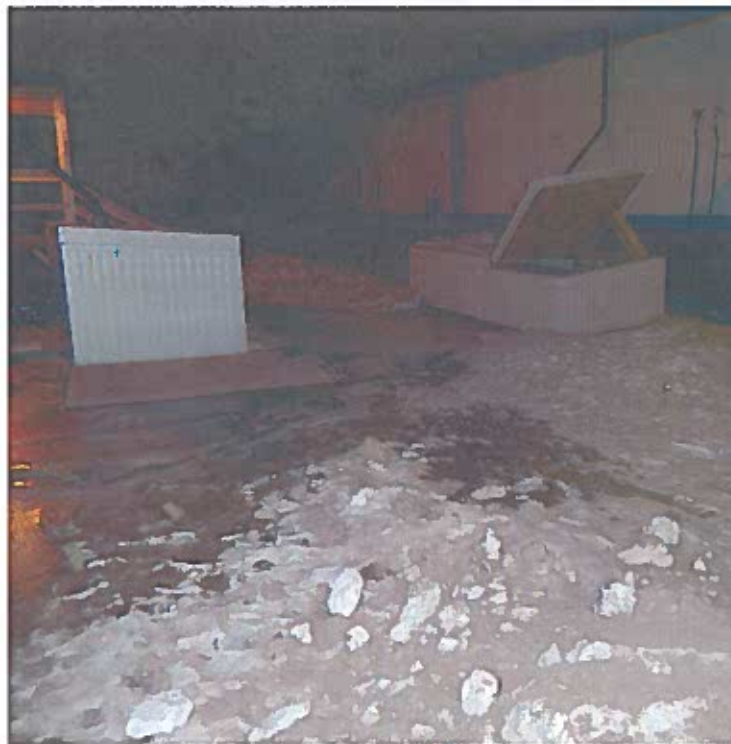
On October 16th, 2014 at approximately 17:30, the kitchen lift station at the Mine Site Complex was observed to be overflowing. It is estimated that approximately 150 litres of sewage was released based on the extent of the spill. Frozen ground conditions limited the depth of soil contamination to more or less just the surface. The location of the spill was greater than 200 m from the nearest water body. The high level float switch failed to turn on the pumps causing the overflow.

Photo 1 - Kitchen Lift Station

Photo 2 - Kitchen Lift Station

Float was replaced as the wiring had been damaged. During regular inspections, lift station floats are tested and the pumps engaged to verify that there is no leakage from the force mains.

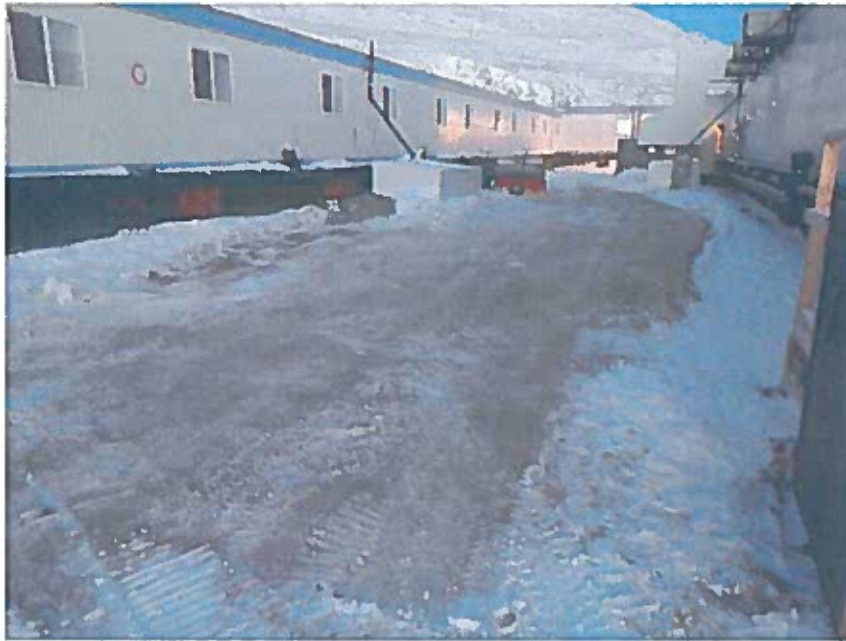
On Friday, October 31, 2014 at approximately 09:00 AM, it was discovered that a high pressure sewer line outside of the AG wing at the MSC had separated, causing sewage to spill onto the surrounding snow and ice covered ground. Frozen ground conditions limited the depth of soil contamination to more or less just the surface. It is conservatively estimated that approximately 200 litres of sewage was released based on the extent of the spill. The closest water body is > 100 m away from this location and is presently frozen.

Photo 1 - Spill location after clean up

Extreme temperature changes which cause the piping to expand and contract promotes leaks and pipe failure. Ongoing routine inspection of the piping systems are required to inspect for leaks and potential locations of failure.

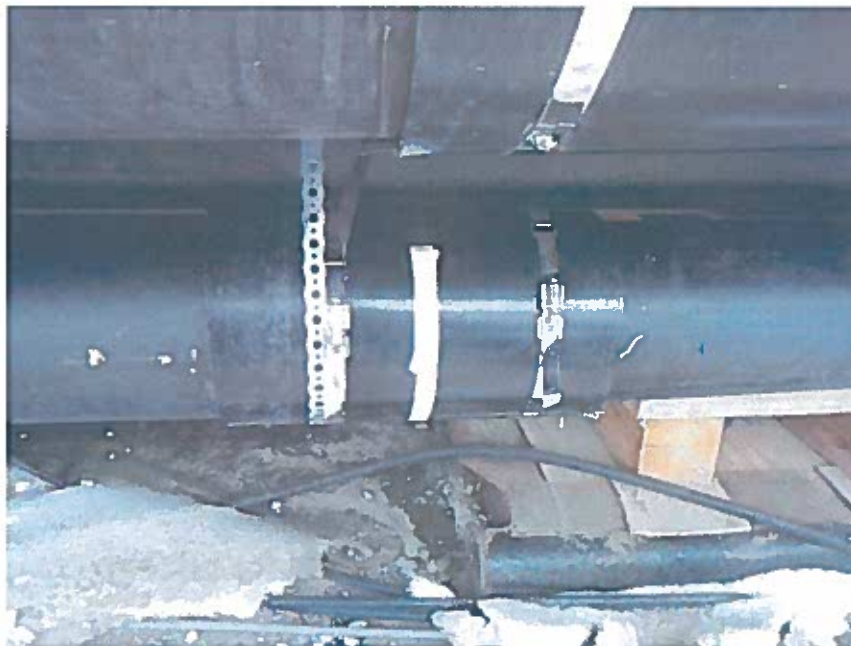
Photo 2 – Repaired sewer line

The source was immediately contained and a front end loader was used to scrape up and dispose of the contaminated snow and ice into the PWSP#1, an engineered and lined containment facility. The broken sewer line was repaired and put back in to service.

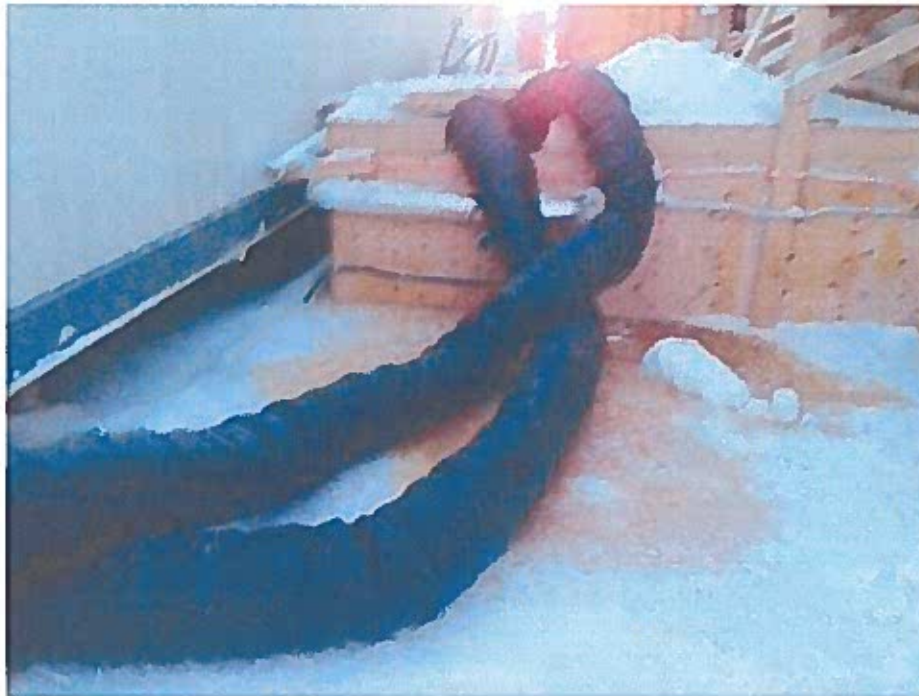
Investigation revealed that a power outage caused the outlet pipe to freeze. The freeze-thaw condition appeared to have caused the shutoff valve to close improperly and crack the tank. Thawing the line caused sewage above outlet line to gravity flow outside the tank. The sewage tank and lined insulated box need to be replaced.

Figure 1. Front of Holding Tank Box

The Site Services Fixed Plant Maintenance group must communicate all power shutdowns to departments that may be affected by a shutdown. It was also recommended that potentially impacted processes be identified to prevent negative impacts caused by freeze-thaw events, such as inspections of critical systems, better insulation, temporary heat, etc.

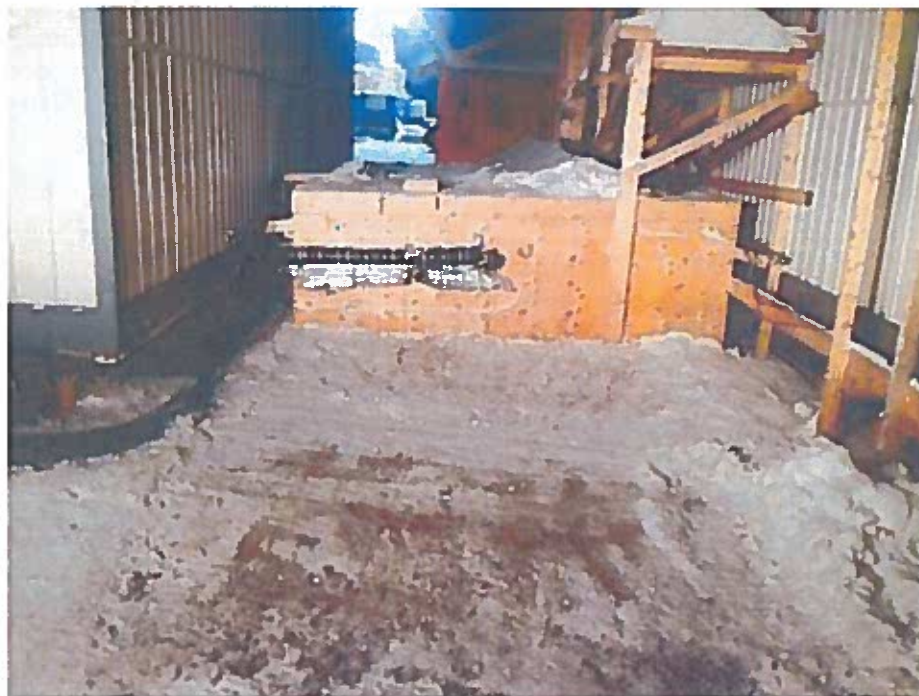
Figure 2. Front of Holding Tank Cleaned

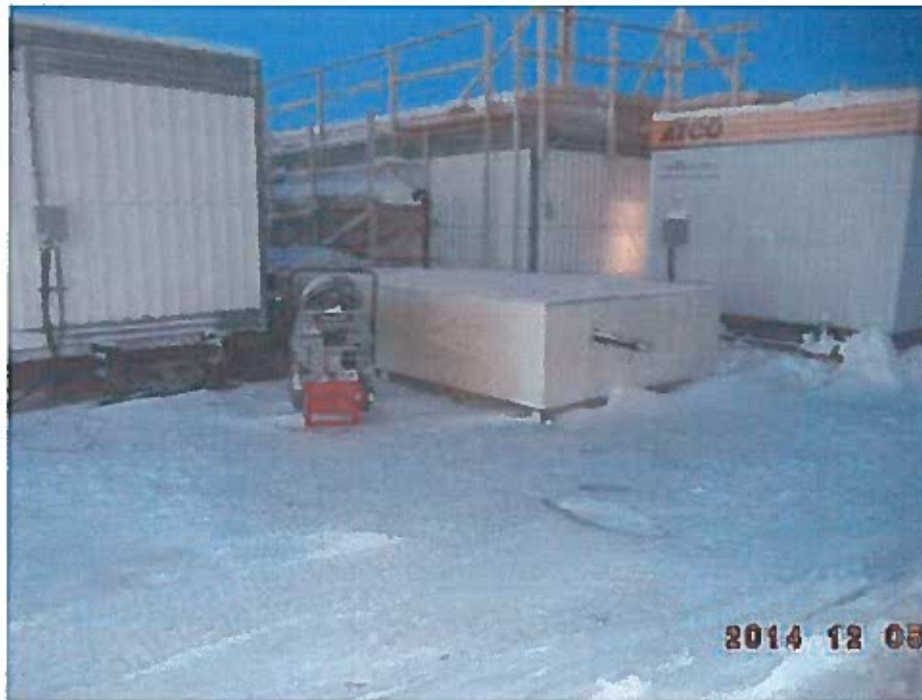
Figure 3. New Holding Tank and Box

The sewage tank and insulated lined box have been replaced (Figure 3). Improved communication procedures have been implemented for planned and unplanned shutdowns / power outages.

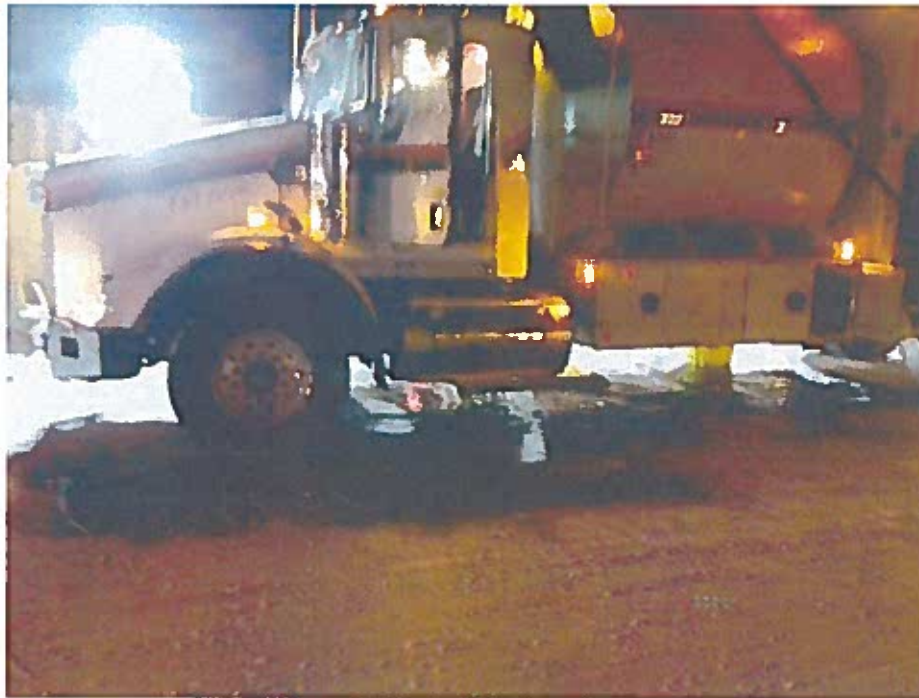
Investigation revealed that the fueling procedure was not adequate for its purpose and the worker did not follow the requirement of having a spotter monitoring the fuel level in the tanker. It was recommended that the fueling procedure be revised and communicated to all personnel involved in bulk tank refuelling. The electronic overflow control (Scully) system was not activated at this location.

Figure 1. Fuel spill before cleanup

The maintenance department is in the process of revising the fueling procedure, and currently working on a solution to repair the "Scully System".

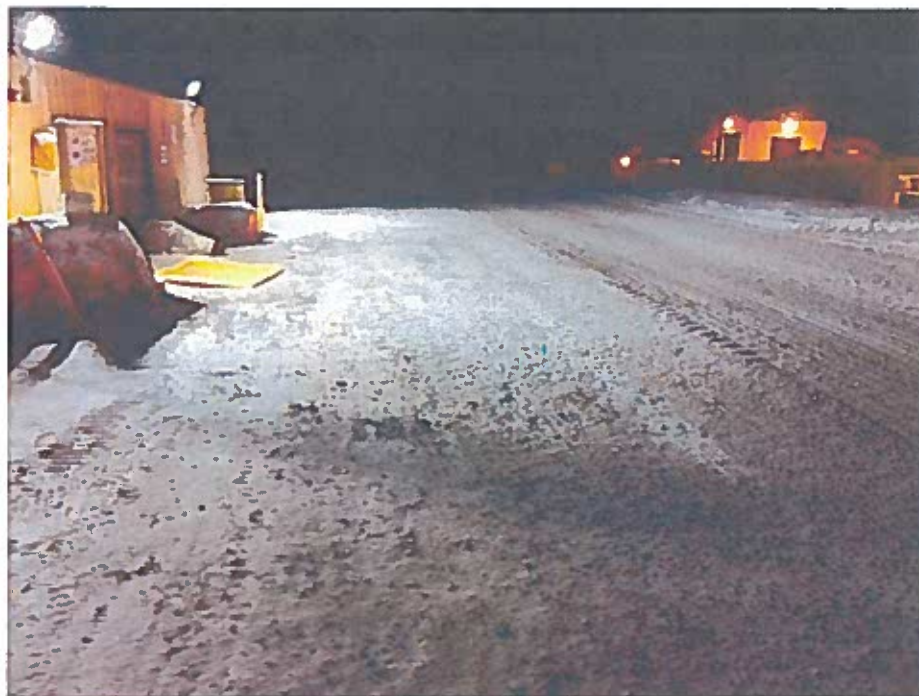
Figure 2. Fuel spill after cleanup

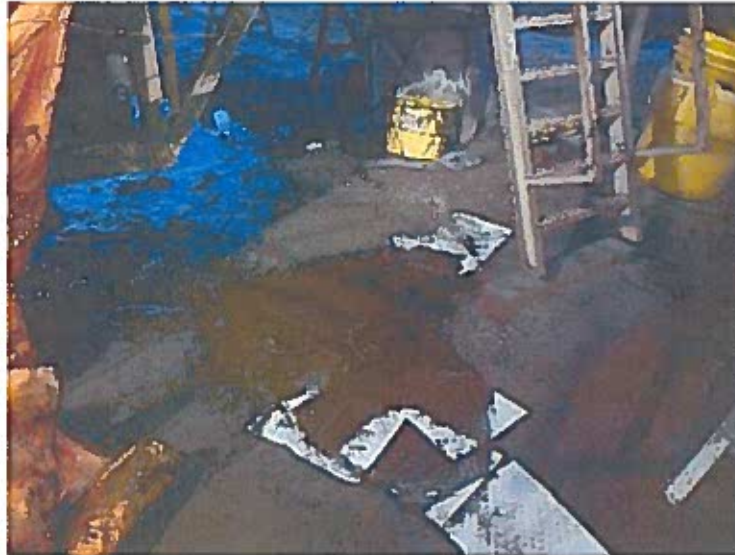
There are heaters in the tank to keep the oil temperature up to operating temperature and the tank is insulated, but the oil lines to and from the tank are not insulated. With the lines being exposed to -36 °C, the oil thickened, restricting flow through the filter, causing high pressures in the tank. This caused the filter cover on the cone oil lube tank to separate and the oil escape to the ground surface. The oil lines require insulating / heating.

Photo 1 - Spill Location

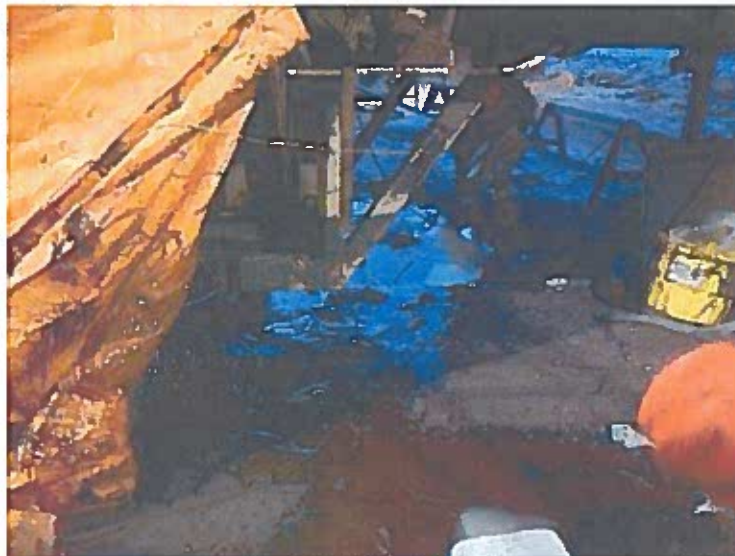
Photo 2 - Using Spill Pads

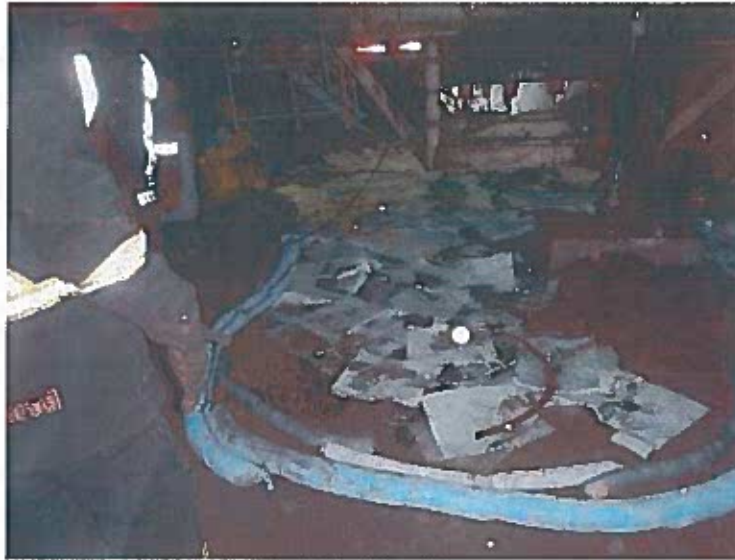
Photo 3 - Using Booms

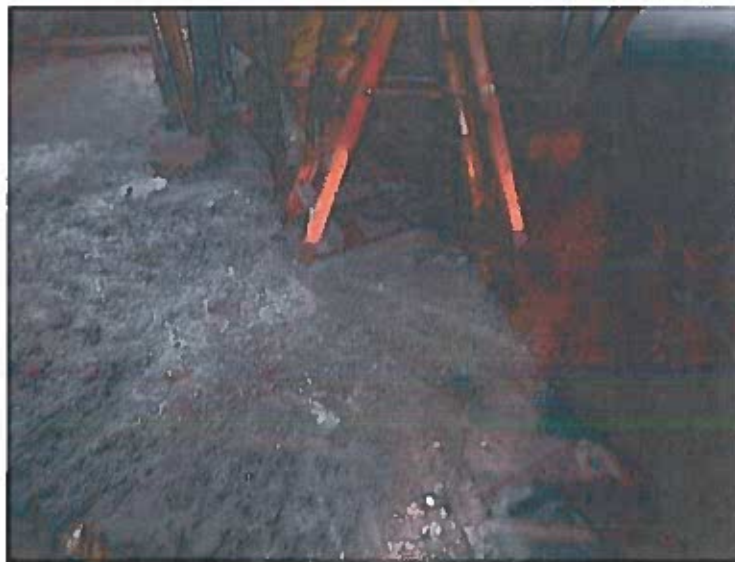
Photo 3 - After Clean Up

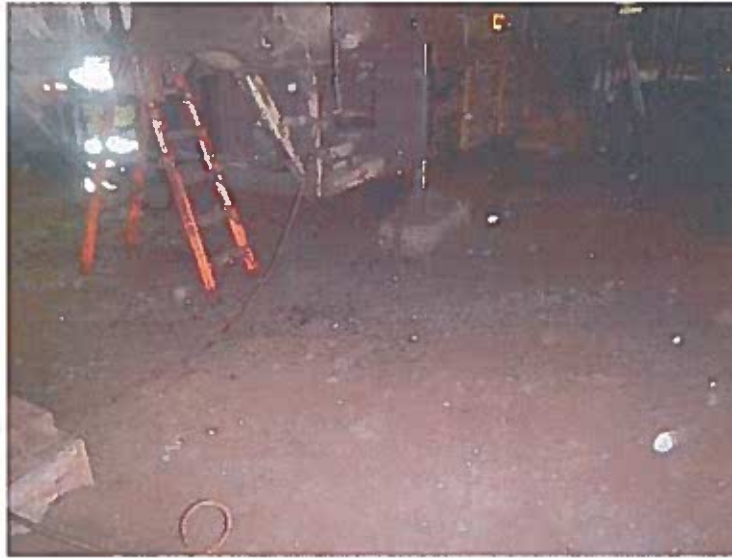
Photo 4 – After Clean Up

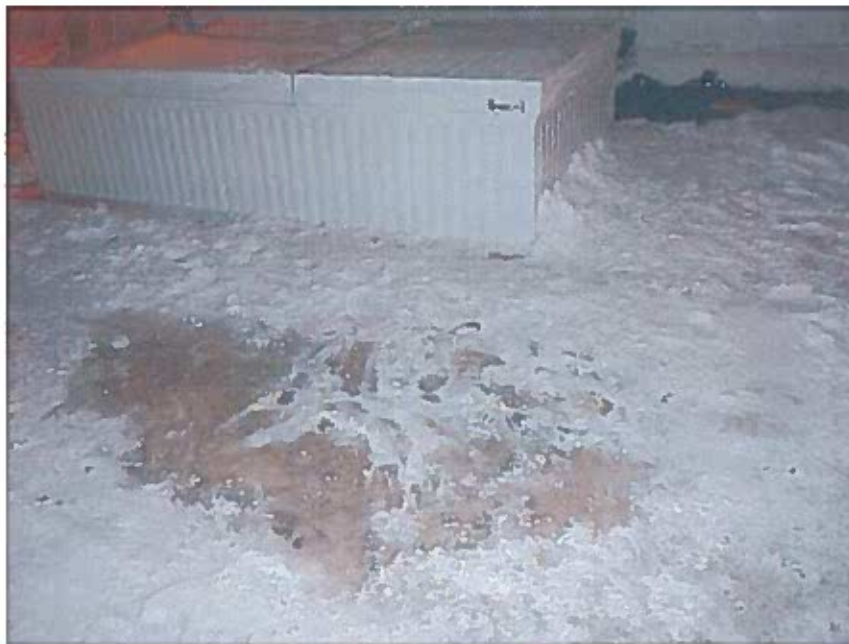
On Monday, December 1, 2014, the water treatment operator reported that the MBR had a large quantity of sewage that was unaccounted for. Site Services investigated and found that sewage had been released from the AF wing lift station at the Mine Site Complex. The surrounding snow and ice covered ground appeared to be slightly impacted, however upon further investigation it was discovered that the majority of the sewage had migrated underneath the AG wing and froze, making the spill volume and area of contamination hard to determine. It is conservatively estimated that roughly 5000 litres of sewage was released to the receiving environment. The pumps were immediately shut off upon discovery and the lift station tank and housing unit were pumped out with a vacuum truck. There was no flow of sewage to the closest water body which is > 200 m away and is presently frozen.

Photo 1 - Spill location AG Wing Lift Station

Extreme temperature changes which cause the piping to expand and contract promotes leaks and pipe failure. Ongoing routine inspection of the piping systems are required to inspect for leaks and potential locations of failure. A longer term plan to solve this issue is in development.

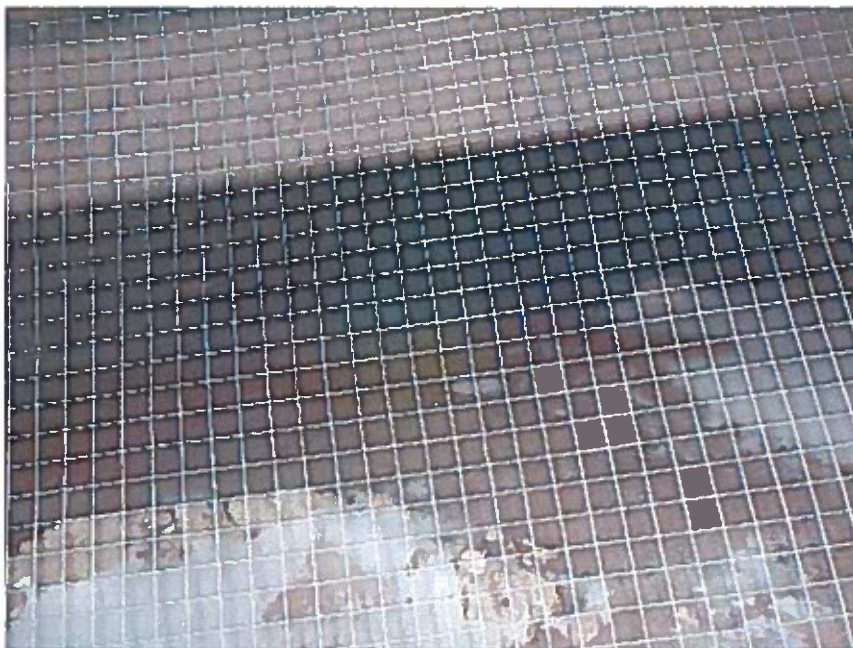
Photo 2 – Sewage under Accommodation Wing

All water was shut off and Environment was notified. The Lift Station and housing unit were pumped out with a vacuum truck and contaminated material was removed and disposed of in the polishing waste stabilizing pond, more remains under the wing. The joint that failed was replaced and tested.

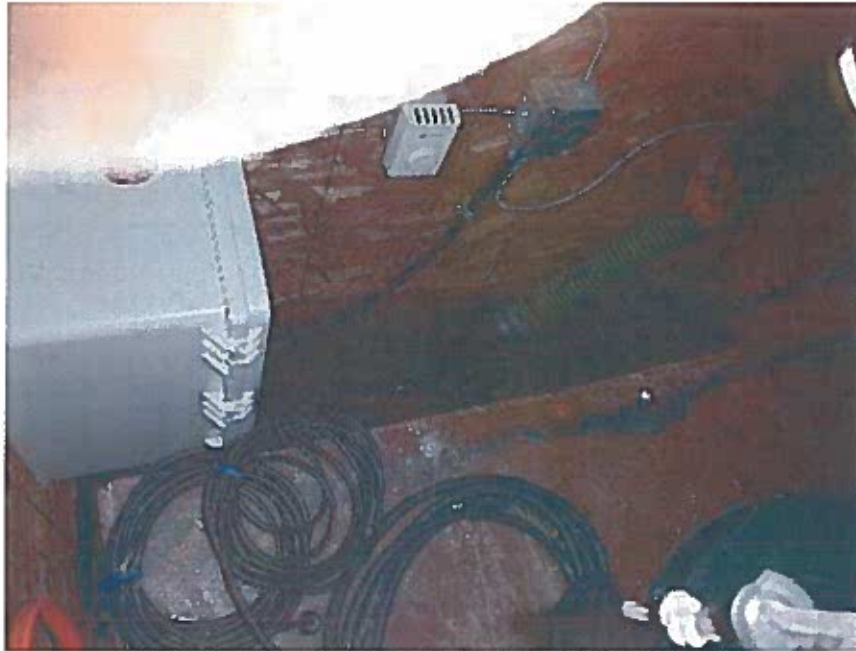
Photo 3 – Sewage being pumped out of lift station box

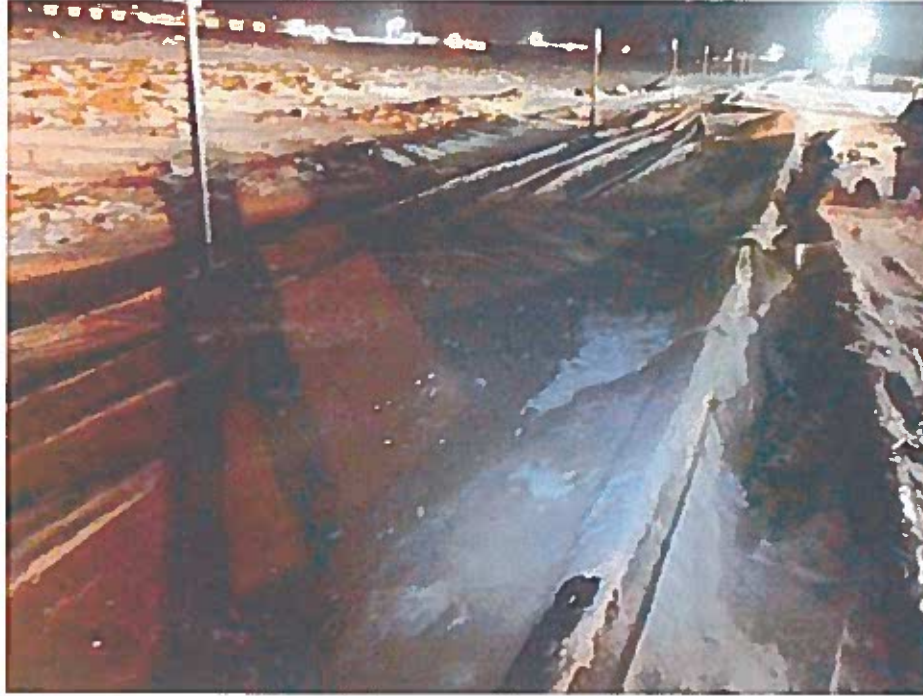
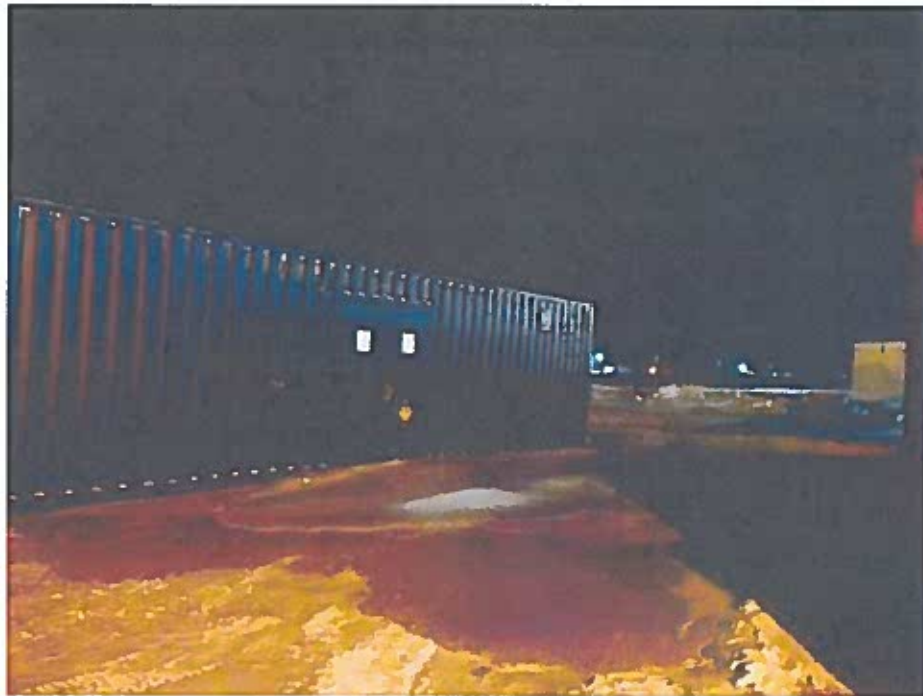
On December 10 2014 at 4:30am, a worker detected a leak at the PSC main sewer line main. He immediately called the housing maintainer who shut off the pump at the main lift station and the vacuum truck mobilized to pump sewage out of the main lift station. It was conservatively estimated that the volume of the spill was 3 m³, based on an area of contamination of approximately 100 square metres. The sewage froze in place and did not migrate further. The closest water body, Milne Inlet, is more than 350 m away and is presently frozen. There was no risk to the water body from the spilled frozen sewage.

Figure 1. Sewage spill before cleanup

Figure 2. Sewage spill before cleanup

Extreme temperature changes caused the piping to expand and contract promotes leaks and pipe failure. Ongoing routine inspection of the piping systems are required to inspect for leaks and potential locations of failure. A longer term plan to solve this issue is in development.

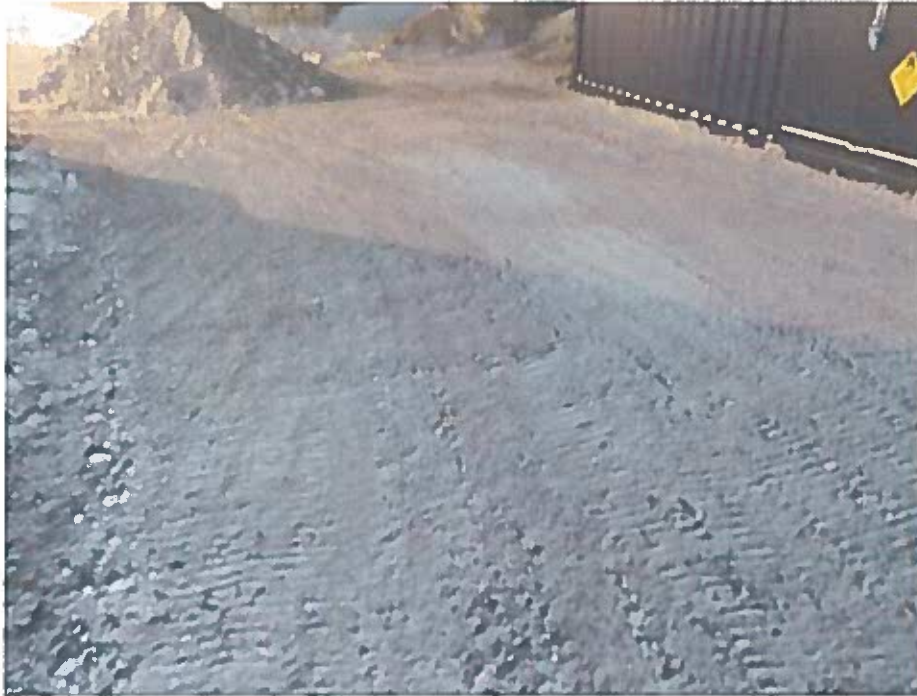
Figure 3. Sewage spill after cleanup
