**APPENDIX E.8**  
**DECOMMISSIONING REPORTS**

## **APPENDIX E.8.1**

### **MINE SITE**

## **INSPECTION OF THE MILNE INLET TOTE ROAD AND ASSOCIATED BORROW SOURCES**

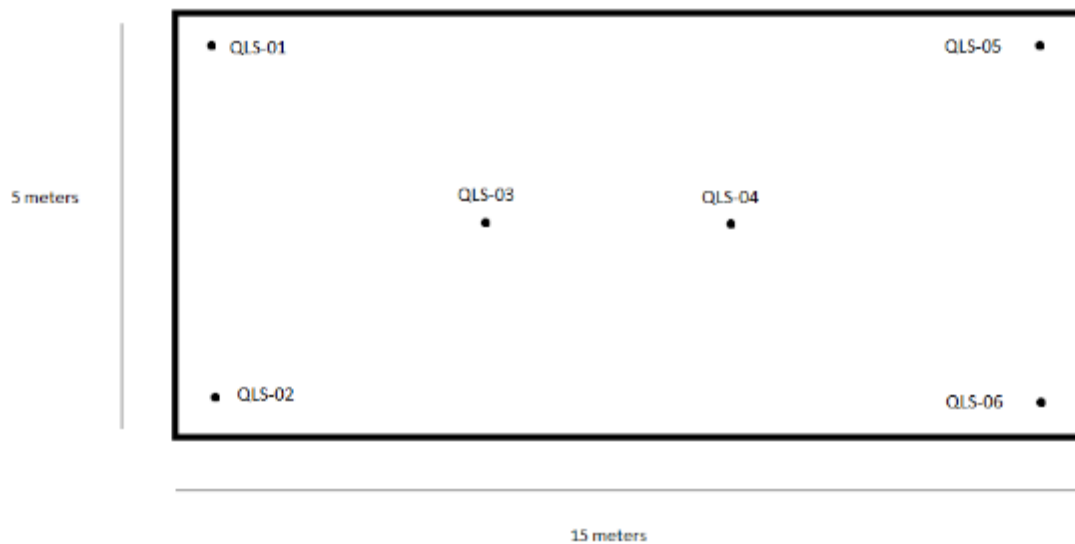
**Figure 2** - Quanset footprint soil sample locations.

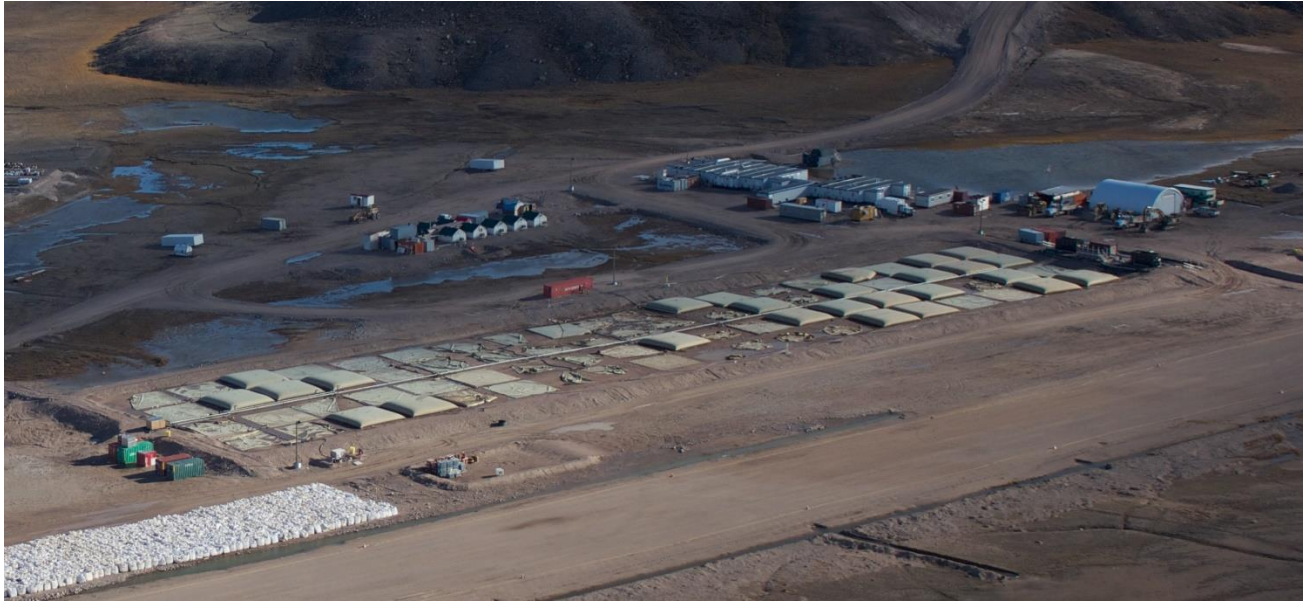
Photo 1 – Fuel Bladder Storage Facility at Milne Port (2012)

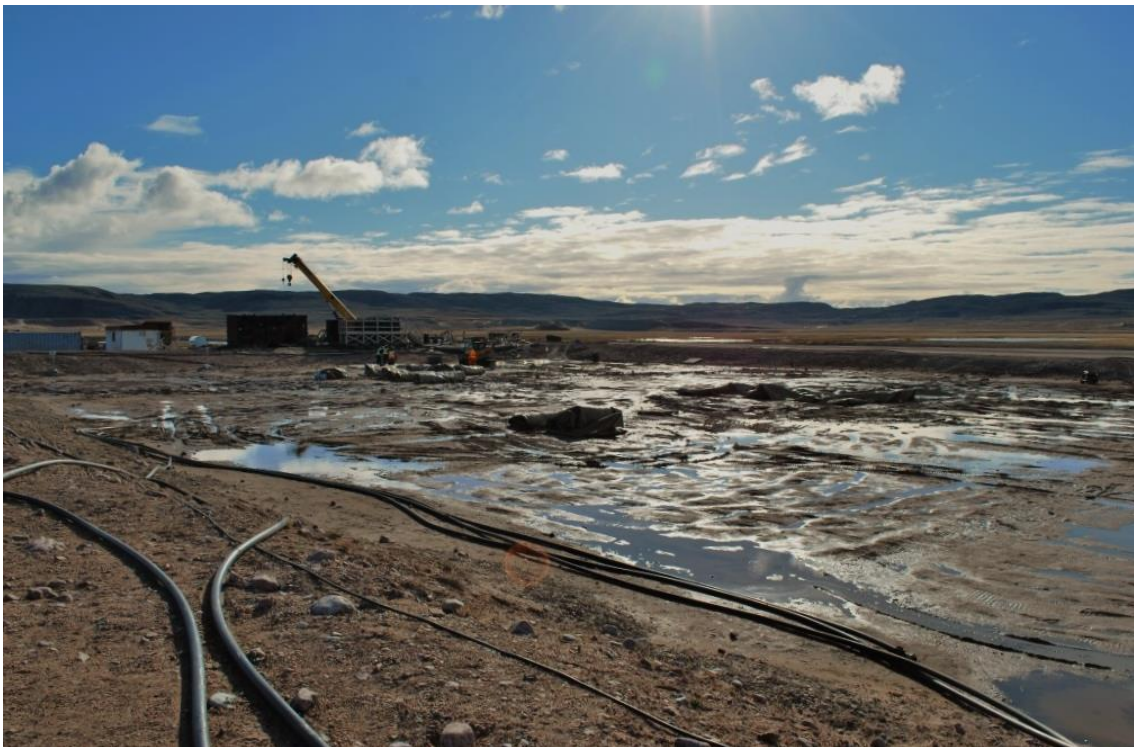
Photo 2 - Removing Fuel Bladders (September, 2013)

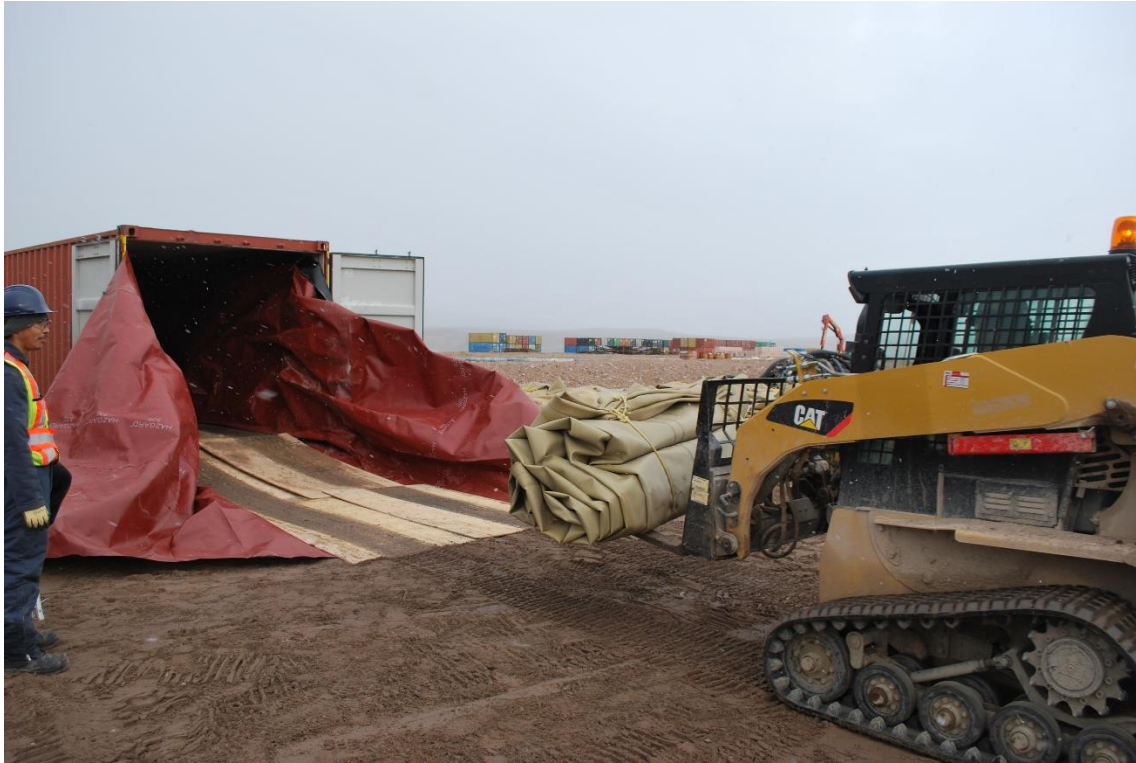
Photo 3 – Loading Fuel Bladders into Lined Sea Containers for Backhaul

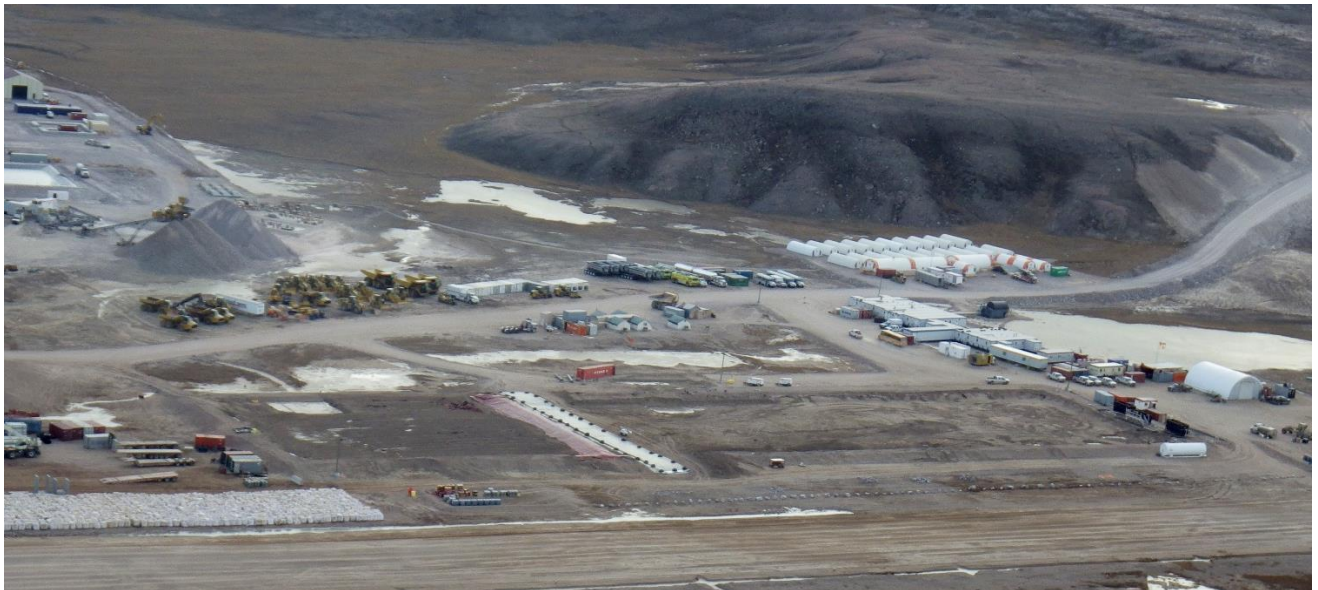
Photo 4 – New Containment Berm Wall Construction after Removal of Fuel Bladders and Piping  
(September, 2013)

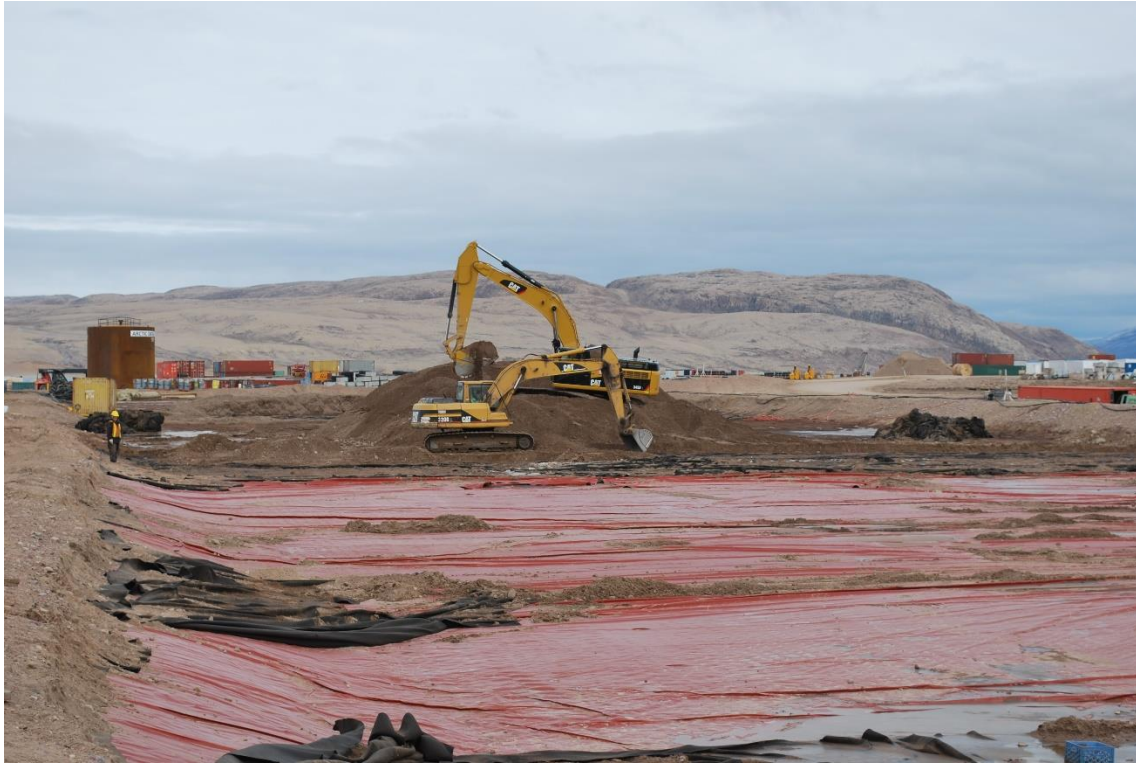
Photo 5 – Transferring the Contained Contaminated Soil to the North End of the Containment Berm

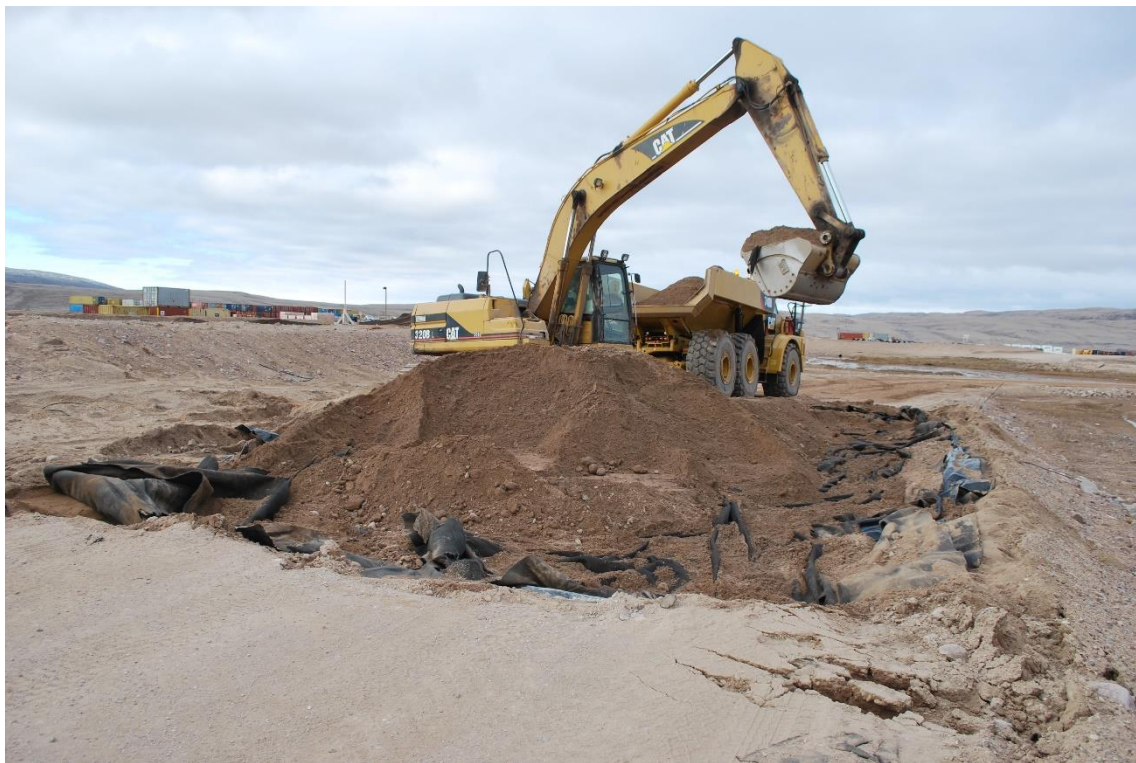
Photo 6 – Demobilization and Remediation of the Refueling Area

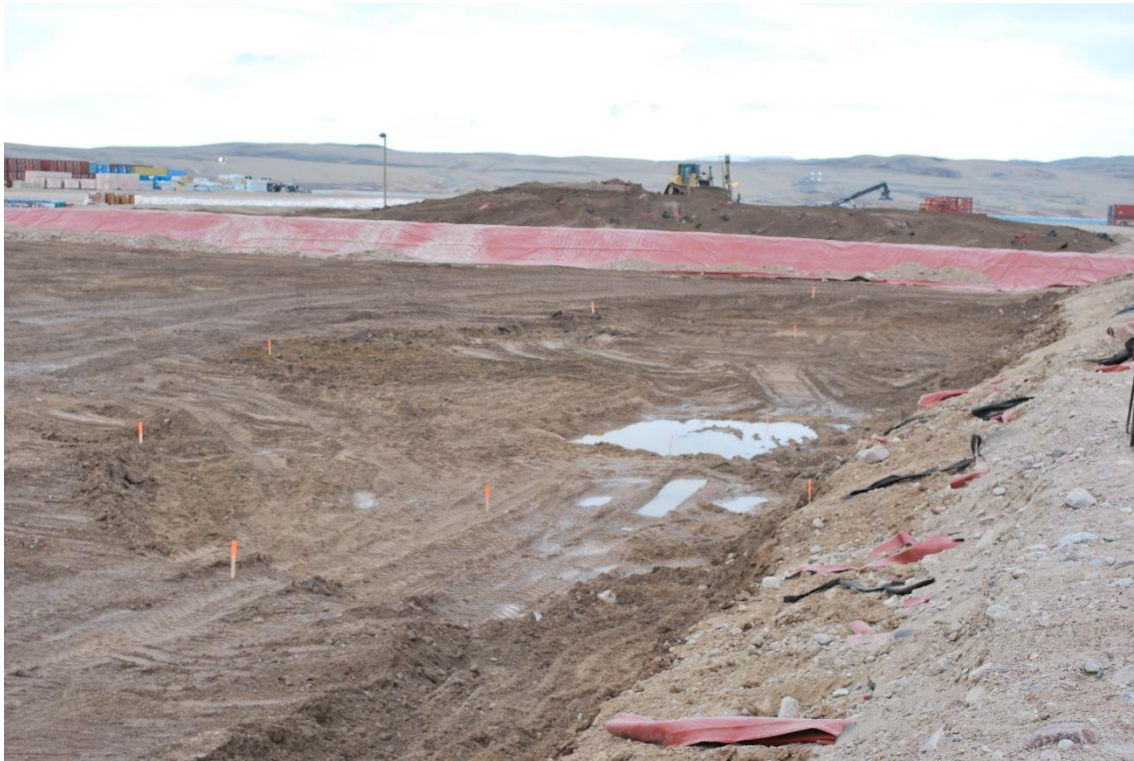
Out of all the PH contaminated areas that were excavated, the sump area of the containment berm registered the highest concentrations of residual PH contamination. The soil underneath the sump area of the containment berm was the most prone to potential PH contamination due to the longer term oily water residing at this location during each open water season. Both the refueling area and containment berm sump area required substantial excavation and removal of soil to the depth of permafrost in some areas.

Photo 7 – Final Excavation of the Containment Berm Sump Area

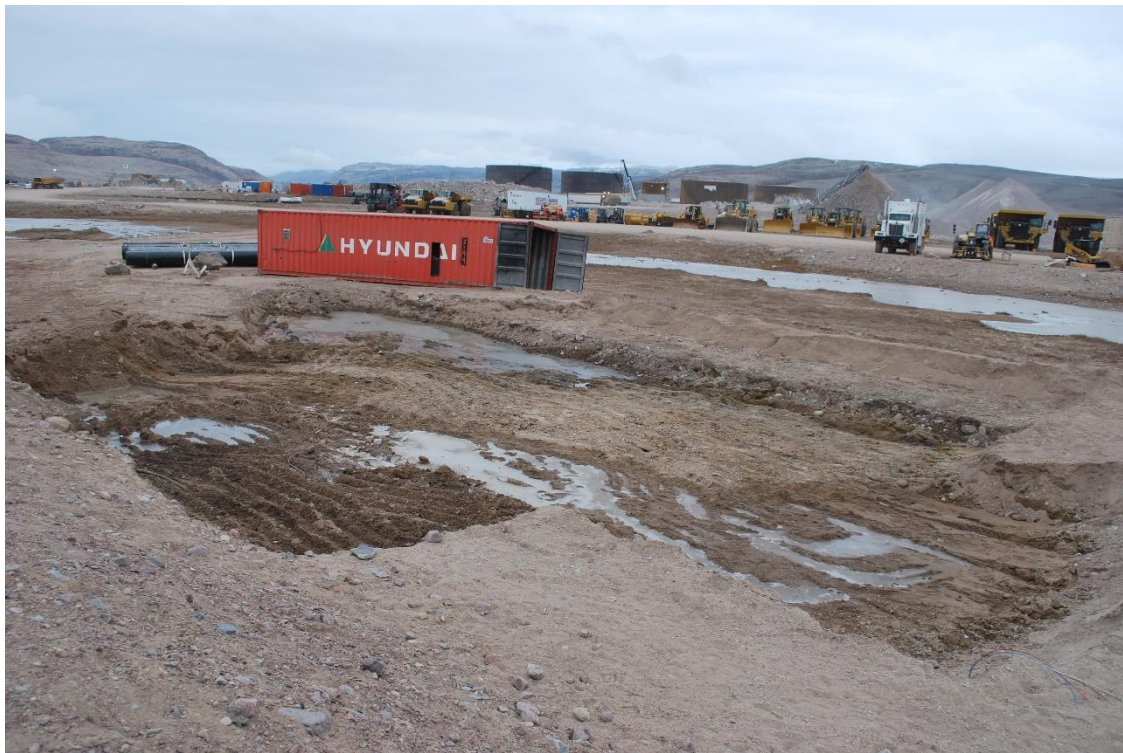
Photo 8 – Final Excavation of the Refueling Area

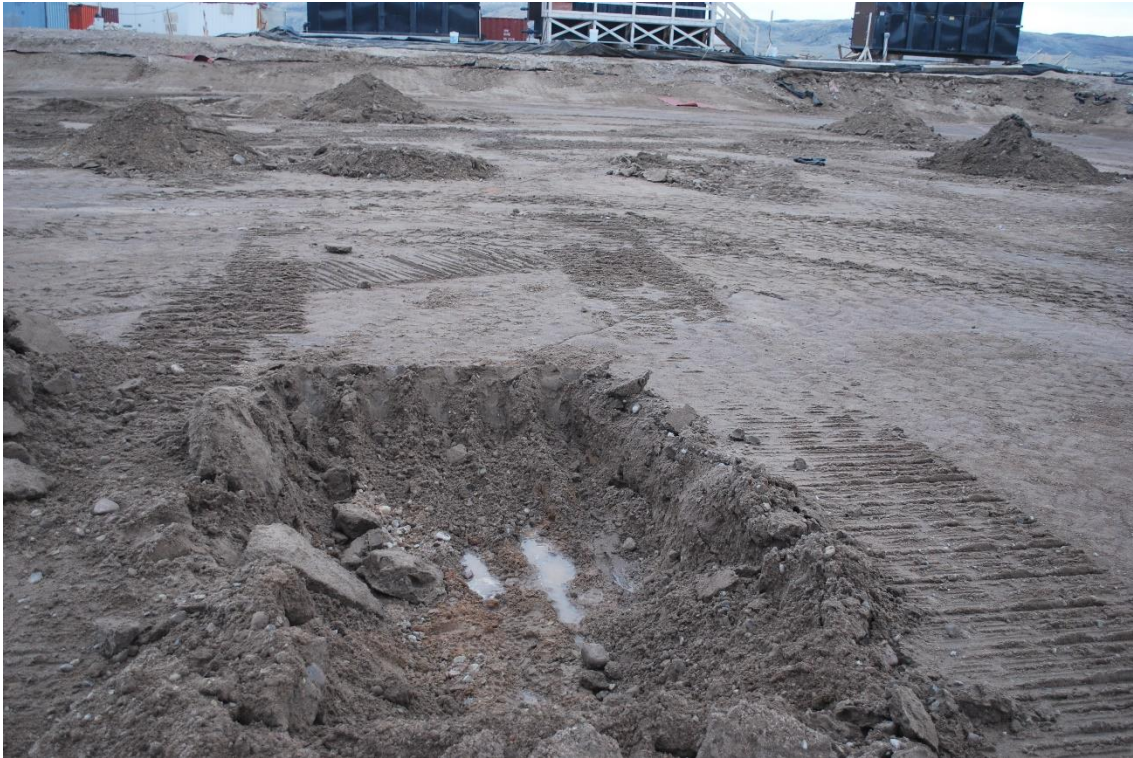
Photo 9 – Test Pits

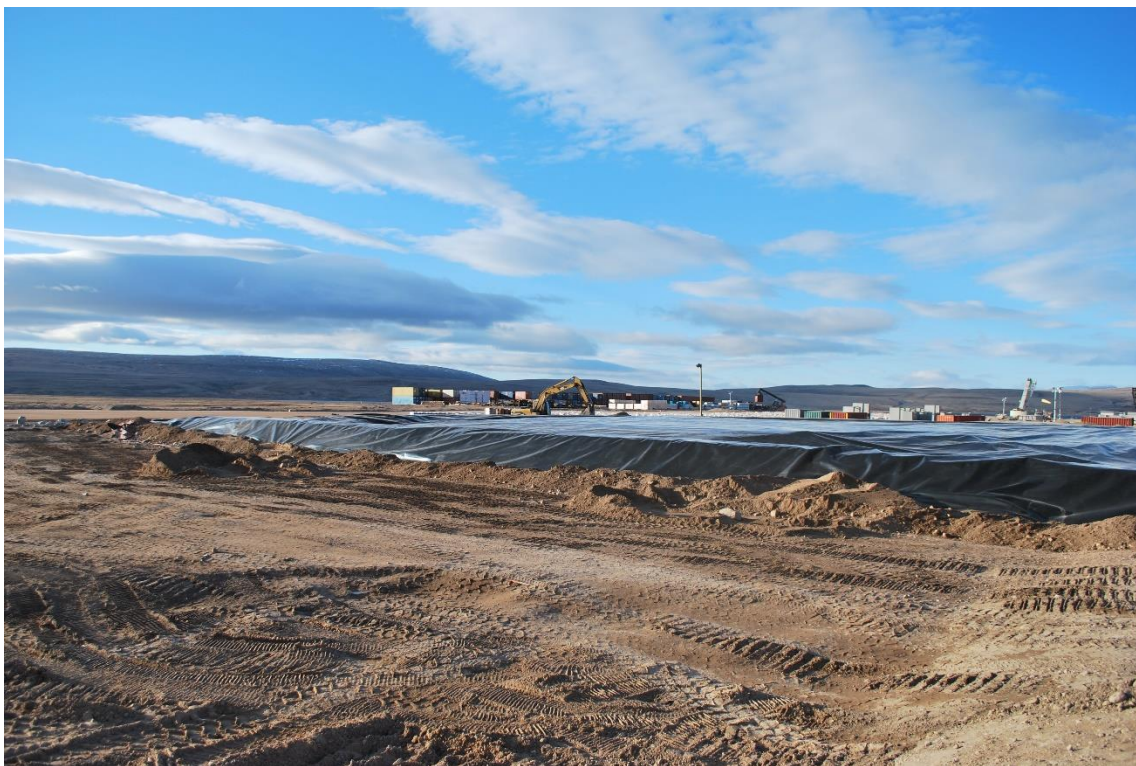
Photo 10 – Sealed Containment Berm on North End of the Facility

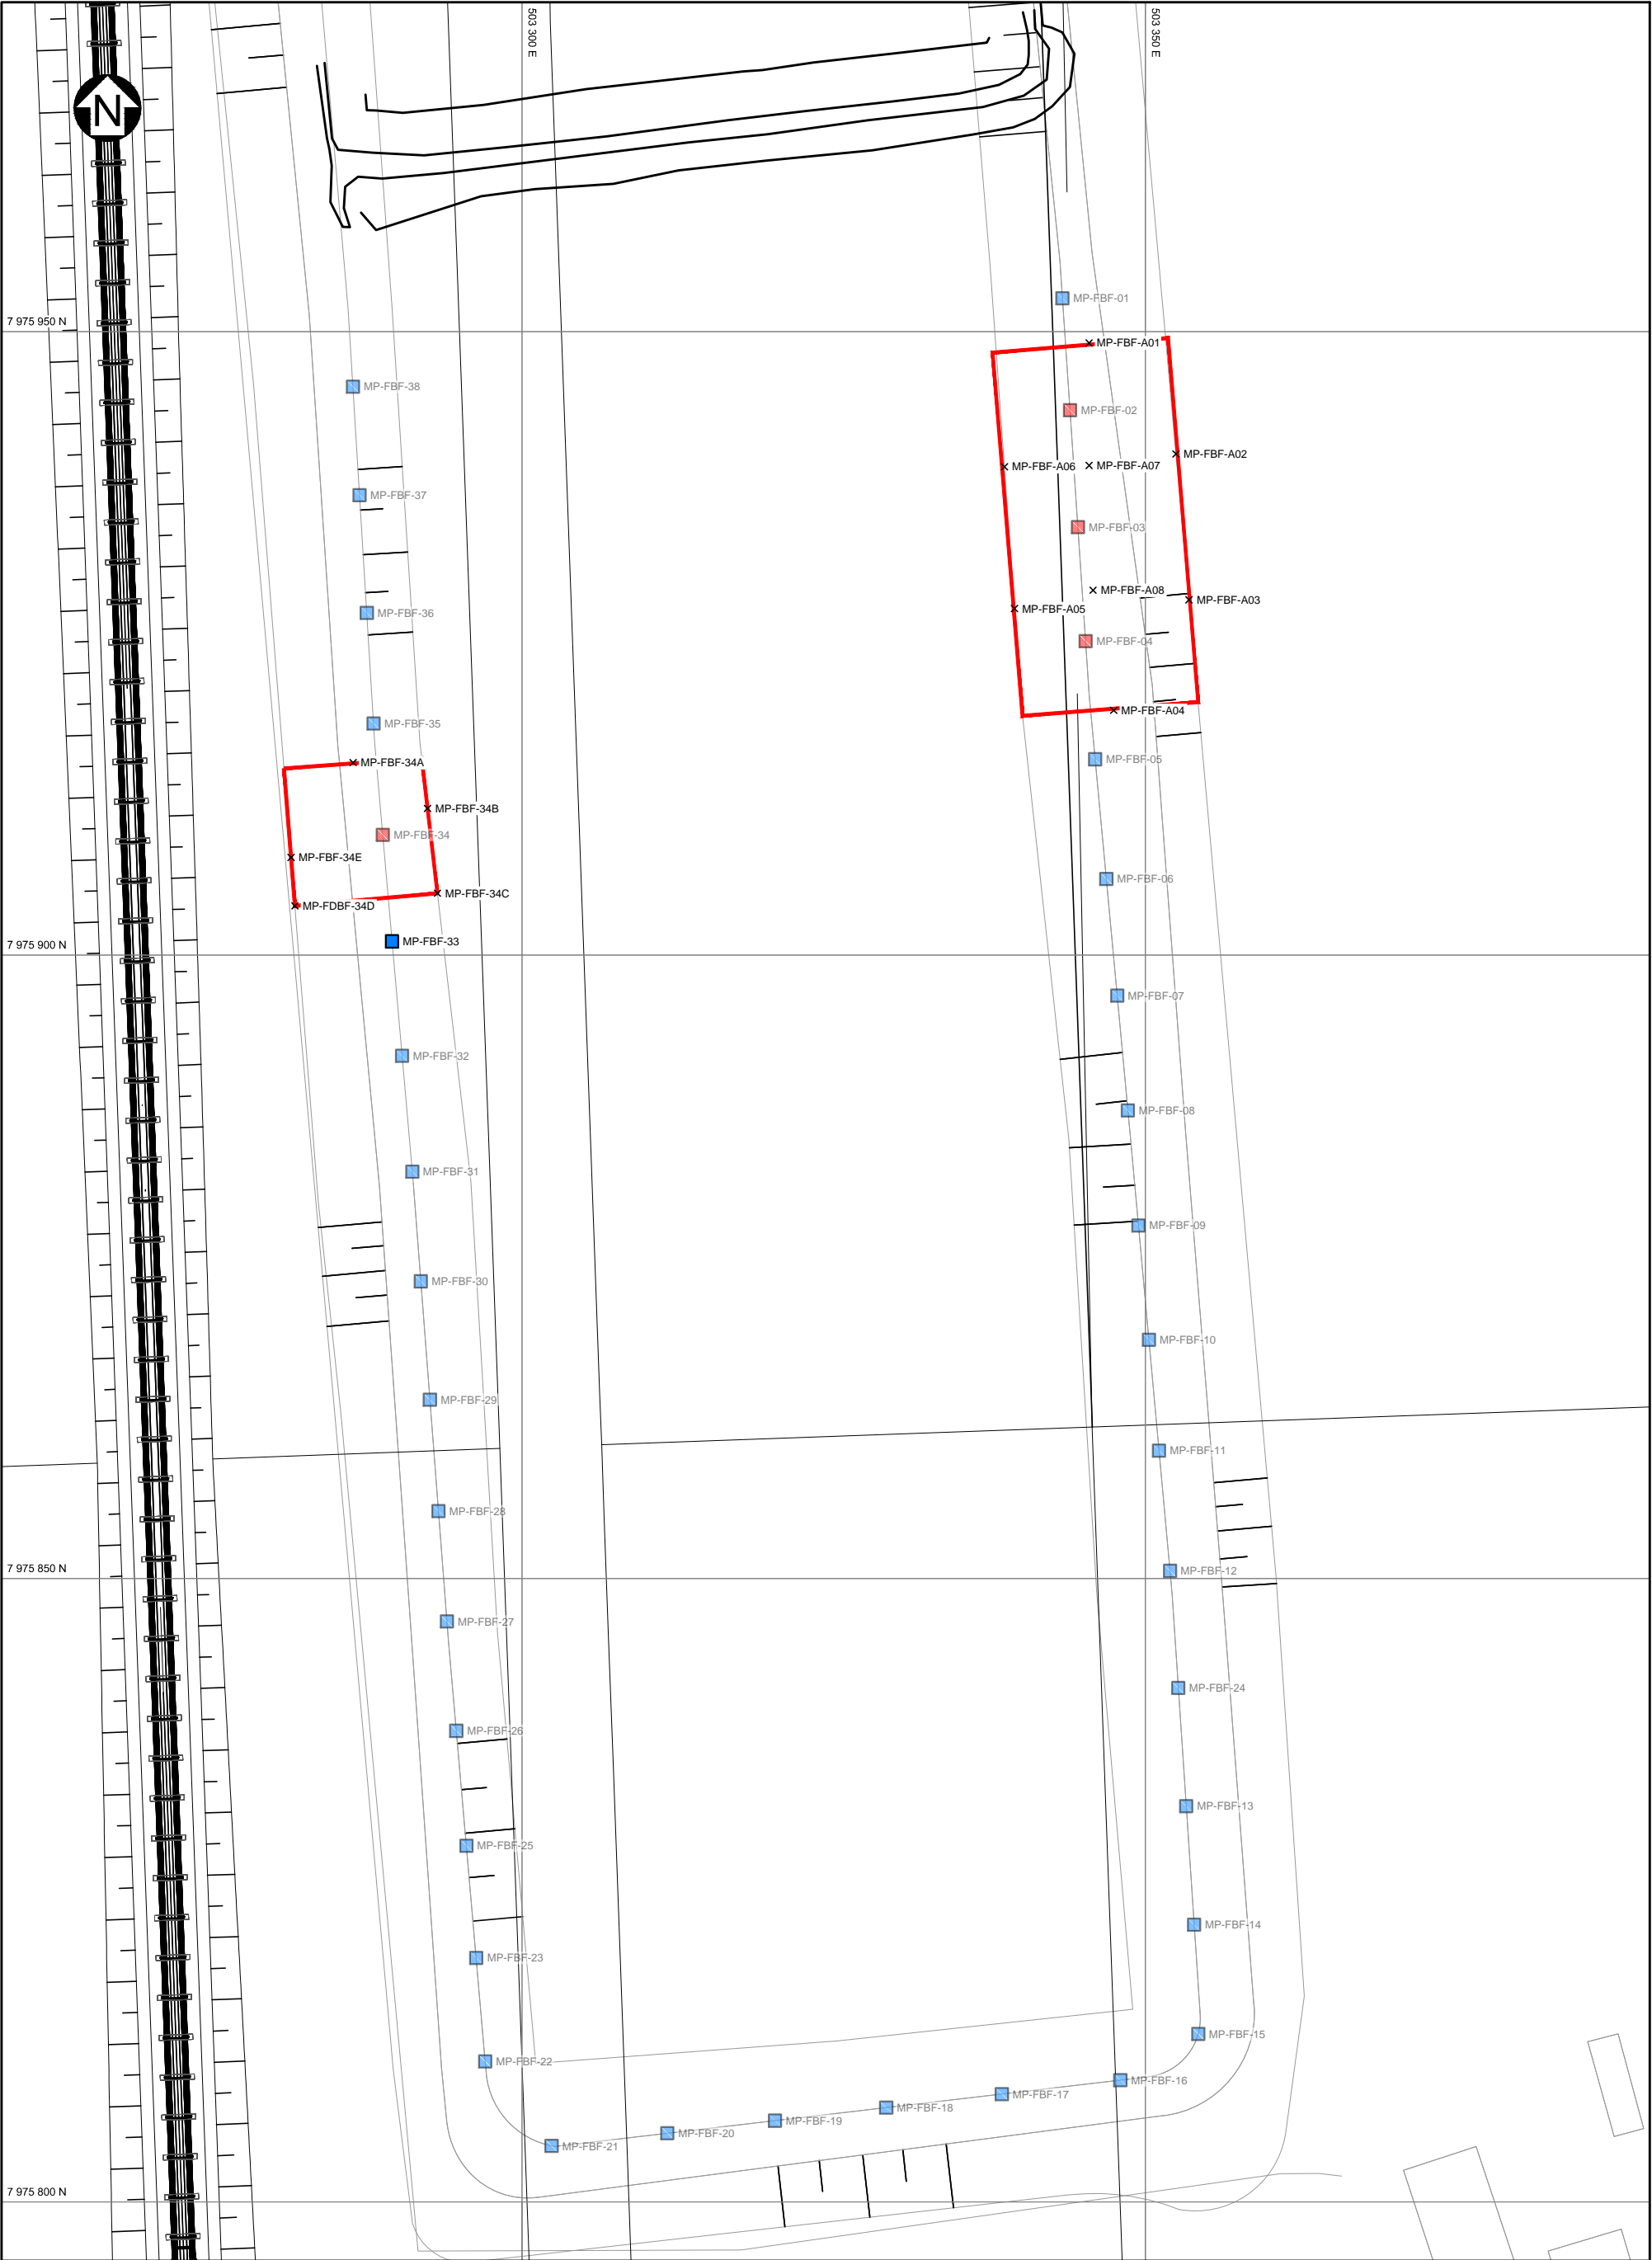
MILNE PORT  
 SOUTH FUEL BLA...ER FACILIT...  
 SAMPLIN... LOCATIONS AN... EXCAVATION LIMITS

The analytical results obtained from the confirmation sampling program (refer to Table 2 Attachment B) confirmed the areas of contamination identified during the 2013 decommissioning work. These areas were identified along the berm wall at the former refueling location (west side) and former Jet-A offloading area (east side). As acknowledged in the 2013 Technical Memorandum (Attachment A) there were identified areas that required additional excavation and removal of soil to the depth of permafrost to complete decommissioning activities. After excavation of the contaminated soil, confirmation resampling was completed on September 24<sup>th</sup> and 27<sup>th</sup>. A review of analytical results (refer to Table 3 and Table 4 of Attachment B) indicated that PHC concentrations were below Tier 1 Criteria and the South Fuel Bladder Facility and the underlying area was cleared for construction.
