Baffinland Iron
Mines Corporation

Mary River Tote Road Quarry Reclamation
Mary River, Baffin Island

PLAN PHOTO LOCATIONS
SHEET 13 OF 13

Figure 13

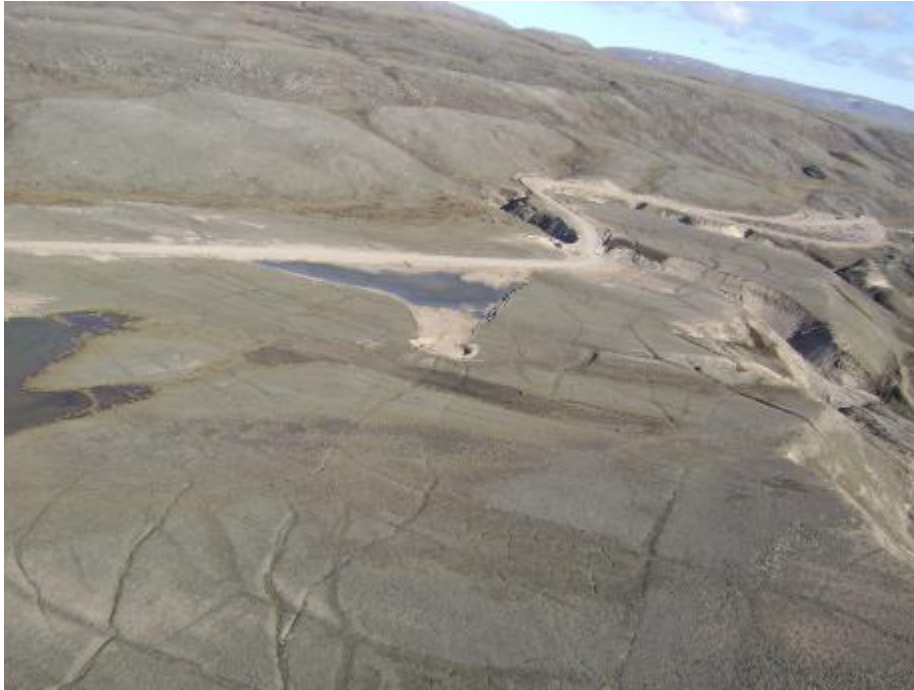
Photo 1 (1612):

Priority C pit at km 6.6 (Figure 1) lies on a gravel terrace with well-established ice wedge polygons. Removal of material from the active layer in the pit has initiated thaw and ponding but it has not changed since 2009 and remarkably is not currently impacting the embankment.

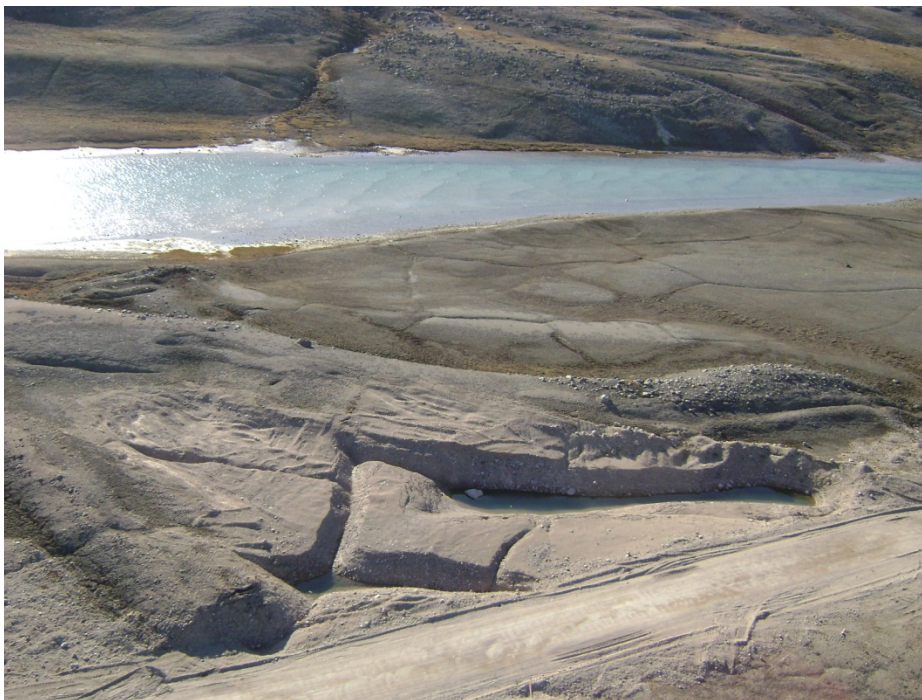
Photo 2 (1585):

Pit at km 20.7 (Figure 2), linear sinkholes from ice wedge melt out, see also Photo 3

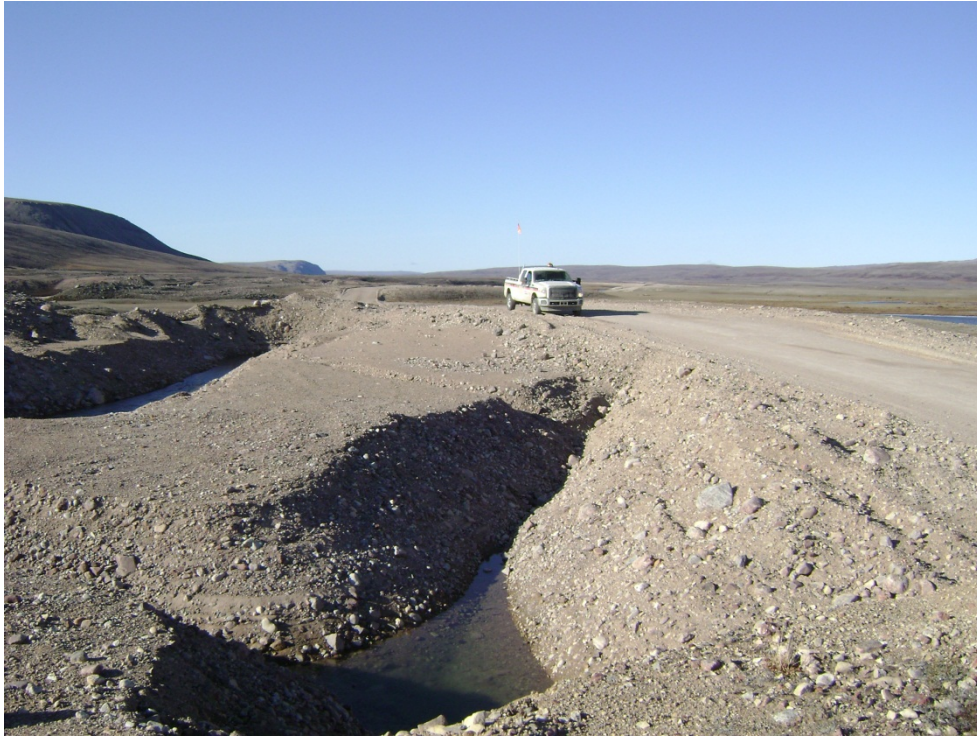
Photo 3 (1697):

Pit at km 20.7 (Figure 3) is threatening the stability of the road embankment as thermal erosion of water is occurring through the ice wedges exposed in the adjacent pit.

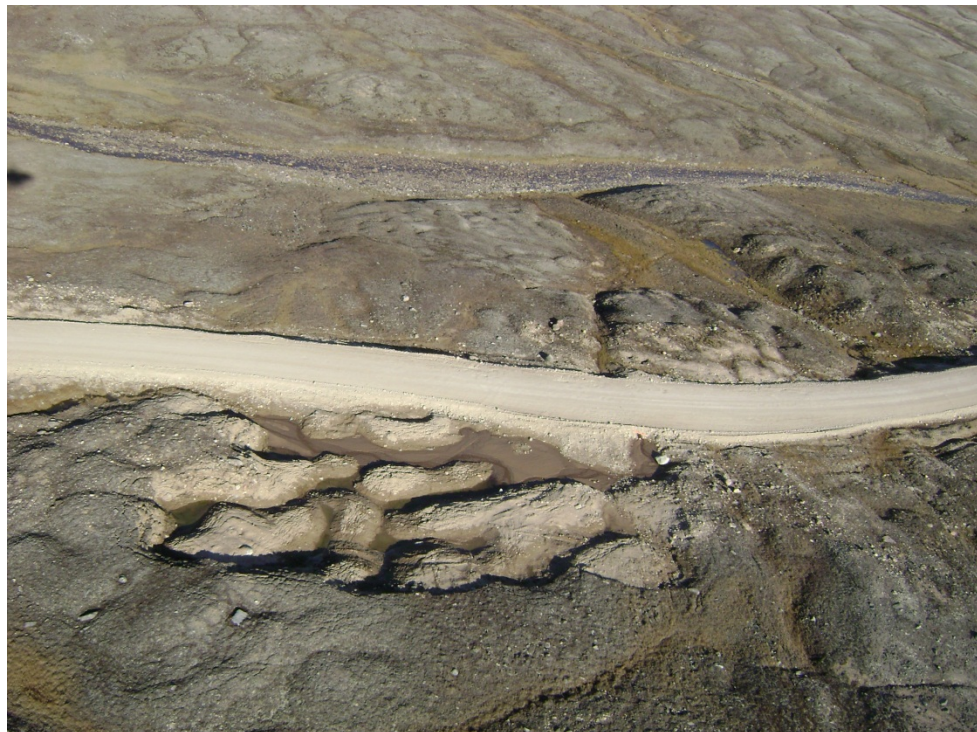
Photo 4 (1645):

Pit at km 71.6 (Figure 10), typical settlement from thaw of segregated ice common in finer-grained lacustrine soils

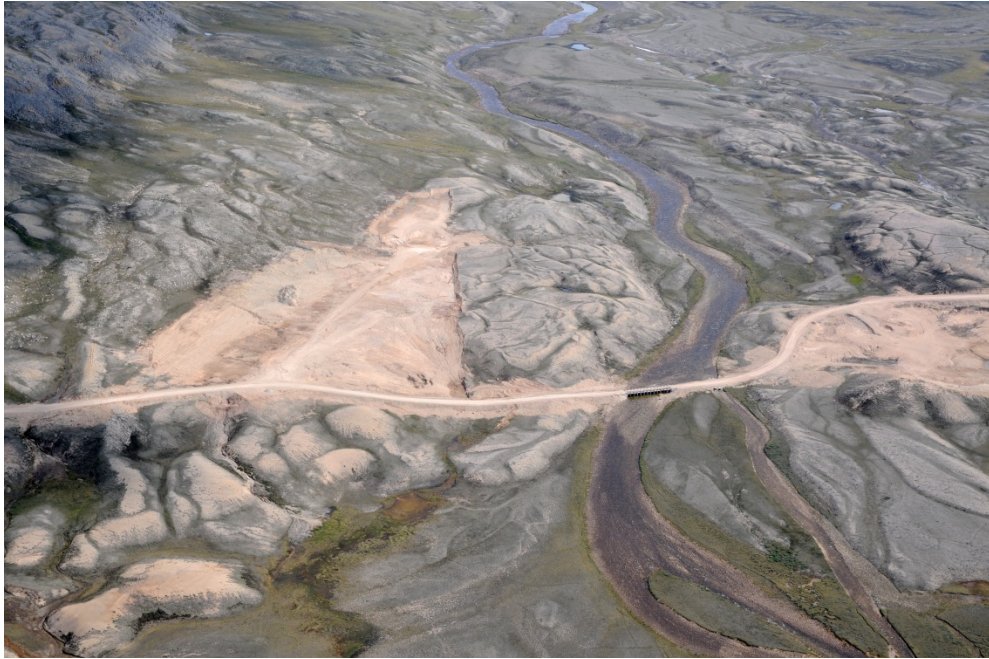
Photo 5 (DWH 593):

Pit at km 61.7 (Figure 8) in 2009, compare to Photo 5A

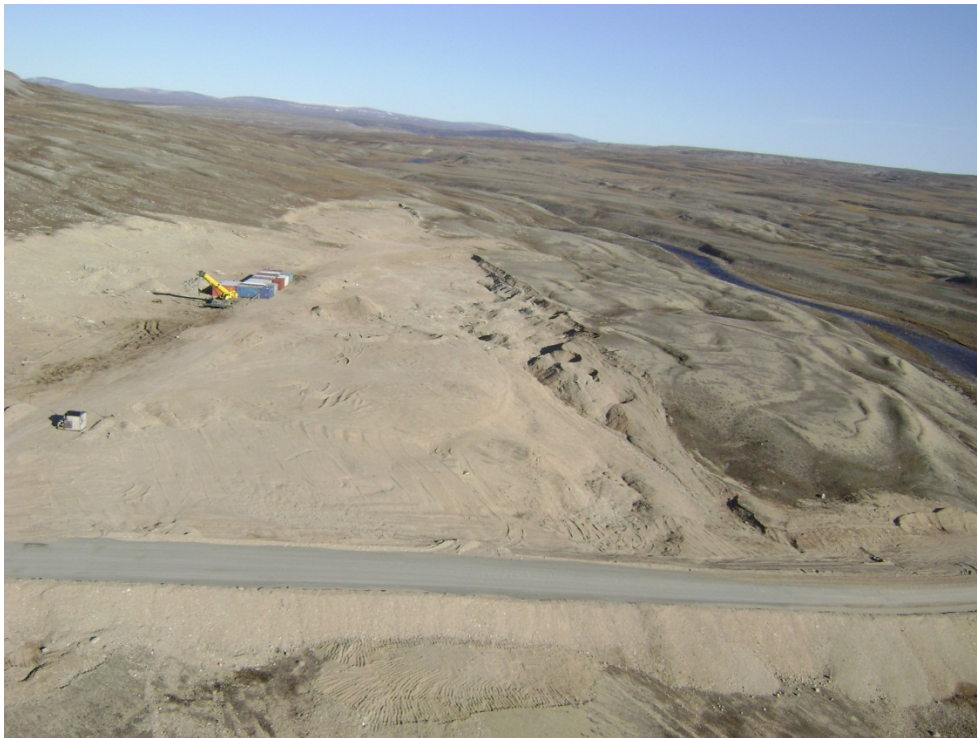
Photo 5A (1637):

Pit at km 61.7(Figure 8), in 2014, note extensive settlement in southern portion (right side) of the developed pit indicative of the presence of massive ice in portions of this deposit.

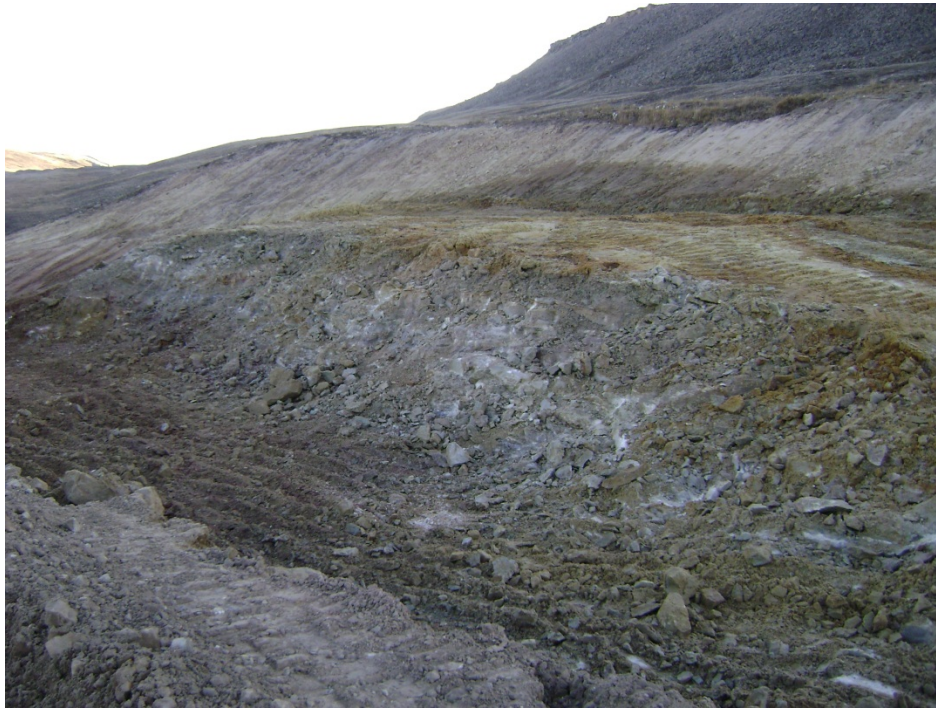
Photo 6 (1712):

Cut made beside road embankment at km 89.3 (Figure 12) only a day or two before the 2014 site reconnaissance has exposed massive ground ice. Unless protected against thaw by placing cover material, significant development of a thermokarst depression should be expected.

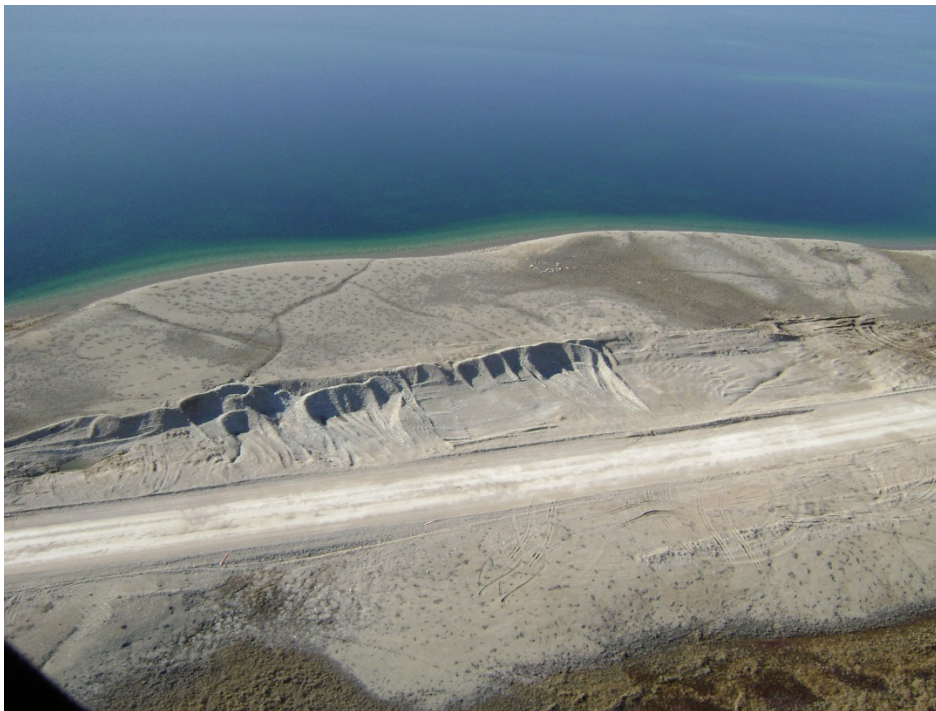
Photo 7 (1576):

Pit at km 32.4 (Figures 4 and 5), typical Priority C pit in thaw stable soils that only requires regrading.
