APPENDIX E.7
INSPECTION REPORTS AND FOLLOW-UP REPORTS

AANDC INSPECTION REPORTS AND BAFFINLAND RESPONSES

INDUSTRIAL WATER LICENCE INSPECTION REPORT

Date: April 15-16, 2014	Licensee Rep. (Name/Title): Tyler Myers, Environmental Superintendent
Licensee: Baffinland Iron Mines Corporation	Licence No.: 2AM-MRY1325

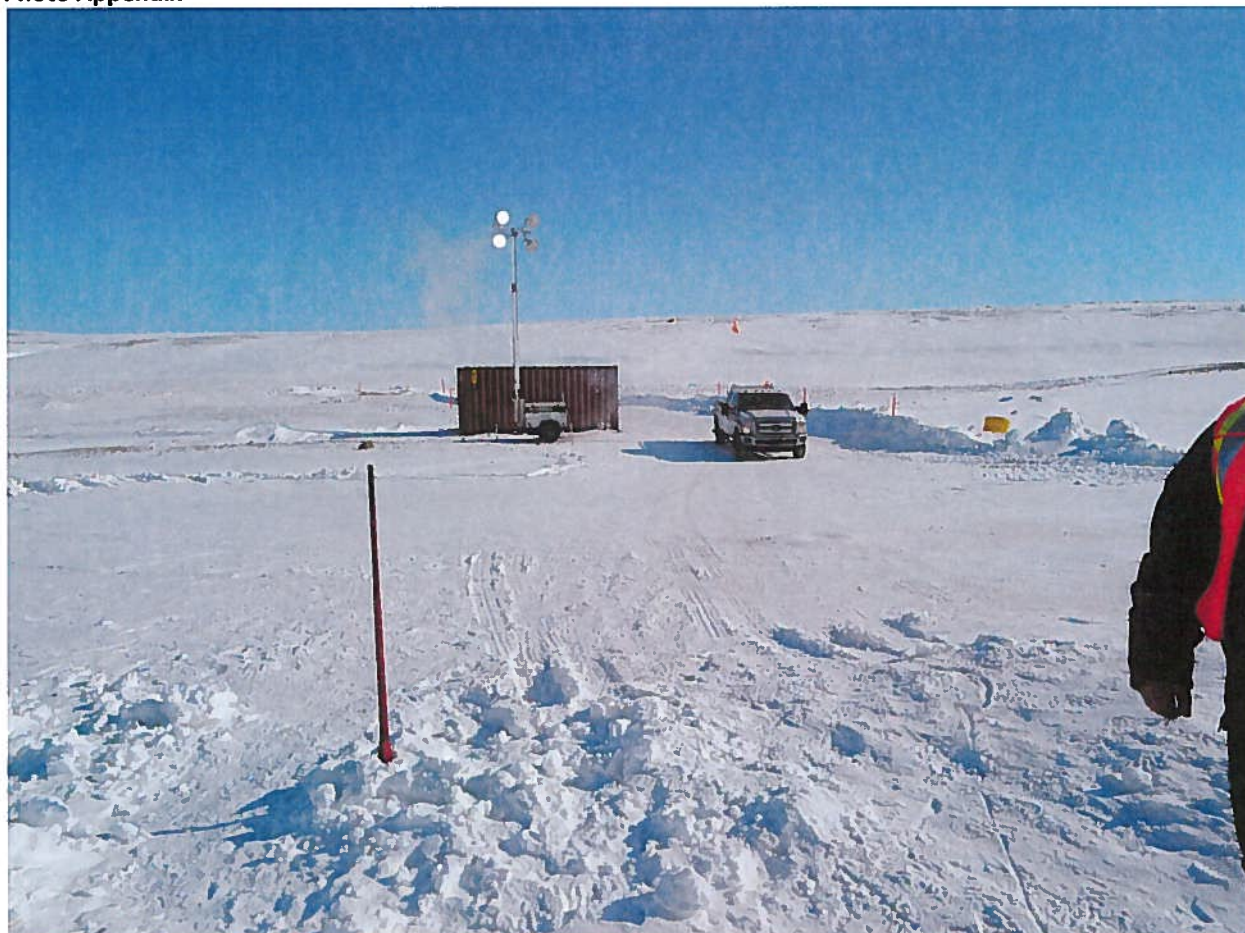
- Currently, potable water is sourced from two lakes for use at the Baffinland project. At the Mary River site, water is pumped from Camp Lake and piped directly to the Mary River camp; whereas, at the Milne Inlet site, water is pumped directly from Km 32 Lake for use at Milne Inlet using a Water Truck. The truck backs onto the ice and withdraws water on an as needed basis.
- At the Km 32 Lake facility, two pieces of equipment, a Terex Light Plant and a seacan were located next to the shoreline for use during the winter to provide light and the storage of equipment (see **Figure 1**). This equipment is within 31m of the high water mark and must be moved back as required in Part D-10 of the Licence.

Figure 1: Terex Light Plant and seacan located on shoreline.

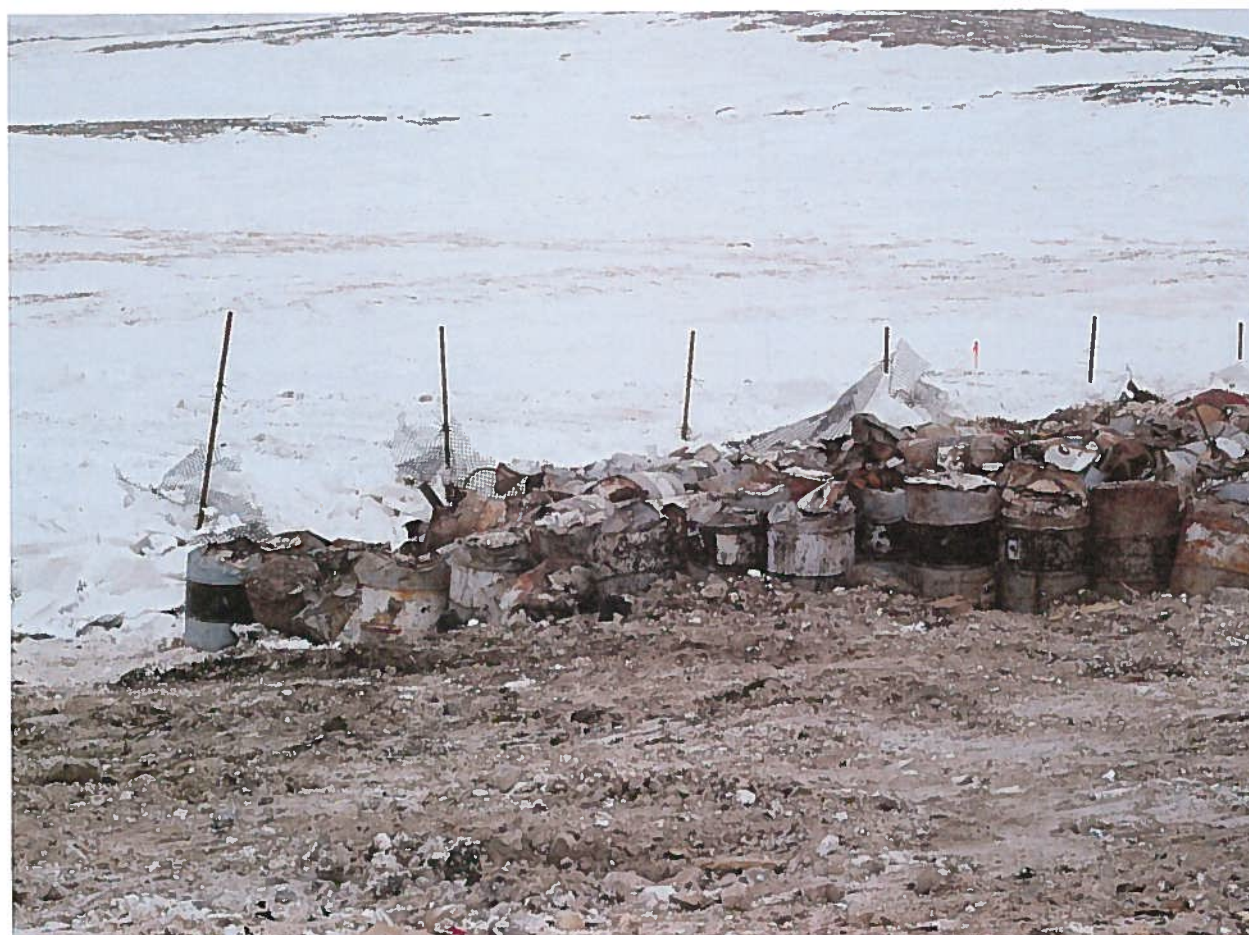
- Non-hazardous waste, including ashes from the incineration process and other unburned residue, is also approved to be deposited at the site. At the time of inspection, a number of ash barrels were waiting to be capped with appropriate cover material.

- Fencing around the facility was in disrepair. Mr. Myers explained that the fencing breaks annually due to the harsh winter and will need to be replaced with proper snow fencing that is less sensitive to winters (see **Figure 2**). Since this important windblown debris control measure is not functioning, Baffinland should monitor any windblown debris leaving the site, collect it and return it to the landfill.

Figure 2: Blown down snow fencing and ash barrels at the inert materials landfill.

- Replace the snow fencing with new fencing that is less sensitive to winters by June 15, 2014. Baffinland shall monitor any windblown debris leaving the landfill facility and return any debris that blew away back to the facility.

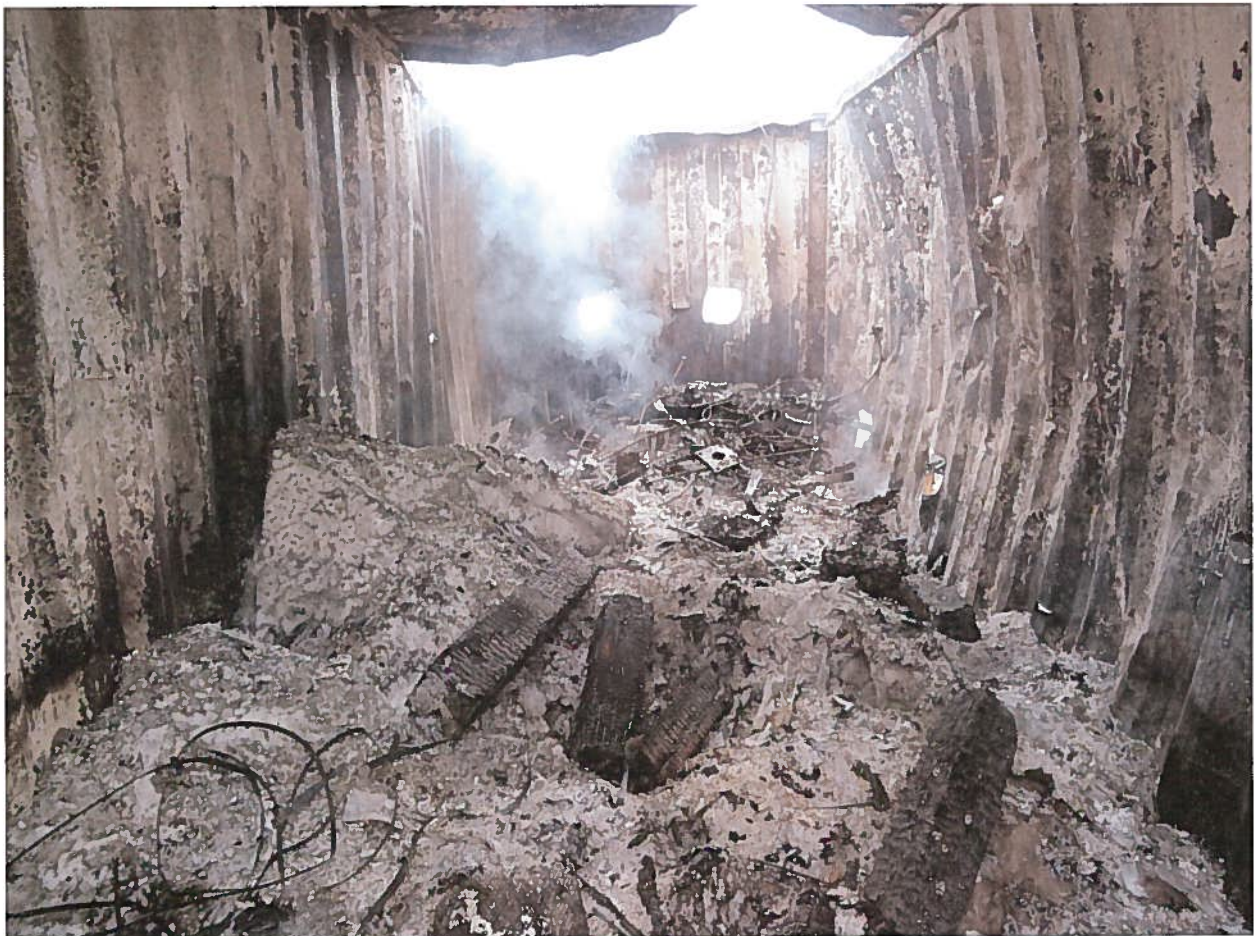
- The open burn facility contained elements not authorized under the Waste Management Plan including the remnants of an air filter, likely from a piece of heavy equipment, and a significant amount of metal strapping (see **Figure 3**).

- It appeared that during the previous burn, there was a significant amount of snow within the facility. As outlined in their Open Burning Procedure, Baffinland is to ensure a hot burn in order to create an efficient burn. Snow within the facility must be monitored and managed before a burn.

Figure 3: Inside view of Open Burn Facility. Note the unapproved waste located in the facility (snow, metal strapping, and air filter).

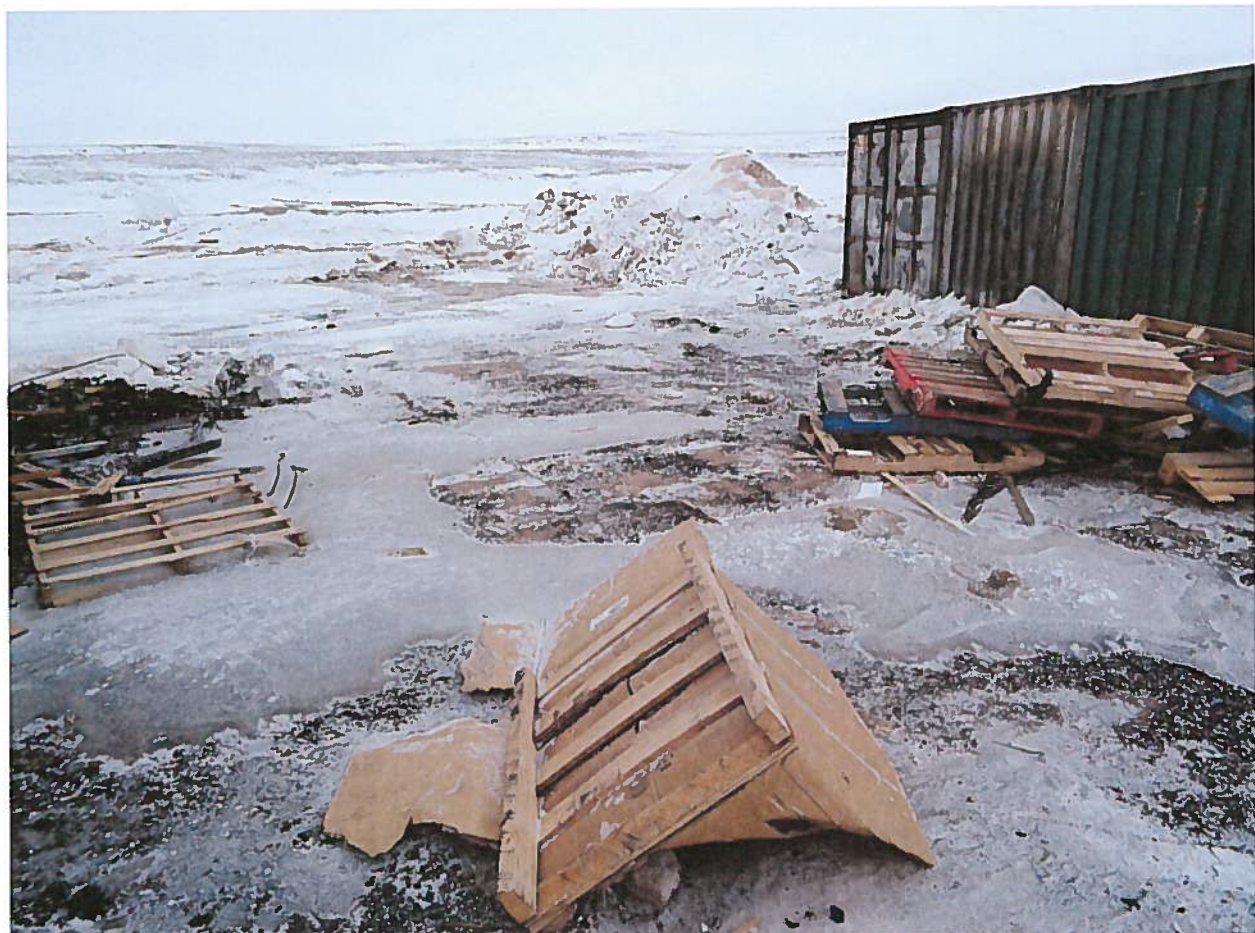
- Outside the facility, there was a significant amount of ash on the tundra (see **Figure 4**). It is not clear how so much ash accumulated here, but material should not be burned on windy days to avoid ash from accumulating on the tundra. As per the *Open Burning of Untreated Wood, Cardboard and Paper Products Procedure, 2014*, all ash is to be disposed of at an approved facility. The Licensee must clean up the spilled ash and secure it at an approved facility.

Figure 4: Outside view of Open Burn Facility. Note the ash on the tundra and unapproved waste.

- Properly secure all ash on site by July 1, 2014.
- The inspector requests that the Licensee re-evaluate the effectiveness of Quality Assurance and Quality Control plan for the Open Burning Facility, and provide this to the inspector by July 1, 2014.

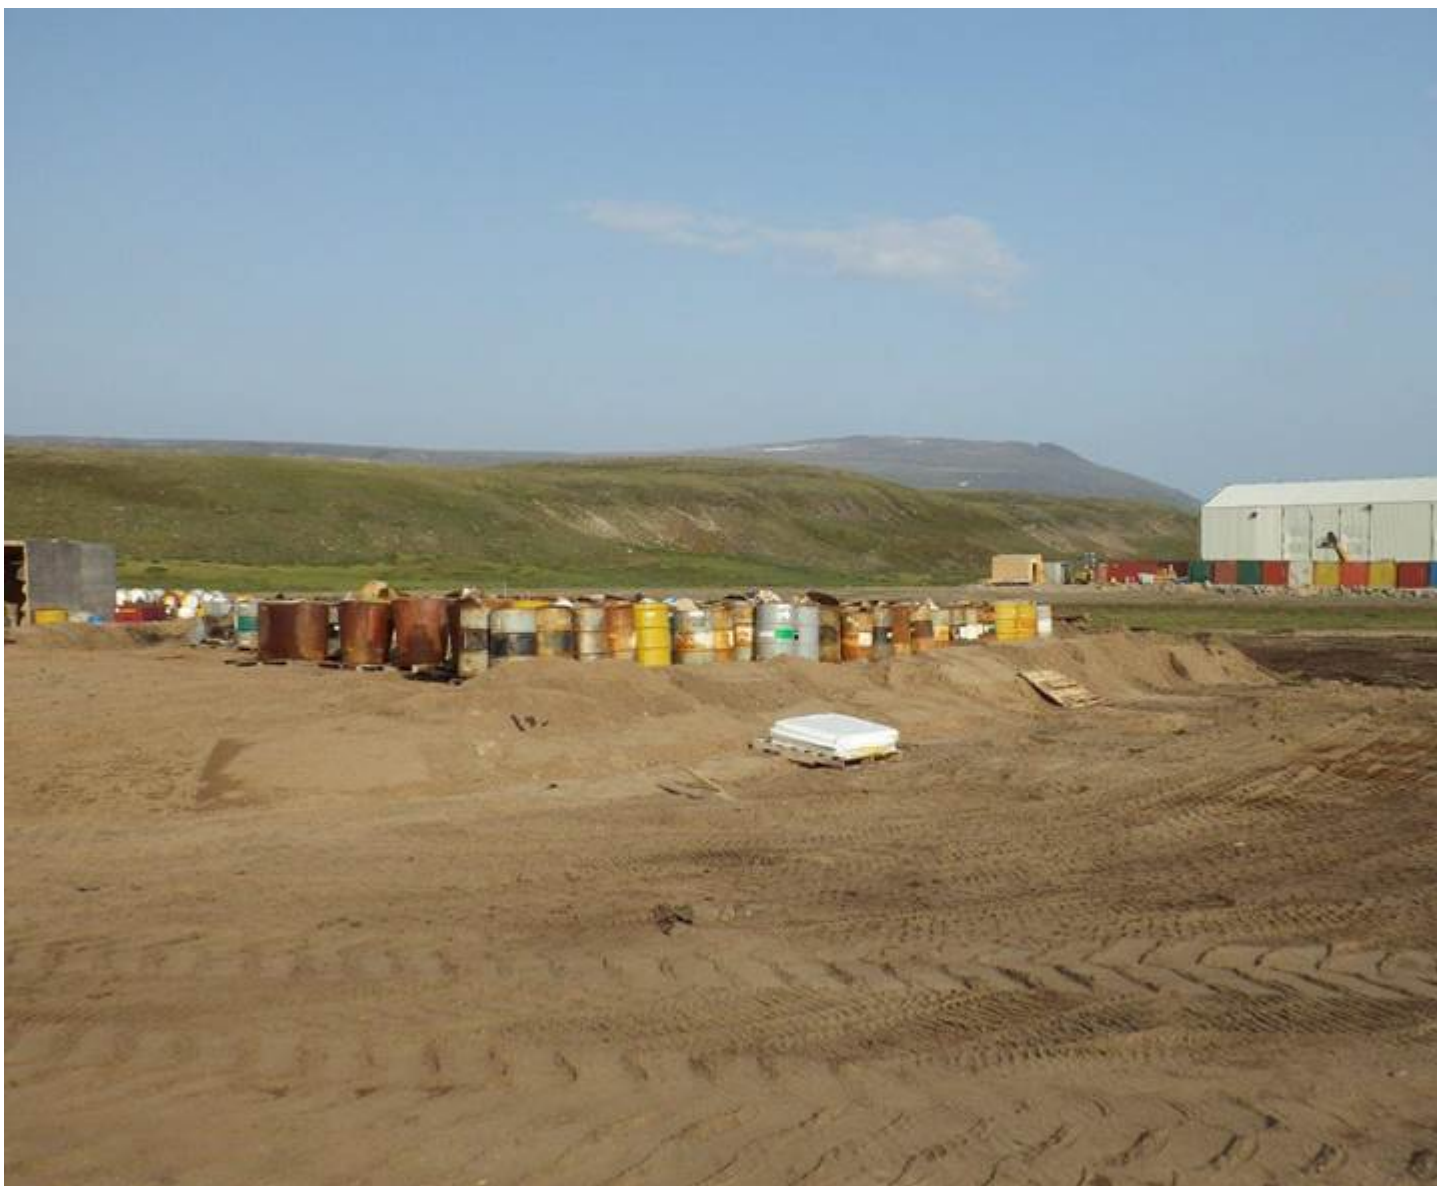
Photo 1: Historic Ash Inventory in Lined Secondary Containment

- 1) Place all historical ash drums that are potentially hazardous into lined contained berms to eliminate all risk of waste impacting the receiving environment.
Schedule: The current construction schedule for the completion of the lined hazardous waste berms calls for the lined berms to be completed at the Milne Port site and the Mary River Mine Site by September 1, 2014, and October 1, 2014, respectively. In the meantime, temporary field designed berms can be constructed for the storage of all ash drums on site. These temporary berms will be constructed by August 1.

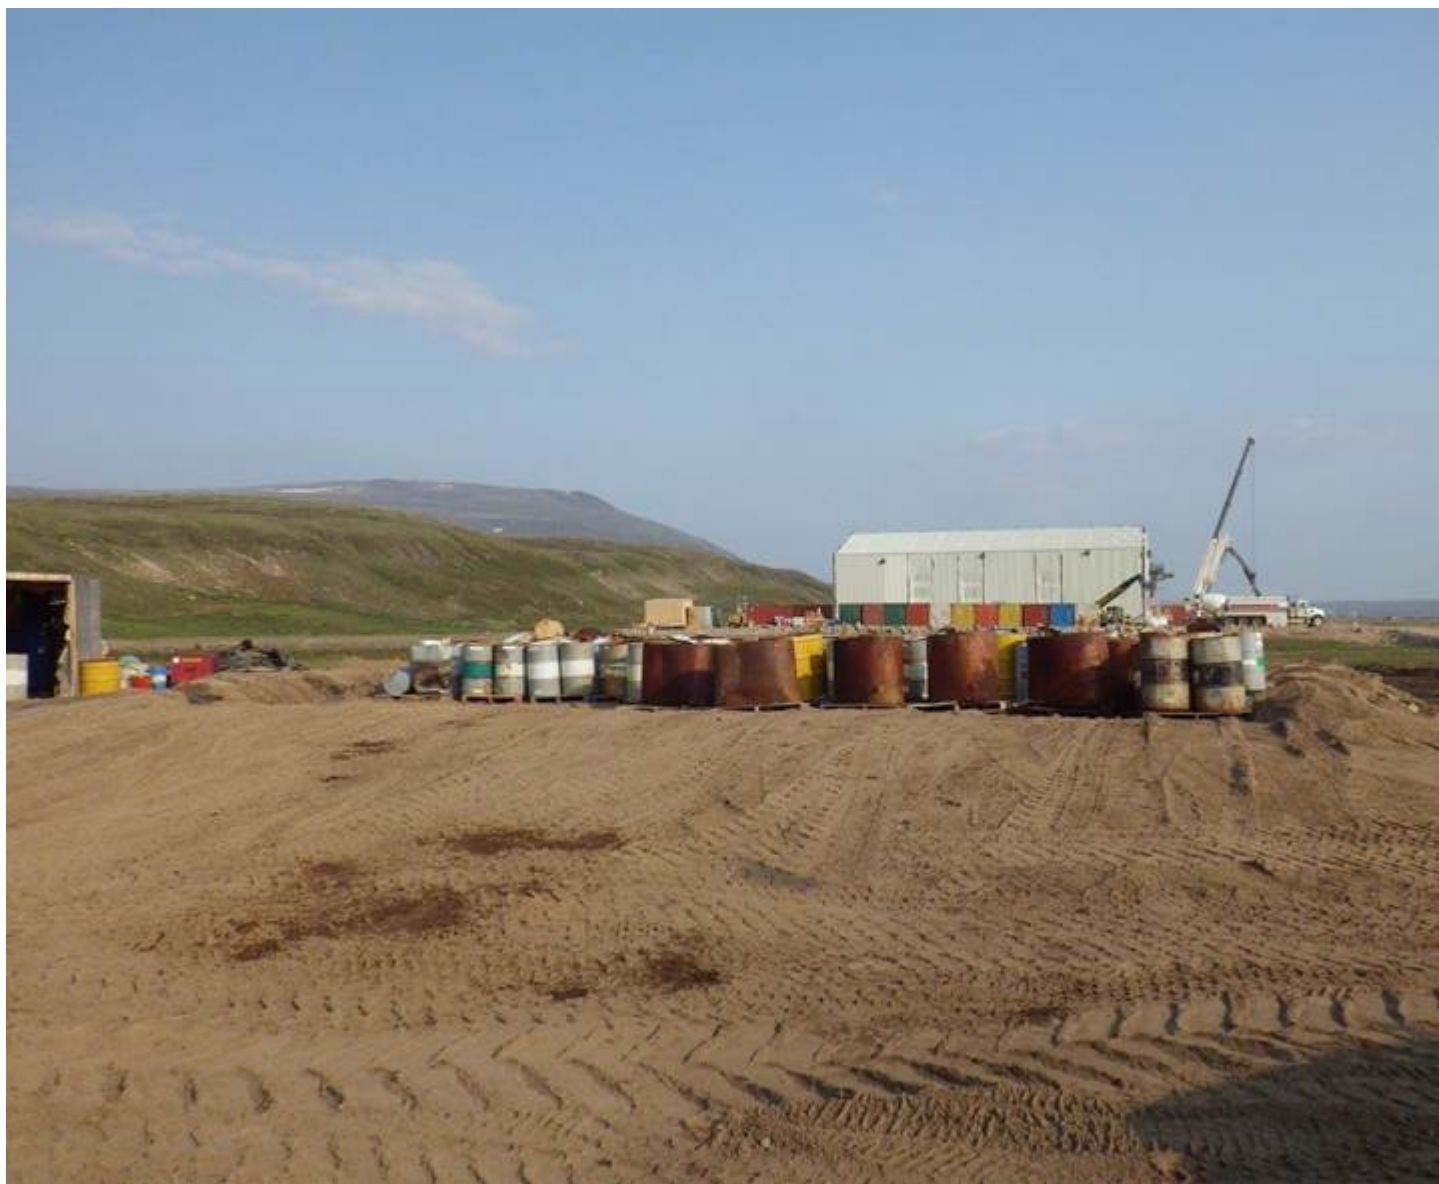
Photo 2: Historic Ash Inventory in Lined Secondary Containment

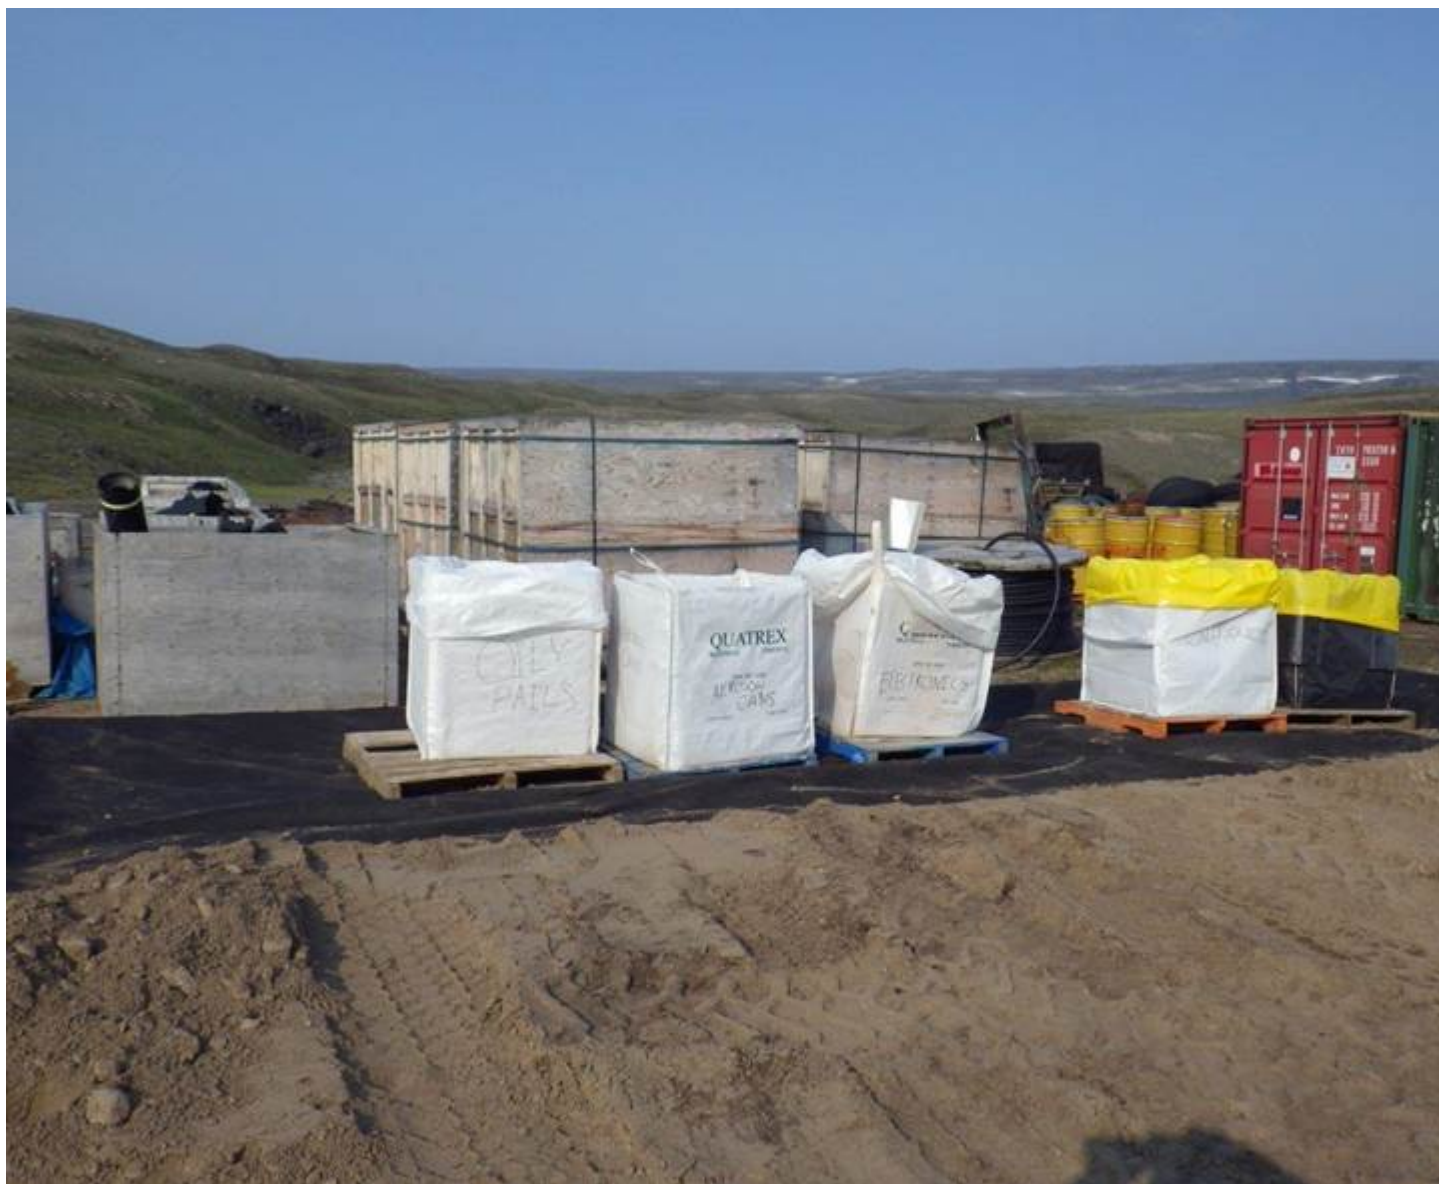
Photo 3: Hazardous Waste Sorting Area near the Incinerator in Lined Secondary Containment

Baffinland Response: It is agreed that a bermed liner would be erected to protect and secure the hazardous waste to prevent accidental discharge of waste to water from batteries and other hazardous waste sorted at this site. Permanent engineered bermed liners will be constructed at the Mary River Mine Site by end of September 2014. In the meantime, a field constructed liner will be installed in this area by the end of July 2014.

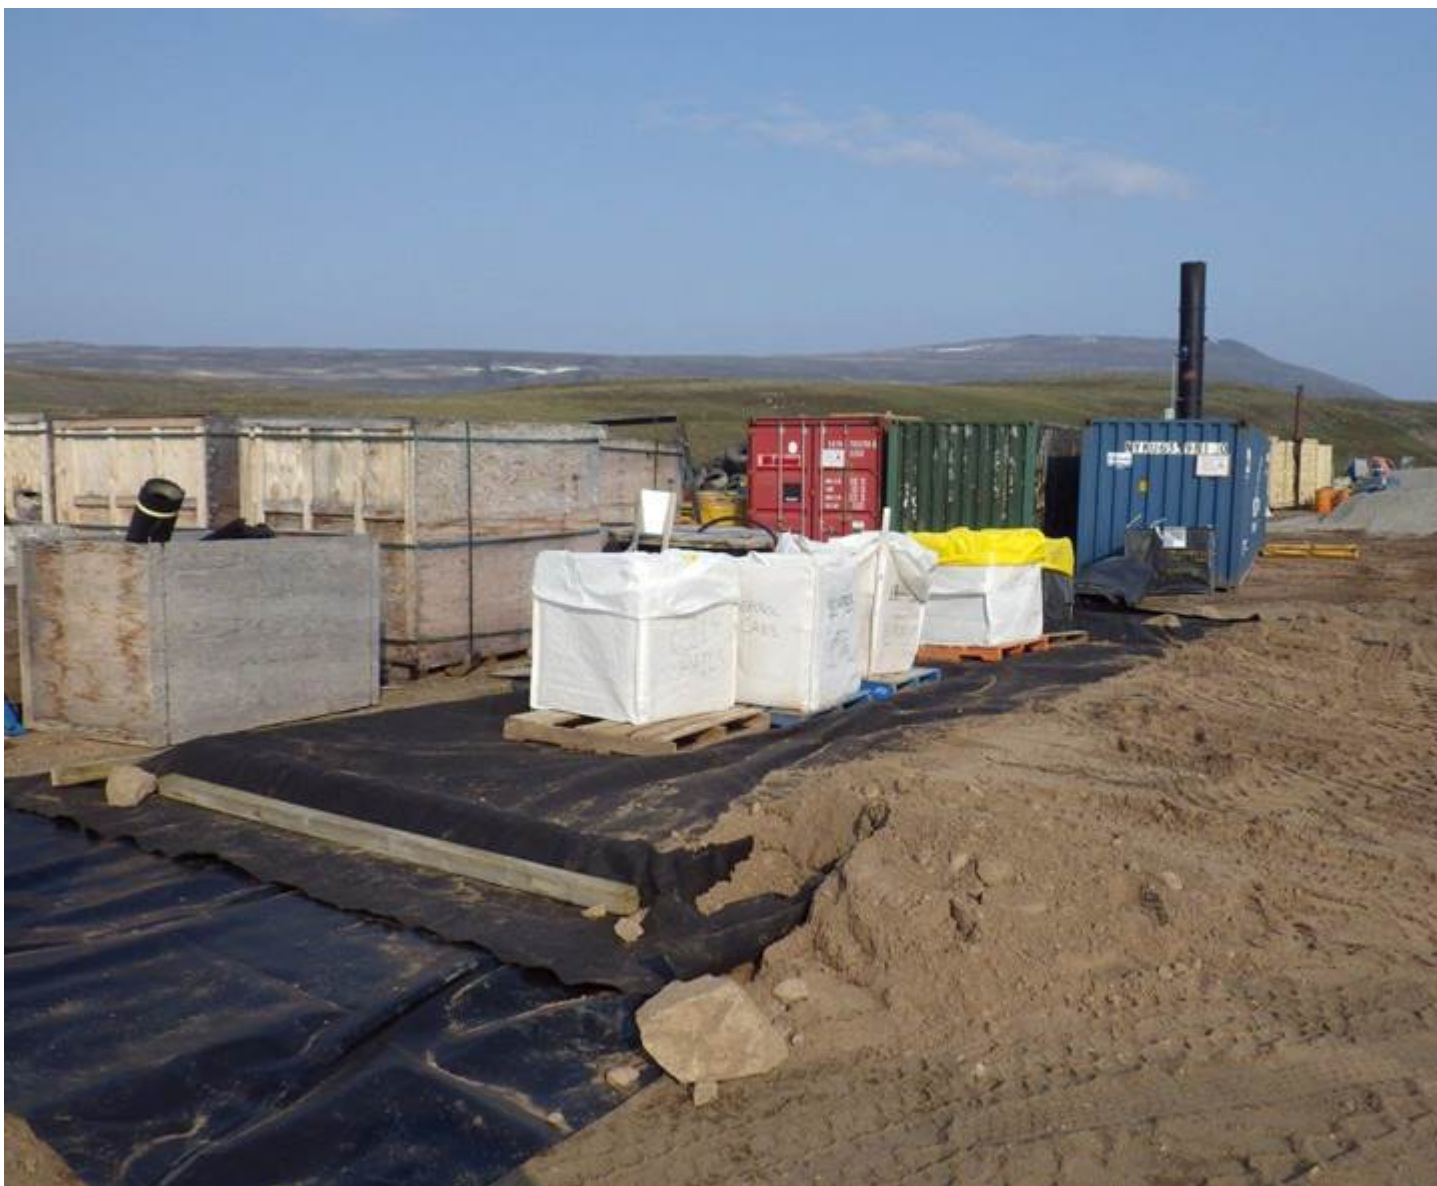
Photo 4: Hazardous Waste Sorting Area near the Incinerator in Lined Secondary Containment

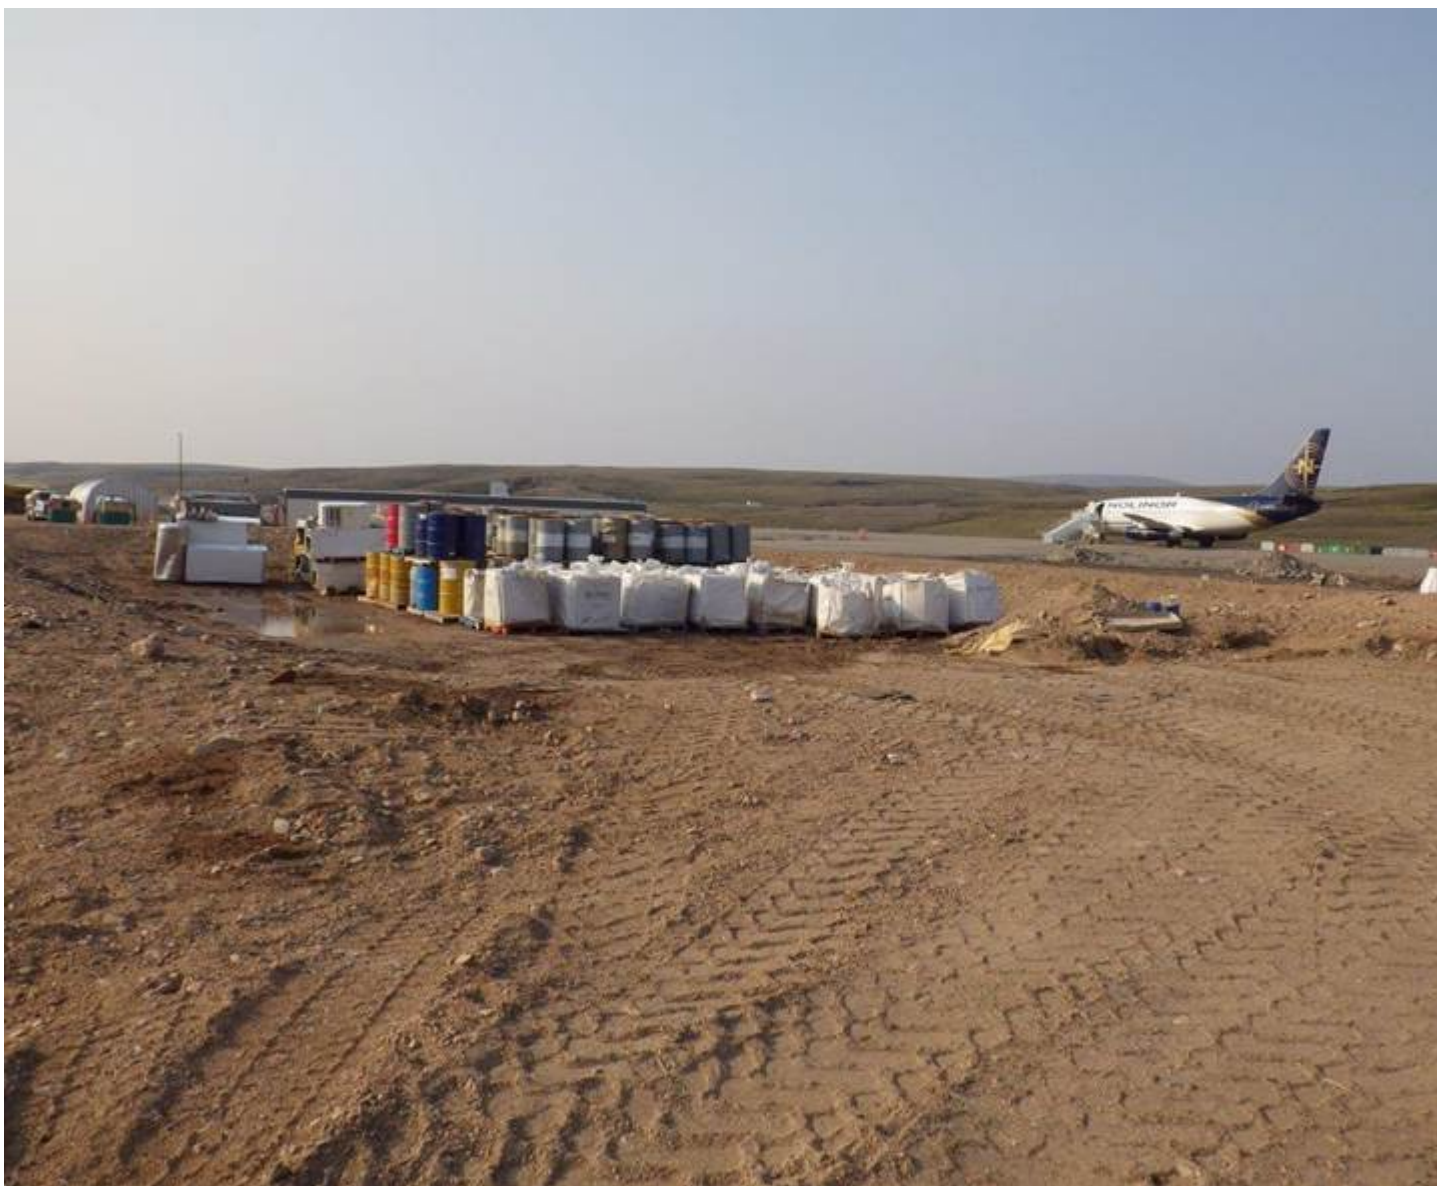
Photo 5: Hazardous Waste Containment Berm after Housekeeping

Baffinland Response: At the time of the inspection in June, the barrelled berms contained water from snow melt, making access and organization in the berms difficult. Three initiatives are currently underway to relieve current waste berm challenges. These include: the treatment and discharge of contact water within the berms, the planned construction of new lined berms to better handle the volume generated, and the packaging and manifesting of waste which is planned for September 2014. The berms continue to be monitored for geotechnical stability and potential leakage. If any issue is identified the Inspector will be contacted immediately.

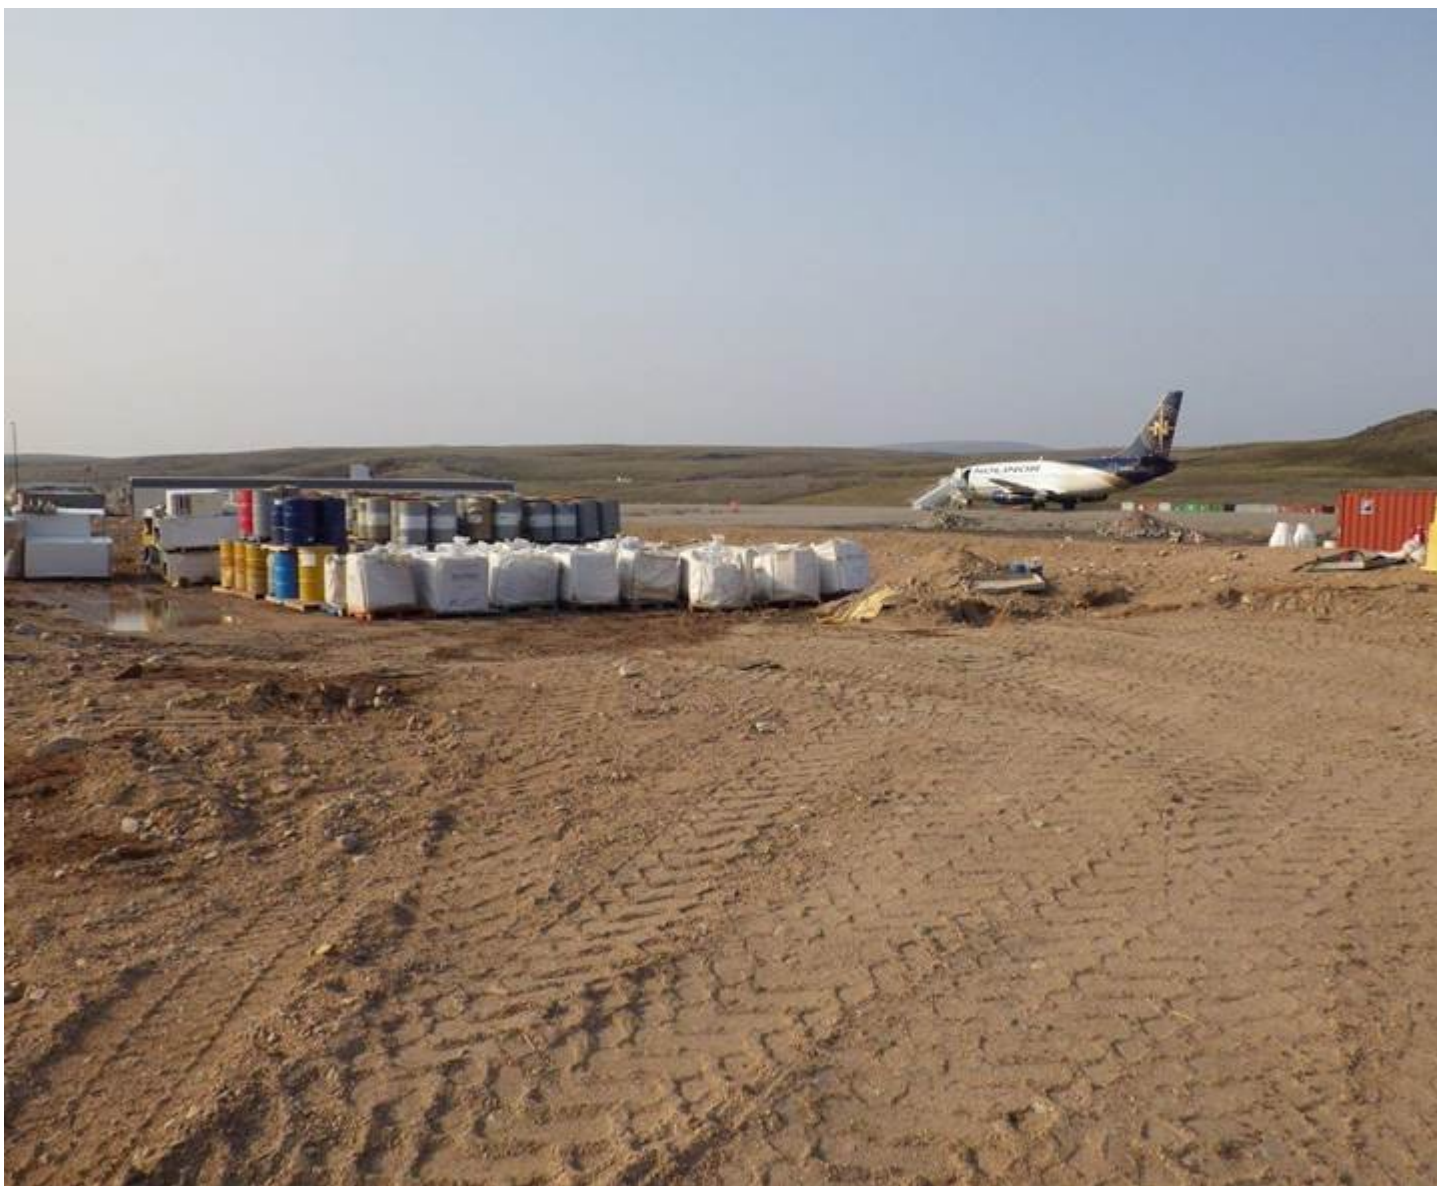
Photo 6: Hazardous Waste Containment Berm after Housekeeping
