**Re: Surface Water Drainage to Camp Lake Near Freshwater Intake – Sedimentation Control Plan
Mary River Project – Water License No. 2AM-MRY1325**

Re: Open Burn Sites –Milne Port and Mary River
Mary River Project – Water Licence No. 2AM-MRY1325

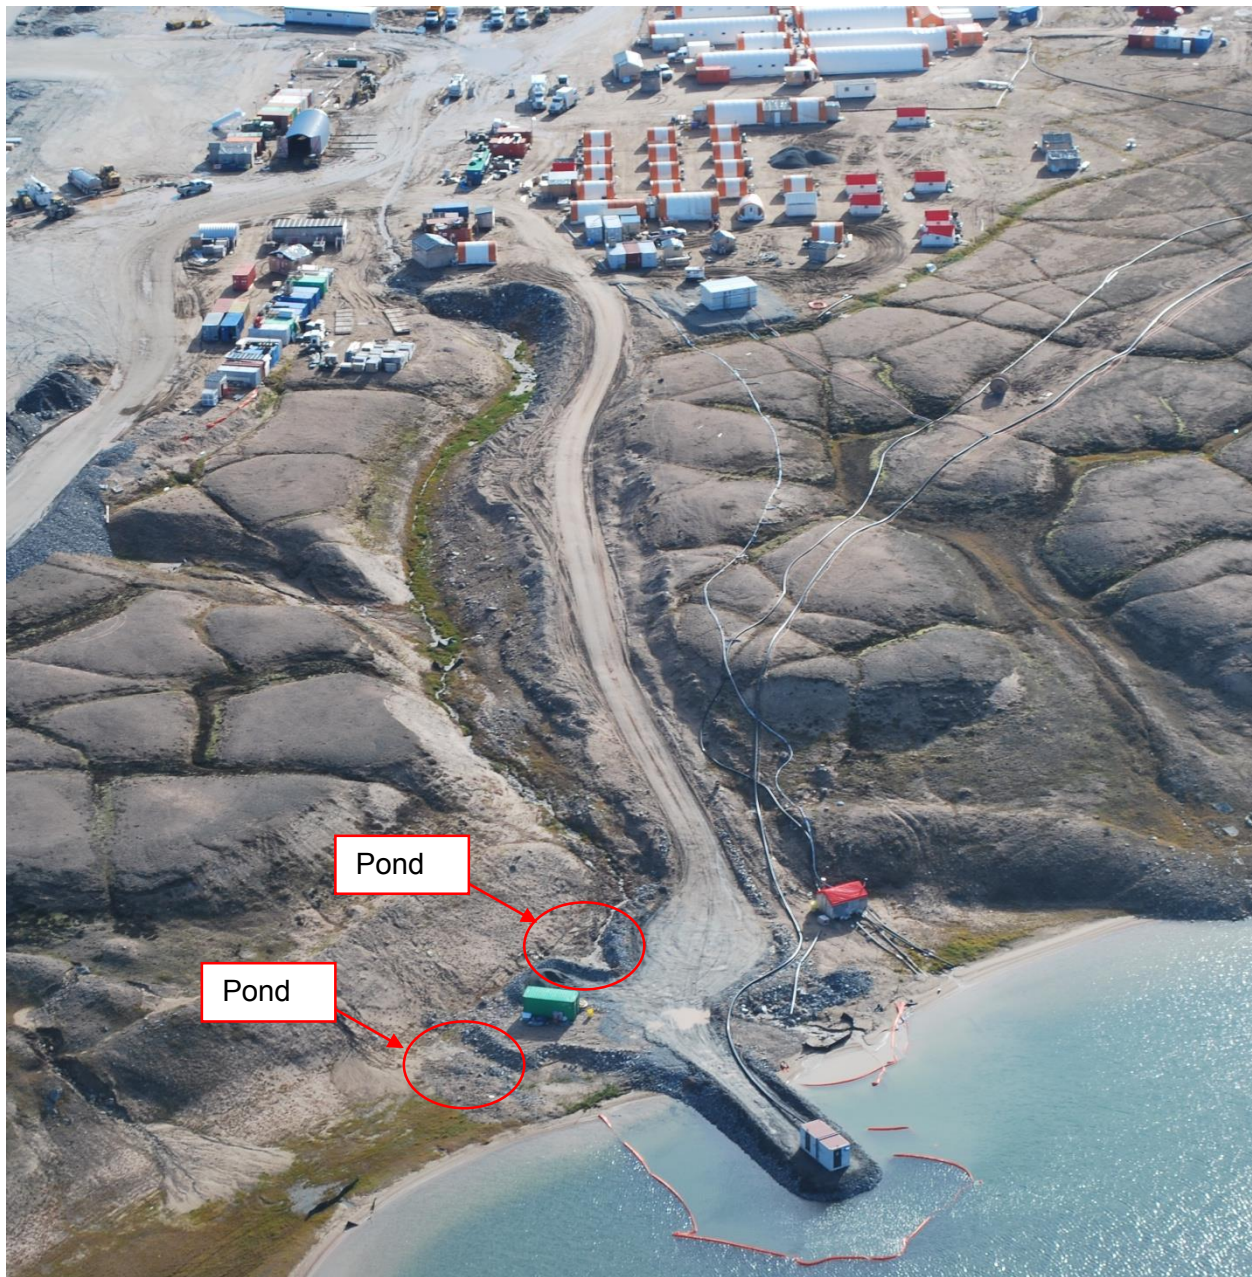
Figure 1 – Location of Settling Ponds

The drainage area in question has an approximate size of roughly 8 hectares and is comprised mainly of hard packed and often frozen sand and gravels with scant vegetation. The area is relatively flat, with an approximate gradient differential of only 1.5 m over the majority of the area. Flows draining from this area occur via a single channel at the north end of the camp. The channel is roughly 200 meters long with an approximate 13% grade. The ground adjacent to the drainage channel has been determined to be ice rich, with visible ice wedge features throughout. In consideration of the sensitivity of the ice rich soils, it was determined that the construction activities would avoid these areas. Therefore, sediment control structures were located at the toe of the embankment, adjacent to Camp Lake, where the ground conditions are stable and where there would be minimal disturbance of the channel itself (Figure 1). The main design consideration for sediment control structures was to minimize the discharge of sediments in general to Camp Lake. It is acknowledged that the sediment control structures as designed will reduce but not eliminate the discharge of sediments to Camp Lake, especially during extremely high flow events.

As was noted in the in the inspector's report from the June 17-19 inspection, the increased water drainage to the area was postulated to be caused from infrastructure work done adjacent to and on the runway. As a result of the runway upgrades, ponding of water has now been identified proximal to the toe of the runway alignment to support this theory. There is already a plan in place and a design produced to redirect the drainage southward and around the Weatherhaven camp to prevent the aforementioned ponding. This will in turn reduce the amount of melt runoff that will flow through the yard of the camp and down the drainage near Camp Lake. Furthermore, the increased silt load in the runoff is a result of the increased traffic passing through the yard and which must drive through the swale through which the runoff flows. Plans are in place to look at the various options for moving the location of the swale to an area that will not be driven through and to recontour the present location of the swale such that vehicle traffic is not required to drive through the runoff and in turn reduce the sediment loading of the runoff. Further details on the drainage diversions will be provided in the final design plan to be submitted to the inspector on or before October 31st, 2014.

Sediment control of the surface water drainage to Camp Lake will be controlled by means of the of two successive settling ponds at the base of the drainage that will be constructed by means of a mechanical excavator. The ponds will decrease the flow velocity and in turn provide additional time to allow for the settling out of suspended sediments prior to the runoff entering Camp Lake (refer to Figure 2). The upstream and downstream settling ponds will have an approximate capacity of 18 cubic metres and 12 cubic metres, respectively. The pond banks and the spillway which connects the two ponds, as well as the outflow location of the ponds will be constructed using coarse rock material and will be lined with geotextile to reduce the possibility of erosion during high intensity flows. The ponds will be periodically monitored and deposited sediment excavated as required to maintain pond capacity and run-off retention times.

Constuction of the settling ponds is scheduled to be completed prior to freshet 2015 or when subsurface conditions allow. A silt curtain will be installed at the outlet to the new drainage discharge and will be maintained during the 2015 open water season to control any residual sediments from construction or from very high flow rainfall/snowmelt events.

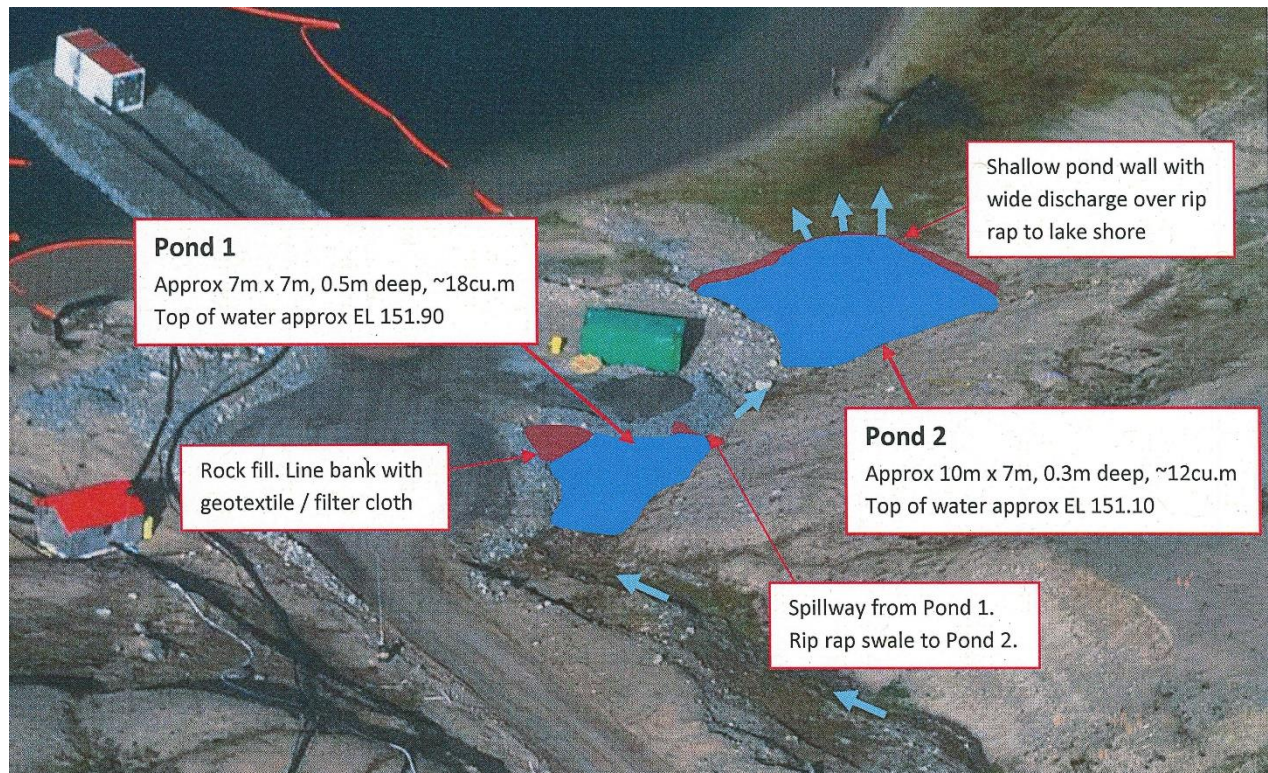
Figure 2 –Settling Pond Design

The design basis for the drainage discharge modeling was undertaken using both the Rational Equation Method (REM) as well as the Technical Release 55 (TR-55) model. The REM is the simplest method to determine peak discharge for drainage basin runoff. It is not as sophisticated as the TR-55 method and the REM runoff coefficient is a function of soil type and gradient. The TR-55 model is more complex and presents a methodical and reliable approach to predicting peak discharge due to a 24-hr storm event. Peak flow rates and the associated resulting residency times (based on planned pond sizes) from a range of precipitation intensities are presented below in Table 1. The combined pond volumes for the purpose of this design is 30 m³.

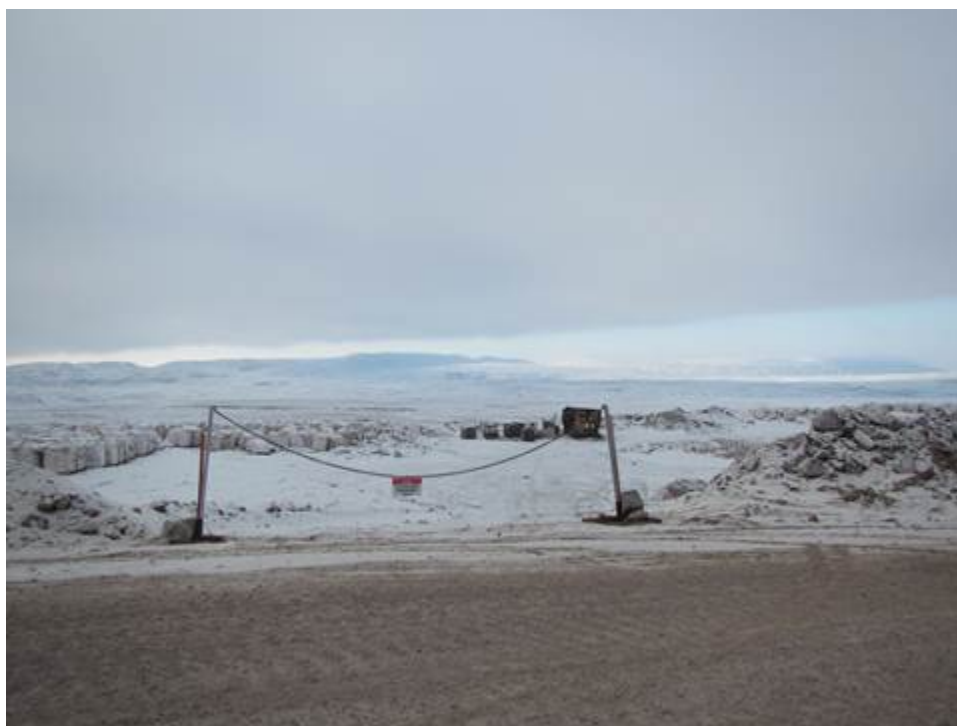
Image 1: Installation of new locking gates

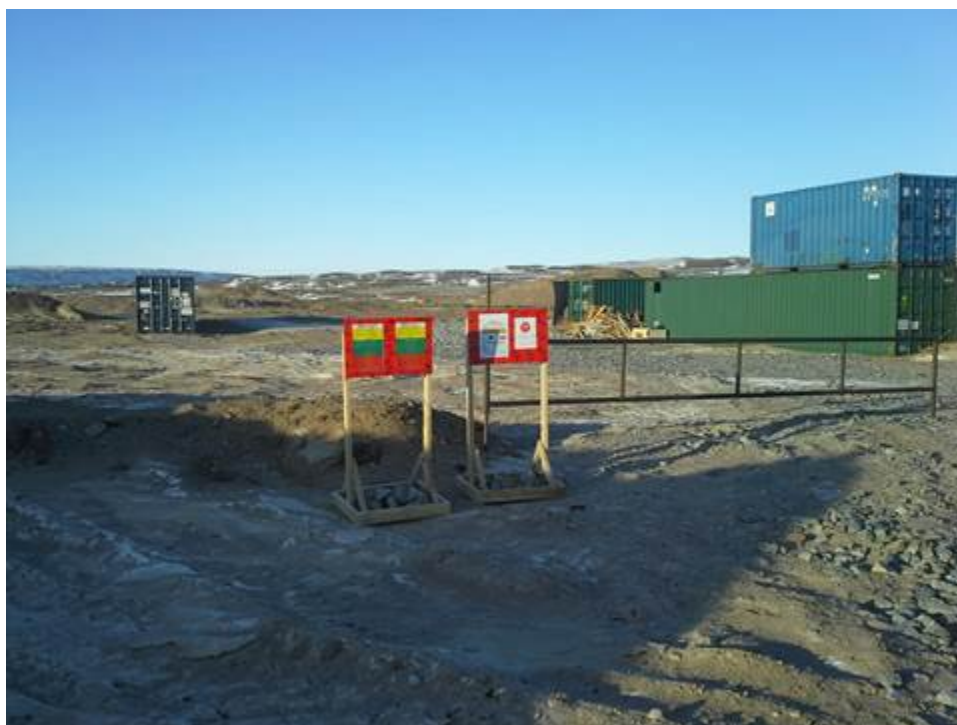
Image 2: Signage posted at the open burn areas

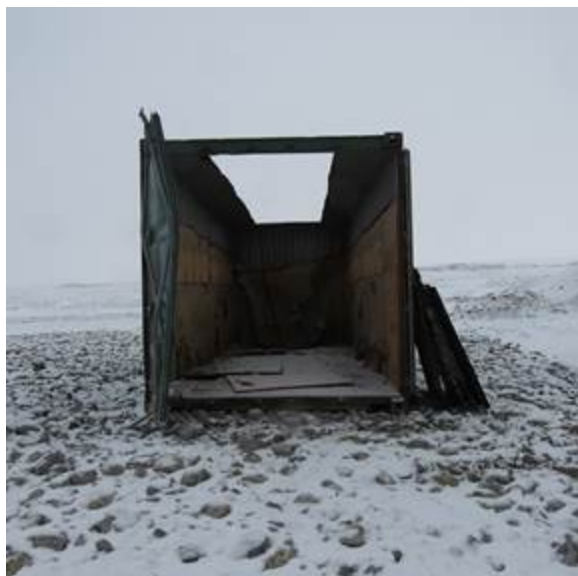
Image 3: New burn bin at Mine Site

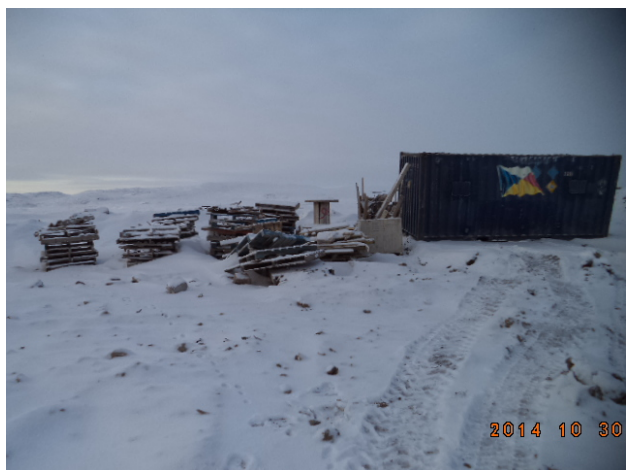
Image 4: New burn bin at Milne Port

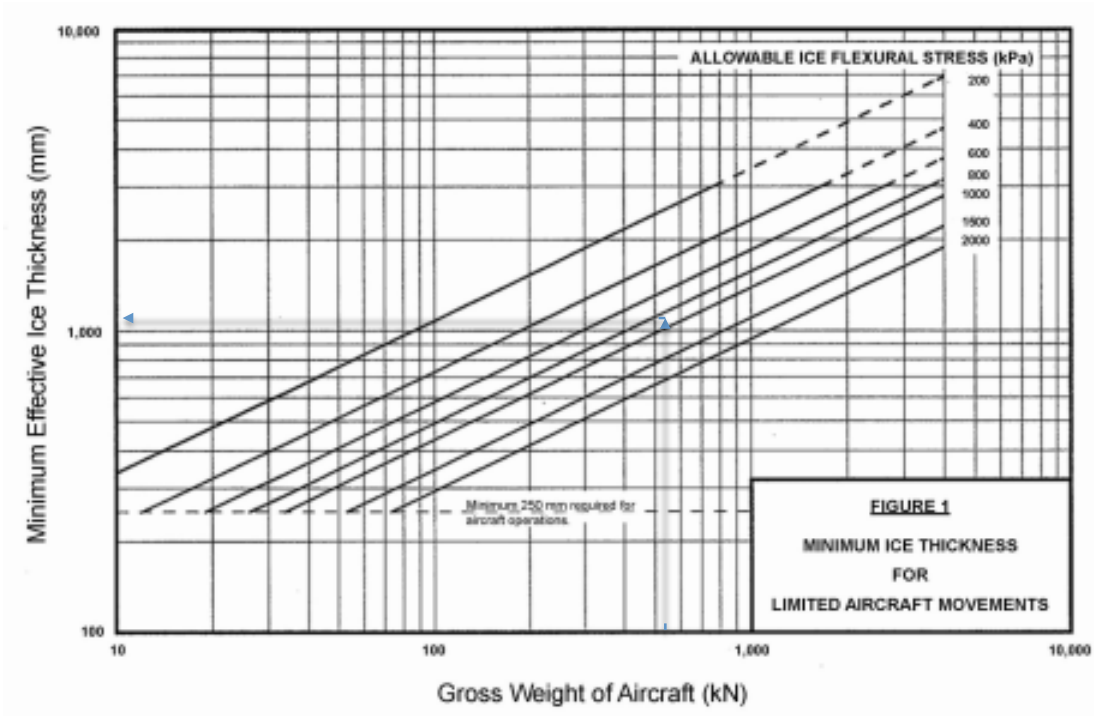
Figure 2 Ice Thickness Chart from Transport Canada Guide

Transport Canada's Advisory Circular 301-001 on ice aerodromes (Civil Aviation, 2011) is the primary reference document for the design and operations of ice aerodromes (airstrips) in Canada. Figure 2 reproduces the Appendix A – Minimum ice thickness for limited aircraft movements from this documents. We used this Figure to estimate the ice thickness for the flexural strength noted in Section 2.1

Based on the Transport Canada method for an allowable ice flexural stress of 800 kPa, the recommended thickness of good quality ice is 120 cm for a maximum aircraft weight of 58,300 kg.
