2016 QIA and NWB Annual Report for Operations

BIWEEKLY REPORTS (ABBREVIATED)

June 7th 2016, Fisheries Act Direction (File number: 4408-2016-05-10-001) and Response to June 16, 2016, INAC Letter of Non-Compliance

Bi-Weekly Report No. 1 for Period June 25 to July 9, 2016

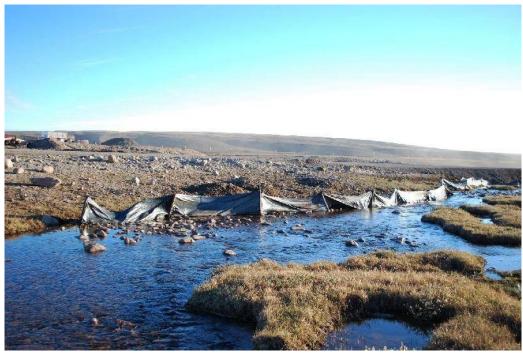
Photo 1 – Silt fence installation along road to prevent road runoff from directly discharging into Sheardown Lake Tributary (SDLT) near CV186.

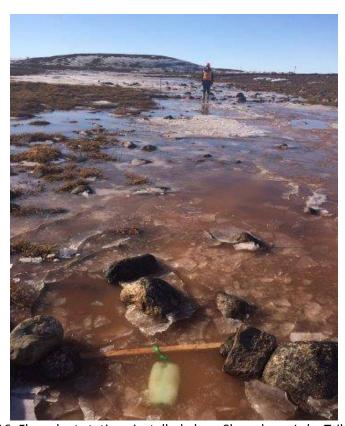
Photo 2 – May 9th 2016. Flocculant stations installed along Sheardown Lake Tributary SDLT and LDFG.

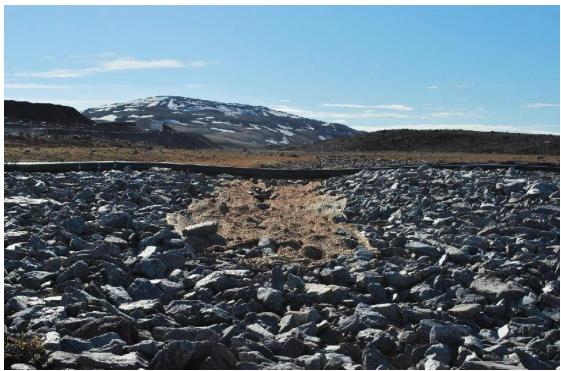
Photo 3 – Treated Jute installed at Check Dam #1 to capture sediments within runoff.

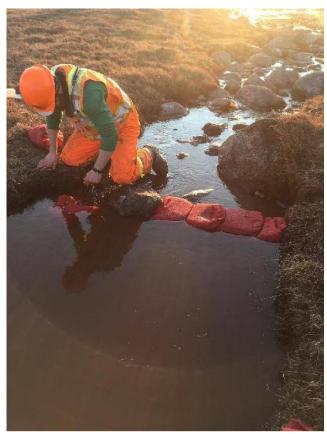
Photo 4 – Sand bag check dams installed along Sheardown Lake Tributary LDFG near landfill access road.

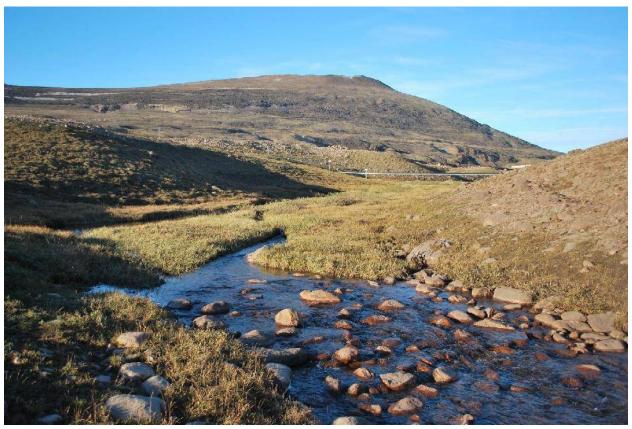
Photo 5 - Improved water clarity and total suspended solid levels at outfall of Sheardown Lake Tributary SDLT following implementation of siltation control measures.

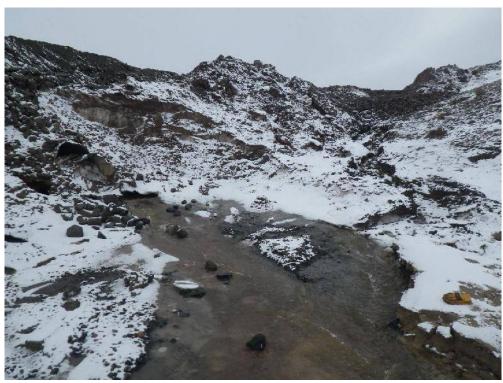
Photo 1 –Airstrip runoff entering Camp Lake Tributary #1.

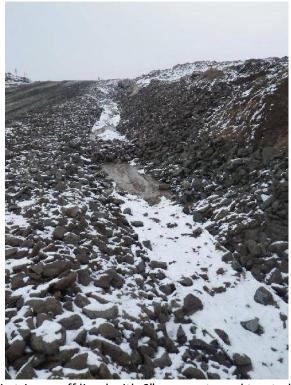
Photo 2 – Swale draining airstrip runoff lined with 6" aggregate and treated jute to capture sediments.

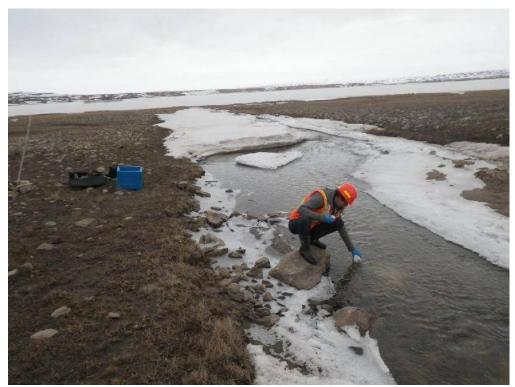
Photo 3 – May 30th 2016. Daily sampling and monitoring of Camp Lake Tributary #1 discharge at Camp Lake outfall.

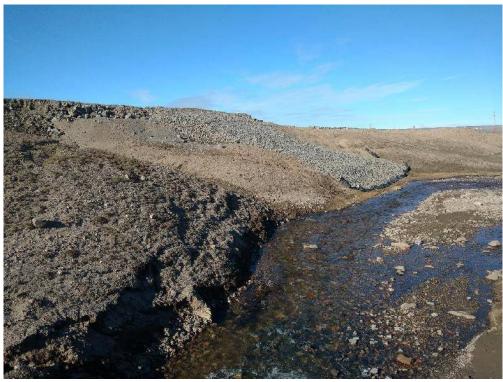
Photo 4 – Improved water clarity and total suspended solid levels at Camp Lake Tributary #1 following implementation of siltation control measures.

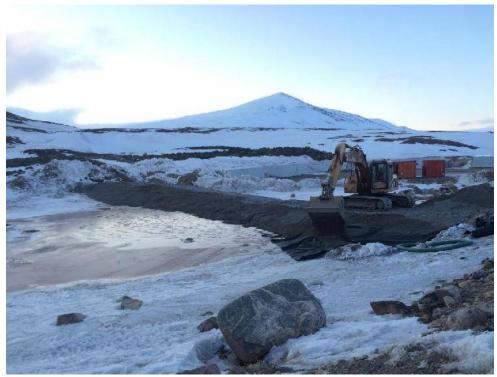
Photo 1– April 28th 2016. Construction of Check Dam # 4 near the end of Magazine Access Road.

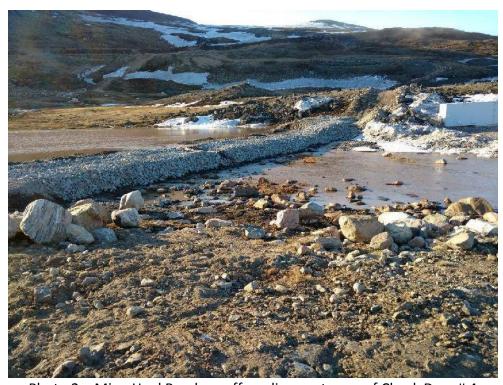
Photo 2 – Mine Haul Road runoff pooling upstream of Check Dam # 4

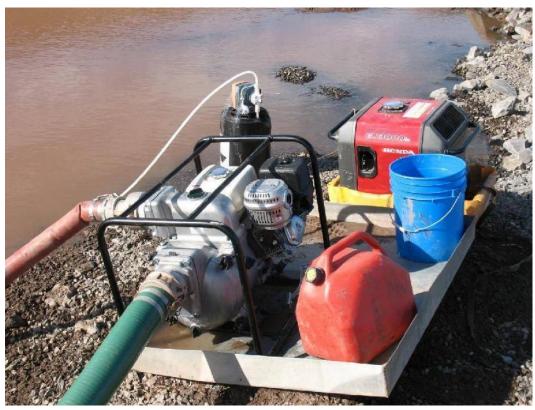
Photo 3 – Flocculant dosing system treating water upstream of Check Dam #4.

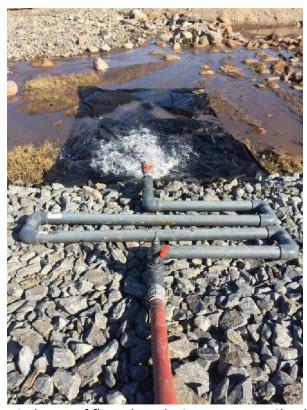
Photo 4 – Discharge of flocculant dosing system at Check Dam #4.

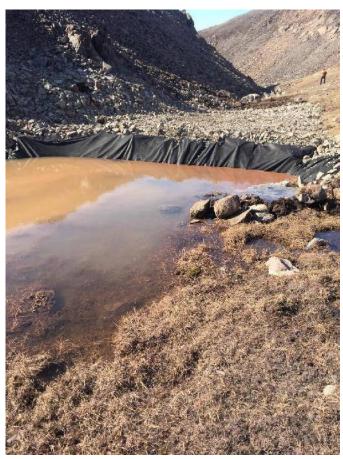
Photo 6 – Check dam constructed at outlet of Sheardown Valley along Mine Haul Road.

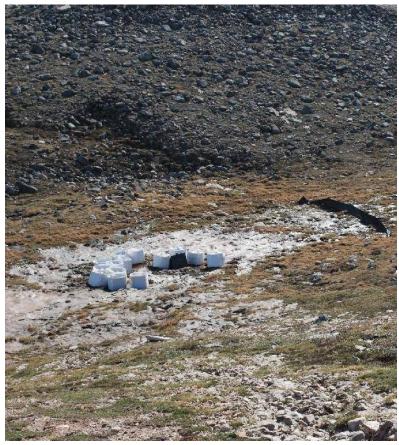
Photo 7 – Sediment deposit removal along upper reaches of Sheardown Lake Tributary SDLT (downstream of km 104.5 of the Mine Haul Road).

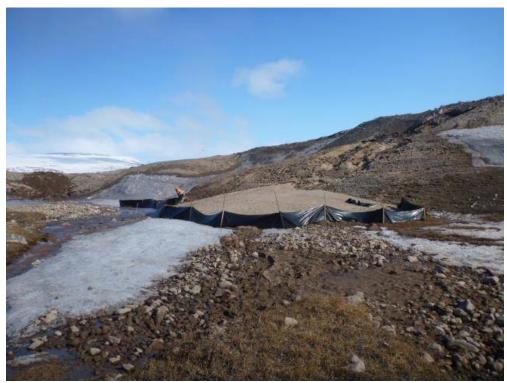
Photo 1 – May 29th 2016. Silt fence installation around sediment deposit from slumping stream bank along Camp Lake Tributary #1.

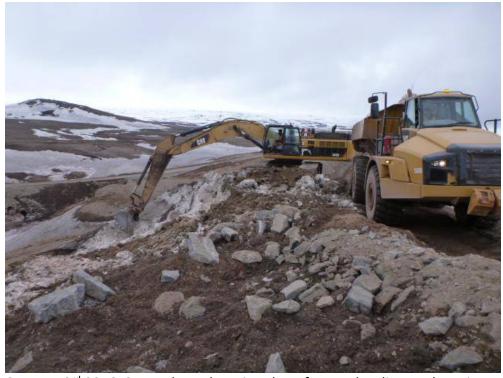
Photo 2 – June 3rd 2016. Snow along slumping slope face and sediment deposit removed.

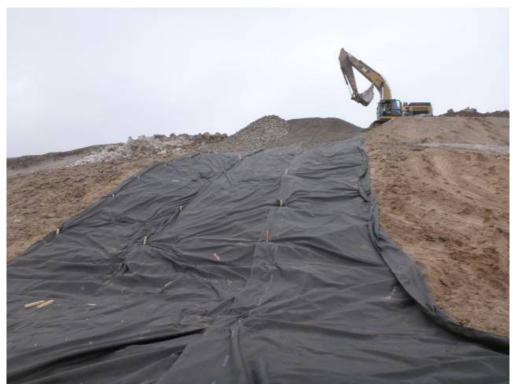
Photo 3 – June 3rd 2016. Slumping stream bank lined with geotextile to protect underlying soil from erosion.

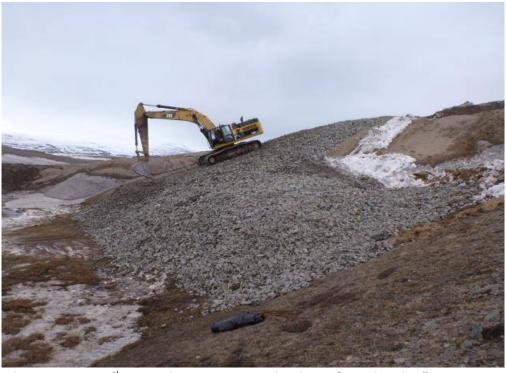
Photo 4 – June 4th 2016.Slumping stream bank reinforced with 6" aggregate.

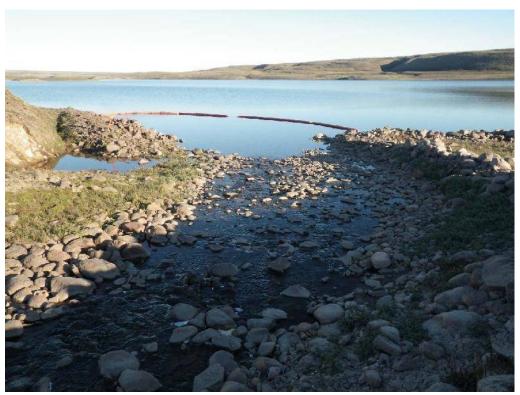
Photo 1 – Outlet at Sheardown Lake Tributary on July 4, 2016

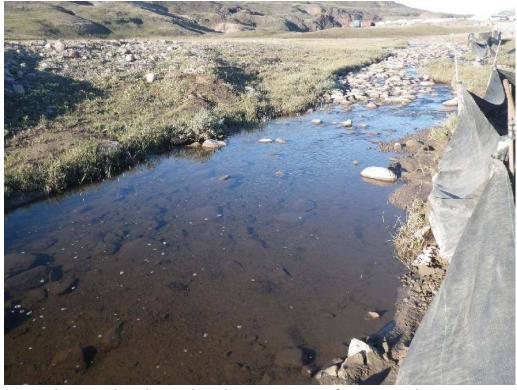
Photo 2 – Sheardown Lake Tributary upstream of CV186 on July 4, 2016

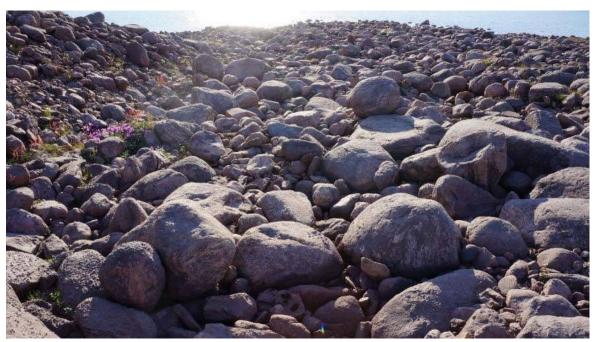
Photo 3 – No flow conditions at Landfill Gate Tributary on July 7, 2016
