APPENDIX D.7.4
2016 INAC INSPECTION REPORTS
AND BAFFINLAND REPONSES

WATER LICENCE INSPECTION FORM

SECTION 1	<input checked="" type="checkbox"/> Comments	<input type="checkbox"/> Non-Compliance with Act or Licence	<input type="checkbox"/> Action Required
Inspectors Statement			
<p>On May 18-20, 2016, a water licence inspection was conducted at the Mary River Project, Qikiqtani Region, Nunavut. Sites inspected included the Mary River Mine Site, the Tote Road and related infrastructure, and the Milne Port area.</p> <p>Weather Conditions on Site</p> <p>The site remained largely snow covered at the time of the inspection; however, due to unusually warm weather freshet had just begun causing significant snowmelt to enter watercourses.</p> <p>Summary of Report</p> <p>At the time of inspection, the Licensee was undertaking activities related to the operation of an open-pit iron ore mine at the Milne Port (Milne Inlet), Mine site (Mary River), Tote Road. Most major construction activities have finished and BIMC is primarily mining ore and transporting it to Milne Port in preparation for open water season.</p> <p>Prior to the Inspection, BIMC has reported high levels of suspended solids ar

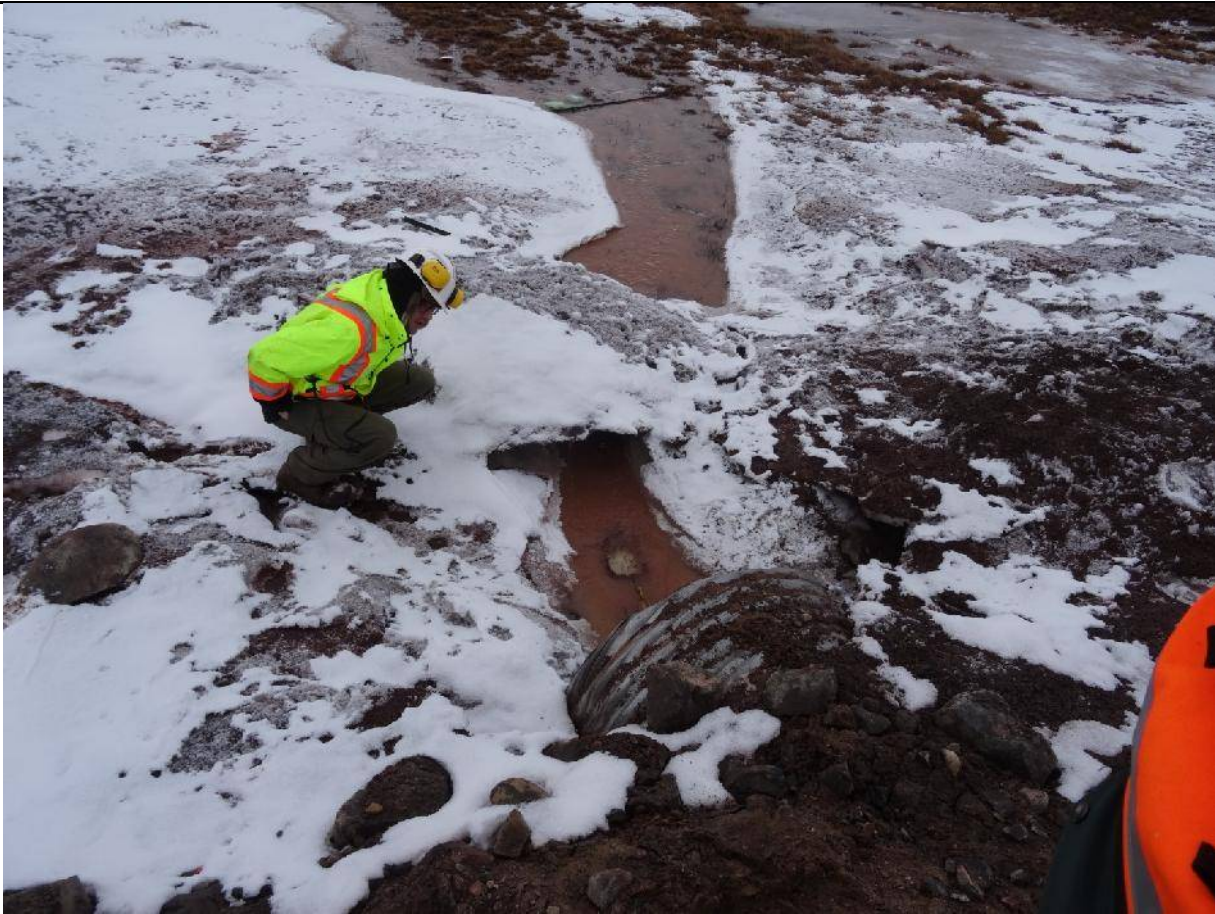
Photo Log # 1

- 6. During the inspection, there were significant sedimentation and erosion events (as indicated by red rust coloured water) actively occurring within watercourses along the Tote Road and entering David Lake, Mural Lake, Kabikok Lake, Sheardown Lake (see *Photo 1*), Camp Lake (see *Photo 2*), Mary River and Phillips Creek.

- a. The cause of this sedimentation and erosion events is likely loose soils becoming suspended during higher flow events, run-off of water from the Tote Road, and from dust entrained within snow (resulting the crusher, the tote road and the ore stockpile) melting and entering the watercourses.

Location: Sheardown Lake Tributary #1

Description: Water laden with sediment entering Sheardown Lake

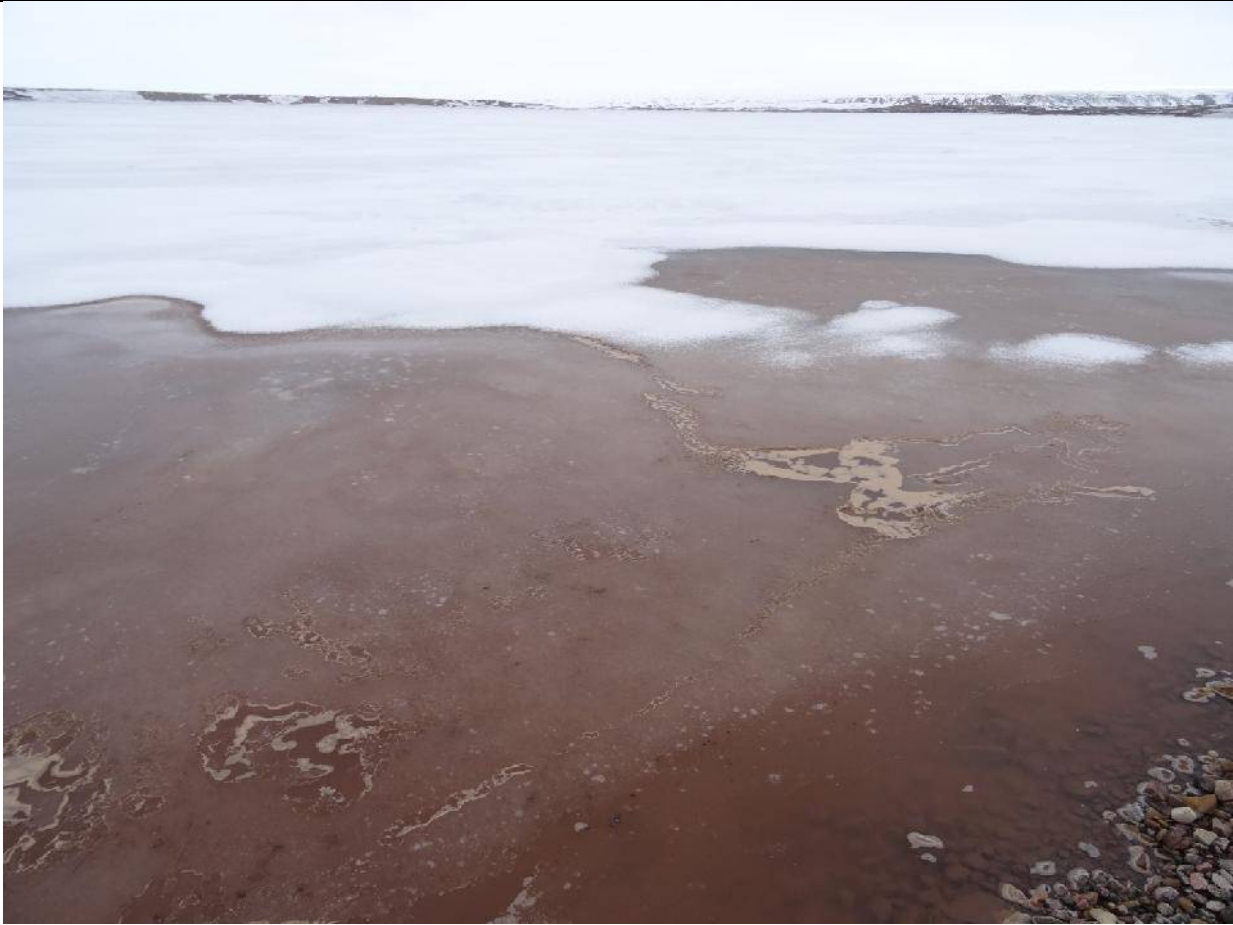
Photo Log # 2

- ii. The water quality sample taken at the stream entering Camp Lake near the monitoring location MS-MRY-1 had a TSS result of 114mg/L. This sample exceeded all effluent quality limits within the licence.

Location: Camp Lake near Water Intake

Description: Sedimentation entering Camp Lake from small camp lake tributary downstream of exploration camp

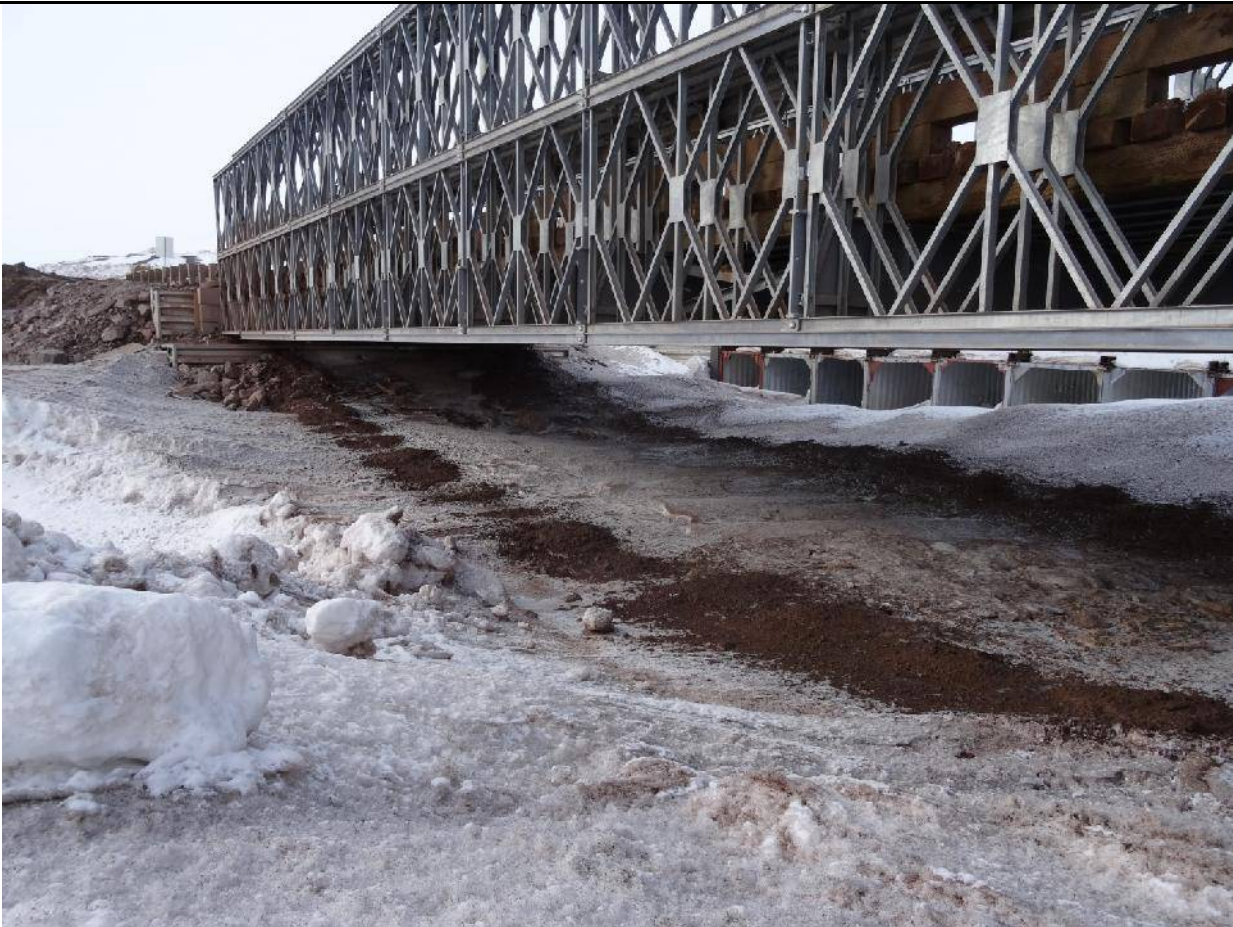
Photo Log # 2

7. Bridges along Tote Road
 - a. During wet conditions on the Tote Road, it was noted that road material is being pushed into all water courses that are crossed by a bridge.

- b. During the inspection, there was significant sediment on snow below the bridge (see *Photo 3*).
 - c. It is requested that BIMC address this concern in their plan due June 22, 2016 which is to address sedimentation issues along the Tote Road.

Location KM62 Bridge

Description: Road material entering stream at KM62 Bridge
