APPENDIX D.7.6
2016 WSCC INSPECTION REPORTS
AND BAFFINLAND RESPONSES

REPORT OF AN INSPECTOR OF MINES

Mine:	Mary River project	Location:	~950 km NW of Iqaluit	
Operator:	Baffinland Iron Mines Corp.	Lat.	71-19'N	Long. 79-24'W
Manager:	Bernard Laflamme	Inspection Date:	20160114 to 19	
Address	2275 Upper Middle Road East - Suite 300 Oakville ON L6H 0C3

Fred Bailey (chief inspector of mines) and Martin van Rooy (engineer/mine inspector) conducted a general safety inspection of Baffinland's Milne Inlet site, Tote Road and Mary River site. Baffinland's response to WSCC's safe advantage program was audited.

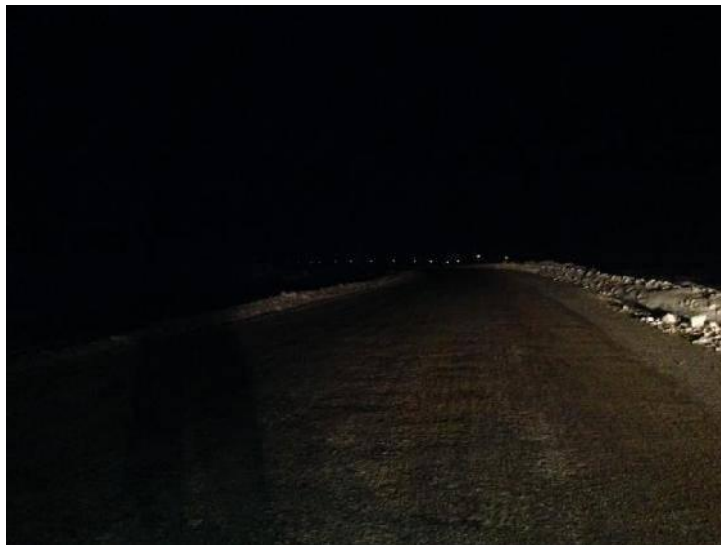
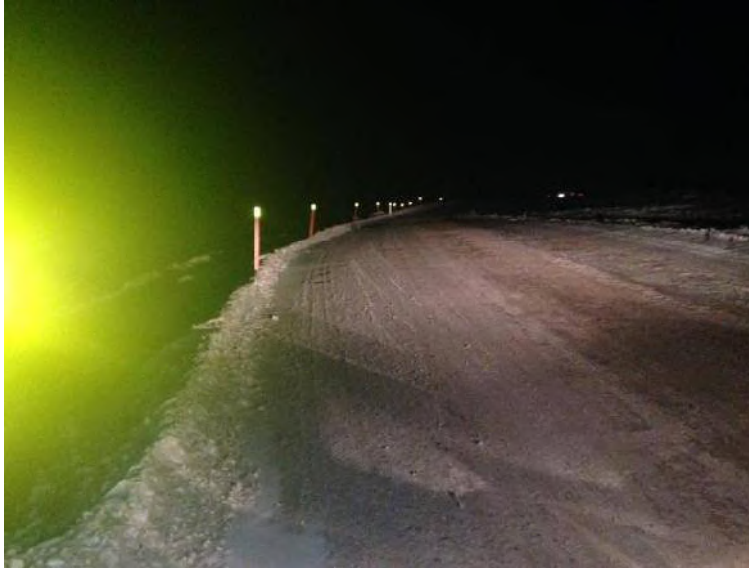
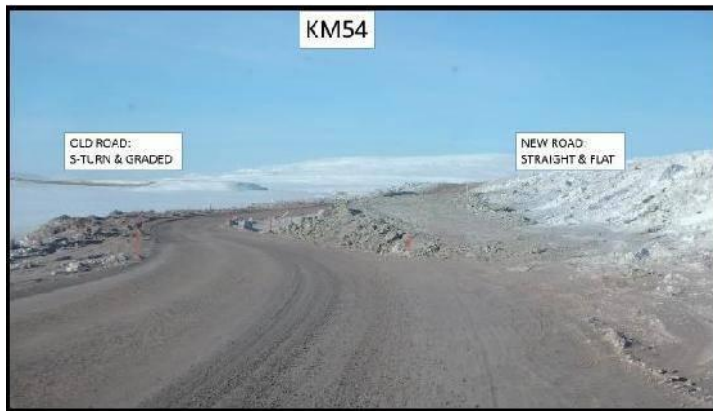
1. Noticed the flagging along some sections of the Tote road and bends is missing, making it difficult to see the road's direction and or edge in the dark.

RESPONSE: *Completed April 8, 2016.*

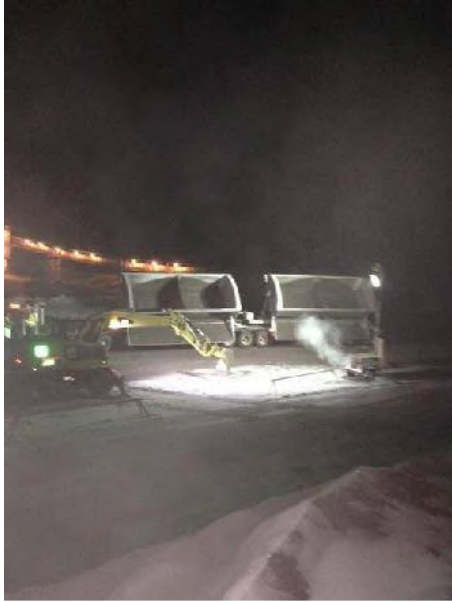
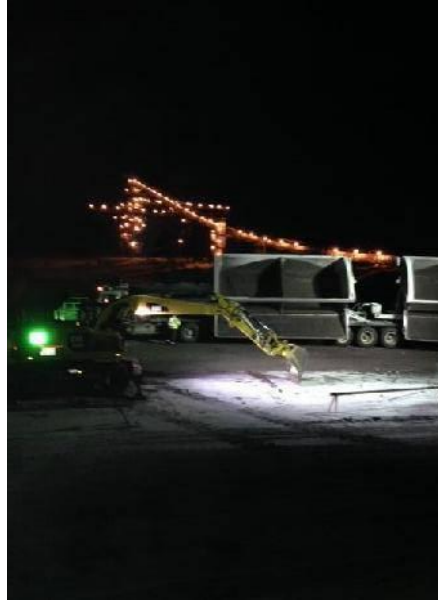
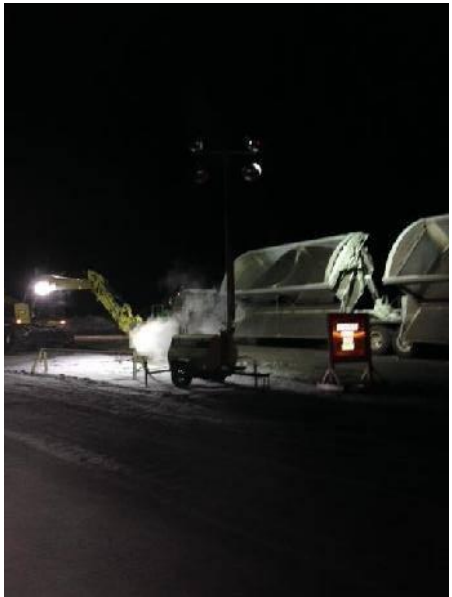
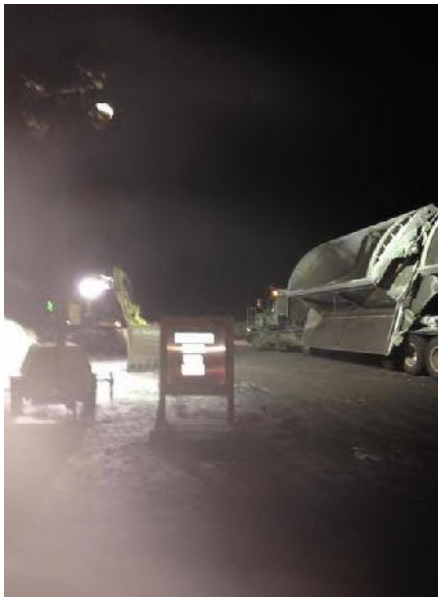
2. Noticed at Milne after the ore haul trucks have dumped their load, the truck is moved away from the dump to check for hang-ups in the trailers and to clean the door gap before closing the dump door. This action requires the operator to walk the full length of the rig in the dark exposing him/her to the mobile equipment working in the area.

Please establish an area complete with suitable flood lighting, away from the mobile equipment work area, where the haul trucks can stop and the operator can check for hang-ups and clean their trailers.

Response: *Developed layout for the truck cleaning and positioned light plants accordingly. See photos below.*

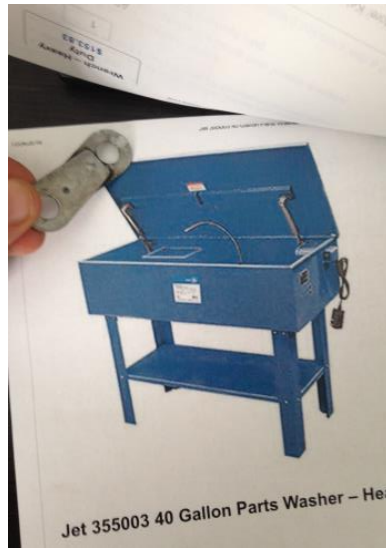
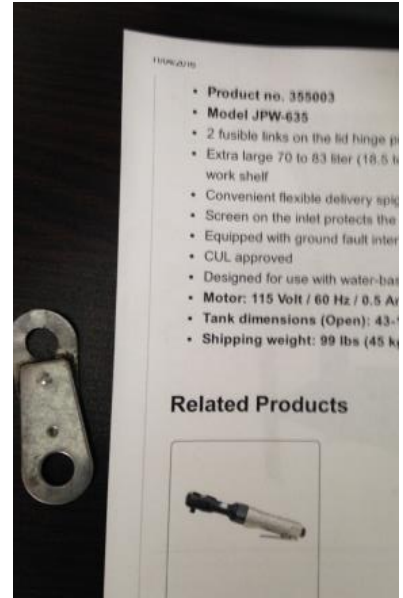
- 16. Noticed further to the 12 October 2015 inspection report, the lid on the Milne Inlet 40-gallon solvent cleaning tank, was repaired however, the Mary River 40-gallon solvent cleaning tank lid is not repaired.

Response: *Latch Installed on April 11, 2016*

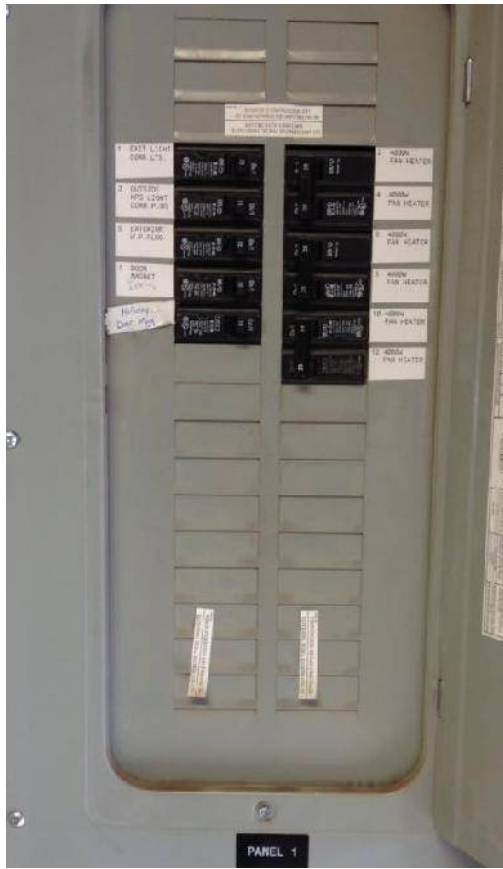
20. Noticed the electrical panel #1 in the Winterhaven camp corridor, has open slots allowing access to the bus duct.

Please cover the open slots.

Response: *Blanks are installed. Completion April 08, 2016*

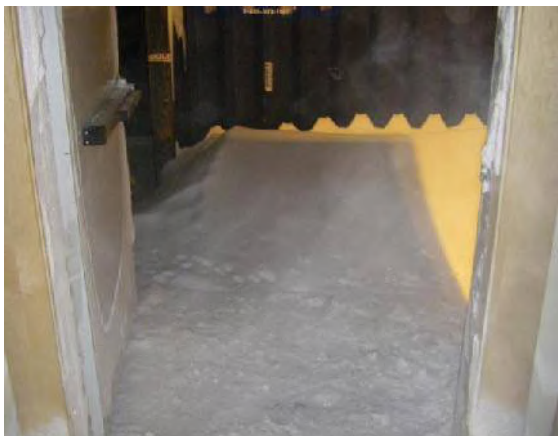
21. Noticed the broken panic bar on the welding shop exit door and that some of the exit doors, in the Winterhaven camp, could not be opened because of ice build-up.

Response: *Emergency exit doors have been repaired.*

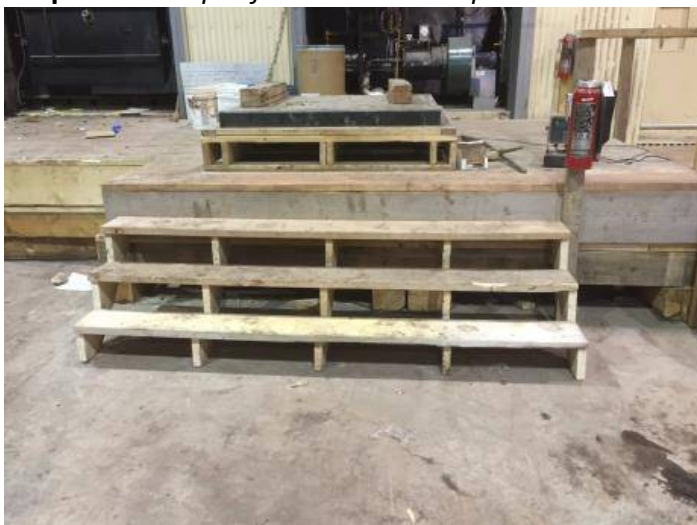
Stairs repaired at the Incinerator Building (Mine Site)

22. Noticed the steps, to Mary River's incinerator service platform, are damaged.

Please repair the damaged steps

Response: *The platform has been repaired.*

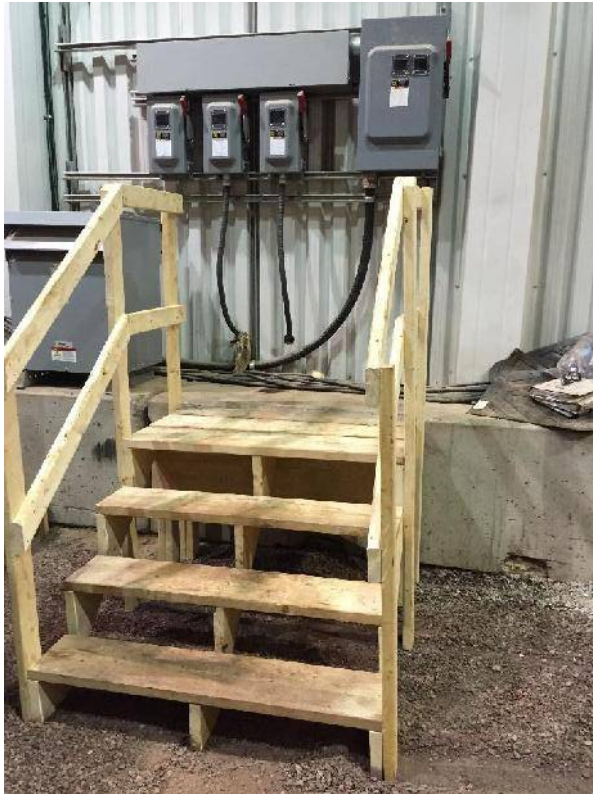
23. Noticed the electrical panel, in the center of Mary River's site service building north wall, has no steps for ease of access.

Please provide a convenient access to the electrical panel.

Response: *Completed Date: April 12, 2016.*

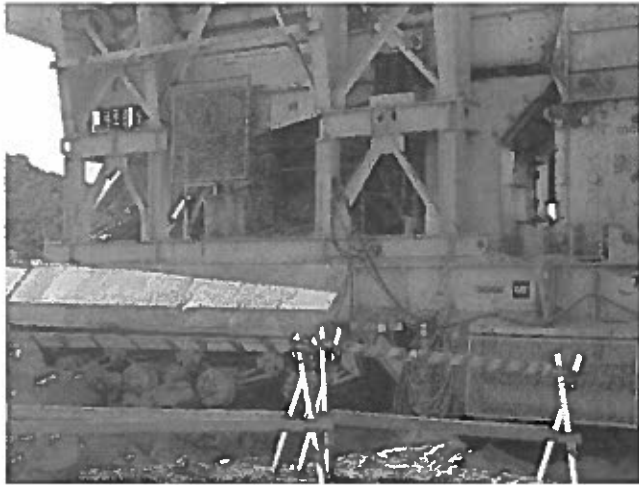
Noticed the vee-belt guard is missing from the vibrating feeder drive at crushing plant 'A' feed hopper.

14 Please replace the missing vee-belt drive guard to prevent contact with the moving parts and to contain a loose or broken vee-belt.

Response: The guard has been replaced on the vee-belt drive guard. Completion: June 05, 2016

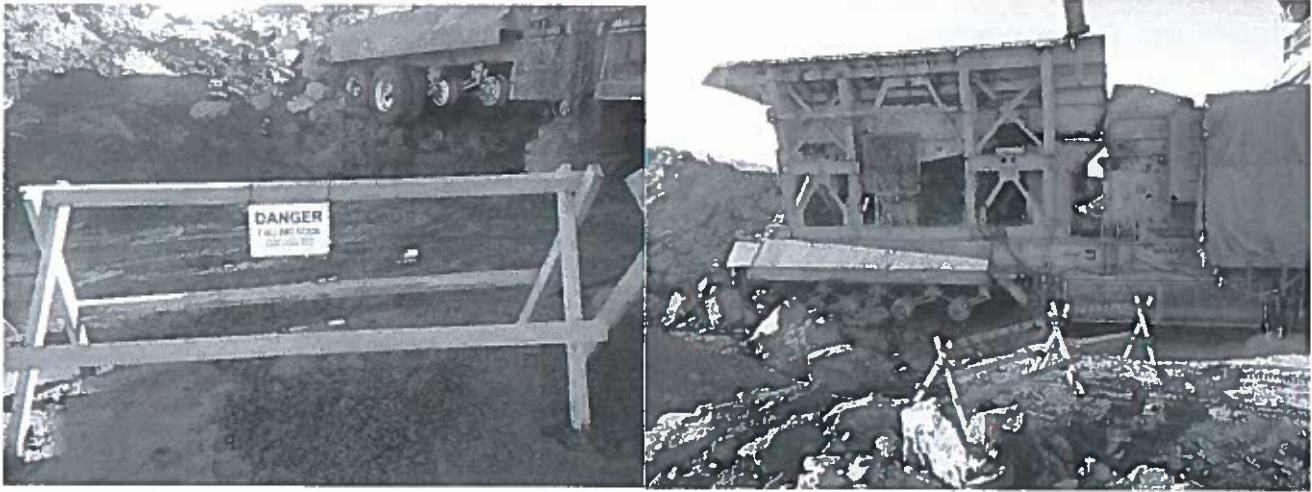
Noticed there is no barrier installed for the exposed tail pulley of the conveyor below the vibrating feeder of crusher 'A' and there are no barriers installed to prevent access by a persons to the missing belt conveyor nip-point guards at crushing and screening plant 'A', 'B' and 'C'.

15 This is a repeat infraction see inspection report 29 January 2016. Please install barricades at the crushing and screening plant 'A', 'B' and 'C' to prevent access to the moving conveyor parts or install nip-point guards.

Response: Barriers have been erected to prevent access to moving conveyor parts. Date completed June 07, 2016

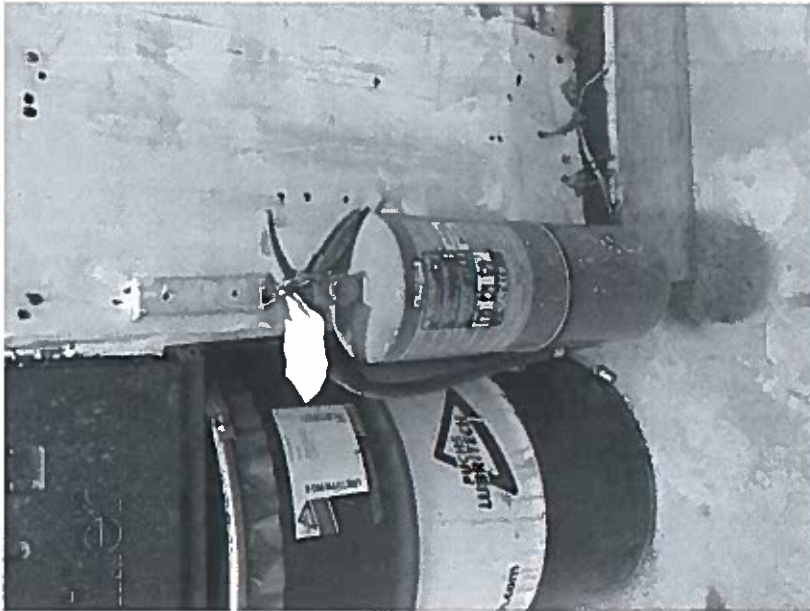
Noticed a fire extinguisher was standing on the floor of Toromont shop at Mary River.

18 Please ensure all fire extinguishers are hung-up and not set on a flat surface where moisture may

Response: The fire extinguisher has been hung on the wall. Completion date: June 12, 2016

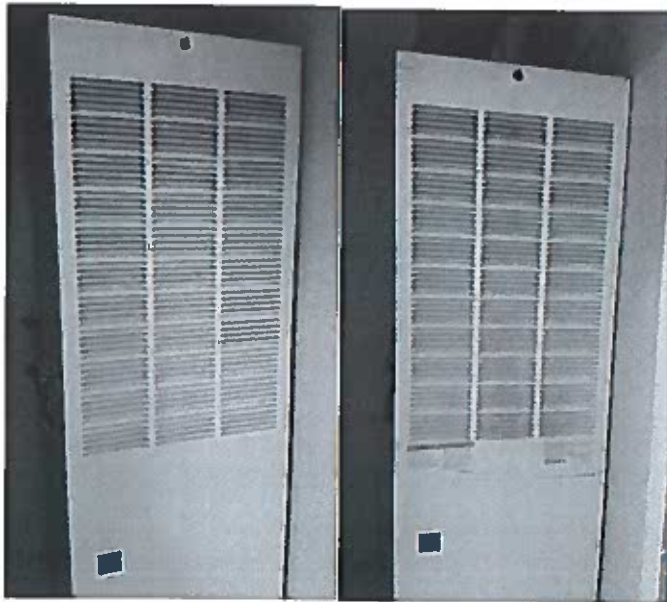
Noticed some furnace covers in the Mary River kitchen complex, are removed.

27 Please ensure the furnace cover is replaced on a furnace after it has been removed.

Response: Covers have been replaced. Completed June 12, 2016

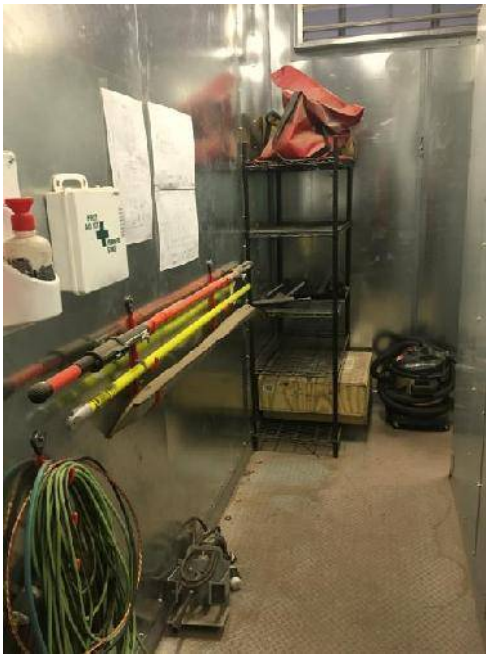
Noticed a few items, not directly associated with the operation and maintenance of the E-Houses at Mary River, stored in the E-Houses

Items were removed.

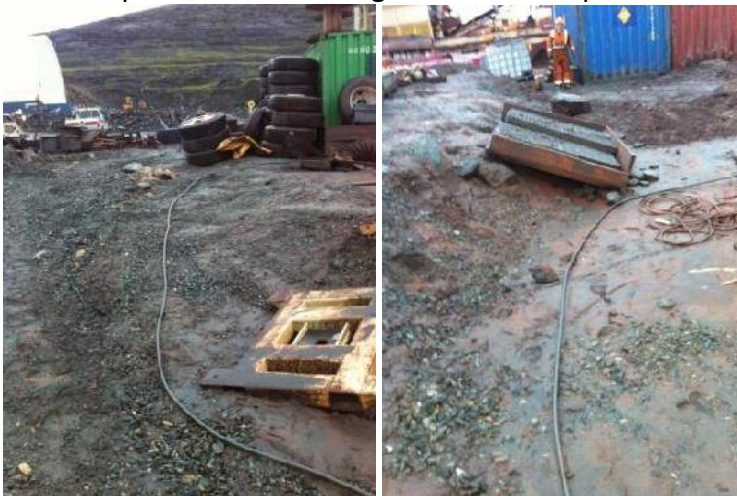
Noticed there is an unprotected portable power cable running on the ground from e-House 8 to a Sea Can. This unprotected cable is routed through an equipment lay down area and is exposed to vehicle or equipment damage.

Portable power cable feeding sea can was replaced with armored cable and rerouted.

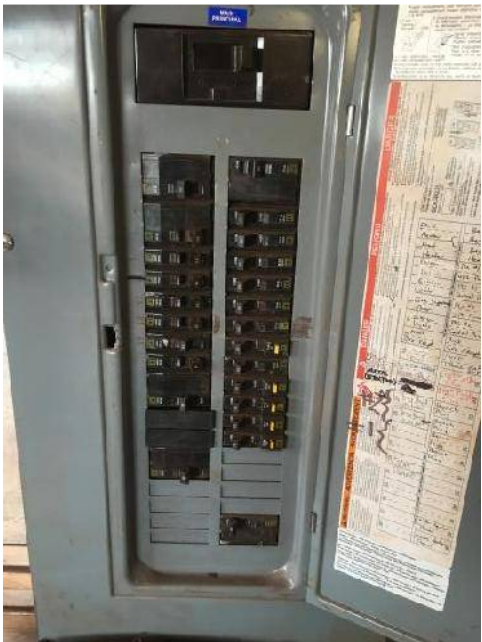
Noticed filler plates are required in 1) the lighting panel at the A-side Crusher MCC, and 2) the 20kW generator distribution panel at the Mine 110 laydown area

Filler plates installed.

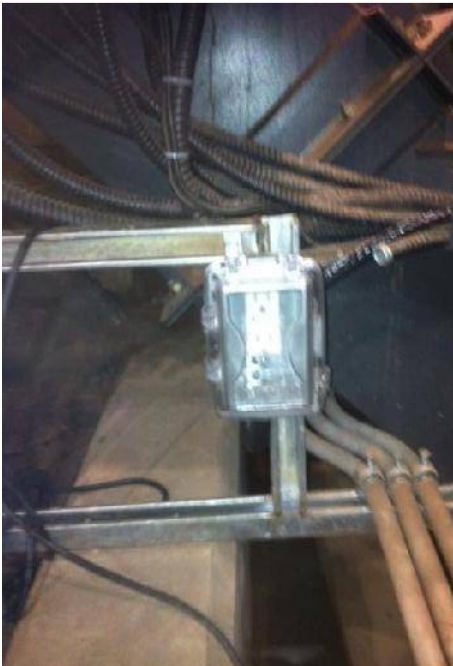
Noticed a sump pump at the South side of the truck wash platform, is fed by an extension cord from a receptacle on the perimeter of the building.

Truck wash sump pump hard wires receptacle.

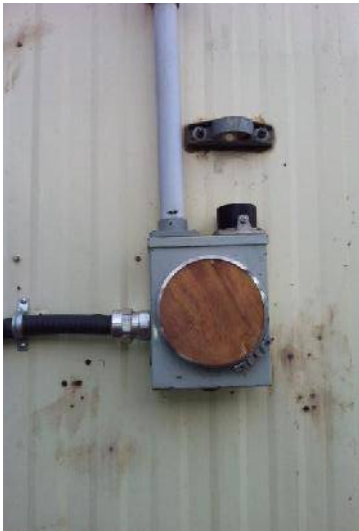
Noticed the meter box used as a pull box at the Mary River Site Services Office trailer, however, it has no covers.

Cover placed on meter box.

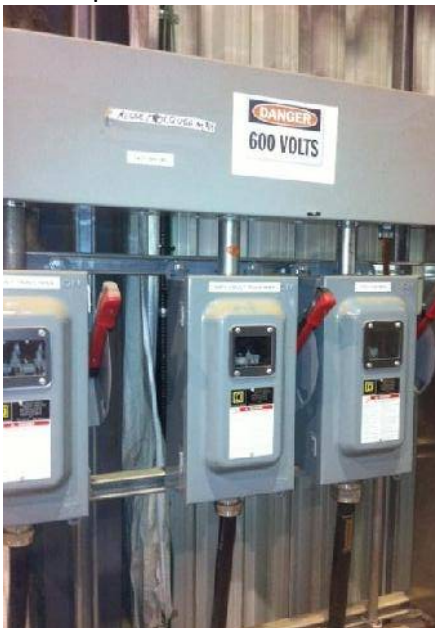
Noticed the 600V switches at splitter 7451-SPL-002, have no labels.

Labels posted.

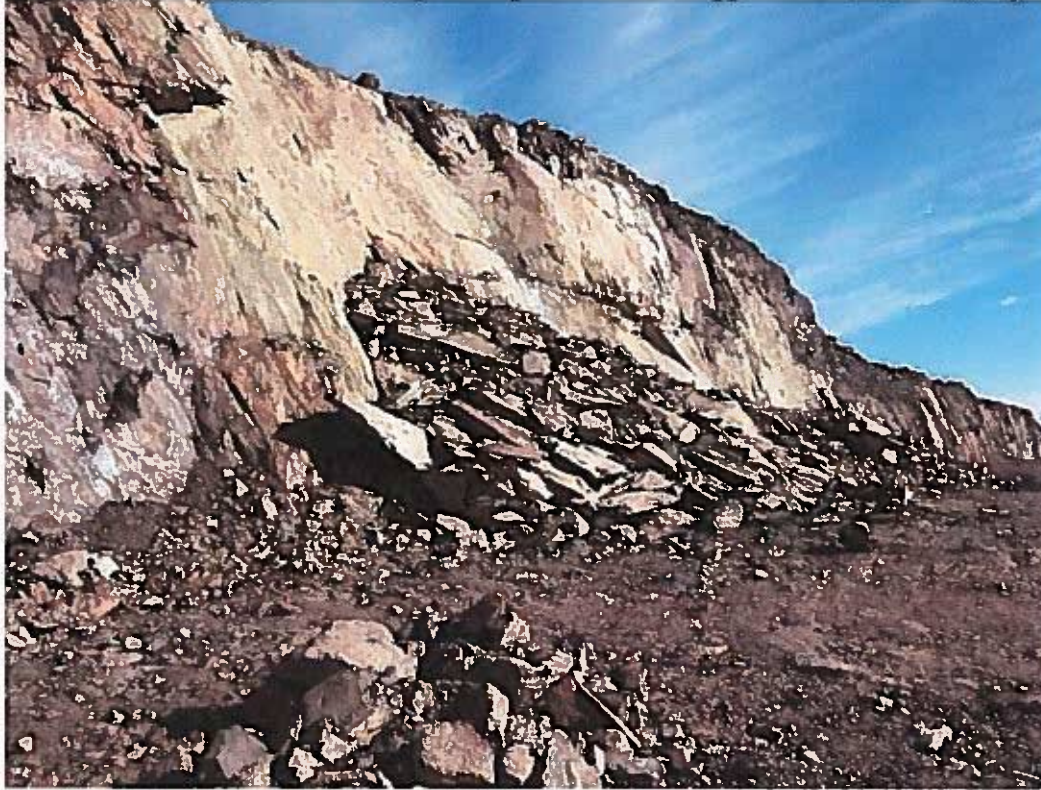
Photo 1: 200 t failure from 15m high final pit wall face on upper bench. Ultimate height will be ~25m

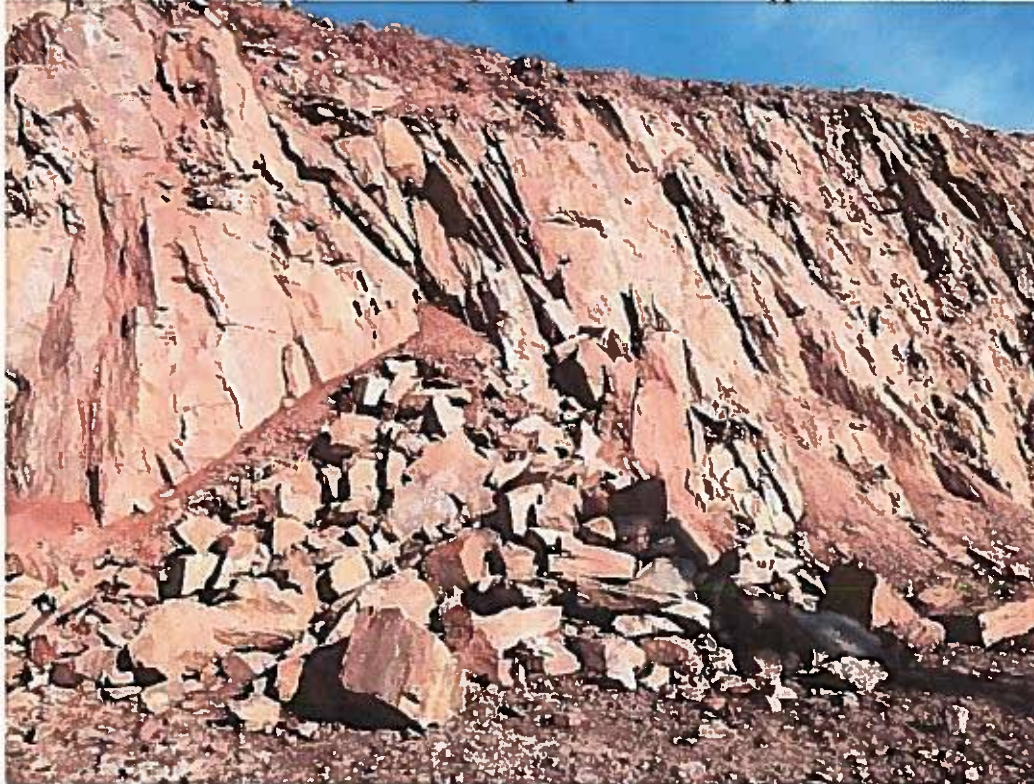
Photo 2: Ongoing raveling from 12m high final pit wall face on upper bench. Ultimate will be ~22m

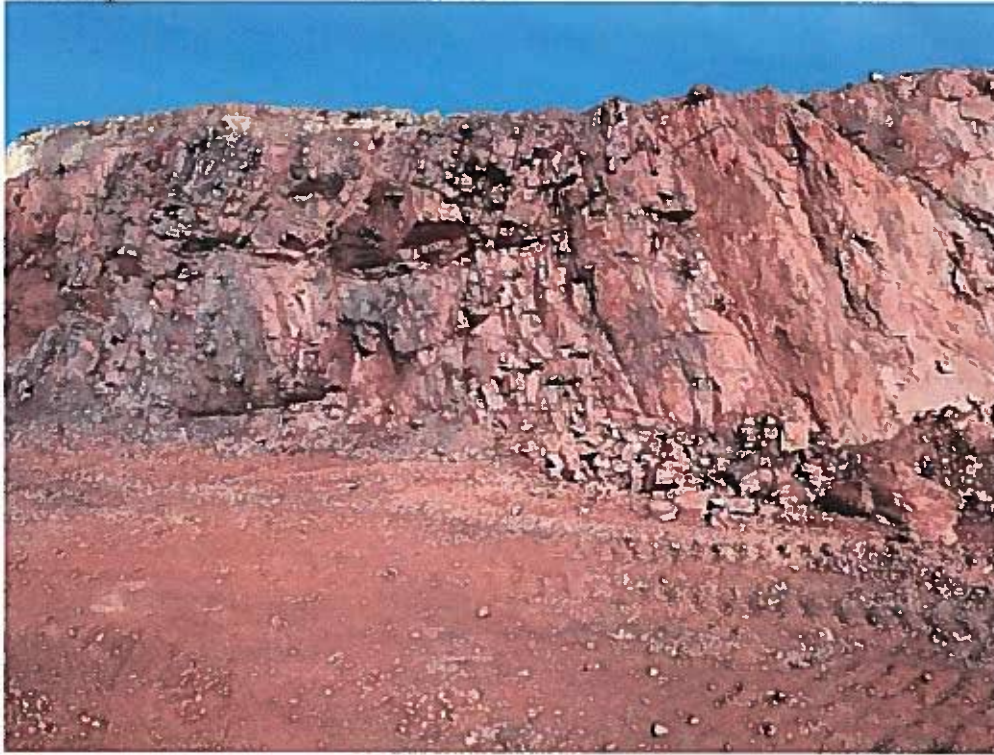
Photo 3: 10m high internal wall on 650 Bench. Geologic structure and blast damage contribute to local instability.

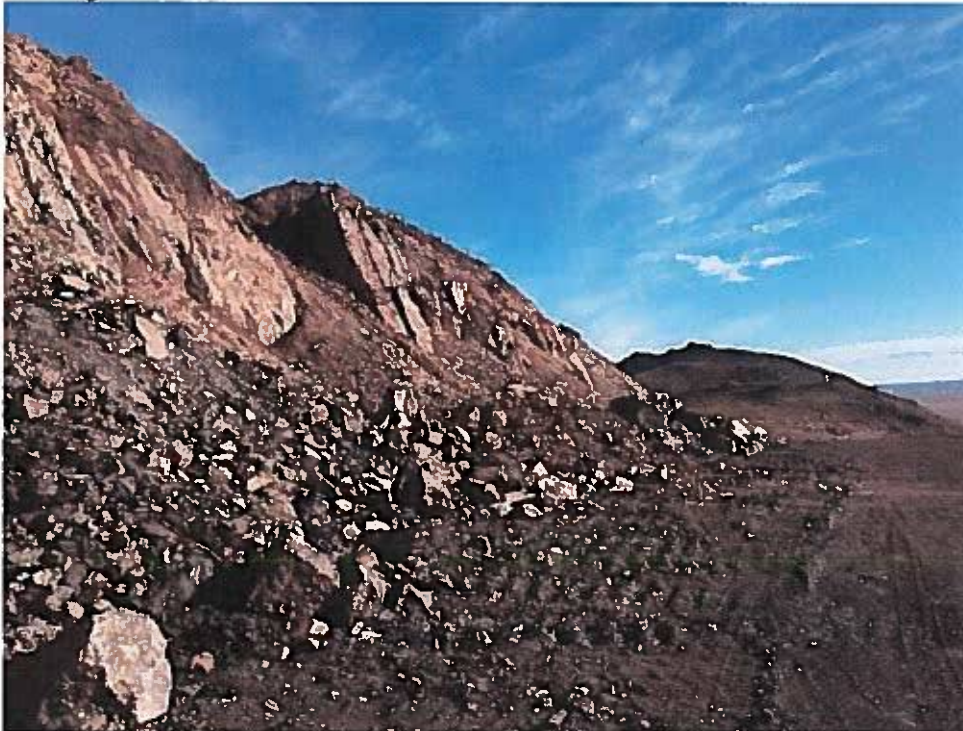
Photo 4: 10m high internal wall on outside edge of 640 Bench. Overburden across top of bench is raveling now that it has thawed.

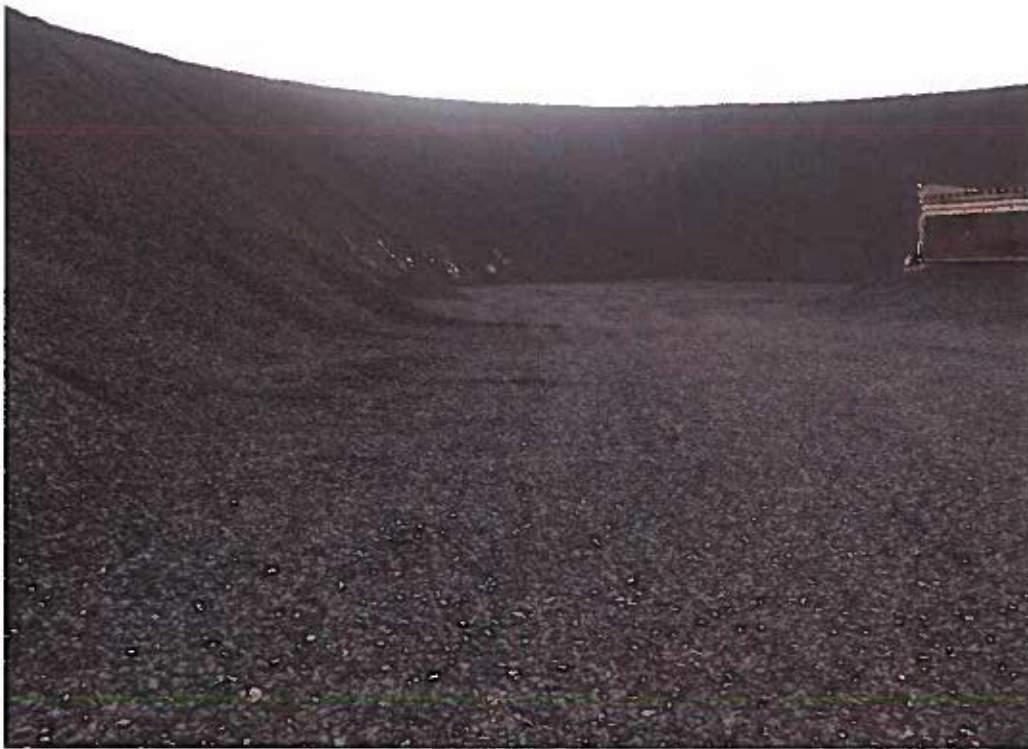
Photo 6: 18m high angle of repose stockpile with frost on surface

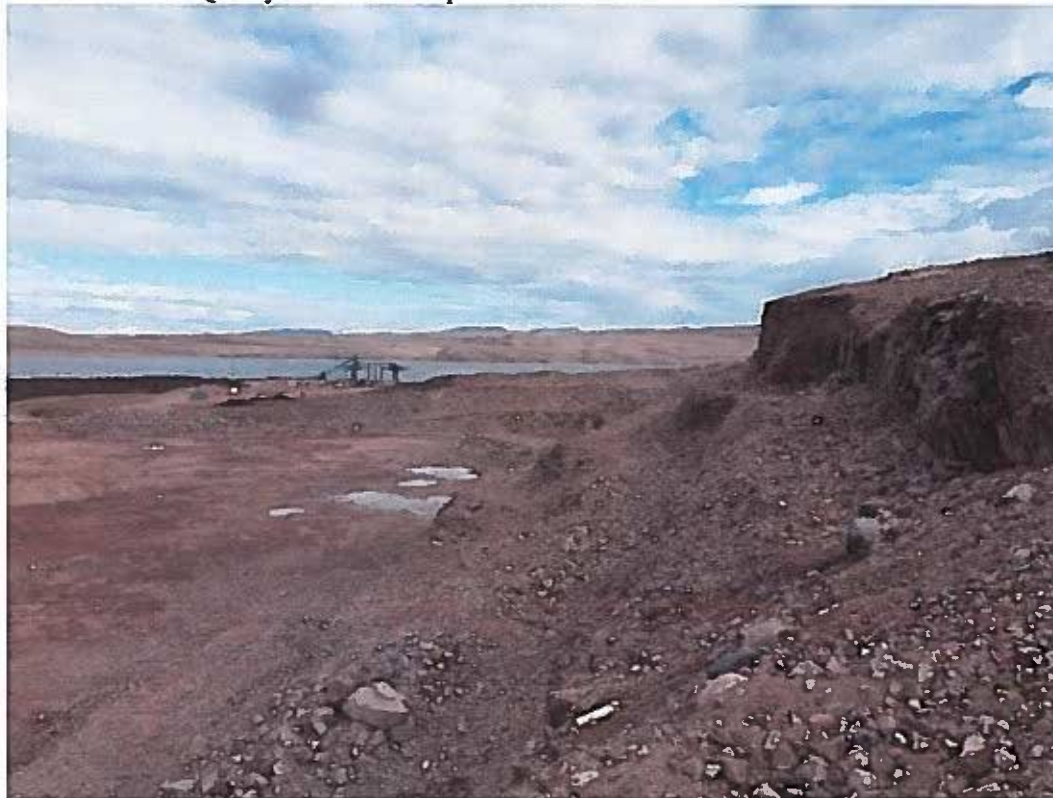
Photo 7: Milne Quarry. Much loose present of faces and bench width less than 8m

Berm is installed at the Milne Quarry. August 17, 2016

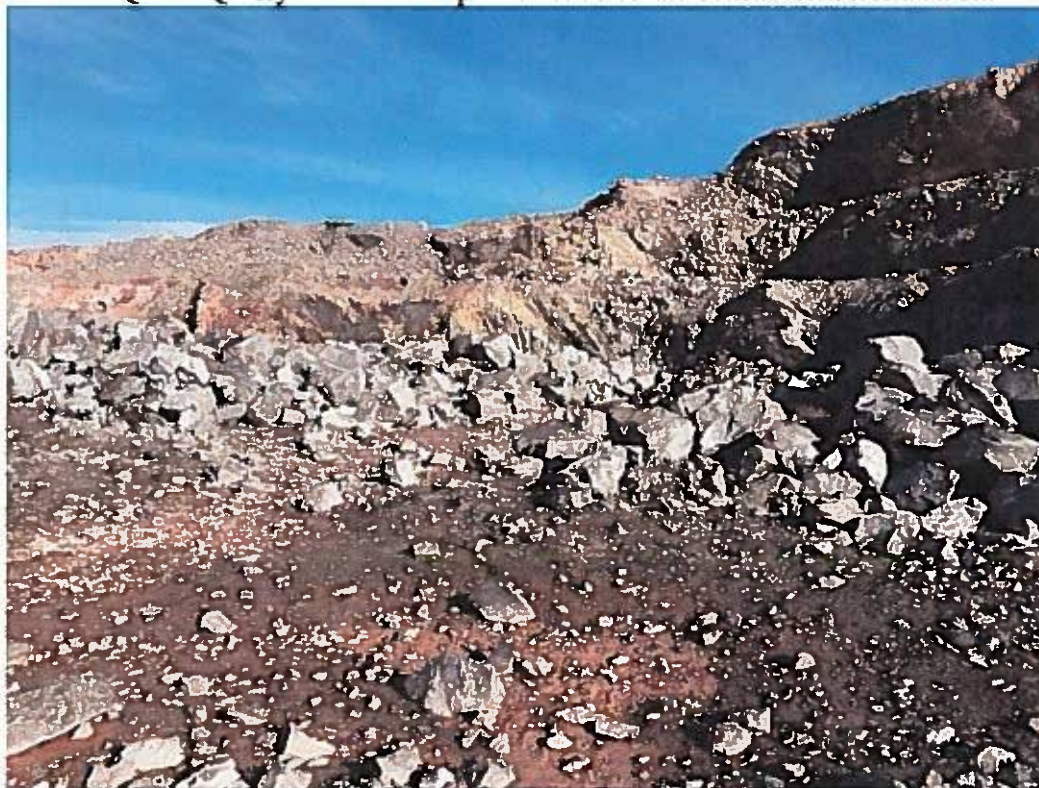
Photo 8: QMR2 Quarry. Much loose present of faces and bench width less than 8m

Berm is installed at QMR2. Installed August 15, 2016
