APPENDIX D.7.7

FOLLOW-UP SPILL REPORTS

Re: Follow-up to Spill #16-006, Reported on Jan 6th, 2016
Mary River Project - Water Licence No. 2AM-MRY1325

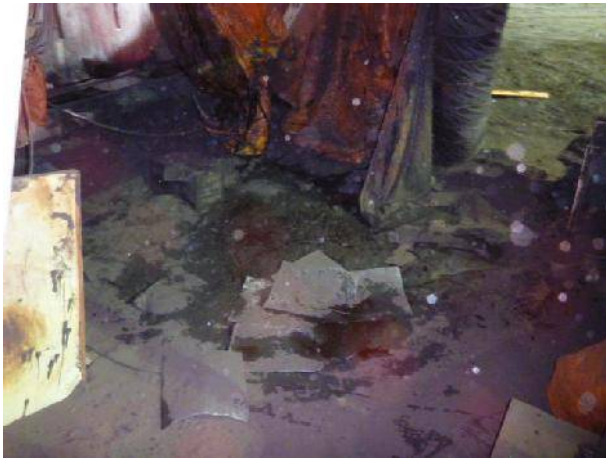
At approximately 07:30 on January 06, 2016, the crusher operator was starting up the equipment on the B-Spread Crusher at the Mine Site Crusher Pad and the belt gave way and broke. This resulted in the belt coming in contact with the lube oil return line on the Tertiary cone, causing the line to release lube oil to the adjacent area. The volume of the spill was approximately 120L covering an approximate area of 4 m². The spill location is > 100 m from the nearest drainage (non-fisheries habitat) and all water bodies are currently frozen.

Photo 1 – Spill Location Pre Clean up

The Crusher Supervisor and Environment Department were notified immediately upon spill discovery. The lube oil was contained and cleaned up with spill pads and the contaminated material was placed in Quatrex bags. The contaminated material from the impacted area was removed for disposal in the Landfarm Facility at Milne Port.

The Crusher lube oil return line was repaired and the crusher is currently operational. The affected area has been cleaned up and the contaminated material disposed of.

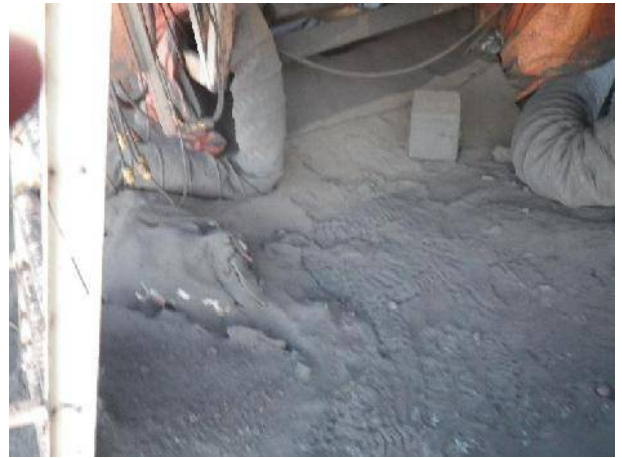
Photo 2 – Spill Location Post Clean up

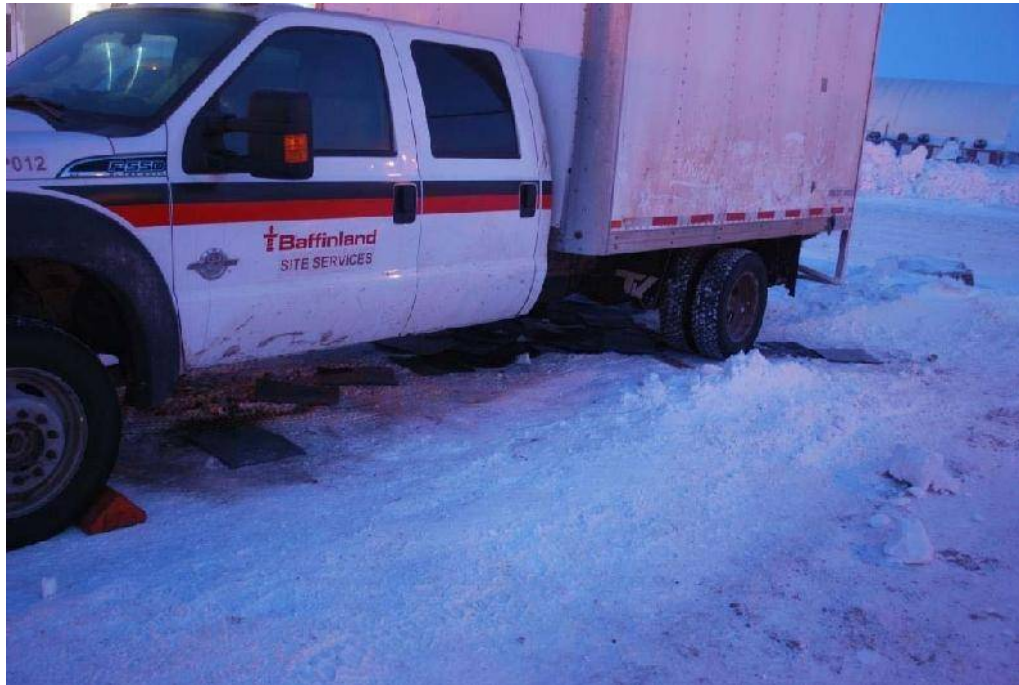
On February 26, 2016 at 5:30 HRS, a worker discovered that the cube van (truck) had leaked approximately 120 litres of diesel onto the ground underneath the vehicle, affecting an area of approximately 10 m2. Upon further inspection, it was determined that the vehicle's fuel line had become damaged and had leaked the contents of the vehicle's fuel tank onto the ground. The location of the spill was greater than 200 meters away from the nearest water body, Milne Inlet, which is currently frozen.

Photo 1 - Cube Van Diesel Spill – 120 L

The cube van (truck) fuel line has been repaired and is back in operation. The affected area has been cleaned up and the contaminated snow and soil have been taken to the Milne Port Landfarm Facility for treatment.

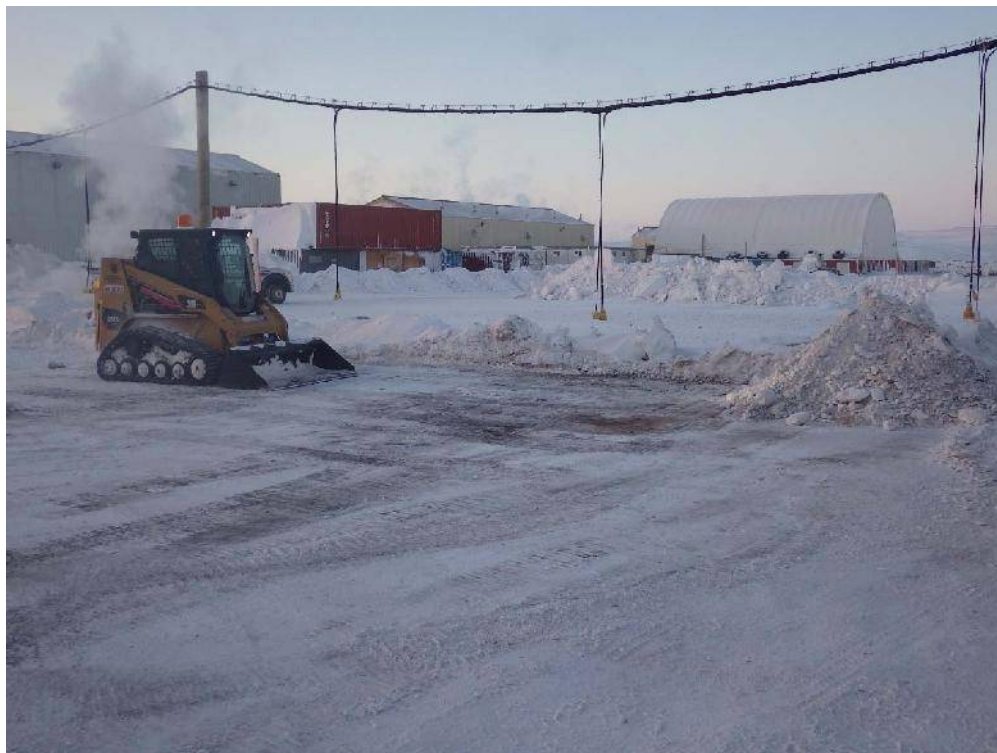
Photo 2 – Spill Cleanup

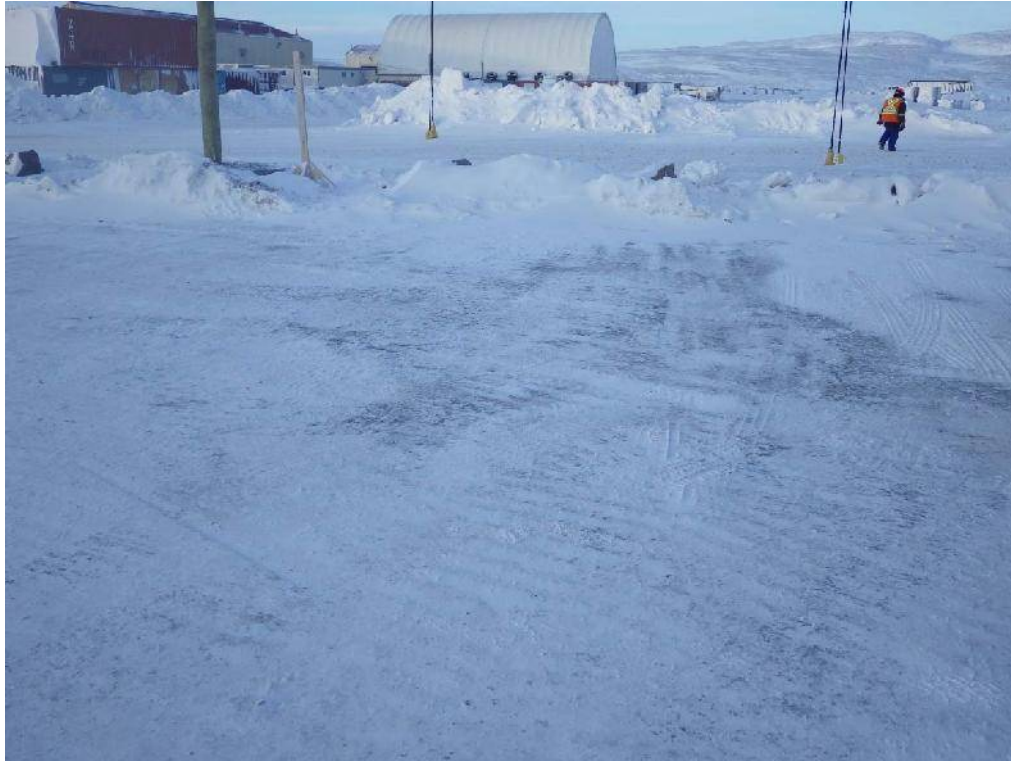
Photo 3 – Spill Location after Cleanup

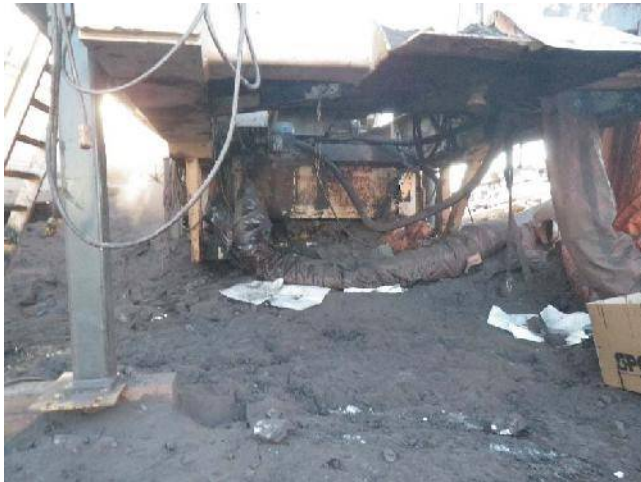
Photo 1 – Spill Location

The lubricant oil hose was tightened and clamps replaced. Crusher A is currently operational. The affected area has been cleaned up and the contaminated material disposed of.

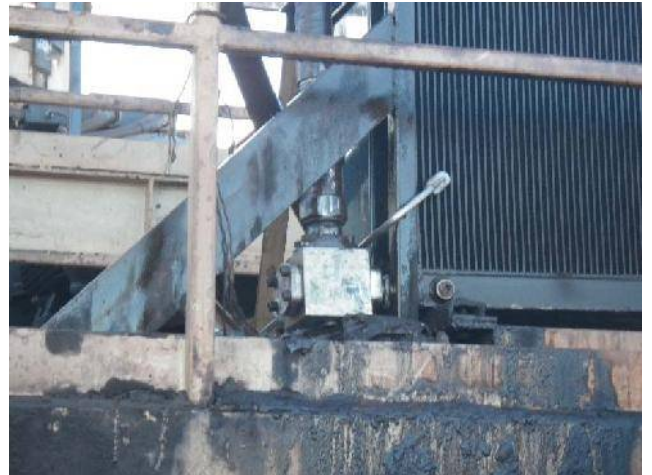
Photo 2 – Location of Hose Failure

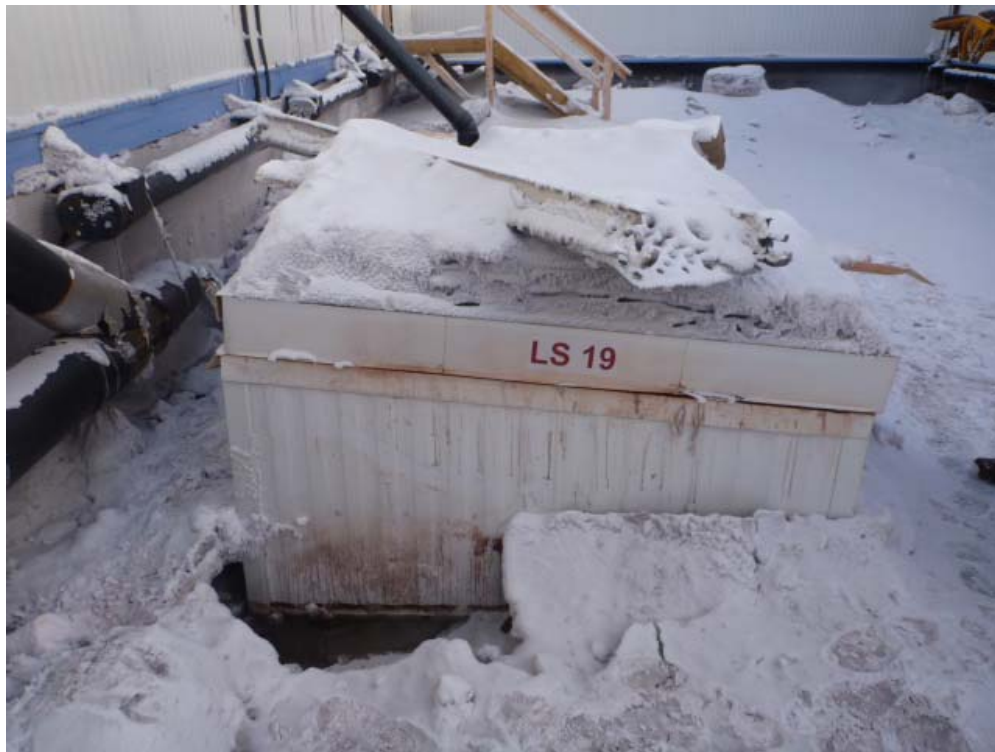
On March 3, 2016 at approximately 13:00, while completing routine daily inspections of sewer lines and lift stations a release of grey water was discovered at lift station 19, located between the office and kitchen complexes of the Mine Site Complex. Upon further investigation, the lift station float switch had malfunctioned, causing an overflow which resulted in 100 Litres of grey water to slowly leak onto the adjacent ground surface. An area of approximately 10m² was impacted. The location of the spill was on the Mine Site camp pad, is greater than 100 meters from the nearest watercourse and all water bodies are currently frozen and ice covered.

Photo 1 – Lift Station Spill

Fixed Plant Maintenance and the Environment Department were immediately notified. The vacuum truck was used to empty the lift station and remove any pooling grey water. The pumps were shut off and the float was system was replaced.

The lift station float switch was replaced shortly after the spill was reported and the lift station is back in service and functioning properly.

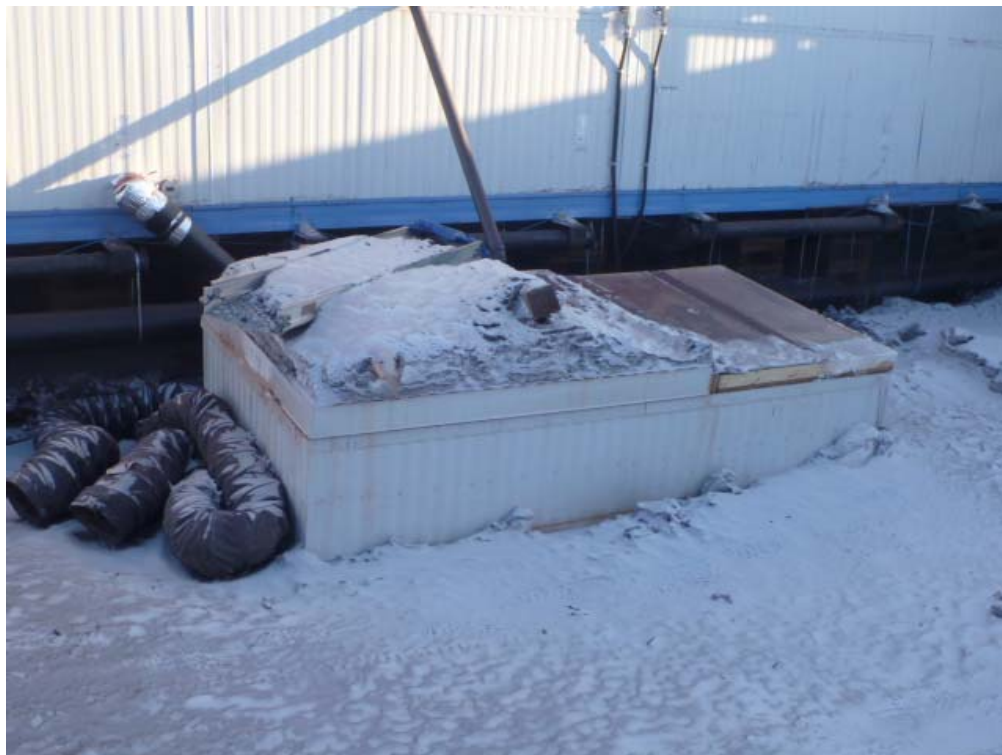
Photo 2 – Lift Station Spill Post Clean Up

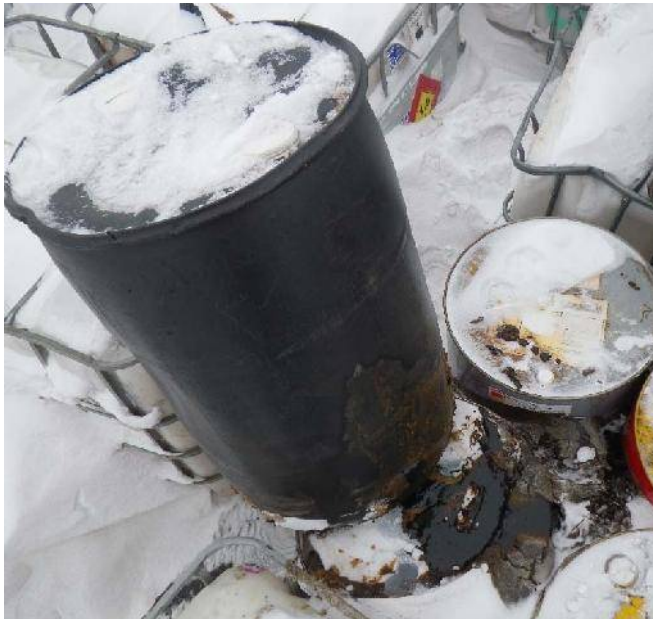
At approximately 17:00 on April 04, 2016, a spill was identified while environmental personnel were doing an inventory of hazardous waste berms at the Mary River Mine Site. It is estimated that 140L of used engine oil was released into the berm covering an approximate area of 3m². The used oil was housed in a plastic drum which had a puncture in the bottom causing it to slowly leak out into the engineered lined containment berm. The spill location is > 100 m from the nearest drainage (non-fisheries habitat) and all water bodies are currently frozen and ice covered.

Photo 1 – Spill Location

Environmental personnel placed the leaking drum in tertiary containment (spill tray). Site services then cleaned up contaminated snow and residual oil with shovel and placed material in quatrex bag. The contaminated snow from the impacted area was removed for disposal in the Landfarm Facility at Milne Port.

Proper placement of hazardous materials within line containment structures has been addressed with responsible departments.

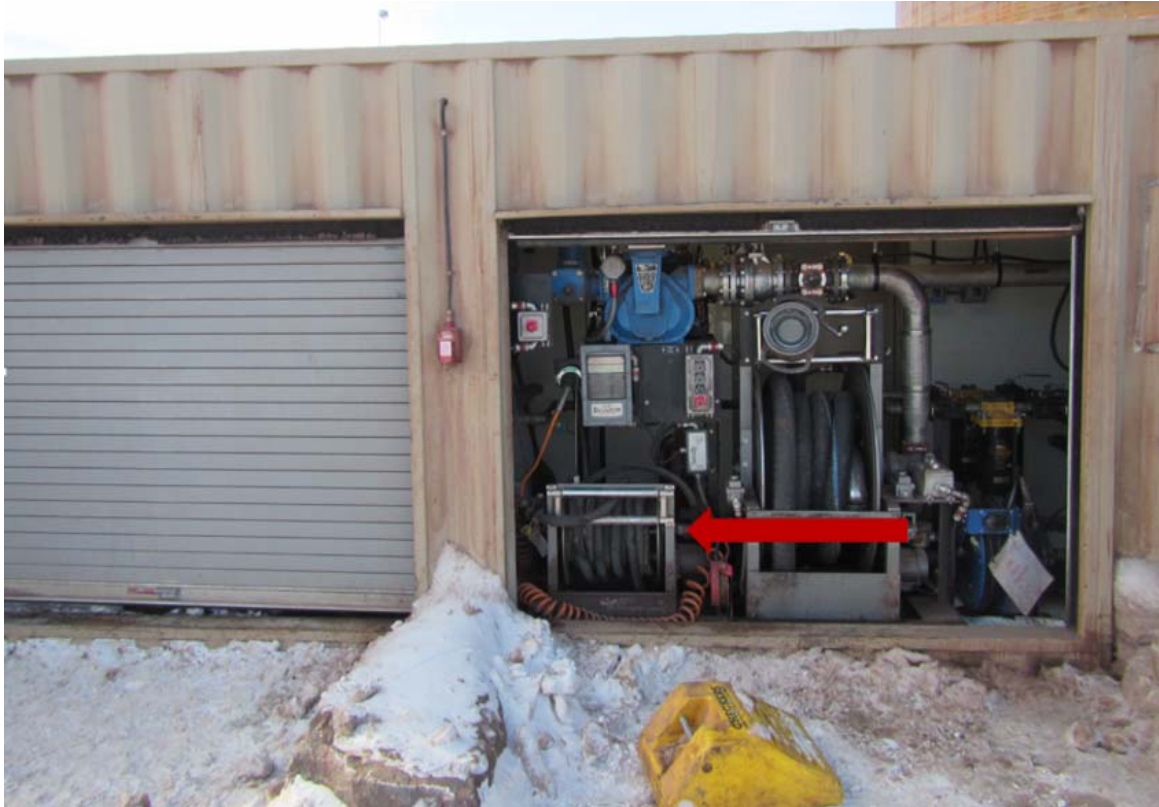
Photo 1 - Source of release – Secondary (back-up) fuel supply line

The Fuel Module's faulty fuel nozzle has been replaced and the fuel line remains locked-out as per proper Baffinland procedure. To provide an additional control, the isolation/ball valve also remains locked-out.

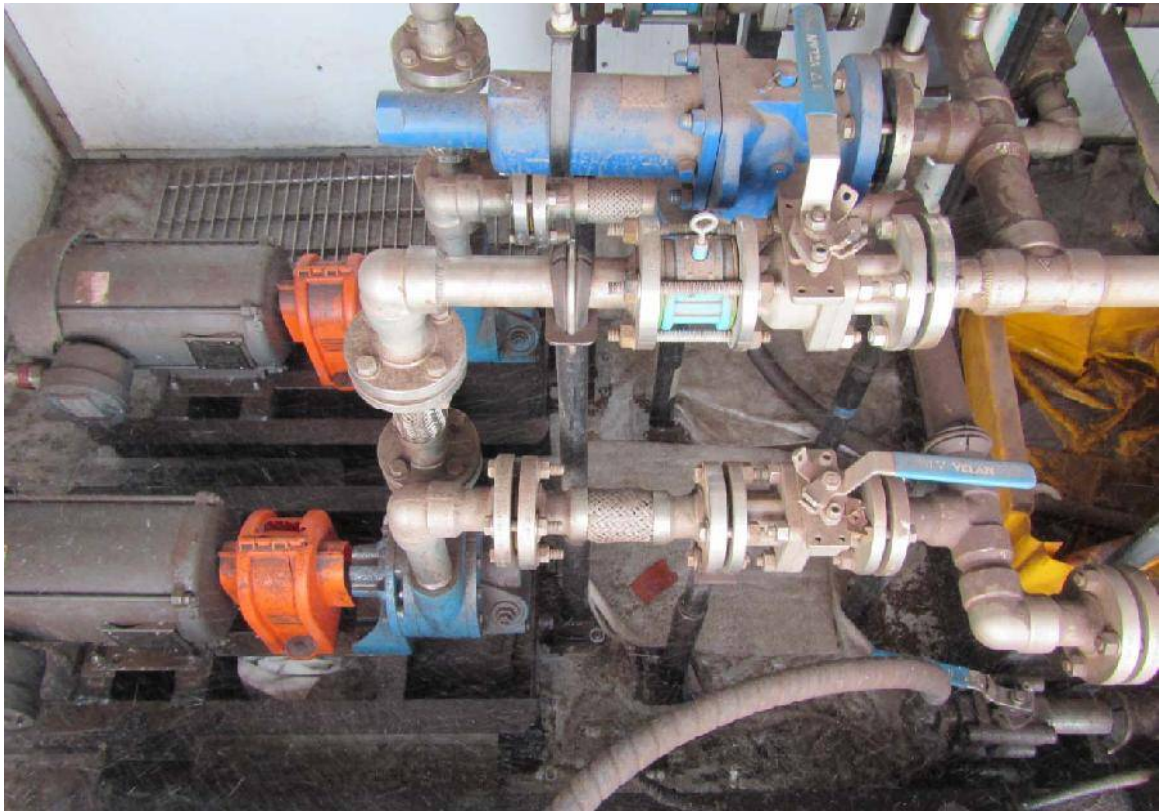
By visual assessment, it was estimated that approximately 300 L of diesel fuel was released into the sea container module. While the fuel was observed to be fully contained within the structure (refer to Photo 2), upon snowmelt further assessment will be completed to determine the extent of a potential release to the surrounding constructed containment berm in which the module is located. The assessment cannot be completed at this time since the east side of the module is inaccessible to snow removal equipment. The location of the spill was fully contained within constructed secondary containment and is greater than 200 meters away from the nearest water body, Milne Inlet, which is currently frozen.

Photo 2 – Spill Contained within Module

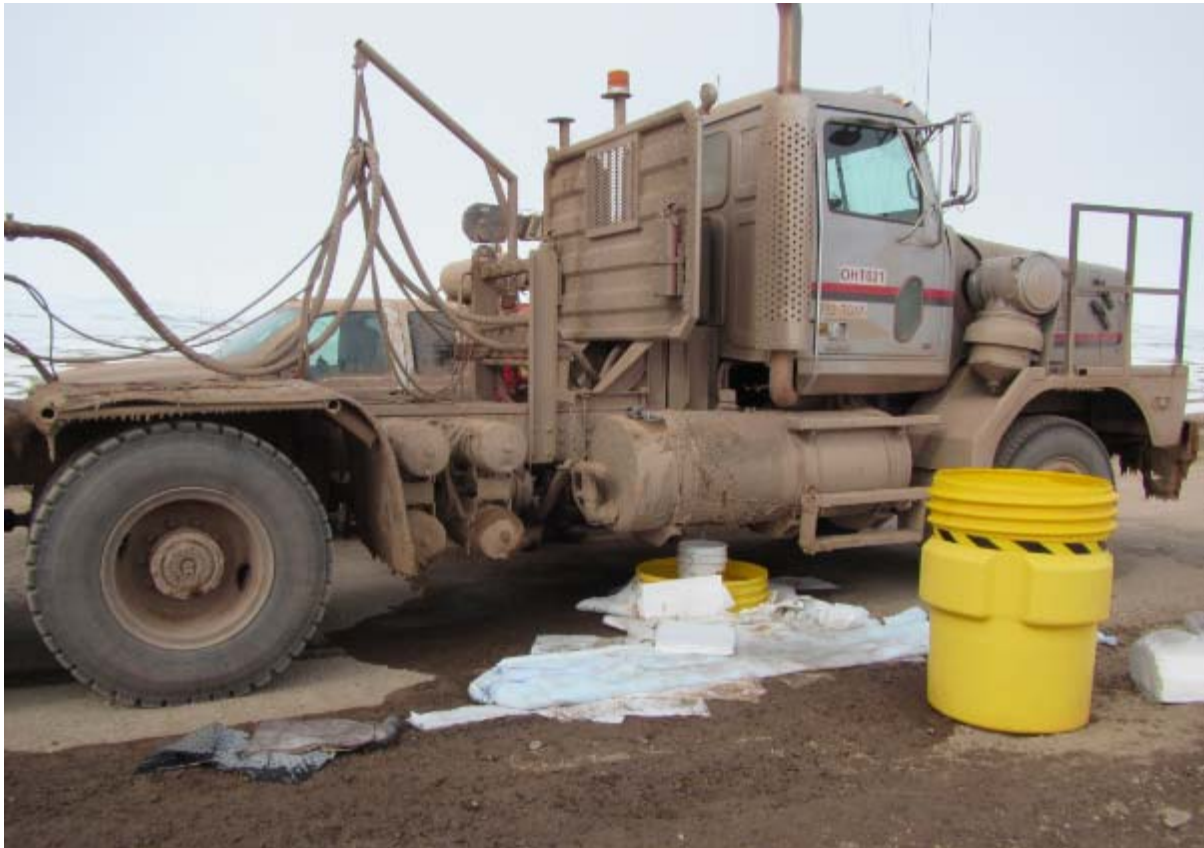
On May 10, 2016 at 10:00, during transport along the Mary River Tote Road, an Ore Haul Truck (OHT) Operator ran over a metal mud-flap bracket puncturing a small hole in the bottom of the passenger side diesel fuel tank. The operator continued to drive a distance before he was notified by Site Personnel approaching from behind that he was leaking diesel fuel at which time the Operator immediately pulled over to assess the leak at Km 37.

Photo 1 - Source of release – Ore Haul Truck Fuel Tank

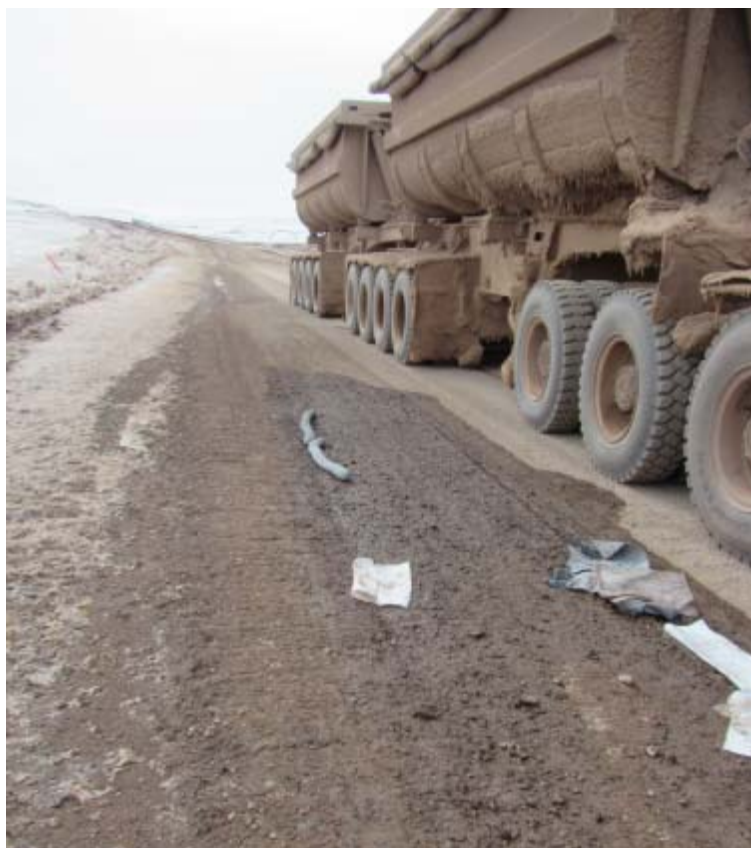
Photo 2 – Spill Area

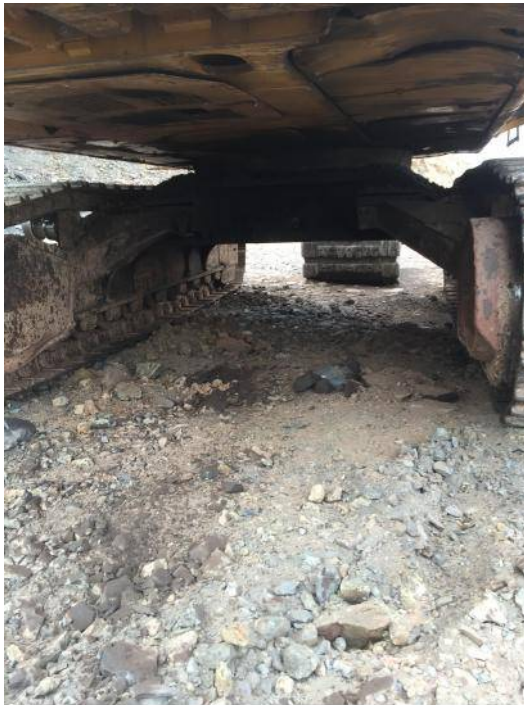
See attached spill report. On July 16, 2016 at 16:00 HRS, the operator of a CAT 390 excavator discovered that his unit was leaking hydraulic oil at a high rate. The excavator was situated on the working bench of the Deposit No. 1 Pit. The operator immediately shut down the equipment and then called his supervisor to investigate. Approximately 200 liters of hydraulic oil was released to the adjacent ground surface, the surface consisting of broken waste rock (recent blast site). The immediate cause of the spill was a hose failure, which was subsequently replaced prior to equipment start-up.

Photo 1 – Spill Location

The hose was subsequently replaced and the unit was put back into service. The affected area was cleaned up and the contaminated material placed in a secure, contained location..

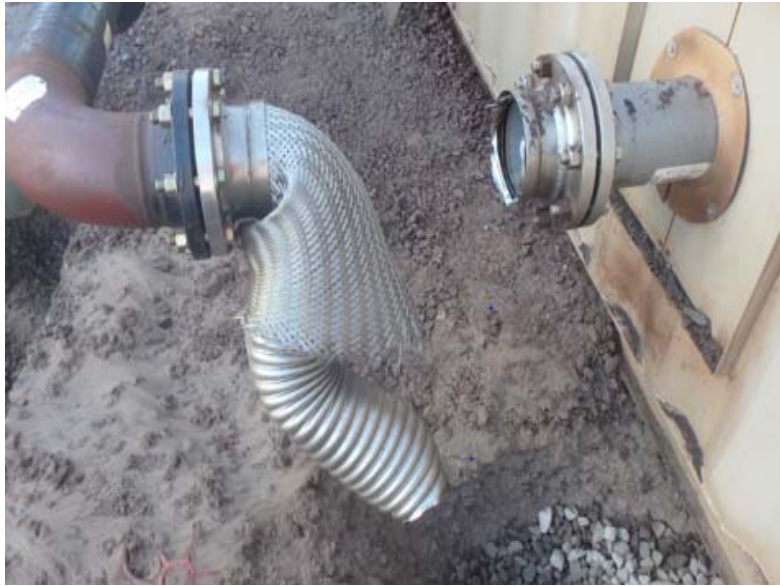
On August 2, 2015 at 18:45 HRS, the 150 psi rated 6" flexible braided pipe supplying the P50 fuel module at Milne Port was observed to have failed, resulting in the release of diesel fuel into the fuel containment facility. The volume of released diesel fuel was approximately 155 cubic meters (m³). Site Services personnel were able to shut off the valve upstream of the detached pipe within several minutes stopping the flow of fuel. Released fuel was contained within the engineered fuel containment liner and was not released to the environment. The location of the contained release is approximately 200 meters (m) south of the Milne Inlet. A response to the loss of control was initiated, and NT-NU Spill Report No. 16-283 was submitted on August 3, 2016.

Photograph 1 – Braided Flex Pipe fuel supply line to back of Module

The damaged pipe was isolated by closing the upstream valve. The section of braided pipe was replaced and the fuel system piping system was inspected by a reliability engineer prior to being put back into service on August 10, 2016.

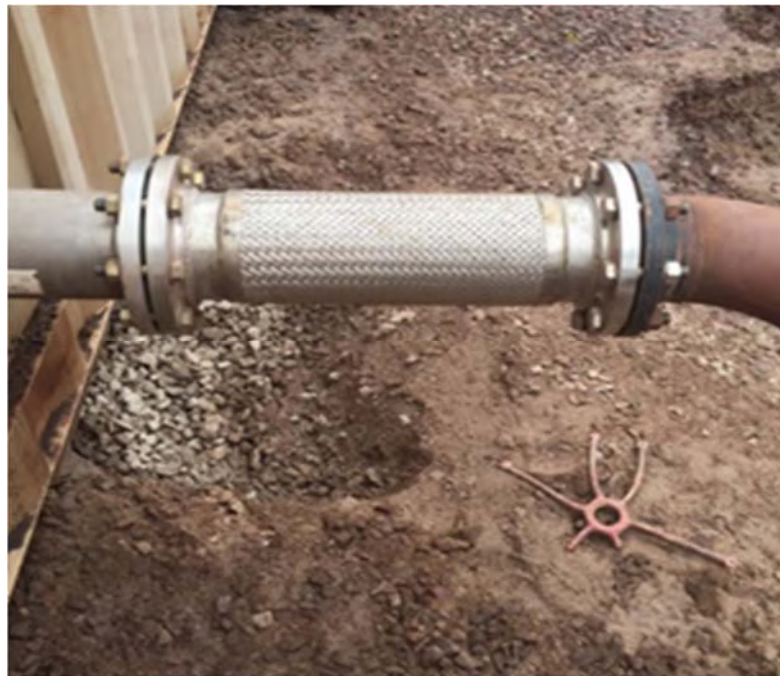
Photograph 2: Section of Braided Flex Pipe after replacement.

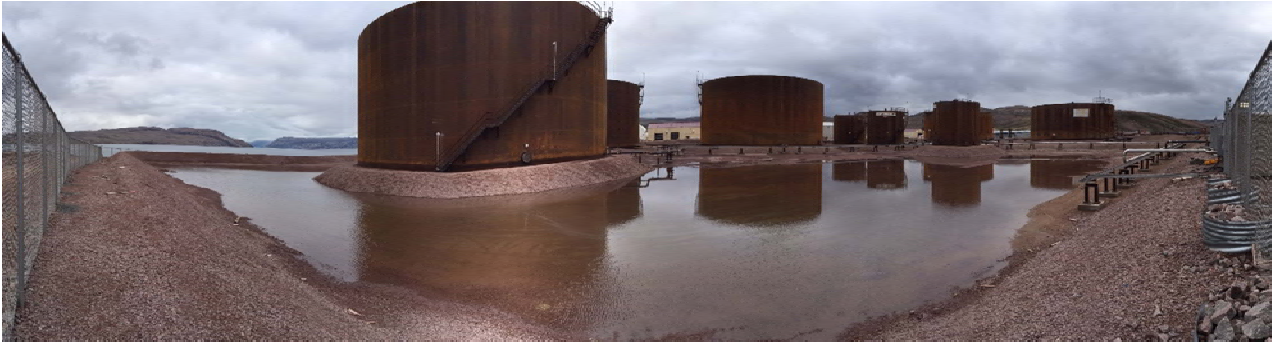
Photograph 3: Showing impacted water pooling within north and west side of interior containment berm.
August 8, 2016

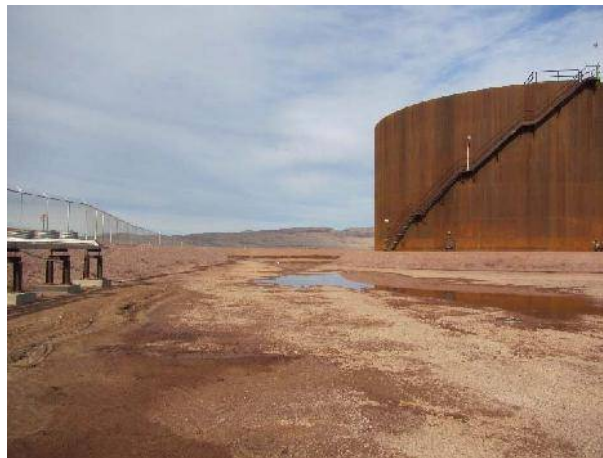
Photograph 4: Showing north side of interior containment berm during collection activities.
August 31, 2016

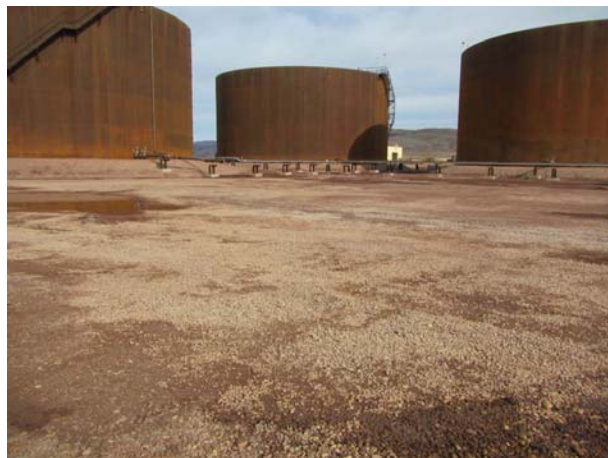
Photograph 5: Showing west side of interior containment berm during collection activities.
August 31, 2016

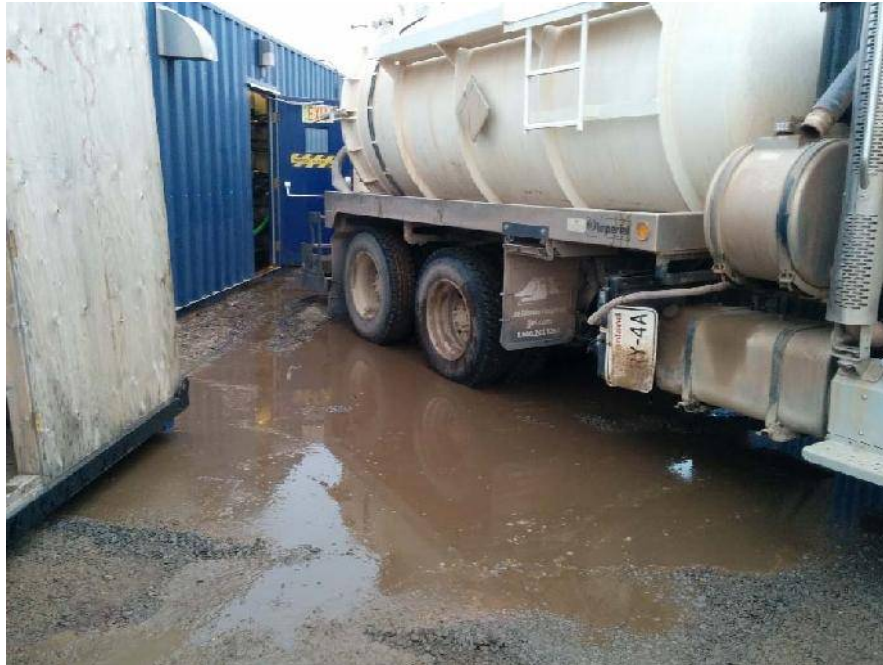
At 0700 HRS on September 6, 2016, Baffinland's water treatment operator observed pooling wastewater inside and outside of the wastewater treatment plant (WWTP). The spill source was located in the backwash room from the aeration tank. Approximately 250 L of aerated sewage was released outside of the WWTP in a 40 m² area. Upon further investigation it was determined that a 2" diam. aluminum camlock fitting on the return line to recirculate aerated sewage failed and disconnected from the tank. Corrosion of the fitting may have contributed to the failure. The closest water body is approximately 100 m to the southwest and is currently frozen. The spill was confined to the WWTP pad.

Photo 1. Spill contained to WWTP pad and vacuum truck used to suck up free liquid September 6th 2016.

The WWTP operator immediately notified the Environment department and Site Services and a preliminary inspection was initiated. A vacuum truck was used to clean up pooling liquid inside of the WWTP. Sand was placed on the contaminated pad to absorb any remaining sewage. All contaminated material was transported to the land farm at Milne Port, an engineered lined containment facility. The corroded cam lock fitting was replaced with a new fitting before the system was put back into operation.

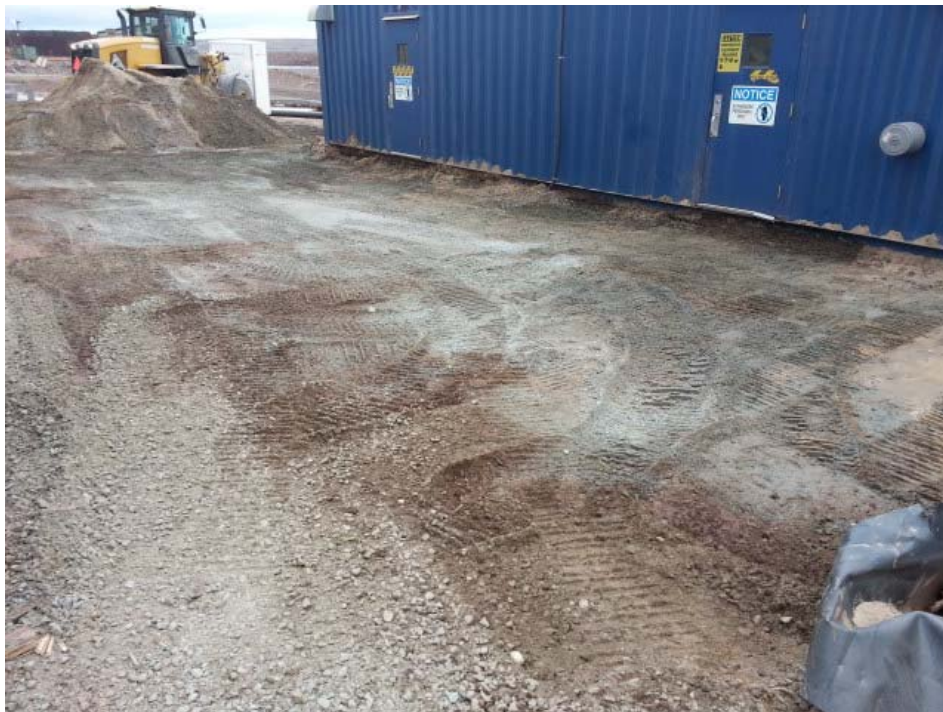
Photo 2. Spill area after removal of contaminated material September 6th 2016.
