Re: Follow-up to Spill #16-338, Reported on September 12, 2016
Mary River Project - Water Licence No. 2AM-MRY1325

**16-338 – 200 L Hydraulic Oil
Spill September 12, 2016**

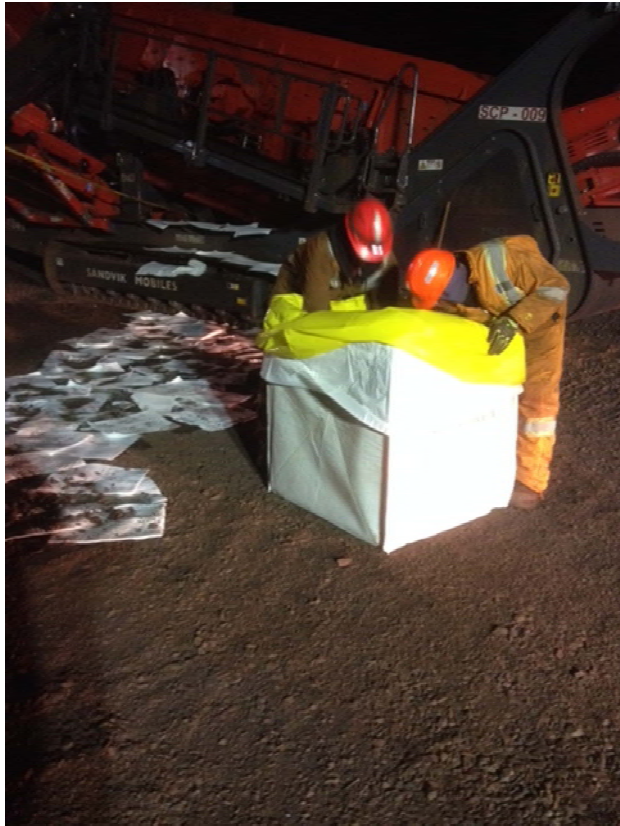
On September 12, 2016 at 00:30 HRS, a loader operator discovered that the Sandvik Screen Plant, located within the Milne Port Ore Storage Pad, was leaking hydraulic oil. The operator immediately shut down the equipment and then called his supervisor to investigate. Approximately 200 litres of hydraulic oil was released to the adjacent ground surface on the Ore Storage Pad, an engineered contained area with ditches and a lined settling pond. Investigation determined the cause of the spill to be fitting failure, which was subsequently replaced prior to equipment start-up. The nearest natural water body is >100 m away from both the spill location and storage location and is currently frozen.

Photo 1 – Hydraulic Oil Spill – 200 L

Ensure pre-op inspections are completed before use of the Sandvik Screen Plant.

The fitting was subsequently replaced and the screener is currently operational. The affected area was cleaned up and the contaminated material placed in a contained location.

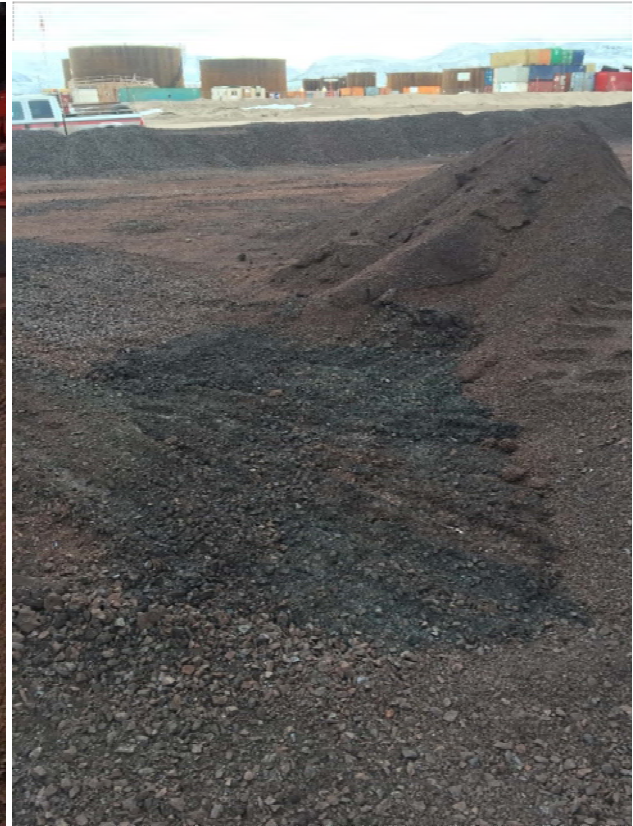
The ship loader Supervisor and the Environment Department were notified immediately by the operator upon spill discovery. The immediate clean-up response utilised spill pads to mop up visible free product; the spill pads were placed in a Quatrex Bag. Contaminated ore was removed and placed in the NW corner of Ore Storage Pad.

Photo 2– Spill Location after Cleanup

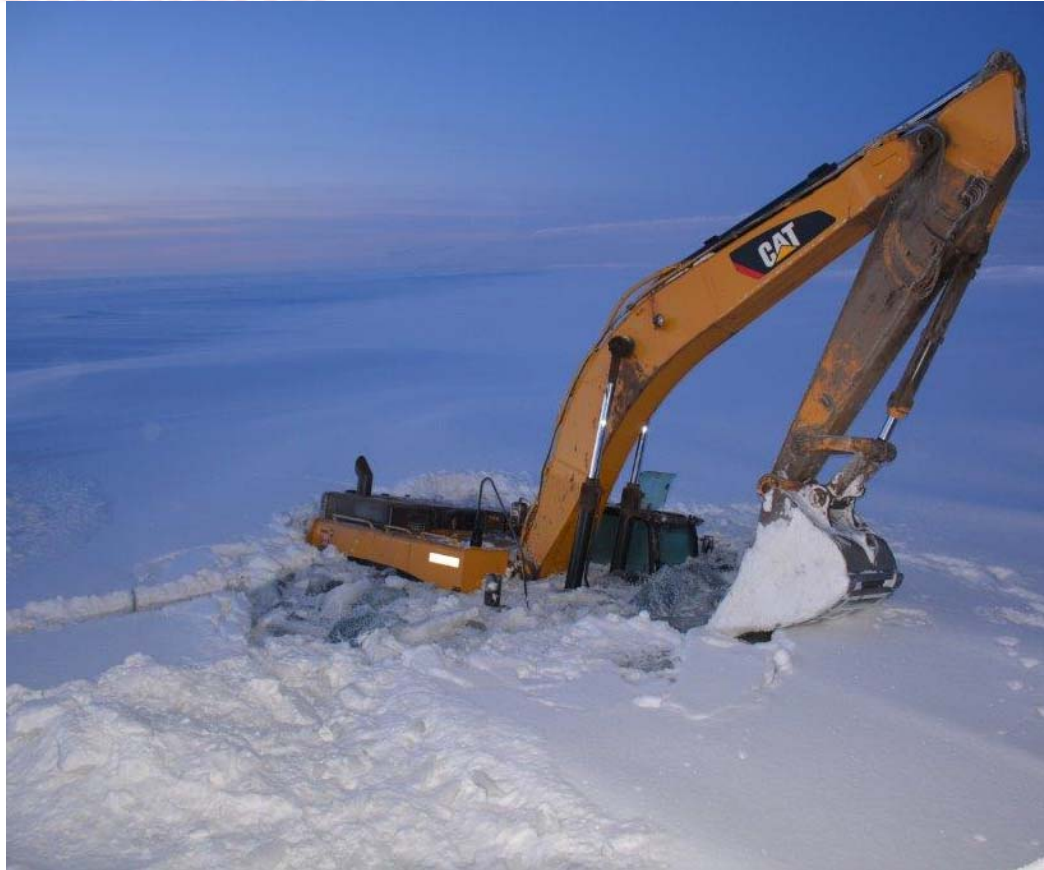
At 02:00 HRS on December 3, 2016 while clearing the area in preparation to remove the former seacan bridge crossing (CV217B) located at the Tote Road km 80 bridge, an excavator (EXC003) broke through the ice layer covering the water body (river outlet from Muriel Lake) submerging the EXC003 by approximately 75%. CV217B is evaluated as fish habitat, although during the fall/winter season, fish are likely not present due to shallow overwintering conditions. At the time of the incident, the freshly exposed water surrounding the submerged machine was observed for signs of a release of fuel and/or lubricating oils. No release was observed at the time of the incident. Monitoring of this area for evidence of a spill was ongoing until the safe and successful extraction of the excavator from the ice/water body. On December 6, an update to spill report 16-414 was submitted after 1 litre of lubricating oil was released to the top layer of the ice at the EXC003's location; this was promptly recovered and cleaned up. The removal of the seacan bridges are a requirement of Baffinland's Tote Road DFO authorization and at the time of the incident, the excavator was engaged in preparing the site for this reclamation activity.

It has been recognized, that the Job Hazard Analysis formulated for the removal of the Tote Road seacan bridge crossings did not account for differences in ice thickness between the three seacan bridge locations scheduled to be removed, nor did it account for timing of removal. The seacan bridges located at km 62 (BG-50A) and km 97 (CV-223) on the Tote Road were safely removed without incident, and were both situated in shallow water (<0.5 m depth) frozen to the bottom. There was an expectation that the water depth at CV217B, would be minimal as well (<1m depth); this was not the case.

Photo 1 – Submerged EXC003

- Prior to completing all future on-ice work, a temporal and geographically site specific JHA will be completed,
- Prior to completing all future on-ice work, augured holes must be drilled to determine ice thickness, this instruction needs to be clearly communicated to all equipment operators working near or on water no matter what the estimated depth of the water column;
- Development of a formal document controlled "working on-ice" procedure to address requirement for ice-thickness measurements to determine suitability for various work activities (personnel and/or equipment), no matter what the assumed ice thickness; and
- Prior to completing all on-ice work, all personnel must be trained in the working-on ice procedure and be aware of risks of the prescribed job and their responsibilities.

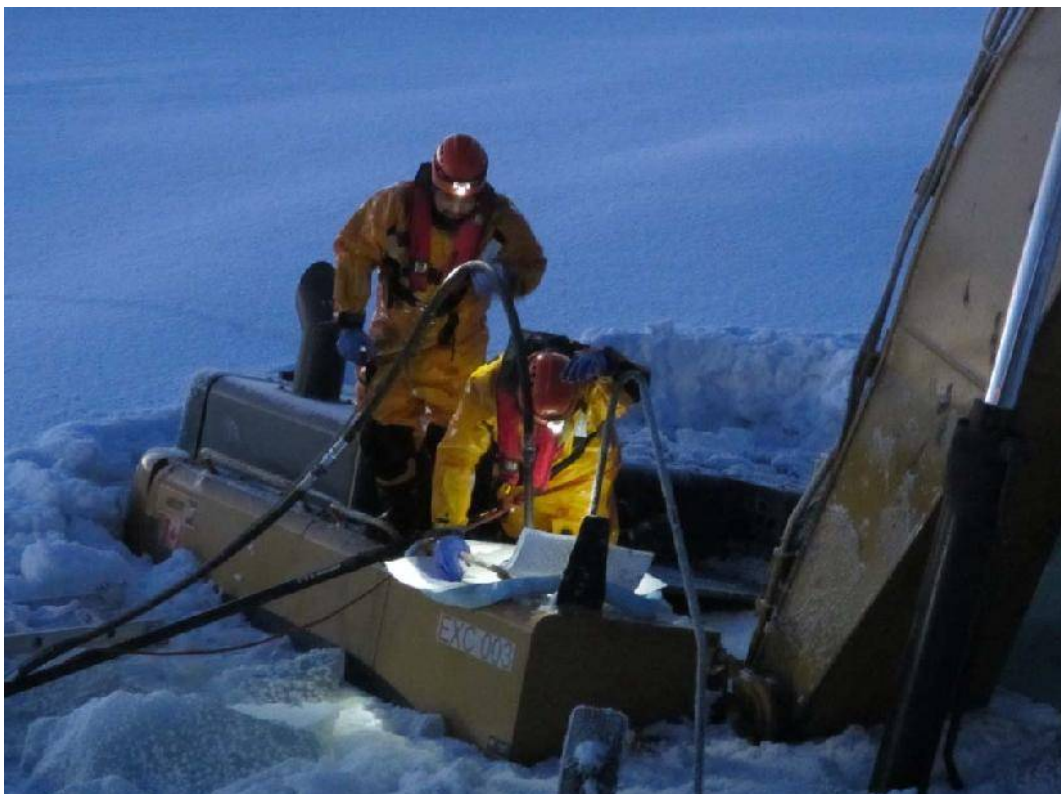
On December 5 and 6, 2016, accessible oil (~25L), diesel (~500L), and glycol (~25L) were recovered from EXC003 compartments. At that time it was observed that lubricating oil was released to the adjacent ice on one side of the excavator cab. Approximately one (1) litre of product was found in two pockets on the surface of the ice, covering an area of approximately 0.25 m². The released product and contaminated ice were recovered for proper disposal. Spill response supplies were proactively stockpiled at the location to mitigate any further incident.

Photo 2 – Diesel Fuel Recovery

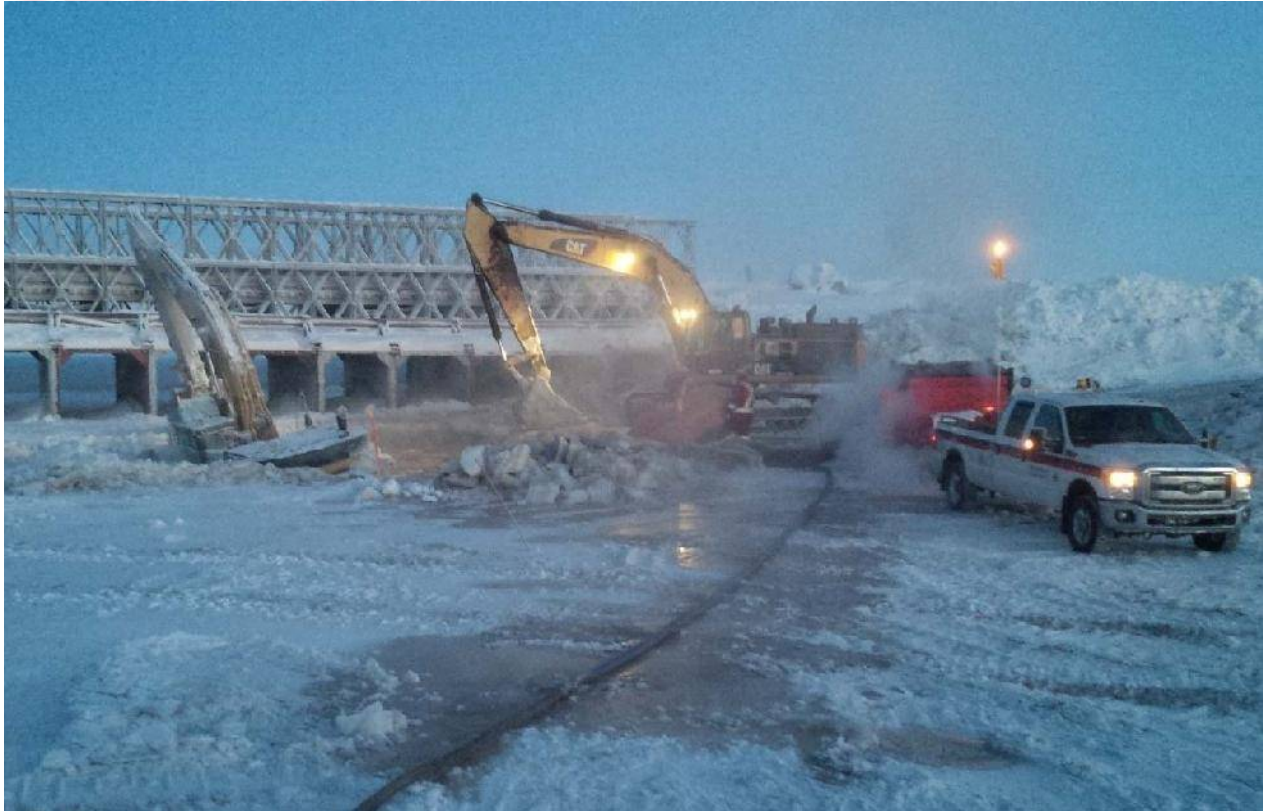
On December 16, 2016, EXC003 was successfully extracted from the CV217B crossing without further incident to worker safety or the environment. The extraction planning process involved careful consideration to minimize potential risks to personnel, equipment and to reduce the risk of the release of any residual hydrocarbons or glycol.

Photo 3 – EXC003 Extraction

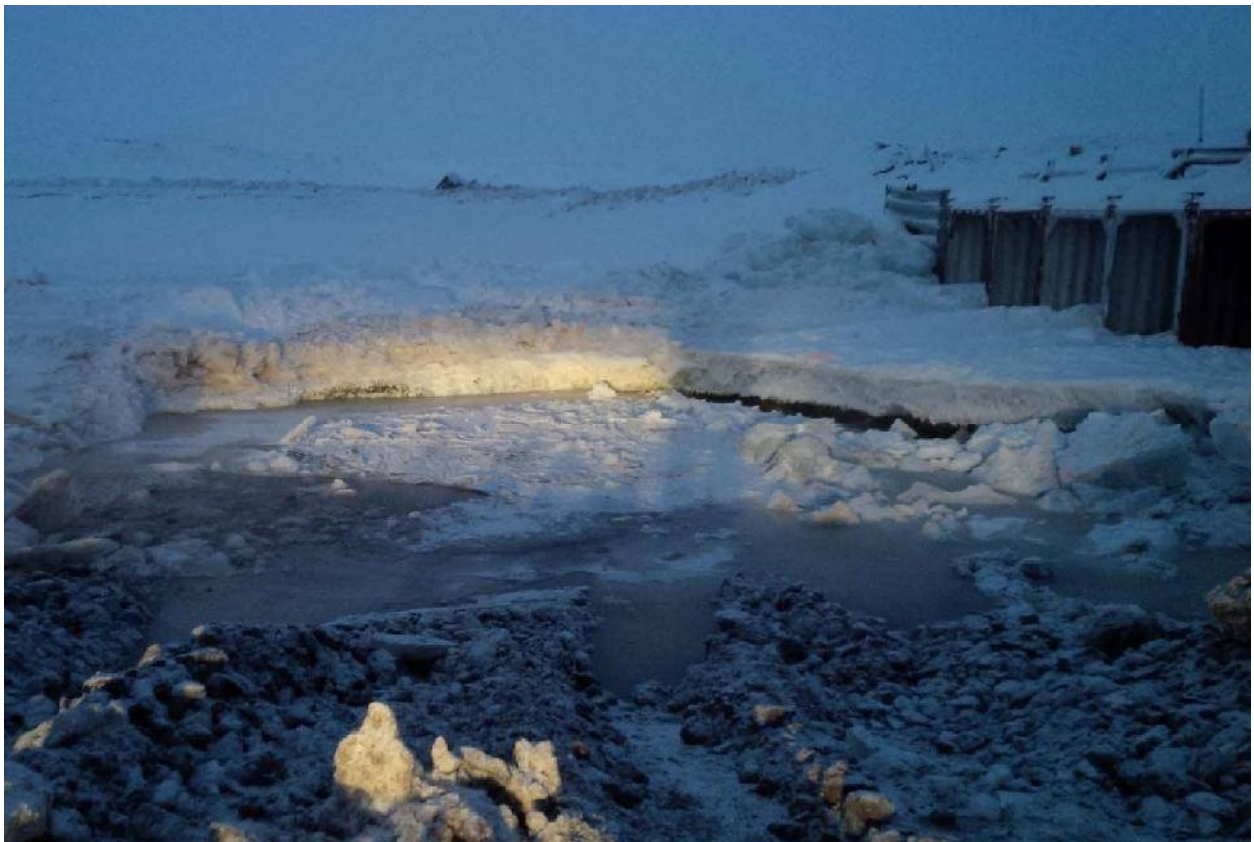
The disturbed areas of the riverbank have been stabilized with 6" clean riprap to prevent subsequent erosion. Slope stability of the impacted area will be monitored during freshet and if required, additional sedimentation controls will be applied at that time.

Photo 4 – After EXC003 Extraction

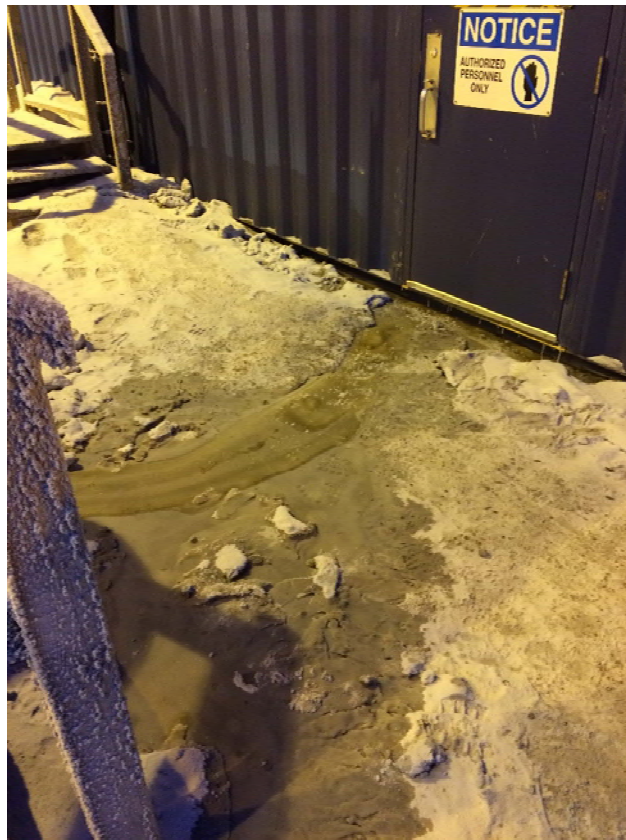
At 5:45 am Baffinland's vacuum truck operator was off loading raw sewage from the vacuum truck into the waste water treatment plant (WWTP). During the transfer, the operator noticed sewage coming out of the WWTP west door. The operators then turned off the vacuum truck pump. Upon investigation, the spill source was determined to be a 1/2" valve left in an improper position inside the WWTP on the influent line. Approximately 150L of raw sewage was released to the adjacent WWTP pad. An additional 150L recovered from inside the WWTP, which did not impact the receiving environment, was reintroduced back into the sewage treatment system. The closest water body is approximately 100 m to the southwest and is currently frozen.

Photo 1 – WWTP Raw Sewage Spill

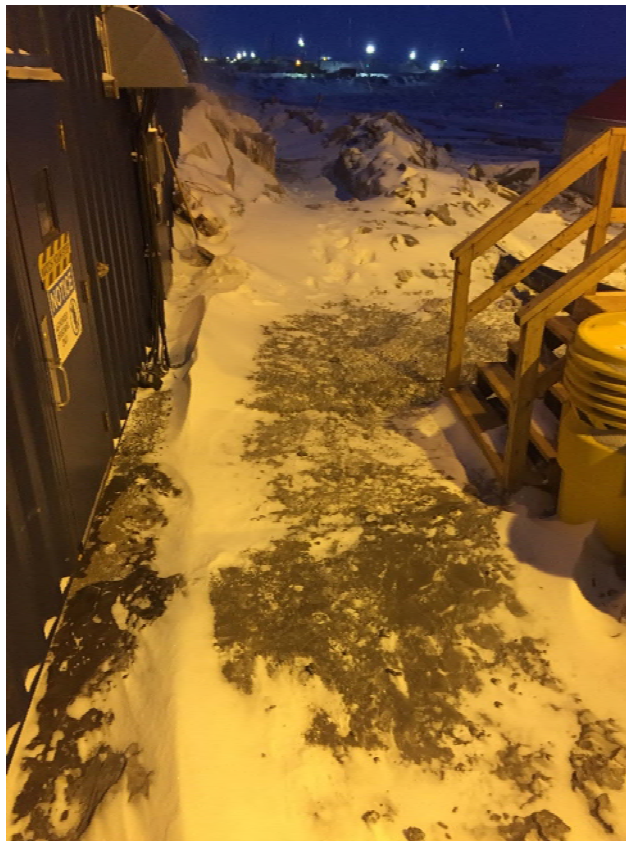
Photo 2 – WWTP Spill Post Clean Up
