APPENDIX C.2

GEOTECHNICAL INSPECTIONS

APPENDIX C.2.1
2017 GEOTECHNICAL INSPECTION NO. 1

RE: Submission of 2017 Geotechnical Inspection Report No. 1 (Aug. 2017)

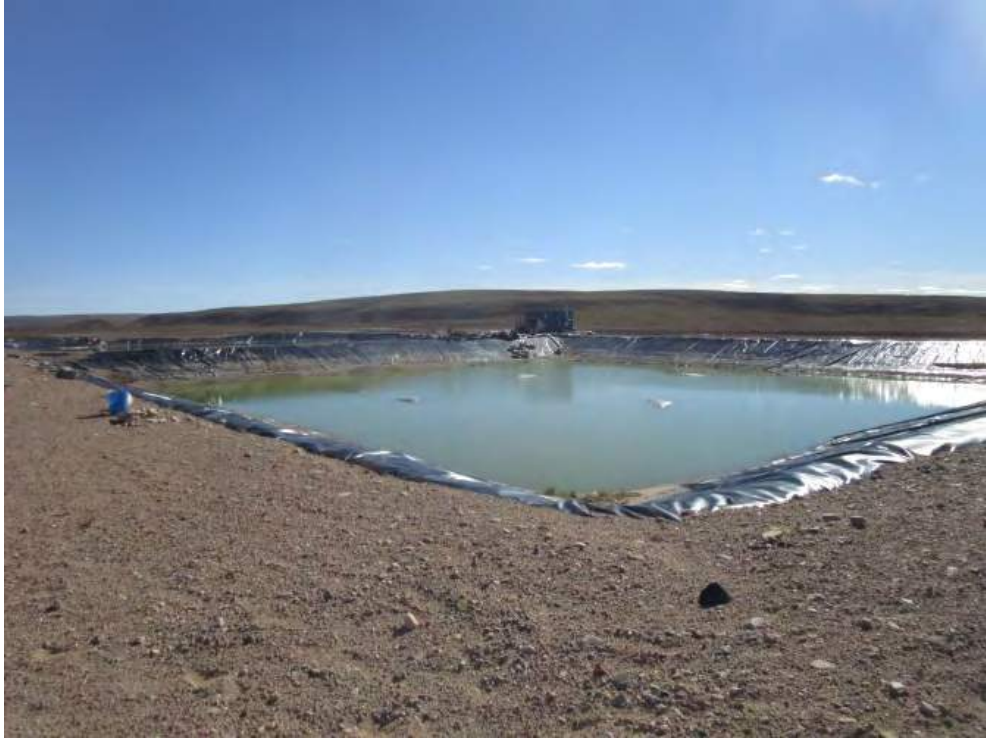
5. PWSP #3

Longitudinal cracking which appeared in the dykes of PWSP #3 due to the melt of permafrost wedges in 2009 has not reoccurred and we consider this structure to be stable in its present condition.

The small bubbles that were observed under the liner at the time of the last year's first inspection have returned.

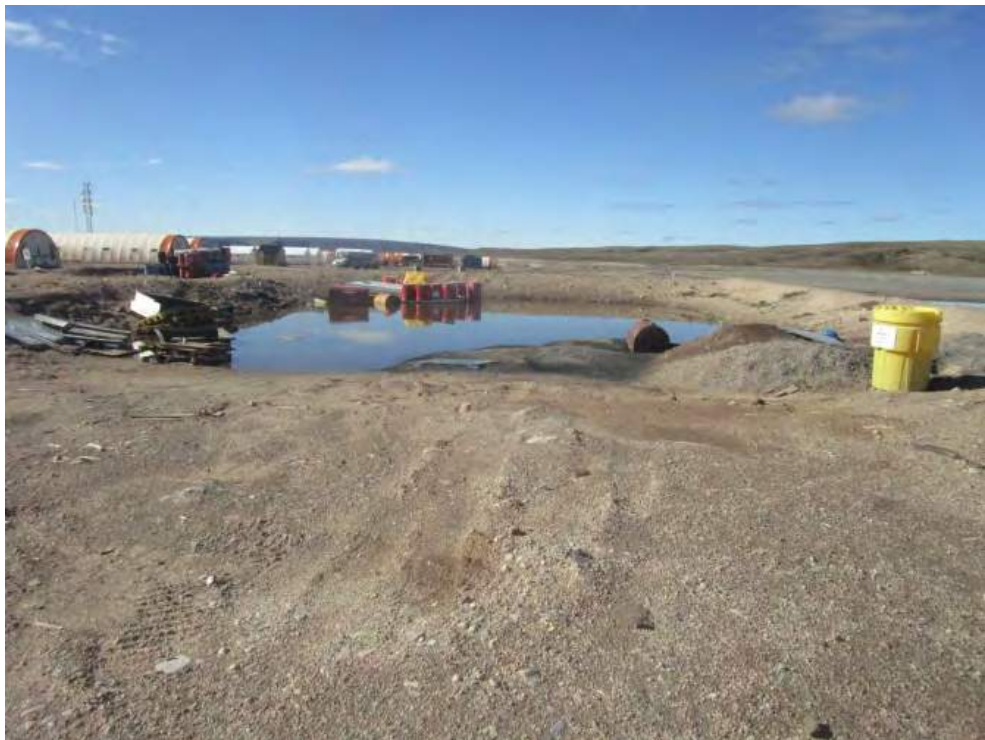
10. Hazardous Waste Storage (MS-HWB-2)

The structure appears to be stable in its present condition. The water in the cell confirms the integrity of the liner.

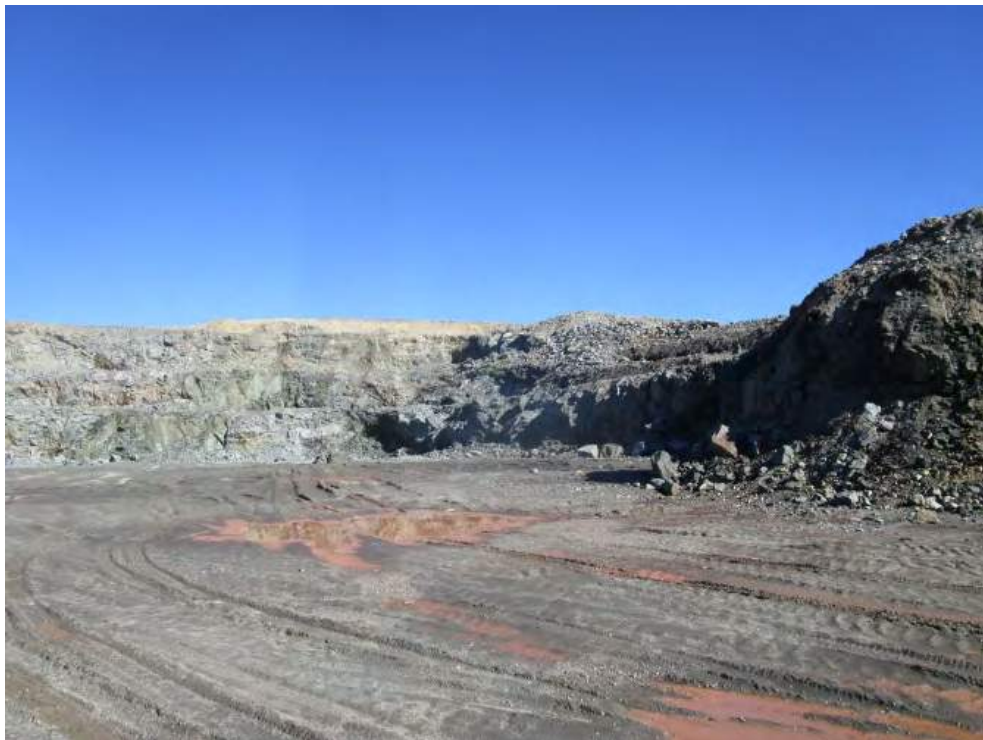
16. Mary River Quarry (QMR2)

The quarry has well defined benches. The quarry faces at the benches are clean except in one end where some subsidences have occurred. This is the fracture zone noted in the last review.

Care must be taken while quarrying in the unstable fracture zone.

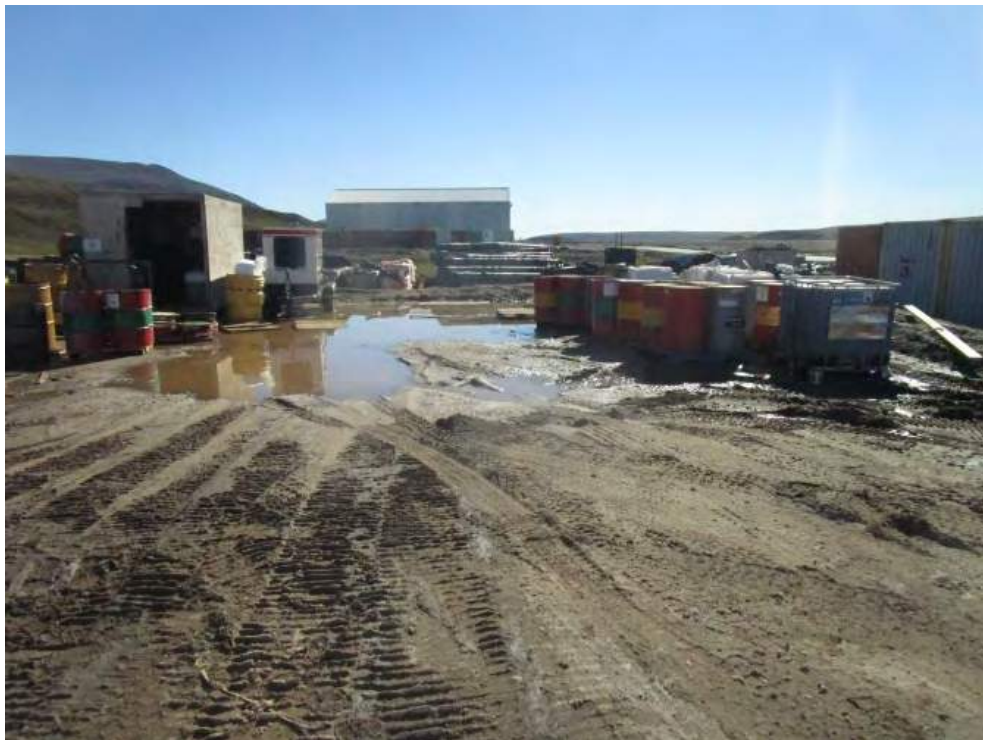
20. Hazardous Waste Containment (MS-HWB-6)

There were 3 locations where the enviroliner is damaged near the top of the dyke.

Baffinland Action: Baffinland will repair the torn liner by the end June 2018. In the meantime, stormwater and snowmelt of the small containment berm will not be allowed to reach the height of the tear.

We have no recommendations with respect to this structure other than making repairs to the damaged enviroliner

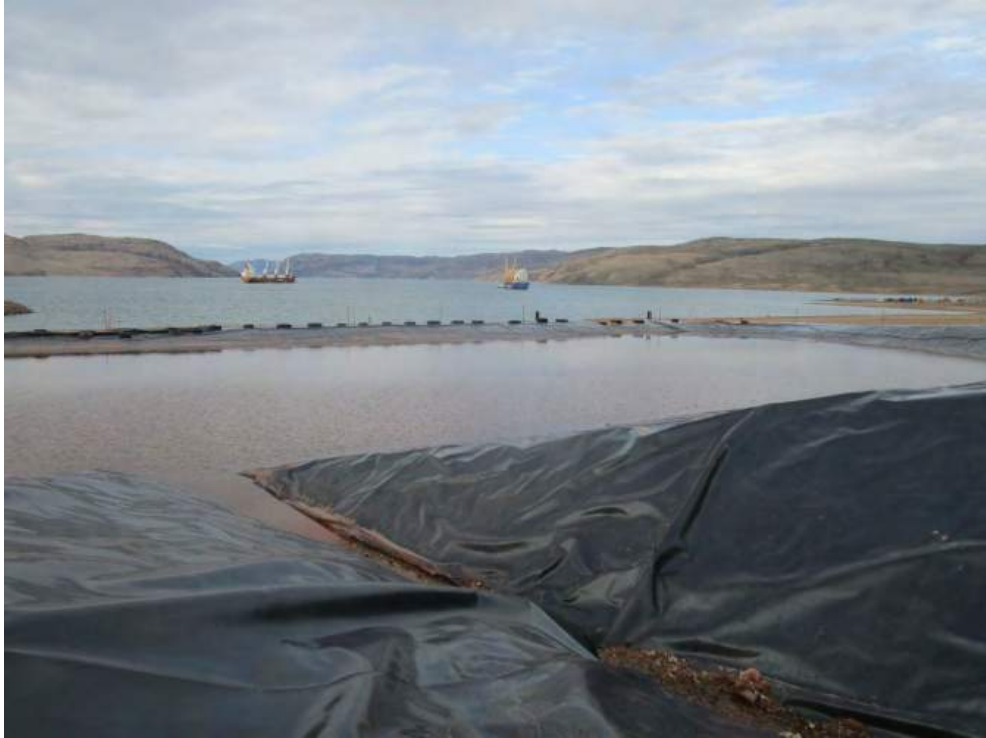
27. Sedimentation Pond East

The two inlets to the pond have very recently been upgraded and the enviroliner has been repaired at these locations.

We have concerns over the stability of the liner on this pond and recommend the possibility of further tire ballast over the liner which appears possibly subject to wind damage. This shall provide a function for used tires.

Baffinland Action: Baffinland will review ballast currently used on the exposed liner and place additional used tire ballast, if deemed required, by the end of November 2016 to prevent potential wind uplift/damage.

We recommend review of the use of a ballast (possibly tires) on the exposed liner at the dyke to prevent wind uplift.

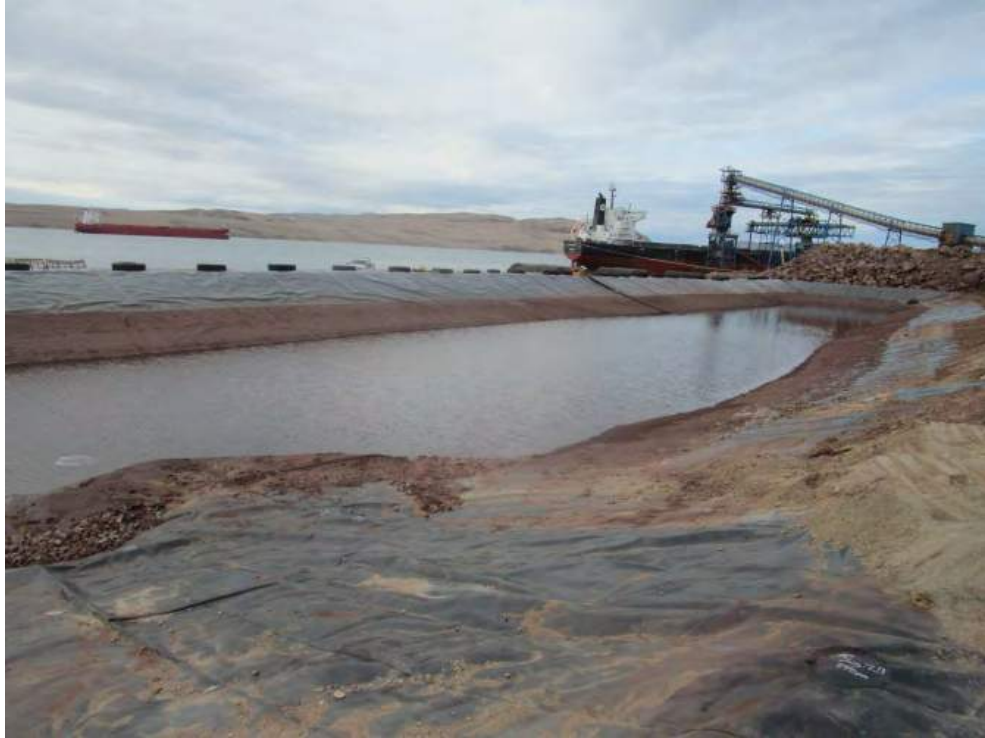
29. Sedimentation Pond West

We have some concern over the stability of the liner on this pond as we have with the east pond and further recommend that used tire ballast be considered.

Baffinland Action: Baffinland will review ballast currently used on the exposed liner and place additional used tire ballast, if deemed required, by the end of November 2016 to prevent potential wind uplift/damage.

We have no concerns other than that of possible wind damage to the liner and recommend the use of tires as ballast.

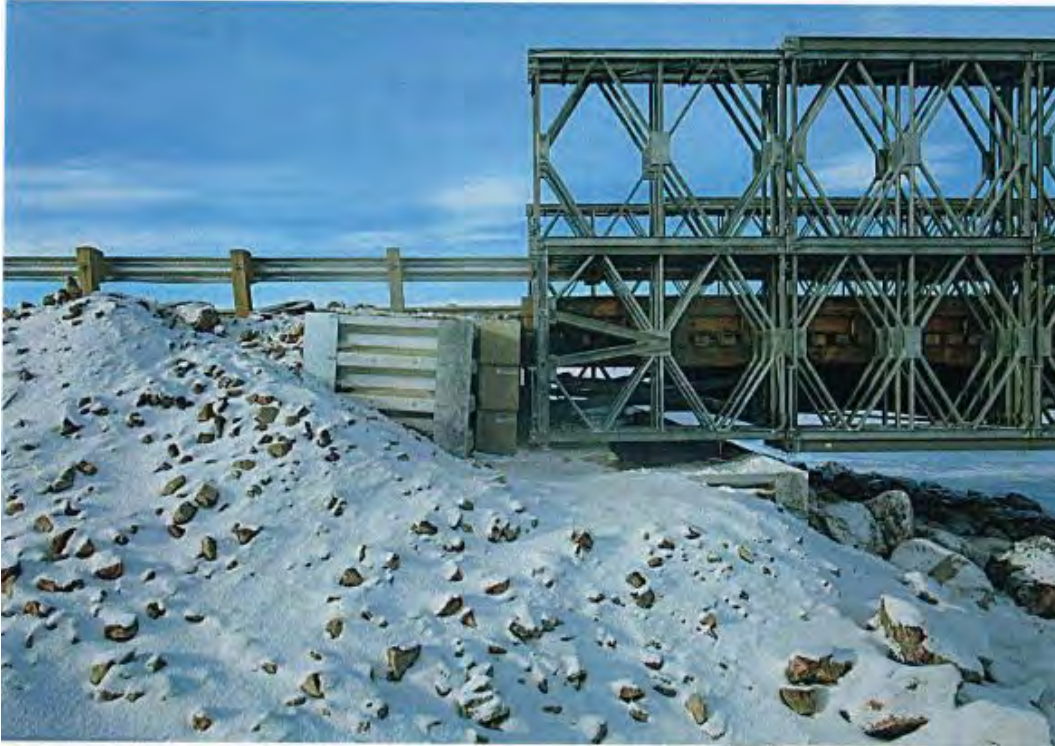
32. Bridge Abutment @ km 97 (Note Space)

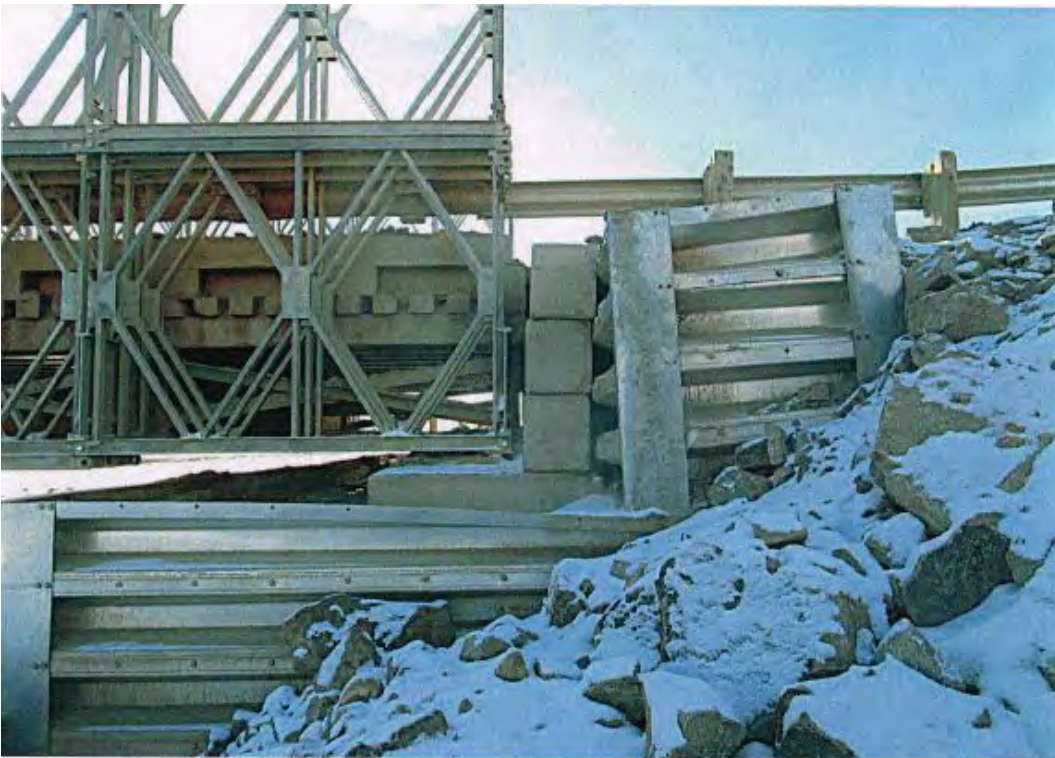
33. Bridge Abutment @ km 63 (Note Space)

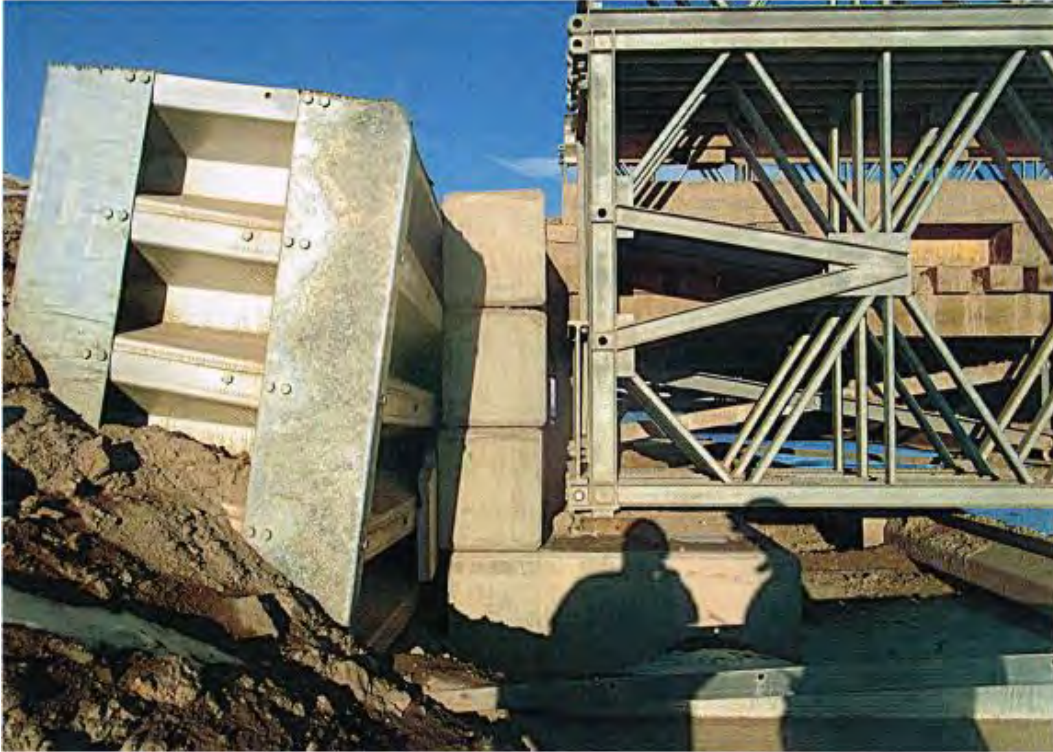
34. Bridge Abutment @ km 80 (Note Space)

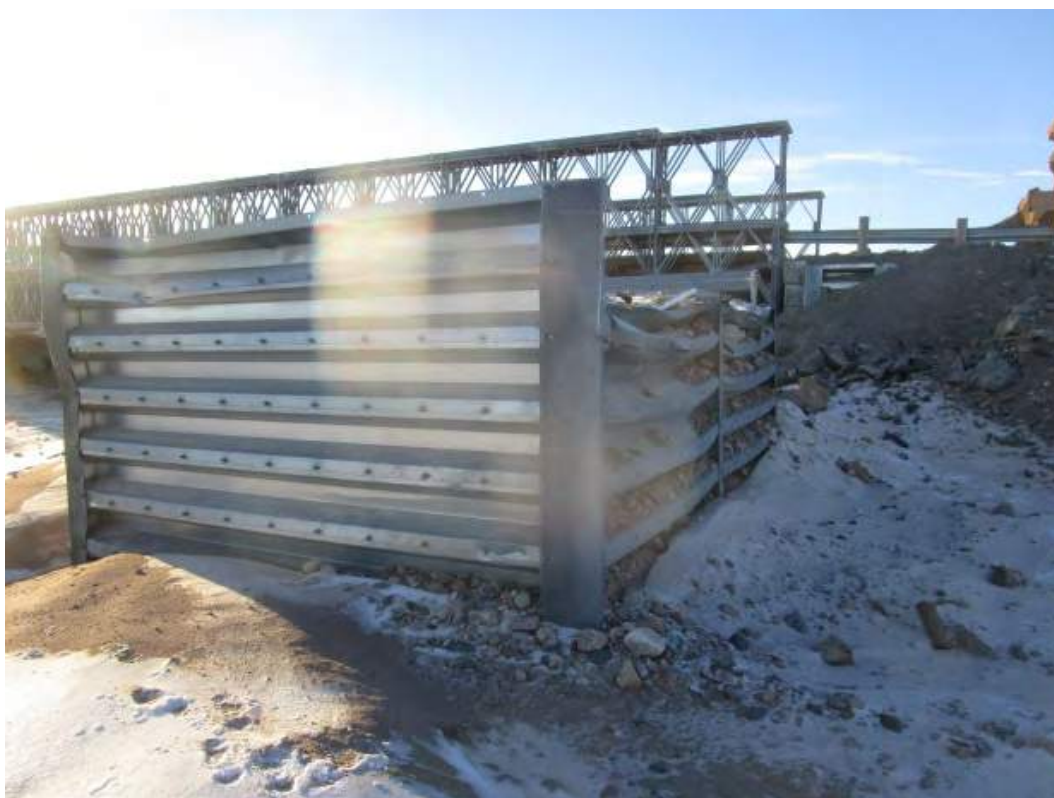
39. Sea can bridge abutments no longer in use. Note there is no deformation.
