**APPENDIX E.10.1**  
**2017 FRESHET MONITORING REPORT NO. 1**  
**(Part 2)**

## **APPENDIX C**

### **Sequence of Events and Actions Taken by Spill Report and Other Concerns**

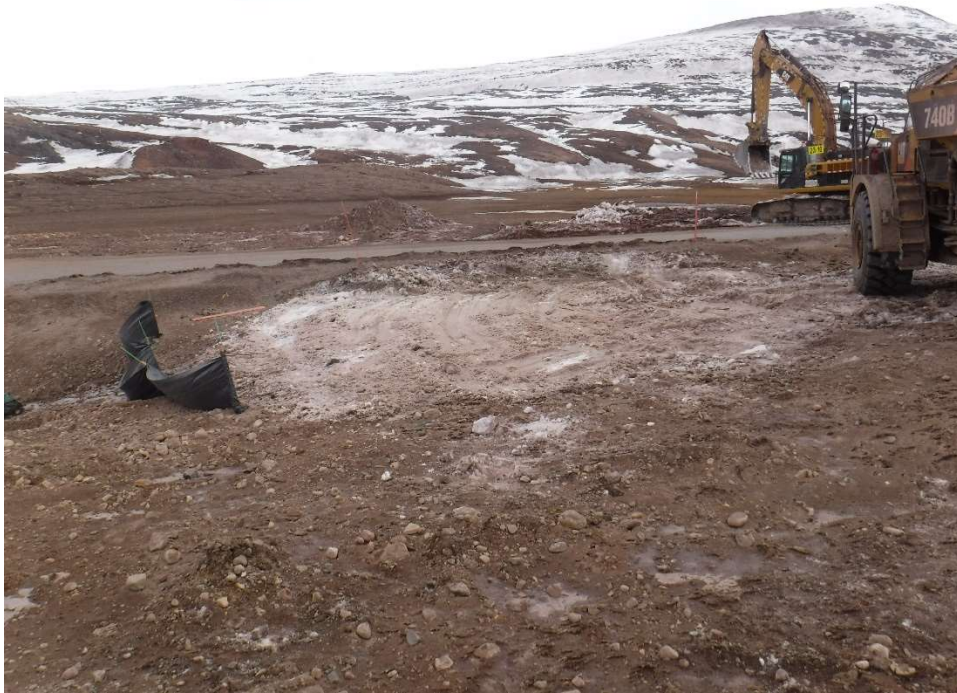
May 16, 2017 – Snow removal south of culvert CV-186 (Sheardown Lake Tributary)

May 15	Road built up at SDLT culvert (CV-186) to prevent road runoff from pooling and directly discharging into tributary (SDLT).
May 16, 17	Sediment laden snow removed near SDLT and placed in natural sumps away from water bodies to allow for sediment settling. Check dams constructed near culvert CV-186 to control surface runoff entering SDLT.
May 23, 2017	Road embankments near SDLT culvert (CV-186) armoured with aggregate (rip-rap).
	Daily water sampling initiated at Sheardown Lake Tributary (LDFG) following field observations of consistent flow at location.
May 29	Environment Canada and INAC inspectors arrive onsite.
May 30 - 31	Environment Canada and INAC inspectors inspect Mine Site, Milne Port and Tote Road.
May 18 - June 14	Daily sampling program of Sheardown Lake tributaries, SDLT and LDFG. Sedimentation control measures employed (silt fences, spring berms) as required.

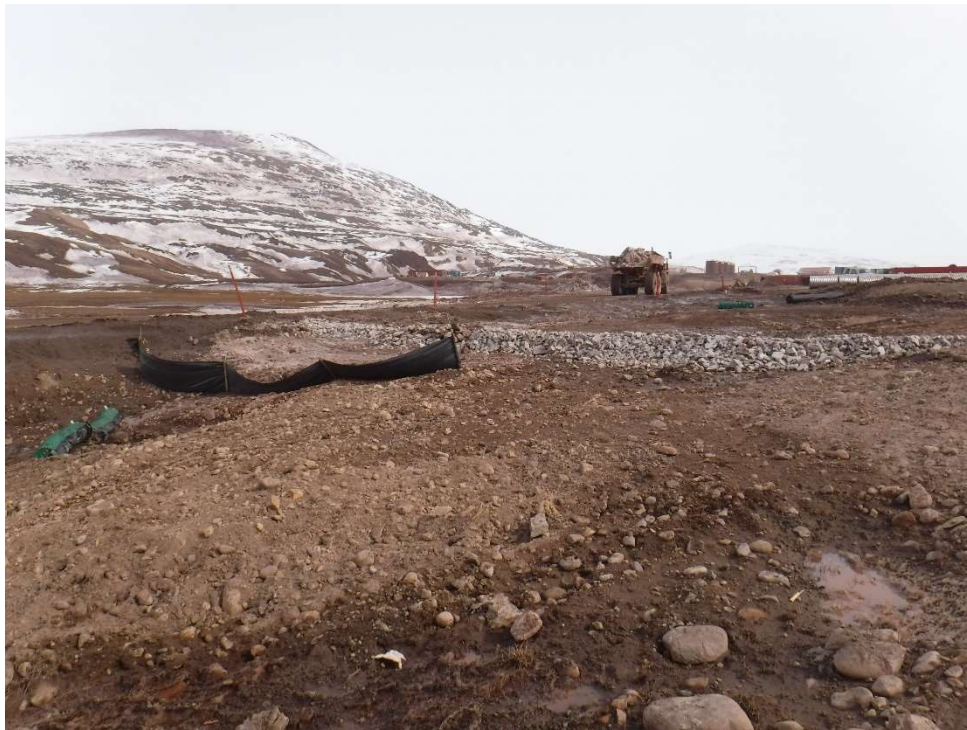
May 16, 2017 - Construction of check dam north of culvert CV-186 (Sheardown Lake Tributary)

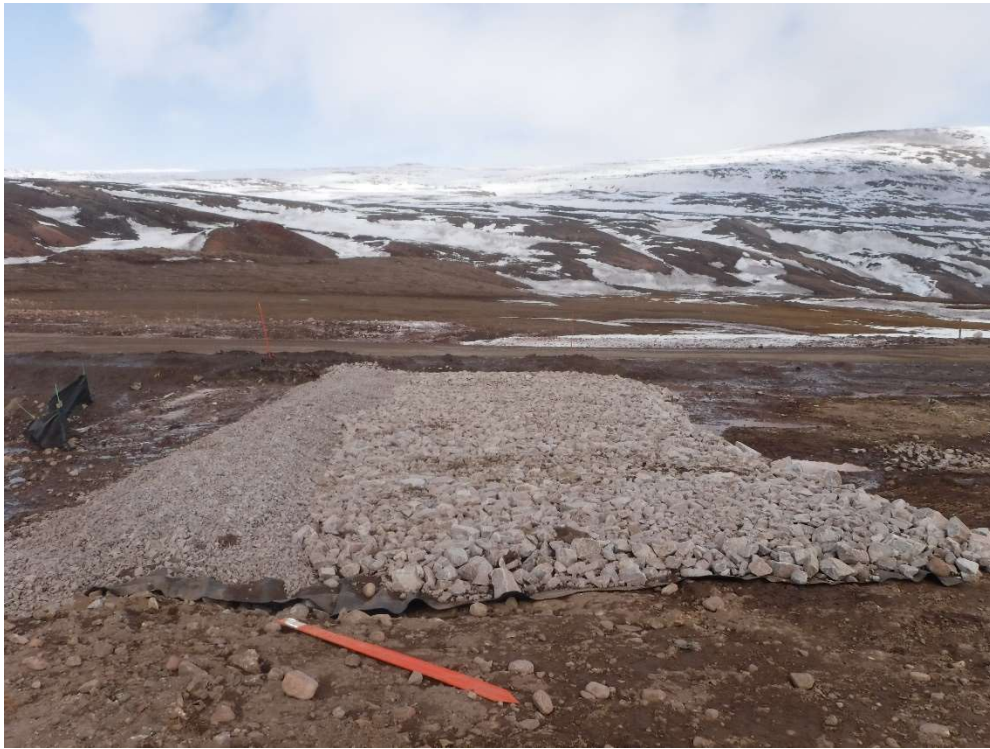
May 17, 2017 - Construction of check dam south of culvert CV-186 (Sheardown Lake Tributary)

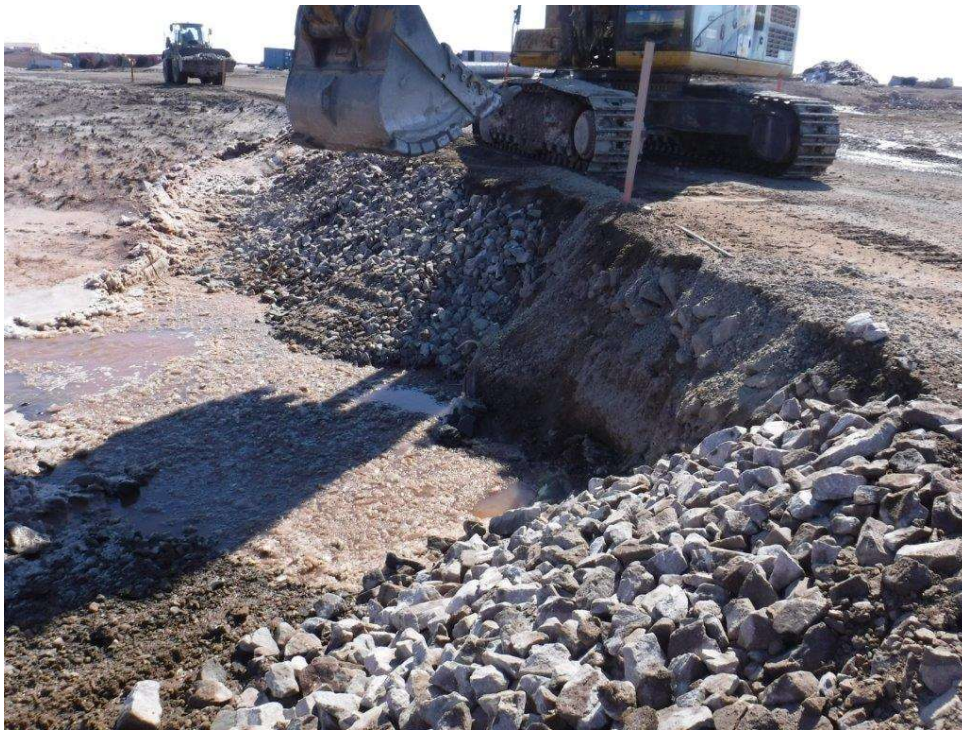
May 23, 2017 – Armouring road embankment near culvert CV-186 (Sheardown Lake Tributary)

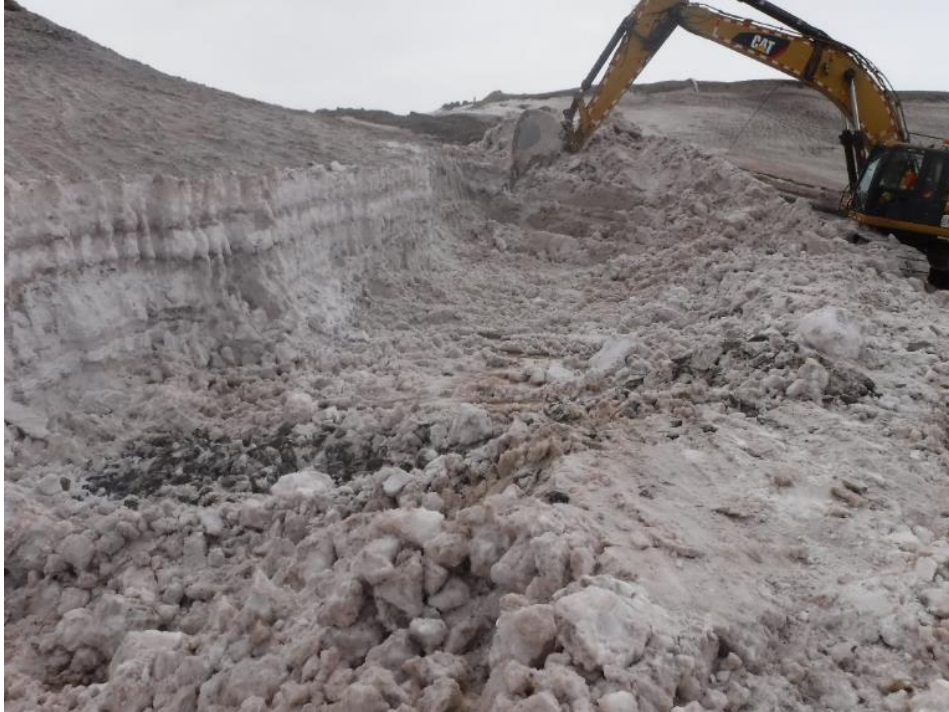
May 14, 2017 – Initial snow removal from ditch along Camp Lake Water Jetty Access Road (upstream of Camp Lake Sedimentation Ponds)

May 14 - 21	Sediment laden snow removed from ditches along Camp Lake Jetty Access Road (upstream of Camp Lake sedimentation ponds) and placed in natural sumps away from water bodies to allow for sediment settling.
May 17 - 21	Road embankments near culvert (BG-01) armoured with aggregate (rip-rap). Sediment laden snow near culvert (BG-01) removed and placed in natural sumps away from water bodies to allow for sediment settling.
May 23	Ditches near the north end of the airstrip armoured with aggregate (rip-rap) to improve water quality of surface water runoff.
May 24	Turbid water observed discharging from Camp Lake sedimentation ponds (CLSP). Daily sampling initiated at monitoring location CLSP-OUT for TSS, TDS, pH and turbidity. Additional sedimentation controls measures implemented downstream of Camp Lake sedimentation ponds. Surface water upstream of ponds diverted to facilitate settling of sediments prior to discharge.

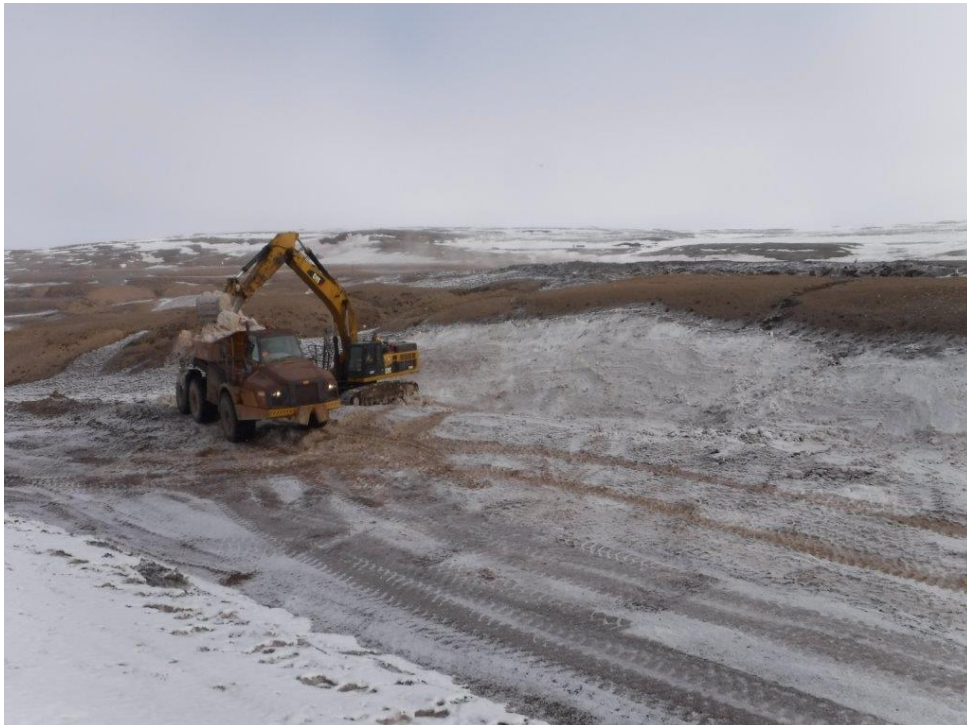
May 21, 2017 – Continued snow removal from ditch along Camp Lake Water Jetty Access Road (upstream of Camp Lake Sedimentation Ponds)

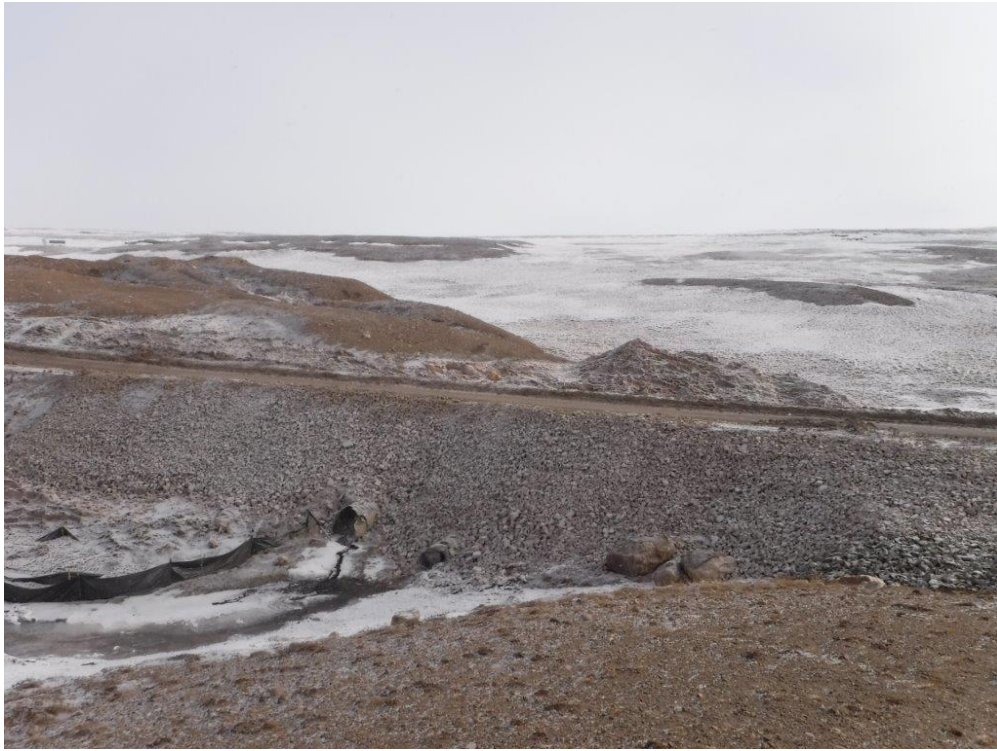
May 21, 2017 – Armouring of road embankments near culvert BG-01 (Camp Lake Tributary 1)

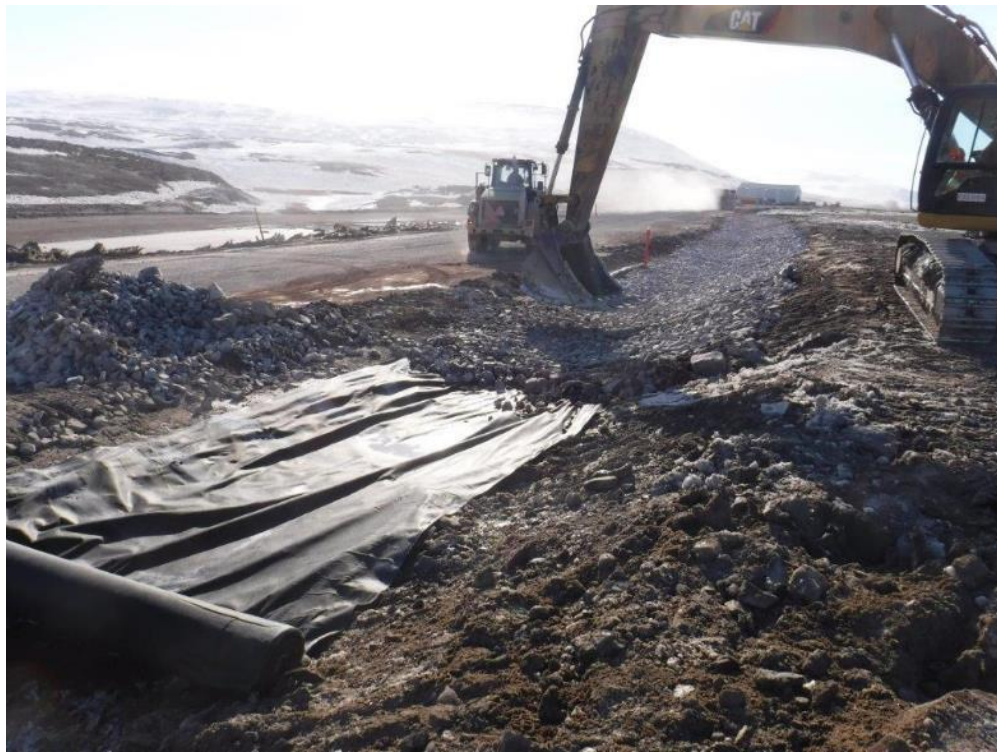
May 23, 2017 – Armouring of drainage ditch on north end of Mine Site airstrip near Km 100 (upstream of Camp Lake Tributary 1)

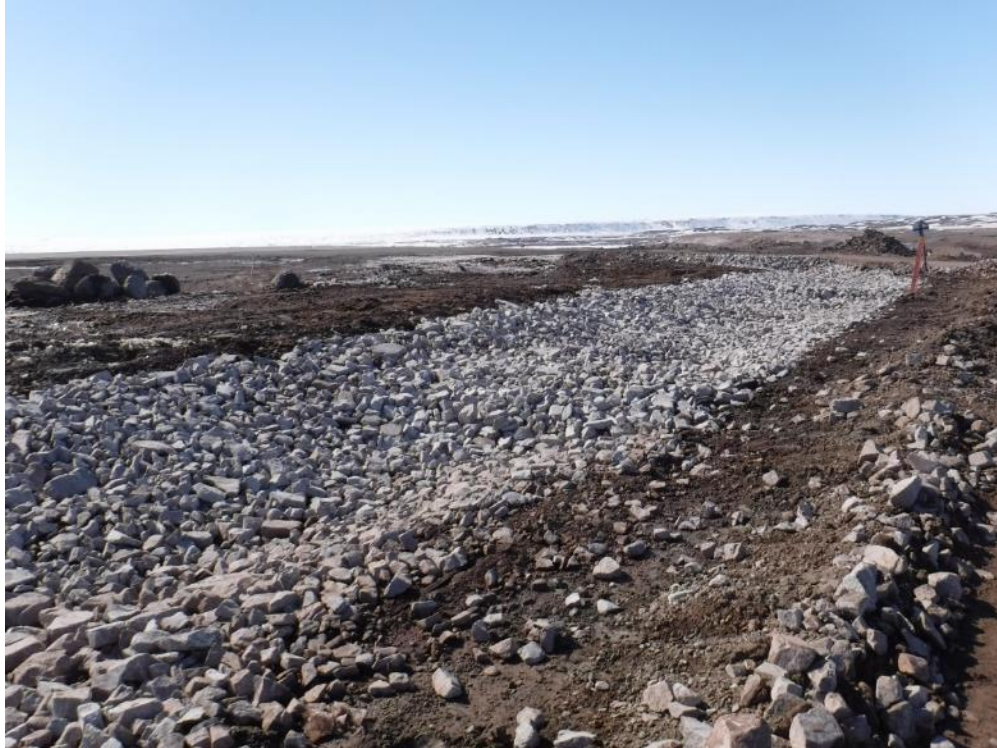
May 23, 2017 – Completion of drainage ditch armouring on the north end of Mine Site airstrip near Km 100 (upstream of Camp Lake Tributary 1)

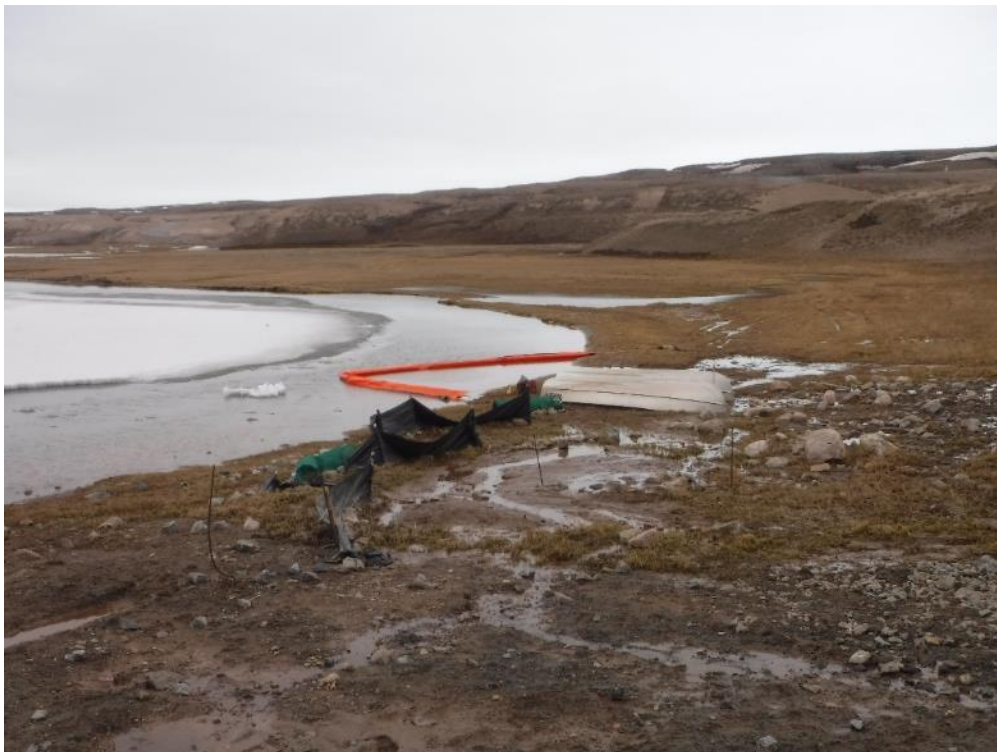
June 11, 2017 – Installation of silt curtain and additional silt fences and spring berms at the outlet of Camp Lake Sedimentation Ponds

Capacity of Camp Lake sedimentation ponds increased by building up berm walls.
May 29	Environment Canada and INAC inspectors arrive onsite.
May 30 - 31	Environment Canada and INAC inspectors inspect Mine Site, Milne Port and Tote Road.
June 11	Silt curtain and additional silt fences installed at the CLSP-OUT Camp Lake outfall to address intermittent elevated TSS levels flowing out of the Camp Lake sedimentation ponds.
May 18 - June 14	Daily sampling program of Sheardown Lake tributaries, SDLT and LDFG. Sedimentation control measures employed (silt fences, spring berms) as required.

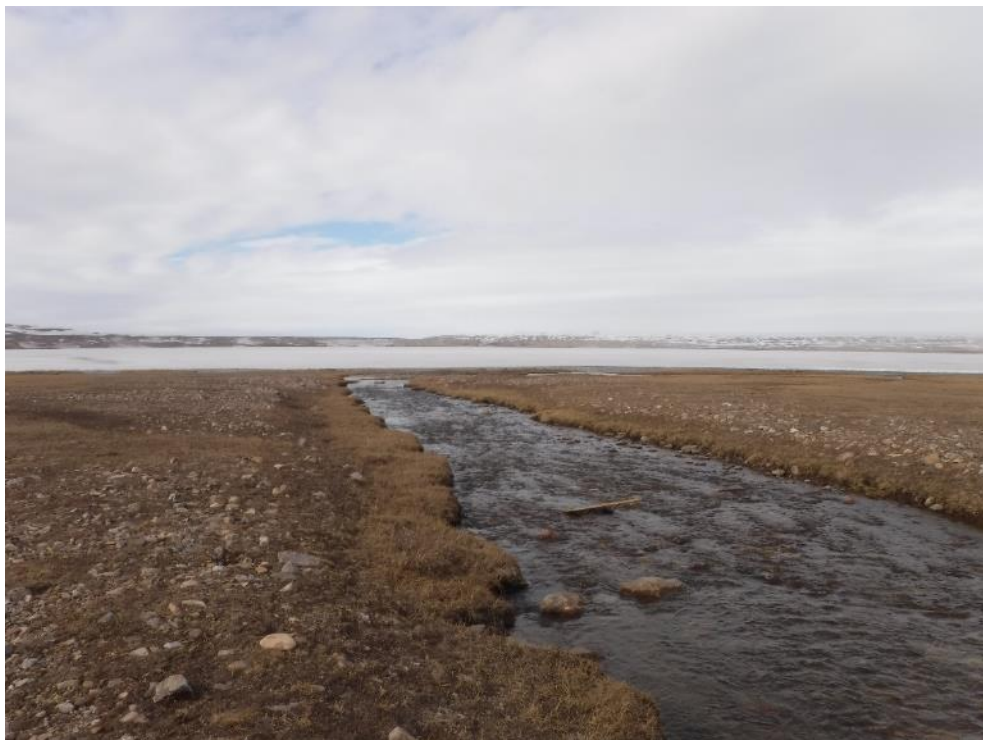
June 11, 2017 – Camp Lake Tributary 1 flowing clear at Camp Lake outfall

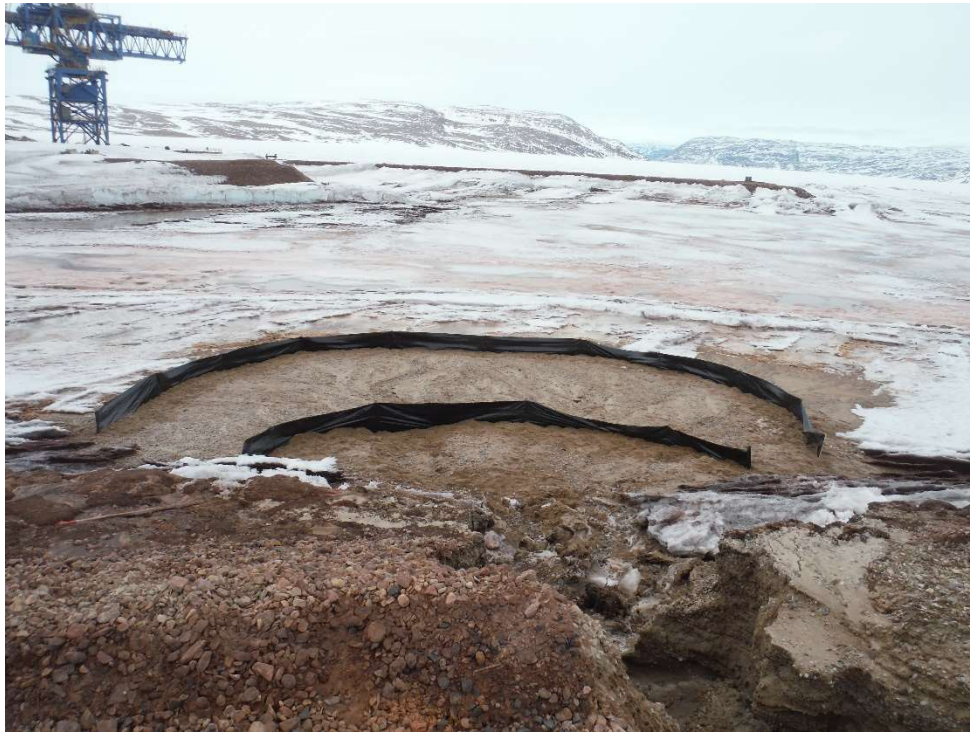
<b>Table C.3 - Spill Report 17-178 - Sequence of Events and Action Taken</b>	
May 25	Milne Port East Sedimentation Pond (MP-05) observed to be overflowing into Milne Inlet. A sudden rise in ambient temperature caused the snow around Milne Port to quickly melt and migrate to the ditches, causing a mass inflow of surface water to the sedimentation pond. Based upon the erosion/sedimentation concerns caused by the overflow and the significant volumes of water entering the sedimentation pond, a controlled emergency discharge was initiated using a pump.
	Monitoring and water sampling program of pond initiated to characterize the water quality of the discharge and mitigate additional overflows. Water samples are primarily being analyzed for total suspended solids (TSS), total dissolved solids (TDS), pH and turbidity.
May 26	Overflow and controlled emergency discharge of East Sedimentation Pond (MP-05) reported to the NT-NU Spill Line and regulators ( <b>NT-NU Spill Report- 17-178</b> ).

May 26, 2017 – Silt fences installed to contain sediment released from bank erosion as a result of Milne Port East Sedimentation Pond (MP-05) overflow on May 25, 2017

Sedimentation control measures (i.e. armouring of bank with aggregate, silt fences) implemented to mitigate additional bank erosion and contain released sediments.
May 27	Water samples taken at both the Milne Port Ore Pad Sedimentation Ponds (East - MP-05 and West - MP-06) analysed for general chemistry (pH, TSS, etc.), acute toxicity, metals, nutrients, oil & grease and major ions.
May 29	Indigenous and Northern Affairs (INAC) inspectors arrive onsite.
May 30	Environment and Climate Change Canada inspector arrives onsite.
May 31 - June 1	Environment Canada and INAC inspectors inspect Mine Site, Milne Port and Tote Road.
May 25 - June 14	Controlled emergency discharges from the Milne Port Ore Pad East Sedimentation Pond (MP-05) continue to occur on an as required basis, with the last discharge occurring on June 7. The current estimated total volume discharged to Milne Inlet from MP-05 is 19,000 m <sup>3</sup> .

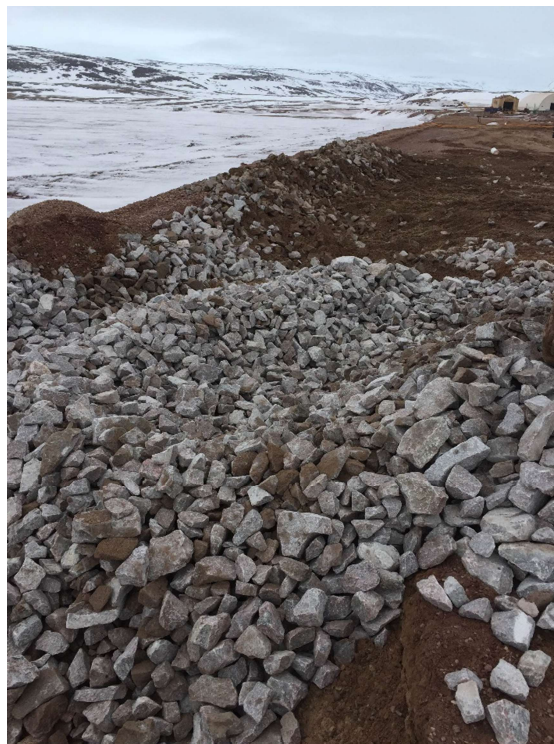
May 26, 2017 – Areas of bank erosion armoured with aggregate (rip-rap)

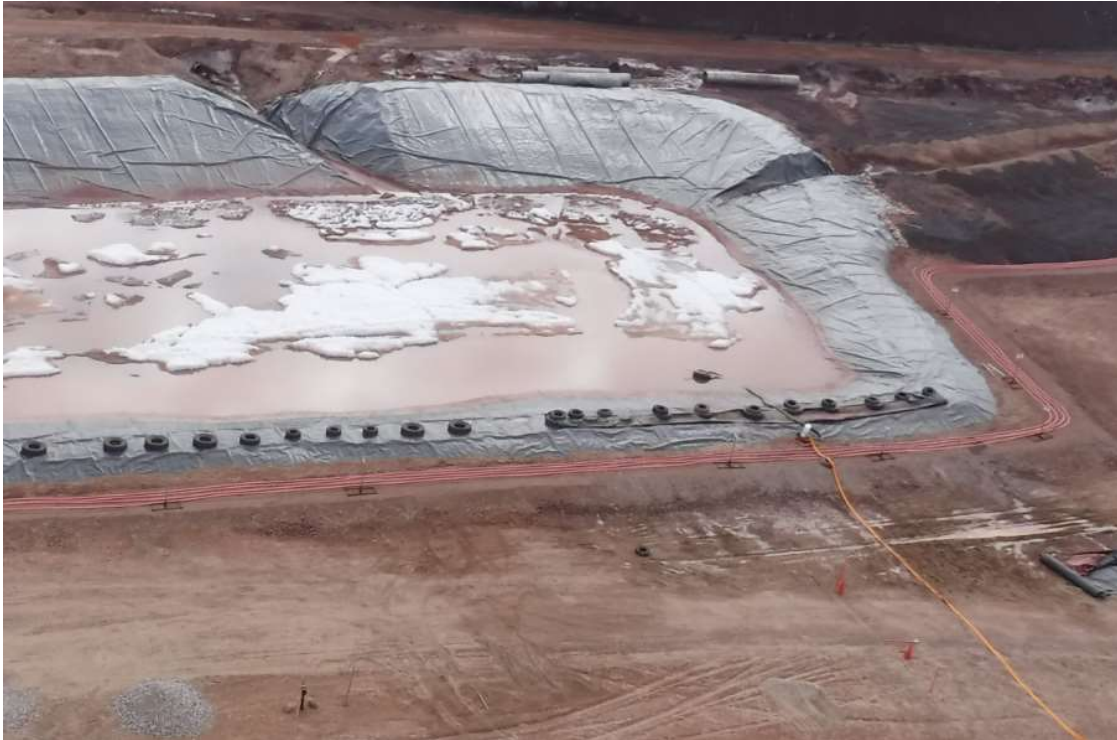
June 7, 2017 – Aerial view of controlled discharge set up from  
Milne Port East Sedimentation Pond (MP-05)
