**APPENDIX E.10.2**  
**2017 FRESHET MONITORING REPORT NO. 2**  
**(Part 2)**

### **Sequence of Events and Actions Taken by Spill Report (Including Photos)**

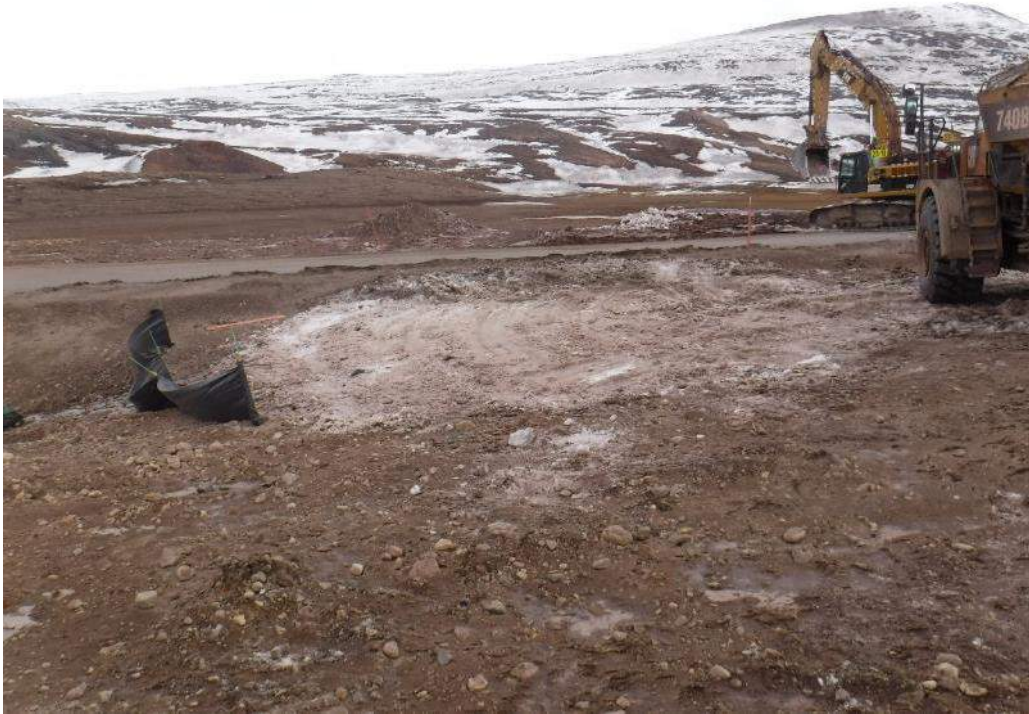
May 16, 2017 – Snow removal upstream of culvert CV-186 (Sheardown Lake Tributary 1)

May 15	Berms built up along Tote Road near SDLT1 culvert (CV-186) to prevent road runoff from pooling and directly discharging into SDLT1.
May 16 - May 23	Road embankments near SDLT1 culvert (CV-186) armoured with aggregate (rip-rap). Check dams constructed near culverts CV-186 and CV-187 to control surface runoff entering SDLT1. Sediment laden snow removed near SDLT1 and placed in natural sumps away from water bodies to allow for sediment settling. Water sampling conducted for additional parameters on May 16, 2017, including acute toxicity, metals, nutrients, oil & grease and major ions.
May 29	INAC Inspectors arrive onsite.
May 30	ECCC Inspector arrives onsite.
May 31 to June 1	ECCC and INAC inspectors inspect Mine Site, Milne Port and Tote Road.
May 18 - June 30	Daily water sampling under Mine Site Freshet Monitoring Program continued. Sedimentation control measures employed (silt fences, spring berms) as required.

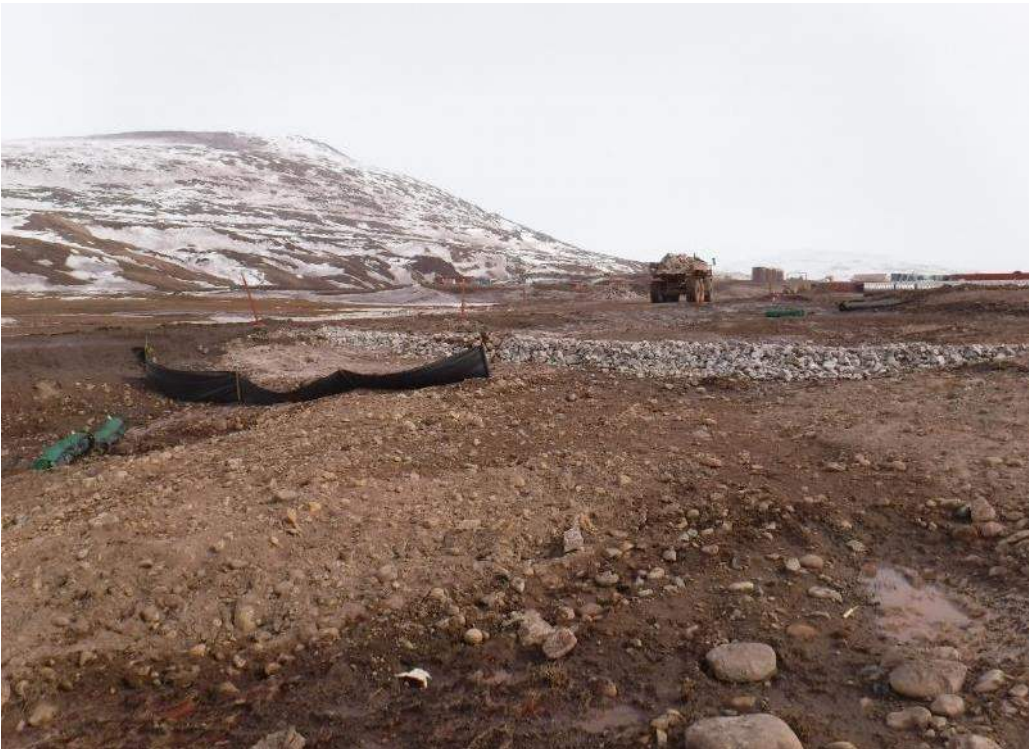
May 16, 2017 - Construction of check dam north of culvert CV-186 (Sheardown Lake Tributary 1)

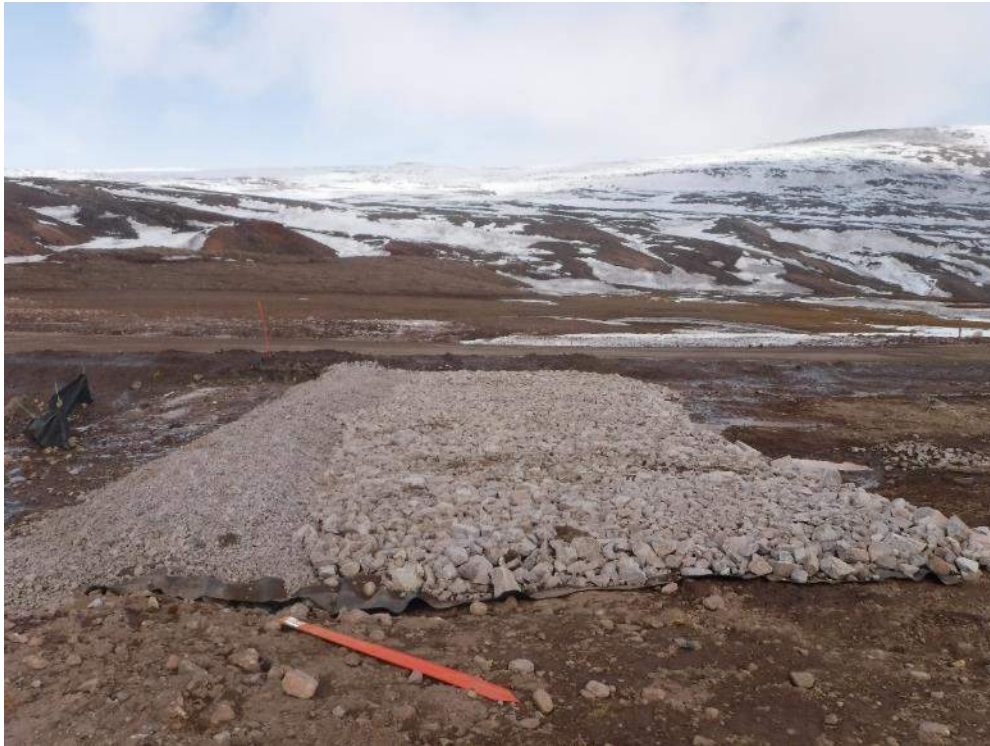
May 17, 2017 - Construction of check dam south of culvert CV-186 (Sheardown Lake Tributary 1)

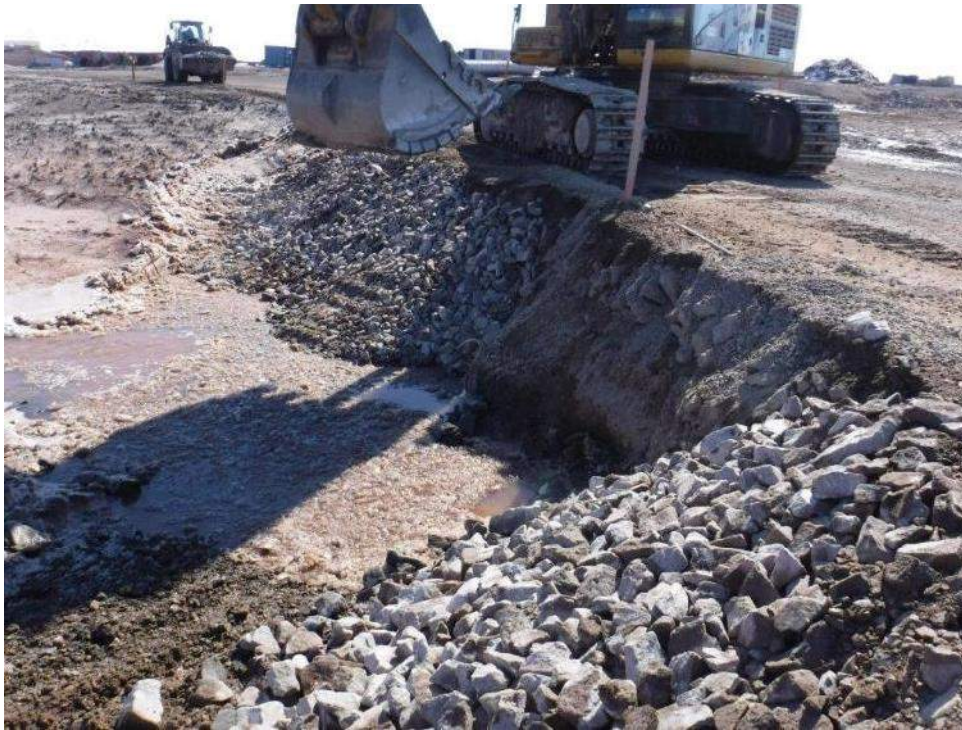
May 23, 2017 – Armouring road embankment near culvert CV-186 (Sheardown Lake Tributary 1)

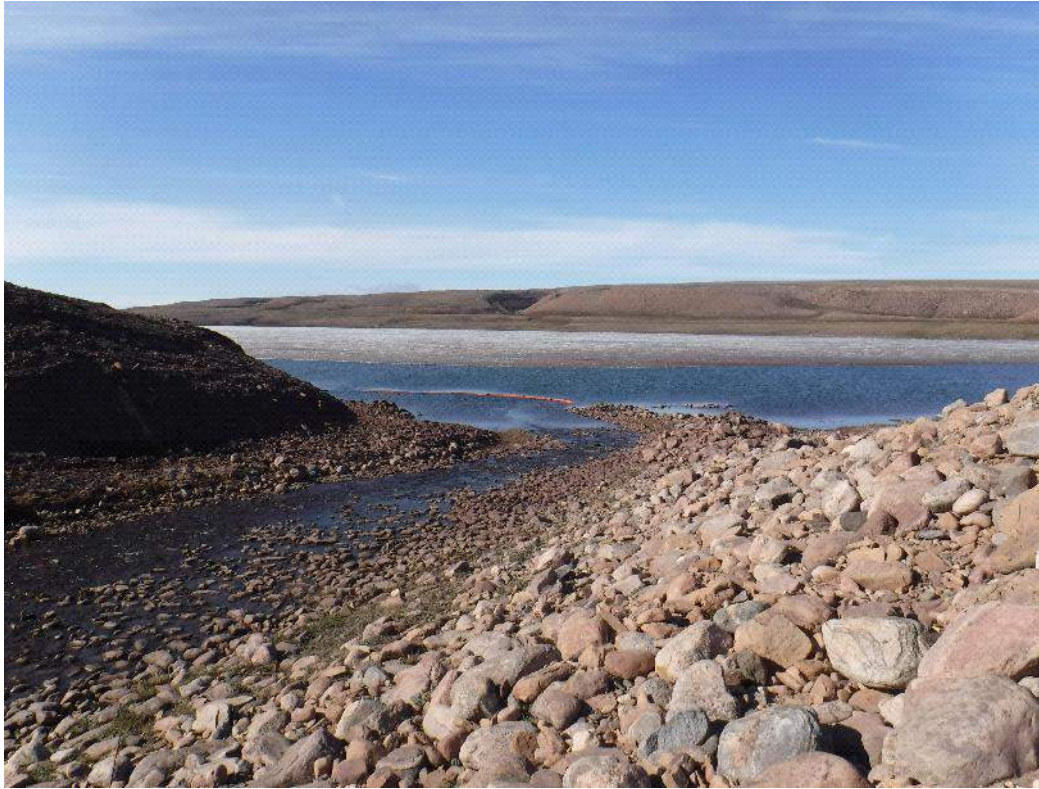
June 30, 2017 – Sheardown Tributary 1 outfall to Sheardown Lake

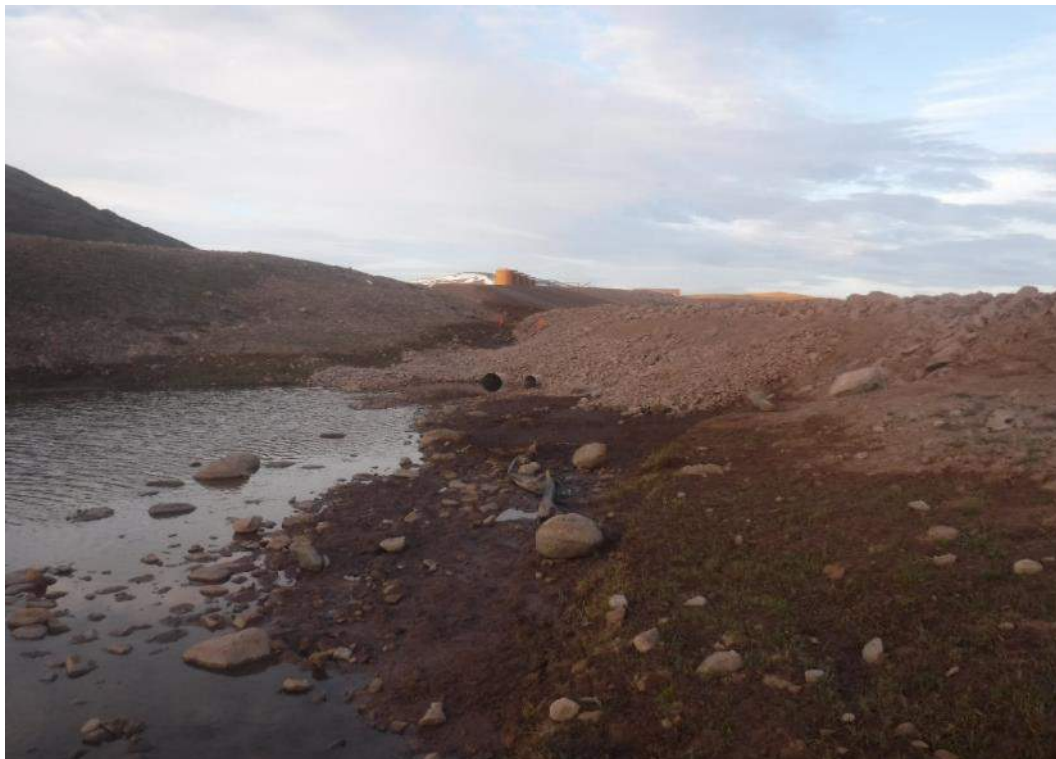
July 2, 2017 - Downstream of CV-187 (Upgraded in April 2017)

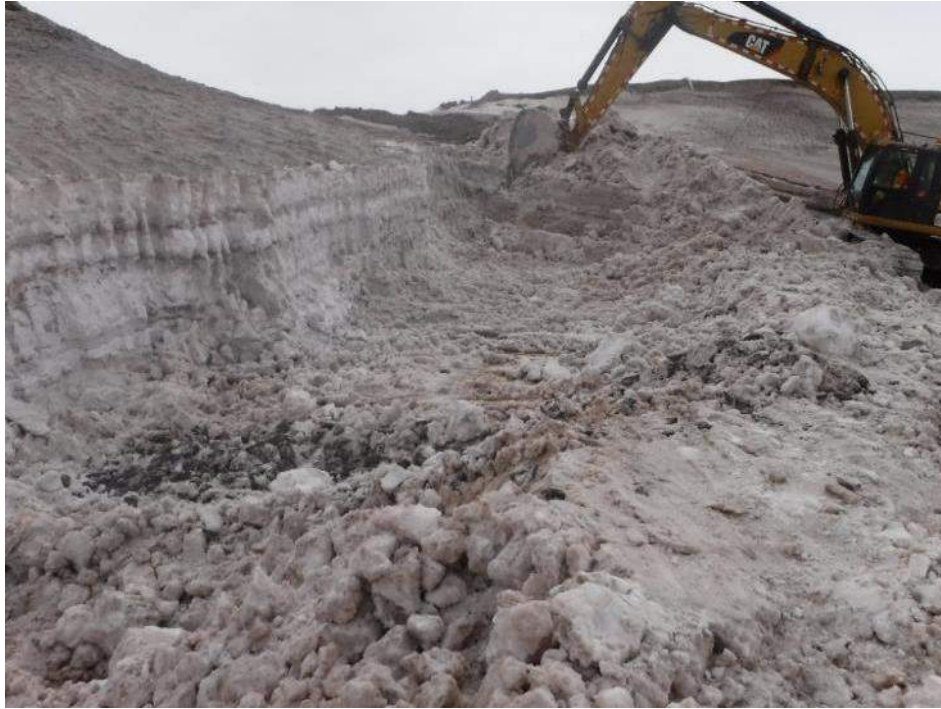
May 14, 2017 – Initial snow removal from ditch along Camp Lake Water Jetty Access Road  
(Upstream of Camp Lake Sedimentation Ponds)

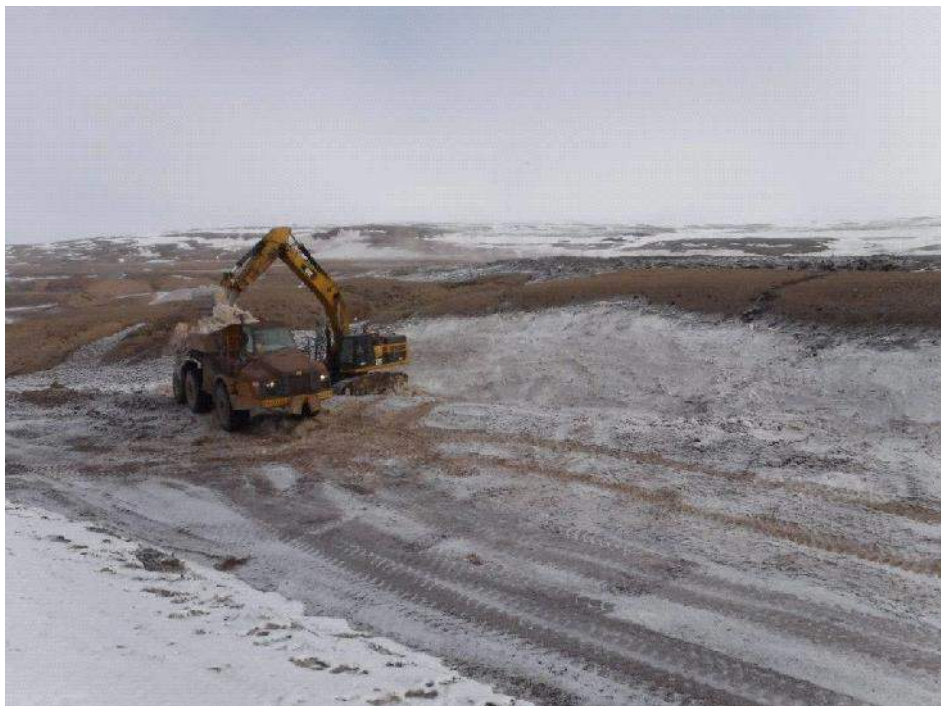
May 21, 2017 – Continued snow removal from ditch along Camp Lake Water Jetty Access Road  
(Upstream of Camp Lake Sedimentation Ponds)

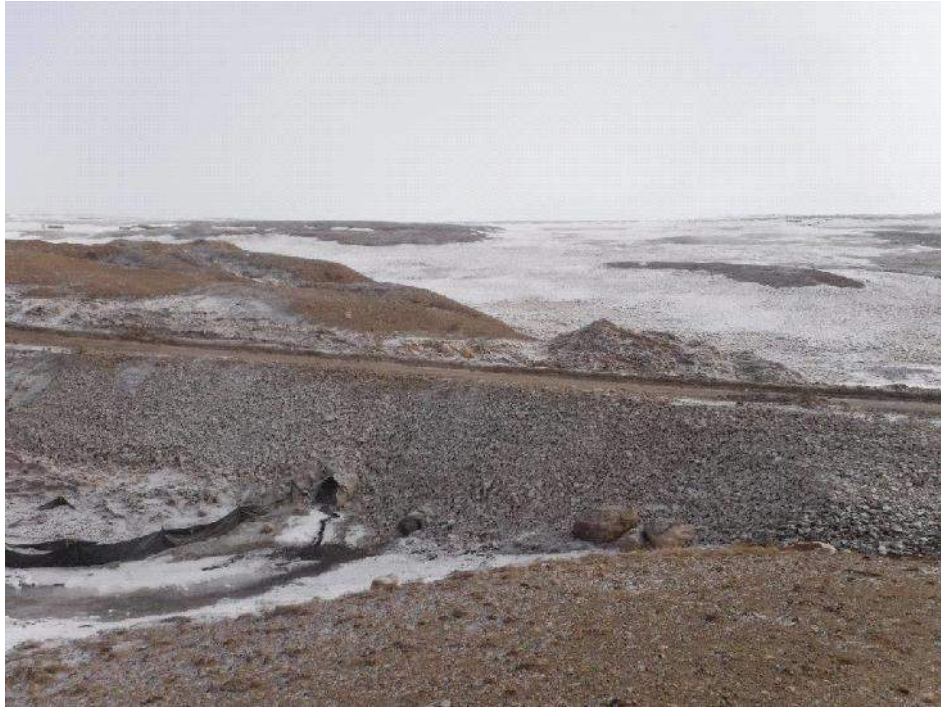
May 21, 2017 – Armouring of road embankments near culvert BG-01 (Camp Lake Tributary 1)

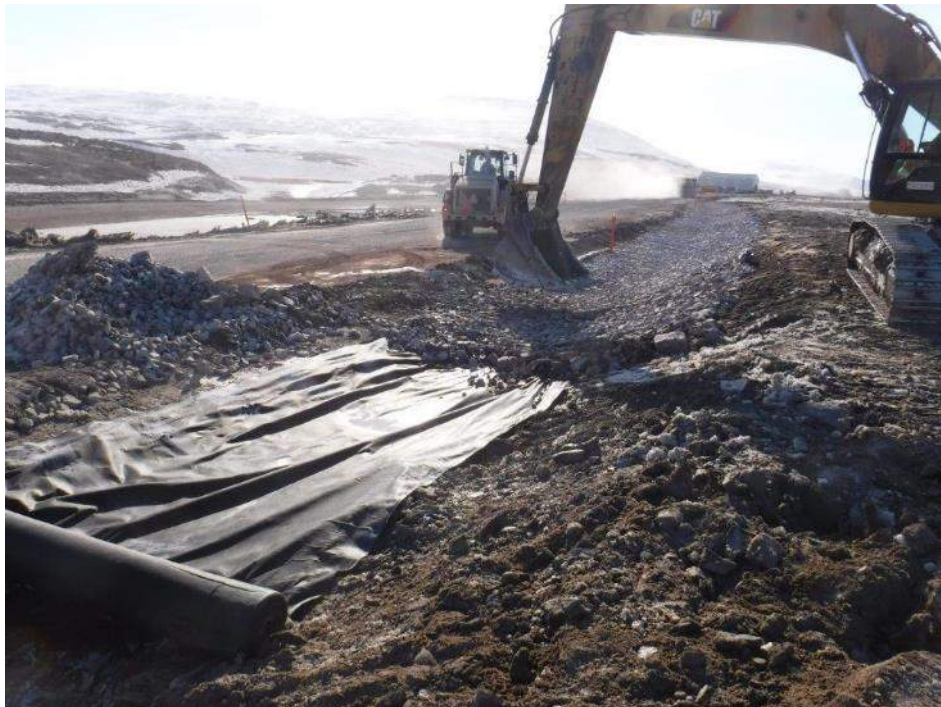
May 23, 2017 – Armouring of drainage ditch on South end of Mine Site airstrip near Km 100  
(Upstream of Camp Lake Tributary 1)

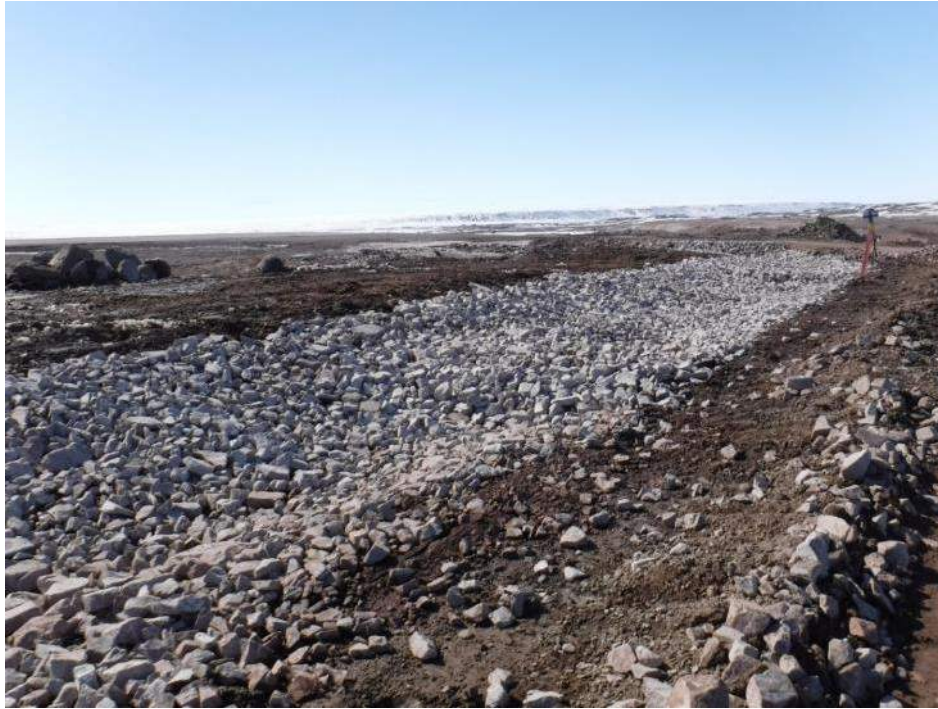
May 23, 2017 – Completion of drainage ditch armoring on South end of Mine Site airstrip near Km 100  
(Upstream of Camp Lake Tributary 1)

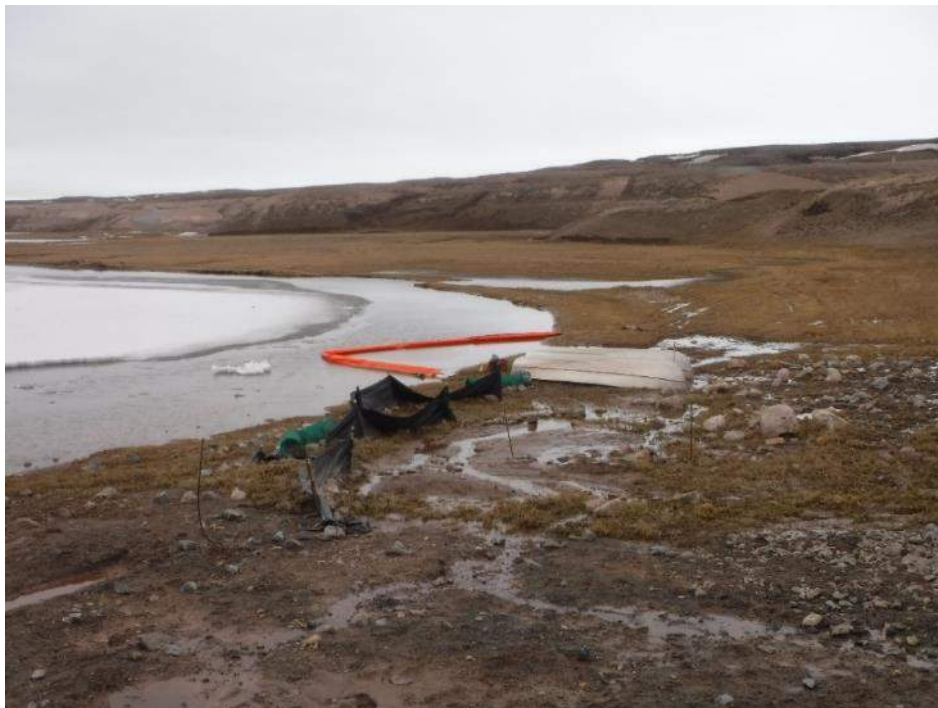
June 11, 2017 – Installation of silt curtain on the outlet of Camp Lake Sedimentation Ponds.  
Spring berms and silt fences installed.

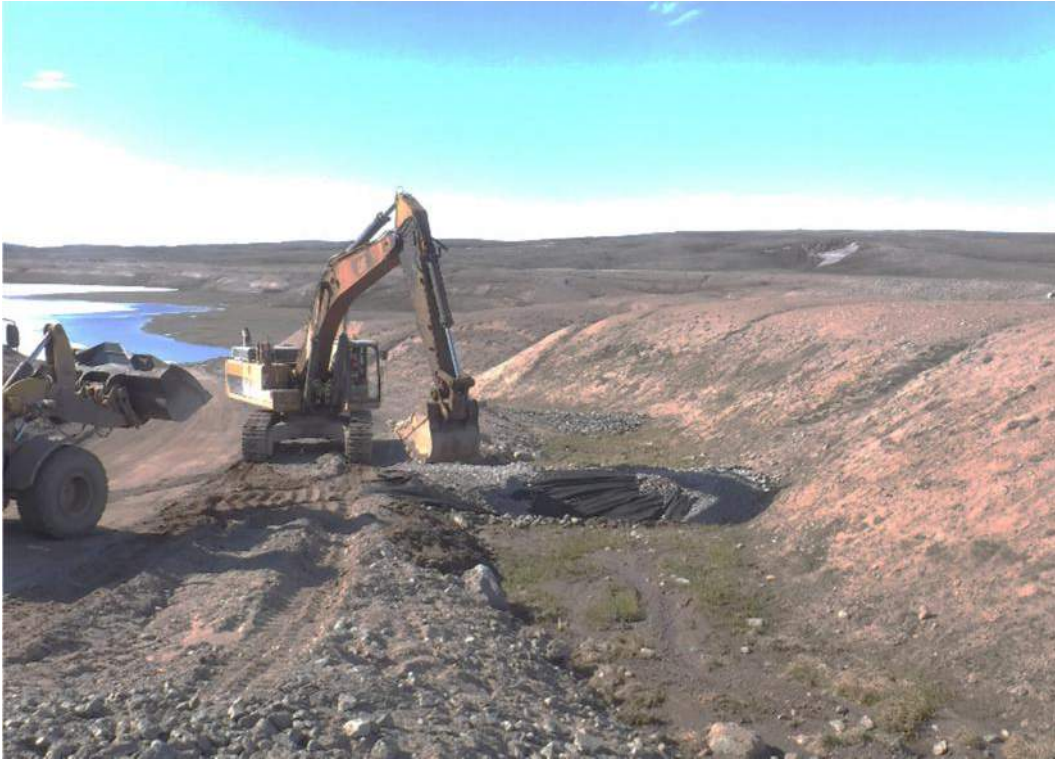
June 22, 2017 – Geotextile installation at check dams in ditch along Camp Lake Water Jetty Access Road

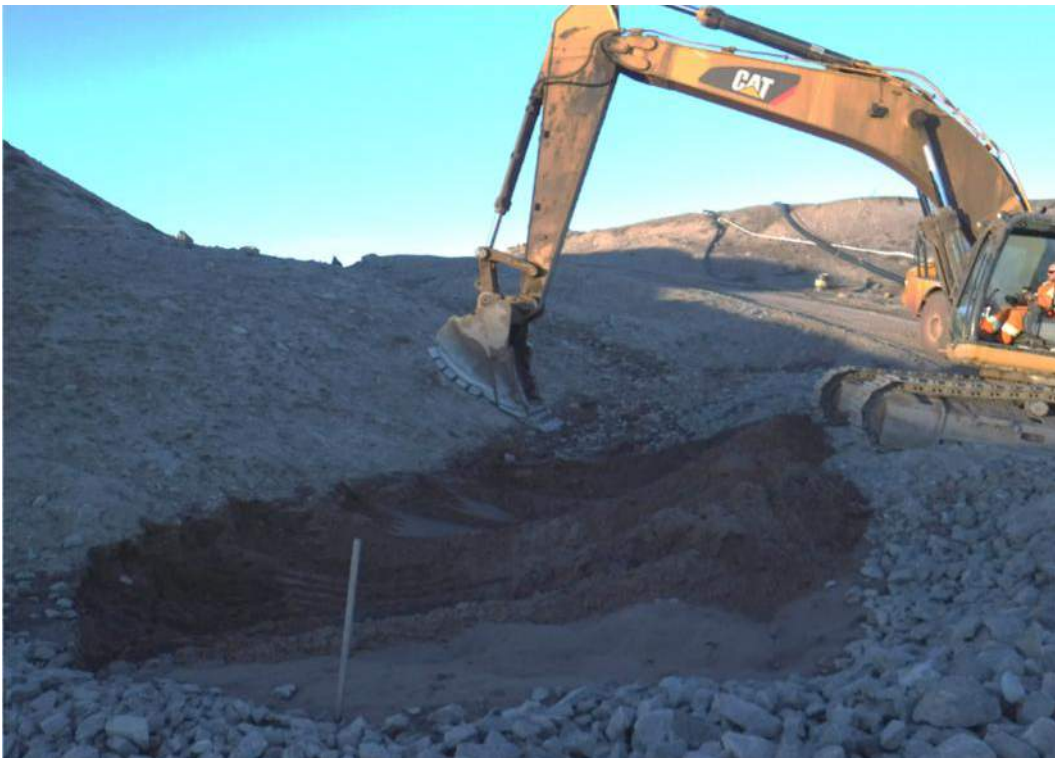
June 23, 2017 – Removing sediment from Camp Lake Sedimentation Ponds

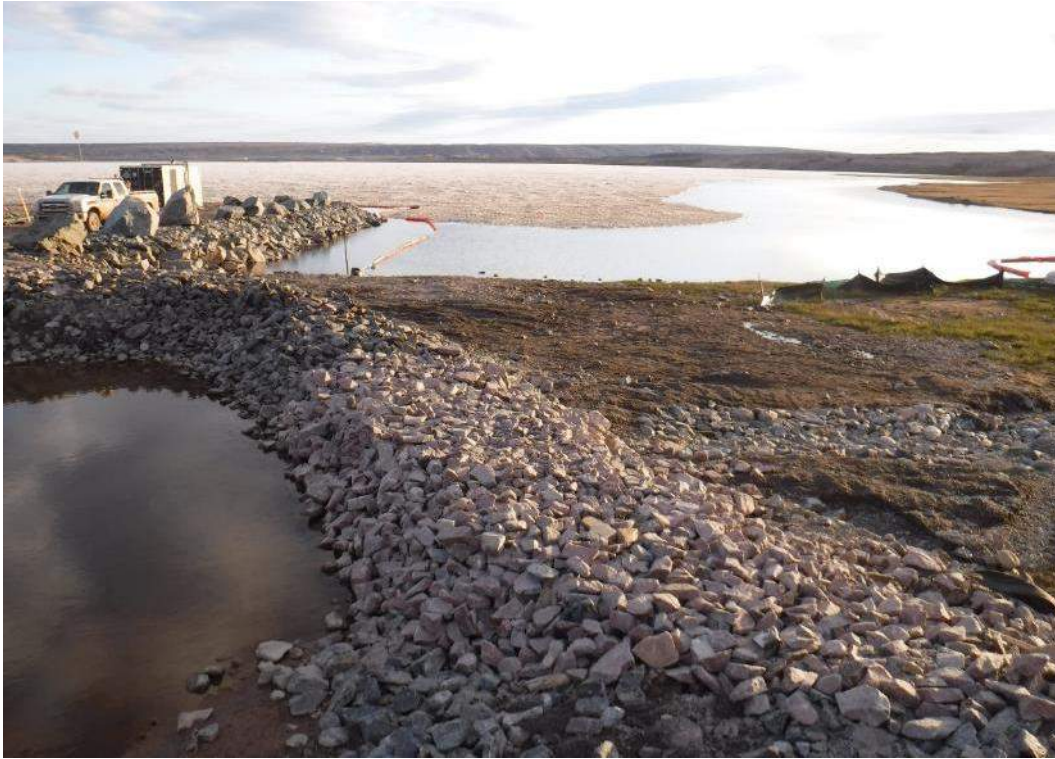
June 26, 2017 – Berm maintenance at Camp Lake Sedimentation Ponds

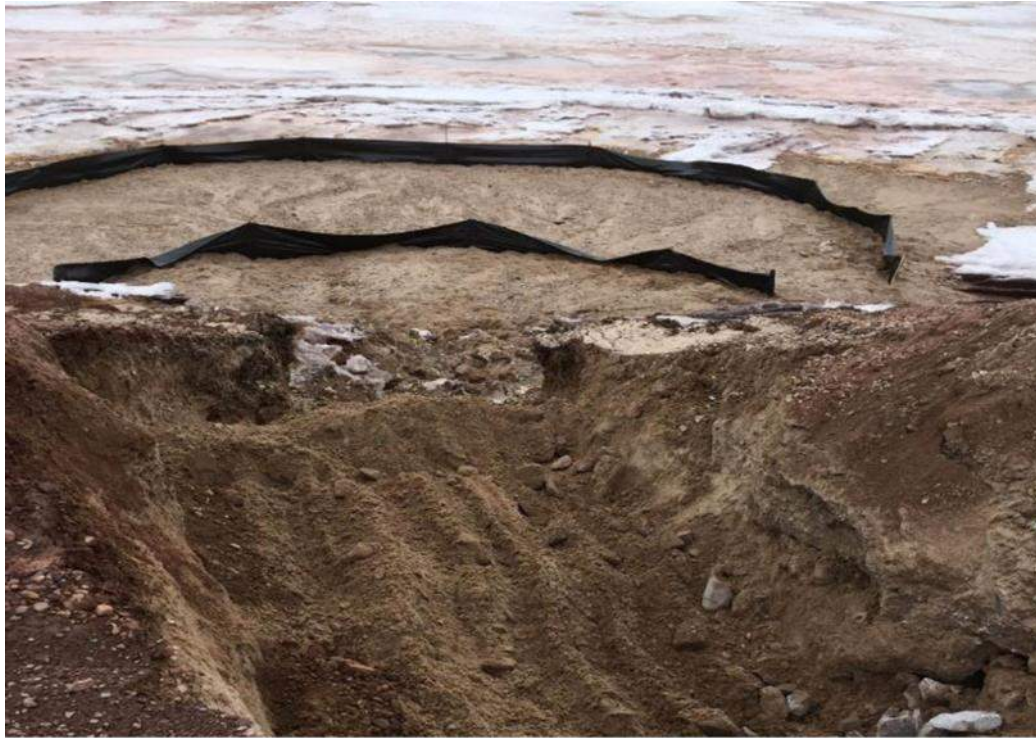
May 26, 2017 – Silt fences installed to mitigate sand washed out from MP-05 overflow

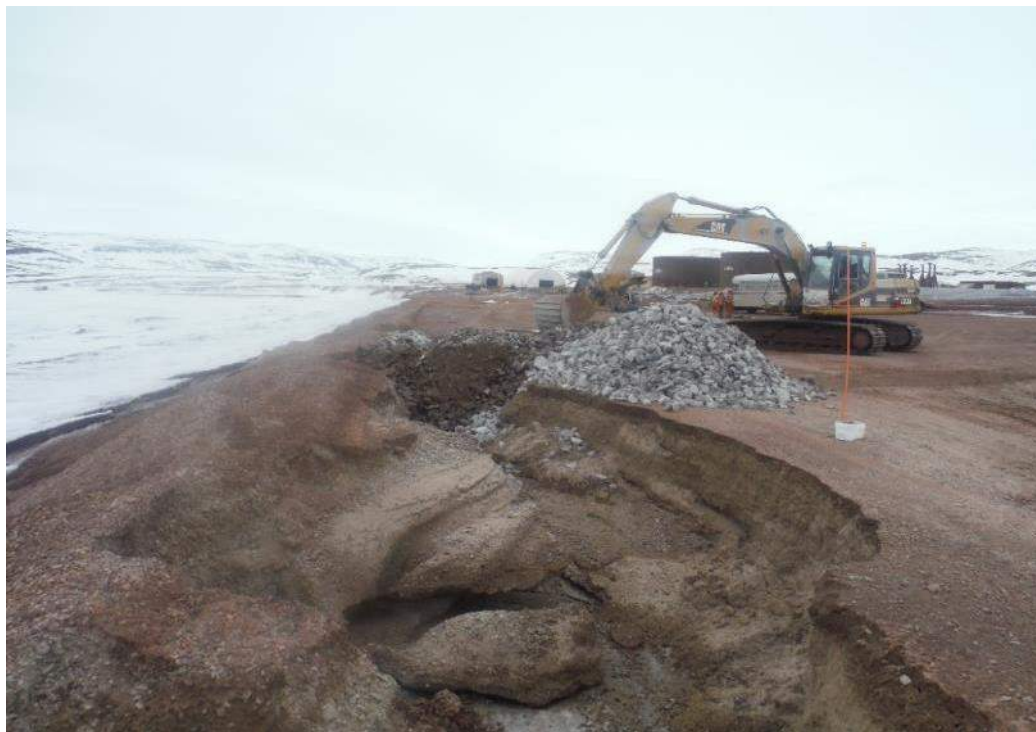
May 26, 2017 – Rip rap used to fill in beach area that was eroded by MP-05 overflow

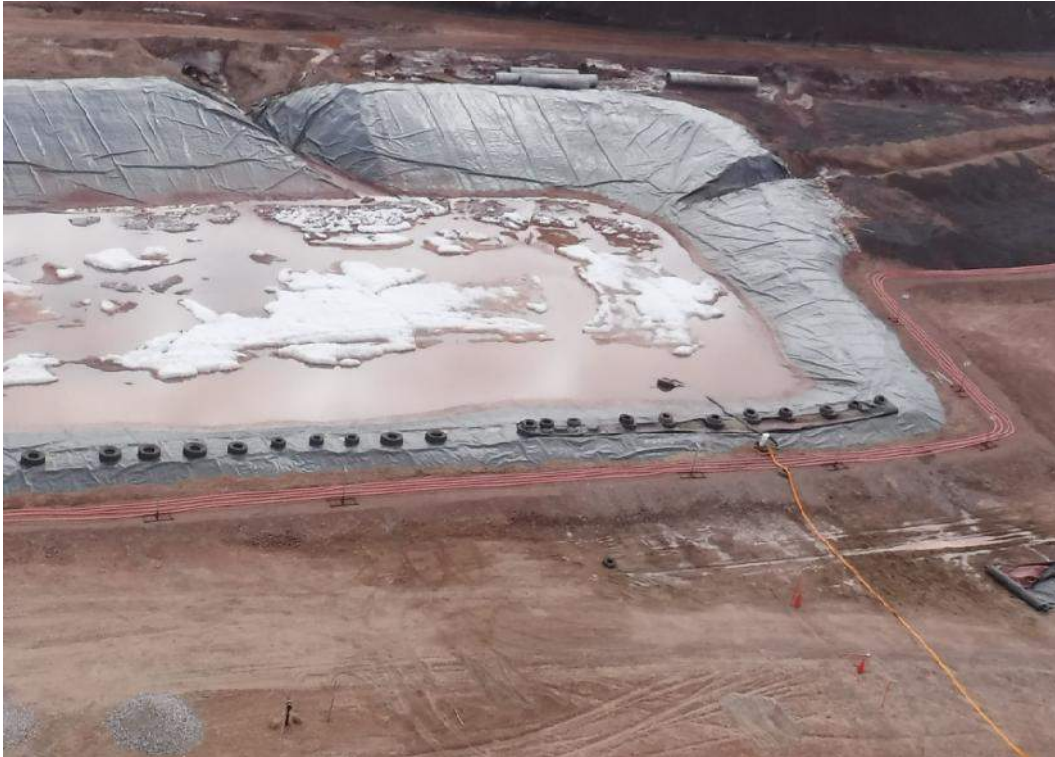
June 7, 2017 – Aerial view of controlled discharge from MP-05

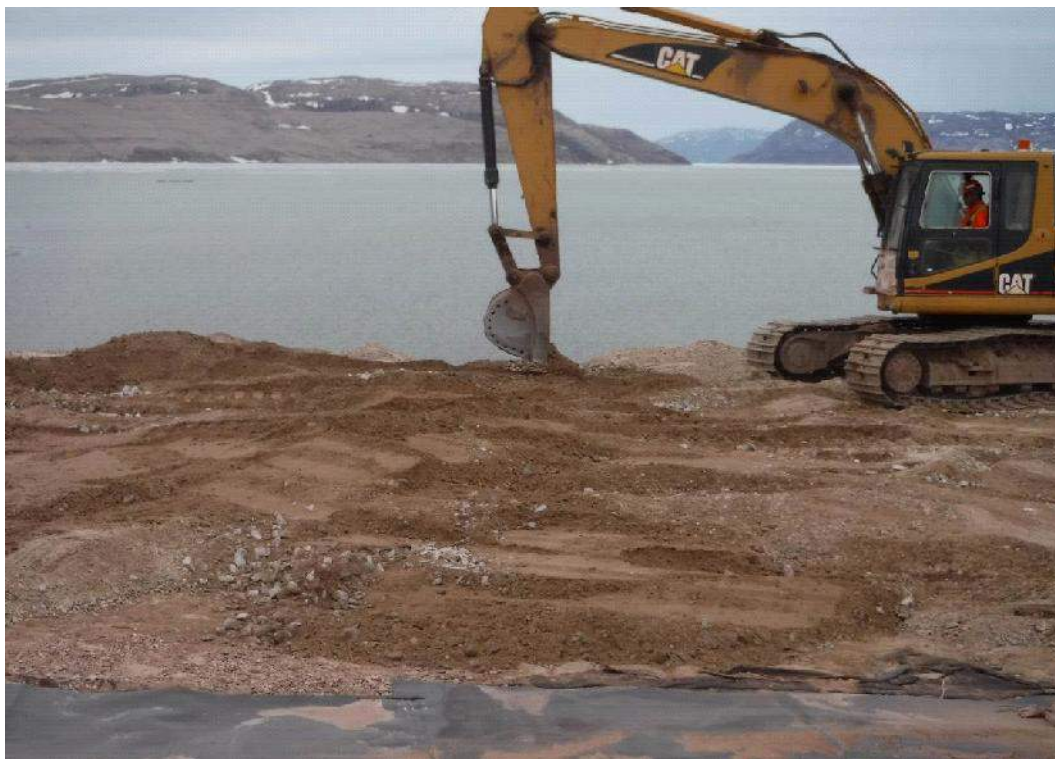
June 29, 2017 – Additional re-grading of locations that experienced erosion during MP-05 overflow

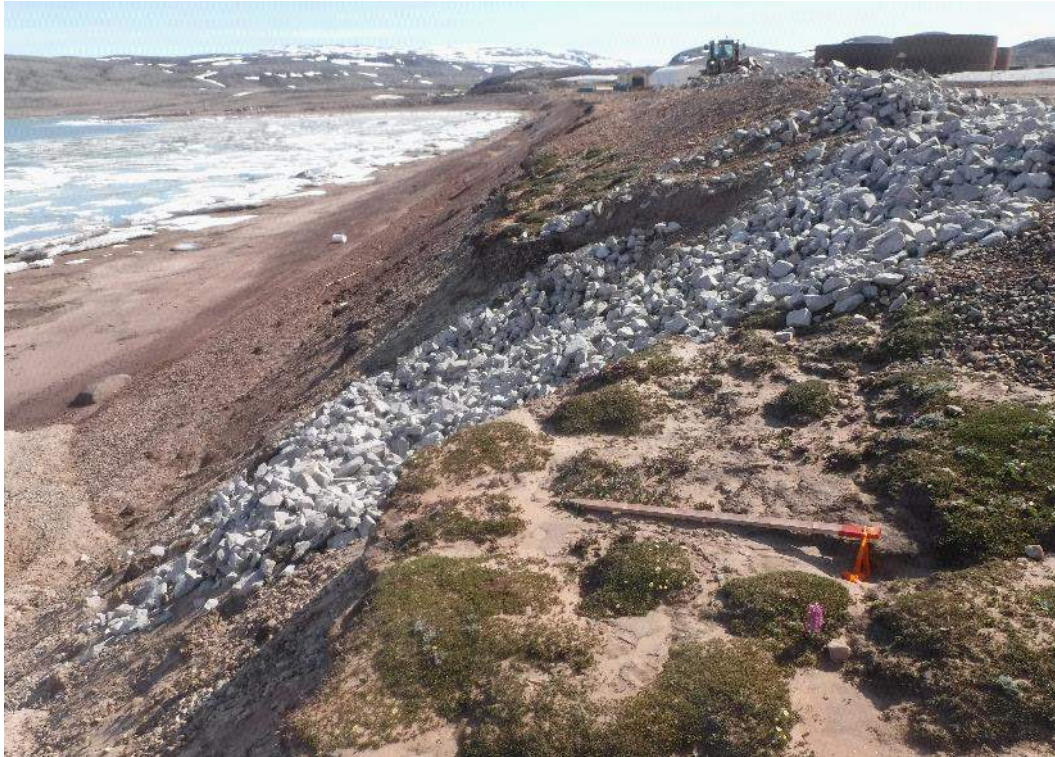
July 1, 2017 - Additional rip-rap placed downstream of MP-05

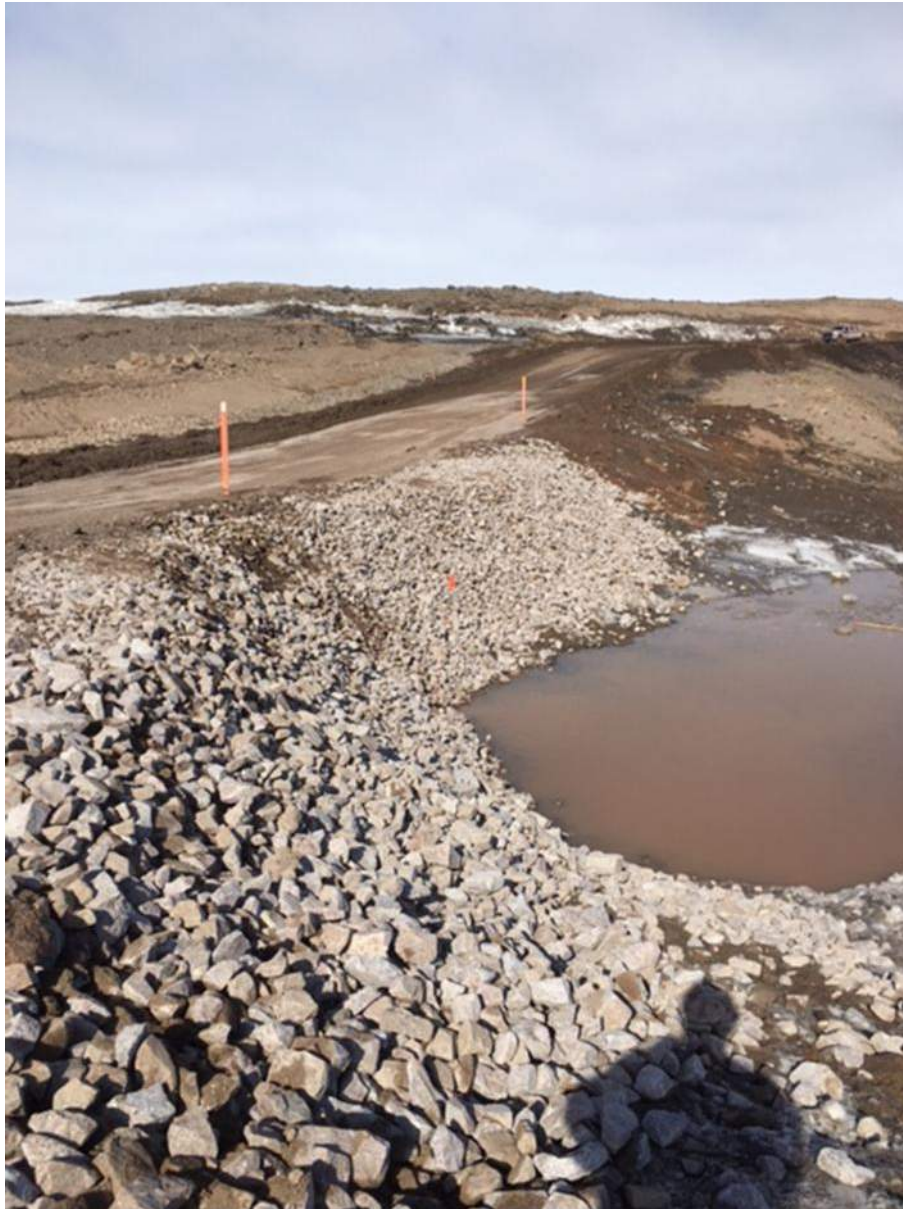
May 30, 2017 – Armouring of road embankments near BG-29

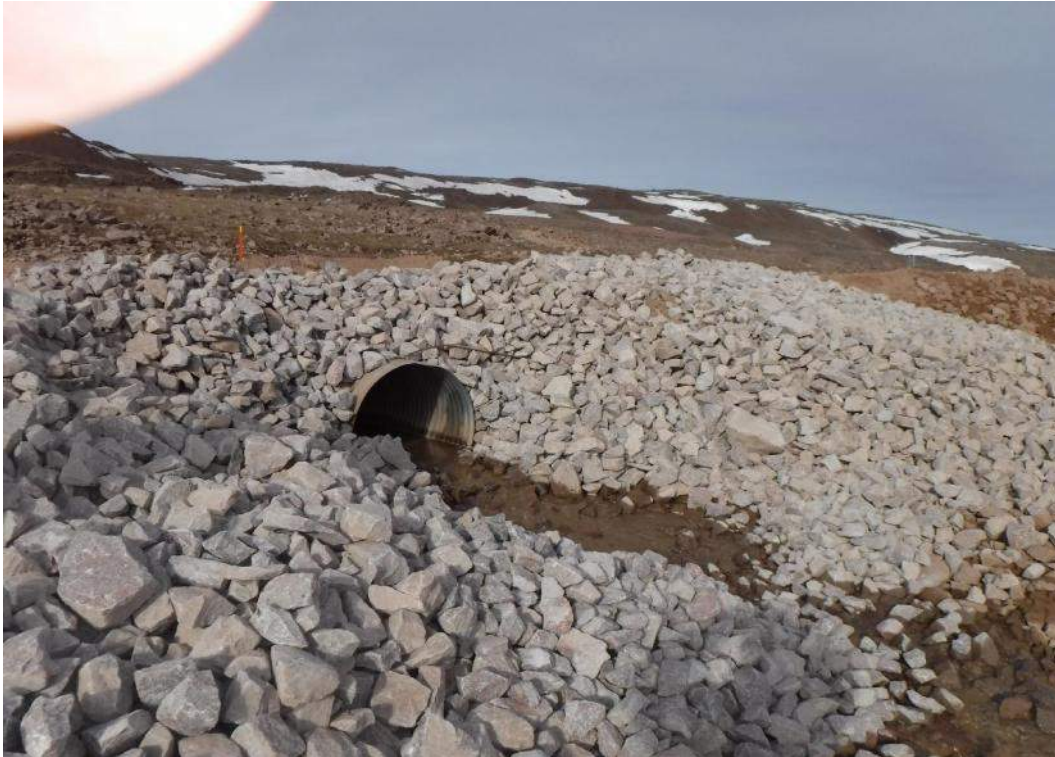
June 10, 2017 – Placement of aggregate (rip rap) near outlet of CV-174

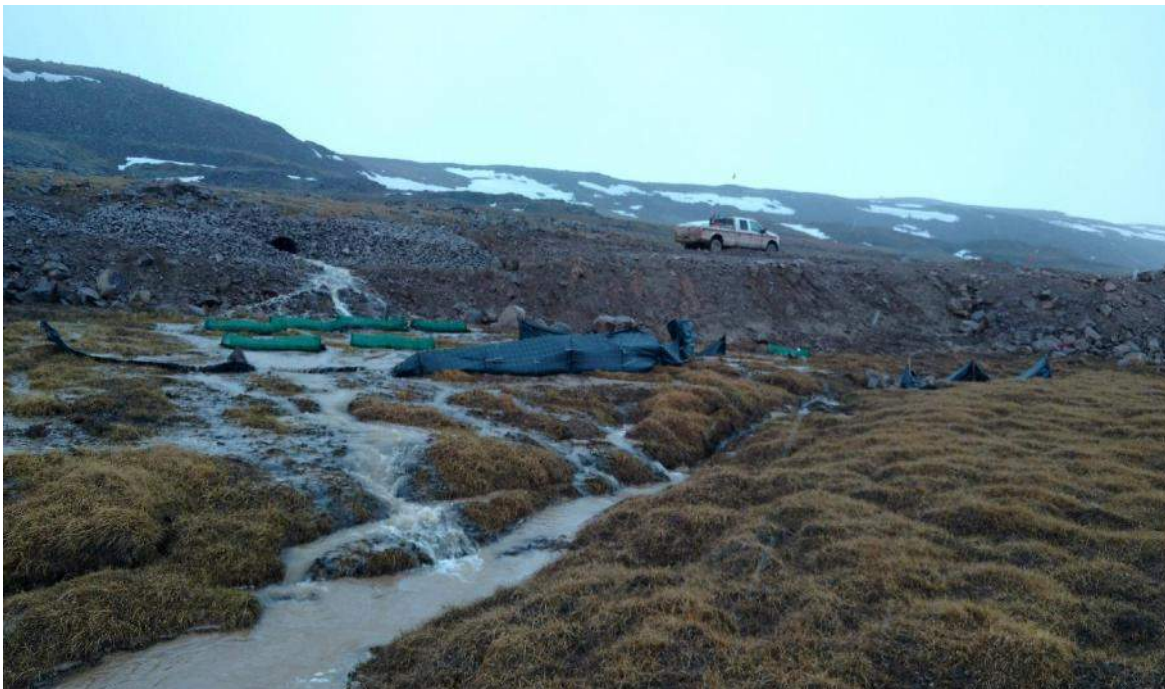
June 15, 2017 - Sedimentation control measures installed at CV-174

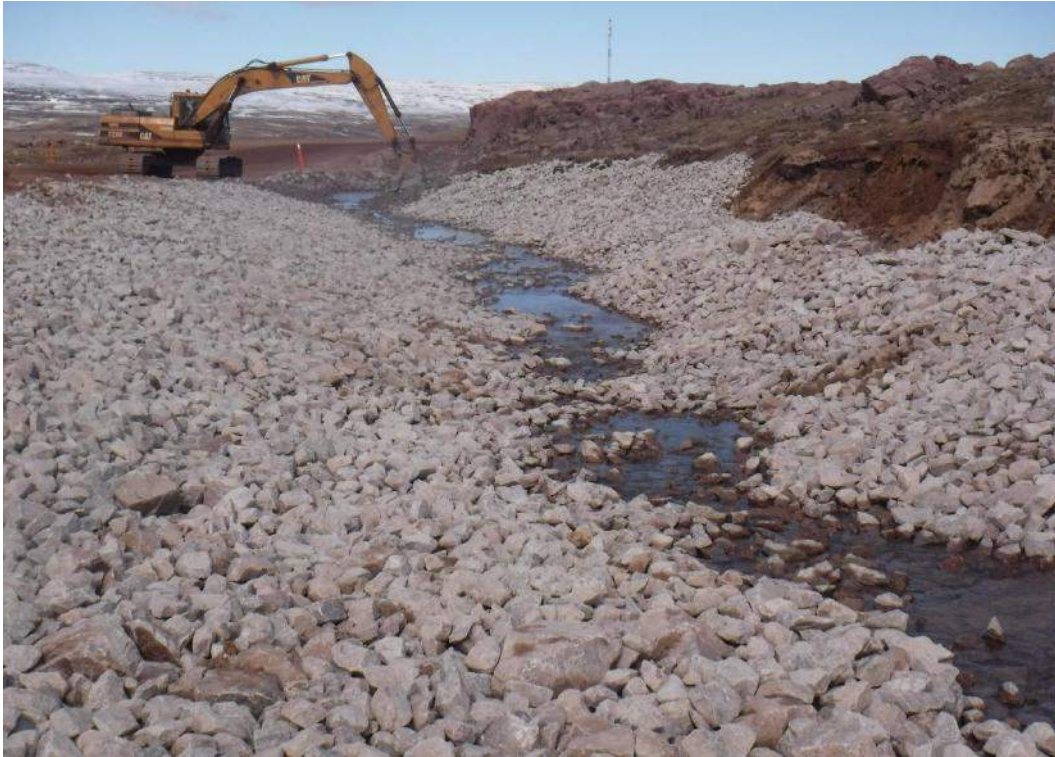
June 17, 2017 – Armouring of ditching near CV-174

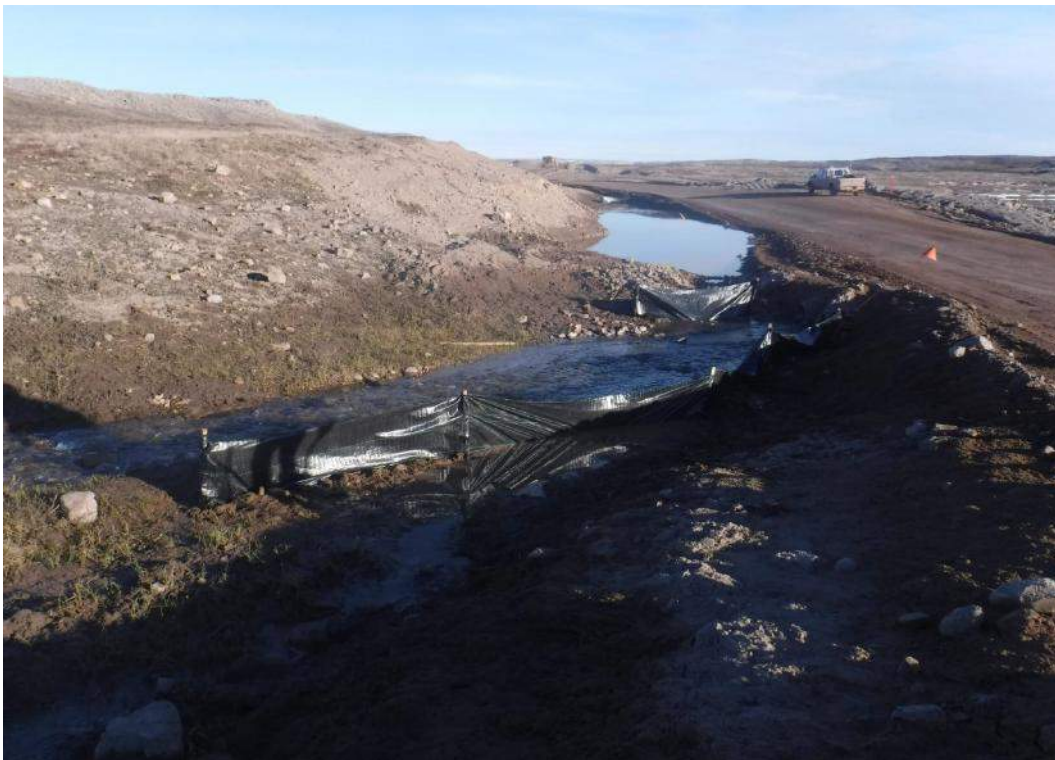
June 25, 2017 – Silt fences installed near BG-17 (upstream)

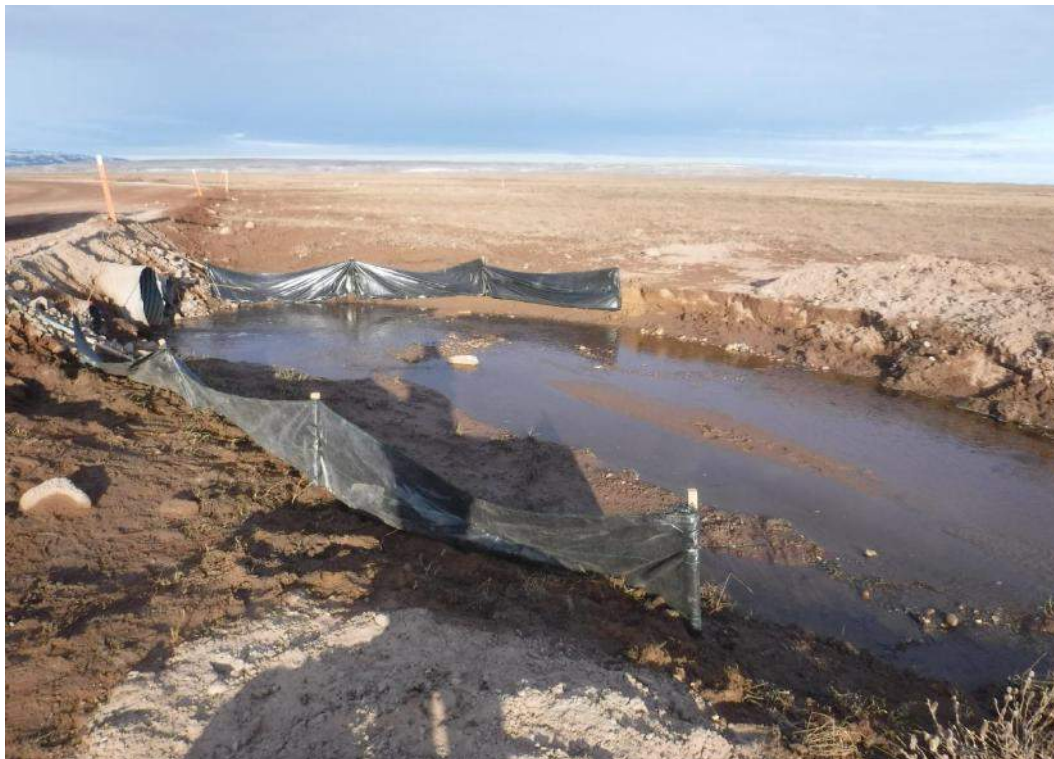
June 25, 2017 – Silt fences installed near CV-001 (downstream)

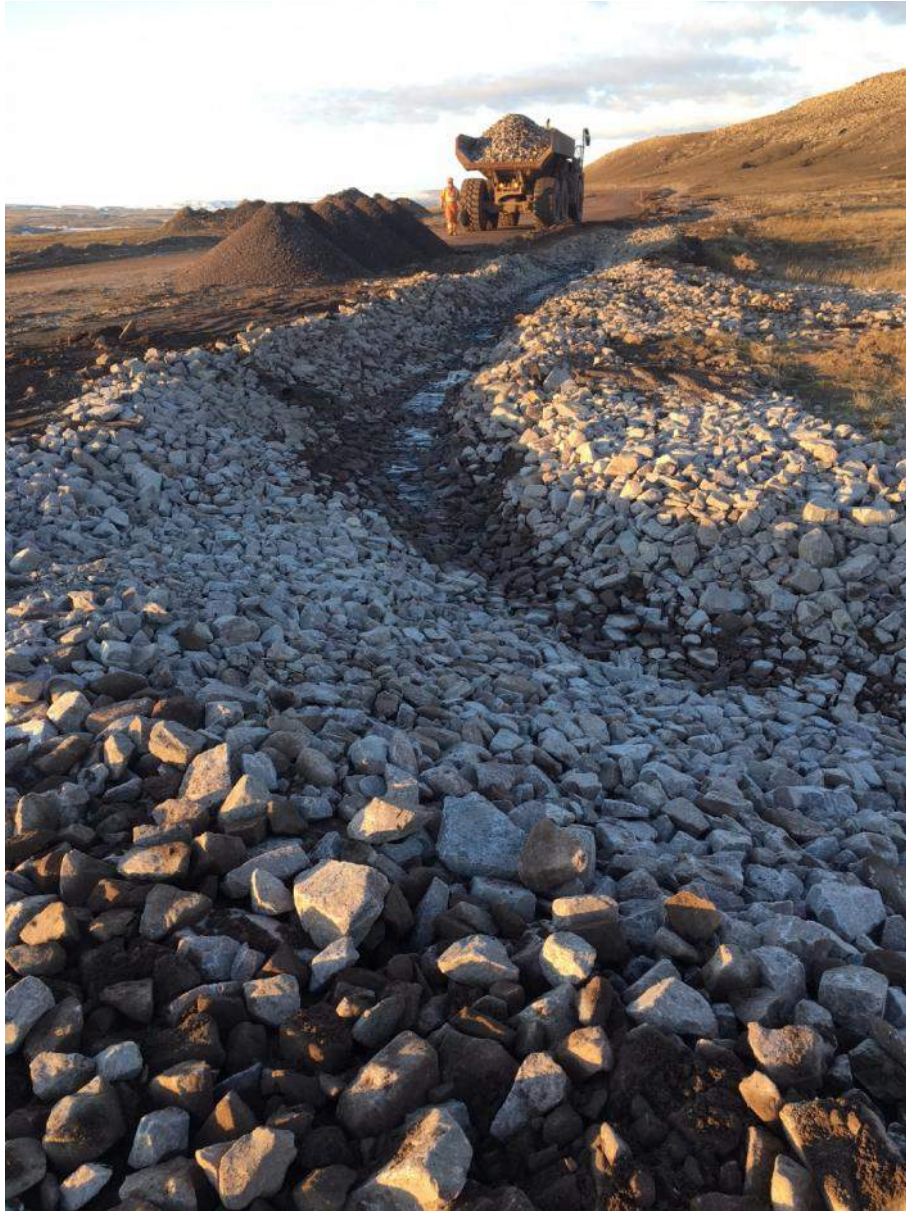
June 25, 2017 – Reconstructed and armoured ditch at Km 85.5

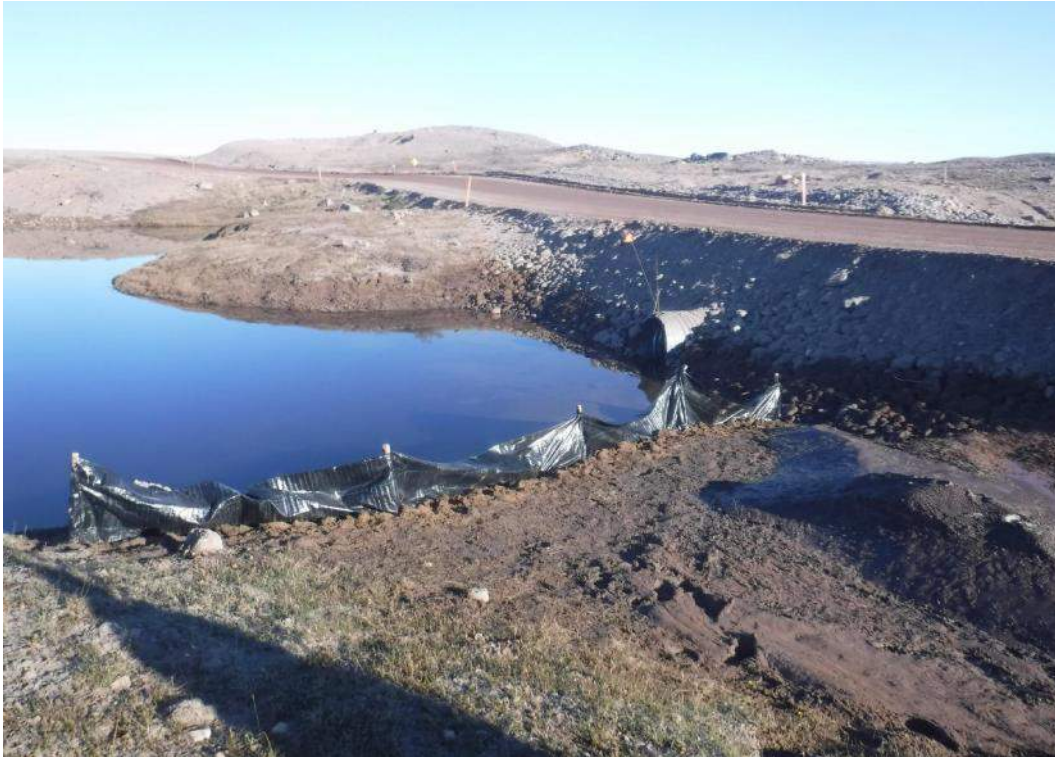
June 26, 2017 - Silt fences installed near BG-30 (upstream)
