**APPENDIX E.10.2**  
**2017 FRESHET MONITORING REPORT NO. 2**  
**(Part 2)**

### **Sequence of Events and Actions Taken by Spill Report (Including Photos)**

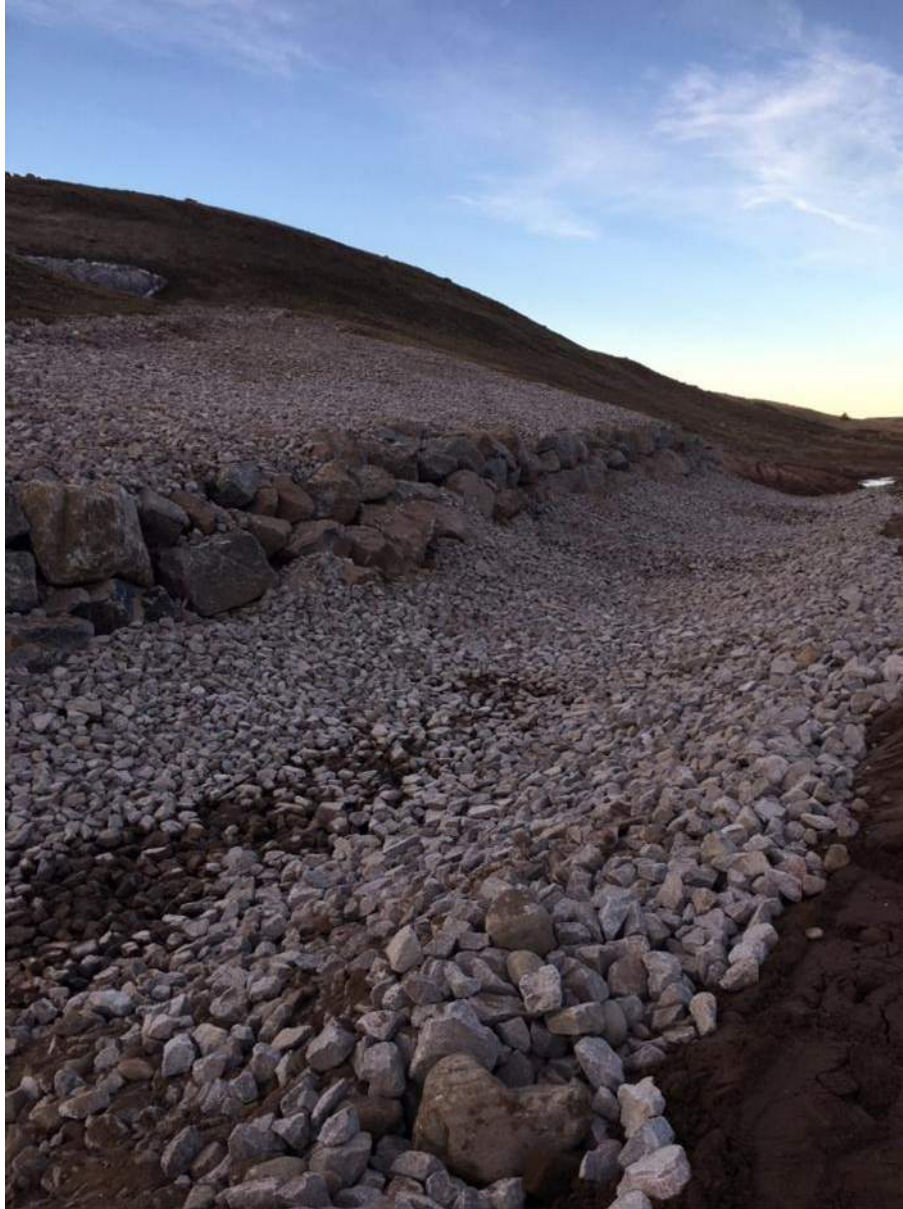
July 4, 2017 – Completion of ditch and slope armouring near Km 90

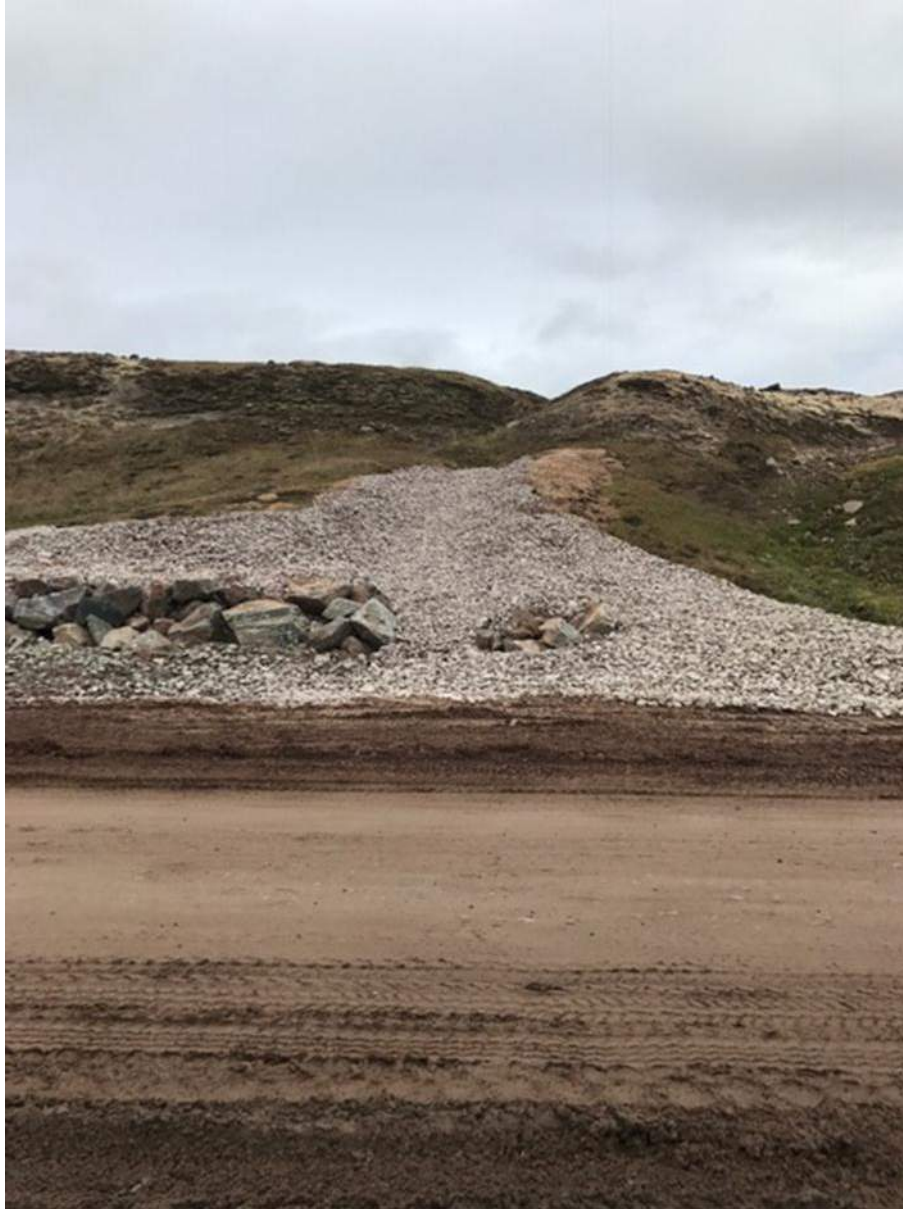
July 10, 2017 – Completion of slope stabilization at Km 90

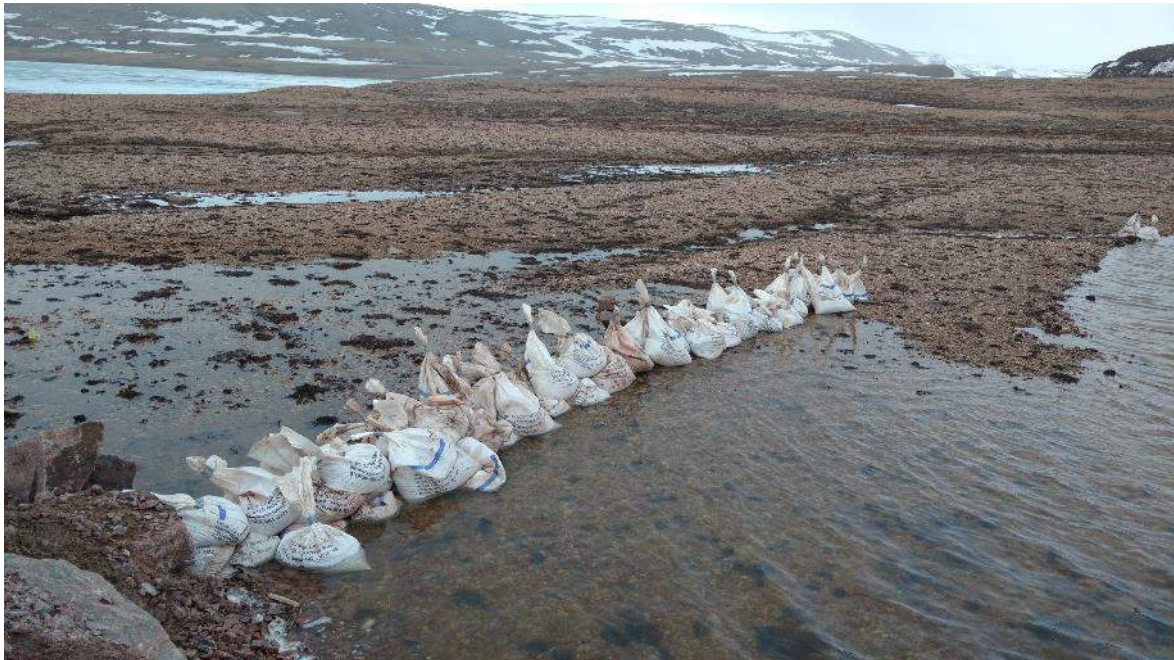
June 15, 2017 - Sand bags installation (looking NE)

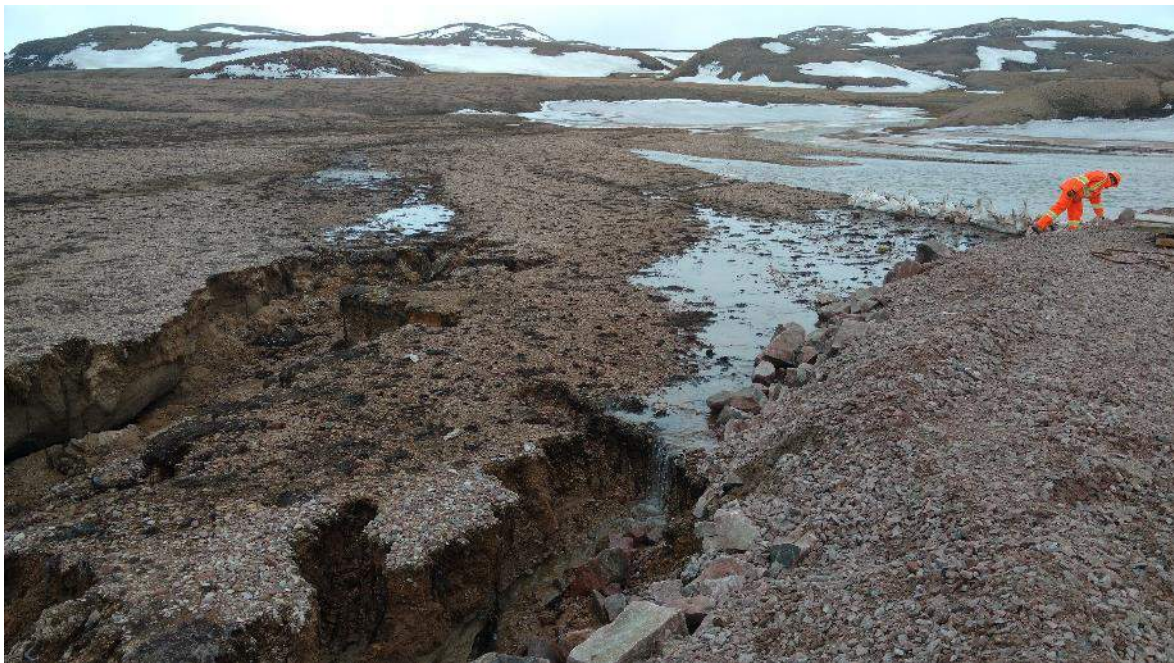
June 15, 2017 – Sand bags installation (looking SE)

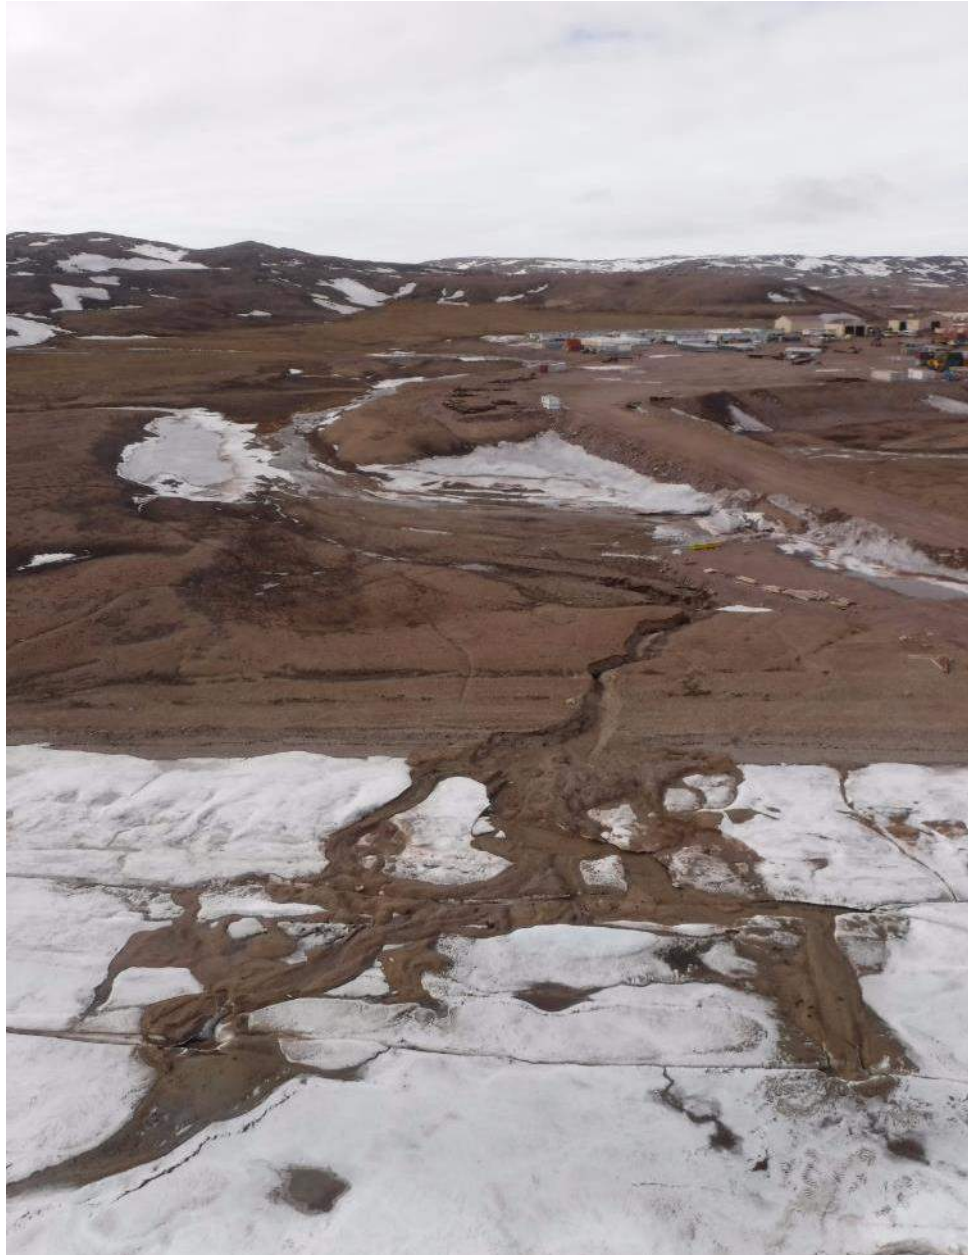
June 16, 2017 – Aerial view of tributary and diverted flow path

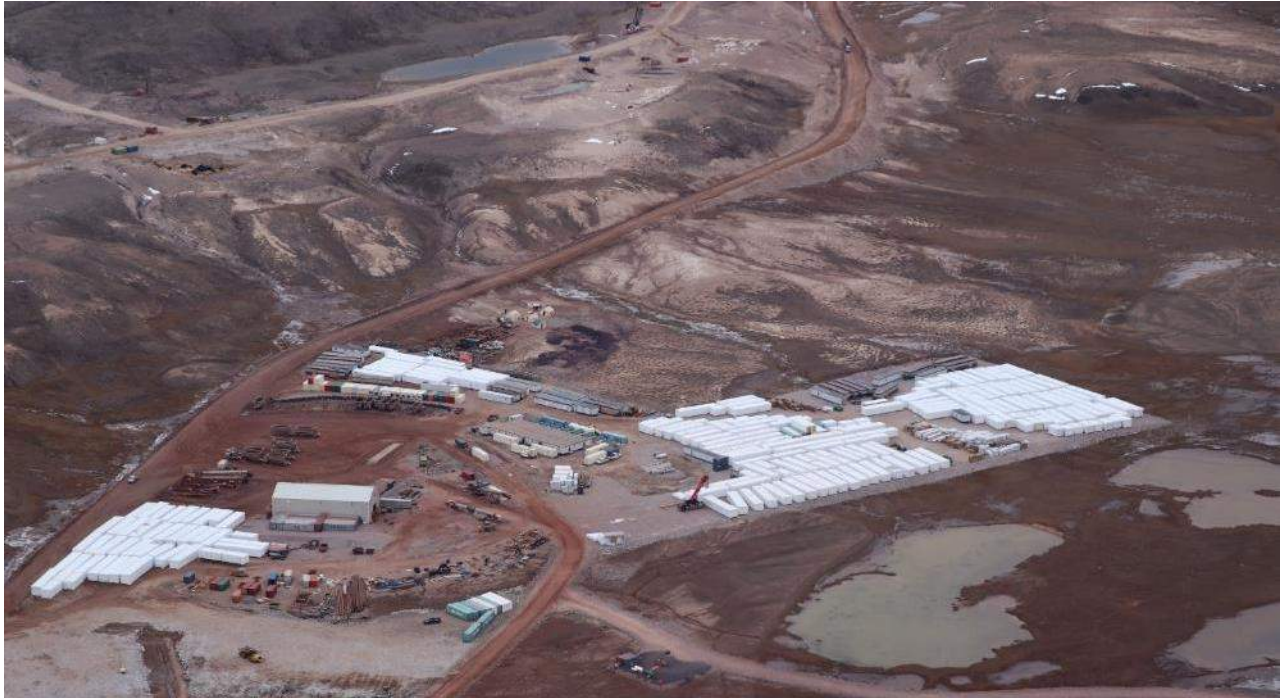
September 12, 2017 – Constructed New Milne Port Camp Pad  
(white camp modules stored on top of pad)

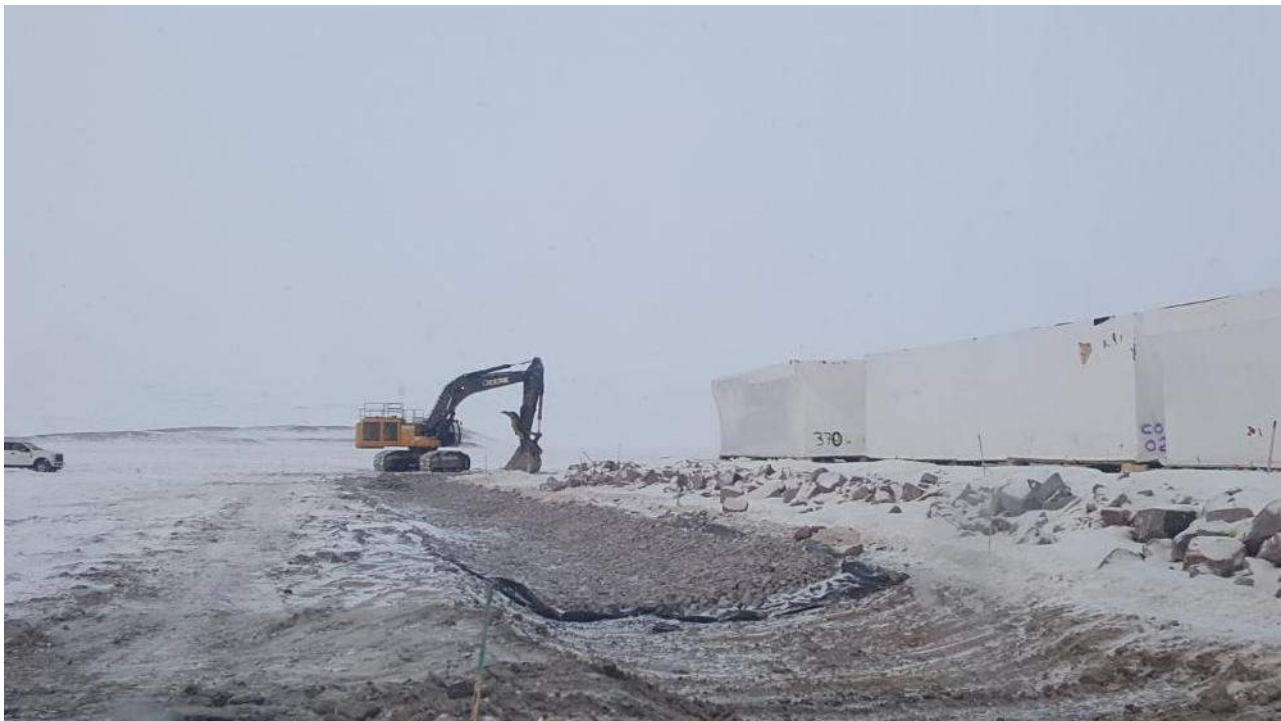
October 2017 – Construction of Milne Port Camp Pad Diversion Ditch

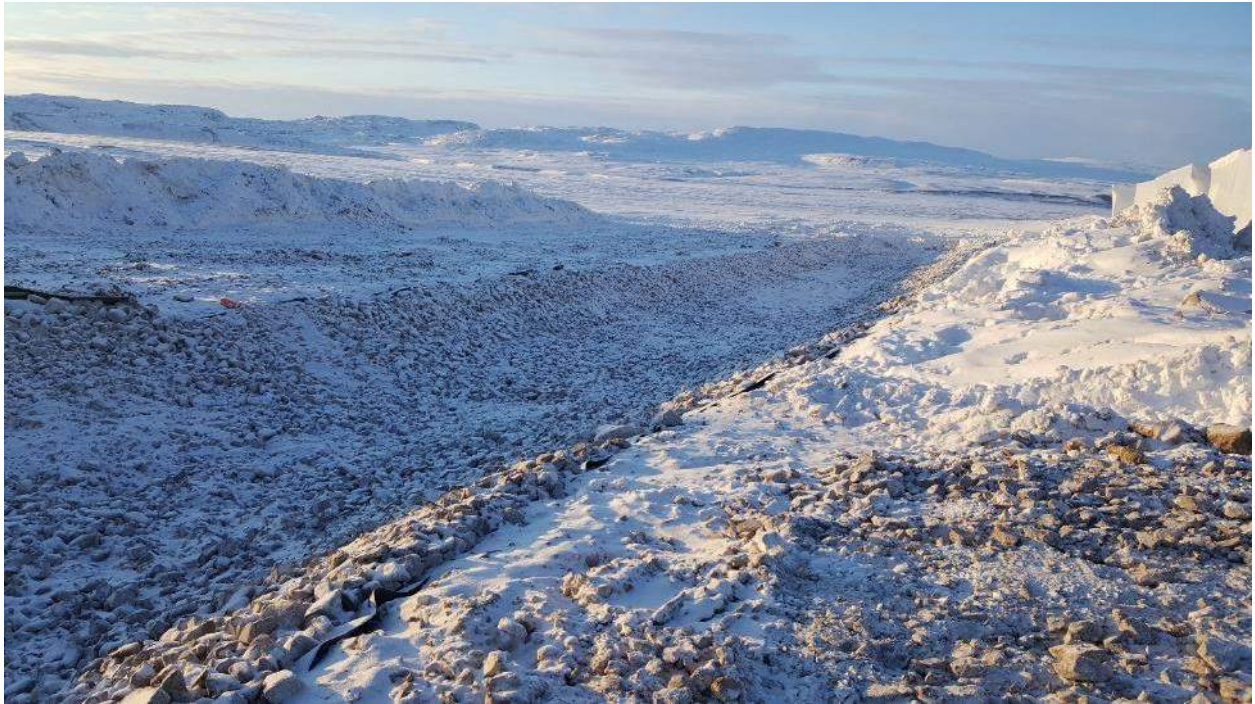
October 2017 – Post-construction overview of Milne Port Camp Pad Diversion Ditch
