APPENDIX E.8.4

INAC INSPECTION REPORTS AND BAFFINLAND RESPONSES

WATER LICENCE INSPECTION FORM

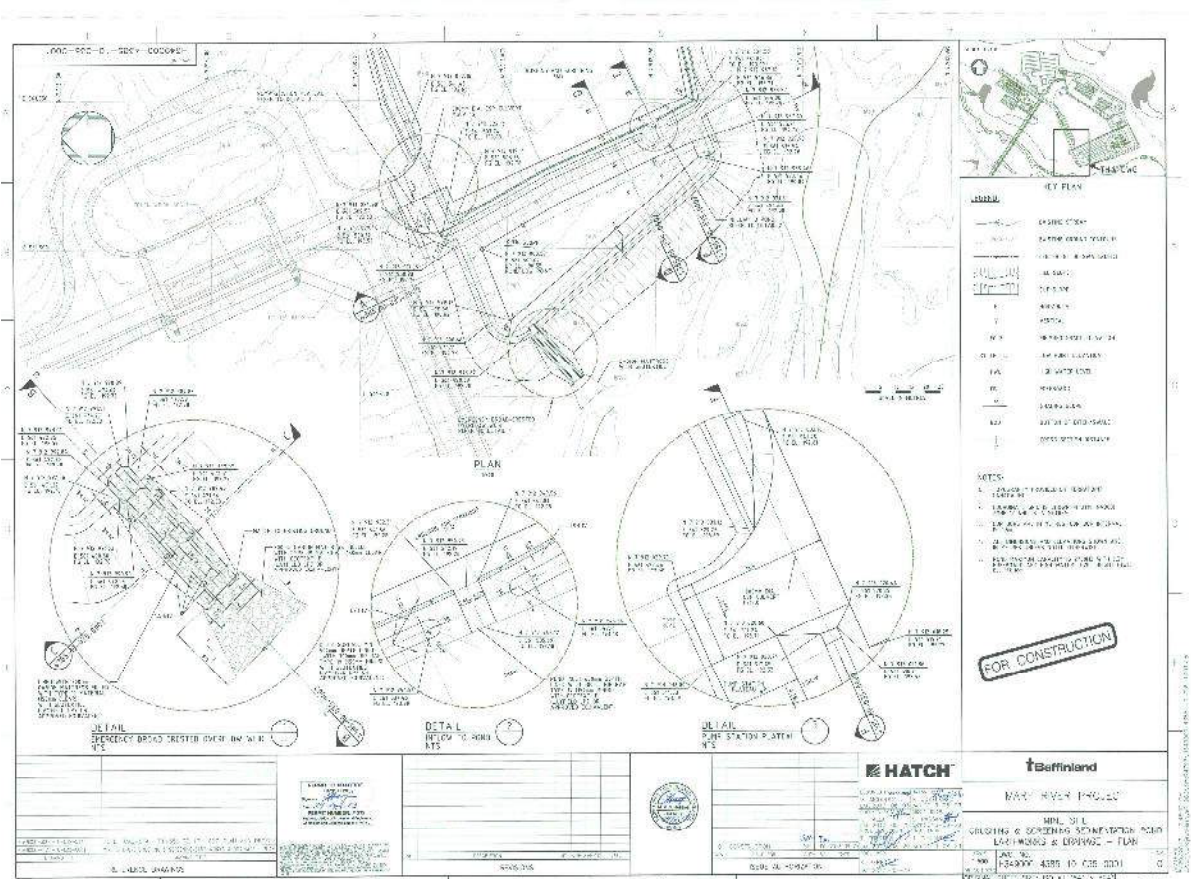
- c. During the Inspection it was noted that there was no culvert in place to allow water from the North West unlined ditches to enter the sedimentation pond, this is a concern to the inspector because in the HATCH for construction drawings below (Figure 1) it shows that there should be a 1000mm DIA CSP culvert installed.

Figure 1 (HATCH drawings confirming the required culvert)

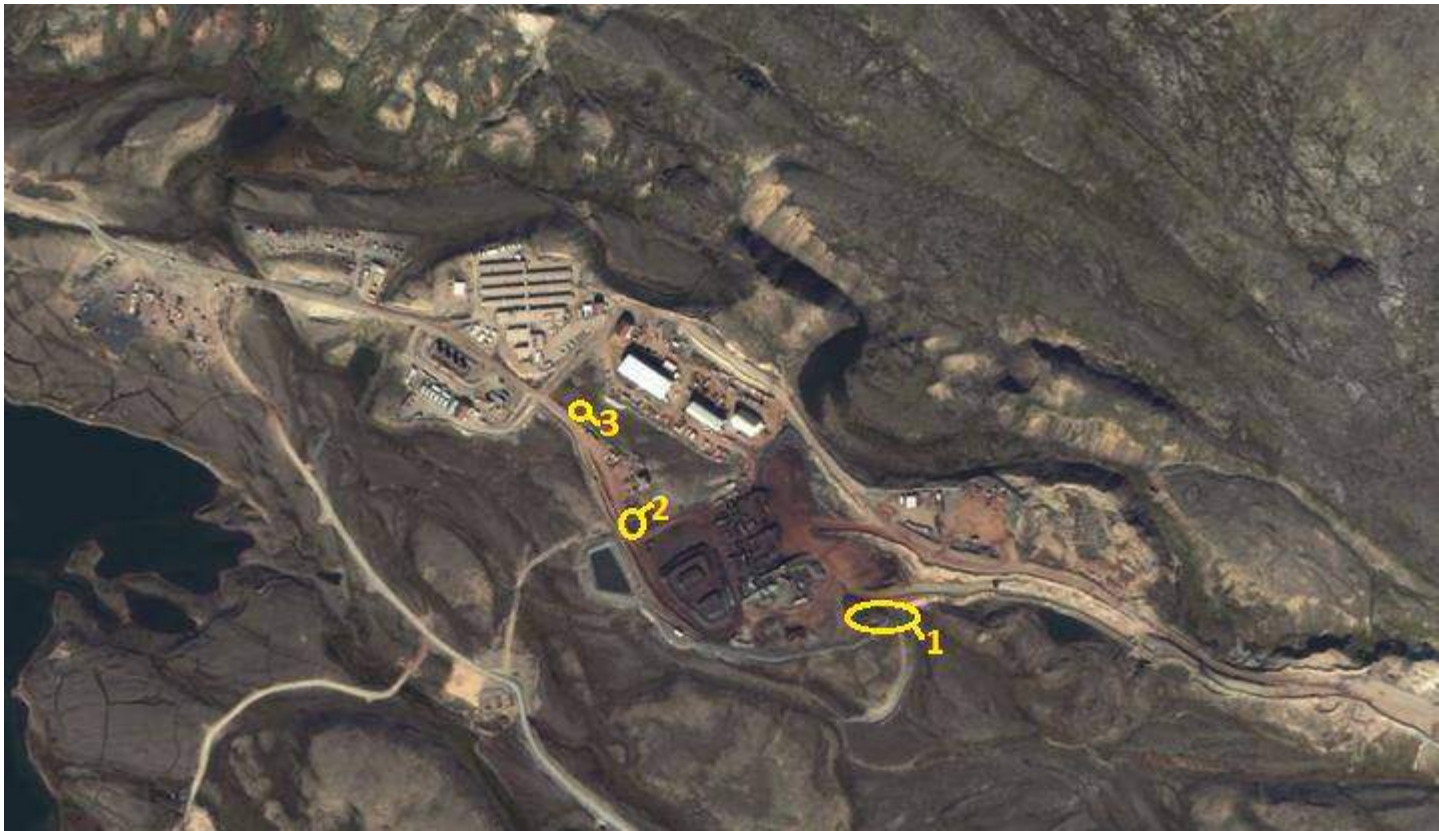
Figure 2 (**Item 1**: Oversized Ore stockpile location. **Item 2**: sampling location. **Item 3**: snow dump sampling location.

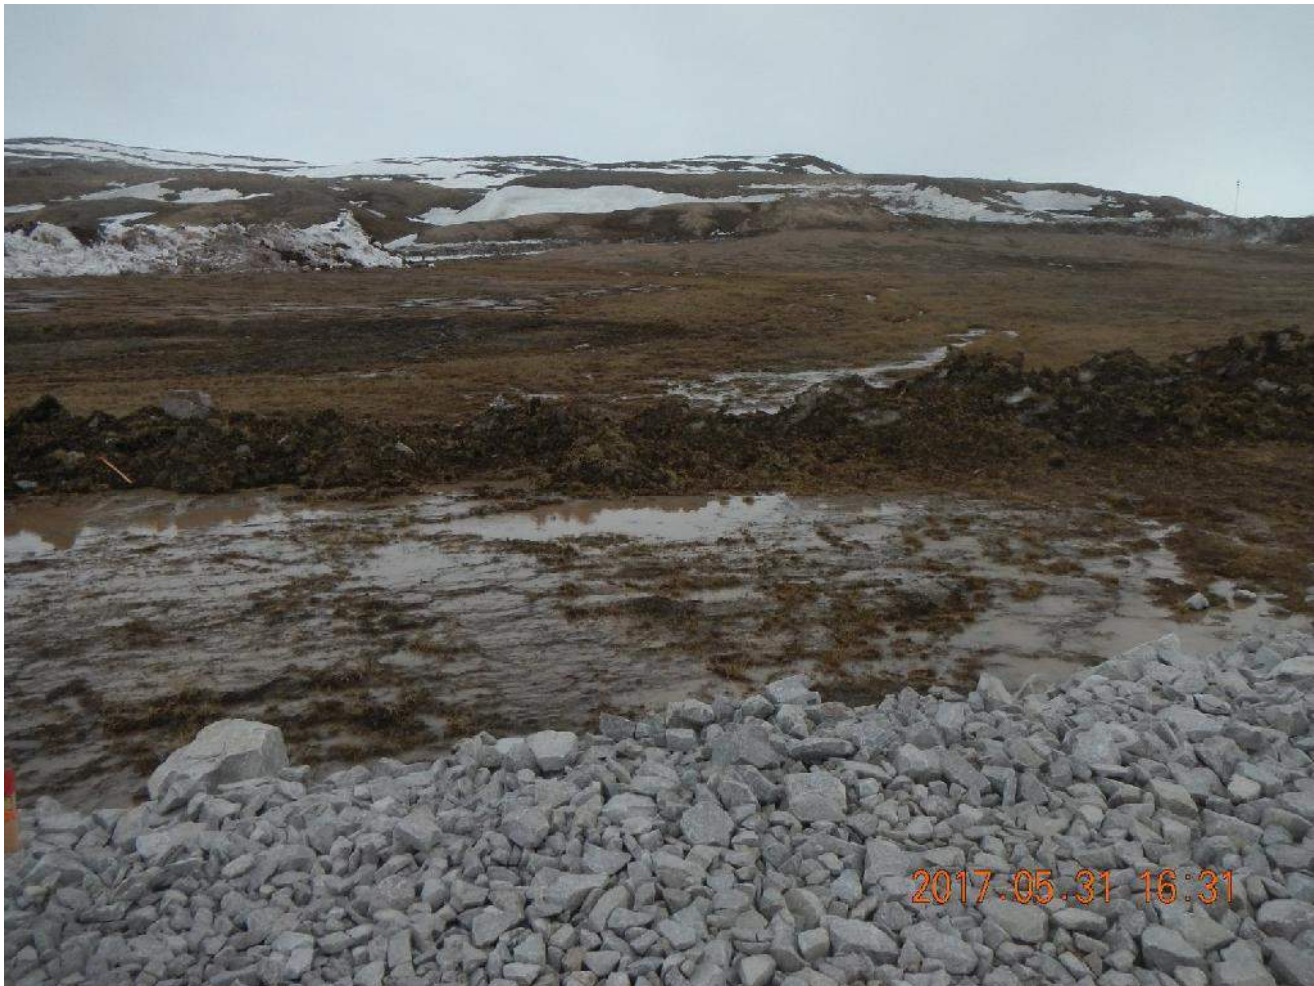
- c. The ditches surrounding the facility do not appear to be graded properly due to water pooling within the unlined ditches.
 - d. The Licensee is removing snow mixed with crushed ore from within the containment facility and dumping it outside of the facility (figure 3).

Figure 3: Snow Dump area, top left of the picture

- i. The inspector is requesting that BIMC discontinue this practice and allow the facility to contain the snow/water that comes in contact with the ore stockpile pad.

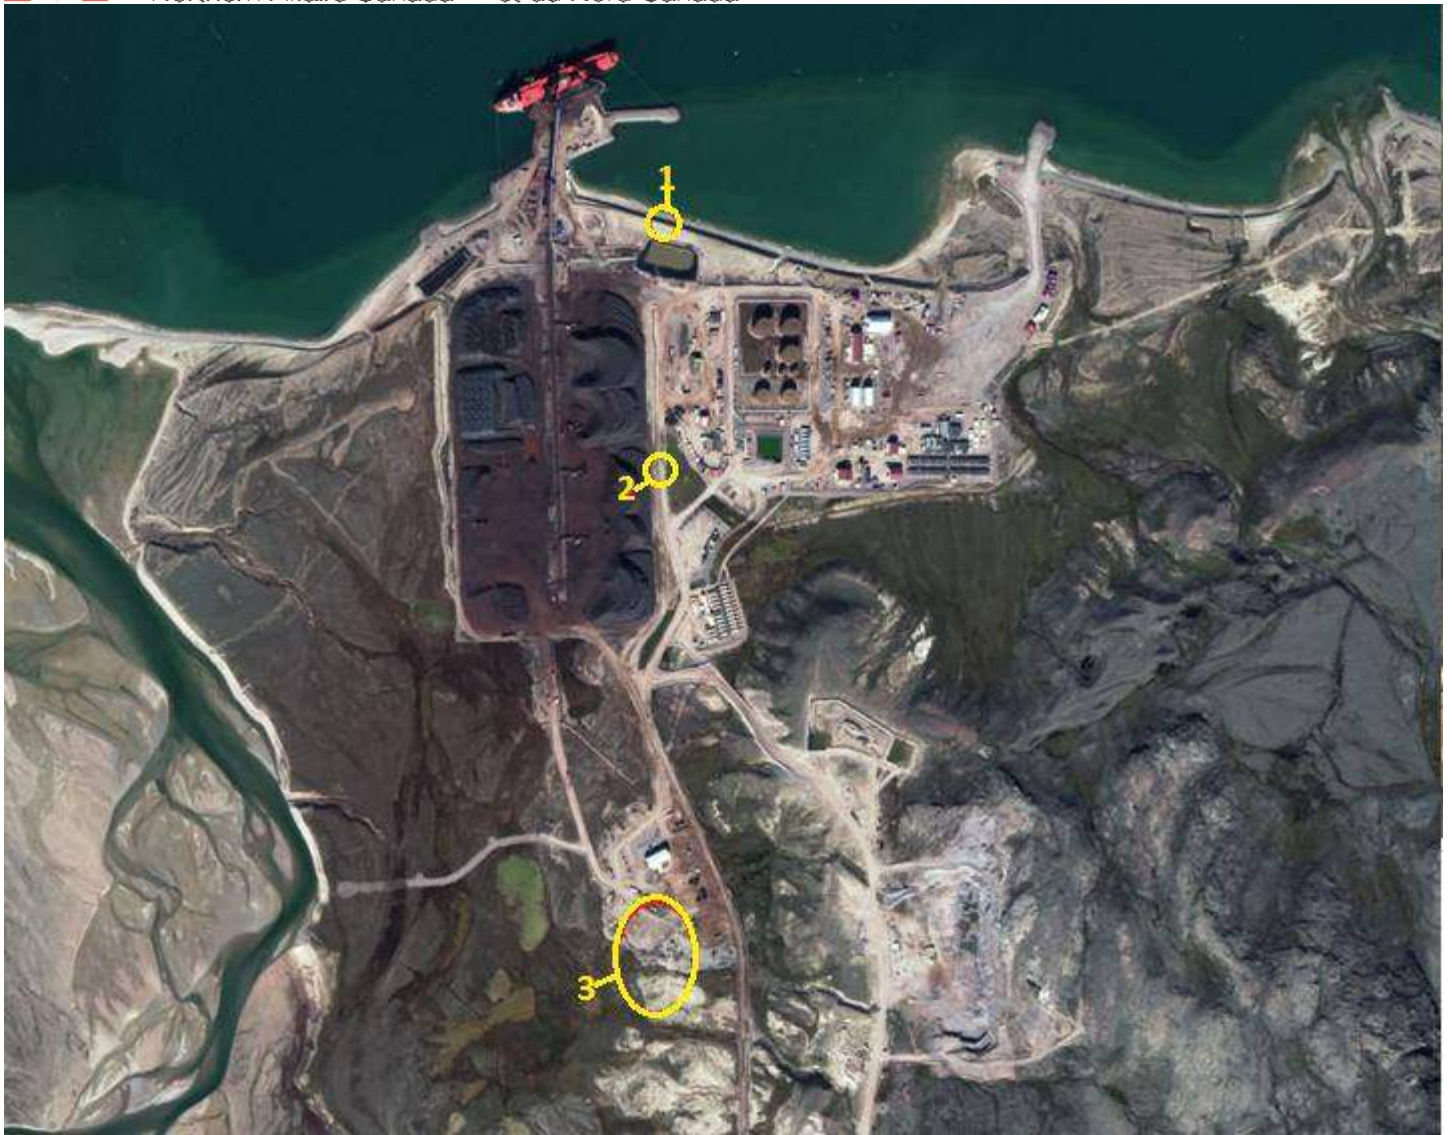
- b. At the time of the inspection there was water infiltrating the ore stockpile pad, see figure 4 Item 2 below. This appears to be the reason of the unauthorized discharge from the east sedimentation pond.

Figure 4: **Item 1:** Washout from East sedimentation pond. **Item 2:** location of water infiltrating ditches, the old snow dump and sampling location. **Item 3:** approximate location of the Camp lay-down Pad

- i. INAC Inspectors have expressed concern with this area where water is pooling before.
 - ii. It's advised that BIMC find a way to properly divert the water away from this area.

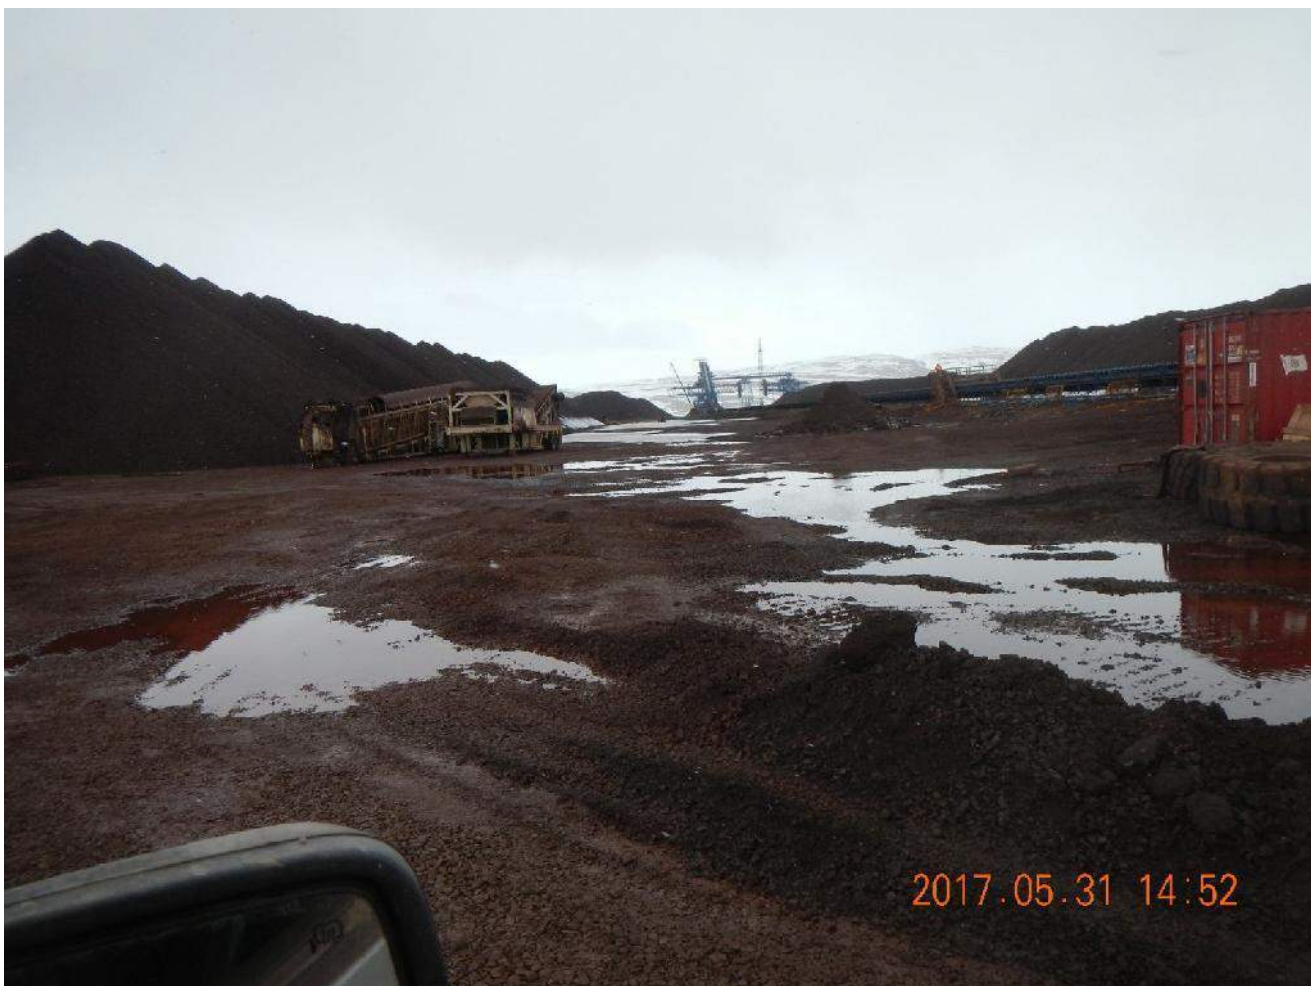
- 1. Ore Stockpile Pad and associated water management structures
 - a. The Ore Stockpile Pad had significant pooling inside the facility (figure 5 below); this leads the inspector to believe the facility is not being maintained properly.

Figure 5: water pooling inside the ore stockpile pad

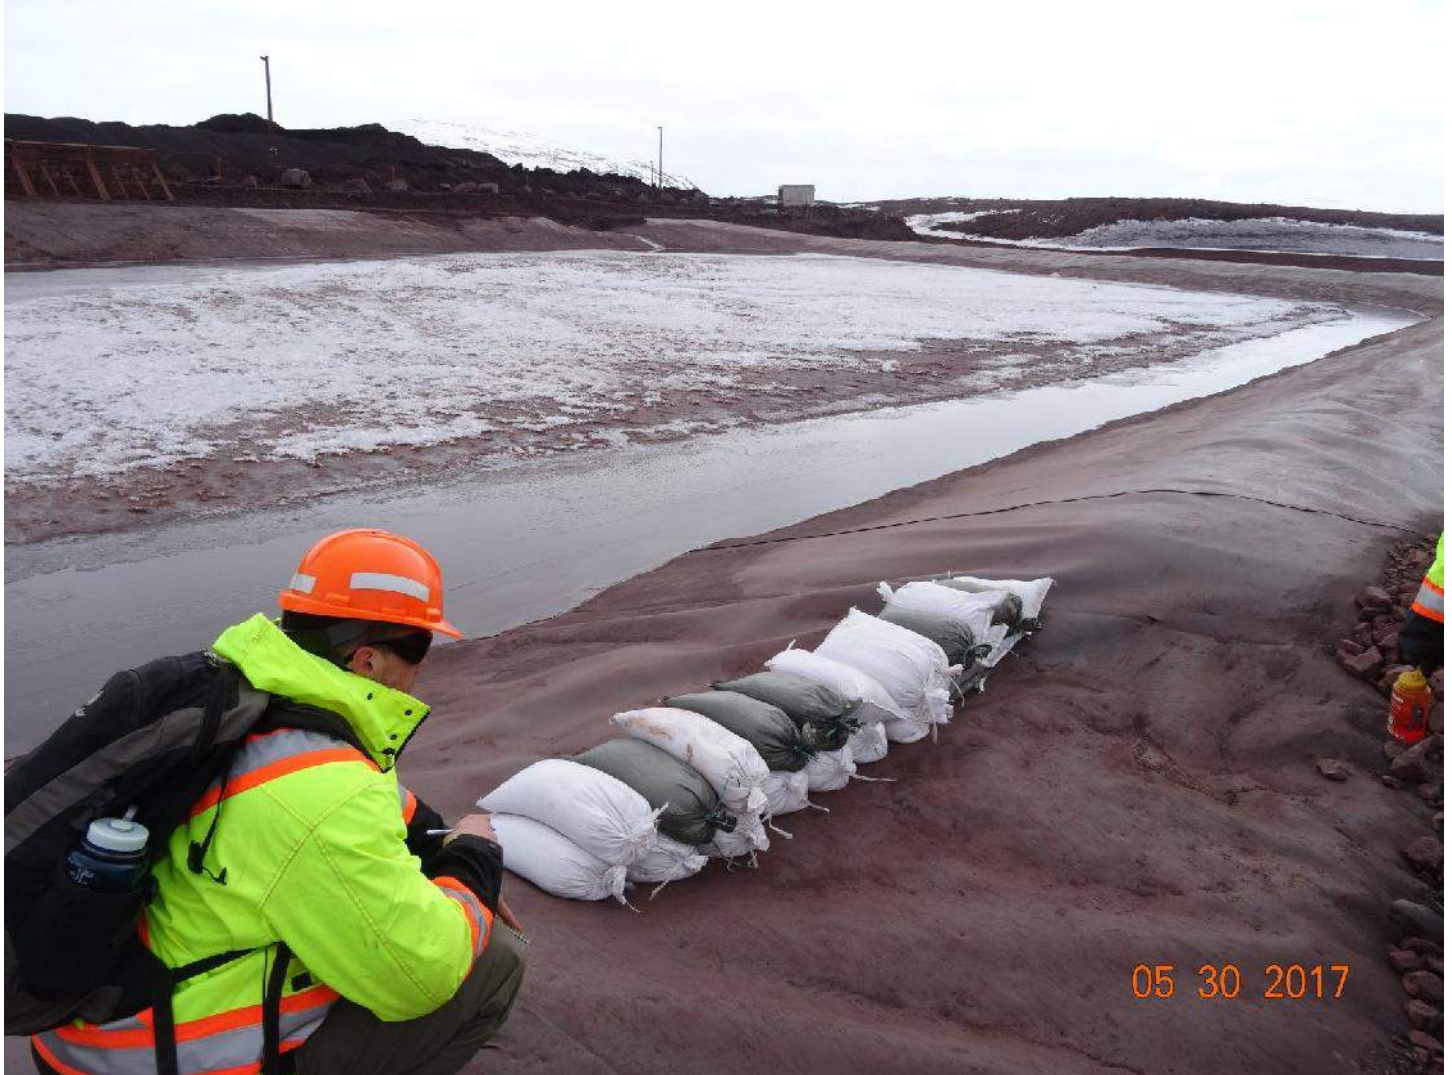
Figure 6: sandbags improperly installed

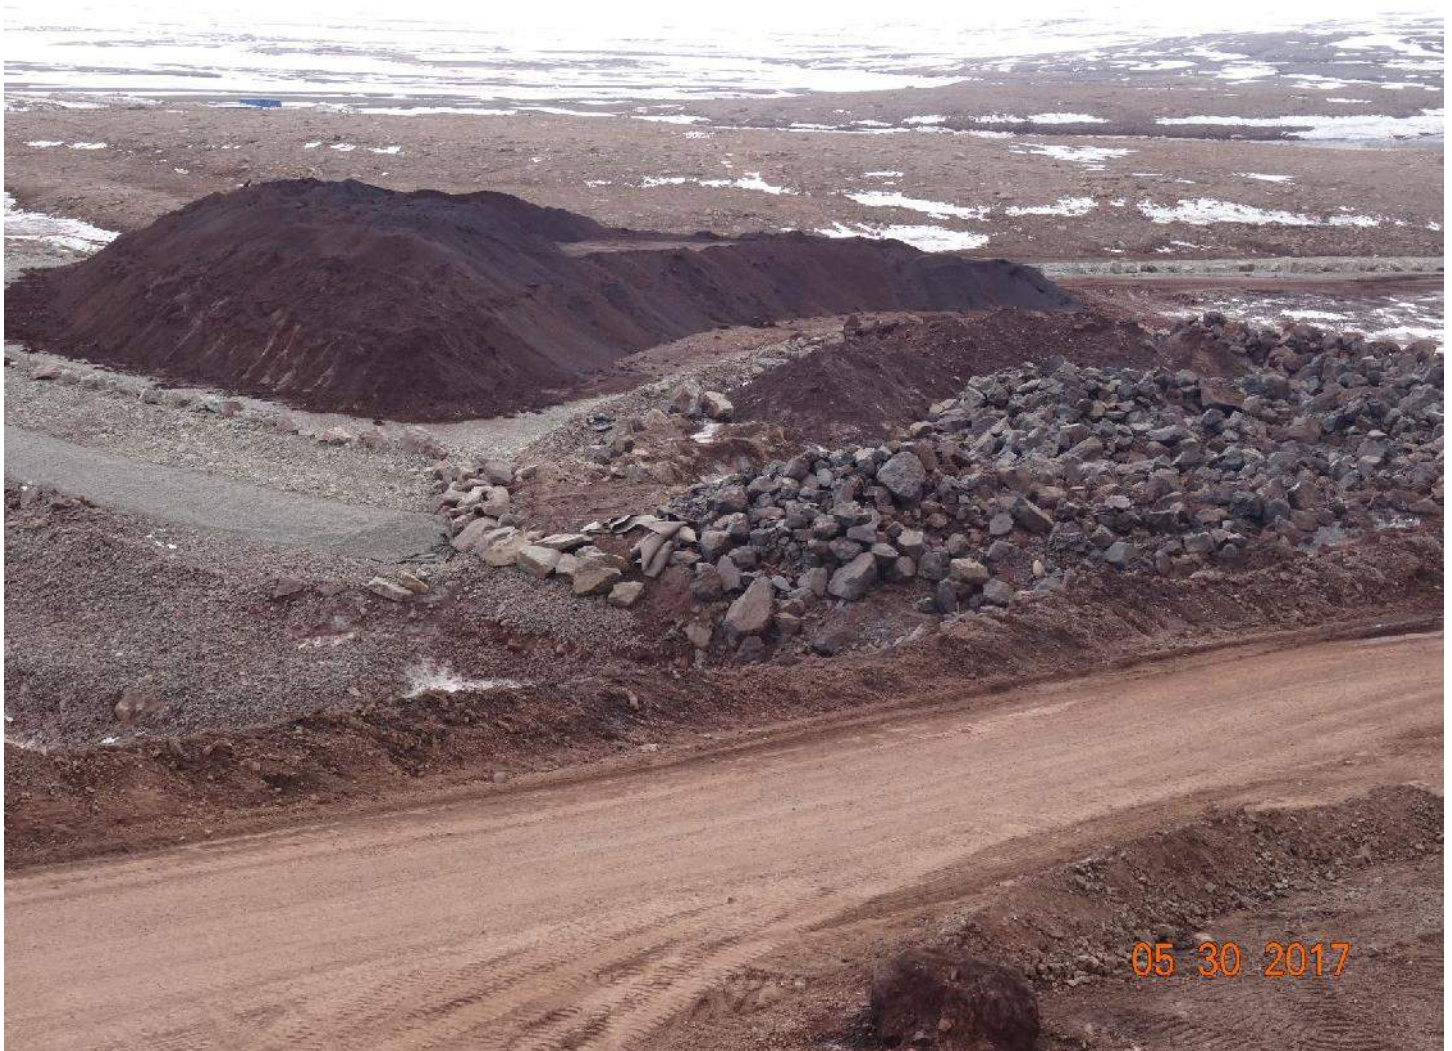
Figure 7: Oversized Ore outside of ditching

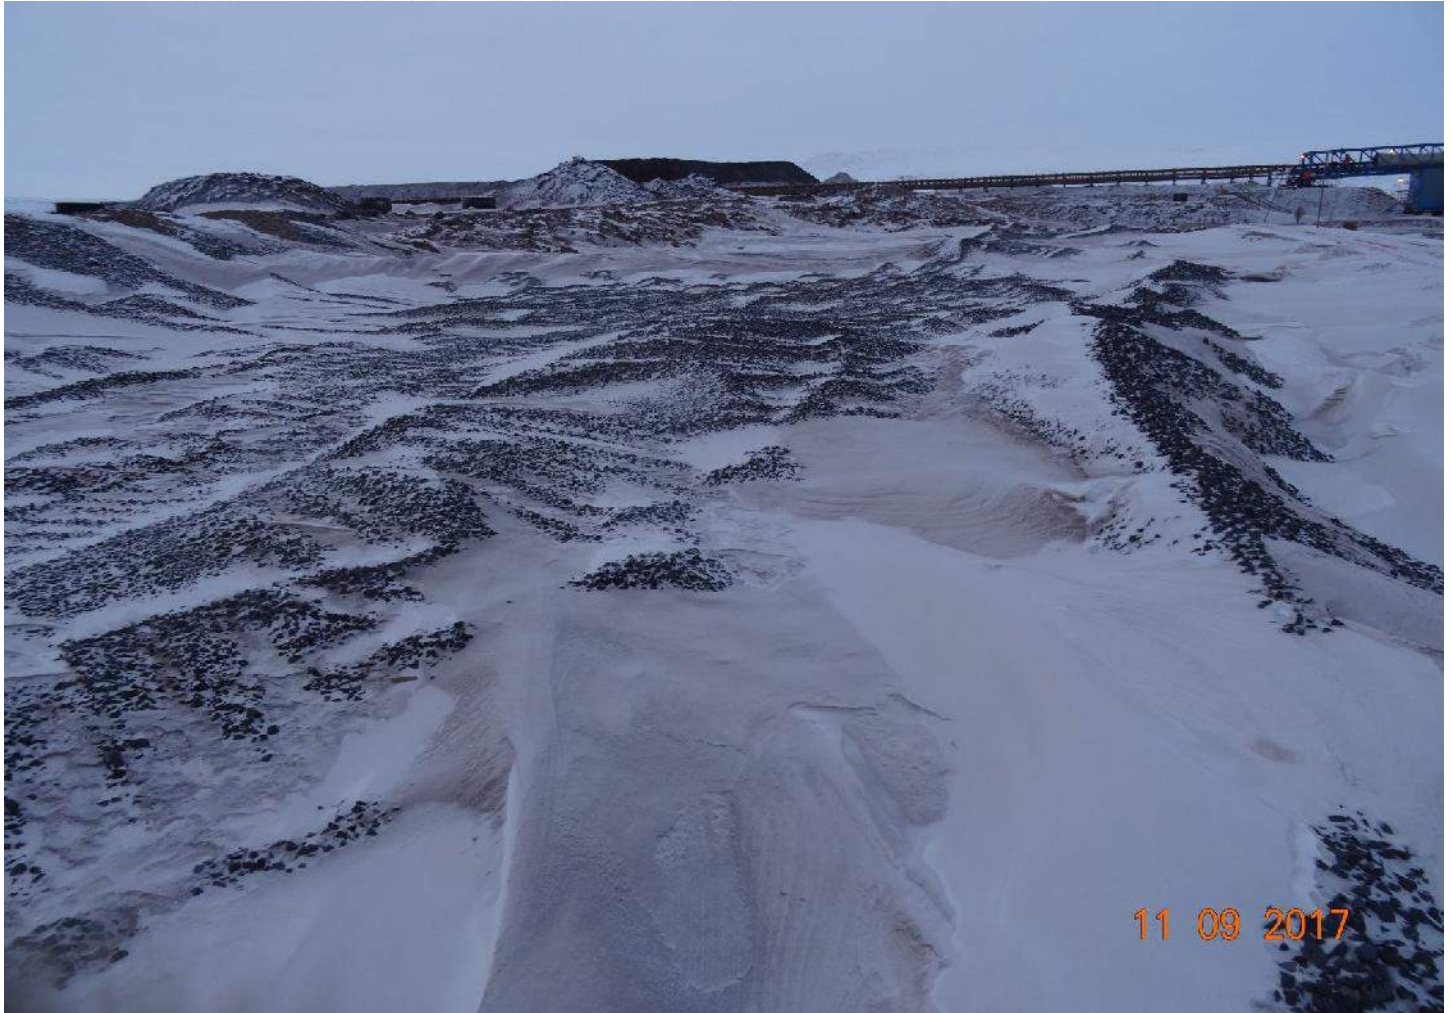
Figure 1: crushed ore being used for fill.

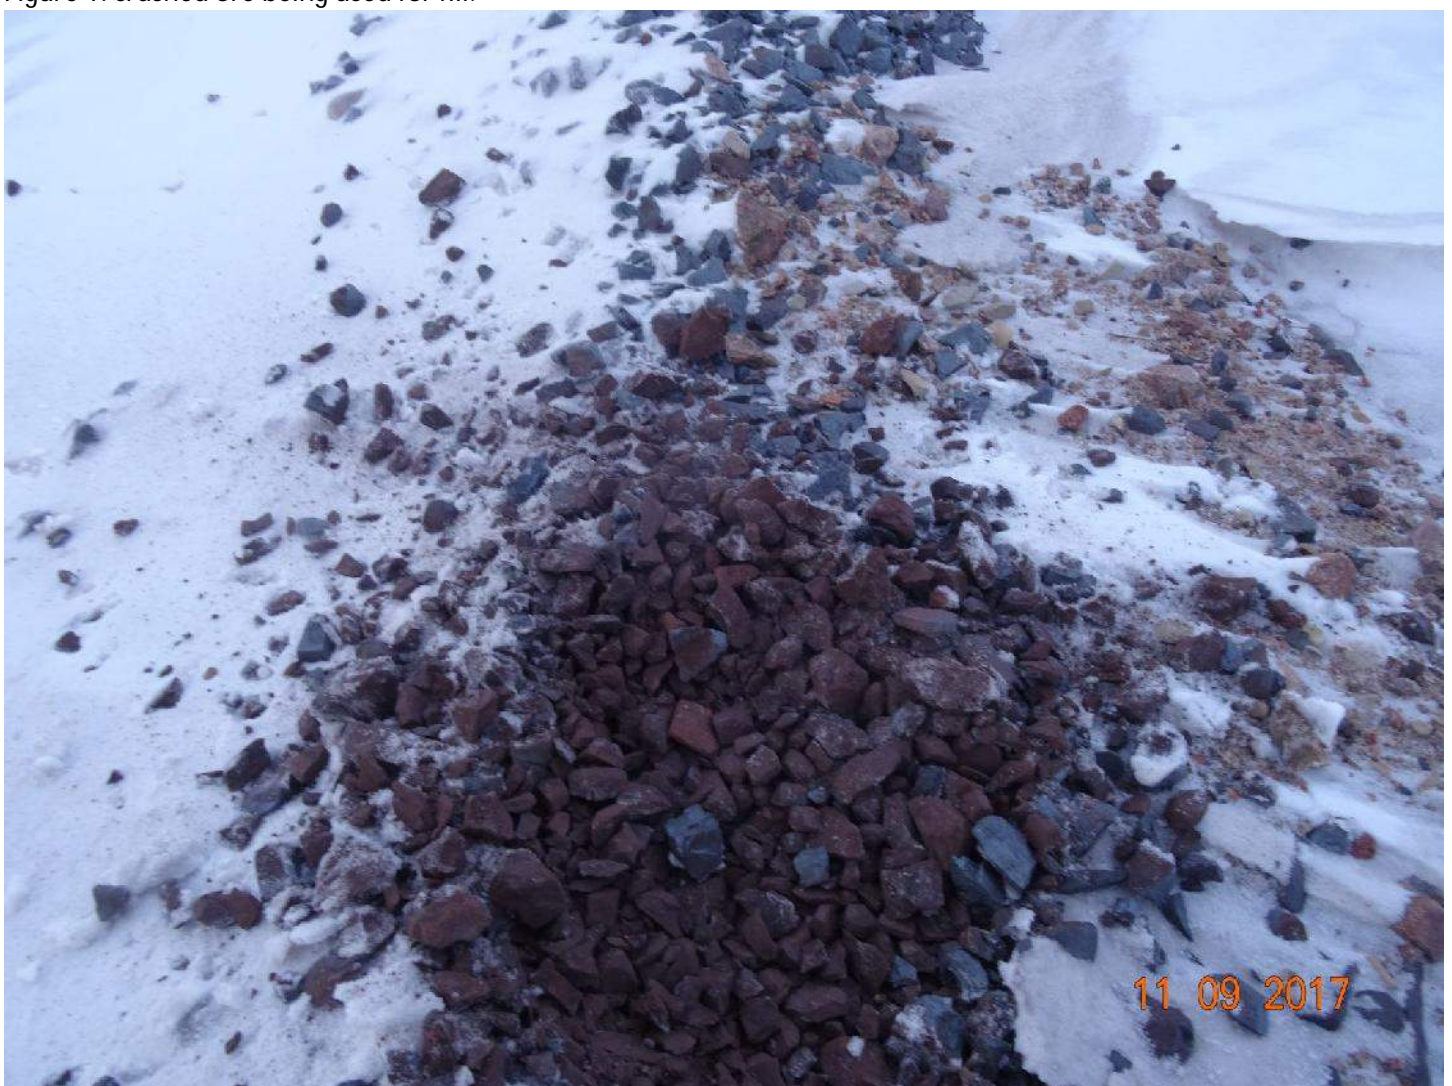
Figure 2: ore being used for fill

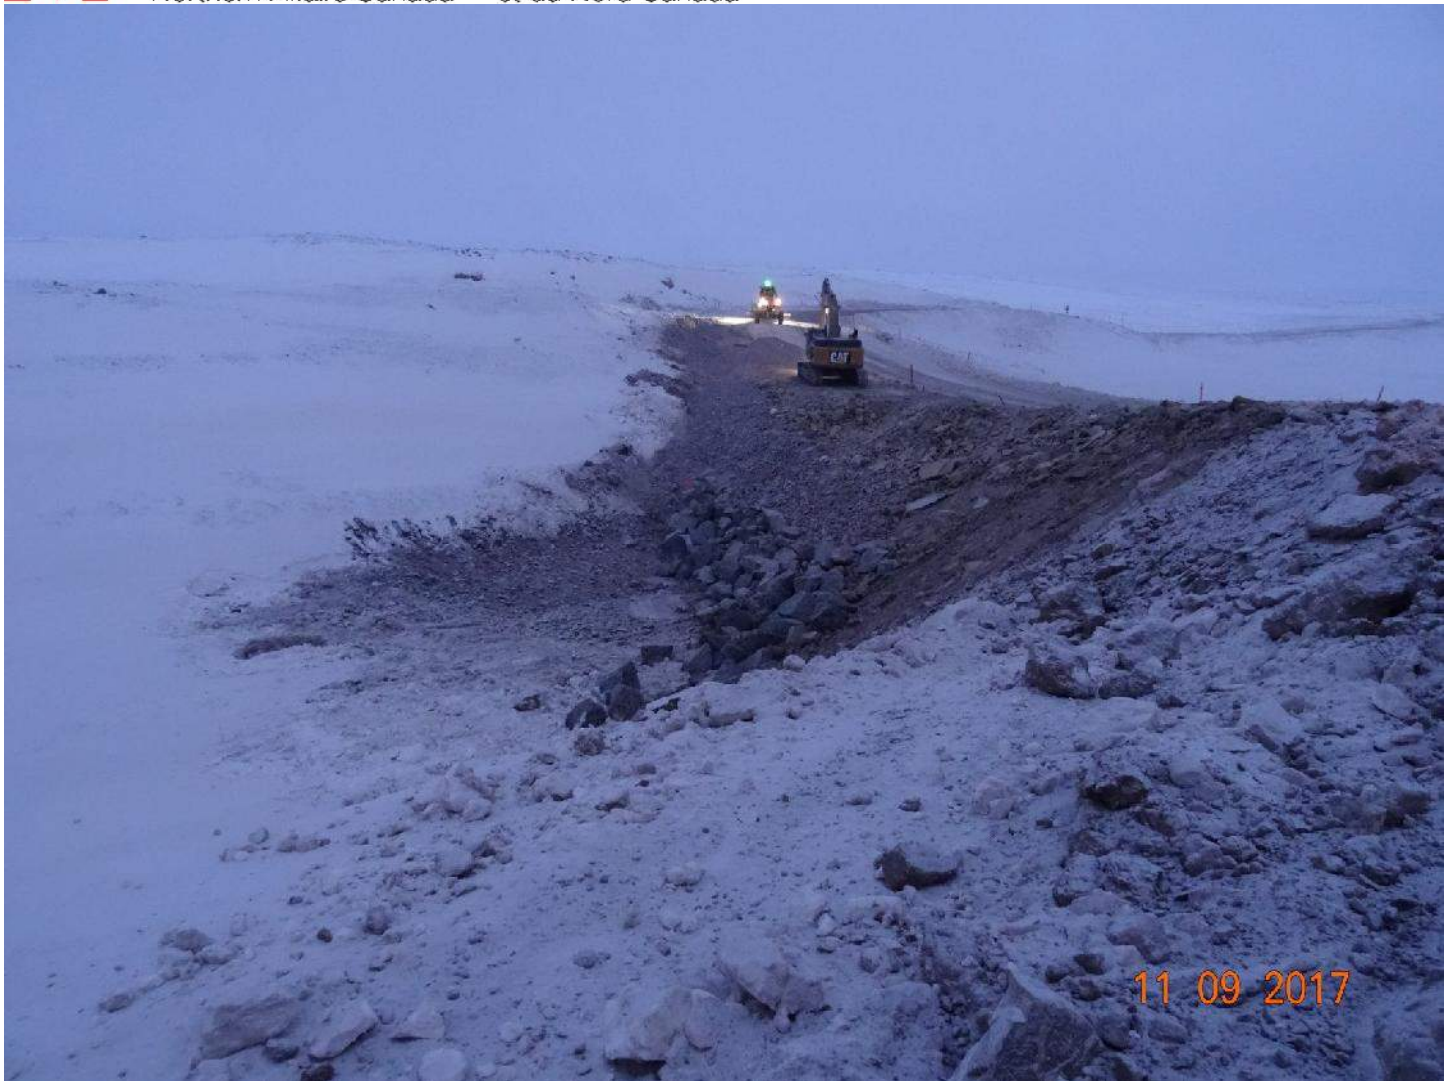
Figure 3: Km 85 construction

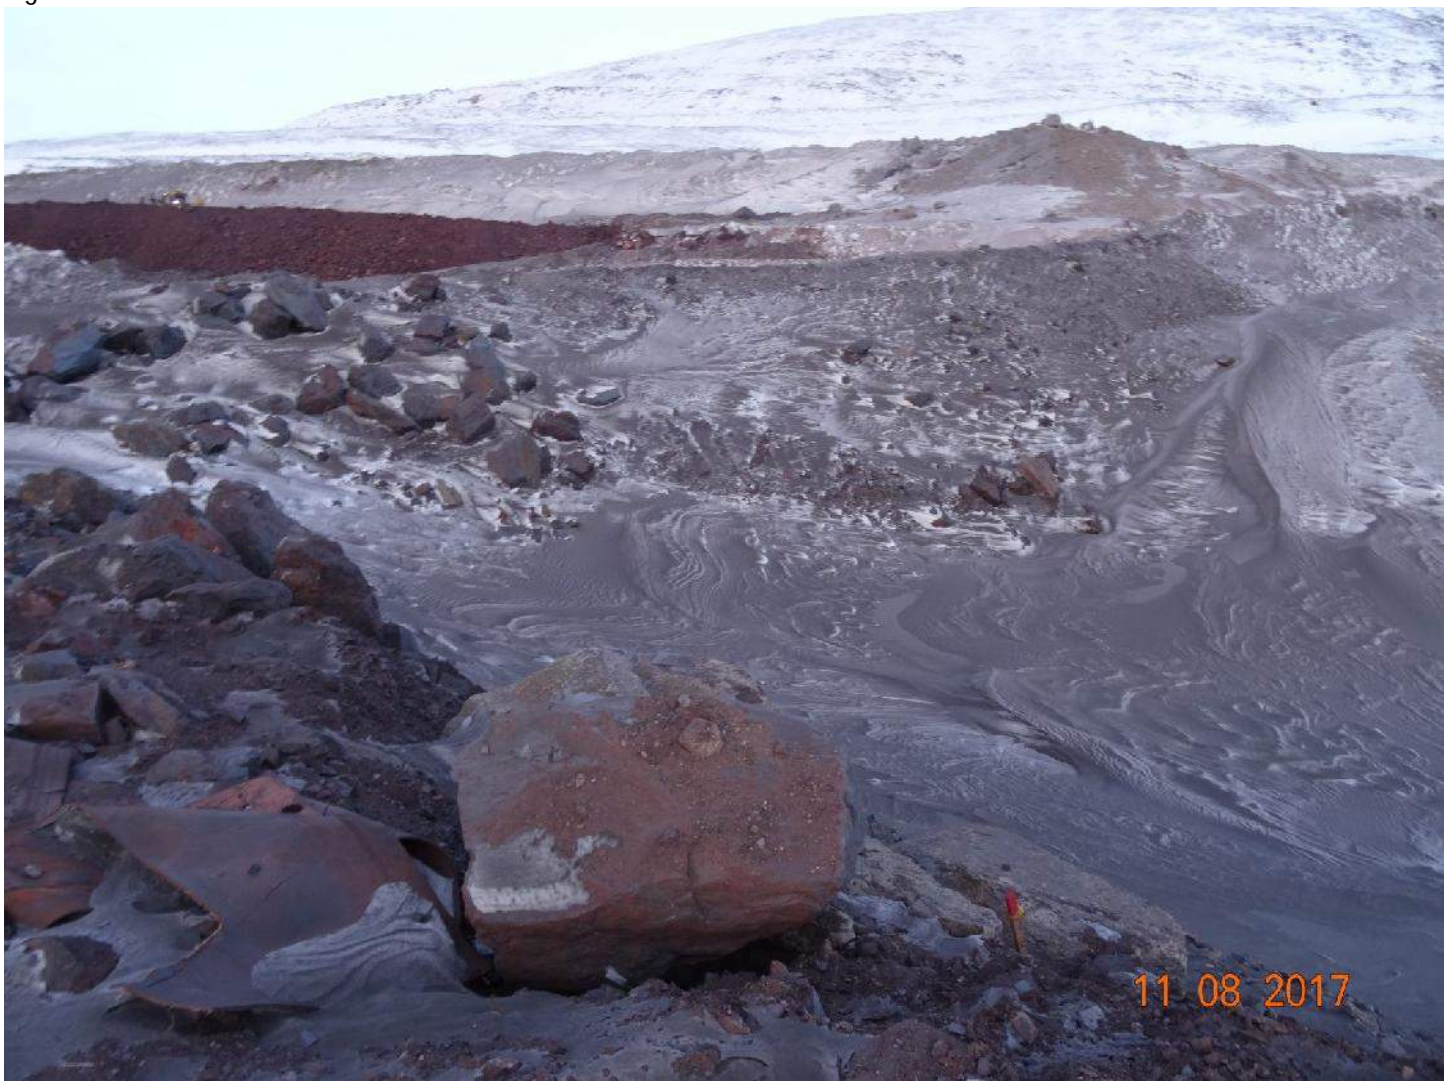
3. **Ore Crushing Area and associated water management structures**
 - a. As noted in the previous inspection, the diversion ditches around this facility do not appear to fully surround the ore crusher pad. See figure 4 for the area that is not contained by ditches.

Figure 4: Crusher pad-There is no diversion ditches below this “oversize” ore.

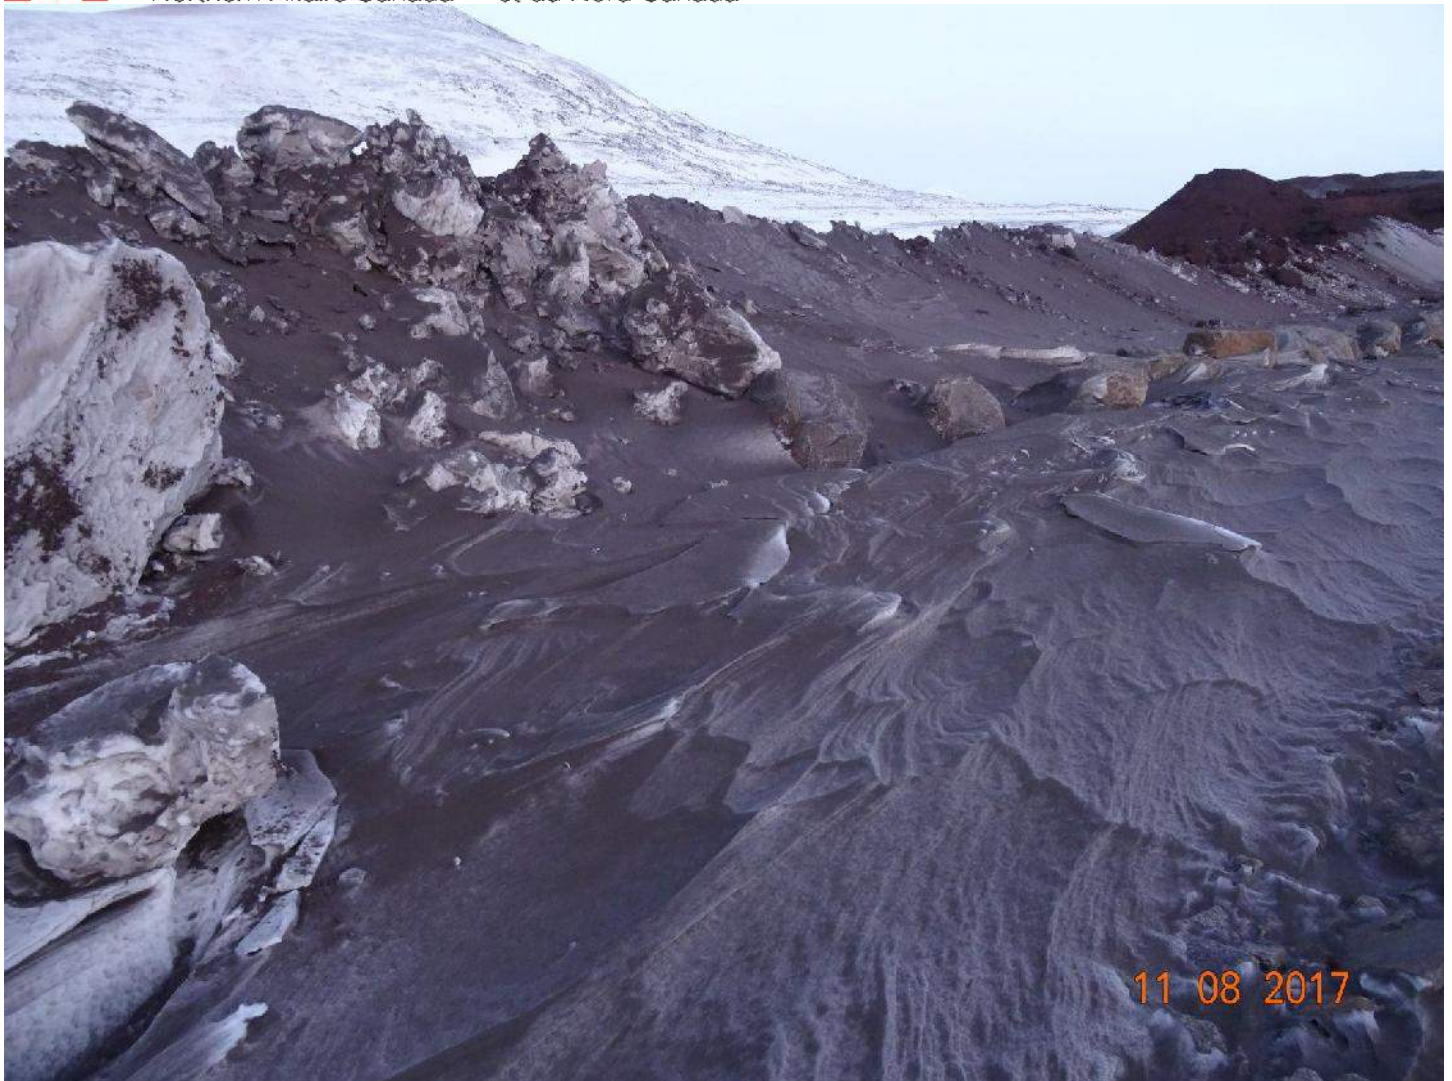
Figure 5: snow pushed into the ditches.

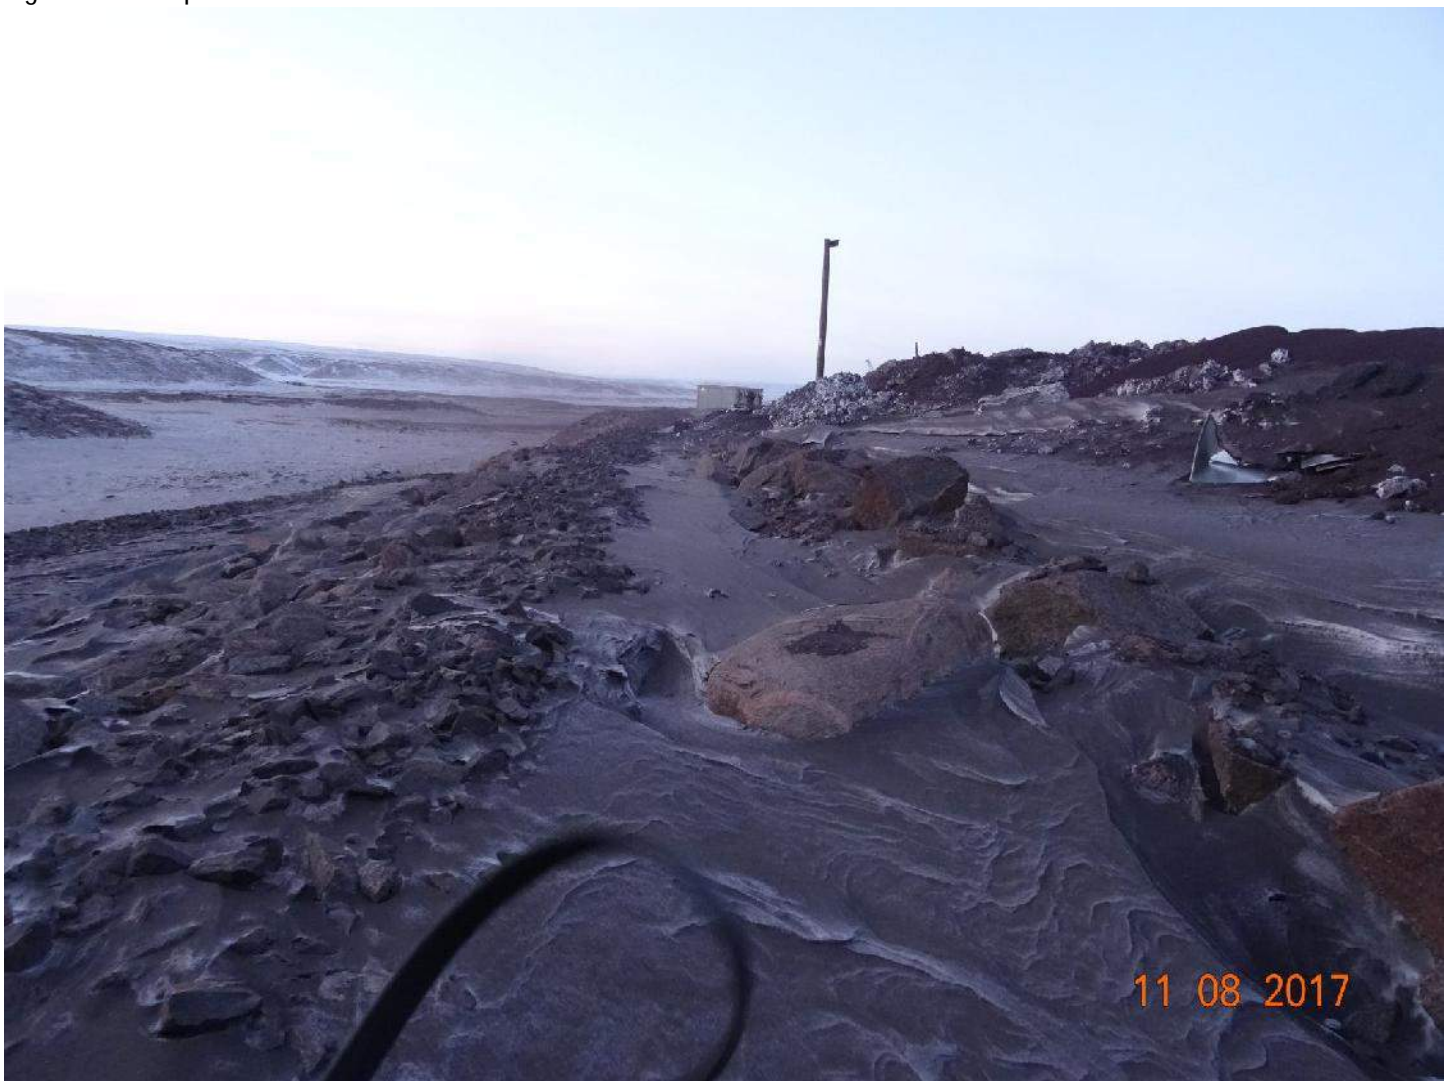
Figure 6: Boulder pushed into the ditch.

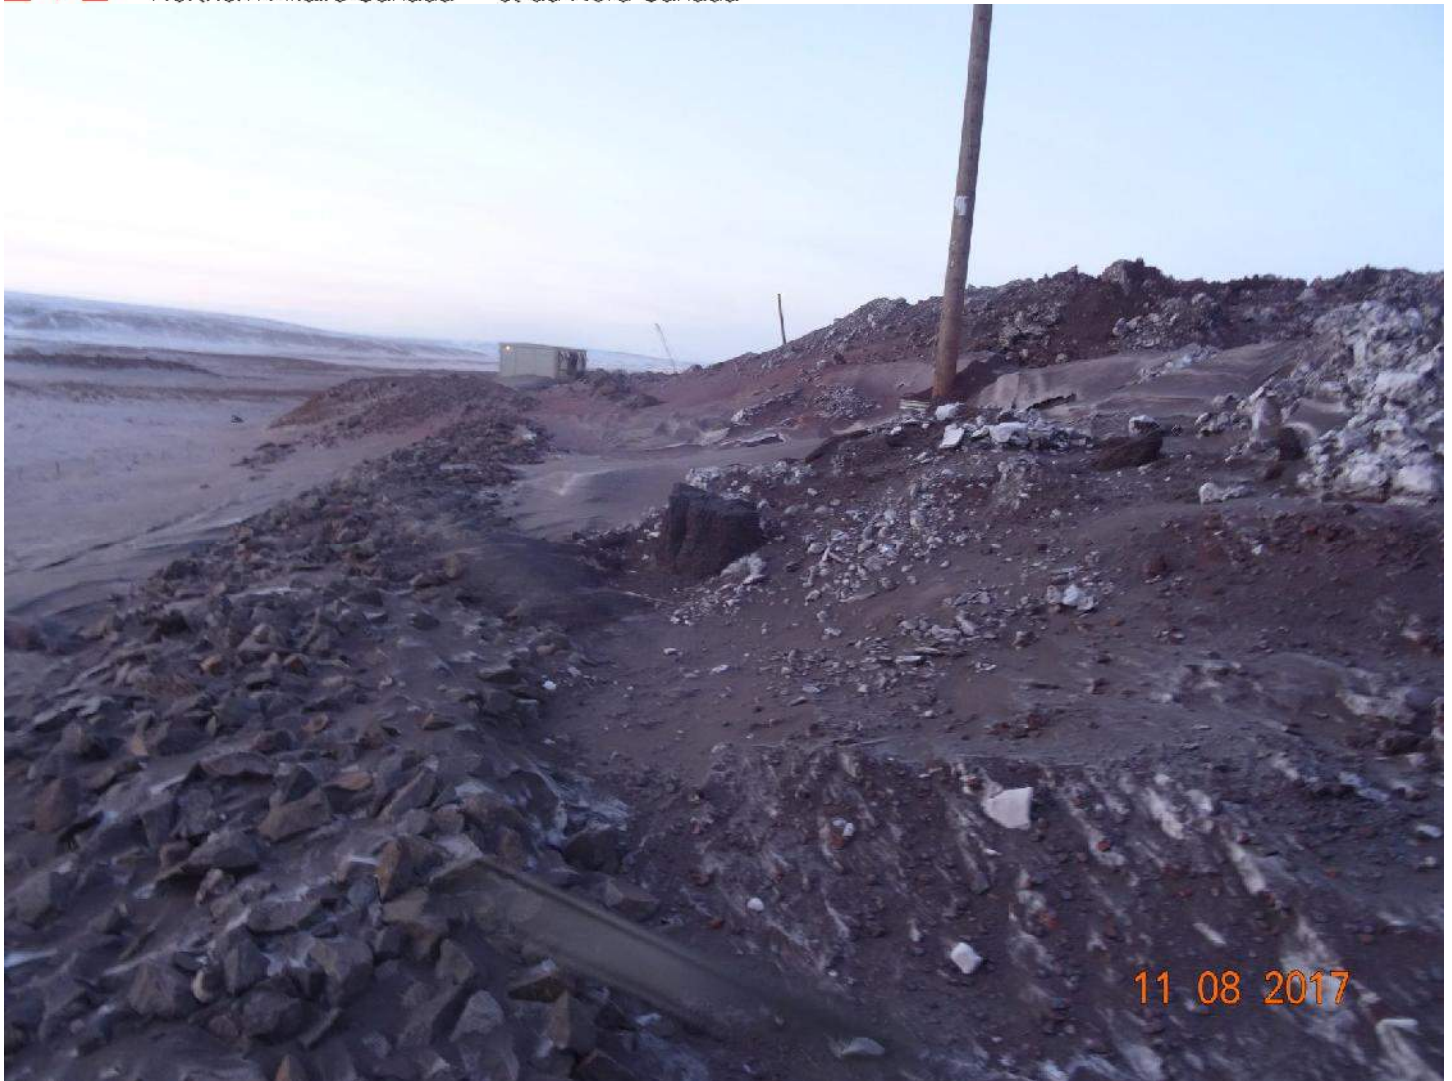
Figure 7: crushed ore pushed into the ditch.

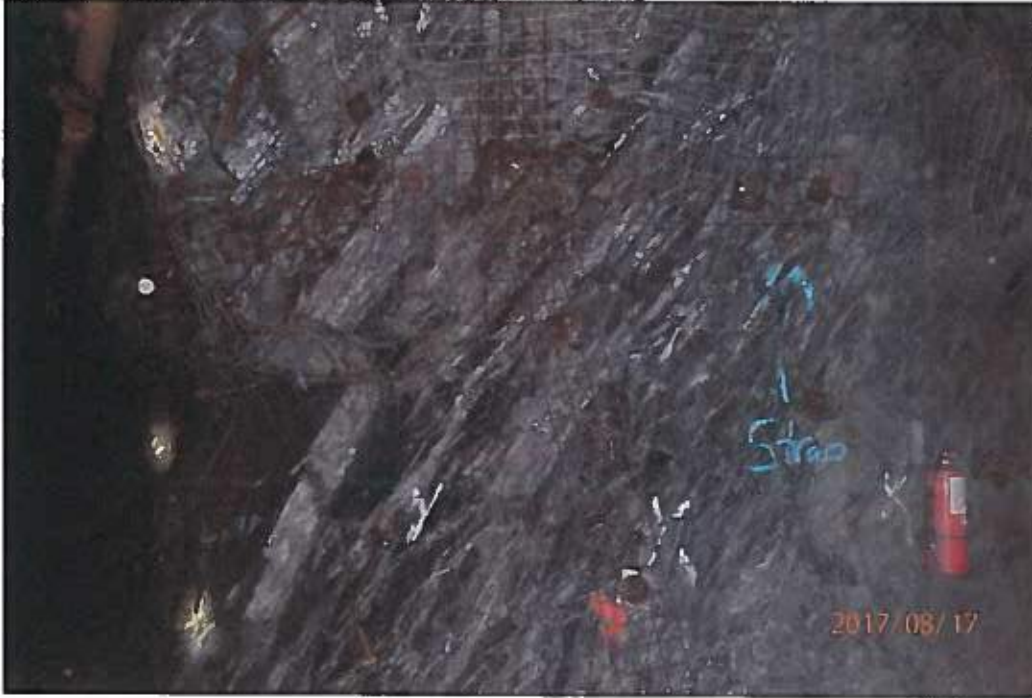
Photo 1. Pillar rehabilitation. Note foliation planes opening

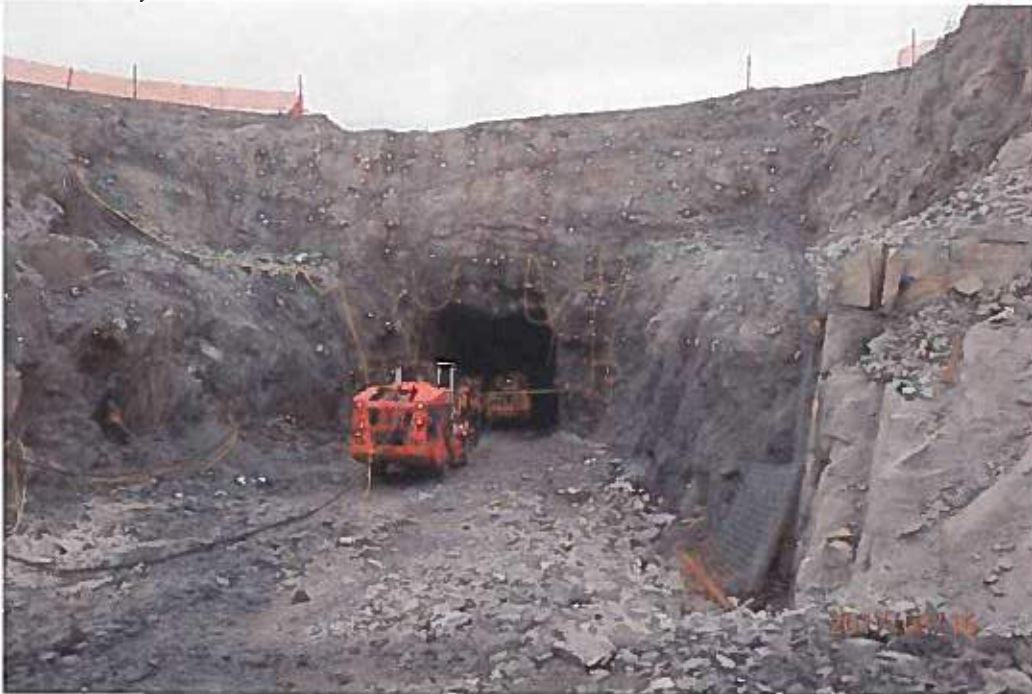
Photo 2. Box cut for Portal 2. Supported as per design. A multi-plate culvert will be socketed into the rock and then backfill placed.
