APPENDIX E.8.4

INAC INSPECTION REPORTS AND BAFFINLAND RESPONSES

WATER LICENCE INSPECTION FORM

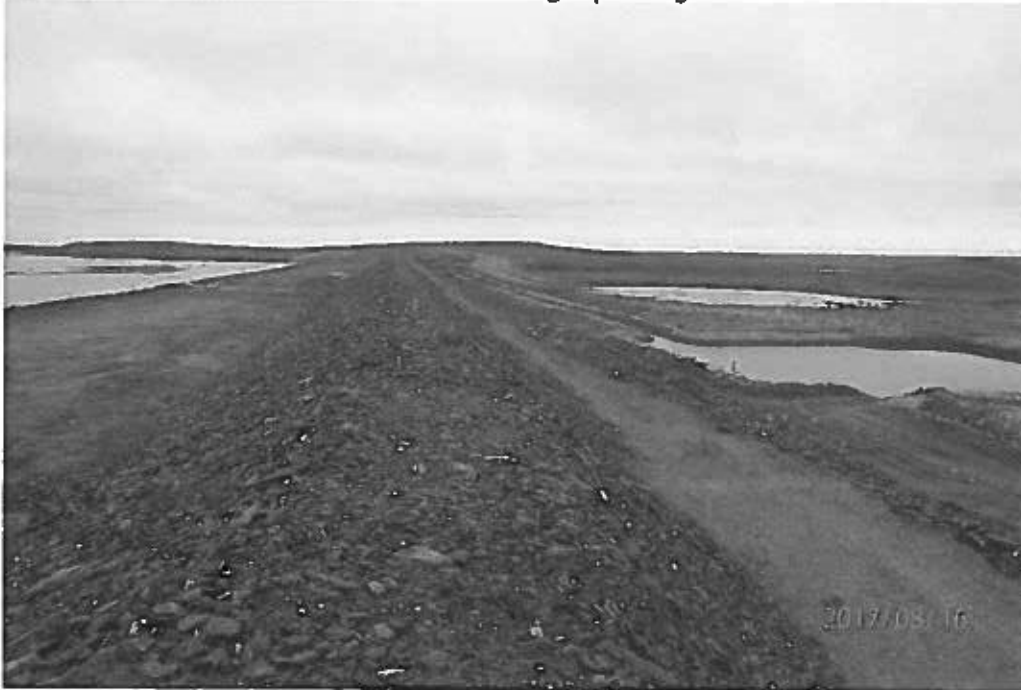
Photo 3: DCP-1, Thermistors indicated core is freezing as per design
