APPENDIX E.8.7.2
INITIAL AND FOLLOW UP SPILL REPORTS
OTHER
(Part 1)

Re: Follow-up to Spill #17-002, Reported on January 2nd, 2017
Mary River Project - Water Licence No. 2AM-MRY1325

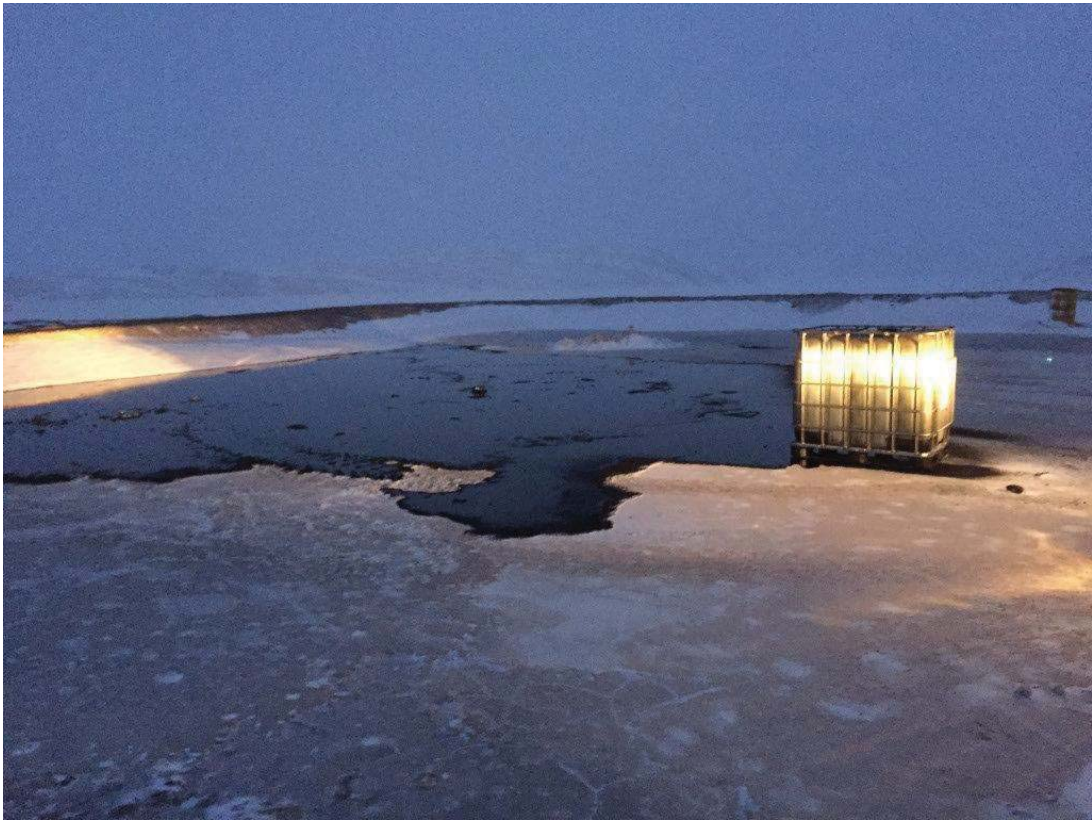
On January 1st, 2017 at 22:00 a Surface Works operator was asked to dispose of sump water totes. Sump water is stored in the contaminated snow dump, a lined engineered facility to be processed during the summer months. The operator took the tote to the snow dump and opened the valve to drain the tote. The operator picked up a second tote and returned to the snow dump. When he entered the snow dump with the second tote he noticed the initial tote had contained waste oil, which had emptied into the lined snow dump. Approximately 1m³ of waste oil was released. The closest water body is >100 m and is currently frozen; the spill is confined to the lined snow dump.

Photo 1: Oil Spill Milne Port Contaminated Snow Dump

The Surface Works Supervisor was immediately notified. The waste oil and affected snow/ice was scraped up using an excavator and placed into over pack drums. The over pack drums were removed and placed into the Milne Port Hazardous Waste Berm 1 (HWB1) which is a lined containment facility. Visual observation indicates that the contaminated material was successfully removed.

Surface Works supervisors are to review sump water disposal procedure with all operators and ensure all new employees understand the procedures related to their work duties. The Surface Works operators are to remain at the scene when emptying totes at the snow dump to verify that the contents are strictly sump water. Maintenance lead hands or supervisors are to ensure all totes are properly labelled indicating the contents.

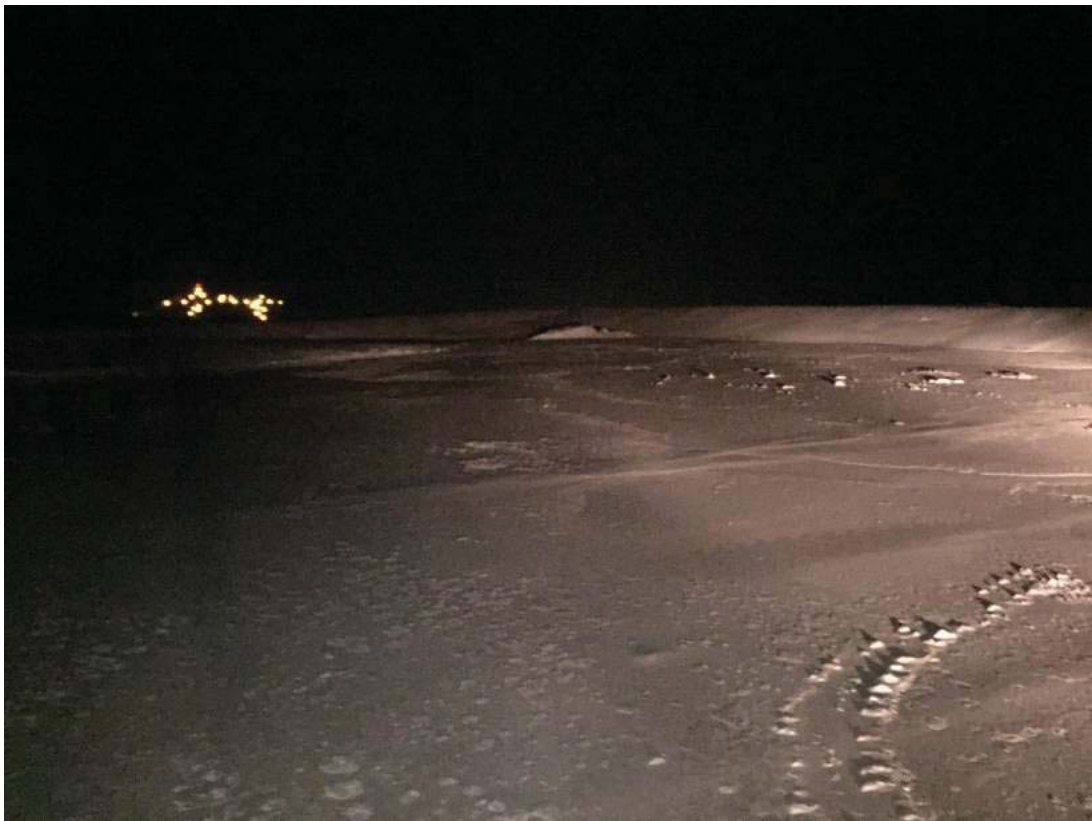
Photo 2: Oil Spill Post Clean Up

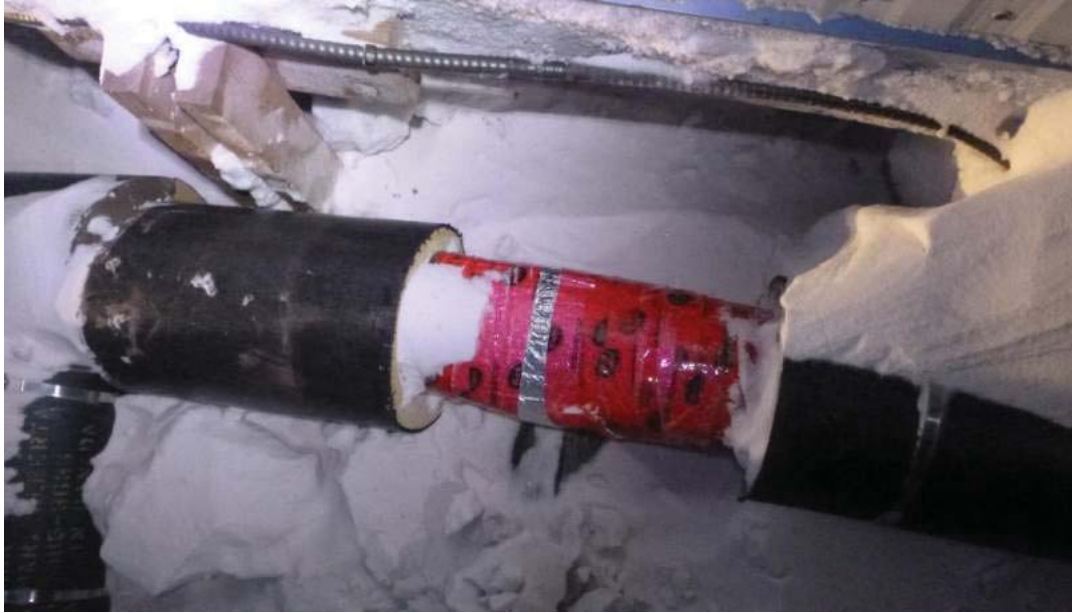
At 09:30 HRS on January 11th, during a daily routine inspection, a Site Service worker noticed and responded to sewage leaking from behind the West AF Wing lift station (LS 15) of the Mine Site Complex (MSC). Approximately 500 L of raw sewage was released to the adjacent camp pad ground surface, impacting approximately a 20 m² area. The leak occurred due to a disconnected coupling on the gravity line. The coupling was repaired within several hours of discovery. This location is greater than 100 m to the nearest water body, which is currently frozen.

Photo 1 – Repaired and insulated coupling prior to fiberglass insulation being installed.

The Employee immediately reported the leak to his Supervisor, and the Environment Department was notified. The coupling was repaired within hours of being reported. Visual observation of the affected area was impeded by surrounding structures and recent snow fall.

Modifications to current lift station styles to allow for shifting are being investigated.

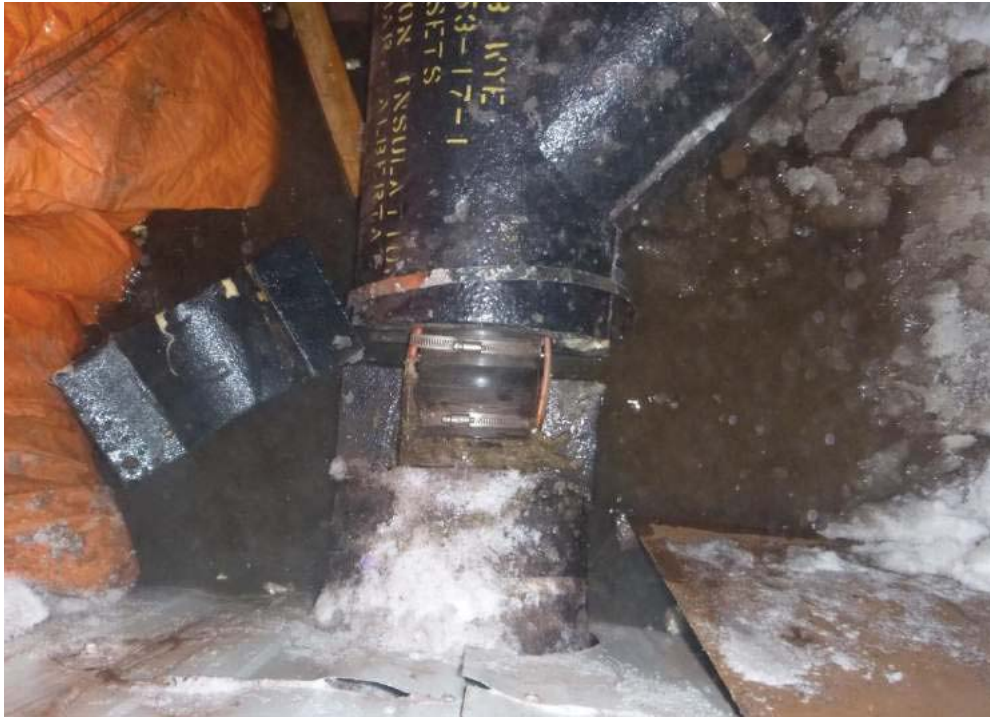
On January 13th 2017 at 9:00 HRS a Site Services Fixed Plant employee was completing the routine (daily) checks of the sewage lines and observed steam coming up through the snow behind the east lift station of the AB wing of the Mine Site Complex (LS 10). After removing snow, it was observed that the gravity line feeding the lift station had become separated by a 2 cm gap, allowing sewage to be released on the camp pad. Based on the daily inspection frequency, it is suspected that it had been leaking for less than 12hrs. It is estimated that an approximate volume of 600 L was discharged to the surrounding camp pad. This location is greater than 100 m to the nearest water course which is currently frozen.

Photo 1: Separated coupling on the gravity line feeding the lift station

The Environment department was notified and completed an inspection at 9:30HRS. Site Services Fixed Plant used a vacuum truck to remove 150L of pooling sewage which was deposited into sewage pond 1. The separated line was repaired and insulated.

Modifications to current lift station styles to allow for shifting are being investigated, as well as the possibility of using enhanced secondary containment berms. Baffinland will continue to perform daily checks of the sewage lines and monitor for potential leaks.

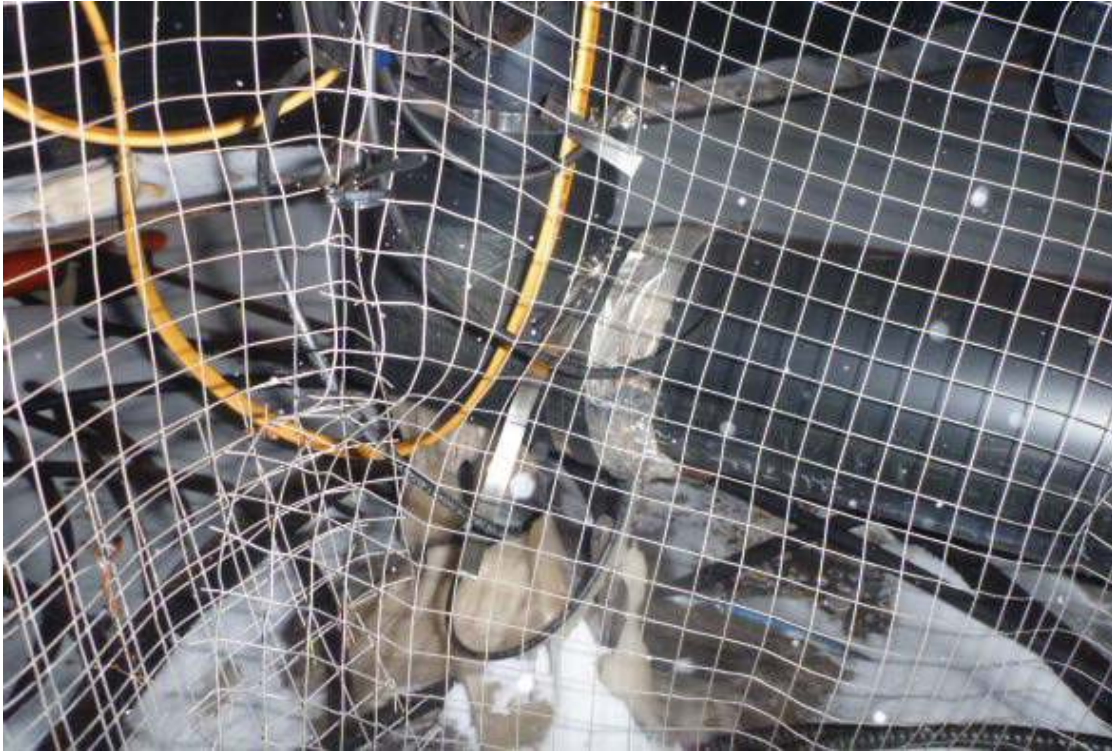
At 16:00 HRS on January 24th, an employee notified the Environment Department of an odour coming from the AC wing of the Mine Site Complex (MSC). It was observed that the discharge line from the lift station on the South side had separated at an elbow. Upon initial investigation, the heat trace had failed contributing to a frozen discharge line. Approximately 1000 L of sewage was released to the adjacent pad, impacting an area of 120 m². The location of the spill was confined to the MSC camp pad, migrating underneath the complex wing, and is greater than 100 metres from the closest water body which is currently frozen.

Photo 1 – Discharge line separated at elbow

The failed elbow and heat trace have been repaired. Snow removal between the accommodation wings continues.

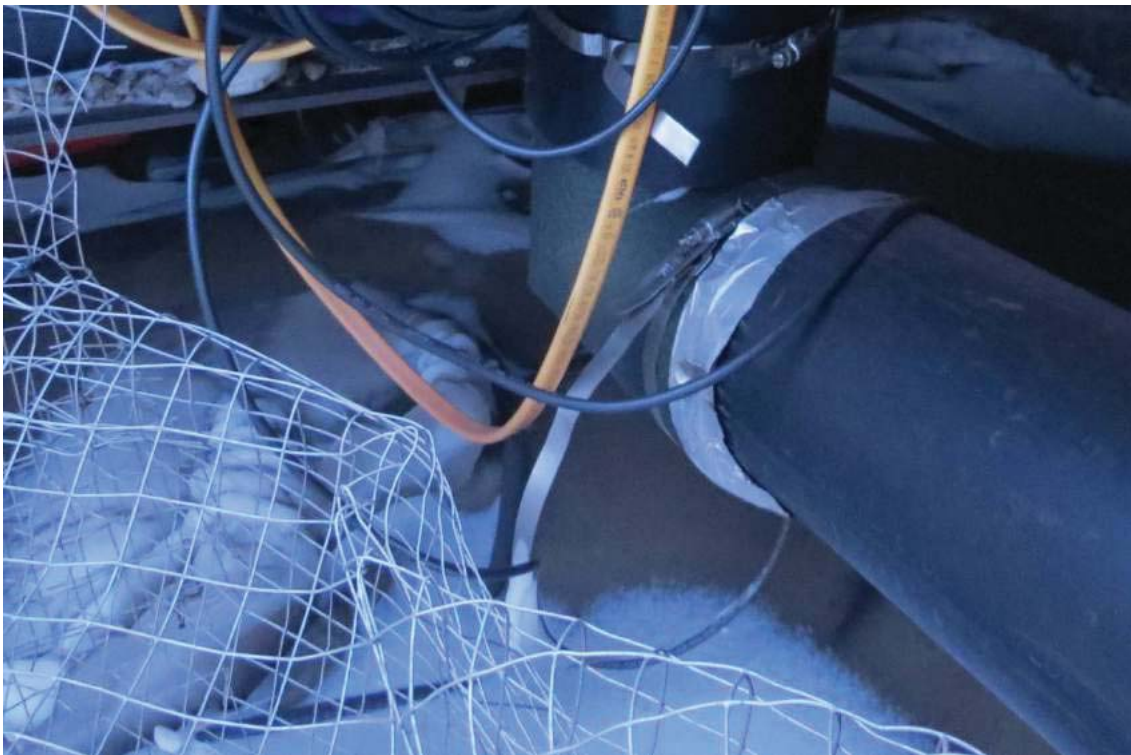
Photo 2 – Discharge Line Elbow Repaired

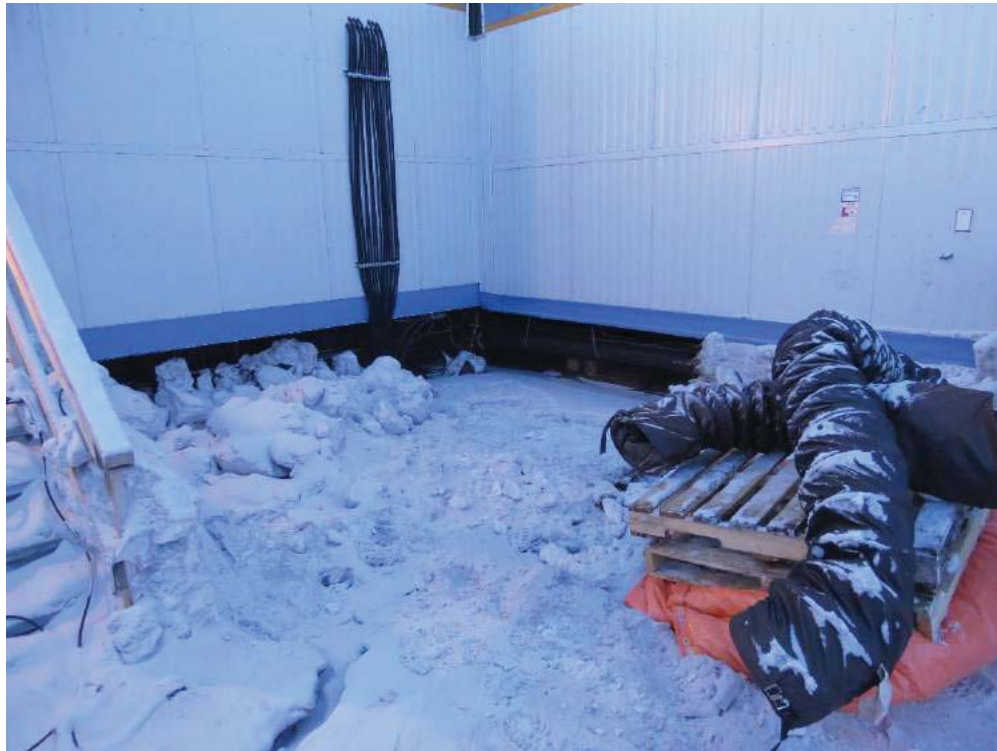
Photo 3 – Location of Failed Discharge Line

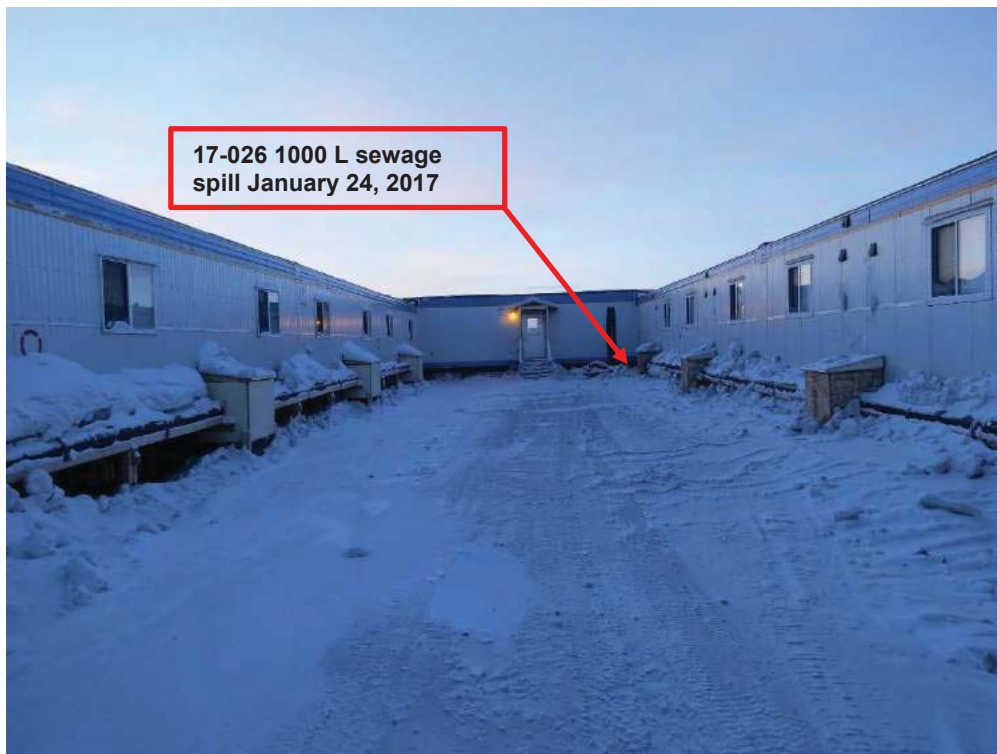
Photo 4 – Snow Clearing Efforts at Location of Release

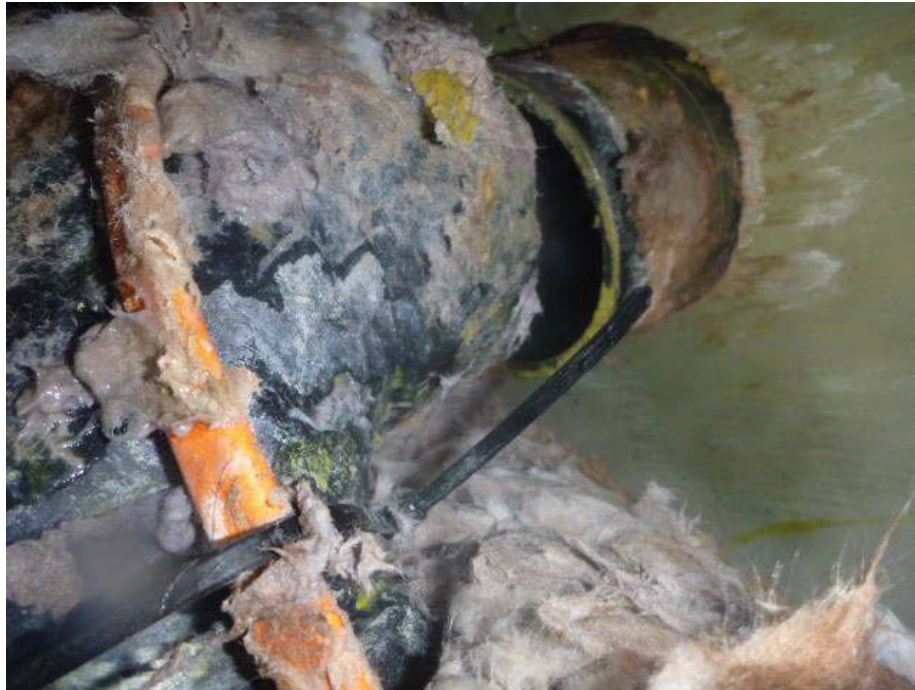
At 16:00 HRS on January 31st 2017, housing maintenance was performing routine inspections when they noticed an ice impacted area below the MSC laundry wing. It was observed that the discharge line from the three industrial washing machines had separated at an elbow. Upon investigation, it is expected that extreme temperatures caused expansion and contraction leading to the pipe fitting failure. Approximately 2 m3 of grey water was released to the below pad. The location of the spill was confined to the Mine Site Complex pad, underneath the laundry complex wing, and is greater than 100 metres from the closest water body which is currently frozen.

Photo 1 – Separation of elbow on discharge line of industrial washing machines

The failed elbow has been repaired and laundry room discharge line is functional.

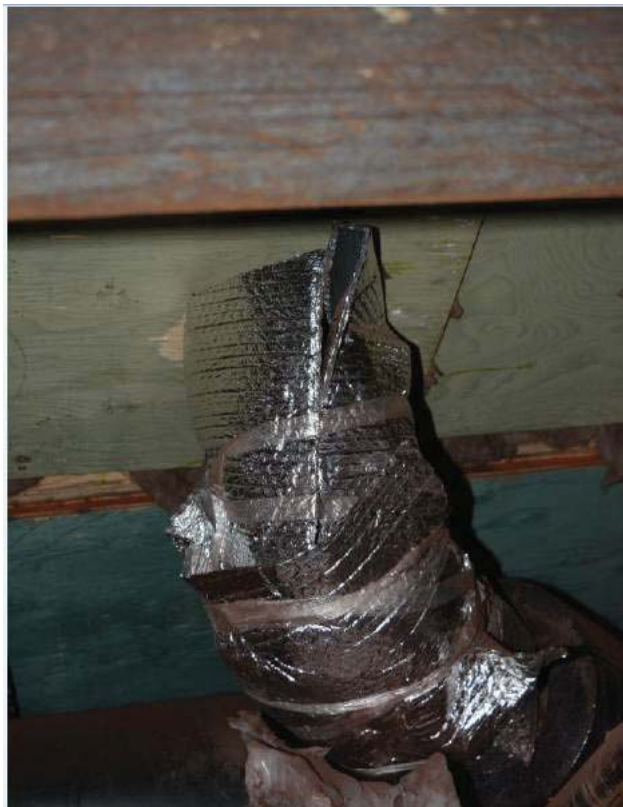
Photo 2 - Repaired elbow on discharge line of industrial washing machines

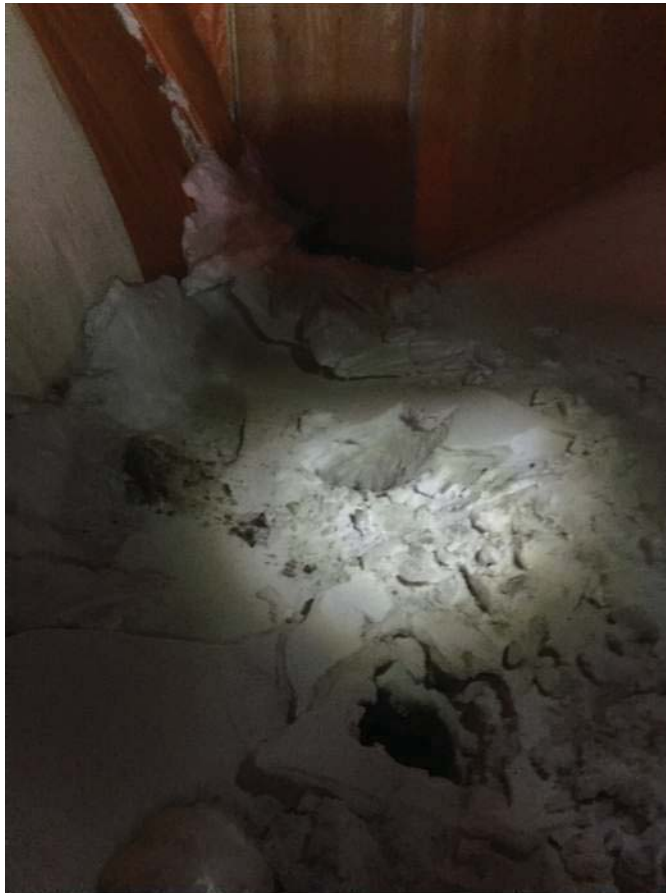
Photo 1 – Lift Station Spill

The lift station sewage sources were cordoned off to prevent further spill. A new lift station was installed closer to the Mine Site Weatherhaven dry and the discharge line, and heat traces were replaced.

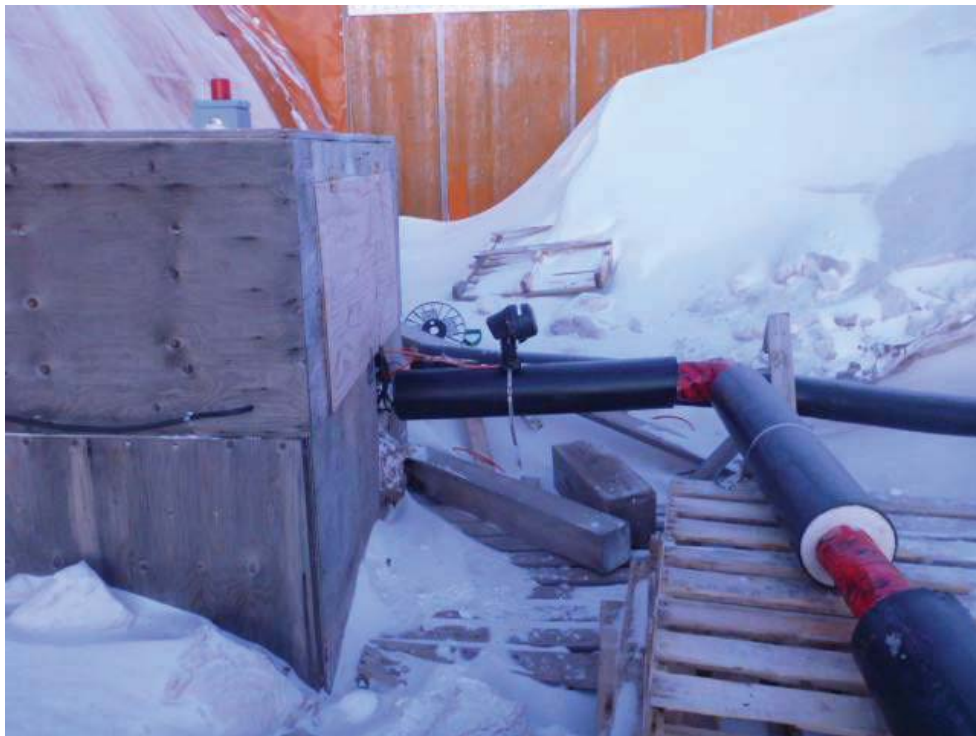
Photo 2 – Lift Station Spill Post Clean Up

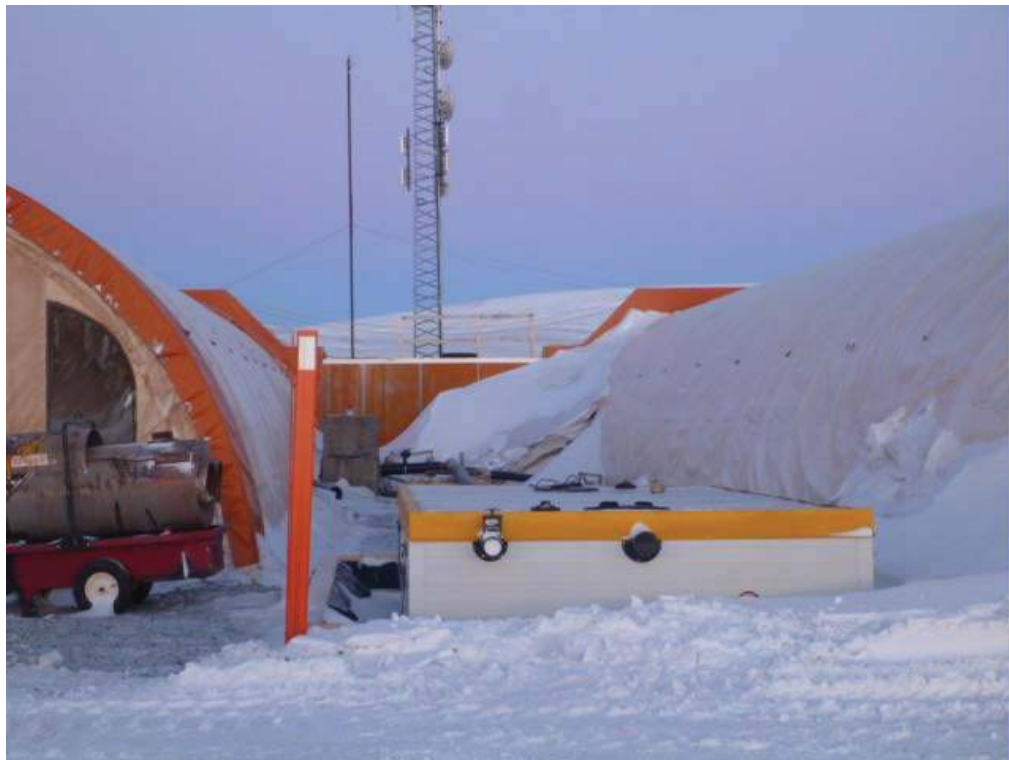
Photo 3 – New Lift Station and Discharge Line

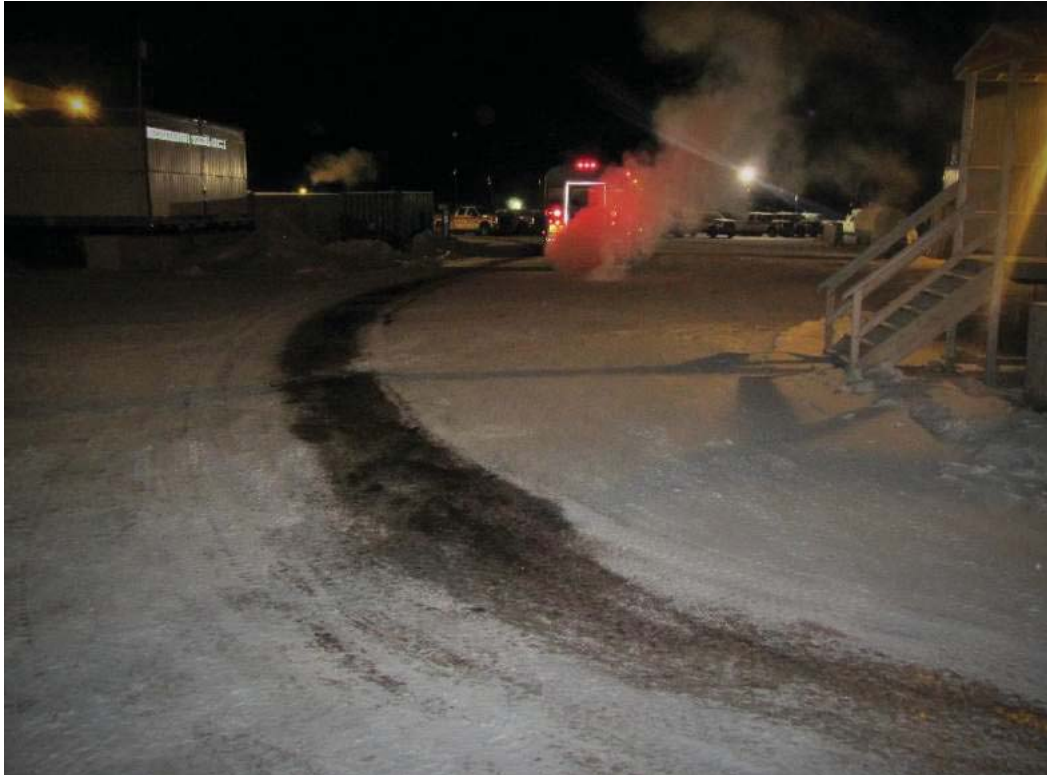
Photo 1 – Trail of sewage at the MSC camp pad

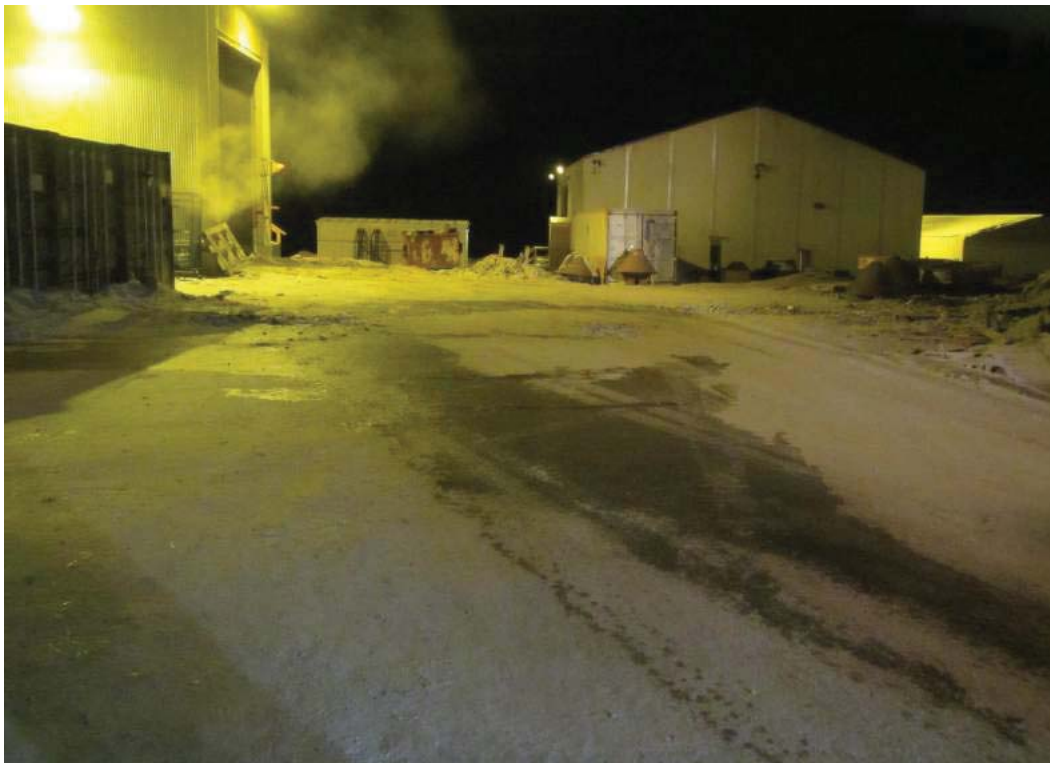
Photo 2 – Trail of sewage at the WWTP where it was first noticed

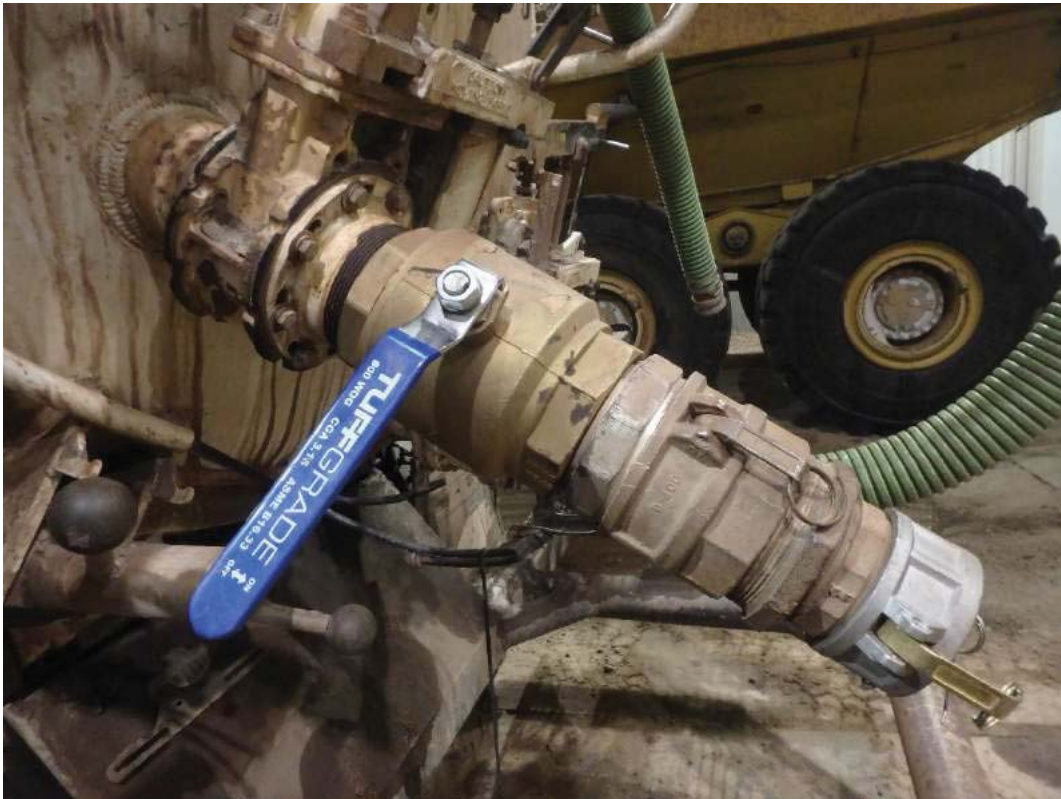
Photo 3 – New ball valve installed on the intake of the vac truck

Routine inspections of the parts of the vac truck should be completed to ensure all components are functioning as designed and there is no worn out or damaged parts.

The ball valve was replaced and the contaminated snow was scraped up with a grader and deposited in the sewage treatment pond #1

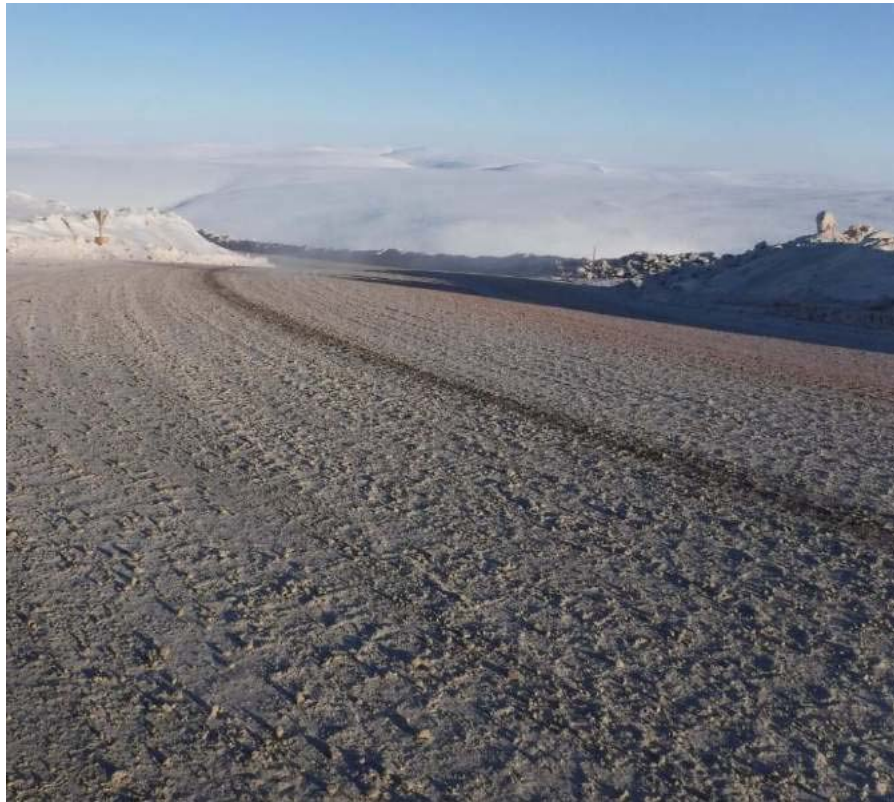
On February 28, 2017 at 13:15 HRS, the operator of a CAT 777 mine haul truck was driving up the Mine Haul Road when a low coolant indicator came on. The operator investigated and discovered that a coolant hose had failed. Approximately 120L of coolant was released to the road surface from KM 108.5 to the entrance of the 640 bench at the Mine in a trail approximately 30 cm wide. The immediate cause of the spill was a hose failure, which was subsequently replaced prior to equipment start-up. The location of the spill was confined to the Mine Haul Road surface, on IOL, with no possibility of migrating and is greater than 100 metres from the closest water body which is currently frozen.

Photo 1 – Trail of coolant 30 cm wide on the Mine Haul Road

The coolant line was replaced and the Cat 777 was put back into service. The affected area was cleaned up and the contaminated snow was placed in the snow dump a lined engineered containment facility.

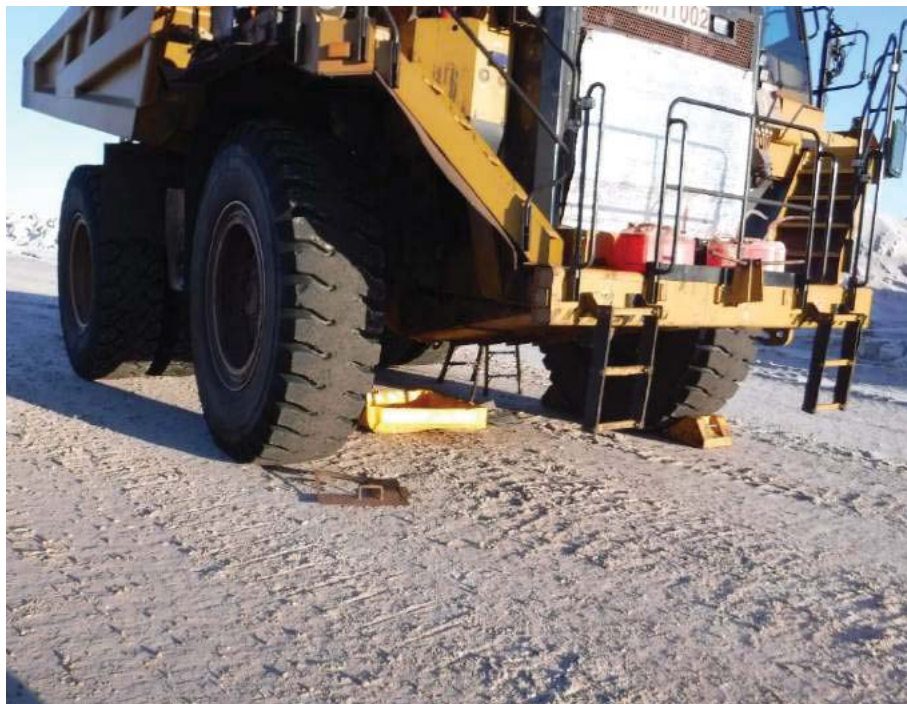
Photo 2 – Spill tray placed underneath CAT 777 while repairs were performed

The operator notified the Mine Operations Supervisor and the Environment Department. A spill tray was placed underneath the CAT 777 while repairs were performed. Spill pads and secondary containment were used to mitigate the spill and the contaminated snow was scraped up and disposed of in Quatrex bags. The Quatrex bags were then transported to the snow dump at Milne Port, a lined engineered containment facility.

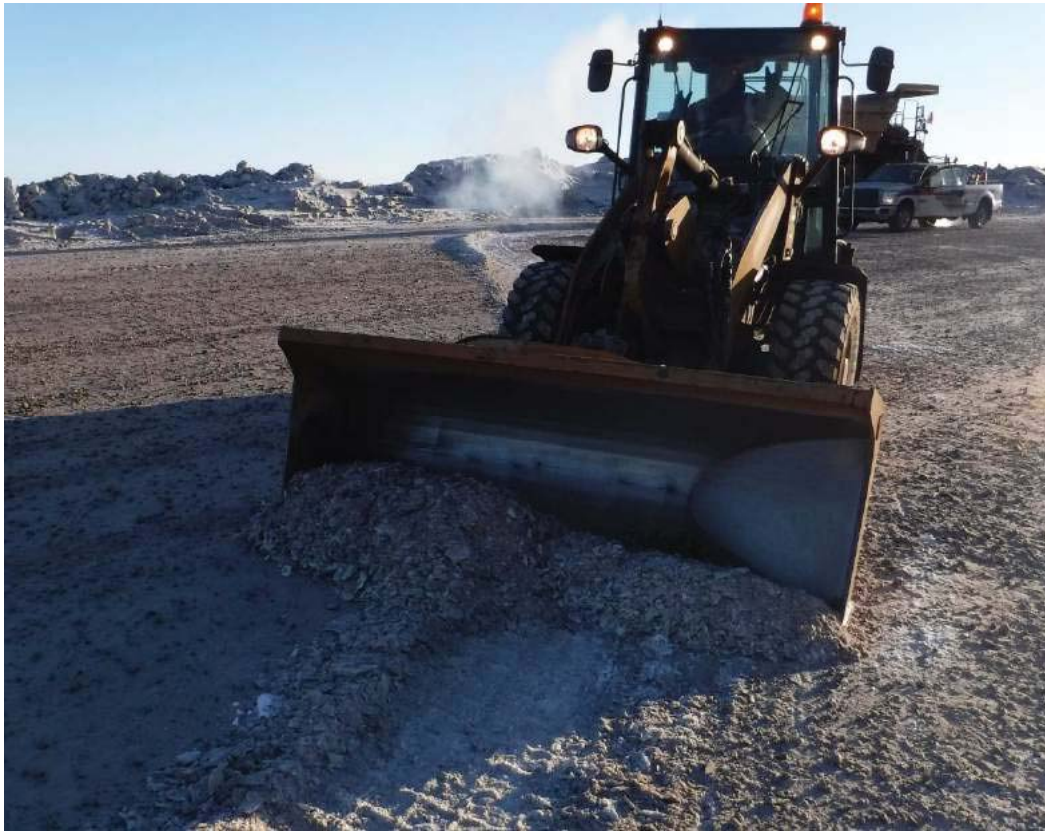
Photo 3 – Contaminated snow being removed from the surface of the Mine Haul Road

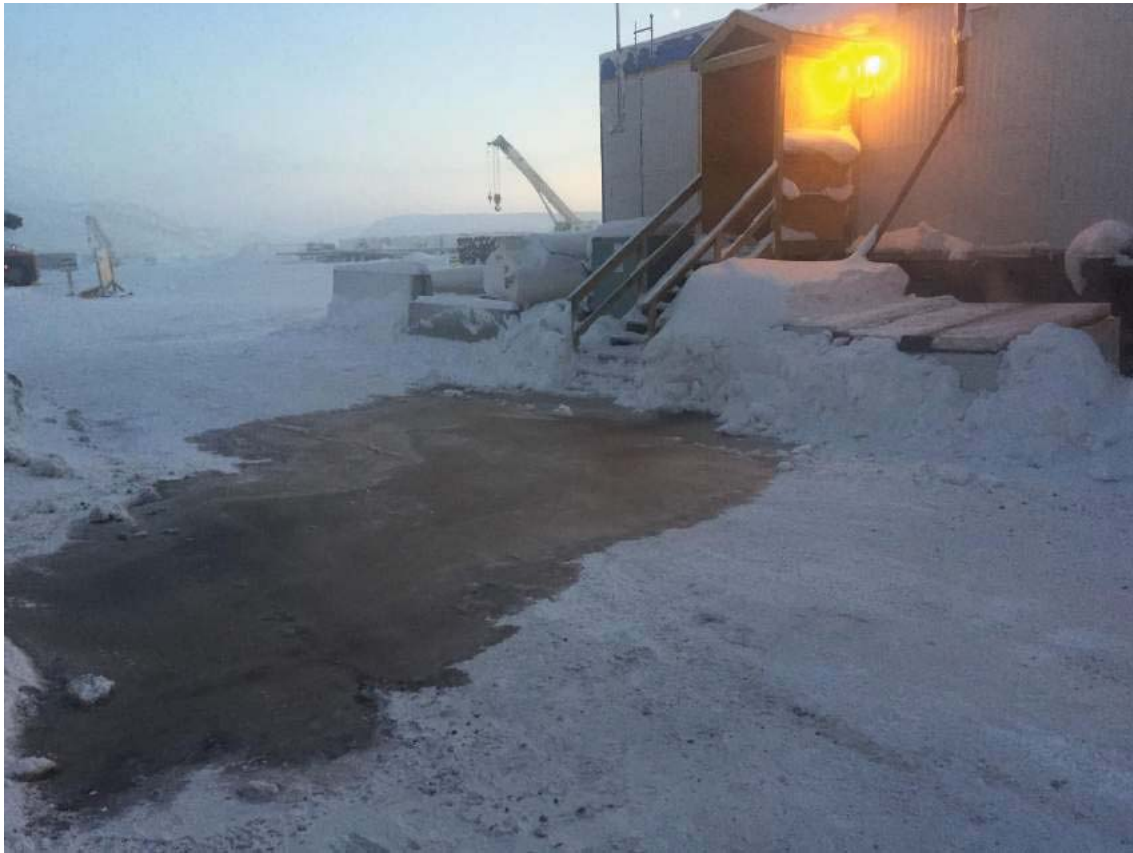
At 06:00 HRS on March 1st, housekeeping staff alerted housing maintenance of a liquid pooling outside of the PSC. It was observed that the lift station from the laundry room had overflowed from the three washing machines. Housing maintainers placed the pumps in manual mode to pump down the tanks. Upon investigation, it was determined that the flow to the pumps was restricted causing them to time out. Approximately 1 m3 of grey water was released to the adjacent pad, impacting an area of 25 m2. The location of the spill was confined to the Port Site Complex pad, and is greater than 100 metres from the closest water body which is currently frozen.

Photo 1: Grey water spill at Milne Port laundry lift station

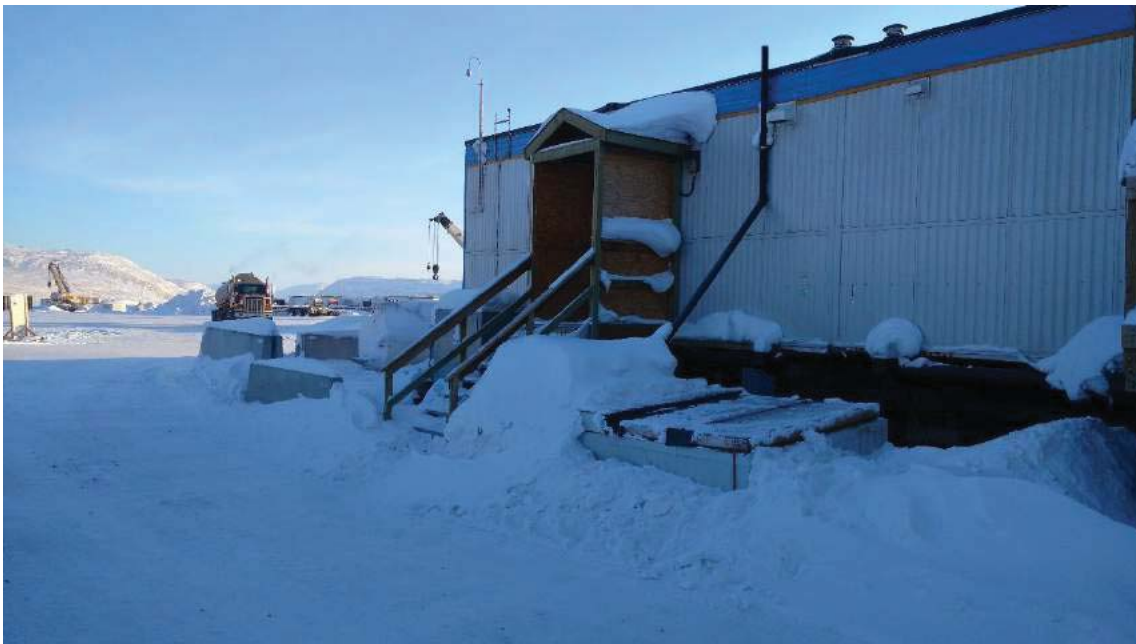
Photo 2: Snow removed to PWSP

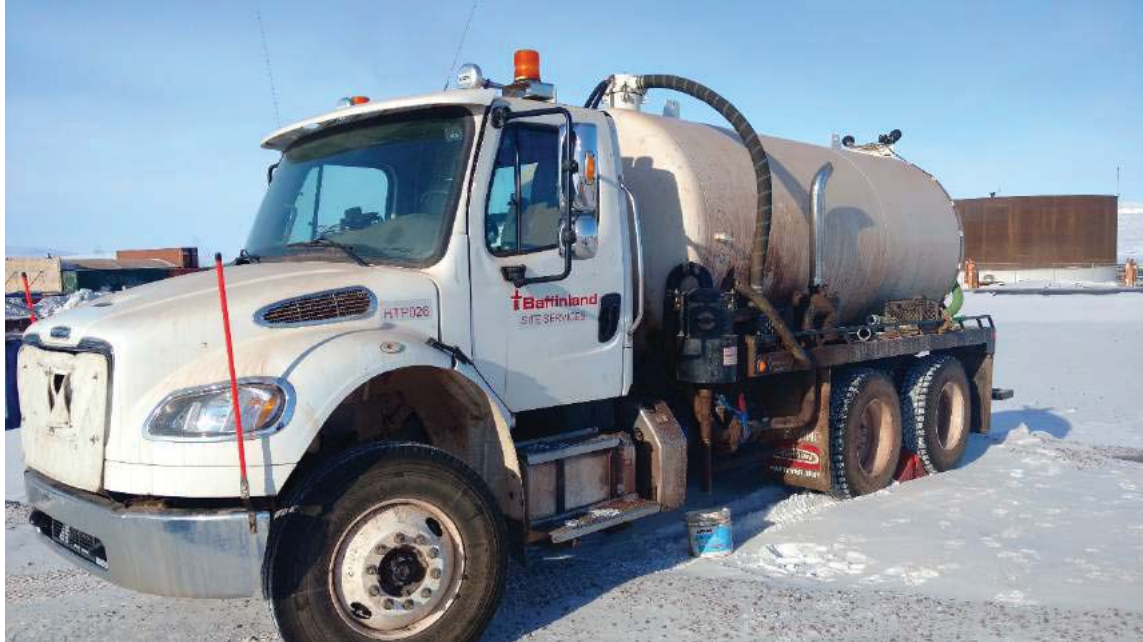
Photo 1: Contaminated vac truck used to transport raw sewage to WWTP

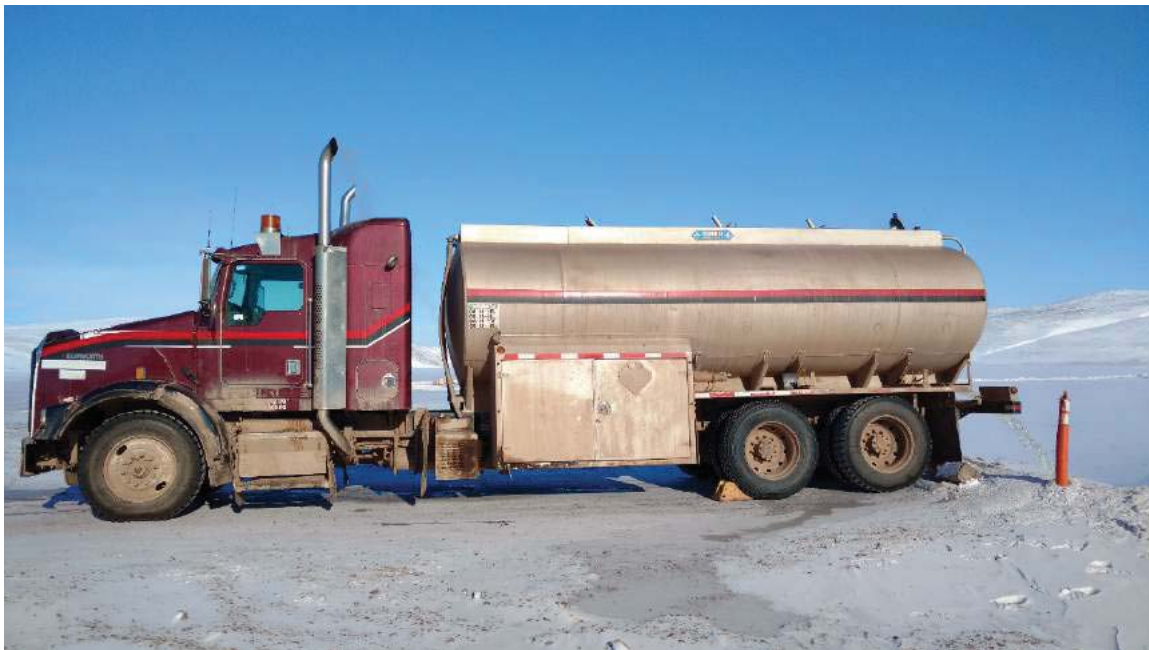
Photo 2 - Dust Suppressant water truck used to transport treated effluent

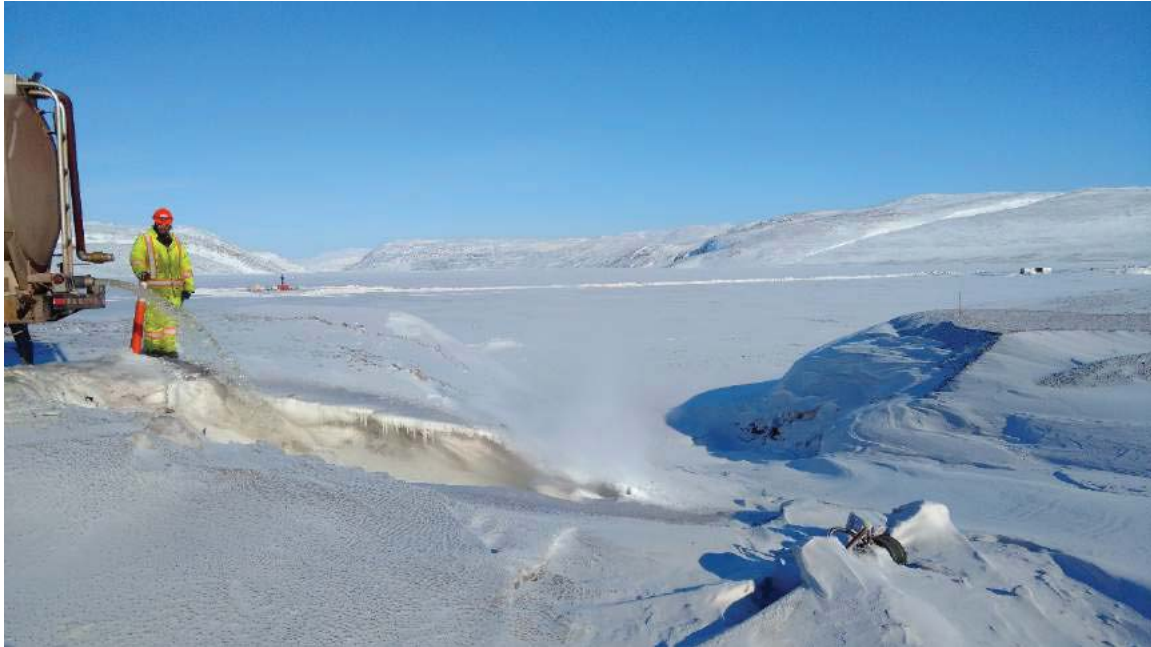
Photo 3: Water truck discharging treated effluent at the discharge point MP-01 on March 25, 2017.

Repair treated effluent discharge pipeline once weather becomes suitable for repairs to be completed. Construct a back up treated effluent discharge pipeline in summer 2017.
