APPENDIX E.8.7.2 INITIAL AND FOLLOW UP SPILL REPORTS OTHER (Part 2)

Re: Follow-up to Spill #17-109, Reported on April 13th, 2017 Mary River Project - Water Licence No. 2AM-MRY1325

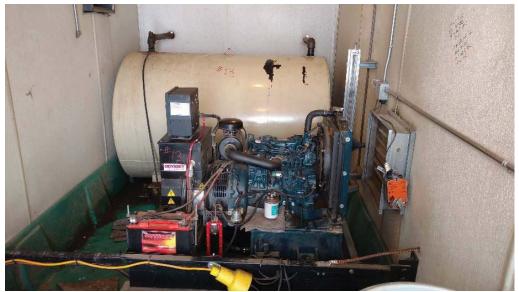
On April 12th, 2017 while an operator was refueling the fuel tank connected to an IT tower generator (Tote Road Km 61) it was noted that fuel was seeping from the tank vent pipe impacting the below adjacent area. Approximately 110L was released, impacting an area of 11 square meters. The location of the spill was confined to the frozen surface below the vent pipe with no possibility of migrating. The spill occurred on crown land, and is greater than 500m from the closest water body, which is frozen. The Environment Canada tank registration number is 00043663.

Photo 1 -Tank set up with vent pipe to outside.

The source of the leak was removed from the system; spill pads and secondary containment were used to mitigate the spill. The contaminated material was removed from site and transported to a Milne Port hazardous storage lined engineered containment. It was identified that the source of the leak was due to snow/ice buildup within the vent pipe blocking the return fuel line to flow back into the tank. The system was modified by removing the external tank vent pipe and replacing it with an internal horizontal pipe which is not exposed to the elements to prevent snow and ice buildup to occur.

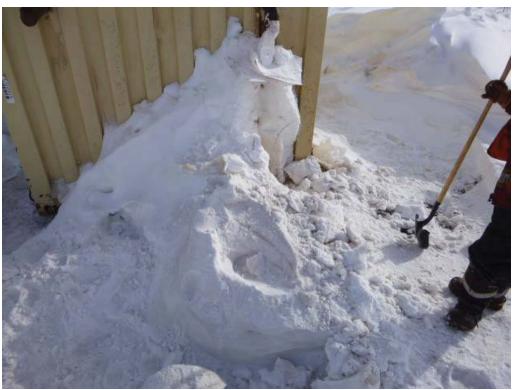
Photo 2 –Contaminated snow impacted by fuel dripping from vent pipe

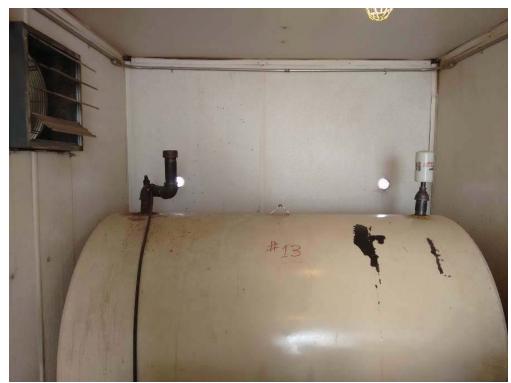
Photo 3 – Tank set up with hose inside secondary containment

The tank is currently back in operation and the vent system repaired/modified. The area will continue to be monitored as the ground thaws.

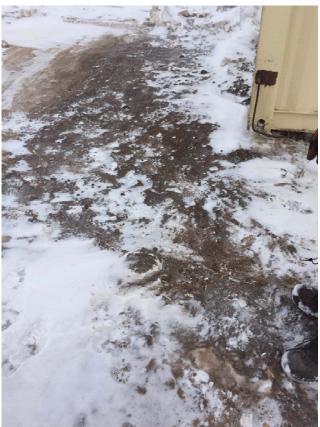
Photo 4 – Contaminated snow removed of outside of seacan

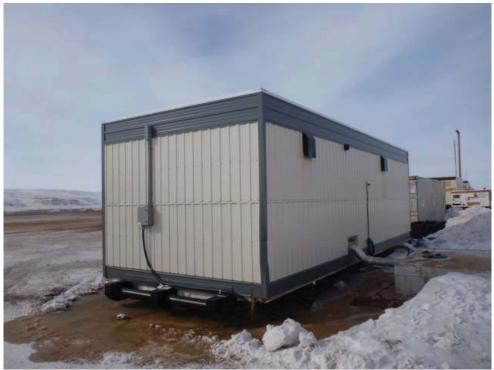
At 09:30 HRS on April 22nd, Surface Works vacuum truck operator discovered that the OHT laydown wash car had overflowed. Upon investigation, it was determined that the heat trace failed causing the contents of the wash car to freeze. Incoming sewage was unable to enter the wash car resulting in an overflow. Approximately 125 L of raw sewage was released to the adjacent pad, on IOL, impacting an area of 9 m2. The location of the spill was confined to the OHT laydown, with no chance of migrating and is greater than 75 metres from the closest water body which is currently frozen.

Figure 1 – Raw sewage spill from washcar in OHT laydown

The operator notified his supervisor and pumped out the remaining sewage in the wash car. The contaminated snow and material was scraped up with heavy equipment and disposed of in engineered lined containment. The heat trace and piping was repaired.

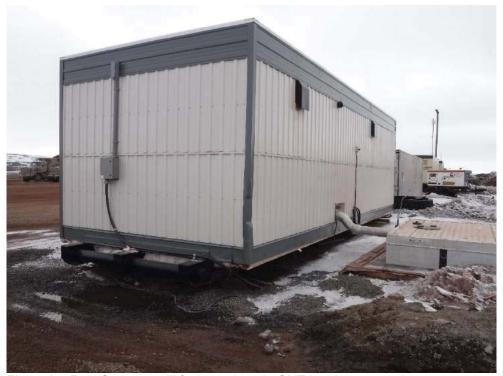
Figure 2 – Raw Sewage spill from washcar in OHT Laydown post clean up

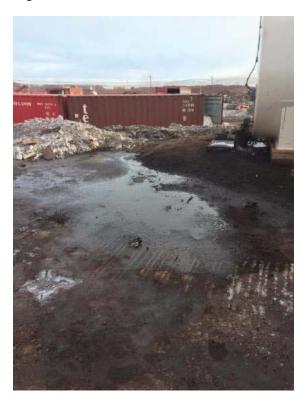
At 10:30 HRS on April 29th, a worker advised the environmental department that there was a dark area on the ground behind the wash bay directly beside a fuel tank. It was determined after inspection that there was a diesel spill from the tank. The workers responded immediately by placing spill pads and duck ponds to collect the diesel. Approx. 270 L of diesel fuel spilled on the camp pad, impacting an area of less than 20m2. The contaminated material was cleaned up and properly disposed of. The location of the spill was confined to the east side of the wash bay pad, and is greater than 100 meters from the closest water body which is currently frozen. The Wiggins Nozzle was tightened to stop the leak.

Figure 2 – Leaking Wiggins Nozzle into drip tray that mixed with snow melt overtopping

Routine checks of tanks is ongoing and will be focusing efforts to inspect the Wiggins nozzles as well as all other devices used on the fuel tanks.

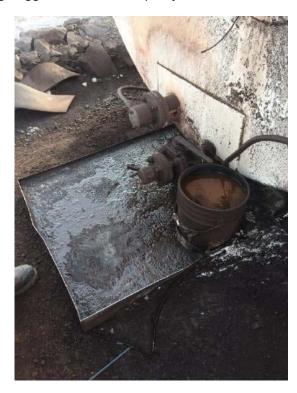
Figure 3 – Area after Occurance

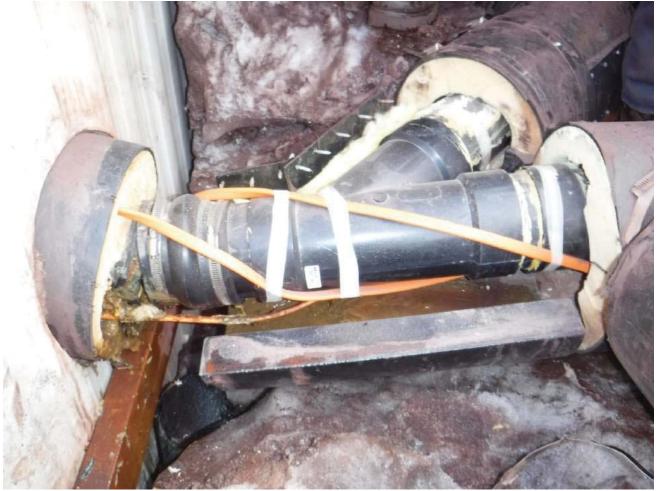
On April 29, 2017 at 07:00 HRS, site services staff notified the environment department of a spill outside a sewage lift station located on the south side of MSC AF Wing. It was observed that the sewage lift station appeared to be functioning properly but raw sewage was observed on the adjacent pad. The source of spill was located at the inlet to the life station where a fernco coupler separated on the 4" gravity line. It is estimated that 170 litres of raw sewage was released to the adjacent ground. The location of the spill was confined to the Mine Site Complex pad, on IOL and is greater than 100 metres from the closest water body which is currently frozen. This spill is being reported as required by the conditions of water license no. 2AM-MRY1325, Part H, item 9 (b) pursuant to subsection 12(3) of the Nunavut Waters and Nunavut Surface Rights Tribunal Act.

Photo 1 – Fernco coupler separated on the 4" gravity line into the lift station

Fernco coupler was replaced and additional support was added underneath the pipe to limit movement.

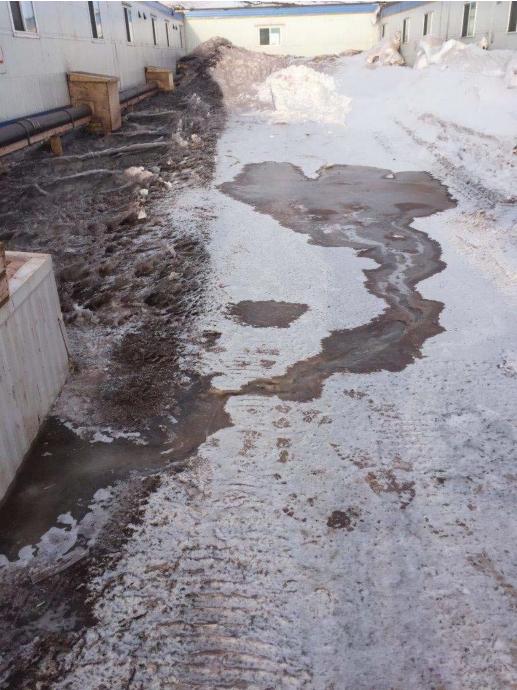
Photo 2 - Raw sewage released to the adjacent ground south of MSC AF Wing

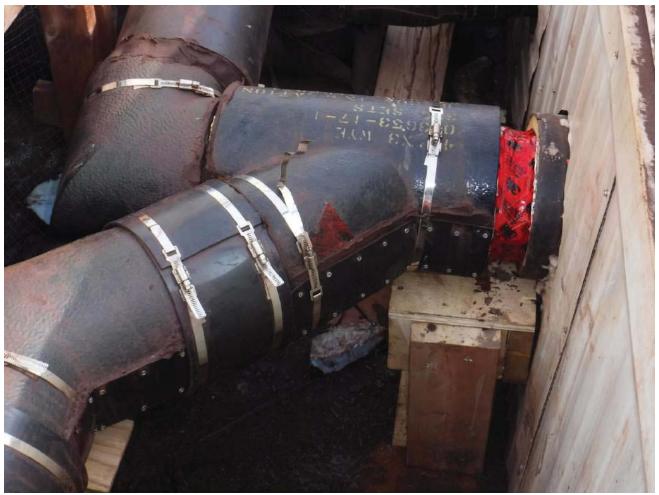
Photo 3 - New coupler and wood support installed on 4" gravity line

The fernco coupler was replaced and fixed on the 4" gravity line into the lift station.

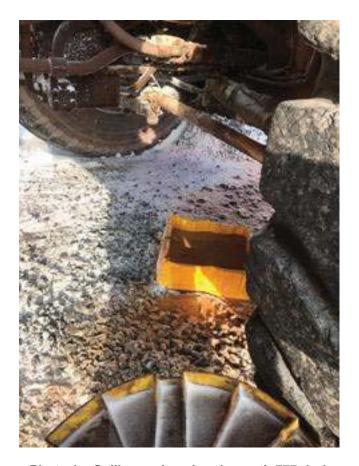
On May 3rd 2017 at 1430 HRS, a 777 haul truck located off to the side of the road between km 109 and km 110 on the mine haul road was waiting for repairs. After the haul truck was repaired it was restarted and at that time the oil cooler causing approximately 220L of coolant to be released, impacting an area of 2 square meters. The location of the spill was confined to the frozen surface of the road with no possibility of migrating, and is greater than 500m from the closest water body which is currently frozen.

Photo 1 – Spill tray placed underneath 777 during spill

A berm was formed around the equipment to prevent the spill from migrating. The source of the leak was removed from the system and repaired. Spill pads and secondary containment were used to removes excess pooling coolant.

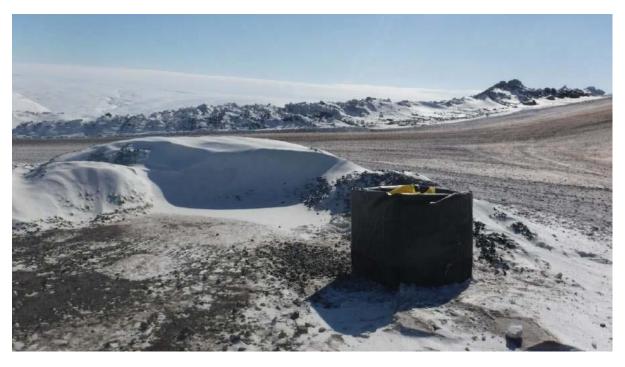
Photo 3 – Photo of spill location after clean up

The coolant line was replaced and the Cat 777 was put back into service. The affected area was cleaned up and the contaminated snow was placed in the snow dump a lined engineered containment facility.

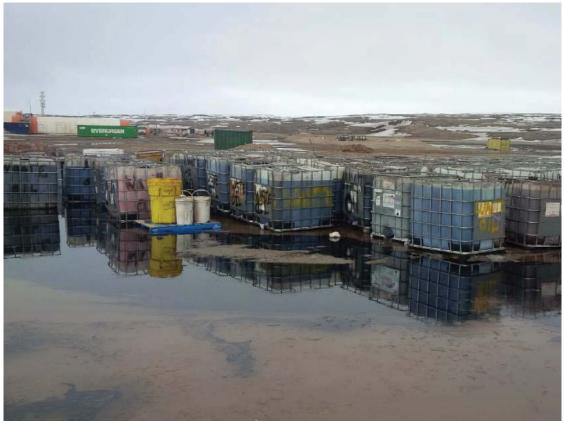
On May 28th, 17:00, during an inspection of the Mine Site Hazardous Waste Berm #7 (HWB 7), a spill of waste oil was observed inside the bermed facility. Upon investigation, it is suspected the source of the spill was from a damaged waste oil tote with a maximum capacity of 1 cubic metre. The spill is entirely contained within the engineered lined containment that is inspected annually by a qualified Geotechnical Engineer. An inspection around the foot of the berm of the facility indicated no leakage to the environment. The spill location is greater than 500 meters from the nearest water body and occurred on Inuit Owned Land.

Photo 1: Initial Spill Area inside MS Old Fuel Bladder Farm (HWB 7)

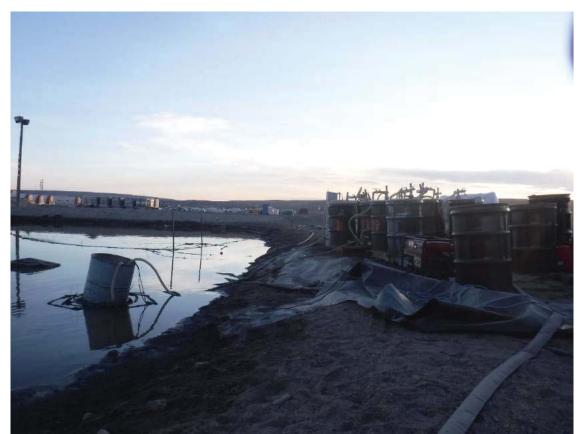
Photo 4: OWS Processing Contaminated Water in MS Old Fuel Bladder Farm (HWB 7

The Oily Water Separator (OWS) was employed to treat the contaminated water in the berm starting June 15, 2017 and has processed 220 M³ to date. Contaminated water processing is ongoing. The berm is storage to numerous 1 m³ totes containing used hydrocarbons awaiting backhaul for proper disposal during the 2017 backhaul sealift program.

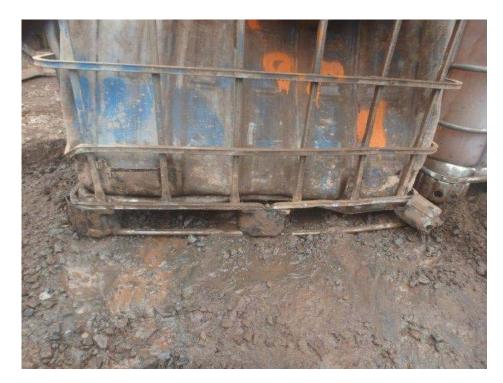
At 17:30 hrs on June 13th, a worker advised the environmental department that there was a leak coming from a tote in front of the maintenance shop. It was determined after inspection that a tote was leaking wash water to the maintenance pad. The workers responded immediately by placing spill pads and duck ponds to collect the sump water that potentially was contaminated with hydrocarbons. Approx.100 L of sump water spilled on the pad, impacting an area of less than 20m2. The contaminated material was cleaned up and properly disposed of. The location of the spill was confined to the west side of the wash bay pad, and is greater than 100 meters from the closest water body. The tote was disposed of and a new tote was put in place for use.

Figure 1 – Area of leak from sump water tote

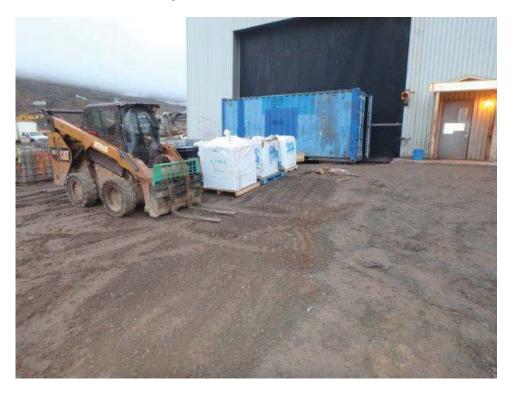
Figure 3 – Area after Occurrence
