APPENDIX E.8.7.2
INITIAL AND FOLLOW UP SPILL REPORTS
OTHER
(Part 4)

Re: Follow-up to Spill #17-360 – Reported on September 22nd, Update No.1 on 25th, 2017
Mary River Project - Water Licence No. 2AM-MRY1325

Re: Follow-up to the #17-312 update reported on September 27th, 2017
Mary River Project - Water Licence No. 2AM-MRY1325

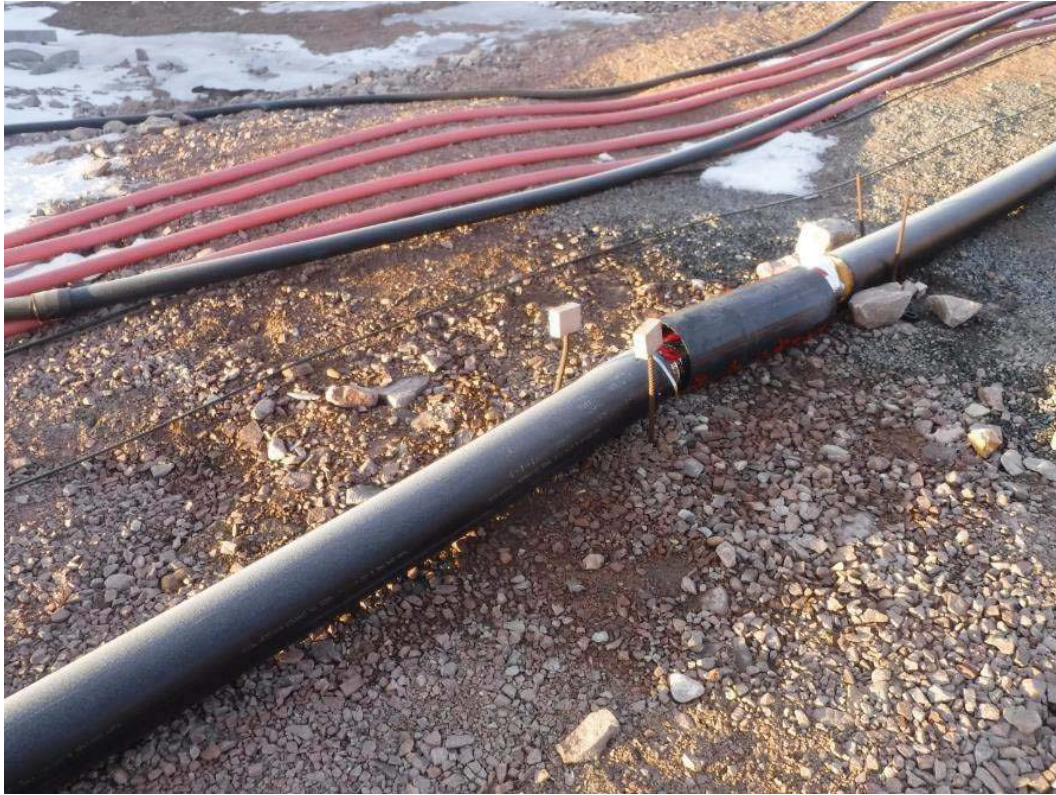
On September 21, 2017 at approximately 17:30, BIM employees responded to a possible break in the effluent water line for the Waste Water Treatment Plant, west of the power house, at Milne Port. After isolating the line and removing the insulation, it was found that the pipe had separated at a coupling and was leaking effluent to the ground in two different locations: at the break and ~20 m upstream from the break, at a union of the line's insulation. Effluent discharge was intermittent; it is estimated that 500 L of treated effluent was released impacting an area of 13 m².

Photo 1: Line break on September 22nd.

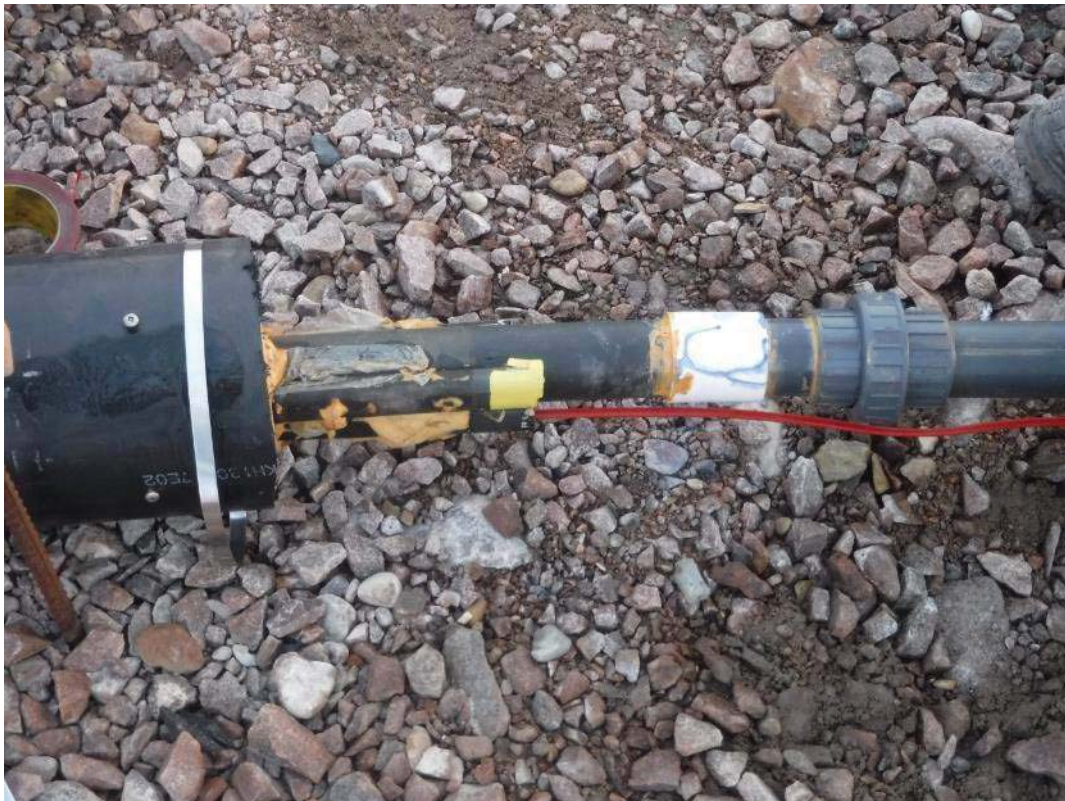
Photo 2: Line repair on September 22nd.

The effluent pump was shut down immediately following the discovery of the leak. The break was located, isolated, and repaired. The glue used for the initial repair proved to be inadequate. Consequently, the pipe was welded using heat fusion, providing a more reliable repair.

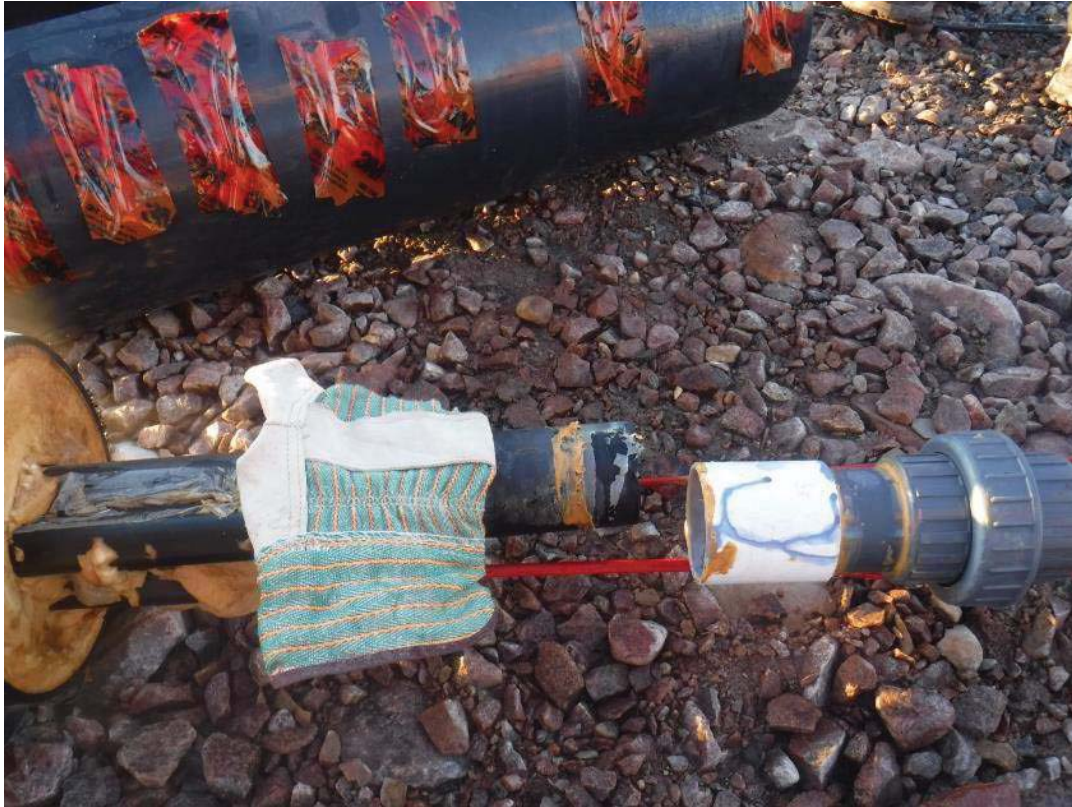
On September 24, 2017 at approximately 09:00, Fixed Plant responded to another spill at the same location of the initial break. The previous repair to the line had come apart, and was leaking effluent to the ground in the same two locations as spill reported on September 22: at the break and ~20 m upstream at a union of the line's insulation. It is estimated that an additional 500 L of treated effluent was released to the same area as the initial spill. An estimated total of 1 m³ of treated effluent was released from the initial and update No. 1 spill. The impacted area was confined to the adjacent pad surface under the break in the WWTP, and did not migrate to the closest natural water body which is non-fish bearing, frozen, and located >100 m away.

Photo 3: Line break on September 24th.

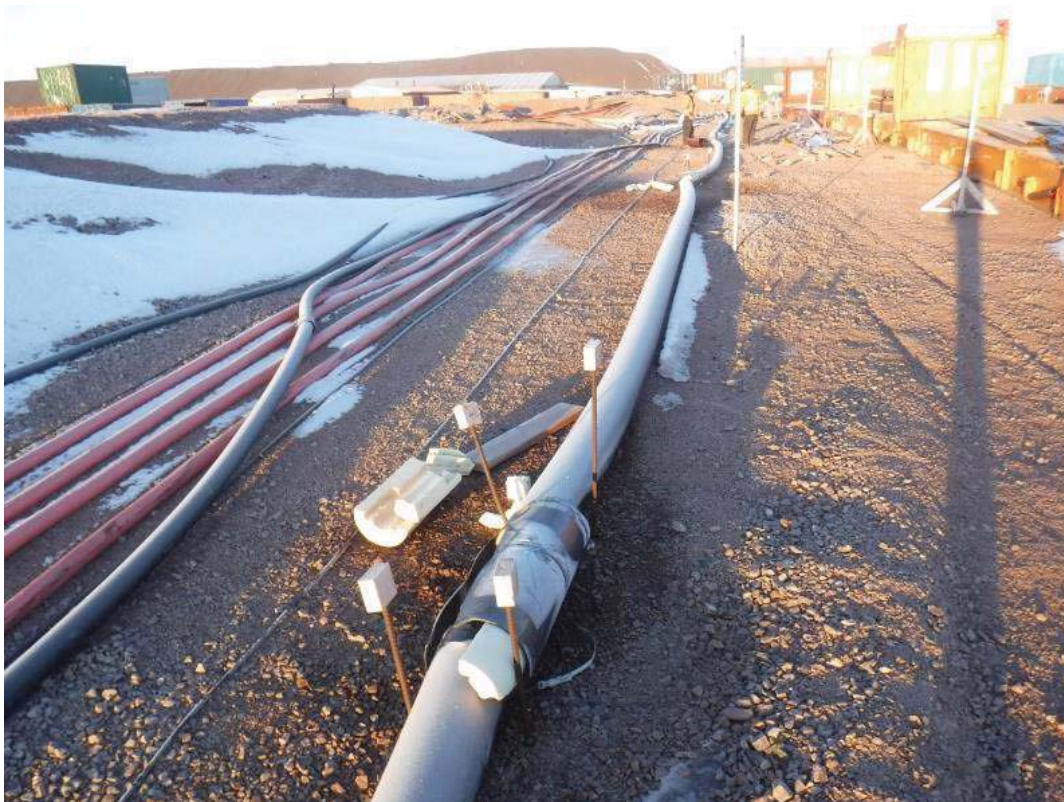
Photo 4: Line repair on September 24th.

WWTP line inspections for breaks and signs of stress during the cold weather. The efficacy on Expansion joints will be evaluated to reduce additional breaks resulting from thermal contraction.

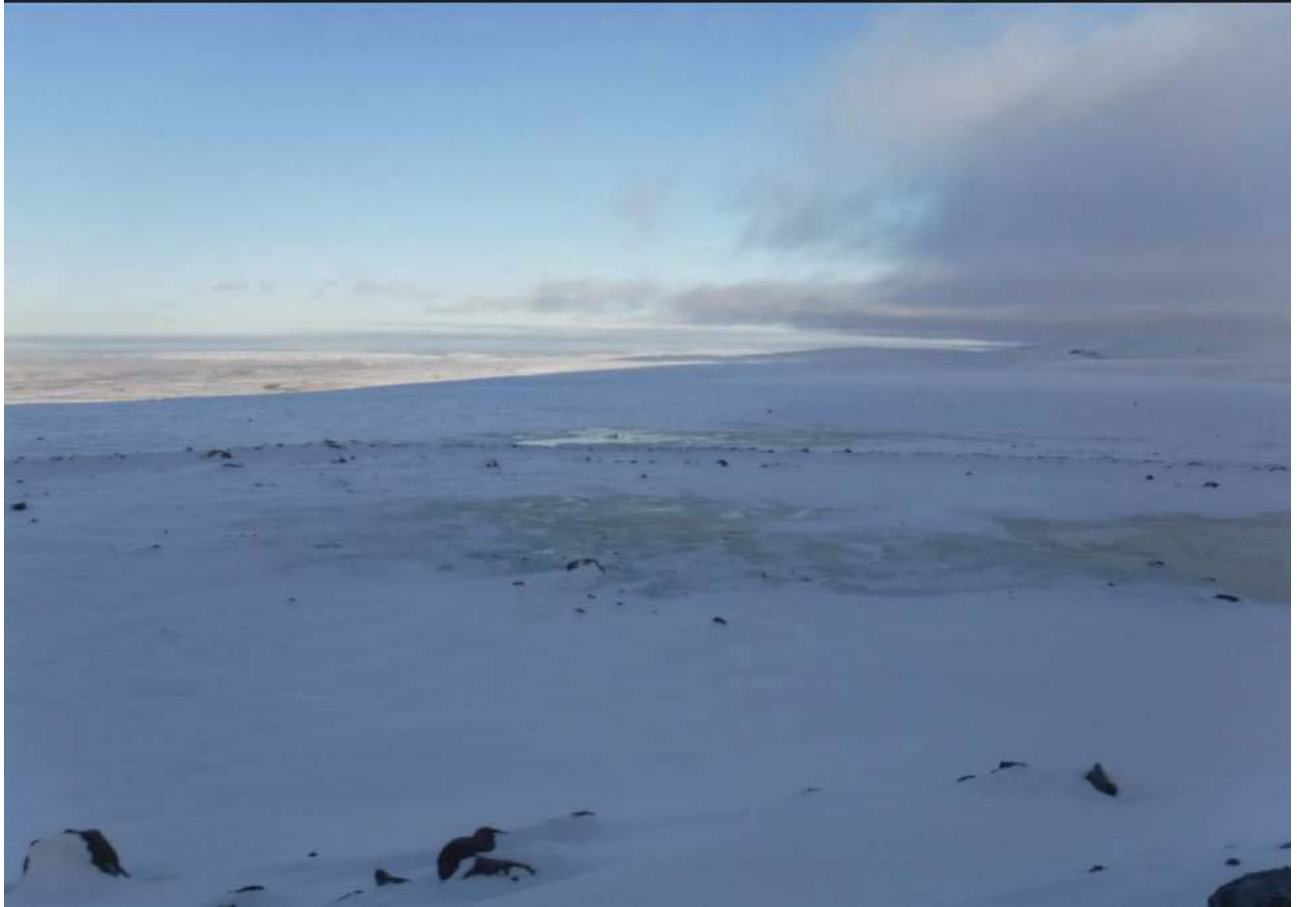
September 26th - Environment Department discovered discolored ice and slush down gradient of the emergency containment ditch.

Photo 1: Frozen Water Inside and Outside of Emergency Ditch

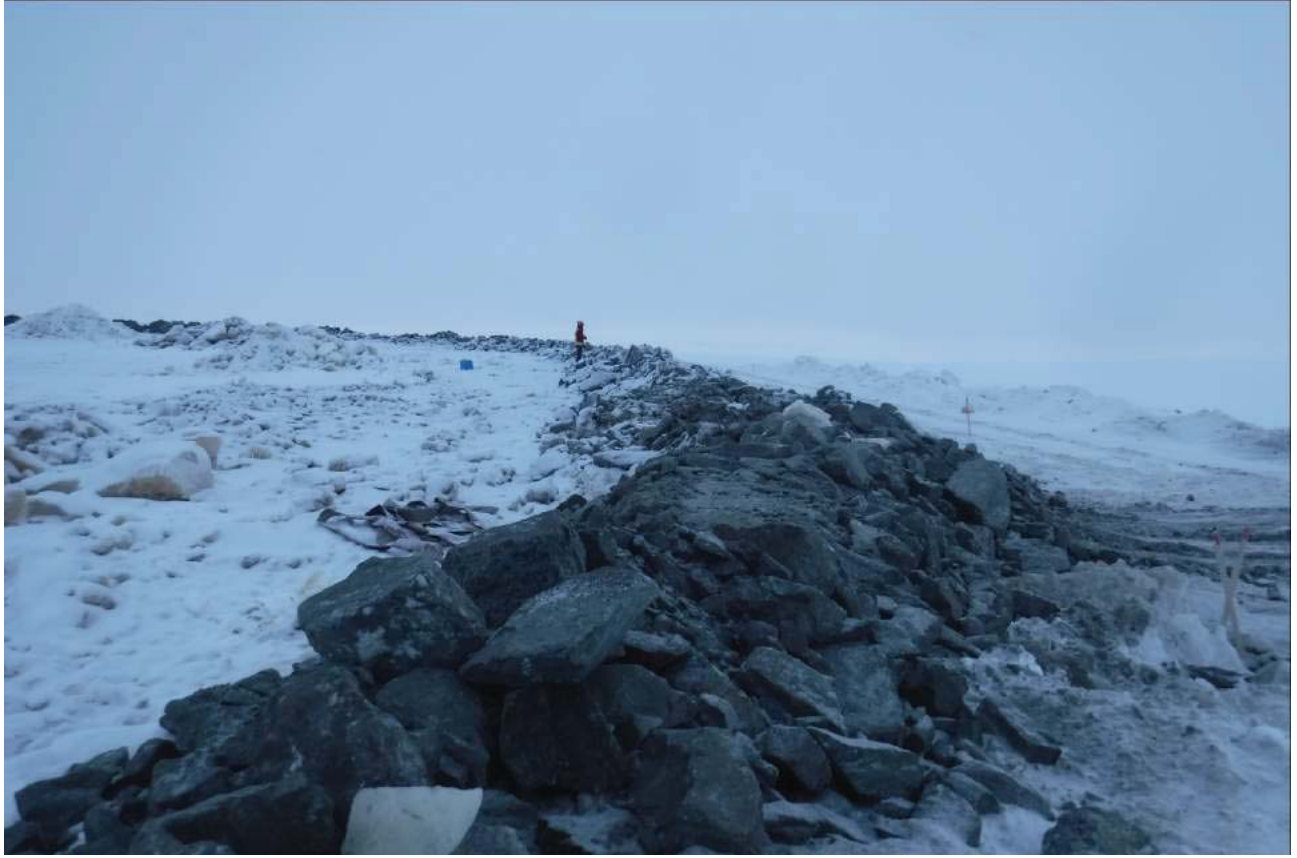
Photo 2: New Berm Being Constructed beside Existing Emergency Ditch

October 21st - Construction of new berm beside the outer rim of the emergency ditch commenced.

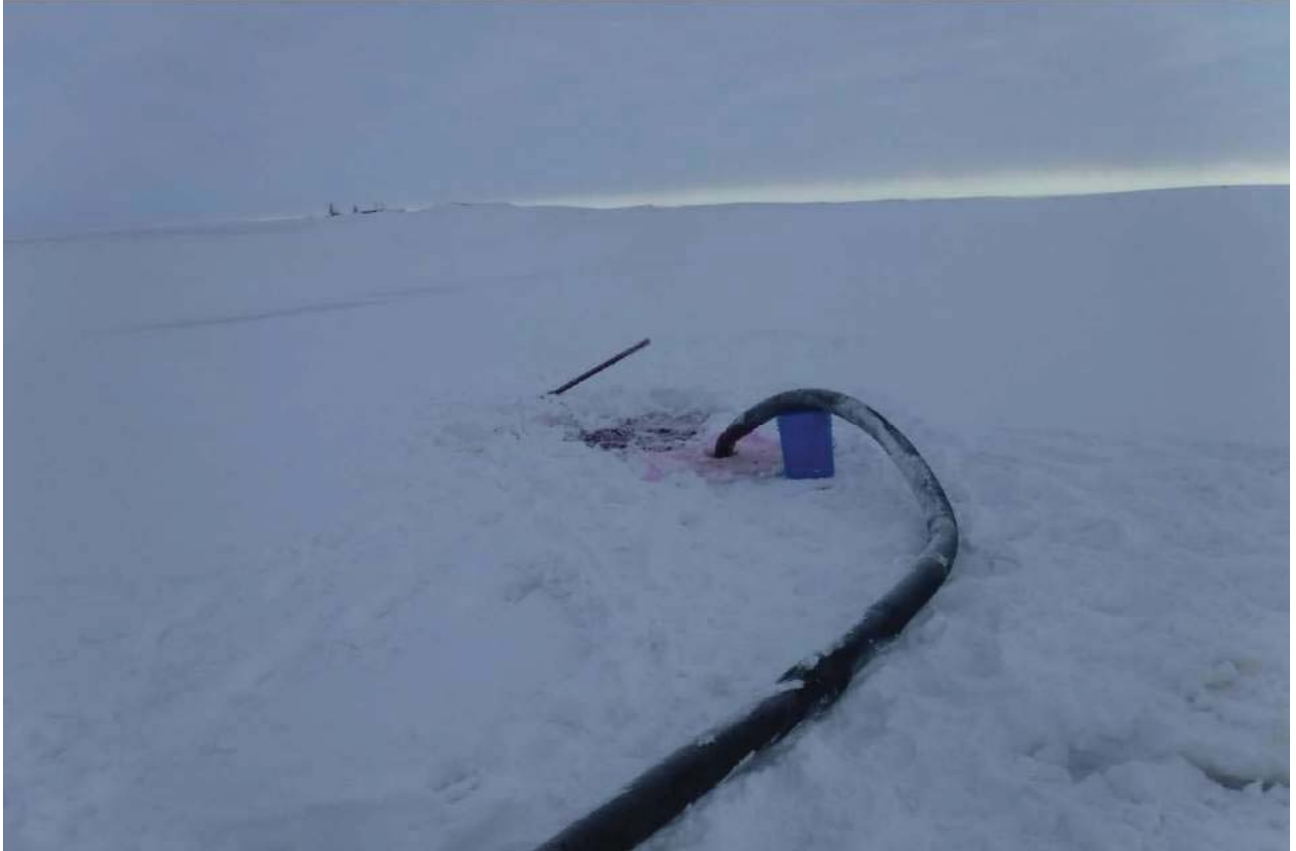
October 20th - Recirculation of the pond commenced. Samples grabbed at the intake of the pump do not show Rhodamine dye has been fully mixed.

Photo 3: Recirculating Pond after Addition of Rhodamine Dye
