**APPENDIX E.8.7.2**  
**INITIAL AND FOLLOW UP SPILL REPORTS**  
**OTHER**  
**(Part 5)**

**Re: Follow-up to Spill #17-392**  
**Mary River Project - Water Licence No. 2AM-MRY1325**

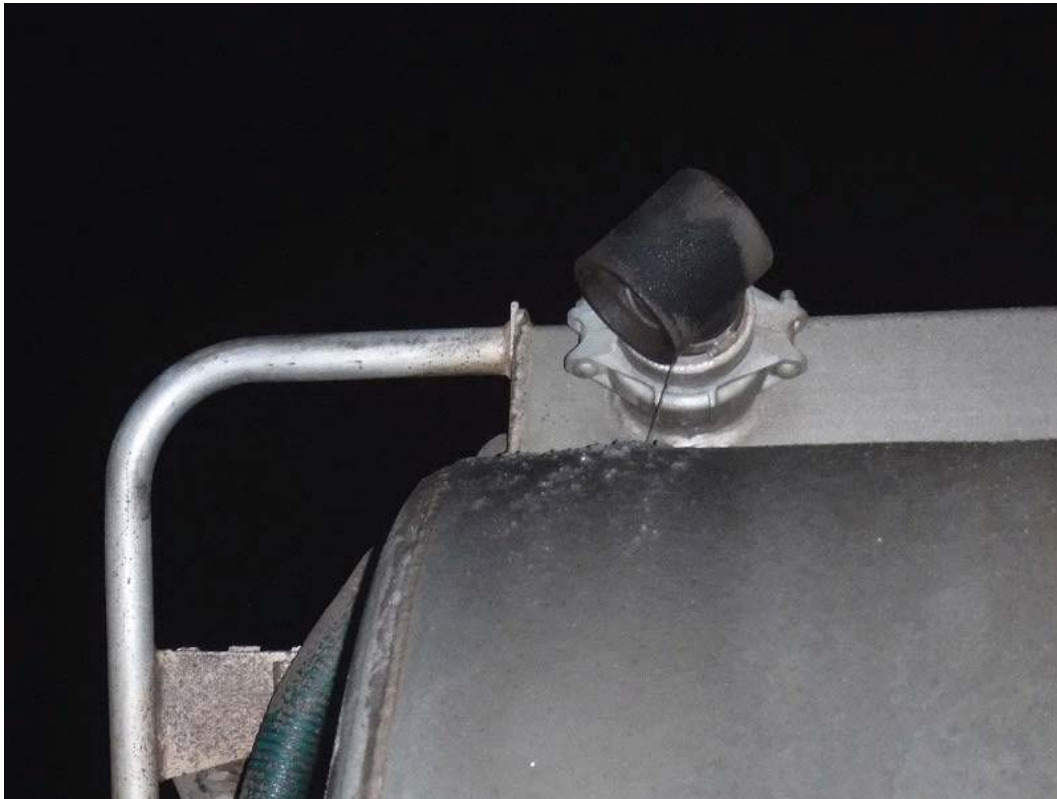
On October 23rd 2017, a fuel tank on the Mile Port refueling station was being filled using a tanker truck, when the overflow valve on the truck began leaking onto the ground. Initial investigation indicated a newly installed generator powering the fuel pump had been installed incorrectly. As a result, the pump did not operate as designed, which subsequently reversed the flow of fuel. An estimated 200 L of fuel was released before the operator was able to stop the flow, impacting an area of approximately 6m<sup>2</sup>. The spill was confined to the fueling station's lined engineered containment berm, which was covered with compacted snow. The spill occurred >200m from Philips Creek with no possibility of migrating.

Photo 1. Overflow release port

The fuel pump station was shut off and valves from the fuel tank were closed. Spill booms and adsorbent pads were deployed in strategic locations to ensure the spill remained within the lined engineered containment berm. The overflow release on the fuel tanker was plugged to prevent ongoing release. The contaminated snow was collected and deposited in an engineered containment berm at Milne Port, specific for hazardous storage. The newly installed generator was reconfigured to power the fuel pump in the intended and labelled direction, addressing the potential for the incident to be repeated.

Inspection of generator configuration including a bump test conducted by an electrician after all new installations and servicing.

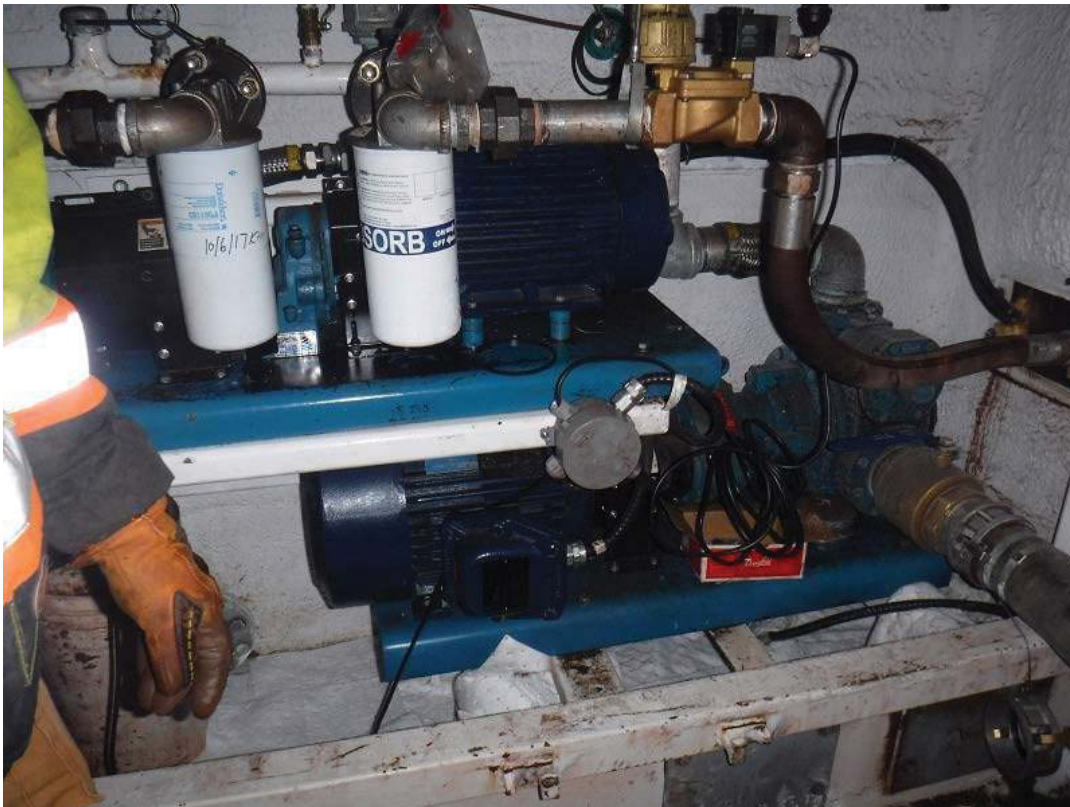
Photo 2. Fuel pump, switch, and valve

The fuel pump station and fuel tanker are currently back in operation and the generators powering the fuel pump station are in the correct configuration for the direction of flow labelled on the pump.

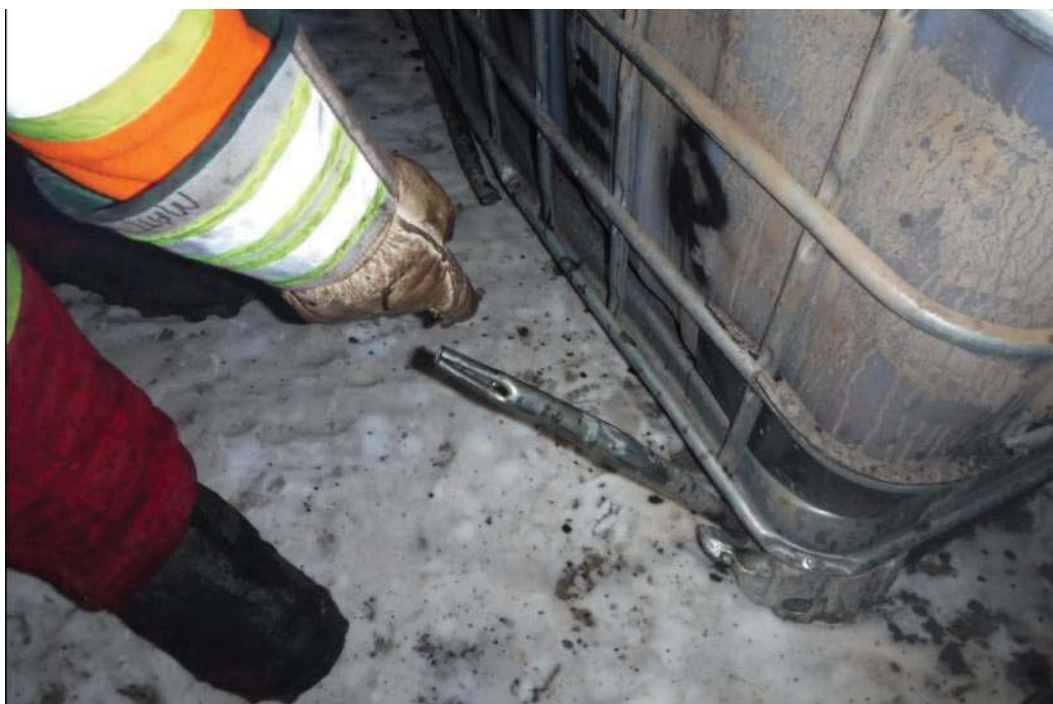
At 14:15 HRS on November 25<sup>th</sup>, 2017, an operator was relocating a tote of waste oil within the Mine Site Hazardous Waste Berm (MS-HWB-7). While he was placing the tote adjacent to a second stationary tote, the unnoticed damaged frame punctured the stationary tote. The operator immediately used a spill pad to slow the release of used oil and turned the tote on its side to contain the remaining product. Approximately 300 L of waste oil was released onto the pad, impacting an area approximately 6 m<sup>2</sup> within MS-HWB-7. The location of the spill was confined to the MS-HWB-7 which is an engineered lined containment facility. The spill occurred >400m from the closet water body with no possibility of migrating.

Photo 1. Damaged metal frame which caused the puncture

Ensure that operators are inspecting totes for structural stability before handling or preparing them for transport.

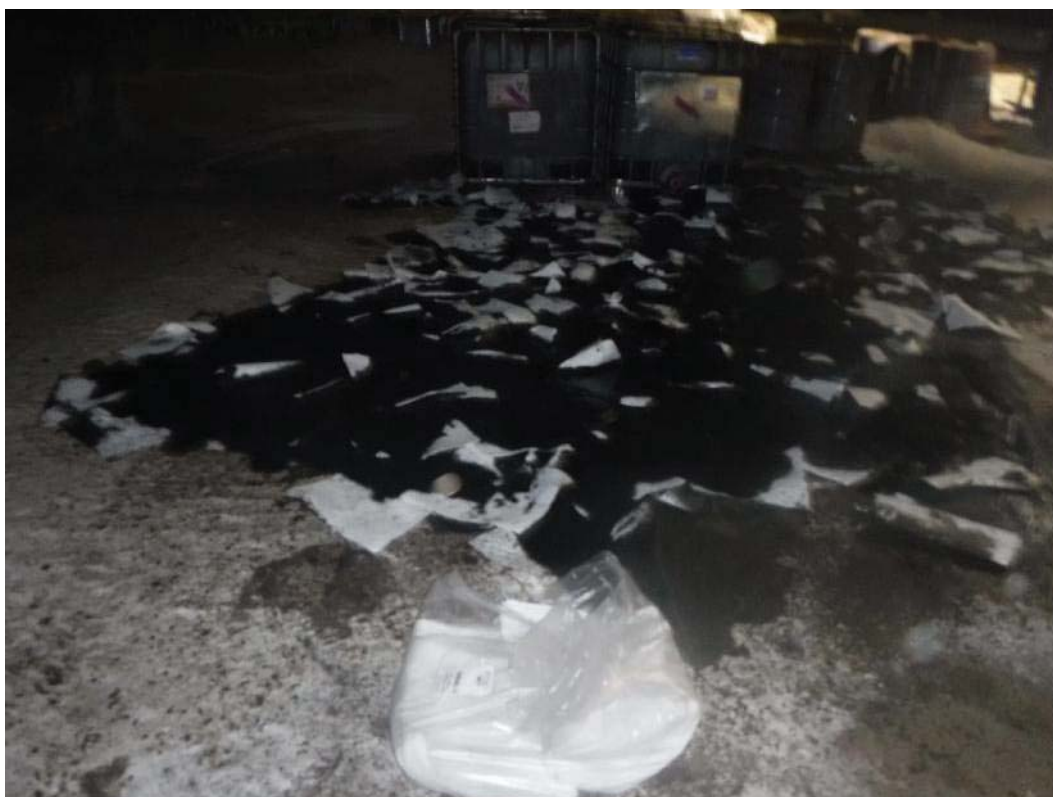
Photo 2. Absorbent booms and pads to prevent migration of the used oil

The tote was immediately placed on its side to prevent further oil being spilt. The spill was then cleaned up using spill pads and the contaminated snow was scrapped up and placed into Quatrex bags, which will be transported to the Snow Dump in Milne Inlet.

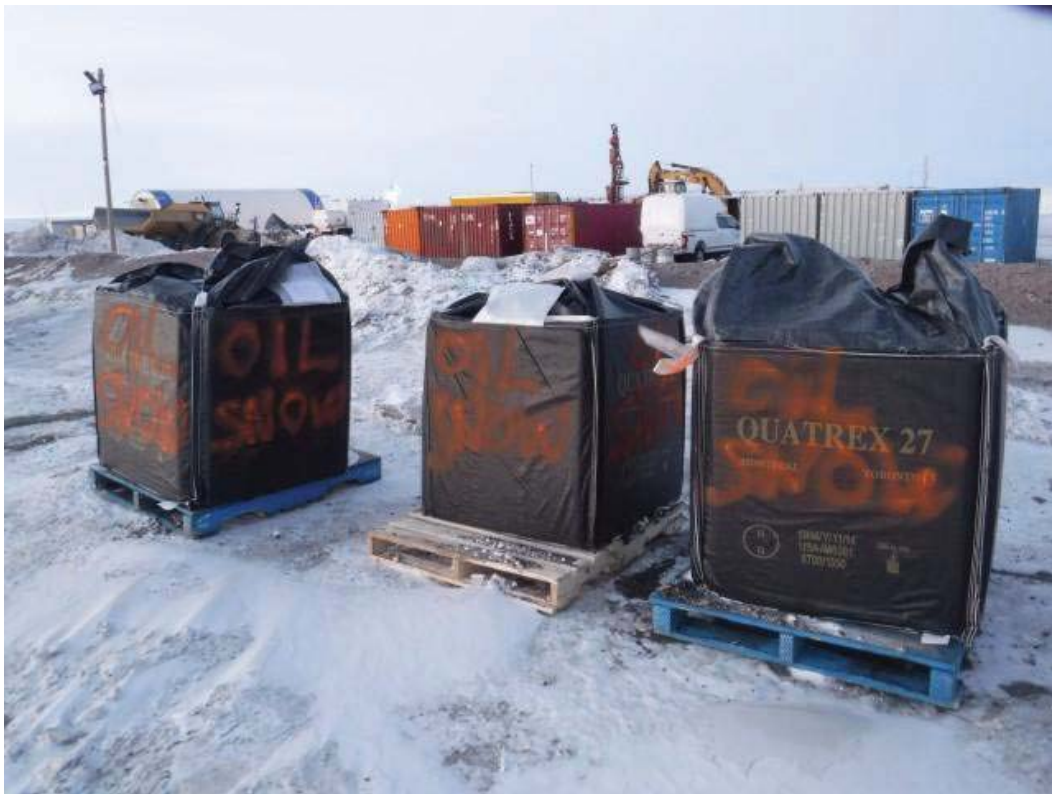
Photo 3. Clean up of affected snow and ice.

The tote has been emptied, the affected area has been cleaned up, and the contaminated snow will be treated using the oily water treatment facility during the open water season.

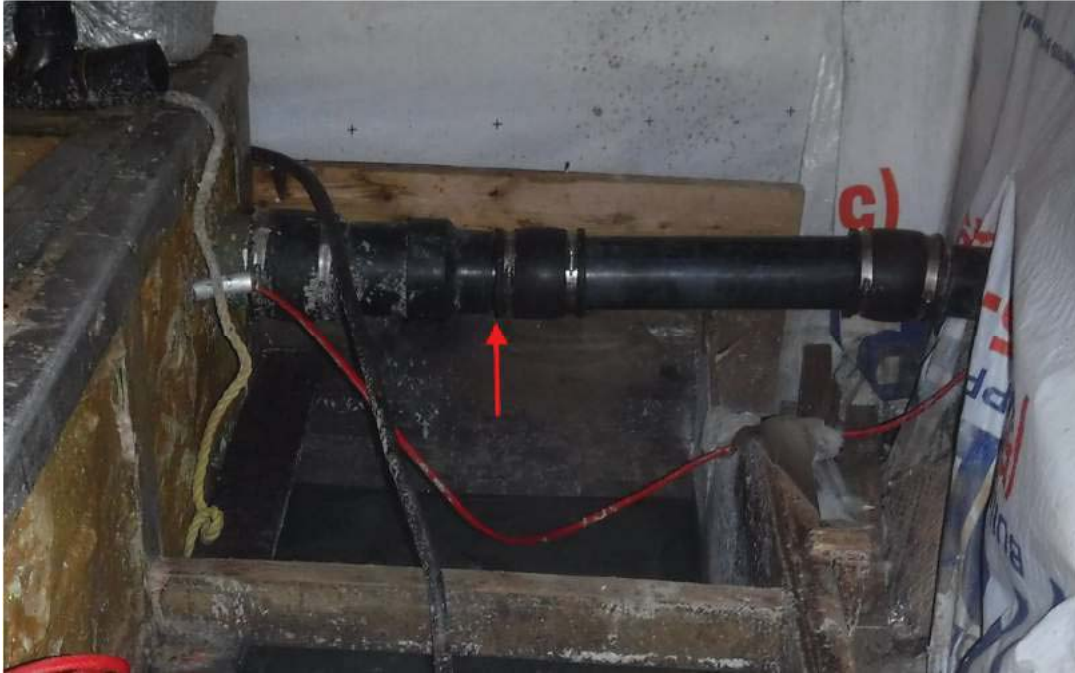
At 16:00 HRS on December 21st, an employee conducting routine lift station inspections observed that the influent line to the Weatherhaven greywater lift station had separated at a coupling. Upon initial investigation, the pipe installed between fittings appeared too short and had separated from adjoining couplings. Approximately 600L of greywater was released into the lift station building, migrating out under the base, impacting an area of 15m<sup>2</sup>. The location of the spill was confined to the Weatherhaven Complex pad. The spill is >200m from Camp Lake which is ice covered.

Photo 1. Repaired coupling at lift station.

Sources to the lift station were immediately shut off. Greywater released inside the building and surrounding camp pad was sucked up using a vac truck and taken to the Polishing Waste Stabilization Pond. The pipes and fitting were replaced before the lift station was put back into service. The contaminated snow was collected and deposited in an engineered containment berm at Milne Port.

Routine inspections of the water lines and lift stations will continue to be completed to ensure all components are functioning as designed.

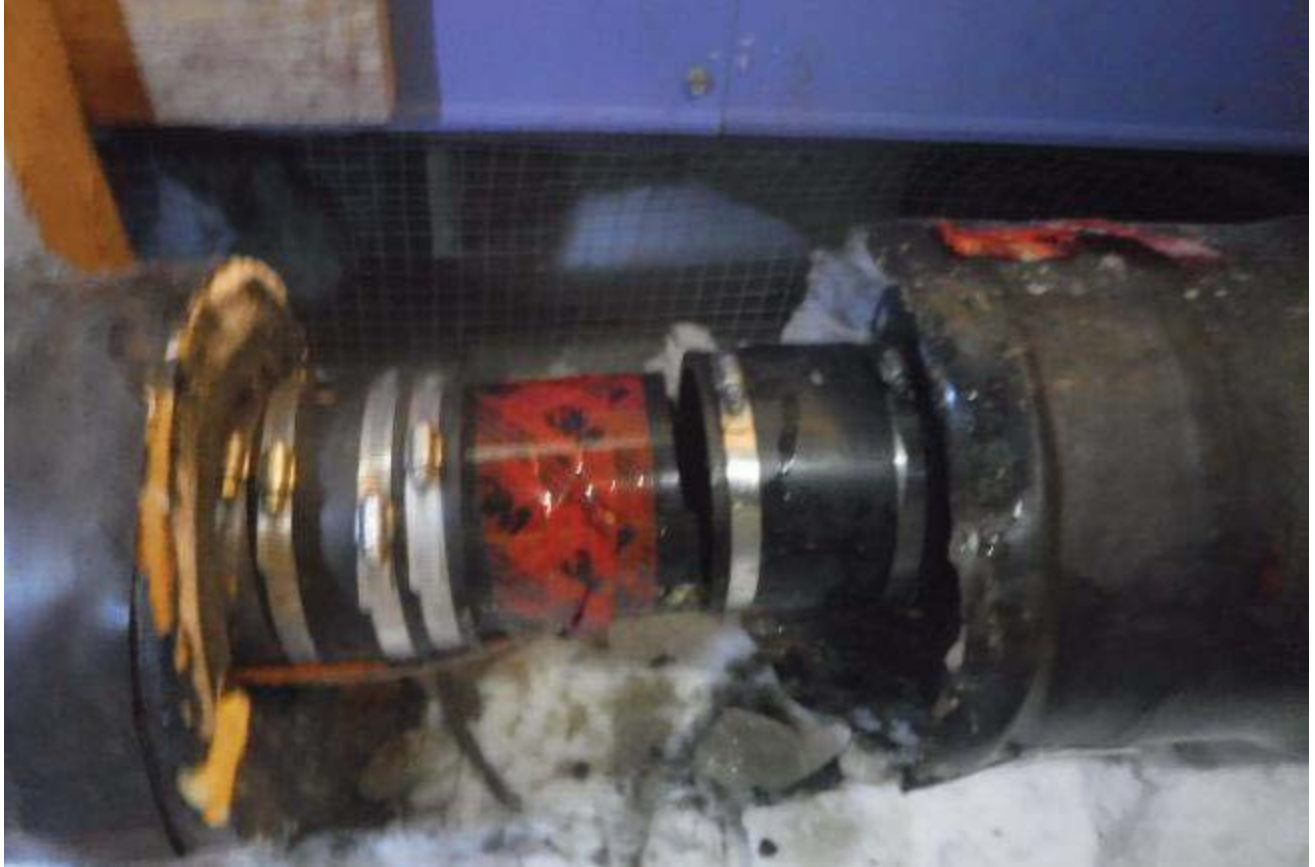
On December 23, 2017 at 9:15 HRS, a Site Services Fixed Plant employee observed fluid outside BA wing south lift station while conducting routine lift station inspections. Upon initial investigation, it was determined that the influent line into the lift station had separated at a Fernco coupling. Approximately 150 litres of raw sewage and grey water was released onto the adjacent ground, affecting an area of approximately 5 m<sup>2</sup>. The location of the spill was confined to the Port Site Complex pad. The spill is >150 m from the nearest water body which is currently frozen.

**Photo 1 – Fernco coupler separated on the 4" gravity line into the lift station**

Routine inspections of the pipes and inlets will continue to be completed to ensure all components are functioning as designed and there are no worn out or damaged parts. Investigation into the functionality of Fernco couplings currently being used versus another type of coupling.

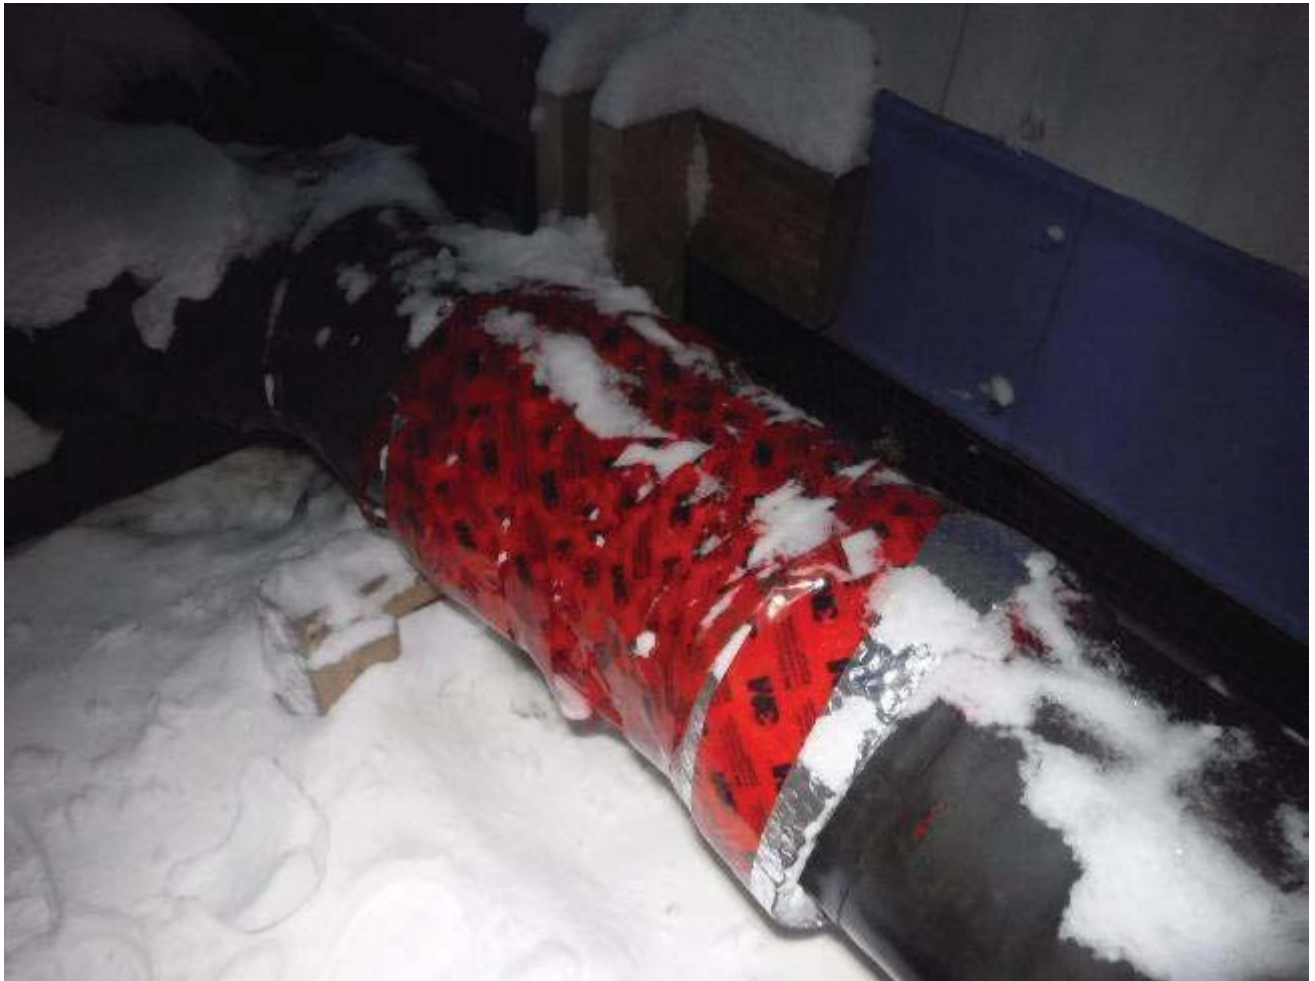
**Photo 2 – New coupler and wood support installed on 4” gravity line**

Fernco coupler was replaced and insulated. A wood block was placed to add extra support for the coupler. The contaminated snow was collected and deposited in the Polishing Waste Stabilization Pond.

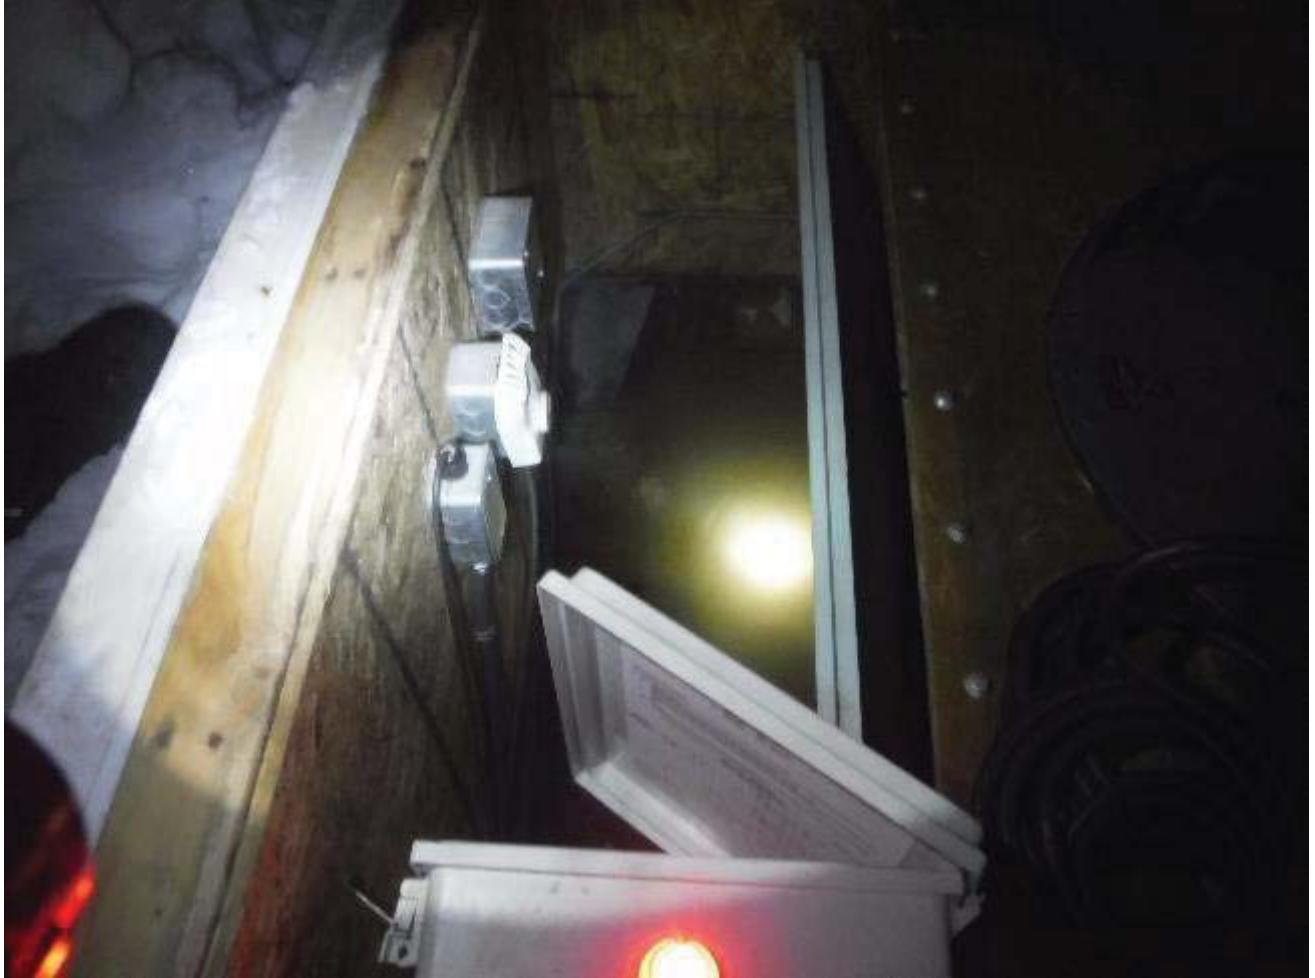
On December 24, 2017 at 08:45 HRS an employee observed steam coming from the perimeter of the BD wing south lift station while conducting daily inspections. Upon initial investigation, it was determined the lift station pump was not operational due to a failed electrical thermostat inside the lift station enclosure causing the main breaker to trip. Therefore no power to float switches or pumps causing the holding tank to overflow. Approximately 300 L of sewage was released to the adjacent camp pad ground surface, impacting an approximately 8 m<sup>2</sup> area. This location is greater than >100 m to the nearest water course (which is currently frozen).

**Photo 1 – Water Pooling on the inside of the Lift Station December 24, 2017**

The thermostat was replaced, system reset and monitored to ensure system was functioning properly. All sewage within lift station box was pumped back through WWTP. The contaminated snow was collected and deposited in the Polishing Waste Stabilization Pond.

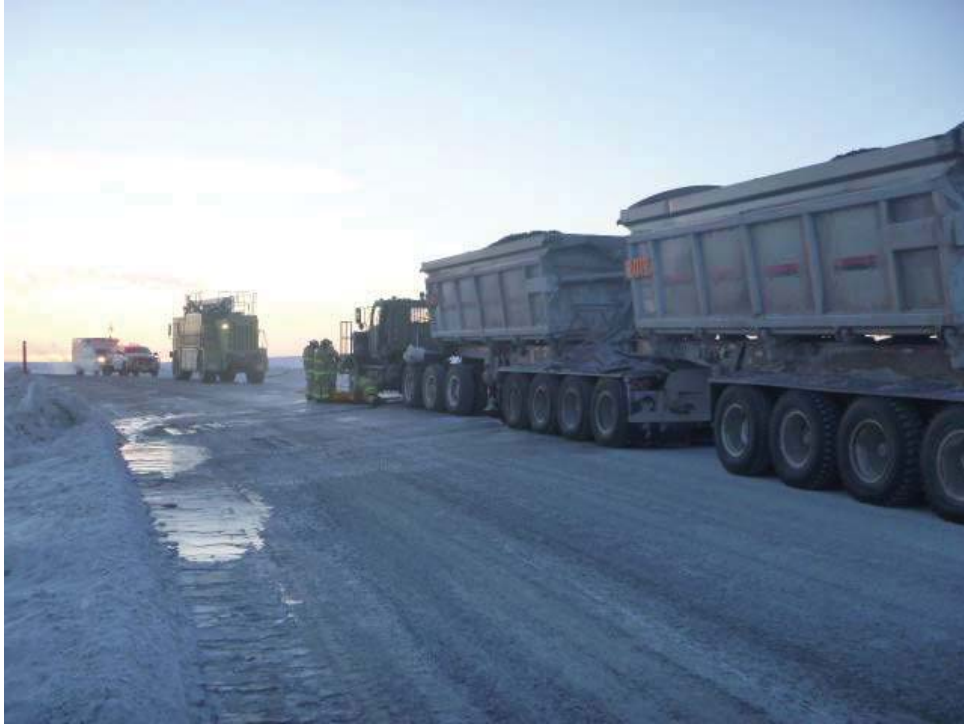
On March 20th, 2017 at approximately 18:00, a fire was reported at KM 70 on the Milne Port Tote Road. The Mine rescue team was dispatched to extinguish the fire. The fuel and hydraulic tanks on the truck were not breached by the fire. Approximately 4m<sup>3</sup> of water was used to extinguish the fire. No foam or chemical suppressants were used.

Photo 1: Impacted water contained on the surface of the Tote Road

The scene of the fire has been cleaned up and the contaminated snow was placed in a lined engineered containment facility. The Ore Haul truck was floated back to maintenance for repair.

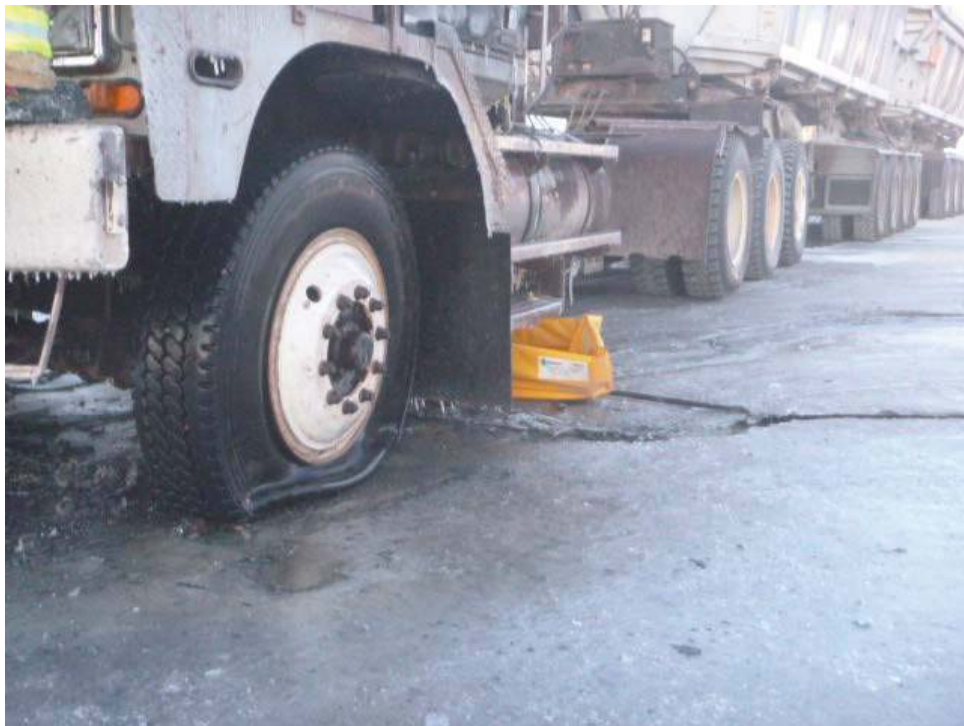
Photo 2: Ore Haul truck front cab tire- source of fire

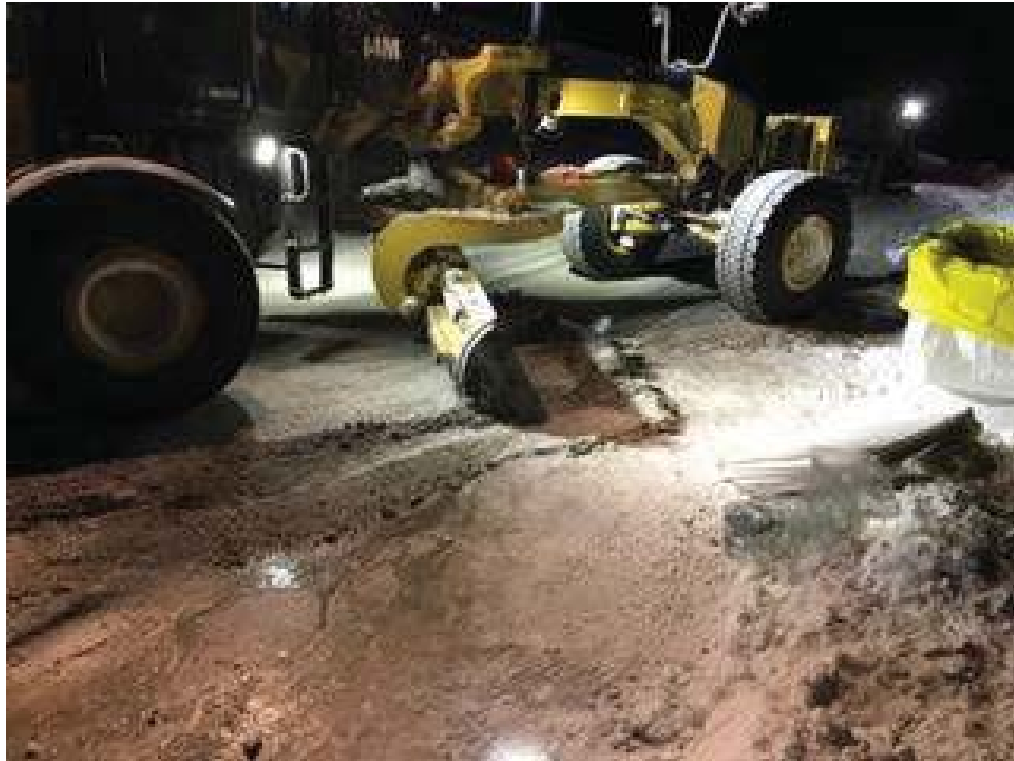
Photo 3: Grader removing contaminated snow for placement into Quatrex Bags

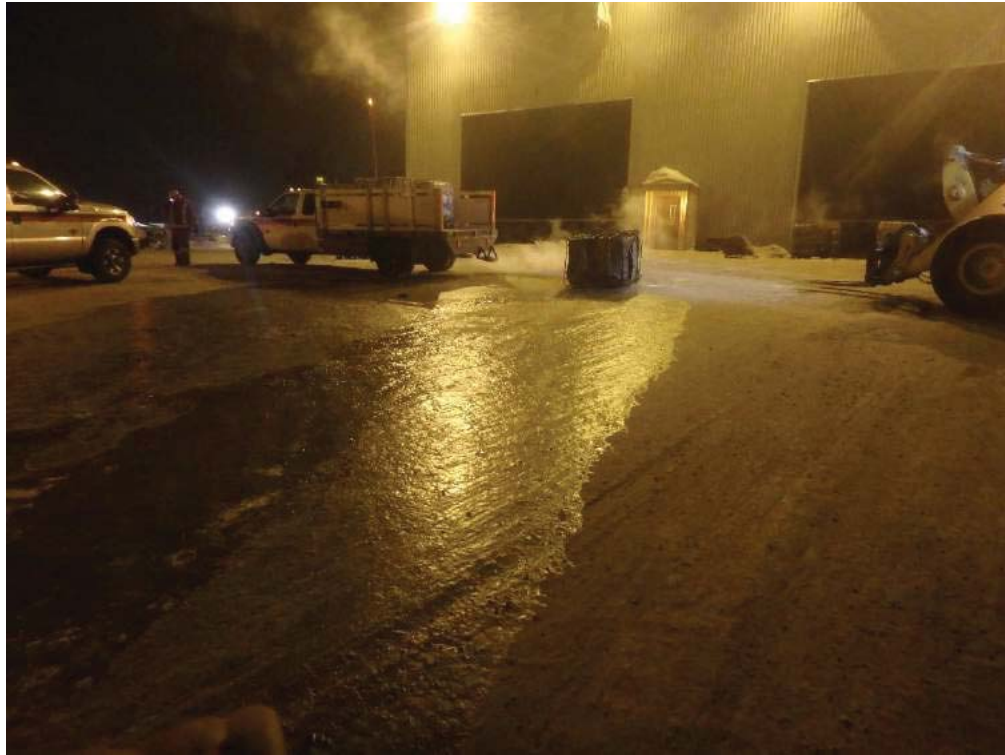
At 03:45 HRS on March 25 an operator was loading sump water totes from the maintenance shop onto the stake truck to deliver the contaminated water tote to the Mine Site Hazardous Waste Berm (MS-HWB-7). While removing the forks the operator noticed structural damage to the tote. The operator then attempted to lower the tote to the ground. At this time it tipped over releasing approx. 400 L of contaminated water to the surrounding camp pad and access road, contaminating an area of approximately 300 m<sup>2</sup>. The location of the spill was confined to the maintenance shop pad and access road, occurred on IOL, and is greater than 200 metres from the closest water body which is currently frozen

Photo 1: Damaged tote spilled while being loaded for transport to MS-HWB-7

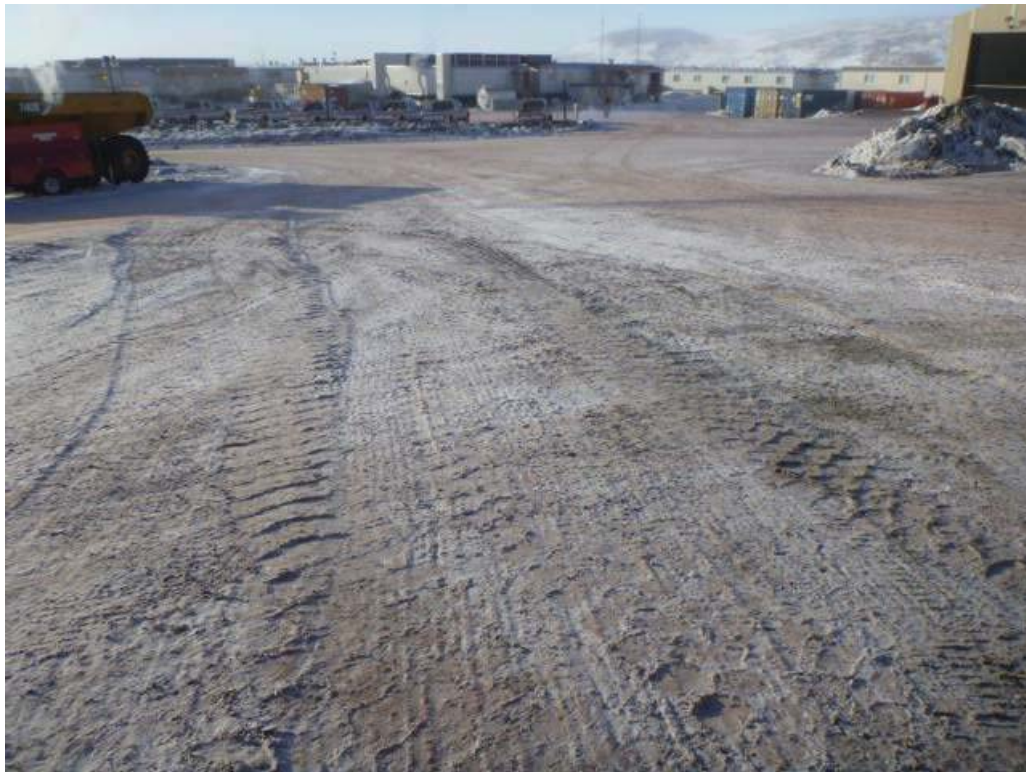
Photo 2: Affected area after cleanup and snow removal

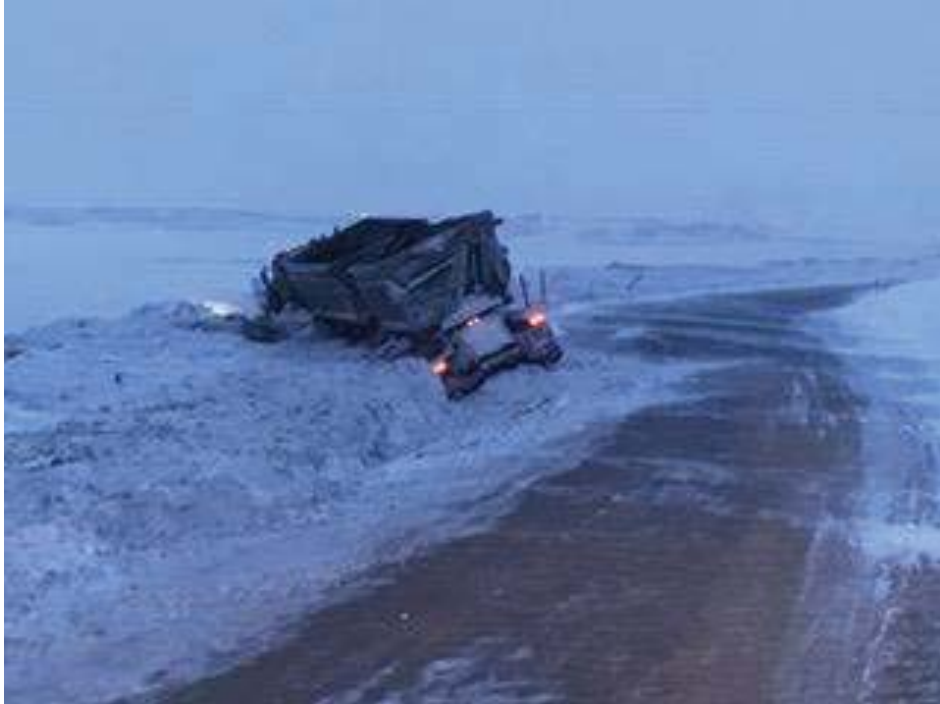
At 10:30 HRS on April 5<sup>th</sup>, night shift superintendent notified environmental personnel that a loaded Ore Haul Truck had driven off the tote road while heading north bound. It was observed that the fuel tank was not punctured but was slowly over topping causing fuel to leak out as the truck was situated on an angle. Operators responded immediately by placing spill pads and a duck pond to collect the diesel being released. Approximately 100 L of fuel was released to the adjacent ground, impacting an area of less than 1m<sup>2</sup>. The location of the spill was confined to the side of the Tote Road at Km 54, and is greater than 50 meters from the closest water body which is currently frozen.

Photo 1: Ore Haul Truck off Tote Road at Km 54

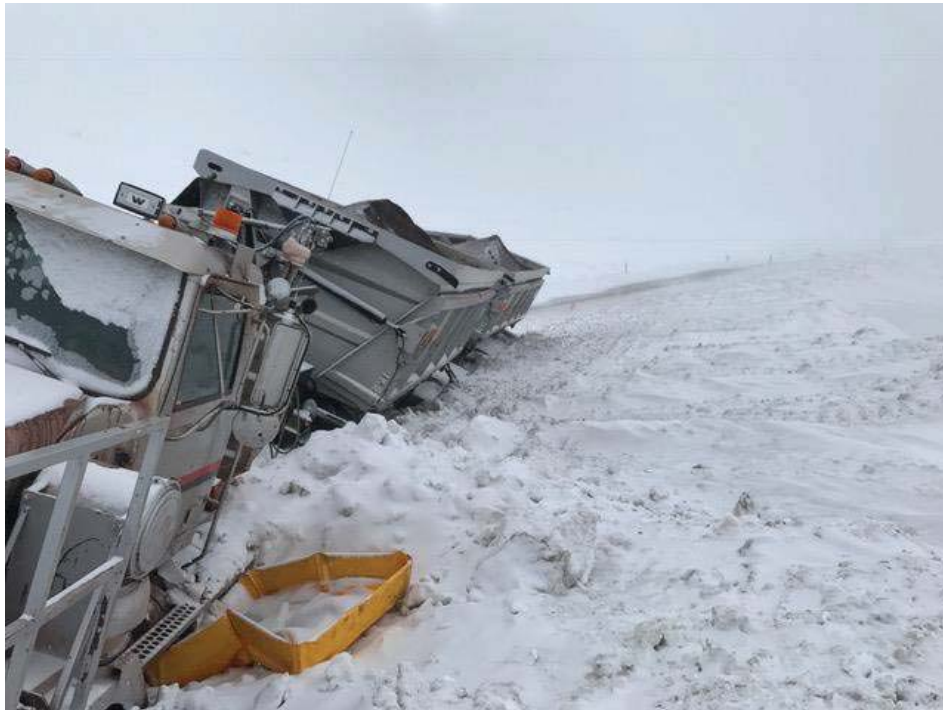
Photo 2: Ore Haul Truck before extraction at Km 54 of Tote Road
