### **GEOTECHNICAL INSPECTIONS**

**APPENDIX C.2.1**  
**GEOTECHNICAL INSPECTION**  
**JULY/AUGUST 2018**

**RE: Submission of 2018 Geotechnical Inspection Report No. 1 (Jul/Aug. 2018)**

FIRST INSPECTION OF TWO

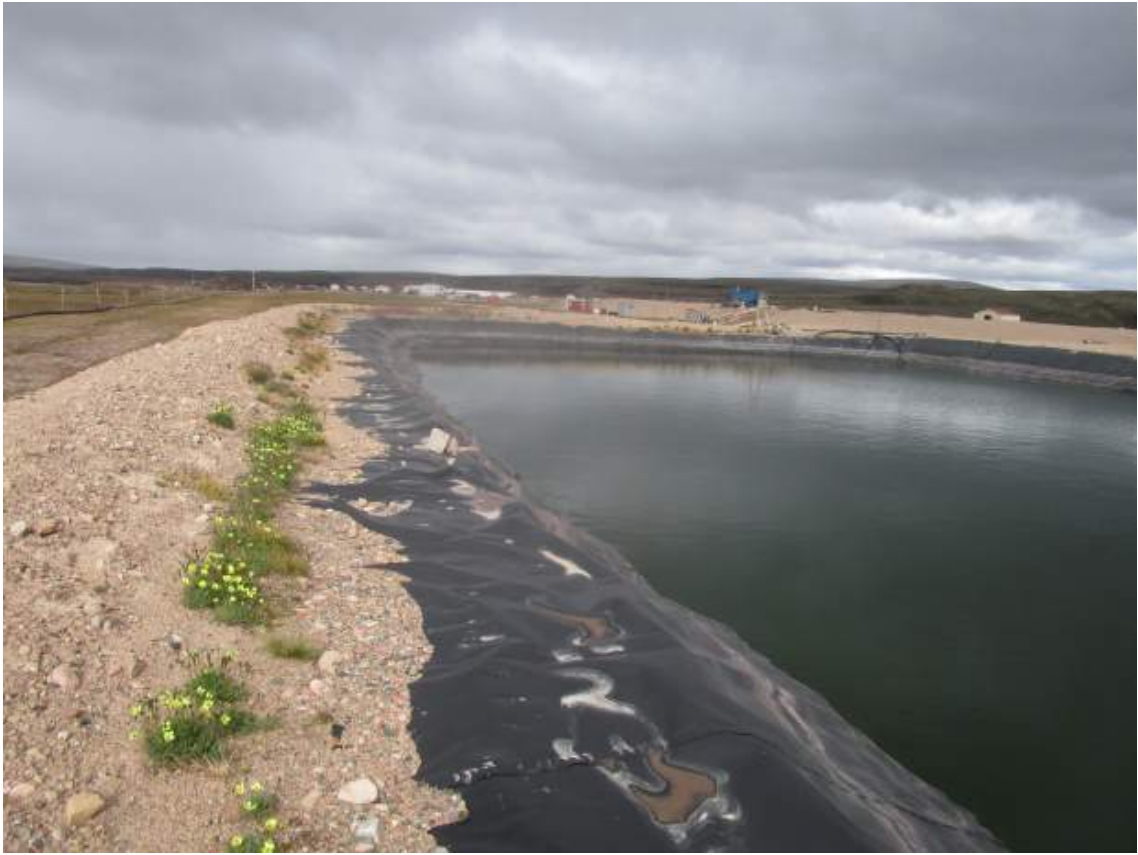
3. PWSP #1

Our review of this area around the pond at the base of the slopes showed no sign of seepage and hence we conclude that the liner has been effective in containing sewage and there are no tears or ruptures in the membrane, excepting some minor tears from past activity at the top of the dyke well above the allowable effluent level in the structure in the horizontal portion of the membrane.

A review of the top of the dyke showed no indication of cracking or settlement which would indicate stresses within the structure.

Many of the tears that had occurred in the liner on the top of the dyke have been patched during the period between reviews in 2008 and 2009 and are holding well. As well, there are no signs of weather related deterioration of the liner where it is exposed.

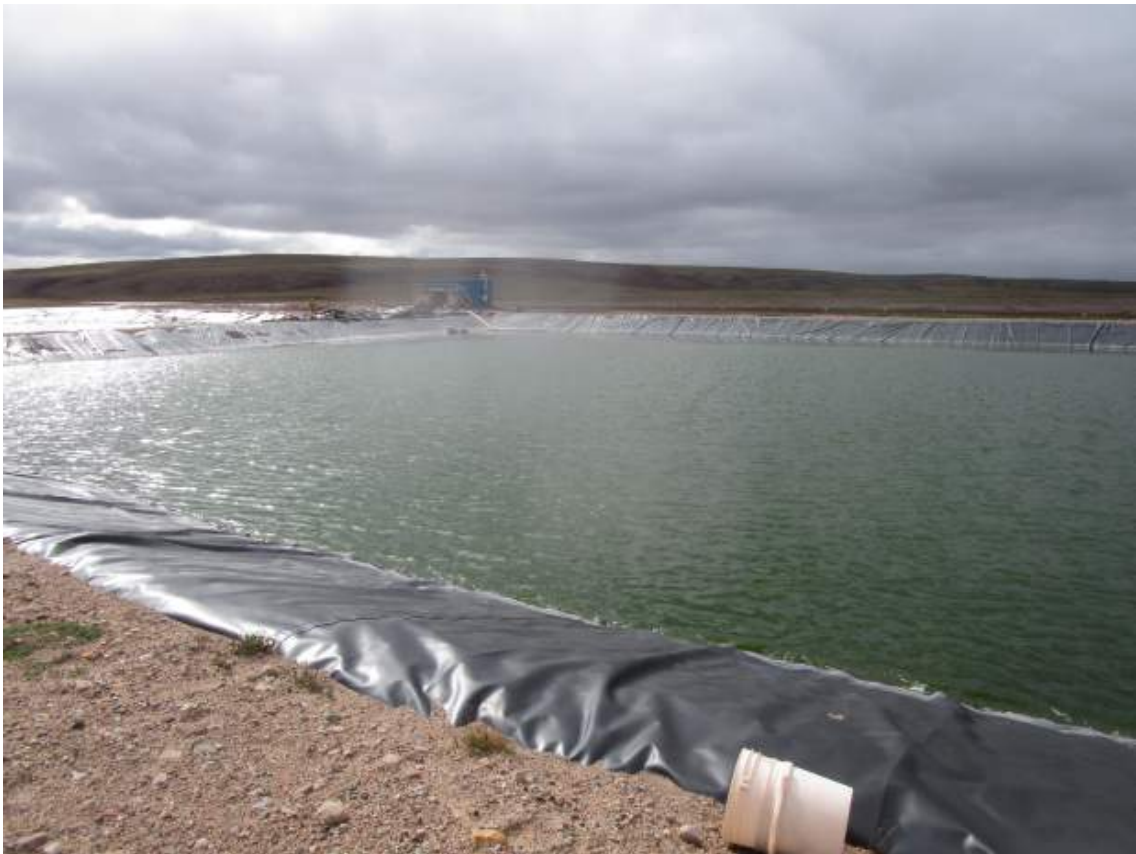
5. PWSP #3

Our review of the area around the pond at the base of the slopes showed no sign of seepage and hence we conclude that the liner has been effective in containing the sewage and there are no tears or ruptures in the membrane.

Longitudinal cracking which appeared in the dykes of PWSP #3 due to the melt of permafrost wedges in 2009 has not reoccurred and we consider this structure to be stable in its present condition.

Monitoring points have been set upon the top of the dyke and have been monitored since 2009. Settlements have occurred since that time. These settlements have not led to any stress cracks in the structure. Monitoring was discontinued three years ago.

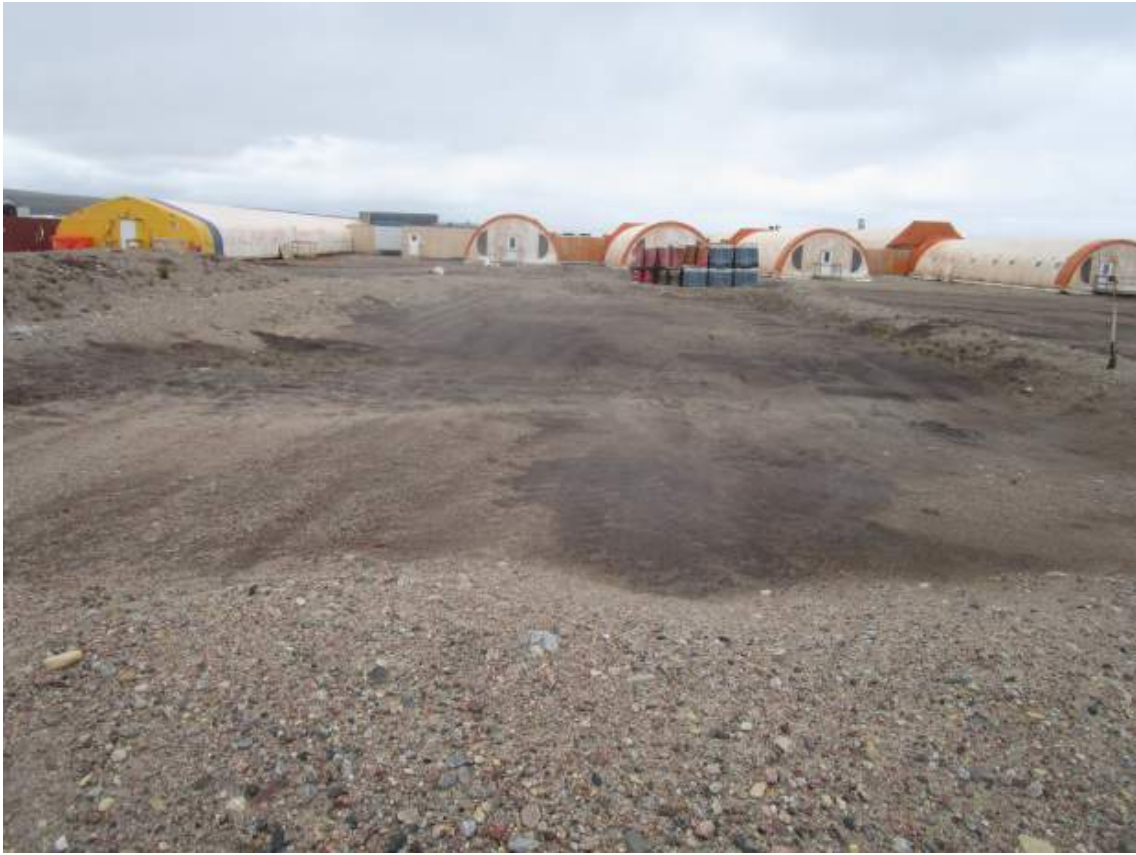
9. Enviro-Tank Storage

This particular structure is constructed contiguous with the Hazardous Waste Storage constructed in 2010 and the Stove Oil Storage cell. It is currently not being utilized and access is blocked.

Baffinland Action: The cell is currently not being used and has been left empty. The Site Services Department supervisors are aware that this area shall not be used for the storage of hazardous waste or substances until it has been repaired. Alternatively, this facility may be decommissioned.

We recommend that the geotextile over the liner be checked and the granular cover be made good prior to continuing use of this cell.

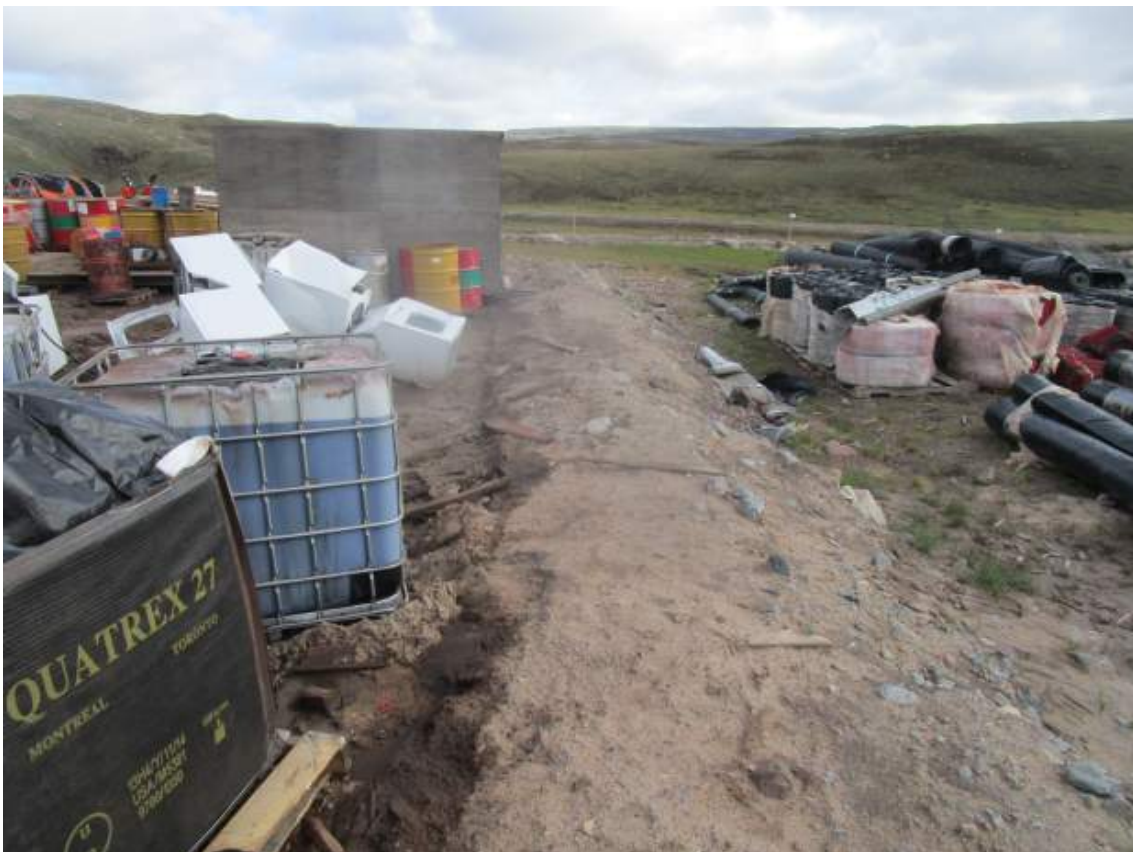
18. Hazardous Waste Containment (MS-HWB-6)

There is water ponding in the bottom of the cell confirming the integrity of the liner. There are tears in the enviroliner noted with 3 in the west side and one in the south east corner. All waste is in barrels or totes and is contained.

There were no signs of cracking of the dykes or seepage around the exterior of the dykes.

Baffinland Action: Baffinland has repaired the enviroliner at this facility and will monitor the status in the future.

We have no recommendations with respect to this structure other than making repairs to the damaged enviroliner. There are four tears in the side of the liner that should be repaired if use is to continue as we understand it shall. The side dykes should be also built up to keep traffic off them.
