# APPENDIX E.10 2018 FRESHET MONITORING REPORT (PART 2 OF 2)

<u>APPENDIX C.1 – Spill Report 18-180 – Camp Lake Settling</u>
<u>Ponds</u>

<u>APPENDIX C.2 – Spill Report 18-182 – Sheardown Lake and</u>
<u>Camp Lake Tributaries</u>

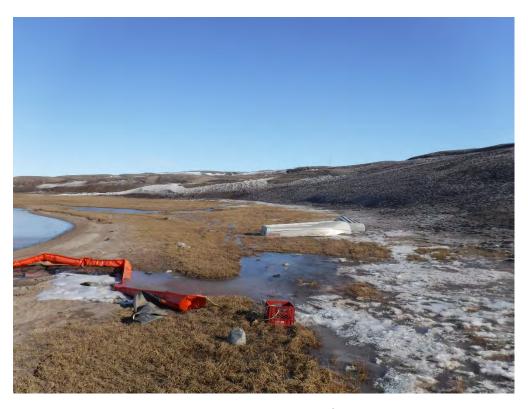
May 17, 2018: Downstream View of CLSP-OUT

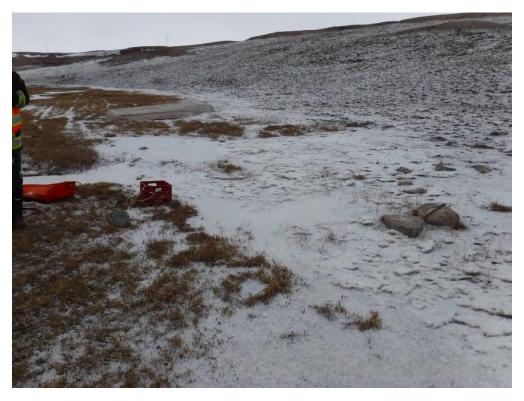
May 18, 2018: Downstream View of Frozen Conditions at CLSP-OUT

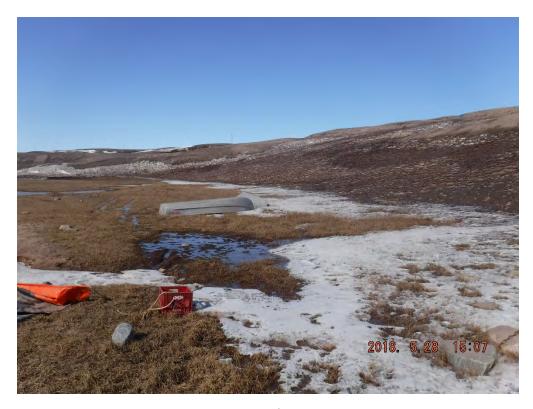
May 28, 2018: Downstream View of Frozen Conditions at CLSP-OUT

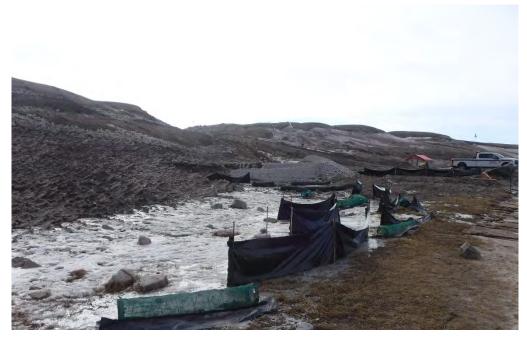
May 28, 2018: Downstream view of CLSP-OUT

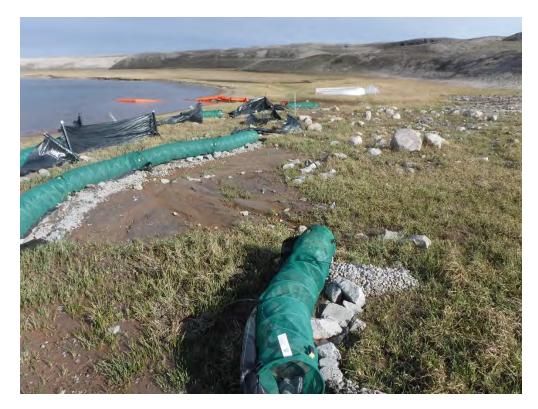
June 23, 2018: Downstream view of CLSP-OUT

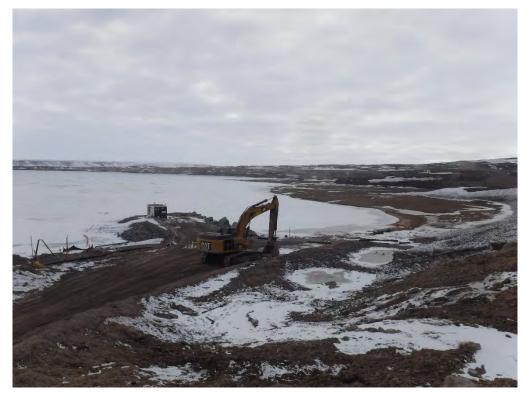
May 20, 2018: Camp Lake Settling Ponds Before Construction Upgrades

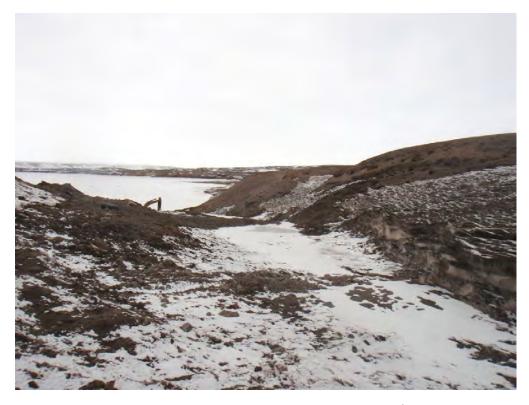
May 20, 2018: Check Dams in Camp Lake Settling Pond Drainage Channel Before Construction Upgrades

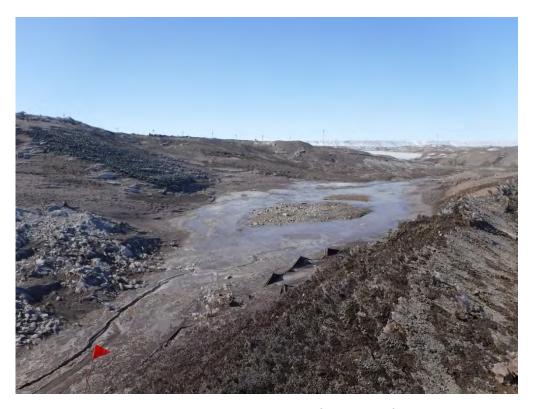
May 13, 2018: BG-01-DS Road Crossing Upstream of CLT-OUT Before Snow Removal

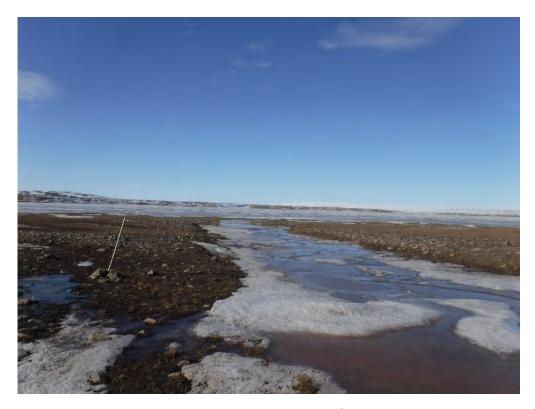
May 17, 2018: Downstream View of CLT-OUT

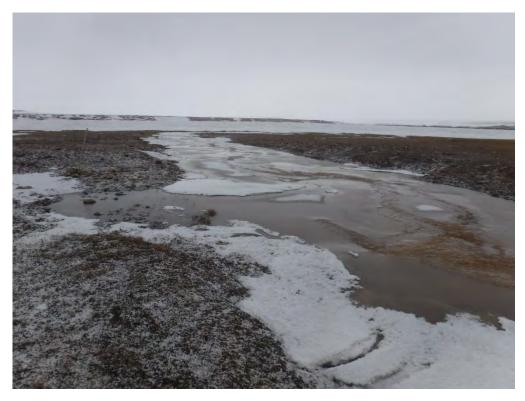
May 18, 2018: Downstream View of CLT-OUT

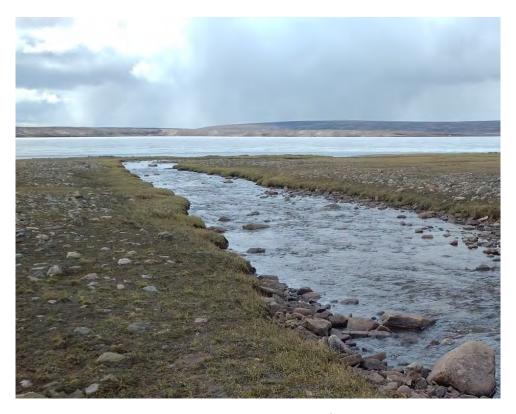
June 25, 2018: Downstream View of CLT-OUT

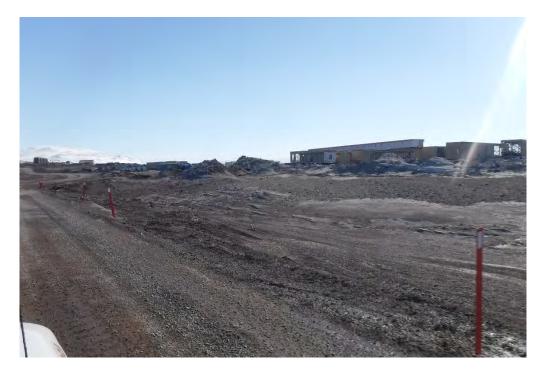
May 8, 2018: CV-186-DS Road Crossing Upstream of SDLT-OUT Before Snow Removal

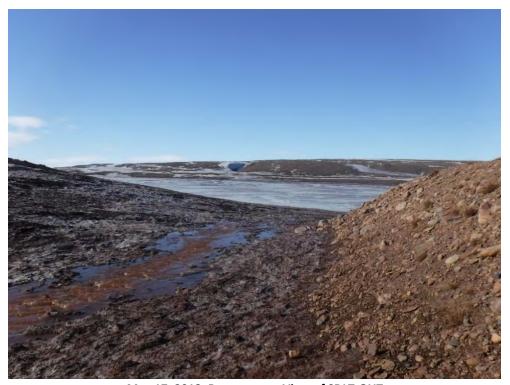
May 17, 2018: Downstream View of SDLT-OUT

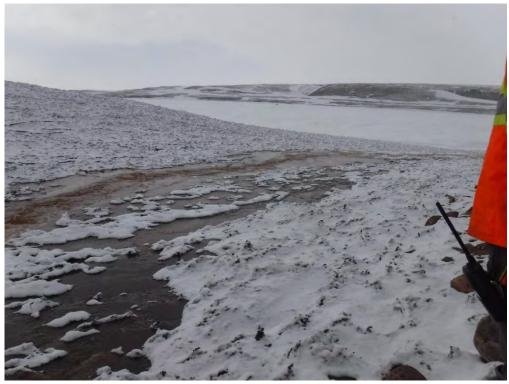
May 19, 2018: Downstream View of SDLT-OUT

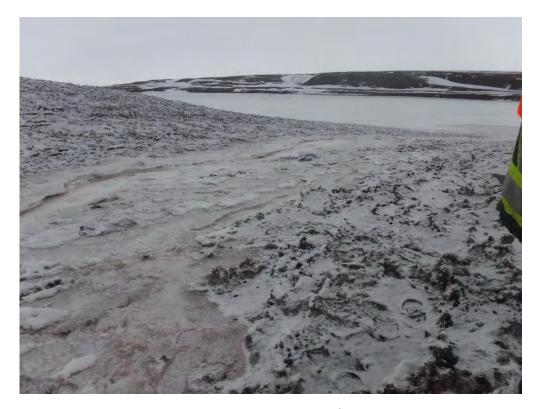
May 20, 2018: Downstream View of SDLT-OUT

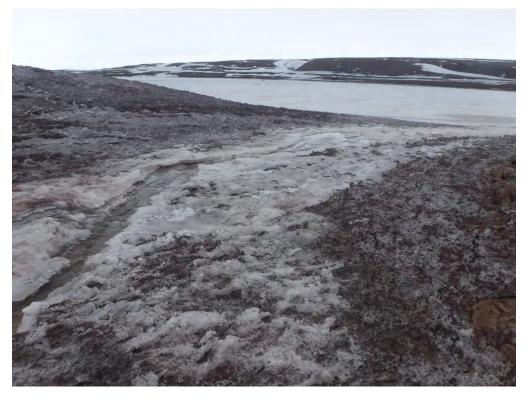
May 22, 2018: Downstream View of SDLT-OUT

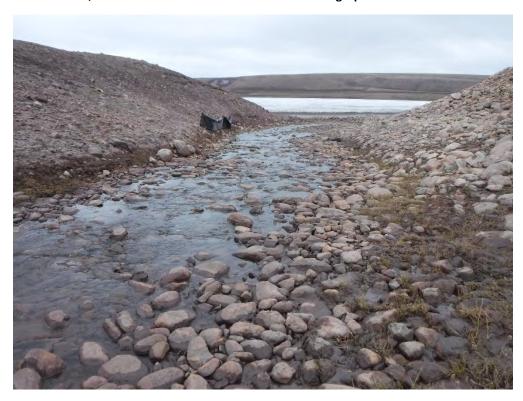
June 24, 2018: Downstream View of SDLT-OUT

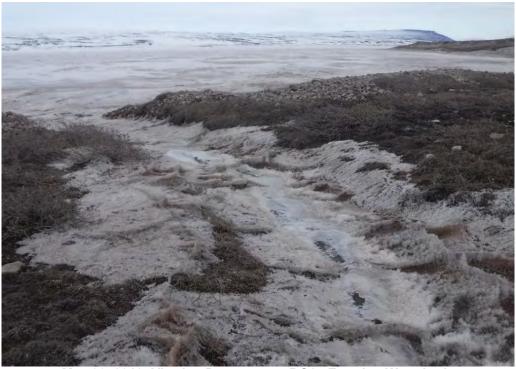
May 30, 2018: Viewing Downstream BG27 Entering Waterbody

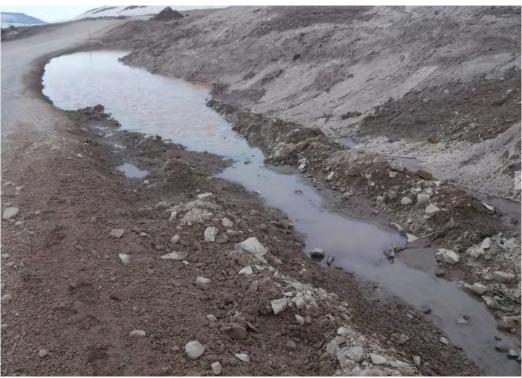
May 30, 2018: Upstream View of BG27 Looking Downstream

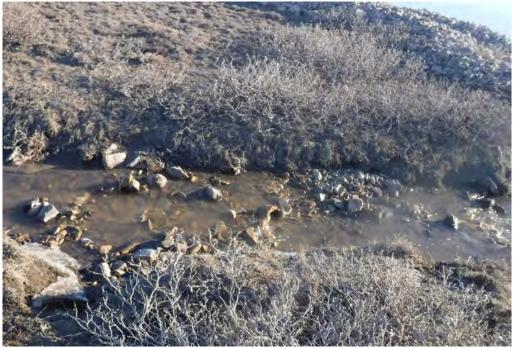
June 7, 2018: Water flowing clear following mitigation measure in place

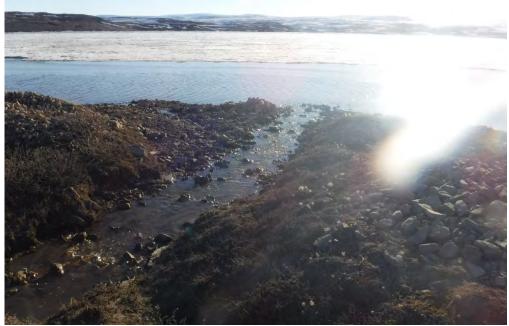
June 7, 2018: Water flowing clear following mitigation measure in place

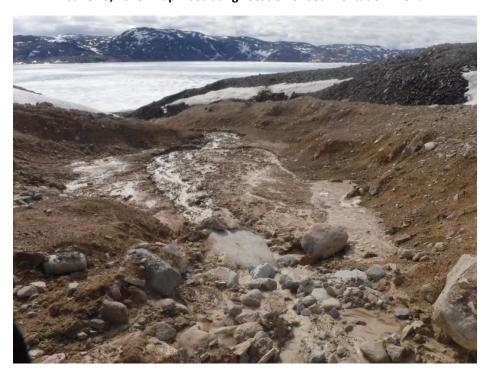
June 23, 2018: Downstream View of MP-NS-01

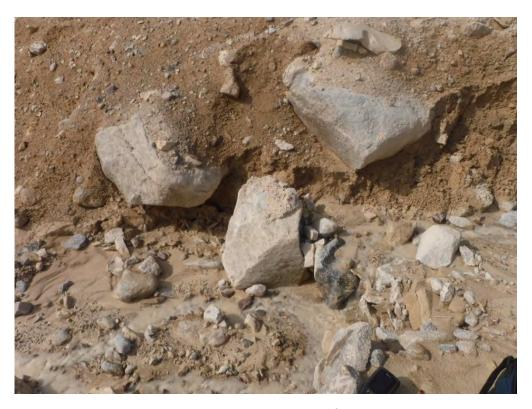
June 23, 2018: Cross-Section View of MP-NS-01
