APPENDIX E.8
REGULATORY CORRESPONDENCE

CIRNAC INSPECTION REPORTS AND BAFFINLAND RESPONSES

WATER LICENCE INSPECTION FORM

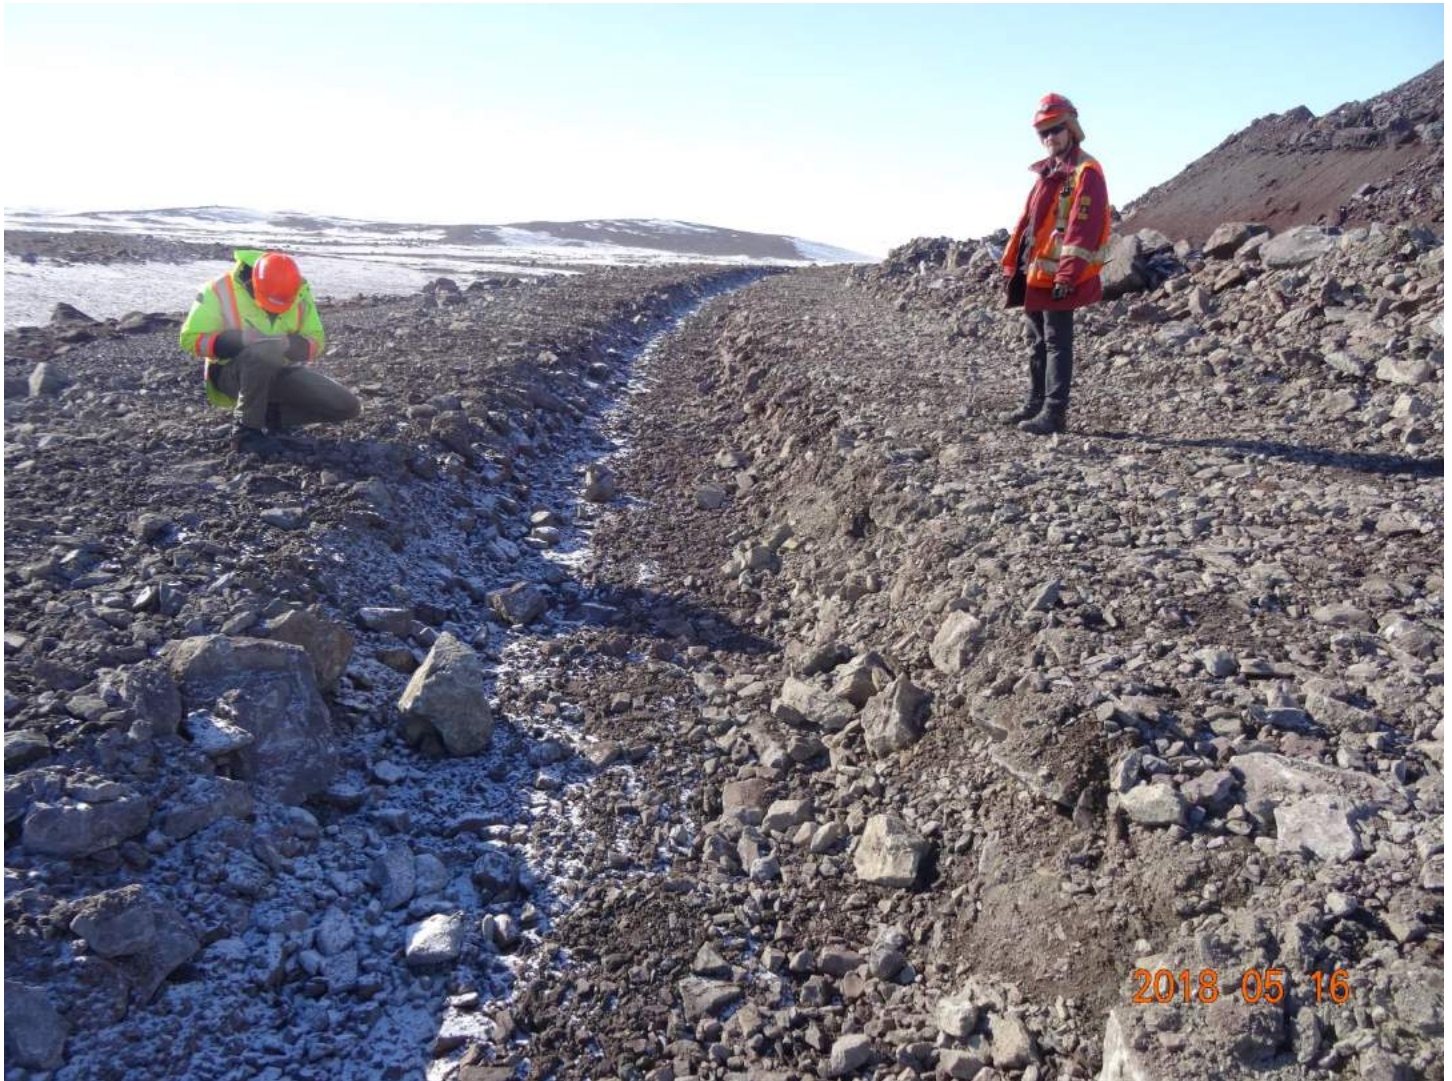
1. Ore Crushing Area and associated water management structures			
a. In the previous inspection report it was noted that the containment ditches surrounding ore stockpile pad were not complete, at the time of this inspections the containment ditches around this facility appeared to be complete. See figure 1

Figure 1: Ditch surrounding Ore Stockpile

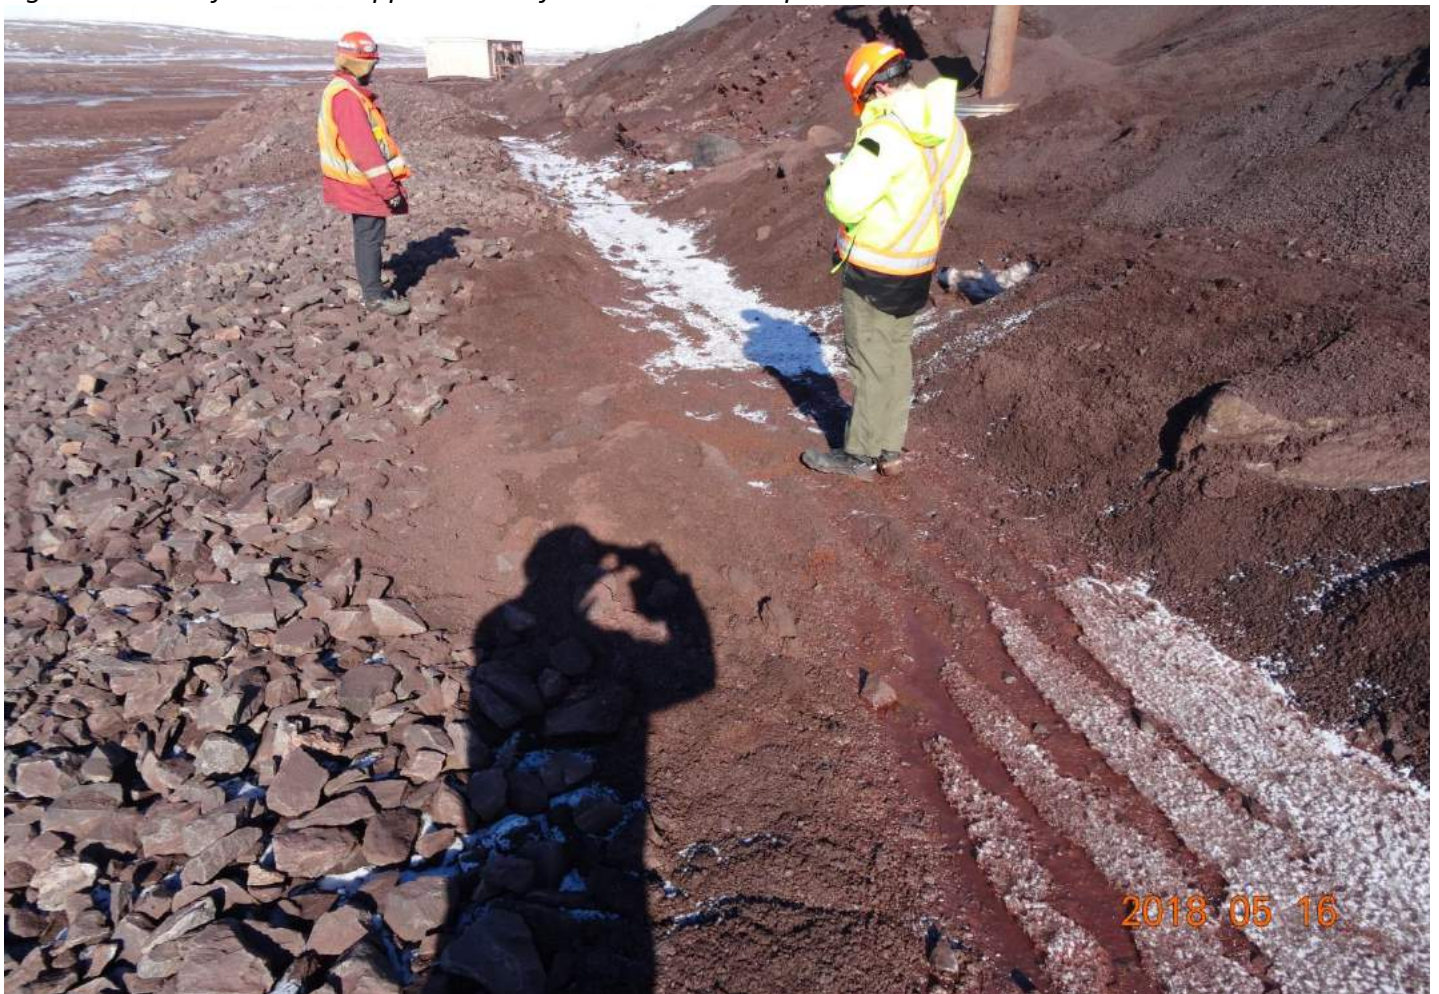
b. It was noted that some debris form what appears to be from the ore stockpile in the ditches (see figure 2) and an outer berm wall was either eroded or is incomplete (see figure 3). This berm wall must be repaired as soon as possible to ensure that contact water does not leach into the environment.

Figure 2: Debris from what appears to be from the Ore Stockpile in the ditch near the “E-house”

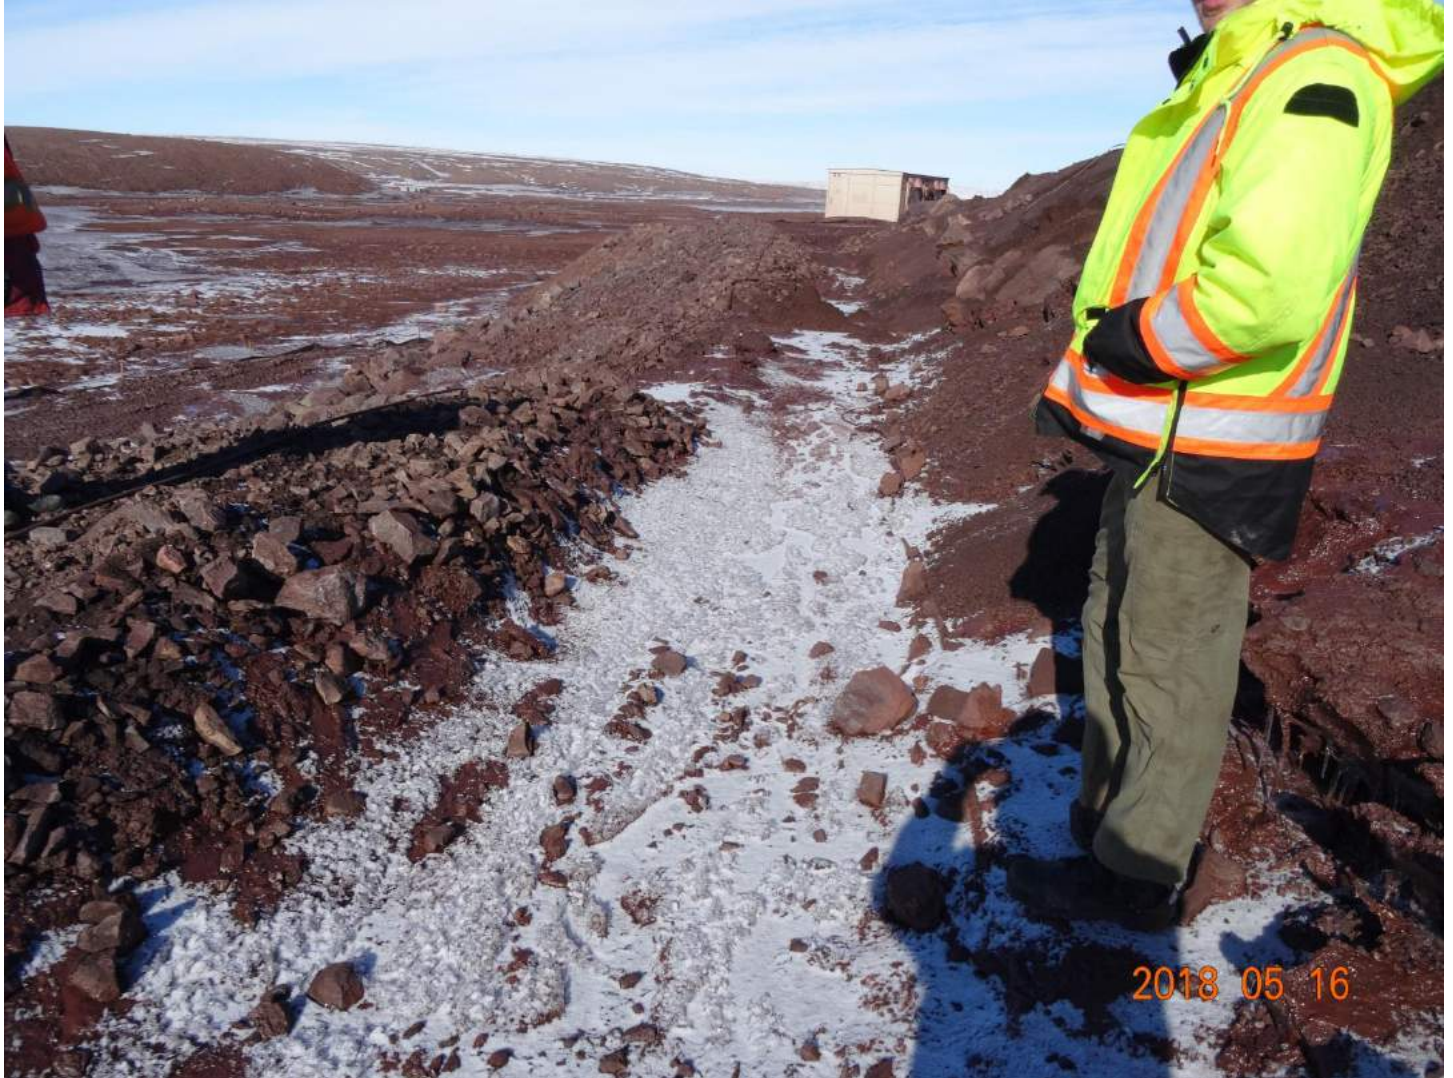
Figure 3: erosion or incompleteness of ditch wall seen in the center of the photograph location near the “Ehouse”

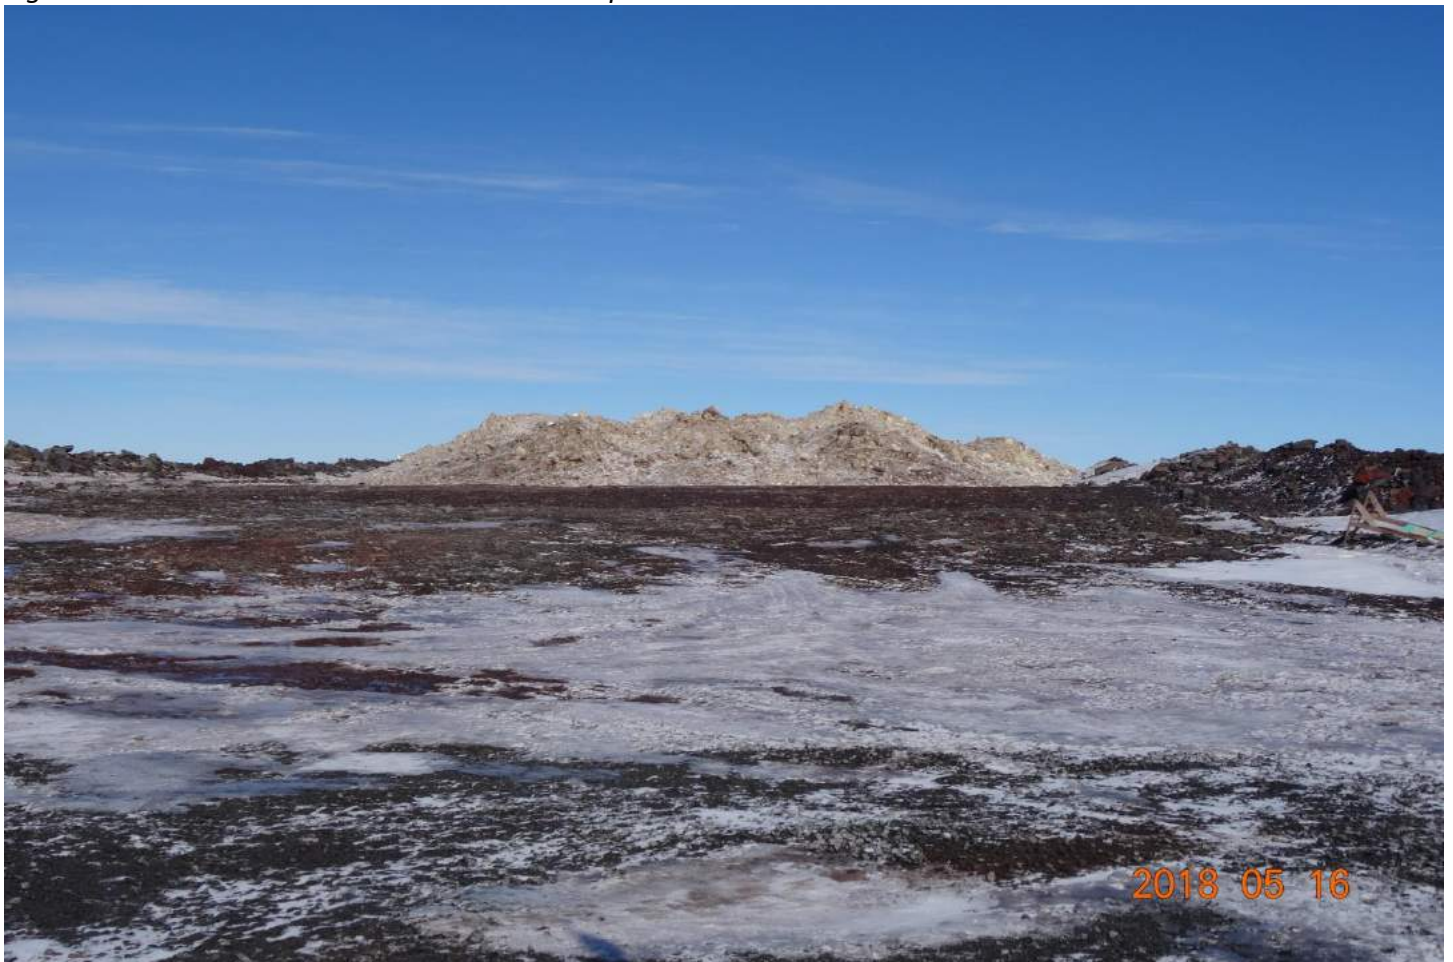
- a. Emergency ditch is cleared and appears to be in good condition; all ice from the emergency ditch has been removed and relocated to the waste rock stockpile (*see figure 4*). However a road was built over top of a diversion ditch on the North East side of the WRSP leading to the waste rock sedimentation pond for containment, this blocks the flow of water to the WRSP sedimentation pond.

Figure 4: ice relocated to the Waste Rock Stockpile

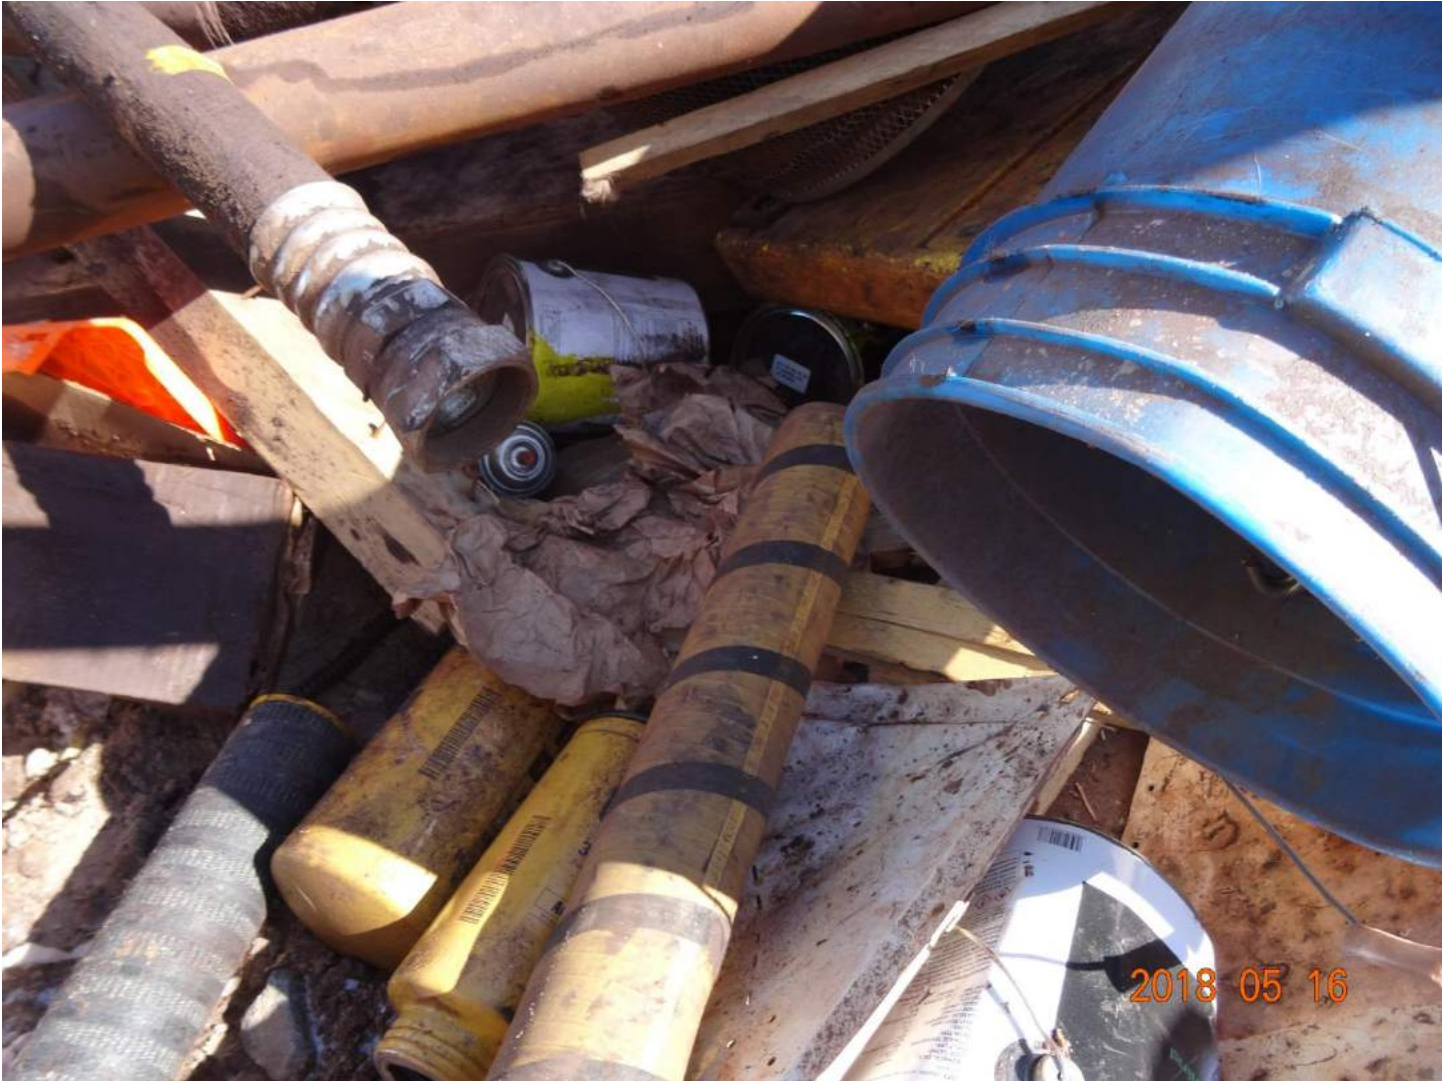
- a. Land fill appears to be properly covered.
- b. Inspector noted that the fence is in poor condition.
- c. The inspector noted that hazardous material was dumped into the land fill. Hazardous waste found in this facility consisted of paint cans, oil filters, and aerosol cans. *See figure 5*.

Figure 5: Hazardous Material found in the Landfill aerosol can, paint cans, used oil filter

- IV. It is BIMC’s obligation to ensure that all BIMC employees understand that this is a non-hazardous landfill.

- V. Hazardous material must be removed from the land fill and stored in an approved lined facility.

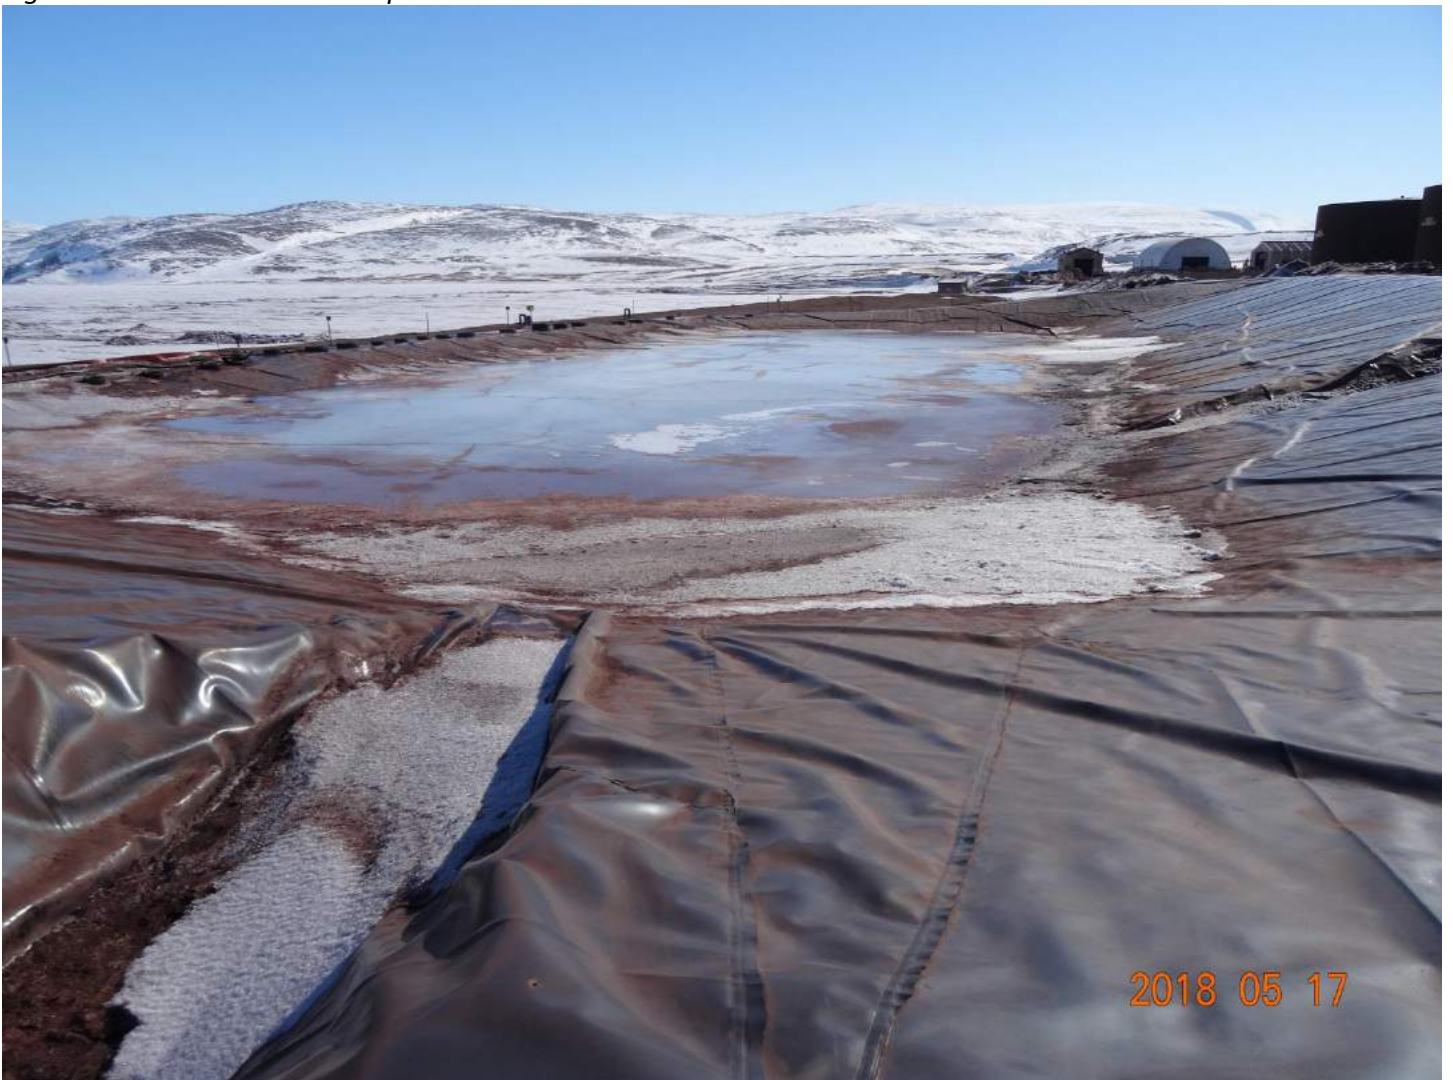
- a. Ore bulk sample remains appear to be removed as requested by the inspector in a previous inspection.
- b. Liners of the East and West sedimentation pond appear to be in good condition.
- c. The culvert on the North East side of the stockpile pad has not been cleared and is allowing water to pool inside of the unlined diversion ditches.
- d. East and west Sedimentation Pond appears to be in good condition. *see figure 6 & 7*.

Figure 6: East Sedimentation pond

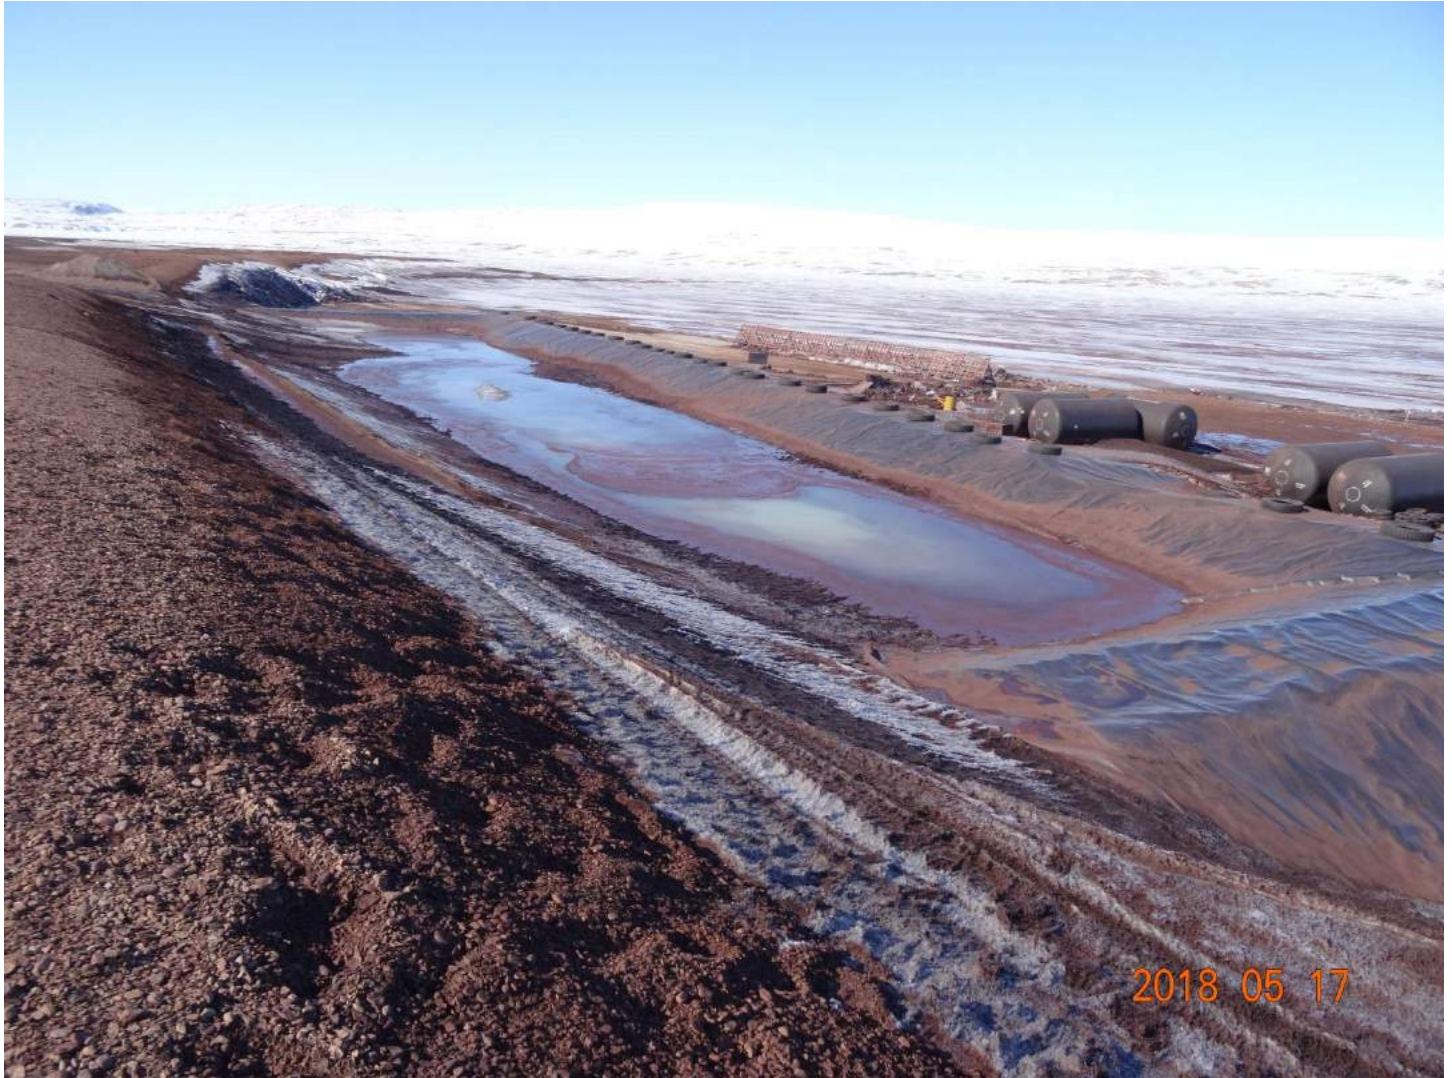
Figure 7: West Sedimentation pond

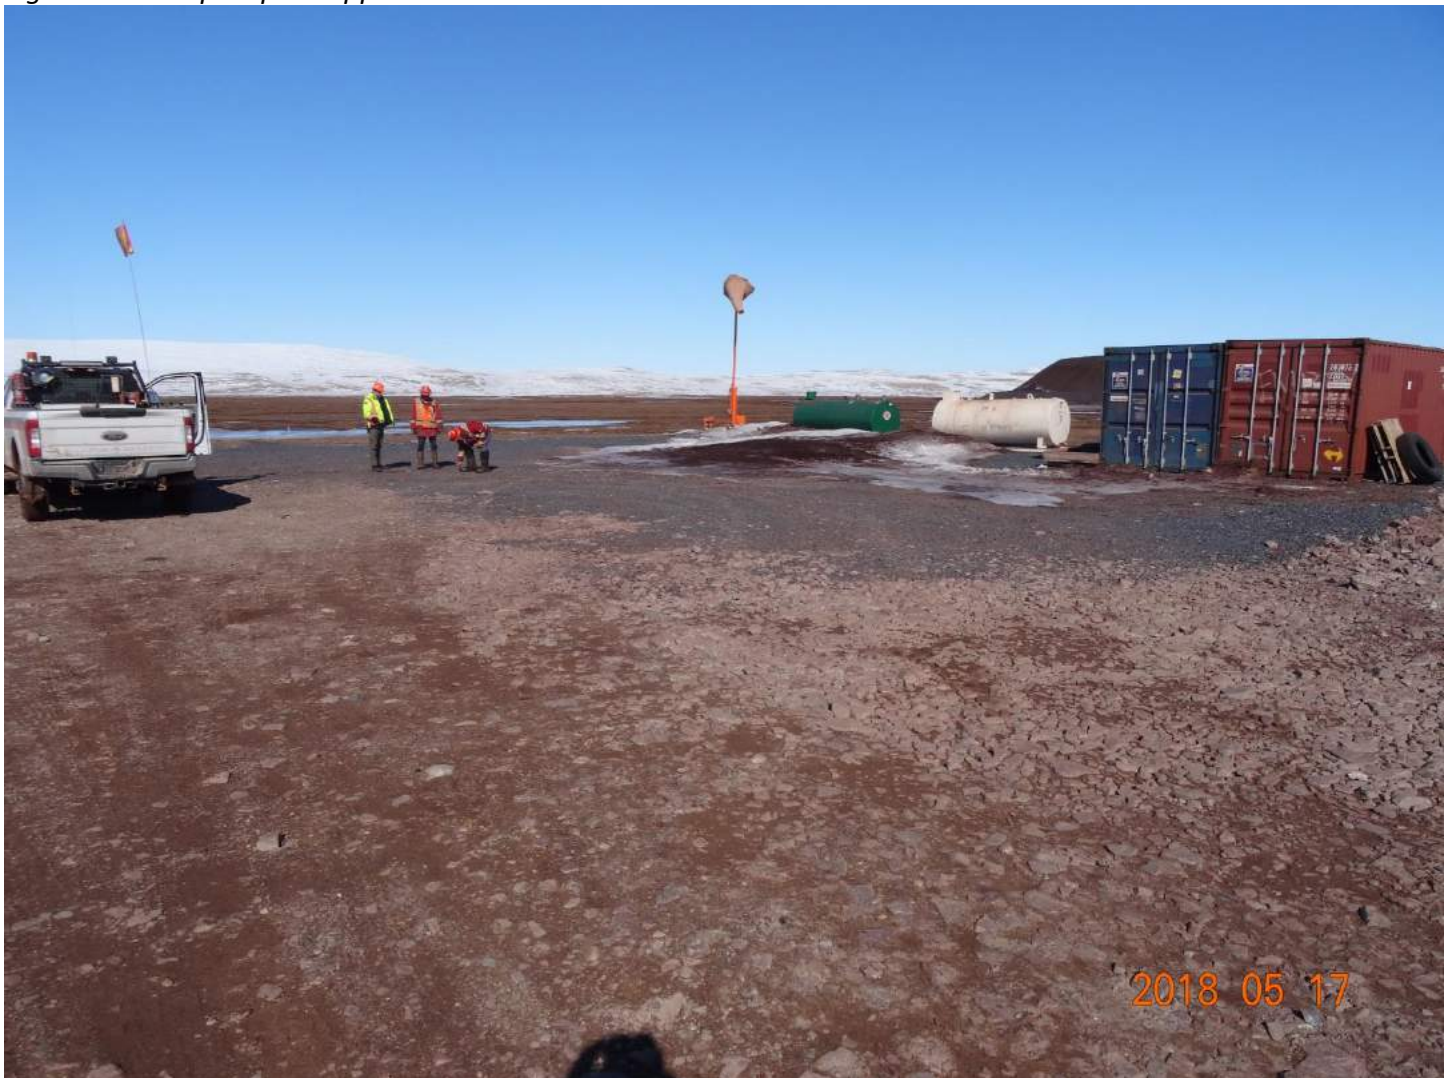
- a. Surface of helicopter pad is topped with Ore, the ore topping the helicopter pad is to be removed or the licensee is provide evidence that this material is approved by the Nunavut Water Board as

construction material. *See Figure 8*

Figure 8: helicopter pad topped with Ore

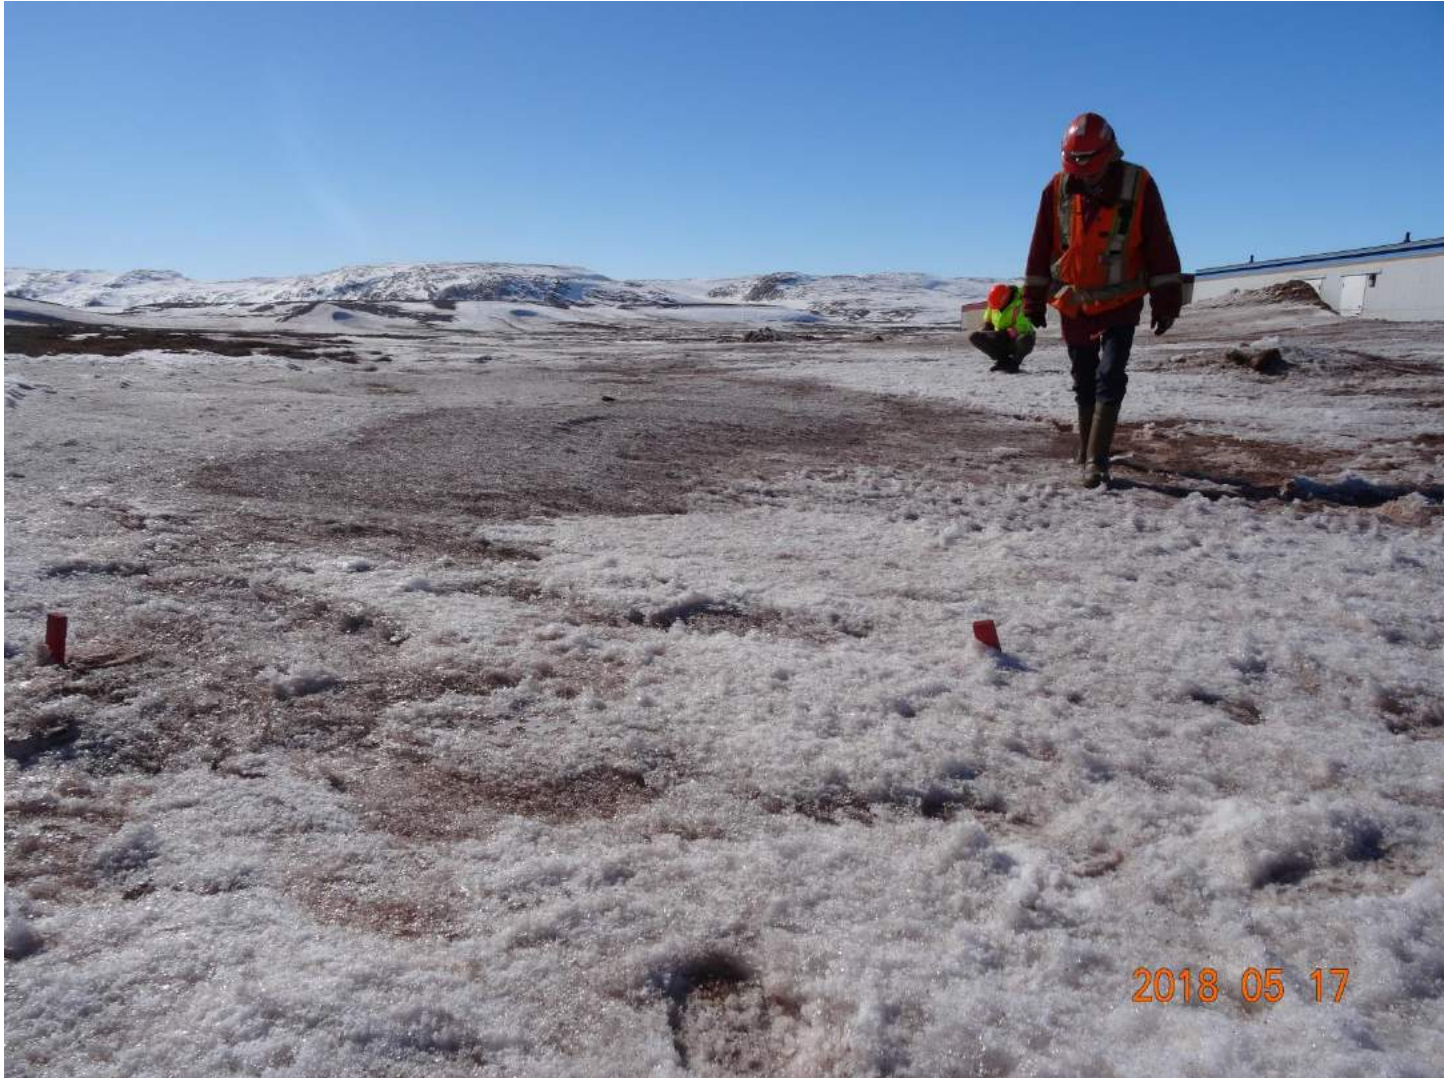
- a. Ditches surrounding new camp pad are unidentifiable due to snow cover
- VI. Ensure that all water management structures are cleared to allow these structures to operate as intended. *See figure 9*
- VII. North of batch plant contaminated soil placed in drums however the drums are not sealed or in containment. *See figure 10 & 11*

Figure 9: Ditch surrounding new camp pad Milne port

6. Ensure that all water management structures are cleared to allow these structures to operate as intended. *See figure 9*

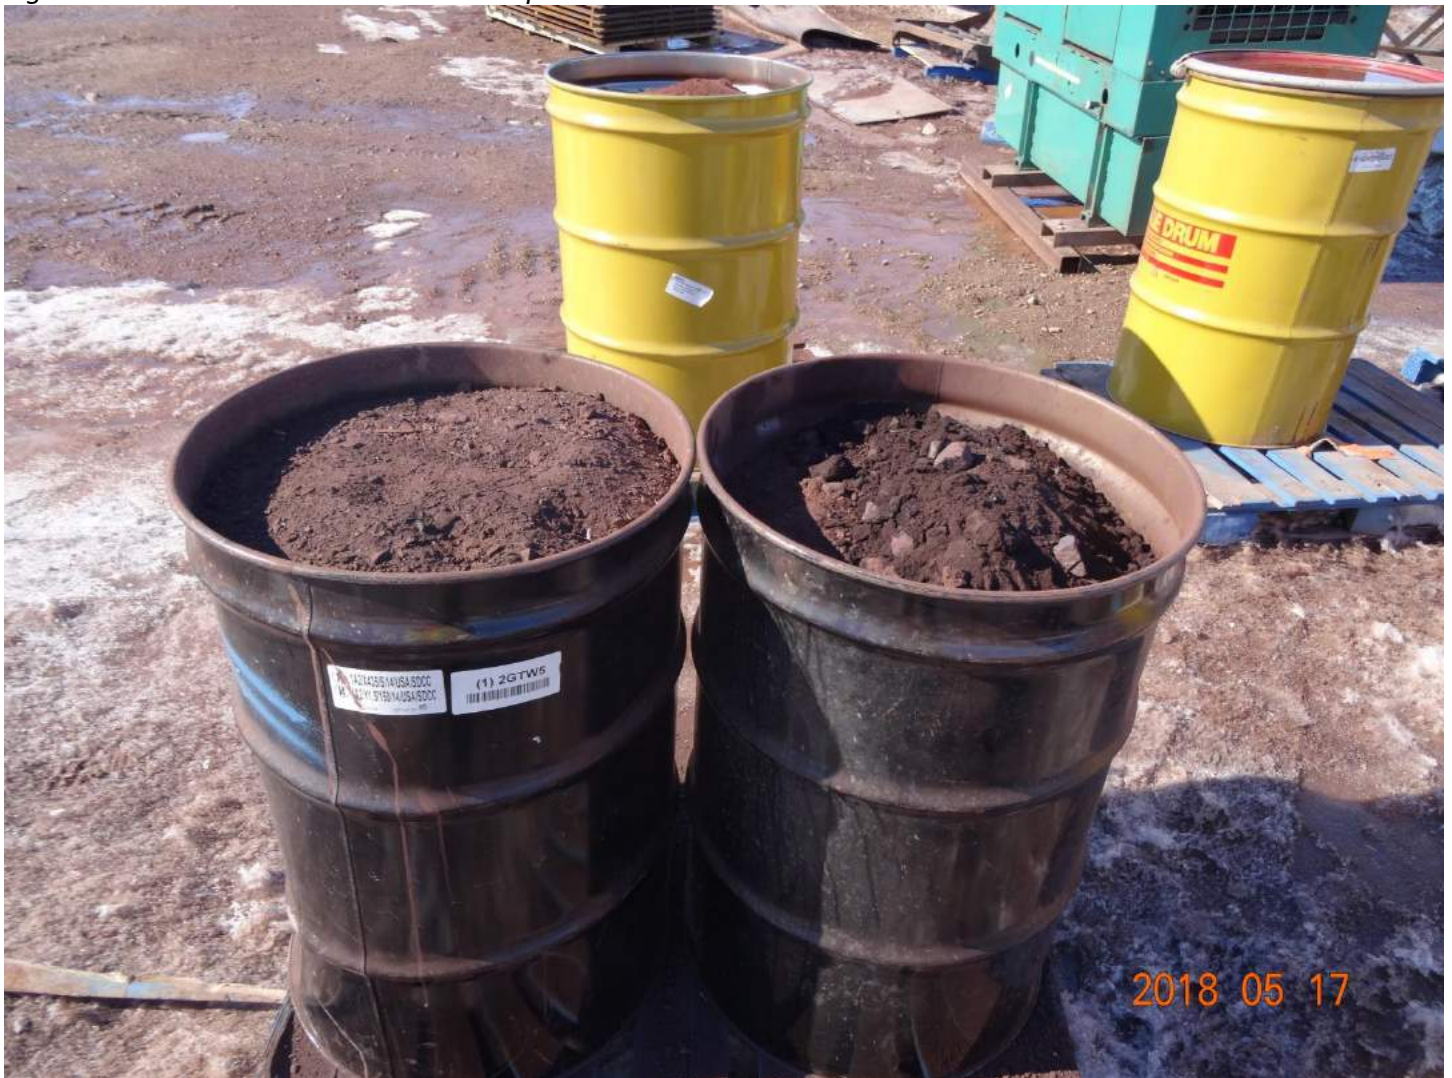
Figure 10: contaminated soil near batch plant

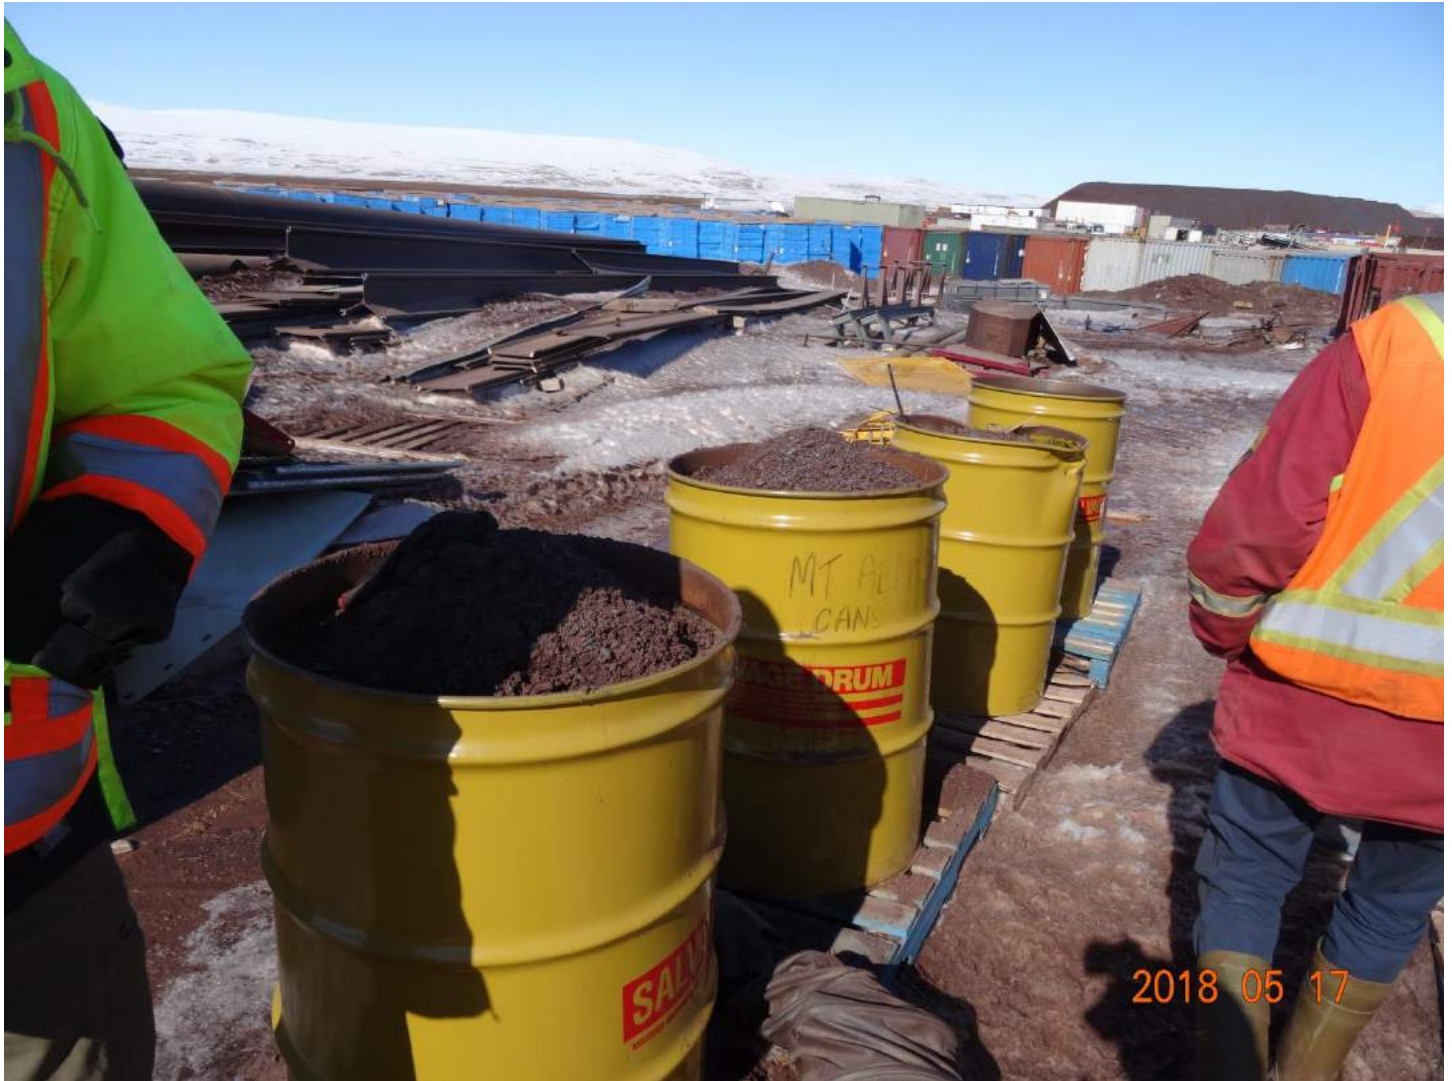
Figure 11: contaminated soil in unsealed containers near batch plant

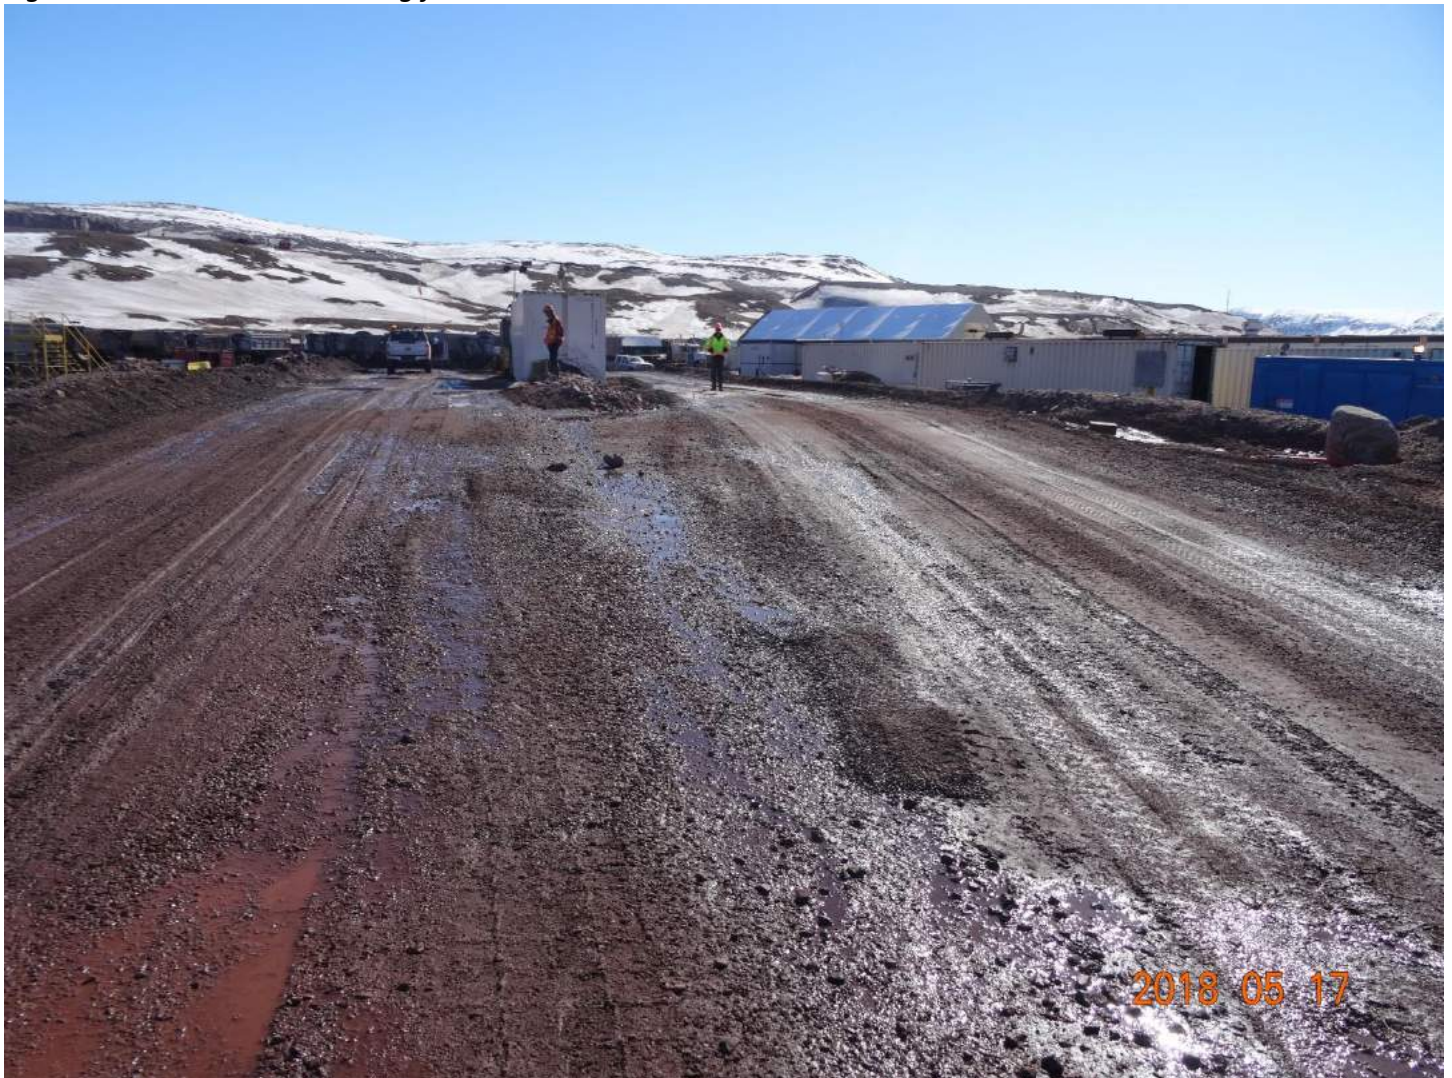
- a. Fuel module does not appear to be properly contained, this facility is lined but, the berms creating the containment area appear to have eroded away or the facility has become full of sediment causing capacity issues. Water from within the facility area appears to be capable of flowing outside of containment area. *See figure 12*
- b. The inspector is requesting for a copy of the as built drawings for this facility.
- c. A grab sample was taken at this location. Waiting for test results for TPH

Figure 12: contact water exiting fuel station module

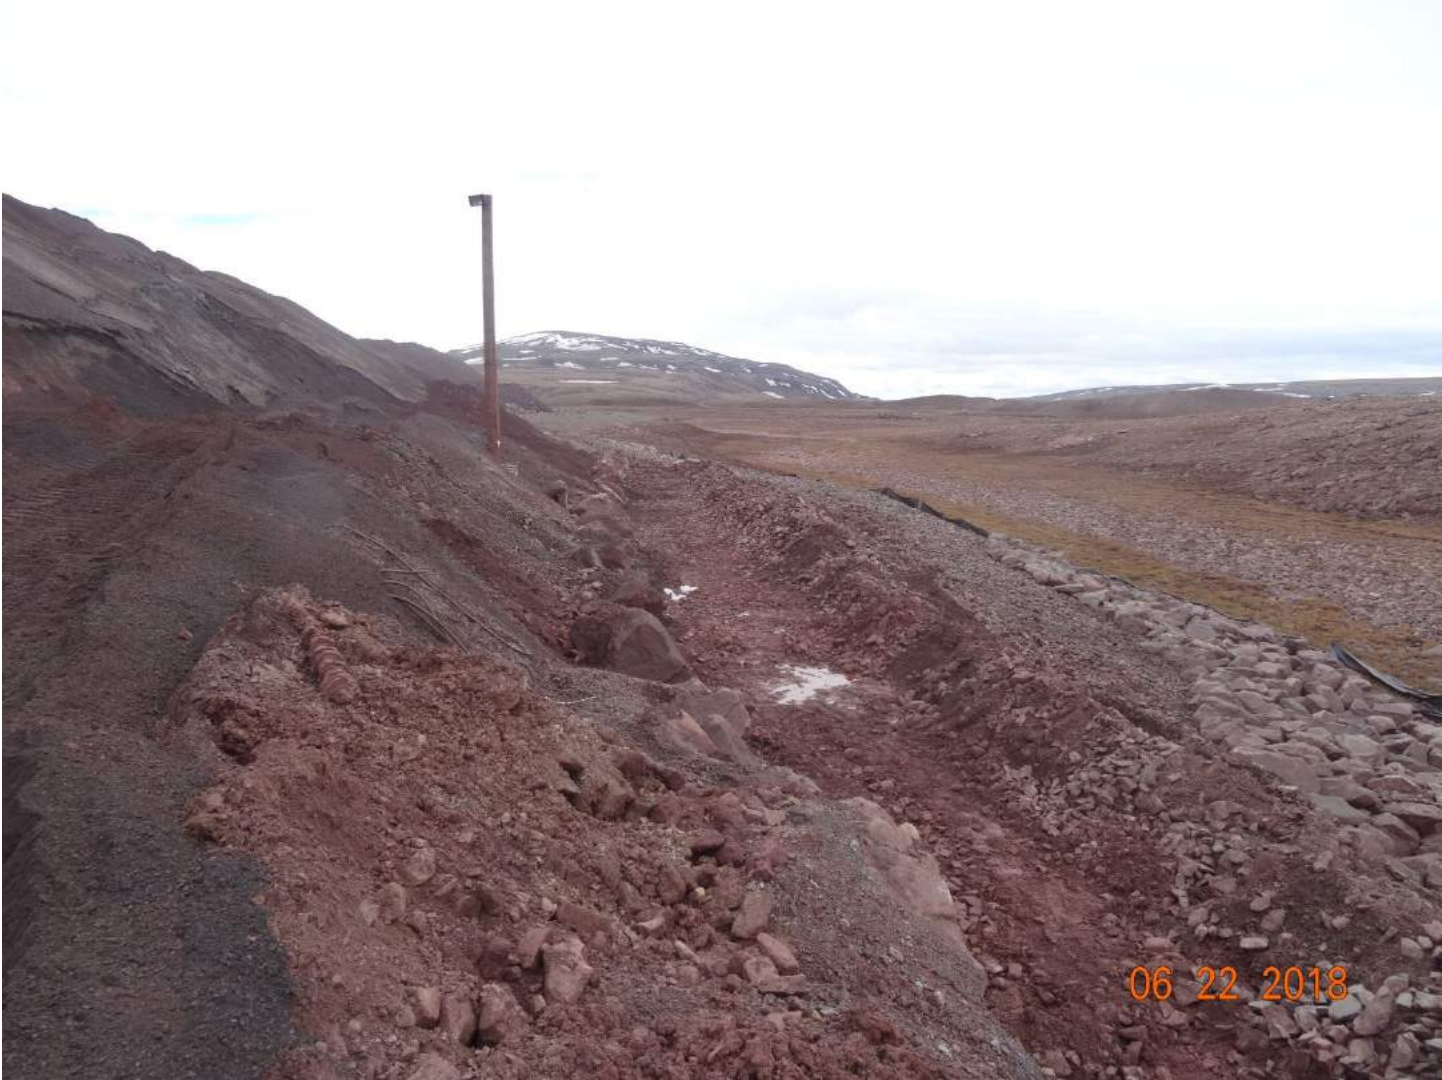
Figure 1: Inconsistent ditch height, land of 8m between ditch and stockpile, ditch inconsistent with approved drawings.

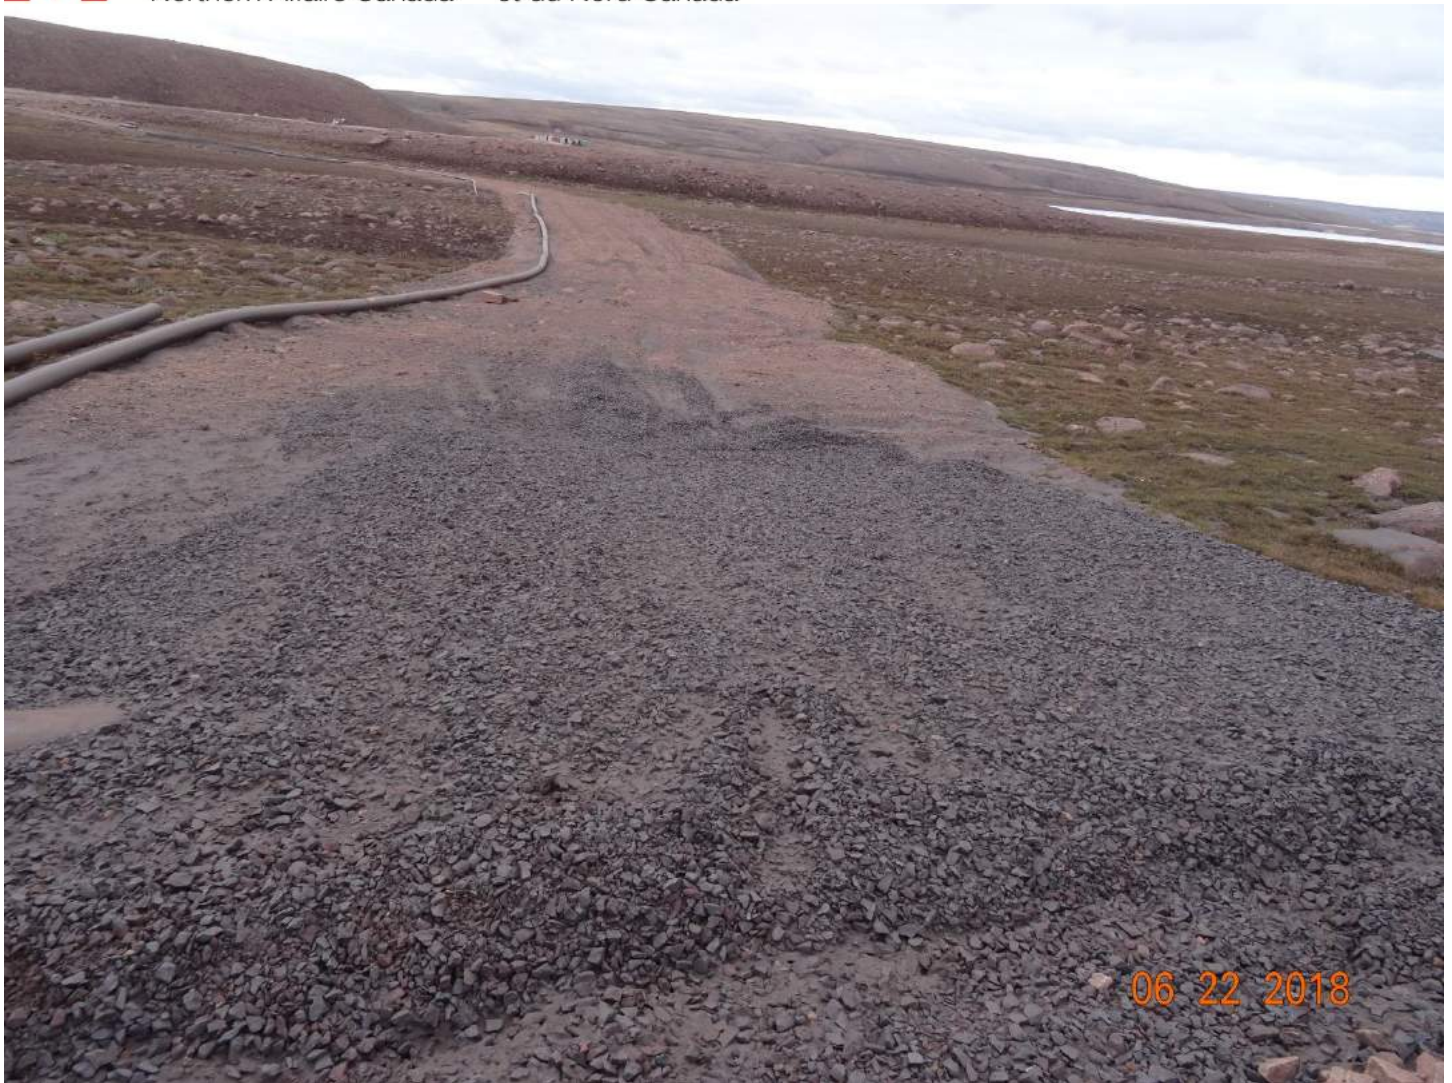
Figure 2: Ore being used as construction material.
