APPENDIX E.8
REGULATORY CORRESPONDENCE

CIRNAC INSPECTION REPORTS AND BAFFINLAND RESPONSES

WATER LICENCE INSPECTION FORM

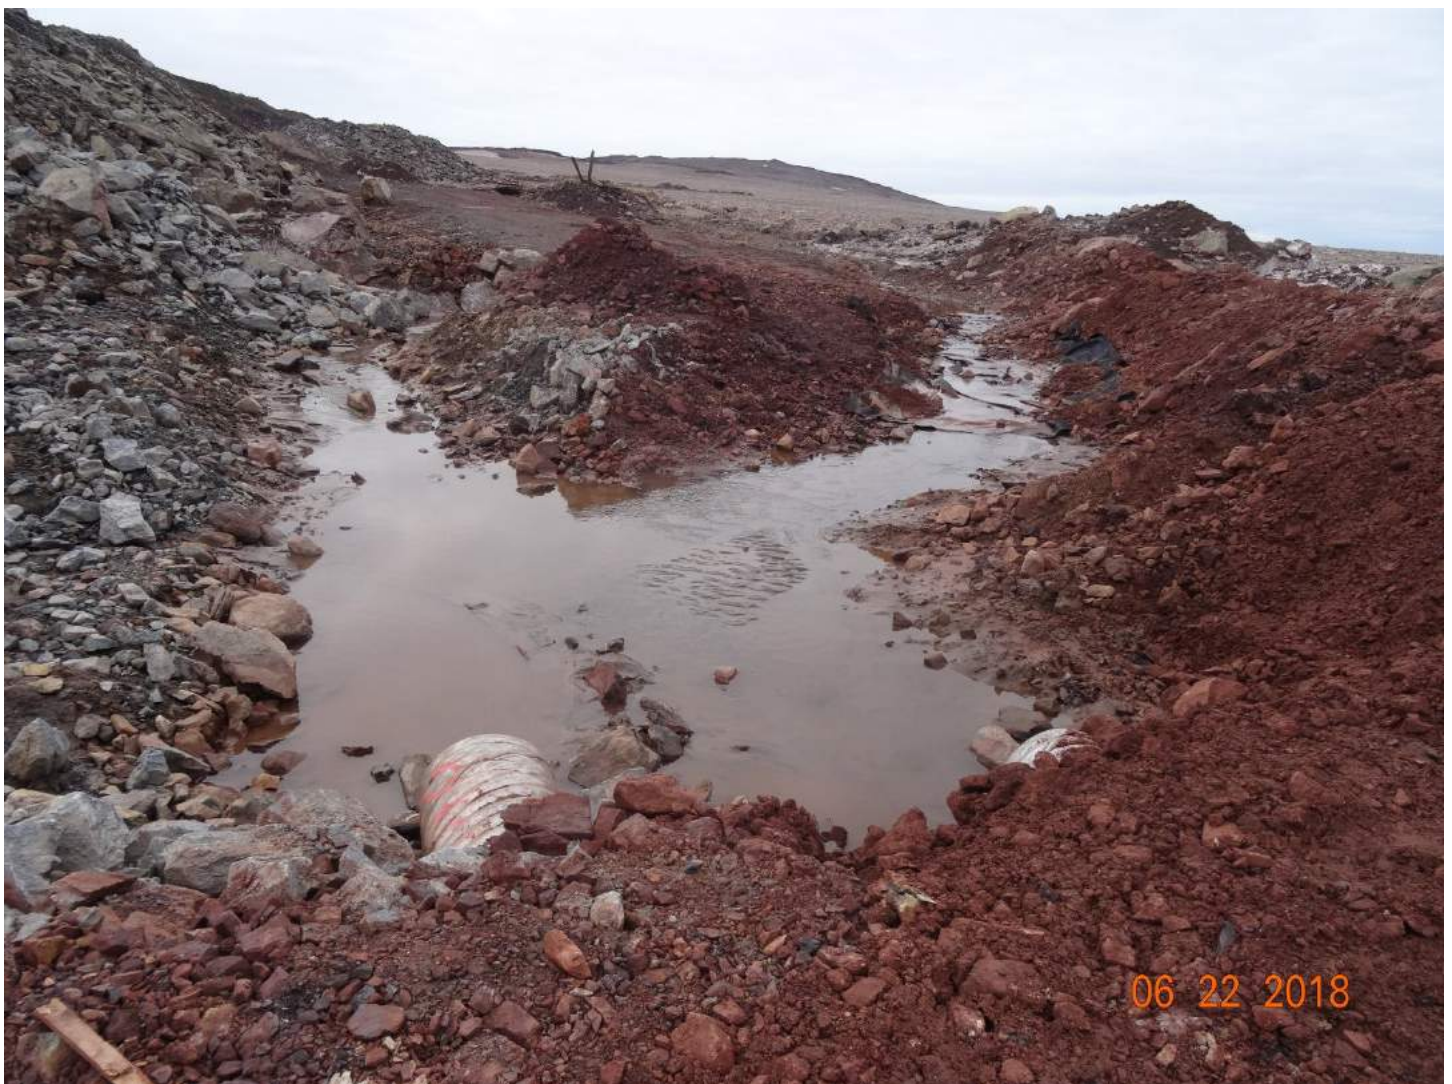
- a. At the time of the inspection the licensee was treating water from the leaking sedimentation pond for low levels of PH and TSS.
- b. Prior to the inspection the Licensee had reported a spill (spill report # 18-244) that occurred at the waste rock stockpile West drainage ditch of the, this location was identified as an area of concern in the past two Water Licence Inspection reports November 2017 and May 2018. The licensee has made two modifications to this water management structure; one being the construction of the road over the ditch to access the emergency ditch constructed to collect seeping waste, the second being the increase of capacity of the ditch. See figure 3 for the spill location.

Figure 3: area of the spill from the Waste Rock Stockpile and modification of ditch.

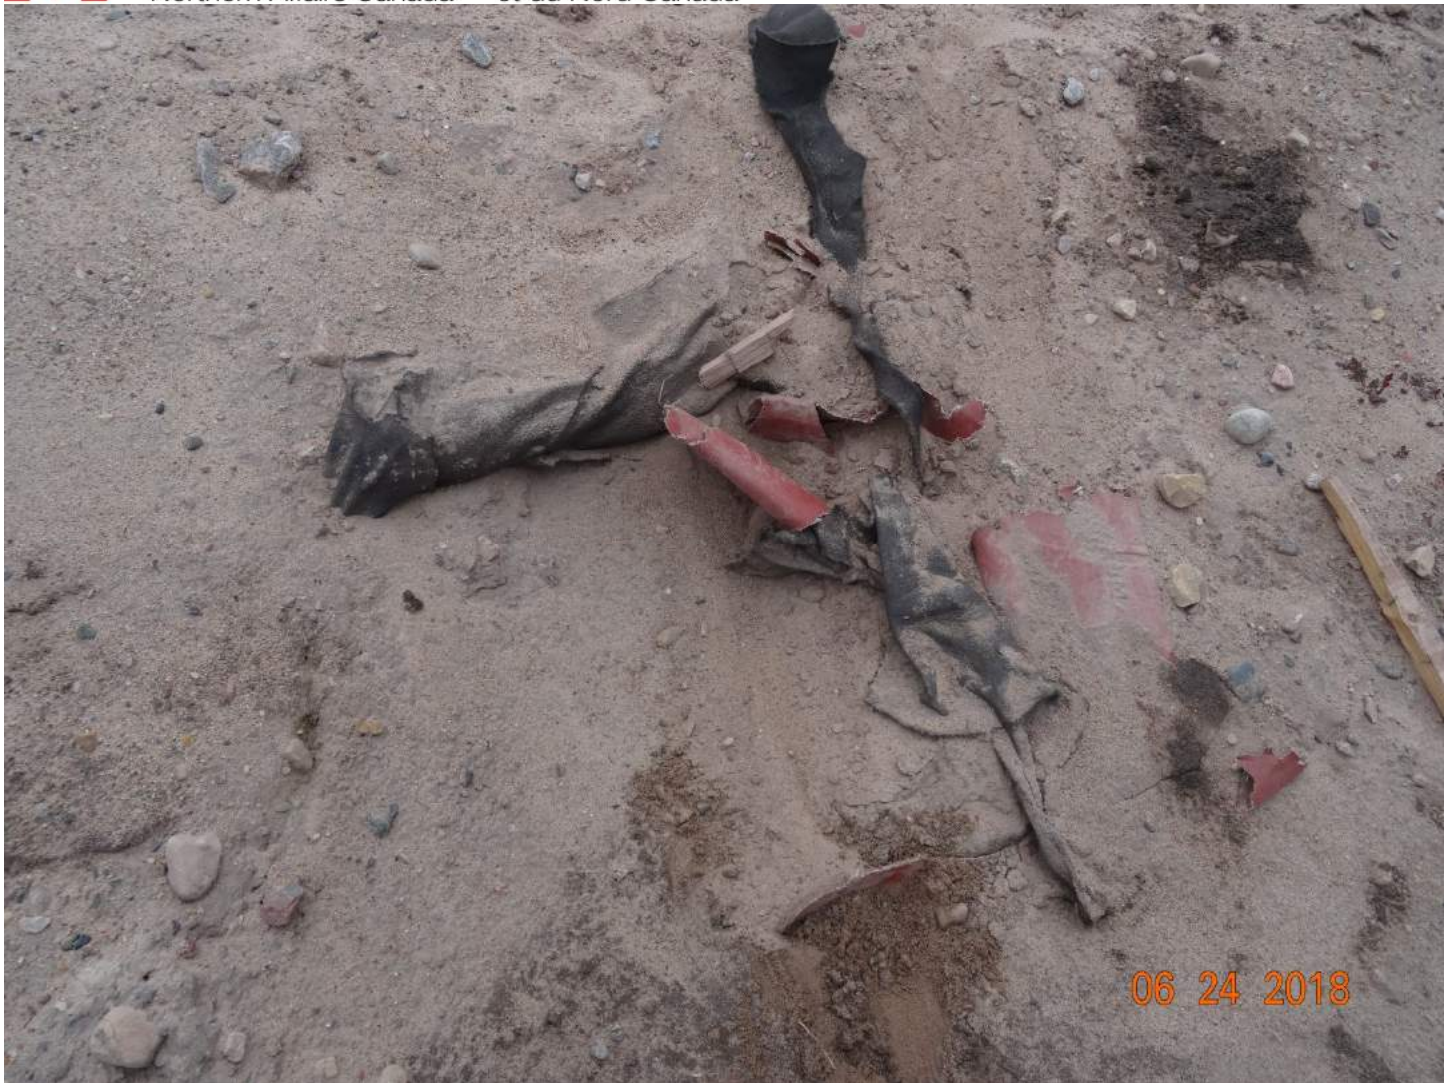
- a. The Hazardous Waste Berm HWB #7 has rips in the liner. See Figure # 6 .
 - I. The licensee is to remove all hazardous waste from this facility until the liner is repaired or provide the inspector and the NWB with a report outlining short term measures put in place to ensure that no waste is capable of leaving this facility.

Figure 6: Hazardous waste secondary containment liner rip.

6. The licensee is to remove all hazardous waste from the ripped hazardous waste berm until the liner is repaired or provide the inspector and the NWB with a report outlining short term measures put in place to ensure that no waste is capable of leaving this this facility. See figure 6 for a photo of the rip.

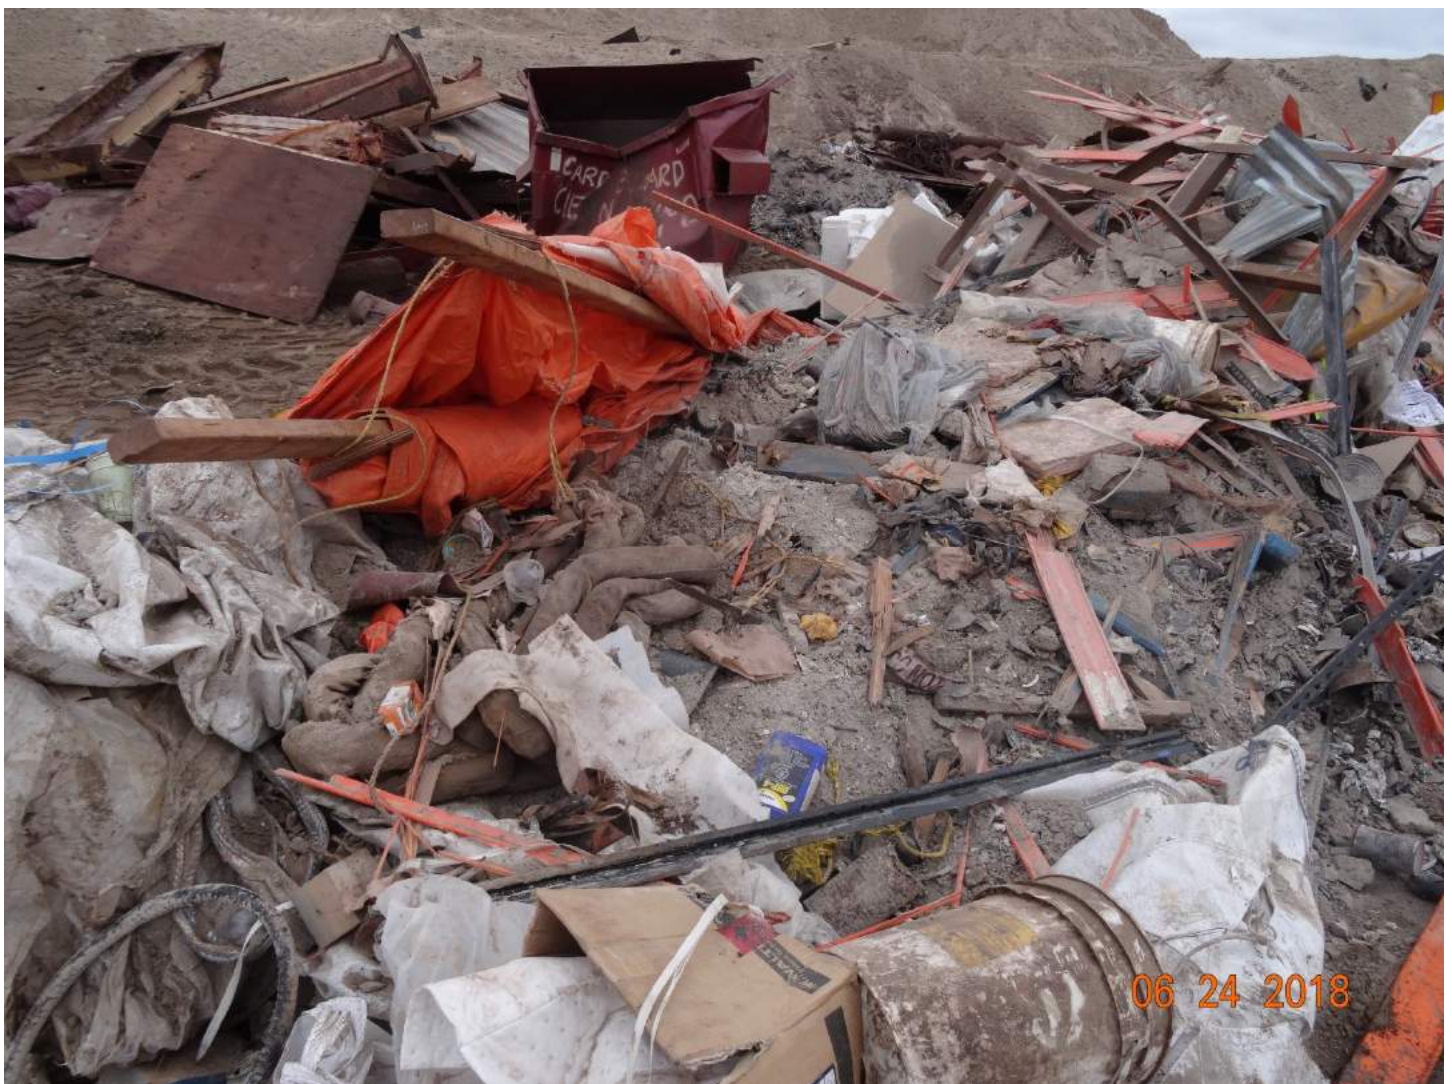
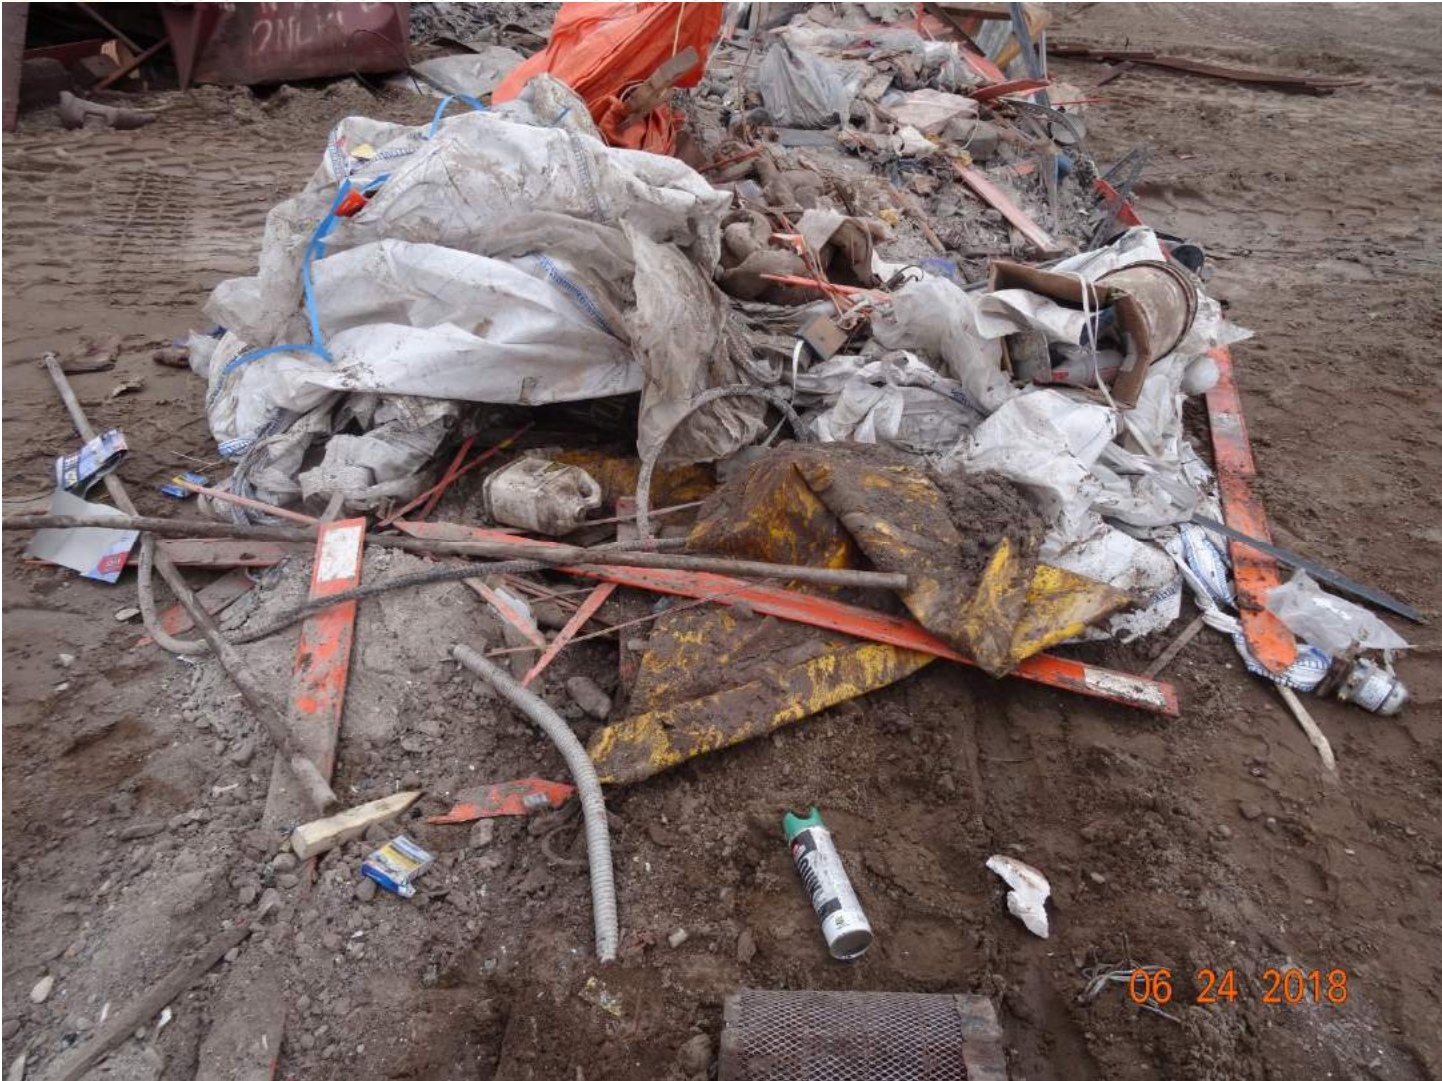
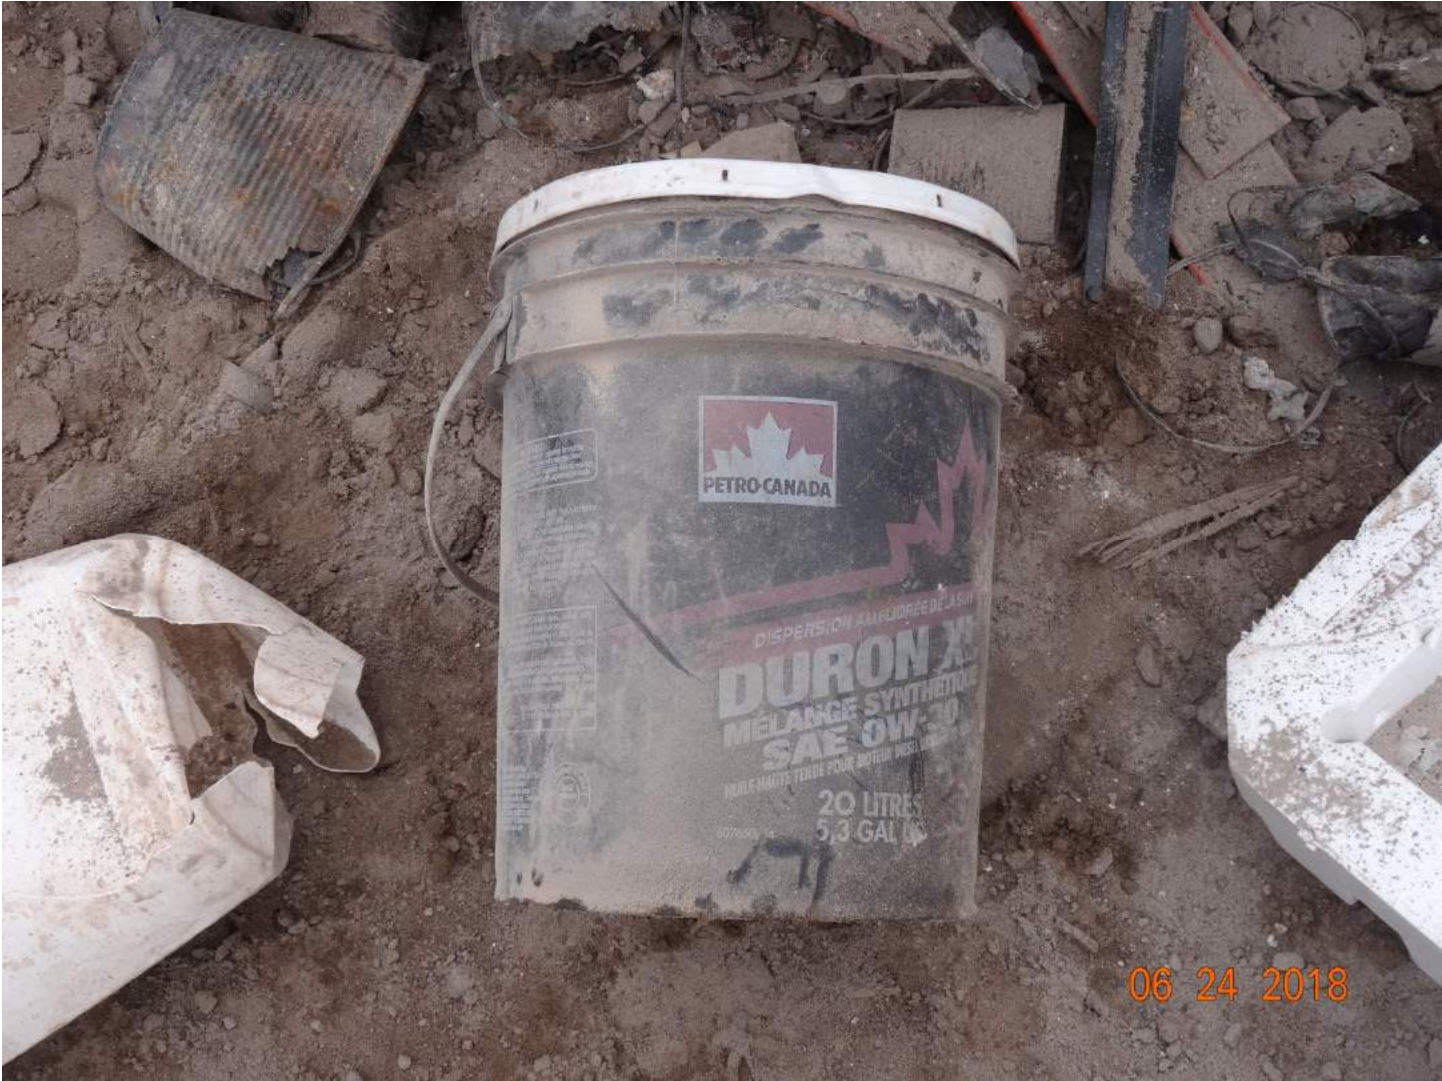
- a. Land fill appears to be properly capped.
- b. Inspector noted that the fence is in poor condition.
- c. The inspector noted potentially hazardous material in the land fill. The waste found in this facility consisted of; drip trays, aerosol canisters, absorbent pads, oil jugs and gas containers.

- I. This is the second time this summer that the inspector has noted potentially hazardous material in the non-hazardous landfill. Baffinland continues to blame other departments for this failure to comply with the licence, in the eyes of the NWB and CIRNA Baffinland is a single cooperation and blaming other departments is no excuse.
- II. The inspector is requesting that Baffinland develop a plan to prevent this non-compliance issue from reoccurring. If the licensee fails to comply with the licence CINRAC may proceed with further enforcement action in the future. See figure 7-9 for photos of the waste mentioned.

Figure 7: landfill waste

Figure 8: Landfill waste

Figure 9: Landfill waste

8. The inspector is requesting that Baffinland develop a plan to prevent the deposit of potentially hazardous waste in the non-hazardous landfill from reoccurring, if the licensee fails to comply with the licence CINRA may proceed with further enforcement action in the future. See figure 7-9 for photos of the waste mentioned.

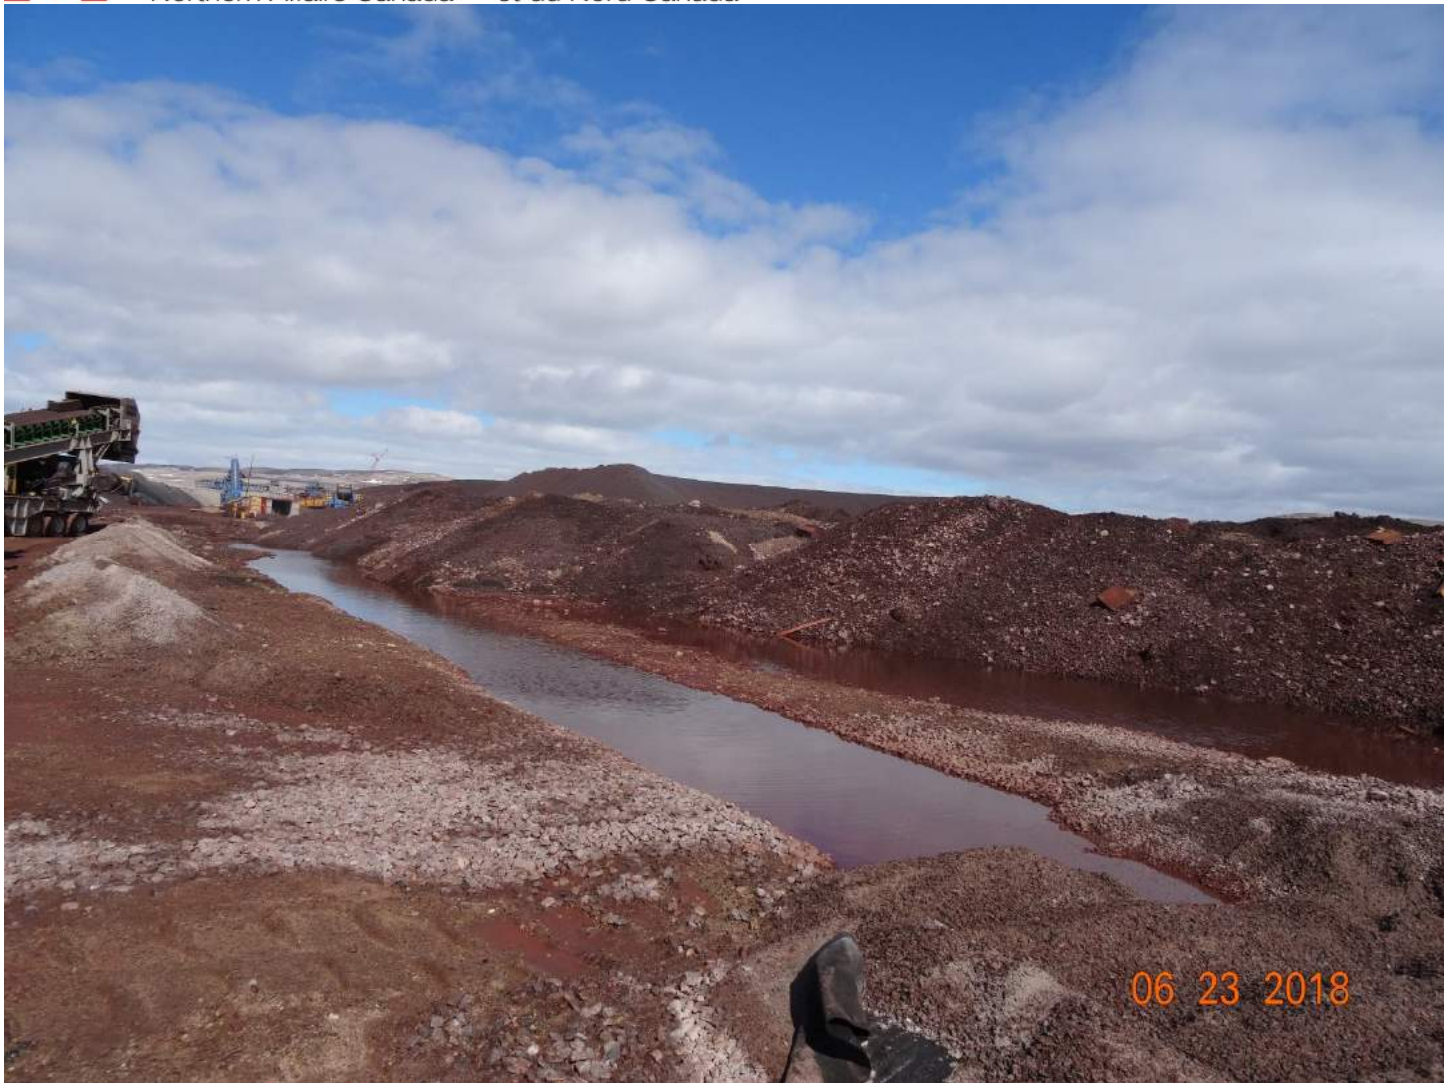
Figure 10: snow dump melt entering the environment.

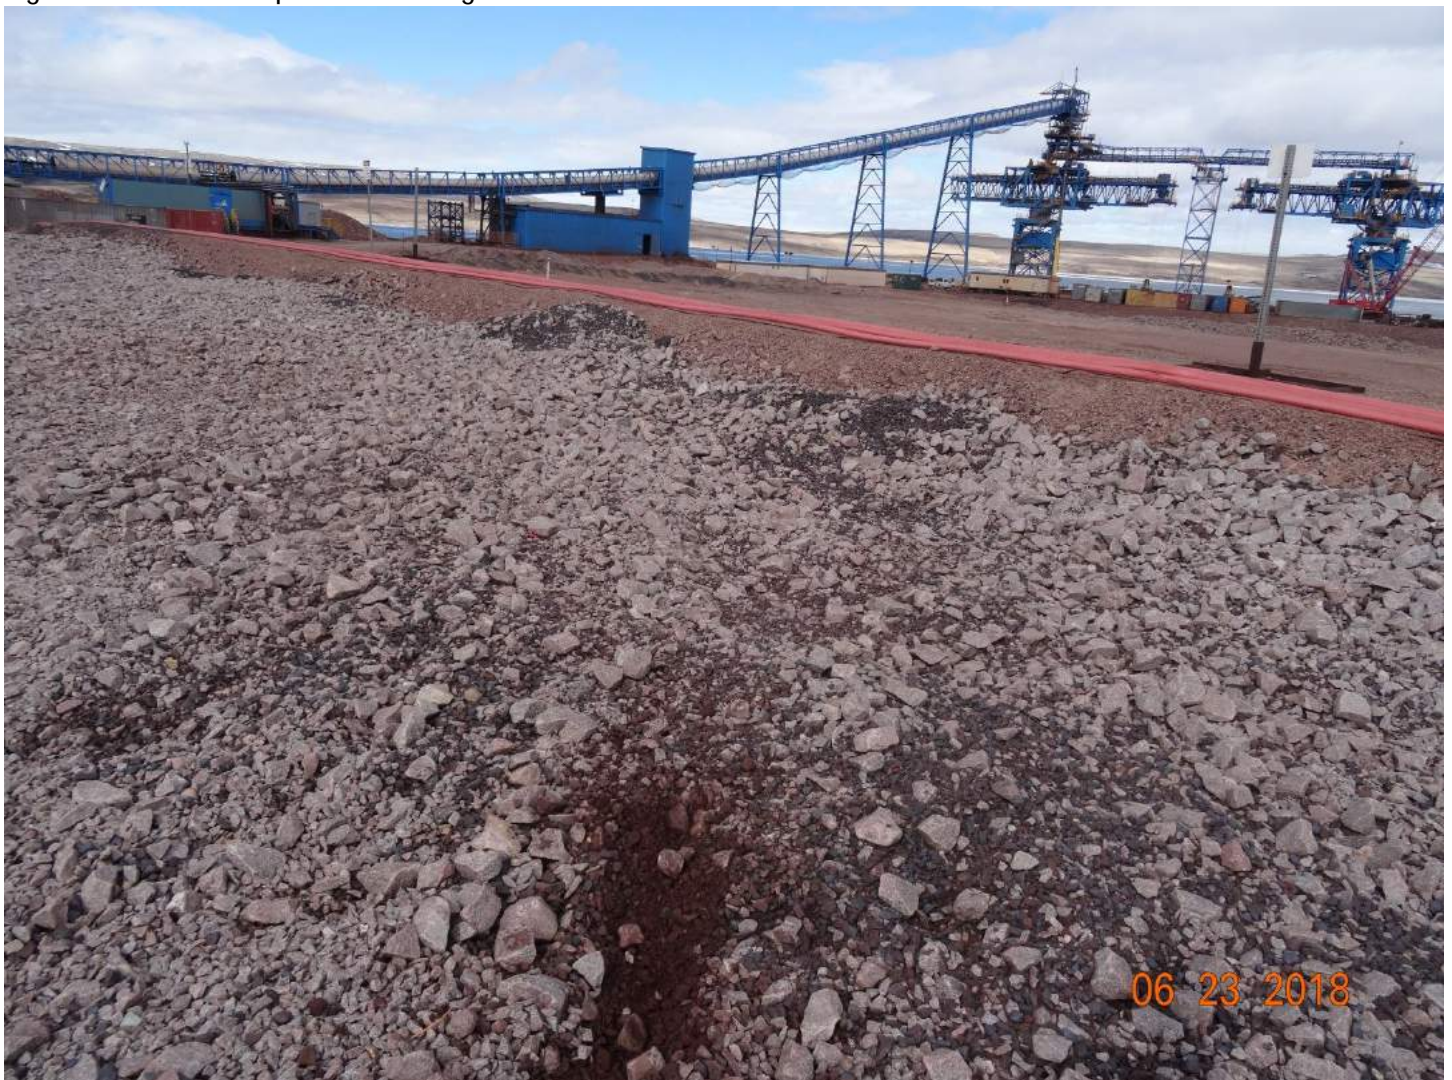
- c. In the previous inspection the inspector noted, "Ore bulk sample remains appear to be removed as requested by the inspector in a previous inspection." During this inspection more snow has melted exposing more Ore, it appears the licensee has removed some ore and covered the rest with crushed rock. See Figure 11.

Figure 11: left over ore from the bulk sample to be remediated.

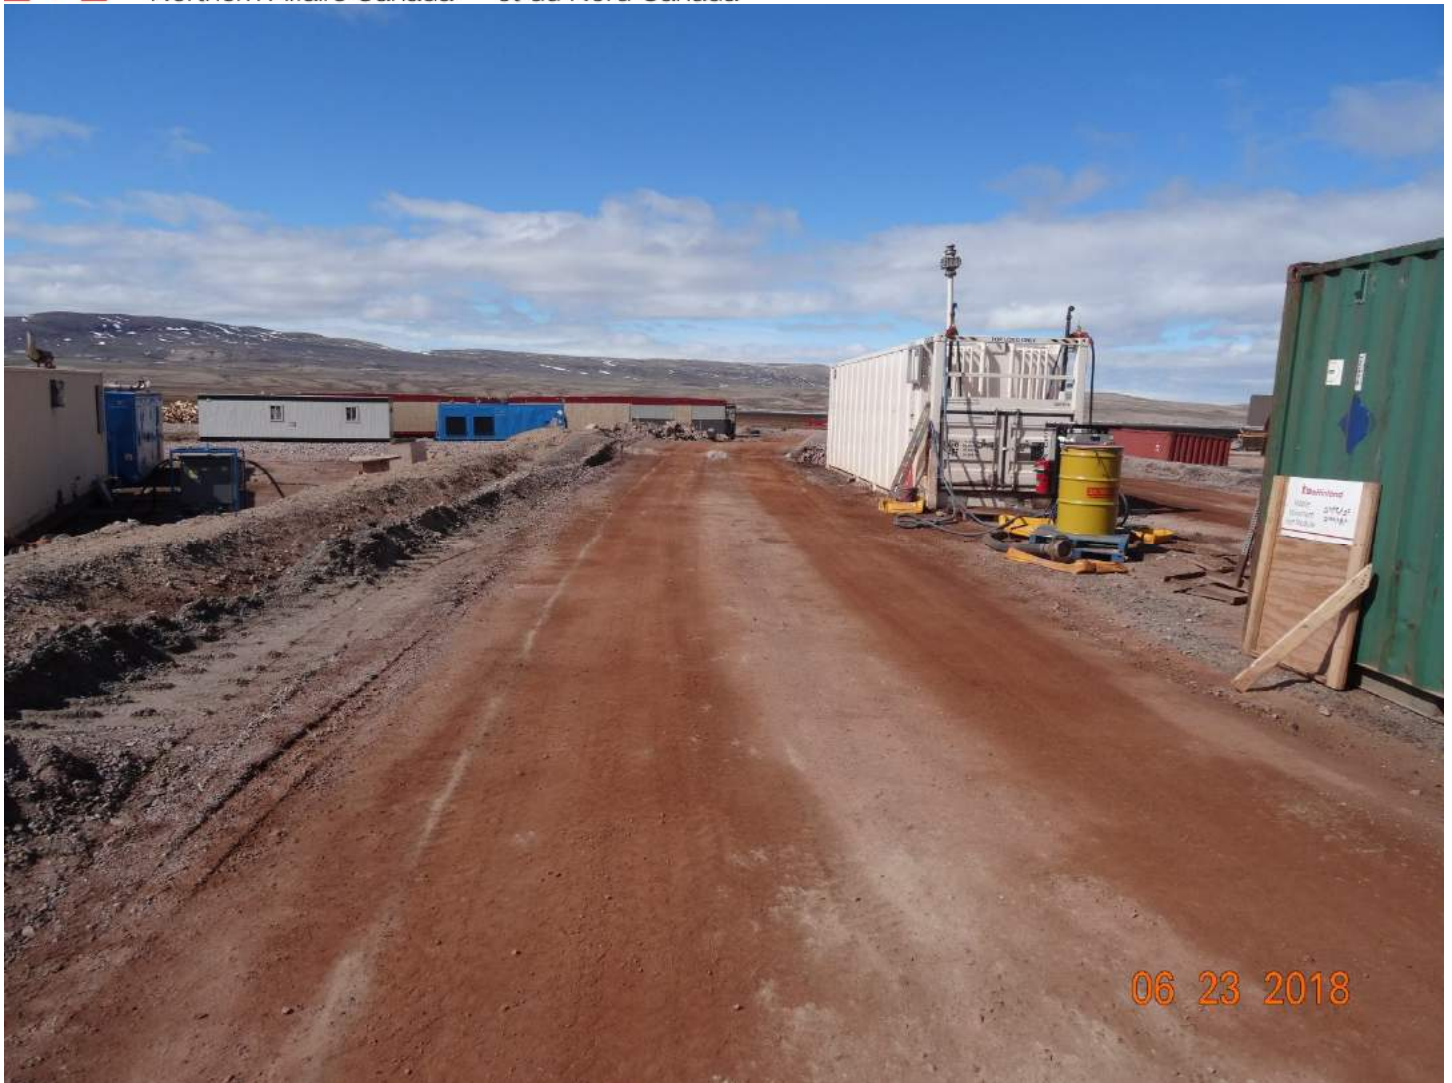
- a. During the last inspection the inspector noted surface water leaving this facility and requested the as built drawings for this facility, nothing has been provided to the inspector.
- b. The Licensee is to return this facility to its approved design. See figure 12 for the fuel module.

Figure 12: fuel module in Milne port.

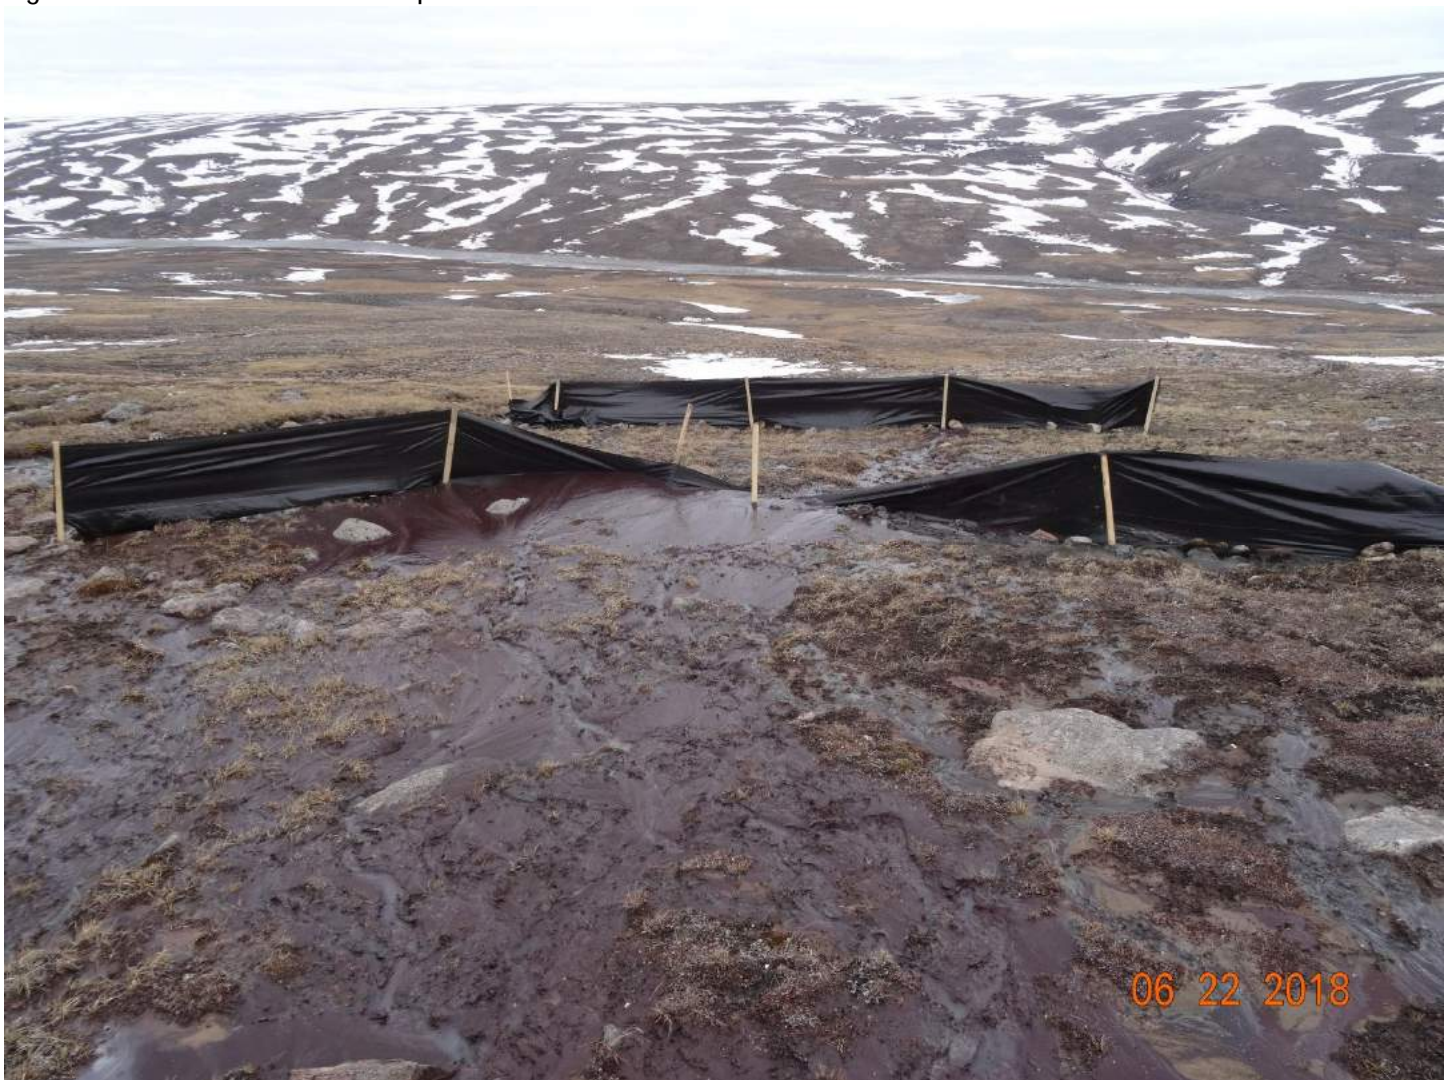
- c. The drill waste was not being deposited in a properly constructed sump or natural depression. The licensee is to discontinue their current practice of depositing drill waste, to ensure the licensee is adhering to the licence and not improperly depositing waste the inspector is requesting that the licensee provide photos of all sumps form the 2018 Exploration drilling program. See photo 13 for the improper deposit of waste.

Figure 13: Lack of a sump as required in the licence.

13. The licensee is to discontinue their current practice of depositing drill waste, to ensure the licensee is adhering to the licence and not improperly depositing waste the inspector is requesting that the licensee provide photos of all sumps form the 2018 Exploration drilling program. See photo 13 for the improper deposit of waste. See Figure 13 for the licensee’s lack of a sump.

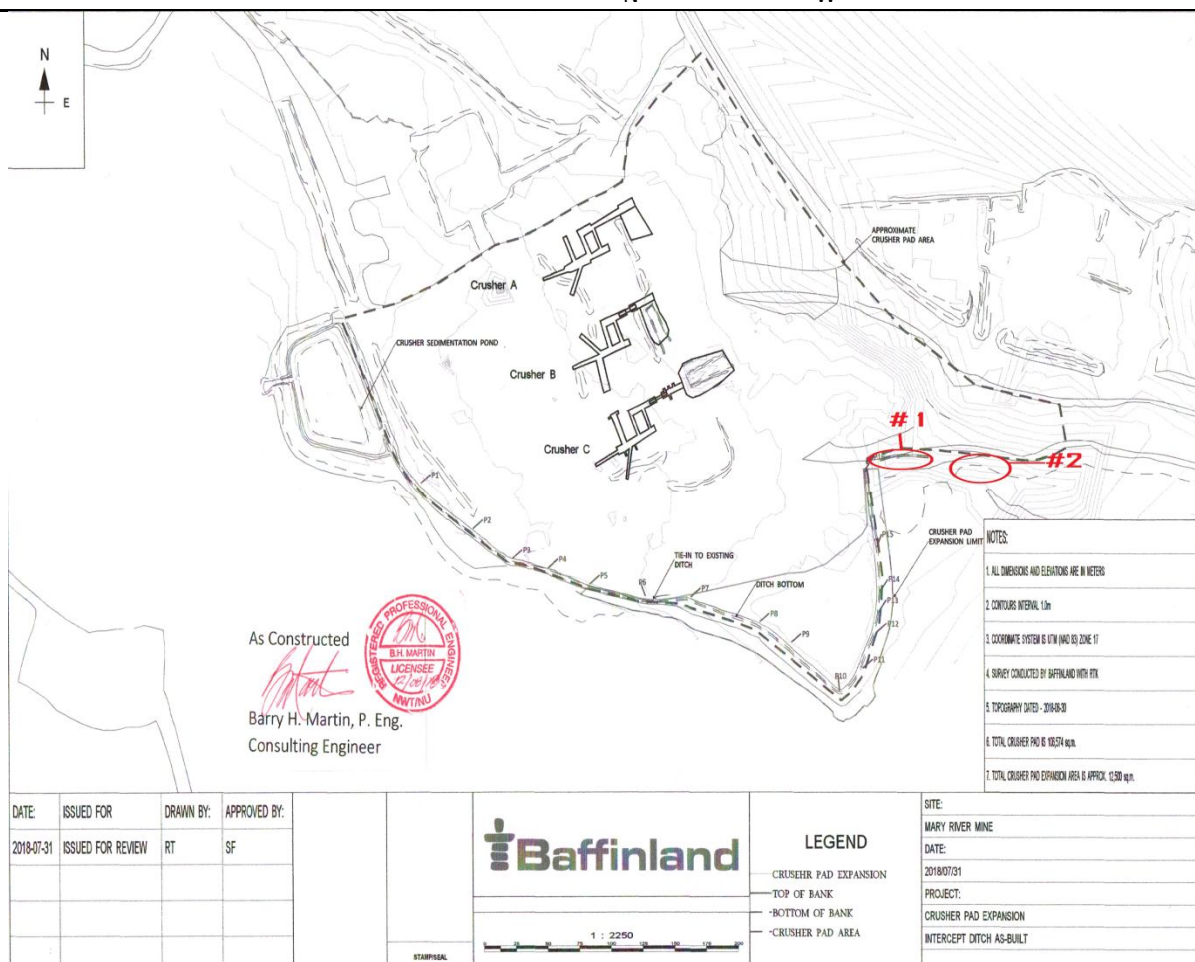
Photo 3

c. During the inspection it was noted that, a pile of iron ore is outside of containment. Please remove the ore from outside containment, see Photo 3. A red circle labeled "#2" identifies the misplaced iron ore's location.

Description: Ore outside of the ditching system.

ITEM No.¹	Action Required with Observation or Item of Concern	Baffinland Responses
Section 1		
1.c.	During the inspection it was noted that, a pile of iron ore is outside of containment. Photo 3; A red circle labeled “#2” identifies the misplaced iron ore’s location.	Baffinland will remove this ore outside of the South-East ditching during October, 2018.

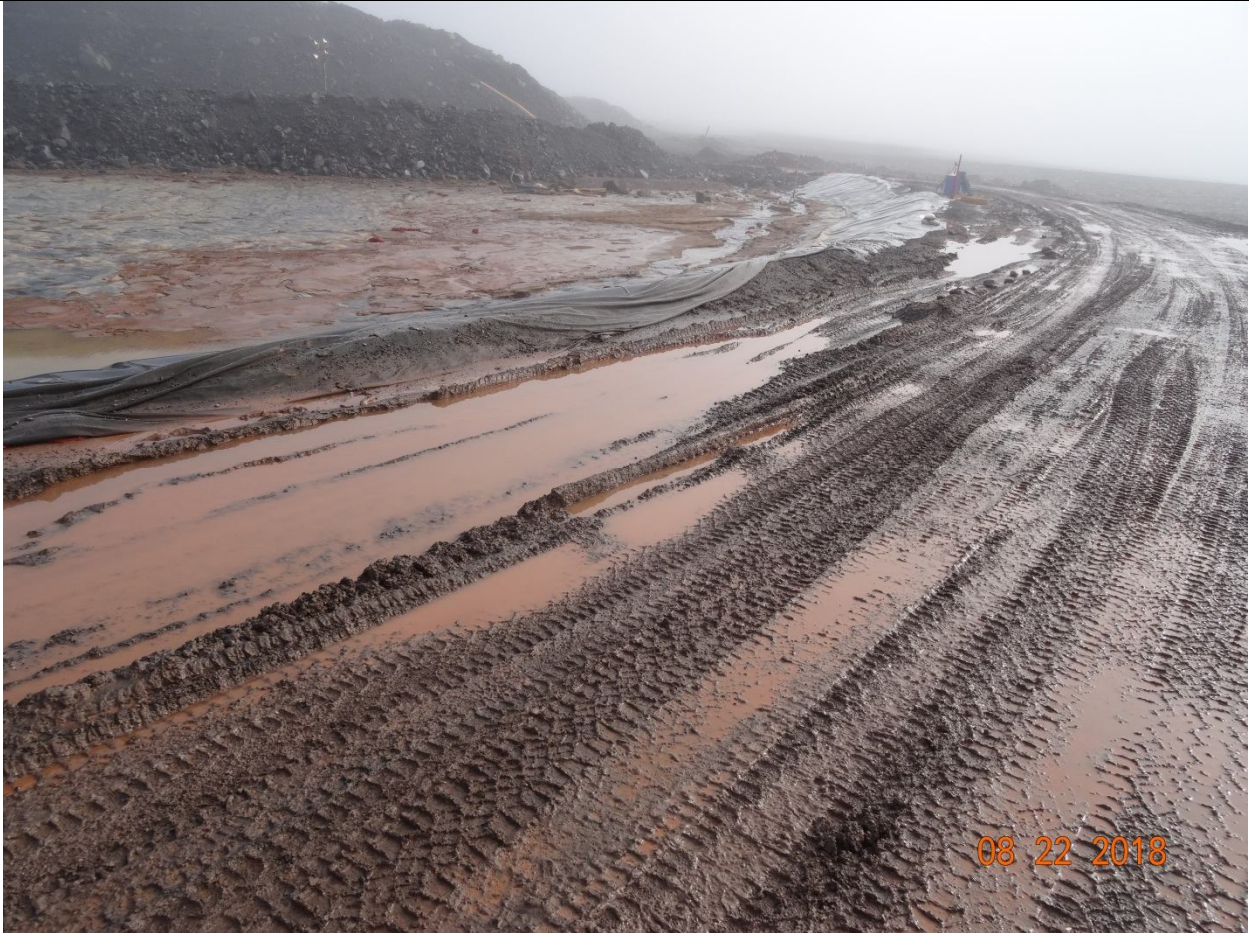
Description: Pooling on Waste rock stockpile sedimentation pond berm

2.b.	There was minor pooling at the top of the sedimentation pond berm walls and some signs of erosion. Photos 4 and 5.	Baffinland will place a fresh layer of material to level the top of the pond berm to reduce the potential for ponding and restore the minor erosion damage on the berm walls.

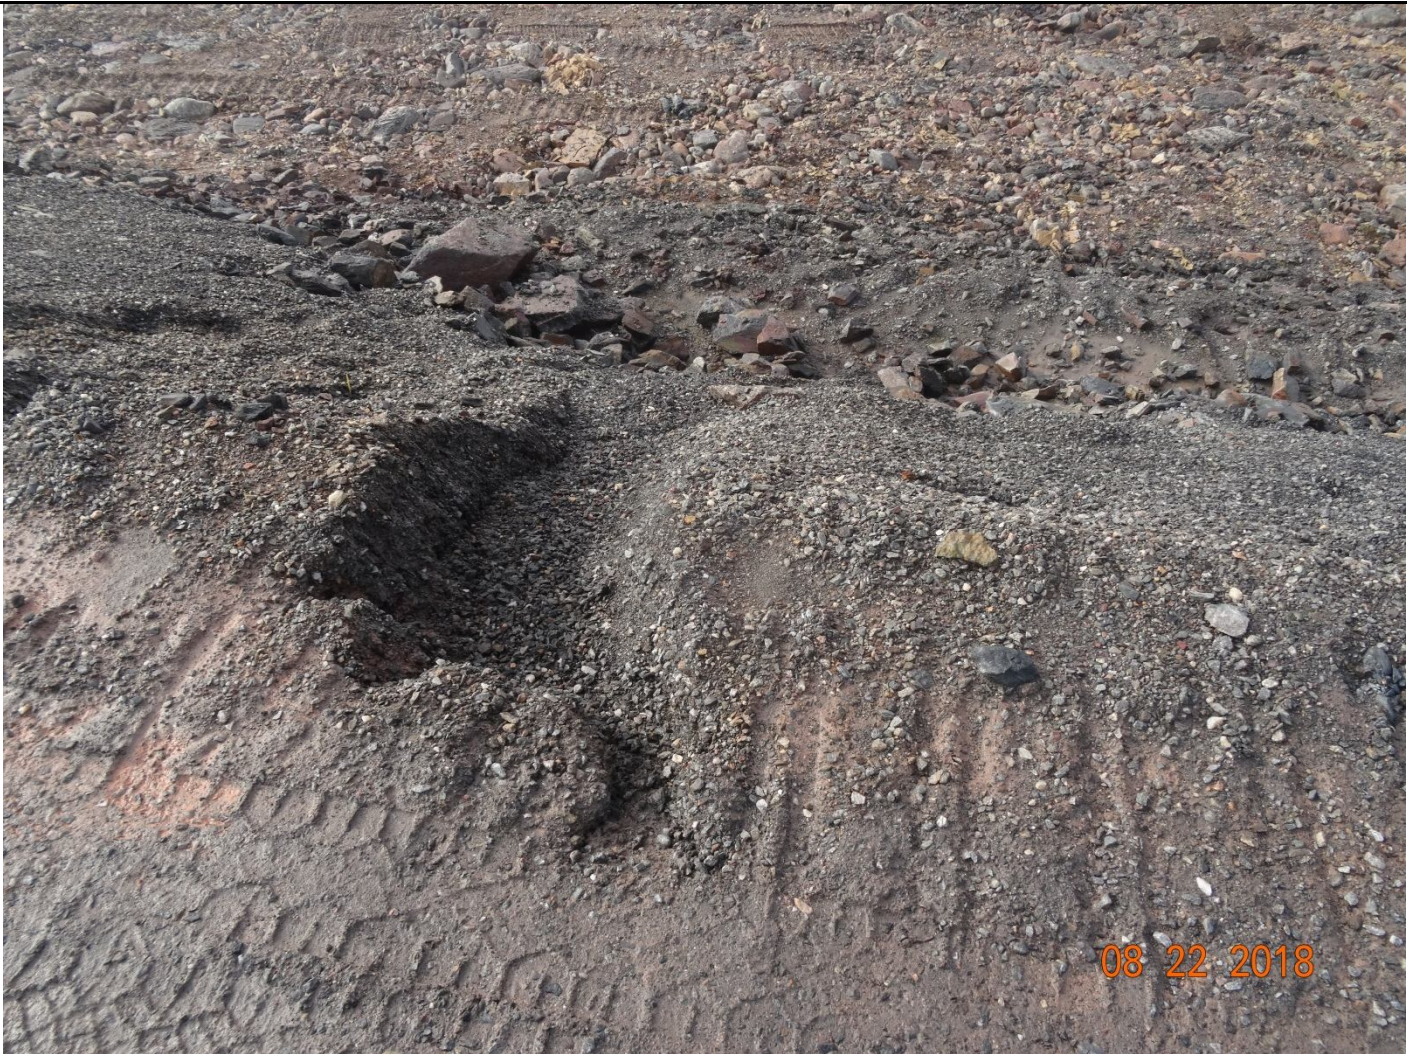
Photo 5

Description: erosion on the waste rock stockpile sedimentation pond berm wall.

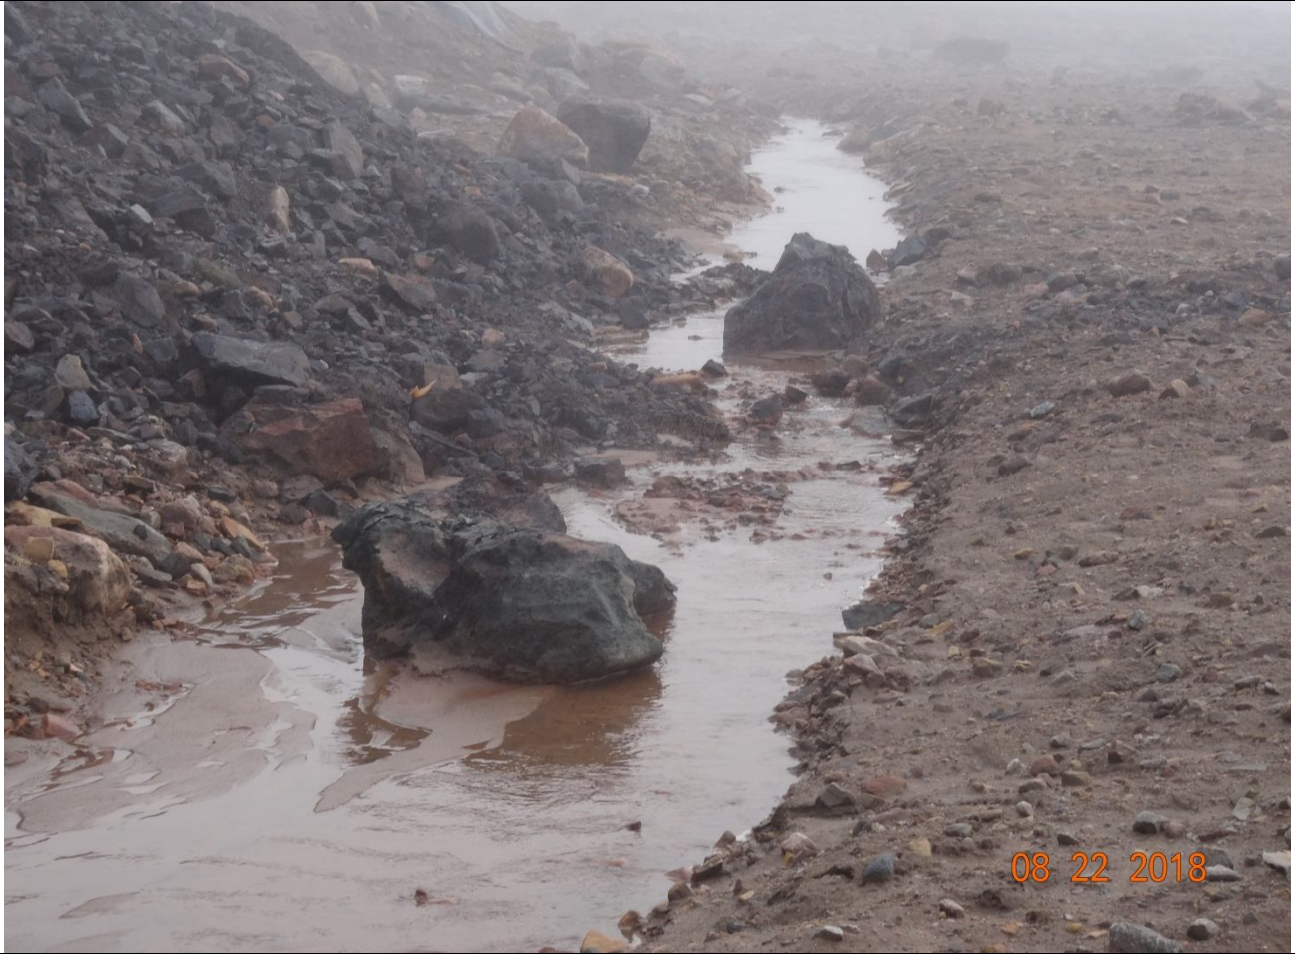
Photo 7

Description: Debris in the WRSP ditches, not a trapezoidal shape, appears to be under capacity and no diversion berms to divert non-contact water.

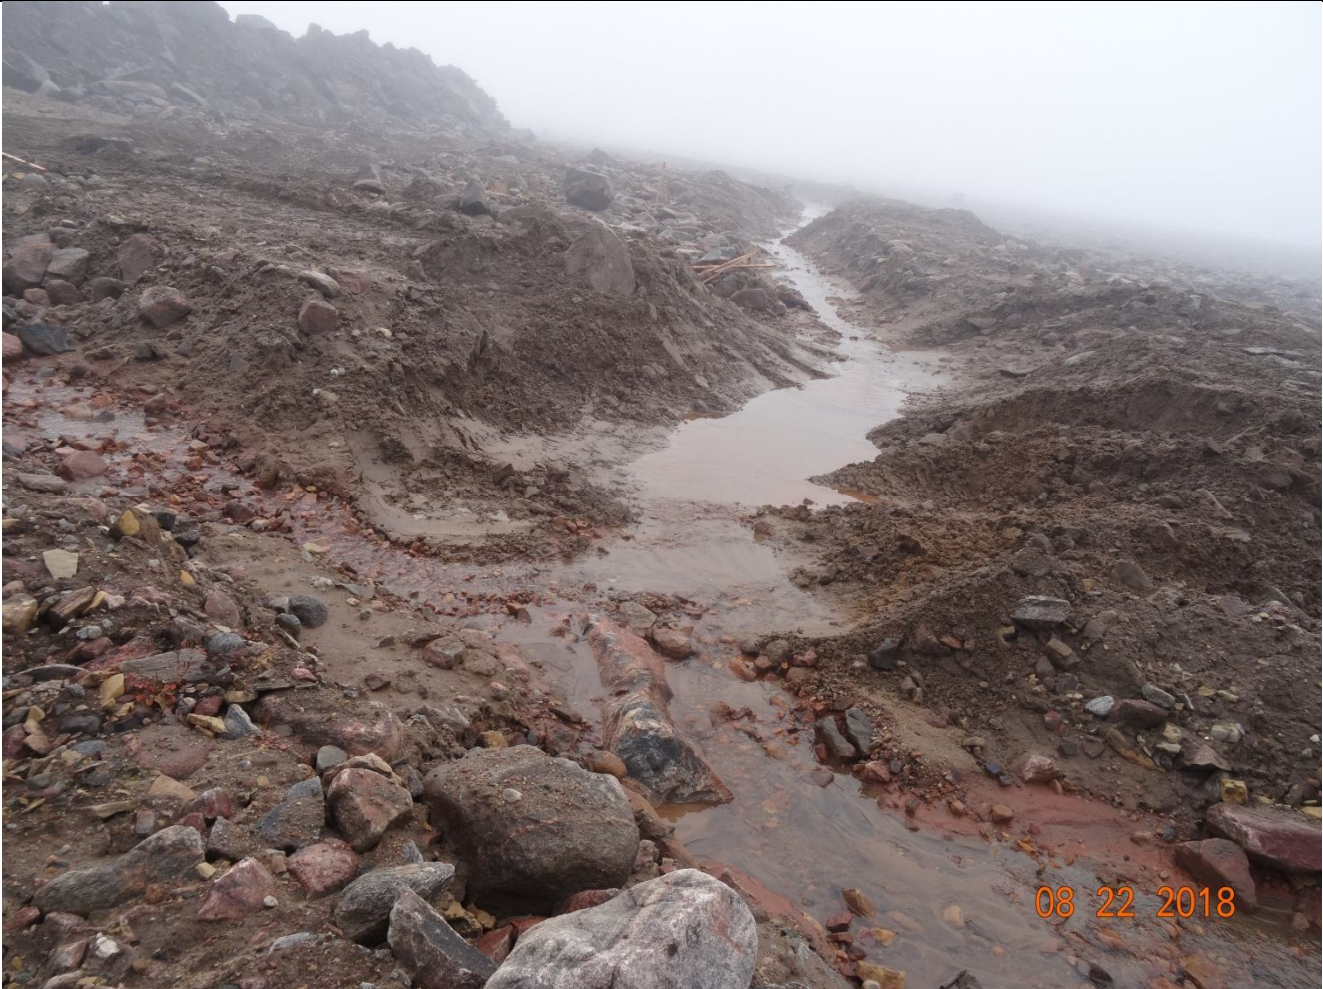
Photo 8

Description; inconsistencies in the ditches, lack of diversion berm and pooling inside ditches.
