APPENDIX E.8
REGULATORY CORRESPONDENCE

CIRNAC INSPECTION REPORTS AND BAFFINLAND RESPONSES

WATER LICENCE INSPECTION FORM

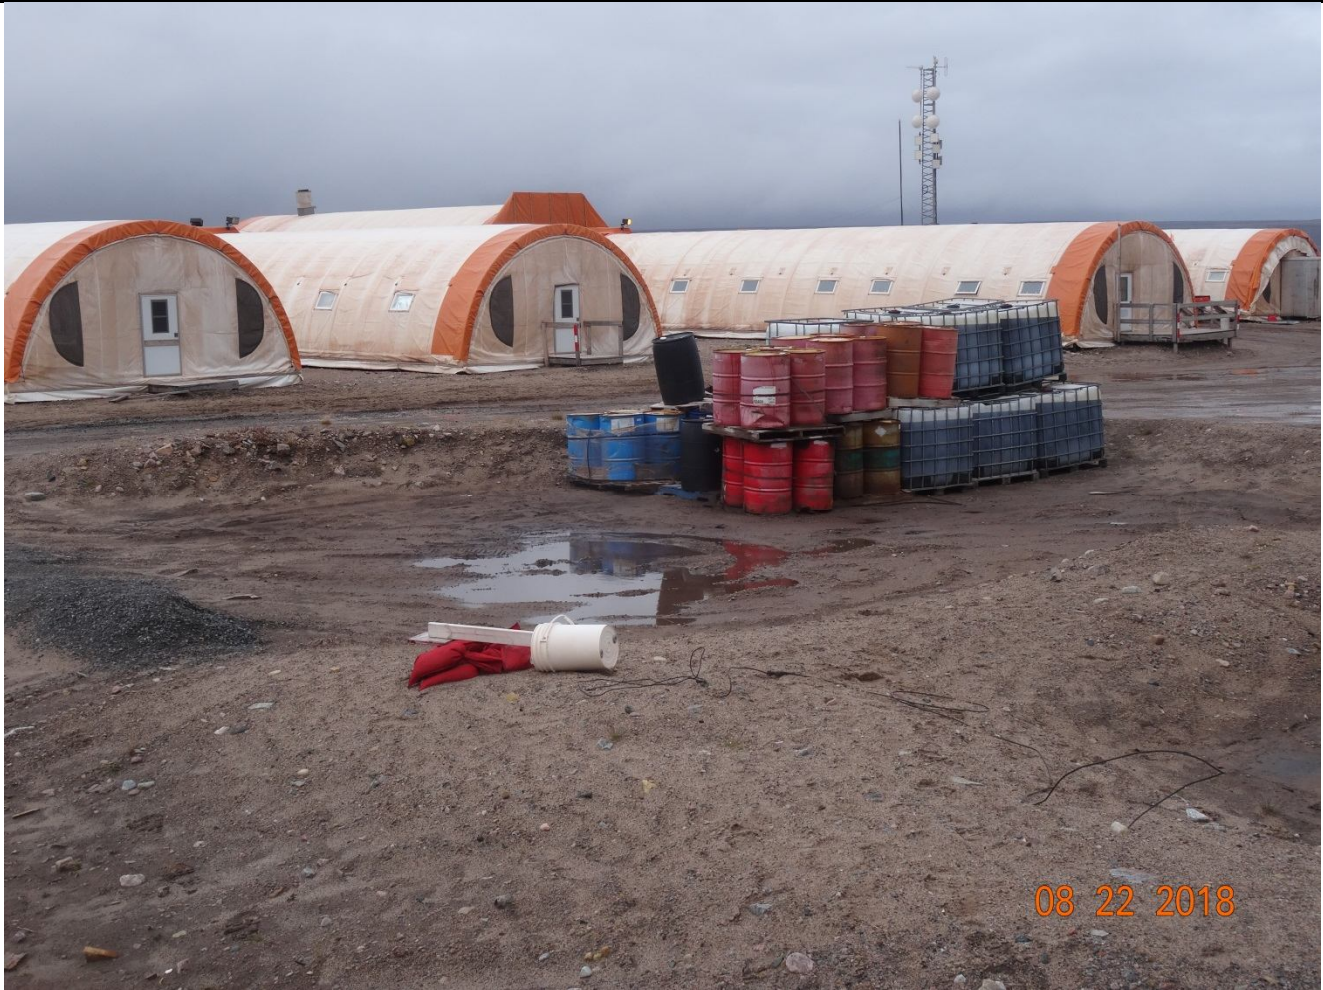
Photo 9

- a. In the past inspection reports, the inspector noted a rip in the liner of Hazardous Waste Berm #7, the licensee has since repaired the liner.
- b. During the inspection all hazardous waste berms were retaining large amounts of potentially contaminated water with the exception of HWB #5; this observation leads the inspector to believe that the liner of this HWB has been jeopardized. Please conduct an internal investigation to determine the condition of this HWB, until this HWB is determined to be operating as intended please discontinue the use of the structure. See Photo #9 for a photo of the concerning HWB.

Description; I Concerning Hazardous Waste Berm

3. The licensee is to ensure that the Hazardous Waste Berm #5 is still capable or retaining water/waste.

3	<p>The licensee is to ensure that the Hazardous Waste Berm #5 is still capable or retaining water/waste.</p> <p><i>During the inspection all hazardous waste berms were retaining large amounts of potentially contaminated water with the exception of HWB #5; this observation leads the inspector to believe that the liner of this HWB has been jeopardized. See Photo #9 for a photo of the concerning HWB. Please conduct an internal investigation to determine the condition of this HWB, until this HWB is determined to be operating as intended please discontinue the use of the structure.</i></p>	<p>An internal investigation into this hazardous waste berm is currently in progress. It is noted that absence of water within the HWB is not unusual as water is regularly pumped and treated throughout the year. No issues with this berm have been identified in geotechnical investigations completed to date.</p> <p>As a preemptive measure, Baffinland will temporarily suspend the use of HWB #5 until the internal investigation is complete.</p>

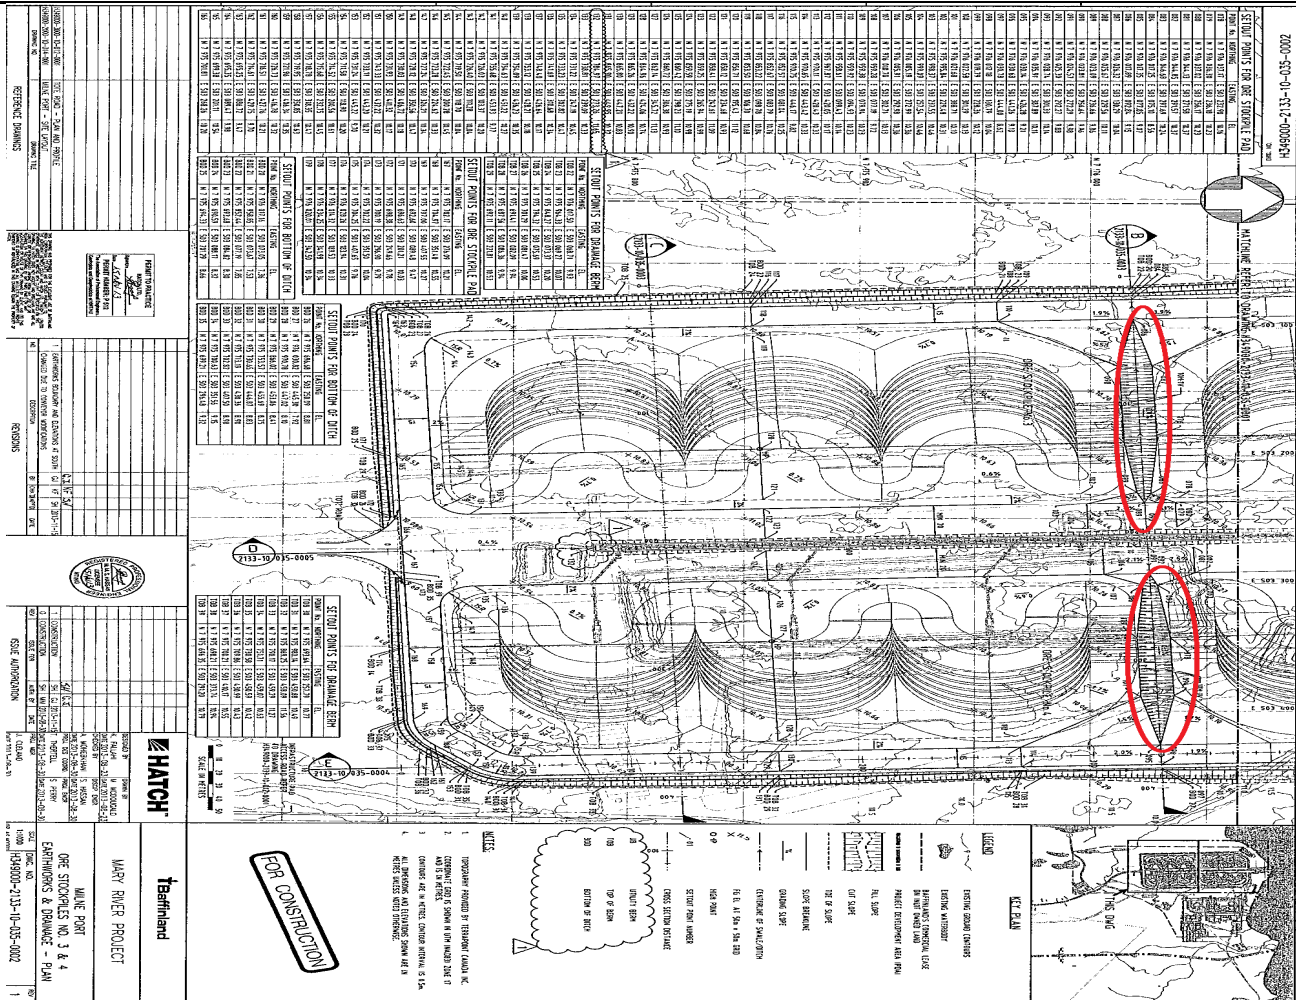
Photo 12

- a. During the inspection it was noted that the swales highlighted in photo #12 have not been installed/implemented.
- b. There was ore outside containment on the South-West corner of the facility; the licensee is to recover this Ore from outside containment.
- c. The ditch on the East side of the conveyer belt appears to be sloping away from the sedimentation pond.
- d. Remnants of the original bulk sample are still left outside of containment to the east of the west sedimentation pond; Baffinland is to remove the remainder of the bulk sample.

Description; Swales circled in red do not appear implemented.

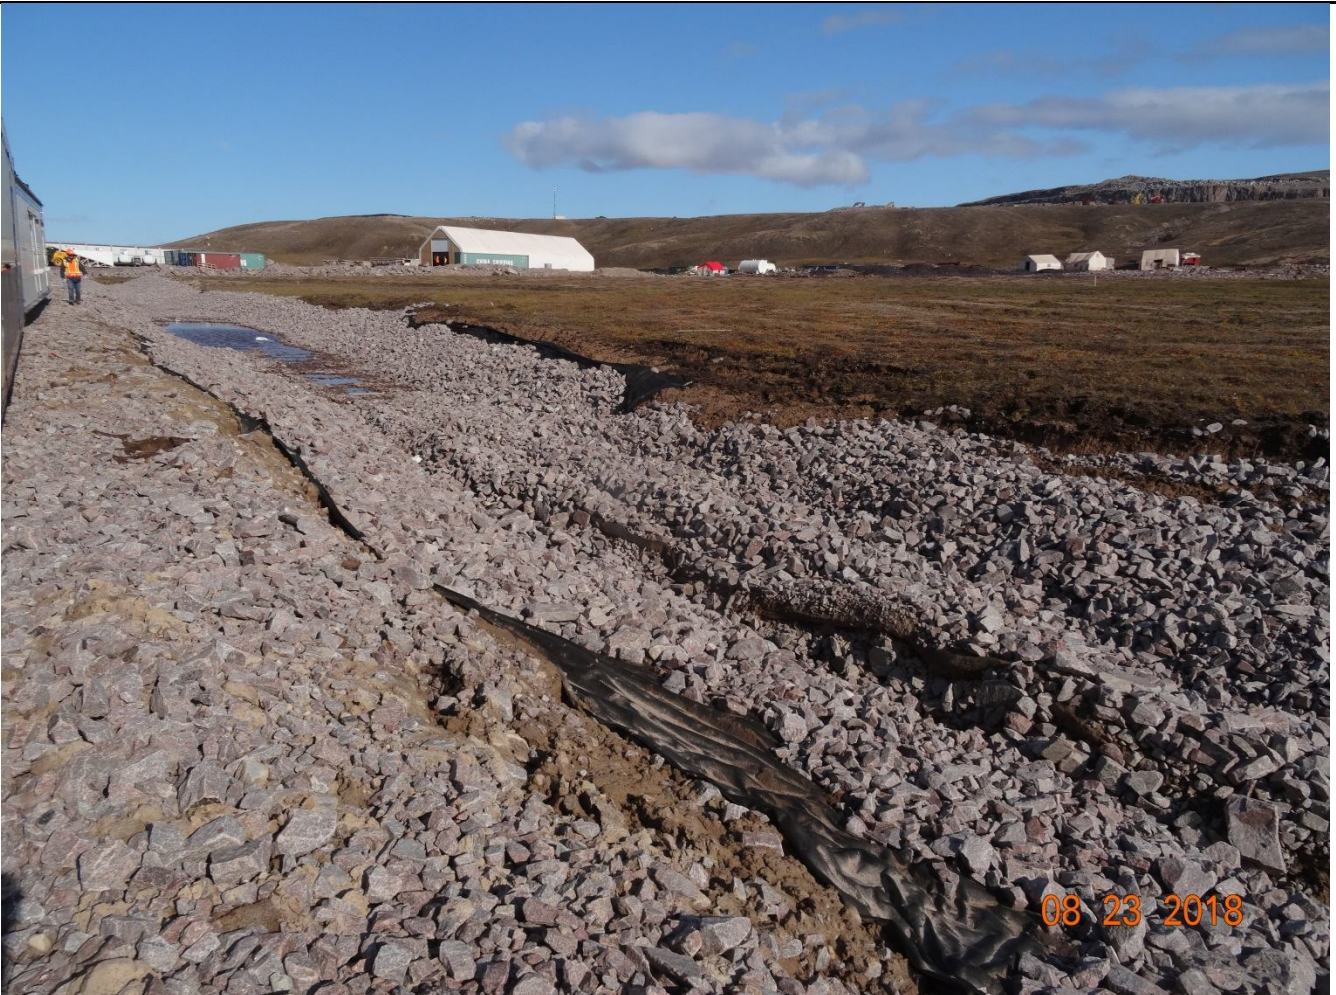
Photo 13

Description; Ditch not constructed to design.

8.a.	The recently constructed diversion ditches around the Milne Port Proposed Camp Pad facility do not appear to be constructed properly. There is aggregate built up in the center blocking the water from flowing out of the ditch. <i>The licensee is to return this water management structure to its approved design.</i>	Baffinland is reviewing the design criteria of this diversion ditch. The ditch will be repaired to remove the aggregate build up and ensure flow is not impeded to the outflow.
