APPENDIX E.8.2

QIA INSPECTION REPORTS AND BAFFINLAND RESPONSES

Table 1. Summary of findings, recommendations, and action items from the June 2018 Site Inspection

RE: Response to QIA June 2018 Site Inspection, Findings and Recommendations

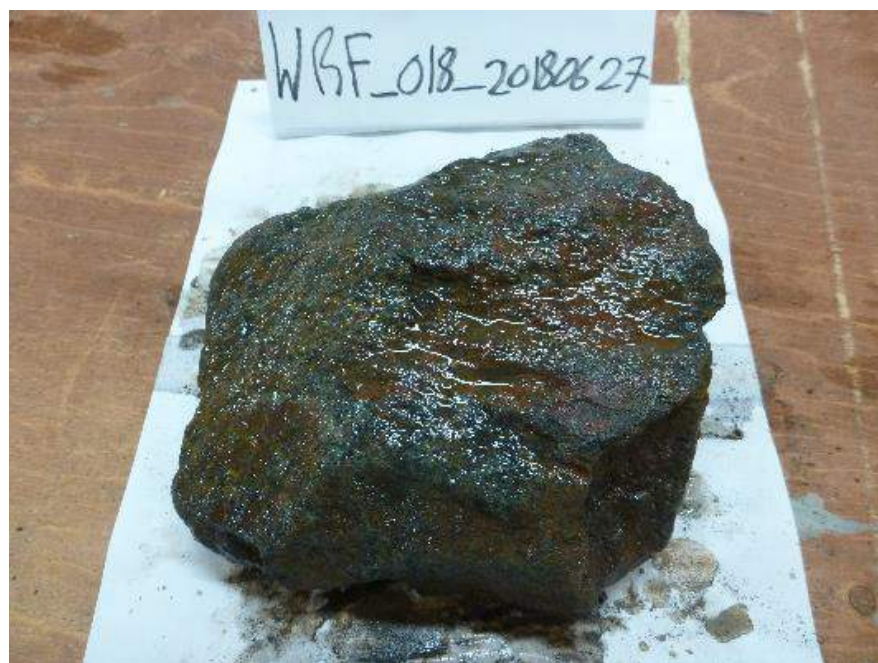
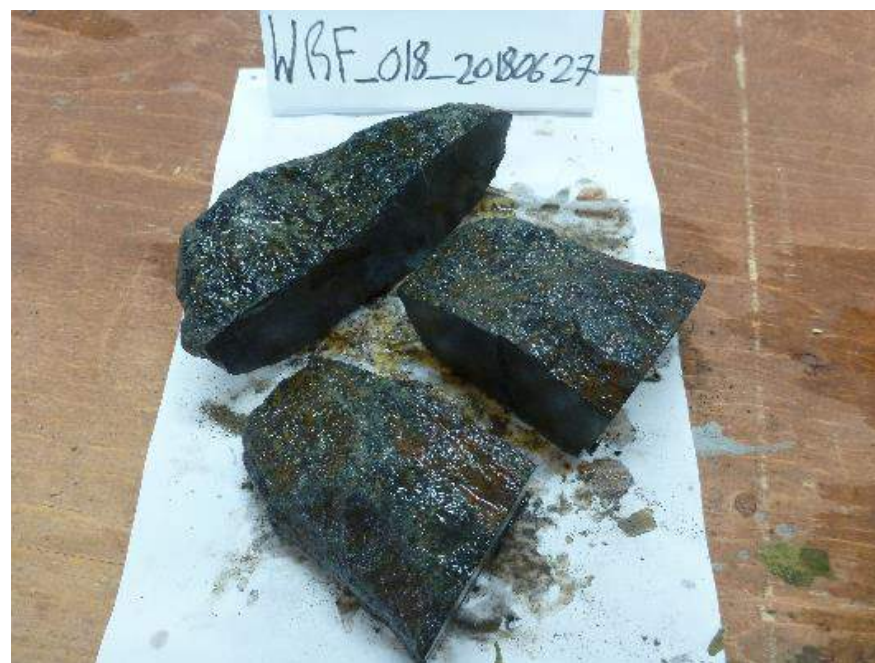
Given the non-compliance observed from the Sample WRF_018_20180626 location, it is required that the sampling and verification program be performed on an annual basis at the minimum to verify the success of PAG rock segregation and placement. This program should be developed by Baffinland and submitted to QIA for approval.

- Sample collected from western facing slope of stockpile
- Area is predominantly schist with minor ore.
- Sample is Chlorite-Garnet Schist.
- Dominant chlorite matrix with mm scale garnet porphyroblasts. Moderately magnetic with local lenses of magnetite. No visible sulphides.

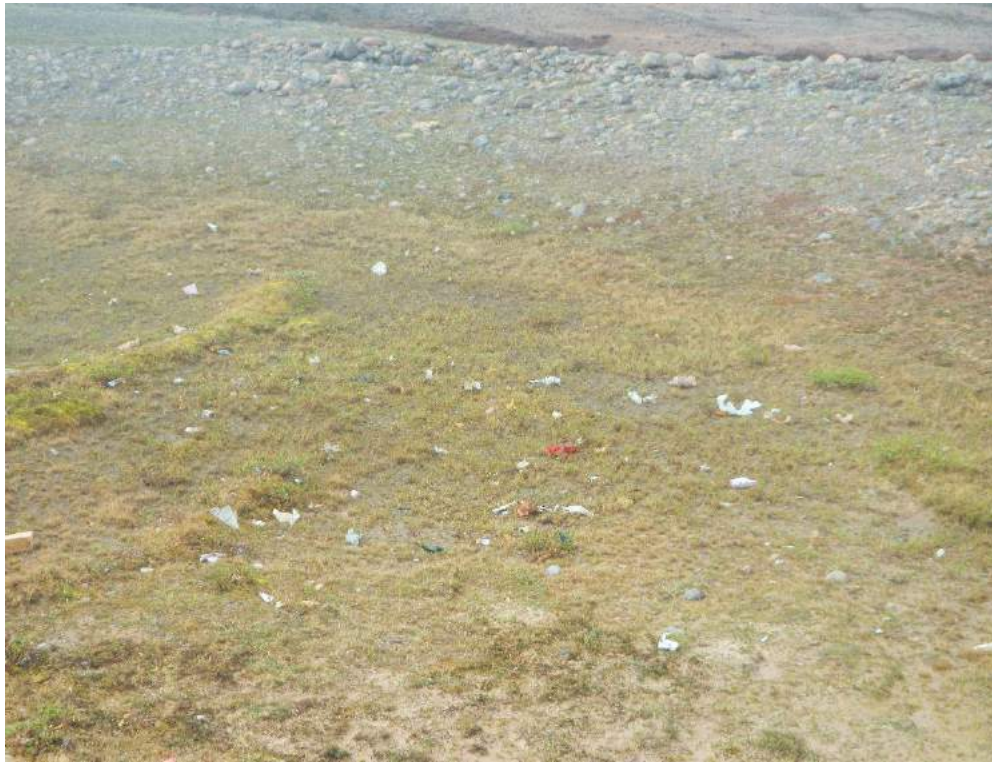
#	Project Location	Description of Concern or Finding	Recommended Action	Timeline
1	Mine site	Windblown waste and plastic bags mostly around snow dumps following melting and the landfill from uncovered waste. (Photo 1)	Requires immediate attention. Baffinland to complete site wide housekeeping and tidying.	18/07/31
2	Exploration Drill MR3-18-P04	Overloaded and not properly installed silt fence unable to stop drill cuttings washed out of the hole and flowing in the drilling fluid (water) down the slope. Accumulation of drill cuttings on the tundra, which may affect the health of vegetation and/or eventually washed down the valley into Mary River. (Photo 2)	Baffinland to use silt or sand bags as first barrier to stop cuttings. Silt fences can be installed behind the sand bags to intercept any cuttings that are not stopped by the sand bags and act as a secondary mitigation measure. All cuttings are to be removed/cleaned from the tundra post drilling. Baffinland asked to continue environmental inspections and the filling of logs for all drilling activities including geotechnical drilling. All drill logs to be included in the annual NWB/QIA report.	18/07/31

Photo 1: Windblown waste west of landfill

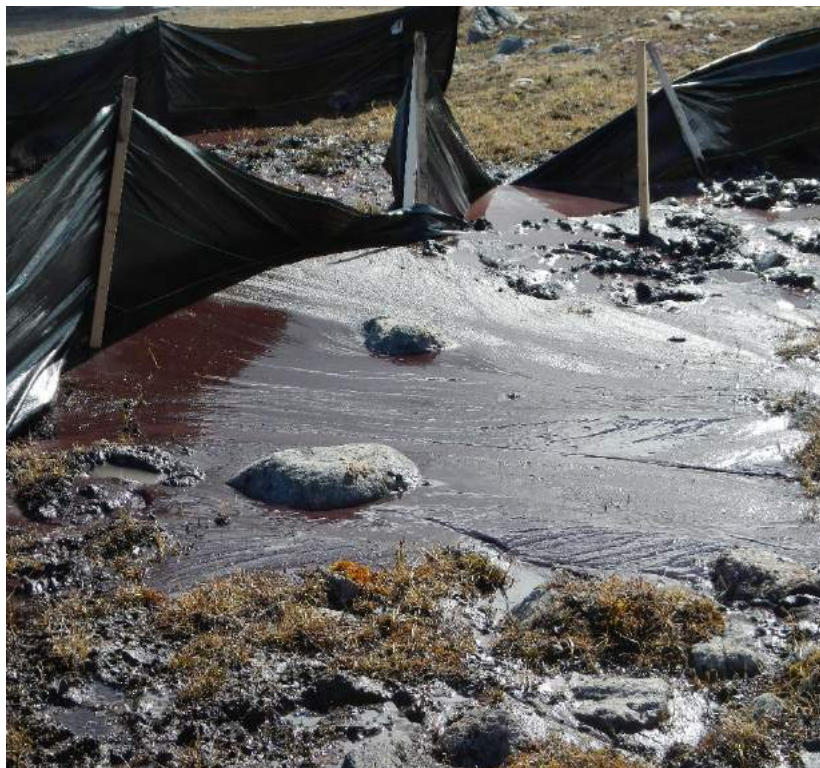
Photo 2: Exploration Drill Location MR3-18-240 – Overloaded and broken silt fence

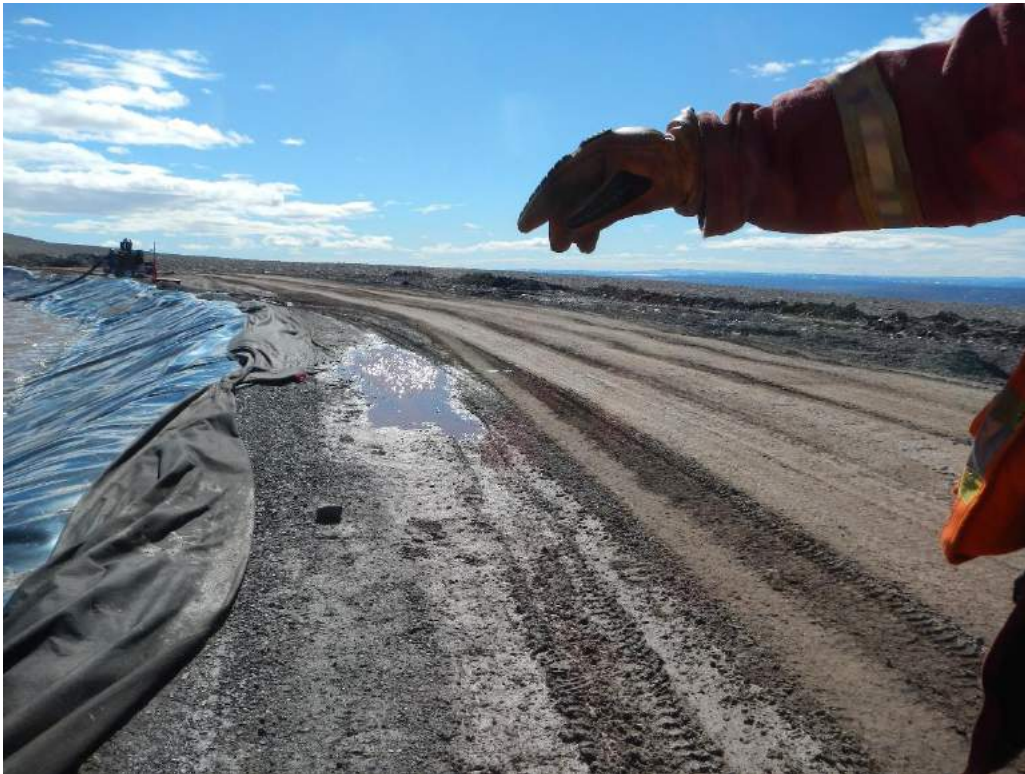
3	Waste Rock Facility Sedimentation Pond	Visual settlement, slumping of top berm, geotextile visible and water ponding between Stations 0+040 and 0+060 of the containment berm and road. (Photo 3)	Baffinland to place, compact, and slope-fill material to provide a slope for water to flow away from the berm and road.	18/07/31
4	Waste Rock Facility Samples	Sample WRF_018_20180626 obtained from a Non-PAG (base layer of Non-PAG placed on existing ground) location tested and classified as PAG. Sample WRF_004_20180626 obtained from a slope that appears to be located outside the identified PAG boundaries.	Baffinland to explain why PAG material was placed in these locations, provide a plan and a schedule to address the situation.	18/08/30
5	Waste Rock Facility	No instrumentation – At the time of the inspection, no ground temperature cables were installed to verify freeze back of material placed to date.	It is recommended that Baffinland finalize design work and install instrumentation for the WRF immediately. Baffinland indicated they are currently working with their consultants to design and install thermistor cables later this year.	18/10/30

Photo 3: WRF Pond - Berm settlement, geotextile exposed & water ponding btw. 0+040 & 0+060

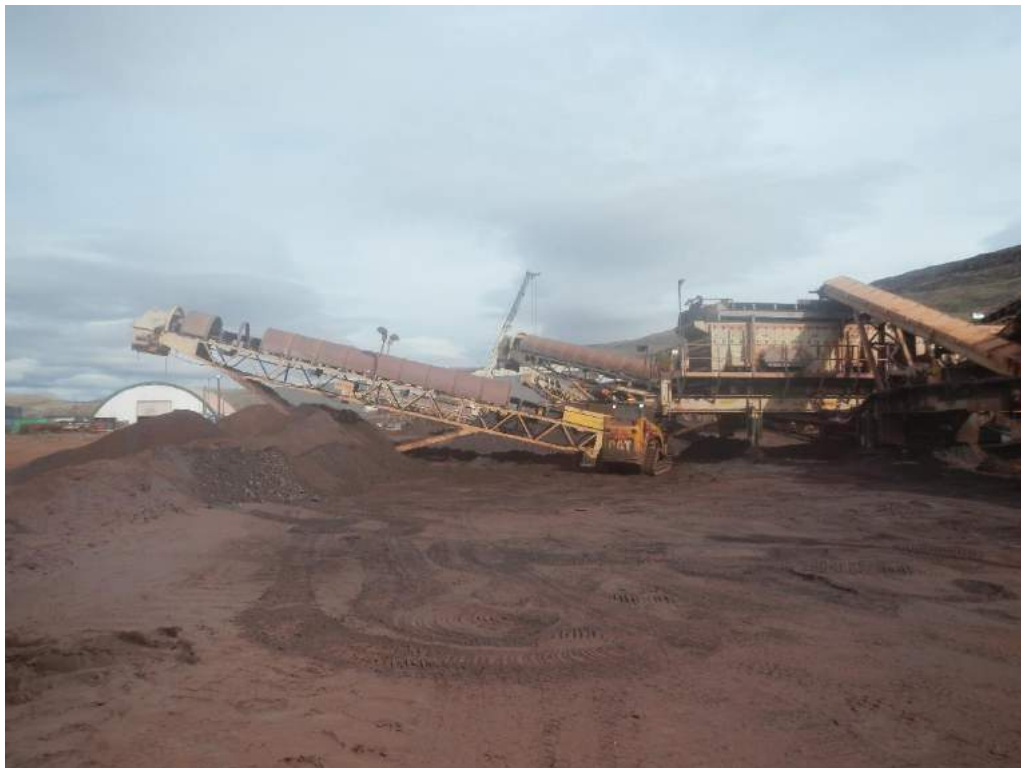
Photo 4: Ore Crusher – Transition points not enclosed to prevent dust dispersion

7	Ore Crusher	Transfer/transition points along conveyor belts not engineered to avoid or minimise spread of dust to the air as is the case with other sections of the belts. (Photo 4)	It is recommended that Baffinland explore and implement measures to enclose these points to prevent the spreading of dust as was observed during the site inspection.	2018-Sep-30	Baffinland continues to research and develop novel methods of dust migration mitigation from the Mary River Crusher Pad. Baffinland has engineered dust reduction measures installed on all three crusher spreads at the identified locations that produce significant dust. In addition, since the June 2018 QIA inspection, Baffinland has installed three conveyors hood chutes that mitigate dust from conveyor transfer points, and is continuing to install conveyor covers.
8	Ore Crushing Pad Water Management	Construction of containment ditches surrounding ore stockpile pad appeared to be complete at the time of the inspection. However, a section of the ditch along the east side of the sedimentation pond was blocked by debris and a snow fence resulting in water ponding in the ditch rather than flowing into the sedimentation pond. Ponding water may infiltrate into and affect berm and liner integrity. (Photo 5)	Baffinland to remove snow fence, clear debris from the ditch, grade and slope the ditch to promote free flow of water towards discharge point into the sedimentation pond.	2018-Jul-31	The section of the ditching identified during the inspection has been worked and graded and the snow fences have been removed

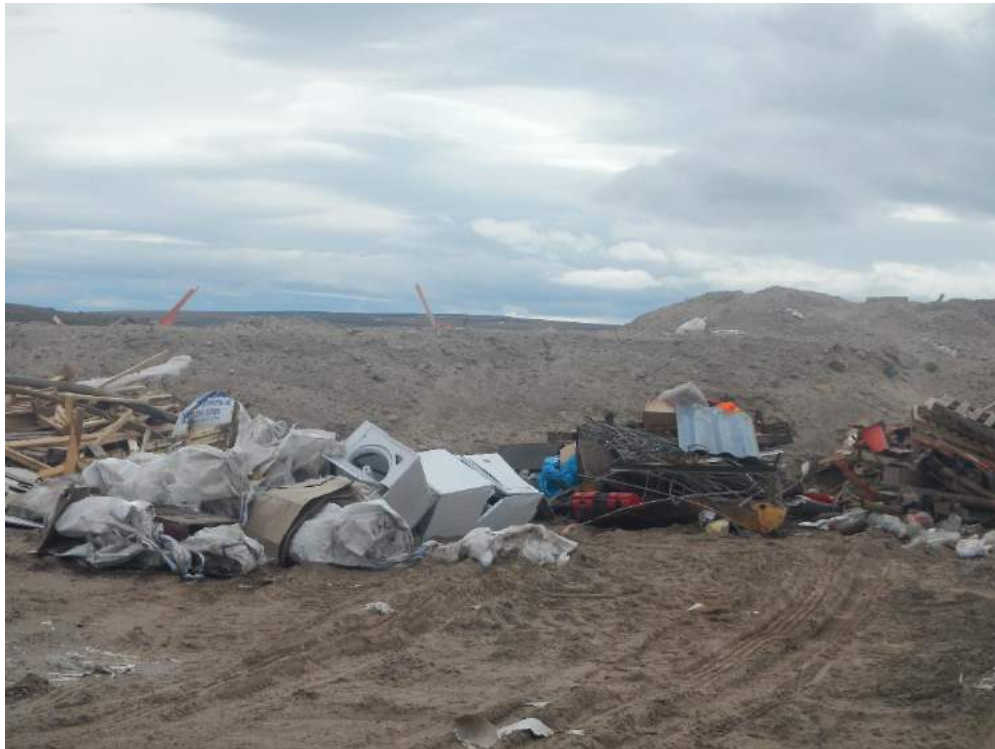
Photo 7: Landfill – Washer and drier amongst recently dumped waste

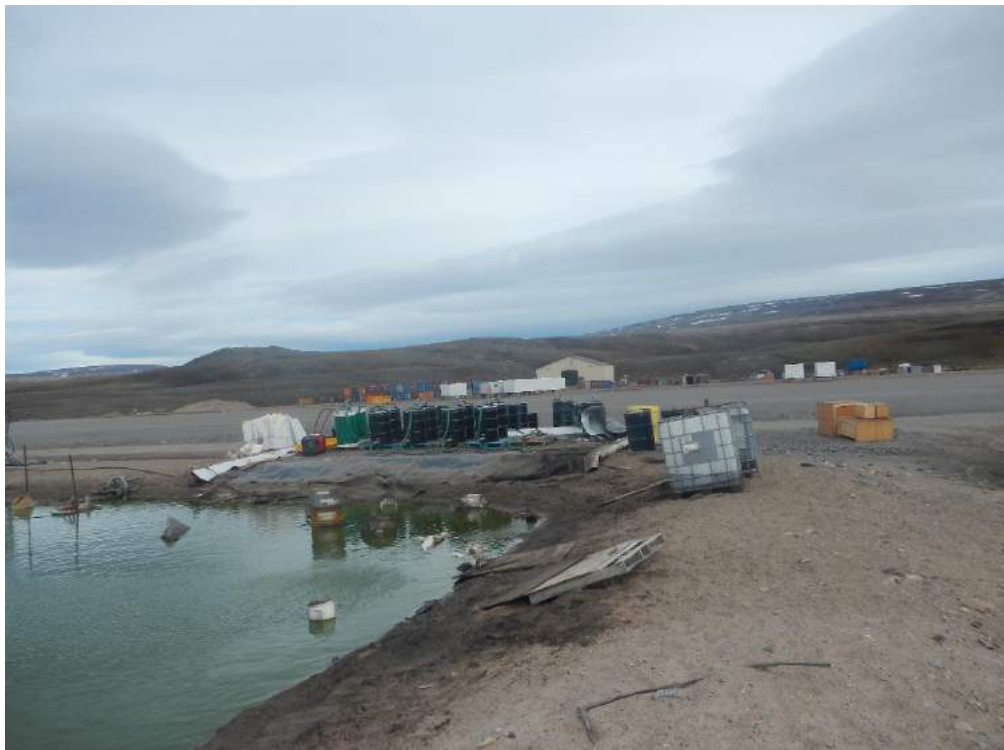
Photo 8: Hazardous Waste Berm #7 – Two totes of unlabeled hazardous material out of containment area

11	Hazardous Waste Berm #7	Two totes containing unlabeled hazardous material outside of containment. (Photo 8)	Baffinland to label waste containers and relocate drums into containment area or use temporary containment beneath drums.	2018-Jun-30	The two totes containing hazardous material outside containment at HWB #7 have been properly relocated inside containment
12	Mine Site Waste Management Facility	Observed a steel container holding kitchen waste with a hole at its bottom that allowed waste to spill on ground. A fox was seen eating the food waste. (Photo 9)	Baffinland to immediately repair hole or replace container and clean all food waste from the ground as it is attracting wildlife.	2018-Jun-30	The hole in the c-can identified has been repaired and repurposed. A new more competent c-can has replaced the older c-can.
13	Tote Road	Baffinland made use of sedimentation and erosion controls along entire road in most areas where this was required. Silt fences and check dams are the common erosion controls put in place. However, some silt fences like those at the km 80 and km 97 bridges were over loaded and in some cases broken with clear evidence that sediment flowed over the fences into the receiving environment. (Photo 10)	Baffinland to replace or repair broken silt fences or use other measures to prevent sedimentation and erosion as warranted.	2018-Jul-31	Clean up and removal of Silt fences following freshet and is an ongoing process. It should be recognized that removal of spent of silt fences is not always a recommended industry standard as this will allow sediment captured to be re-mobilised. Baffinland will continue to repair and replace silt fencing in 2018 in preparation for freshet 2019.

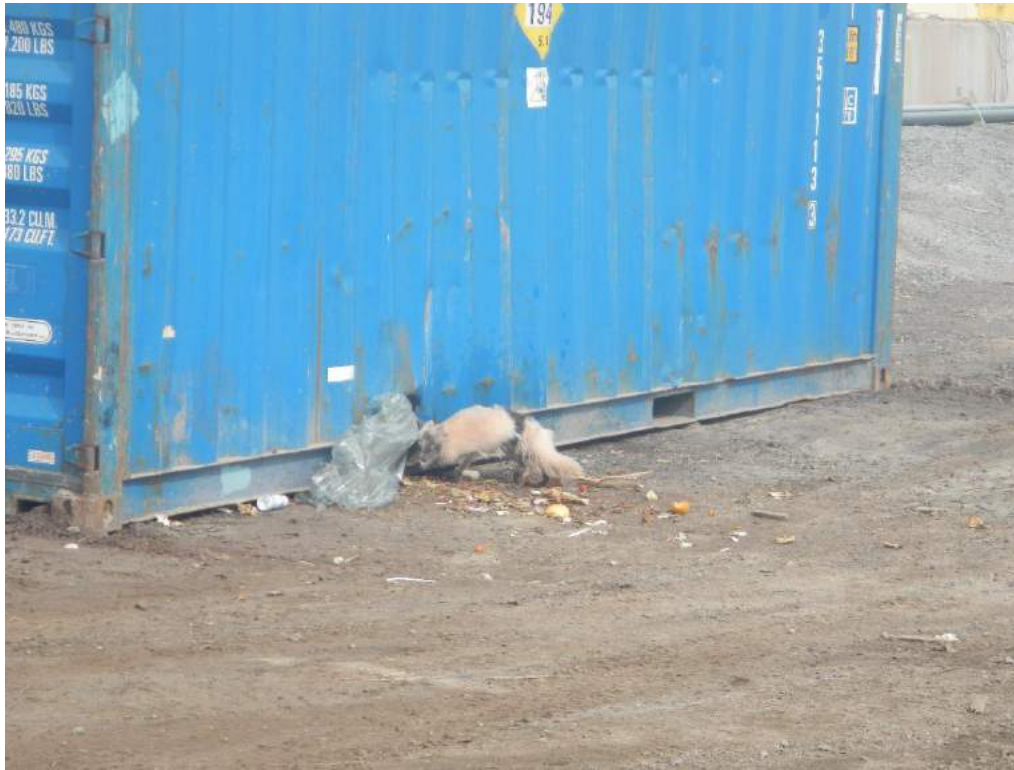
Photo 9: Mine Site Waste Management Facility – Fox eating kitchen waste from seacan outside facility

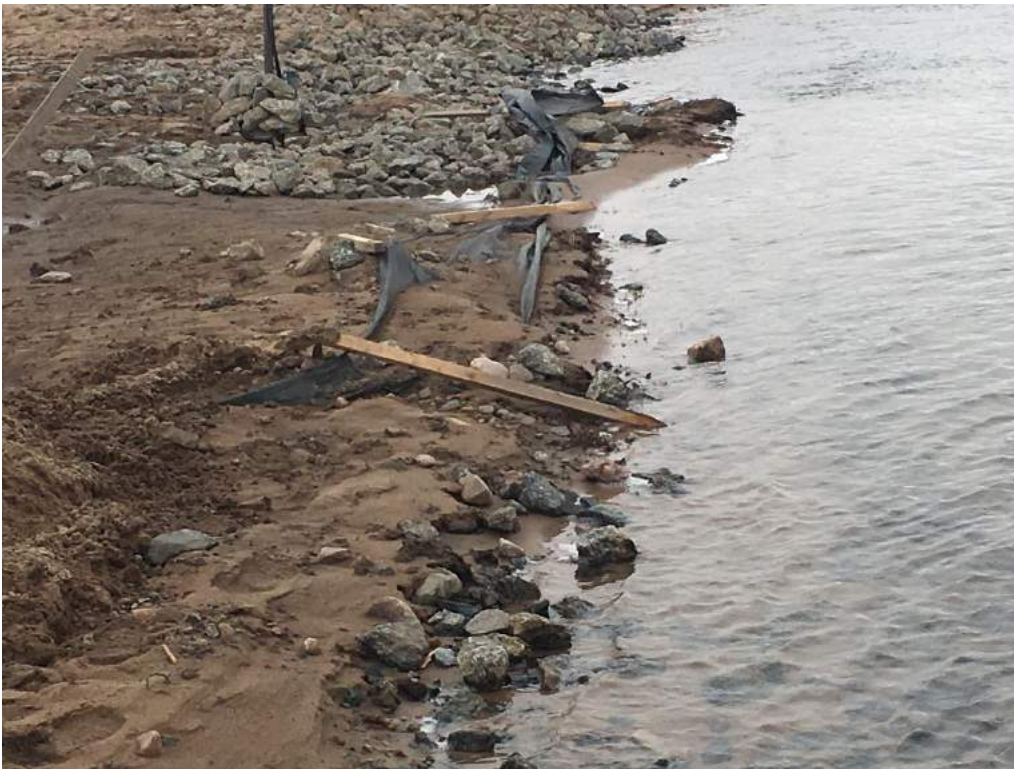
Phot0 10: Southside Downstream of km 80 Bridge – Broken silt fence, sediments went over

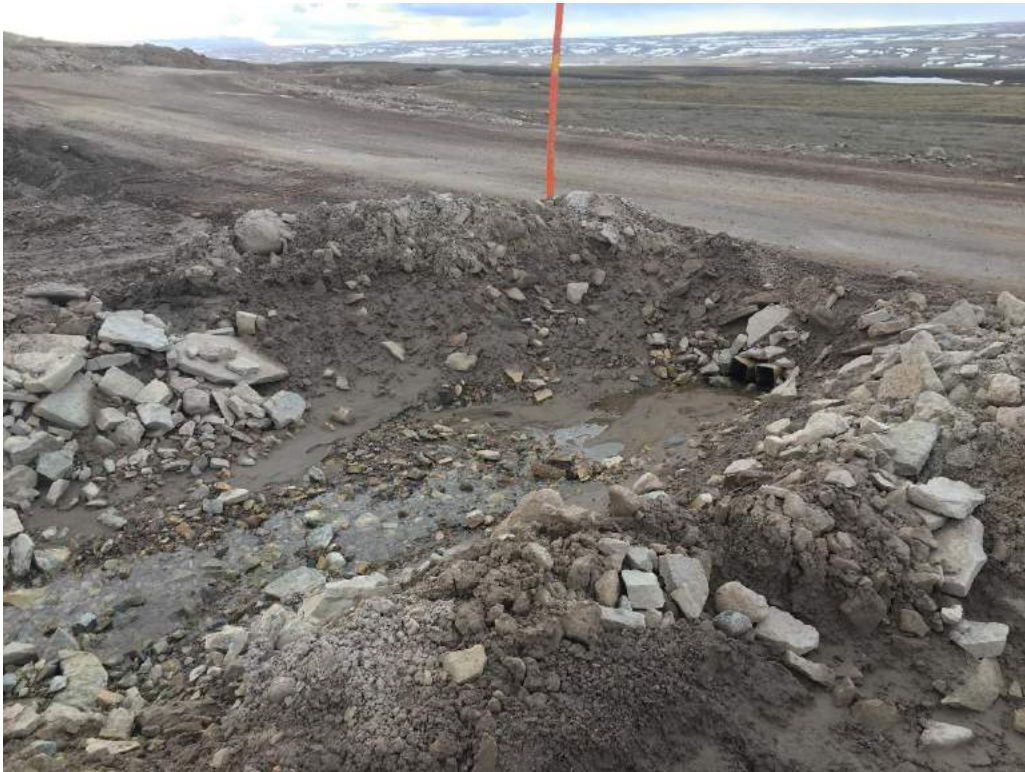
Photo 11: Tote Road Km 74 – Pipes installed in place of damaged culvert

14	Tote Road	Damaged culvert around Km 74 resulted in possible sediment loaded water flowing on road surface to the receiving environment. Baffinland installed two pipes as a temporary measure at the time of the site inspection. (Photo 11)	A permanent solution that may require approval as per Section 2.8 of the Commercial Lease is required immediately. Baffinland to install a designed and approved culvert at this location.	2018-Aug-30	The km 74 culvert issue was a culvert exhibiting a damaged inflow end a couple meters away. The culvert was repaired/ buffed out and the steel pipes were removed as they were no longer necessary or holding water.
15	Tote Road	Permafrost degradation along roadside cuts and some old borrow sources still an ongoing issue. Baffinland currently working on stabilizing some of the slopes with the use of geosynthetic material and riprap, as is the case around Km 32. (Photo 12)	Baffinland to continue working on stabilizing and protecting the areas identified in the Tetra Tech EBA 2015 ² report.	Ongoing	The km 32 area is part of ongoing erosion mitigation efforts on the tote road and part of the projects that will be executed in 2018 following QIA approval of a TRAN submission.

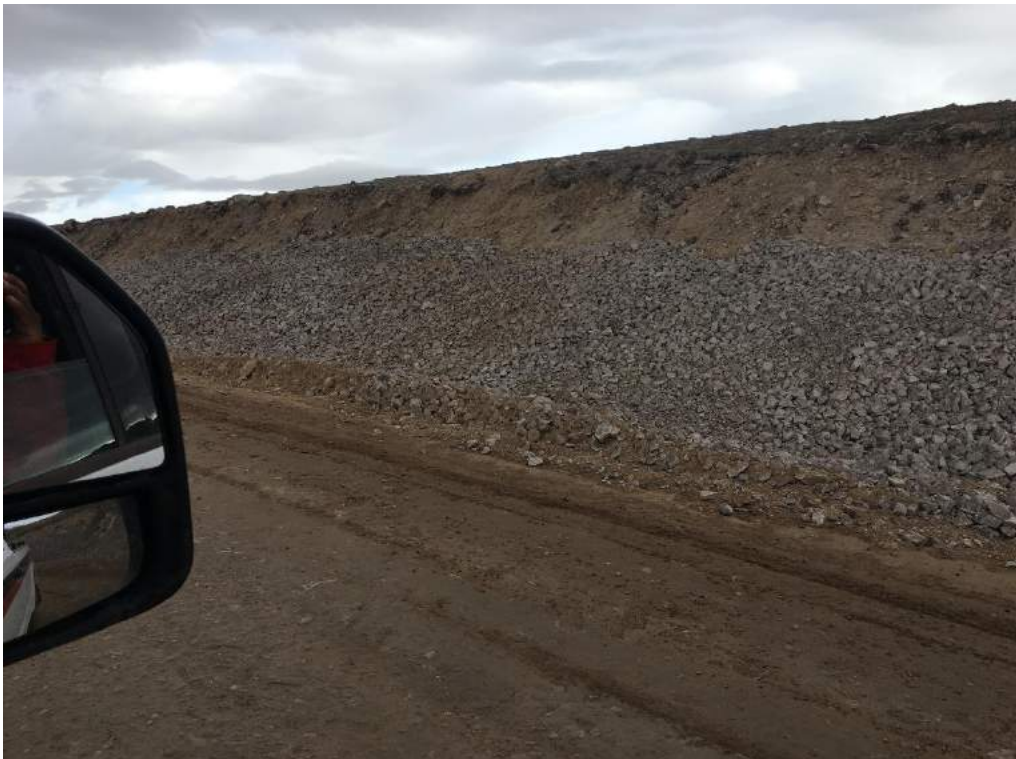
Photo 12: Tote Road – Slope stabilization work ongoing on road cut around km 32

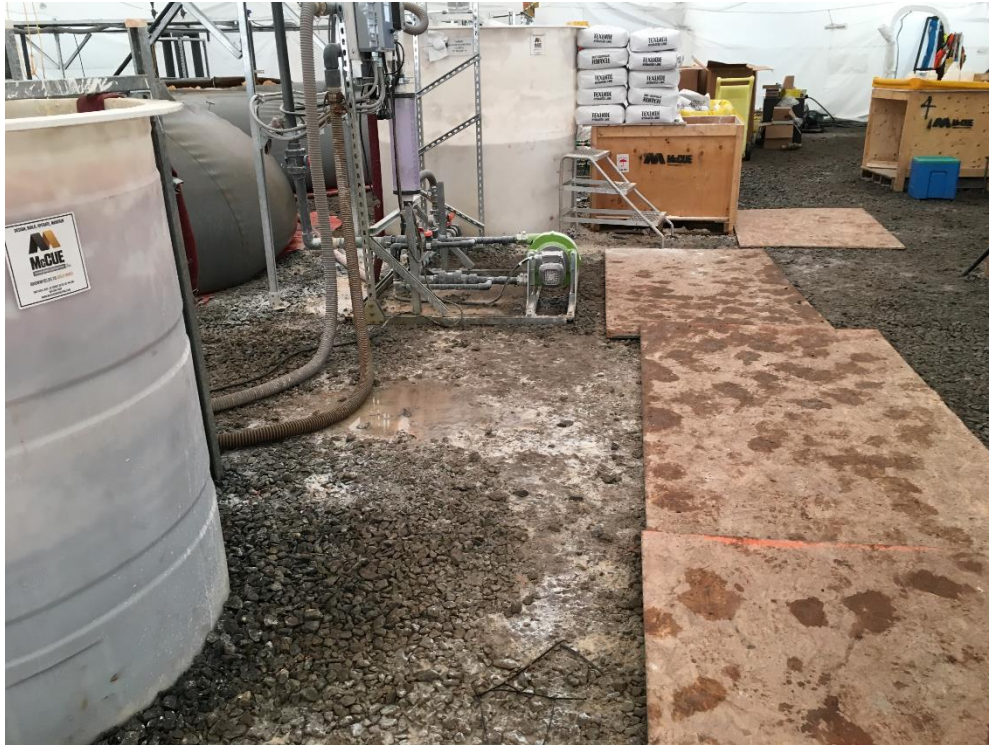
Photo 1: Water treatment plant pad floor – white substance is hydrated lime

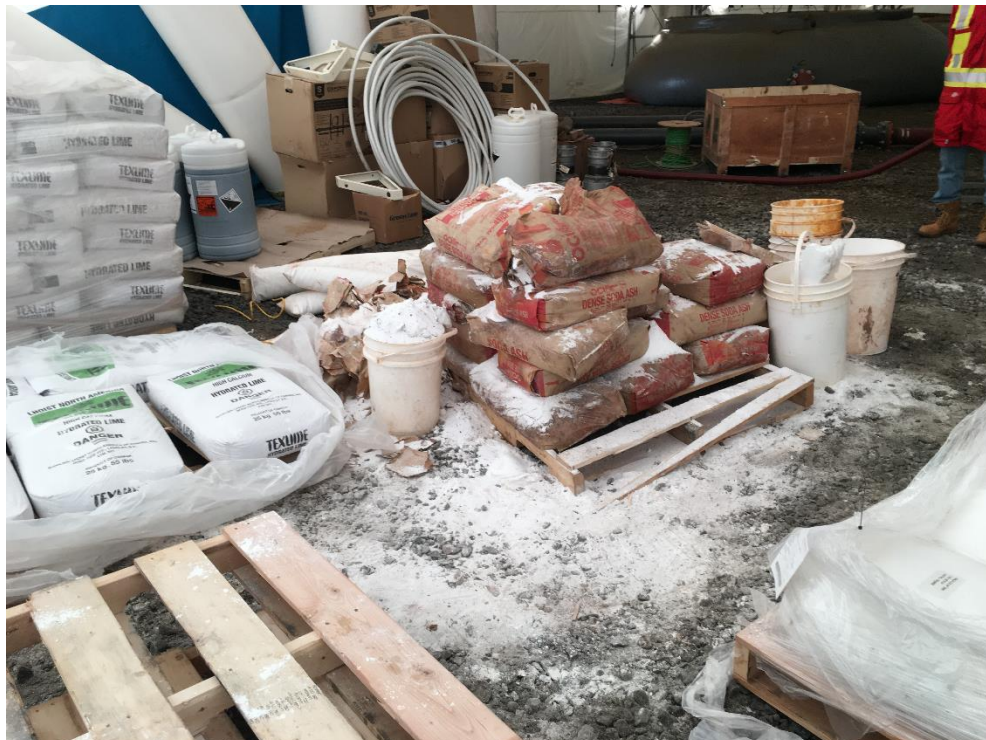
Photo 2: Water treatment plant pad floor – soda ash on floor

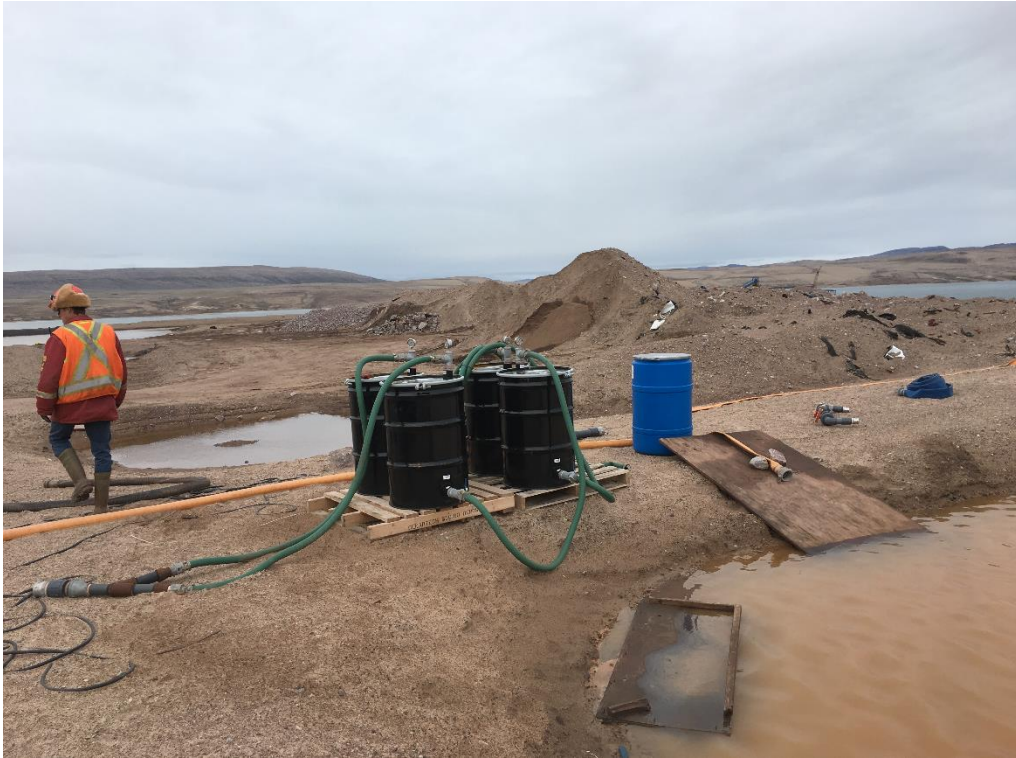
3	Milne Landfarm	Liner and other unauthorised substances observed though it was noted that some of these had been removed after the June 2018 inspection. (Photo 3)	It is recommended that Baffinland continue to sort, segregate, and remove all unauthorized material, finalize the construction of berms as designed and re-instate the landfarm to its original intent and use.	18/09/30
4	Milne Port Snow dump	Waste and plastic bags on and around snow dump following melting. (Photo 4)	Requires immediate attention. Baffinland to complete site wide housekeeping and tidying.	18/08/31

Photo 3: Milne Landfarm

3	Milne Landfarm	Liner and other unauthorised substances observed though it was noted that some of these had been removed after the June 2018 inspection. (Photo 3)	It is recommended that Baffinland continue to sort, segregate, and remove all unauthorized material, finalize the construction of berms as designed and re-instate the landfarm to its original intent and use.	Baffinland continues to sort and remove plastics and other materials through the management of the landfarm in 2018 and will continue these efforts in 2019. Baffinland has demonstrated a commitment to manage the landfarm in an appropriate manner through the efforts expended in 2018 and will continue to improve on landfarm management and performance.
4	Milne Port Snow dump	Waste and plastic bags on and around snow dump following melting. (Photo 4)	Requires immediate attention. Baffinland to complete site wide housekeeping and tidying.	Baffinland continues to address debris collected during snow movement and storage, and has expended significant effort to reduce the volume of debris in the area of the snow dump, as well as Site wide. Baffinland will continue through winter 2018/19 to reduce debris present in snow dump locations and will continue to engage in spring and summer season site cleanup days and other efforts.

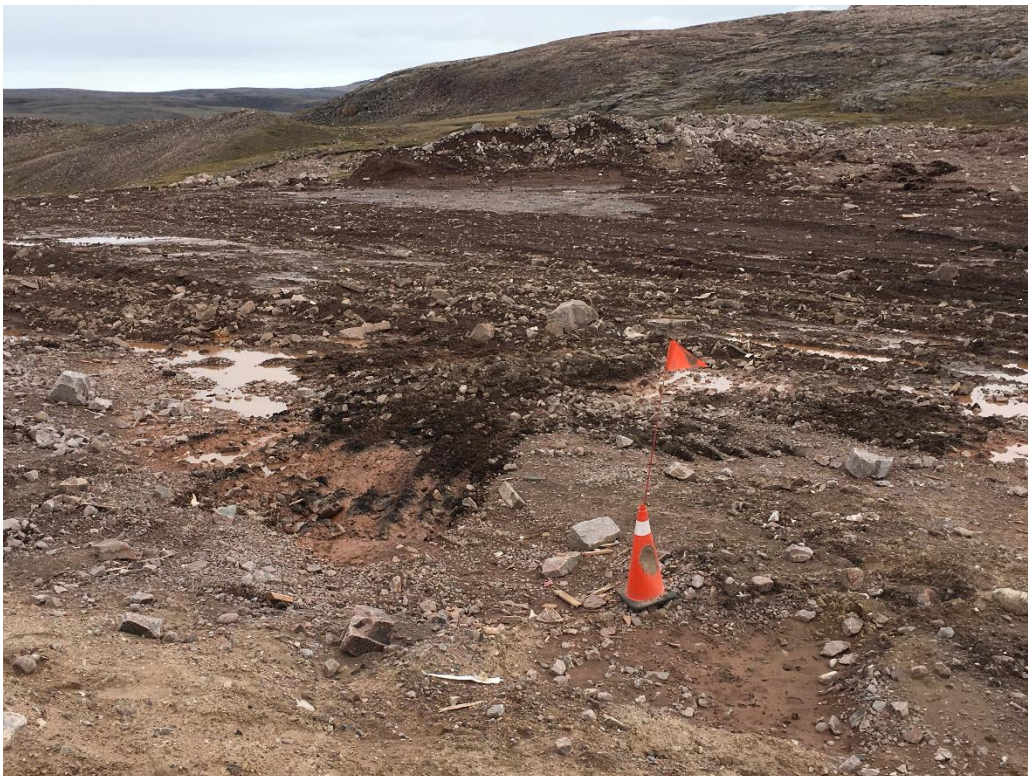
Photo 4: Milne Landfarm
