**APPENDIX E.8.3**  
**WSCC INSPECTION REPORTS**

# Inspection Report

**Report Reference:**  
Inspection #: 2018-JP-00071

**Mary River Mine Site**  
***MINE MANAGER***  
**Sylvain Proulx**

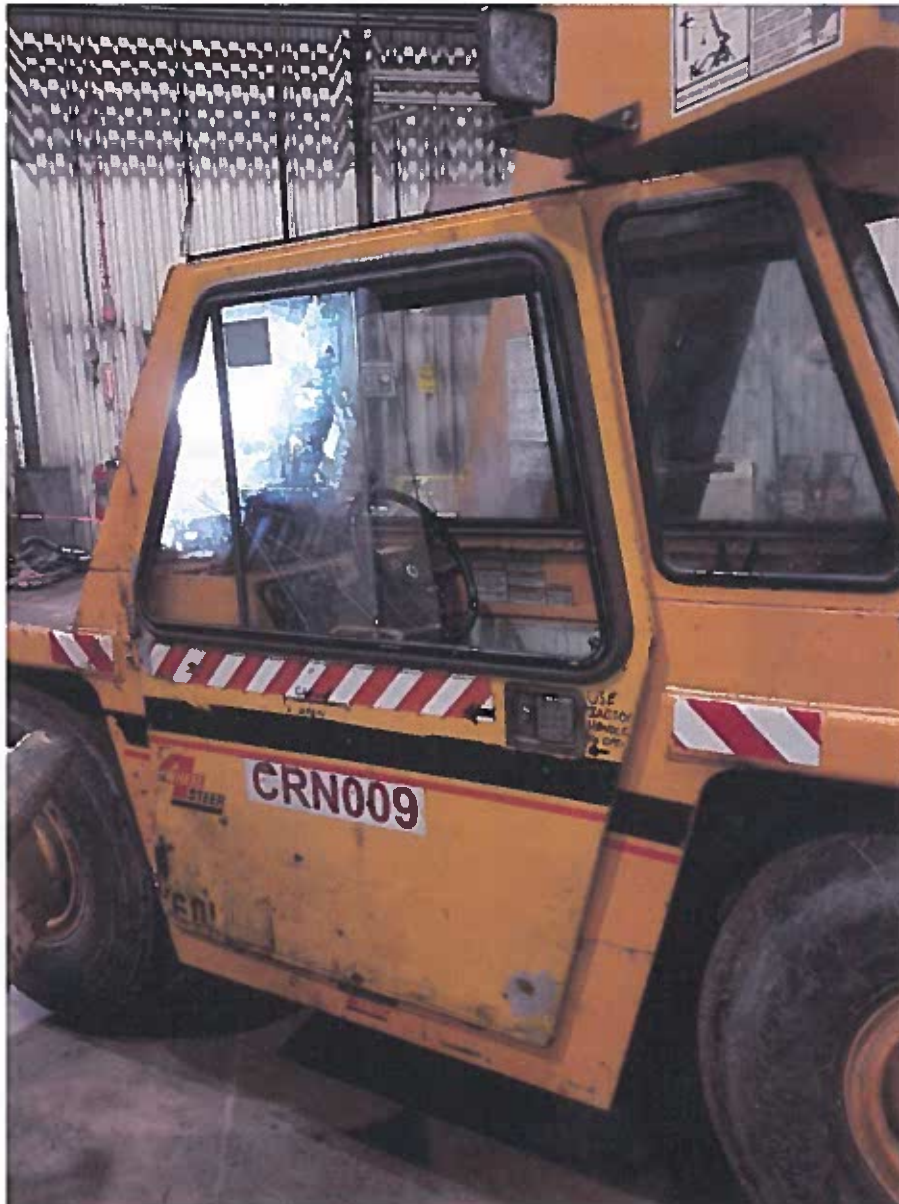
| <b>Observations:</b> | <p>In the Mobile Maintenance shop:<br/>A mobile crane (Model IC-08-3G, Serial Number 538260) was observed to be in use however was not in proper working condition with several noted deficiencies appearing in the vehicle inspection book going back to Feb 11, 2018 (start of the book) including broken glass, issues with the exhaust, and a broken door latch. The door latch was tested on site and was confirmed to be not in proper working order.</p> |

| <b>Direction:</b> | <p>The Employer shall ensure that all equipment is used, inspected, and maintained as per the manufacturers specifications or an approved standard. Any equipment found to be not in safe operating condition shall be locked out and not be used until fixed or replaced.</p> |

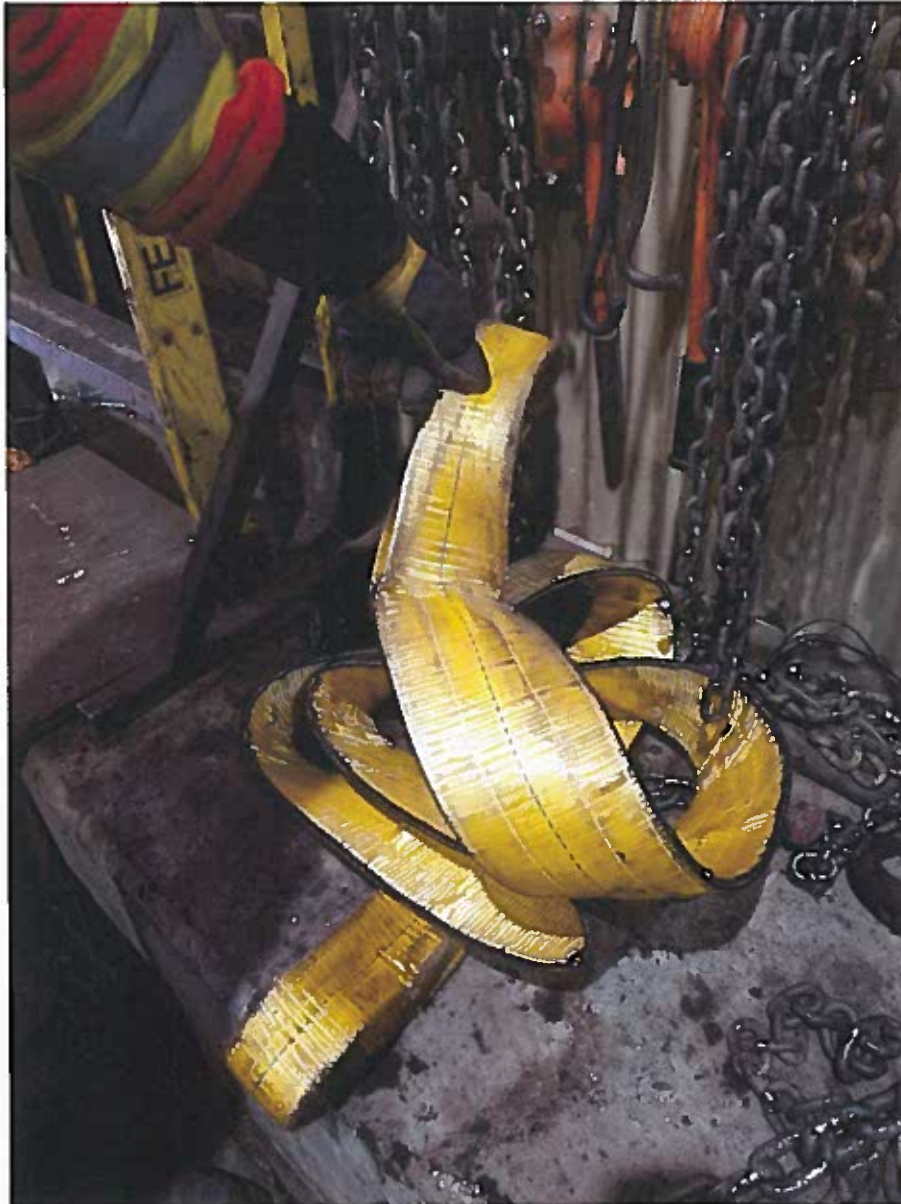
**Observations:** In both the Port Warehouse and the Mobile Machine Shop, tow straps or slings/straps were observed to be in service, however both were damaged.

Photo depicts damaged strap however the specific area of damage is not noted in this photo.

**Direction:** The Employer shall ensure that there is a process in place for the regular inspection of equipment and that any equipment found to be not in proper working order according to the manufacturers specifications be immediately removed from service until it is fixed or replaced. Additionally, all workers must be trained in this process.

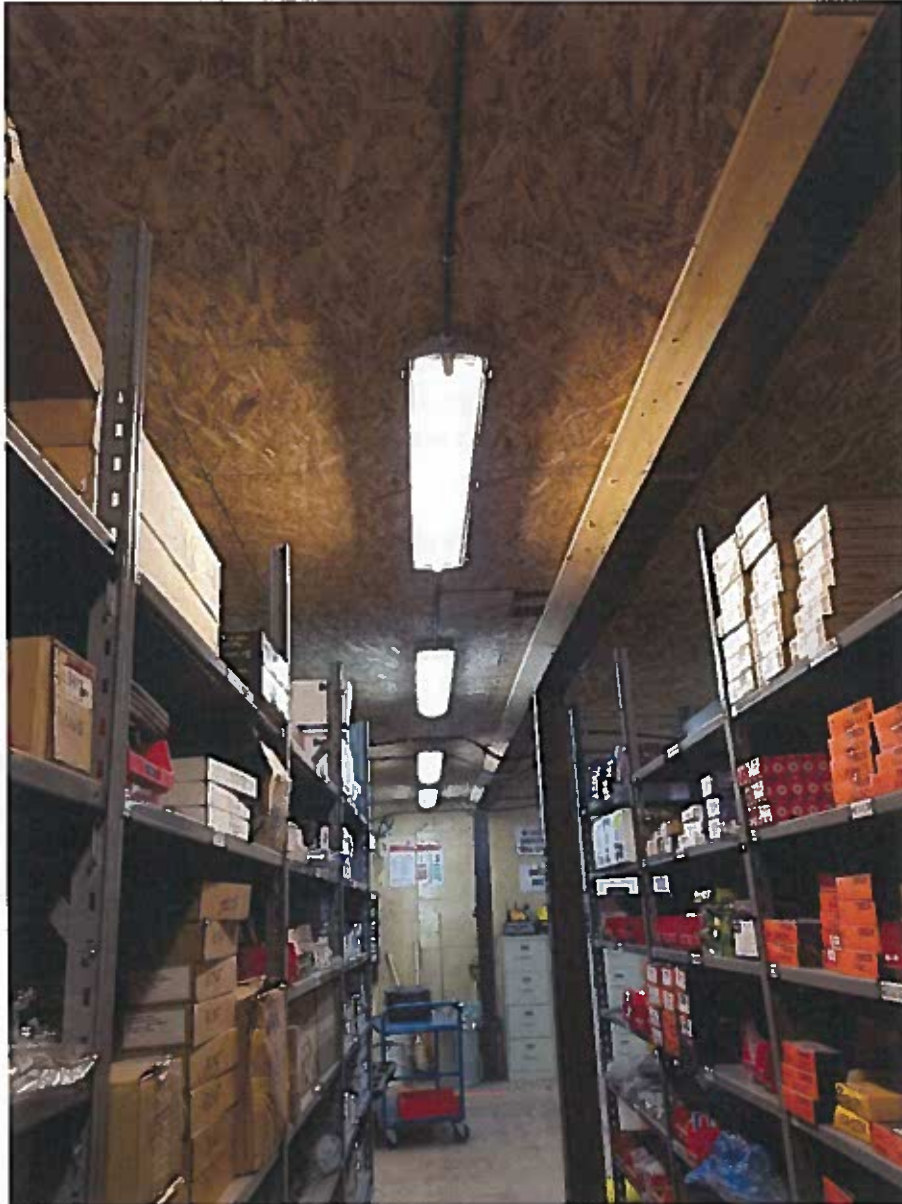
<b>Observations:</b>	<p>Port Warehouse:</p> <p>An overhead light in one of the isles in was missing the guard to protect it from damage.</p>
<b>Direction:</b>	<b>The Employer shall ensure that lights have appropriate guards installed.</b>
<b>Legislation:</b>	Occupational Health and Safety Regulations(Nunavut)
<b>Section 450:</b>	An employer shall ensure that a luminaire that is located at a height of less than 2.1 m above a working or walking surface, is protected against physical or mechanical damage.

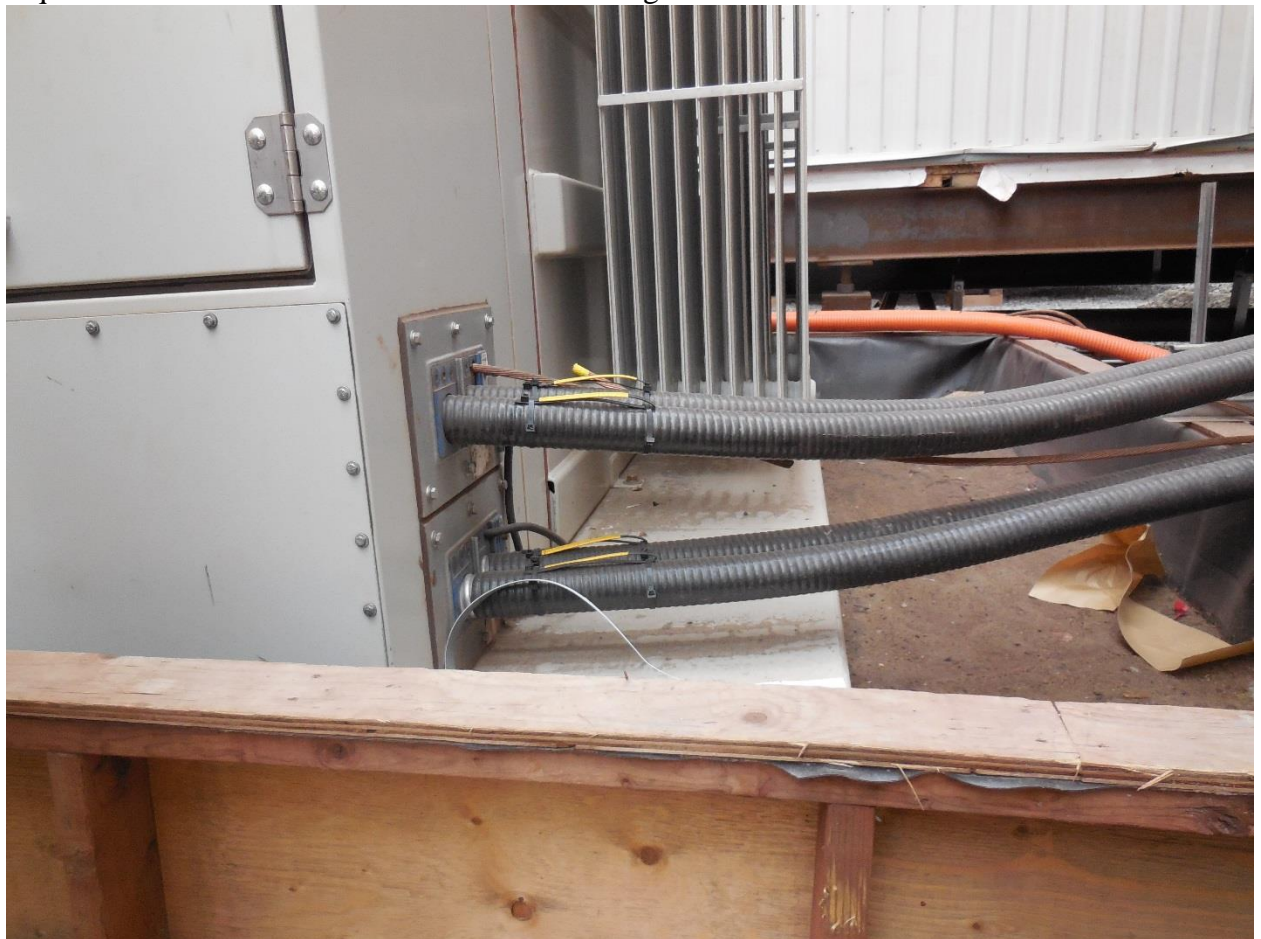
2. Submersible pumps fed with SOW cable were noticed disconnected and lying on the ground beside one of the lift stations. CSA M421 Clause 4.4.1.4 states, Submersible pumps operating at voltages exceeding 150 V to ground shall be supplied by shielded portable power cable and have ground-fault protection and ground-conductor monitoring. Depending on the usage submersible pumps may or may not fall under this requirement. Ensure that submersible pumps are suitable for their intended purpose.
3. Containment for pad mount transformer 1611-SUB-002 is higher than the low voltage cable entries. Review the certified design for containment, revise and re-certify as required such that cable breakouts are not submerged.

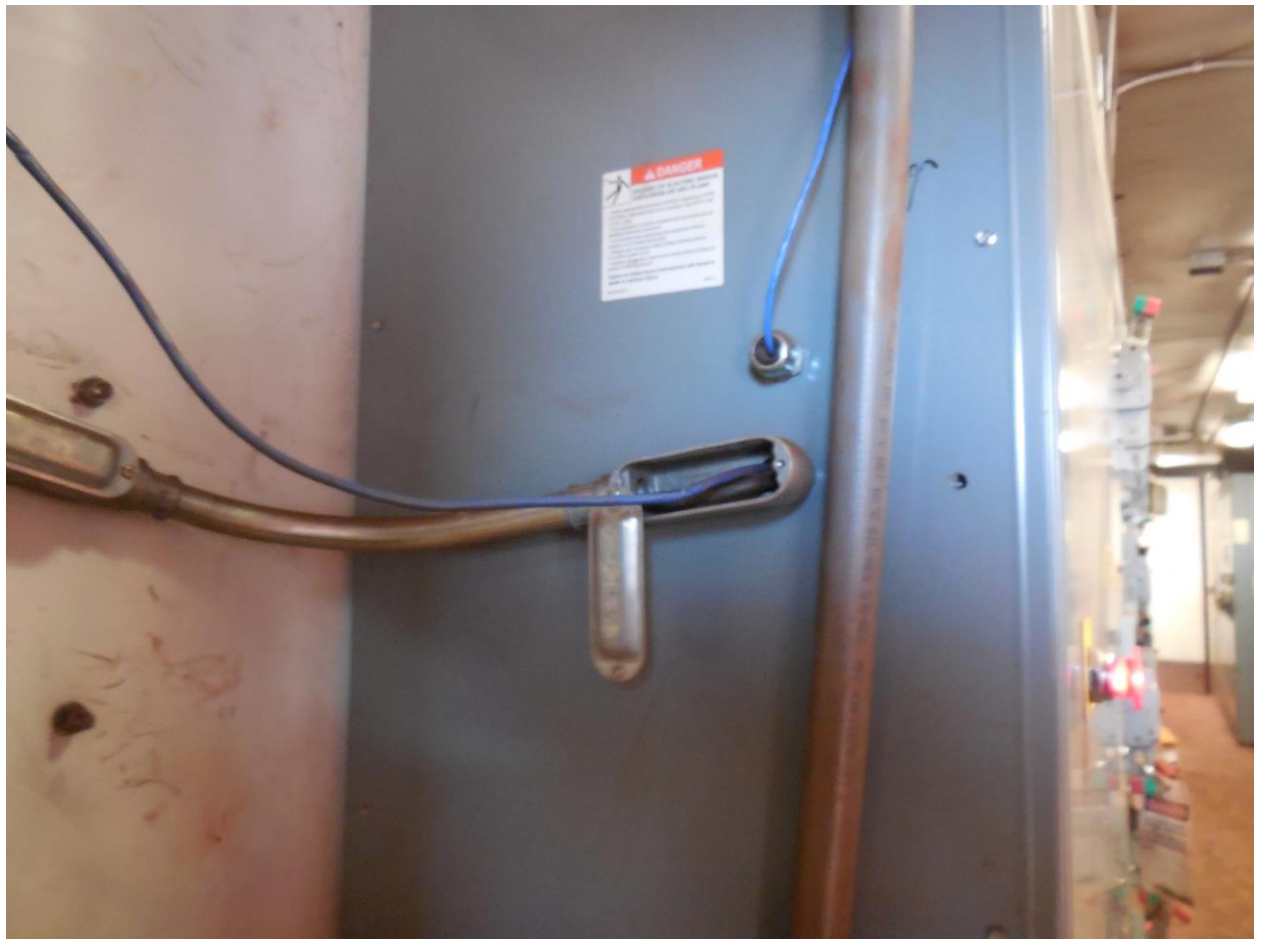
1. At Crusher C MCC a Category 5 cable is inserted through the access opening on an LB fitting such that the cover cannot be closed.

The CEC Rule 2-112 requires the mechanical arrangement and execution of the work in connection with any electrical installation to be acceptable. Reroute this cable through a proper cable connector or conduit.

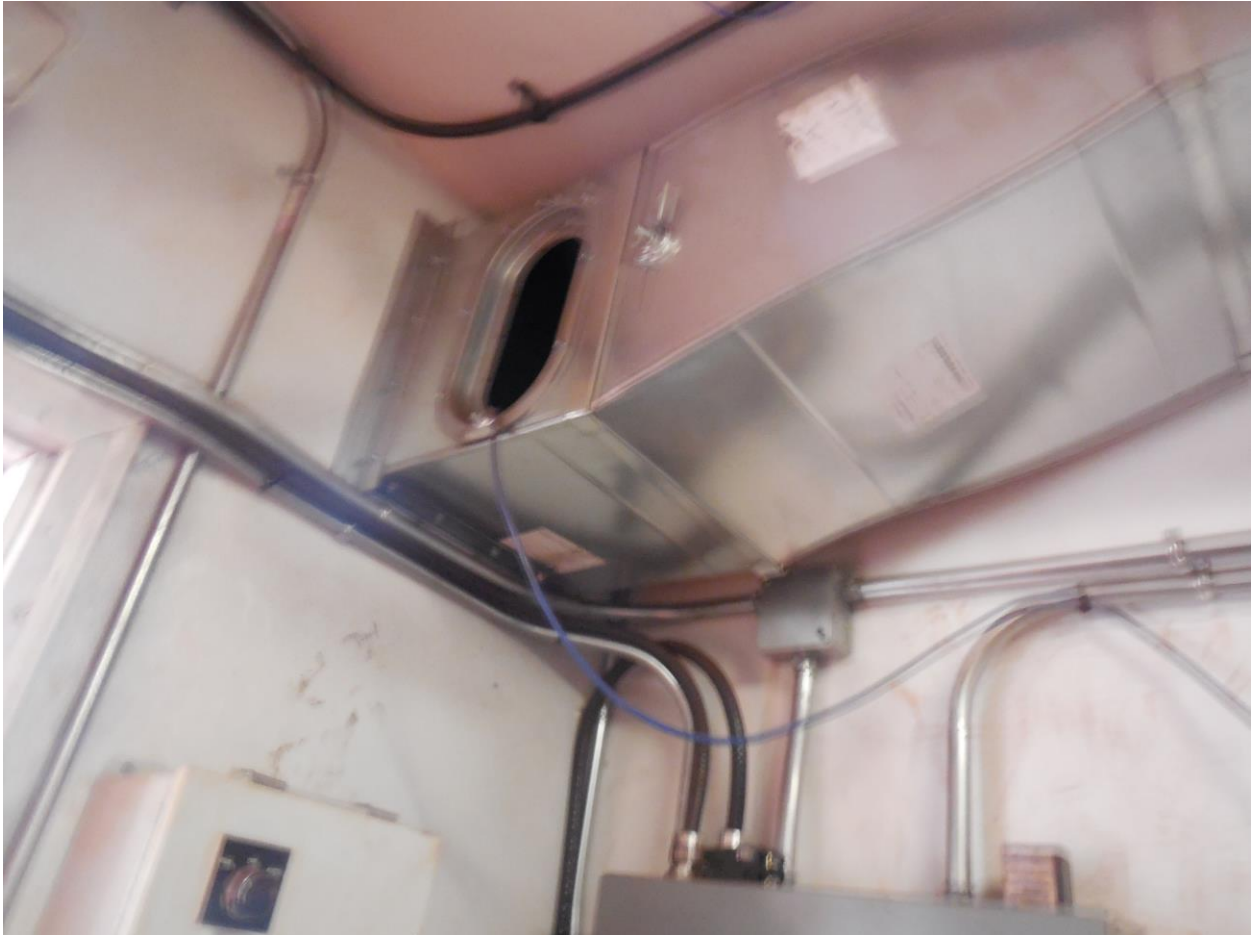
2. At Crusher C MCC a Category 5 cable is run through an opening in the ventilation duct such that the cover cannot be installed.

The CEC Rule 2-112 requires the mechanical arrangement and execution of the work in connection with any electrical installation to be acceptable. Also, CEC 60-314 states that communication conductors shall not be placed in ducts or plenum chambers except as permitted by Rules 2-130 and 12-010.

Reroute cable such that it does not interfere with ventilation equipment.

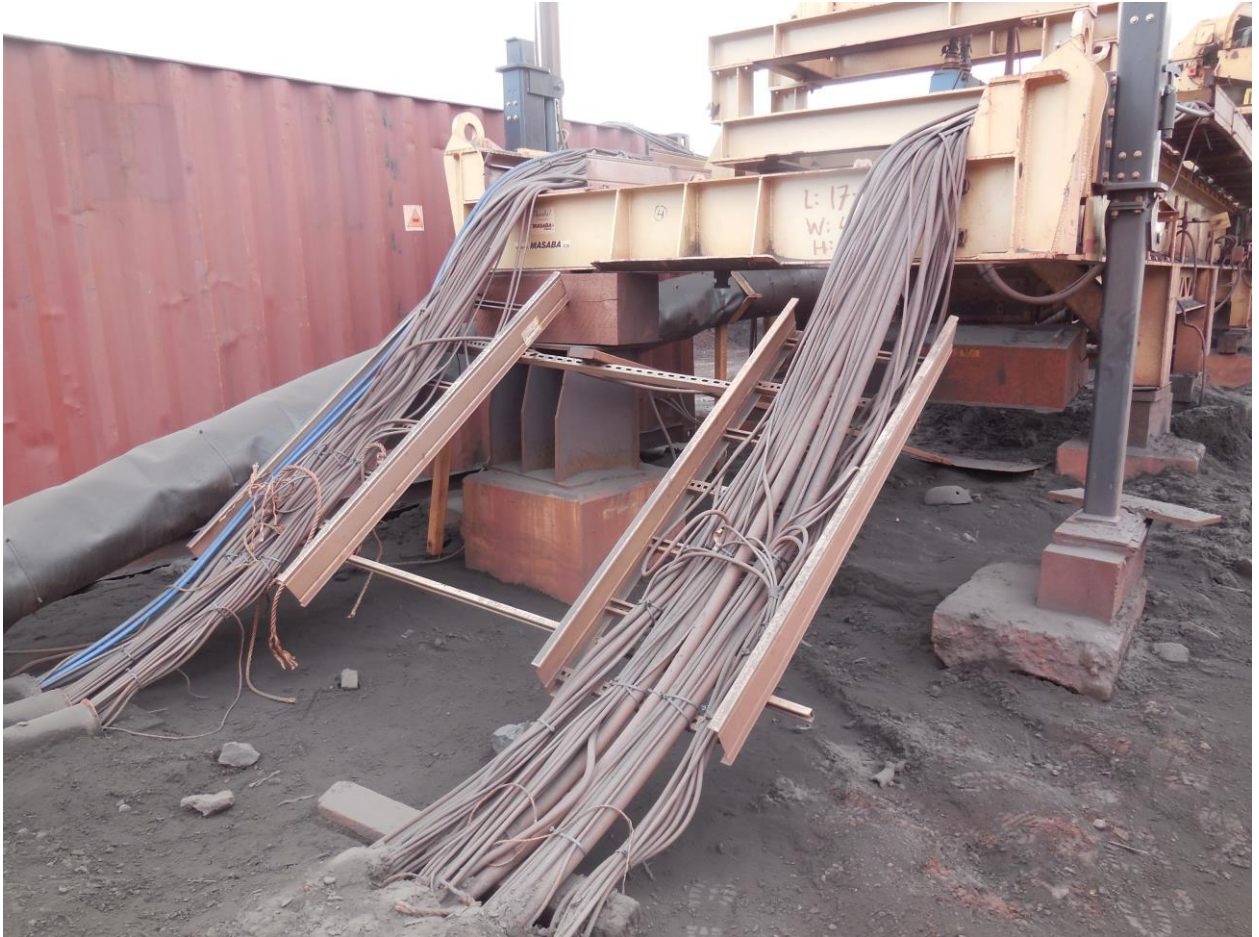
3. At the secondary chassis, sections of cable tray are not supported or bonded. These trays are carrying energized cables.

CEC Subrule 12-2200 (5) states, “Cable trays shall be adequately supported by non-combustible supports”. CEC Subrule 12-2208 (1) states, “Except as provided for in Subrules (2) and (3), metal cable tray shall be bonded at intervals not exceeding 15 m and the size of bonding conductors shall be based on the ampacity of the largest ungrounded conductor as specified in Rule 10-814 in the circuits carried by the cable tray. Provide support for and bond the cable tray.

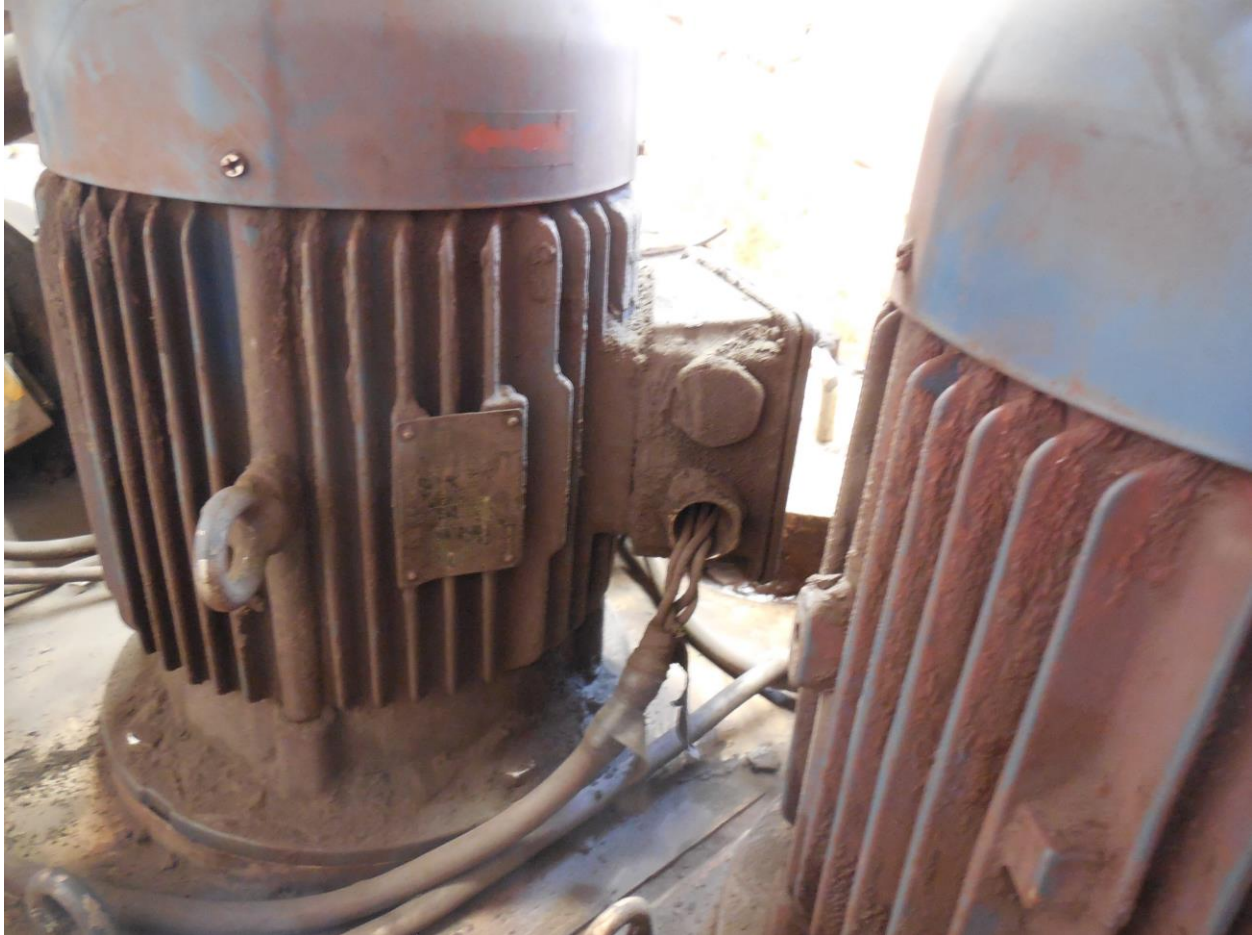
4. The hydraulic and lube pump motors for Crushers B & C require strain relief connectors at the motor JB's.

Subrule 12-3022 (1) states, “Where conductors pass through the walls of boxes, cabinets, or fittings, provision shall be made to (a) protect the insulation on the conductors from damage; (b) protect terminal connections from external strain; (c) provide electrical continuity between a metal box, cabinet, or fitting and conduit, armour, or metal sheathing of conductors, whether or not the armour or metal sheathing is to be used as a grounding conductor; (d) prevent damage to a non-metallic sheath applied over armour or metal sheathing for protection against moisture or corrosion; and (e) close the openings through which the conductors pass in such a manner that any remaining opening will not permit entrance of a test rod 6.75 mm in diameter.

Re-serve cables into motors using appropriate connectors

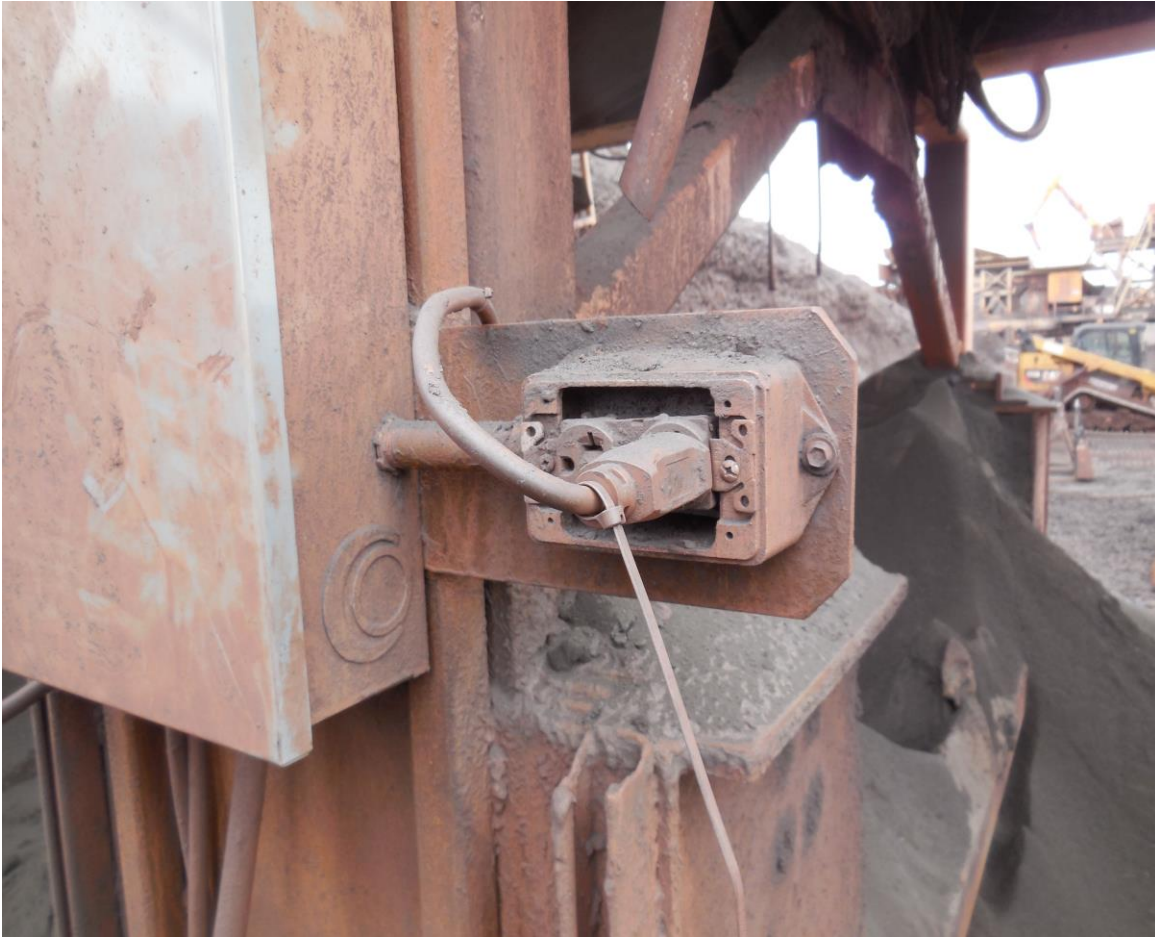
5. Noticed a receptacle with the cover missing at crusher B jaw discharge.

CEC Subrule 2-300 (1) states that, “All operating electrical equipment shall be kept in safe and proper working condition.  
Replace the cover.

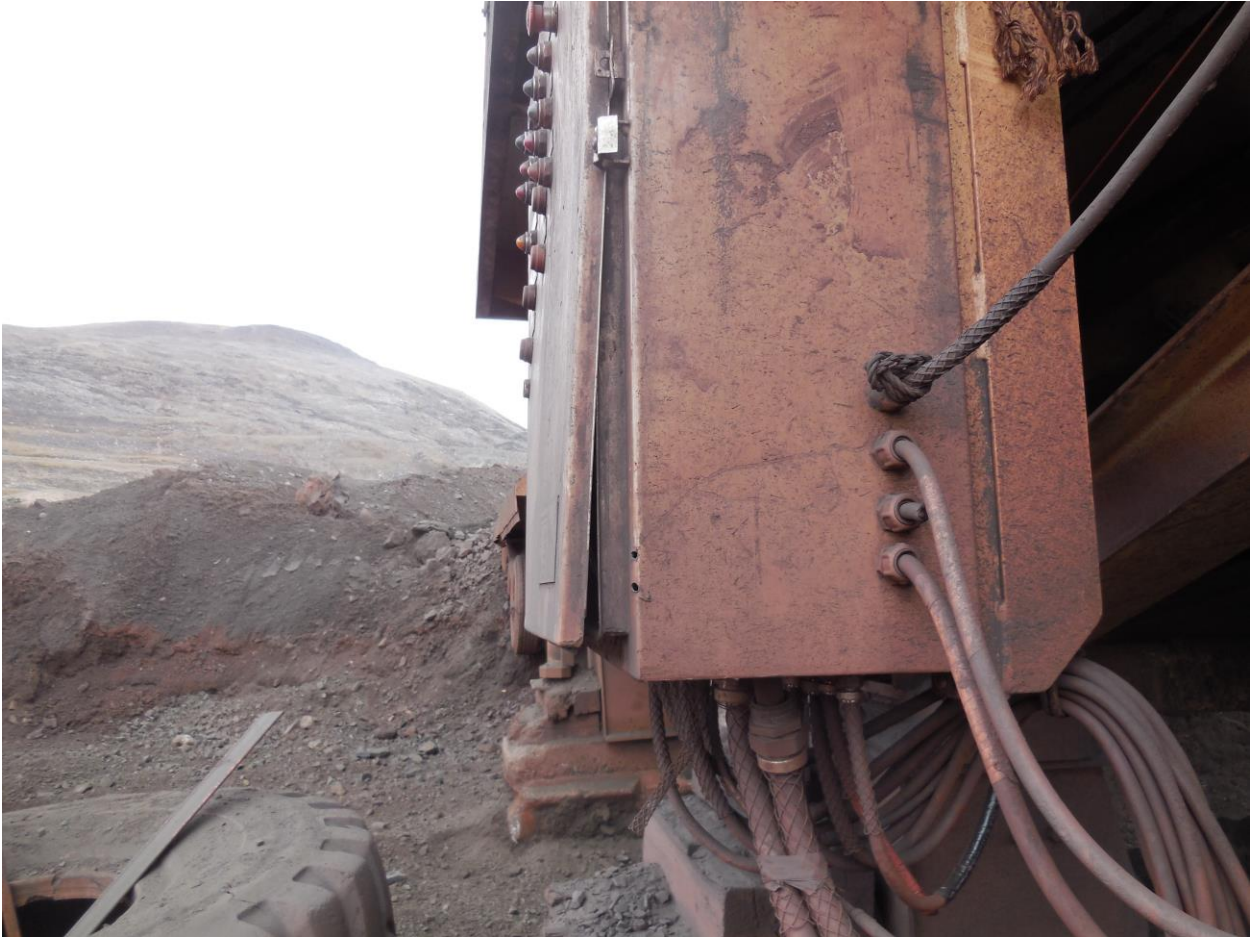
6. The crusher B control panel door has been damaged and will not close. One of the door fasteners is missing.

CEC Subrule 2-300 (1) states that, "All operating electrical equipment shall be kept in safe and proper working condition.

Repair or replace such that the cover closes tightly and replace the missing fastener.

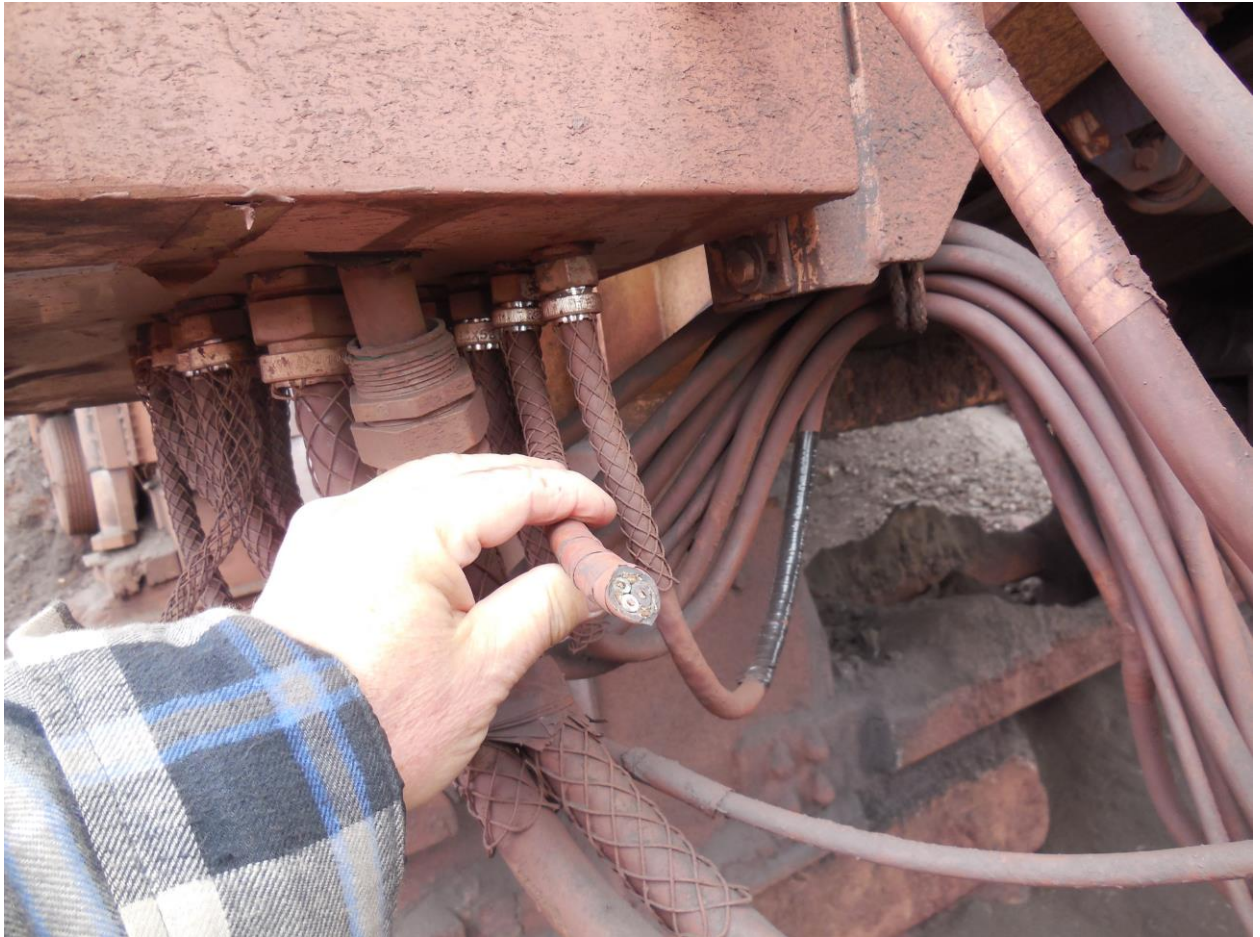
7. The crusher B control panel has uncapped cable stubs protruding from it.

CSA M421 Clause 4.2.4.1 requires damaged or out of service wiring to have its bare conductors guarded. The cable stubs have been taped.

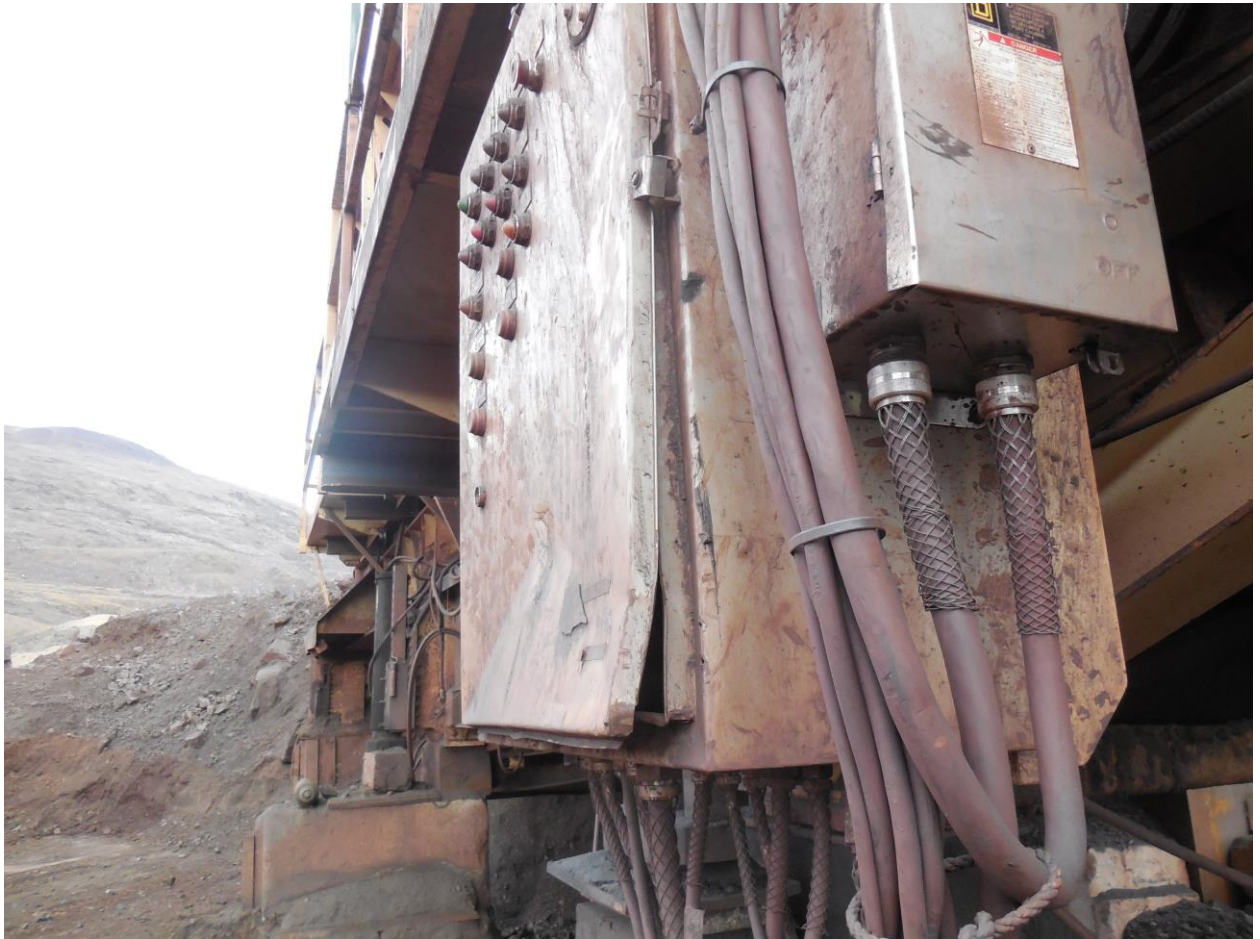
10. The crusher A control panel door has been damaged in exactly the same way as the crusher B panel in Item 6 above.

CEC Subrule 2-300 (1) states that, “All operating electrical equipment shall be kept in safe and proper working condition.

Repair or replace such that the cover closes tightly and replace the missing fastener. Take measures to avoid this same damage from occurring again.

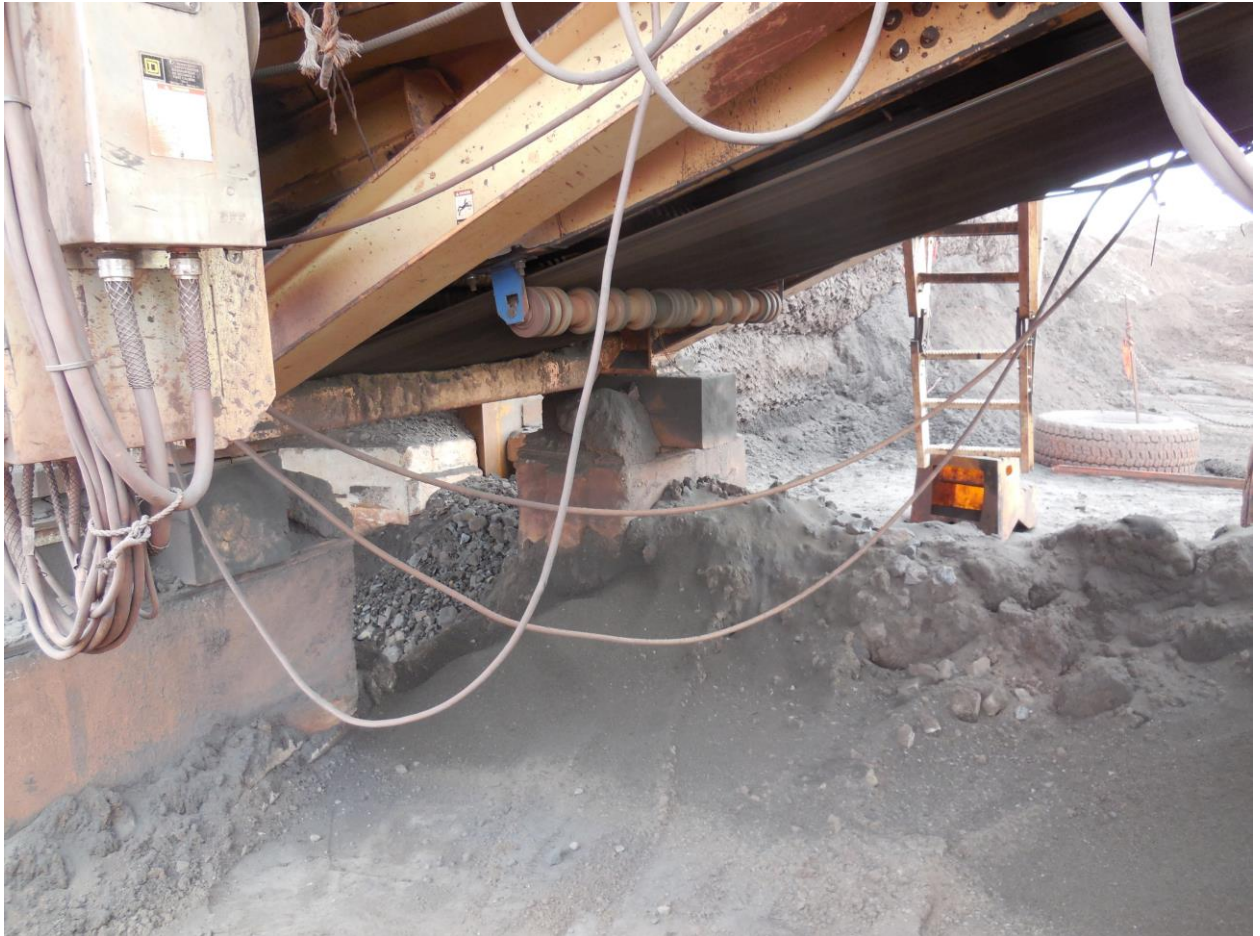
11. At crusher A electrical cables are hanging in the way of clean up activities.

The CEC Rule 2-112 requires the mechanical arrangement and execution of the work in connection with any electrical installation to be acceptable. Properly support the cables such that they are protected from physical damage during clean up operations.

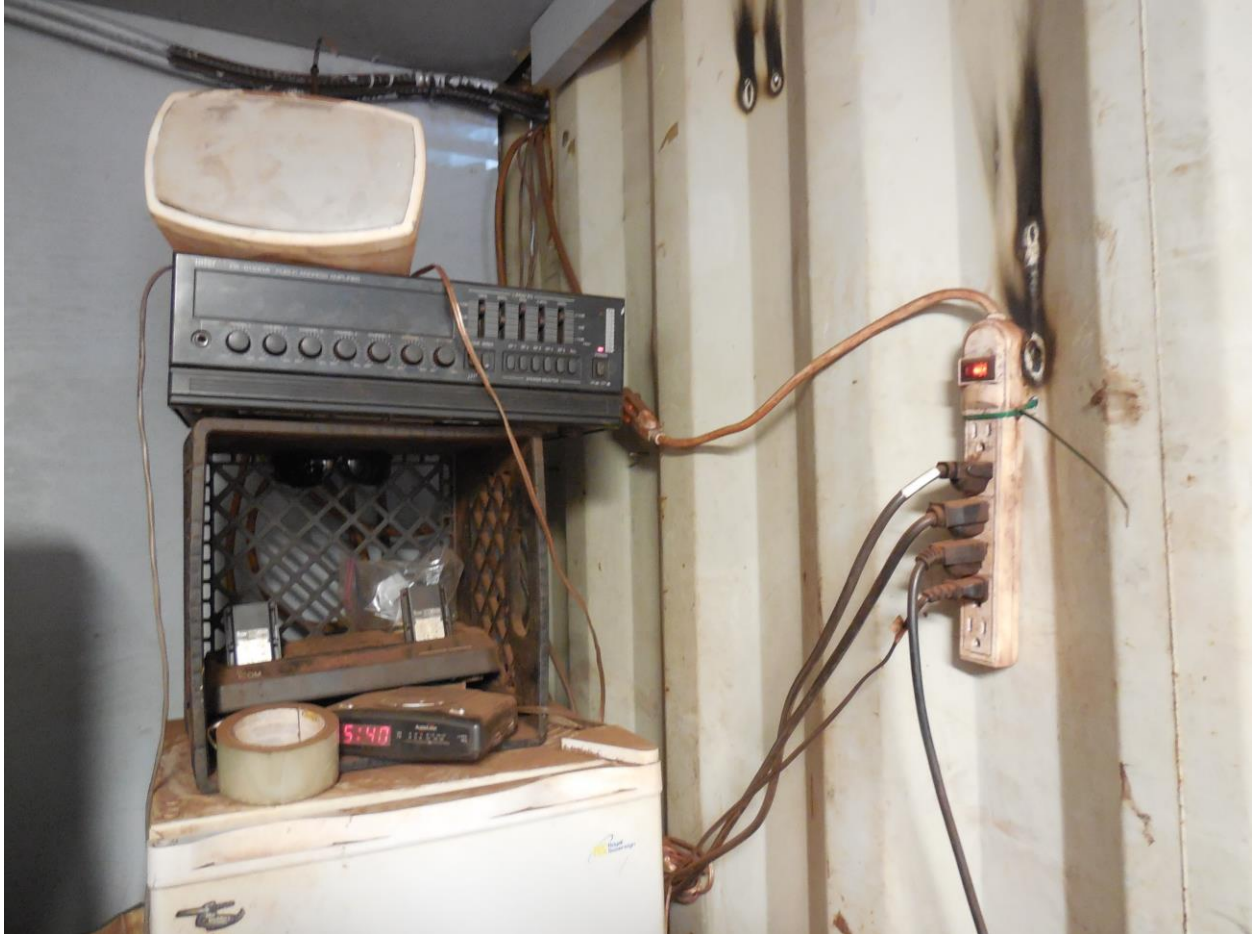
13. At the crusher maintenance shop lunch room extension cords have been run through a hole in the wall of the sea can. A power bar was used to feed miscellaneous loads in the lunchroom. The power bar had been damaged by heat from welding on the outside of the sea can.

The Canadian Electrical Code Item 4-012 (3) (a) states that, “Flexible cord and cord sets shall not be used as a substitute for the fixed wiring of structures and shall not be (i) permanently secured to any structural member; (ii) run through holes in walls, ceilings, or floors: or (iii) run through doorways, windows, or similar openings.” The CEC Subrule 2-300 (4) requires defective equipment to be put in good order or permanently disconnected.

The damaged power bar was removed from service.

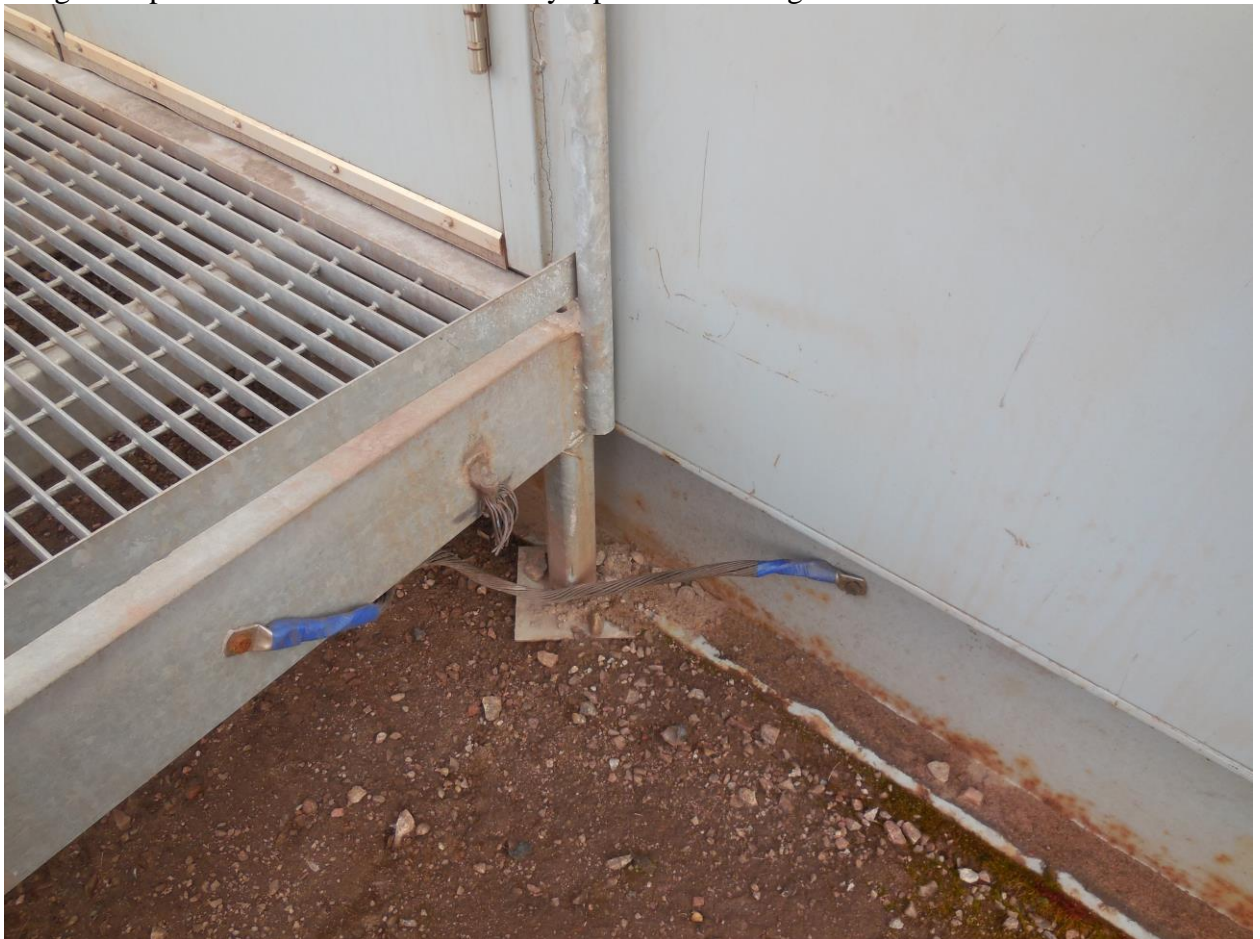
1. When the stoop at the maintenance door was removed the cadwelded bond was cut and replaced with a bolted connection. The bolted connection was loose and made to a painted surface. The Mine Health and Safety Regulations section 13.01. (1) (b) requires the electrical systems and electrical equipment at a mine to be constructed in accordance with a design and plans that have been certified by a professional engineer.

Reinstall the stair bonds in accordance with the approved design.

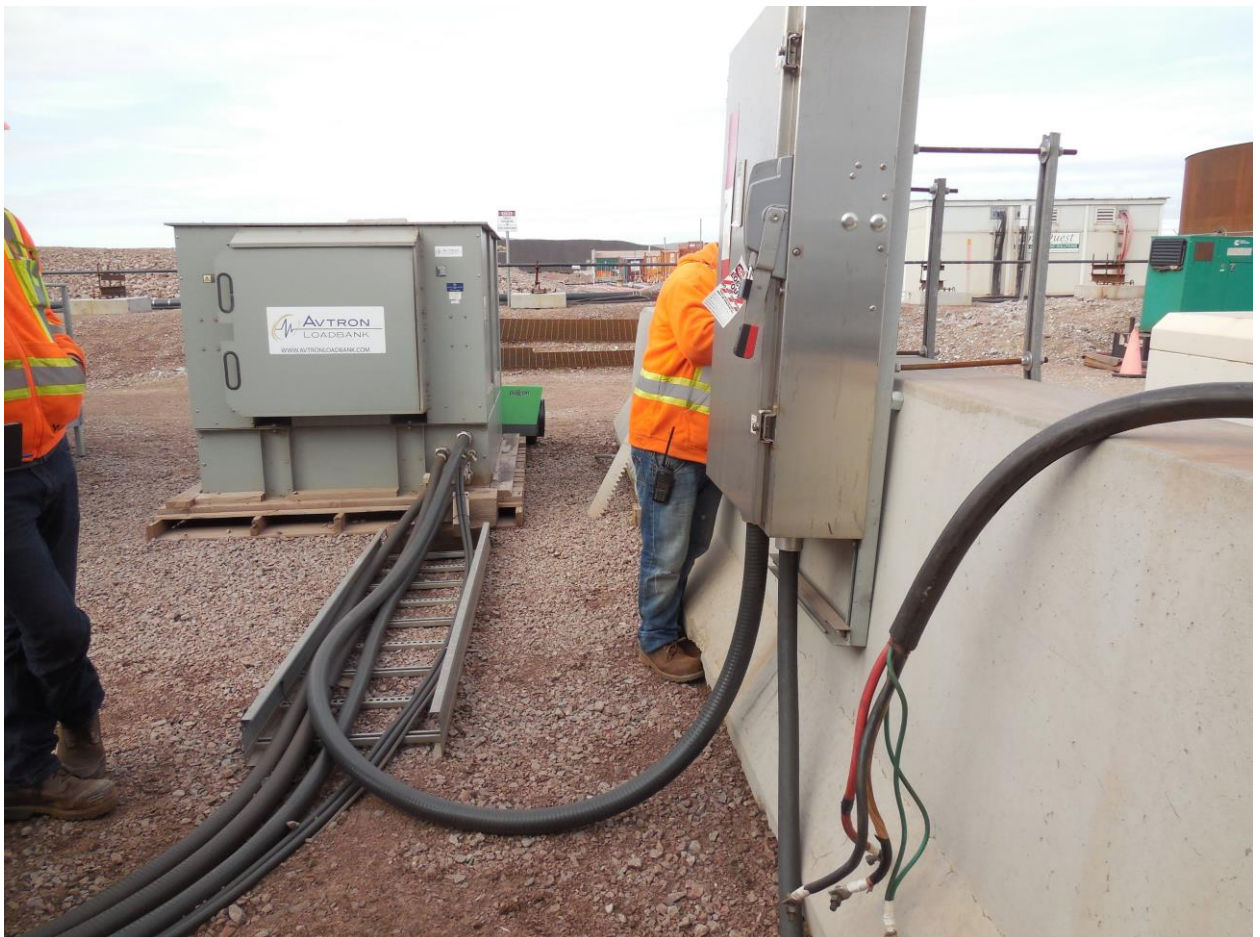
3. A circuit was added to the load bank for the power house to provide for load testing of other generators outdoors. The posted single line did not reflect the addition of this potential back-feed into the power house bus. There was also a potential for back-feeding the load side of the disconnect bare conductors outside left in place for connecting to generators. Locks and tags had been placed on the load bank feeder breaker and on the disconnect switch outside in recognition of the potential hazard. The Mine Health and Safety Regulations section 13.01. (1) (b) requires the electrical systems and electrical equipment at a mine to be constructed in accordance with a design and plans that have been certified by a professional engineer. Disconnect and remove the outdoor switch and cabling for testing of other generators using the power house load bank.

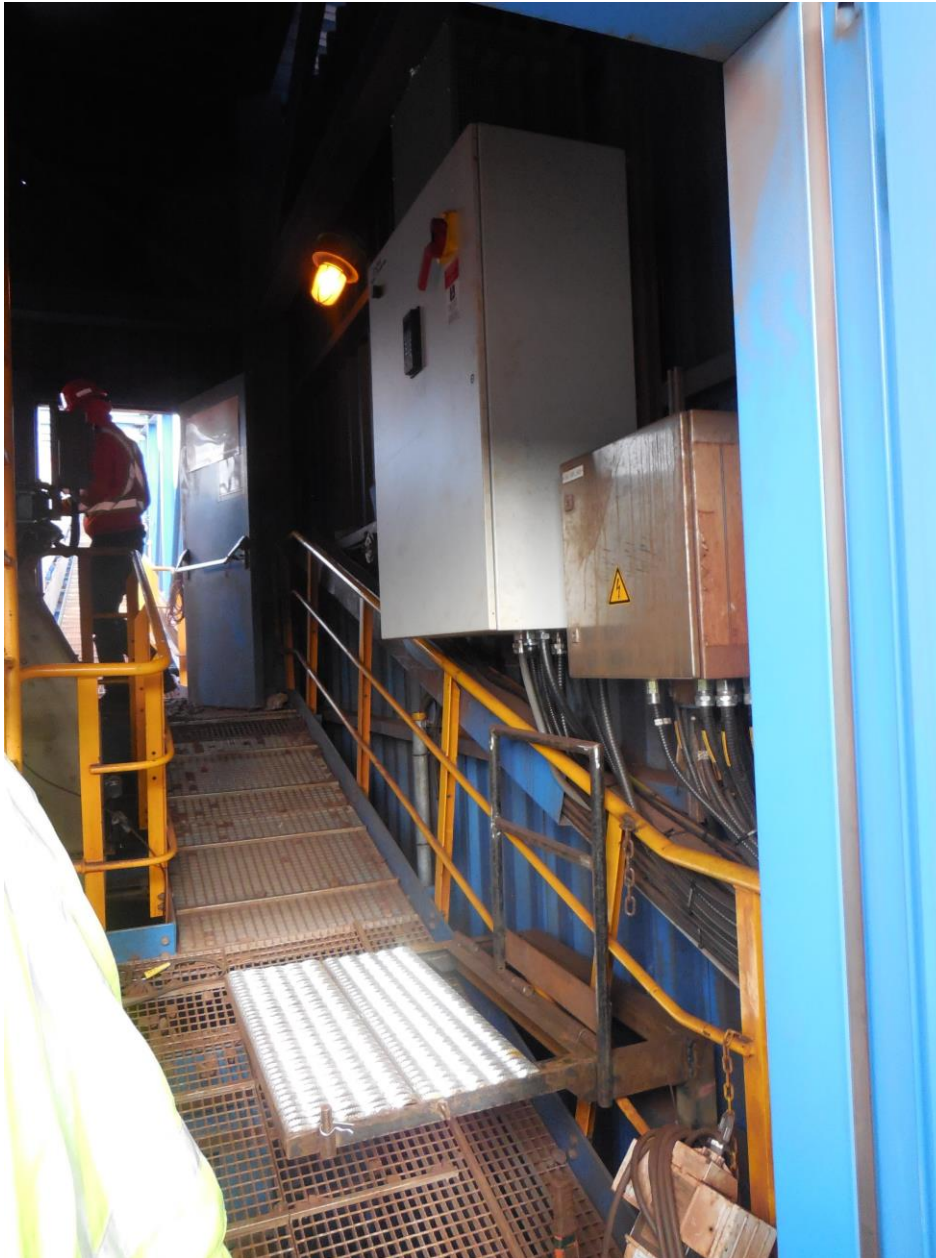
1. The VFD for the sample hammer is mounted on the outside wall of the walkway. The height necessitates an access platform. The foldable access platform provided only extends approximately 0.5 m from the face of the VFD enclosure.

CEC Subrule 2-308 (1) requires a minimum working space of 1 m with secure footing about this type of electrical equipment. Modify the design of the platform to provide 1 m working space. A suggestion was made to add a removable railing on the downhill side as the platform doesn't extend much past the edge of the enclosure and an electrician attempting to use the left hand rule for switching would be well over to that side.

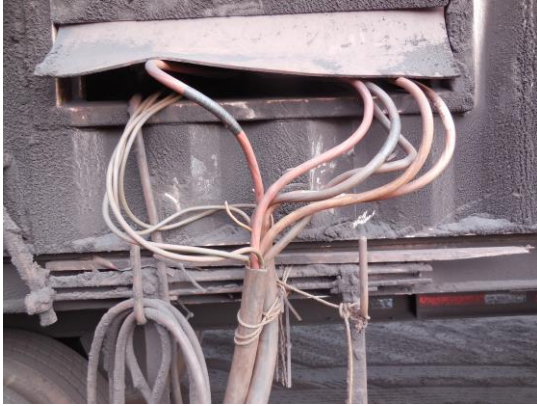
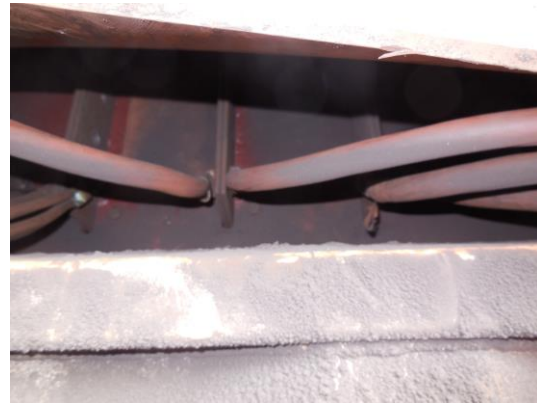
1. Energized 600V connections are within easy reach of the ground. A rubber flap is draped over the connection area. As can be seen in the pictures below there is nothing preventing contact with the energized terminals. We were told that this arrangement is common to all the feeder conveyor generators.

The CEC Subrule 2-202 (1) states, Bare live parts shall be guarded against accidental contact by means of approved cabinets or other forms of approved enclosures except where the bare live parts are (a) located in a suitable room, vault, or similar enclosed area that is accessible only to qualified persons; or (b) as permitted elsewhere by this Code.

Install a suitable junction box to enclose the energized connections. Use approved strain relief connectors and Kellems grips to connect and support the cables. Areas around the cable terminations were to be barricaded immediately and signage placed to restrict access to authorized personnel and to warn of the 600 V potential.
