APPENDIX E.8.4
INITIAL AND FOLLOW-UP SPILL REPORTS
(PART 4 OF 4)

Re: Follow-up to Spill #18-363, Reported on August 27, 2018
Mary River Project - Water Licence No. 2AM-MRY1325

Re: Follow-up to Spill #18-436
Mary River Project - Water Licence No. 2AM-MRY1325

Re: Follow-up to Spill #18-451
Mary River Project - Water Licence No. 2AM-MRY1325

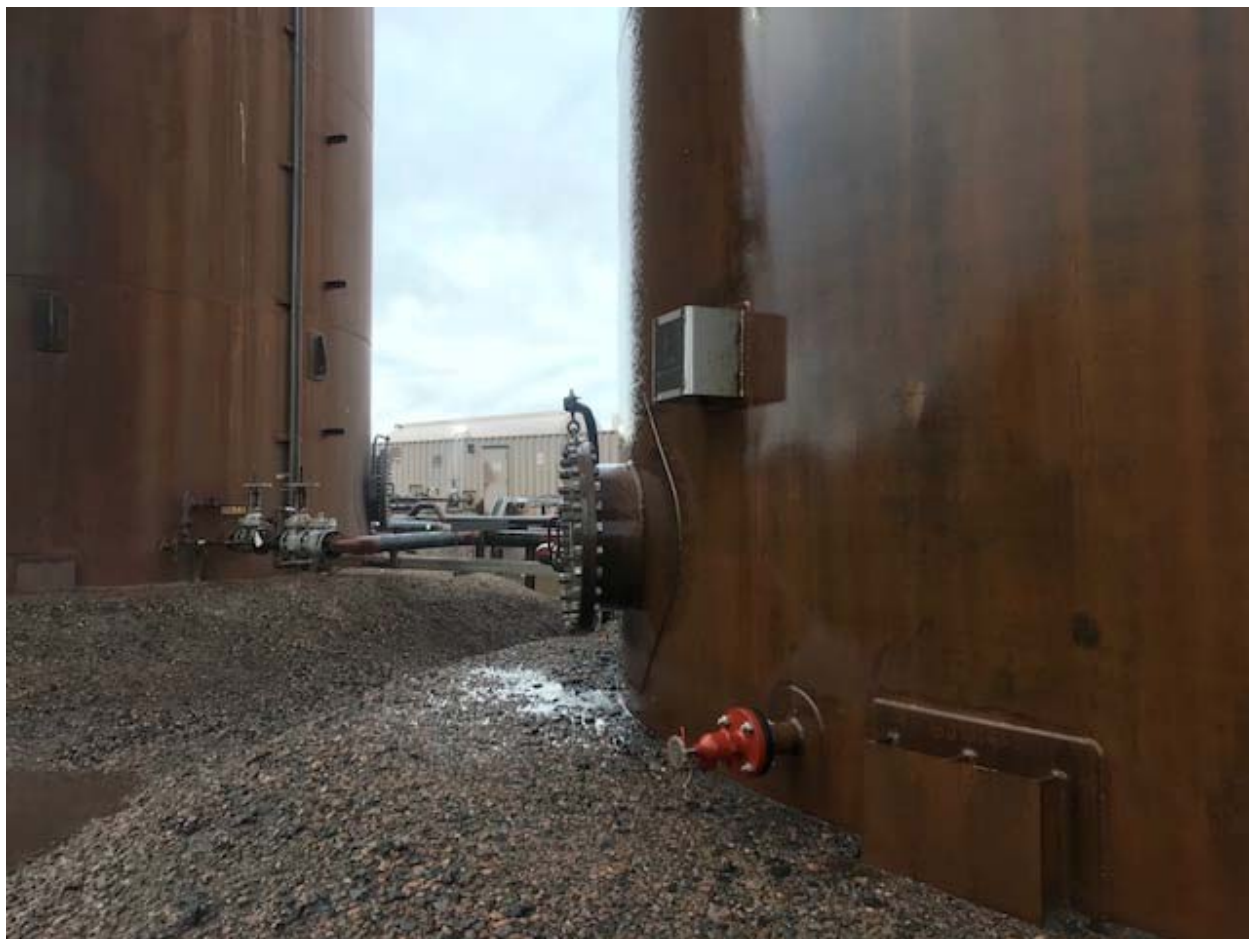
On August 27, personnel observed a release of Arctic diesel in the Bulk Fuel Tank Farm at the Mine Site. Upon initial investigation, a bulk fuel tank in a lined engineered containment facility experienced an overflow of diesel from the top of the tank during resupply operations. The fuel tanker resupply was immediately arrested upon overflow discovery and lines were isolated and closed from the fuel resupply module. Spill clean-up in the lined berm mitigated berm contamination. Approximately 1.1 m³ was released and contained in the lined engineered berm, with no possibility of migration outside of containment, and is >100 meters from the nearest water course.

Photo 1. Spill location, TK-001.

Upon notice of the overflow, the operator immediately shut off the tanker fuel pump, and closed all valves. Once flow had stopped, the valves between TK-001 and TK-002 were opened, allowing the fuel level in TK-001 to return to 91%. Standard operating procedures have been reviewed with operators and updated. Updates include: pre-offload and post-offload fuel percentages in tanks added to the Fuel Transfer sheets, and a secondary inspection of valve position before offloading fuel.

Retrofit valve signage of valves to be larger and easily visible when in both OFF and ON positions.

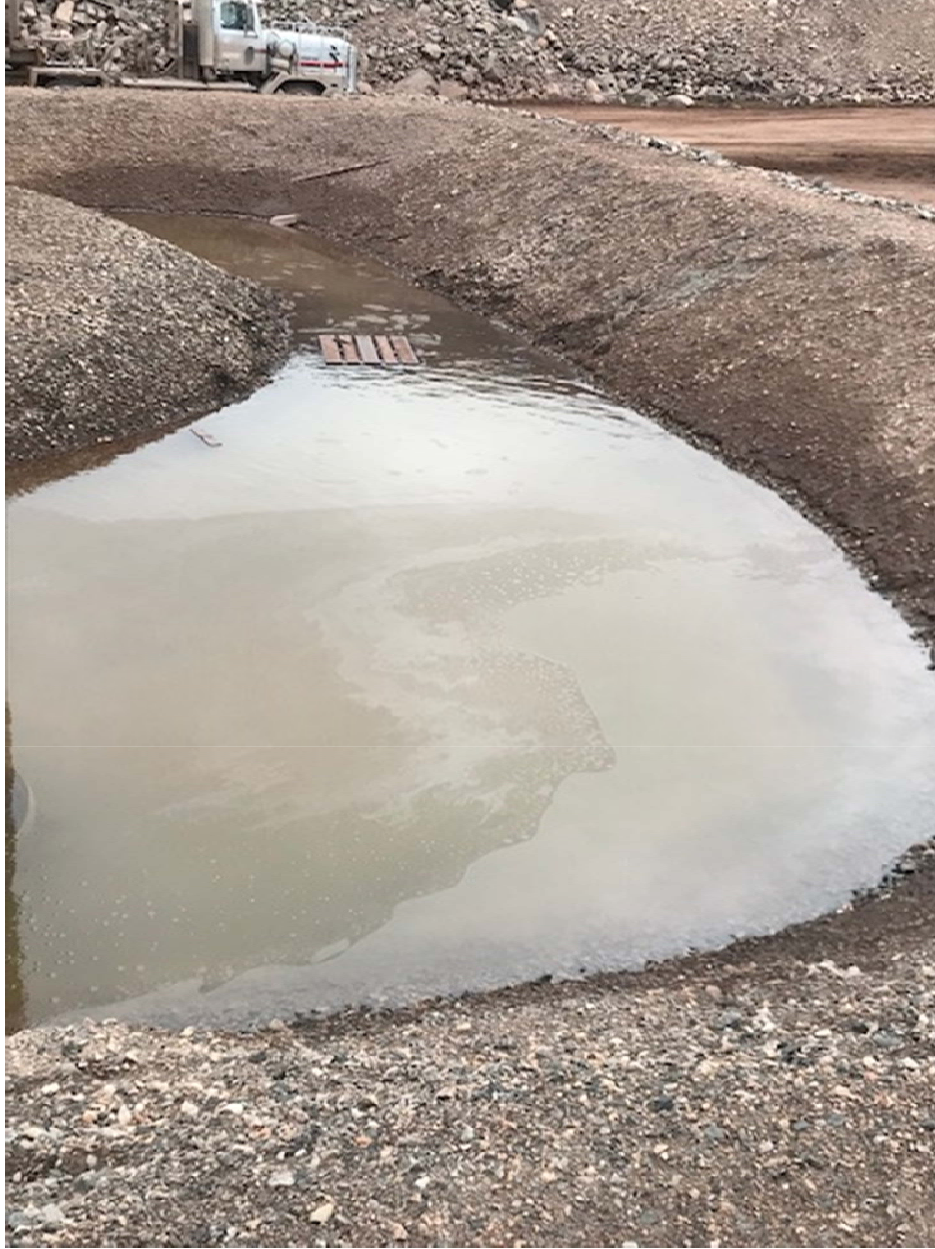
Photo 2. Spill contained within fuel mod berm.

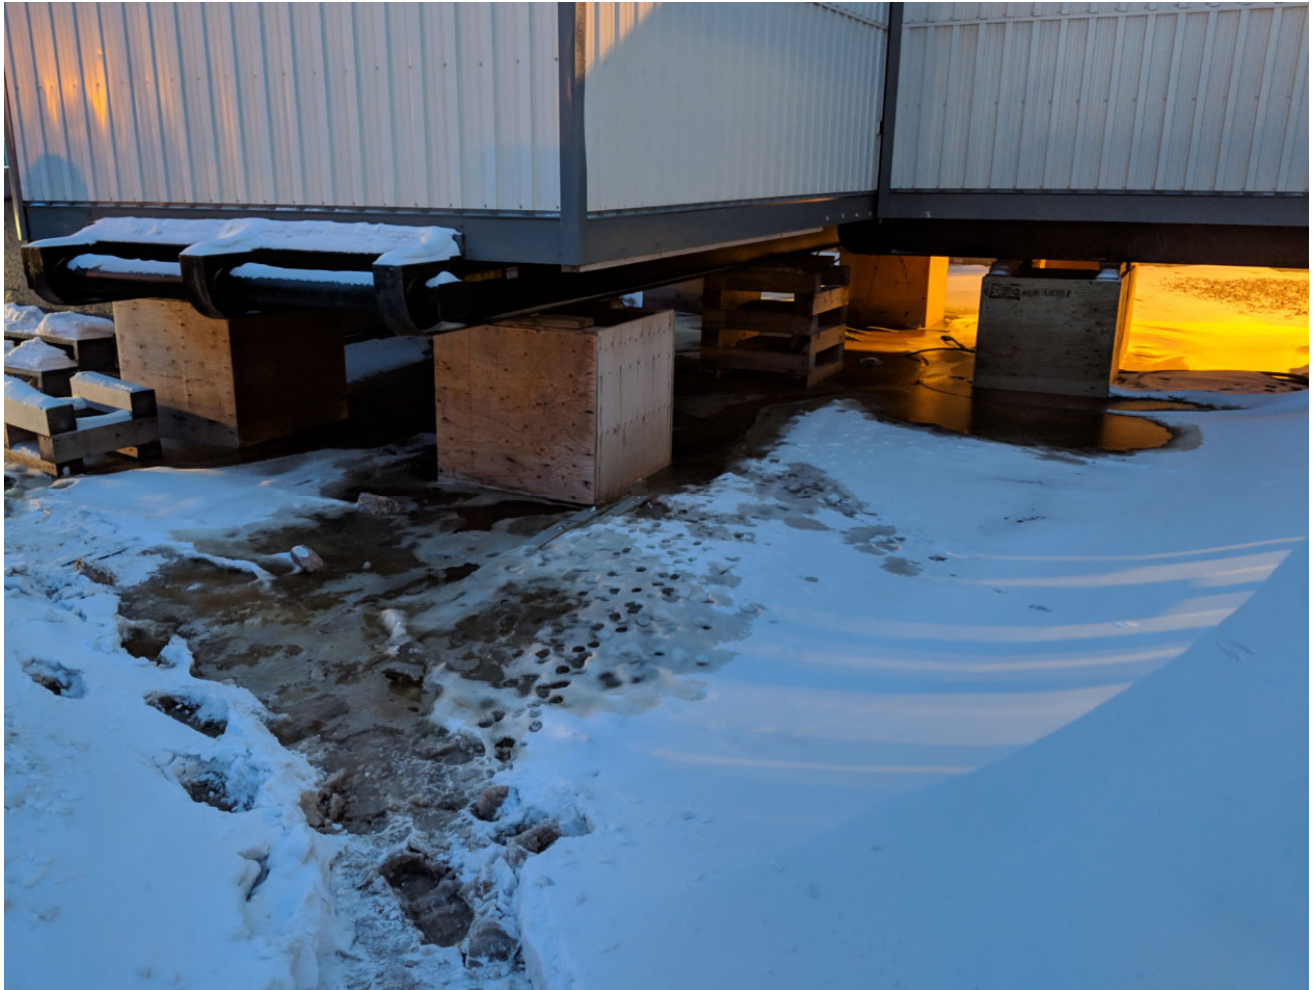
At 17:45 Hrs on October 25, 2018, a housing maintainer observed water adjacent to the sewage holding tank for the Mobile Maintenance building at Milne Port. Upon investigation, it was determined that the toilet had a malfunctioning valve which caused the tank to overflow, releasing approximately 1m³ of raw sewage. The spill was confined to the laydown and is greater than 100 m from the nearest water body, which is currently frozen. A second minor release of approximately 40L from the holding tank occurred Oct 31, 2018 due to high volumes in the tank resulting in an overflow.

Photo 1. Overflow spill on ground surrounding the holding tank. Oct 25, 2018.

A vacuum truck was utilised to remove sewage from the holding tank to prevent any further release. Sewage released onto the surrounding pad was removed and placed in an engineered lined containment facility. Upon further investigation it was determined that a faulty valve within the toilet caused the tank to over flow. The second minor release, was determined to be the result of a non functioning over flow alarm due to a non functioning emergency float.

Building occupants are to alert the Housing Maintainer as soon as a toilet is observed to be malfunctioning. An overflow alarm system to be researched with focus on an audible alarm to the system. Operators will complete visual tank inspections of volume capacities every site visit.

The faulty valve has been replaced and the issues with the holding tank overflow alarm system have been repaired. The holding tank and toilet are operating as designed.

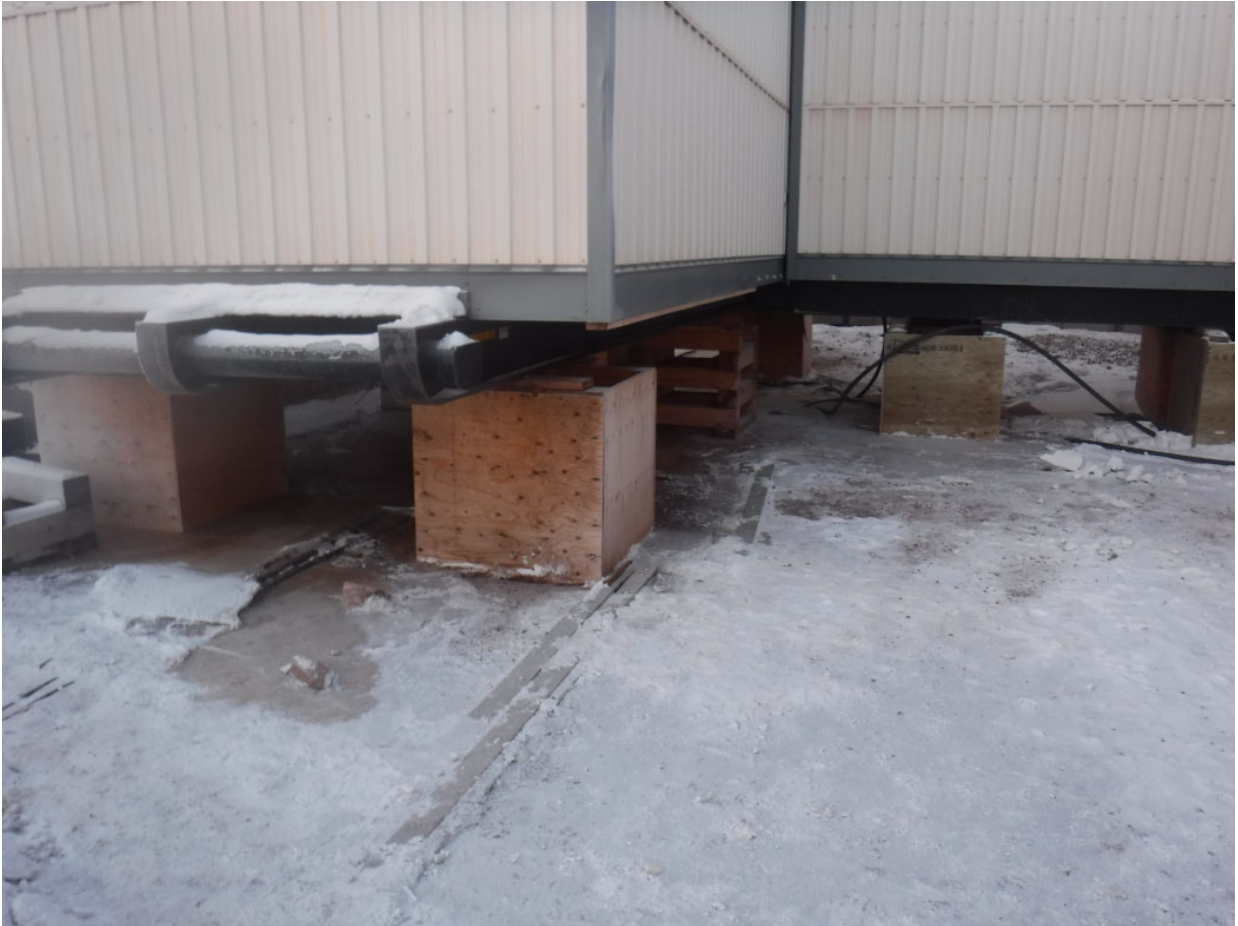
Photo 2. Holding tank area after site clean up. Nov 01, 2018.

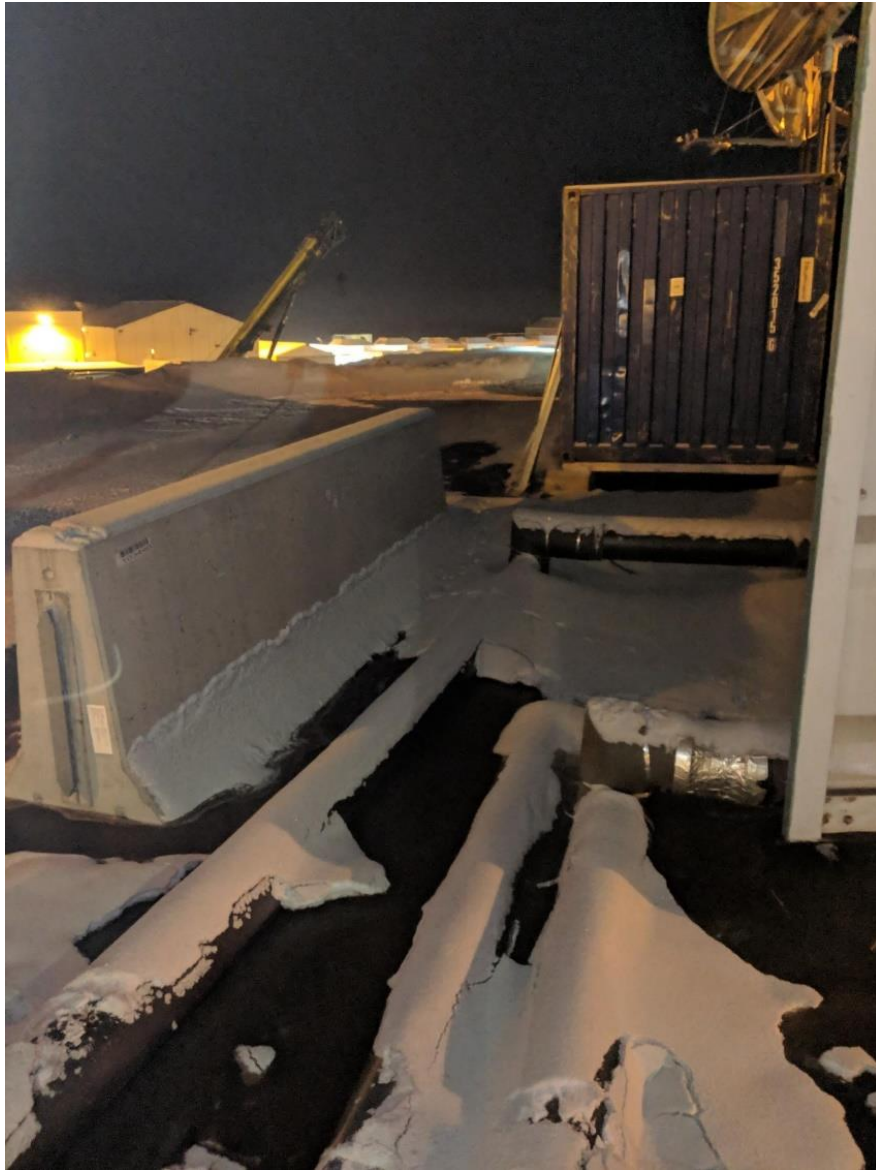
At 07:25 Hrs on November 13, 2018 the Site Services Supervisor, on inspection observed liquid sourcing from the main sewage lift station at the Mine Site Complex (MSC), impacting the adjacent MSC pad. Upon investigation it was determined that the high level float malfunctioned and failed to engage the lift station pumps which caused the tank to overflow, releasing approximately 0.5m³ of raw sewage. The spill was confined to the MSC pad, impacting an area of approximately 20m², and was greater than 100m from the nearest water body which is currently frozen.

Photo 1. Overflow release on camp pad adjacent to main holding tank..

The sewage overflow was immediately arrested, and the lift station holding tank pumped down to prevent further release. The contaminated snow was collected, to the extent possible, and deposited in an engineered lined containment facility. The lift station pumps were serviced and the high level float was replaced and tested. Following the repair both pumps turn on when the high level float is engaged.

Continue inspections of lift stations to mitigate potential releases.

Upgrade the alarm system to identify pump failure with externally visible lights.

The faulty high level float has been replaced and the pumping system tested. The holding tank and pumps are operating as designed.

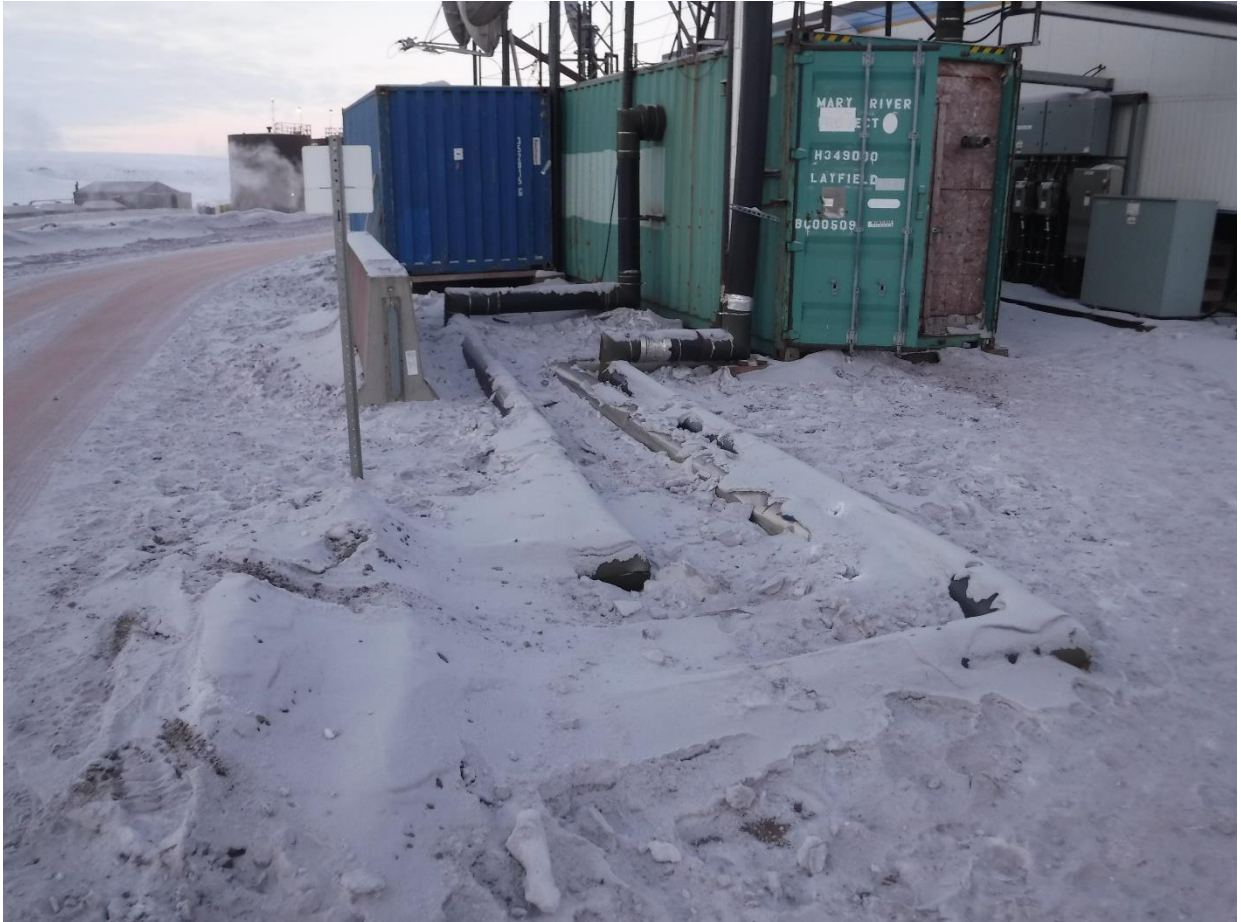
Photo 2. Overflow release after site clean up..

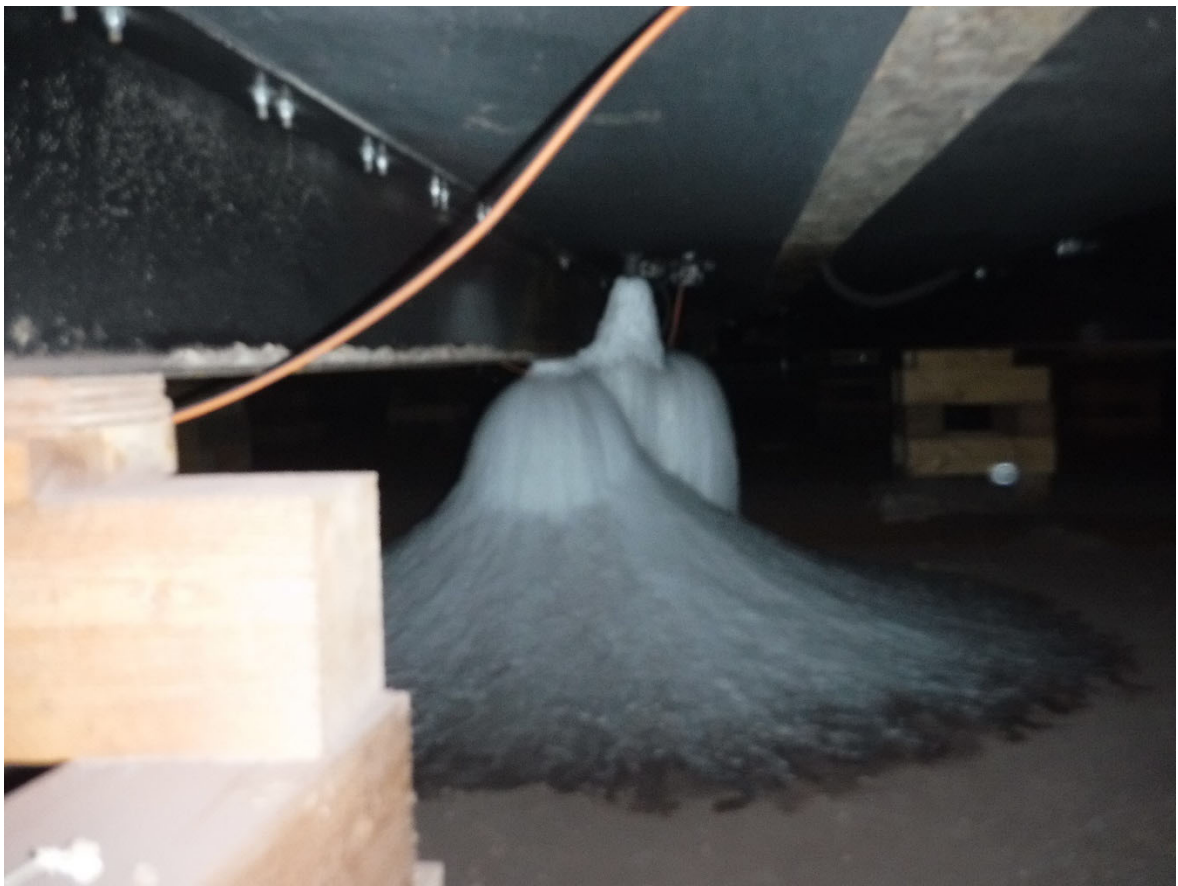
At approximately 17:00 HRS on November 19, 2018 during a routine inspection, a release of water from the piping of the Mary River Mine Site Complex (MSC) was discovered. At the time of the discovery, the release of water was frozen solid and was not active. Because the water was originally assessed to be greywater from the MSC kitchen, the release, estimated to be 0.5 m³, was reported to the NT-NU Spill Line and other relevant regulators on November 20, 2018. Upon further investigation, the release was determined to be potable water from a drain associated with the MSC ice machine, and not a greywater spill from the MSC kitchen.

Photo 1 - Potable Water Release (Nov. 19, 2018)

The piping associated with the release has been addressed. No further action is required.

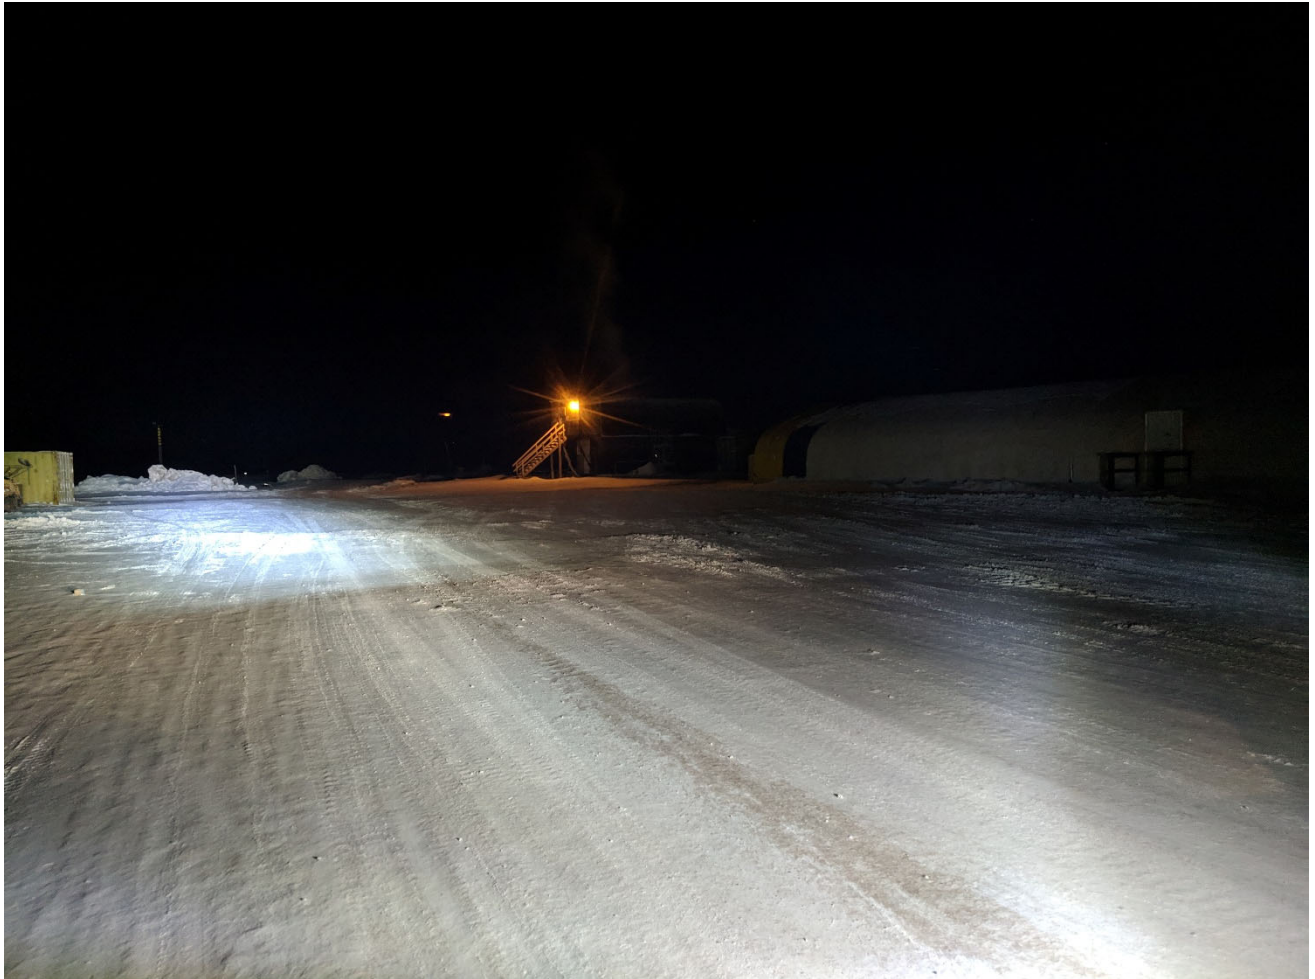
At ~01:00 Hrs on November 25, an operator was filling the vacuum truck with raw sewage from the RBC holding tank at the Mine Site. Upon completion, the operator placed the intake hose into travel position without closing the valve or attaching the end cap and started to drive away, which allowed sewage to drain out through the hose. The operator stopped the truck after a short distance to close the valve and prevent further release. Crews then initiated removal of contaminated snow/ice which was disposed of in the engineered lined containment facility. Approximately 0.5 m³ was released, impacting the road and covering an area of approx. 140 m². The location of the spill is greater than 100 m from the nearest water body which is currently frozen.

Photo 1. Sewage drainage release on camp pad adjacent to RBC holding tank.

The sewage release was immediately arrested. The contaminated snow was collected and deposited in an Polishing Waste Stabilization Pond. Standard operating procedures were reviewed with operators.

Standard operating procedures will require the operator to verify the valve is closed and an end cap is attached to the hose upon completion of filling or emptying holding tanks.

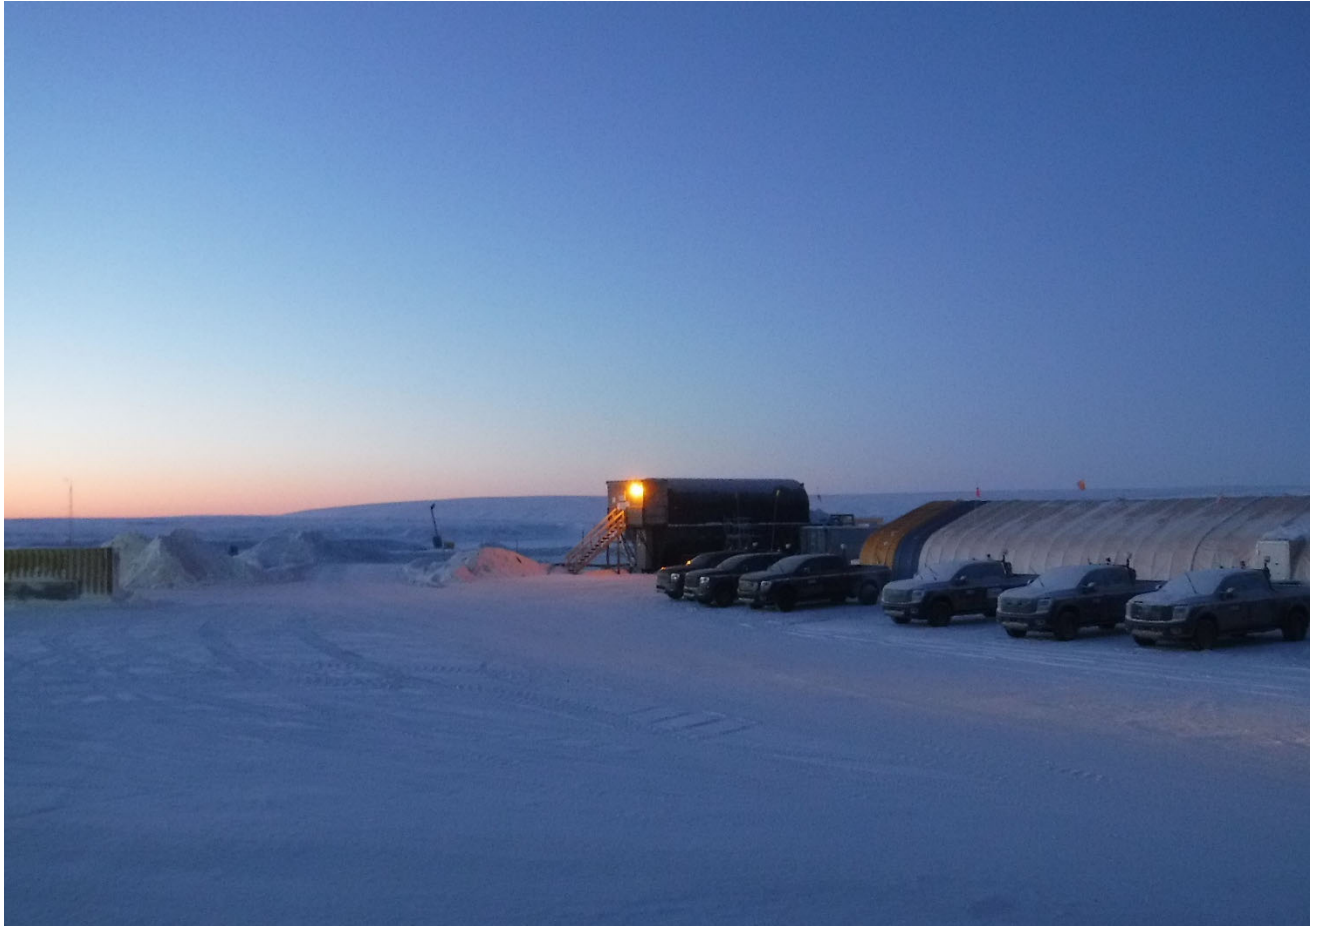
Photo 2. Camp pad adjacent to RBC holding tank after site clean-up.

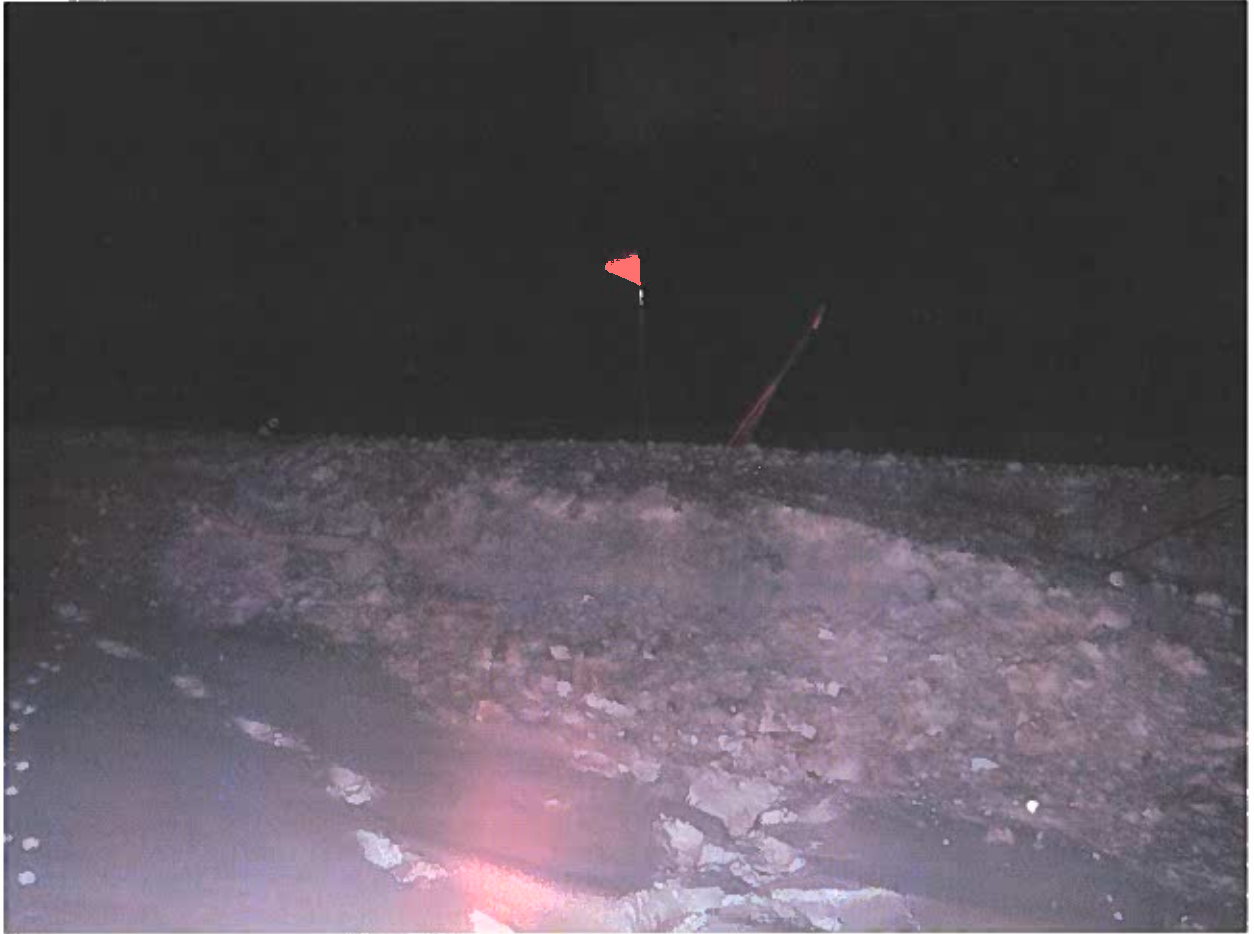
On December 14, a raw water truck was reported to have veered off the Tote Road and come to rest on its side at KM21. The Emergency Response Team (ERT) was dispatched to retrieve the driver and passenger, and to respond to a potential spill. Upon initial investigation, it was determined that approximately 100L of diesel fuel and 10L of hydraulic oil were released onto the snow covered tundra surface adjacent to the Tote Road, impacting approximately 75m². The source of the release was arrested and contained with no ability to migrate beyond the immediate impact area. The spill location was situated 90m away from Phillips Creek which is currently frozen.

Photo 1. Spill location, KM21.

Upon arrival, the ERT worked swiftly to identify and arrest the source of release. The spill was successfully contained to the immediate impact area adjacent to the Tote Road with no further migration. Contaminated snow and ice was promptly segregated and clean up of the material was initiated. On December 15th personnel returned to auger the ice surrounding the contaminated area to ensure that water released from the damaged truck was frozen to prevent further potential spread during remedial excavation. On December 23rd the water truck was extracted from the side of the road with no further spills. The contaminated snow and ice was excavated and transported to a lined engineered containment facility at the Milne Port Site.

A structured progressive driving training program is to be implemented for drivers with limited experience operating equipment on the Mary River Project.

Further signage will be installed on the Milne Inlet Tote Road to identify areas that are narrow.

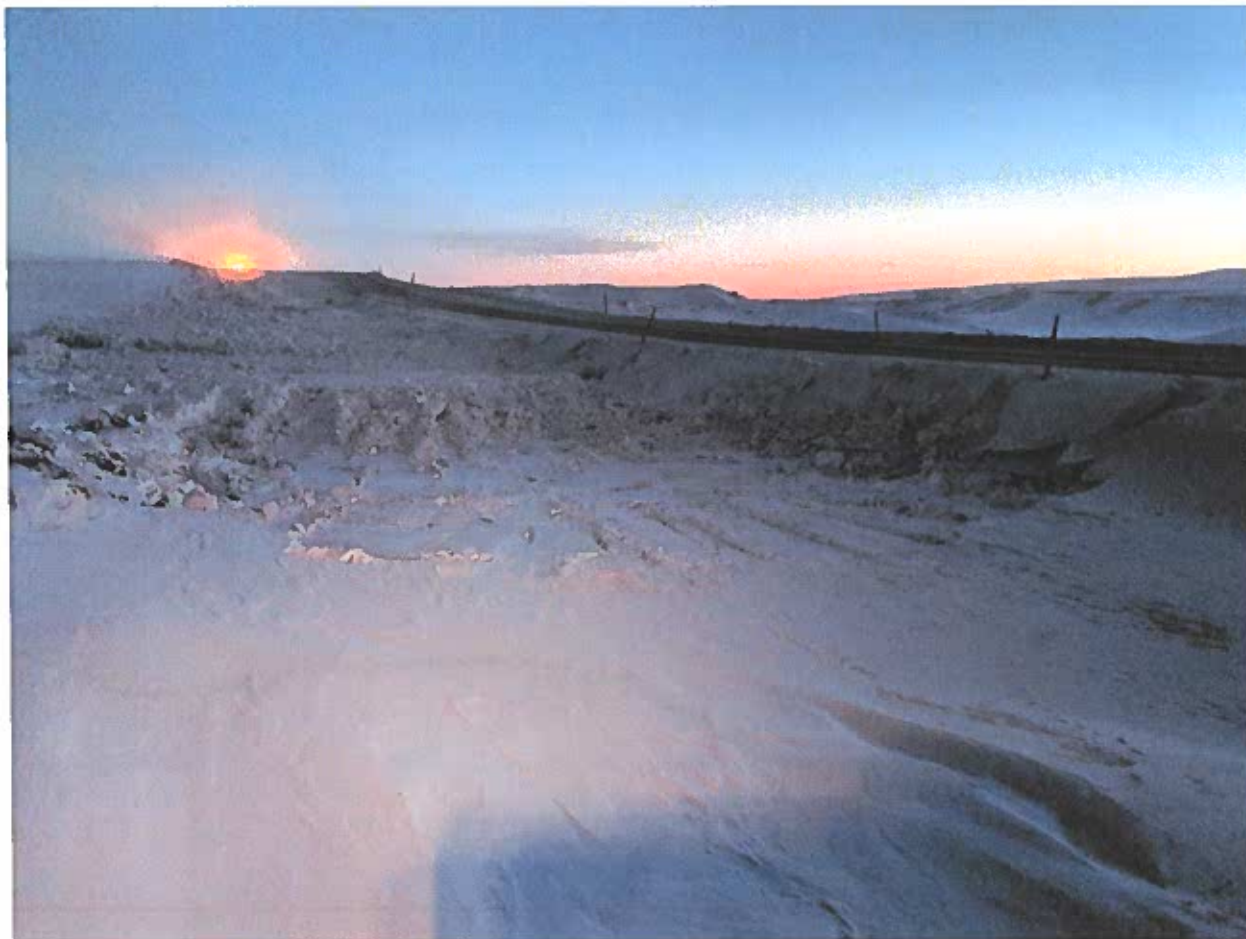
Photo 2. Contaminated snow and ice removed from impacted area.

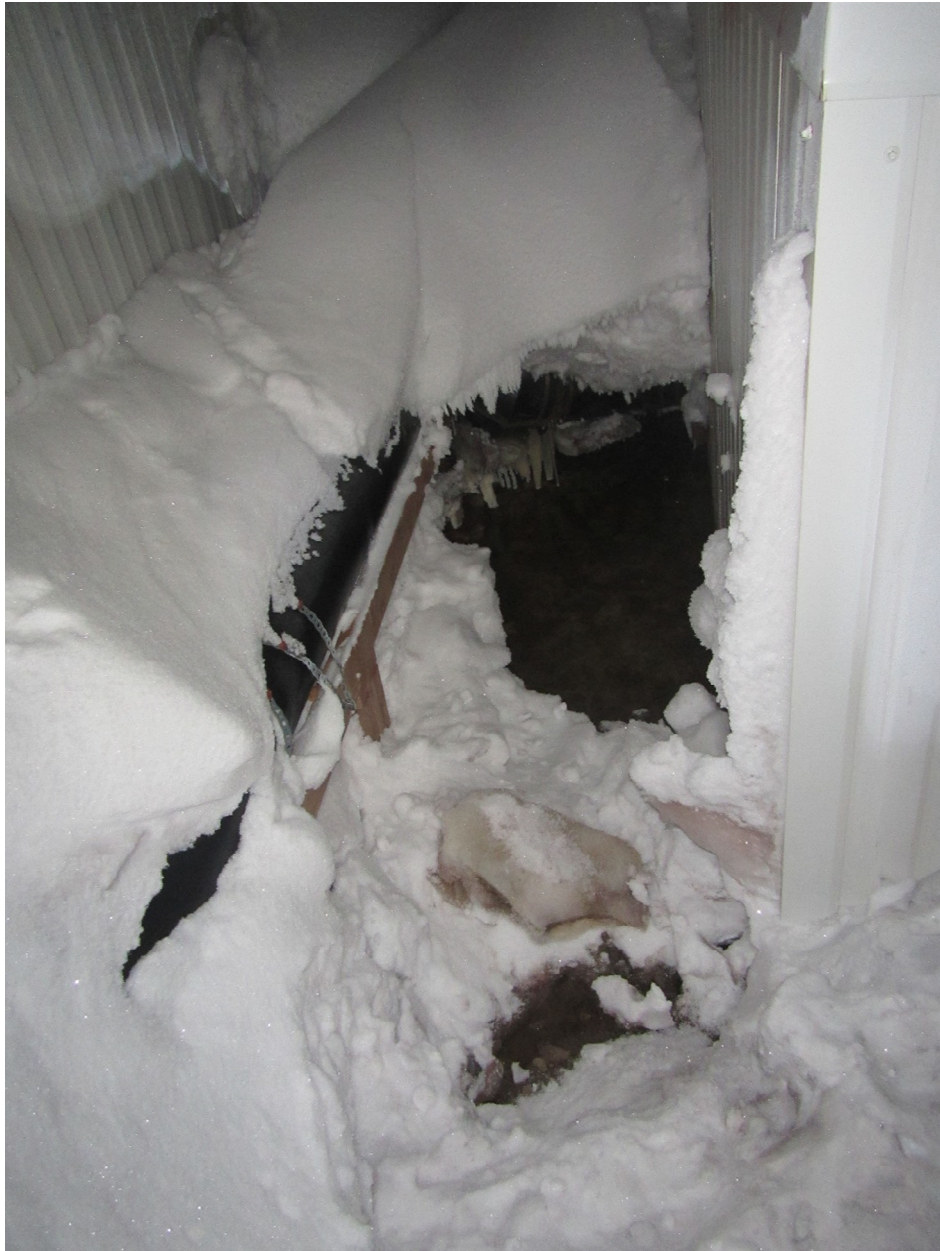
On December 18, 2018 at approximately 17:15 hrs, while conducting inspections of the MSC lift stations, a housing maintainer observed liquid behind the AC wing north lift station. Upon initial investigation, it was determined that the lift station had overflowed. The housing maintainer immediately engaged pump two to empty the lift station and prevent further overflow. Upon further investigation, the housing maintainer noticed the Fernco coupler had separated from the 4" gravity drain directly behind the lift station. Approximately 600L of sewage was released to the adjacent camp pad ground surface, impacting an approximate area of 15 m². This spill is >100 m to the nearest water course, which is currently frozen.

Photo 1. Sewage release on camp pad adjacent to AC North lift station.

The sewage release was immediately arrested, and the lift station holding tank pumped down to prevent further release. The contaminated snow was collected and deposited in an engineered lined containment facility. The coupling was repaired and the gravity line was subsequently reconnected.

Continue daily inspections of lift stations and snow/ice removal from lines to mitigate potential releases.

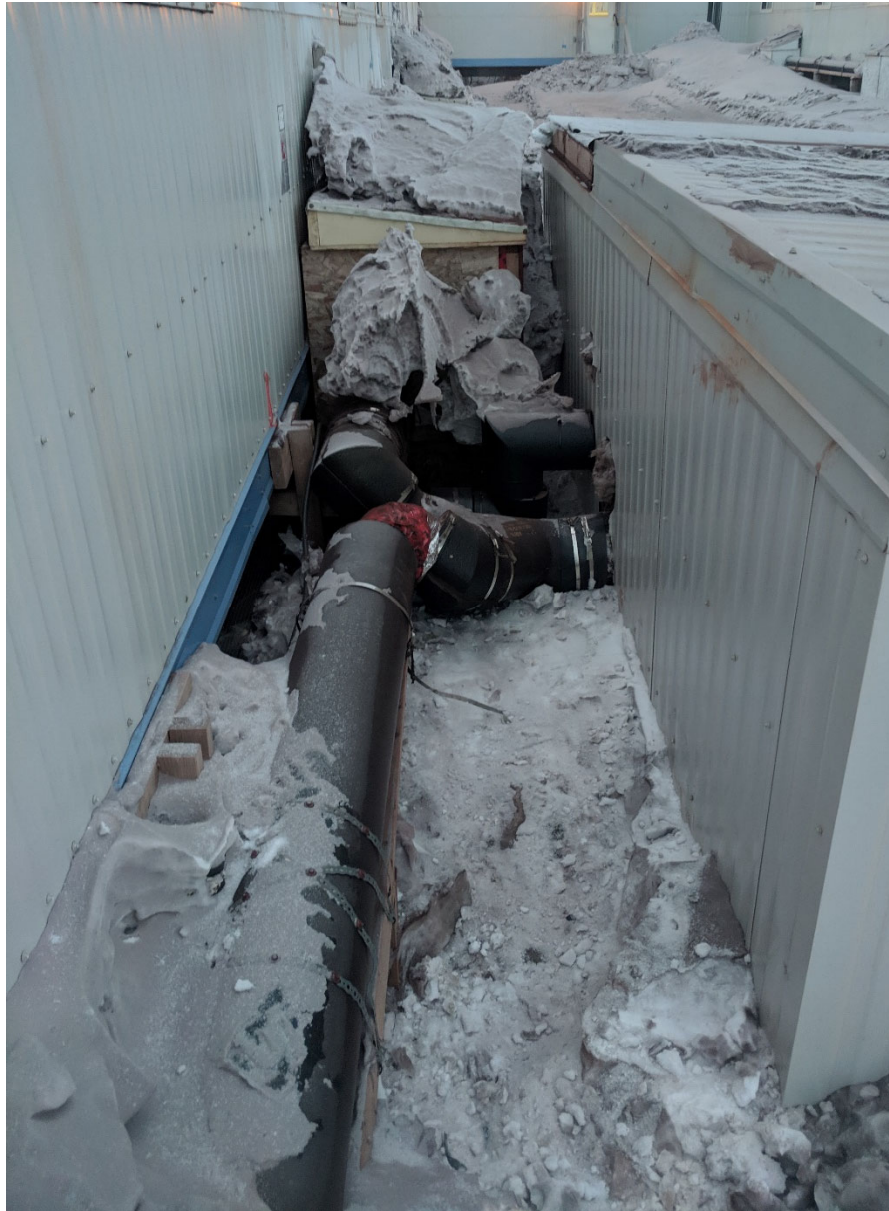
Photo 2. Contaminated snow removed from camp pad adjacent to AC North lift station.
