**APPENDIX E.8.4**  
**INITIAL AND FOLLOW-UP SPILL REPORTS**  
**(PART 1 OF 4)**

**Re: Follow-up to Spill #18-016**  
**Mary River Project - Water Licence No. 2AM-MRY1325**

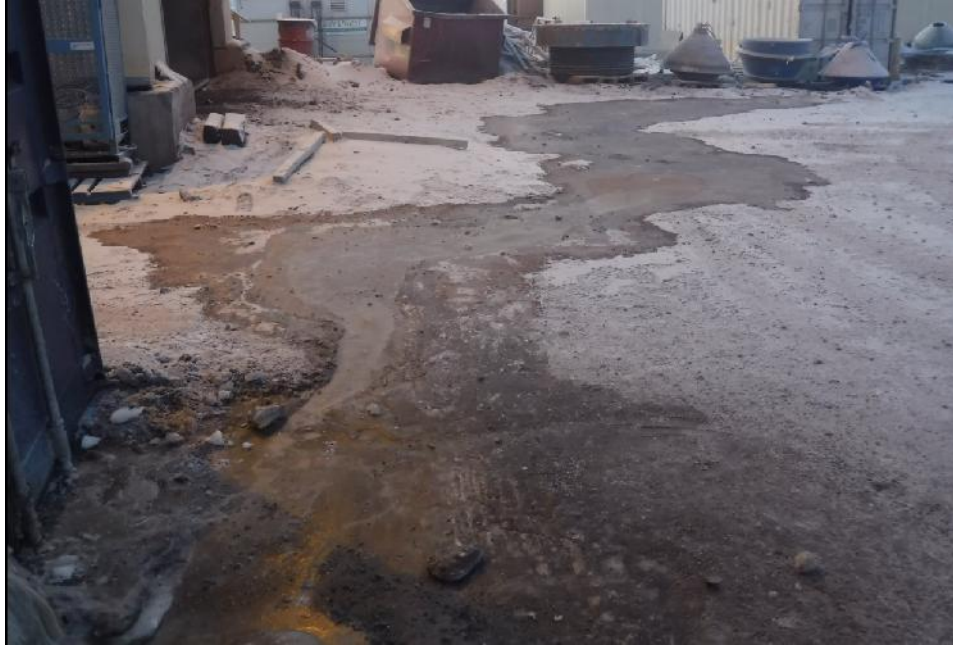
On January 18, 2018 at 06:30 hrs a vacuum truck operator was approaching the wastewater treatment plant (WWTP) at the Mine Site and observed liquid leaking from a vent line on the plant. It was determined that the equalization (EQ) storage tank was full and sewage had spilled over into the exhaust fan line. An investigation determined that a float level switch malfunctioned and did not action the pump which moves waste to the aeration tank from the EQ tank causing the backup and overflow out of the fan vent. Approximately 200L of sewage was released to the WWTP pad, impacting an area of approximately 15m<sup>2</sup>. The location was >100m to the nearest water course which is currently frozen.

Photo 1. Overflow spill on ground surrounding WWTP.

On arrival the operator placed a hose on the vent line to prevent any further spillage and notified supervision and the WWTP operator. A vacuum truck was then used to pump down the level of waste in the EQ tank. Once the pumping system malfunction was determined by the WWTP operator, the operator replaced the float level switch and the system was brought back into normal operation.

Continued routine inspections of system and pumping system.

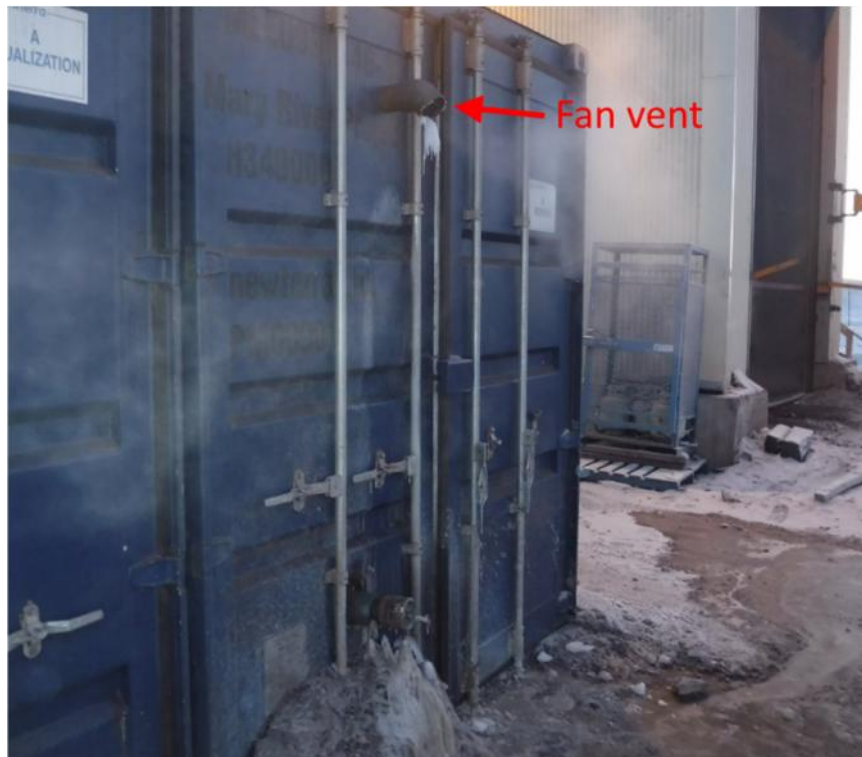
Photo 2. Fan vent discharge location.

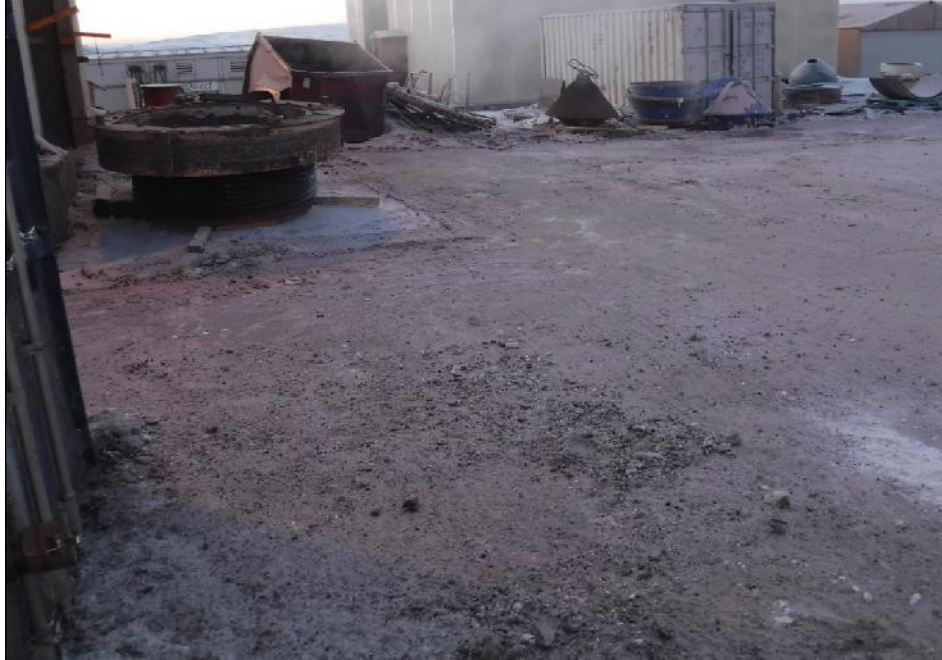
Photo 3. Surrounding WWTP pad after site clean up.

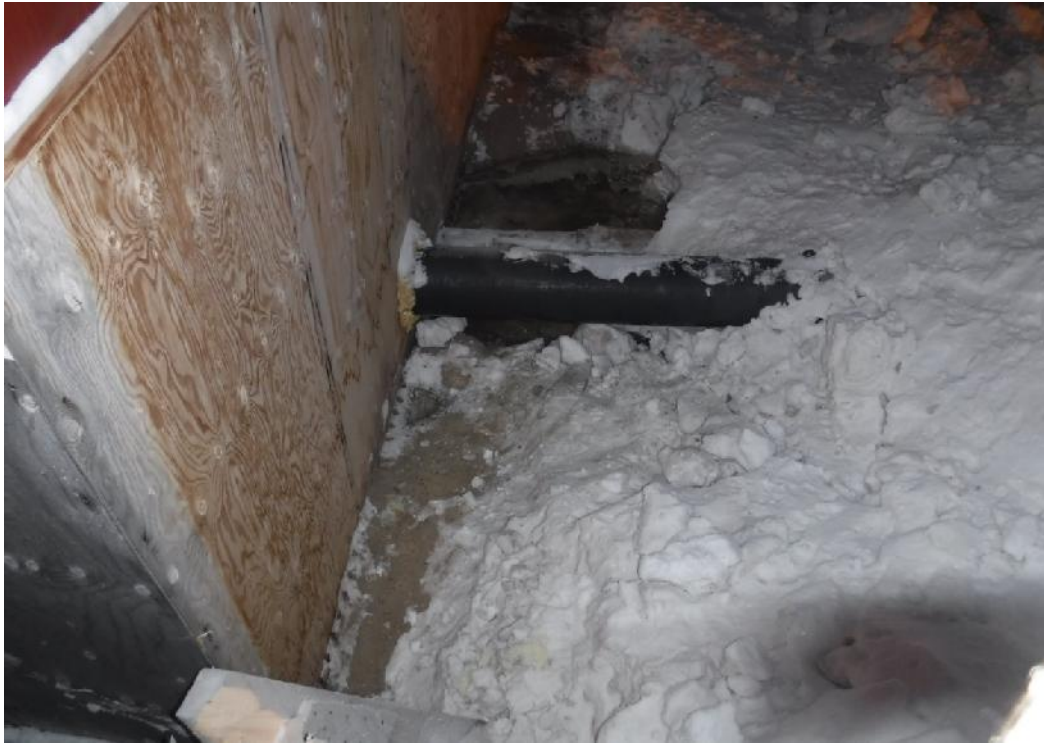
At 03:30 hrs on January 21<sup>st</sup>, 2018, kitchen staff noticed the high level fault light was on at the Weatherhaven grey water lift station. Upon initial investigation, it was determined that a coupling had failed causing the discharge pipe to separate inside the lift station building. Approximately 400L of grey water was released into the lift station building, migrating out under the base, impacting an area of 10 m<sup>2</sup>. The location of the spill was confined to the Weatherhaven Complex Pad. The spill is >200m from Camp Lake, which is ice covered.

**Photo 1. Overflow spill on ground outside Weatherhaven lift station**

All influent sources to the lift station were immediately shut off. Grey water released inside the building and surrounding camp pad was sucked up using a vac truck and taken to the Polishing Waste Stabilization Pond. The pipe and fittings were replaced before the lift station was put back into service.

Continued inspections of the piping and lift stations to be completed to ensure all components are functioning as designed. Provide additional support under connection points on horizontal lines to reduce stress at the coupling.

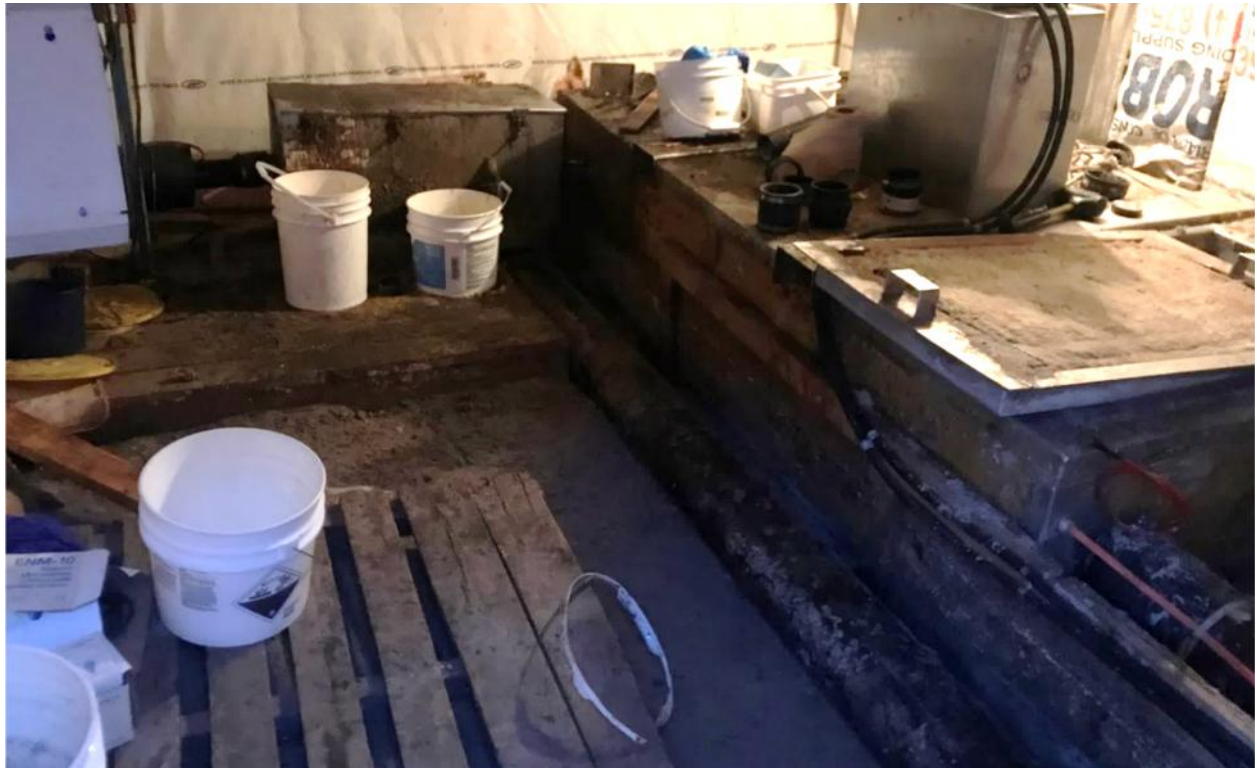
**Photo 2. Spill clean up inside Weatherhaven lift station**

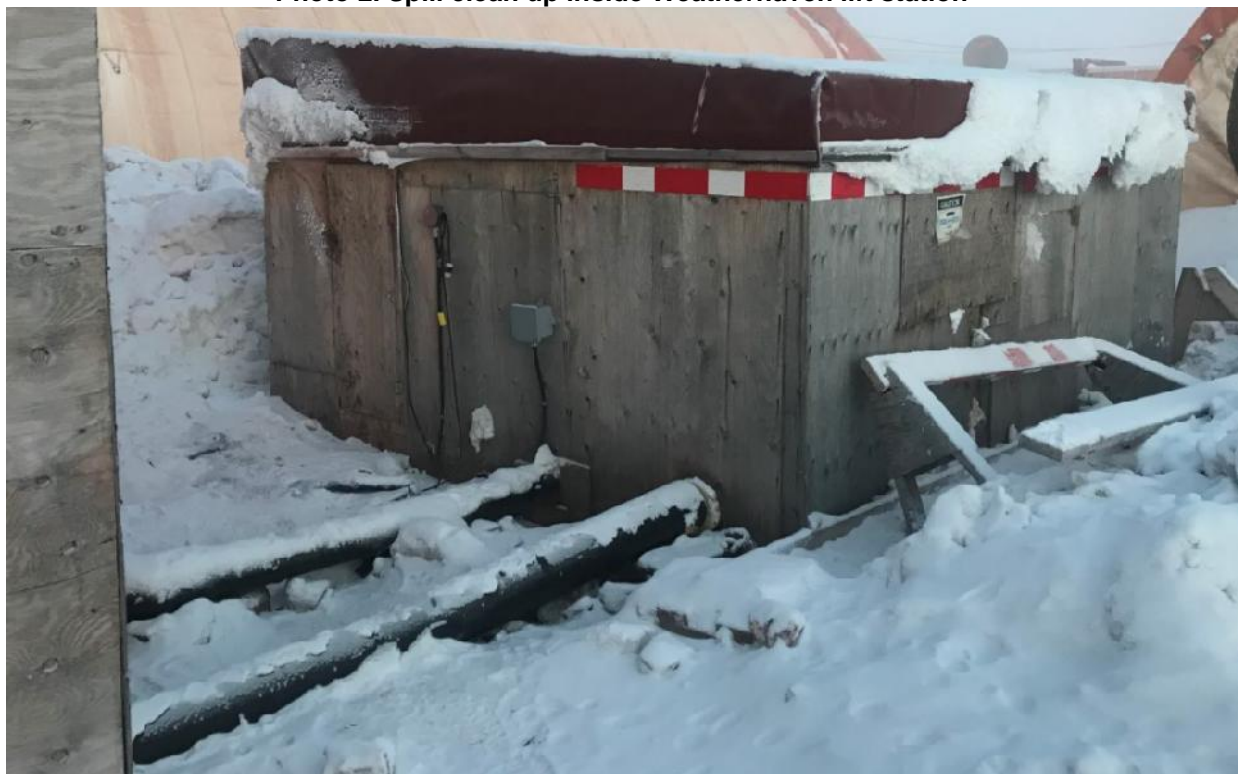
**Photo 3. Spill Clean up outside Weatherhaven lift station**

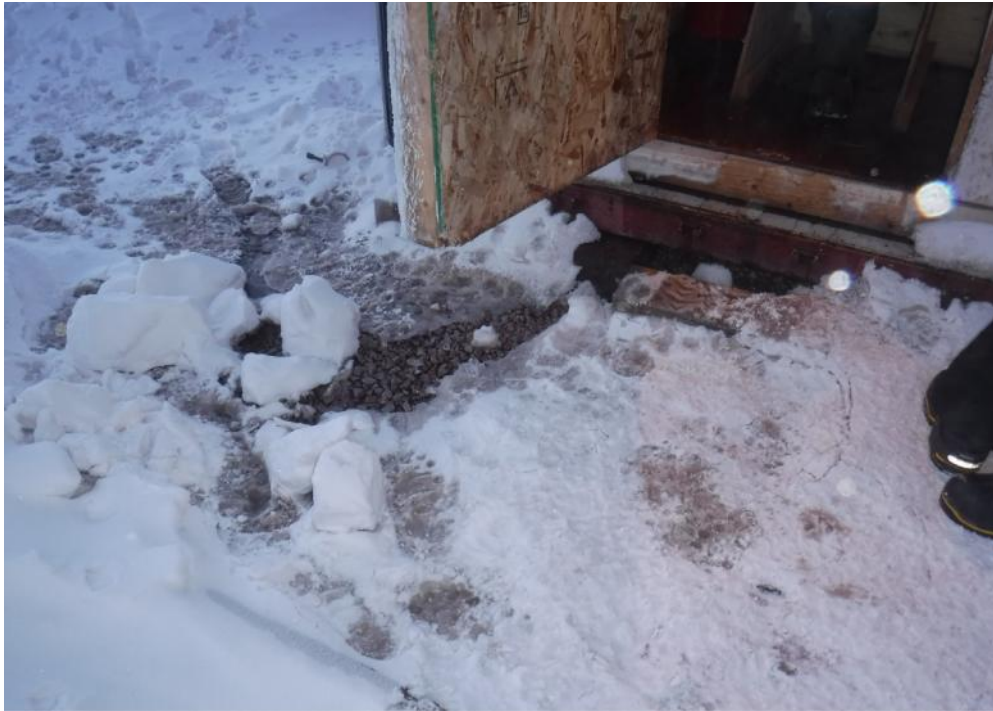
On January 21, 2018 at 12:30 hrs, Site Services Fixed Plant workers noticed raw sewage coming out of the bottom of the main lift station door at the Port Site Complex. Upon initial investigation, it was determined the floatation switch to turn on the pump had failed to trigger, causing the main tank to overflow. Approximately 150L of sewage was released to the adjacent camp pad ground surface, impacting approximately 5 m<sup>2</sup> area. This location is greater than >100 m to the nearest water course which is currently frozen.

**Photo 1. Overflow spill on ground outside PSC lift station**

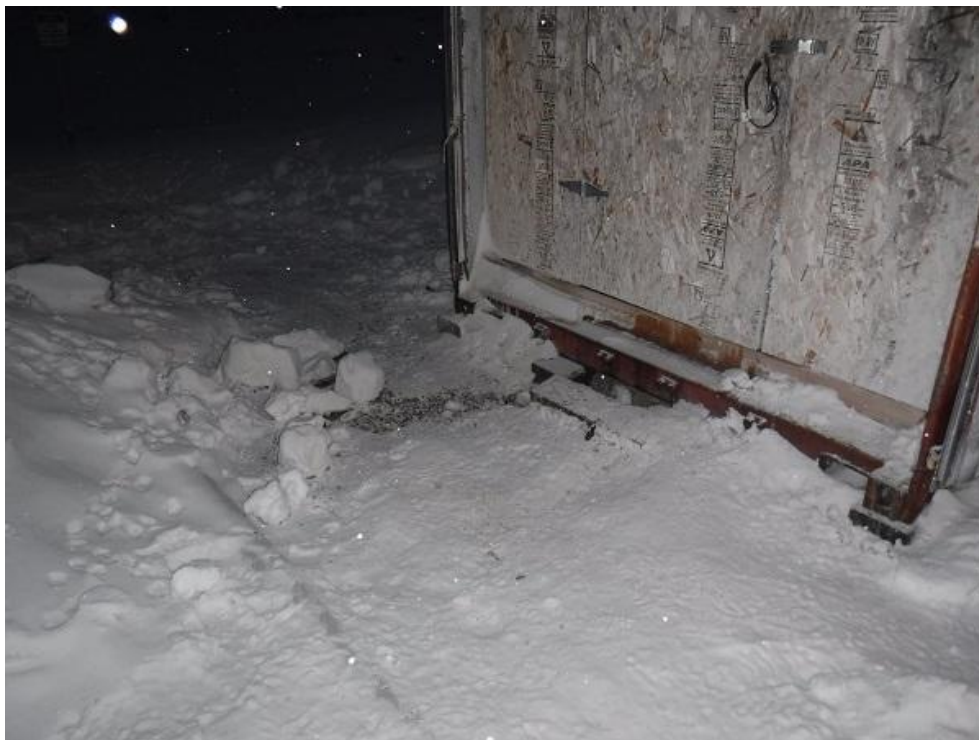
**Photo 2. Spill clean up outside PSC lift station**

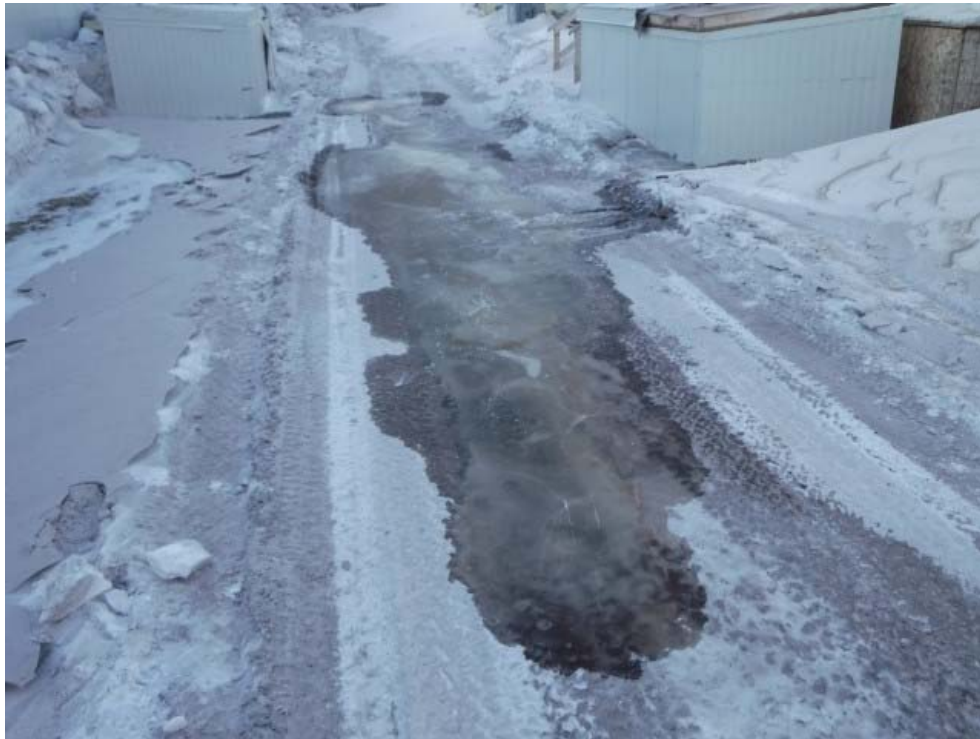
On February 7, 2018 at 09:00 hrs, while conducting inspections of the MSC lift stations, a housing maintainer observed water adjacent to the South AA lift station. Upon initial investigation, it was determined that the lift station pumps had failed to activate, due to the tank floats inside becoming entangled causing the tank to overflow. Approximately 225L of sewage was released to the adjacent ground surface, impacting an area of 14 m<sup>2</sup> contained to the camp pad. The spill location is greater than 100 m to the nearest water body which is currently frozen and non-fish bearing.

**Photo 1. Overflow spill on ground outside MSC AA South lift station**

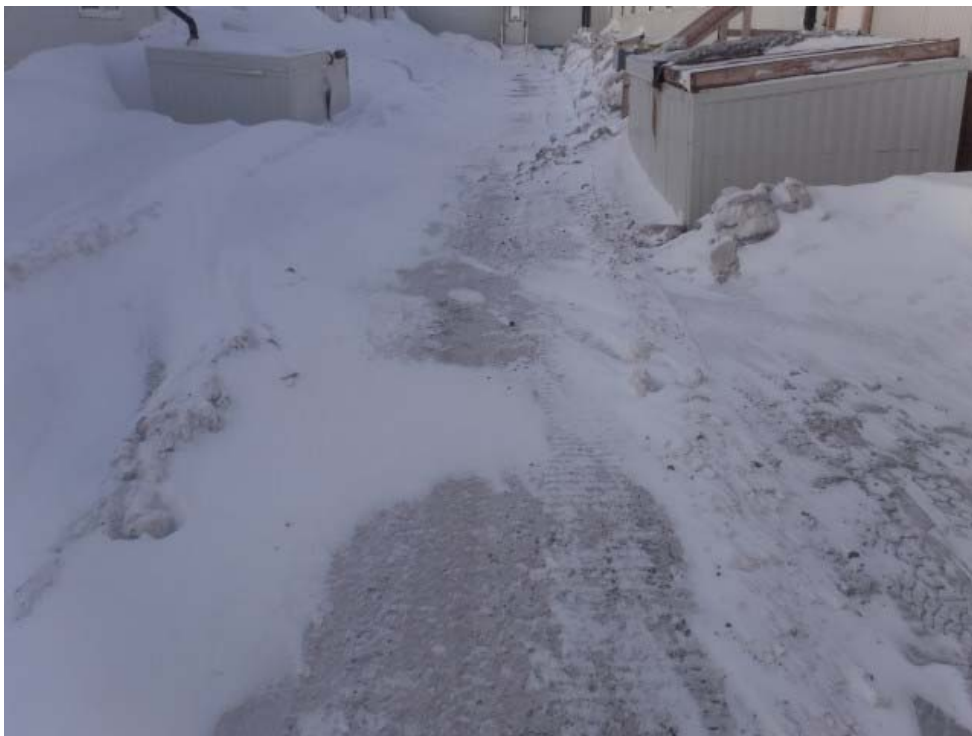
**Photo 2. Spill cleaned up outside MSC AA South lift station**

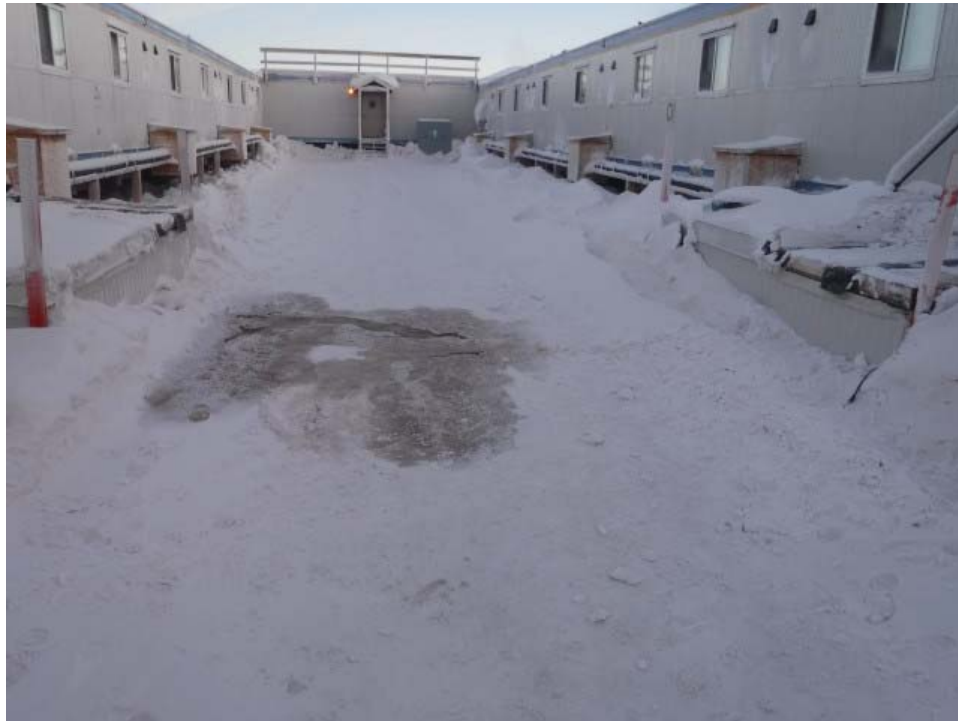
On February 9, 2018 at 11:30 hrs, while conducting inspections of the PSC lift stations, a housing maintainer observed frozen water outside the BB wing north lift station. Upon initial investigation, it was determined that there was a blockage in the discharge line to the main lift station, resulting in the lift station to overflow. Approximately 2m<sup>3</sup> of sewage was released to the adjacent camp pad ground surface, impacting an approximate area of 24 m<sup>2</sup>. This spill location is greater than 100 m to the nearest water course which is currently frozen.

**Photo 1. Overflow spill on ground outside PSC  
BB North lift station**

Relocate existing warning light to outside the lift station to reduce response time to address possible upset conditions. Additional insulation will be installed at the elbow joint of the discharge line which has proven to be prone to freezing. Continued daily lift station inspections of the system.

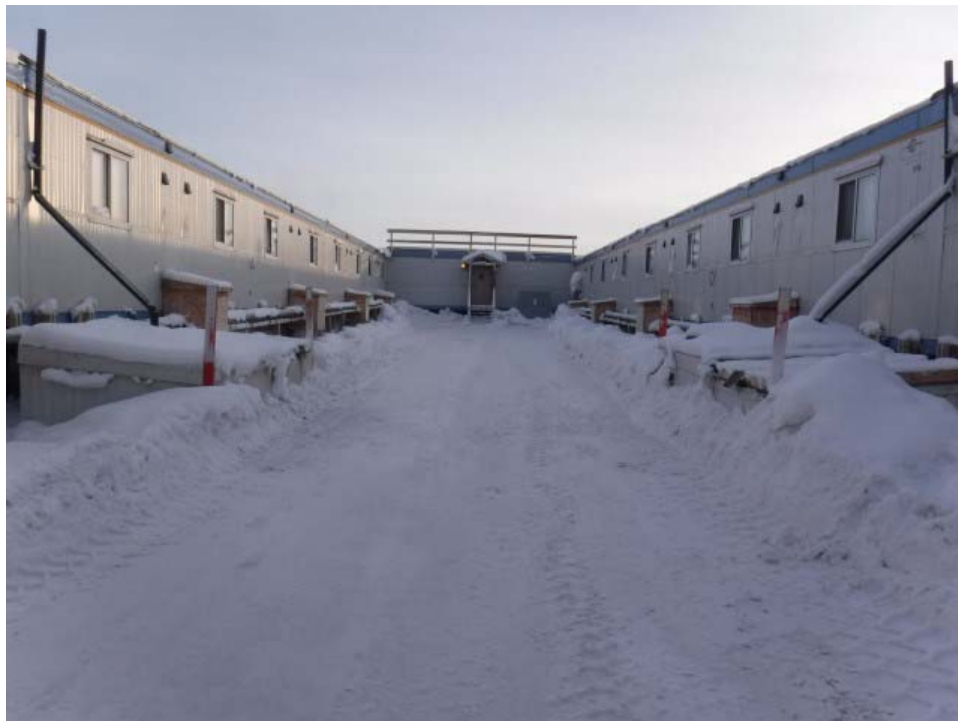
**Photo 2. Spill clean up outside PSC BB North lift station**

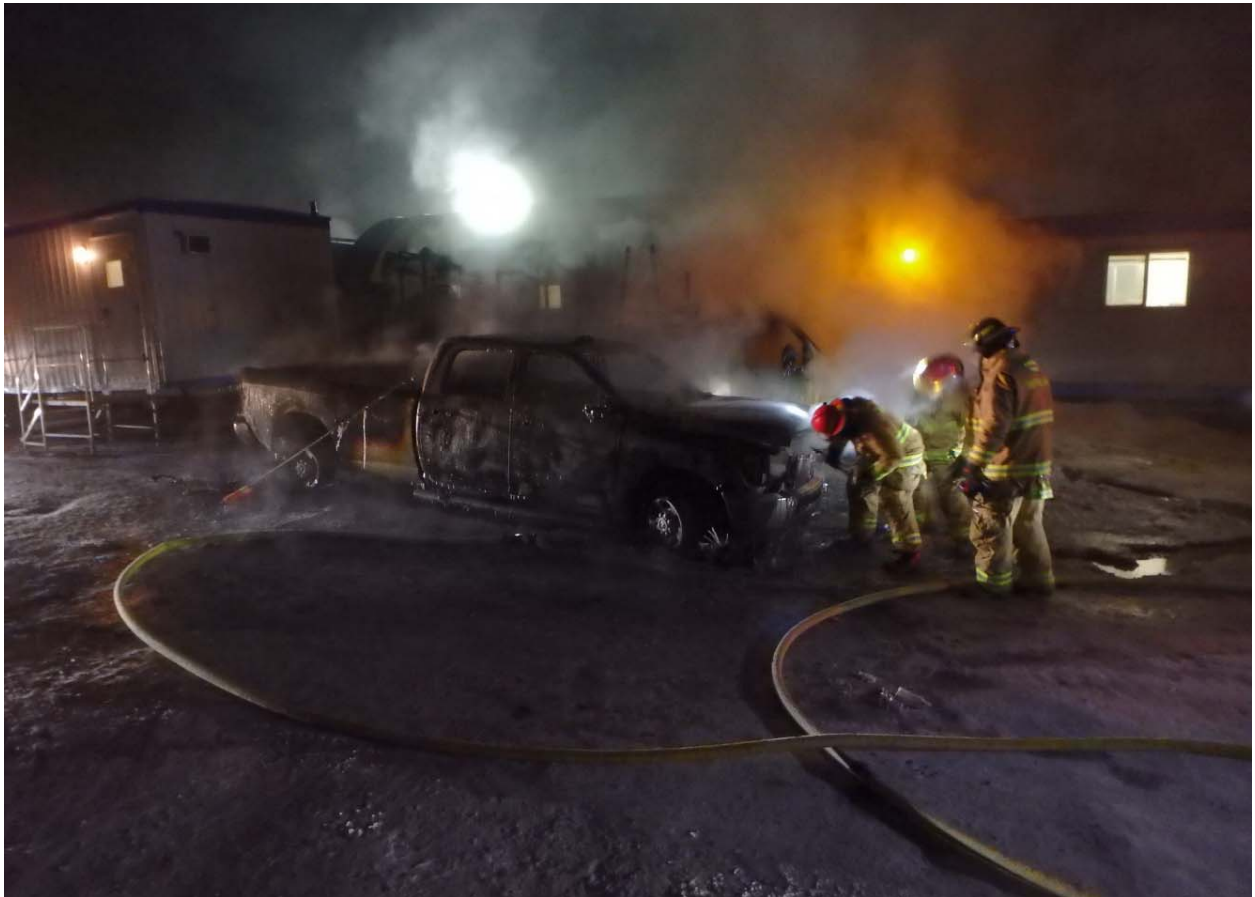
On February 14, 2018 at approximately 06:30, a fire was reported beside the Nuna shop in proximity to the Mine Site Weatherhaven complex. It was discovered that two light vehicles, one pick up, one cube van, had caught fire. The ignition source is unknown. The Mine Rescue Team was dispatched to extinguish the fire, which took approximately one hour. As a result, there was a significant amount of fire impacted water that was produced, which immediately froze to the adjacent pad where the pick ups were parked due to extreme cold conditions. Approximately 10m<sup>3</sup> of fire impacted water was produced, confined to the pad. Constructed berms and extreme temperatures mitigated the migration of the water. This spill is >160m to the nearest water course (which is currently frozen).

**Photo 1 – Trucks Being Extinguished by MRT Personnel**

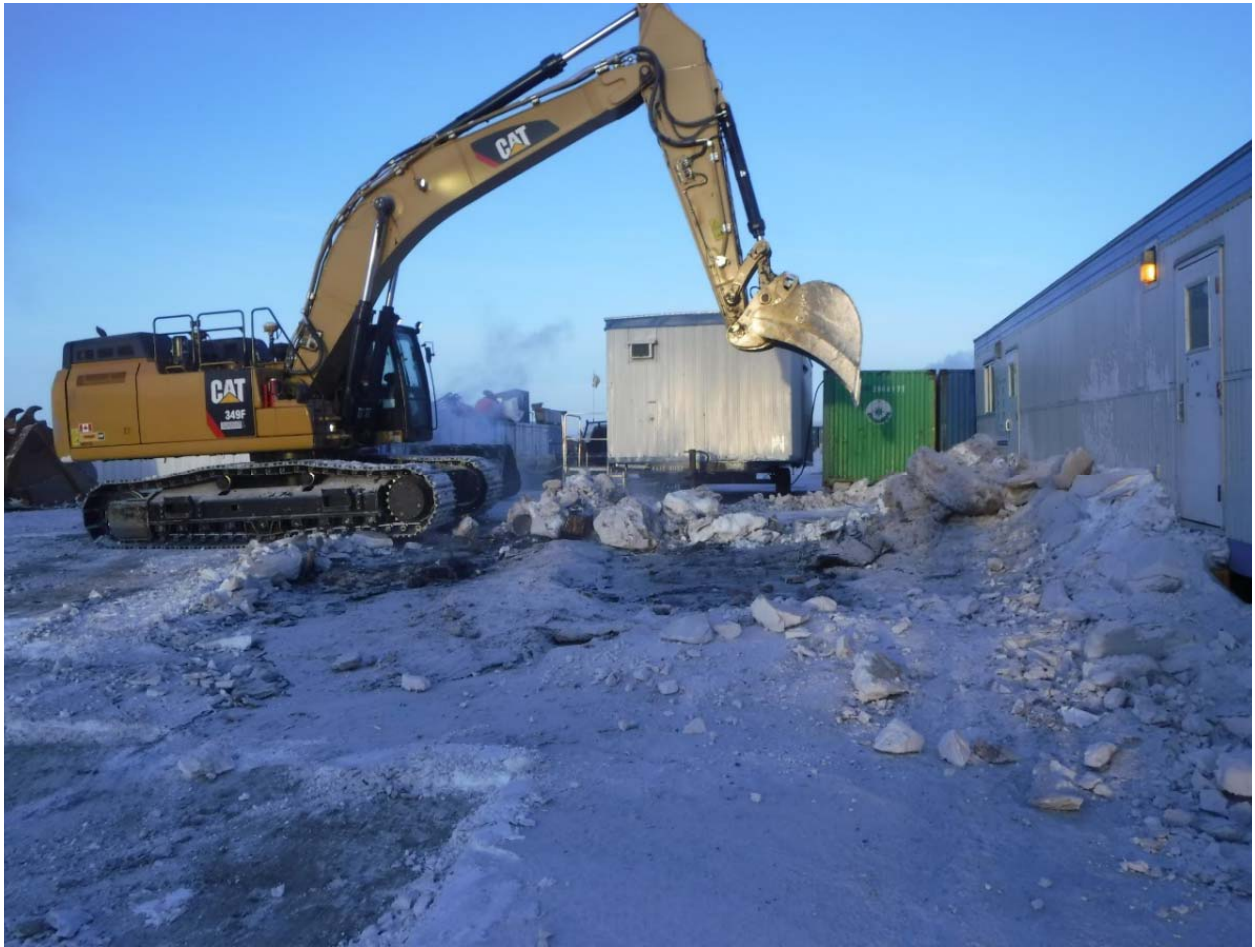
**Photo 2 – Impacted ice/snow being scrapped up by excavator**

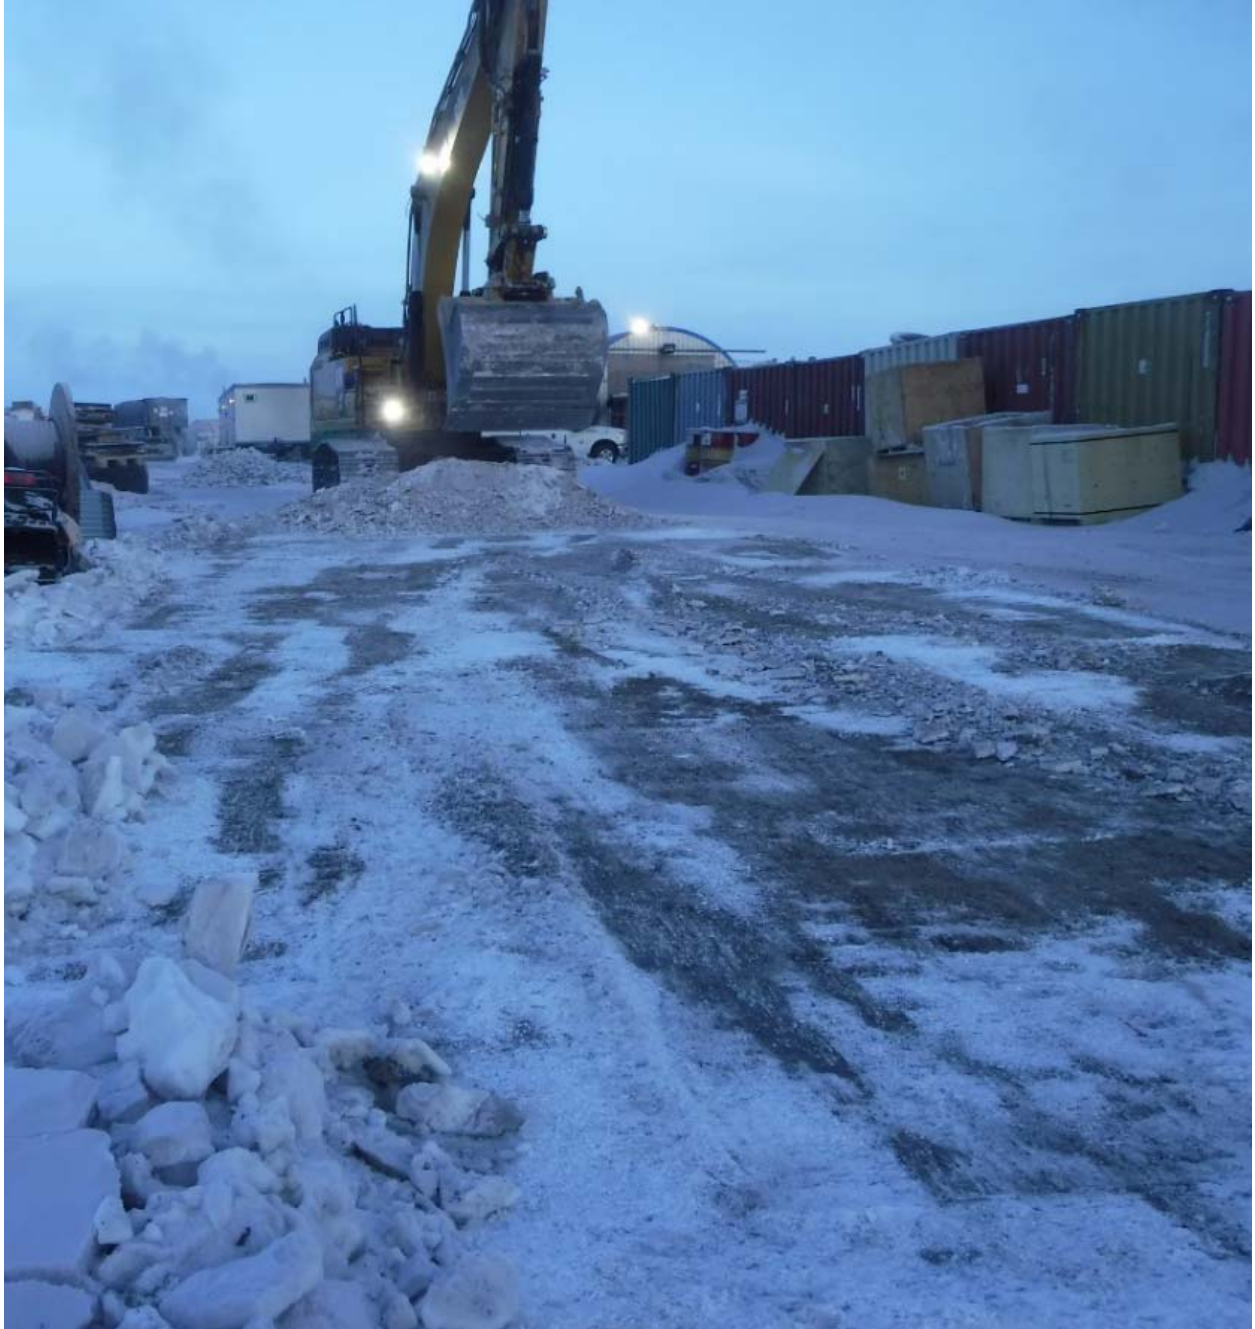
**Photo 3 – Impacted ice/snow being scrapped up by excavator**

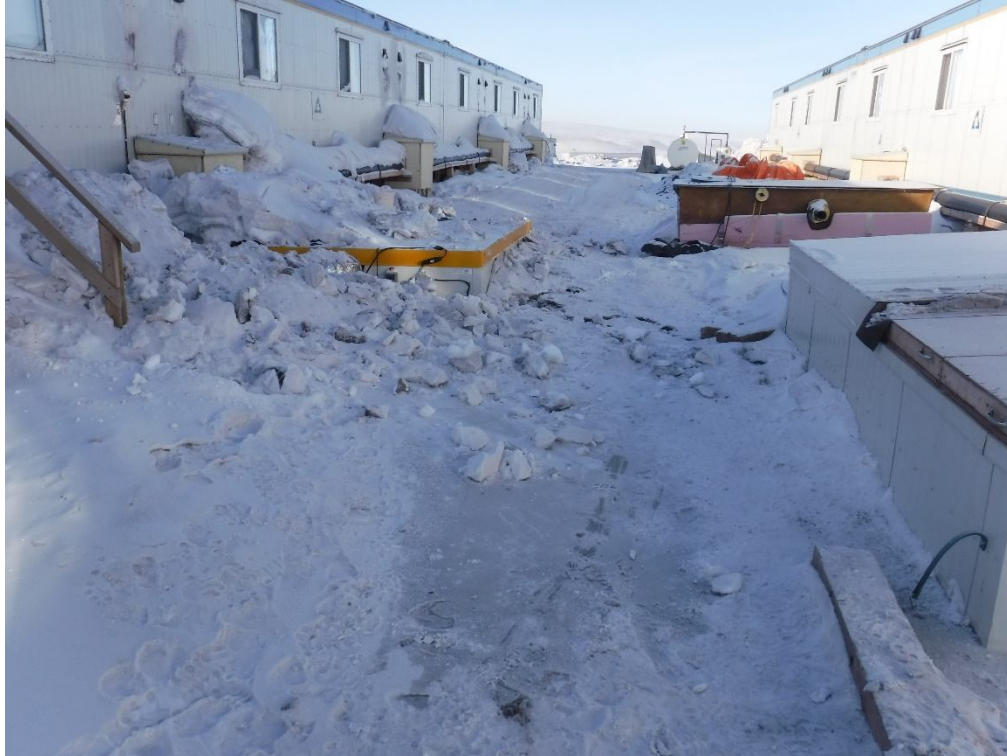
On February 22, 2018 at approximately 07:50 hrs, while conducting inspections of the MSC lift stations, a housing maintainer observed frozen water outside the AD wing north lift station. Upon initial investigation, it was determined that the lift station had overflowed. The lift station was immediately emptied by vacuum truck to prevent further overflow. Approximately 200L of sewage was released to the adjacent camp pad ground surface, impacting an approximate area of 15m<sup>2</sup>. This lift station is emptied via vacuum truck and the increased influent between loads caused the lift station to overflow. This spill is >100 m to the nearest water course (which is currently frozen).

**Photo 1: Lift station and camp pad following clean up**

Baffinland has recommended more frequent checks and vacuum truck operating so that raw sewage levels stay below the emergency overflow levels of the holding tank.

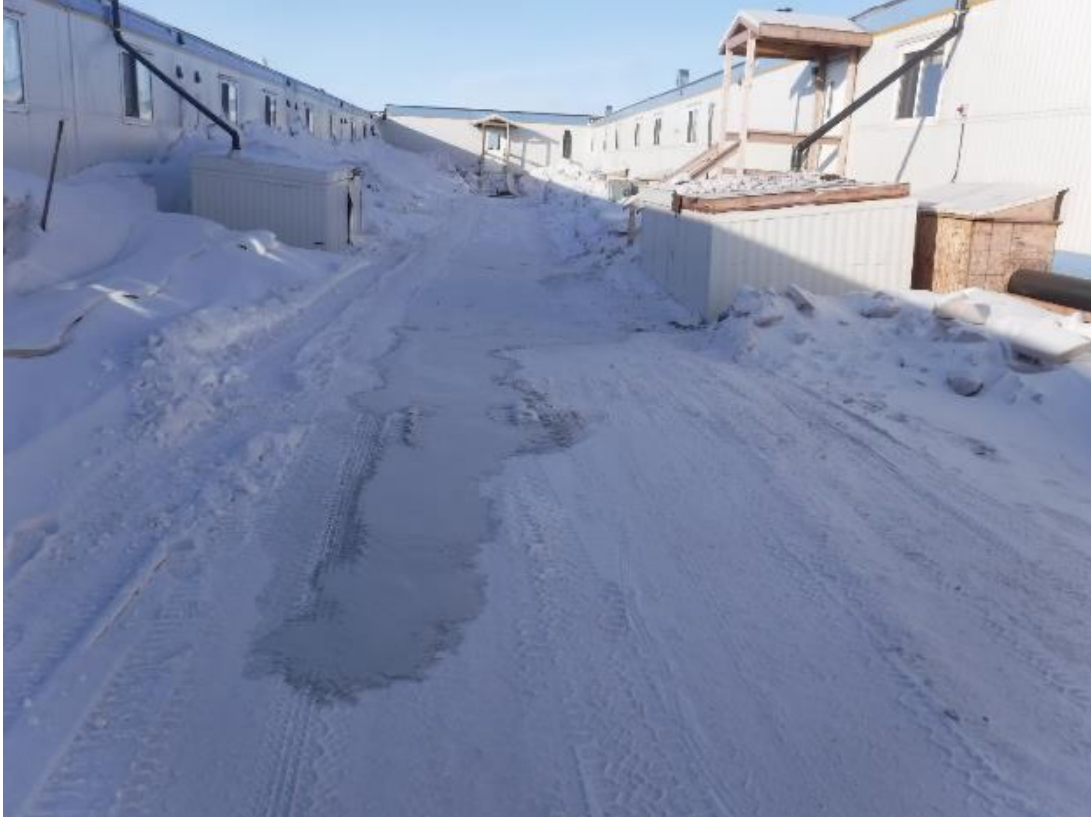
On February 23, 2018 at approximately 16:30 hrs, while conducting routine inspections of the MSC lift stations, a housing maintainer observed frozen water outside the AA wing south lift station. Upon initial investigation, it was determined that there was a blockage in the discharge line to the main lift station, resulting in the lift station overflowing. Approximately 150L of sewage was released to the adjacent camp pad ground surface, impacting an approximate area of 10m<sup>2</sup>. This spill is located greater than 100 m to the nearest water course, which is currently frozen.

**Photo 1. Spill location before clean-up**

The lift station was immediately emptied by a vacuum truck to prevent further overflow. The contaminated snow was collected and deposited in an engineered lined containment facility. Additional insulation was added to the discharge line, and the heat trace has been tested to confirm it is in good working condition.

Investigate the cause of the frozen discharge line and develop a remedy to prevent the line from freezing again. Continue daily lift station inspections of the system.

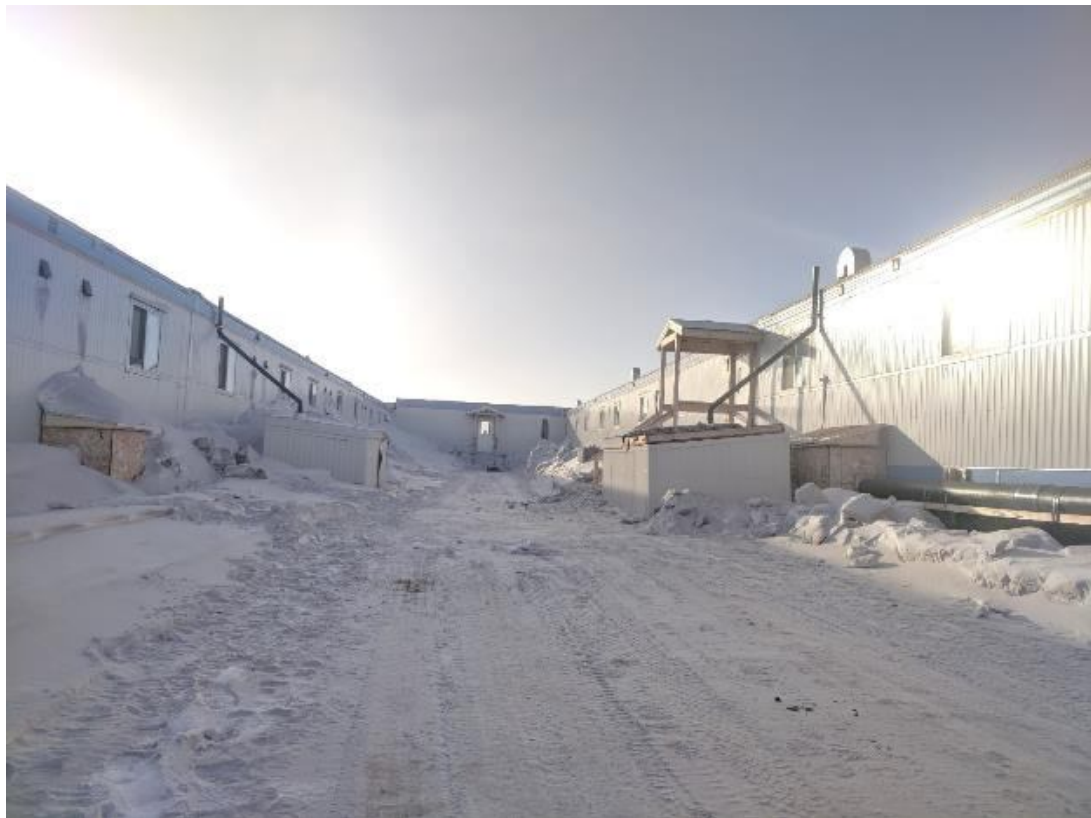
**Photo 2. Lift station and camp pad following clean-up**

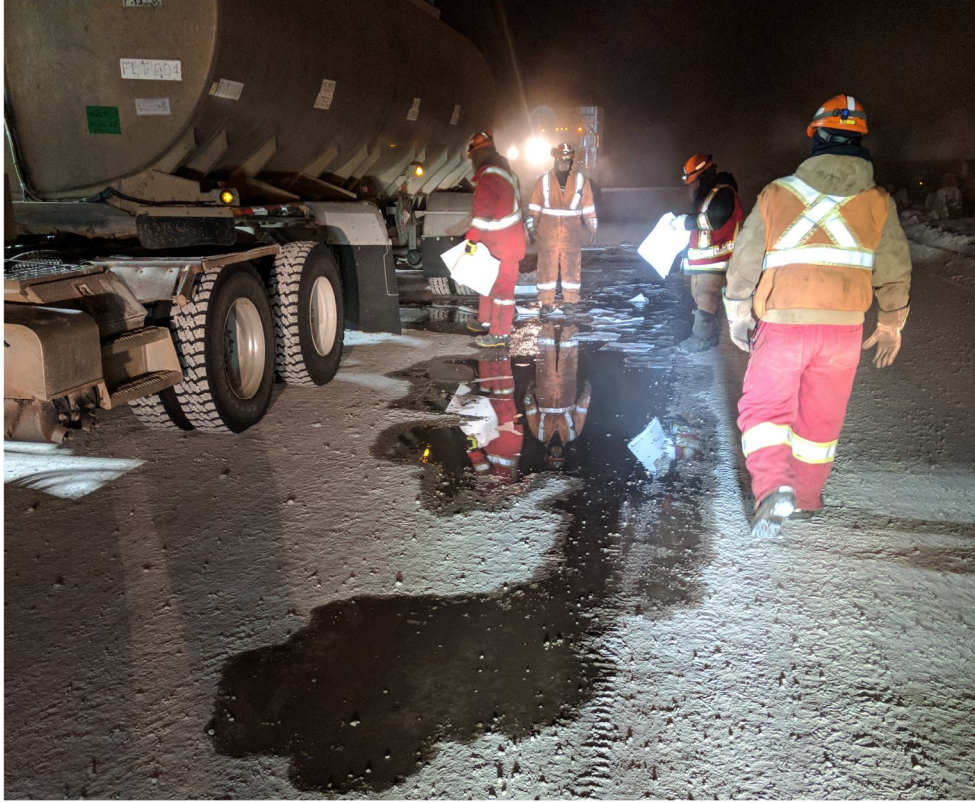
**Photo 1. Spill location before clean-up**

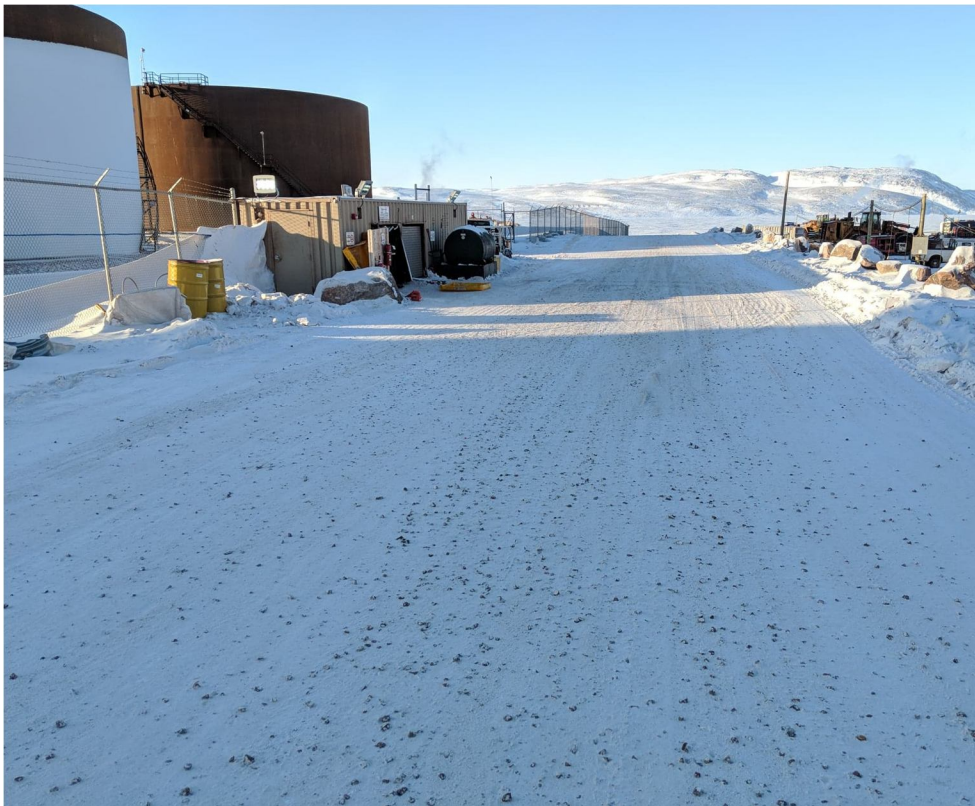
**Photo 2. Spill location following clean-up**

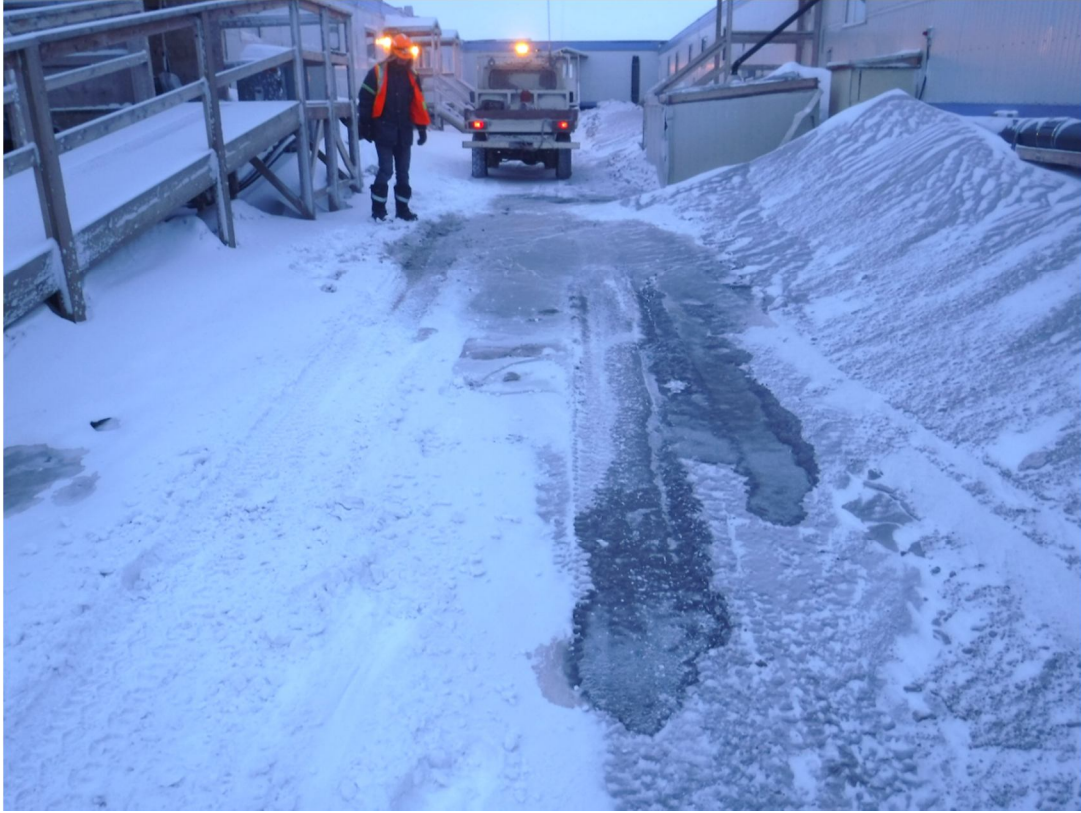
On February 27, 2018 at approximately 06:40 hrs, while conducting inspections of the MSC lift stations, a housing maintainer observed frozen water outside the AE wing south lift station. Upon initial investigation, it was determined that the lift station had overflowed. The lift station was immediately emptied by vacuum truck to prevent further overflow. Approximately 200L of sewage was released to the adjacent camp pad ground surface, impacting an approximate area of 30m<sup>2</sup>. A frost fighter was brought in to heat and thaw the ice blockage in the discharge line and have the system brought back into service. This spill is >100 m to the nearest water course (which is currently frozen).

**Photo 1. Spill location before clean-up**

Investigate potential causes of the frozen discharge line and develop a remedy to prevent the line from freezing again. Continue daily lift station inspections of the system.

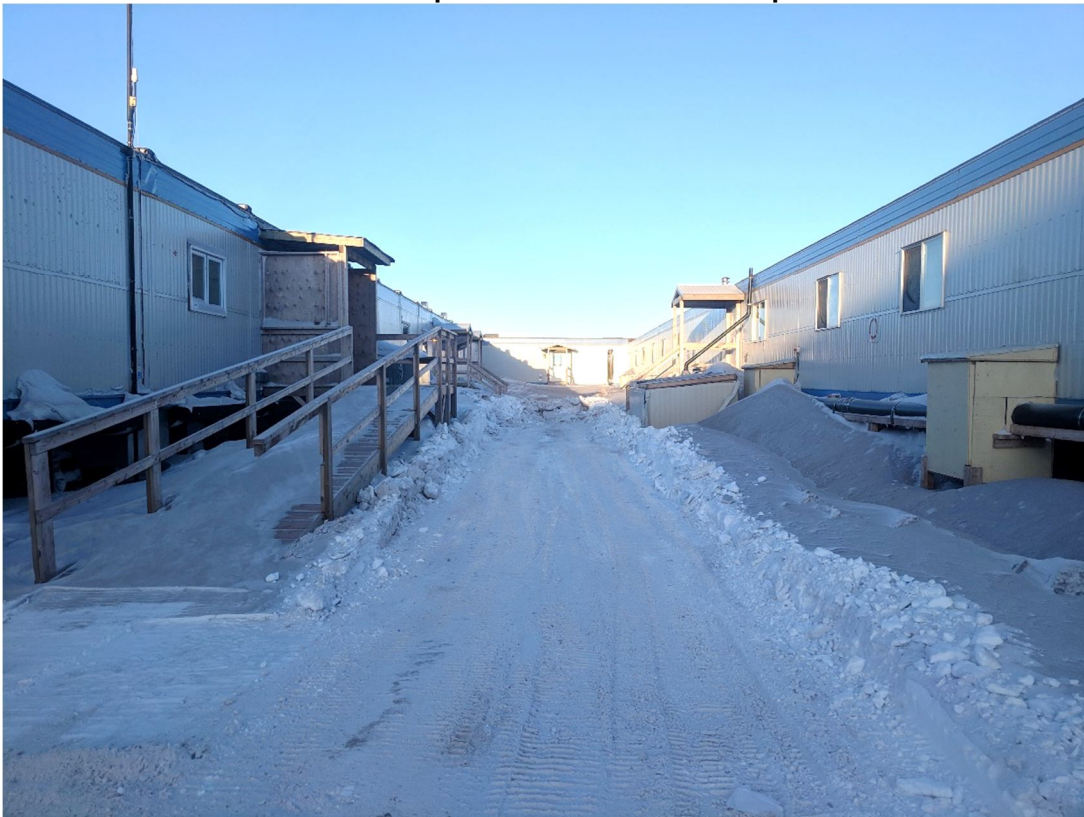
**Photo 2. Lift station and camp pad following clean-up**

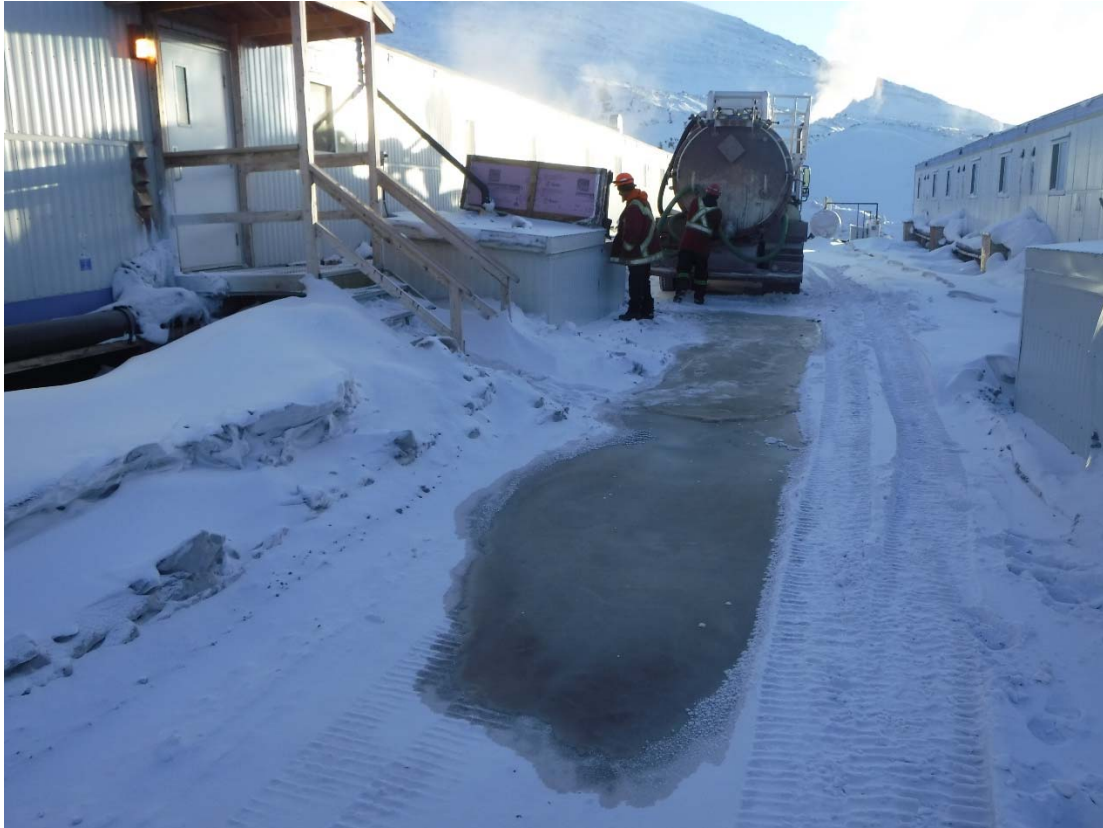
At 10:30 on March 16, 2018, while performing inspections of the Mine Site Complex (MSC) lift Stations, a housing maintainer observed water adjacent to the South AA lift Station. Upon initial investigation, it was identified that the lift station pumps had failed to activate due to the tank floats malfunctioning and the discharge line had plugged due to extreme winter conditions. The lift station was manually pumped down via vacuum truck to prevent further overflow and supervision notified. Approximately 200L of sewage impacted the MSC pad adjacent to the lift station, migrating over an area of approx. 10 m<sup>2</sup>. The spill is >100 m from the nearest water body which is currently frozen.

**Photo 1. Spill location before clean-up**

The lift station was immediately emptied by a vacuum truck to prevent further overflow. The contaminated snow was collected and deposited in an engineered lined containment facility. Additional insulation was added to the discharge line, and the heat trace has been tested to confirm it is in good working condition. Further repairs were performed and are ongoing to the lift station tank after the tank integrity was called into question.

Repairs to the lift station tank were recommended and will be monitored along with discharge line repairs. Action further repairs, including tank replacement as required. Continue daily lift station inspections of the system.
