**APPENDIX E.8.4**  
**INITIAL AND FOLLOW-UP SPILL REPORTS**  
**(PART 1 OF 4)**

**Re: Follow-up to Spill #18-016**  
**Mary River Project - Water Licence No. 2AM-MRY1325**

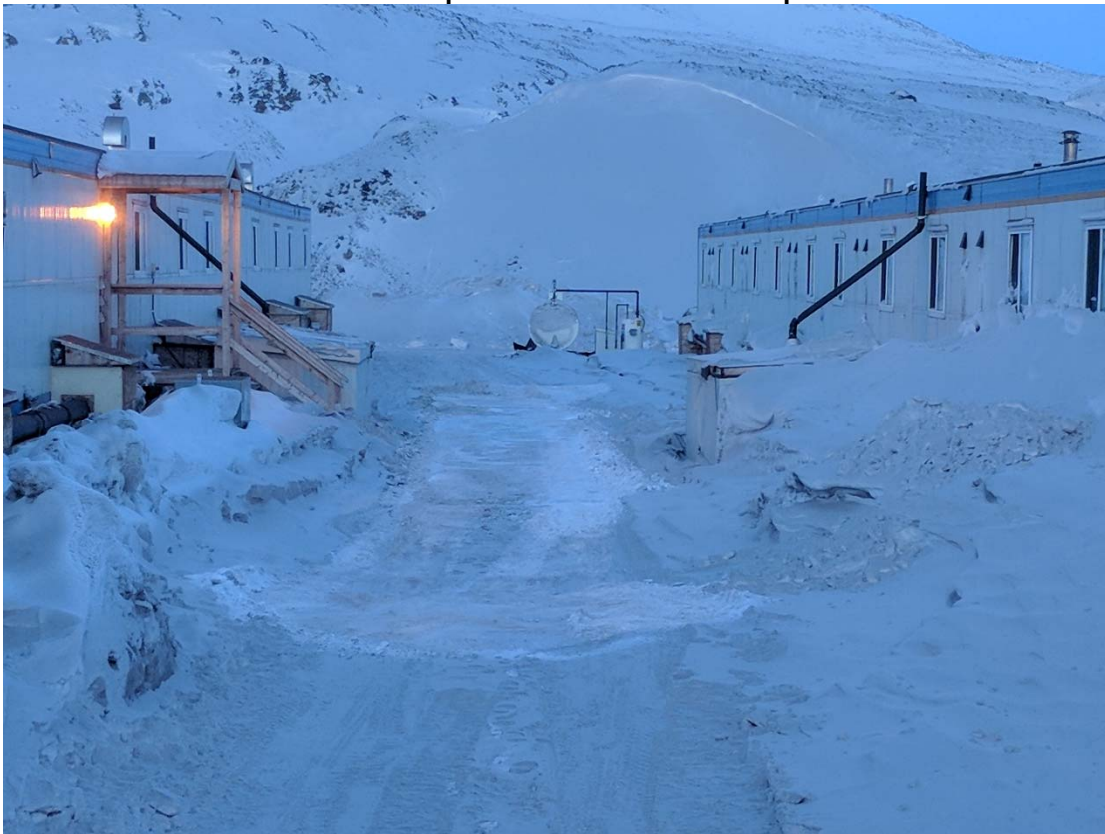
**Photo 2. Lift station and camp pad following clean-up**

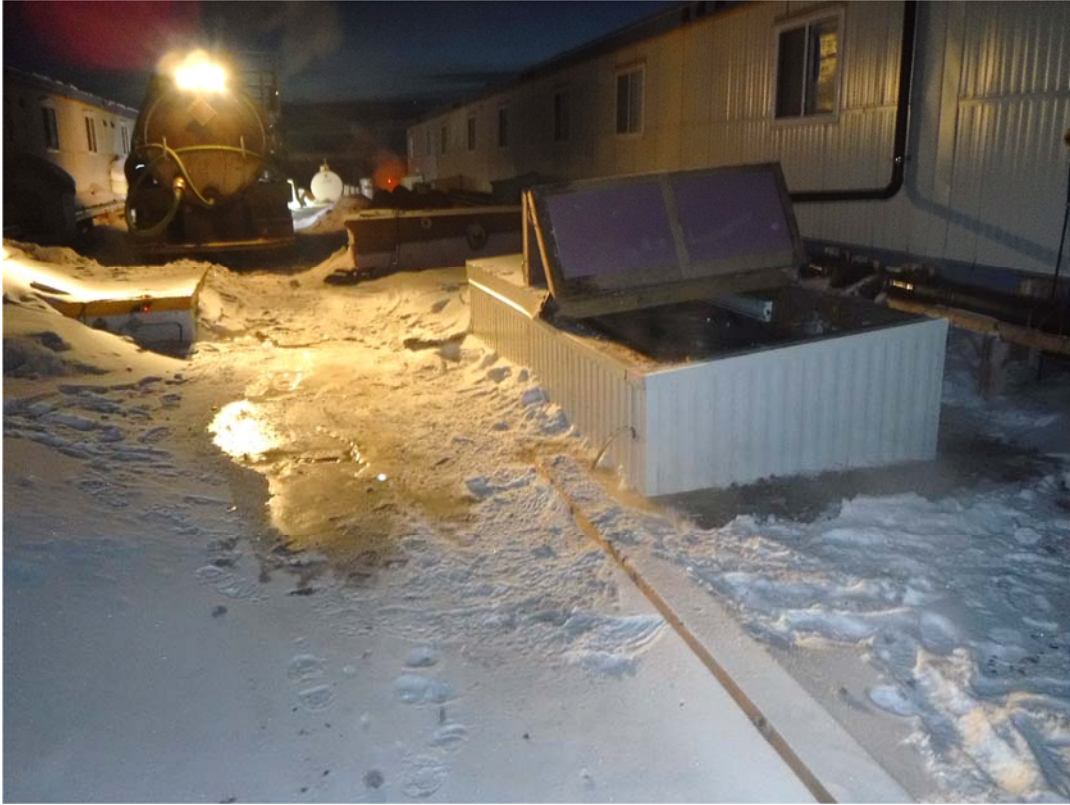
**Photo 1. Spill location before clean-up**

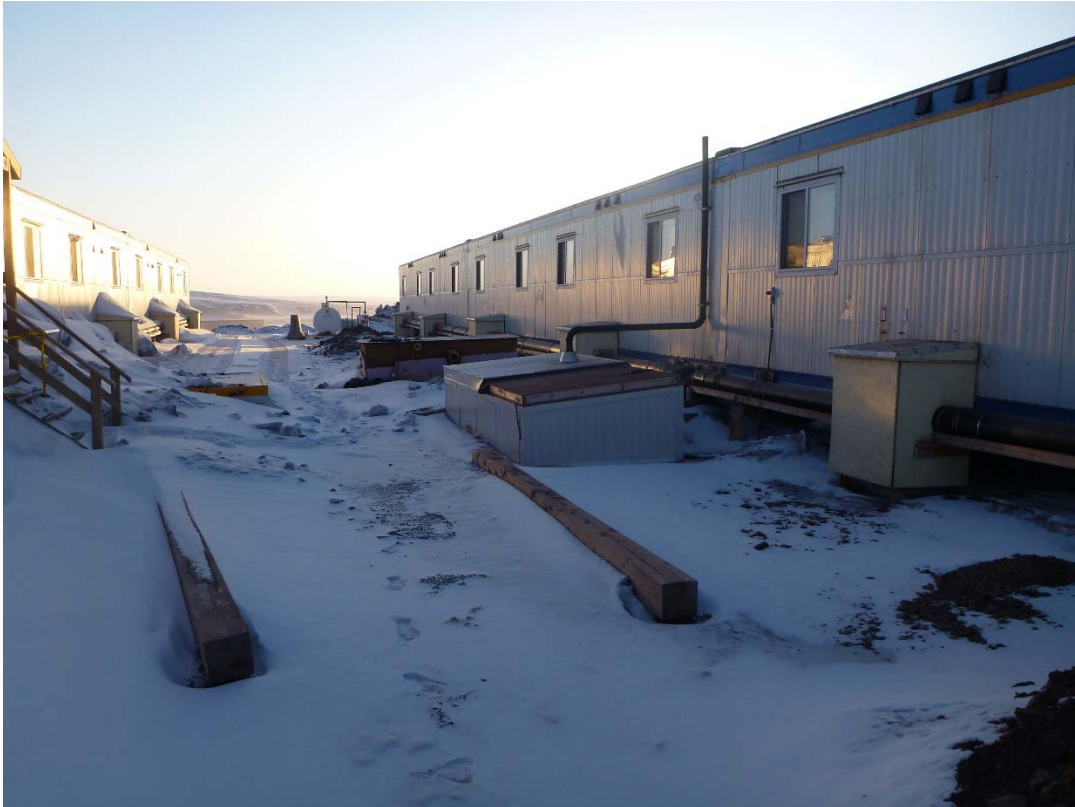
**Photo 2. Lift station and camp pad following float readjustment**

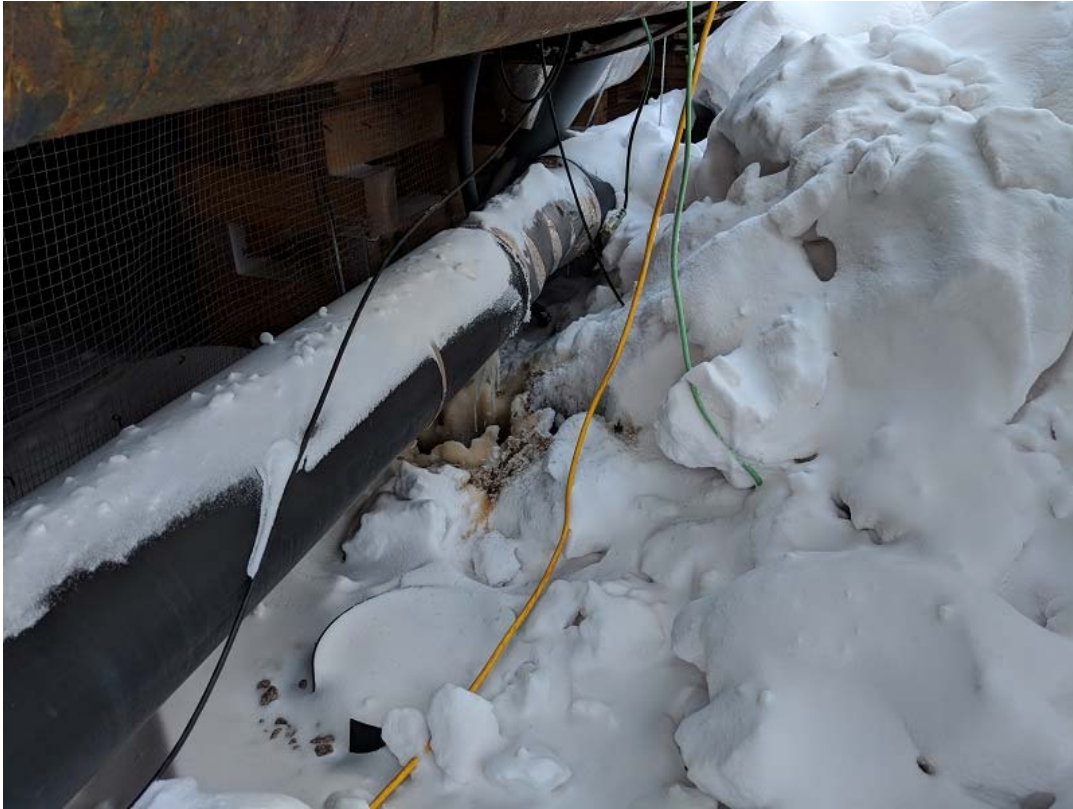
On March 19, 2018 at approximately 09:00 hrs, during routine sewer line and lift station inspections a housing maintainer noticed sewage leaking from the gravity drain line originating at the Port Site Complex men's dry. It was determined that a Fernco coupling had separated on the gravity drain line due to expansion/contraction of the piping system from extreme temperature change. Approximately 300L of raw sewage was released to the adjacent camp pad ground surface, impacting an approximate area of 15m<sup>2</sup>.

**Photo 1. Spill location before clean-up**

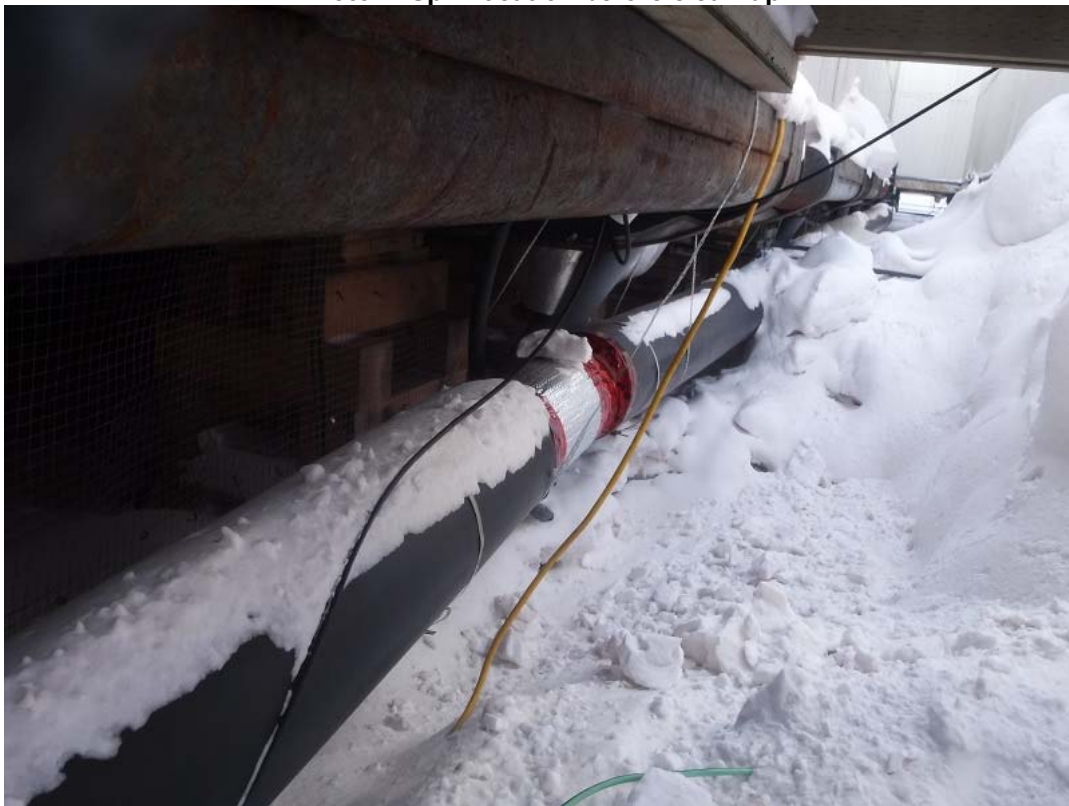
**Photo 2. Gravity Drain Line after repairs completed**

The repair to the coupler is currently functioning and the gravity line is in operation and inspected regularly.
