APPENDIX E.8.4
INITIAL AND FOLLOW-UP SPILL REPORTS
(PART 2 OF 4)

Re: Follow-up to Spill #18-118, Reported on April 9, 2018
Mary River Project - Water Licence No. 2AM-MRY1325

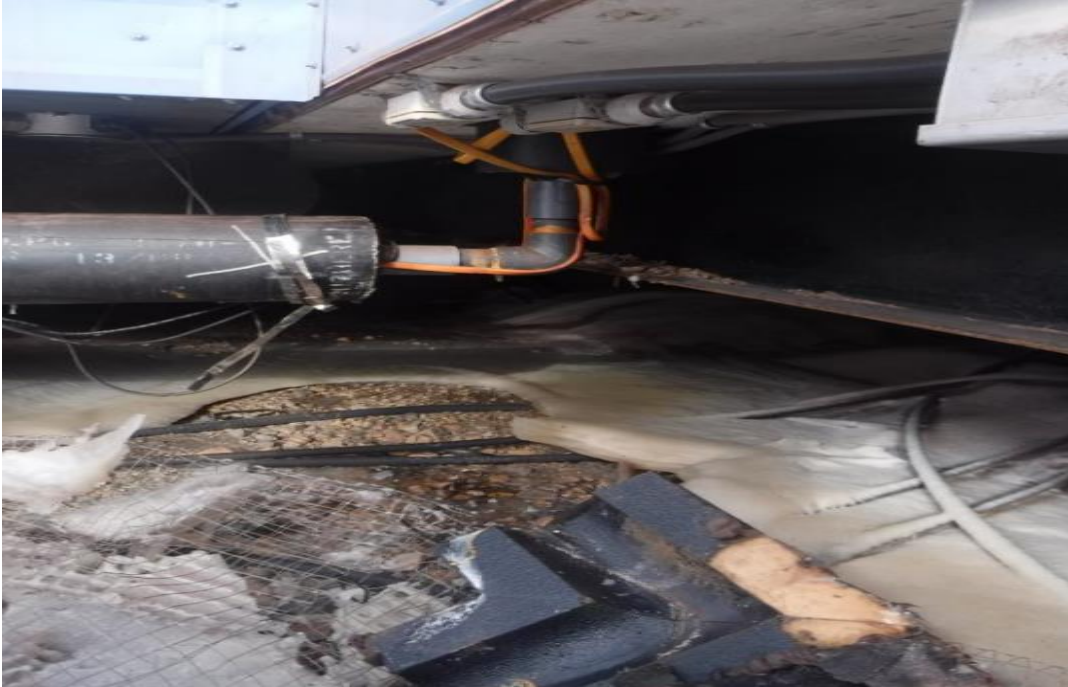
On April 9, 2018 at approximately 09:00 hrs, a housing maintainer conducting routine sewer line inspections observed a 90-degree elbow had separated from the AF South lift station discharge line under the Mine Site Complex (MSC). Upon investigation, it was determined the elbow glue had failed causing the joint to split. Approximately 1m³ of sewage was released and confined to the camp pad adjacent to the lift station, migrating to an extent underneath the MSC, impacting an approximate area of 20 m². This spill is >100 m to the nearest water course (which is currently frozen). The investigation is ongoing and further details will be provided in the follow-up report. This spill is being reported as required by the conditions of NWB Water License no. 2AM-MRY1325, Part H, Item 9 (b) pursuant to subsection 12(3) of the Nunavut Waters and Nunavut Surface Rights Tribunal Act.

Photo 1. Discharge line before elbow repair

The lift station was immediately shut off to prevent further discharge and Supervision was contacted. The lift station was pumped down by vacuum truck and the elbow was repaired.

Consider strategic secondary containment at repeat failure locations and research different style of coupler aimed to address the expansion and contraction conditions. Continue daily lift station inspections of the system.

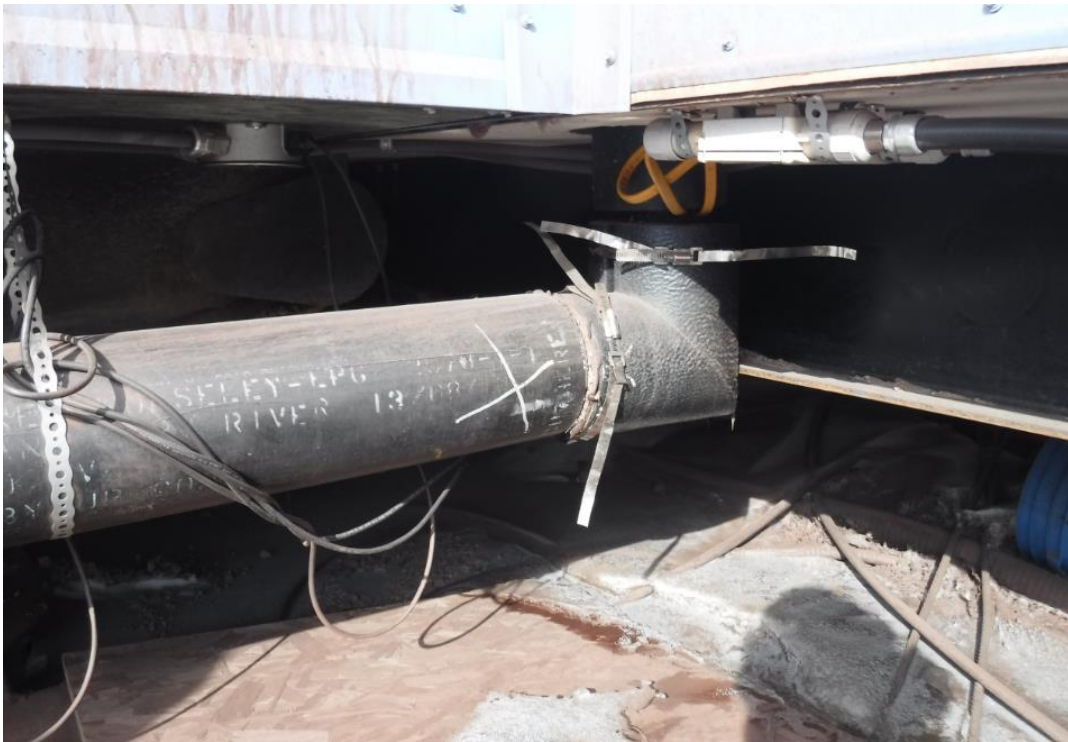
Photo 2. Discharge line following elbow repair

The elbow joint is repaired and the discharge line is back in operation. Daily inspections continue

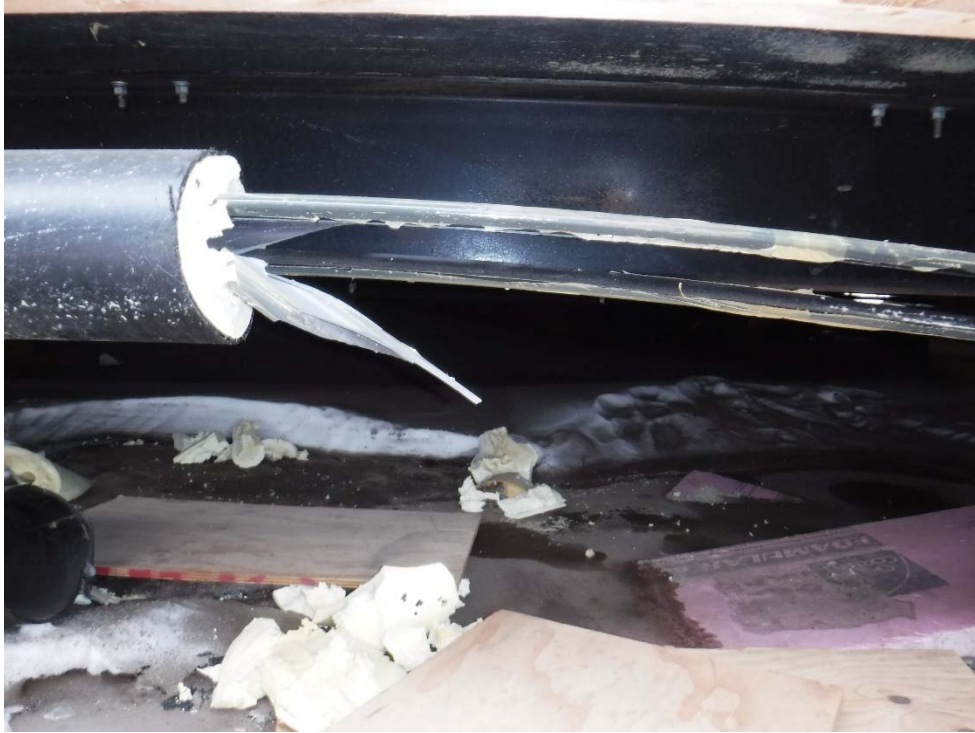
On April 23, 2018 at approximately 05:30 hrs, it was noted that there was sewage seeping from under the snow at the Mine Site Complex (MSC) AE South wing. Upon investigation, it was determined the leak was coming from the discharge line of the lift station. Approximately 250 liters of raw sewage was released and confined to the camp pad adjacent to the lift station, impacting an approximate area of 10m².

Photo 1. Discharge line in need of repair for approx. 20 feet

Continued monitoring of lift station levels to ensure contents are emptied via vacuum truck and delivered to waste water treatment plant. Provide additional structural support under connection points on horizontal lines to reduce stress at the coupling as required once commissioned.

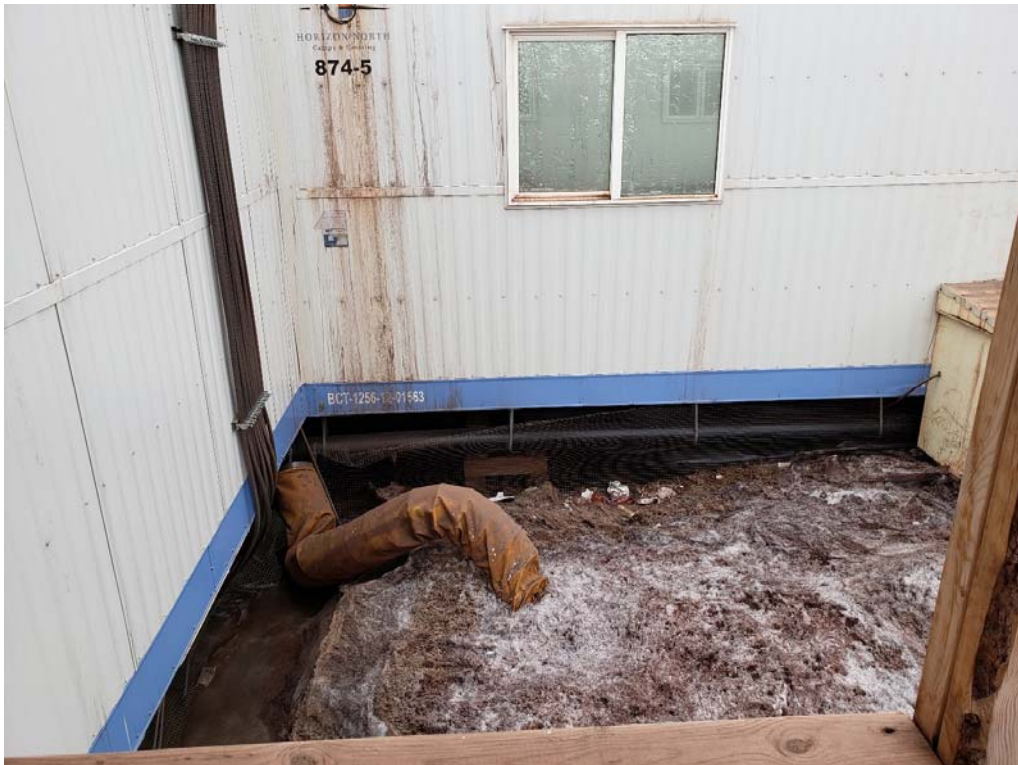
Photo 2. Discharge pipe problematic location

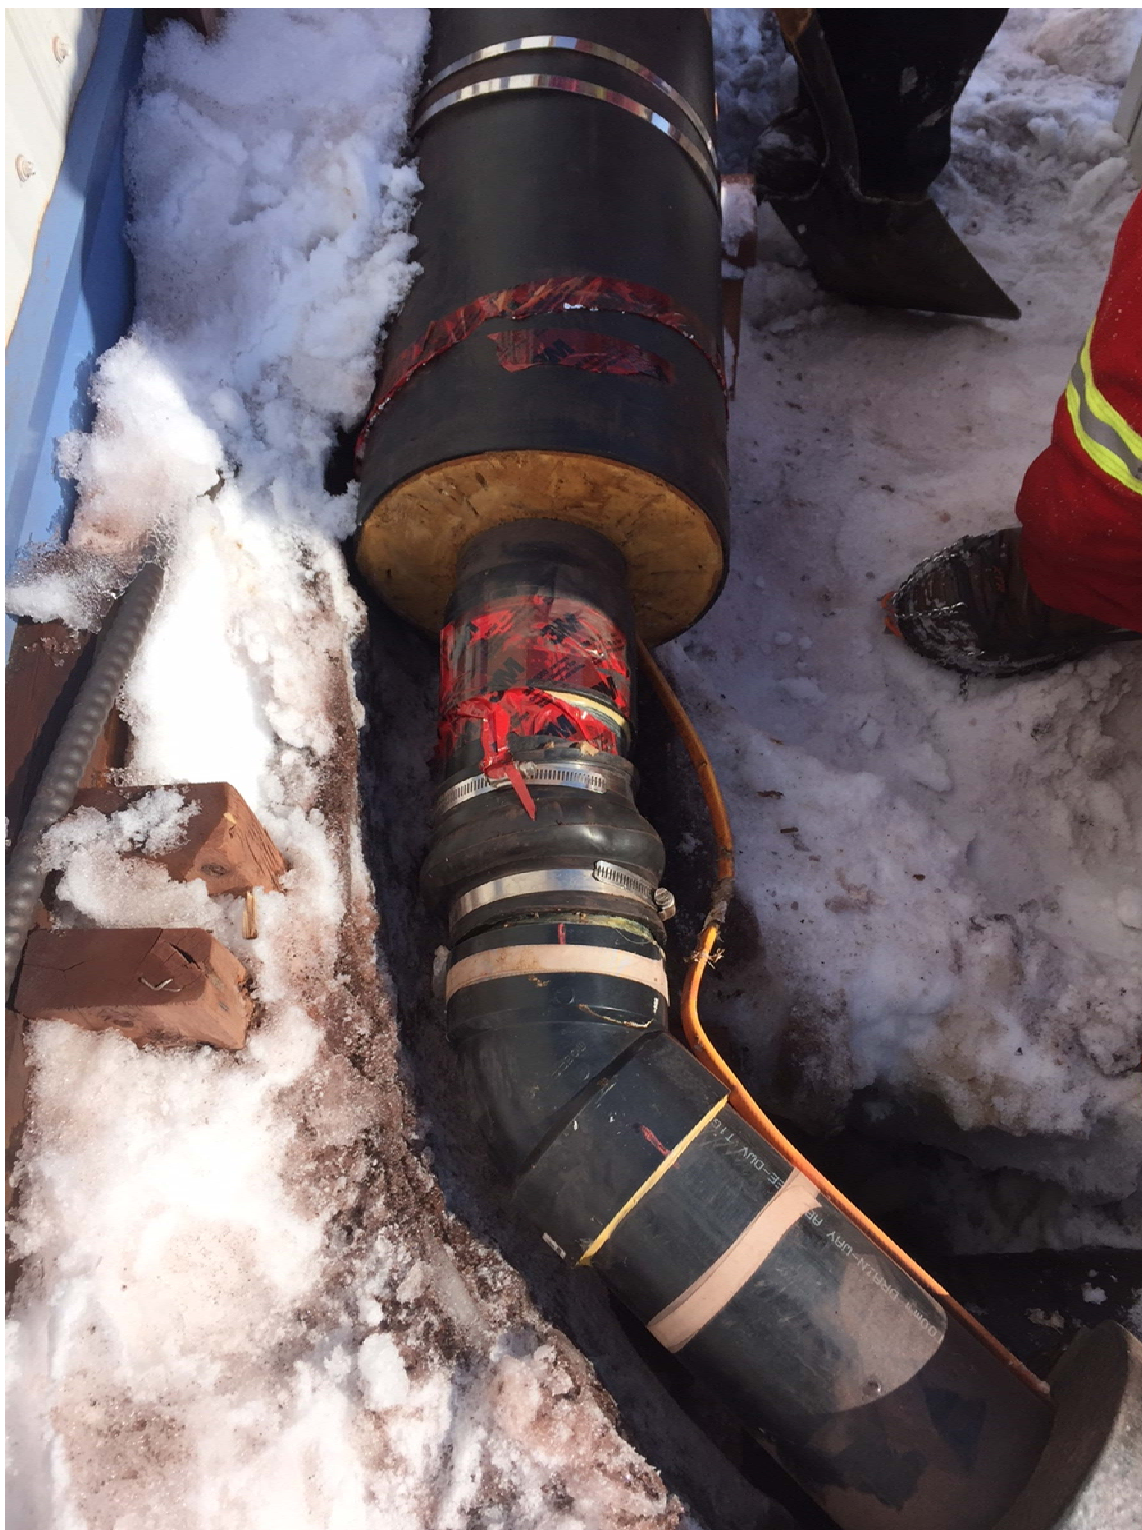
On April 24, 2018 at approximately 22:00 hrs, while conducting inspections of the MSC lift stations, a housing maintainer observed frozen water outside the AD wing south lift station. Upon investigation, it was determined that the gravity drain line from the wing had separated at the coupling, resulting in raw sewage discharging to the ground. Immediately upon discovering the release the sources to the affected wing were shut off while the coupling was repaired. Approximately 250 L of sewage was released to the adjacent camp pad ground surface, impacting an approximate area of 20 m². The coupling and gravity line was subsequently reconnected and the system was brought back into operation. The contaminated snow was collected and properly disposed of in the polishing waste stabilization pond. This spill is >100 m to the nearest water course (which is currently frozen).

Photo 1: Gravity drain line following repair of the separated coupling.

Procure horizontal flow fittings for install on gravity line. Continue inspections of lift stations to ensure components are functioning as designed.

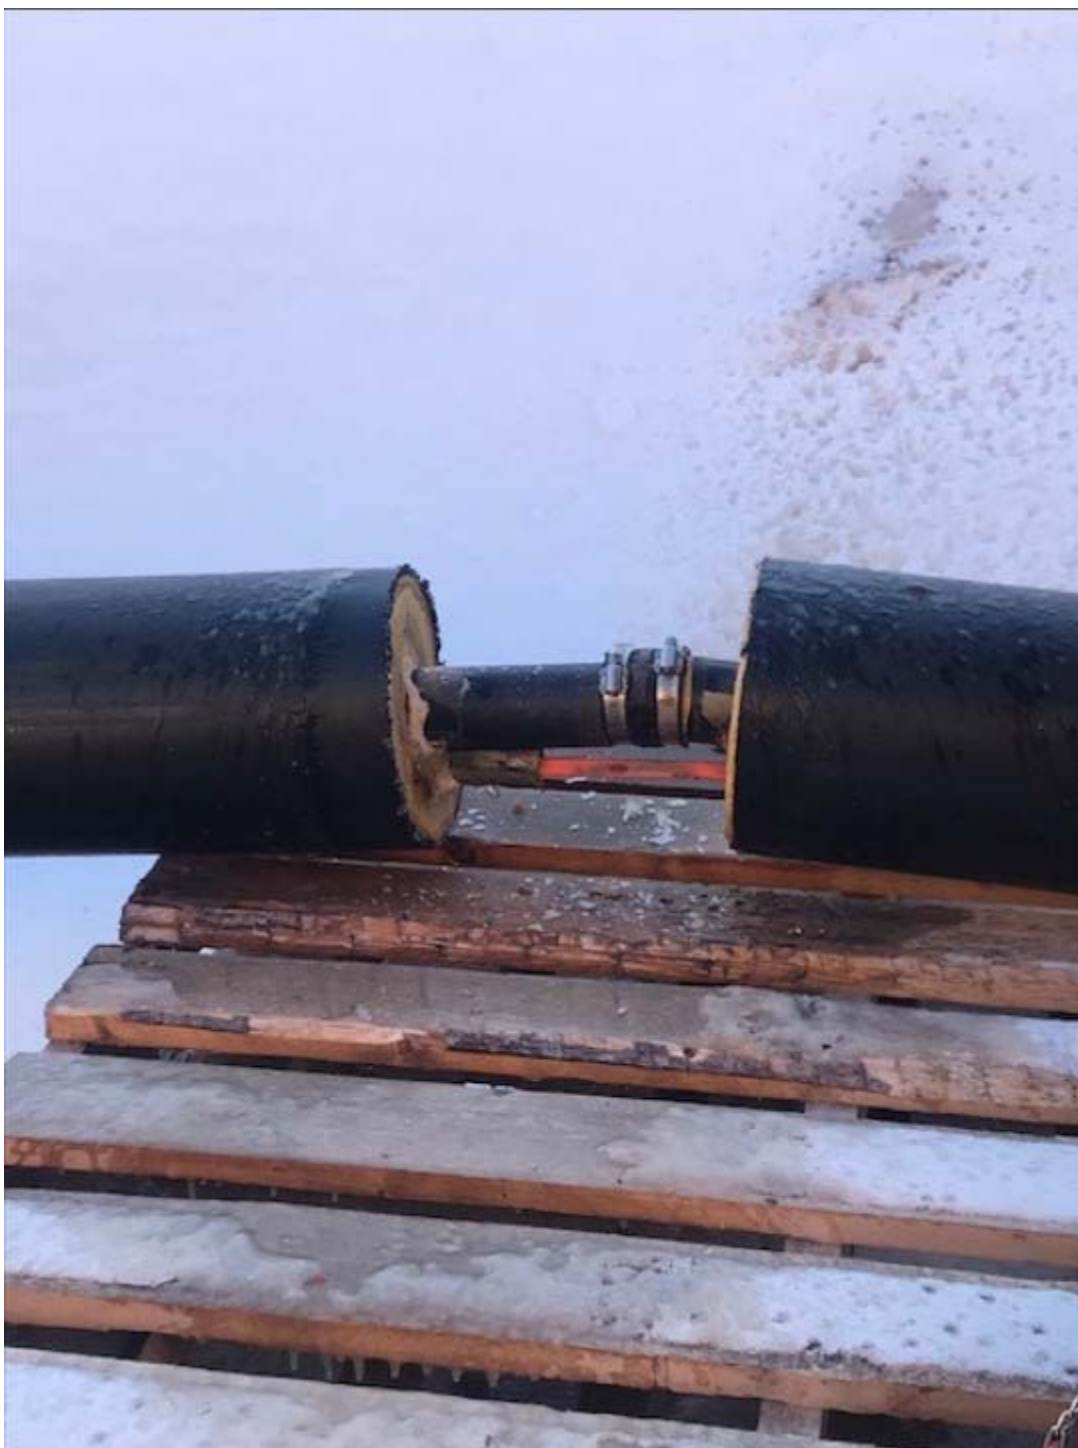
On April 26, 2018 at approximately 09:00 hrs during a routine inspection, housing maintenance found a leak at the Weather Haven Complex at the Mine Site. Upon initial investigation, it was determined that the discharge line sourcing from the dry lift station had separated at a coupling. The coupling was immediately repaired and bump tested to ensure a tight seal. Approximately 300L of sewage was released to the adjacent camp pad ground surface, impacting an approximate area of 15m². The location of the spill was confined to the Weatherhaven Camp pad and is greater than 100 metres from the closest water body which is currently frozen.

Photo 1. Spill location before repairs are made

Procure fit for use horizontal flow fittings for install on discharge line. Continued daily lift station inspections of the system, and continued snow/ ice removal during these inspections to prevent build-up and pressure on the couplings.

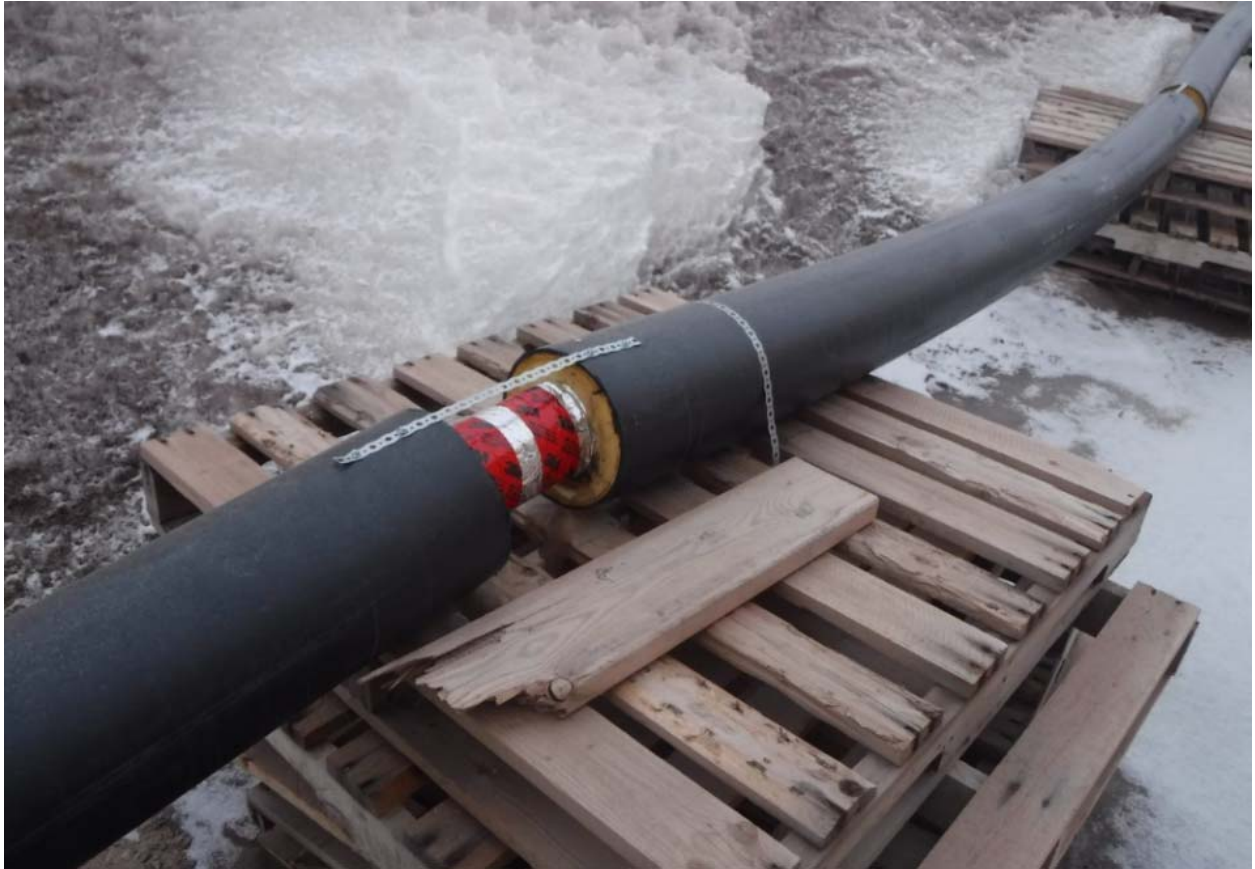
Photo 2. Lift station discharge line after repairs were completed.

The coupling was repaired and the discharge line subsequently reconnected. The coupling was bump tested before the system was put back into service. Contaminated snow and ice was removed and disposed of at the Polishing Waste Stabilization Pond.

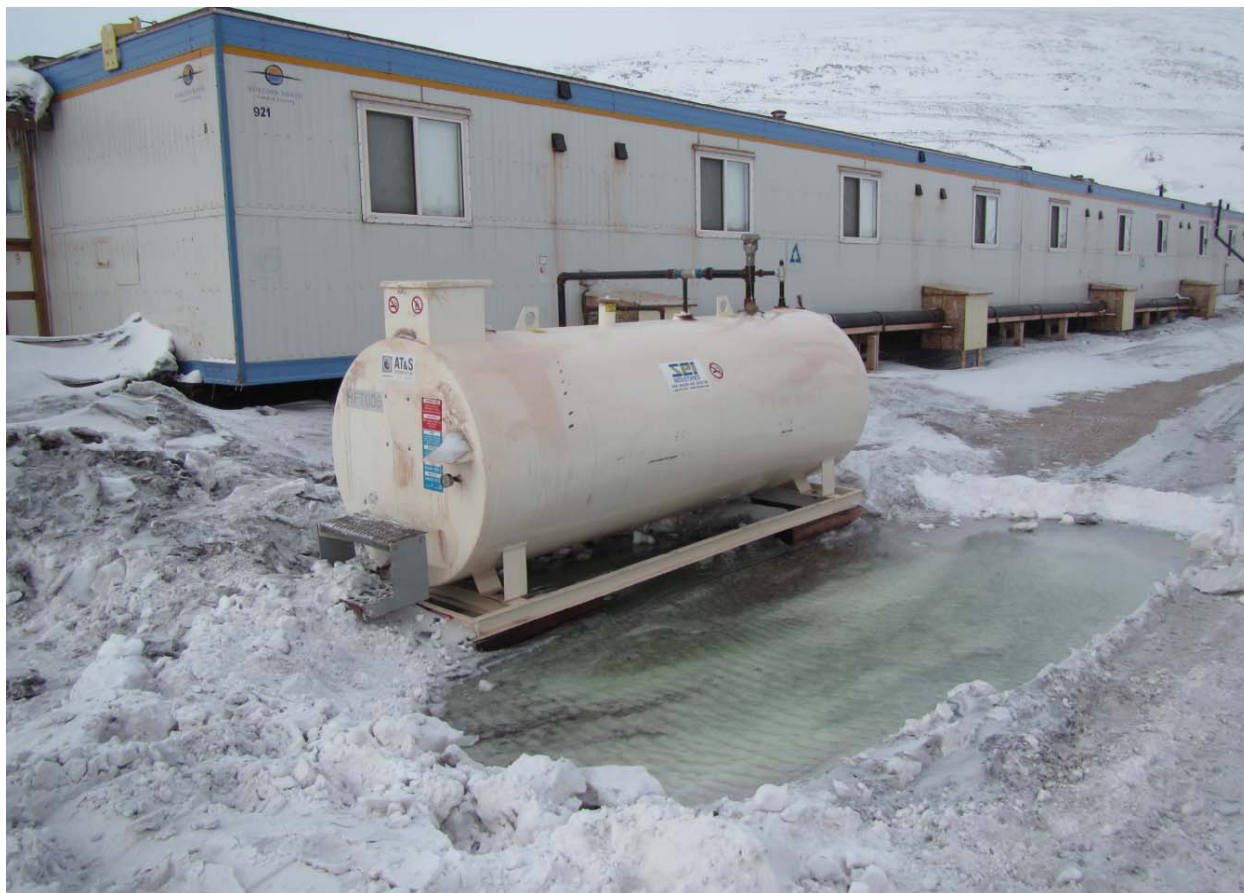
At 19:00 HRS on April 29th, security informed Site Services supervisor of a leak at the AD wing fuel tank. Upon arrival, the supervisor discovered a flow of fuel coming from the venting cap at the top of the tank. Upon initial investigation, it was discovered that the float for the fuel tank had failed due to a compromised electrical wire and approximately 0.5m³ of diesel fuel was released onto the camp pad, impacting an area approximately 23m². An investigation determined that due to a compromised wire that provided power for the float switch, the float failed causing the day tank pumps to continually be operating. As the supply of fuel exceeded the demand, the day tank filled and excess fuel returned to the main tank through a two inch return line. An audible quarter inch orifice whistle fitting, which was installed on the two-inch line (red fitting under the main vent camp), did not allow the fuel to return at the same rate and the fuel overflowed through the vent on the main tank.

Photo 1. Spill location before clean-up

The supervisor shut off the valves immediately, which stopped the release and initiated spill response. Snow berms were constructed and absorbent pads confined the spill to an area directly beside the fuel tank. The emergency response truck was deployed to collect the remaining fuel into a tote. The contaminated material was subsequently scraped up and placed in quatrex bags.

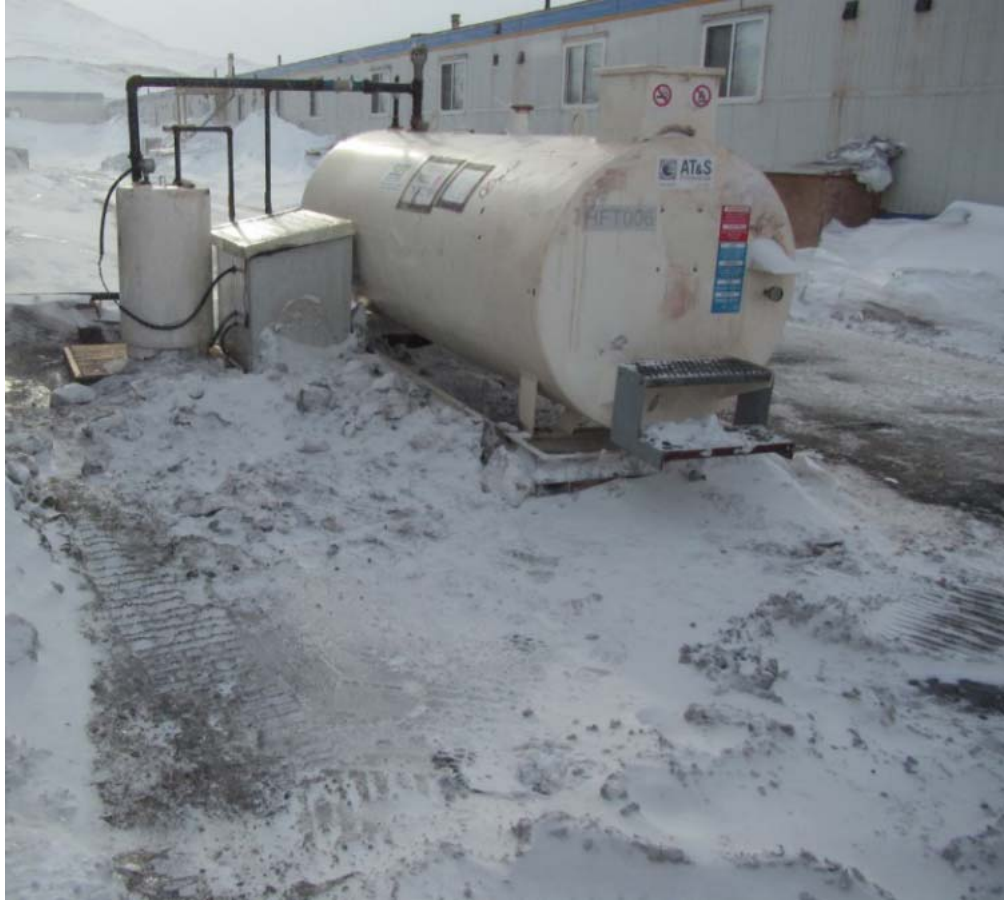
Photo 2. Spill location after cleanup

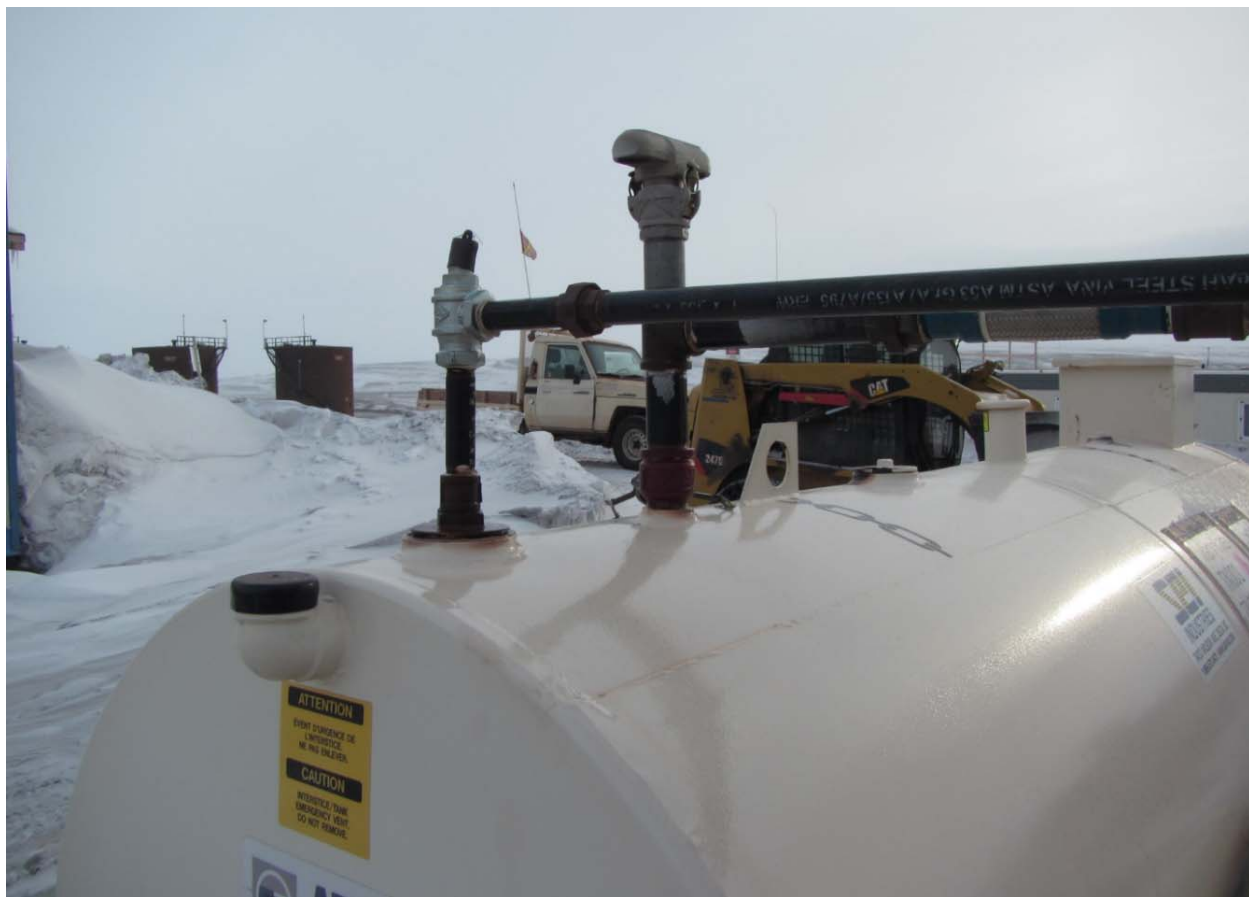
Photo 3. Vent pipe and whistle before retrofit

A retrofit of the remaining fuel tank systems across site to isolate the audible orifice whistle fitting and vent piping to another manifold on the tank and pipe the return line directly into the tank to ensure a closed loop even if float switches failed again.

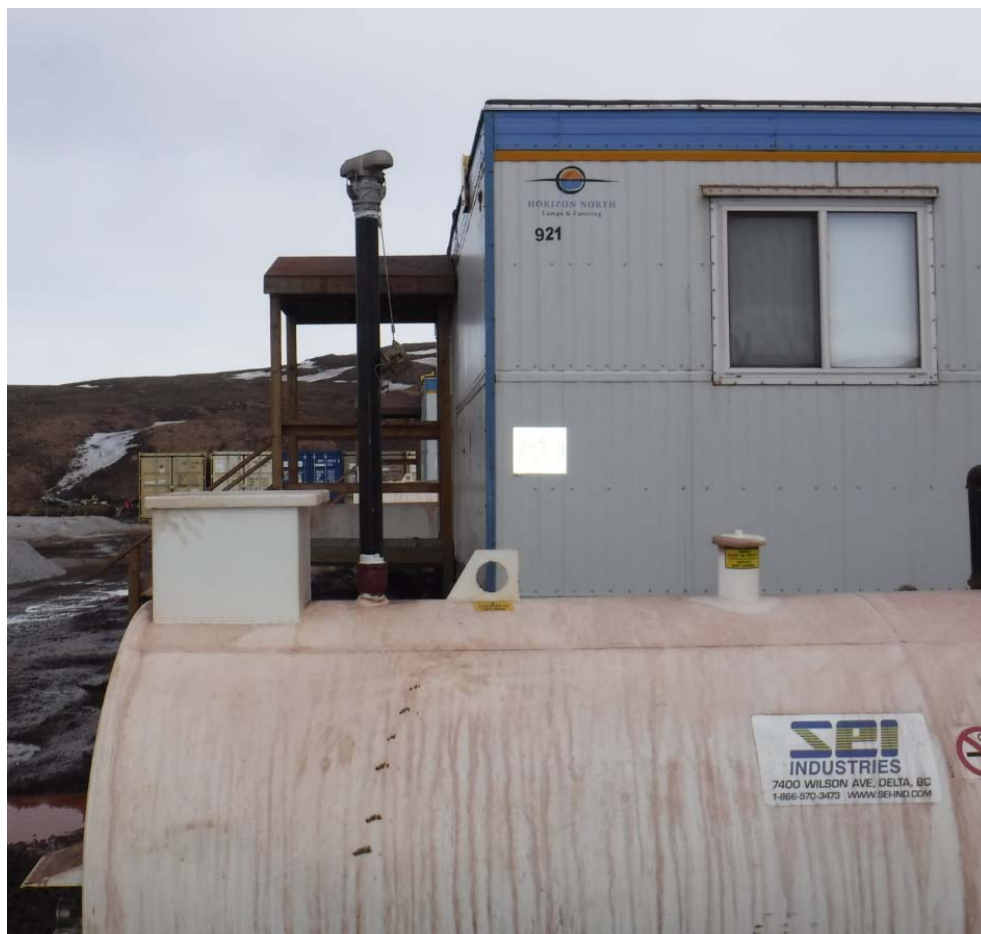
Photo 4. Retrofit implemented on main tank

AD wing fuel tank has been retrofitted with new design to enable continued circulation of fuel. The whistle was moved to a new location, along with the vent cap, to ensure continual recirculation between the tank and the pump if float failure were to occur. Parts are being procured for the retrofit of all fuel day tanks at the Mine Site and Port Site complexes.

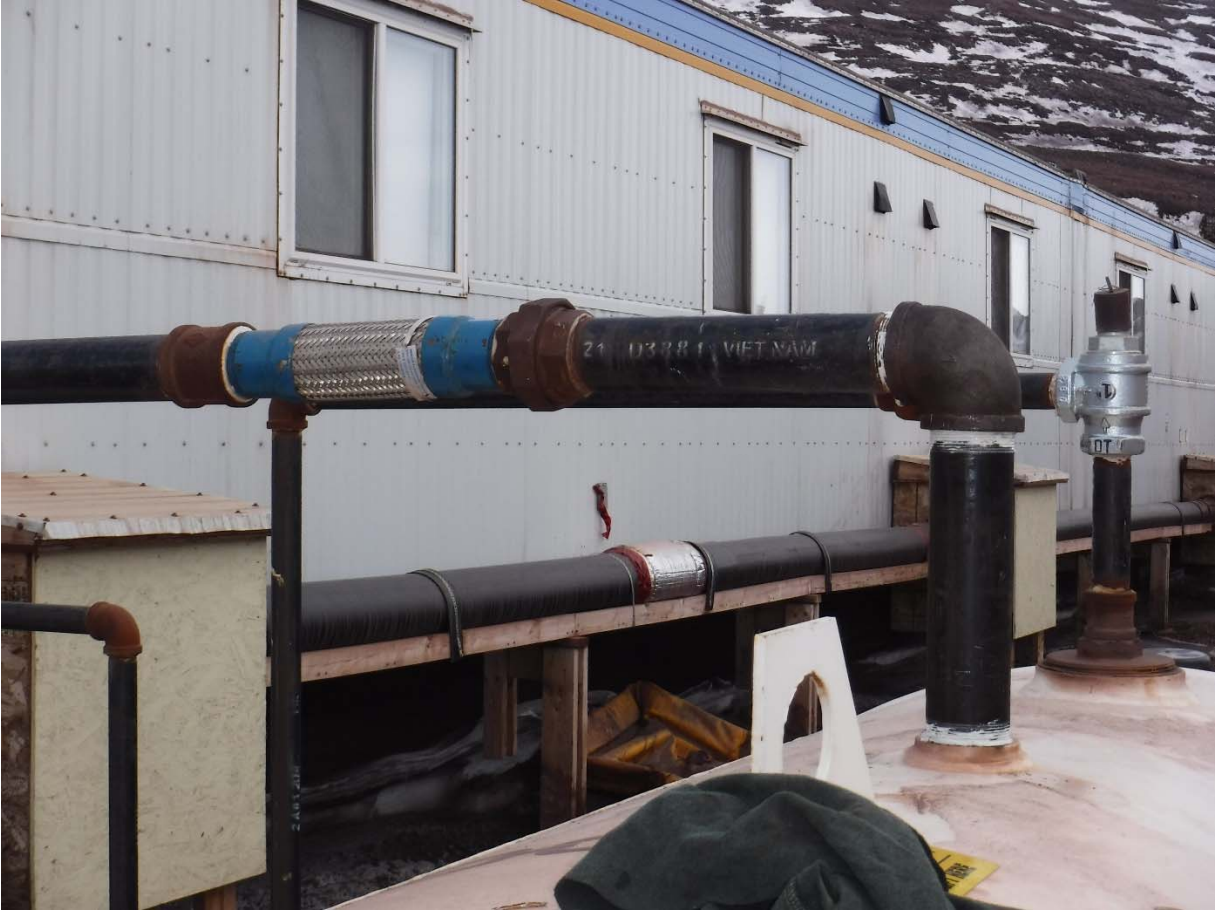
Photo 5. Return line without audible whistle fitting on main tank

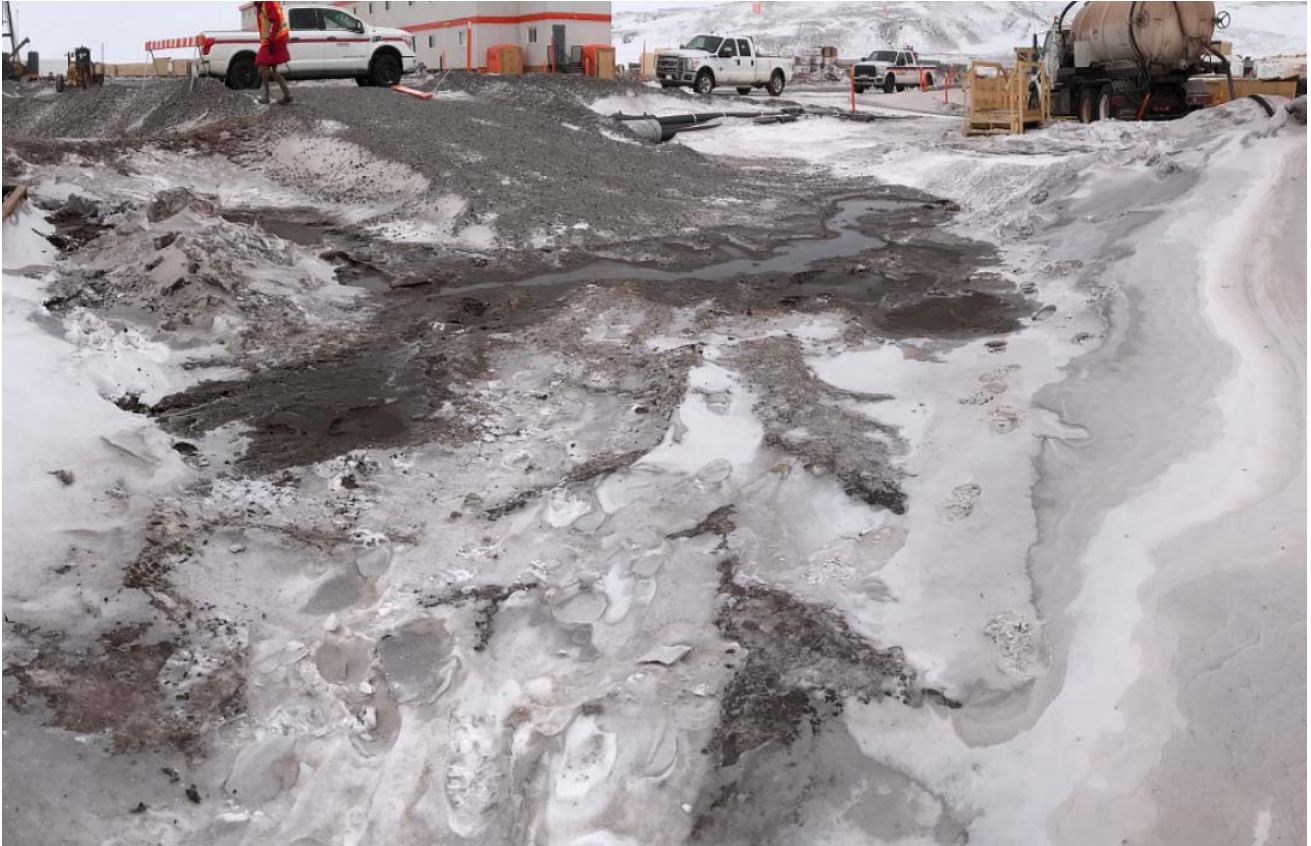
On April 30 at 11:00 Hrs, a vac truck operator discovered water around the outside of the wasting door at the new Waste Water Treatment Plant (WWTP). Upon investigation, it was discovered that the wasting pump had overfilled the tank, overflowing through the door onto the surrounding camp pad. Approximately 1.3 m³ of raw sewage was released and confined to the adjacent pad. Due to a communication breakdown, one WWTP operator had manually overridden the system and failed to communicate the change to his colleague operator. This caused the wasting pumps to operate permanently, not on a timed cycle, resulting in the overflow.

Photo 1. Overflow spill on ground surrounding the WWTP

All operators at sewage plants need to be in communication throughout the day with systematic checks. It is not common practice to have two operators in the WWTP; any changes in the system must be verified by both operators through a Standard Operating Procedure (SOP). All contractors operating both the WWTP and WTP must follow and implement.

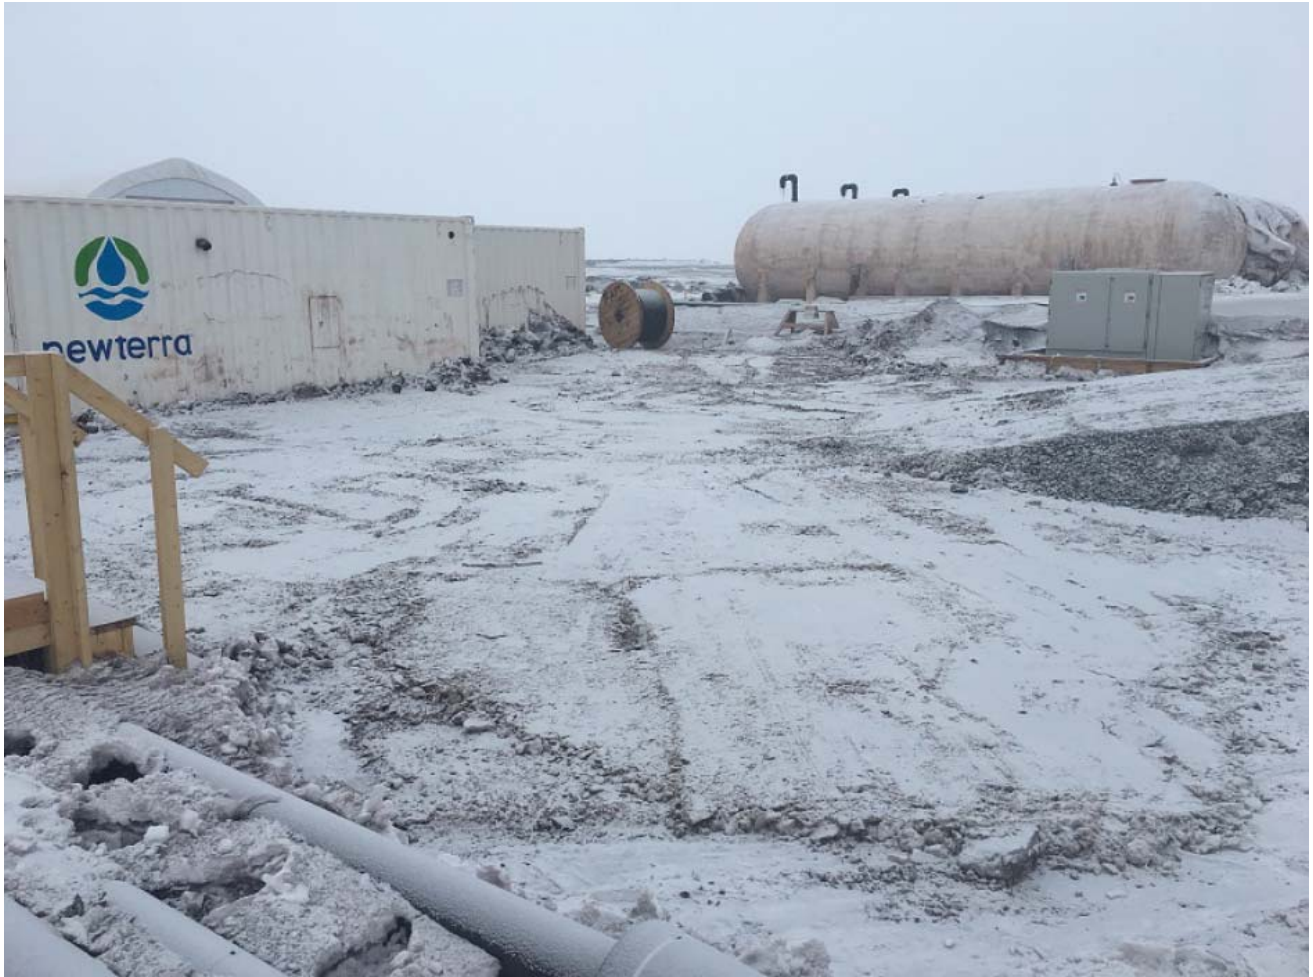
Photo 2. Surrounding the WWTP pad after site clean up.

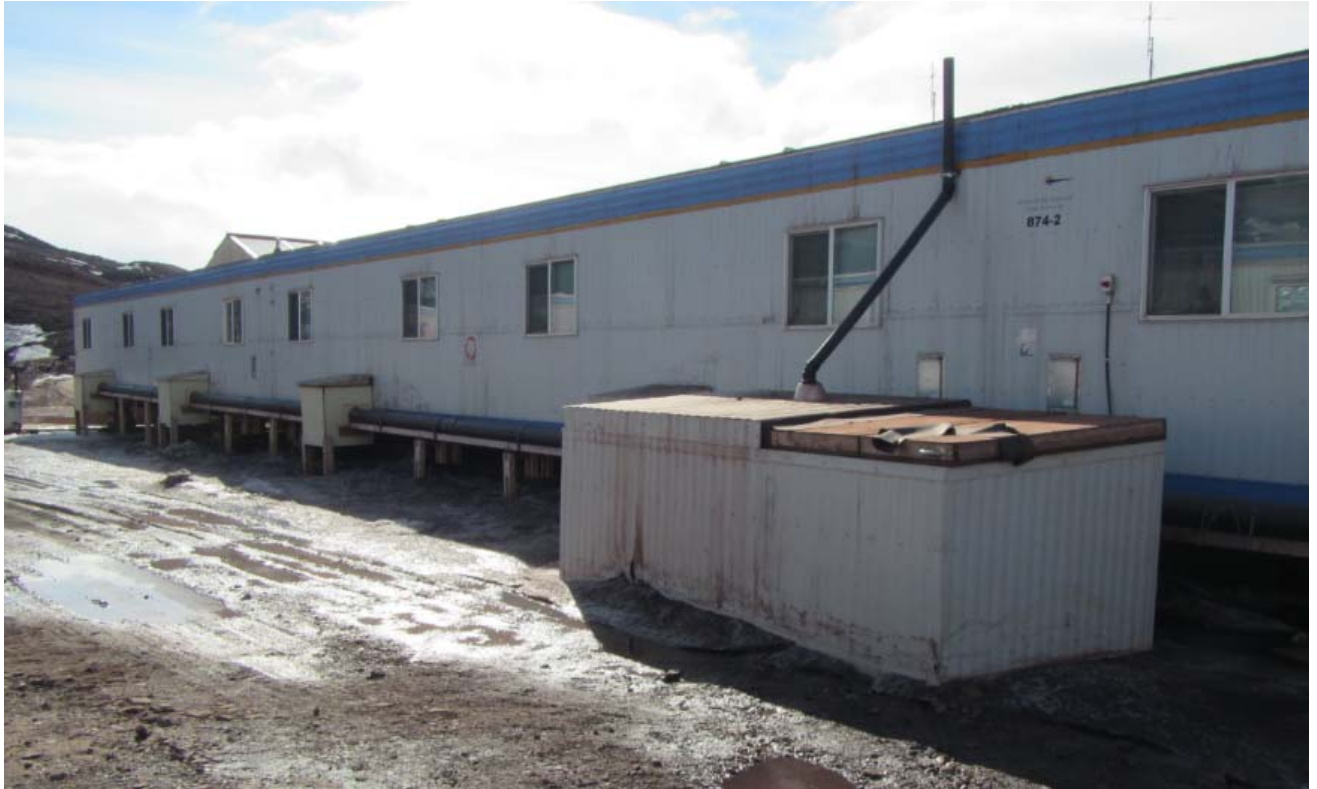
On May 4th, 2018, 20:00 Hrs, an Environment Department employee observed discoloured water near Lift Station 5 at AE Wing North. It was determined to be sewage upon inspection. Housing Maintenance and Surface Works Supervision was notified immediately. The source of the spill was an overflow of lift station 5. The lift station was being discharged through a regular vacuum truck schedule however due to an error in the implementation of this schedule the overflow occurred. Communications and associated vacuum truck scheduling procedures are being revised to prevent an overflow reoccurrence. Approximately 250 Litres impacted the adjacent MSC pad to the lift station migrating over an area of approx. 15m². The spill is >100 m from the nearest water body which is currently frozen.

Photo 1. AE Lift Station after clean up

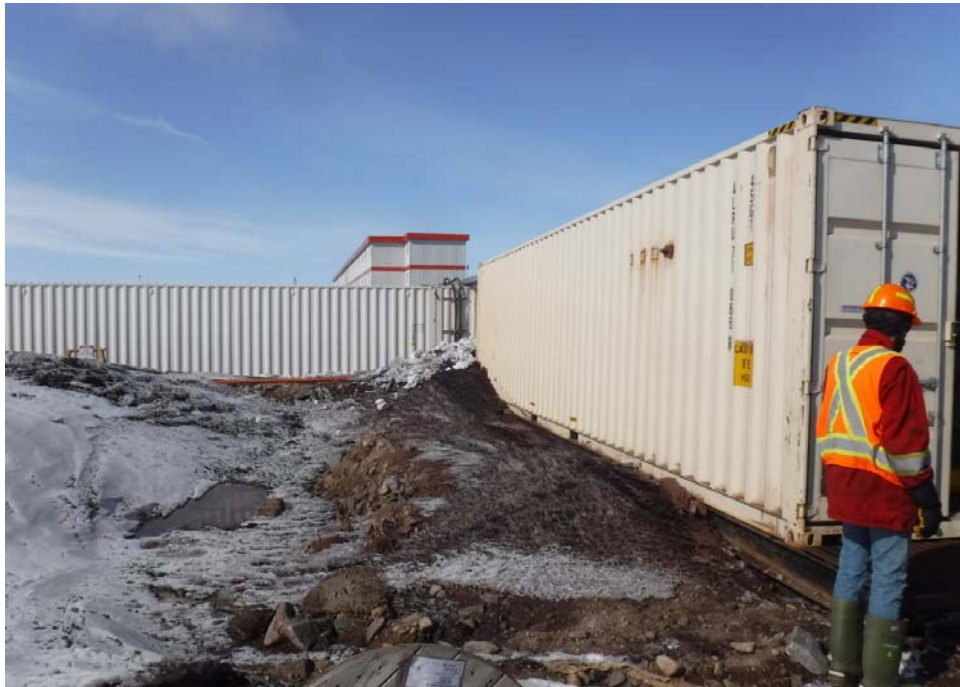
On May 5, 2018 at 11:00 Hrs a vac truck operator was approaching the new wastewater treatment plant (WWTP) at the Mine Site and observed liquid leaking from the effluent tank door. Upon investigation, it was determined that the effluent tank had overflowed and approximately 0.5m³ of treated effluent was released to the WWTP pad, impacting an area of approximately 10m². Communications and associated vacuum truck scheduling procedures are being revised to prevent an overflow reoccurrence. The location is >100m to the nearest water course which was frozen.

Photo 1. WWTP Before clean up

It was recommended that a Standard Operating Procedure (SOP) be implemented to define operational check and balances of the plant while ensuring all communication and responsibility requirements of an operating WWTP and discharge system are clearly outlined. An audio alarm system was recommended for installation to warn of high tank levels

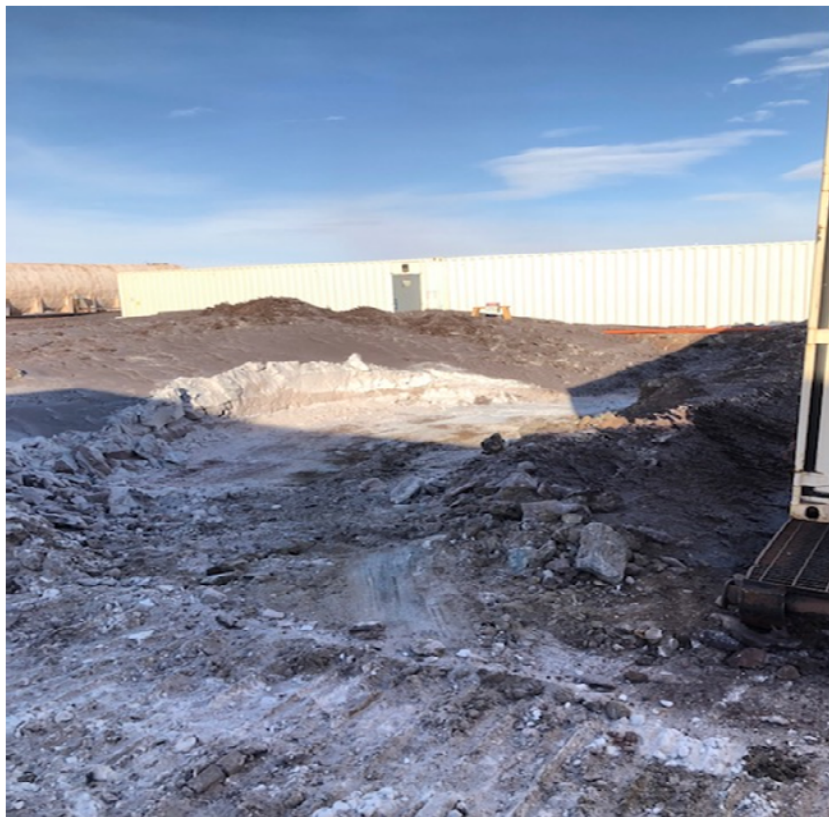
Photo 2. AE Lift Station after clean up
