APPENDIX E.8.4
INITIAL AND FOLLOW-UP SPILL REPORTS
(PART 3 OF 4)

Re: Follow-up to Spill #18-180, Reported on May 18, 2018, Mary River Project - Water Licence No. 2AM-MRY1325

Re: Follow-up to Spill #18-182, Reported on May 19, 2018, Mary River Project - Water Licence No. 2AM-MRY1325

Re: Follow-up to Spill #18-209, Reported on June 05, 2018, Mary River Project - Water Licence No. 2AM-MRY1325

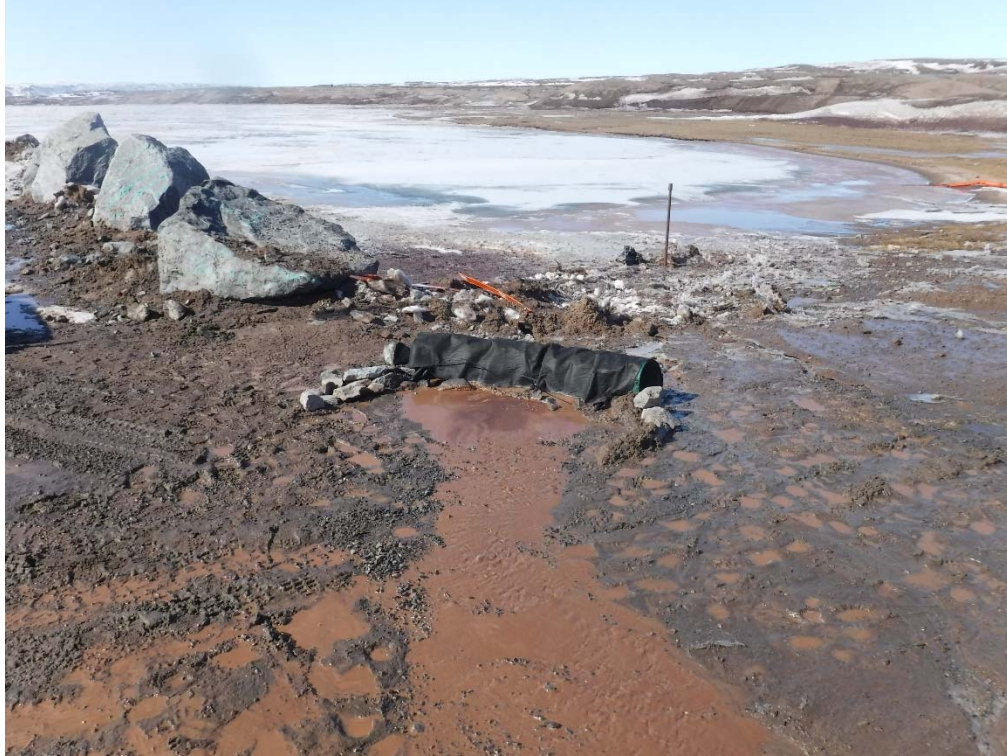
At approximately 13:00 HRS on May 16th, 2018, during the execution of the daily freshet monitoring program at the Mary River Mine Site, environmental technicians observed sediment-laden water to be breaching the series of sediment ponds/check dams that have been constructed along the Camp Lake Jetty access road. Elevated levels of suspended solids were observed from sediment impacted snow melt which mobilized due to the overland flow. In addition to the implementation of erosion and sediment control measures, water quality sampling was conducted of water entering Camp Lake.

Photo 1. May 15, 2018: Sediment-laden water flowing into spring berm before entering Camp Lake

Personnel worked to re-direct flow so that it travelled through the series of check dams, as well as installed silt fencing and spring berms at strategic locations to minimize flow, increase retention time in sediment ponds, and reduce further mobilization of sediment prior to water entering Camp Lake. Once short-term erosion and sediment control mitigation measures were implemented, controls for longer-term solutions to minimize similar occurrences at this location were constructed. The existing series of check dams down the Camp Lake Jetty access road drainage channel were excavated and reinforced, as well as reinforcing and increasing the capacity of the existing settling pond structures.

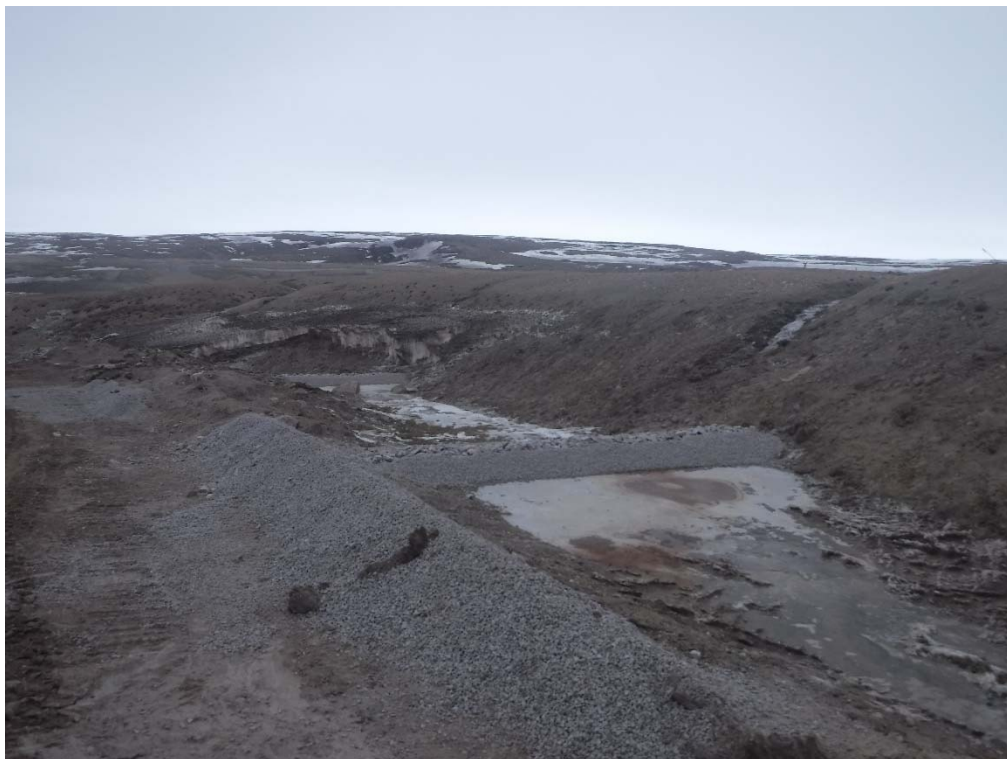
Photo 2. May 22, 2018: Camp Lake Jetty access road drainage channel check dam

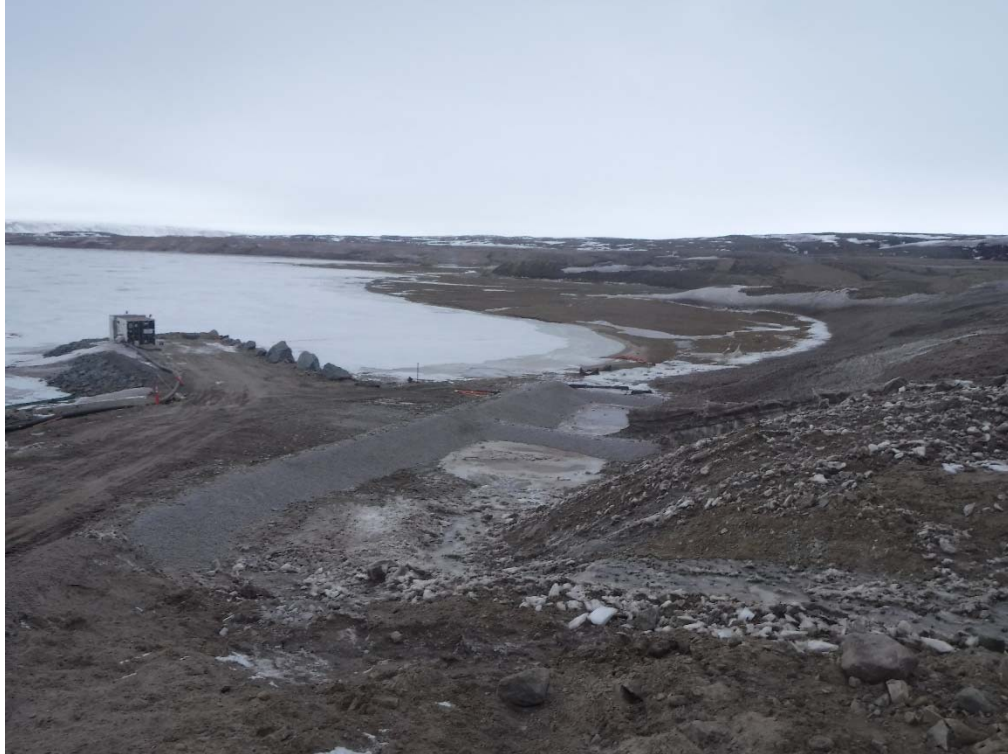
Photo 3. May 22, 2018: Camp Lake Jetty access road drainage channel check dams and berm

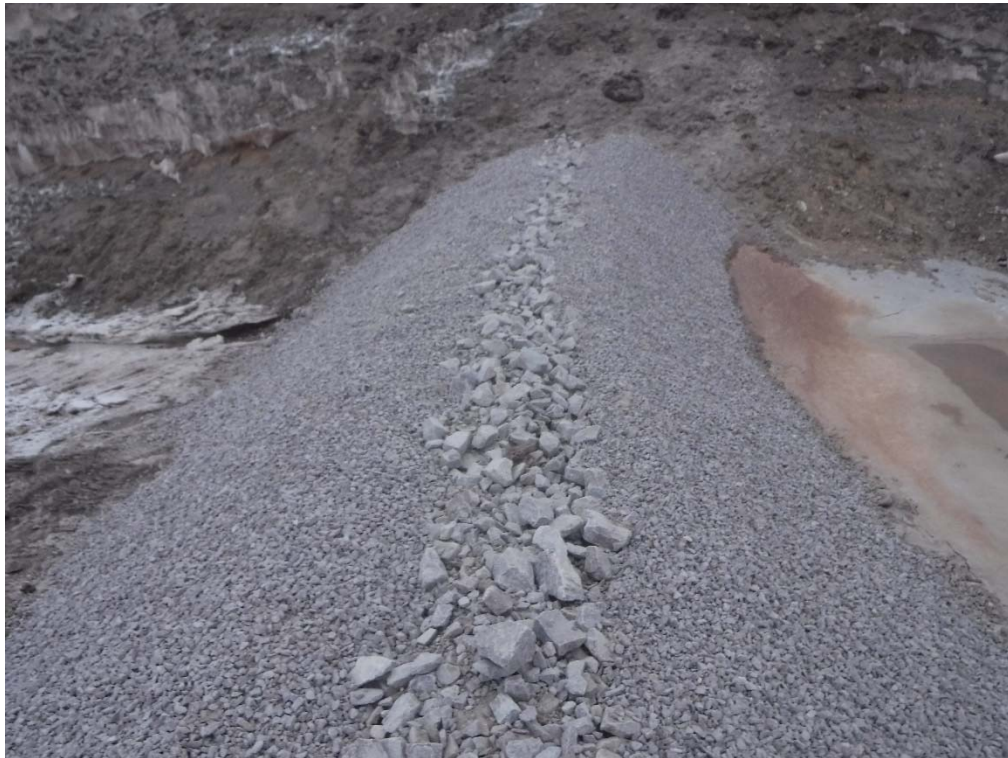
Photo 4. May 22, 2018: Typical check dam/berm cross section

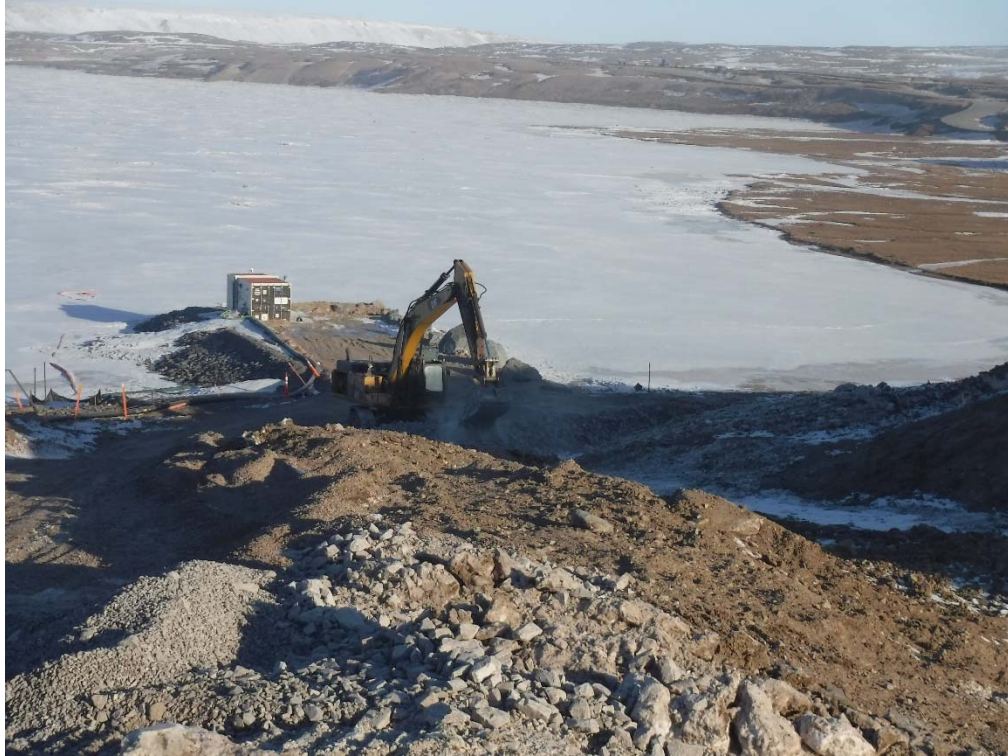
Photo 5: May 21, 2018: Reinforcement of berms/check dams at Camp Lake Jetty, during frozen conditions

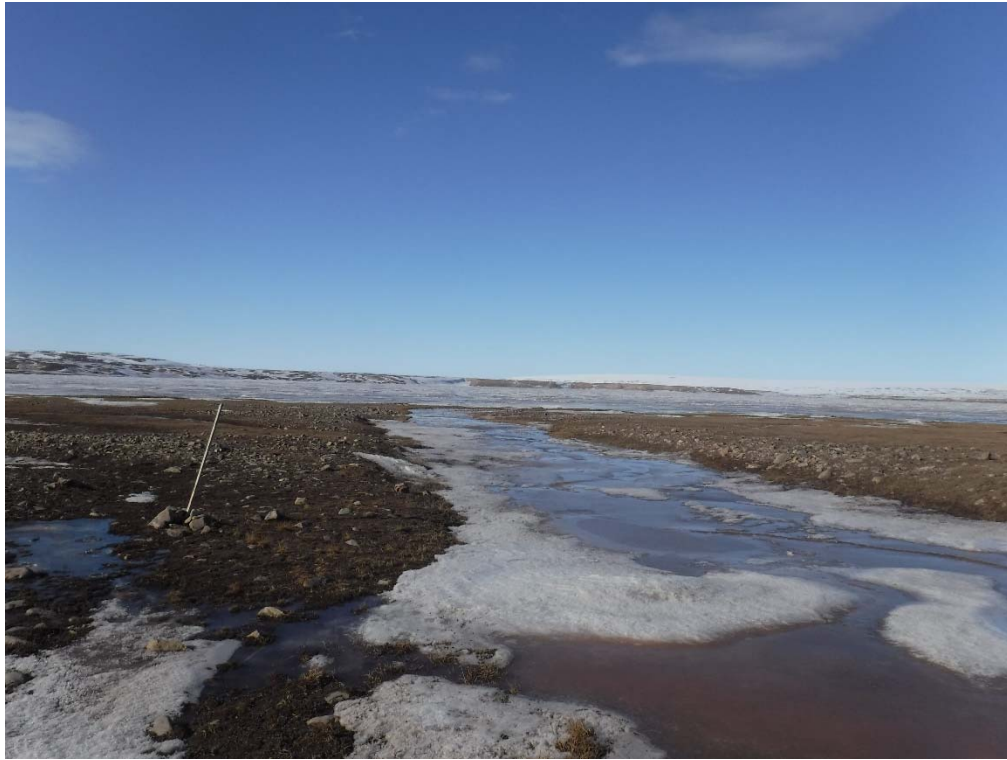
At approximately 15:00 HRS on May 17th, 2018, during the execution of the daily freshet monitoring program at the Mary River Mine Site, environmental technicians observed sediment-laden water to be flowing at multiple locations at the Mary River Mine Site (SDLT and CLT). Elevated levels of suspended solids were observed from sediment impacted snow melt which mobilized as a result of increased overland flow. In addition to the implementation of erosion and sediment control measures in accordance with the Surface Water Management Plan, water quality sampling was conducted of water entering the receiving water bodies. SDLT reports to Sheardown Lake, while CLT reports to Camp Lake.

Photo 1. May 17, 2018: Viewing downstream of sediment-laden water at CLT entering Camp Lake

Upon discovery of the elevated instream TSS conditions at these drainages, personnel worked to install sedimentation mitigation measures, including silt fences and spring berms, in accordance with the Surface Water Management Plan, in an attempt to slow flow and settle sediments prior to entering the streams.

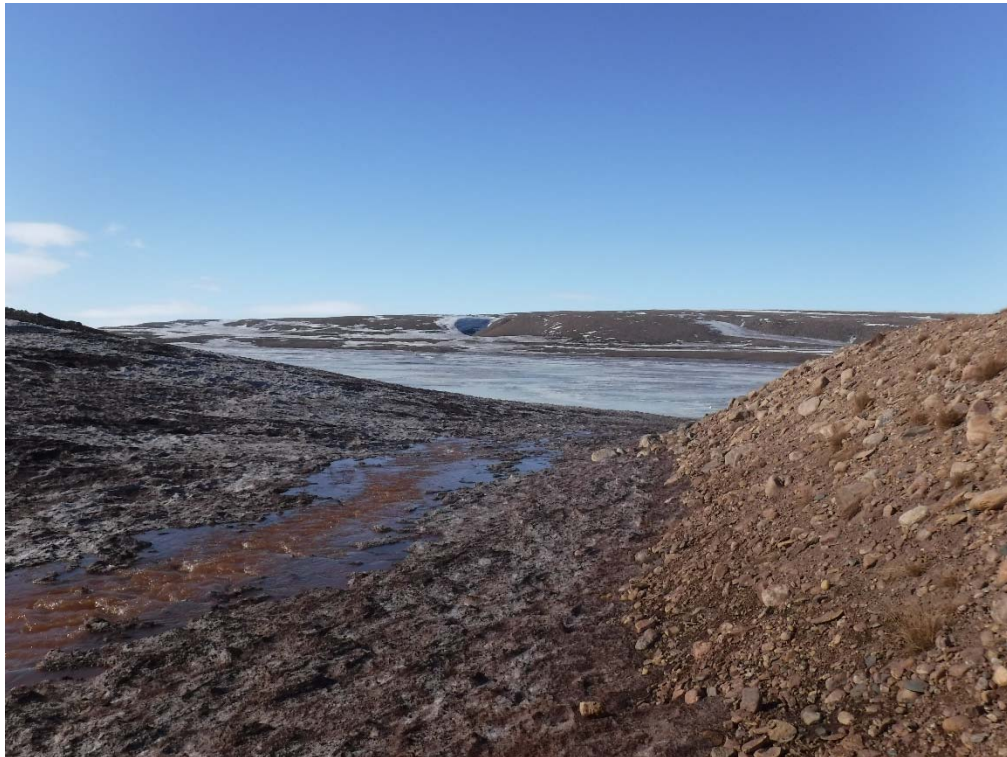
Photo 2. May 17, 2018: Viewing downstream of SDLT of sediment-laden water entering Sheardown Lake

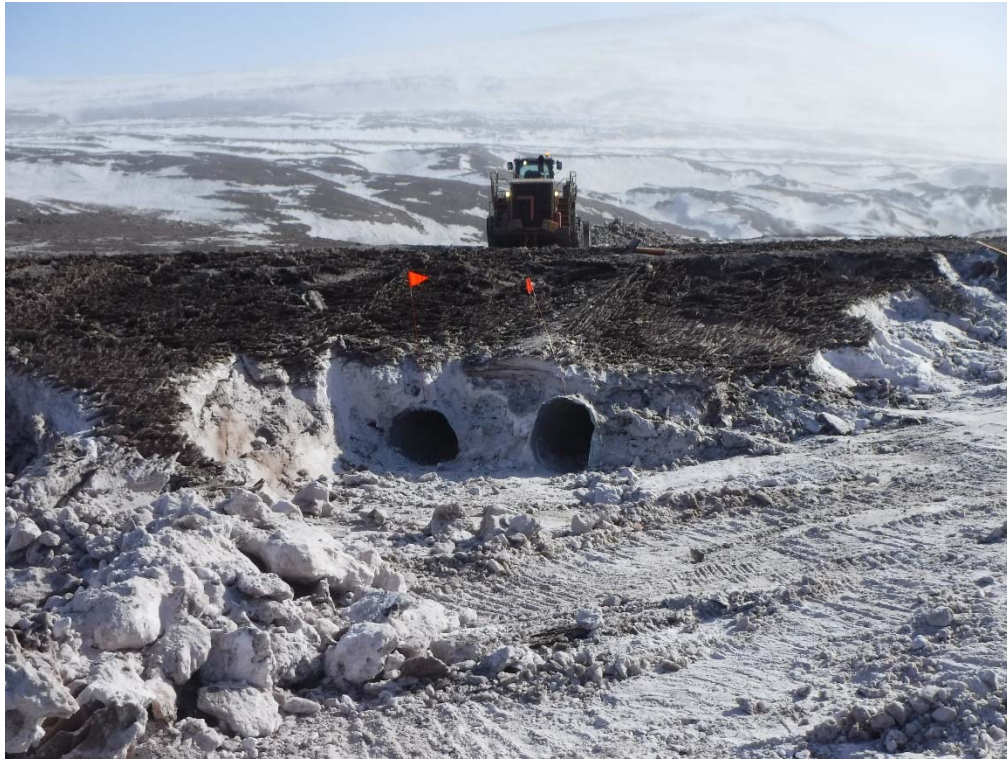
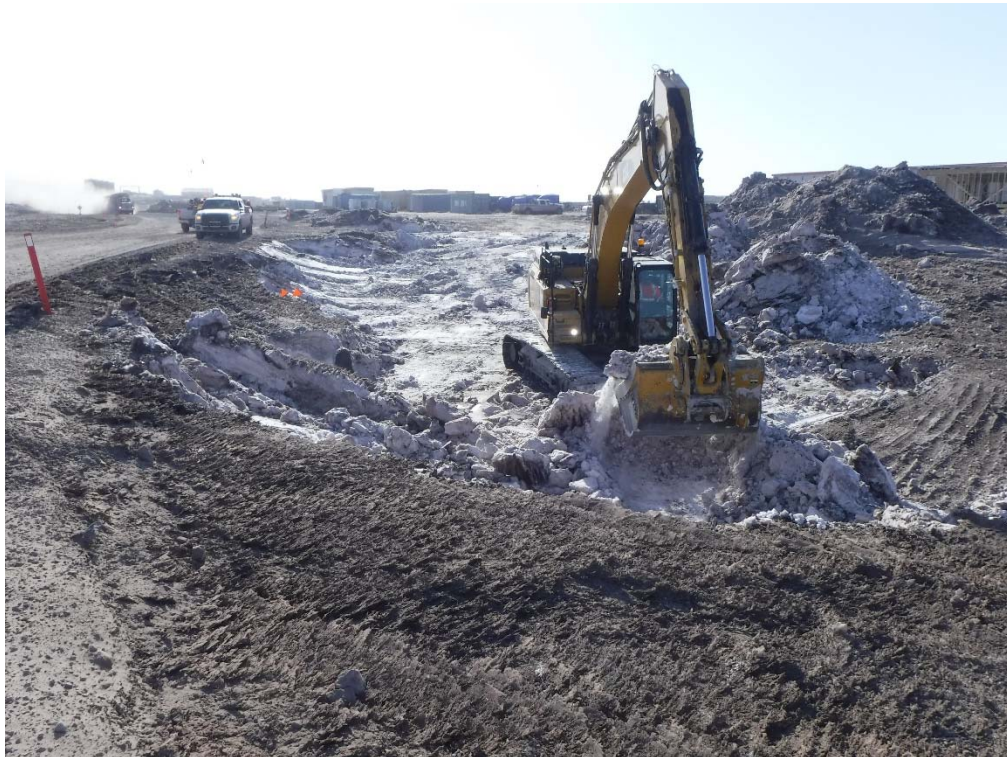
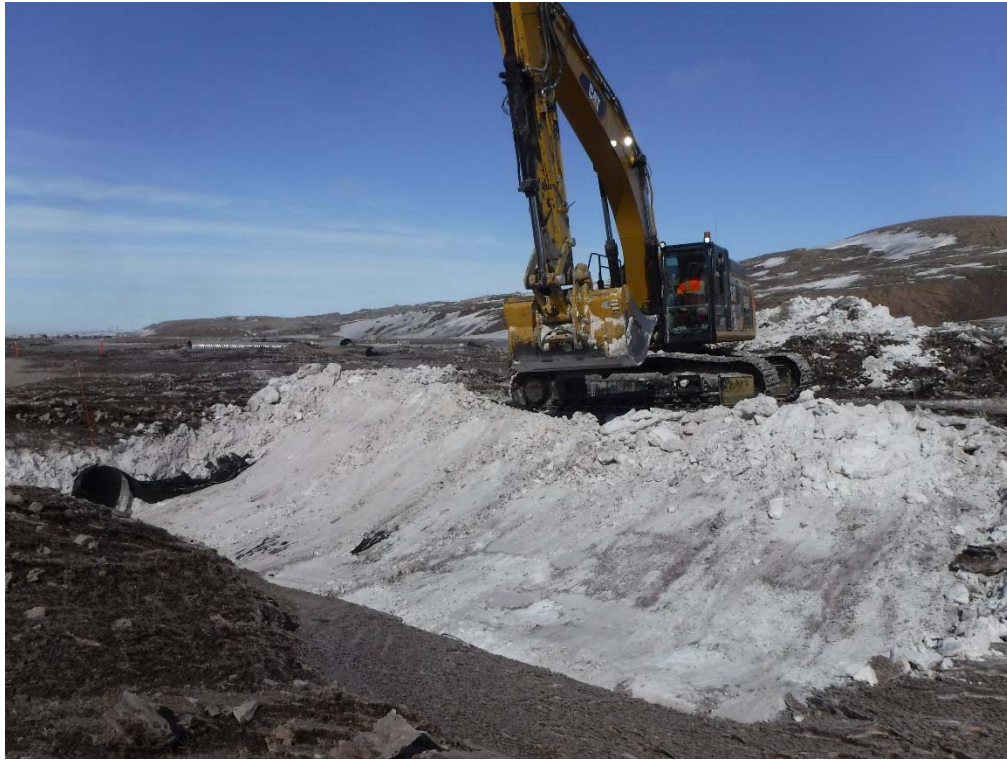
Photo 3. May 9, 2018: Removal of excess snowpack from road crossing above SDLT

In the days leading up to freshet, snow pack around the inlets and outlets of select culvert locations was excavated, including the SDLT and CLT crossings, to reduce the volume of snow melt and thus, the amount of overland flow present to mobilize sediment. The excess snow was removed and transported to the approved snow dump areas. By reducing the excess snow at these locations, the severity and frequency of elevated instream TSS events has been reduced.

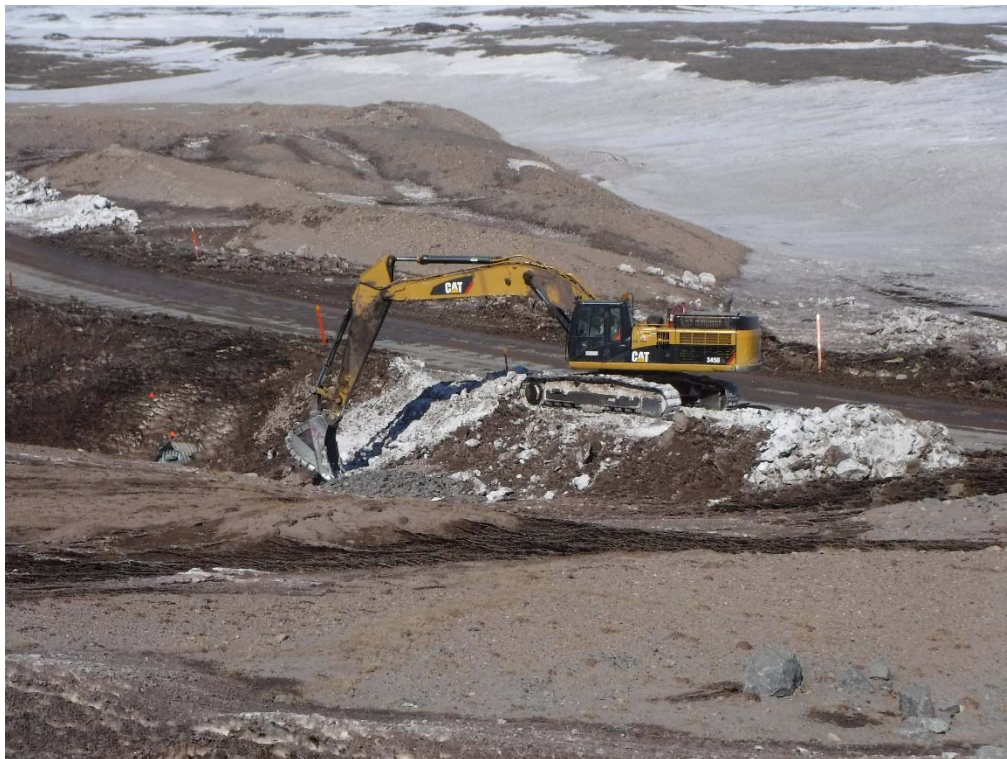
Photo 6. May 13, 2018: Removal of excess snowpack from road crossing above CLT

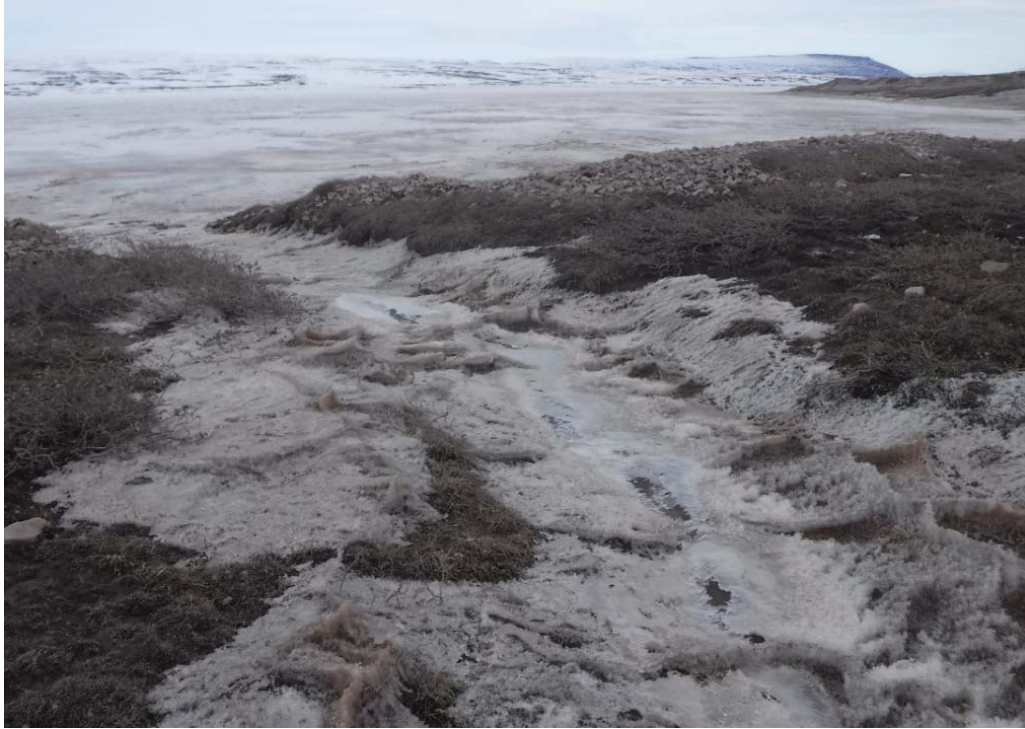
As part of Baffinland's 2018 Tote Road monitoring program, on May 30th, a crossing located at Km 86 (BG27) was identified from received sample results to be flowing above applicable water licence criteria for total suspended solids (TSS). The sediment was generated by the melting snow pack adjacent to the road and other sample results indicate natural sedimentation upstream is also contributing to the elevated TSS in the stream.

Photo 1. May 30, 2018: Viewing downstream BG27 entering waterbody

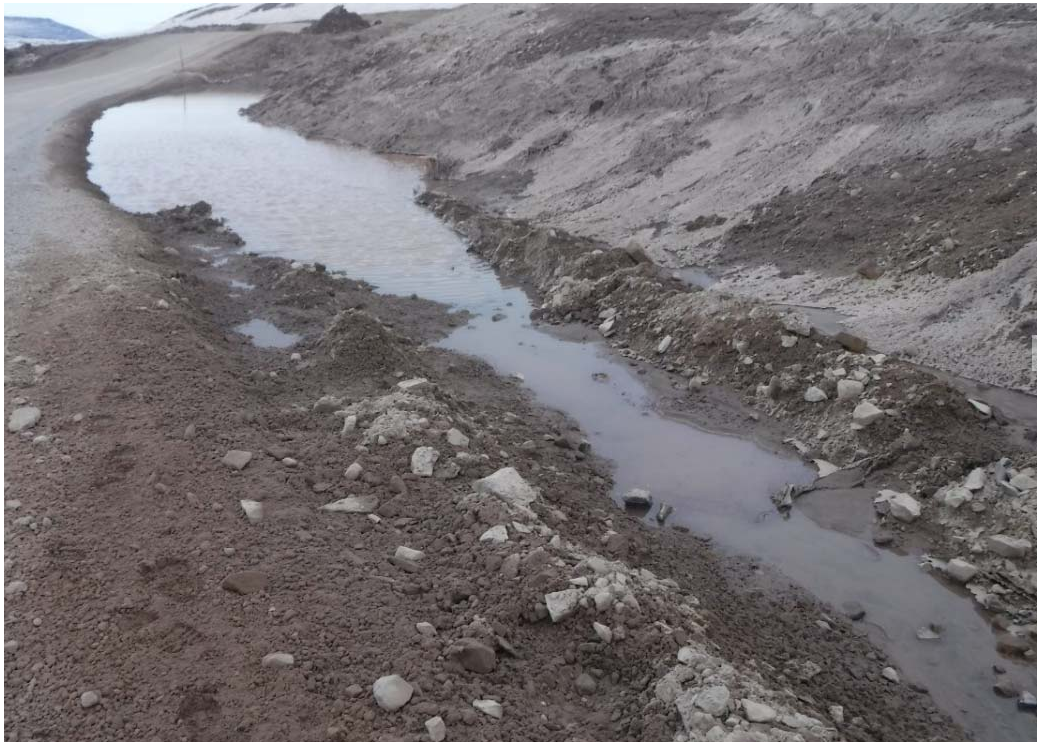
Photo 2. May 30, 2018: Viewing Upstream of BG27

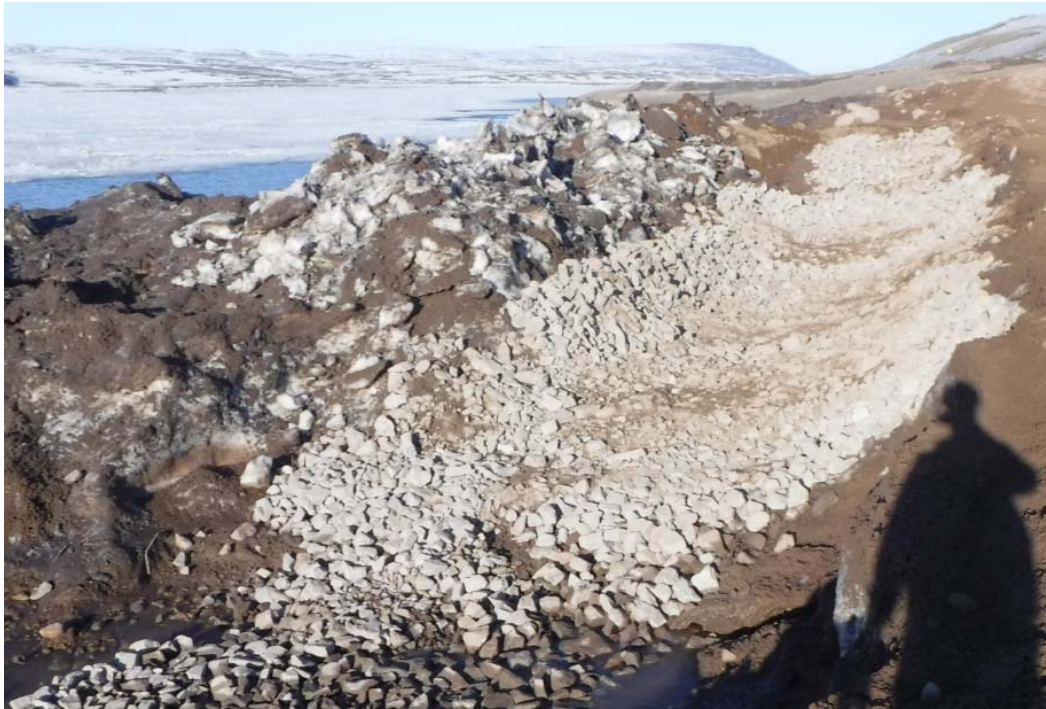
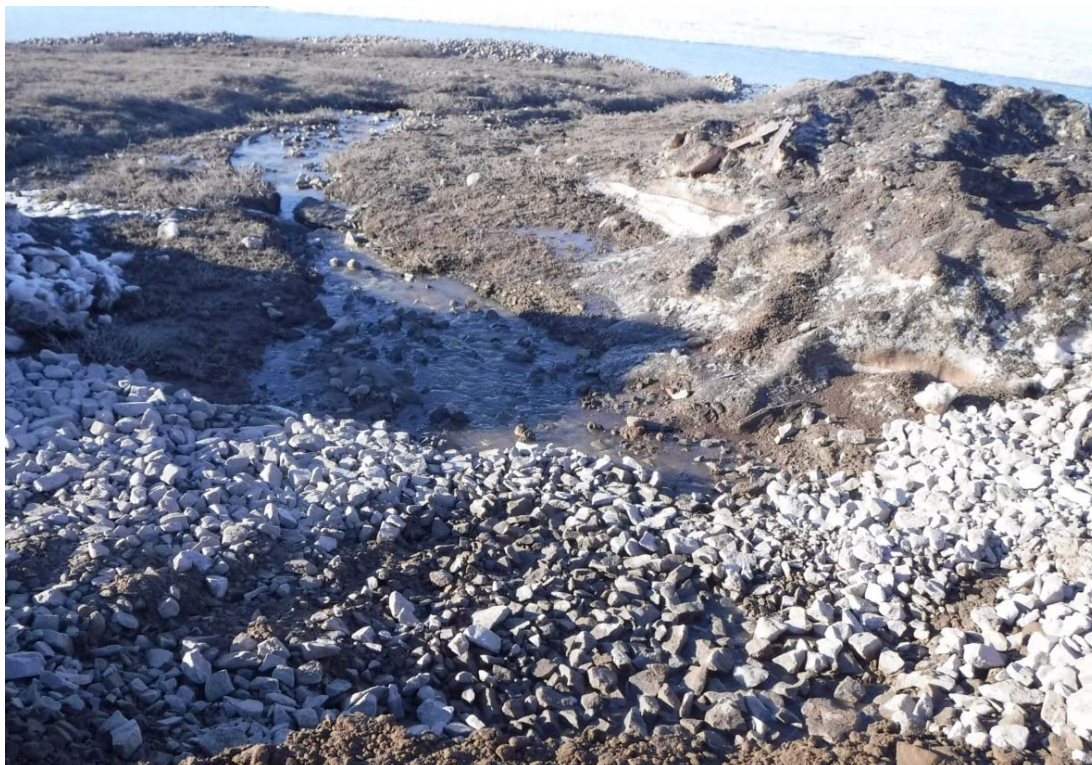
Photo 3. June 6, 2018: Bank armoring with riprap

Upon discovery of the elevated TSS conditions downstream of the culvert crossing, personnel installed sedimentation mitigation measures. Mitigation measures included riprap armoring of the ditches and silt fences to slow flow velocities and settle sediments prior to entering the culvert and stream, as outlined in the Surface Water Management Plan.

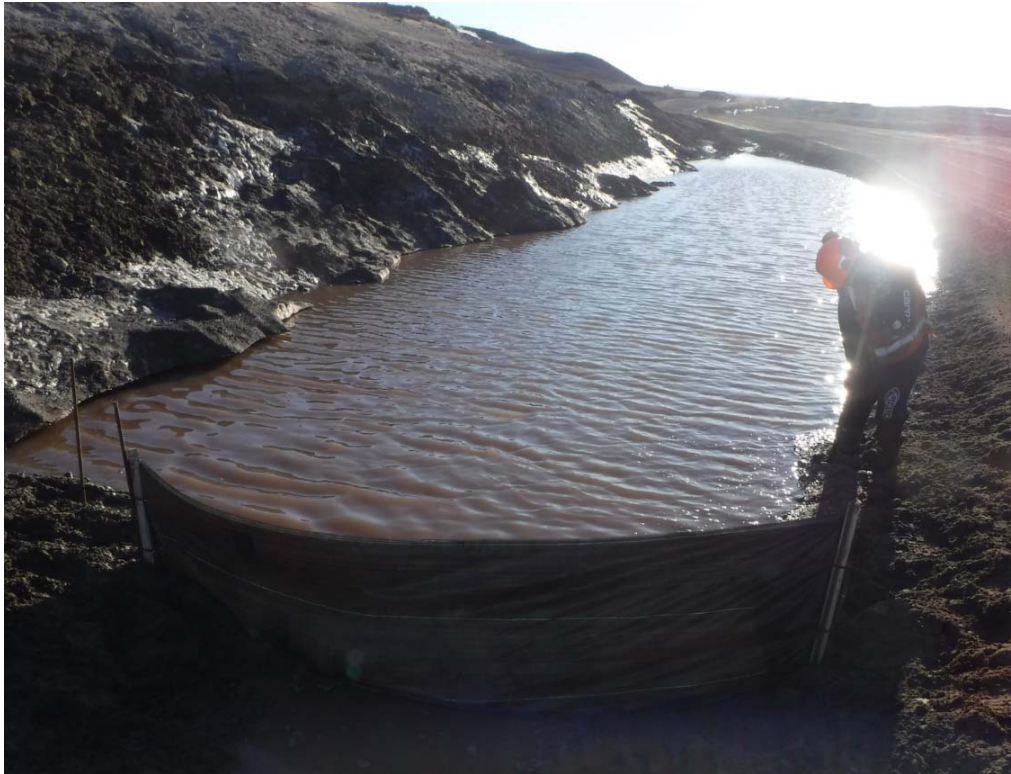
Photo 5. June 6, 2018: Silt fence being installed upstream of crossing

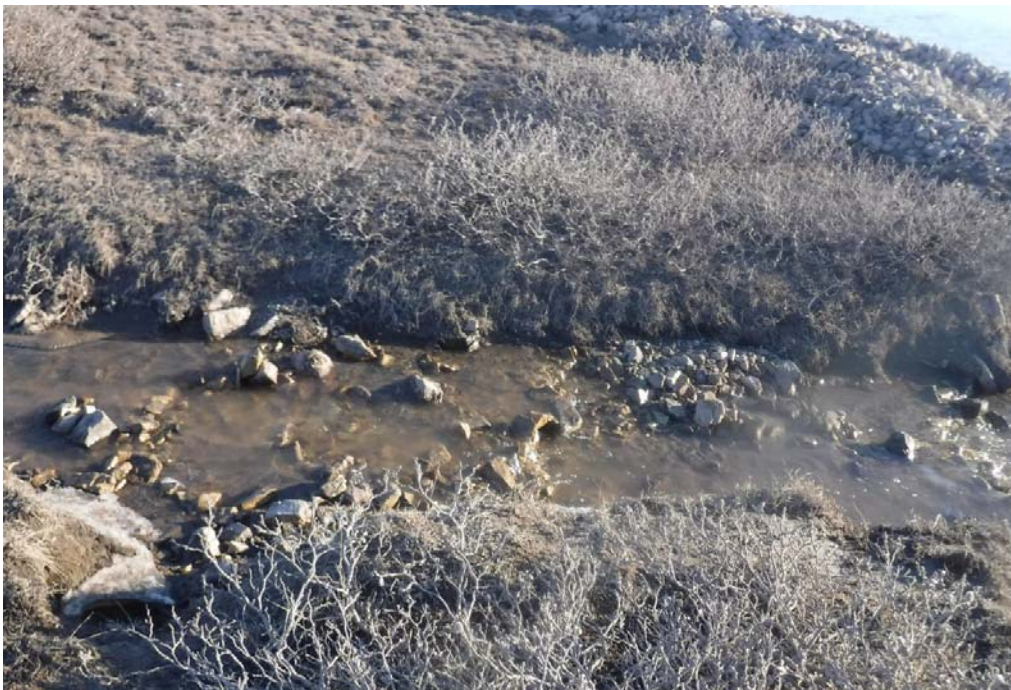
Conditions at BG27 improved following the installation of sediment control measures, with TSS levels returning to below applicable water licence criteria. A more comprehensive Freshet Report will be submitted to document the water quality of surface water crossings along the Tote Road and summarize the areas of concern identified during freshet 2018.

Photo 6. June 7, 2018: Water flowing clear following mitigation measures in place

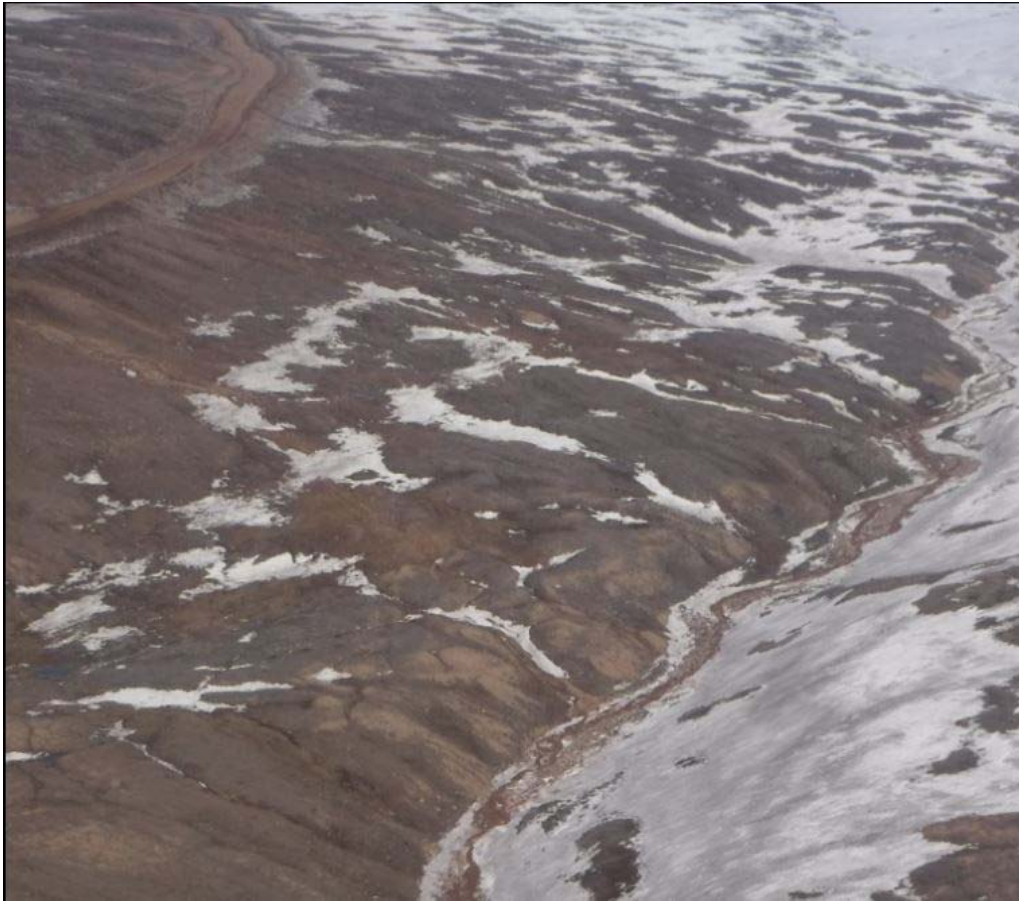
On June 8th, 2018, runoff from the tundra was observed to be flowing into the adjacent ditches between kilometer 107 and 108 along the Mine Haul Road. Upon investigation, surface water runoff from the surrounding tundra entered two culverts resulted in sediment impacted water entering Mary River tributary (non fish bearing). Surface water was immediately diverted away from the Mary River tributary preventing any potential sedimentation impact.

Photo 1. June 9, 2018: Mine Haul Road and Mary River Tributary

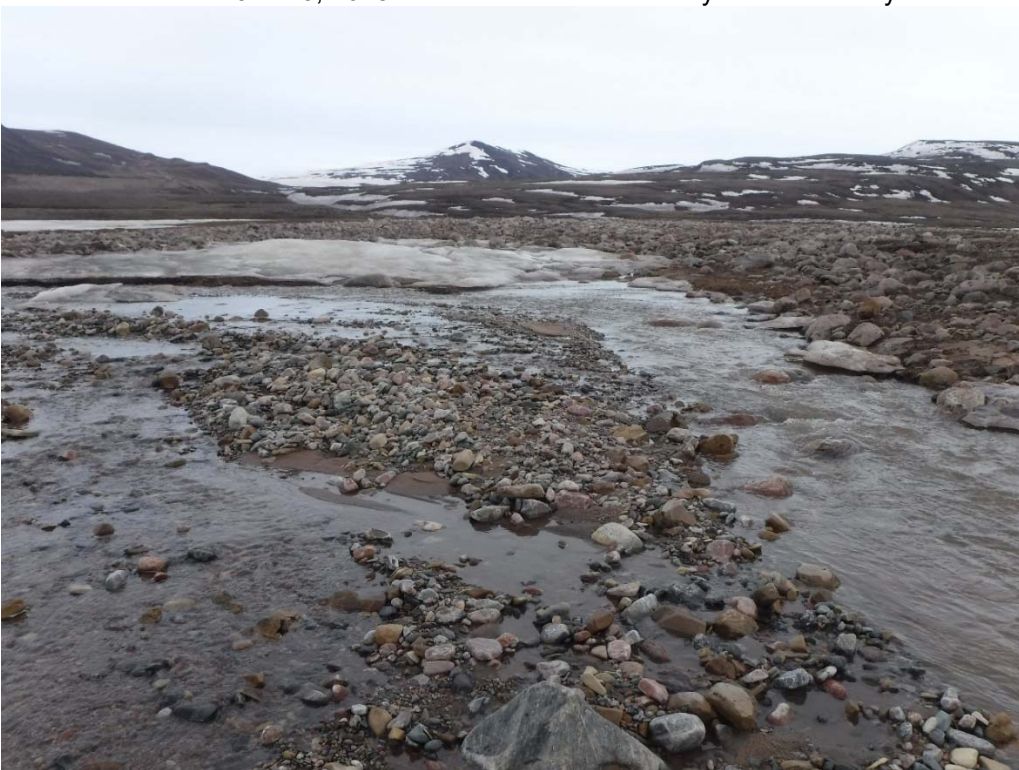
Photo 2. June 13, 2018: Mary River downstream of Mary River Tributary

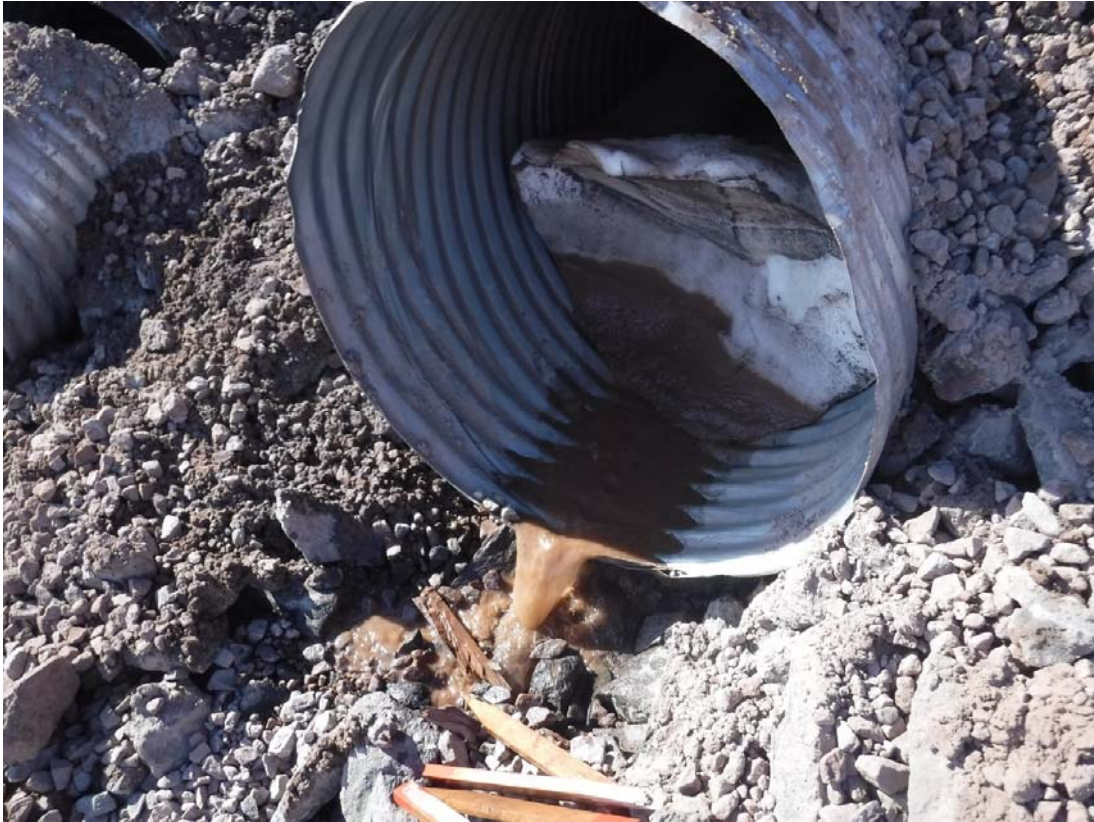
Photo 3. June 10, 2018: Minimal flow from culvert outlet after inlet was blocked off to divert runoff from the Mine Haul Road

Culvert inlets along the Mine Haul Road drainage ditch were blocked off to divert water away from the Mary River catchment area preventing any further sediment laden water. The check dam at the end of the magazine road was also excavated to capture suspended solids.

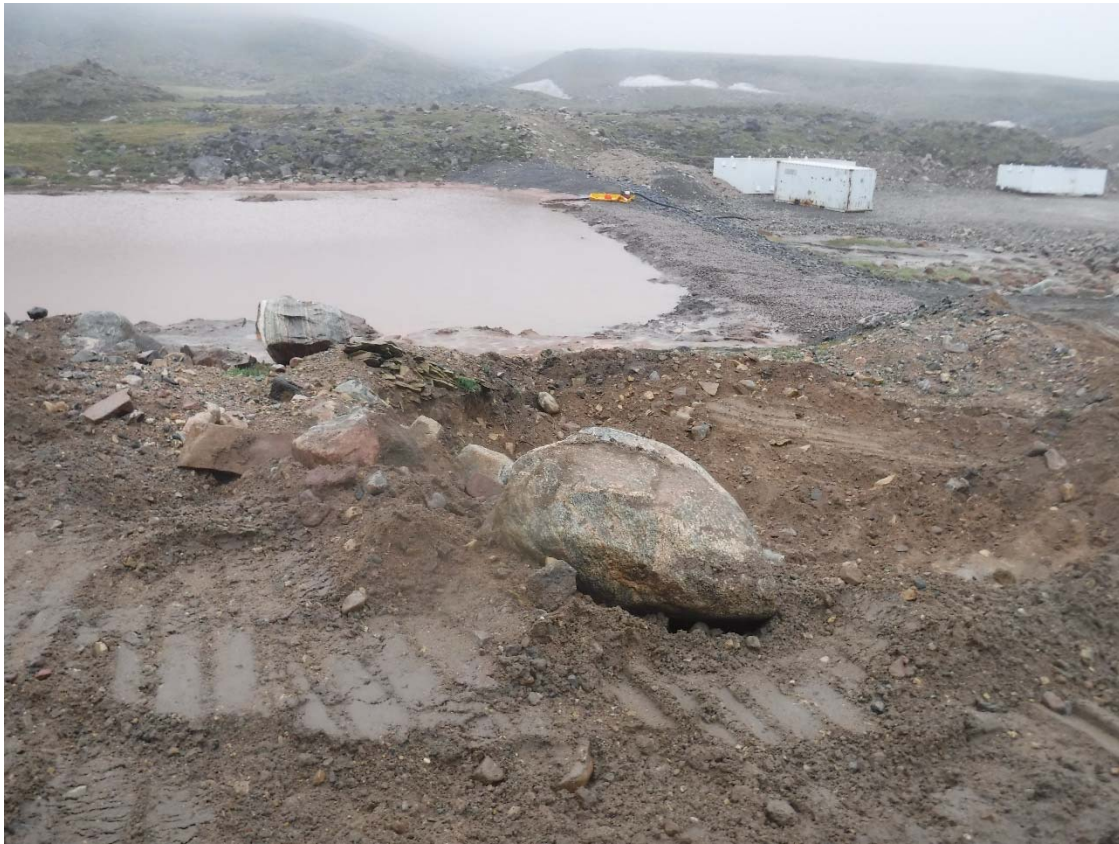
Photo 4. July 9, 2018: Reinforcement of Check Dams as part of ongoing maintenance

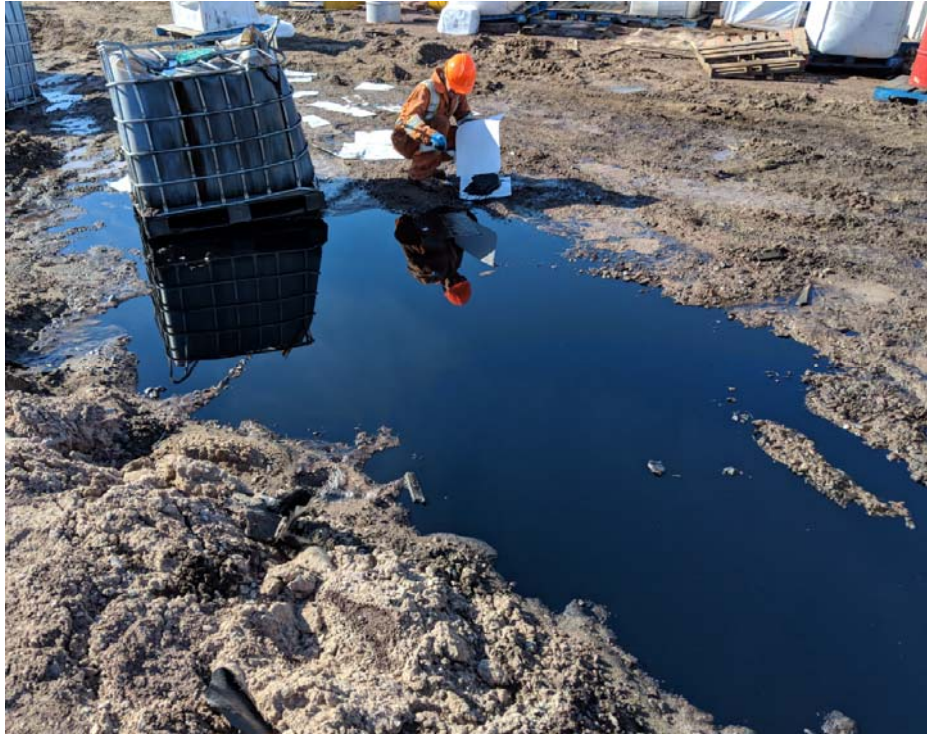
On June 14 2018, during an inspection a spill was discovered at the Port Site Hazardous Waste Berm #1 (MP-HWB-01). Upon investigation, it was determined that the source of the spill was caused by damage to a waste oil tote. The spill is contained within the MP-HWB-01 which is an engineered lined containment berm. Estimates of product released is approx. one cubic metre.

Photo 1. MP-HWB-01 oil spill

Upon discovery of the spill, crews cleaned up waste oil using absorbent pads and the contaminated berm cover material was removed. Clean material was then placed in the influenced areas to return the berm back to its original condition. The damaged tote was pumped out and packed for backhaul disposal. The remaining water in MP-HWB-01 was transferred to the contaminated snow dump to be treated utilizing the oily water treatment facility

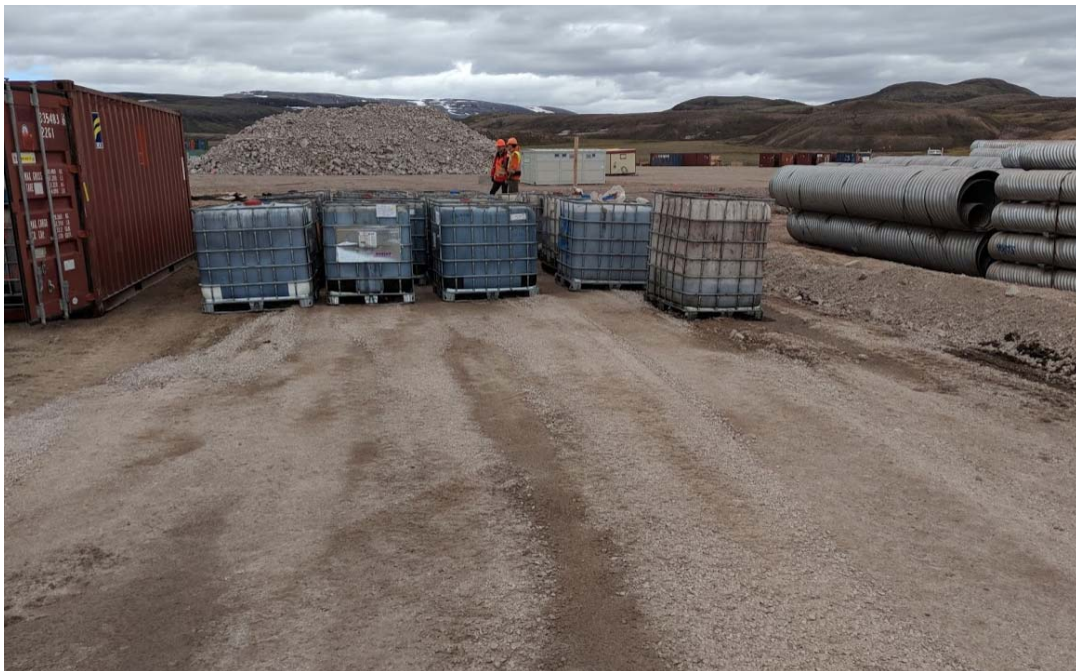
The containment berm has been cleaned of all oil and contaminated material. Influenced area has been replaced with clean cover material.

Photo 2. MP-HWB-01 after clean up

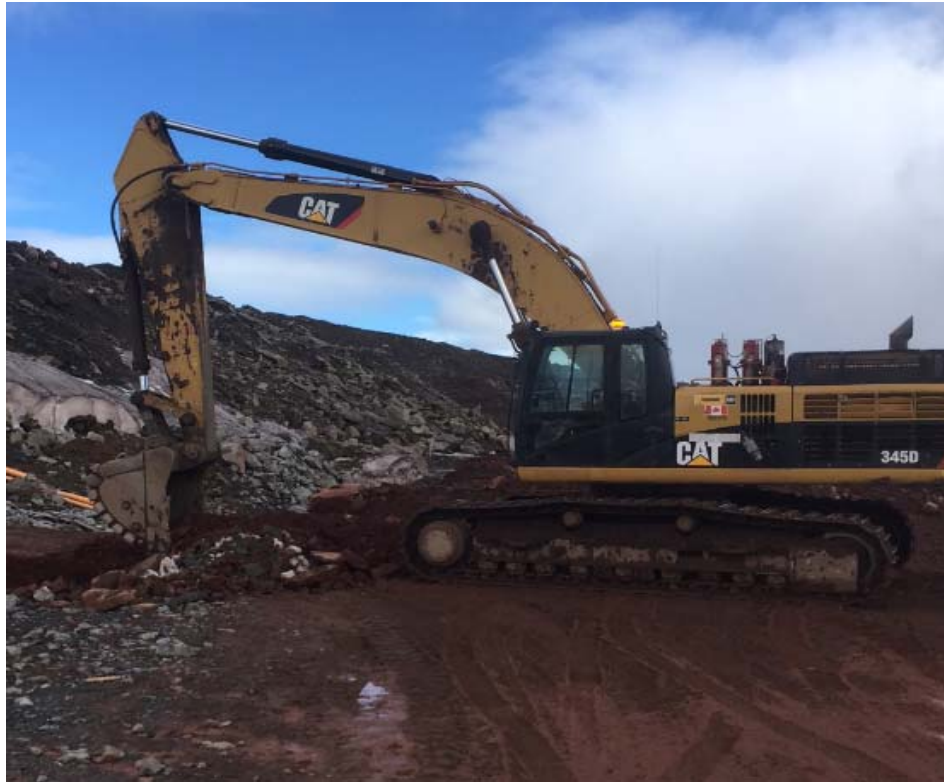
On June 19th, personnel monitoring the Waste Rock Stockpile Pond (MS-08) and facility's ditching, observed an overflow of water from the west drainage ditch of the facility. This water under normal operating conditions reports the Waste Rock Stockpile Pond. Upon investigation, the overflow was resultant of specific berm walls being insufficient to contain the surface water flow sourcing from the stockpile and reporting to the Waste Rock Stockpile Pond at a crossing where a culvert was installed which resulted in pooling water and overflow.

Photo 1. June 19th, 2018 -Heavy equipment support upon discovery to arrest over flow from West Drainage Ditch.

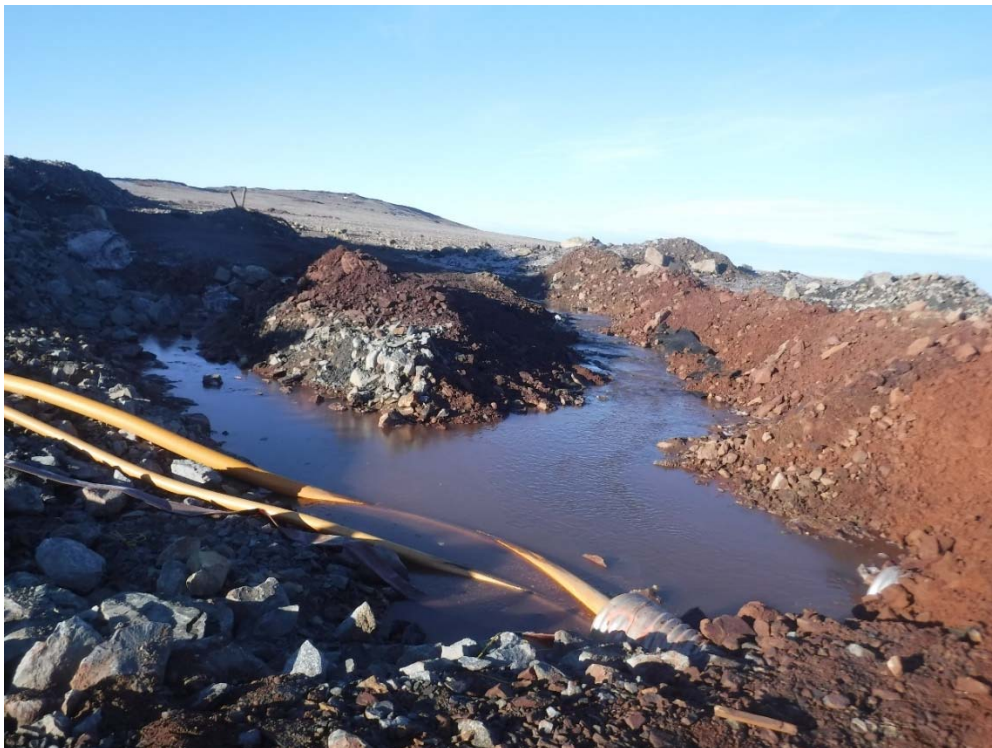
The West drainage ditch is flowing as intended and no further overflow has been observed from either drainage ditch resident of the facility during daily monitoring.

Photo 2. June 20th, 2018 – West drainage ditch inflow into the Waste Rock Stockpile Pond following berm reinforcement.

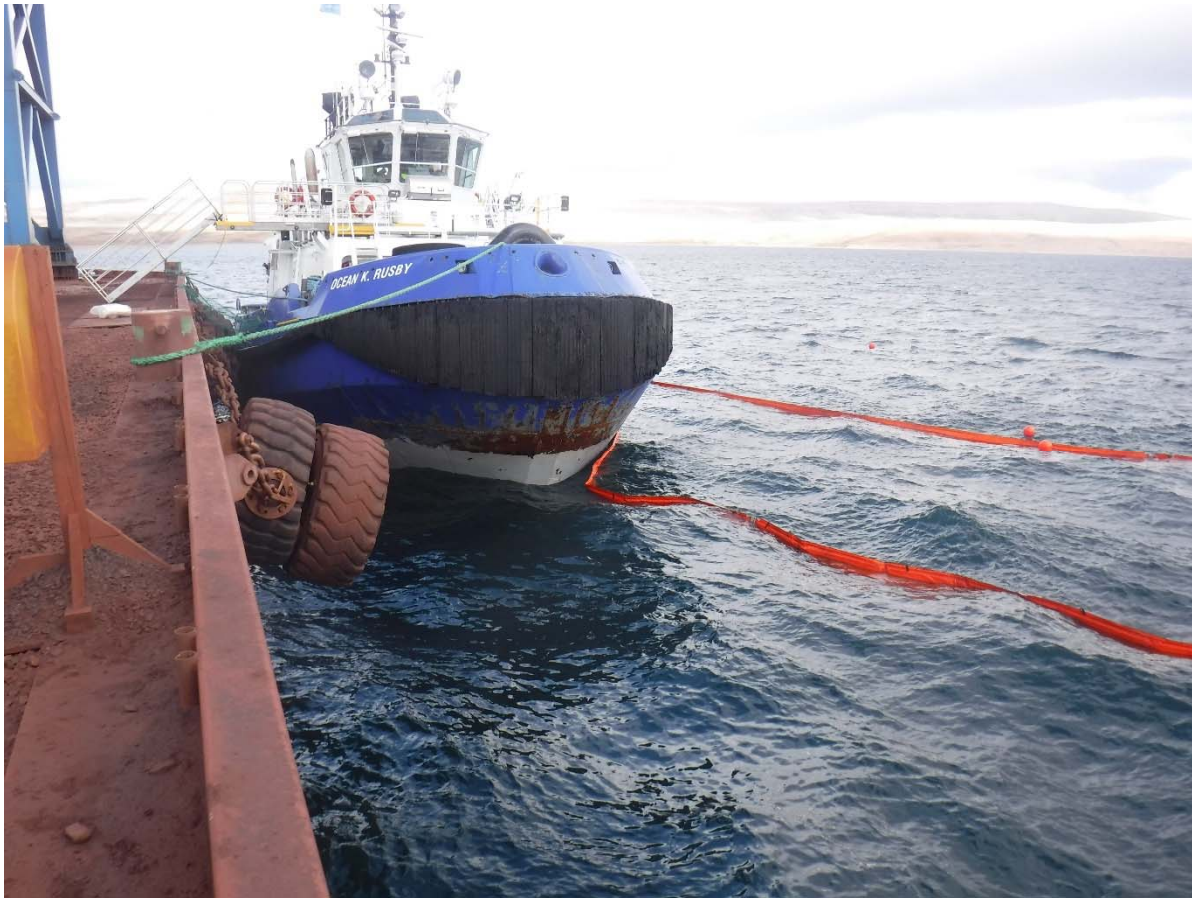
Photo 1 – OCEAN K. RUSBY at Milne Port upon arrival with two spill containment booms in place, July 22nd, 2018.
