APPENDIX E.8.4
INITIAL AND FOLLOW-UP SPILL REPORTS
(PART 3 OF 4)

Re: Follow-up to Spill #18-180, Reported on May 18, 2018, Mary River Project - Water Licence No. 2AM-MRY1325

Re: Follow-up to Spill #18-182, Reported on May 19, 2018, Mary River Project - Water Licence No. 2AM-MRY1325

Re: Follow-up to Spill #18-209, Reported on June 05, 2018, Mary River Project - Water Licence No. 2AM-MRY1325

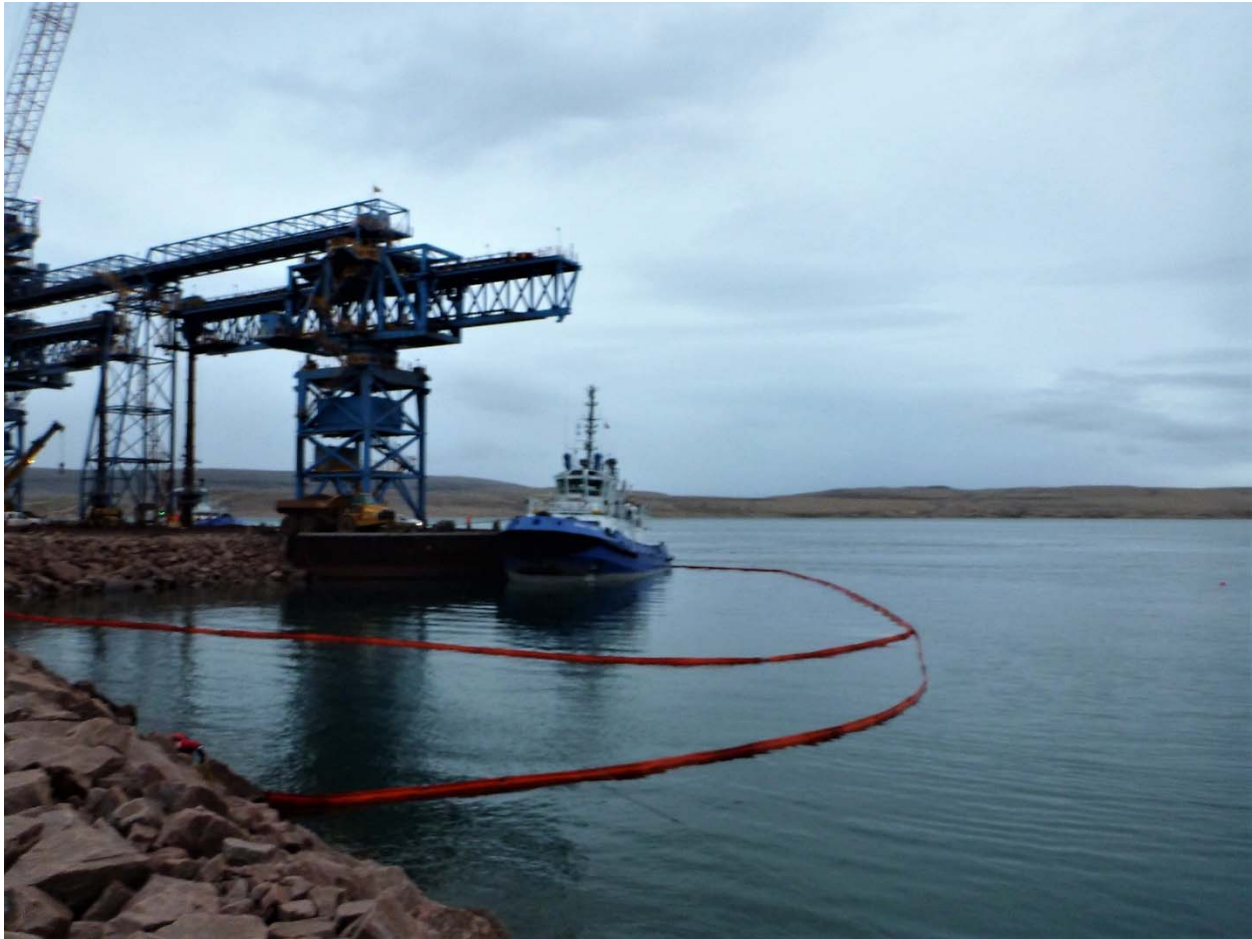
Photo 2 – July 24th, 02:00. Vessel following relocation contained within double booms.

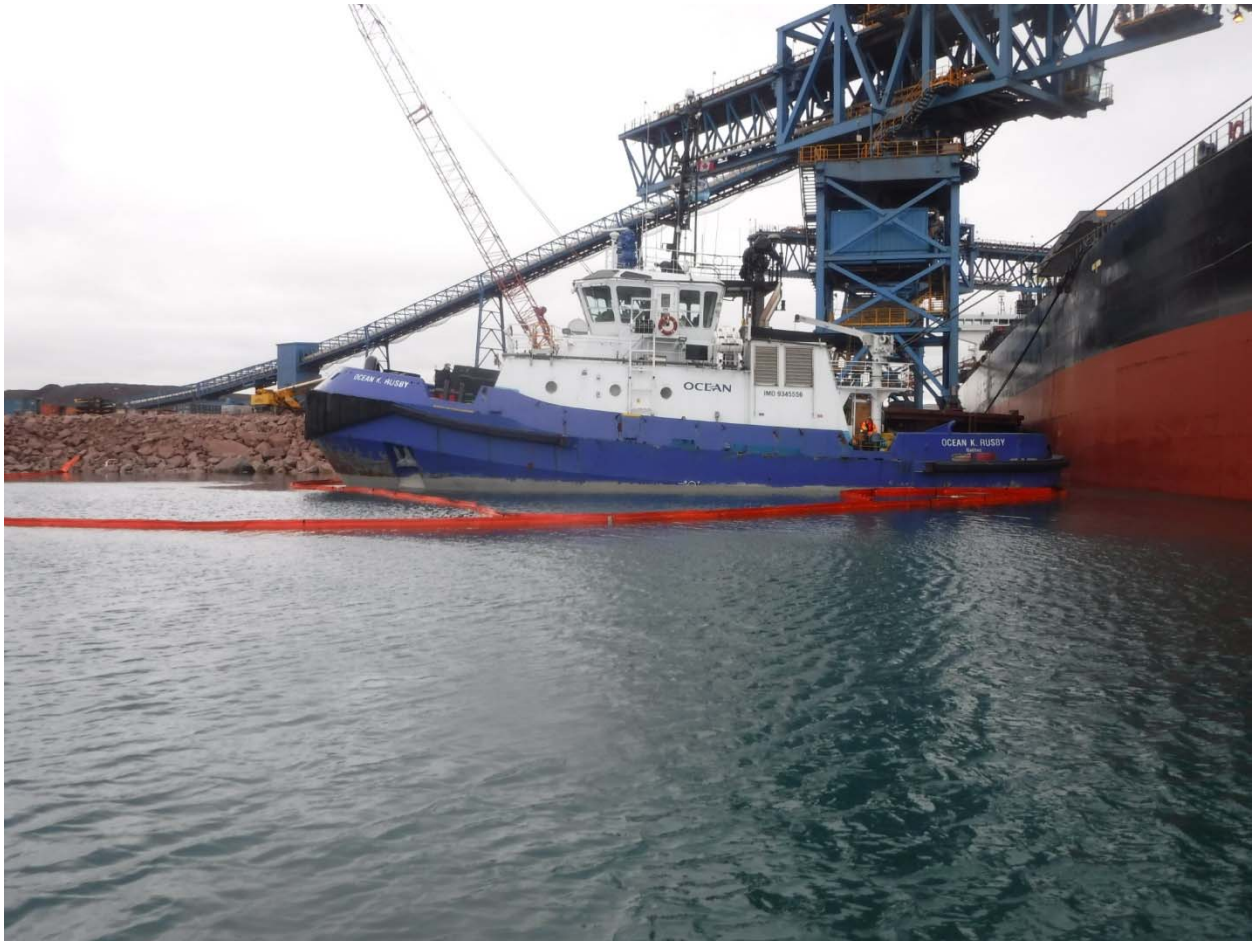
Photo 3 – OCEAN K. RUSBY at East side of Milne Port Ship Loading dock with two spill containment booms in place, July 27th, 2018.

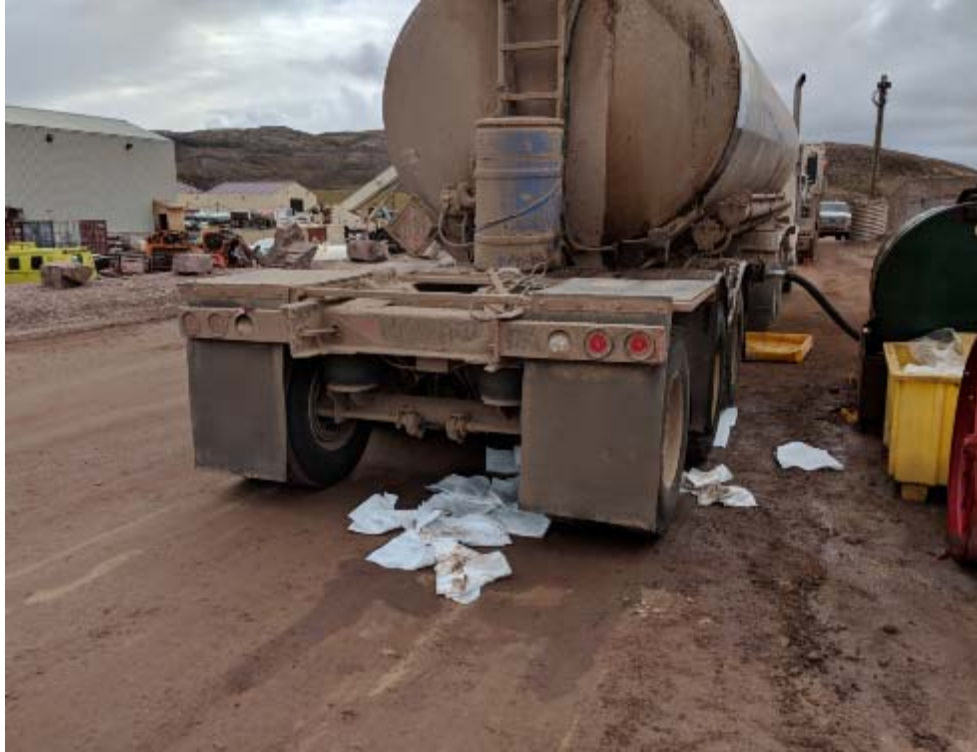
Photo 1. Spill location before clean-up

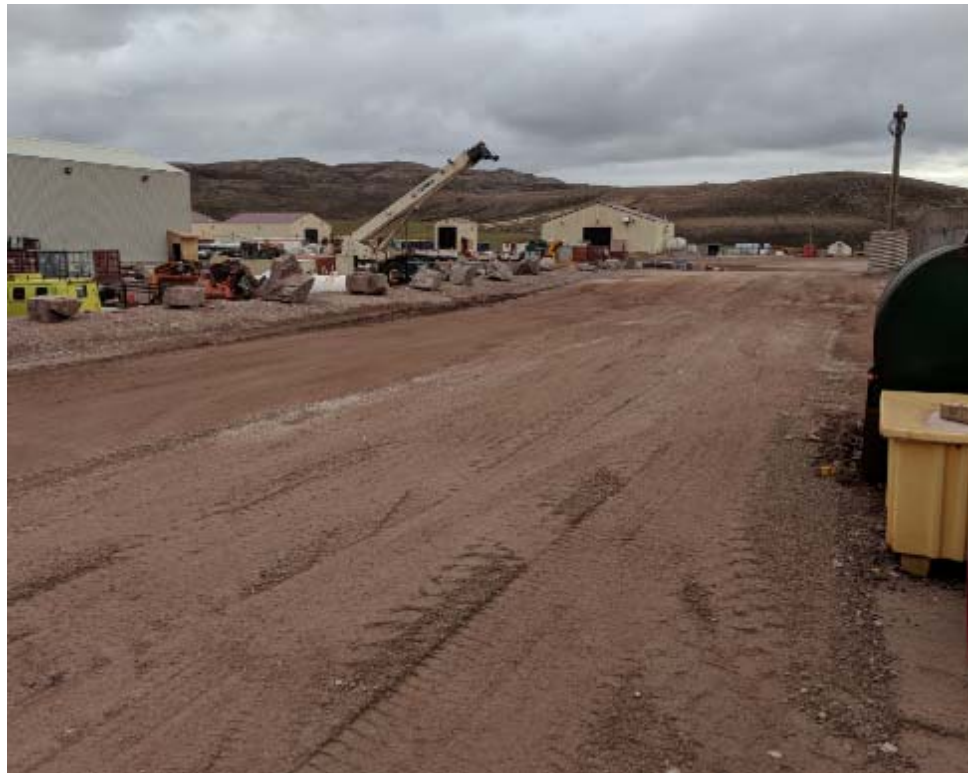
Photo 2. Spill location following clean-up
