**Baffinland Iron Mines LP
Mary River Expansion Project
Construction Summary Report: Pond 1A**

2019-03-31	0	Approved for Use	G. Peace, P.Eng	K. Campbell	B. Chaput	T. Atiba
Date	Rev.	Status	Prepared By	Checked By	Approved By	Approved By
HATCH						Client

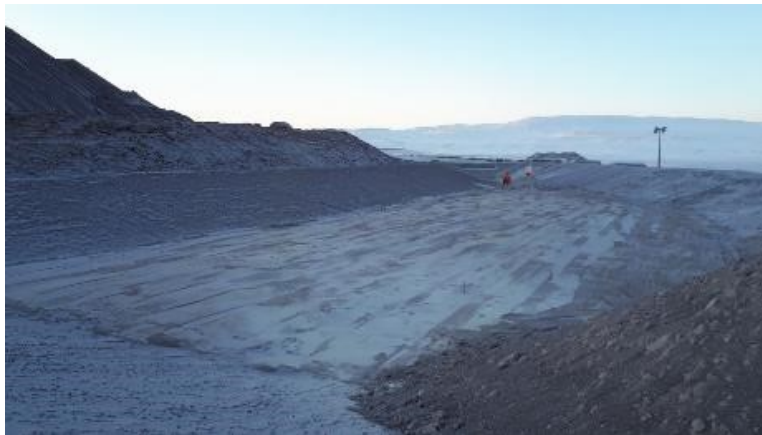
Pond 1A: Snow removal Inspection requested: The entire area was cleared of snow and OK to complete the final lift of type 9 sand. A light frost was also present but did not pose a concern for removal. The type 9 sand is to be compacted using placement equipment as directed for all previous lifts of subgrade materials. This lift was partially installed January 29, 2019, on the base and along and part of the north-west side.

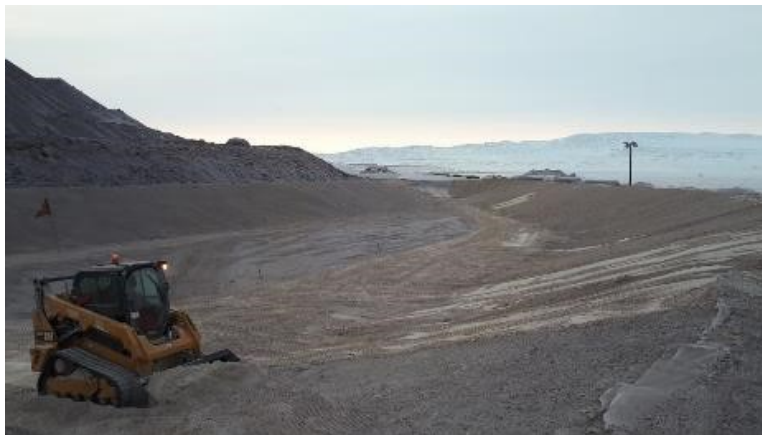
A.3 Feb 7/19

Pond 1A: Completion of type 9 sand ongoing. Survey on site verifying final grades and required touch-ups to be completed. Type 9 is out of specification but has been approved for use as the sand generally meets specification but is running coarse (refer to related emails). The type 9 was compacted using placing equipment.

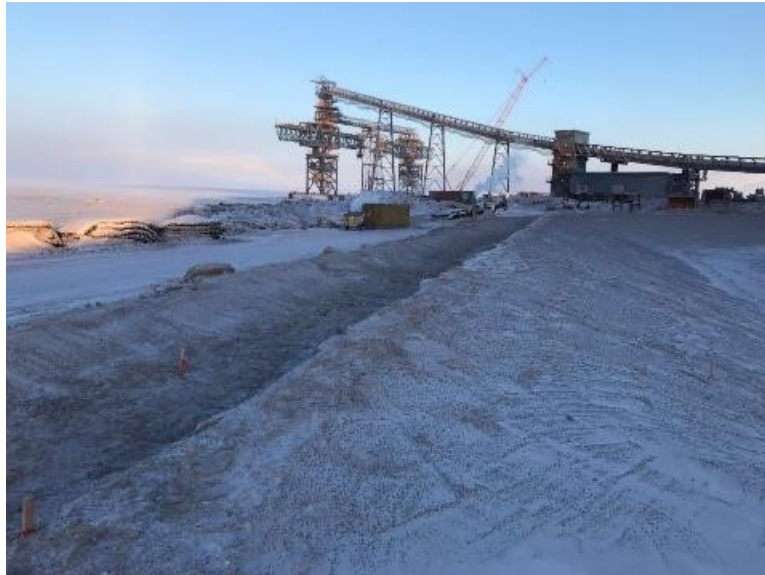
Pond 1A: Allnorth Survey working out issues with the liner trench, still needs work to define the liner trench to design specs, another check identified that work to date is still not cut deep enough around the perimeter. Cut of 0.1 m - 0.25 m on the south side, cut of 0.45 m- 0.75 m along the south side, operator should have those areas completed by mid day tomorrow and ready for sand bedding in the trench bottom. See attached photos of Pond 1A.

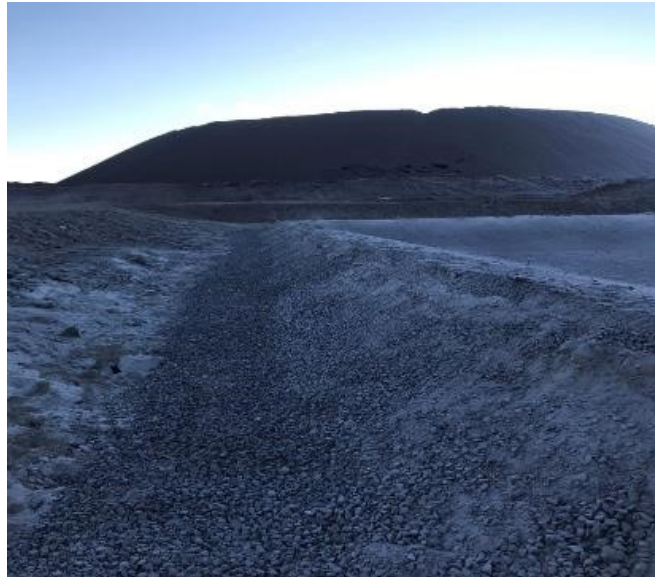
Type 5 in Base of Crest Trench Compacted

No fines to compact and everything is frozen. They would only be consolidating the stone it to make it flat for the liner/sand layer to have a consistent 100 mm bedding for liner protection in the crest trench.

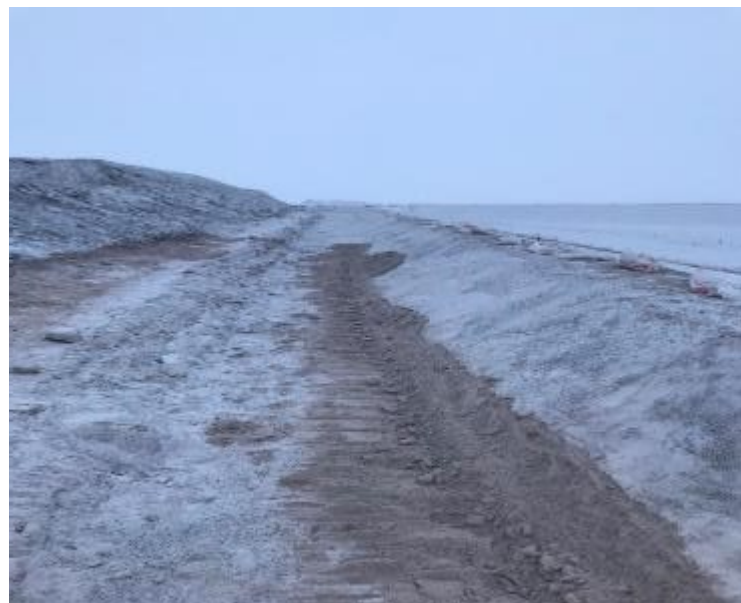
Checked Pond 1A 100 mm sand placement in base of crest trench, looks good just need survey to topo and ready for liner placement after Hatch approval. Layfield laid out first run of liner by end of day. Pond 1A and bedding placed, approved and liner to start this afternoon.

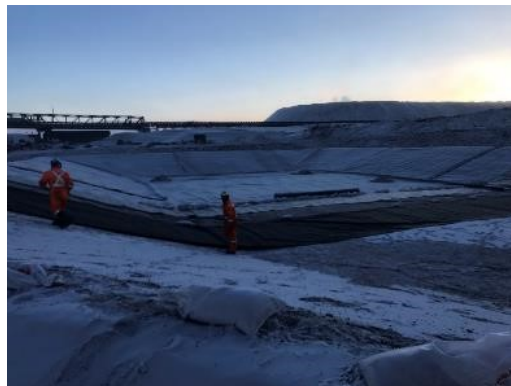
Liner placement to continue in Pond 1A. Spoke to Layfield after I received the ITP today, they just received it themselves and have only been overlapping the geo-fabric by 300 mm and the ITP calls for 1000 mm. Brought it to Dave Burry's attention, they are seam sealing the geo-fabric, the entire length of the seams. Hold each test for 5 minutes at 40-50 psi, only require 30 psi. Air testing each seam of liner and destructive test every 150 liner meters of seam. Liner placement to continue in Pond 1A by Layfield. Spoke to Layfield after receiving the ITP today from others, Layfield just received it themselves and have only been overlapping the geo-fabric by 300 mm. The ITP calls for 1000 mm overlap. Issue was brought to Hatch's attention, they are seam sealing the geo-fabric, the entire length of the seams. Hold each test for 5 minutes at 40-50 psi, only require 30 psi. Air testing each seam of liner and destructive test every 150 liner meters of seam.

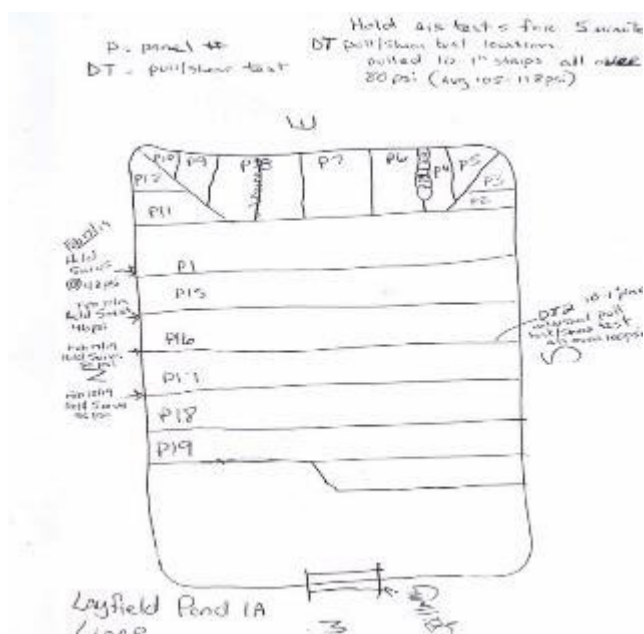
Liner placement continuing today, witnessed air tests and pull tests/destructive test. Starting at Panel 1 welded to Panel 15, test info in sketch. First 14 short panels around east slope were welded and tested before Allnorth was requested to witness the testing. A sketch and record of the tests witnessed attached. Times and pressures on each panel tested to date. Layfield will provide a complete QC package at the end of the project including pressure tests and tensile tests. Allnorth witnessed pull/shear test of DT2 today, 10-1" strips pulled from inside and outside of weld, as well as a shear from both sides, minimum is 80 psi and each one of the 10 strips recorded over 100 psi. Air tests require to hold 30 psi minimum for 5 minutes but Layfield aim for 45+ psi for each air test, all were good from what was witnessed to date.

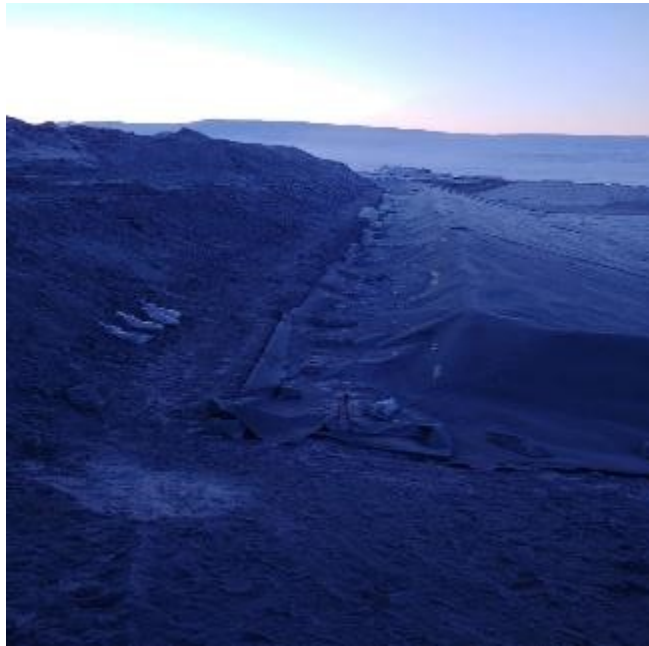
Liner placement held off again today due to temperatures, the anchor trench is not completed as designed but has been approved with RFI for the change by Nick Mills

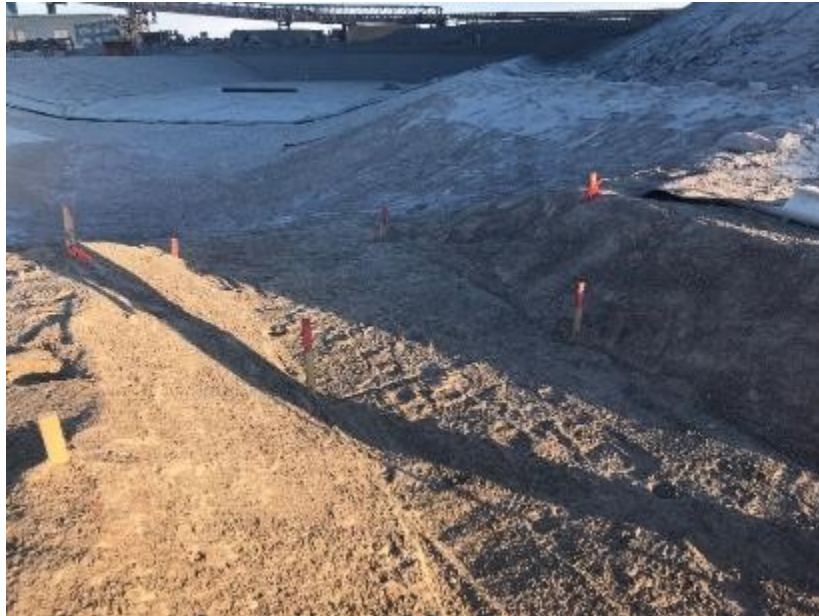
Spillway Cut Out

Spill way at Pond 1A was cut out to grade and type 9 was placed last night, picked up topo with Survey. Bucket packed the type 9 on the spill way. Layfield to continue liner and testing of seams today if temperatures cooperate. Spill way at Pond 1A was cut out and type 9 was placed last night, picked up topo with Alex. Bucket packed the type 9 on the spill way. Layfield to continue liner and testing of seams today if temperatures cooperate.

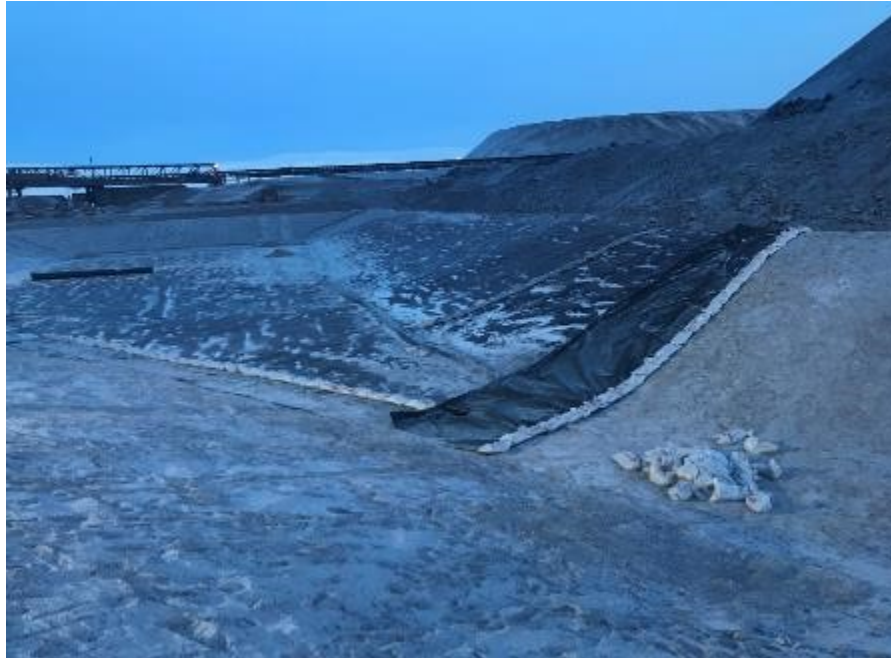
Pond 1A: Liner crew air tested a seam yesterday but too cold for liner fusing today. Spill way is ready just need temperature to cooperate. Can only fuse the seams up to -37 degrees.

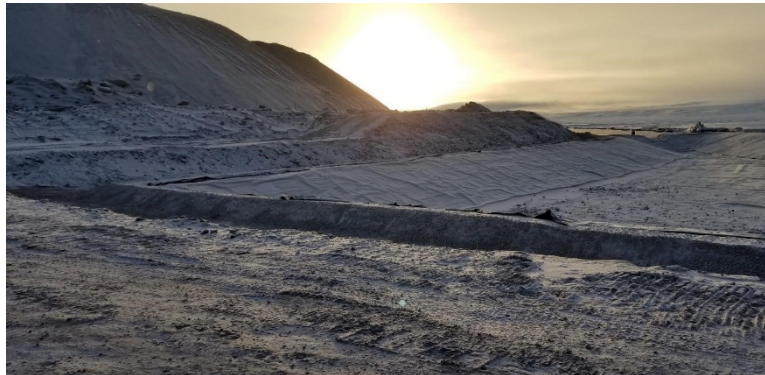
Pond 1A Dressing of the Ditch and Berm

Pond 1A: Layfield completing final patch on outfall of the line Pond 1A to Pond 1 including pressure test. Nuna shaping ditching on the southern side of the pond. Concern on the slope facing the ore pile. Survey to assess.

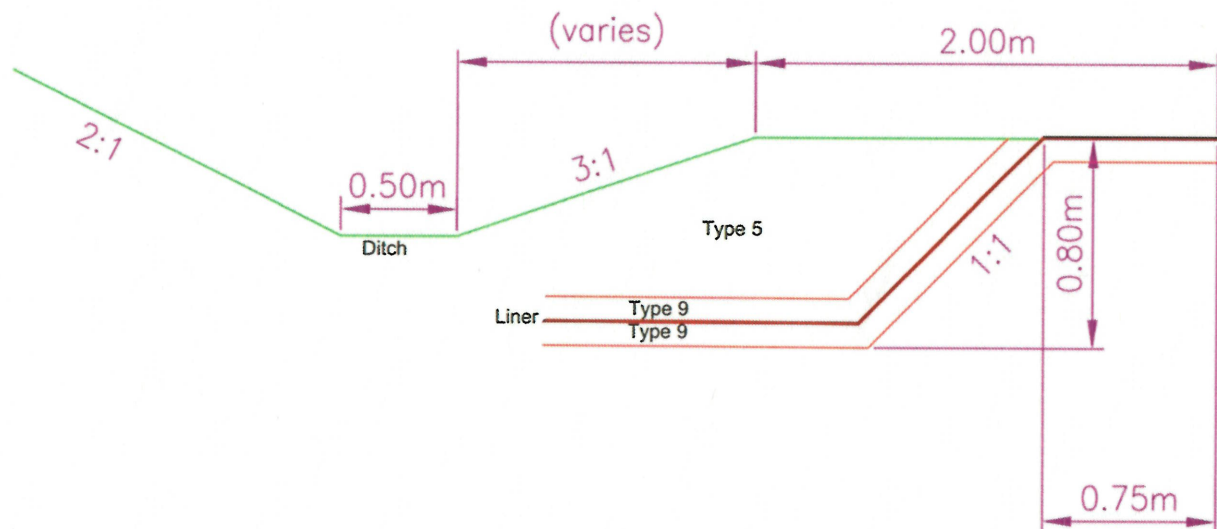
Nuna is proposing a design change to the trench liner detail to make it constructible. The current design is not feasible to build with the available material and ground conditions. The key cut cannot be made as a straight wall due to the risk of the pond crest collapsing during construction and liner installation. Nuna proposes to cut the liner key at a 1:1 slope to allow for geotechnical stability during construction and installation. This would override RFI 15

In order to be able to construct the pond liner anchor trench in the existing frozen conditions, Nuna is proposing to change the design as detailed in the bottom right diagram.

The geotextile will then be covered with 100mm of Type 9 material and the rest of the berm will be built up with Type 5 material.

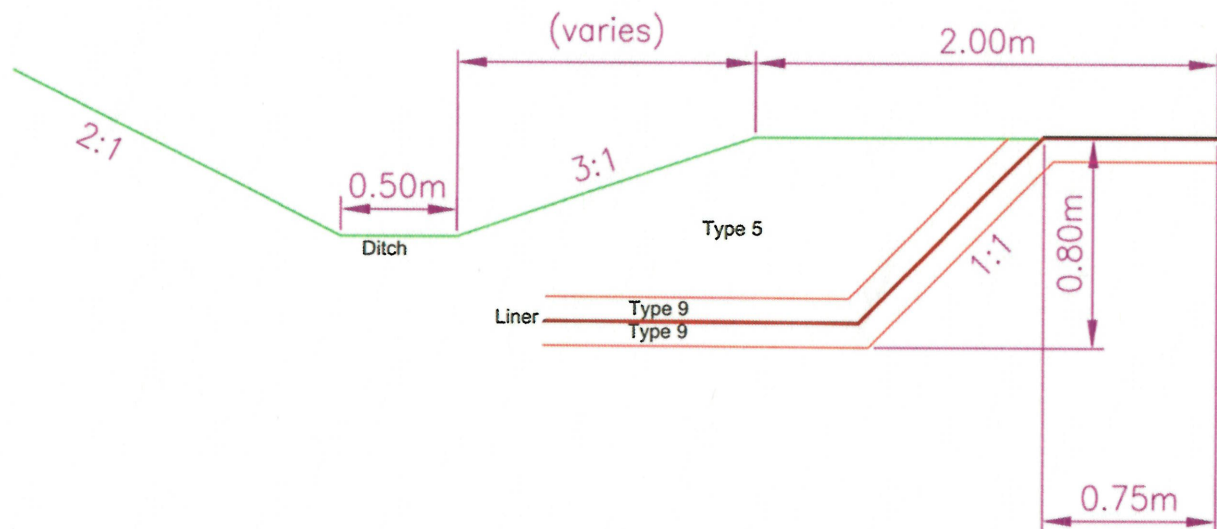
Nuna is proposing a design change to the trench liner detail to make it constructible. The current design is not feasible to build with the available material and ground conditions. The key cut cannot be made as a straight wall due to the risk of the pond crest collapsing during construction and liner installation. Nuna proposes to cut the liner key at a 1:1 slope to allow for geotechnical stability during construction and installation. This would override RFI 15

The geotextile will then be covered with 100mm of Type 9 material and the rest of the berm will be built up with Type 5 material.
