Geotechnical Inspection Report

RE: Submission of 2019 Geotechnical Inspection Report No. 1 (July 2019)

Annual Geotechnical Inspections – 2019 Report 1. Mary River Iron Mine Complex – Nunavut

Annual Geotechnical Inspections – 2019 Report 2. Mary River Iron Mine – Nunavut

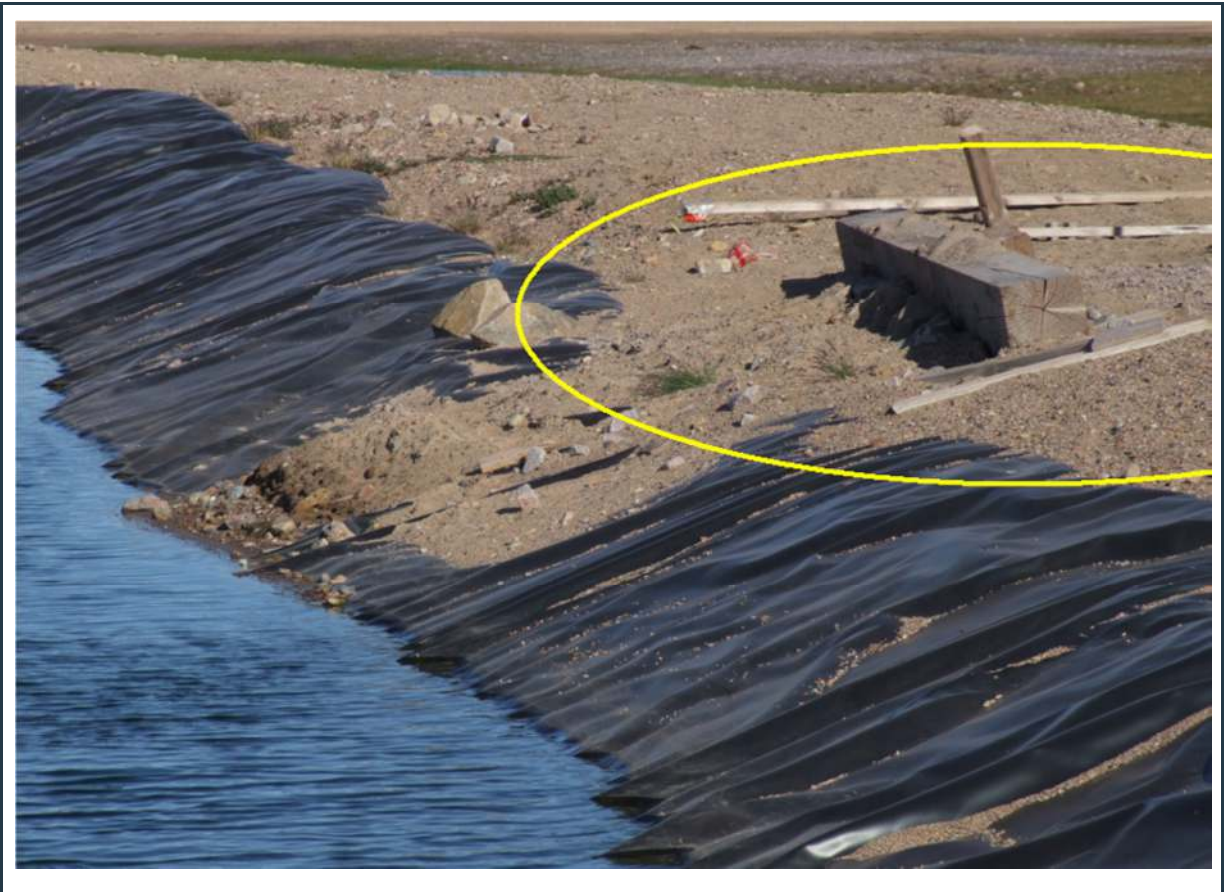
Figure 7: PWS pond #1 – Lower crest elevation (yellow circle) and damages to the liner (red circles)

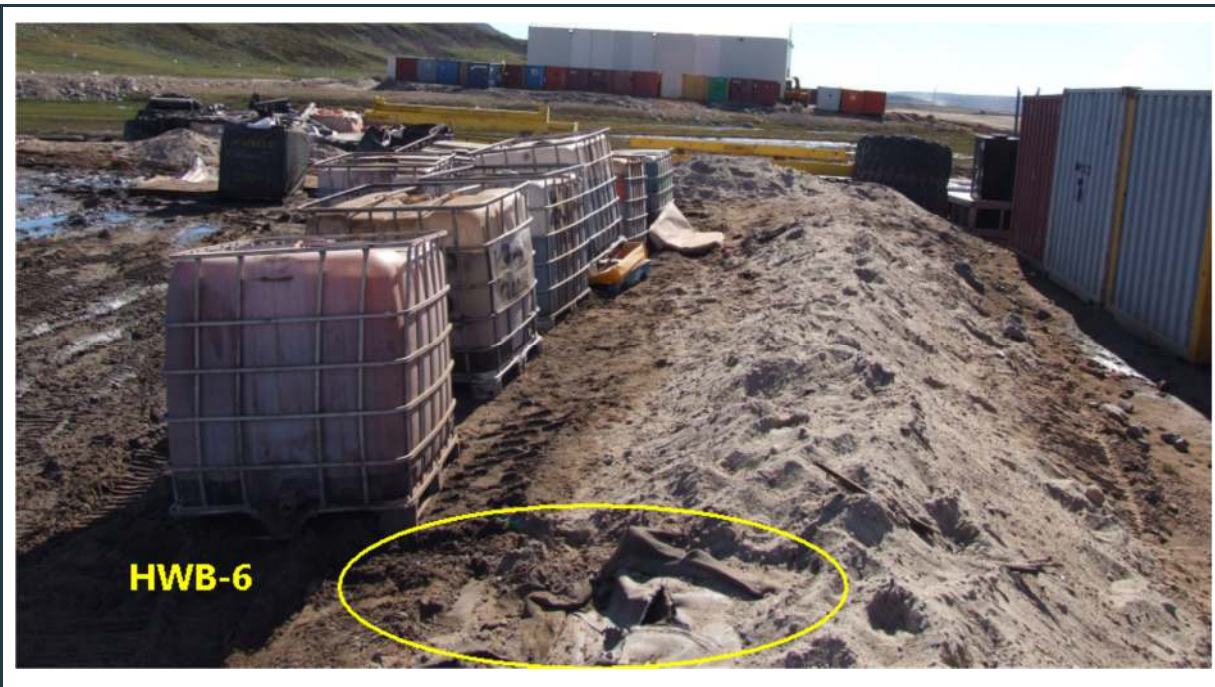
The berms have been extensively disturbed by truck and foot traffic, particularly at the northern section of the berm. Cracking and tearing of the liner are also visible at several locations on the upstream face and crest of the berm.

Figure 16: View of HWB-6. Note the damaged liner at the yellow circle.

Baffinland Action: Baffinland is aware HWB-6 will require repairs to continue receiving waste materials in the future. A repair of both the berm structure and the liner is scheduled to be completed.

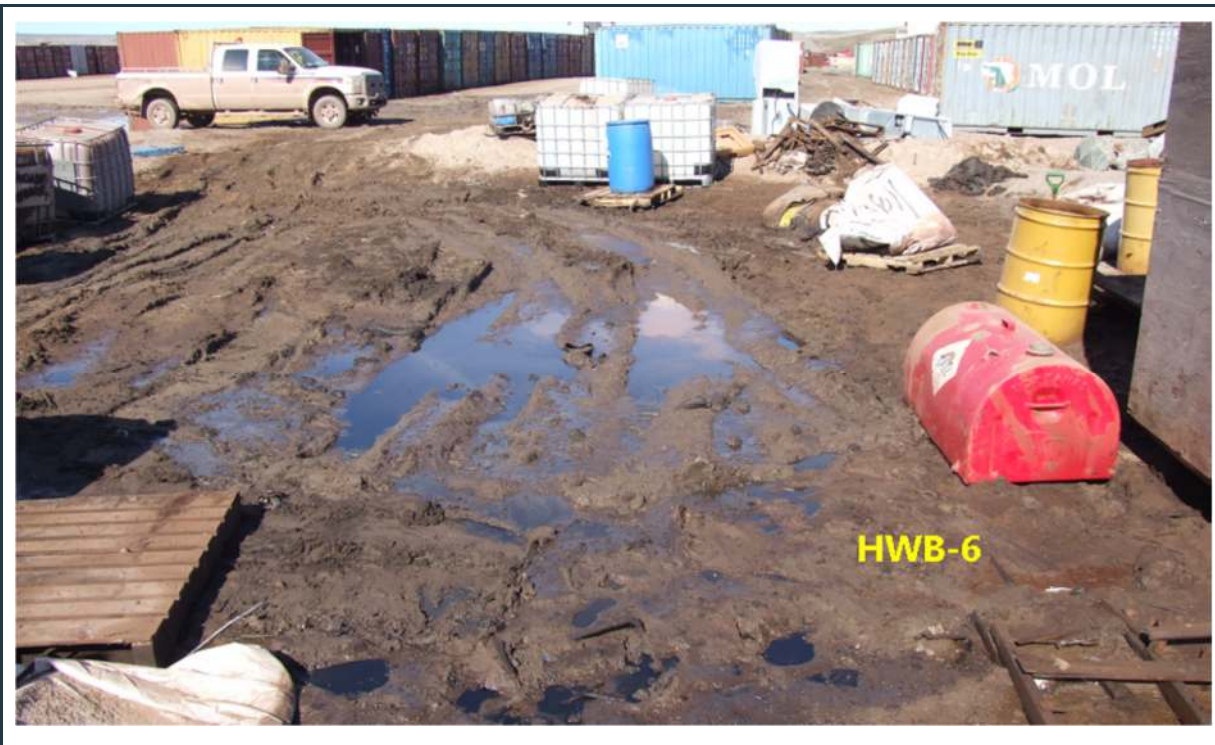
Figure 17: View of HWB-6. Note the shallow berm near the pickup truck.

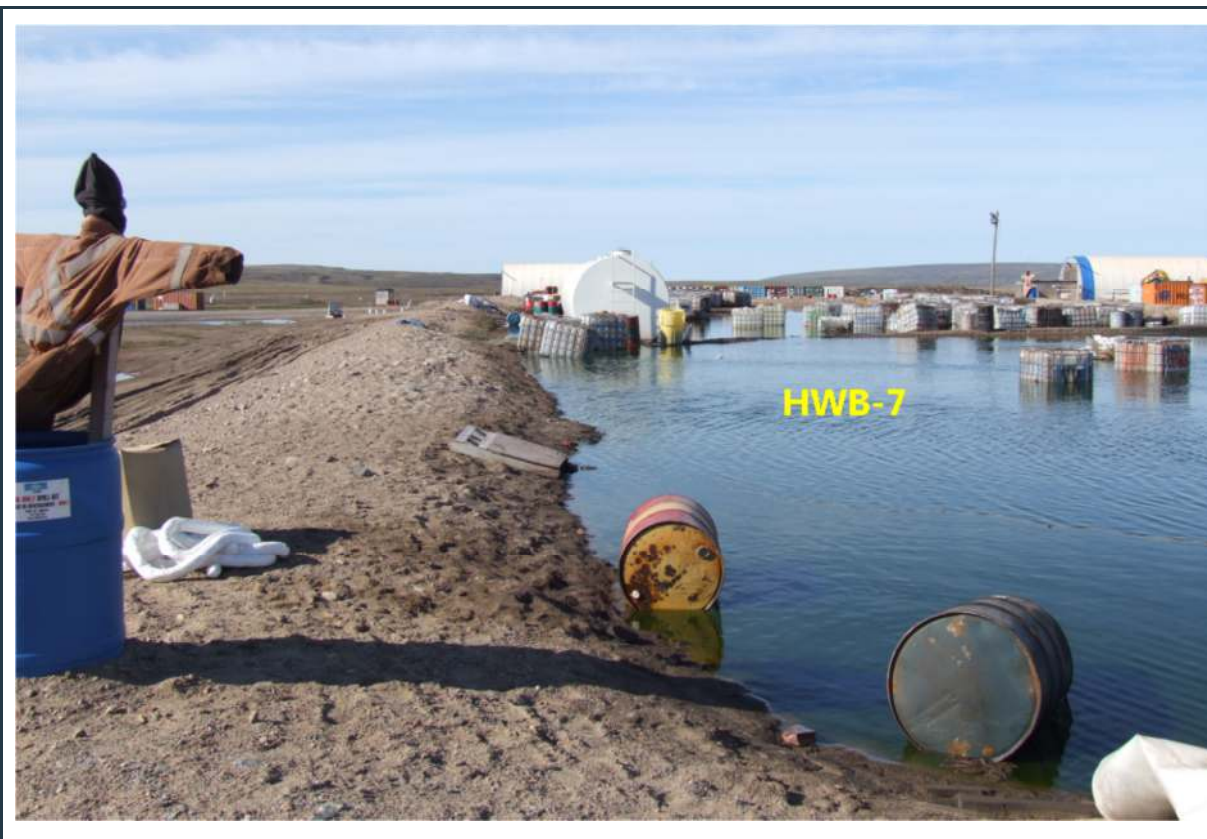
Minor damages to the geotextile (covering the liner) were noted at a few locations on the crest and downstream slope of the berm.

Figure 18: View of HWB-7

Baffinland Action: Baffinland commits to reinstating geotextile and soil cover in the specified areas in order to prevent potential damage to the liner in the future.

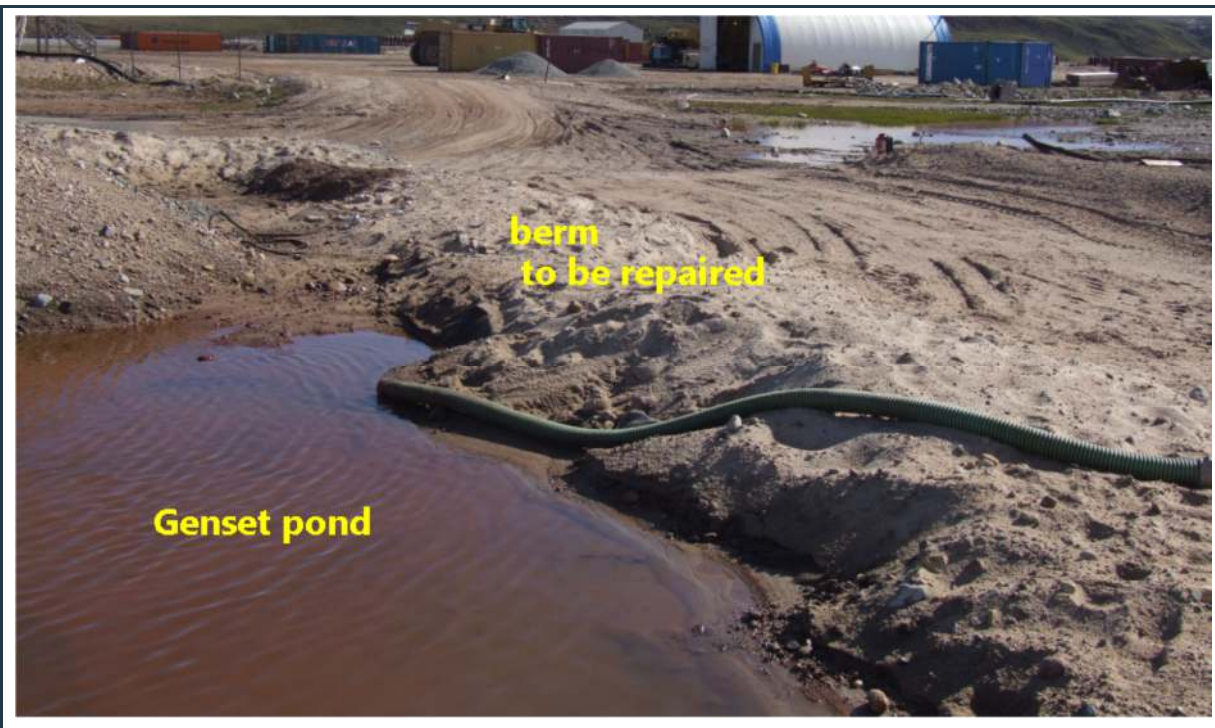
Figure 31: View of the south section of the berm that needs to be repaired (raised and regraded)

Baffinland Action: Baffinland commits to bringing granular fill to this location to re-fill the slope and regrade the area. In addition to the repair work on the slope, the southern, lower section of the berm will be reconstructed to its original geometry.

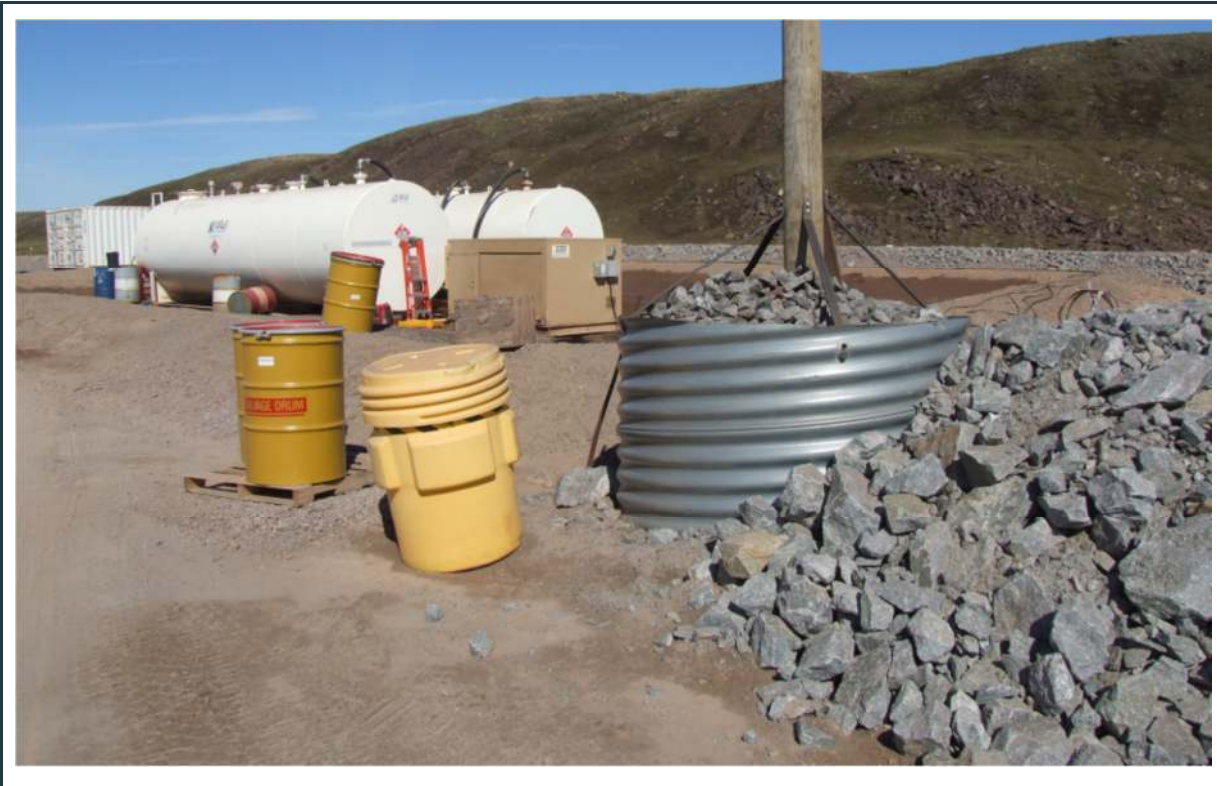
Figure 32: View of the jetfuel farm's double berm system (note the additional crushed rock berm)

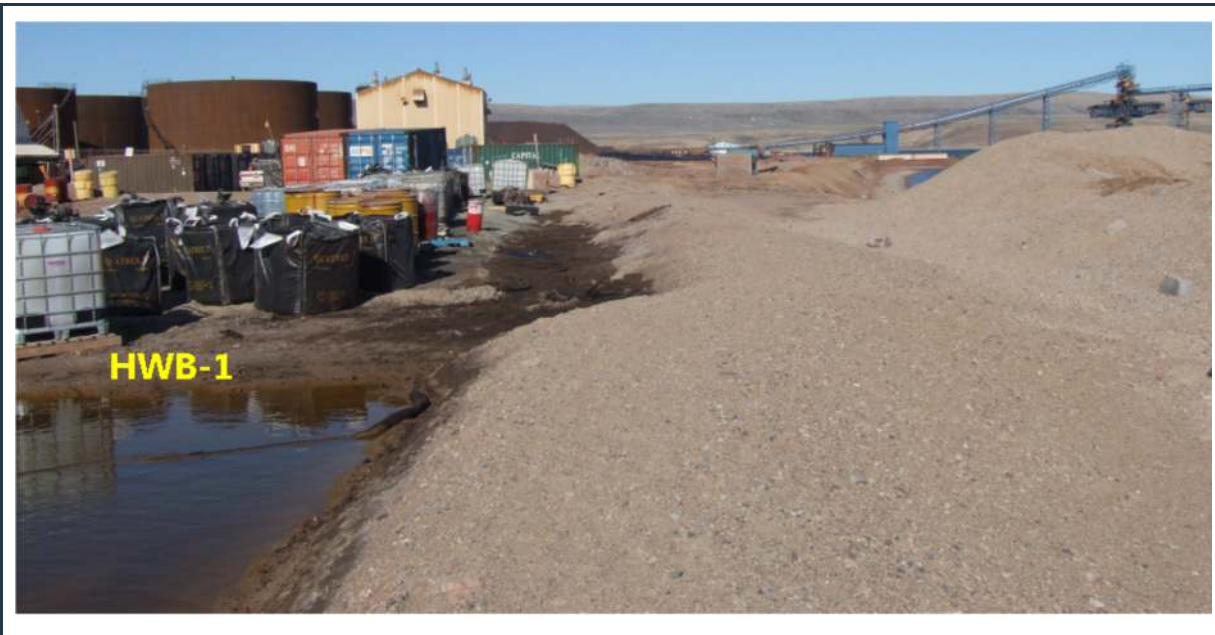
Figure 42: View of the HWB-1 pond with stable berm and ponding water within the cell

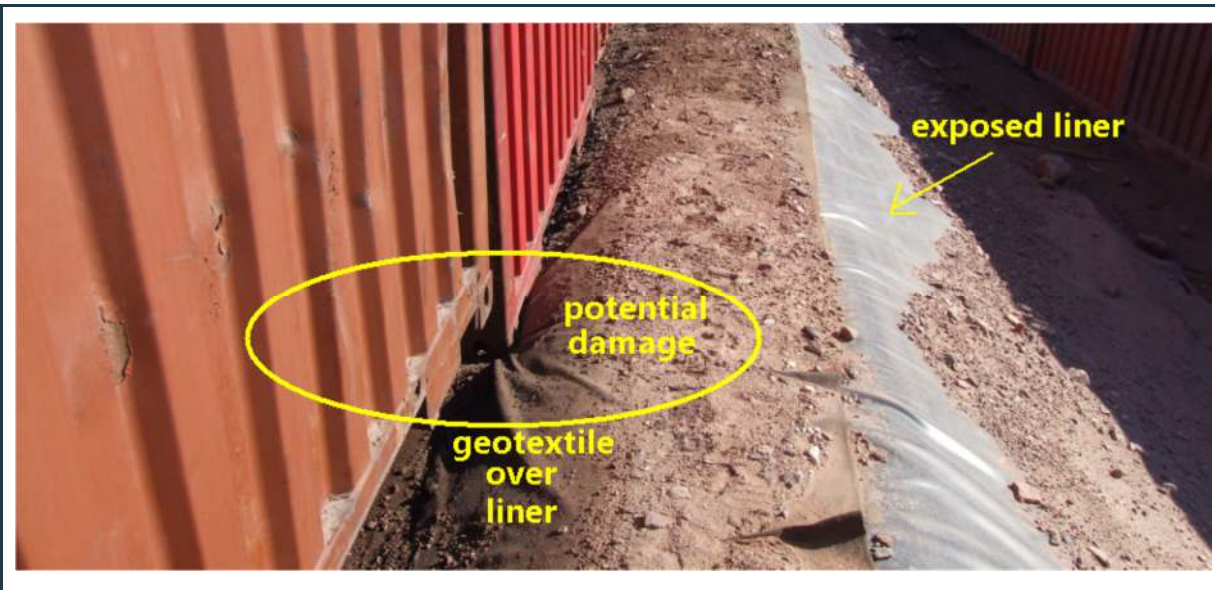
Figure 48: Exposed geotextile and liner at the HWB-4 pond, with location of potential damage to liner

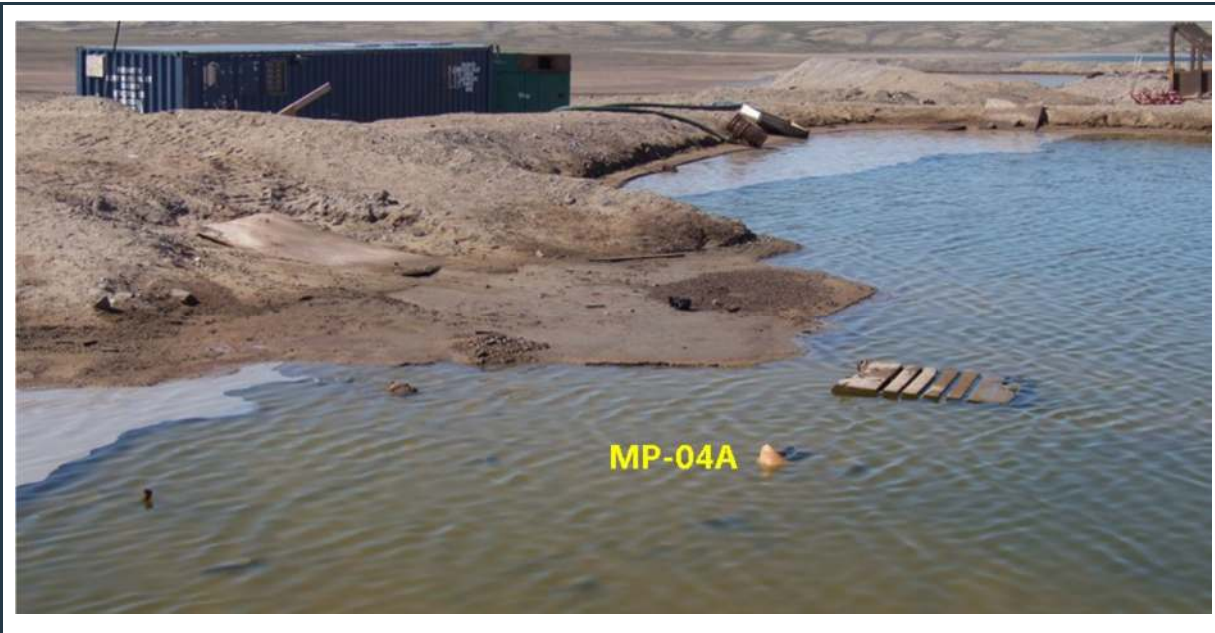
Figure 54: Condition of the ramp at the MP-04A contaminated snow dump

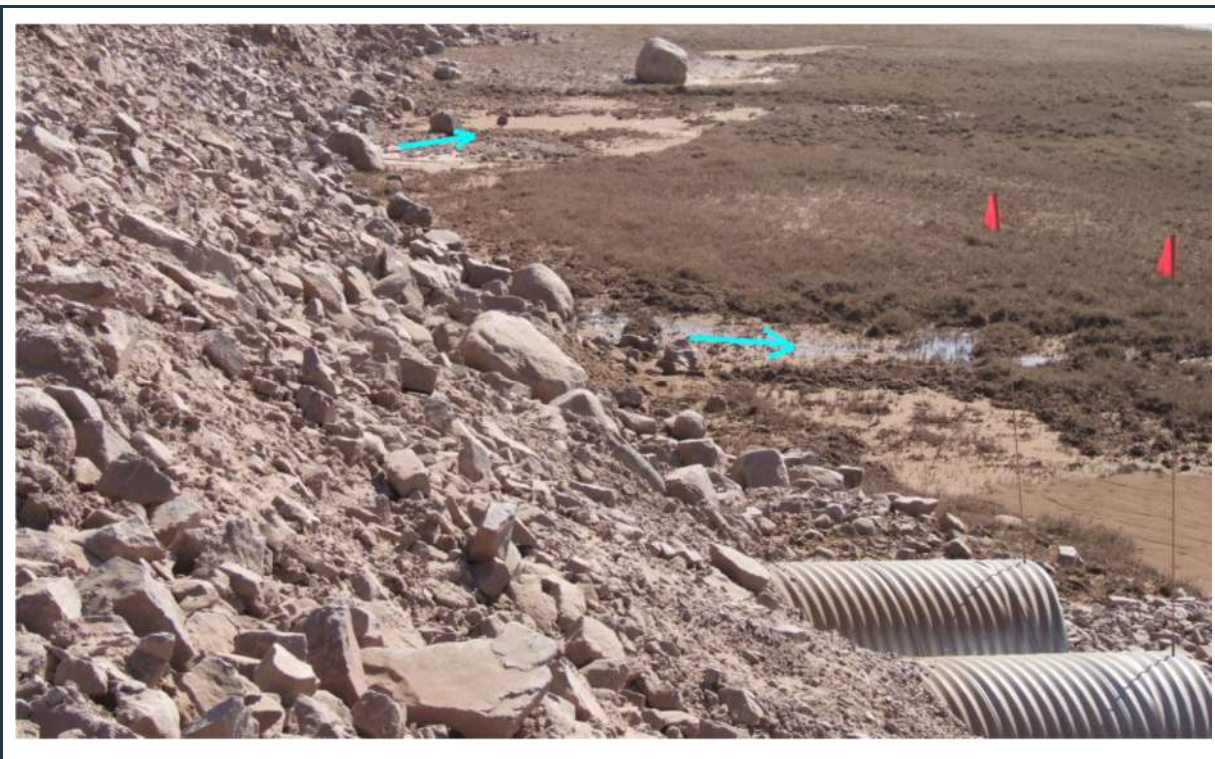
Figure 71: Water seepage through the road embankment adjacent to the tote road culverts

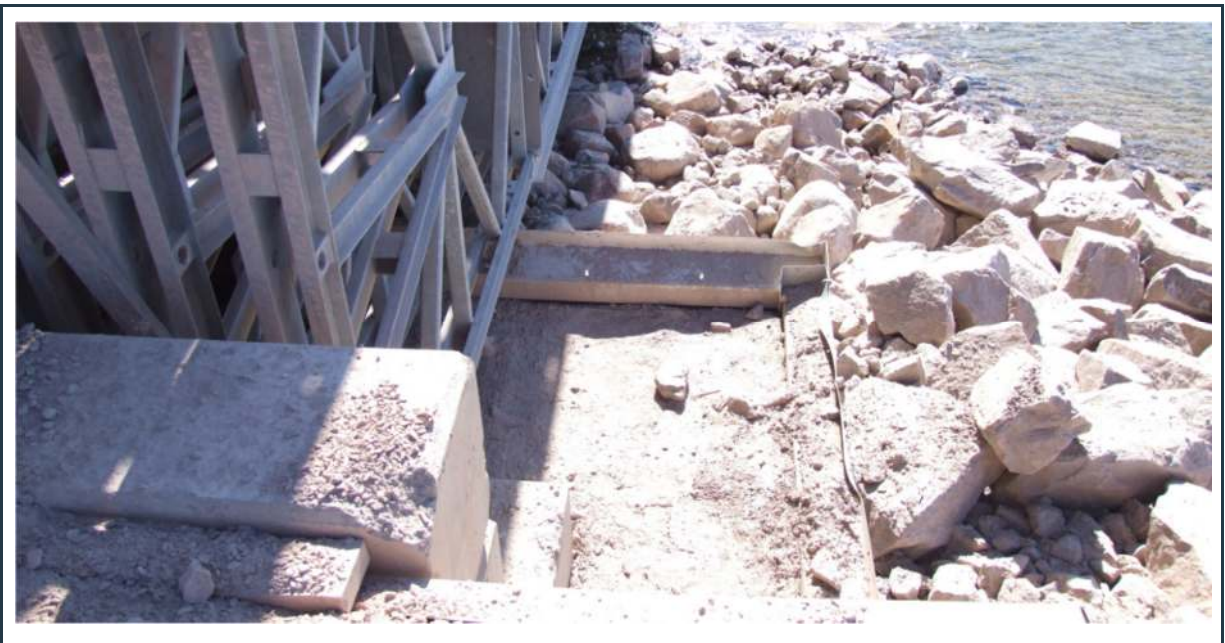
Figure 73: Foundation and rip-rap conditions at one of the abutments at bridge 17

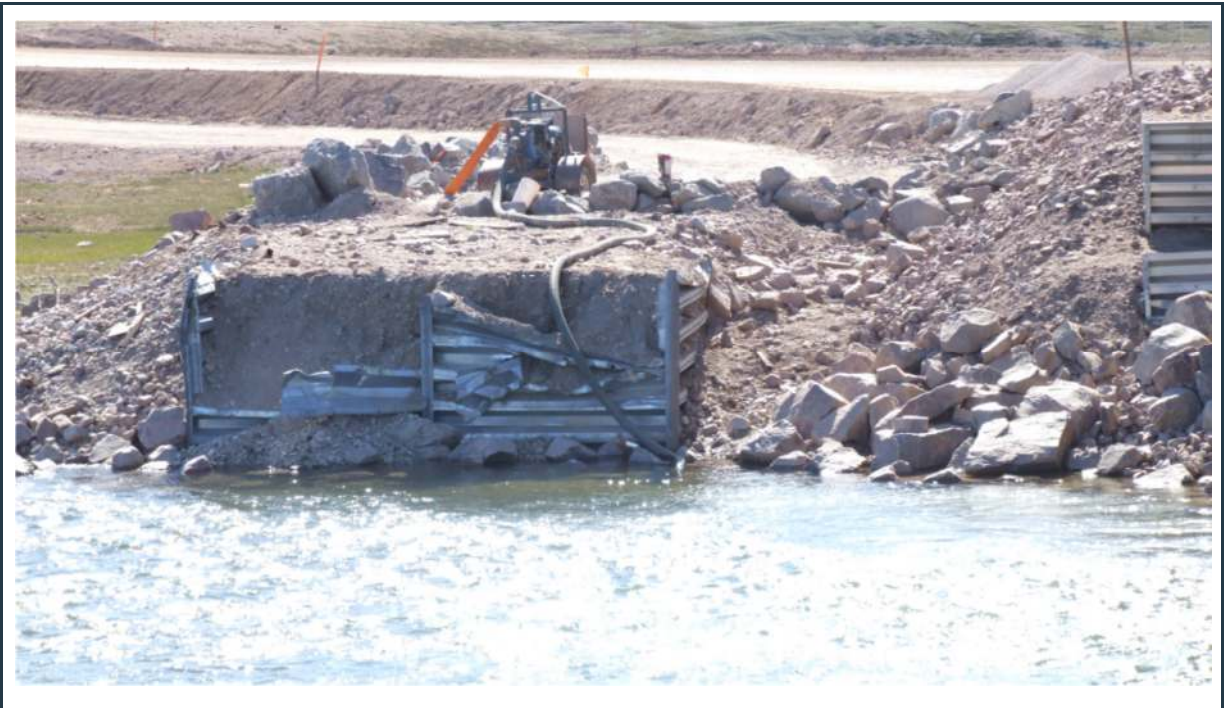
There are two historic abutments, located immediately adjacent to the “new” ones. The metal front and wing walls of both “old” abutments have suffered damages in the past, particularly the south abutment.

Figure 74: The "old" south-east abutment at bridge 17

Baffinland Action: To maintain the stability of the currently used bridge abutments, Baffinland will keep the two old abutments in place since they provide support to the adjacent new structures. Baffinland will schedule repairs to the damaged sections of the abutments identified during the inspection. Additional rip-rap on the regraded granular fill slopes will also be placed to prevent erosion.

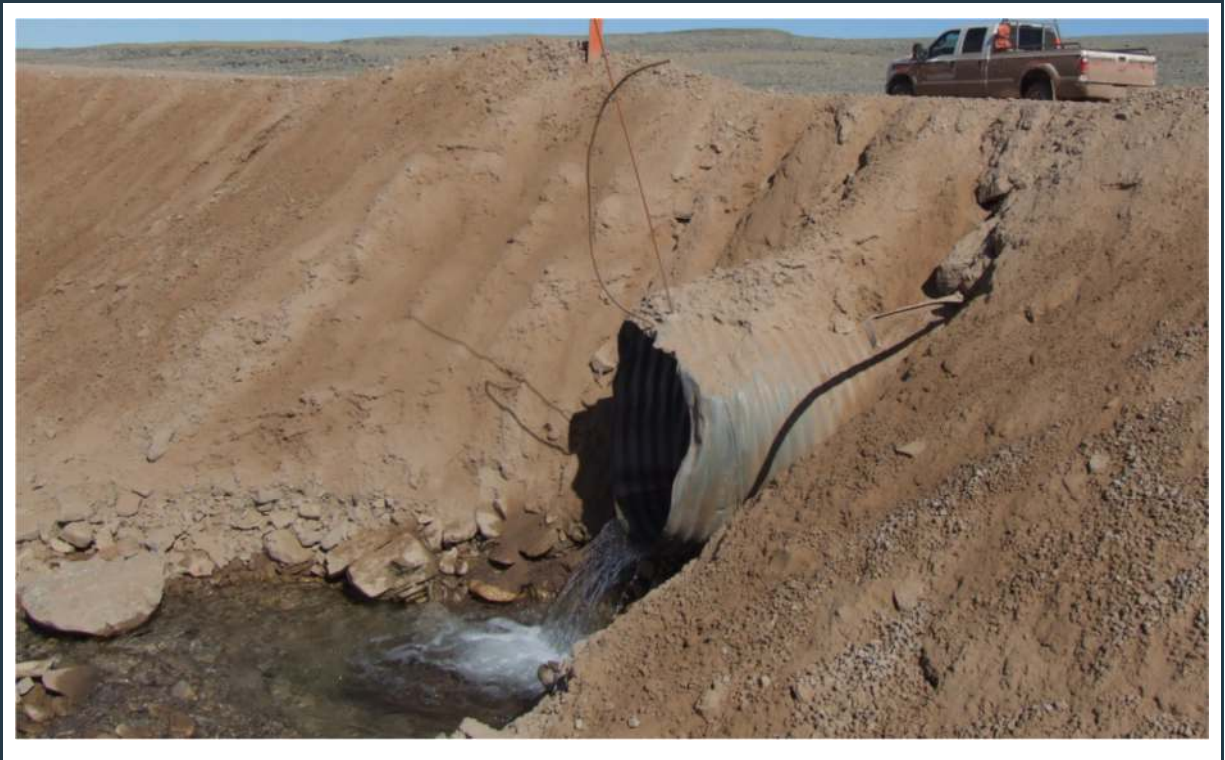
Figure 86: View of culvert 083 (outlet) with some slope erosion

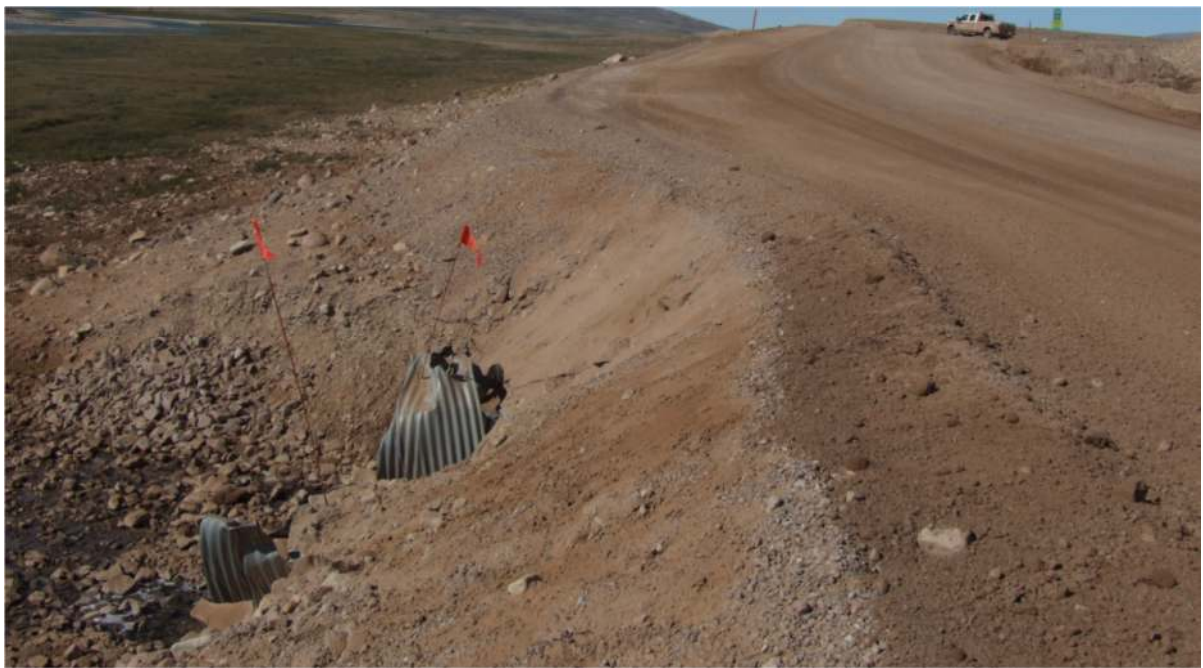
Both ends of this double-barrel culvert are damaged and too short, particularly at the outlet end.

Figure 100: View of culvert(s) 114D (somewhat damaged outlet). Repair and extension is required.

Baffinland Action: Baffinland commits to further inspecting this culvert to determine if replacement with a longer, larger pipe is required. If replaced, both pipes will be repaired and extended. Once the pipes are repaired and extended, the road embankment may be widened.

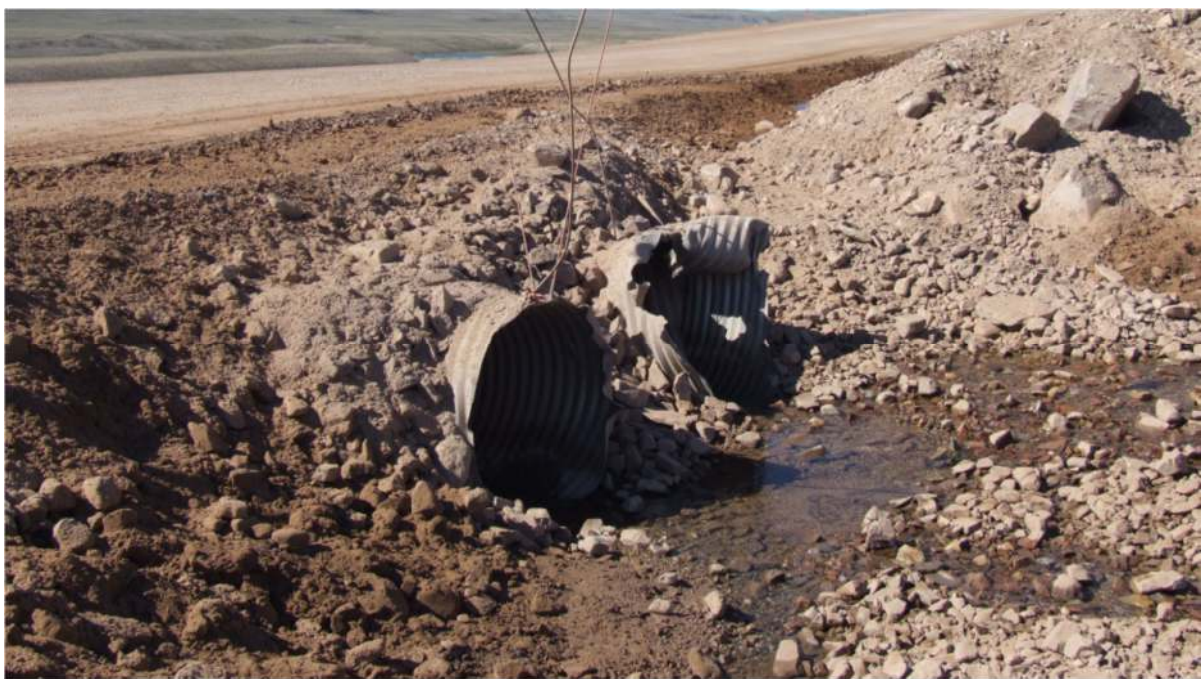
Figure 101: View of culvert(s) 114D (somewhat damaged inlet). Repair is required.

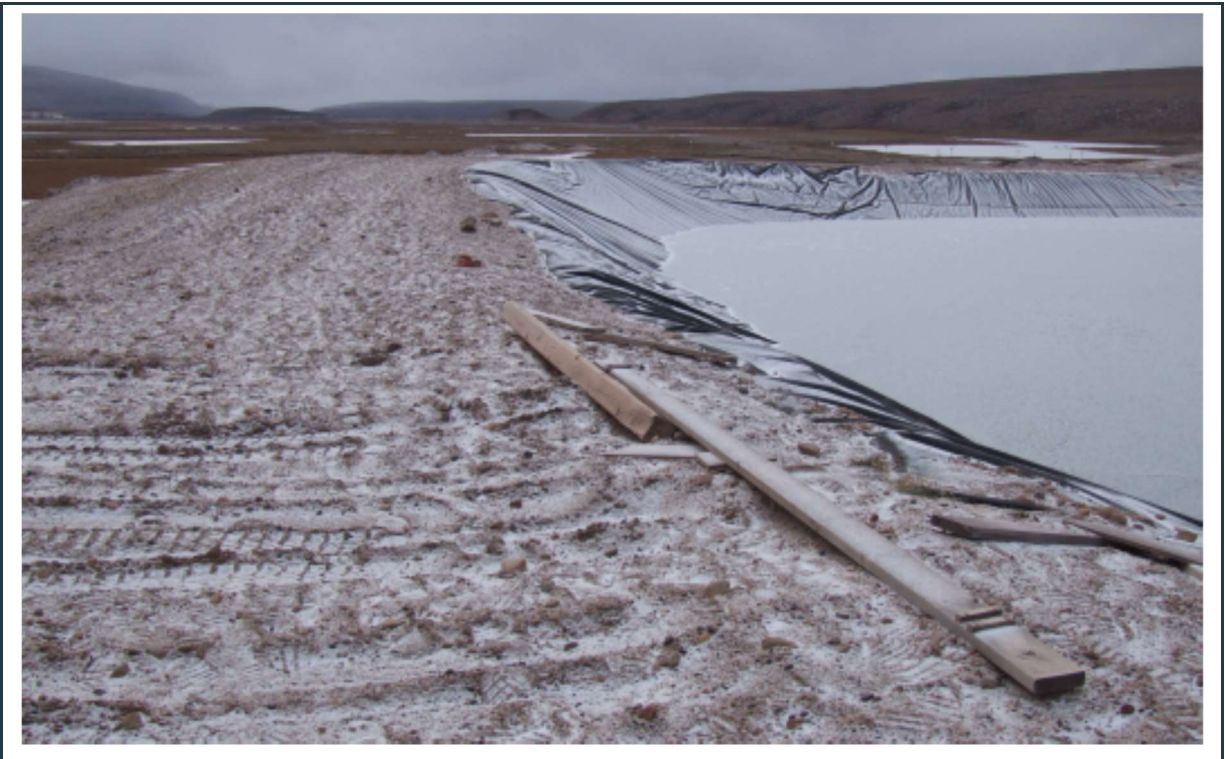
Figure 7: PWS pond #3 – Timber/lumber debris visible on the crest that should be removed.

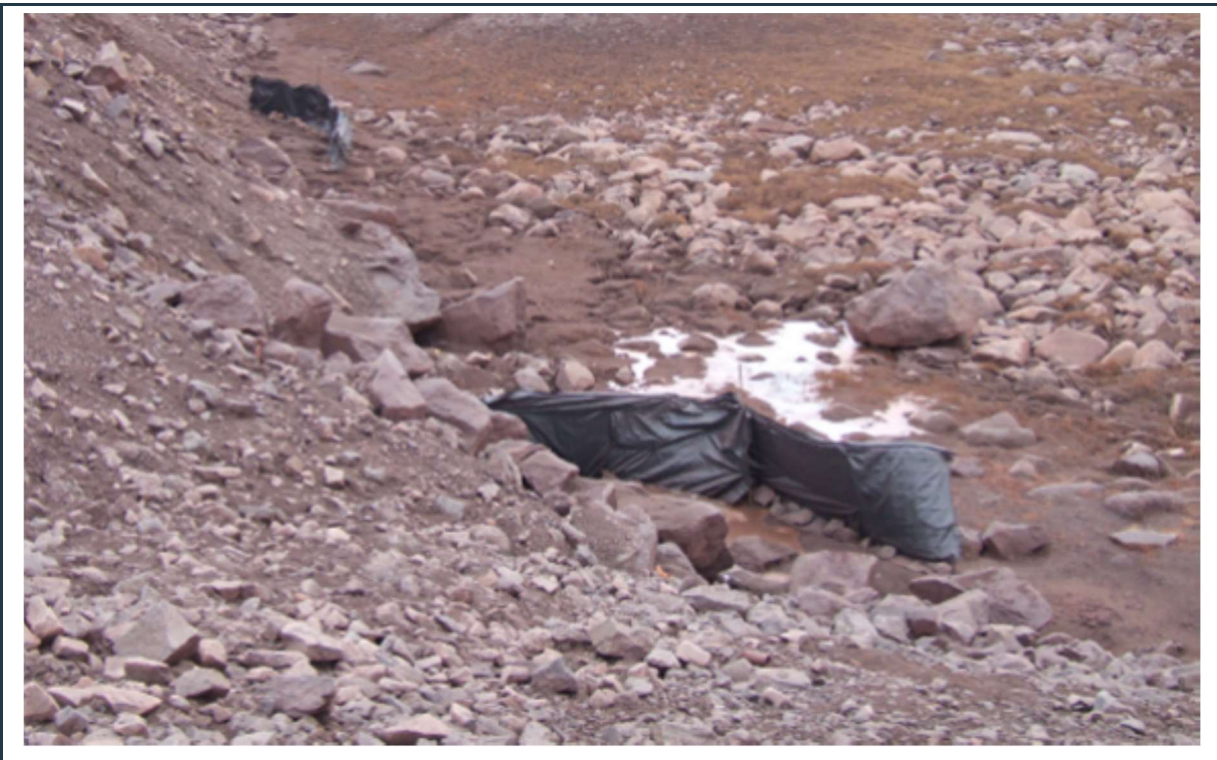
Figure 20: Minor water seepage as ice mount at the toe of the embankment where the crusher pad ditch embankment fill meets the tundra.

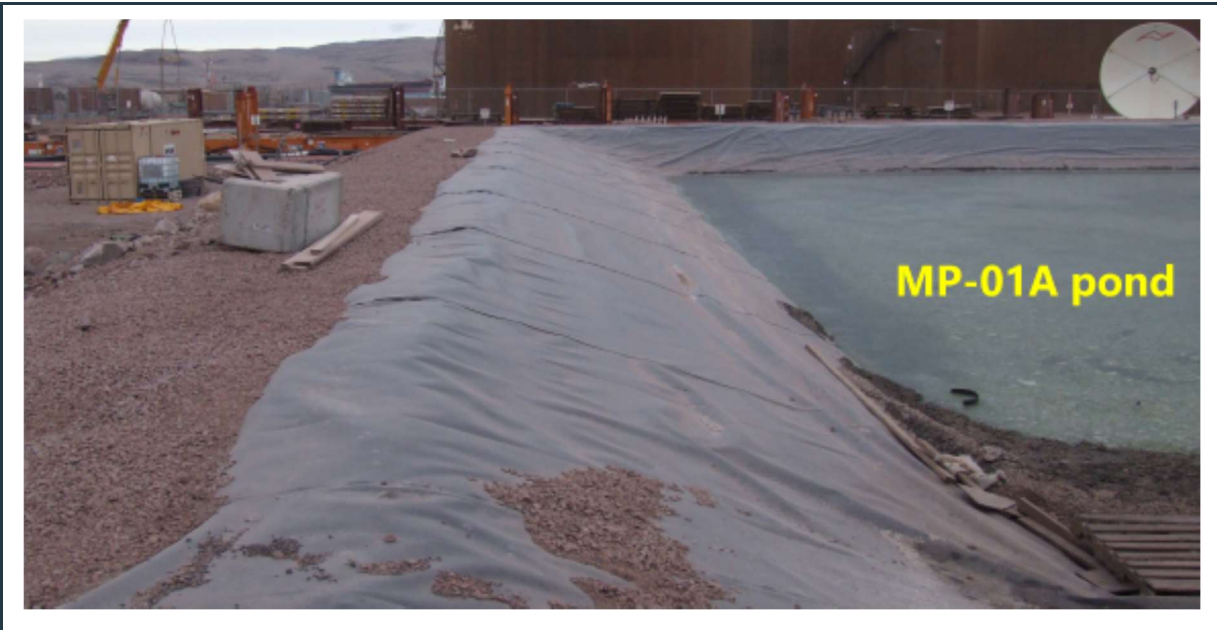
Figure 45: Berms and liner in good condition, with stable slopes around the MP-01A pond.
