## 2019 Inspection of the Milne Inlet Tote Road and Associated Borrow Sources

PRESENTED TO  
**Baffinland Iron Mines Inc.**

OCTOBER 30, 2019  
ISSUED FOR REVIEW  
FILE: ENG.EARC03171-01

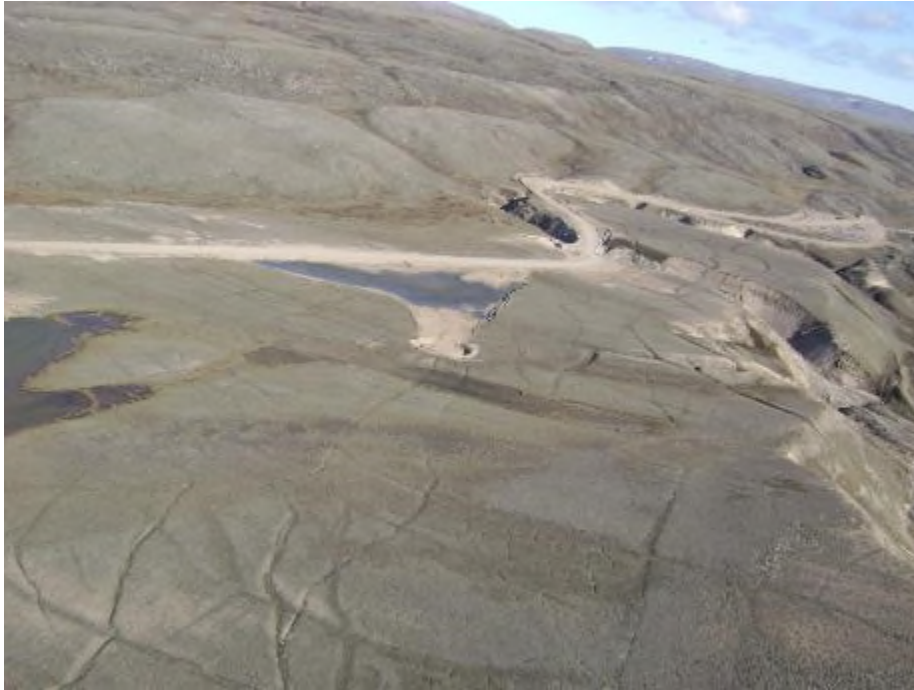
**Photo 1 (2014 Photo 1612):**

Priority C pit at KM 6.6 (Figure 1) lies on a gravel terrace with well-established ice wedge polygons. Removal of material from the active layer in the pit has initiated thaw and ponding but it has not changed since 2009 and remarkably is not currently impacting the embankment.

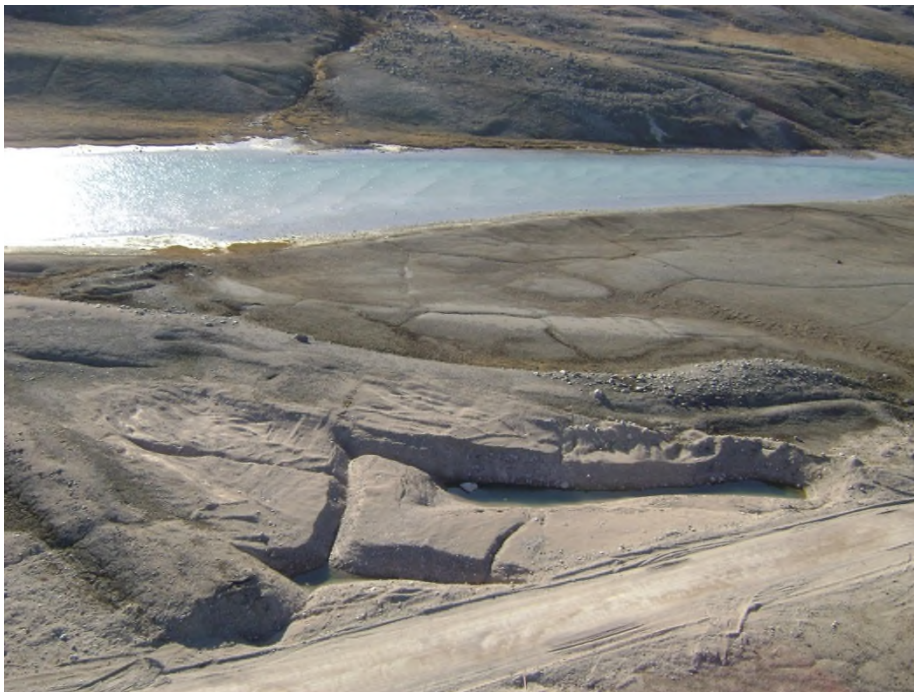
**Photo 2 (2014 Photo 1585):**

Pit at KM 20.7 (Figure 2), linear sinkholes from ice wedge melt out, see also Photo 3.

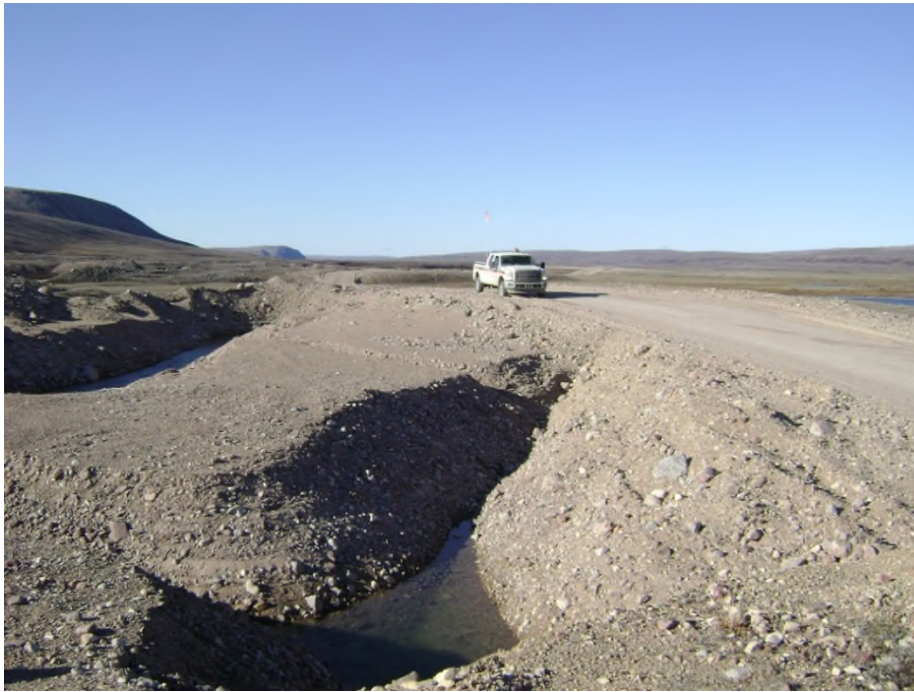
**Photo 3 (2014 Photo 1697):**

Pit at KM 20.7 (Figure 3) is threatening the stability of the road embankment as thermal erosion from water is occurring through the ice wedges exposed in the adjacent pit.

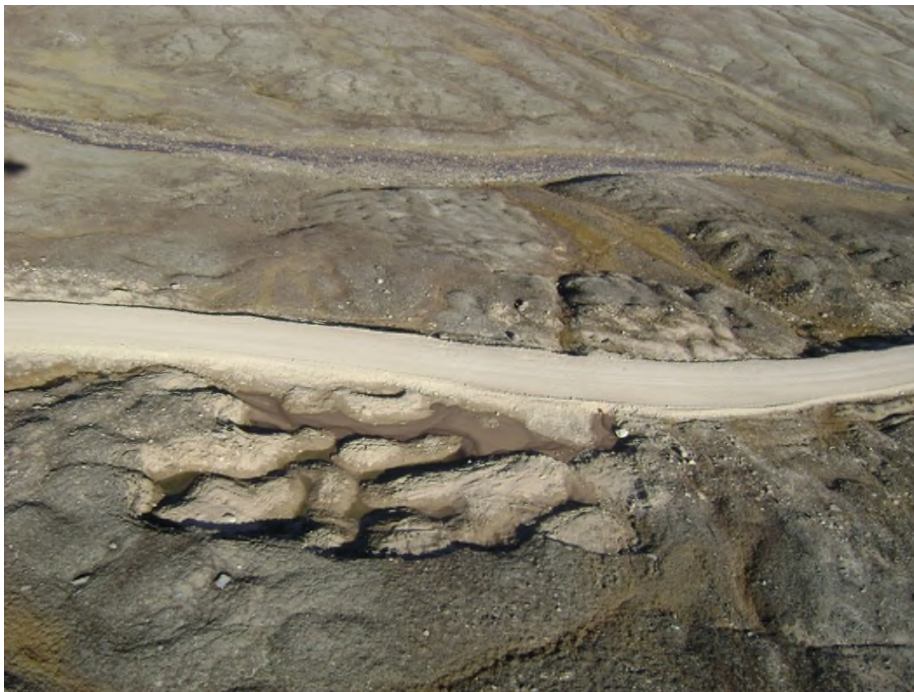
**Photo 4 (2014 Photo 1645):**

Pit at KM 71.6 (Figure 10), typical settlement from thaw of segregated ice common in finer-grained lacustrine soils.

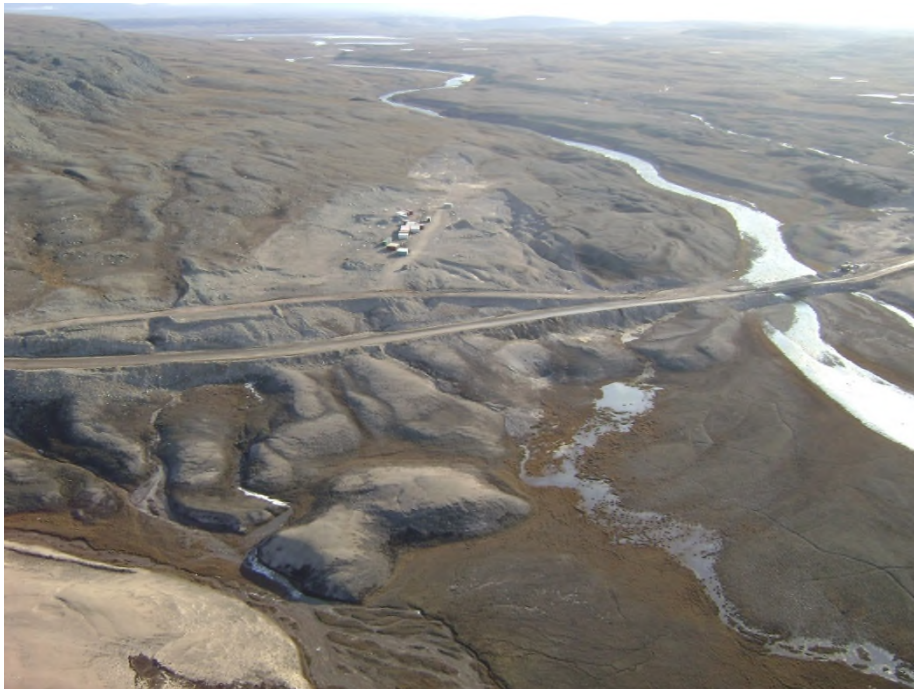
**Photo 5A (2593):**  
Pit at KM 61.7 (Figure 8), in 2014, note extensive settlement in southern portion (right side) of the developed pit indicative of the presence of massive ice in portions of this deposit. Note road realignment to improve grade.

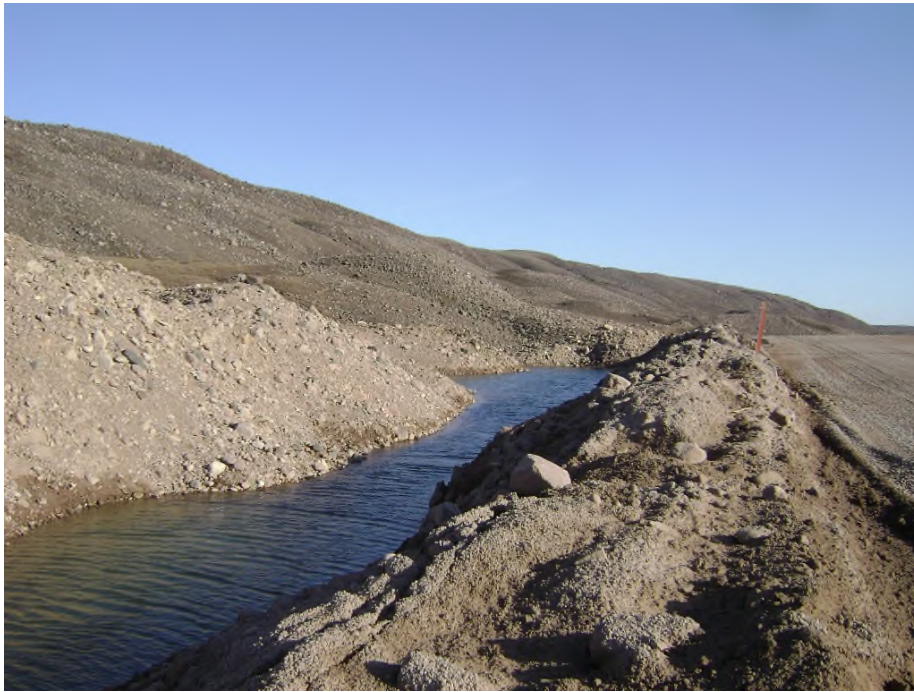
**Photo 10 (2536):**

Pit at KM 7.9 showing extensive settlement and ponding that is leading to embankment instability.

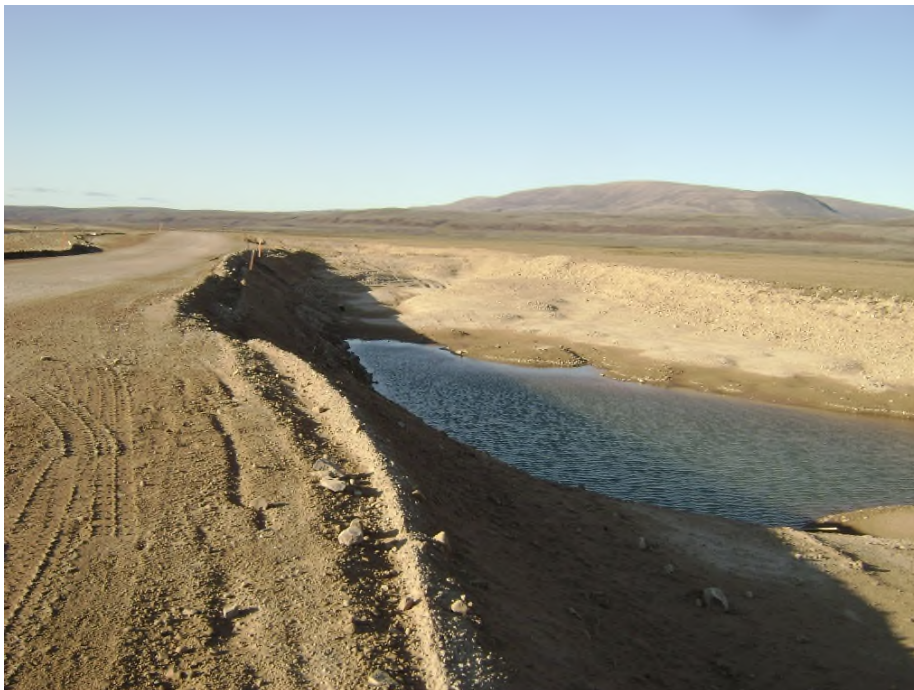
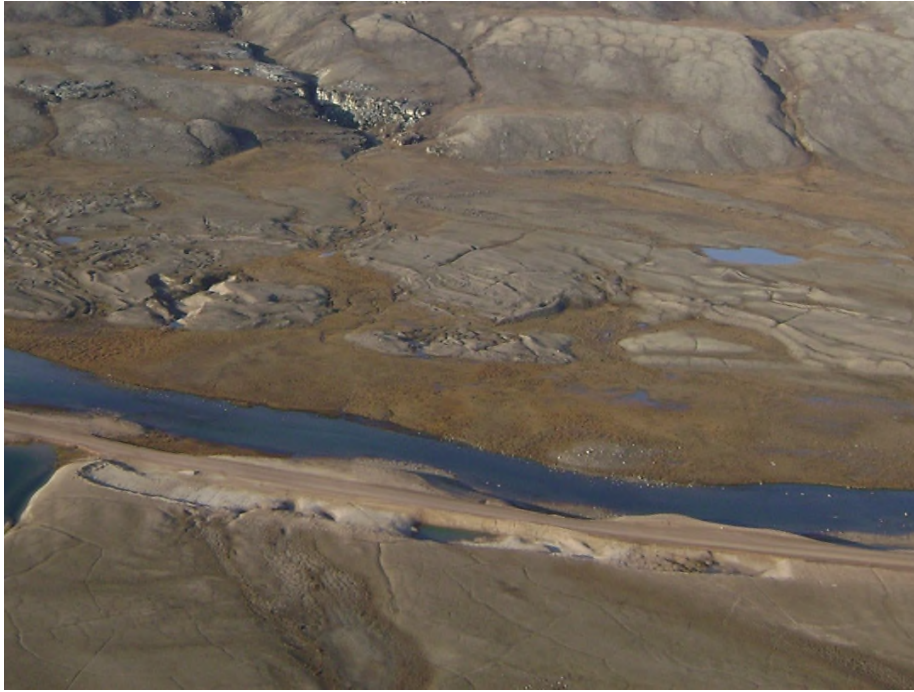
Pit at KM 19.8 (Figure 4), pit is deepening due to continued thaw of ice-rich ground. Side slopes are very steep and there is considerable cracking on the shoulder and side slopes indicating that thaw is progressing under the road embankment. See Photo 12 for an aerial view of this pit.

Pit at KM 19.8 (Figure 3), note ponded water resulting from thaw of ice-rich material and over-steepened side slopes where water is ponding.

3. KM 19.8 (pit 72) – See Photos 11 and 12. Thaw of very ice-rich ground continues in this pit. Side slopes are too steep, and the shoulder and side slopes show signs of instability. To guard against catastrophic failure, this pit should be backfilled or at a minimum a 2.0 m or so high berm should be placed along the toe of the steep slopes to provide stability and push ponded water away from the toe of the slope.

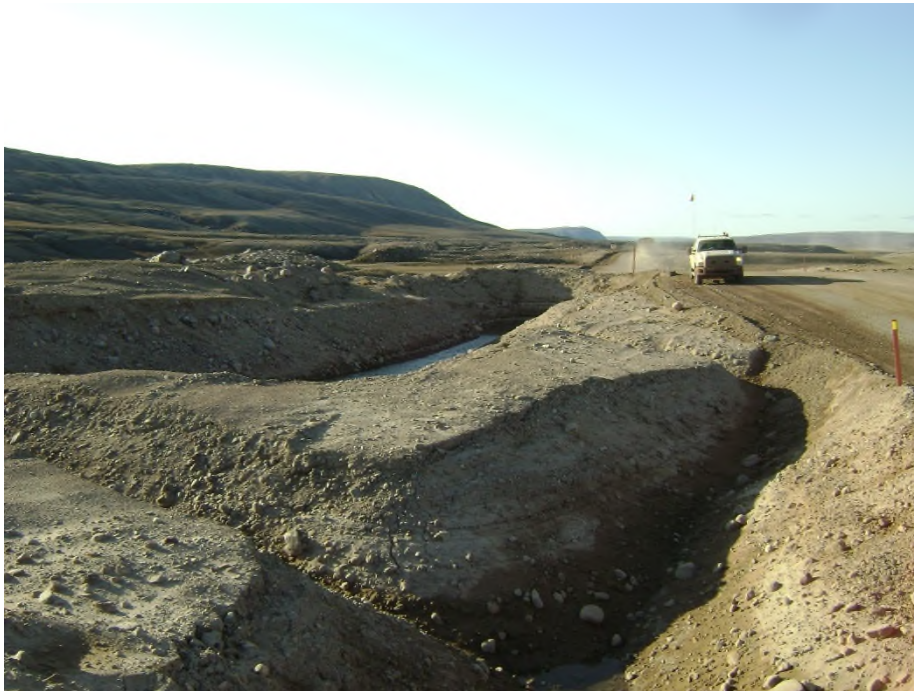
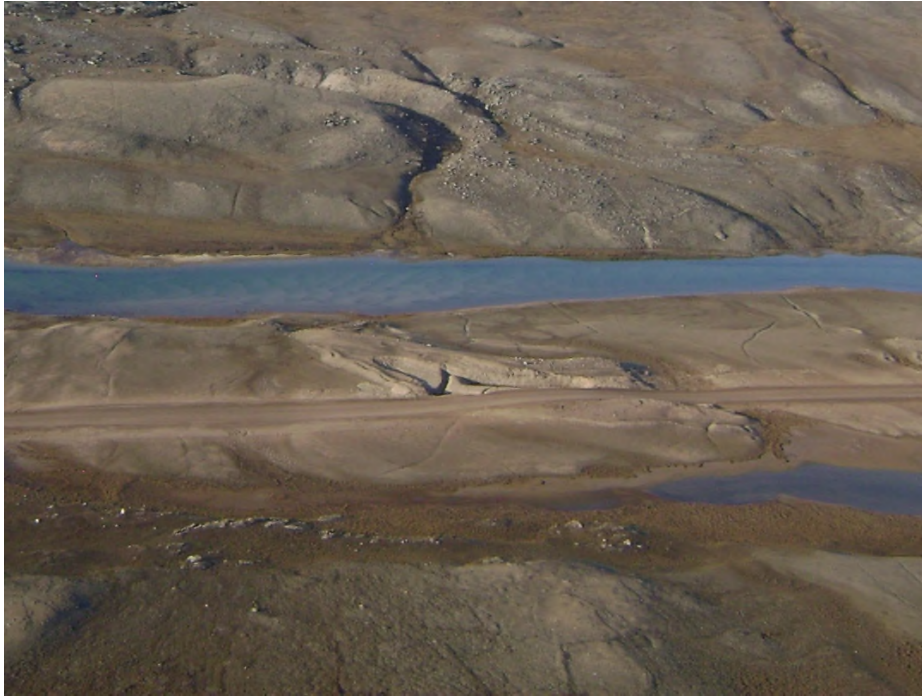
Pit at KM 20.7 (Figure 3), continued melt out of wedge ice since 2009, embankment side slope is at angle of repose and there is substantial cracking on the side slope. There is evidence that the wedge ice that extends under the road is thawing because there are dips on the road surface. See also Photo 3 for comparison to 2014 condition.

Pit at KM 20.7 (Figure 3), see Photo 13 for closeup of this pit.

4. KM 20.7 (pit 71) – See Photos 13 and 14. Continued thaw of wedge ice is increasing settlement depth and there continues to be evidence that the ice wedge ground that the road is constructed on is thawing. This pit should be backfilled, and the surface regraded to cause the permafrost to aggrade and thereby stabilize the embankment side slopes and hopefully arrest thaw of the wedges below the embankment.

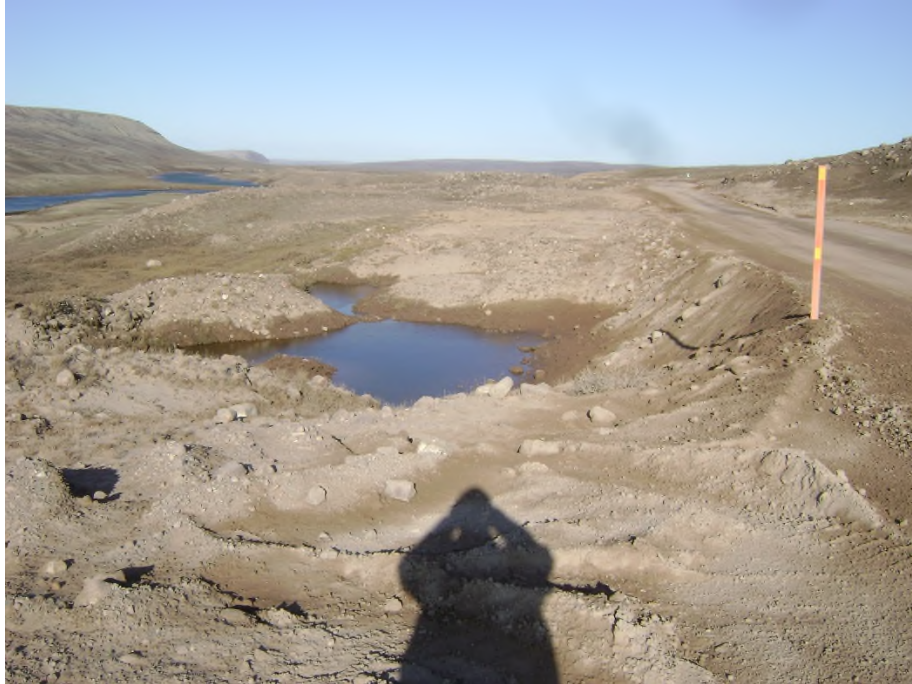
**Photo 15 (2693):**

Pit at KM 21.9 (Figure 3), continued thaw of ice-rich material exacerbated by the ponding leading to steep side slope and instability of the embankment.

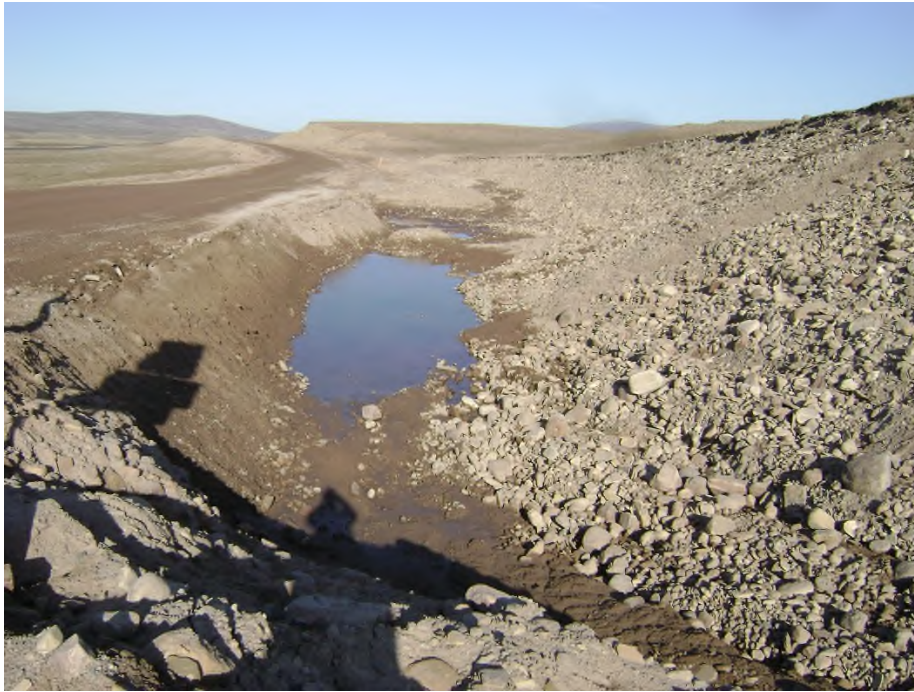
**Photo 16 (2693):**

Pit at KM 29.1 (Figure 4), continued thaw of ice-rich material exacerbated by the ponding leading to steep side slope and instability of the embankment. See also Photo 17. The central portion of this pit had been backfilled since 2014 dramatically improving embankment stability.

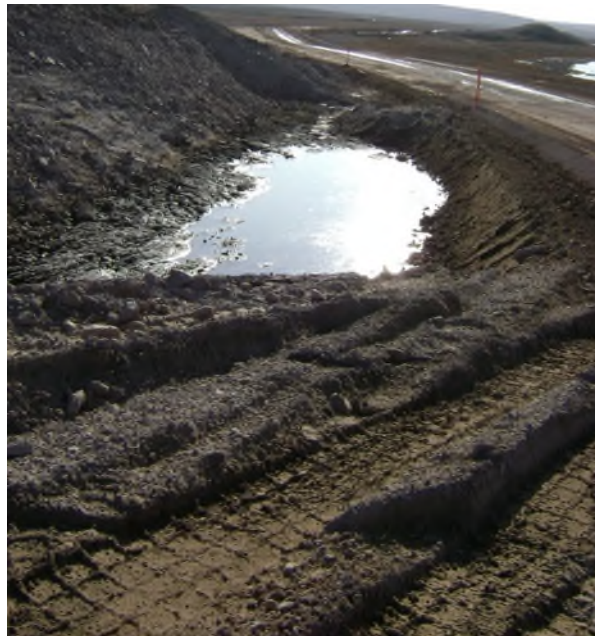
**Photo 17 (2695):**

Pit at KM 29.1 (Figure 4), continued thaw of ice-rich material exacerbated by the ponding leading to steep side slope and instability of the embankment. The central portion of this pit had been backfilled (bottom of the photo) since 2014 dramatically improving embankment stability.

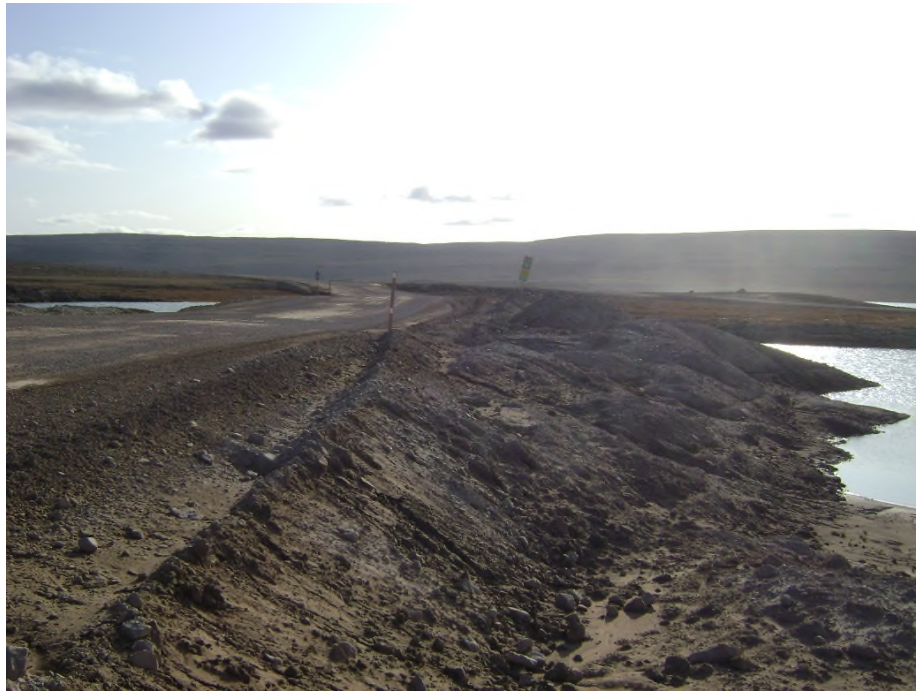
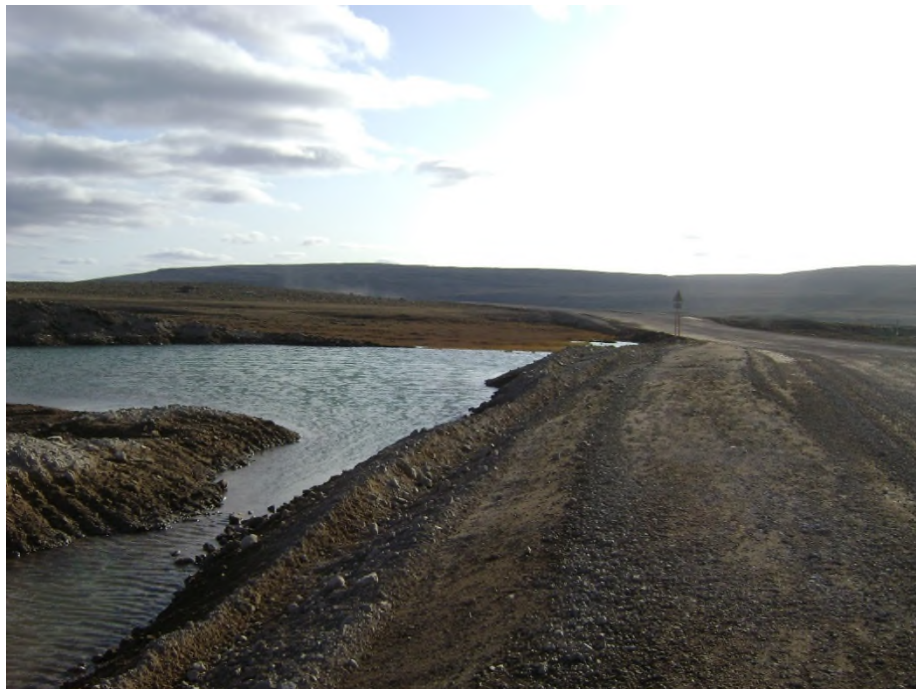
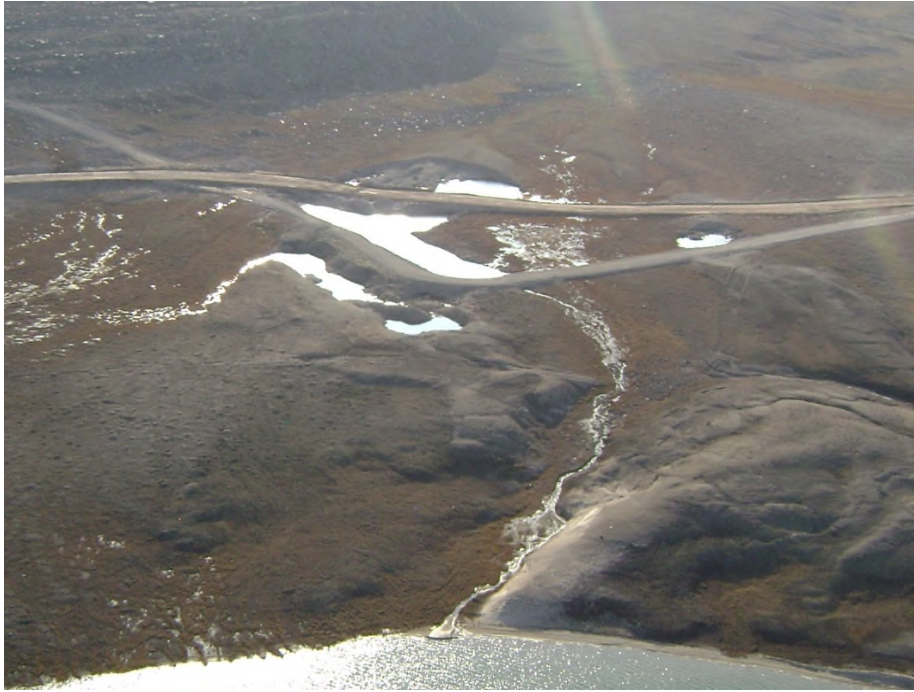
Pit at KM 56.8 (Figure 8), berms along this (right) side of the new road effectively push water away from the embankment providing thermal protection to the embankment foundation soils and enhancing stability.

Pit at KM 56.8 (Figure 8), the left side of the new road has steeper side slopes particularly where it narrows at the culvert inlet (close to the KM marker). This increases the potential for instability. The water needs to be pushed back from the toe of the slope by constructing berms on this side of the road (see Photo 18).

Pit at KM 56.8 (Figure 8), drainage at this location is clearly shown in this photo. The culvert under the old road (near the hairpin corner) is currently being relied upon to keep water levels low around the new road.

7. KM 56.7 to 56.9 (pits 32 and 33) – See Photos 18, 19, and 20. The new road alignment runs through the old pit which had experienced extensive melt out of ice-rich permafrost. The old embankment is now failing quite significantly. Water is ponding on both sides of the new road bringing concern of instability as further thaw is expected. Drainage from the pond on the left of the embankment passes through the new embankment through a culvert into the area between the new and the old road, from there it flows towards the lake (see Photo 20). With no maintenance on the old road there is concern for the continued performance of the culvert on the old road. If it was to fail or become blocked, water levels beside the new road would rise significantly perhaps leading to more thaw along the new road. Two remedial measures are therefore suggested. Provide wider berms along the full length of both sides of the new road (like those shown in Photo 18) or backfill the old pit in its entirety. Also, remove the culvert on the old road and breach the road so continued reliance on the old culvert is not required.

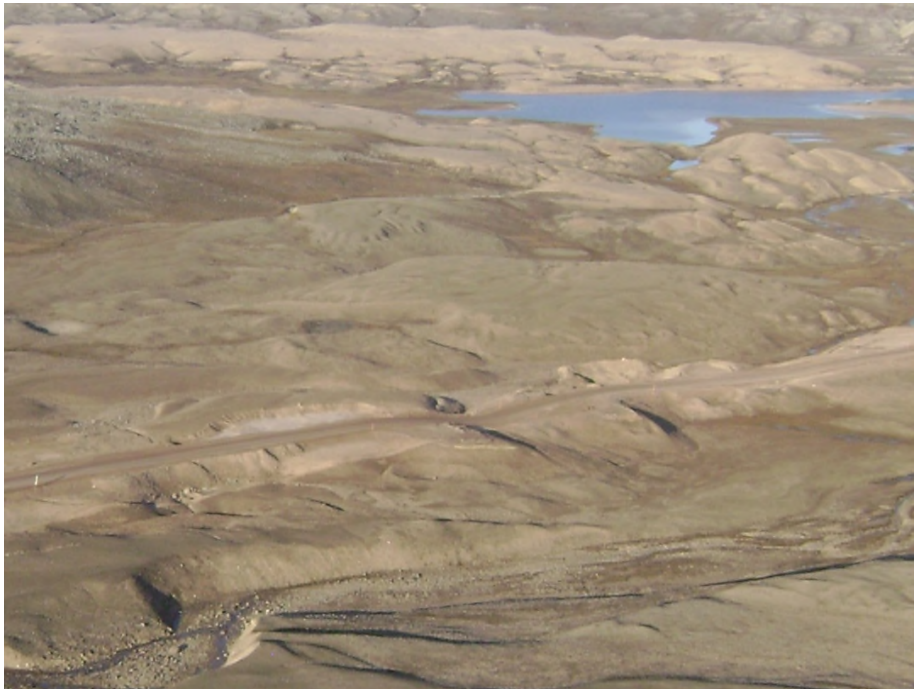
**Photo 21 (2558):**

Pits at KM 63 to 63.8 (Figure 9), continued thaw of ice-rich material threatens road stability at this location.

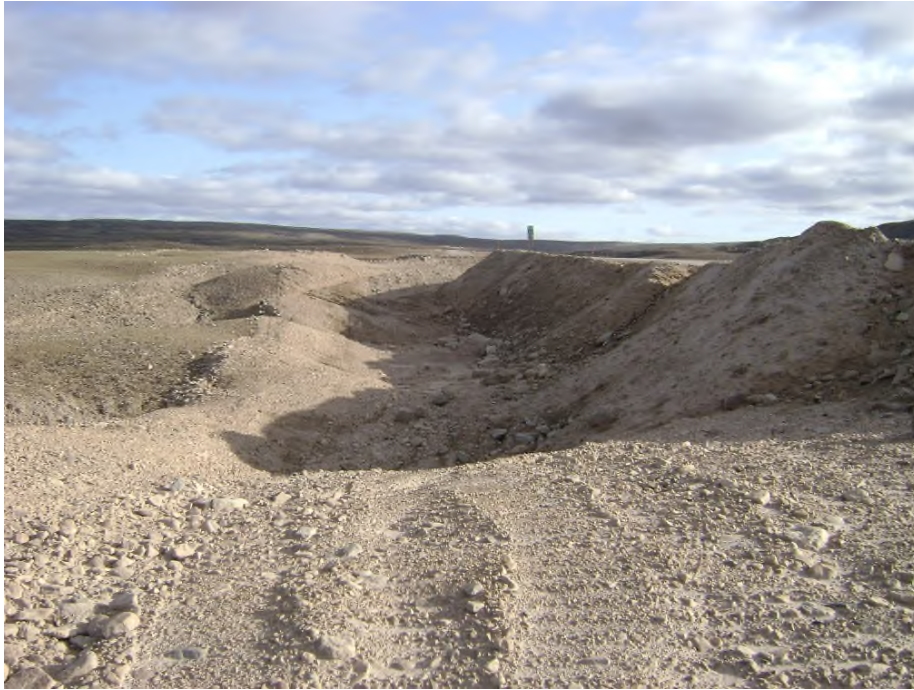
**Photo 22 (2657):**

Pit at KM 63.8 (Figure 9), continued thaw of ice-rich material beside the realigned road leading to steep side slope and instability of the embankment. Side slopes need to be significantly flattened to provide better thermal protection and stability.

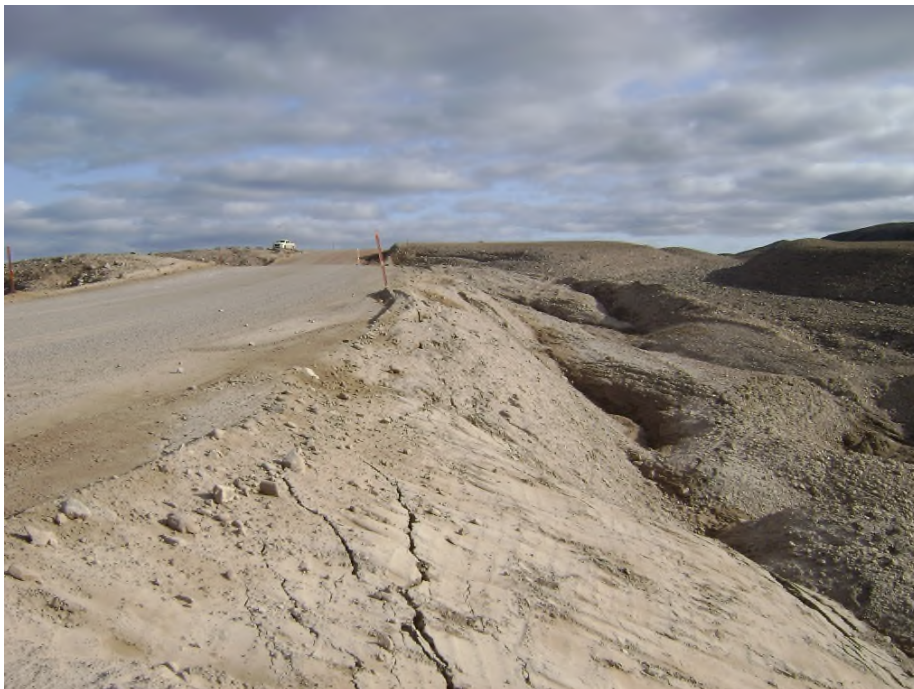
**Photo 23 (2662):**

Pits at KM 63 to 63.4 (Figure 9), continued thaw of ice-rich material beside the realigned road leading to steep side slope and instability of the embankment. Side slopes need to be significantly flattened to provide better thermal protection and stability.

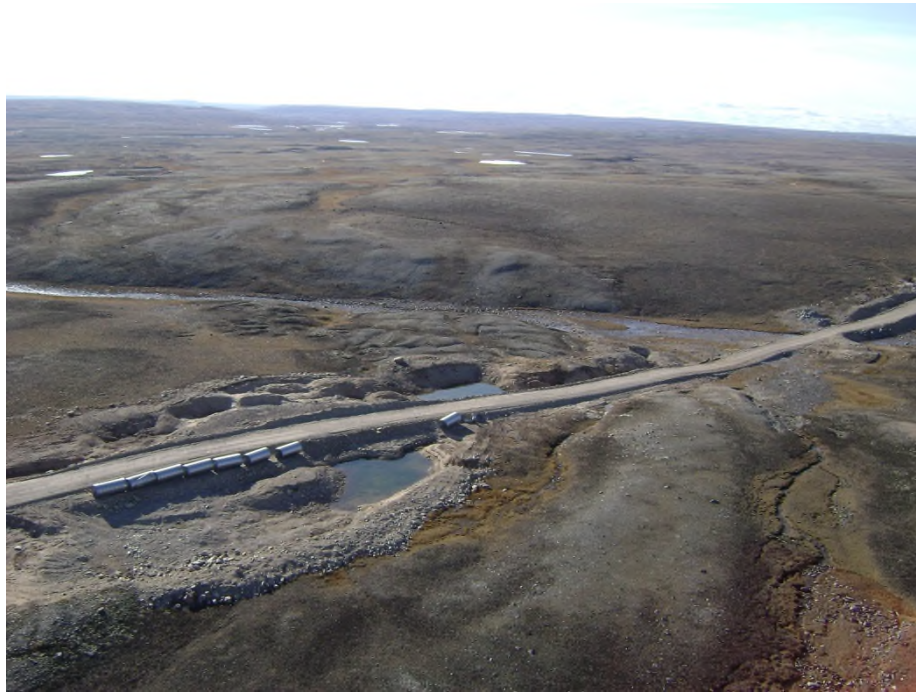
**Photo 24 (2014 Photo):**

Pit at KM 72.4 (Figure 10), extensive thaw settlement of very ice-rich soils in the borrow pits on both sides.

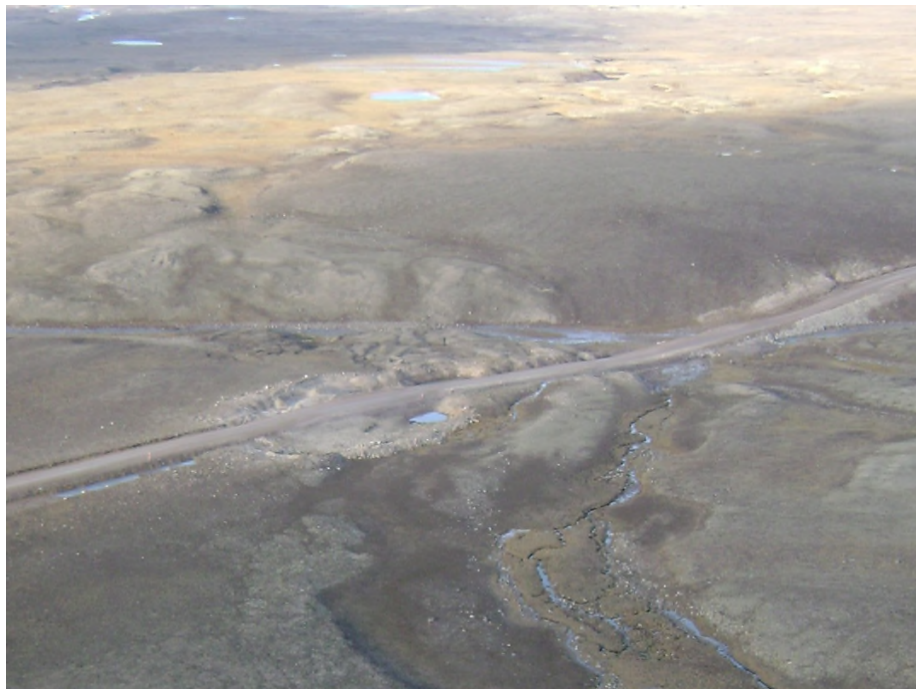
**Photo 25 (2555):**

Pit at KM 72.4 (Figure 10), compare to Photo 24. Thaw settlement is ongoing. Road was rebuilt after a failure occurred at the location of the pond on the left side of the road. Erosion channel from the left side is now more visible. When the water rises in the thaw settlement areas on the right side of the road it flows out and down to the creek and may be a source of sediment.

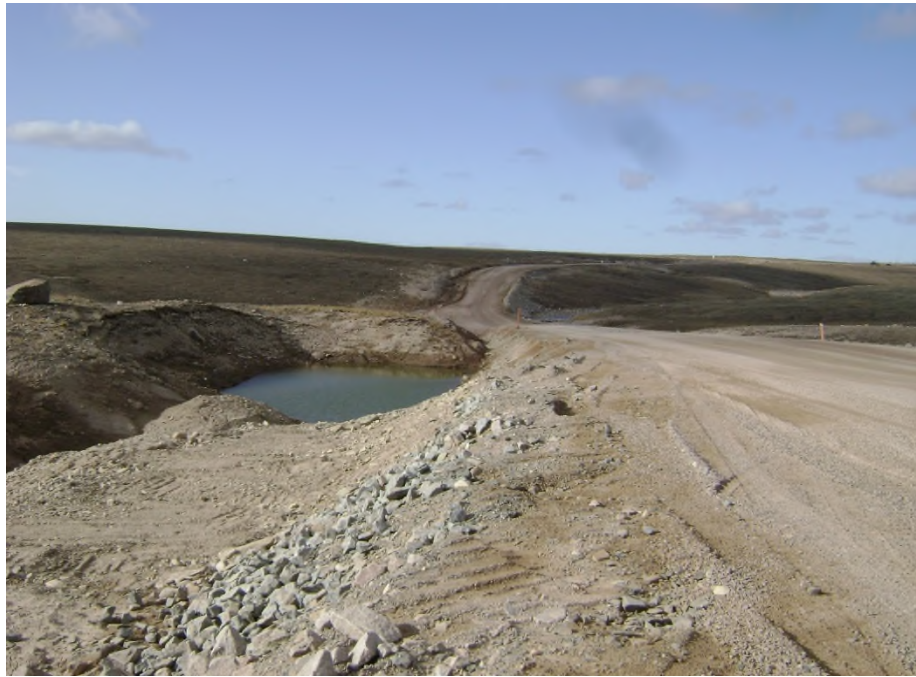
**Photo 26 (2555):**

Pit at KM 72.4 (Figure 10), photo shows right side borrow pit with very deep ponding due to thaw. Embankment shows signs of instability due to very steep slopes. Outlet for ponded water can be seen and is probably the source of sediments noted by the QIA.

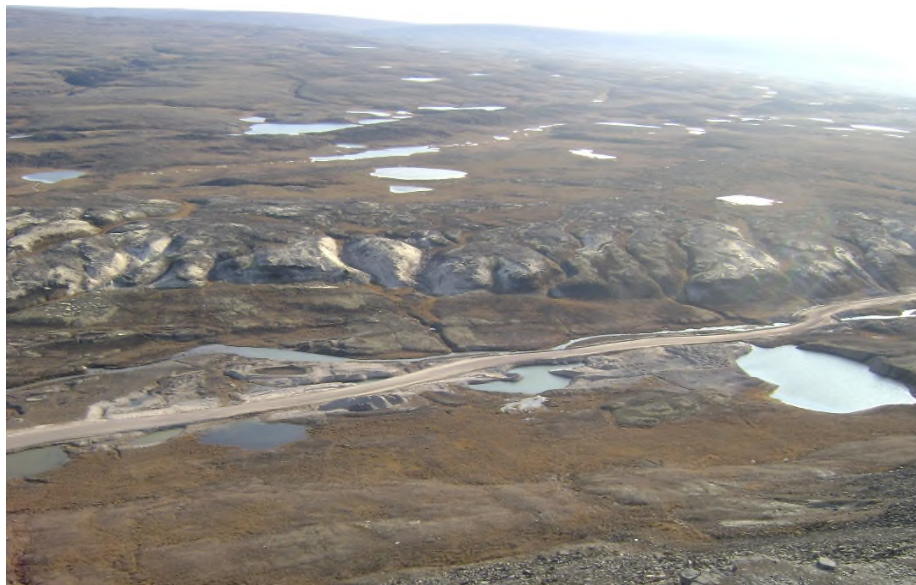
**Photo 27 (2597):**

Pit at KM 89.8 (Figure 12), photo shows borrow pit on the right side with very deep ponding due to thaw (centre of photo). Larger pond on the right is a natural thermokarst pond that existed before the road was constructed and is typical of the ponds that form due to thaw of massive ice bodies. This was likely also the case at the borrow pit location where the removal of the active layer initiated thaw of massive ice.

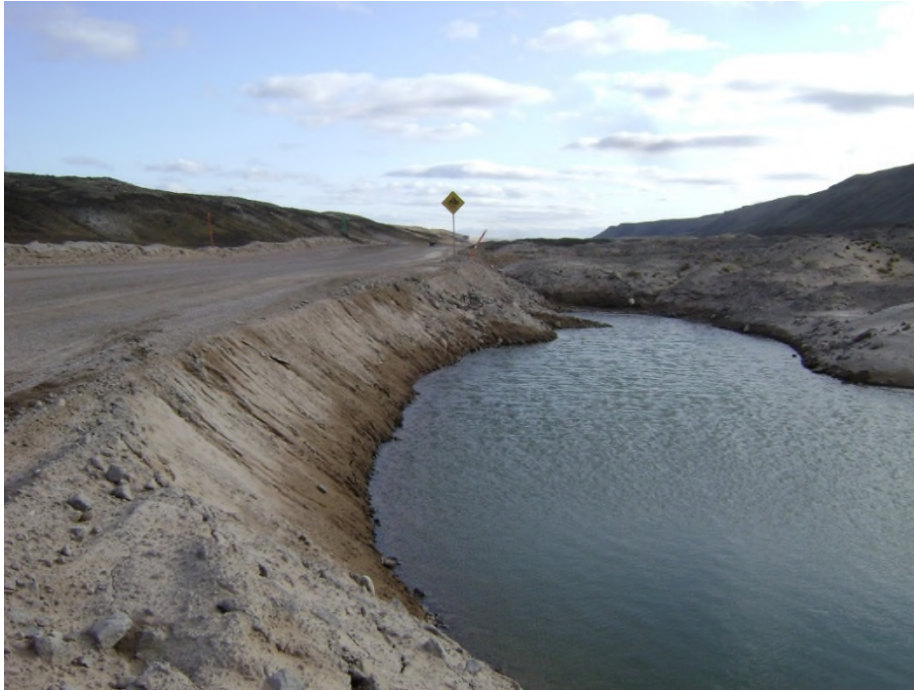
**Photo 28 (2656):**

Pit at KM 89.8 (Figure 12), photo shows right side borrow pit with very deep ponding due to thaw. Embankment shows signs of instability due to very steep slopes and ongoing thaw.

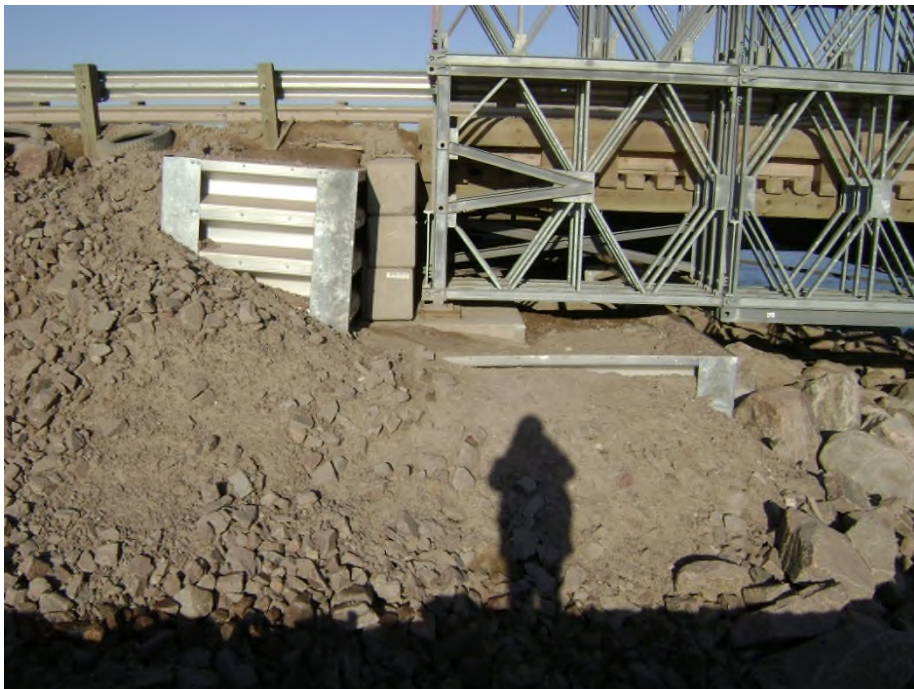
**Photo 29 (2678):**

KM 17 Bridge, west abutment. Note tilting of upper bin wall.

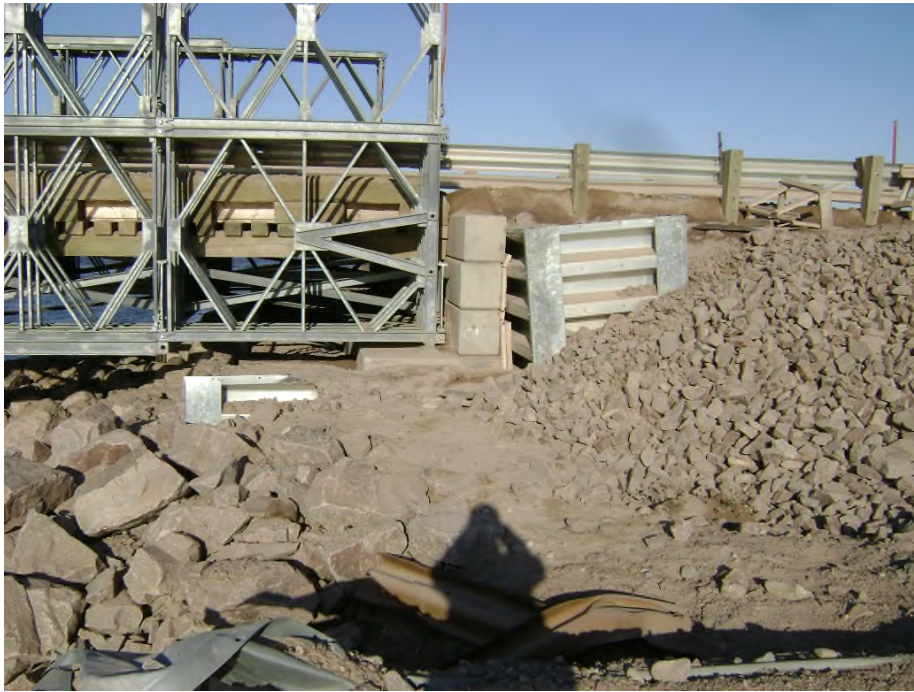
**Photo 30 (2683):**  
KM 17 Bridge, east abutment. Note tilting of upper bin wall.

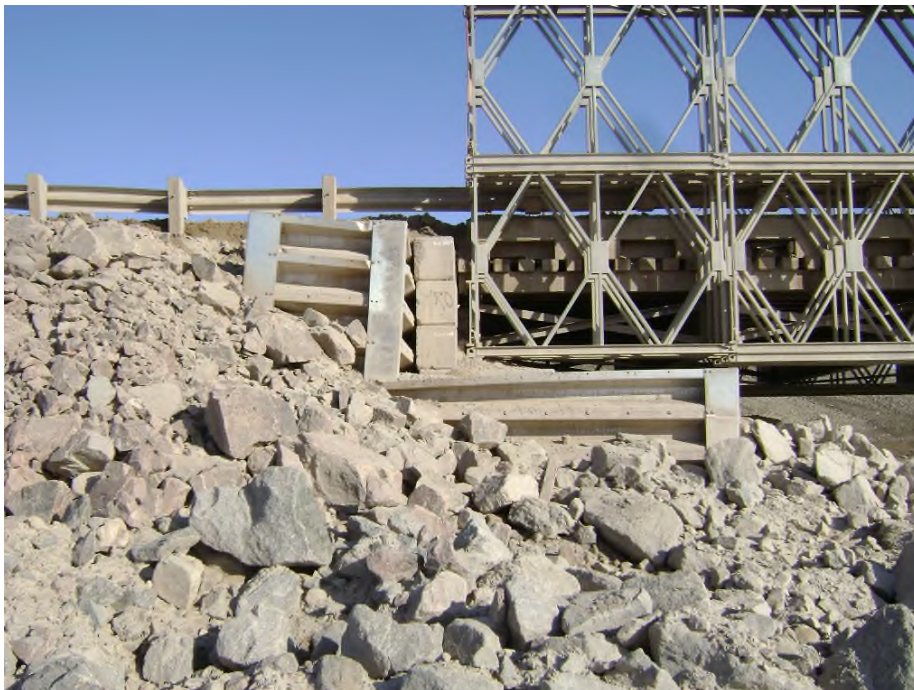
**Photo 31 (2683):**  
KM 63 Bridge, north abutment. Note tilting of upper bin wall.

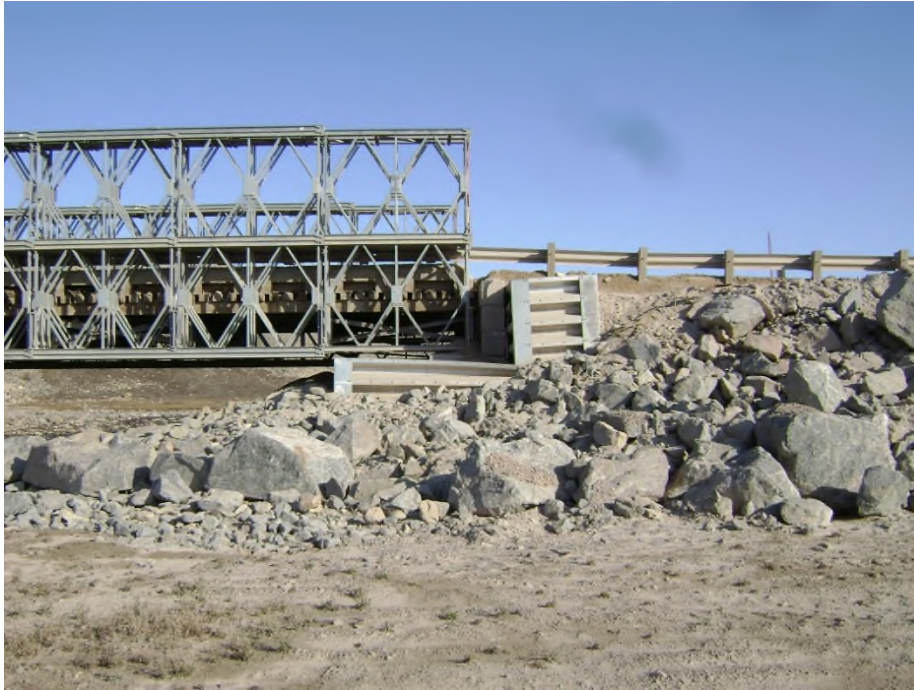
**Photo 32 (2708):**  
KM 64 Bridge, south abutment. Note tilting of upper bin wall.

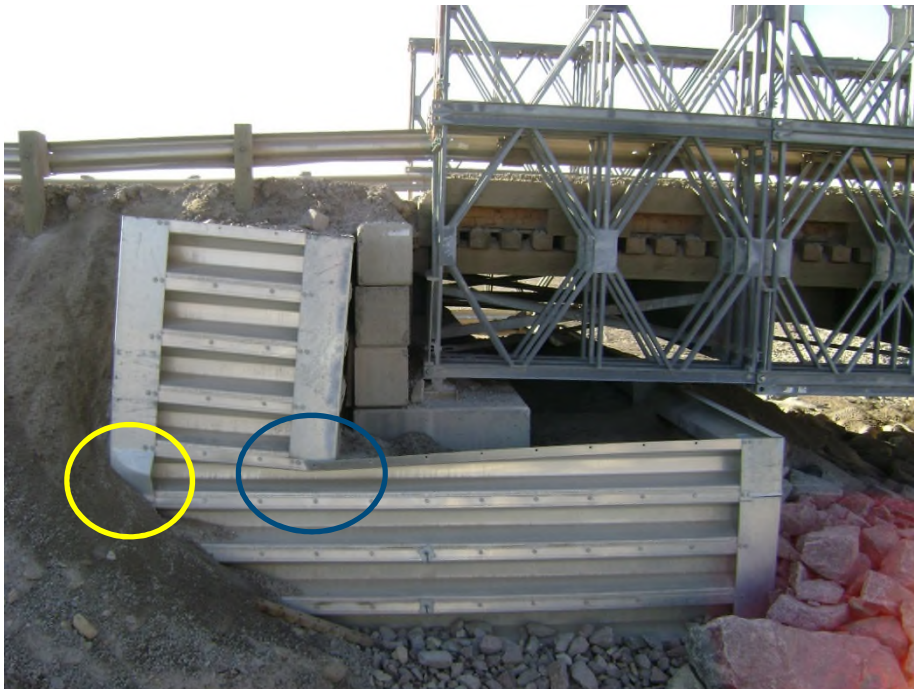
**Photo 33 (2712):**  
KM 64 Bridge, south abutment. Note tilting of upper bin wall, buckling of back bin wall corner post (yellow) and bending of upper plate in the lower bin wall (blue).

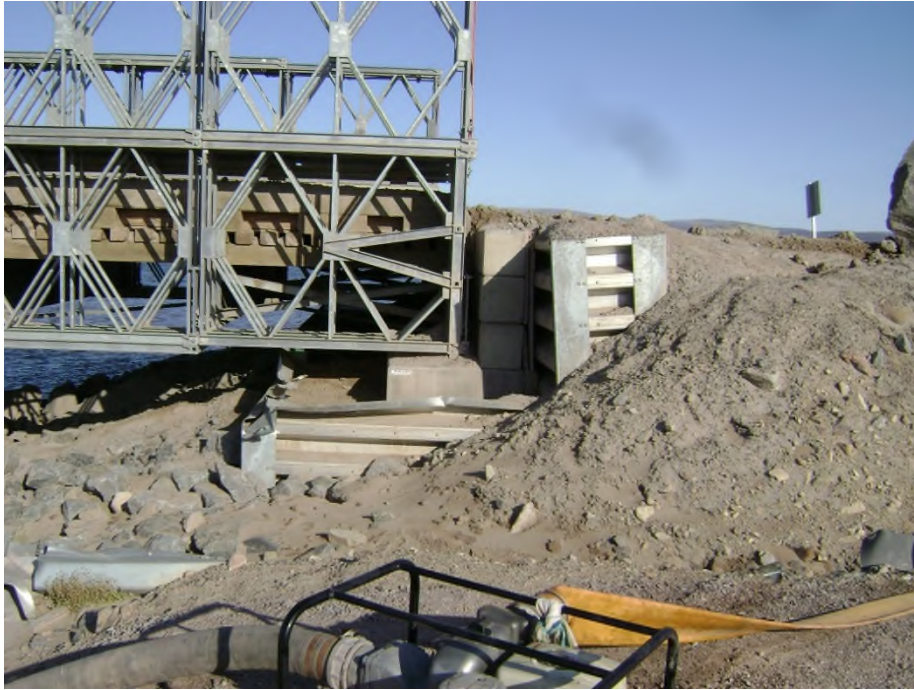
**Photo 34 (2715):**  
KM 80 Bridge, south abutment. Note tilting of upper bin wall.

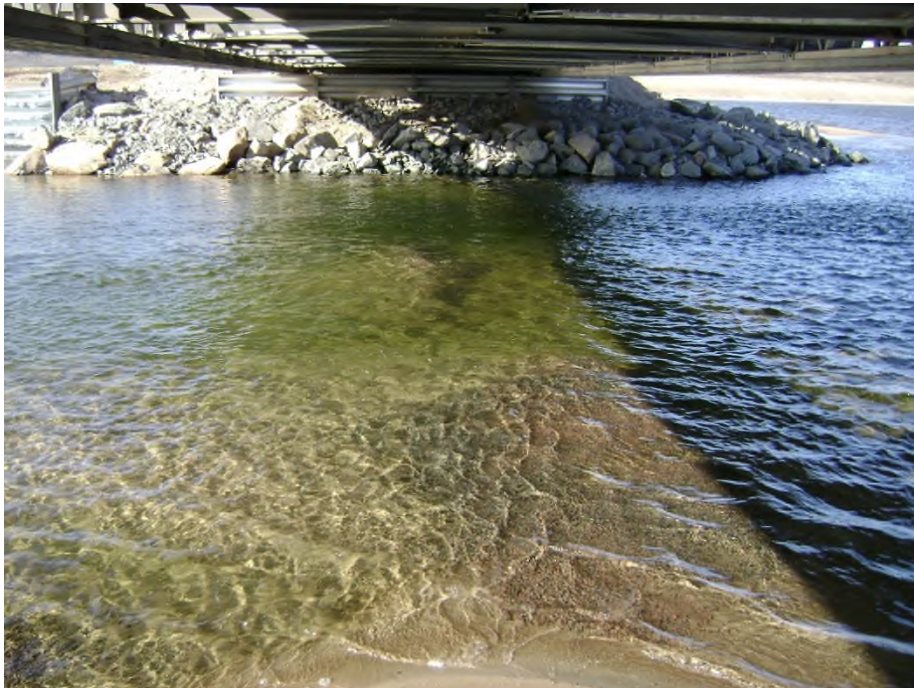
**Photo 35 (2718):**  
KM 80 Bridge, road surfacing gravel that has fallen through the centerline joint in the bridge deck and is visible in the river.

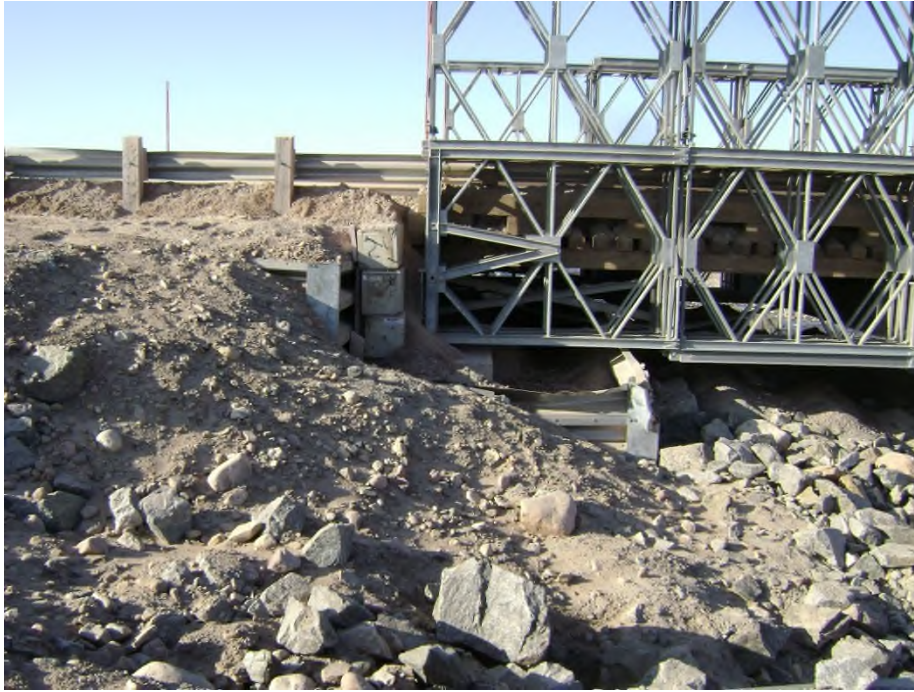
**Photo 36 (2719):**

KM 97 Bridge, north abutment. Shorter upper bin wall has not tilted as much as other bridges. Lower chord of the bridge truss appears to be in contact with the lower bin wall.
