APPENDIX E.8

CIRNAC Inspection Reports and Baffinland Response

RE: Water Licence 2AM-MRY1325 January 2019 Inspection Report

WATER LICENCE INSPECTION FORM

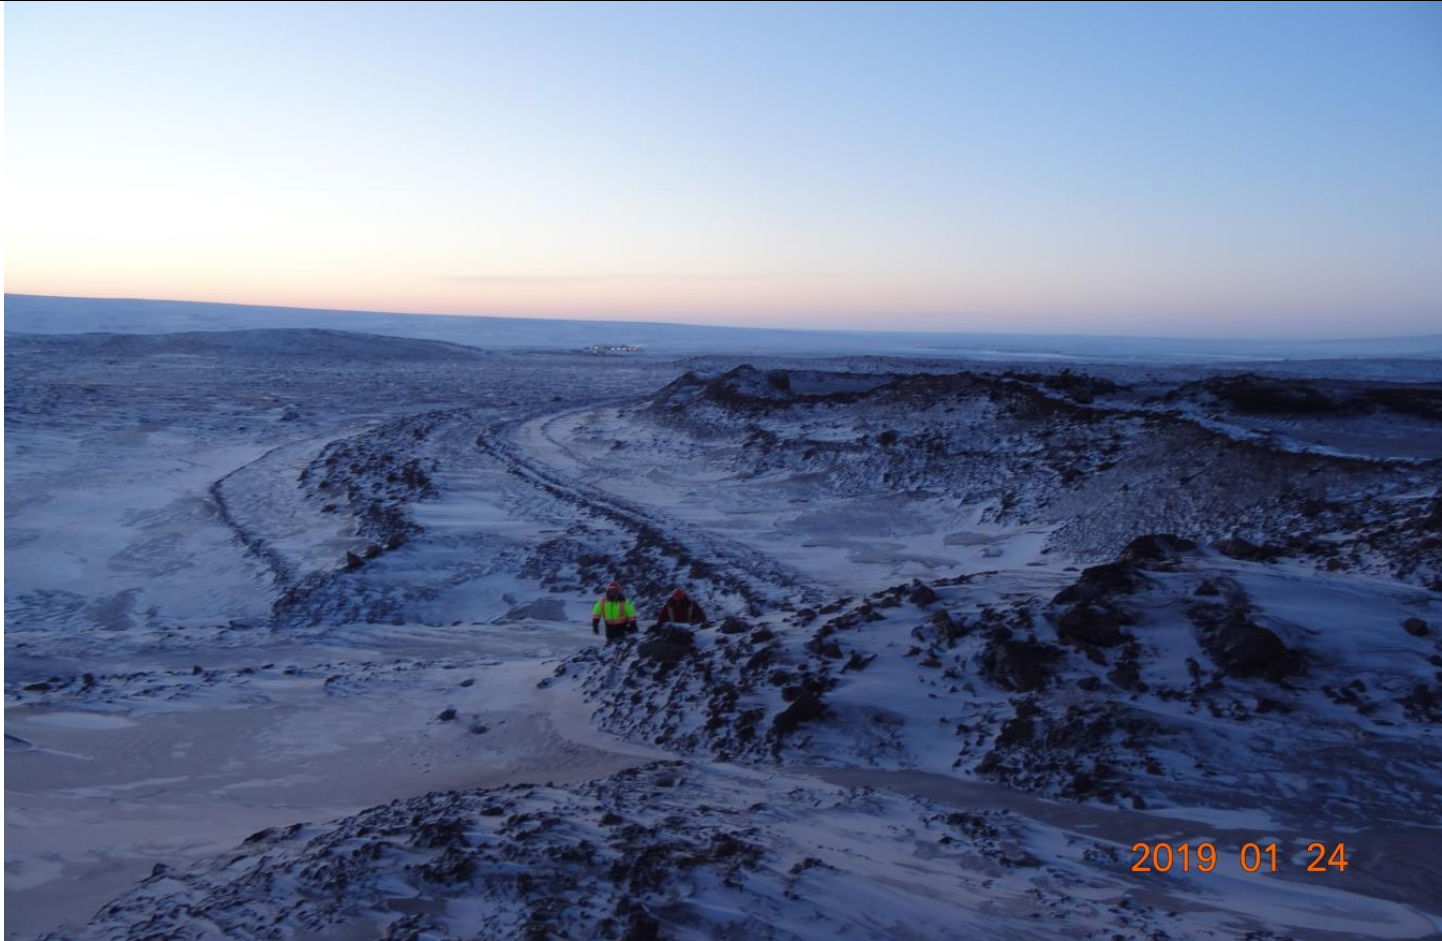
Photo 1

Description: Inspector Jeremy FRASER and Chase, Manager of Ore crusher pad, walk parameter of crusher pad. Managers have verbally agreed to have Ditching and single lane traffic road to be constructed prior to May 15 2019.

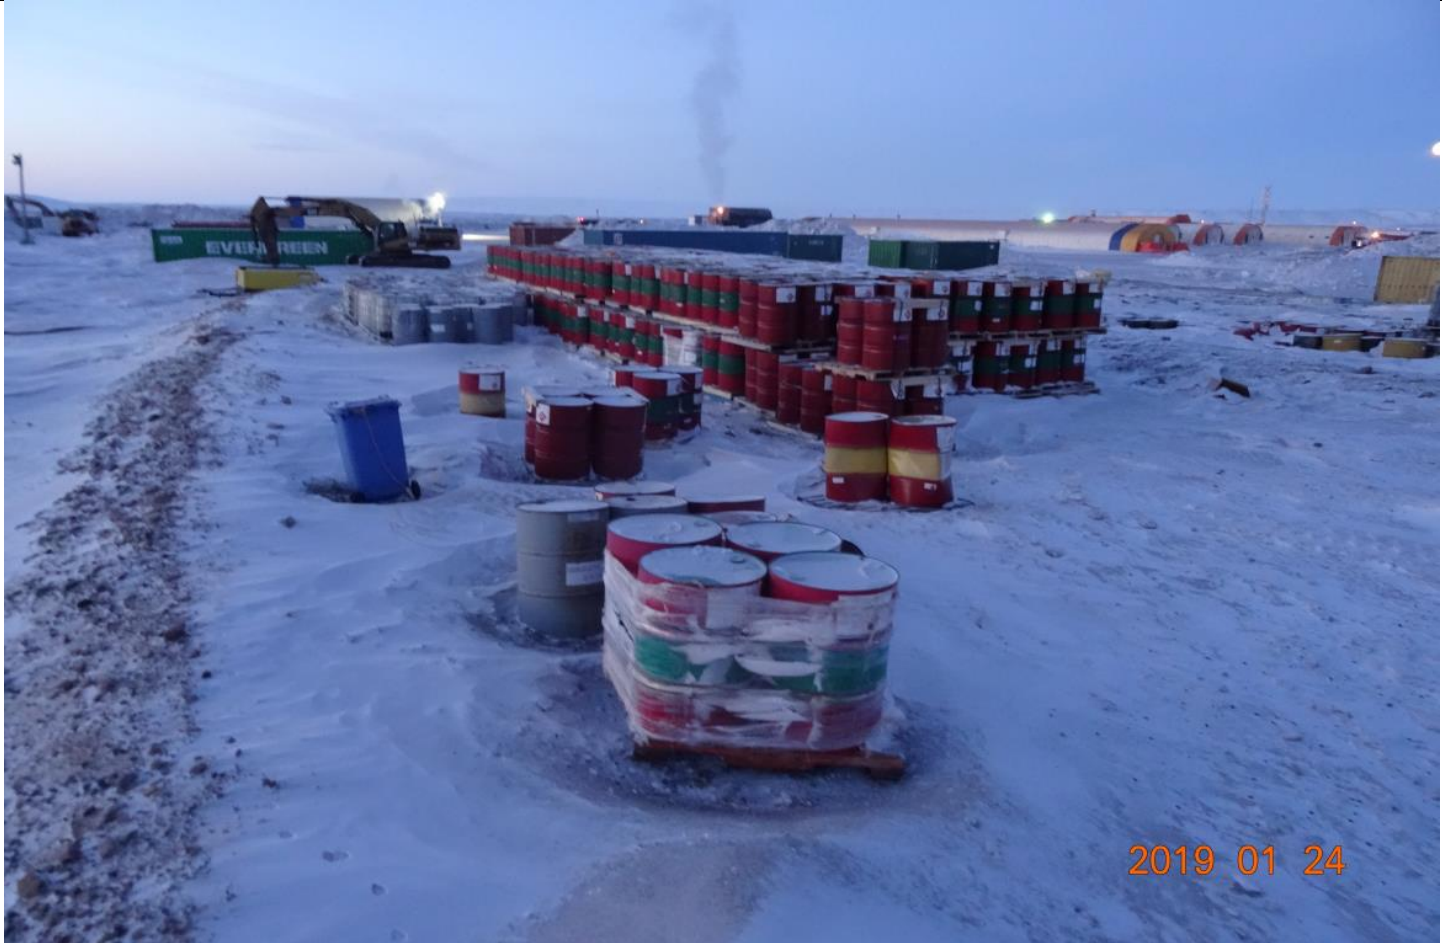
Photo 2

Description: Snow covered hazardous waste storage facility

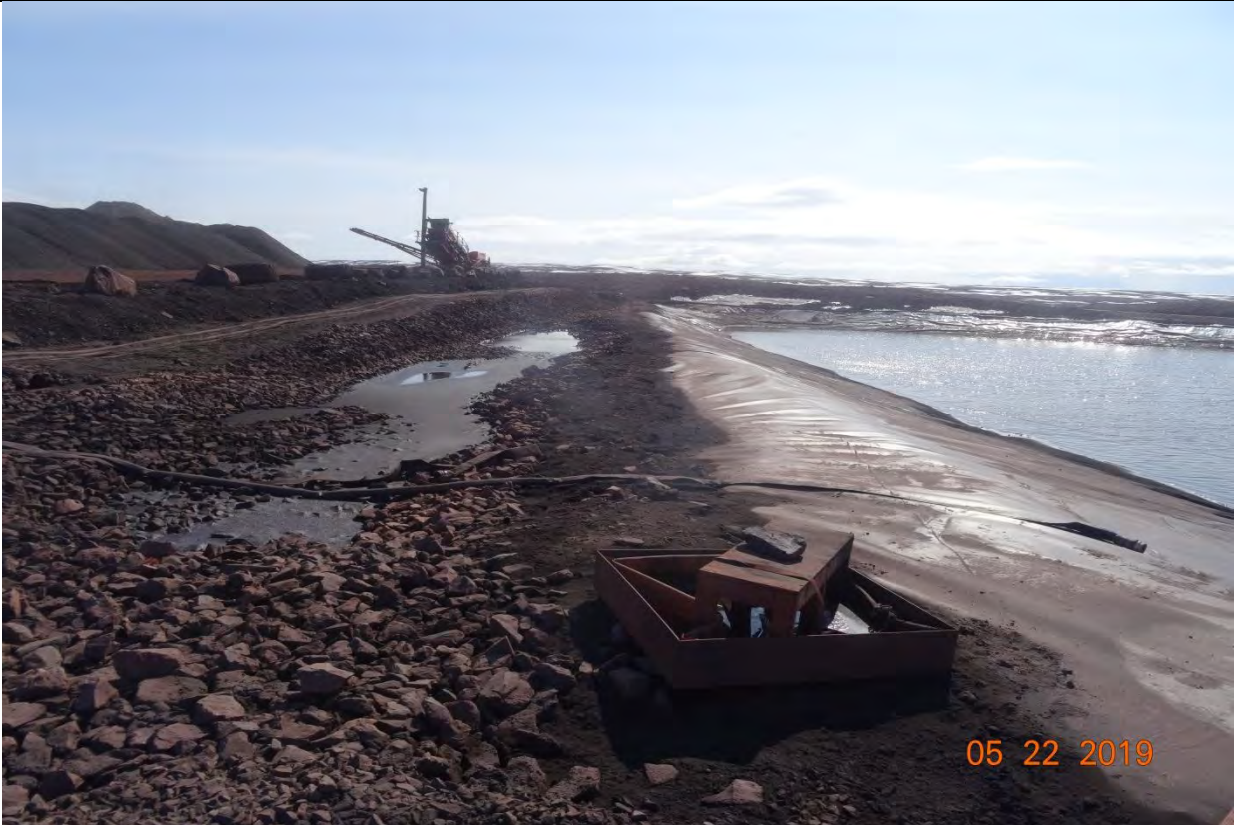
Photo 1

Description: Pooling in unlined ditches of the Crusher pad

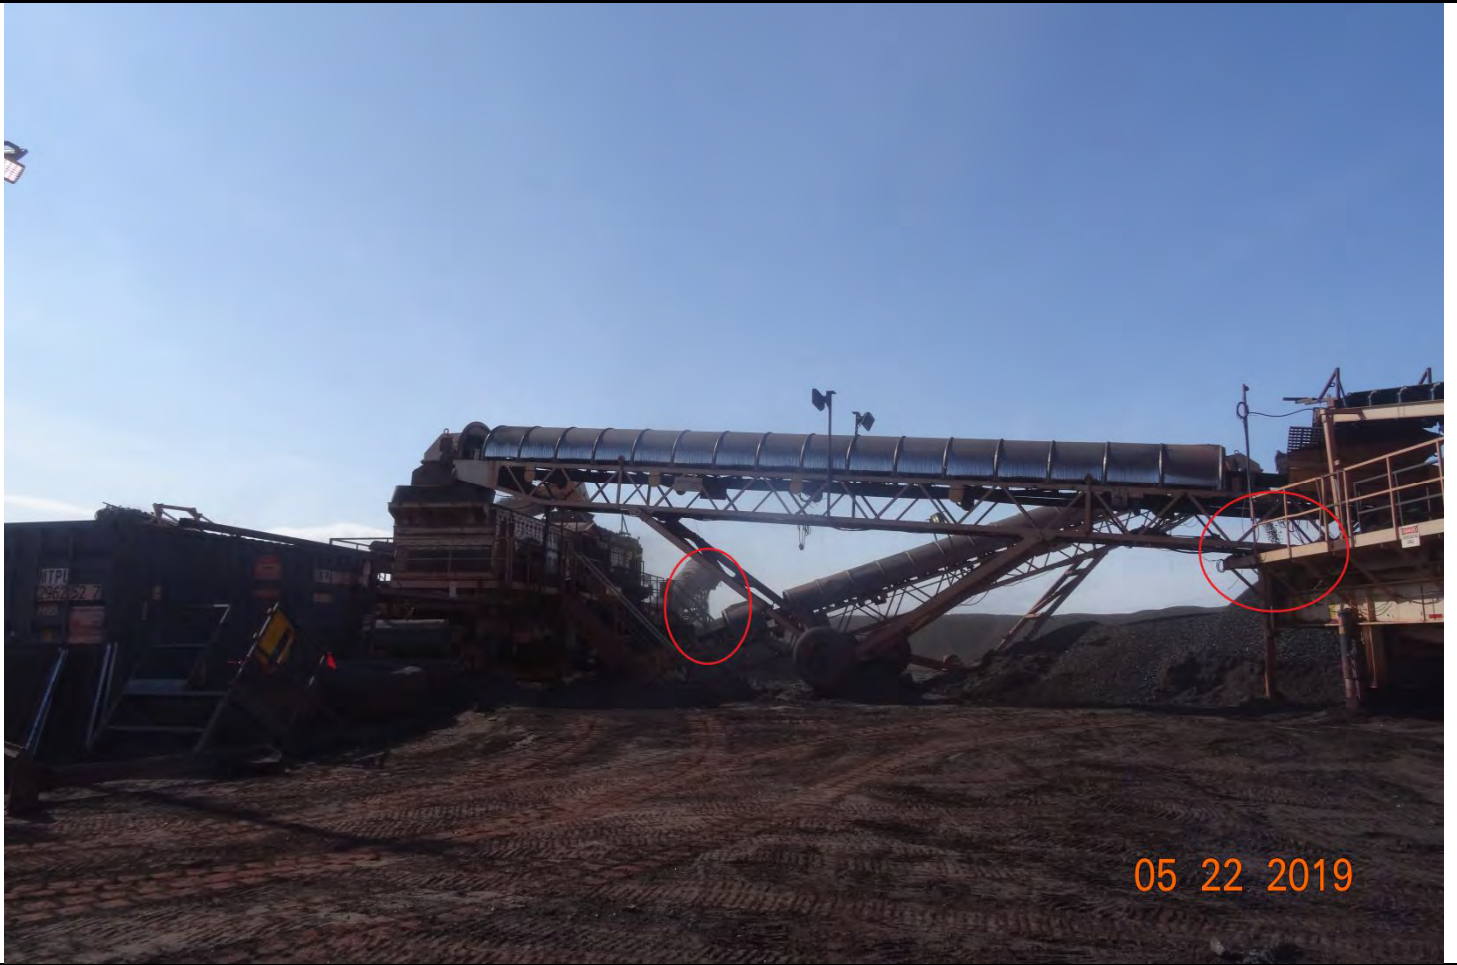
Description: Lack of dust control

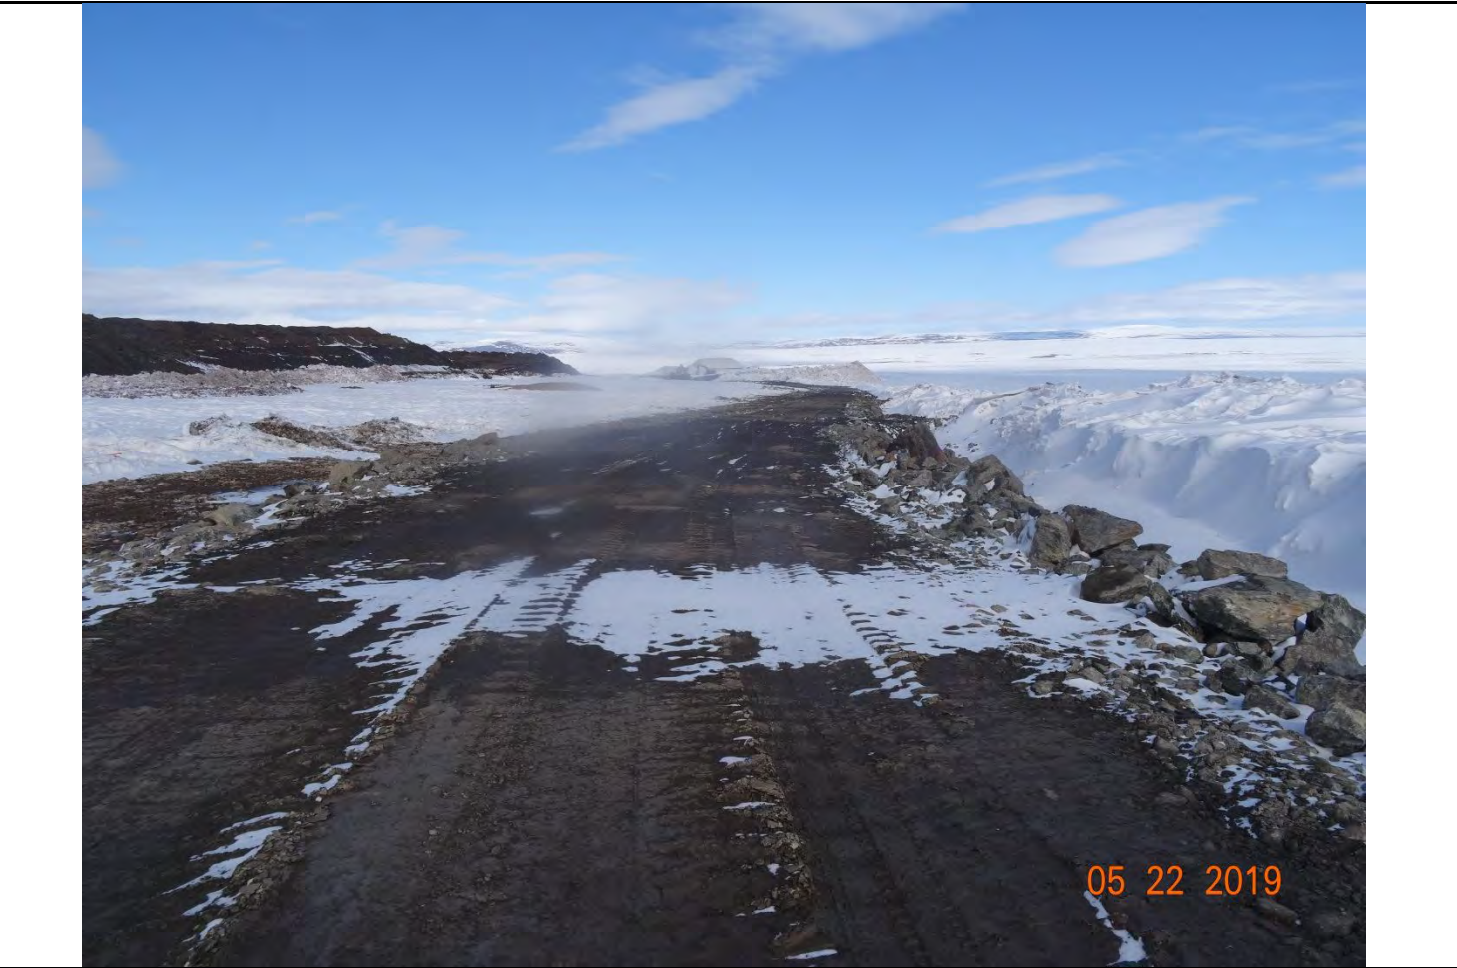
Description: Waste Rock Stockpile Ditches/ perimeter road construction

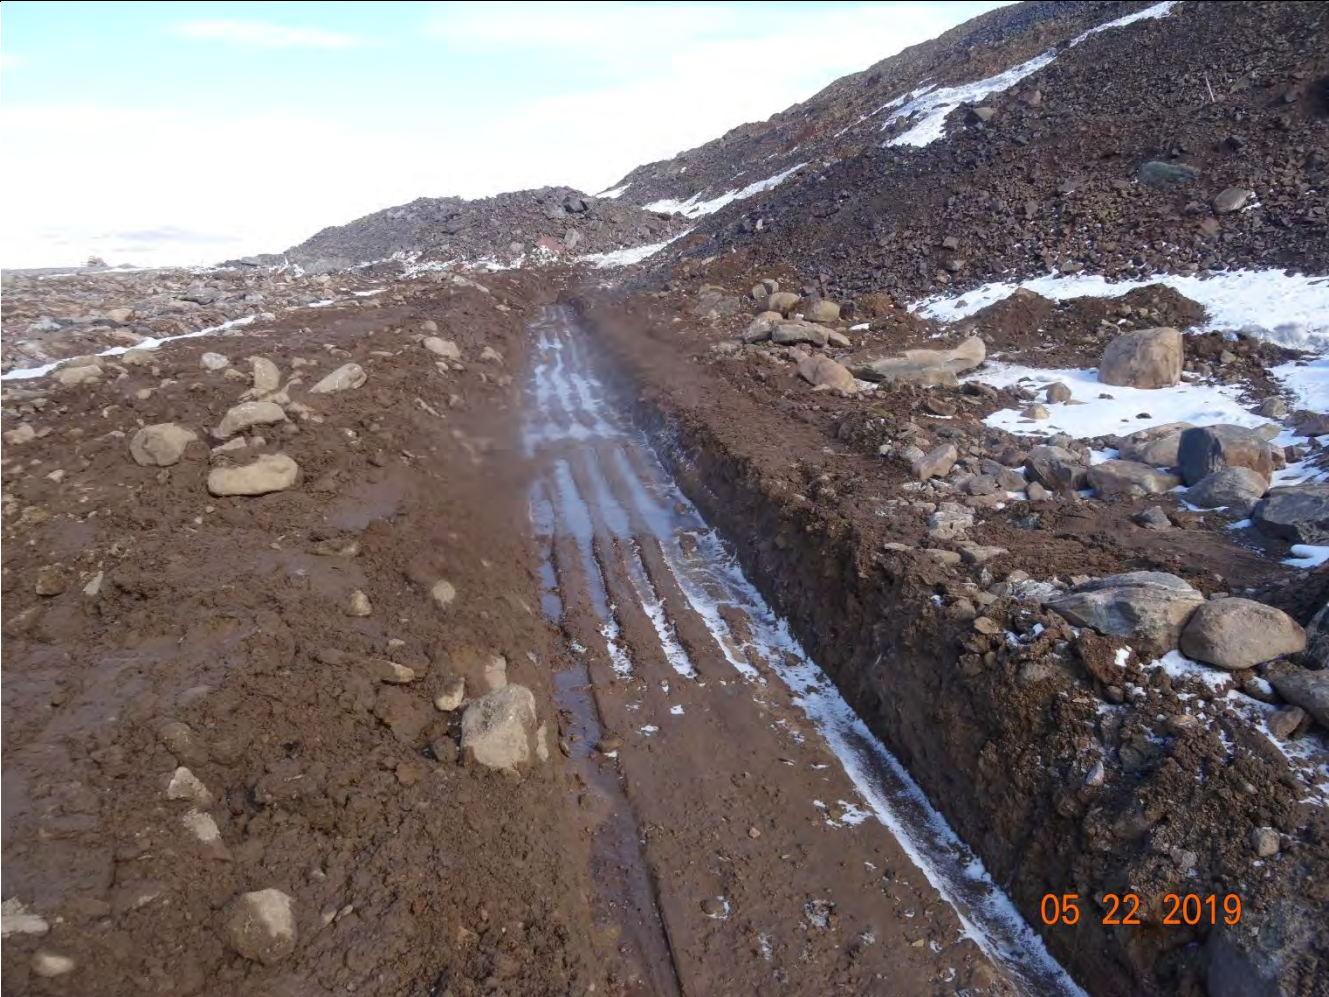
Photo 5

Description: Waste Rock Stockpile improperly constructed Ditches

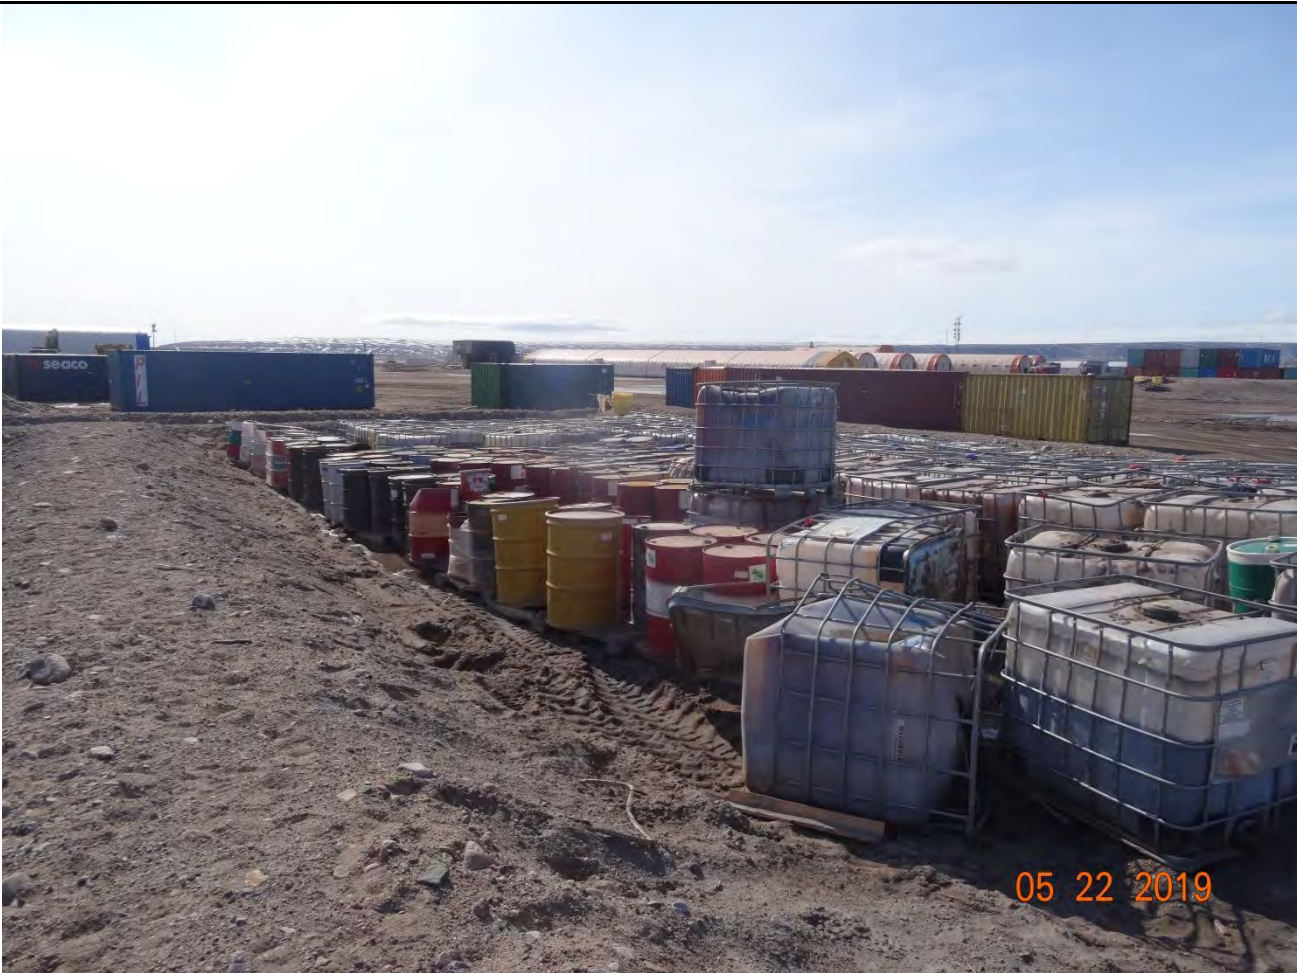
Photo 6

- a. The inspector noted that Hazardous waste berm #7 had limited capacity and the berm walls were inconsistent, the inspector is requesting that the licensee provide the for construction and As-built drawings for all Hazardous waste berms.
- b. The inspector noted damaged containers within the Hazardous Waste Berm, Section 4.4.2of the Hazardous Material and Hazardous waste Management Plan states that; "Regular inspections are performed and recorded. Containers are placed so that each container can be inspected for signs of leaks or deterioration. Leaking or deteriorated containers will be removed and their content transferred to a sound container." The Licensee is to remove all damaged containers and transfer the hazardous material to sound containers. (see Photos #6)

Description: Damaged Hazardous waste containers.

3. The licensee is to remove all Hazardous material from any damaged containers and place it in sound containers.
4. The licensee is to repair/ Key-in the liners at MP-05 and MP-06 to ensure all runoff is proper captured.

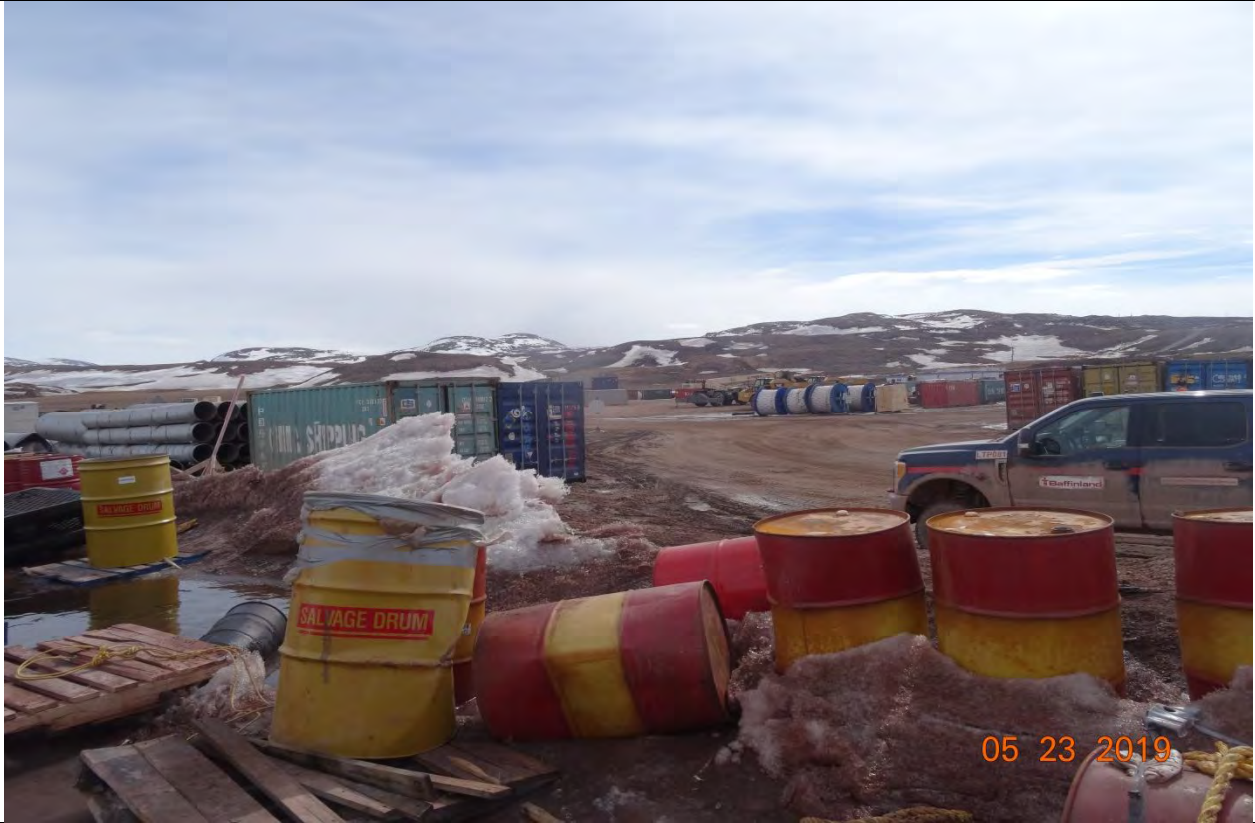
Photo 7

- c. The inspector noted damaged containers within the Hazardous Waste Berm, Section 4.4.2of the Hazardous Material and Hazardous waste Management Plan states that; "Regular inspections are performed and recorded. Containers are placed so that each container can be inspected for signs of leaks or deterioration. Leaking or deteriorated containers will be removed and their content transferred to a sound container." The Licensee is to remove all damaged containers and transfer the hazardous material to sound containers. (see Photo 7)

Description: Damaged Hazardous Waste containers.

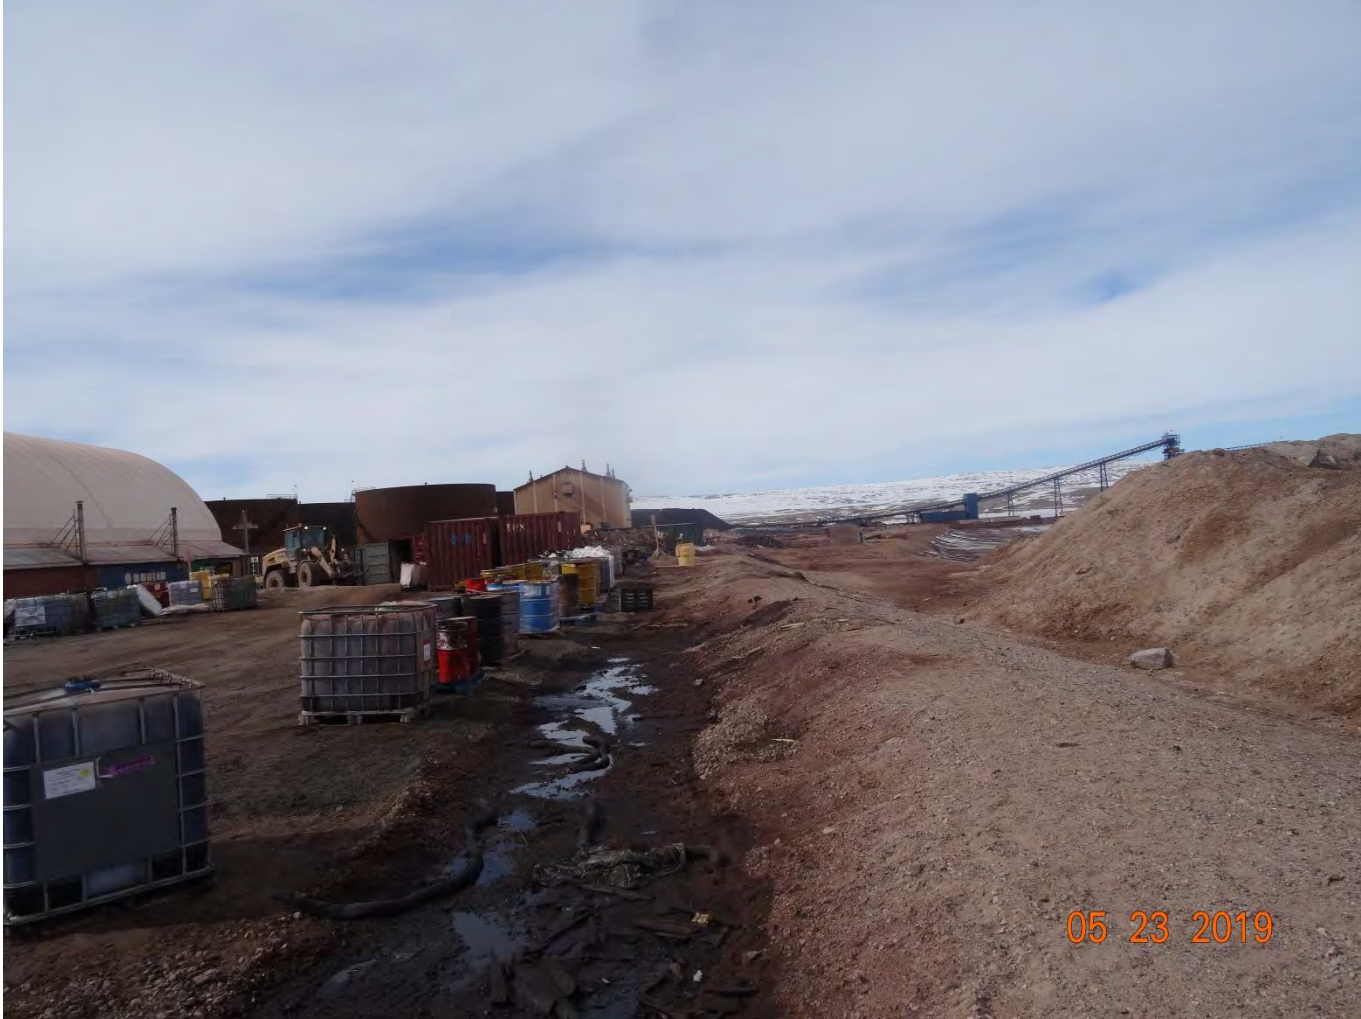
Photo 8

- a. During the inspection there was machinery operating in the hazardous waste berm and significant staining from spills in the facility, the machinery was freely driving in and out of this facility potentially spreading the spilled hazardous material and contaminating the surrounding area The inspector is requesting that the licensee remove the contaminated soil and appropriately dispose of it. (See Photo 8)

- b. The inspector noted that the licensee has recently placed new crushed rock in the facility over a portion of the spilled area and had absorbent material scattered over the affected area.(See Photo 8)

Description; Spill within Hazardous waste facility at Milne Inlet.

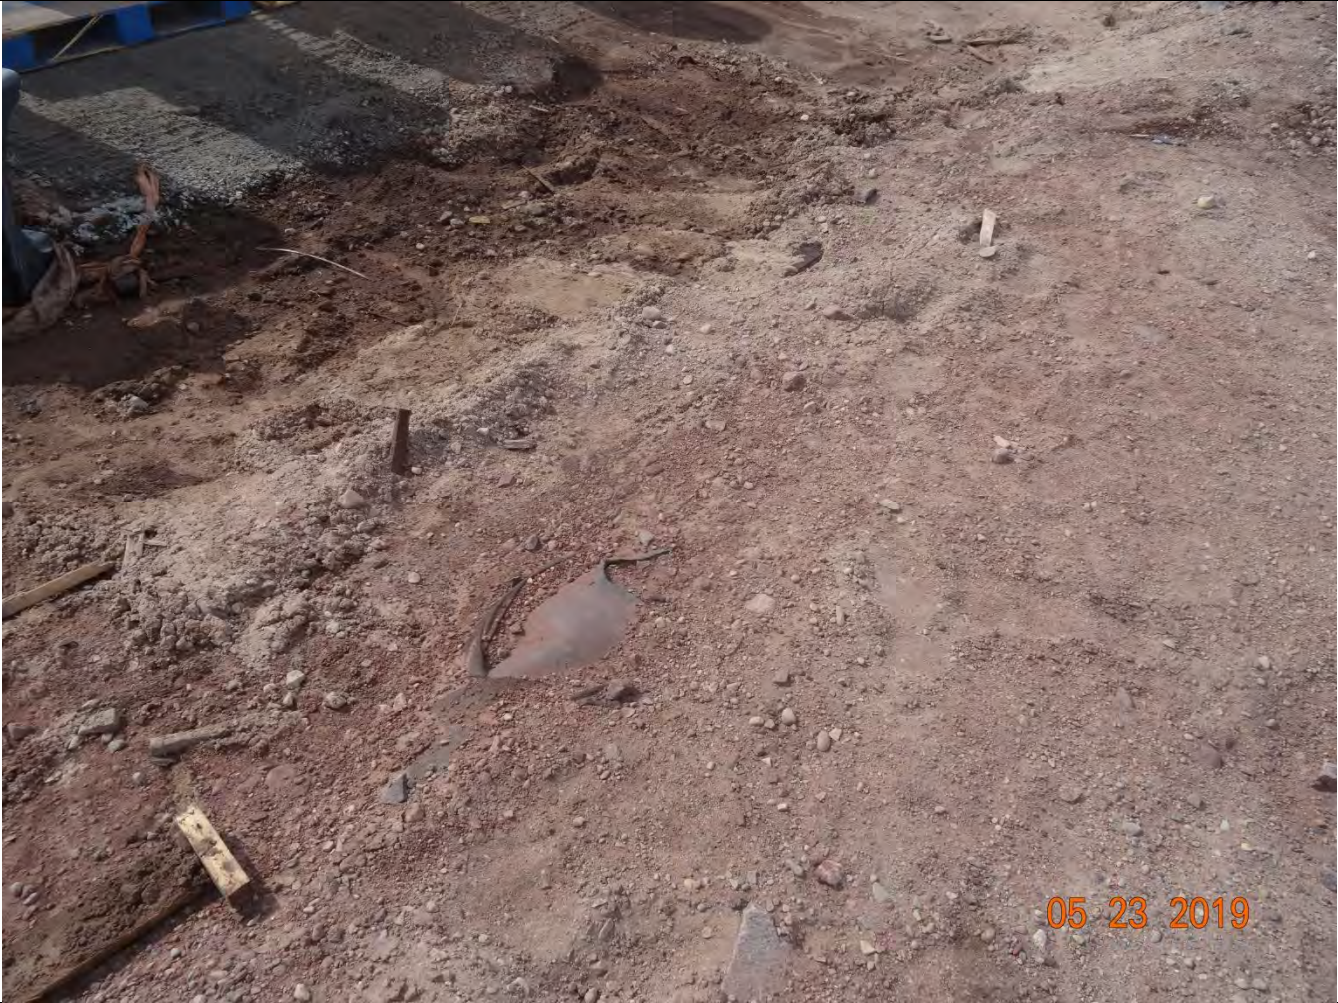
Photo 9

- d. The Inspector also noted rips in the liner of the facility that require repairs. (see Photo 9)

Description; Milne inlet Hazardous waste liner puncture.

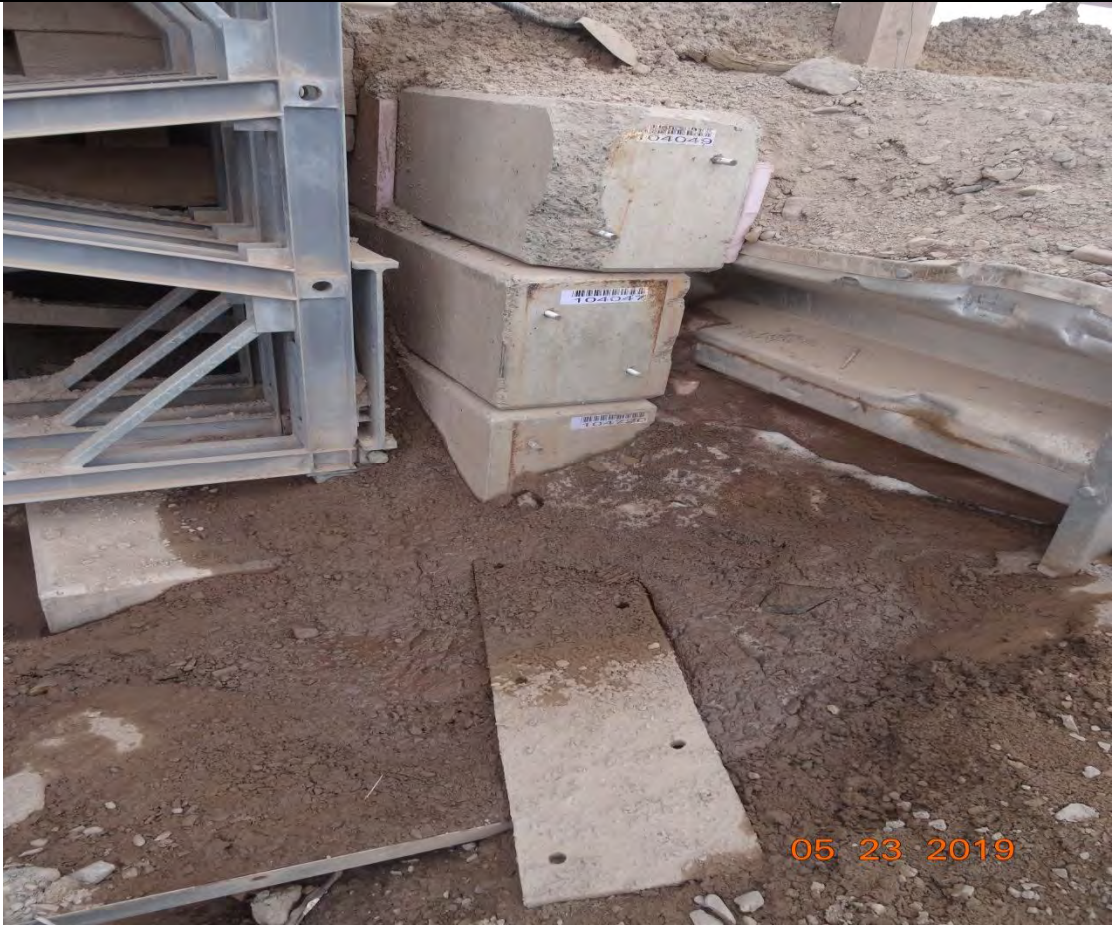
Photo 10

- a. During the inspection there was sediment noted below the bridges.
- b. The abutments on Km 80 and Km 97 bridge appear to have shifted, CIRNAC's Civil engineer made the following suggestions based on the photos provided;

Description; Km 97 Bridge abutment concern

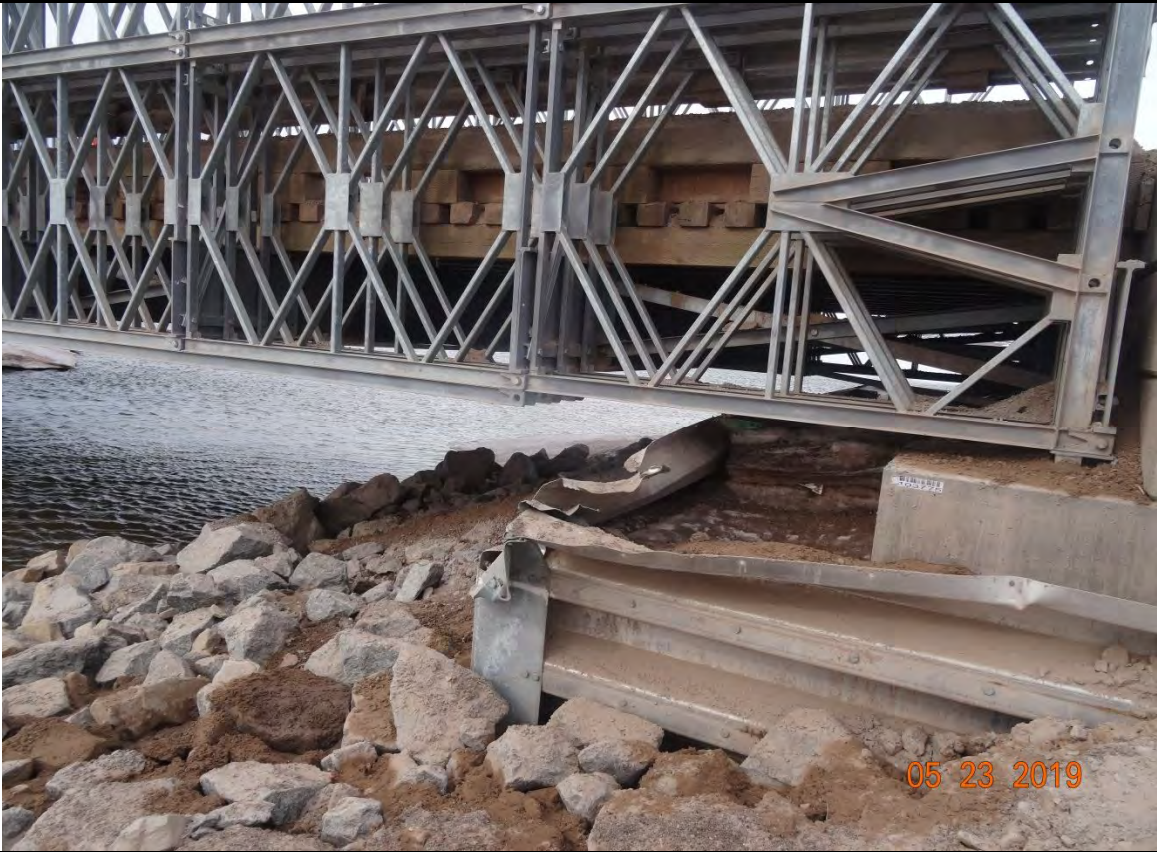
Photo 11

- II. Km 80 Bridge, Photo 11: Sizing and placing of the existing rip rap appear deficient and need to be reviewed. We would suggest having Baffinland look into a new design approach for the bridge abutment armoring features.

Description; Km 80 Bridge damage

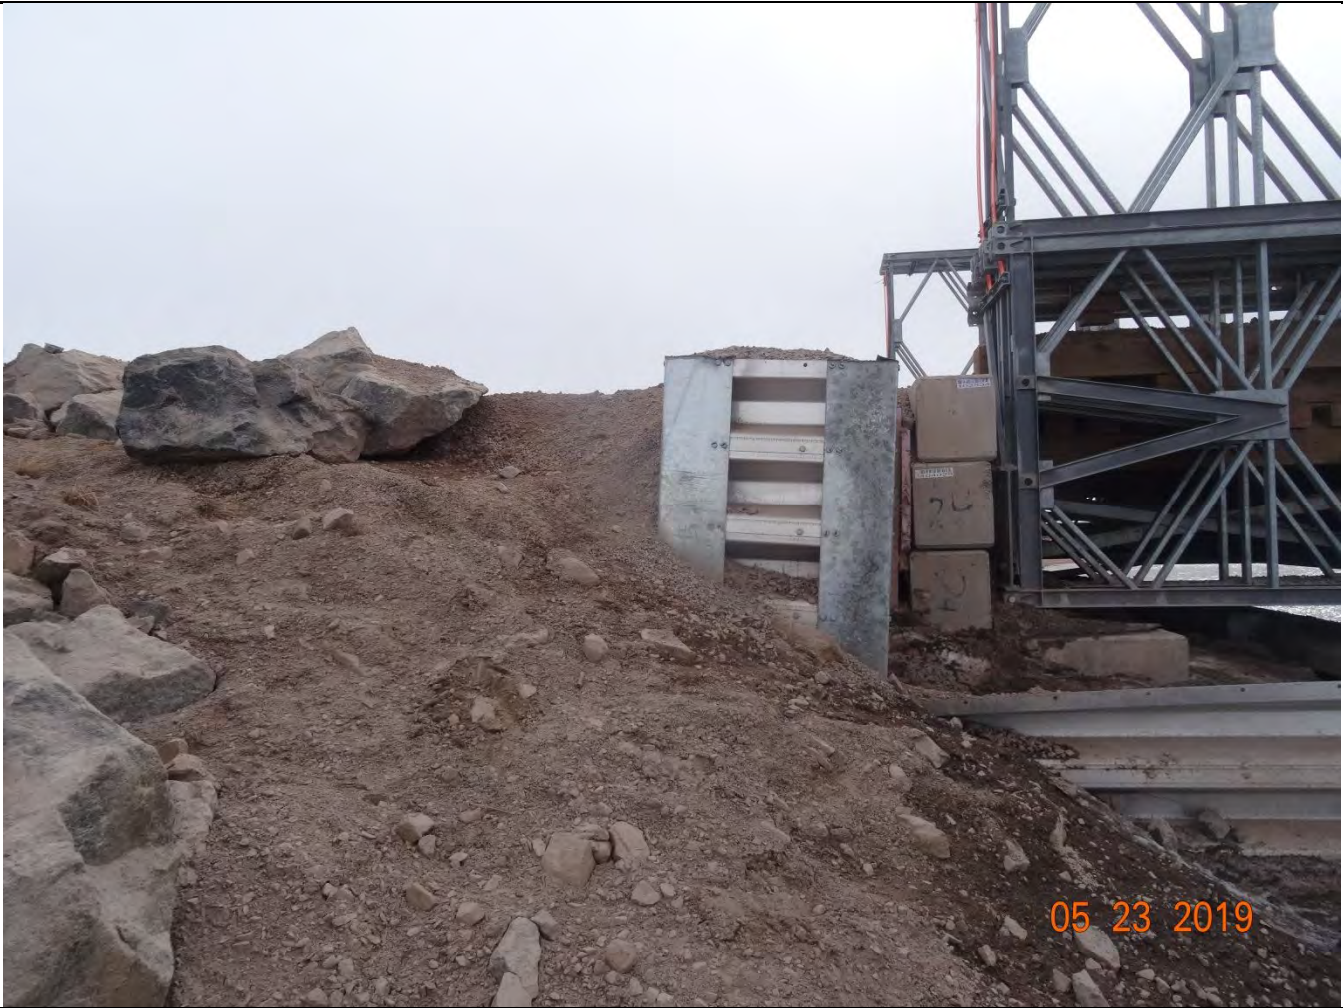
Photo 12

- III. Km 80 Bridge Photo 12: Armoring features are deficient. The existing abutment wall components do not appear stable. Baffinland is to investigate and provide adequate mitigation measures in place to ensure that the structural integrity of the bridge is not compromised.

Description; Km 80 Bridge abutment.

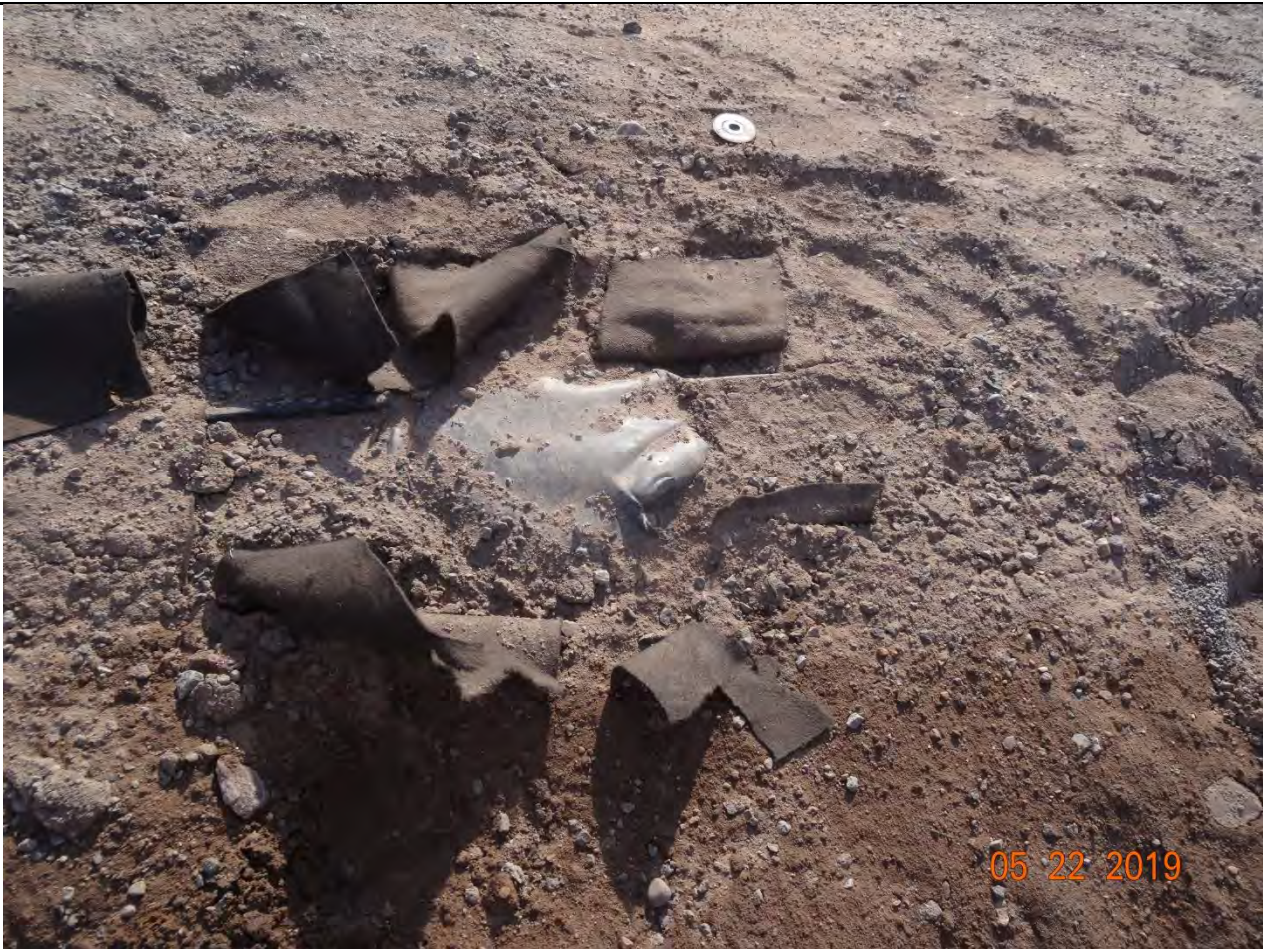
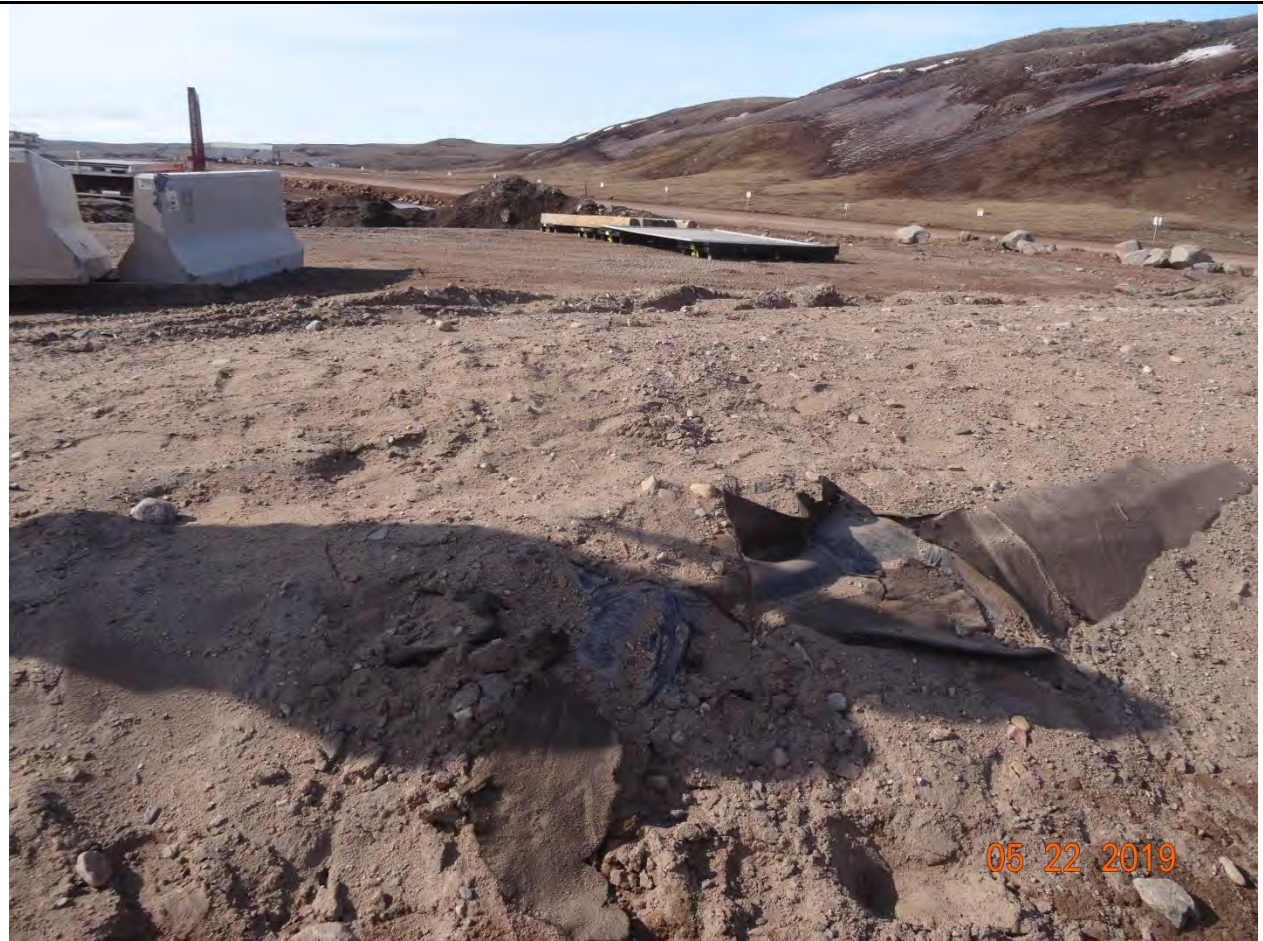
- a. While inspecting the Jet A storage it was noted that there was a high water mark significantly lower than the current water level. See Photos 13 and 14 for the noted concerns.
- b. There were rips in the Liner of this containment structure it appears to have hydrocarbons in the pooling water.

Description; Jet A storage liner rip.

6. The licensee is to repair the liner at the Jet “A” storage.
7. The licensee is to Install the appropriate water management structures or imply the appropriate snow management practices to limit machinery from driving through this surface water at Lay down #2.

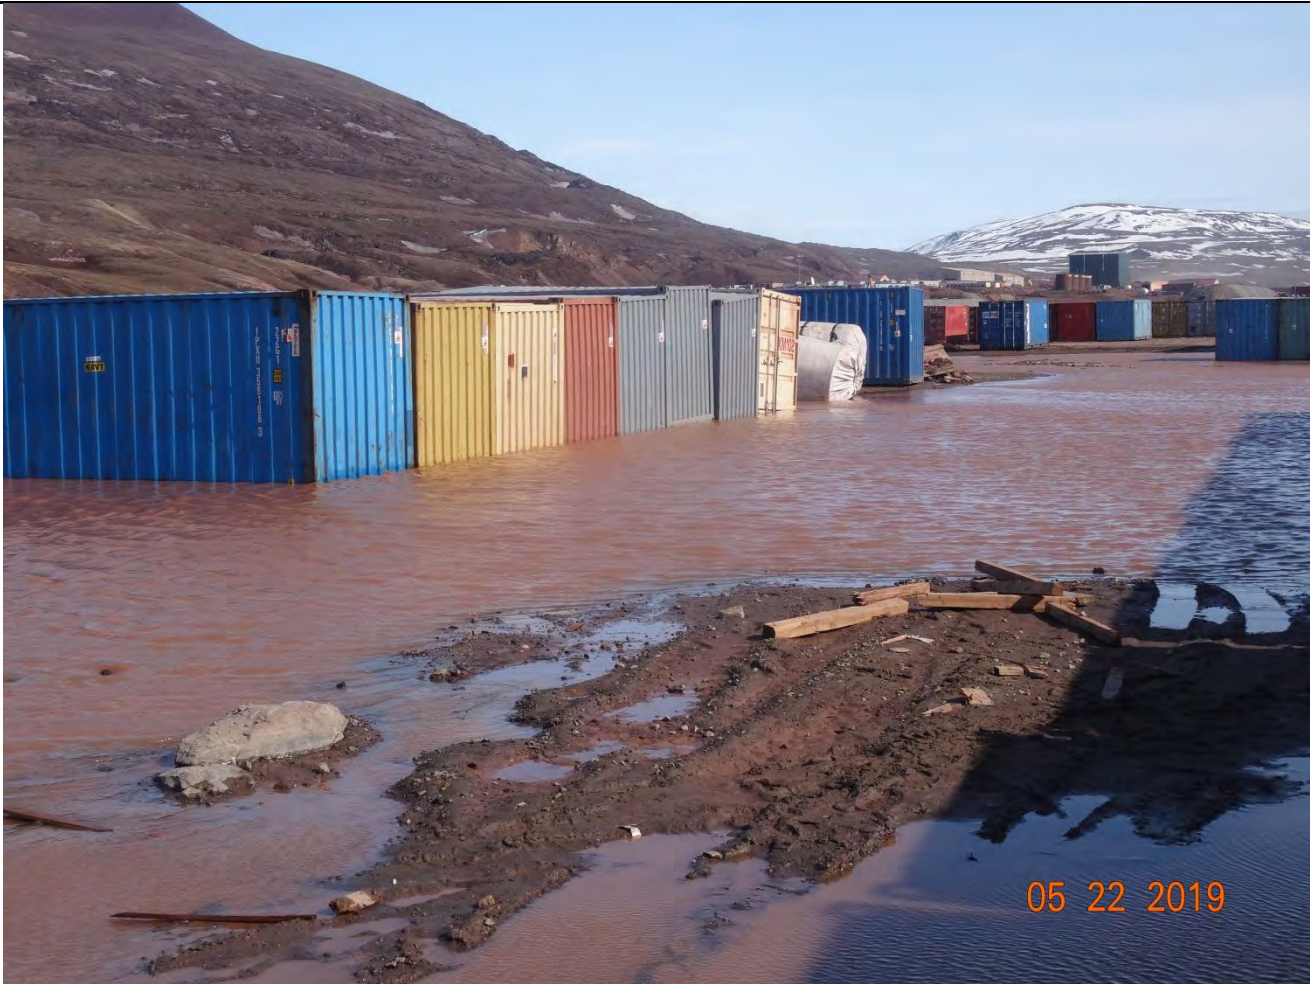
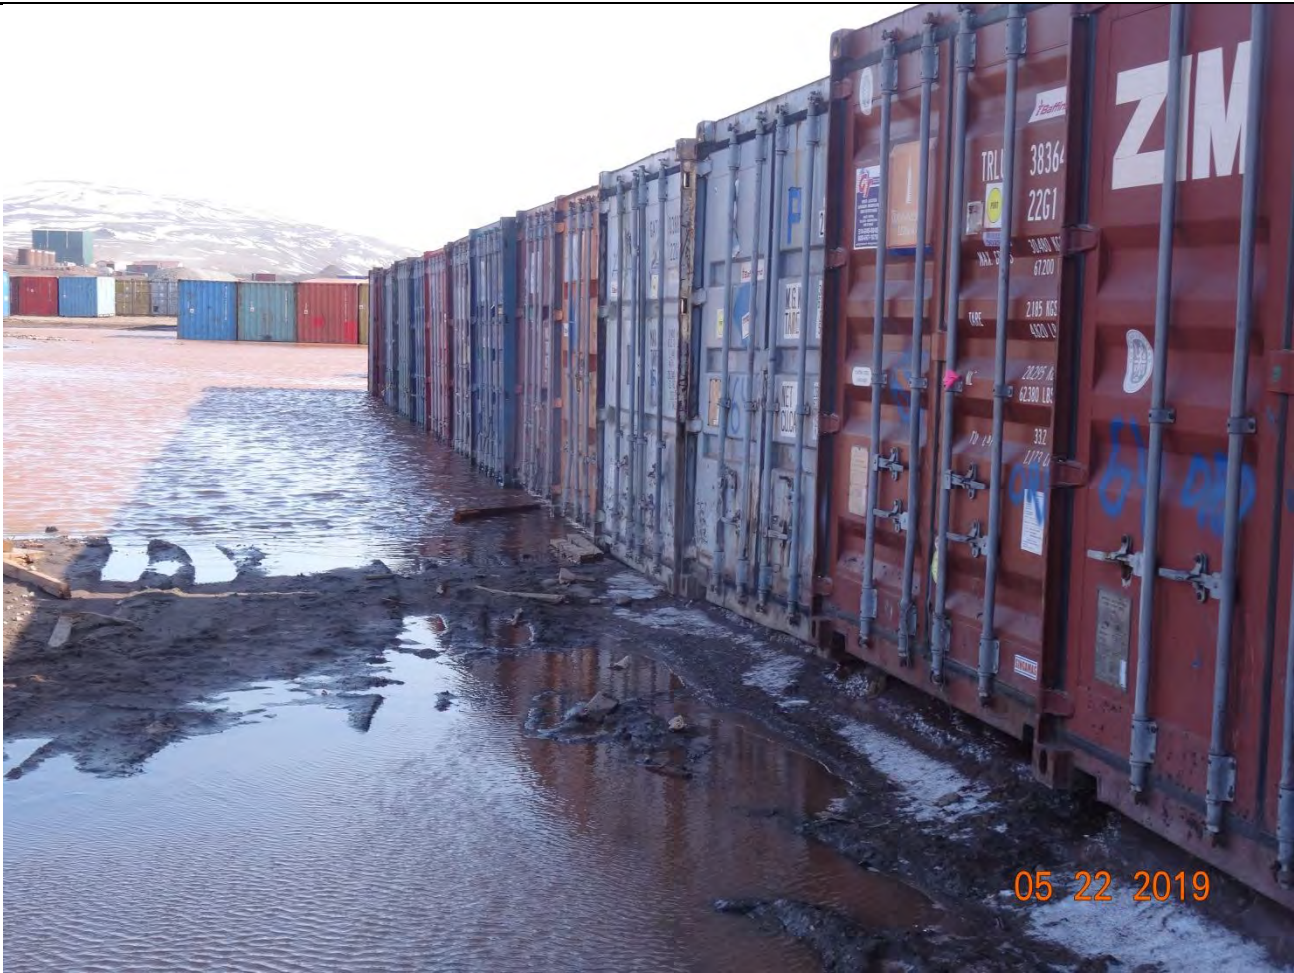
Description; flooding of Laydown #2.

Description; flooding of Laydown #2

5) Laydown #2 at Mine Site			
5a	At the time of the inspection there was significant flooding of this laydown, in the flooded area there was multiple storage containers sitting in the water.	7. The licensee is to Install the appropriate water management structures or imply the appropriate snow management practices to limit machinery from driving through this surface water at Lay down #2.	Ongoing maintenance is underway to properly regrade and drain the noted area at Laydown #2. The water will be redirected to prevent significant pooling. It should be noted that no visible sheen was observed in the water upon inspection.
5b	PART D item 22 states that; "The Licensee shall undertake necessary corrective measures to mitigate impacts on surface drainage resulting from the Licensee's activities." (see Photos 15 and 16 for photos of flooding).
