APPENDIX E.8

CIRNAC Inspection Reports and Baffinland Response

RE: Water Licence 2AM-MRY1325 January 2019 Inspection Report

WATER LICENCE INSPECTION FORM

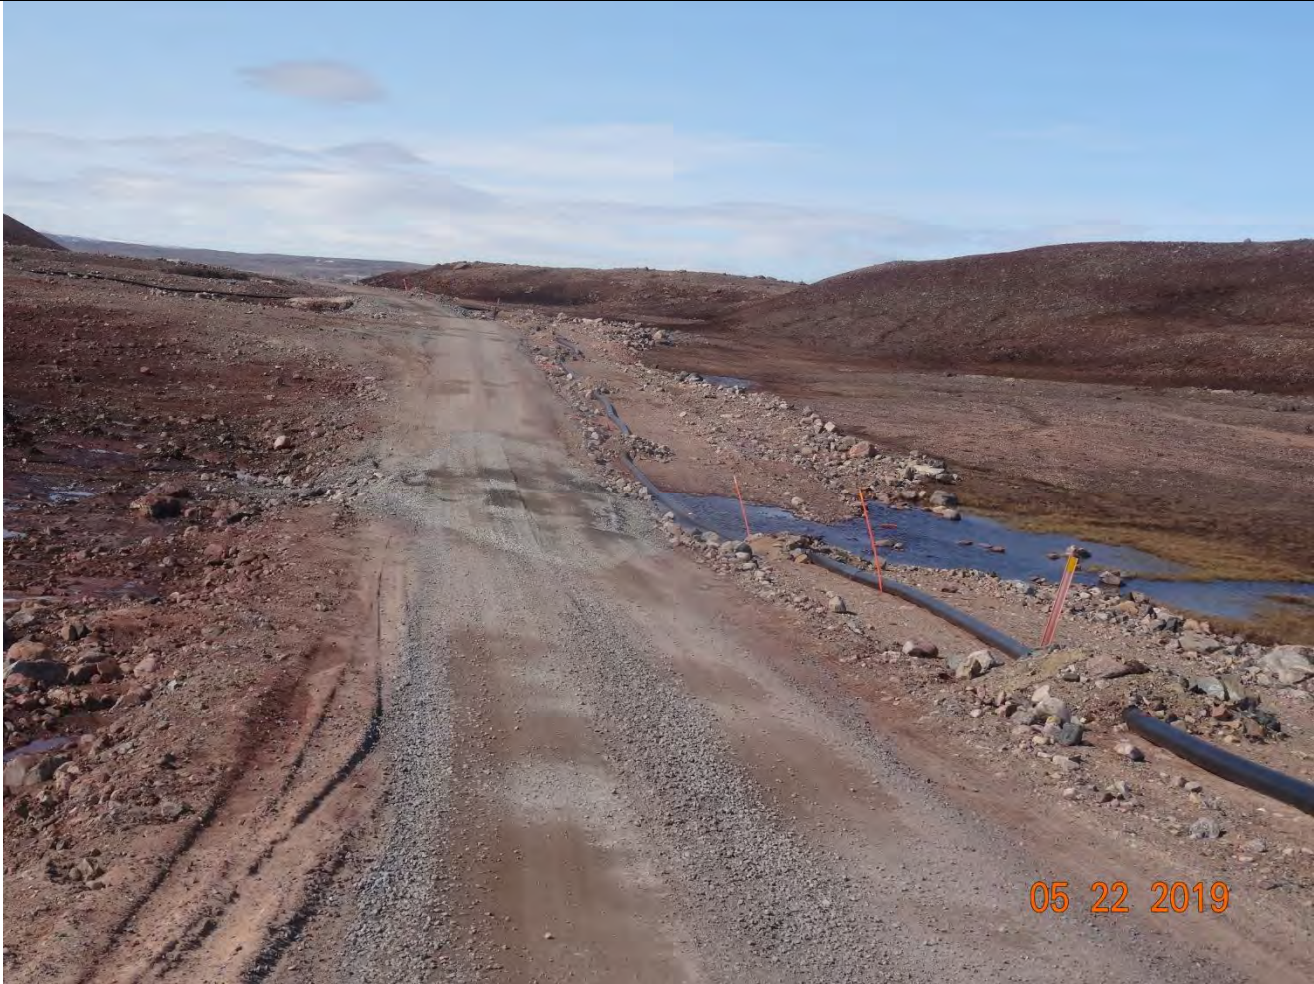
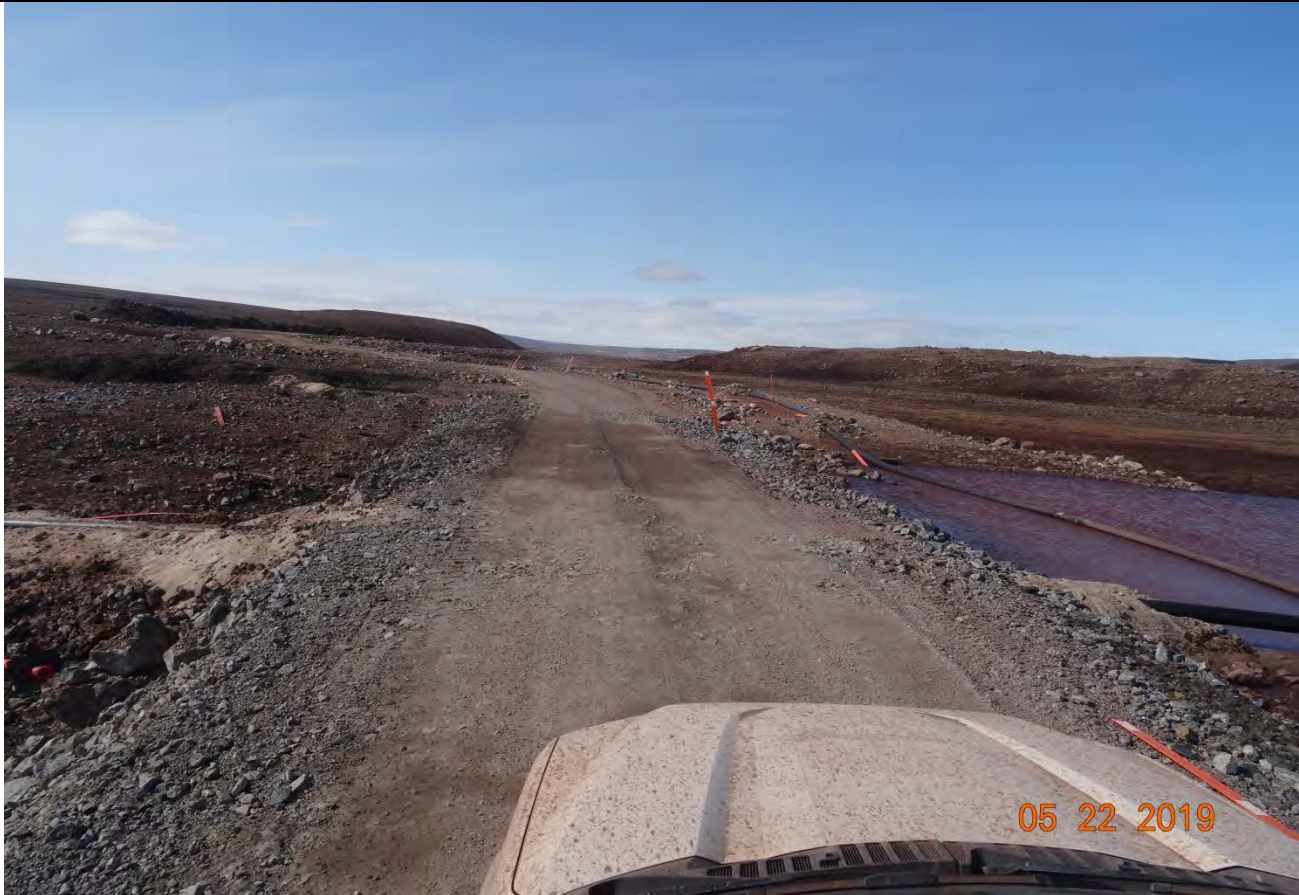
- a. During the inspection it was again noted that on this road there are area where the road blocks natural drainages which leads to flooding and washouts of the road.
- b. PART D item 22 states that; "The Licensee shall undertake necessary corrective measures to mitigate impacts on surface drainage resulting from the Licensee's activities." (see photos 17 and 18 for the concerns noted above)

Description; Areas where natural drainage is blocked by the Mary River effluent access road

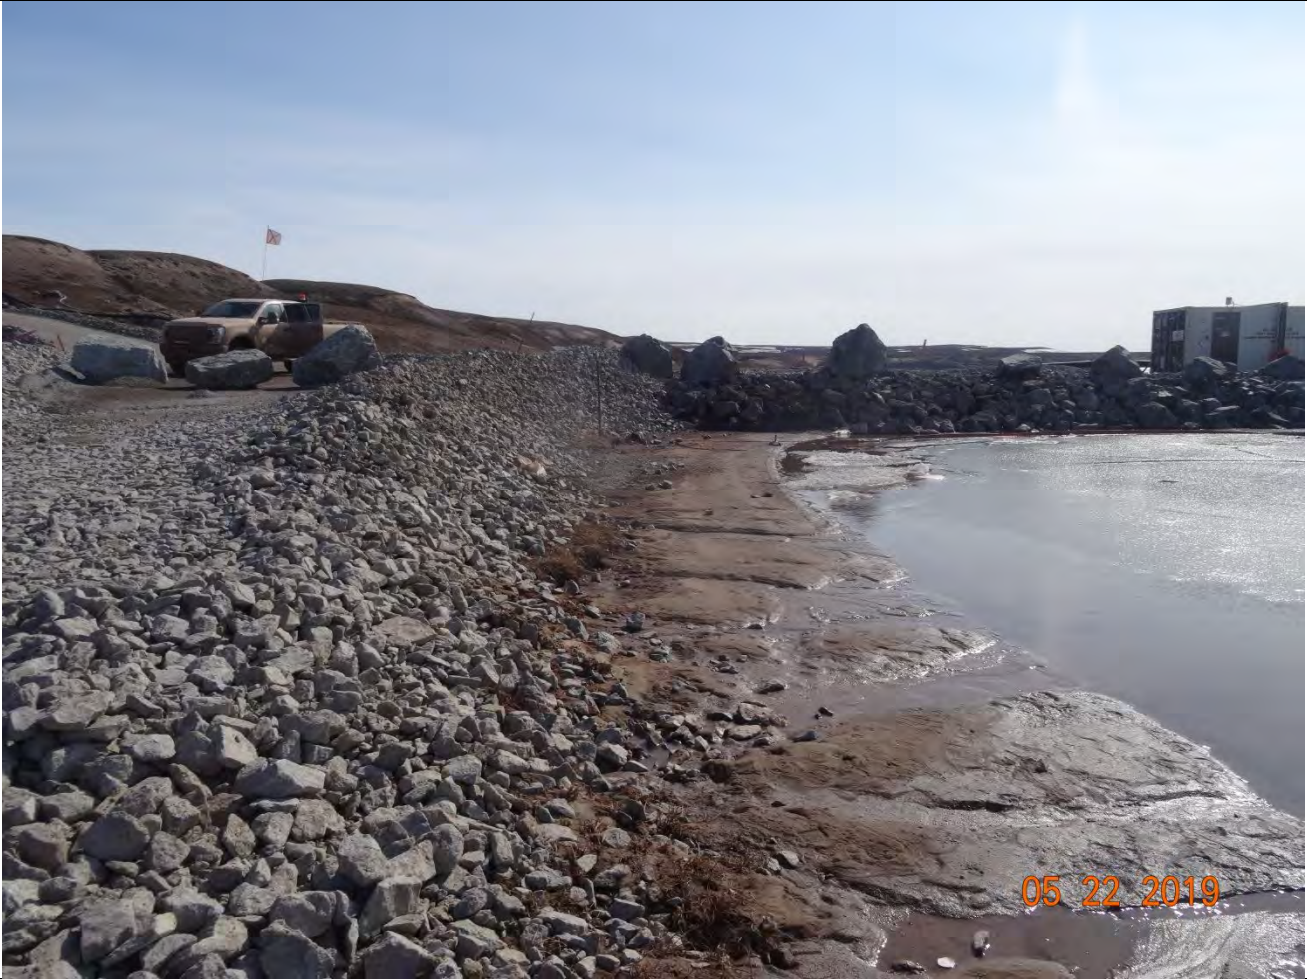
Photo 19

Description; Construction within 31m of Camp Lake

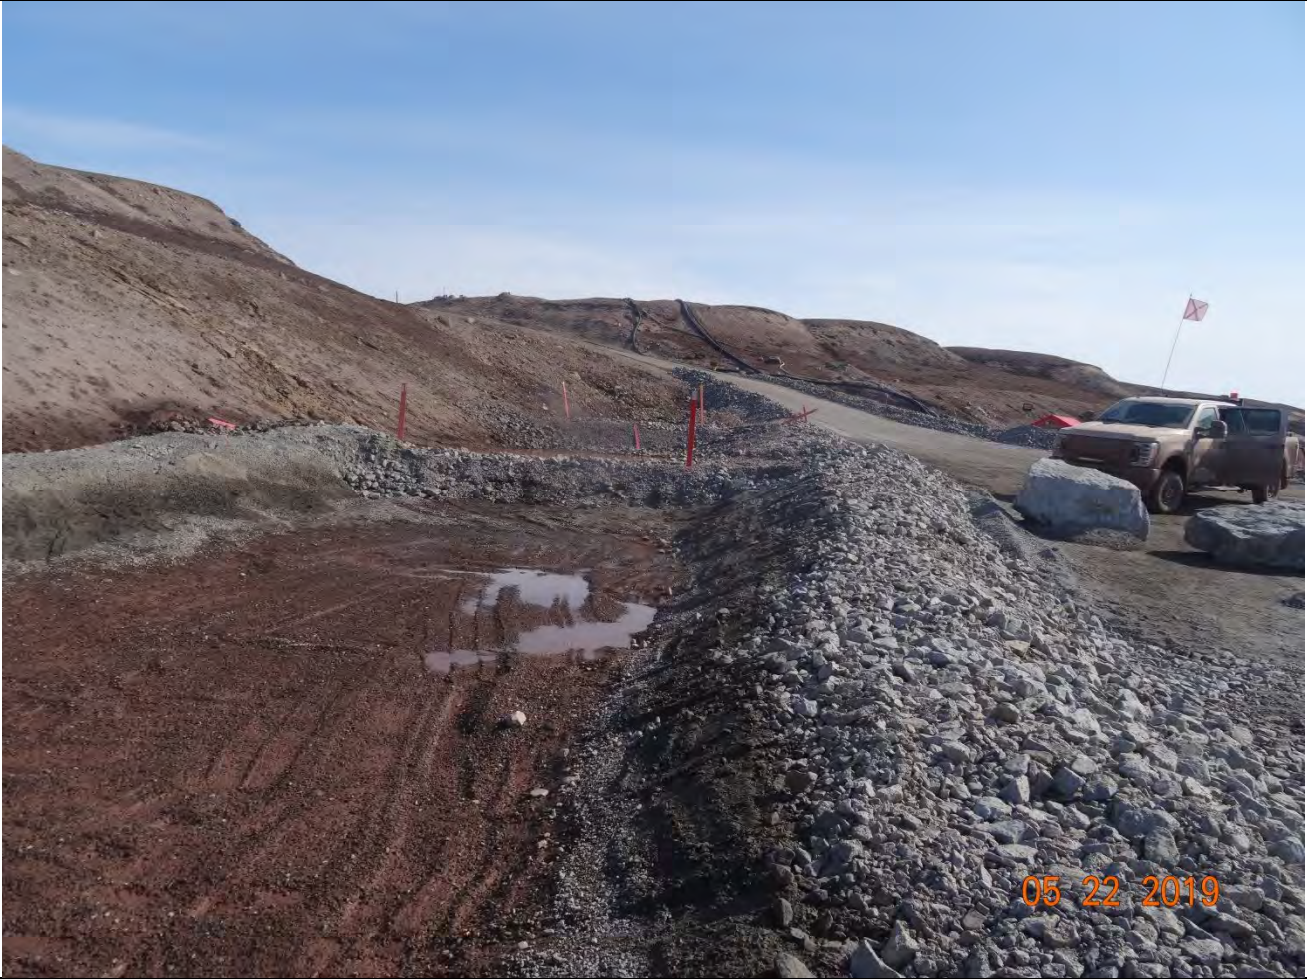
Photo 20

Description; Water Management Structures constructed without approval.

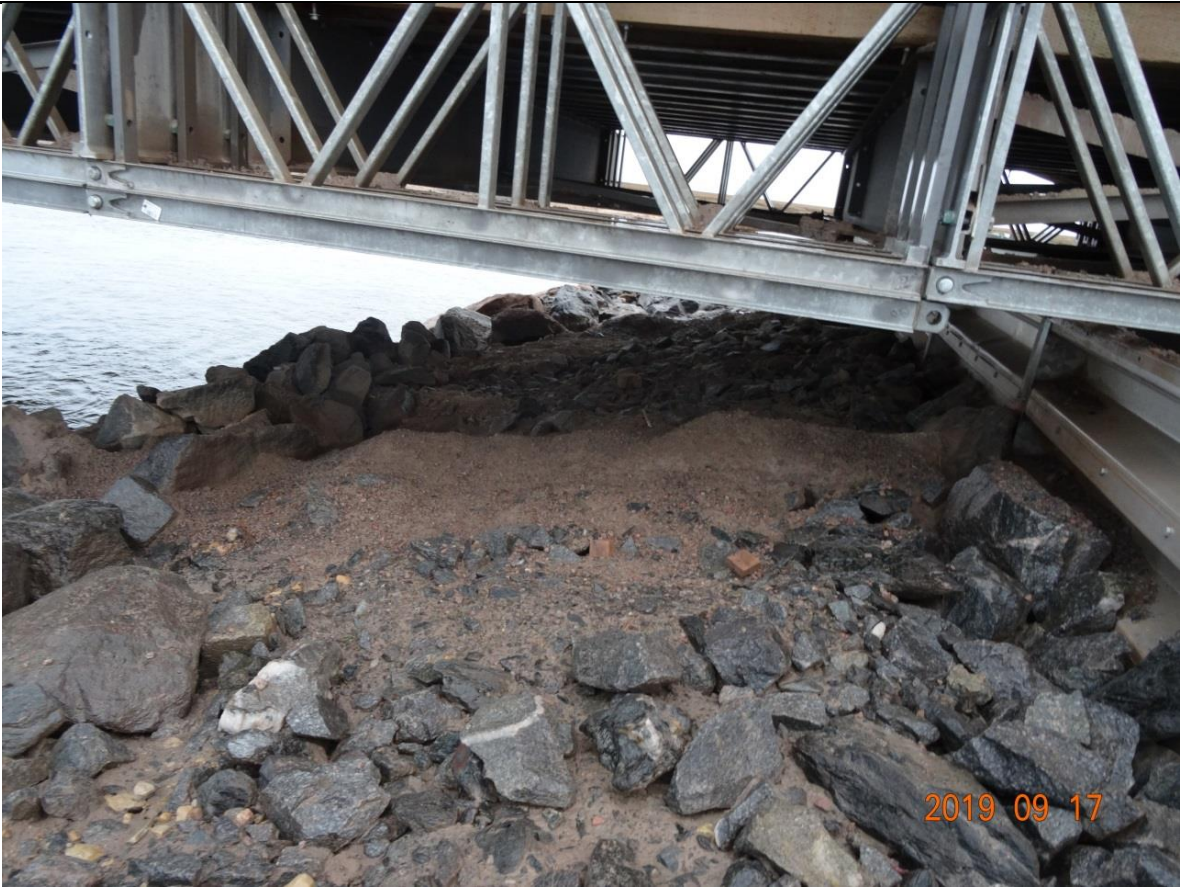
Photo 1

Description: sediment under bridges

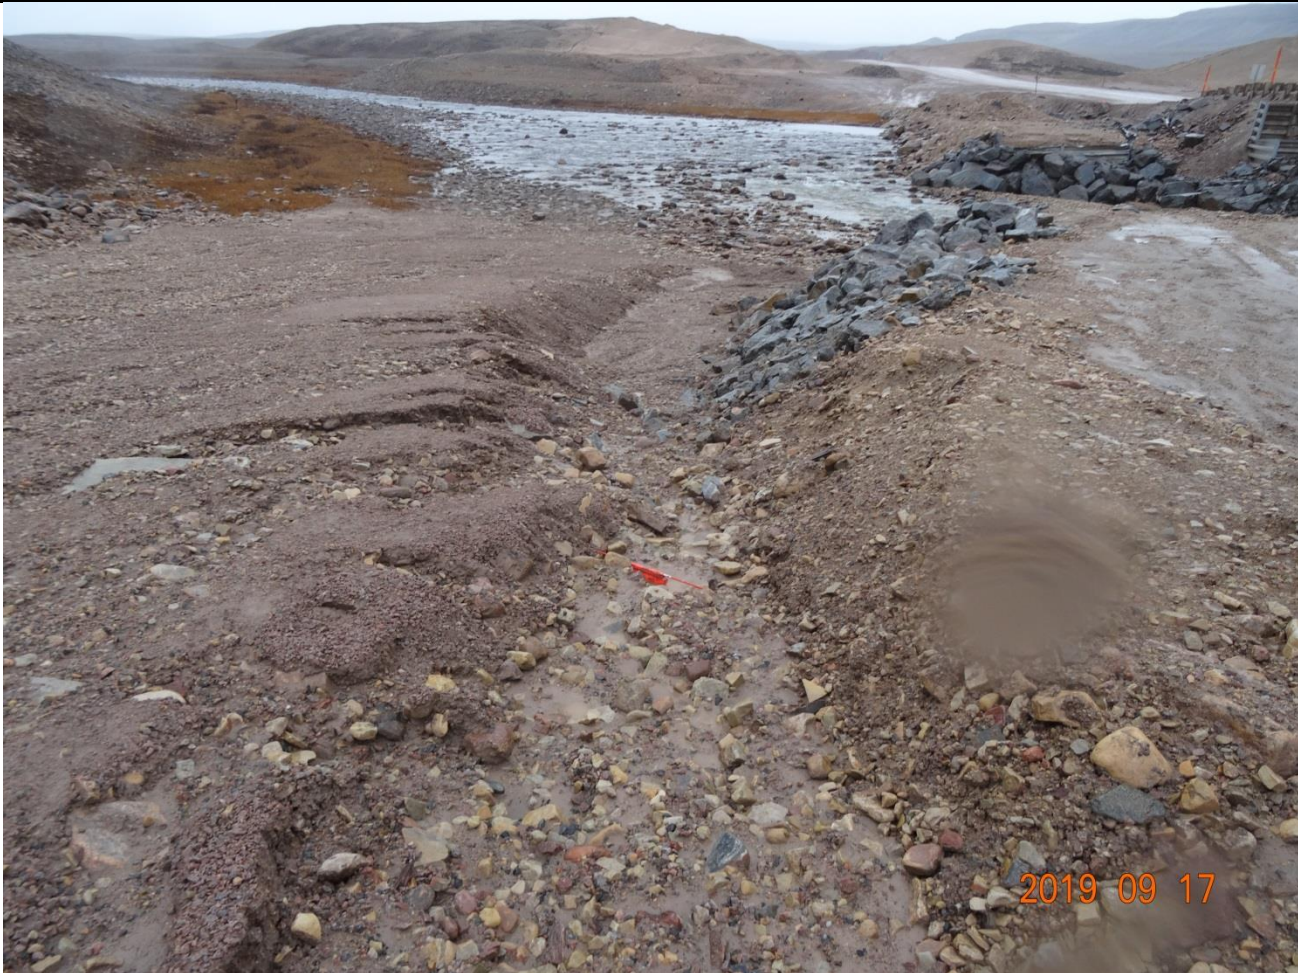
Description: erosion near bridge

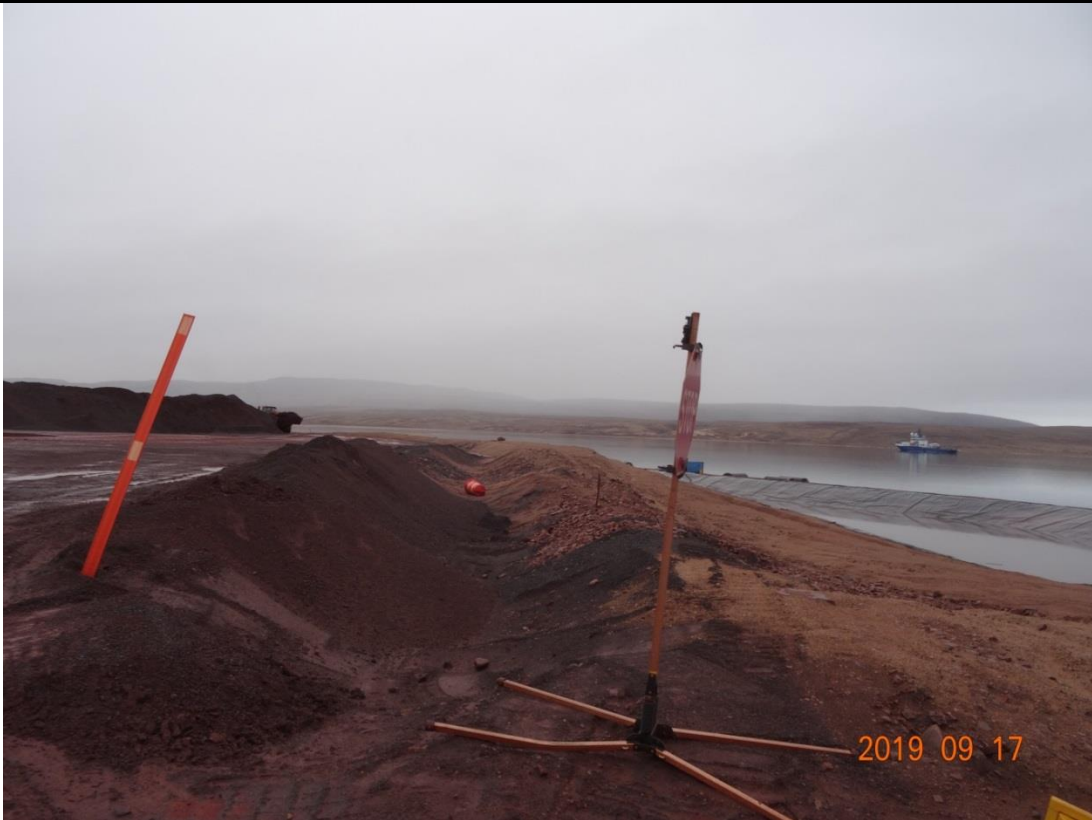
Description: ore in ditch at ore stockpile

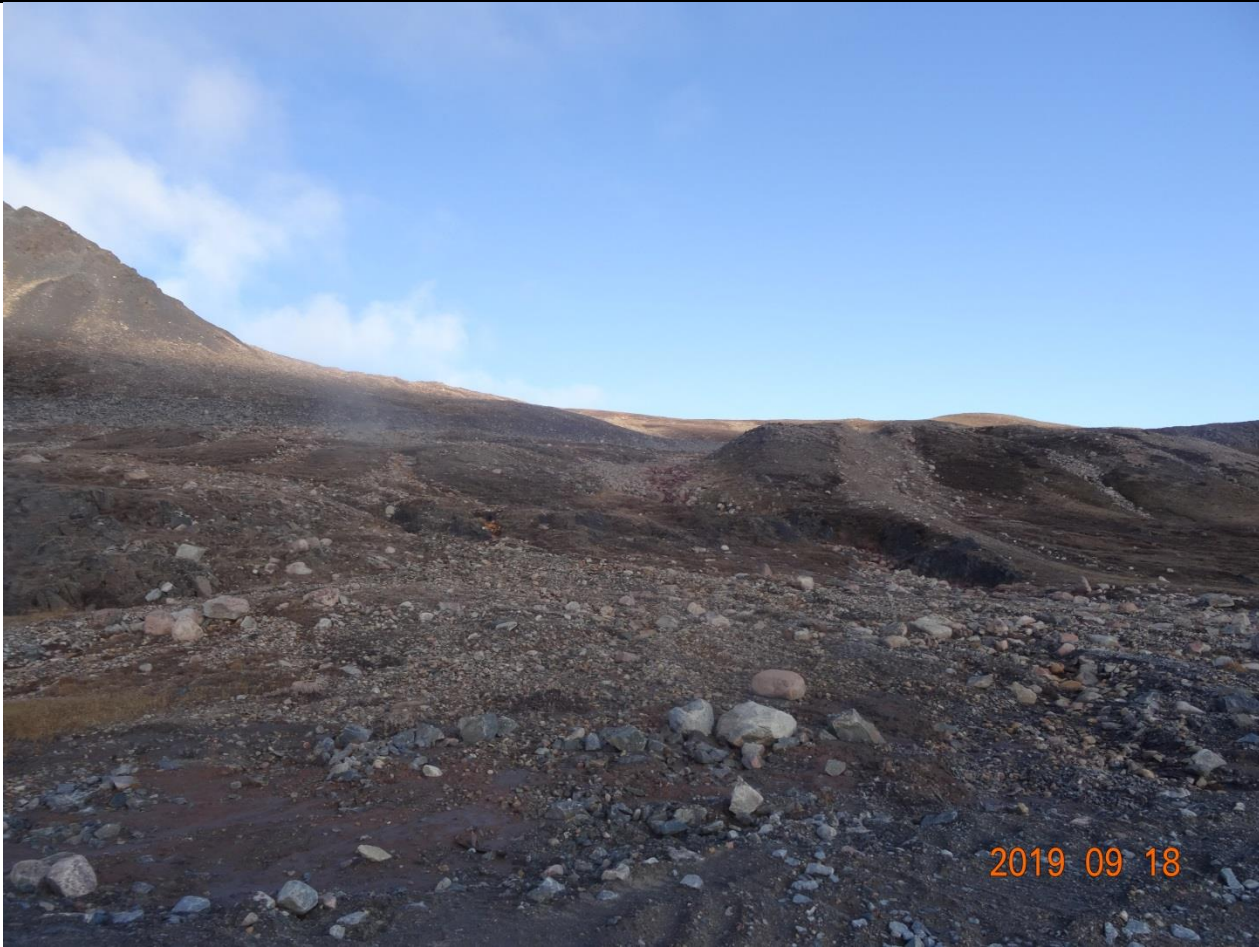
Description: erosion near mine haul road			
Date	Camera	Inspector	Authorization
	Sony Cyber-shot	J.Mesher	2AM-MRY
Photo Log		Location Iqaluit	
Photo 9

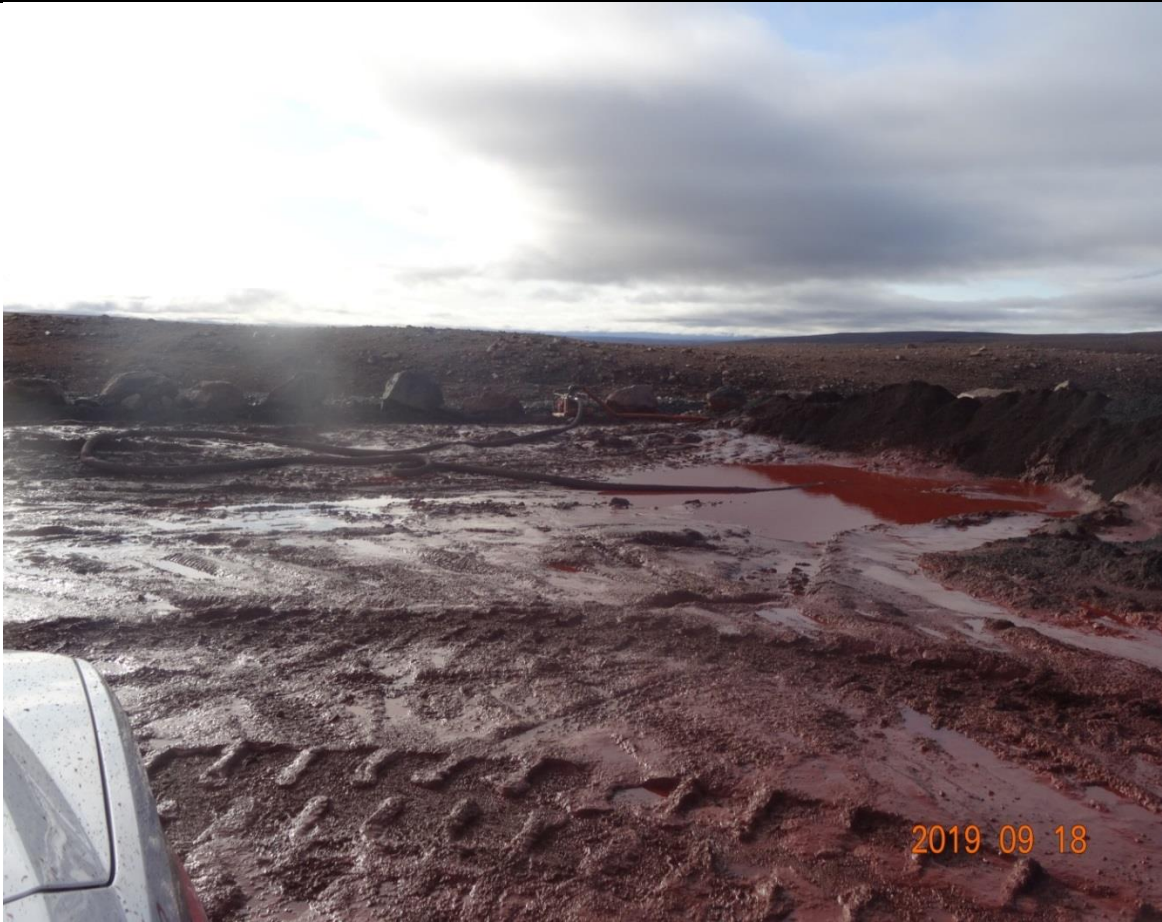
Description: Crusher pad water pumping

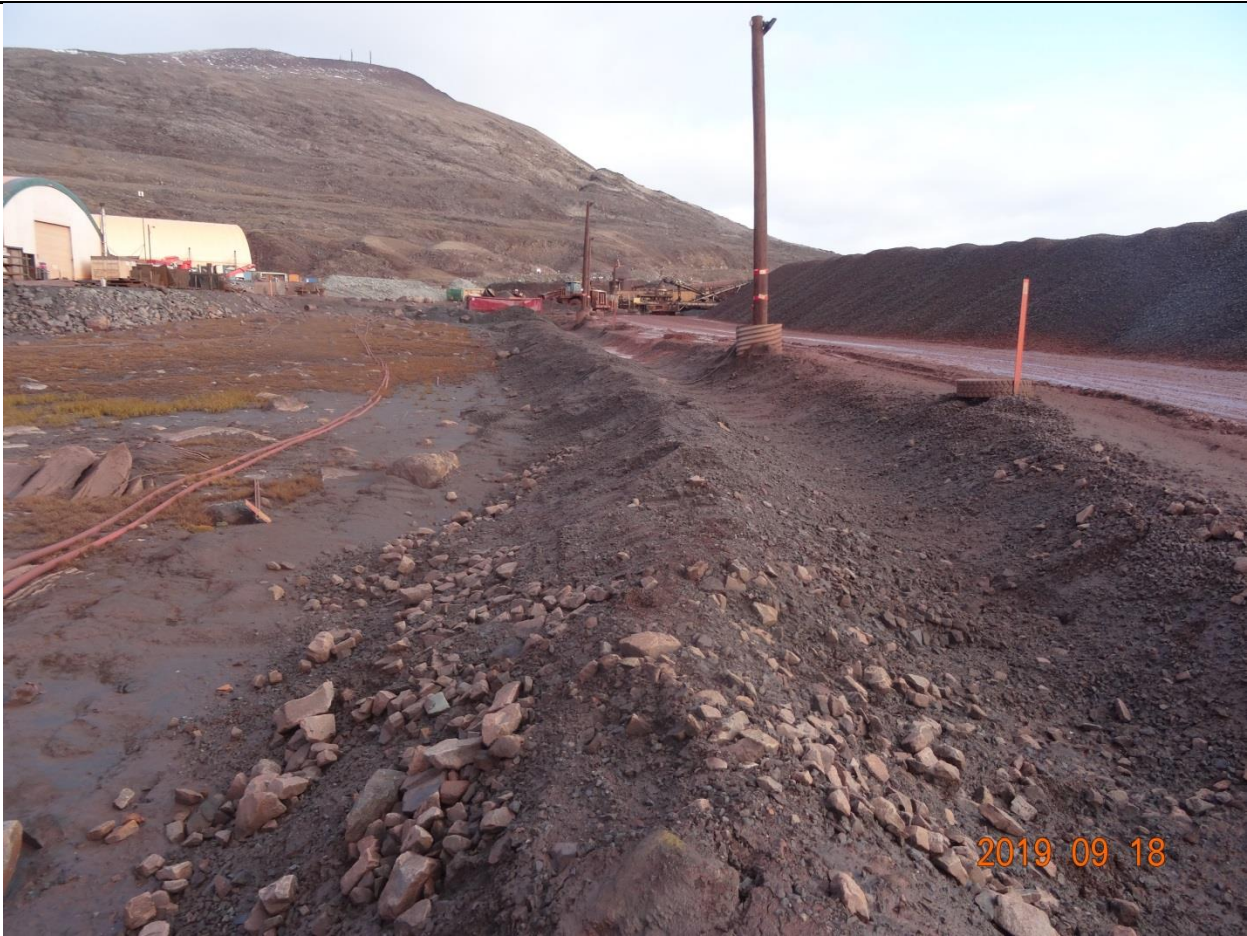
Description: ore in ditch and outside containment. On the left there is a area where water regularly pools

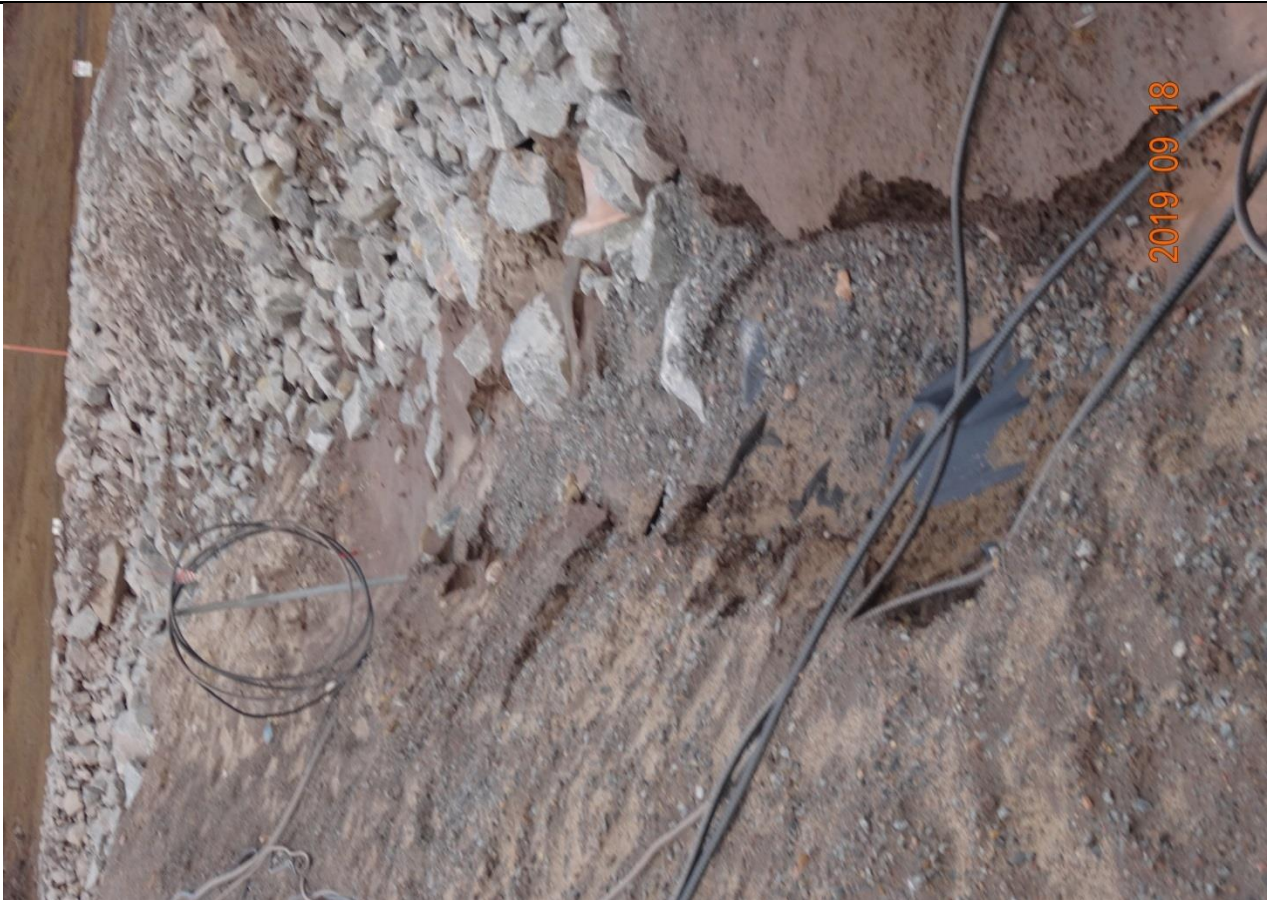
Description: erosion on Jet A fuel berm.
