APPENDIX E.8.2

QIA Inspection Reports and Baffinland Response

RE: Response to QIA May 2019 Site Inspection, Findings and Recommendations

RE: Response to QIA July 2019 Site Inspection, Findings and Recommendations

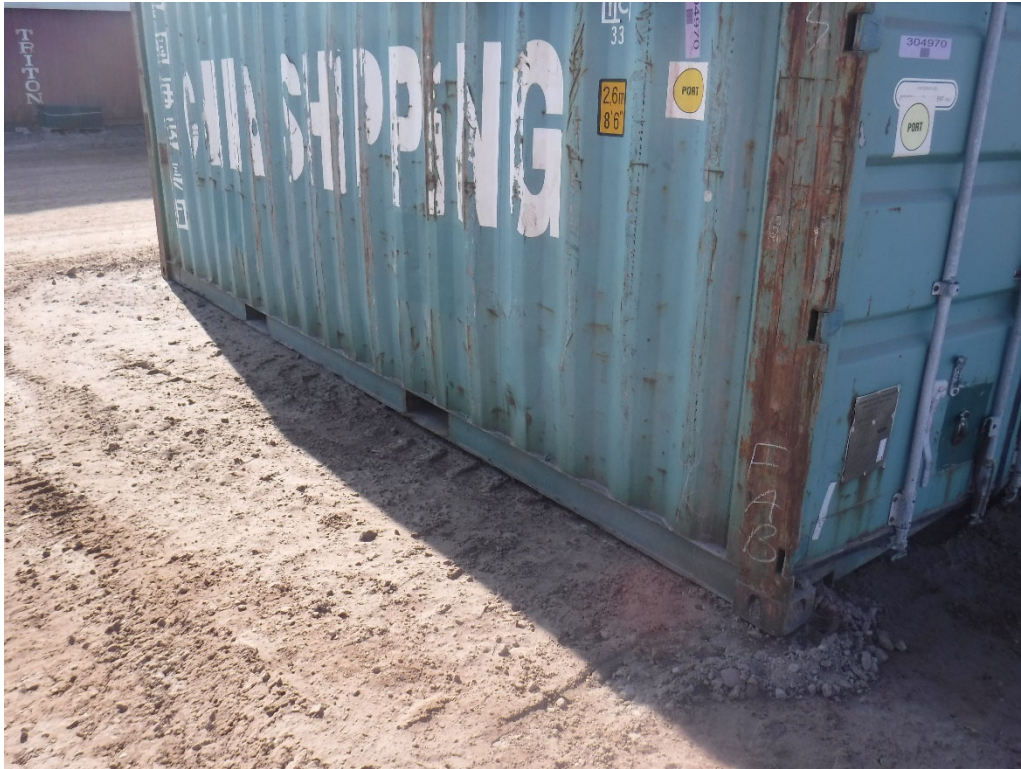
PHOTO 1 – Spill cleaned up, area outside MP-HWB-01

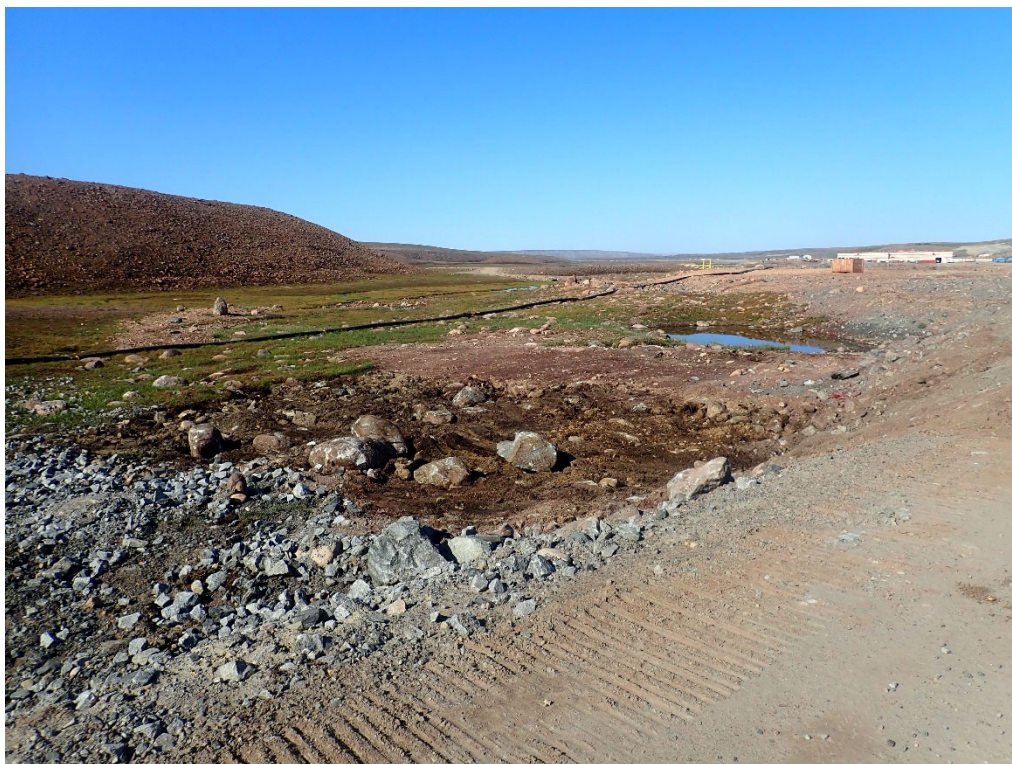
PHOTO 2 – Area of Kalamar spill cleanup, following additional remediation

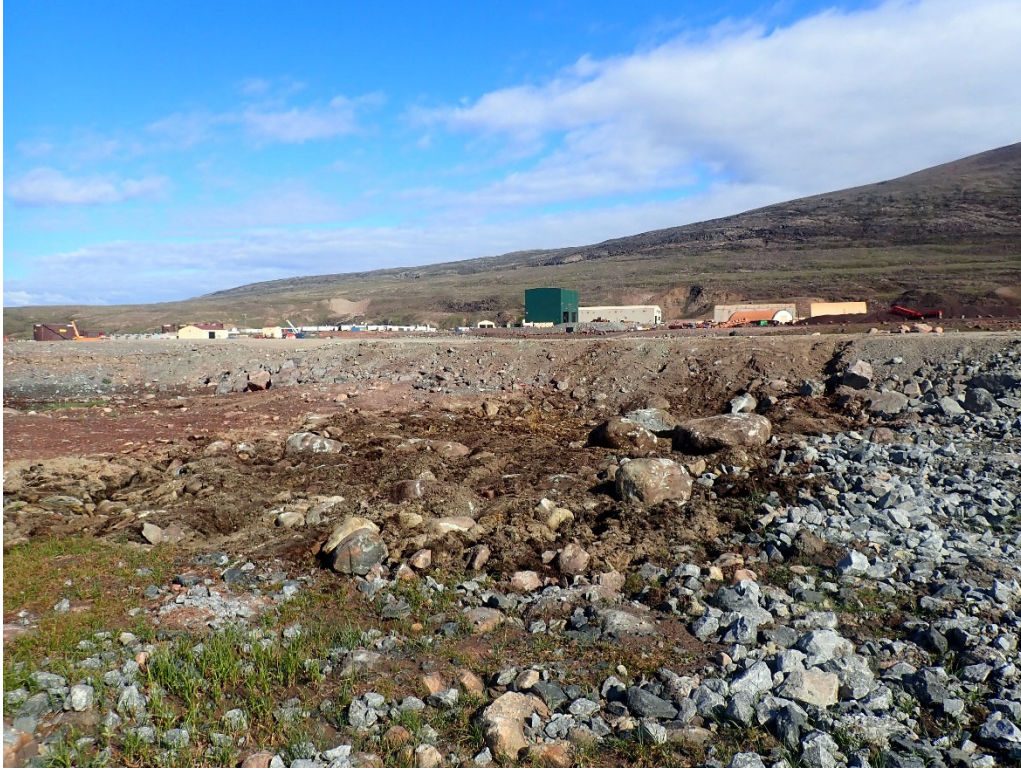
PHOTO 3 – Area of Kalamar spill cleanup, following additional remediation

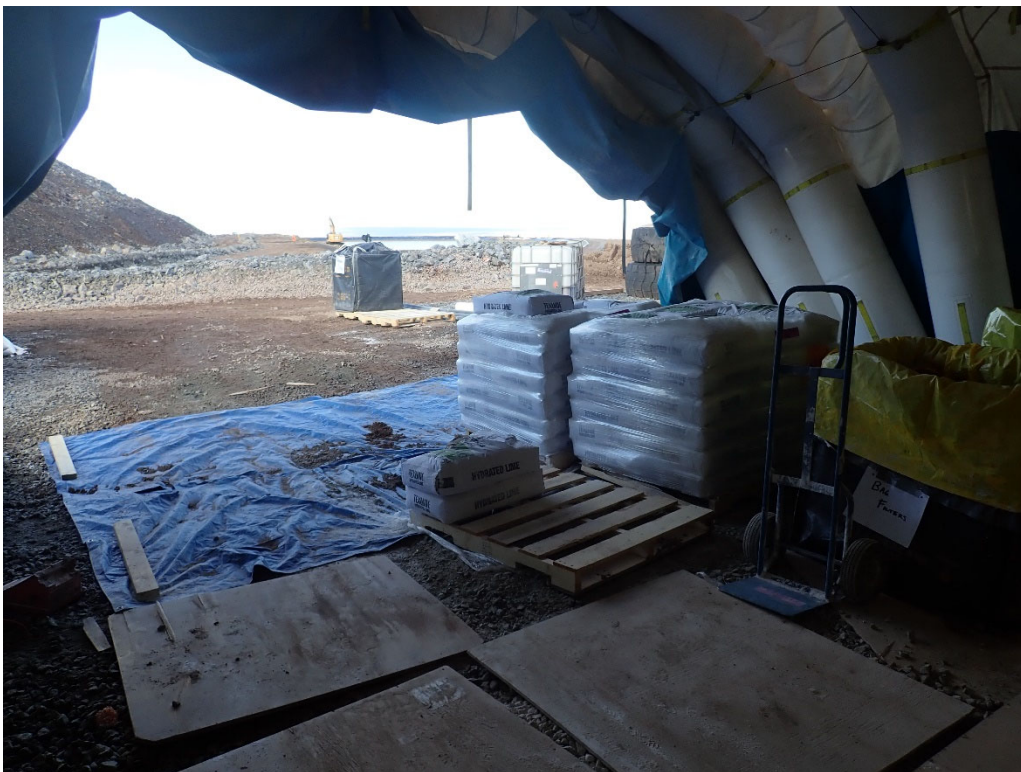
PHOTO 4 – Lime secondary containment at WRF Water Treatment Plant

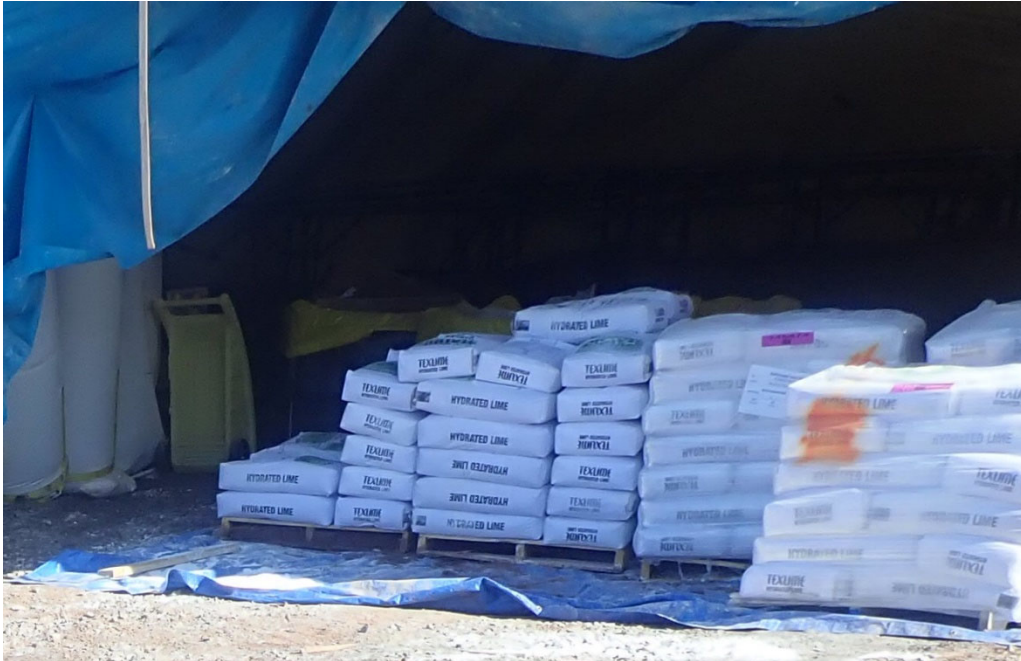
PHOTO 5 – Lime placed on secondary containment at WRF Water Treatment Plant

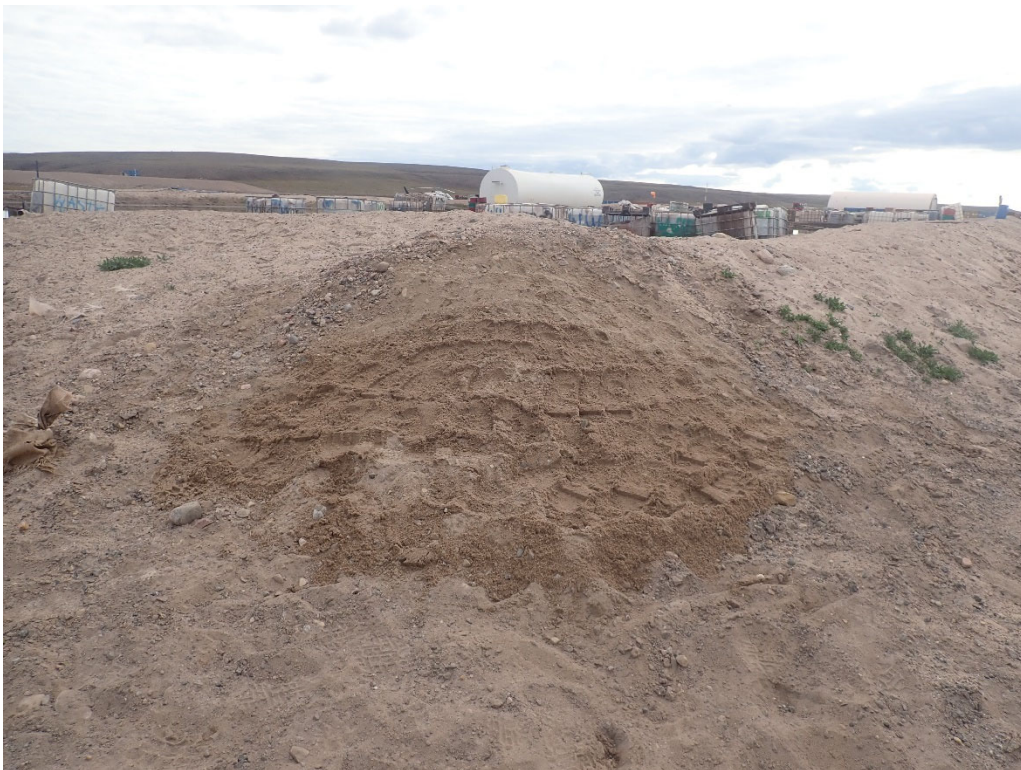
PHOTO 6 – Stained soil at MS-HWB-7 removed

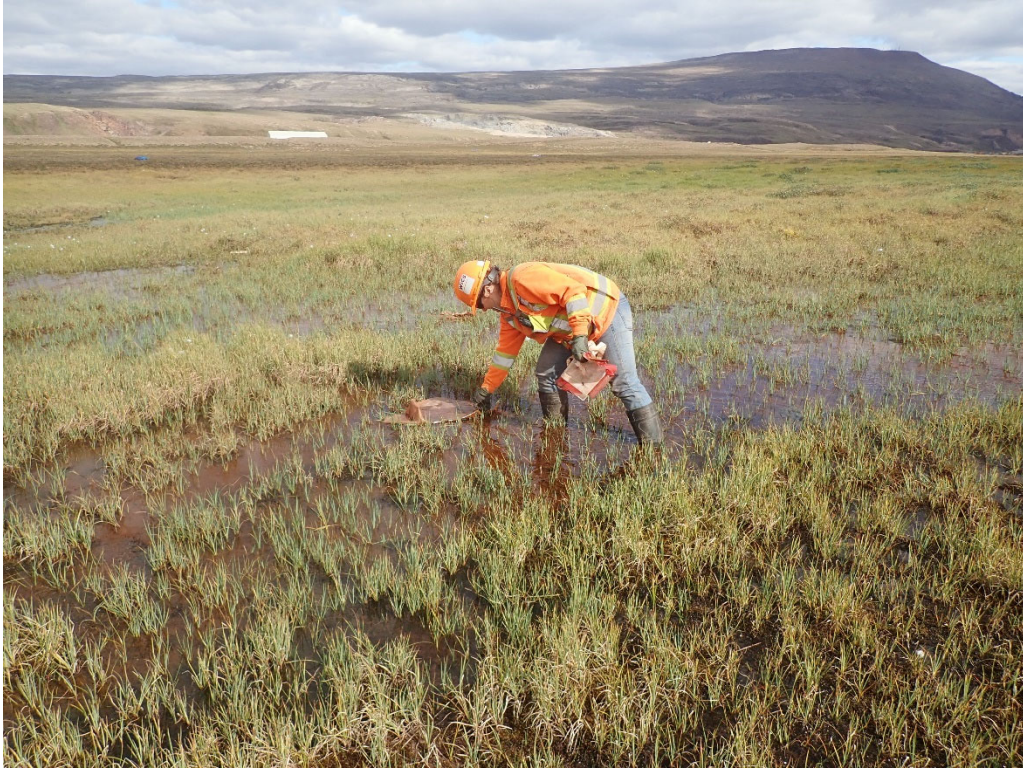
PHOTO 7 – Cleanup of debris outside the Mine Site area
