Km106 Run of Mine Stockpile & Sedimentation Pond

MARY RIVER PROJECT

Construction Summary Report

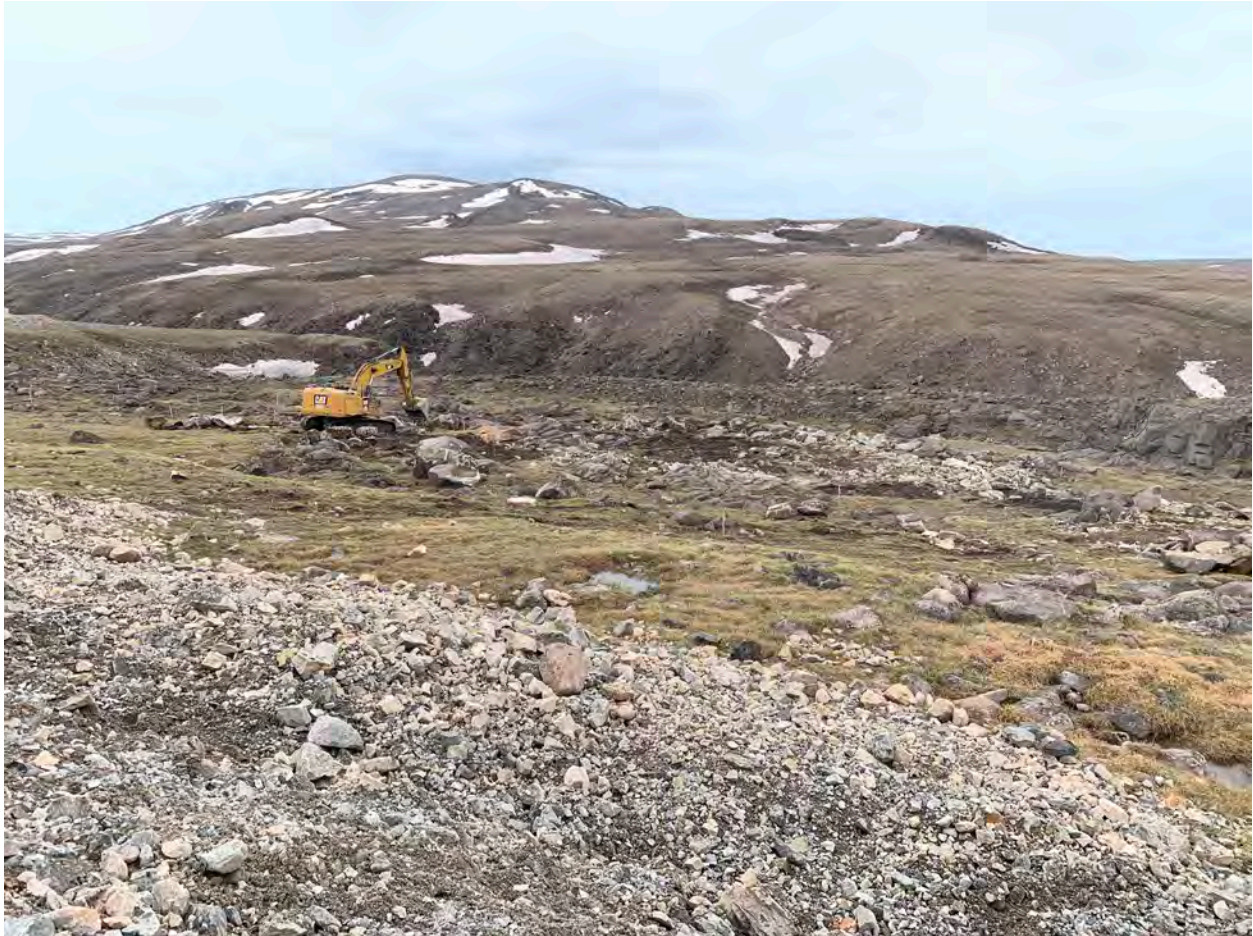
Prepare Foundation – Removal of Large Boulders - 27Jun20

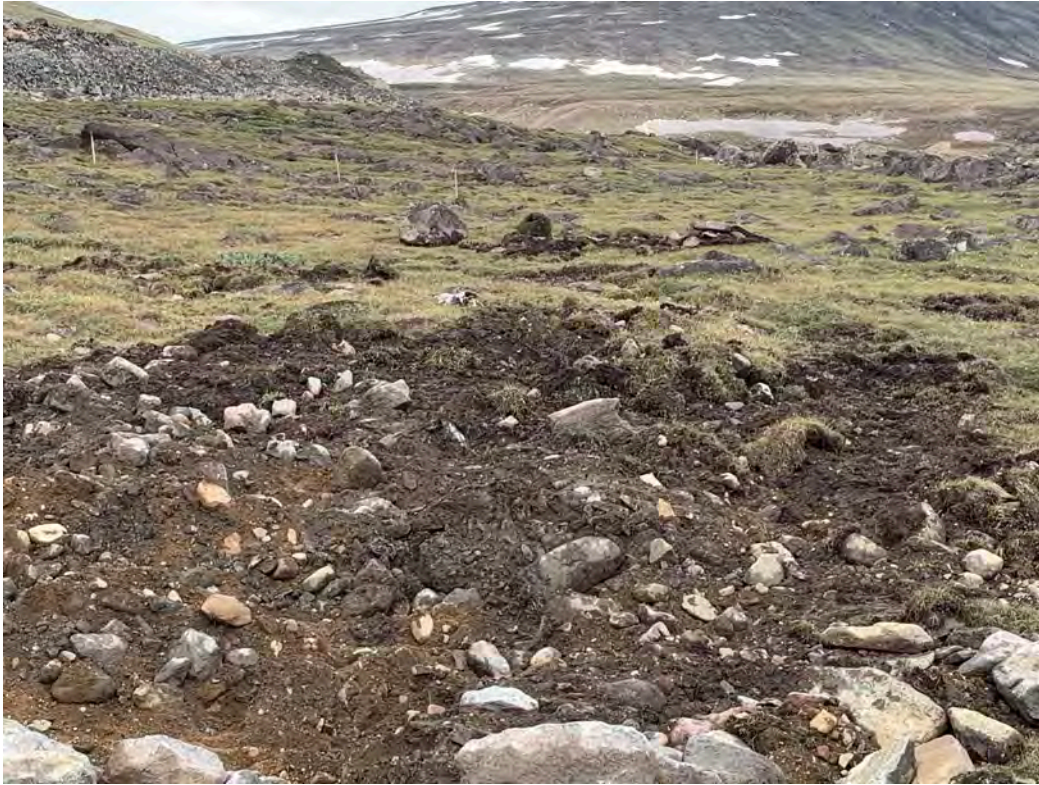
Prepare Foundation – Removal of Organic Material – 1Jul20

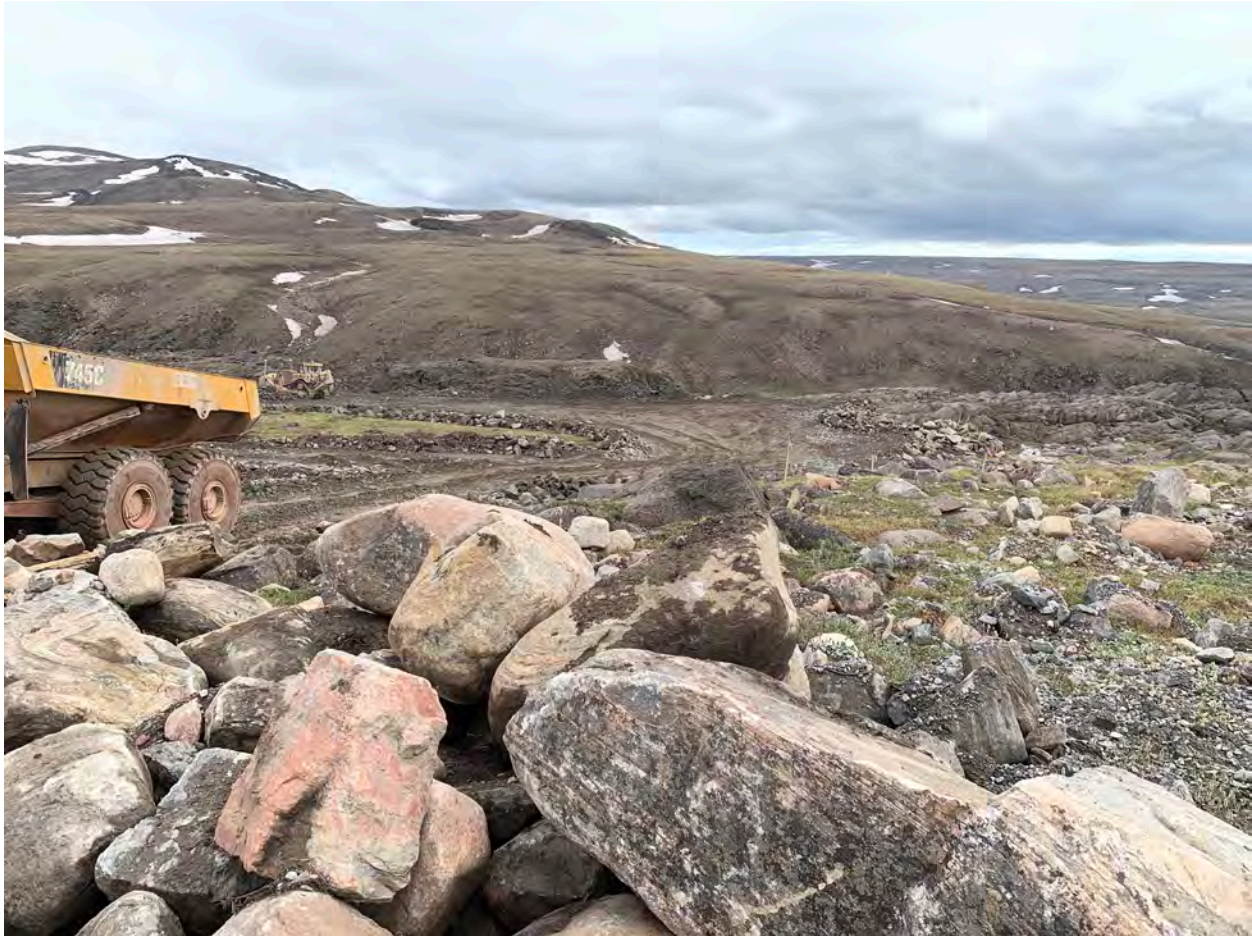
Preparing Foundation and Berm Raise 1st Layer – 1Jul20

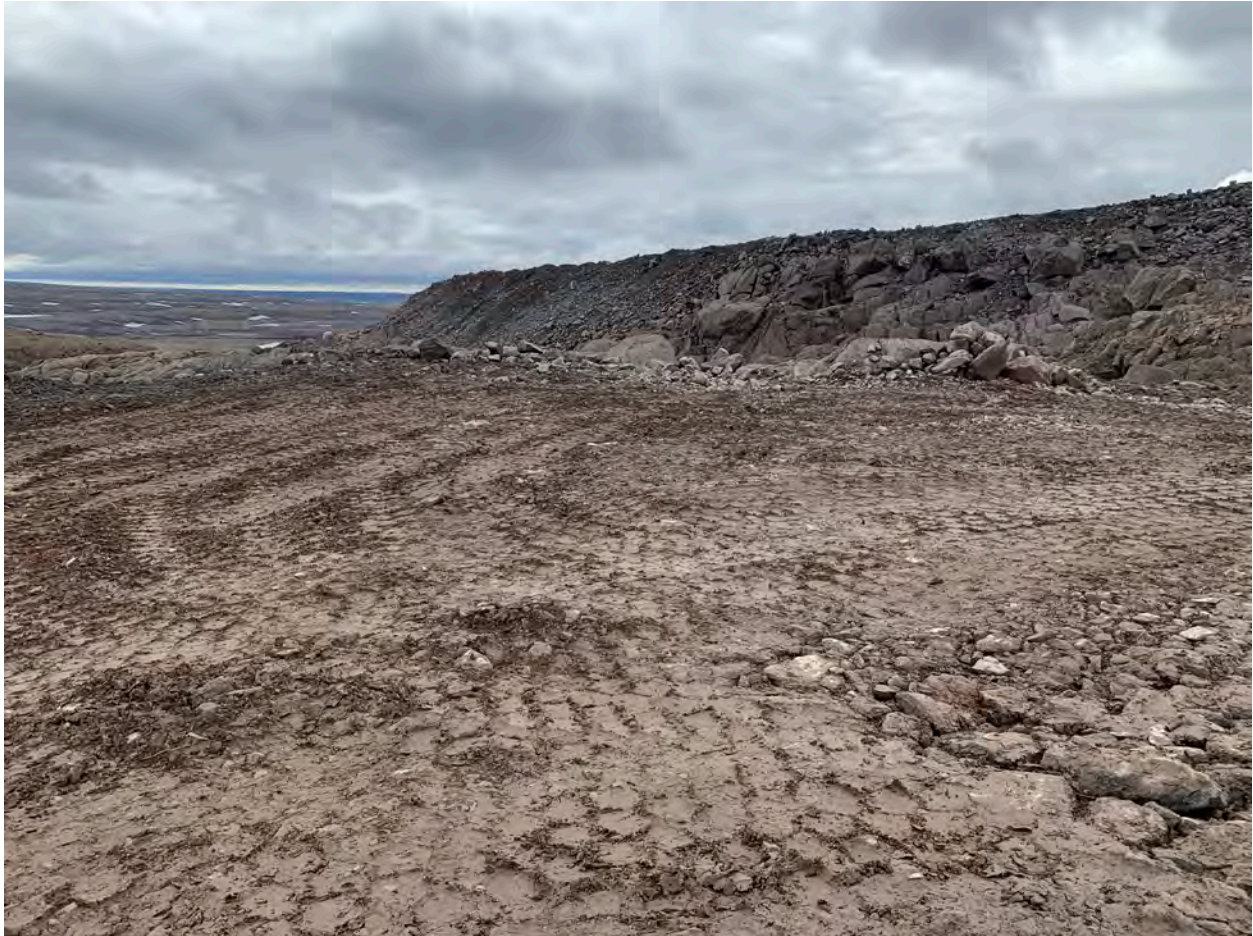
Stockpile Pad Layer Start – June 22, 2020

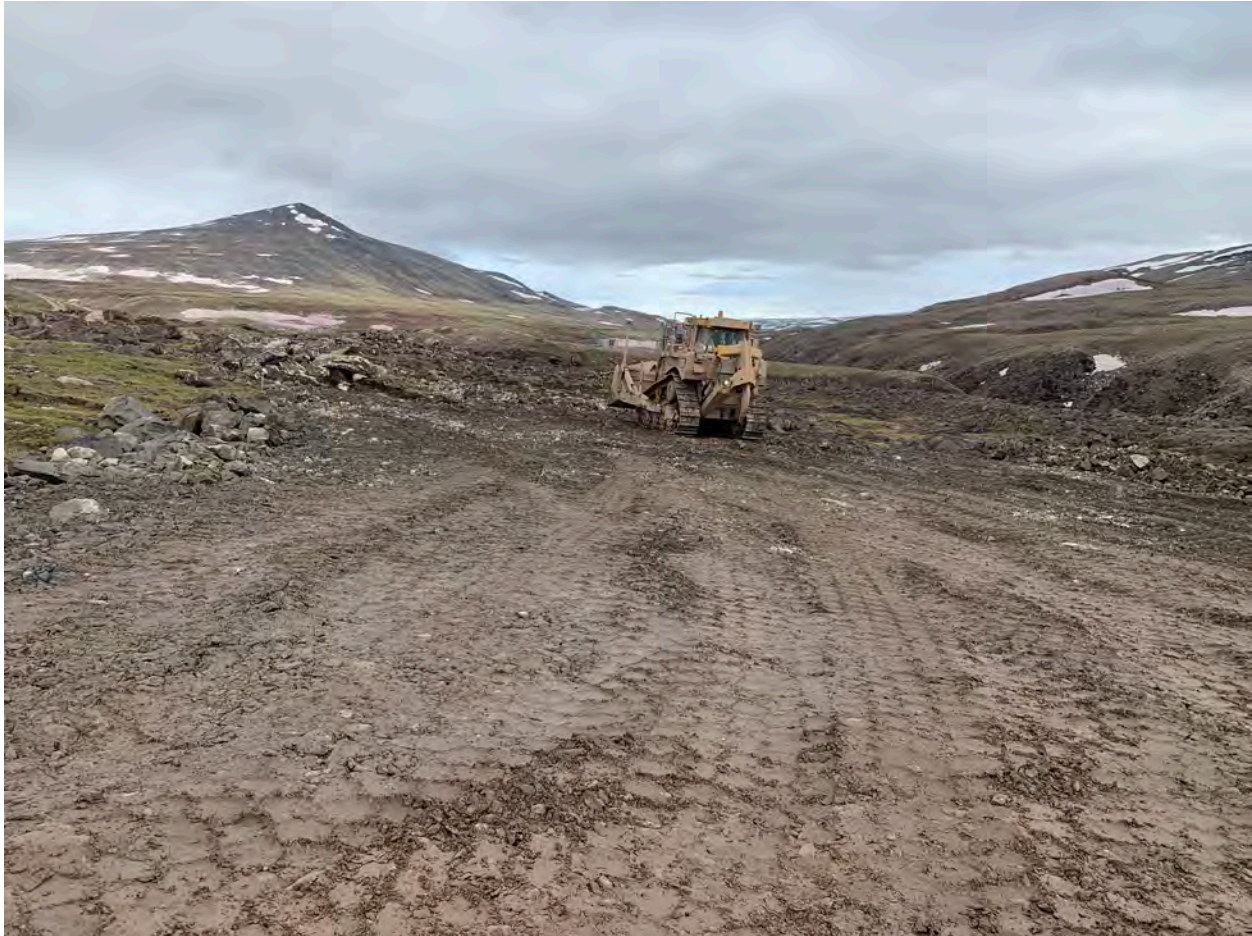
Founding Layer of Berm Rise – 1Jul20

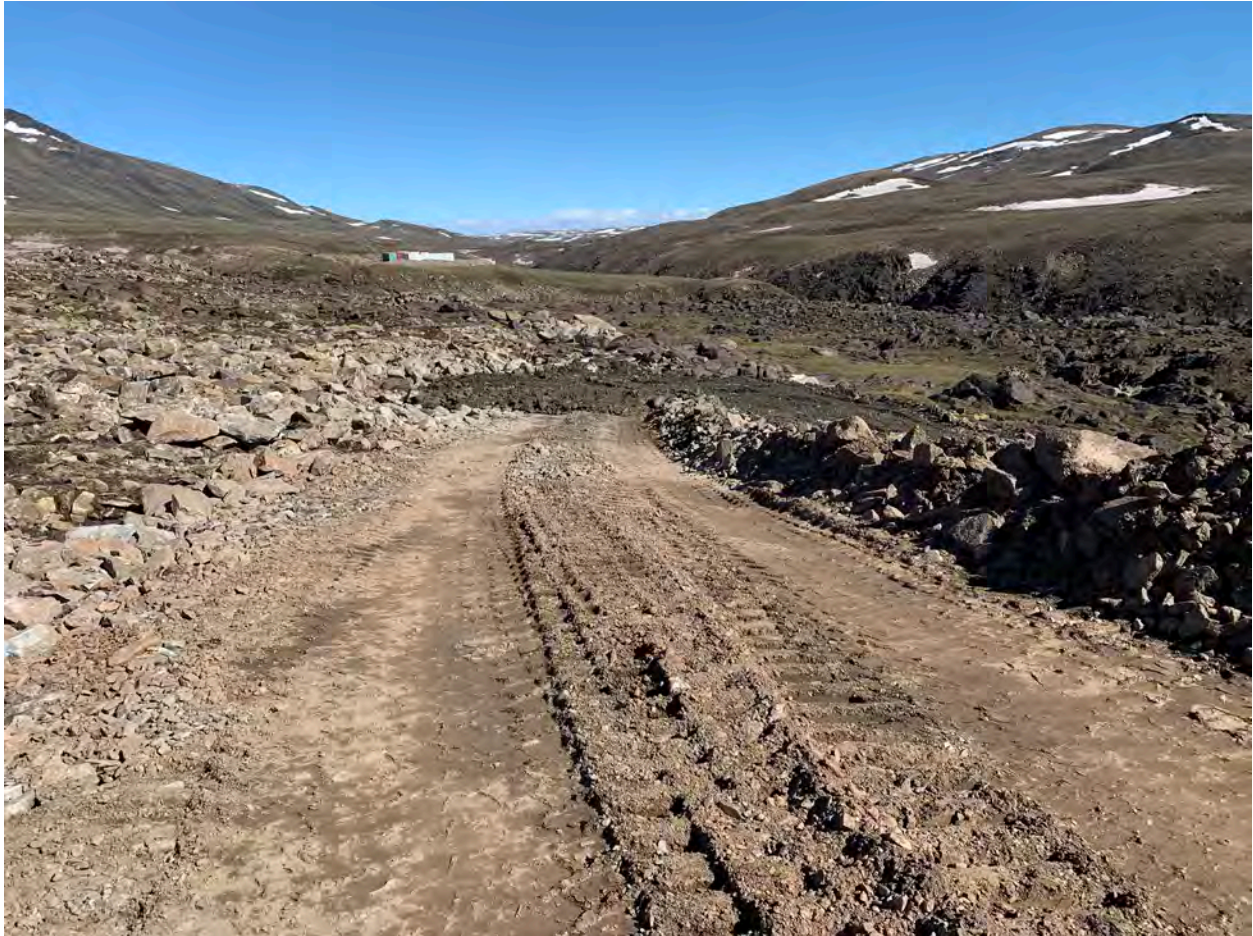
Extending 2nd Layer of Berm Rise – 2Jul20
