APPENDIX C.2

Geotechnical Inspection Reports

RE: Submission of 2019 Geotechnical Inspection Report No. 1 (July 2020)

Wood Environment & Infrastructure Solutions (Wood), has completed the first geotechnical field inspection of 2020 at the Mary River Iron mine complex, which is a condition of the Type "A" Water License No: 2AM-MRY1325 – Amendment No.1 ("Water License").

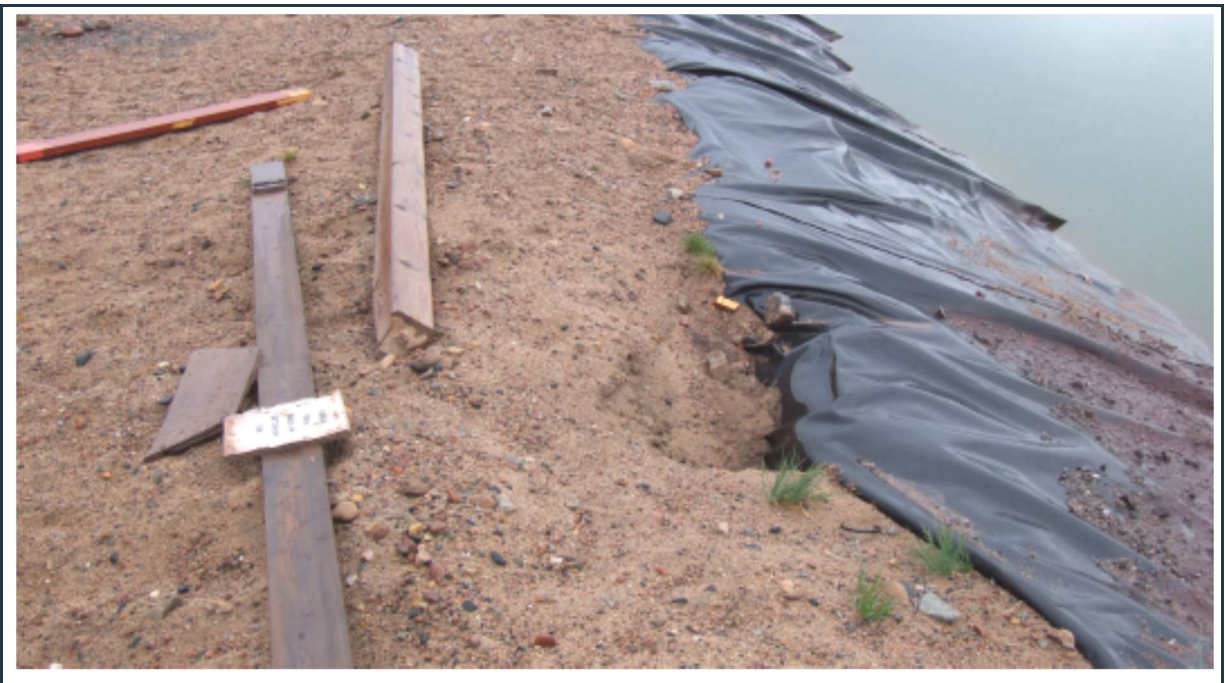
Some minor damage (i.e. "sinkhole") was visible on the crest of Pond #3, shown in Figure 10. It appears that the finer sand particles migrated down into the larger voids within the rock fill. Furthermore, large timbers and miscellaneous other elements (e.g., used tires etc.) are utilized as weight to secure the liner in-place at the berm's crest.

Figure 9: PWS pond #2 – Berm and liner in good condition. The water was recently lowered, and ice still visible in the pond.

Baffinland Action: Baffinland commits to having the minor damage to the liner repaired as part of the regular maintenance program. Baffinland will continue to monitor the PWSPs and initiate cleanup of this area to remove excess materials.

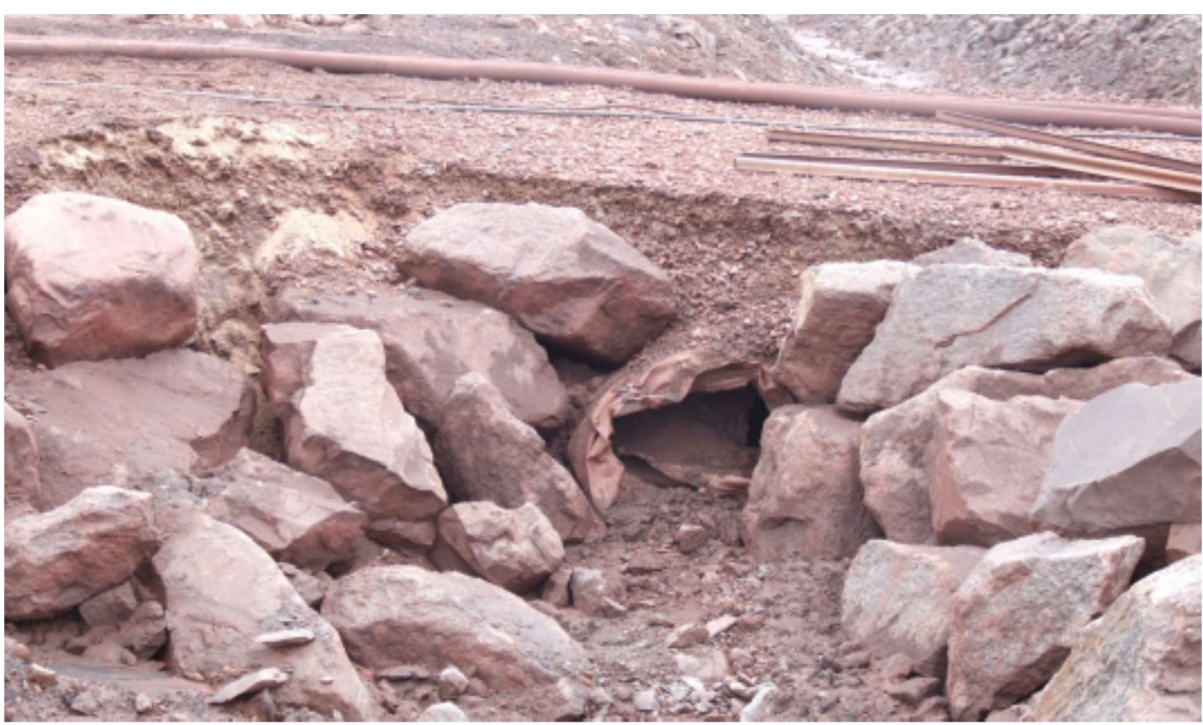
Some damage was noted at a culvert located near the southeast inlet to the pond. Additional minor damage was noted at the culvert located beneath the Tote Road, adjacent to the northeast corner of the pond.

Figure 23: Damaged and clogged (silted) culvert in the ditch shown in Figure 22, near the MS-06 pond.

Baffinland Action: Baffinland commits to repairing and cleaning the culverts identified during the inspection. The collected excess silt will be deposited at an appropriate disposal location onsite.

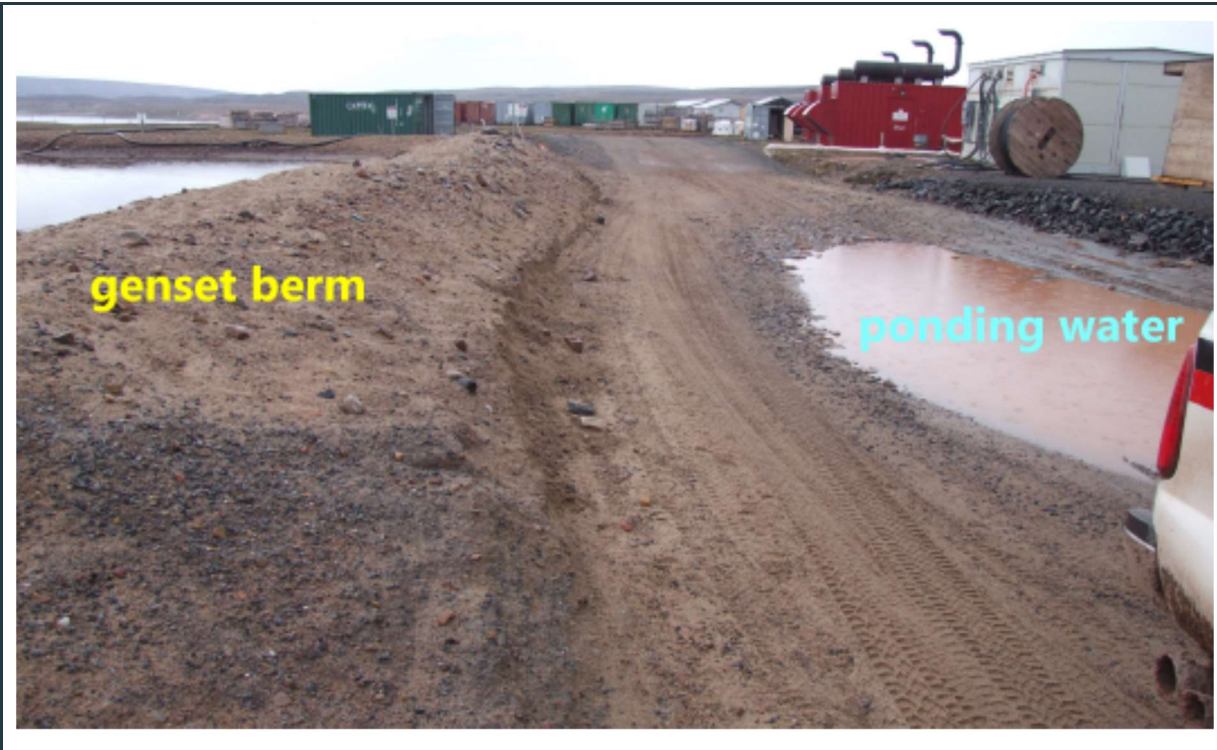
Figure 33: View of slope deterioration at a section of the berm near the generators. Trucks bypassing ponding surface water on the road are “cutting” into the toe of the berm.

Baffinland Action: Baffinland commits to bringing granular fill to this location to re-fill the slope and regrade the area. In addition to the repair work on the slope, the southern, lower section of the berm will be reconstructed to its original geometry.

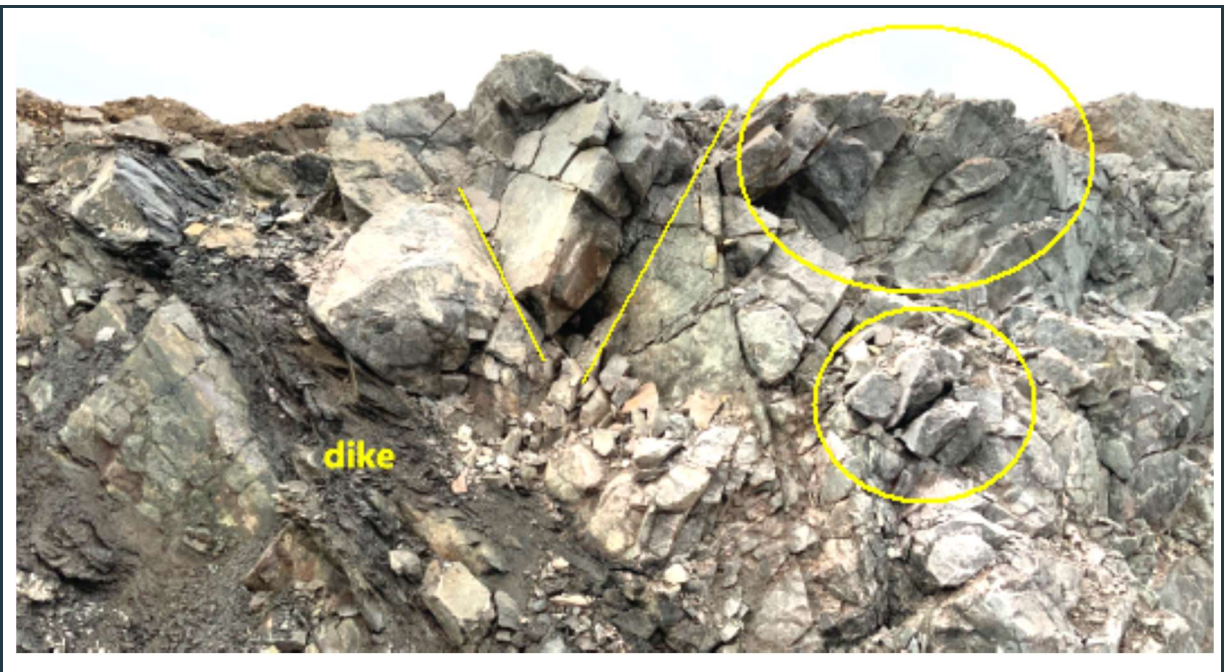
Figure 46: Potential hazards at one of the highwalls (weak dike, loose boulders and sliding wedge).

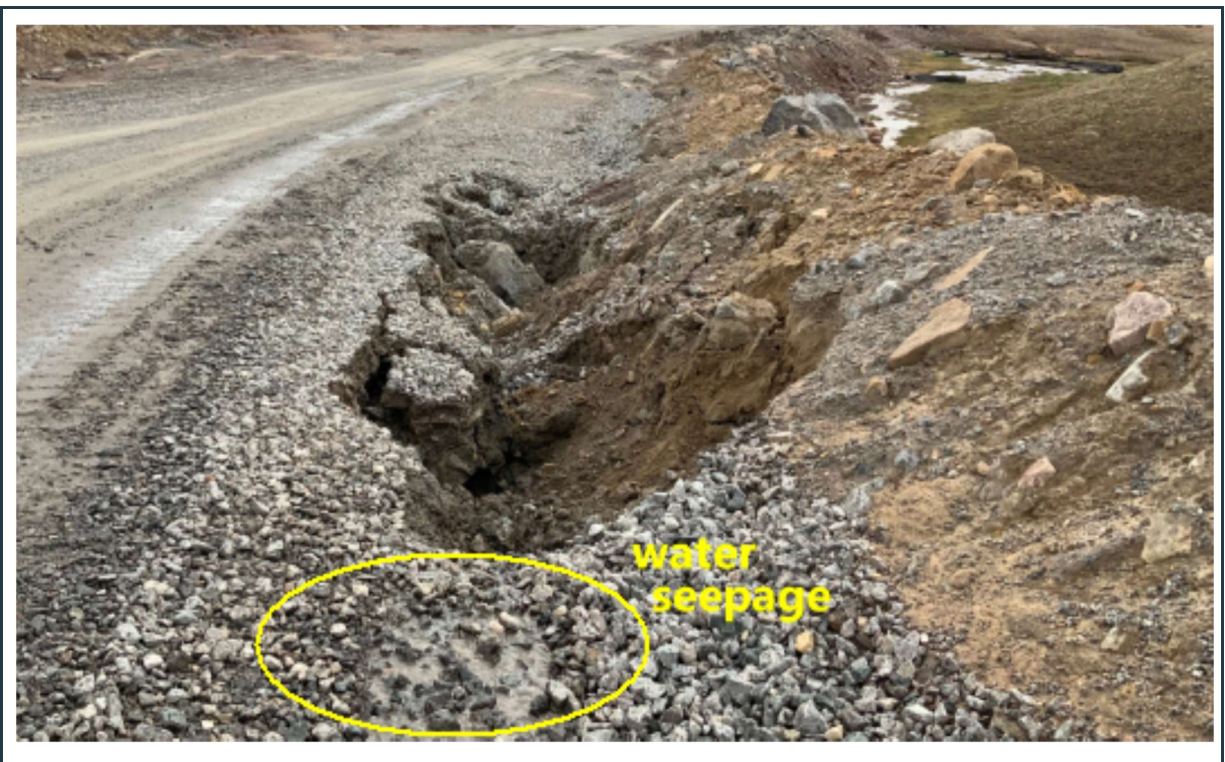
Additional measures for surface water management (excavation/formation of drainage ditches at strategic locations) within the quarry was recommended. In order to maintain traffic safety along the access road, immediate repair of the road was recommended.

Figure 48: Surface water flowing from the quarry area along the road resulted in a failure of the edge of the access road leading to the quarry. Immediate repair was requested to prevent accidents.

Baffinland Action: The damaged road section was repaired during the inspection. Baffinland commits to further improving of surface water control in the quarry through excavation/formation of additional drainage ditches at strategic locations.

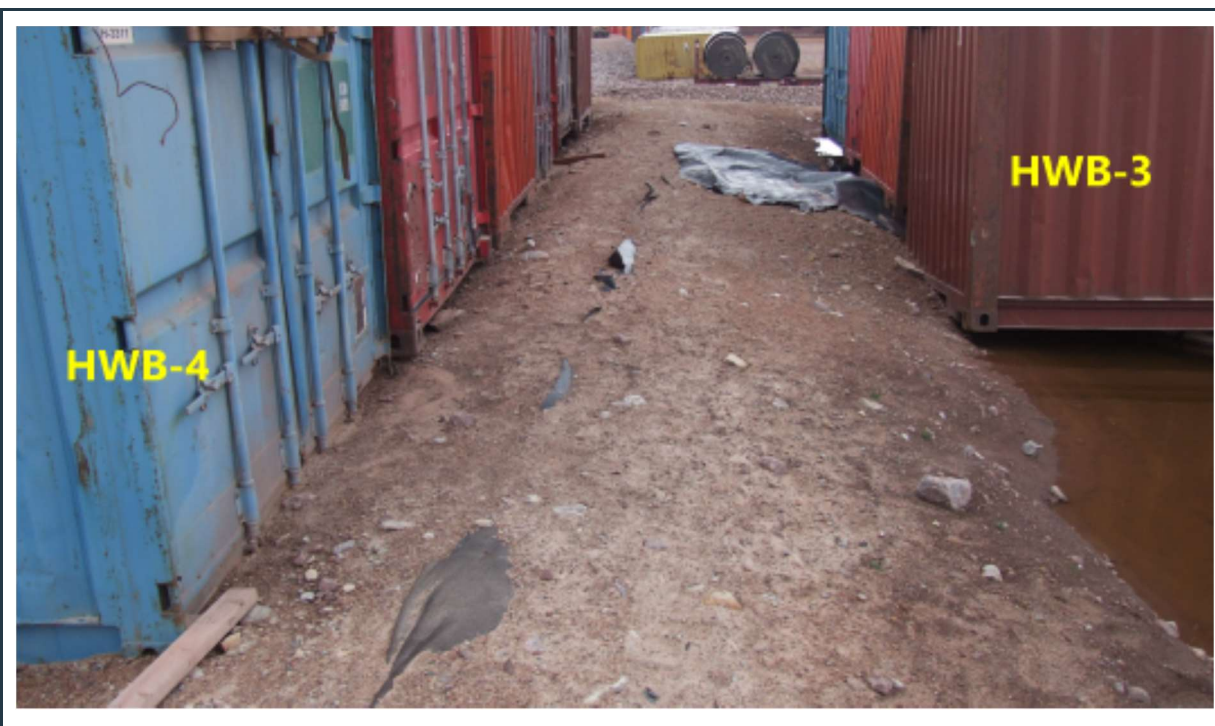
Exposed geotextile and liner were noted at a few locations on the internal slopes of the otherwise stable berms.

Figure 58: Exposed geotextile and liner on the internal berm between the HWB-3 and HWB-4 cells.

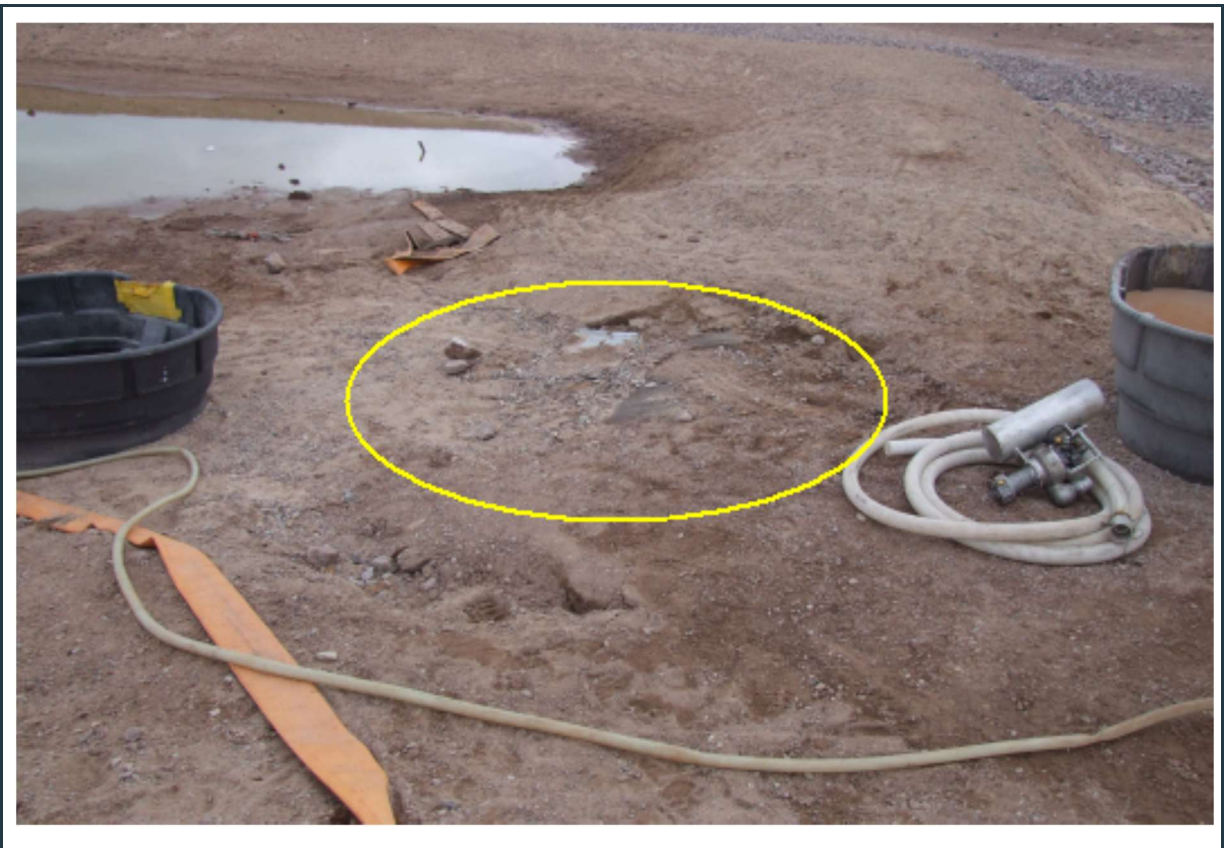
Figure 66: Condition of the ramp to the MP-04A snow dump, with exposed liner (yellow circle).

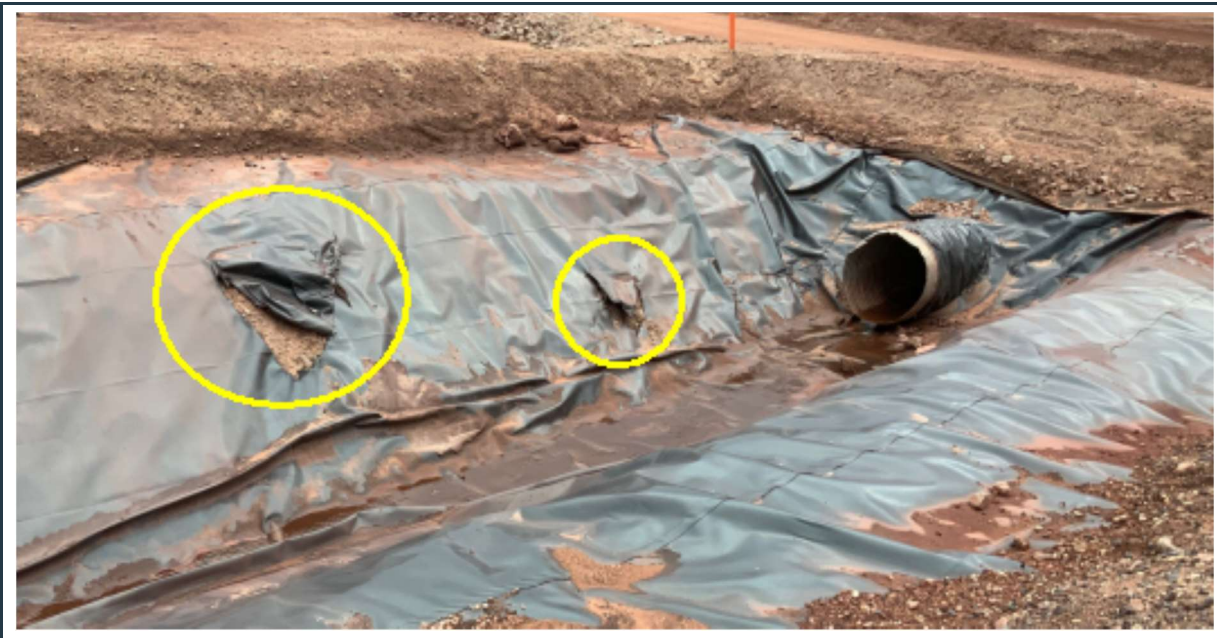
Minor liner damage was noted on the slope of the southern intake channel to the pond. Some erosion on the slope of the drainage ditch to the MP-05 was noted.

Figure 68: Some liner damage on the slope of the southern intake channel to the MP-05 settling pond.

Baffinland Action: Baffinland commits to addressing the minor liner and erosion damage observed.

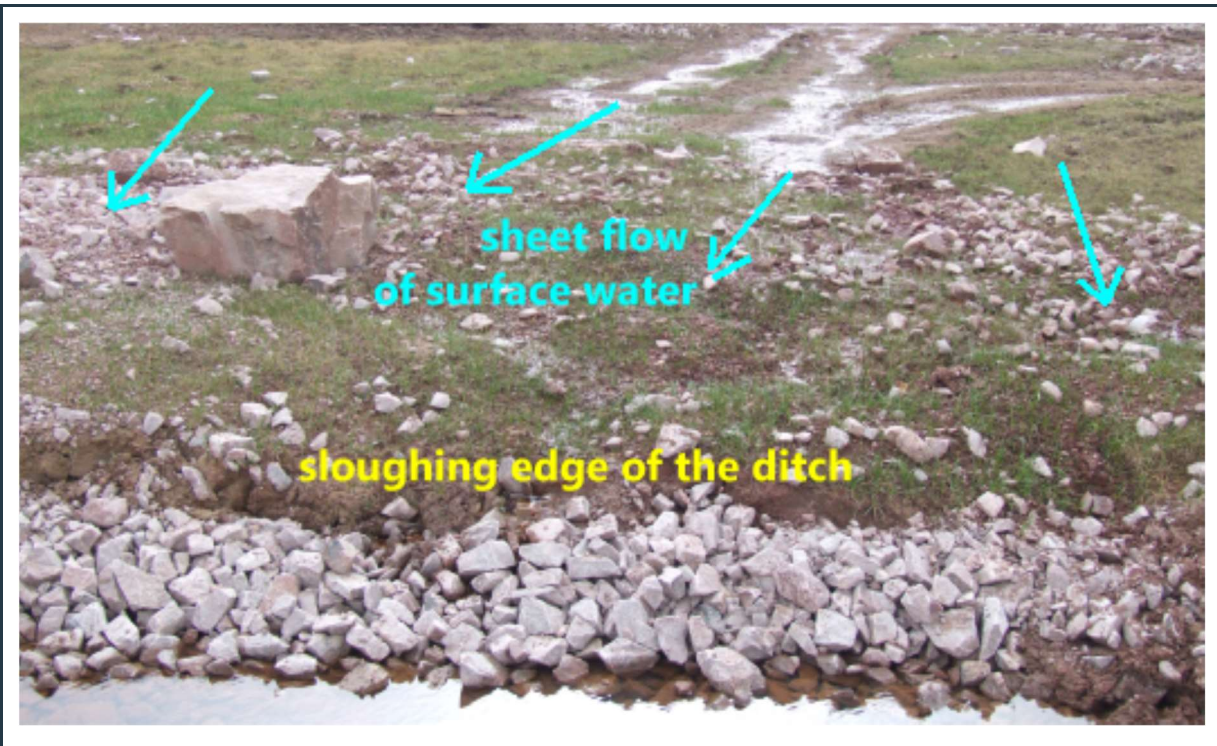
Sloughing of the sides of ditch P-SWD-3, adjacent to the LP2 laydown area, is visible at several locations along the ditch. The riprap appeared to be missing at a small section of the P-SWD-5 ditch. Minor sloughing of the riprap was also observed in the 380M ditch. It is recommended that the culvert should be shortened at the PSC drainage ditch under construction to facilitate uninterrupted flow of water within the ditch.

Figure 77: Sheet flow of surface water resulting in sloughing of one side of the P-SWD-3 ditch.

Baffinland Action: Baffinland commits further assessing the sloughing observed on the sides of ditch P-SWD-3 and the 380M ditch. Baffinland will replace the missing riprap observed in the P-SWD-5 ditch and further assess the culvert installation at the PSC ditch.

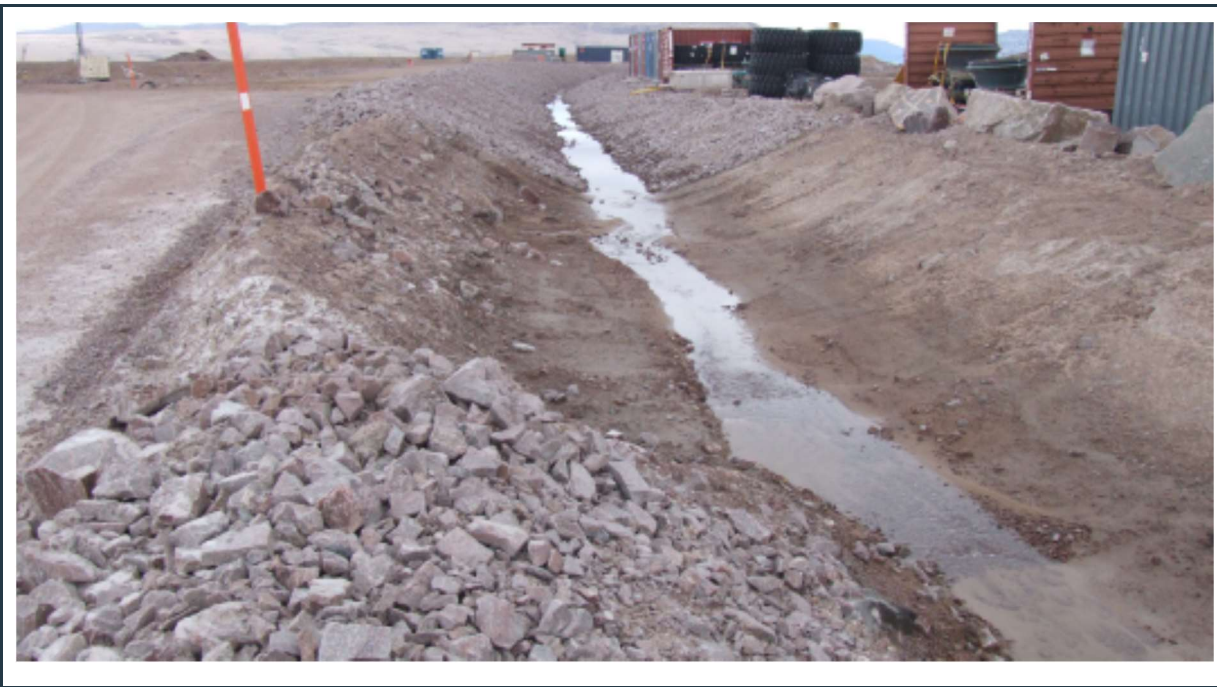
Figure 78: P-SWD-5 – "Q01-North" surface water collection ditch. Riprap is missing at one section.

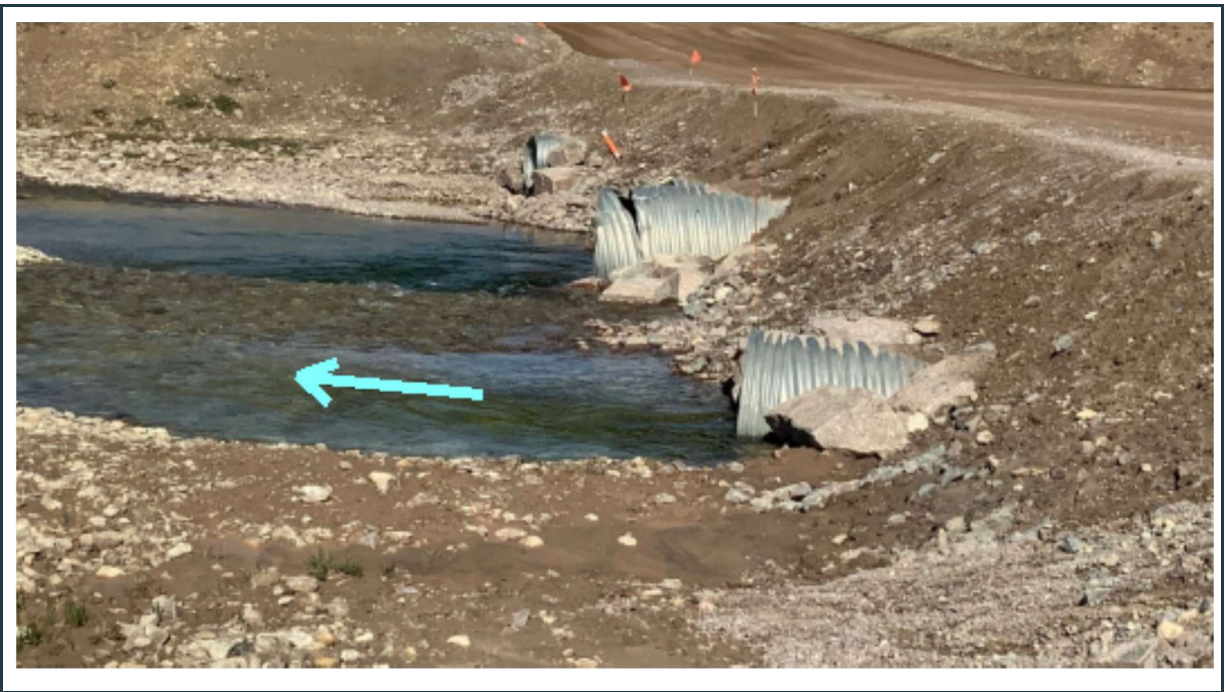
Figure 100: View of culvert(s) 078 (outlet). Minor damage visible on one pipe.

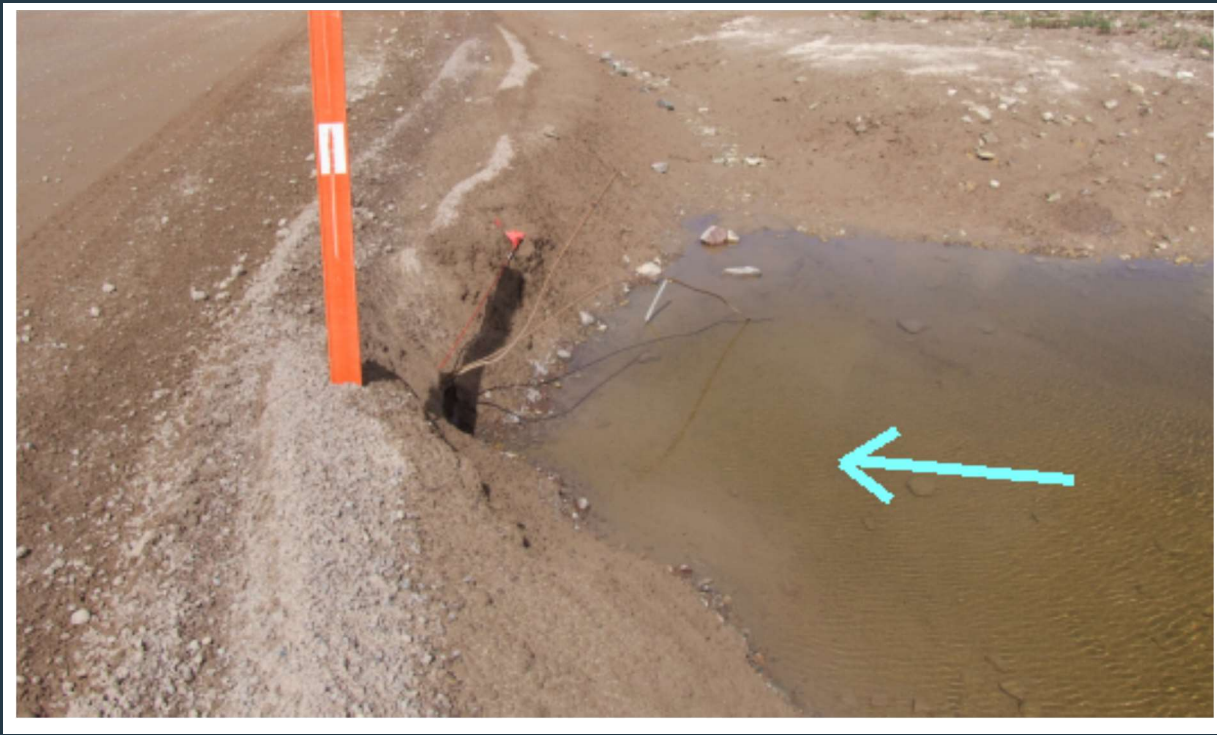
Figure 107: View of culvert 107 (inlet). Extension of the culvert and placement of riprap are required.

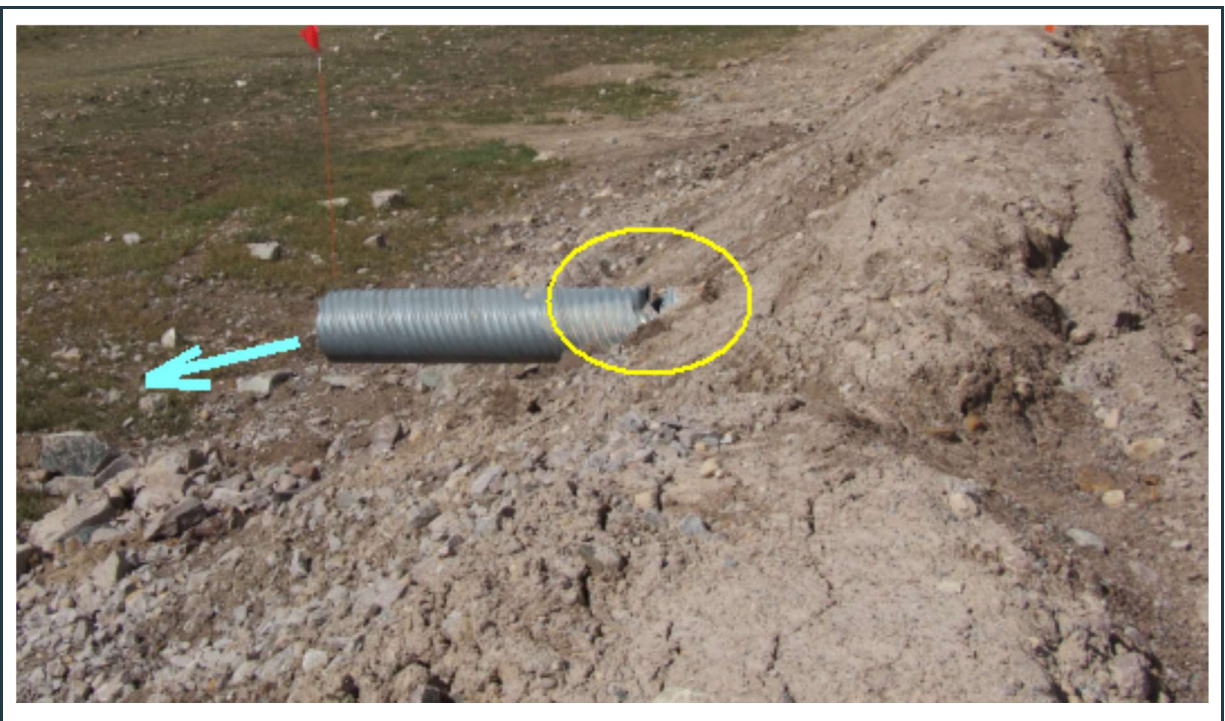
Figure 110: View of culvert 110A (outlet) with minor damage on the top of the pipe (yellow circle).

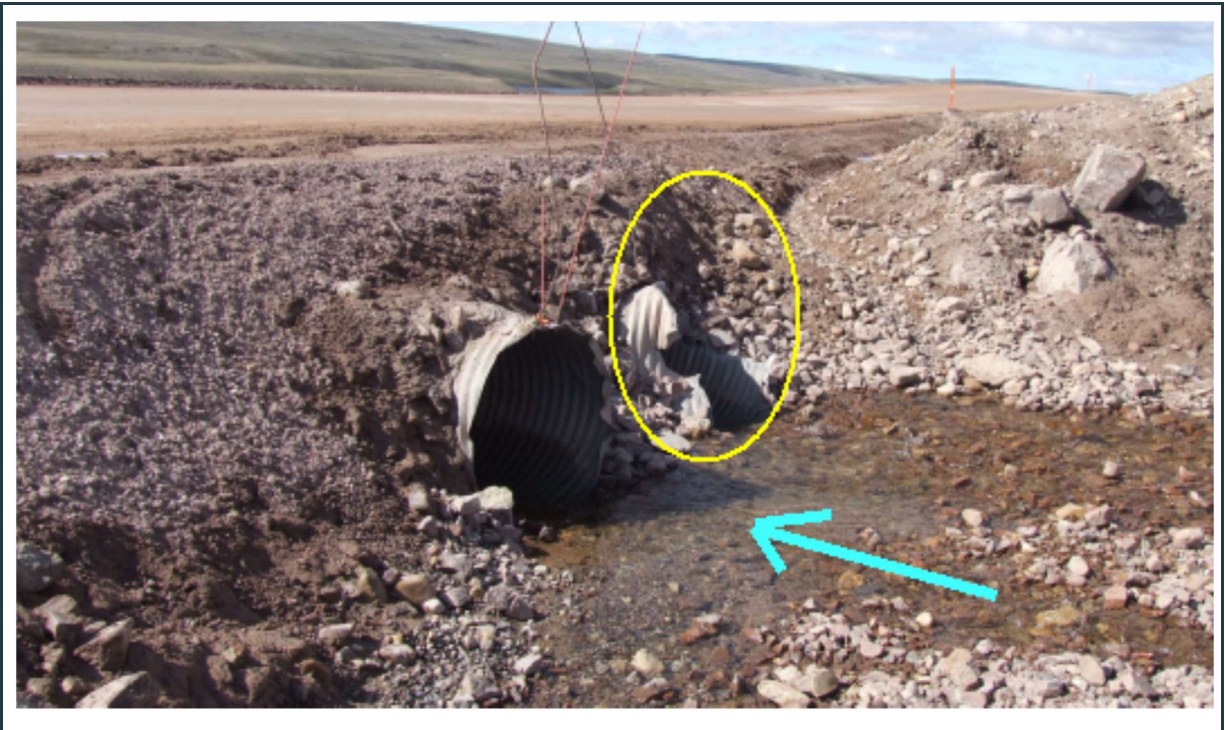
Figure 115: View of culvert(s) 114D inlet. Repair of the northern pipe is required (yellow circle).

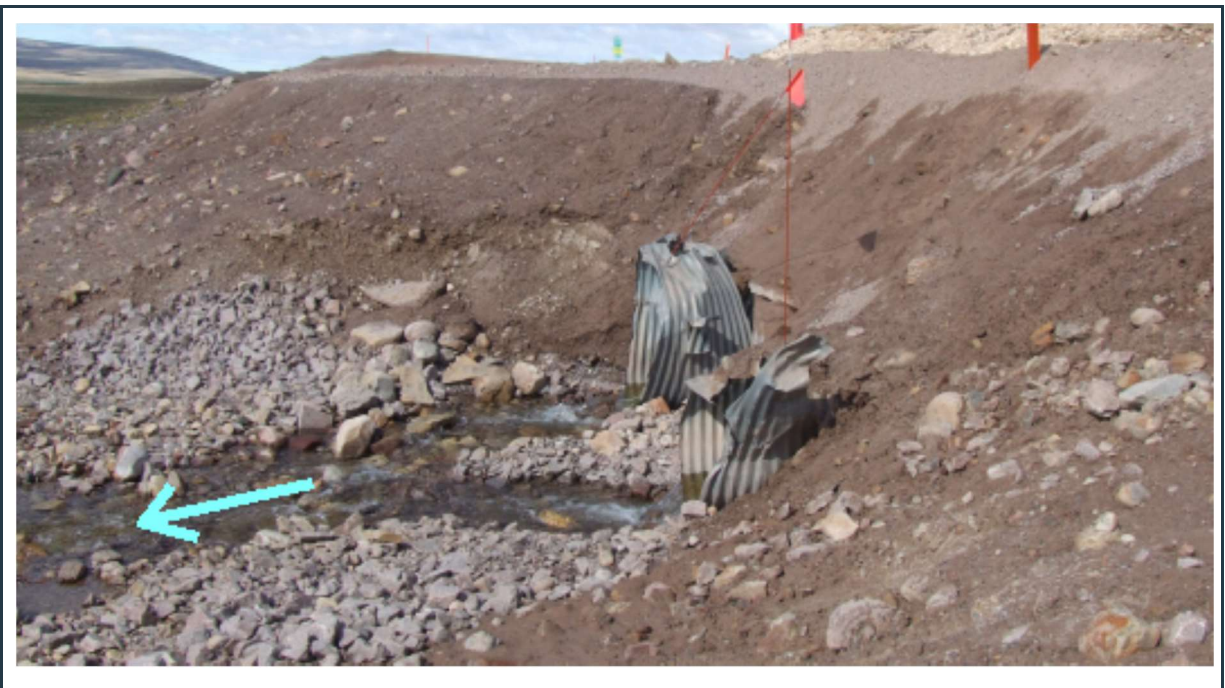
Both ends of this double-barrel culvert are damaged and too short, particularly at the outlet end.

Figure 116: View of culvert(s) 114D (somewhat damaged outlet). Repair of both pipe ends required.

Baffinland Action: Baffinland commits to further inspecting this culvert to determine if replacement with a longer, larger pipe is required. If replaced, both pipes will be repaired and extended. Once the pipes are repaired and extended, the road embankment may be widened.

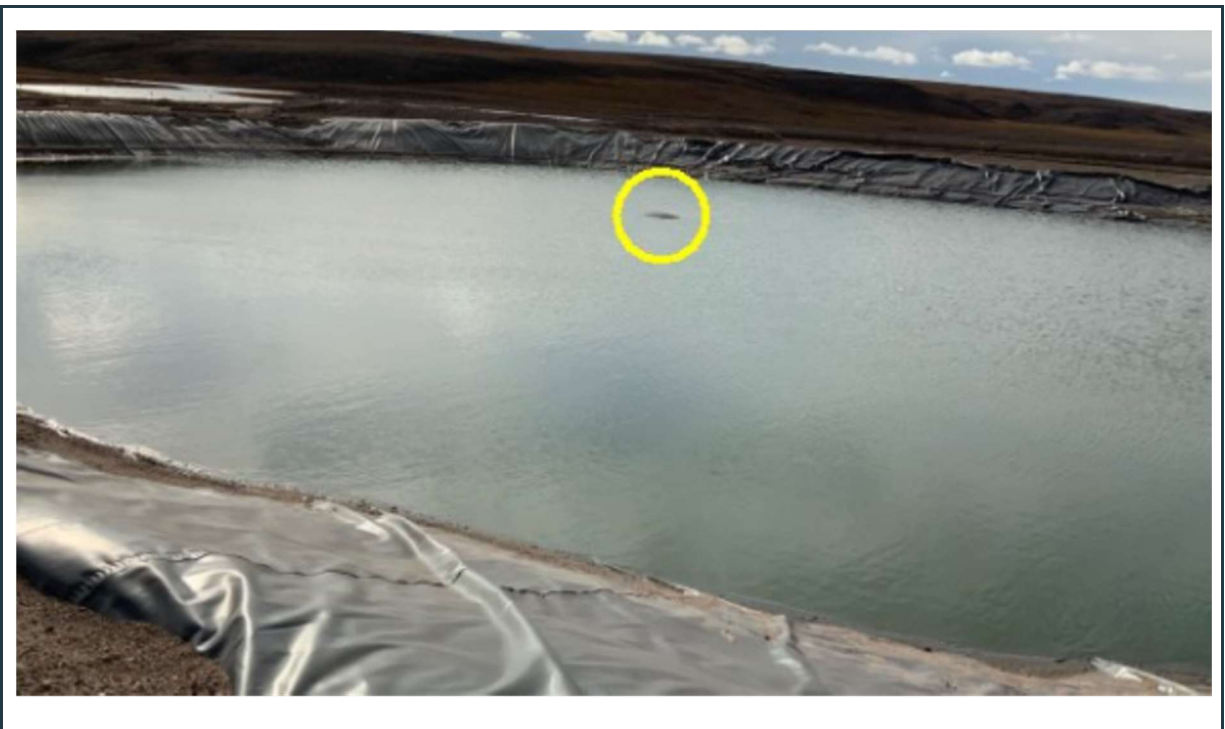
Figure 12: Stable perimeter berms at the PWS pond #3 – A small “floating” section of the liner is visible in the pond (yellow circle).

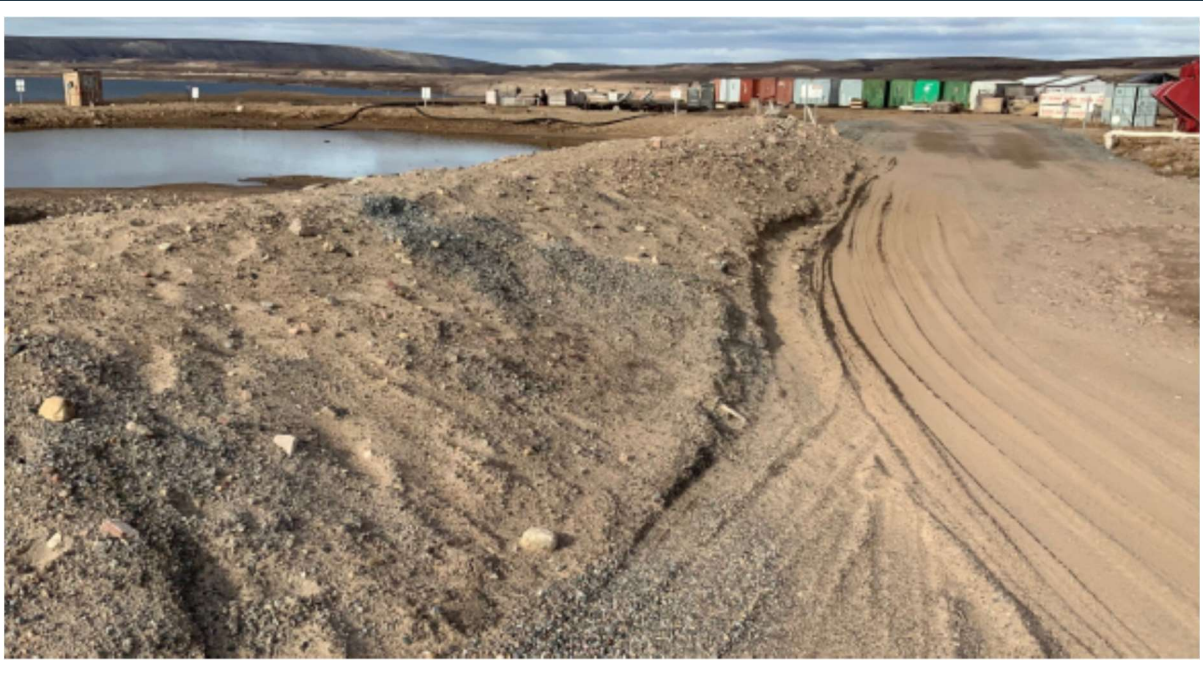
Figure 29: View of slope deterioration at a section of the generator fuel berm. Trucks bypassing occasional ponding surface water on the road are “cutting” into the toe of the berm.

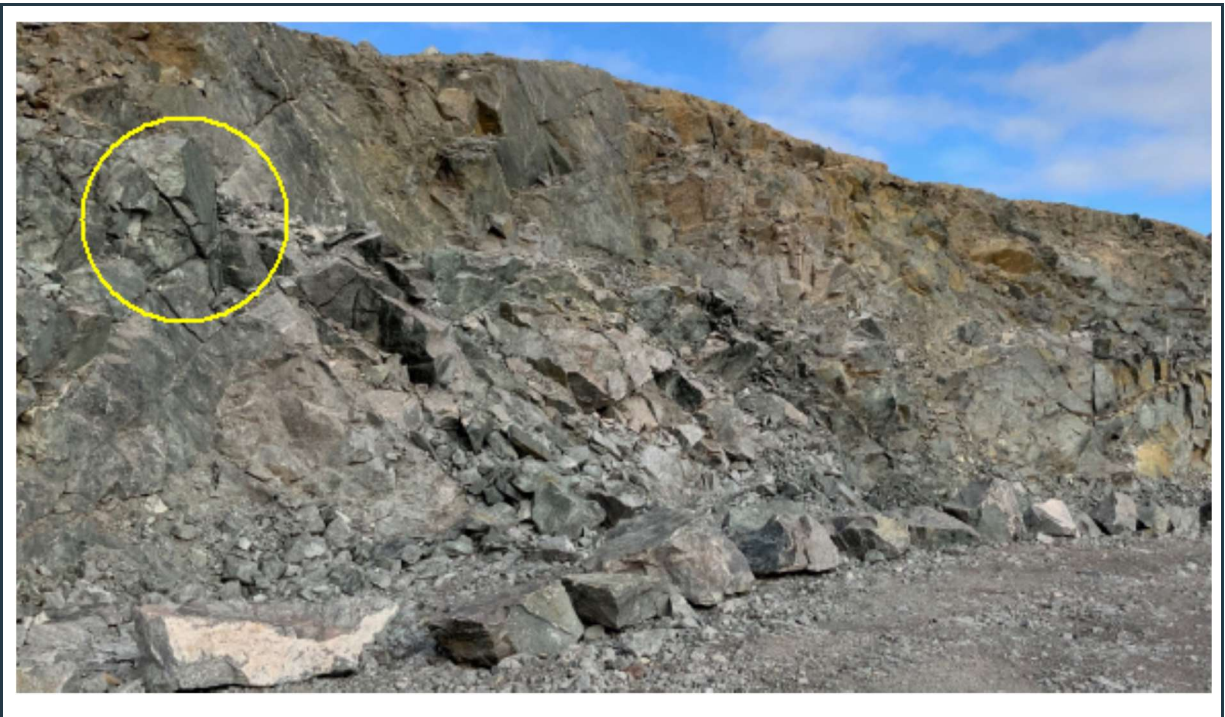
Figure 38: Stable rock face with some minor potential hazards (weak dike, loose boulders and sliding rock wedges). Boulders placed along the toe of the "rock face" block access to the slope.

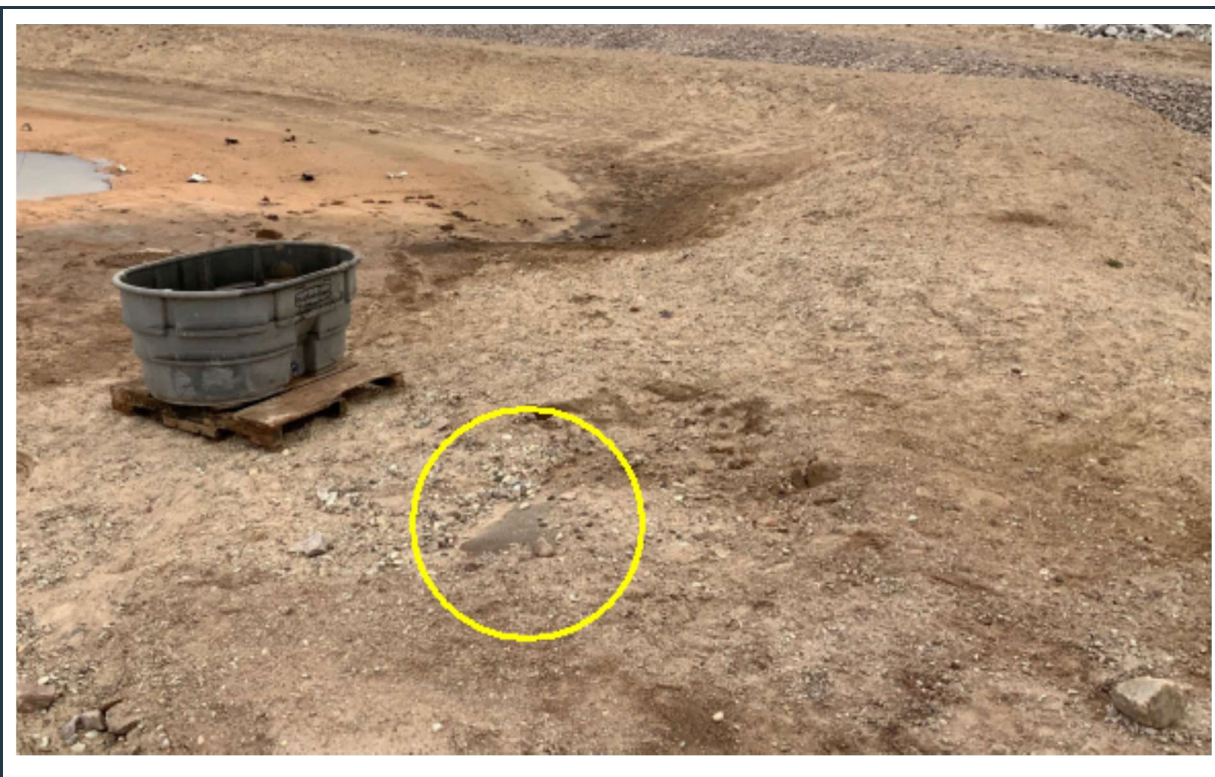
Figure 52: Condition of the ramp to the MP-04A snow dump, with exposed liner (yellow circle).

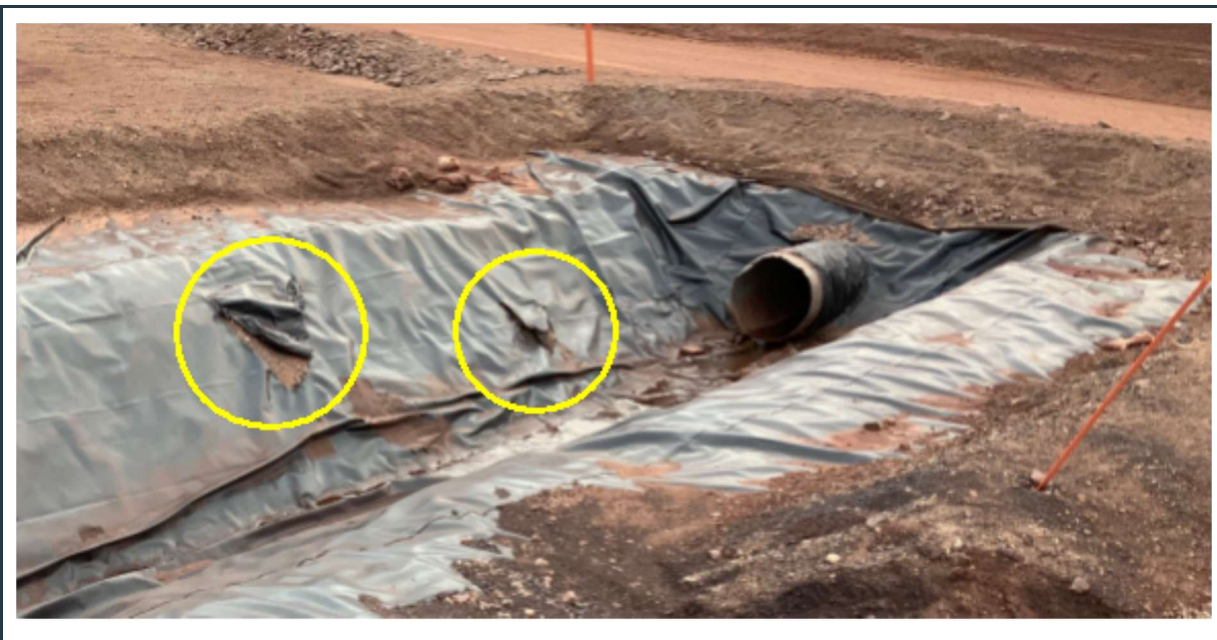
Figure 54: Some liner damage on the slope of the southern intake channel to the MP-05 settling pond.

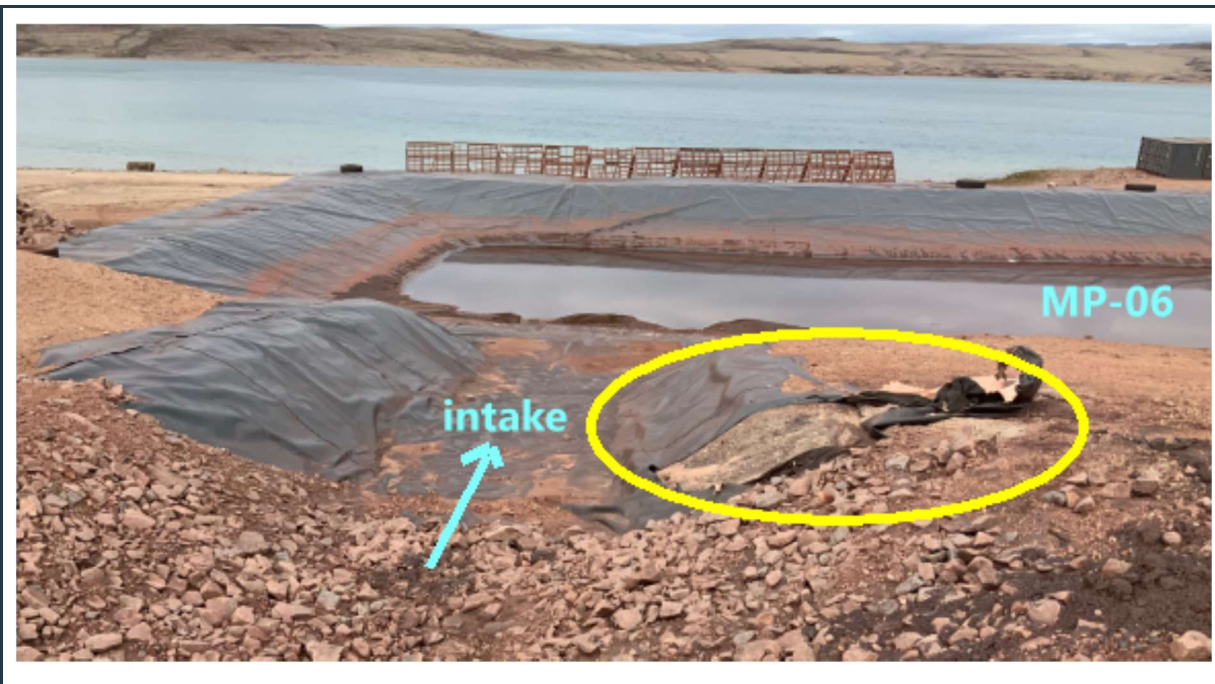
Figure 56: View of the lined MP-06 pond with robust, stable berms (north-west corner of the ore stockpile). Note the liner damage on the slope of the intake to the pond (yellow circle).

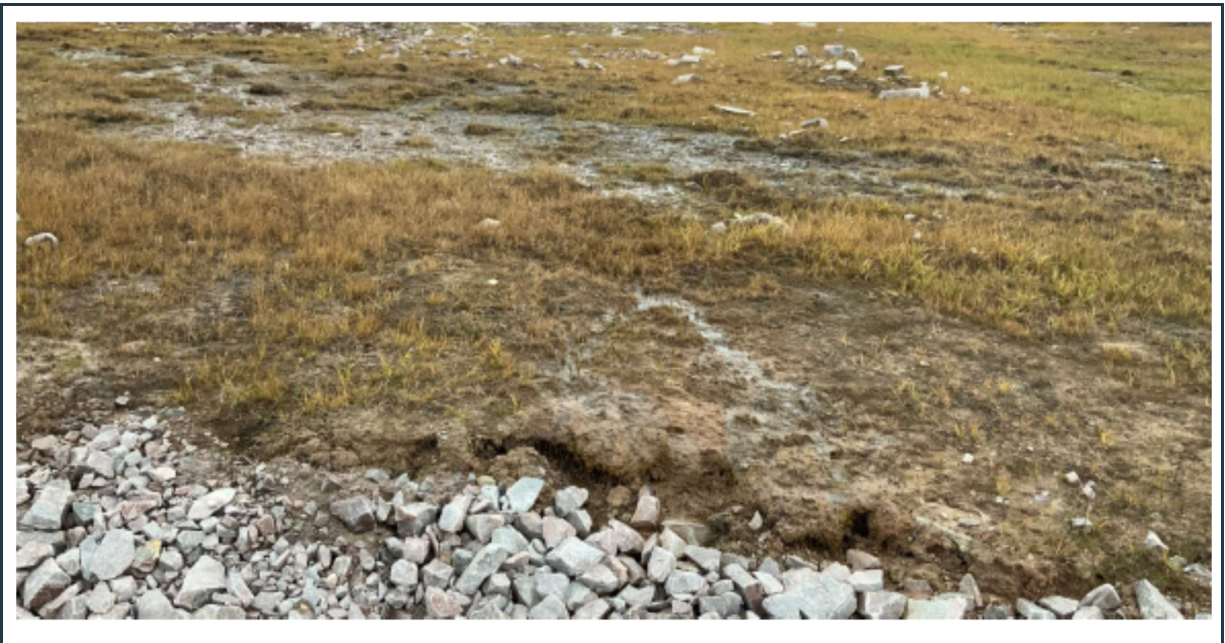
Figure 62: Continuous sheet flow of surface water from a large area, resulting in sloughing of one side of the P-SWD-3 ditch.

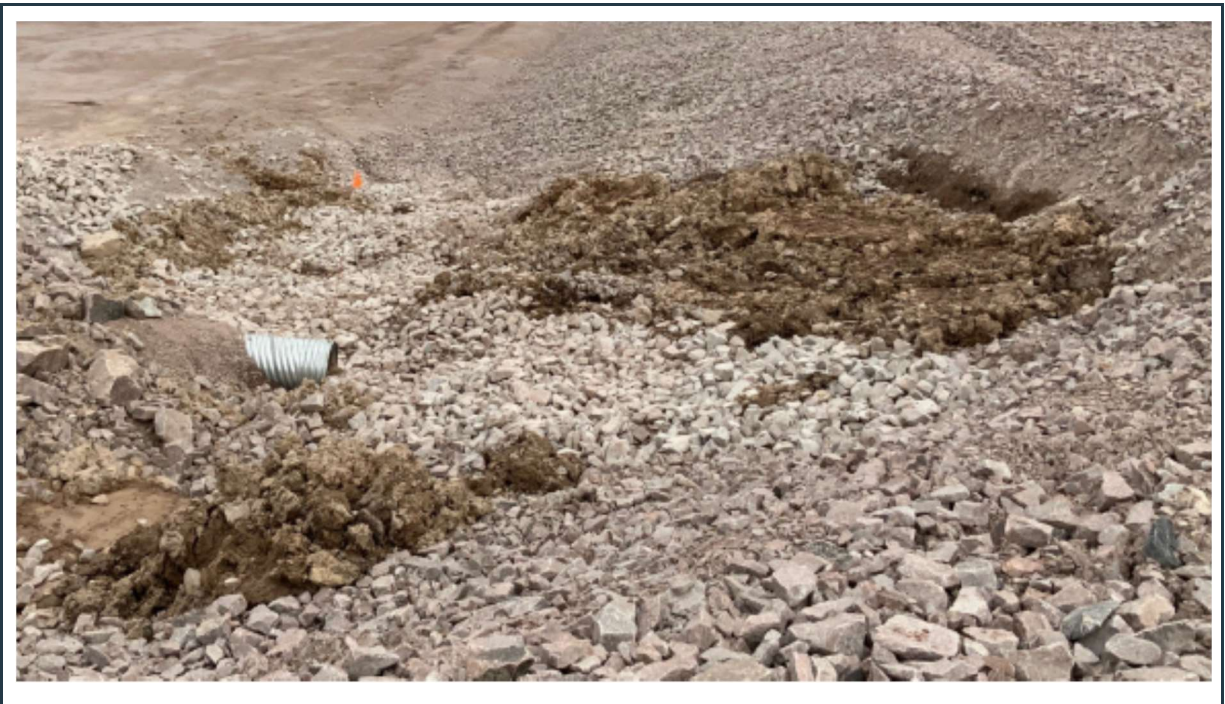
Figure 70: View of the PSC surface water collection ditch and culvert (still under construction). The culvert will need to be shortened and the slope with rip-rap regraded.

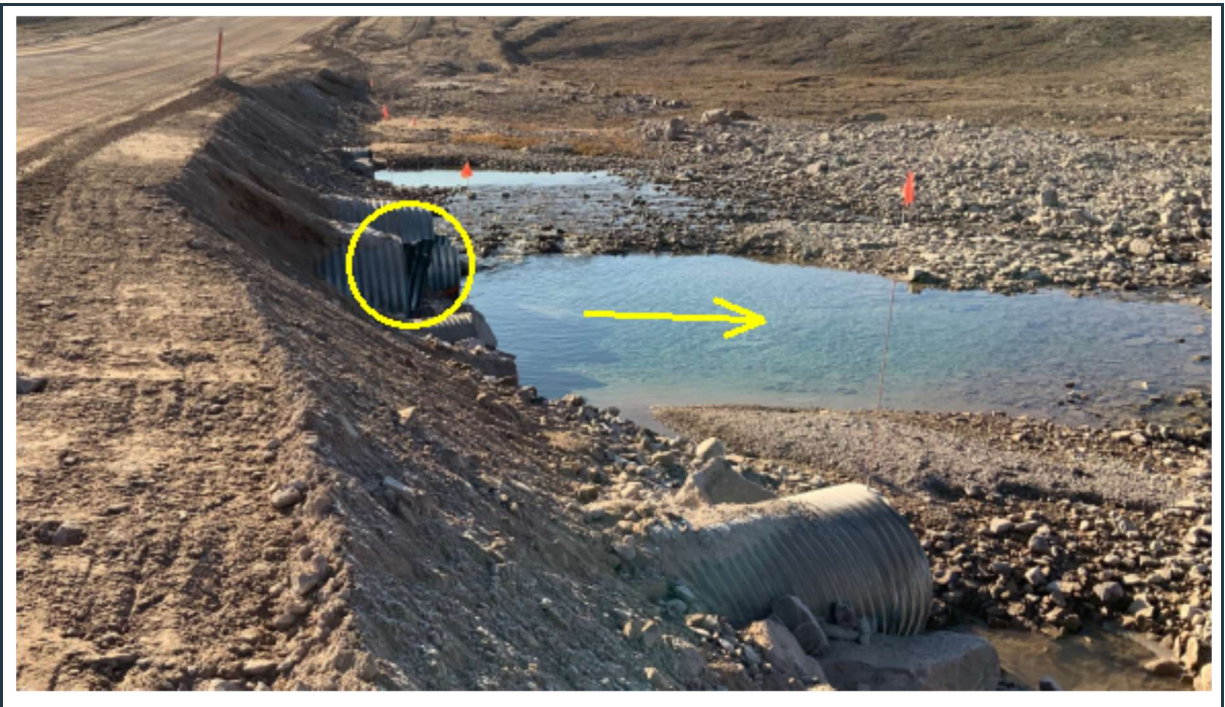
Figure 84: View of culvert(s) 078 outlet (looking south). Minor damage visible on one of the pipes (second from north - yellow circle).
