APPENDIX C.2

Geotechnical Inspection Reports

RE: Submission of 2019 Geotechnical Inspection Report No. 1 (July 2020)

Wood Environment & Infrastructure Solutions (Wood), has completed the first geotechnical field inspection of 2020 at the Mary River Iron mine complex, which is a condition of the Type "A" Water License No: 2AM-MRY1325 – Amendment No.1 ("Water License").

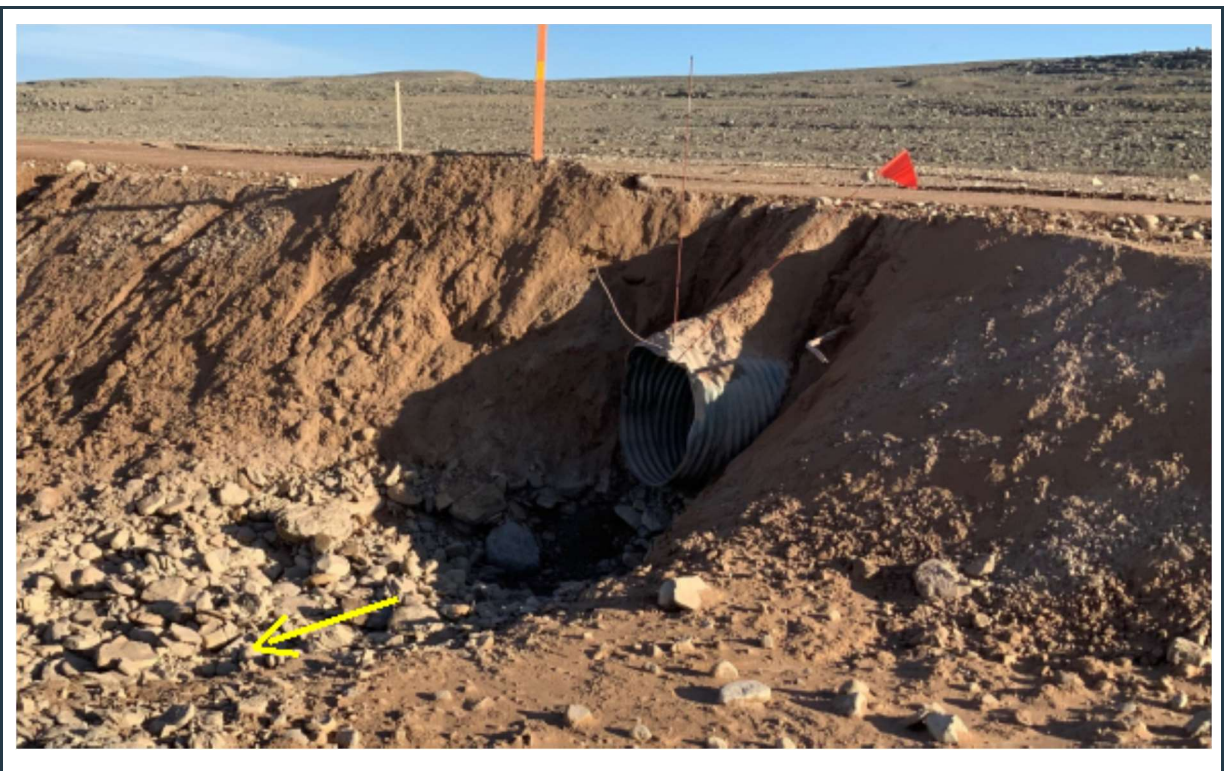
Figure 86: View of culvert 083 outlet (looking north-east), with slope erosion of the embankment around the culvert.

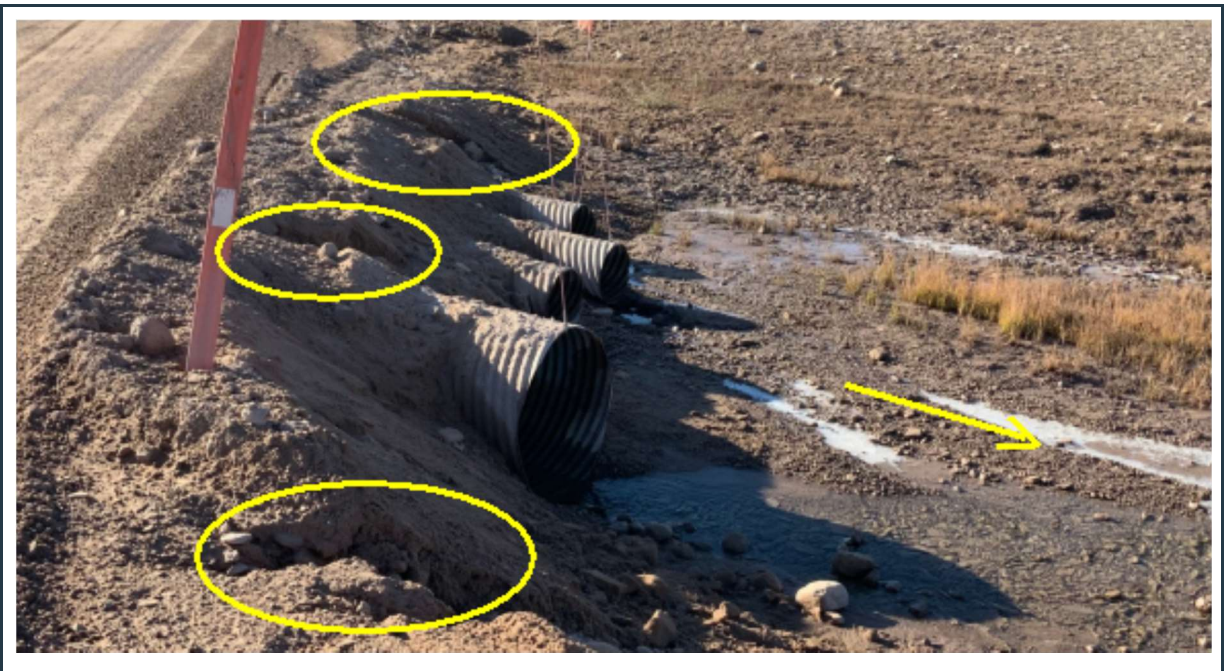
Figure 90: View of culvert(s) 102 outlets in good condition (looking south). Note some erosion on the slopes of the road embankment around the culverts (yellow circles).

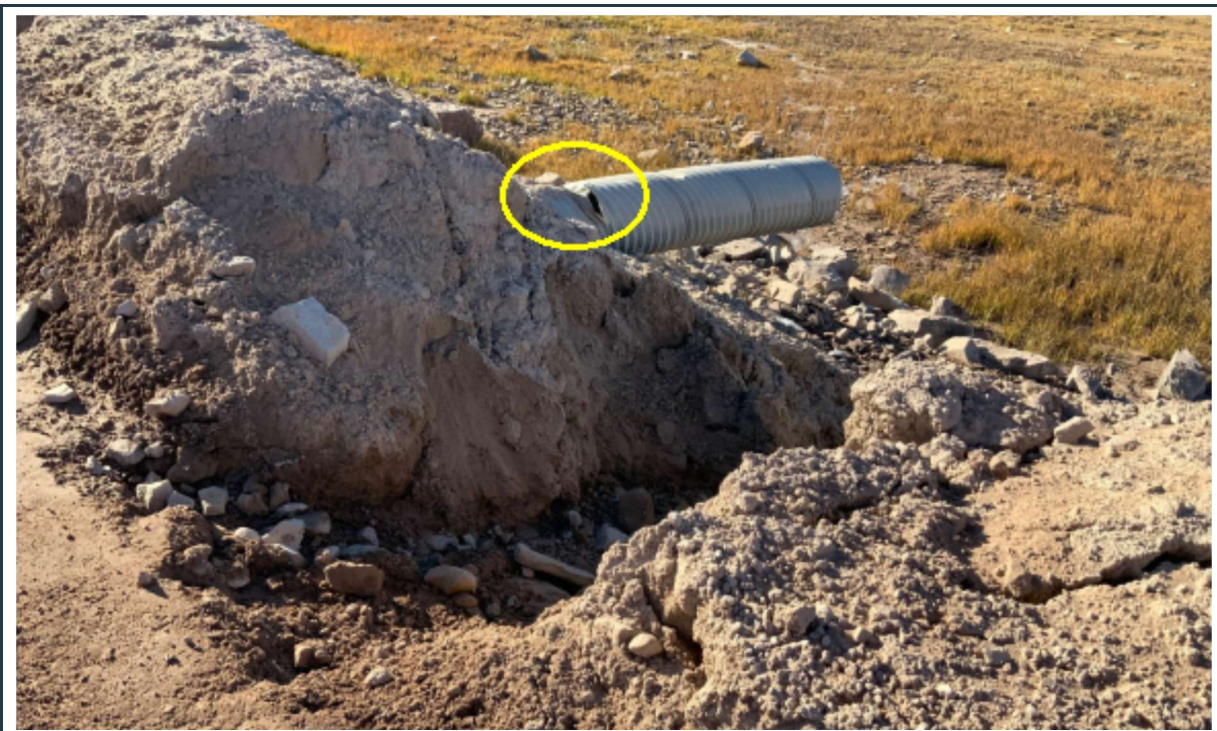
Figure 94: View of culvert 110A outlet (looking south-west). Note the minor damage on the top of the pipe (yellow circle), and the recent erosion of the road embankment adjacent to the culvert.

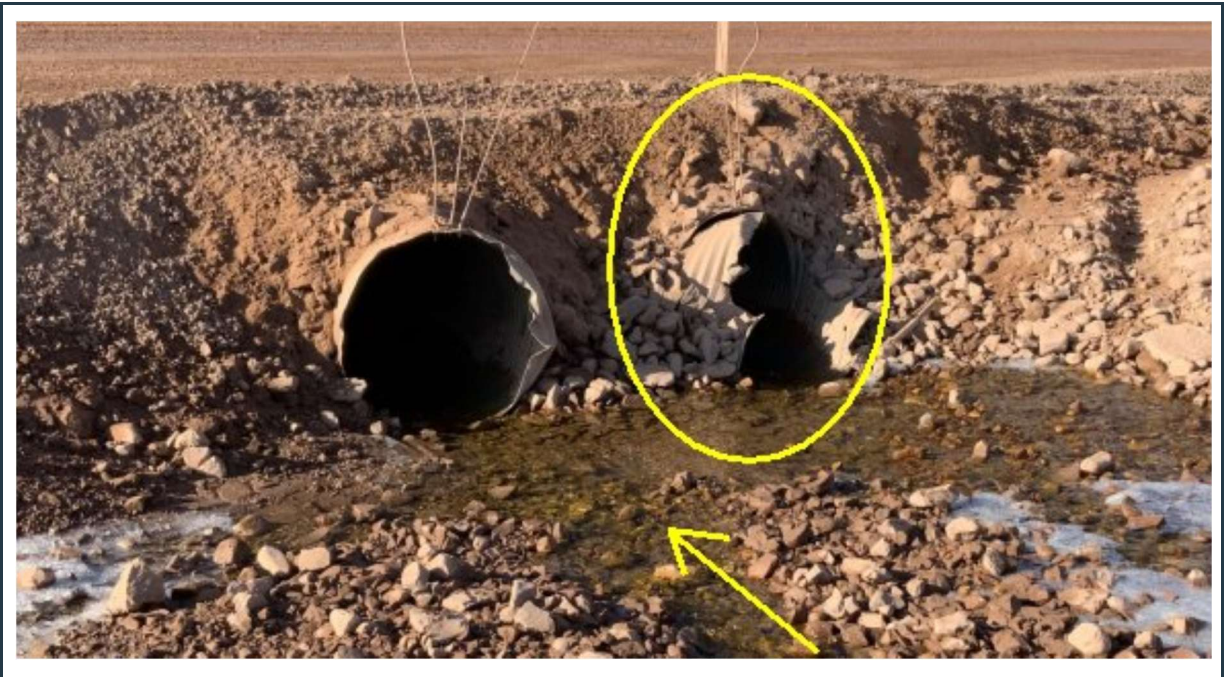
Figure 99: View of culvert(s) 114D inlets (looking west). Repair of the northern pipe is required (yellow circle).

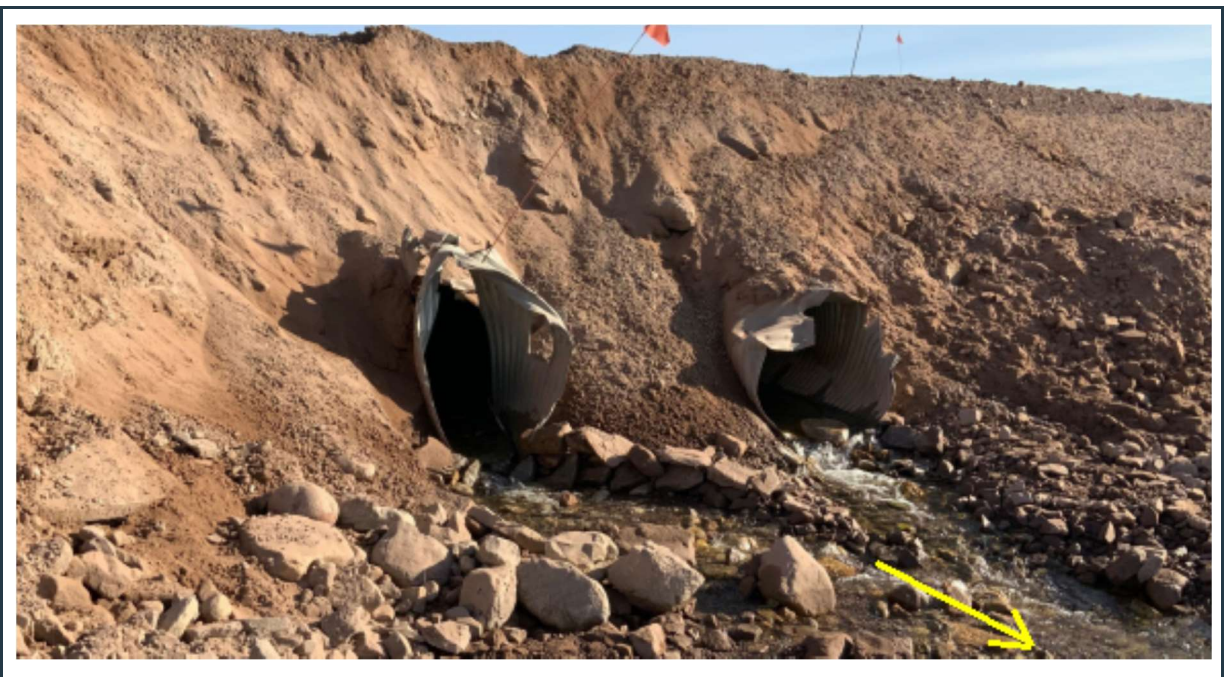
Figure 100: View of culvert(s) 114D damaged outlets (looking south-east). Repair of both pipe ends is required.
